Prepared for
Montana Resources, LLP
600 Shields Avenue
Butte, Montana
USA, 59701

Prepared by
Knight Piésold Ltd.
Suite 1400 - 750 West Pender Street
Vancouver, British Columbia
Canada, V6C 2T8

VA101-126/23-2

YANKEE DOODLE TAILINGS IMPOUNDMENT 2020 ANNUAL INSPECTION REPORT

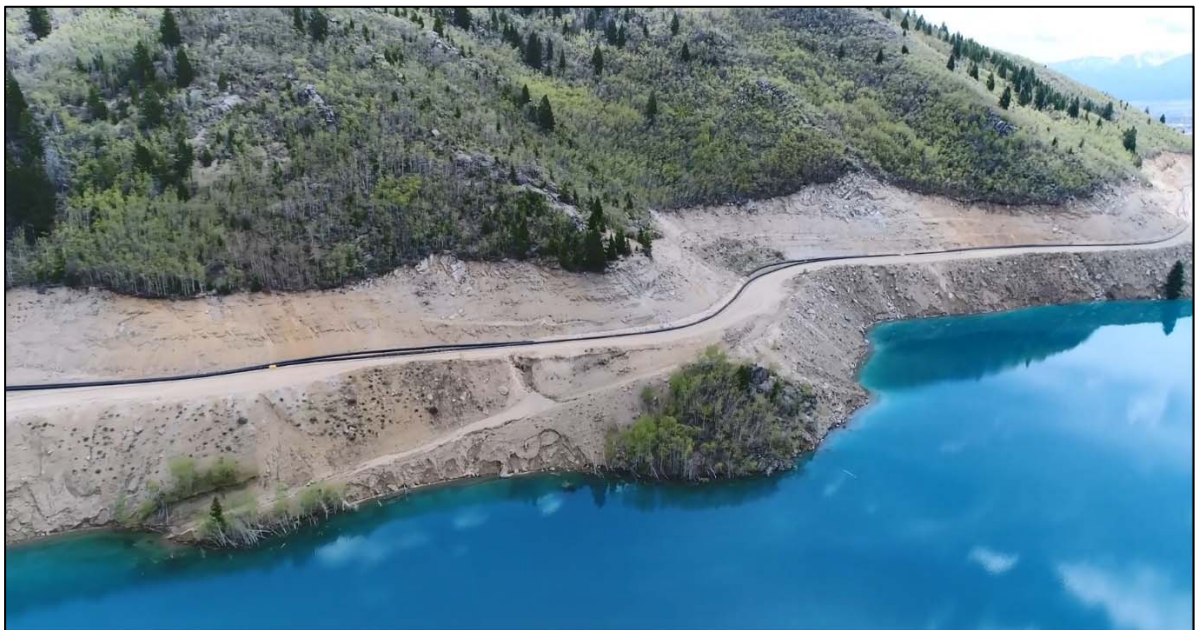
PHOTO 4 – Reclaim water pipeline road.

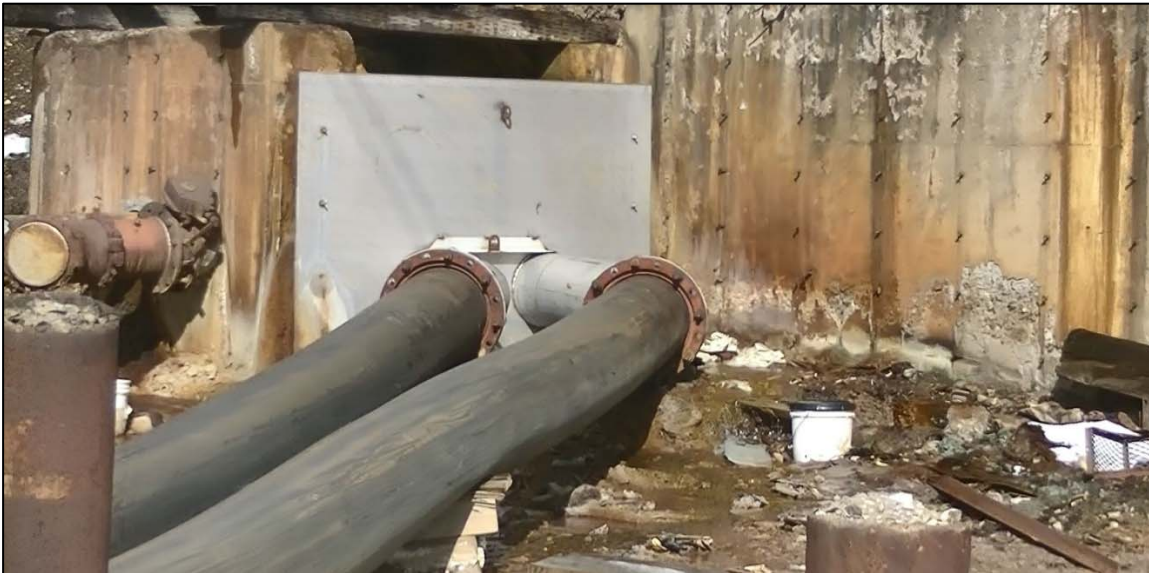
A leak was observed from the bulkhead at the Precipitation Plant where the discharge pipelines exit the plant during the 2019 annual inspection and additional repairs were recommended following the inspection. The bulkhead was replaced in 2020, which has substantially decreased leakage at this location.

PHOTO 65 – Bulkhead replacement for discharge lines from the #5 and #6 Cells.

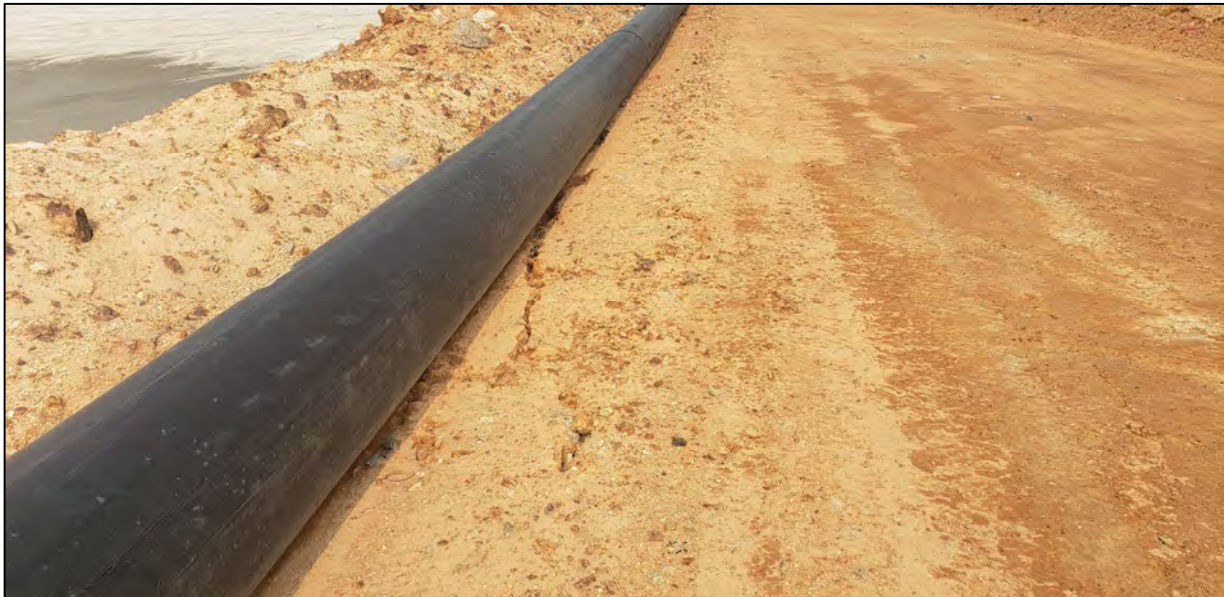
PHOTO 4 – North-South Embankment – Example of cracking along the upstream edge of the tailings discharge corridor

3. Periodically inspect the dormant settlement cracking along the North-South Embankment tailings discharge corridor and the cracking near the Terramac access road along the East-West Embankment tailings discharge corridor. Relocate the pipeline(s) along the discharge corridor and regrade the surface to improve drainage and stability as required if cracking or erosion begins to undermine the pipeline.

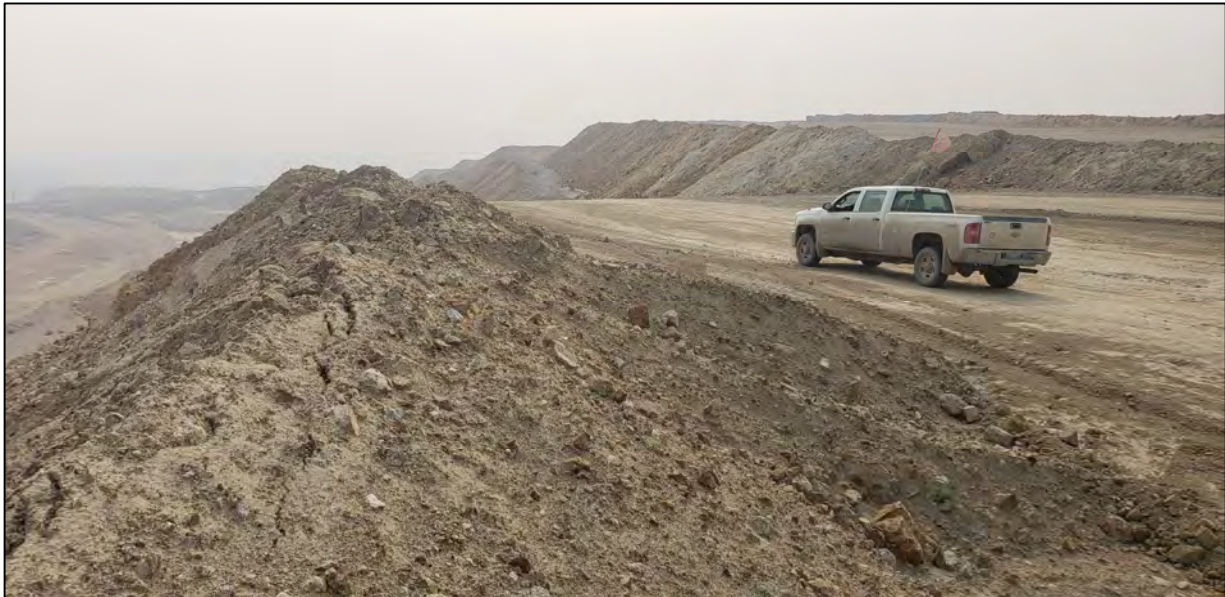
PHOTO 5 – North-South Embankment – Downstream edge of Haul Ramp showing minor settlement cracking along EL 6,400 lift

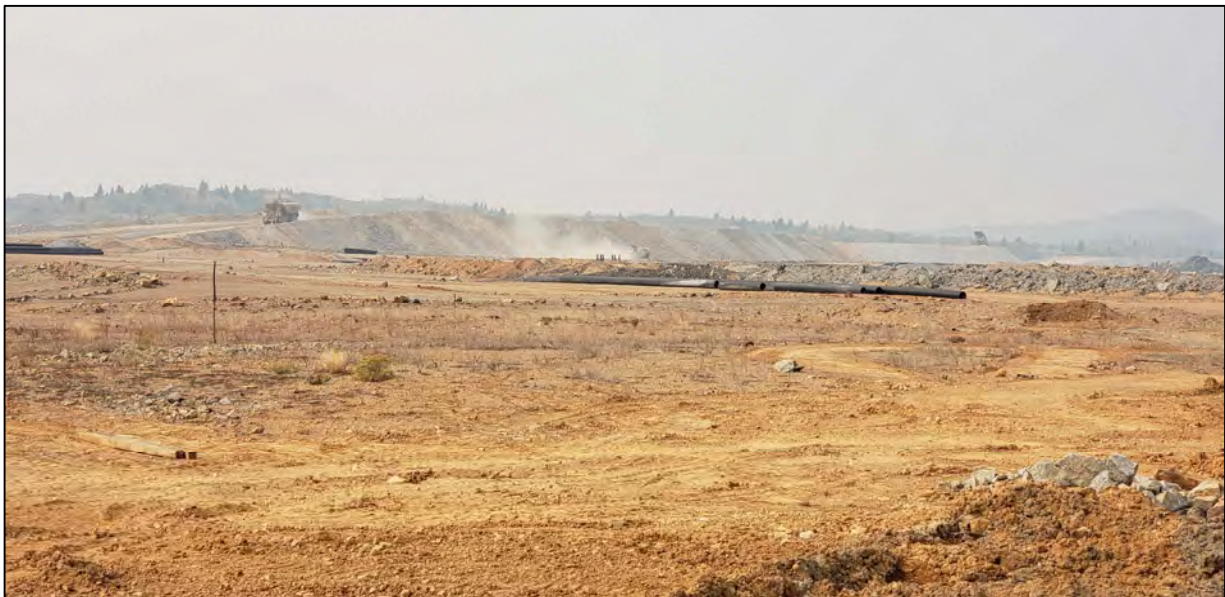
PHOTO 6 – East-West Embankment – EL 6,450 ft construction progress

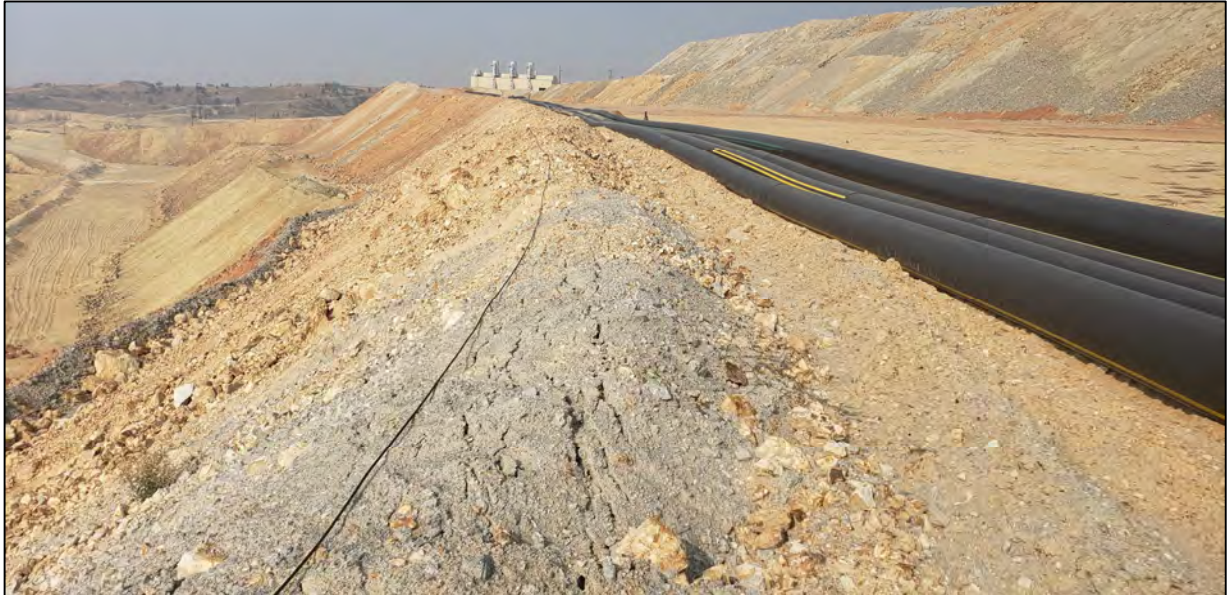
- Construction of the new tailings pipeline access ramp along the East-West Embankment was completed and tailings discharge pipelines were realigned along it. Minor settlement cracking was observed near the outside edge of the ramp in the general vicinity of drillhole DH20-S1, which continues to be monitored by MR. InSAR monitoring indicates settlement rates of approximately 3 inches/year between June 2019 and June 2020 at targets upstream and downstream of this area of cracking.

PHOTO 7 – East-West Embankment – Downstream edge of pipeline ramp showing minor settlement cracking

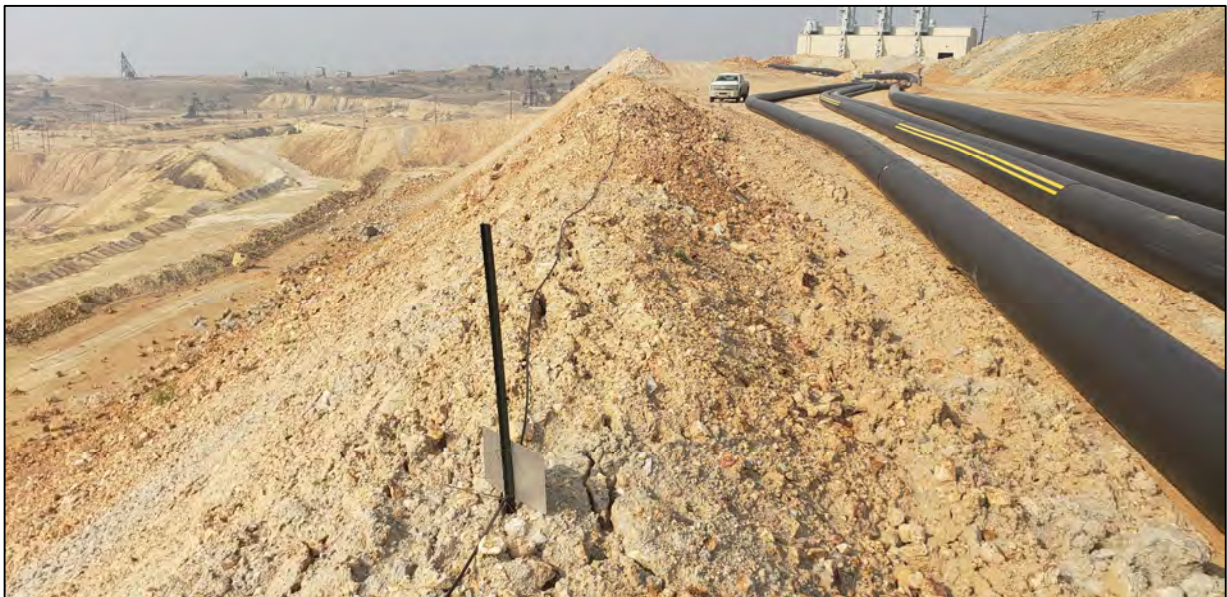
PHOTO 8 – East-West Embankment – Downstream edge of pipeline ramp showing minor settlement cracking

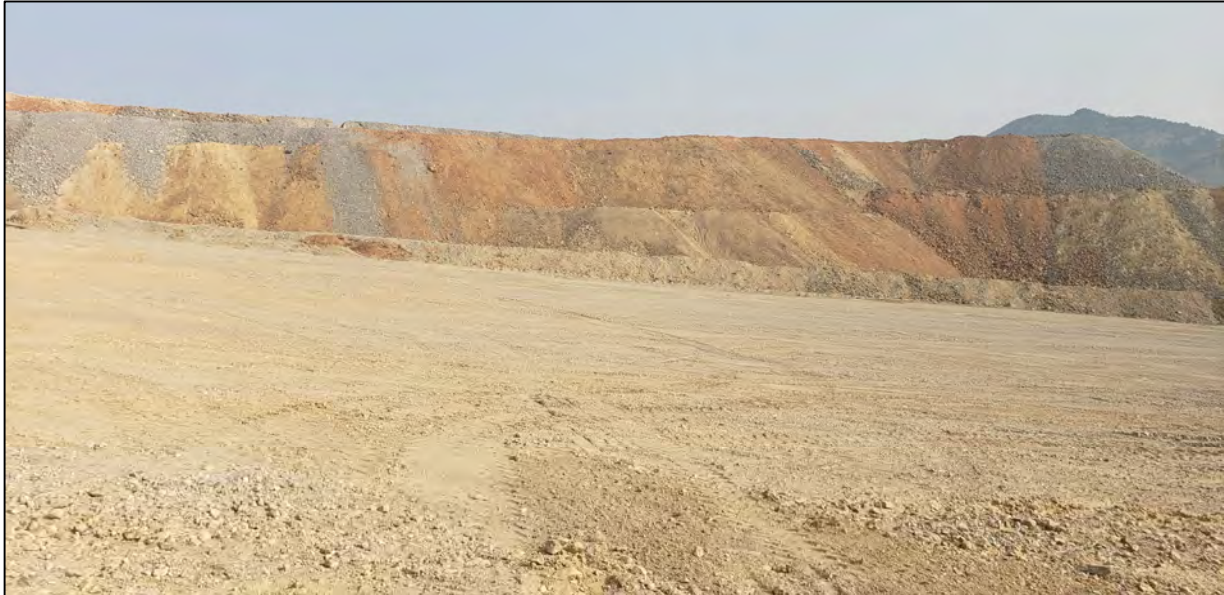
PHOTO 9 – East-West Embankment – Corner to be completed between East-West and North-South Embankments viewed from the haul road

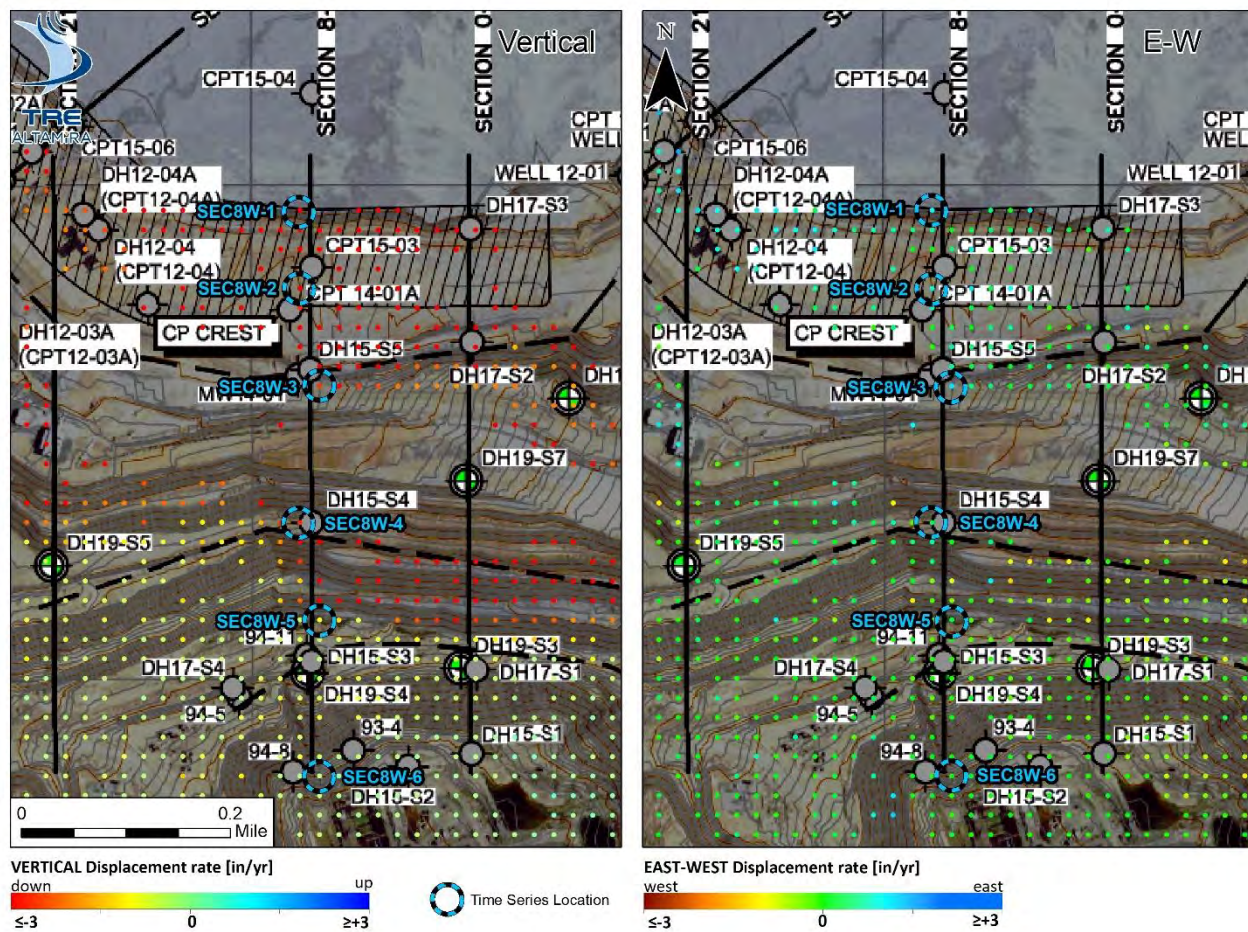
The analysis of six time series along Section 8+00 W indicated that the highest displacement rates were observed within the rockfill surcharge (Figure 14). Vertical displacement ranged from -5.50 in/yr within the rockfill surcharge upstream of the embankment to -2.95 in/yr at the crest of the embankment and 0.15 in/yr at the toe of the embankment. Horizontal displacement ranged from 1.35 in/yr towards the east at SEC8W-3 (Figure 16) to 0.01 in/yr E at SEC8W-6. Time series plots are shown in Figure 15 and Figure 16.

Figure 14: Location of TS analyzed along the Sec 8+00 W transect. Vertical displacement is represented in the left panel while the right panel shows the east-west movement.

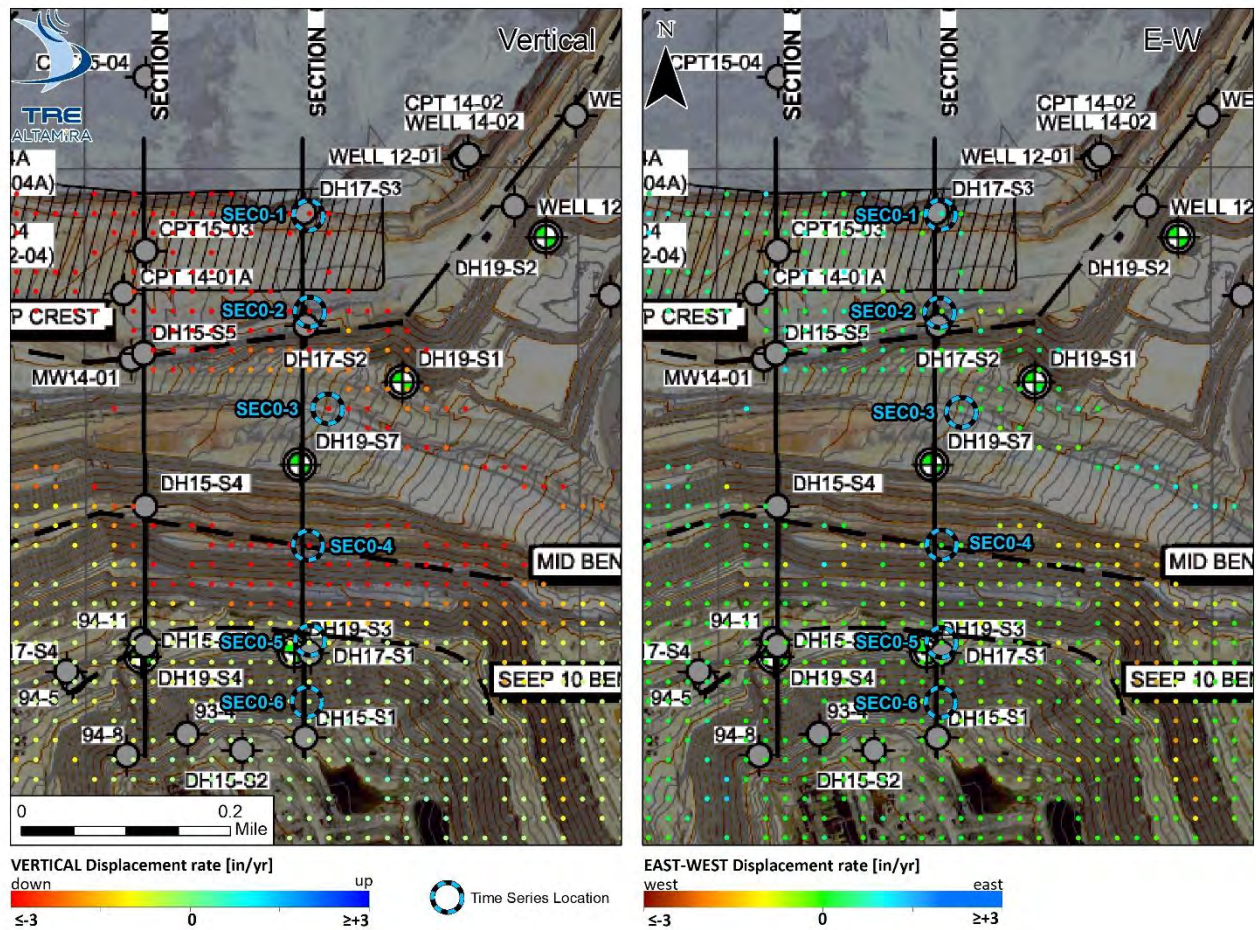
Six time series were used to analyze displacement along Section 0+00 (Figure 17). Vertical displacement ranged from -7.40 in/yr at SEC0-4 within the recently constructed tailings pipeline ramp (Figure 18) to -0.13 in/yr at the toe of the embankment (Figure 19). Motion of up to -3.89 in/yr was observed at the crest of the embankment. Eastward motion of up to 0.67 in/yr occurred near the top of the escarpment.

Figure 17: Location of TS analyzed along the Sec 0+00 W transect. Vertical displacement is represented in the left panel while the right panel shows the east-west movement.

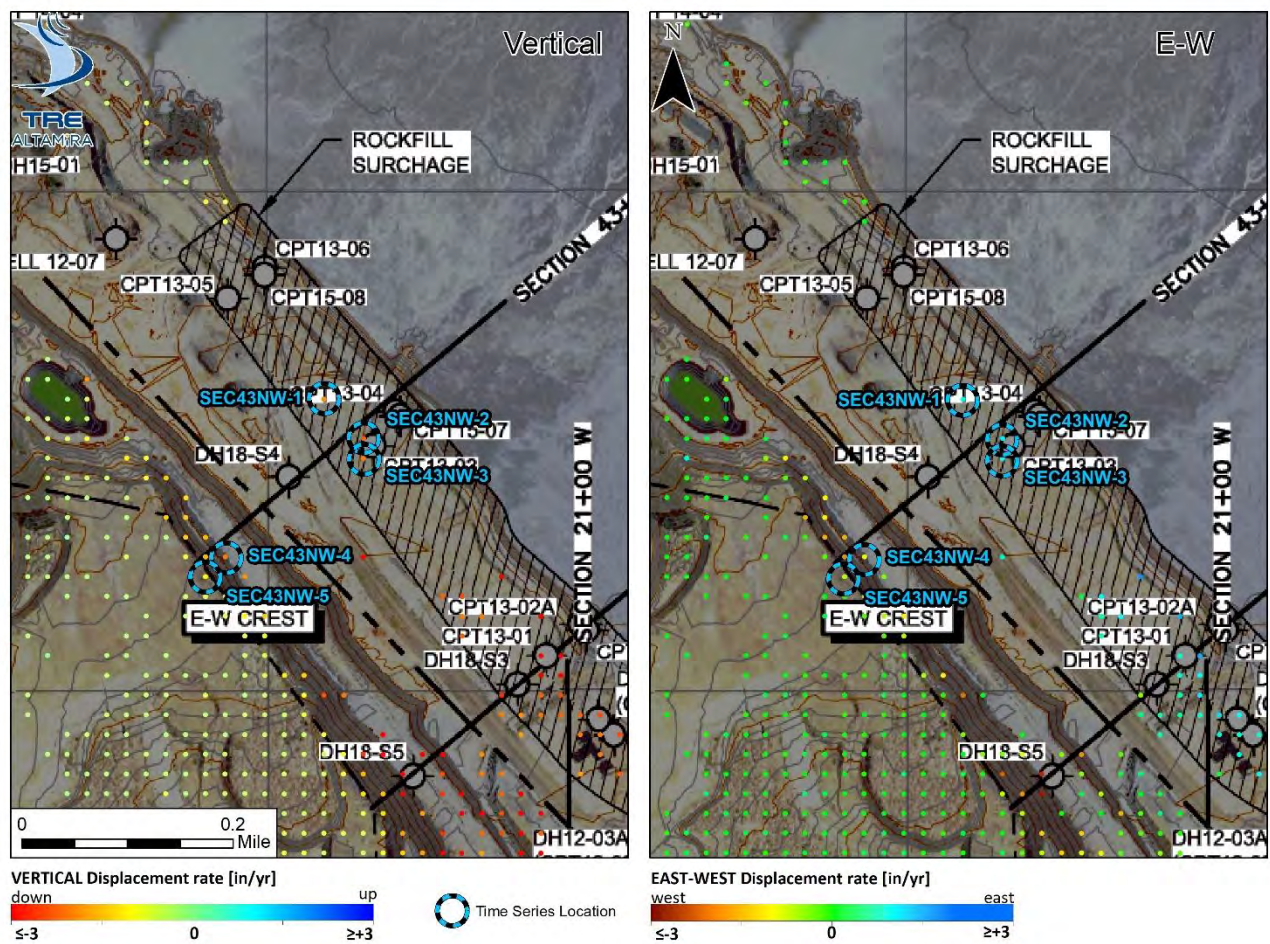
Movement along Section 43+00 NW (Figure 20) was analyzed by plotting the vertical and east-west motion (SEC43NW-1 – SEC43NW-5; Figure 21 to Figure 22). The highest rates of displacement occurred within the rockfill surcharge (rockfill over tailings material) with up to -2.12 in/yr of settlement associated with 0.98 in/yr of eastward motion. Rates of displacement decrease closer to the toe of the embankment, with -1.10 in/yr of subsidence and 0.68 in/yr of westward motion observed. No data are available for the embankment crest (showed with a dashed line on Figure 20) due to recent construction activity.

Figure 20: Location of TS analyzed along the Sec 43+00 NW transect. Vertical displacement is represented in the left panel while the right panel shows the east-west movement.

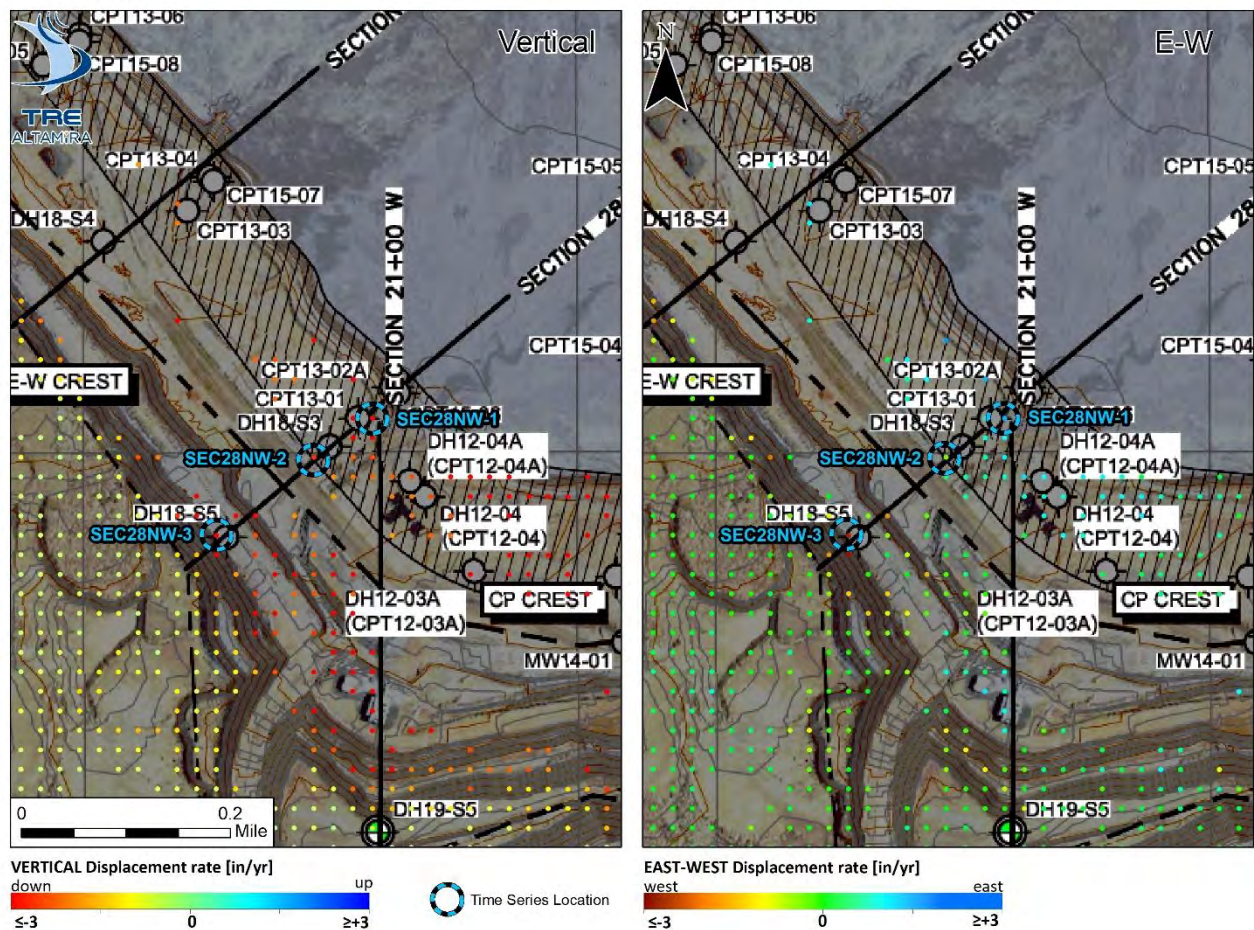
Three time series were selected to examine displacement along the 28+00 NW transect (Figure 23). Motion north of the piezometric monitoring site DH18-S5 showed up to -3.41 in/yr of vertical motion, and 2.07 in/yr of westward motion (SEC28NW-1; Figure 24). Near the toe of the embankment, -3.66 in/yr of vertical motion was observed along with 2.65 in/yr of westward motion (SEC28NW-3; Figure 24). No data are available for the embankment crest (shown with a dashed line on Figure 23) due to recent construction activity.

Figure 23: Location of TS analyzed along the Sec 28+00 NW transect. Vertical displacement is represented in the left panel while the right panel shows the east-west movement.

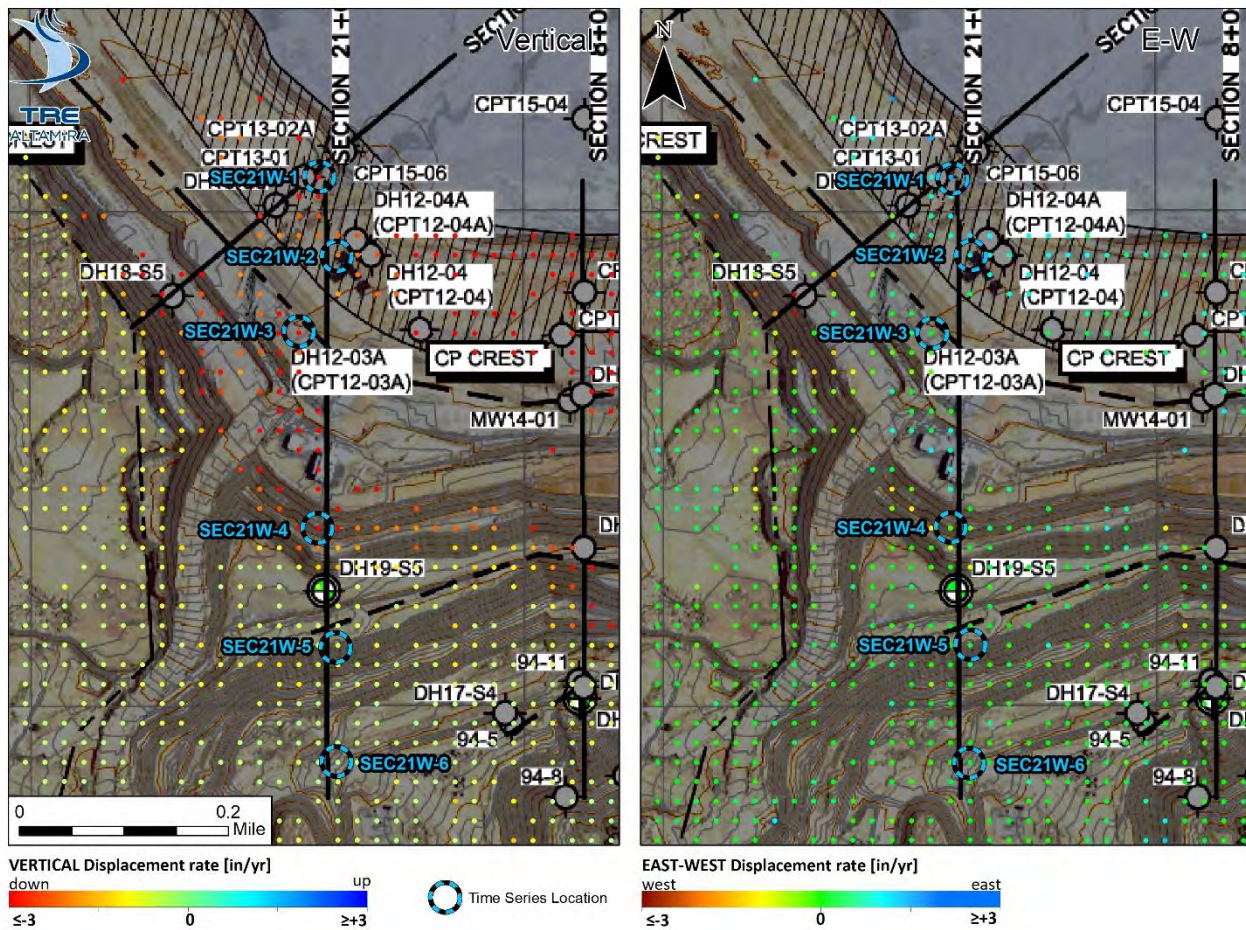
Section 21+00W was analyzed using six time series (Figure 25). Motion at the rockfill surcharge upstream of the embankment reached -3.41 in/yr vertically and 2.07 in/yr in an eastward direction. Motion of up to -3.49 in/yr was monitored at the embankment crest. The toe of the embankment shows the lowest rate of motion with -0.14 in/yr of vertical movement and 0.13 in/yr of westward motion

Figure 25: Location of TS analyzed along the Sec 21+00 W transect. Vertical displacement is represented in the left panel while the right panel shows the east-west movement.

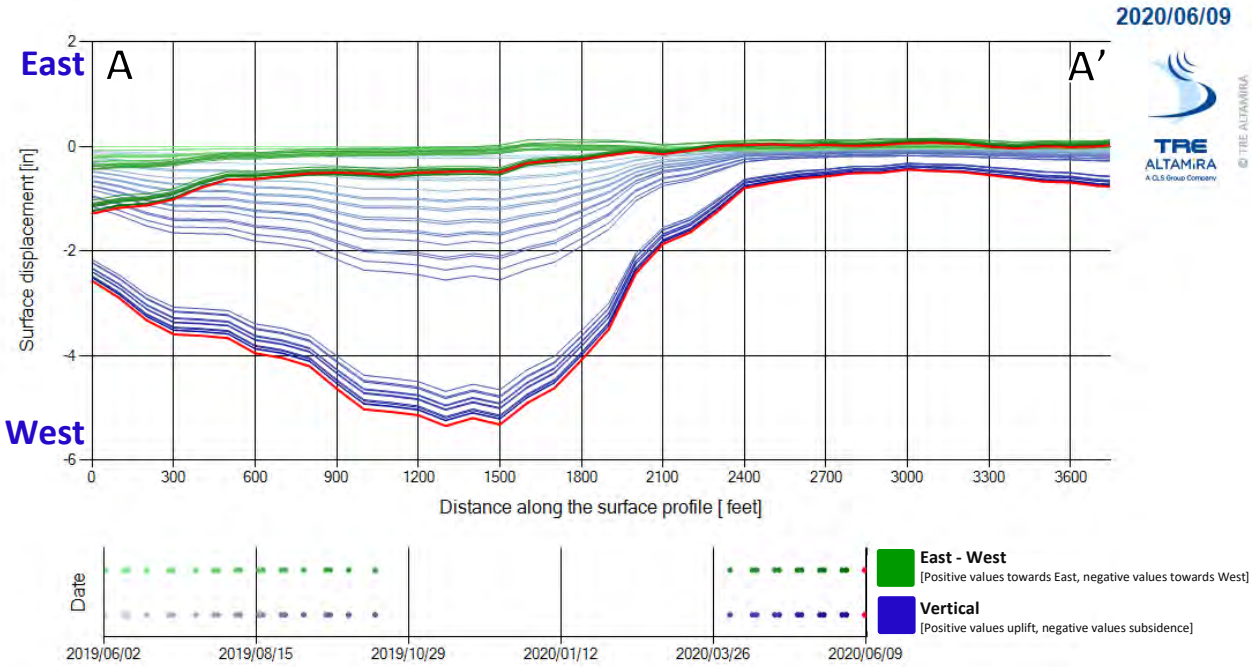
- A-A': Vertical motion reaches up to -5.25 inches at the 1300 ft mark. Horizontal motion reaches 1.50 inches of westward motion at the 0 ft mark.
- B-B': Vertical motion of up to -1.75 inches of settlement at the 900 ft mark. Horizontal motion reaches a maximum of 0.60 inches of westward motion at the 0 ft mark.
- C-C': Settlement of up to -0.50 inches at the 0 ft mark and uplift reaches +0.30 inches at the 1400 ft mark. East-West motion reaches up to 0.5 inches of eastward motion at the 0 ft mark and 0.6 inches of westward motion at the 1400 ft mark.

Figure 30: Evolution of the surface profile over the A-A' cross-section. Green lines represent the vertical motion, while blue lines represent the E-W movement. Red lines represent the last image in the dataset.

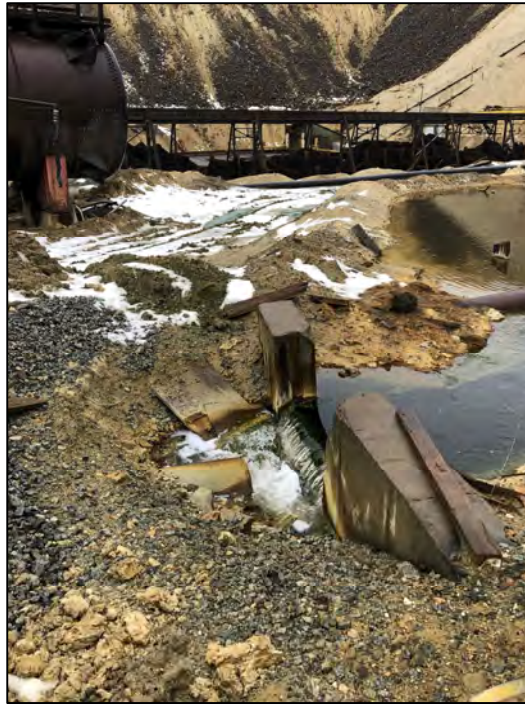
Photo 7.1 Bypass Flow at Hooligan Pond Weir
