Prepared for
Montana Resources, LLC
600 Shields Avenue
Butte, Montana
USA, 59701

Prepared by
Knight Piésold Ltd.
Suite 1400 - 750 West Pender Street
Vancouver, British Columbia
Canada, V6C 2T8

VA101-126/27-2

YANKEE DOODLE TAILINGS IMPOUNDMENT 2022 ANNUAL INSPECTION REPORT

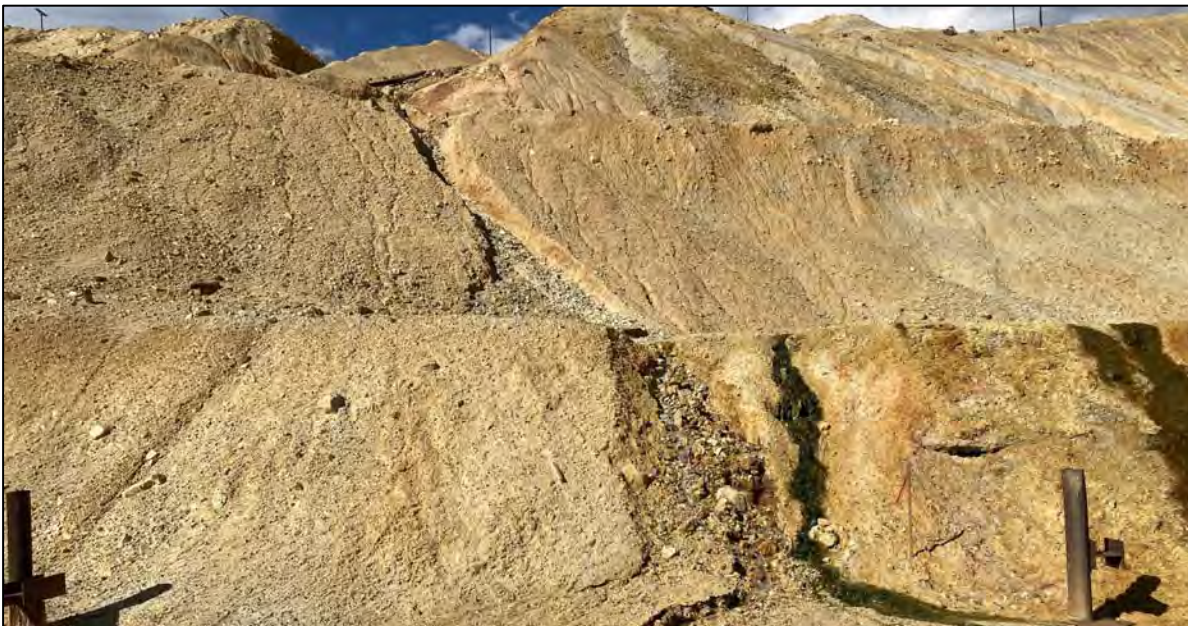
PHOTO 64 – Rilling observed along the downstream embankment shell in the HsB area, facing north.

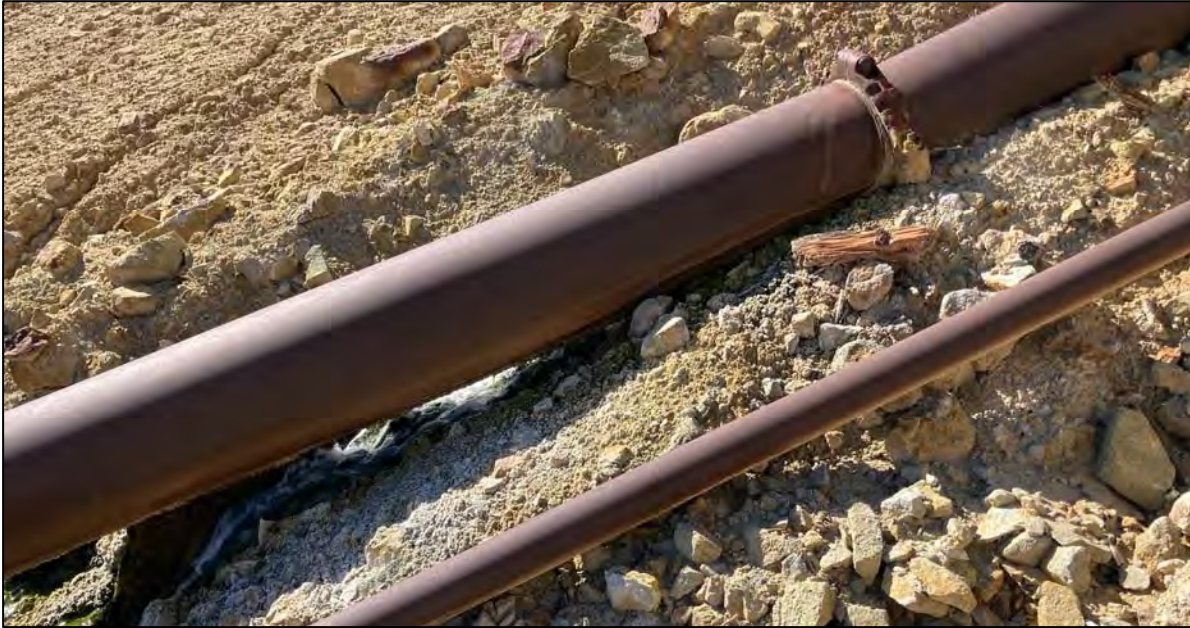
- The pipeline conveying flows from the Seep 10 stilling basin to the upper HsB area appears to have shifted and settled in the vicinity of a bracket along the slope between the Seep 10 bench and HsB area (see Photo 75 in Appendix A). This has resulted in a leak at the location of the bracket connection that was initially observed in approximately Q2 2022, and some flow from the leak is now being conveyed along surface on the lower section of the embankment slope to the upper HsB collection area.

PHOTO 75 – Seep 10 pipeline with observed leak, facing west.

- 4. Develop and implement a new system to collect flows along the Seep 10 bench and convey these flows to the HsB Pond (continuation of 2021 recommendation).**

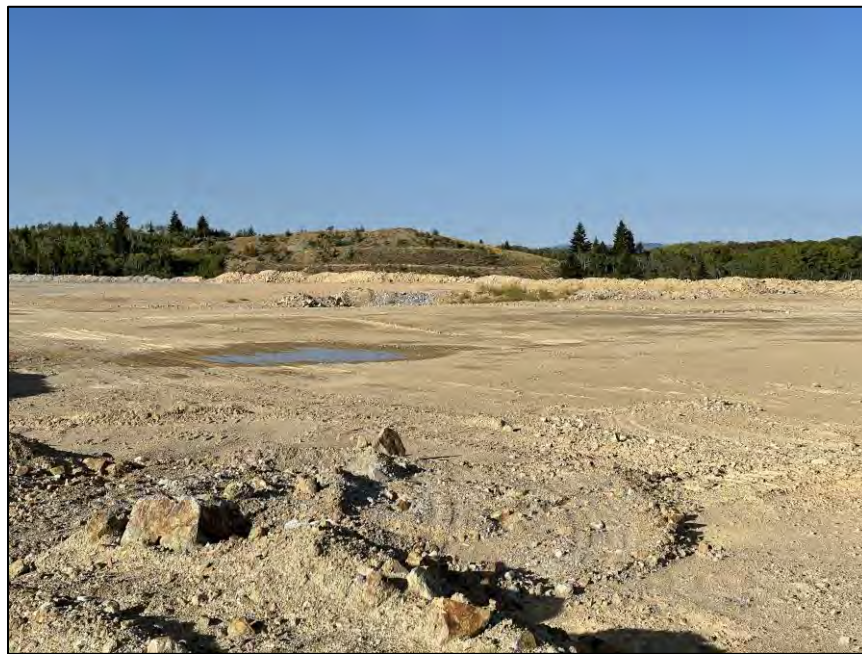
The EL. 6,450 ft crest has a variety of undulations and depressions which are likely a function of bulk material settlement, differential settlement caused by haul truck routing during material placement, and construction practices where the end dumped materials are spread by a dozer operator in 50 ft lifts with limited survey controls. Similar conditions along the EL. 6,450 ft crest were previously observed in the Q2 Field Review (KP, 2022b). Despite relatively dry conditions for weeks leading up to the field review, several of these areas were filled with standing water at the time of the field review, with one example at approximately Section 108+40 W shown on Photo 3.1.

Photo 3.1 EL. 6,450 ft West Embankment Crest and Ponding

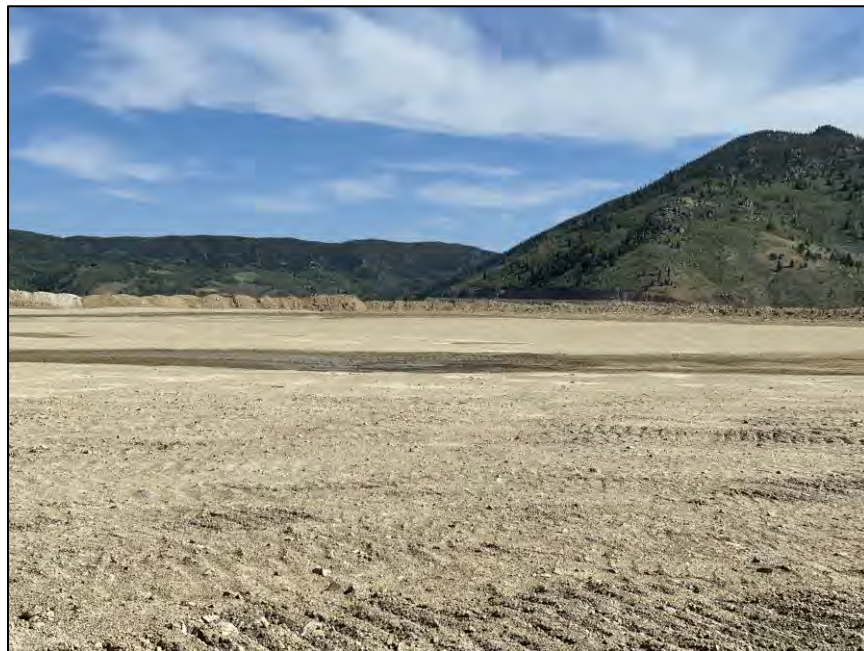
The EL. 6,450 ft crest has a variety of undulations and depressions, similar to those described along the West Embankment and in the Q2 Field Review (KP, 2022b). Ponding was observed at various locations along the crest at the time of the review, with the largest apparent depression and resulting ponding shown on Photo 3.4.

Photo 3.4 EL. 6,450 ft East-West Embankment Crest Depression and Ponding

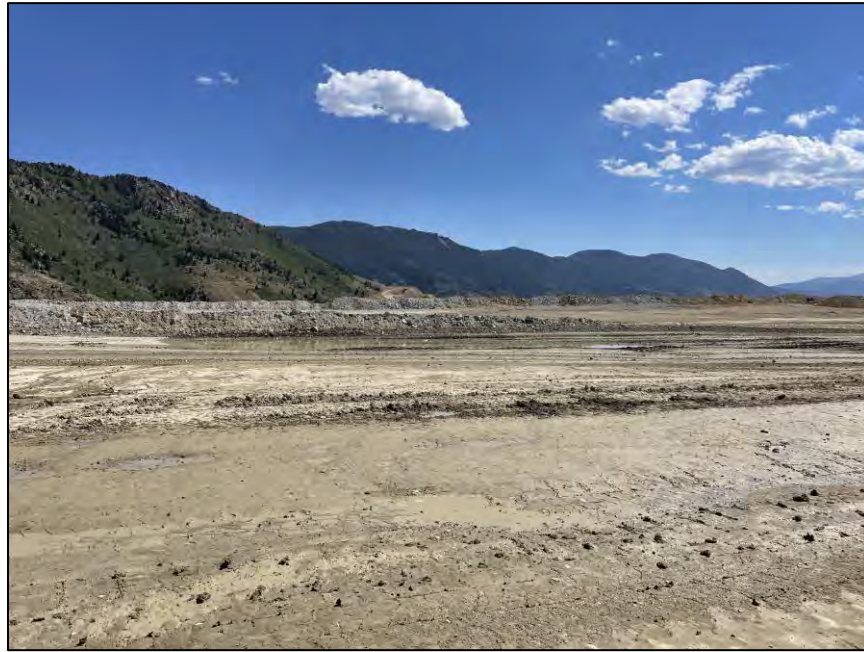
No obvious signs of ponding were observed in areas that were infilled and regraded along the EL. 6,400 ft crest north of Section 43+00N in Q2 of 2022 as per the 2021 EOR AIR and CAP. Several undulations and depressions were observed in the area between Sections 28+00N and 38+00N, similar to the conditions described above along the West and East-West Embankment crest and in the Q2 Field Review (KP, 2022b), with an example shown on Photo 3.6.

Photo 3.6 EL. 6,450 ft North-South Embankment Crest Depression and Ponding

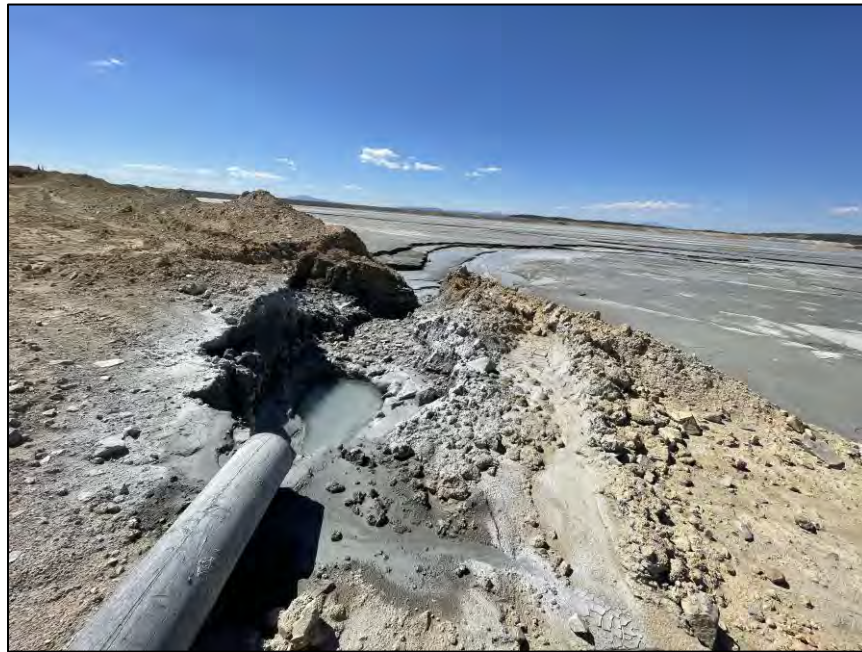
Tailings discharge lines connected to Line 1 were operating during the time of the field review. Erosion was observed at a 12-inch discharge south of discharge 3-5 near Section 58+00 N as shown on Photo 4.1. MR Engineering indicated they will work with Operations to extend the 12-inch line onto the tailings beach, although the line had not yet been extended at the time of this summary and the exact timing remains to be determined.

Photo 4.1 Erosion Along Tailings Discharge Corridor Near Section 58+00 N

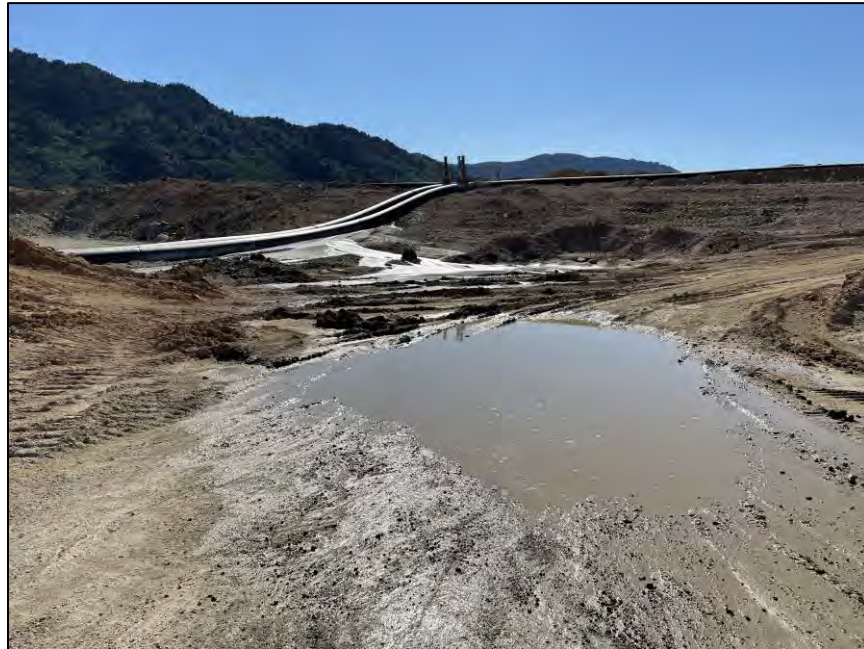
Valve leaks were observed at discharge 3-2, 3-3, and at both 12-inch discharges in between. This caused ponding on the bench near discharge 3-3, shown on Photo 4.2, as well as minor tailings seepage into the embankment at all locations with observed valve leaks. MR Engineering indicated that Operations is working to repair these valve leaks; however, the valves had not been repaired at the time of this summary and exact timing remains to be determined.

Photo 4.2 Discharge 3-2 Valve Leak and Minor Ponding

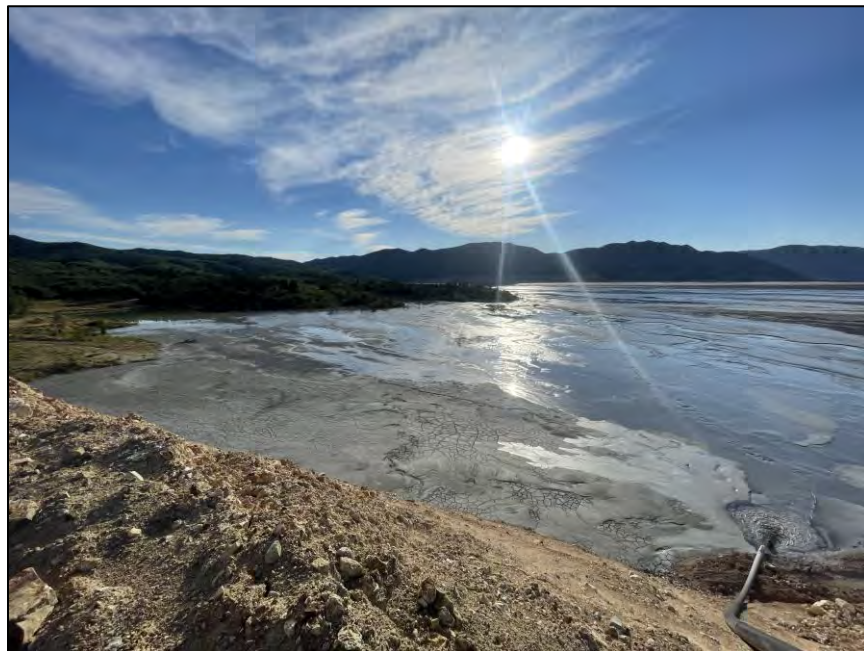
Infilling of the tailings beach adjacent to the north end of the West Embankment continued with the use of the 12-inch discharges near discharge 1-4. Minor ponding was previously observed during the 2021 Q4 and 2022 Q1 field reviews; however, no ponding was observed in this area at the time of the field review, as shown on Photo 4.3.

Photo 4.3 Tailings Beach Near Discharge 1-4

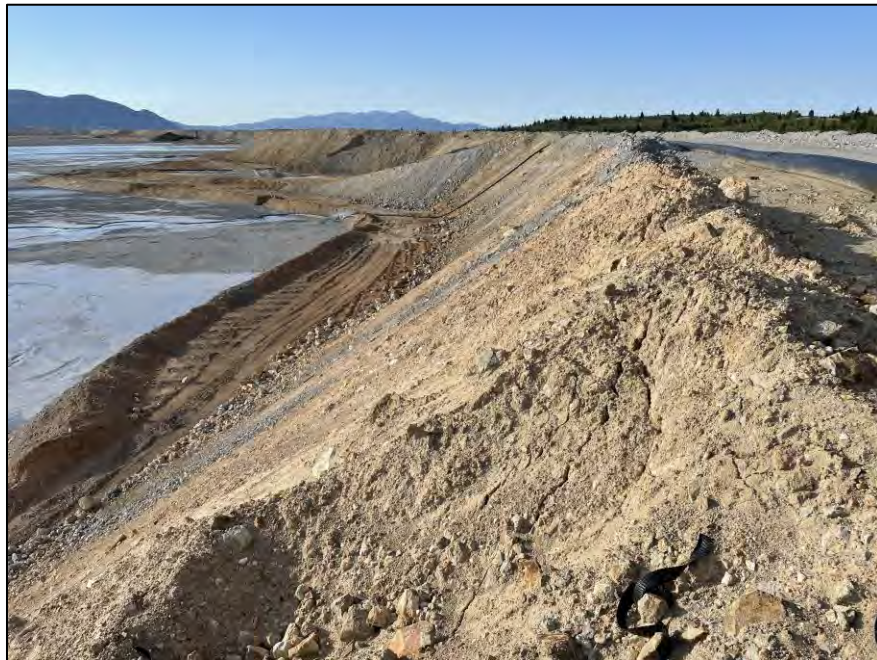
PHOTO 4 – West Embankment – Tailings discharge corridor loosely placed berm cracking

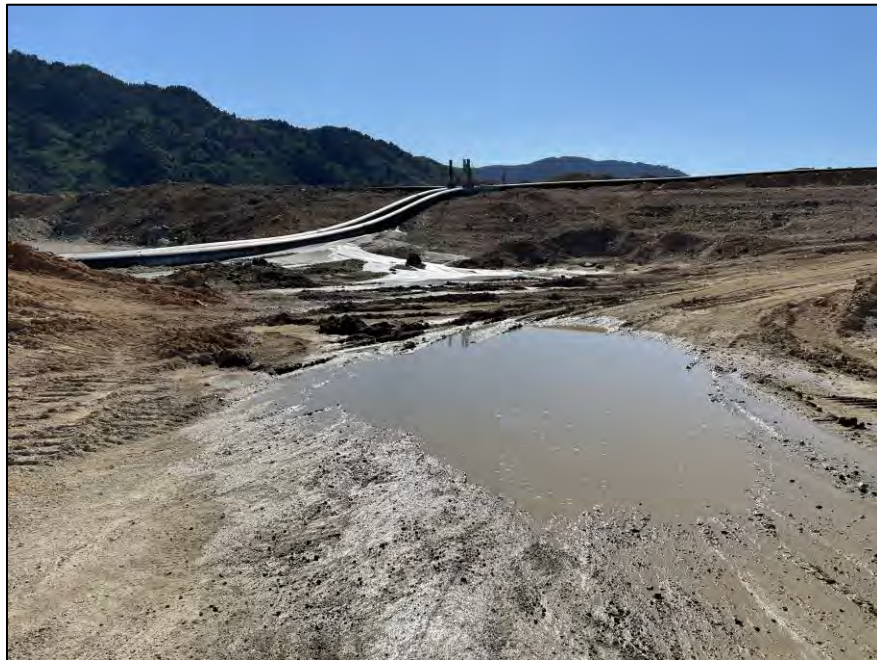
PHOTO 6 – East-West Embankment – Tailings Discharge 3-2 valve leak and pooling
