VA101-126/27-1

YANKEE DOODLE TAILINGS IMPOUNDMENT

2022 RISK ASSESSMENT REPORT

Rev	Description	Date
0	Issued in Final	July 7, 2023

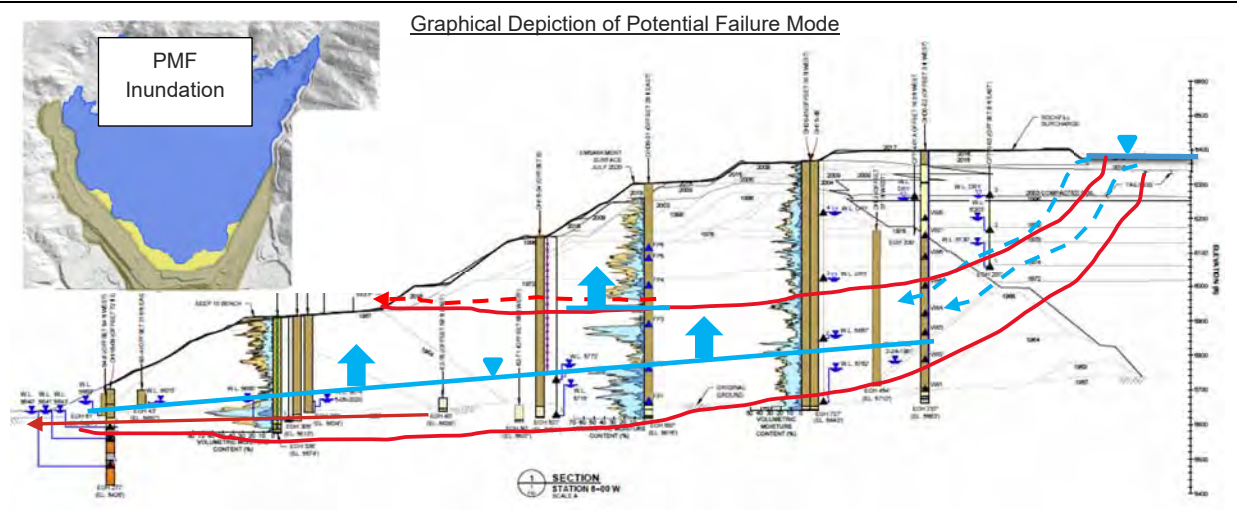
- (1) Severe natural flooding occurs resulting from some combination of extreme rainfall and snowpack.
- (2) Flood waters lead to rising pond surface inundating the long, drained tailings beaches and flooding the upstream facing of the embankment.
- (3) Embankment facing sufficient to prevent concentrated leakage, but excess drainage into the embankments results in rising pore pressures within the rockfill.
- (4) Rise in pore pressures within the embankment rockfill is sufficient to decrease effective stress in critical resisting areas near the downstream side of the embankment resulting in slope instability.

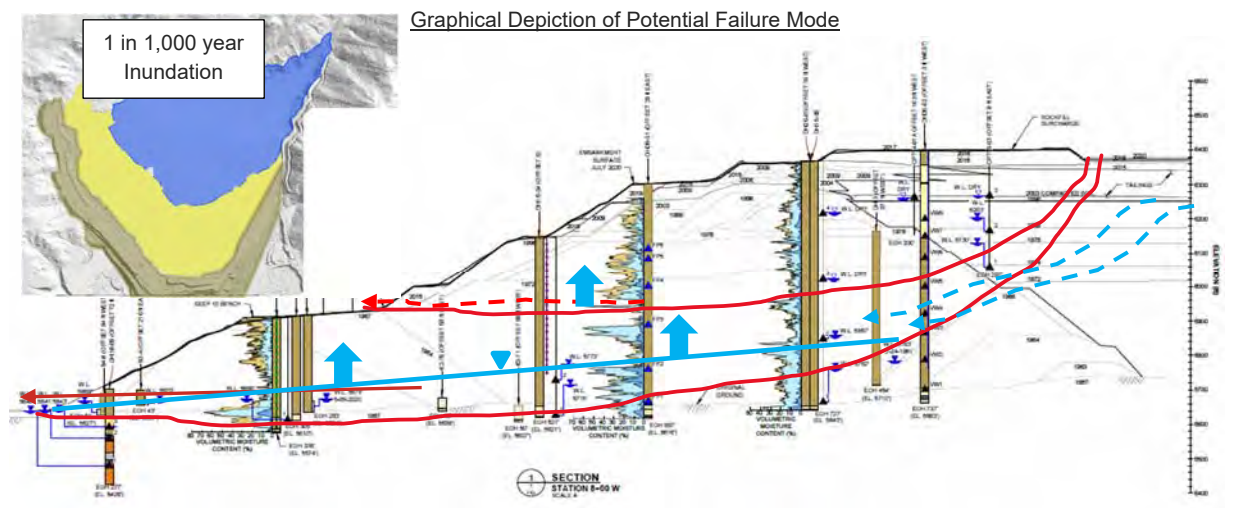
- (1) Severe natural flooding occurs resulting from some combination of extreme rainfall and snowpack.
- (2) Flood waters lead to rising pond surface inundating the long, drained tailings beaches, but flooding not sufficient to reach the upstream side of the embankment.
- (3) Drainage into the embankments from inundated beaches results in rising pore pressures within the embankment rockfill.
- (4) Rising pore pressures within embankment are sufficient to decrease effective stress in critical resisting areas near the downstream side of the embankment resulting in slope instability.
- (5) Potential consequences could range from single or multi-bench failure with no major impacts to operations to a full facility breach, depending on the nature and extent of instability.

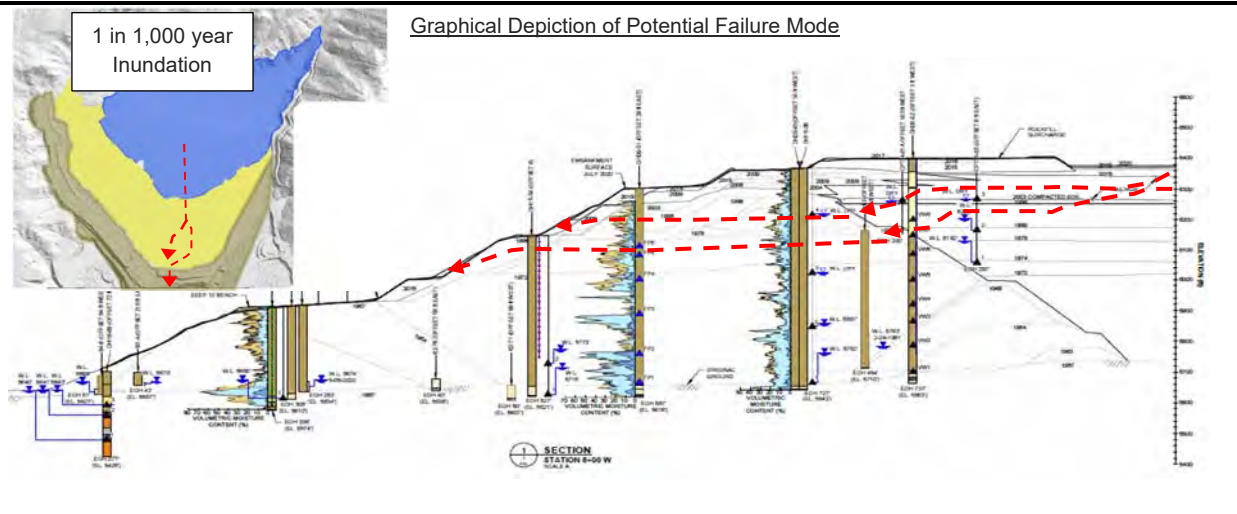
- (1) Severe natural flooding occurs resulting from some combination of extreme rainfall and snowpack.
- (2) Flood waters lead to rising pond surface inundating the long, drained tailings beaches, but not reaching the upstream facing of the embankment.
- (3) Drainage gradients from the tailings into the permeable rockfill increase in subsurface interface between the two materials.
- (4) Embankment facing zone and extensive rockfill surcharge not completely present at depth at the drainage interface or is insufficient to prevent tailings migration into the embankment fill.
- (5) Tailings results in concentrated tailings migration through a more permeable pathway and tailings are discharged onto a bench on the downstream side of the embankment resulting in undesirable seepage and possibly some settlement cracking.

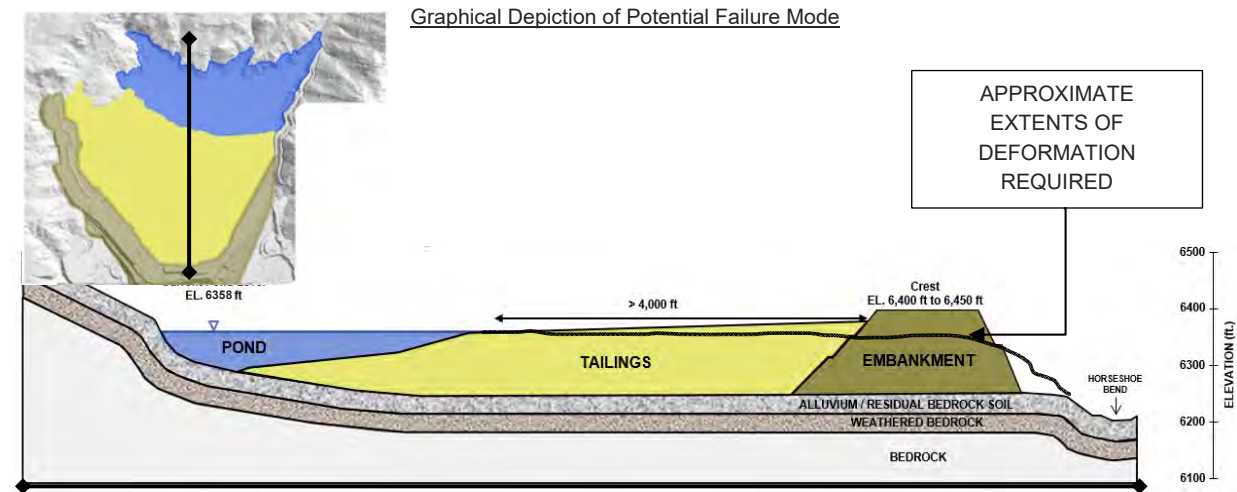
- (1) Closure design basis maximum credible earthquake (84th-Percentile MCE) occurs along the Continental Fault during operations.
- (2) The embankment deforms and crest settles due to the seismic loading of the embankment.
- (3) Tailings upstream of the embankment experience seismic liquefaction causing settlement and allowing the supernatant pond to come southward to the embankment.
- (4) Embankment crest settles to a final position that is lower than the resulting supernatant pond elevation and the tailings settlement allows the pond to reach the embankment.
- (5) Overtopping at the lowest point results in erosion and downcutting through the embankment ultimately leading to a full breach of the facility.

- More Likely (Adverse) Factors
- Increased uncertainty in material compressibility due to oxidation/acid weathering processes playing out within the embankment fill; uncertainty in spatial extents of potential highly compressible materials
 - High seismic area, significant ground motions possible

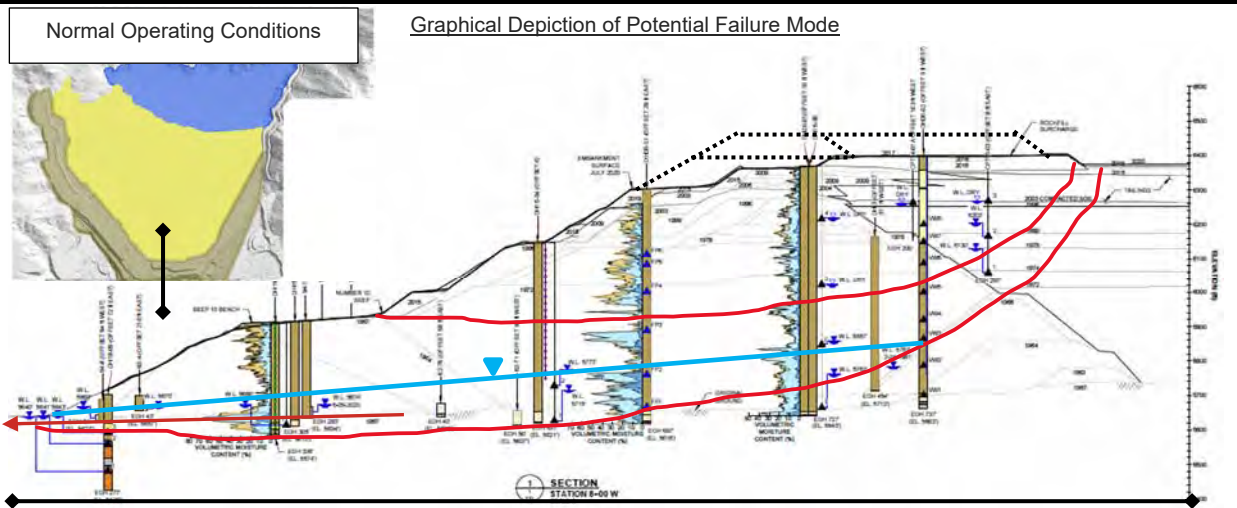
- (1) Severe earthquake occurs.
- (2) Seismic loading results in excess pore pressure development within critical resisting areas of the embankment or foundation soils.
- (3) Increasing pore pressures result in decreasing shear resistance leading to slope instability.
- (4) Embankment instability occurs through a deeply seated slip surface impacting the full embankment height.
- (5) Large-scale landslide and/or slumping deformation occurs in the central pedestal area causing debris flow within the HsB area impacting mine infrastructure in the area.

<u>More Likely (Adverse) Factors</u>	<u>Less Likely (Resisting) Factors</u>
<ul style="list-style-type: none"> • There is currently a basal saturated zone and some evidence of perched drainage • Embankment layering (compacted haul surfaces, finer-grained lift tops, and rockfill material source differences) • Known areas of historical leaching activities • Potential for lower material strength within the alluvium foundation unit / saturated rockfill • High seismic area, significant ground motions possible • Variability of embankment fill increases uncertainty 	<ul style="list-style-type: none"> • Very low likelihood of earthquake event(s) • Reasonably competent rockfill that drains well • Geometry of rockfill surcharge improves tailings response and decreases likelihood of liquefaction • Relatively modest slope angles • Long well-drained beaches may limit potential for surficial tailings liquefaction • Variable rockfill dumping orientation and resulting fabric • Well monitored and positive performance observed

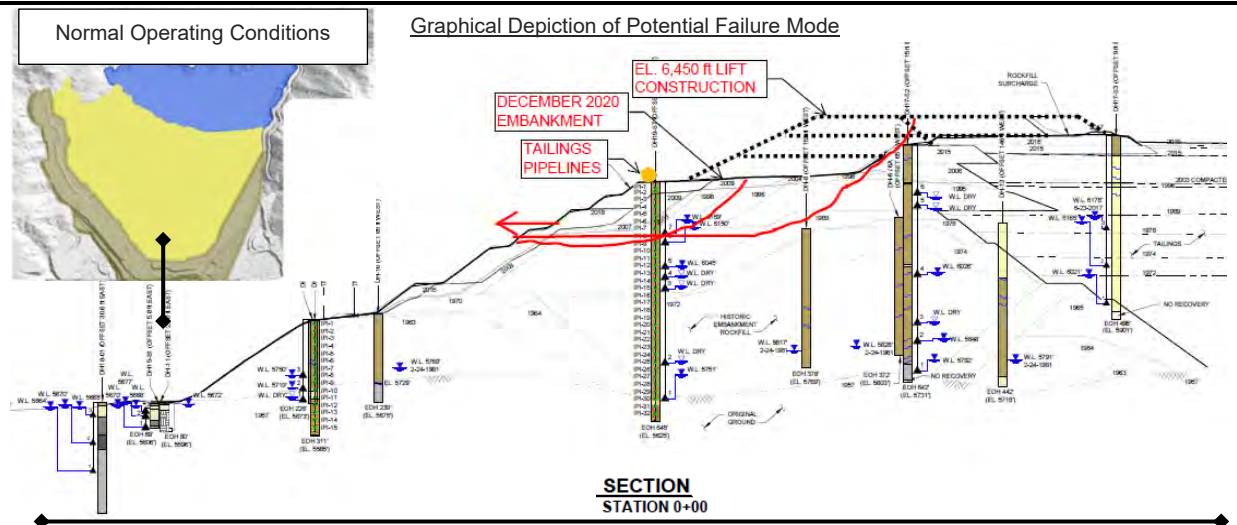
- (1) Severe earthquake occurs.
- (2) Seismic loading results in excess pore pressure development within critical resisting areas of the embankment.
- (3) Increasing pore pressures result in decreasing shear resistance leading to slope instability.
- (4) Embankment instability occurs through a relatively shallow slip surface impacting the central portion of the embankment.
- (5) Multi-bench instability and/or slumping deformation occurs in the central pedestal area resulting in damage to the tailings distribution pipelines between the No. 2 and No. 3 Booster Pump Stations. Resulting failure surface does not result in loss of tailings containment within the YDTI.

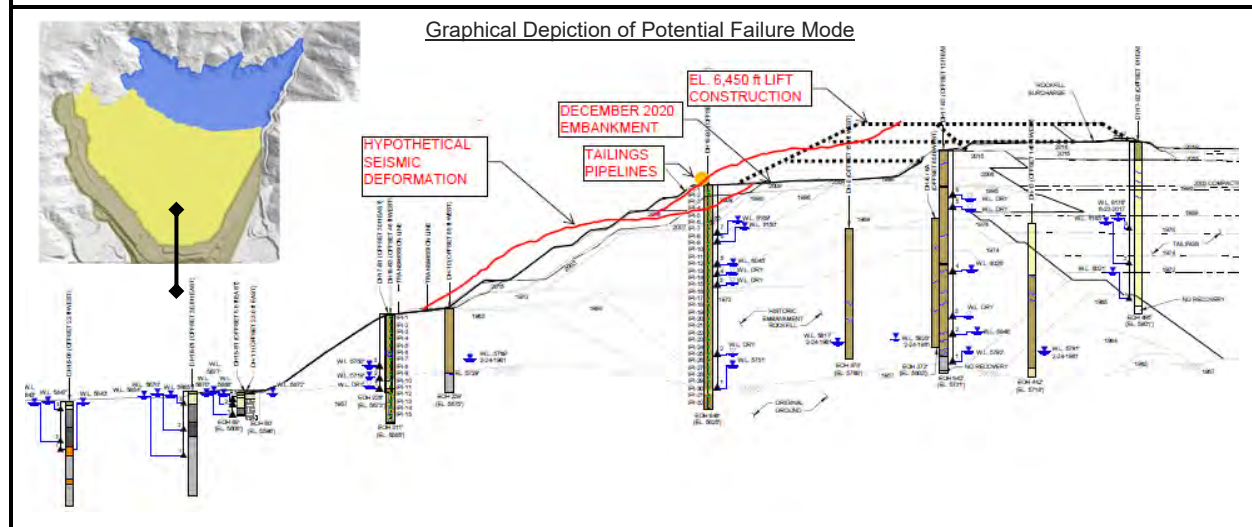
- (1) Severe earthquake occurs.
- (2) The embankment deforms due to the seismic loading of the embankment.
- (3) Resulting deformations cause slope adjustments and/or bench settlement through the central pedestal area impacting the tailings distribution pipelines between the No. 2 and No. 3 Booster Pump Stations and/or No. 3 Booster Station.

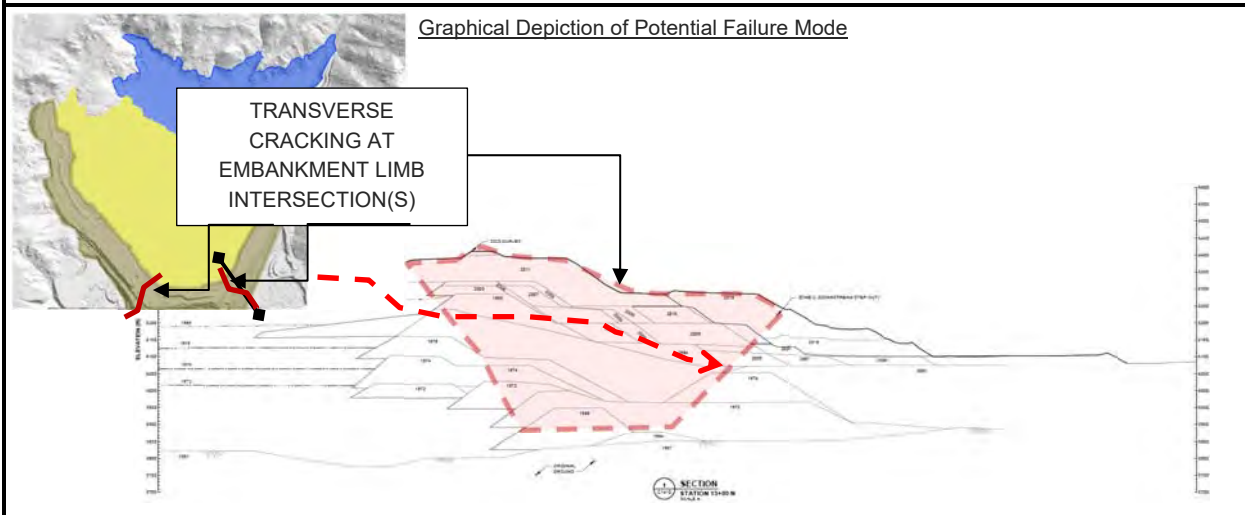
- (1) Severe earthquake occurs.
- (2) The embankment differentially deforms resulting in vertical cracking at points of intersection of section geometry/embankment limbs without any internal seepage controls (e.g. filters) upstream.
- (3) Results in potential preferential flow paths that are difficult to assess.
- (4) (i) either tailings mobilized during seismic loading finds resulting flow paths or (ii) continued operations leads to tailings slurry interacting with unidentified flow paths
- (5) Loss of tailings occurs.

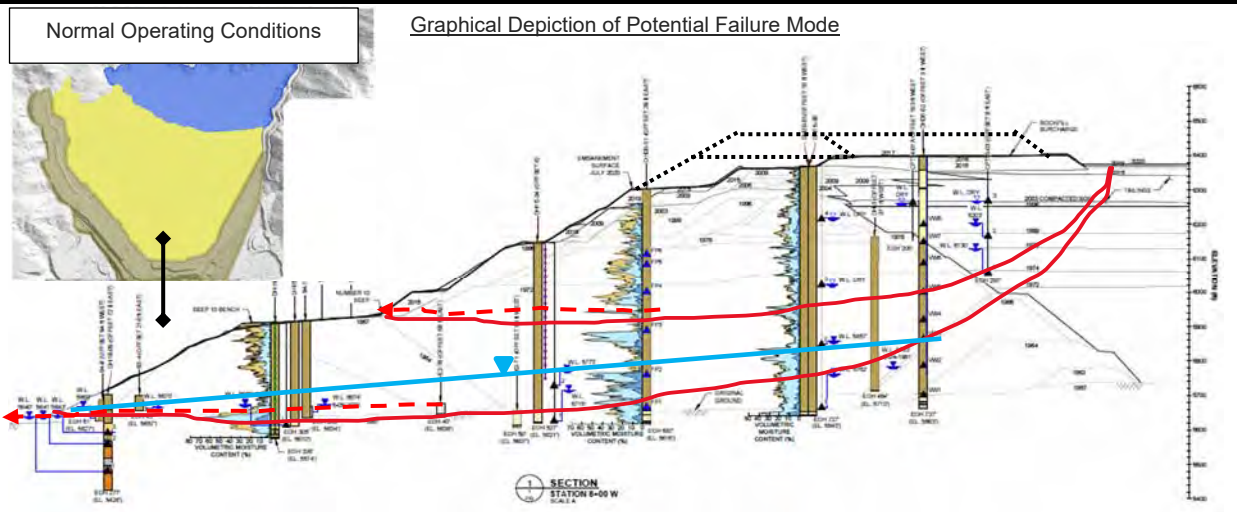
- (1) Creep occurs within basal saturated zone or a perched saturated zone within the embankment.
- (2) Deformation causes either (i) excess pore pressure development or (ii) reduced confining pressures resulting in induced strain softening within critical resisting areas of the embankment.
- (3) Embankment instability occurs either through (i) a deeply seated slip surface impacting the full embankment height or (ii) hypothetical perched saturated condition aligned with the Seep 10 bench.
- (4) Large-scale landslide and/or slumping deformation occurs in the central pedestal area causing debris flow within the HsB area impacting mine infrastructure in the area.

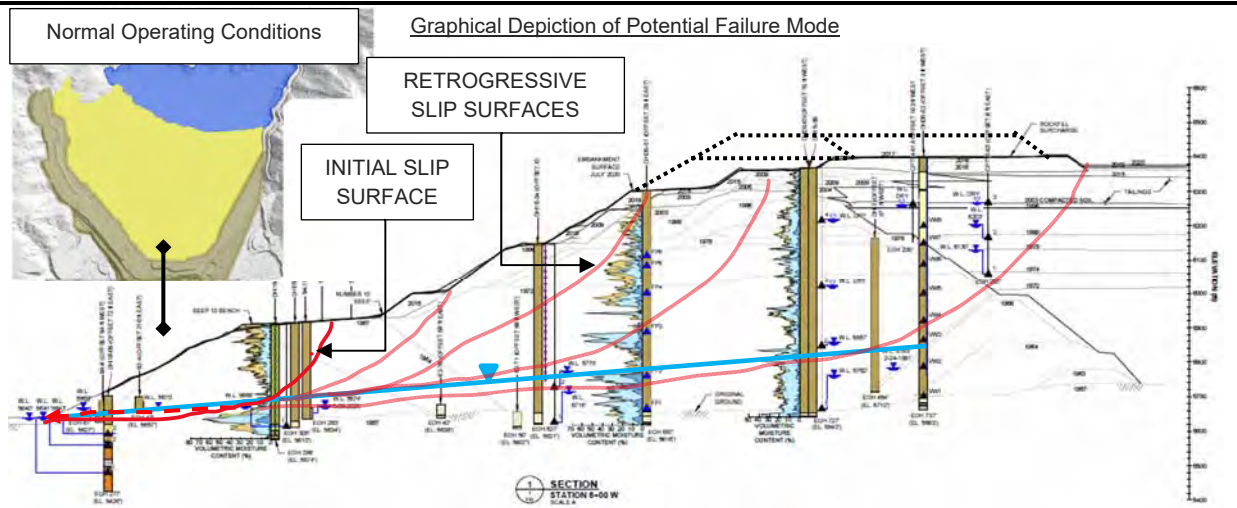
- (1) Creep occurs locally within basal saturated zone of the embankment in the vicinity of the Seep 10 bench.
- (2) Deformation causes either (i) excess pore pressure development or (ii) reduced confining pressures resulting in induced strain softening within critical resisting areas of the embankment.
- (3) Embankment instability occurs locally at the Seep 10 bench.
- (4) Retrogressive slope instability follows the initial instability causing debris flow within the HsB area impacting mine infrastructure in the area.

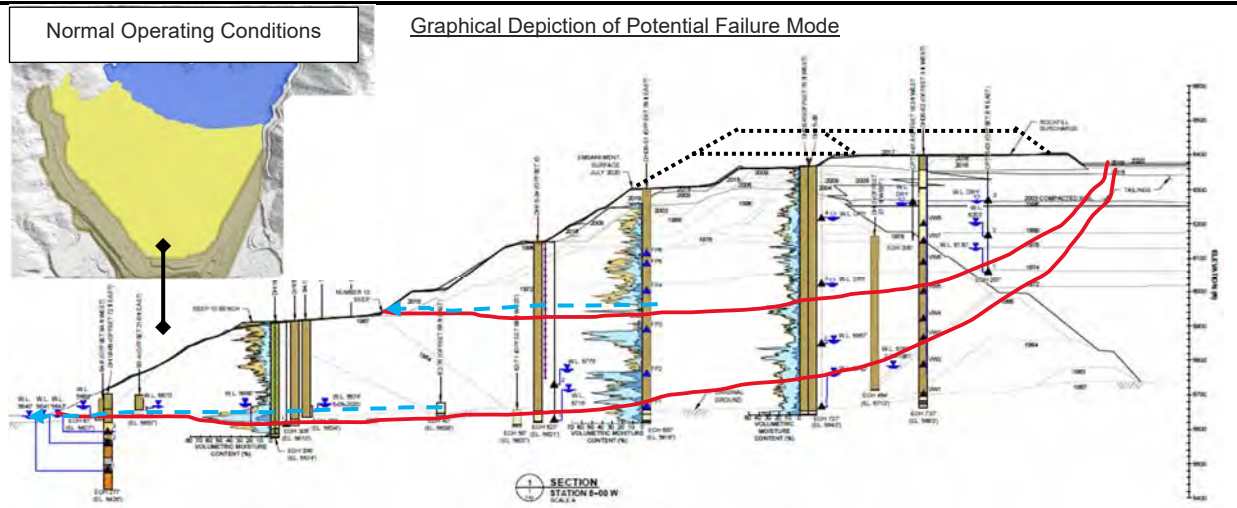
- (1) Continuous acidic drainage within embankment fill material.
- (2) Chemical weathering results in decreasing strength properties within critical resisting areas of the embankment.
- (3) Embankment instability occurs through a deeply seated slip surface impacting the full embankment height or aligned with the Seep 10 bench.
- (4) Large-scale landslide and/or slumping deformation occurs in the central pedestal area causing debris flow within the HsB area impacting mine infrastructure in the area.

- More Likely (Adverse) Factors
- Do not know the outcome of various material degradation processes and their spatial distribution
 - There is currently a basal saturated zone and some evidence of perched drainage
 - Known areas of historical leaching activities
 - Potential for lower material strength within the alluvium foundation unit / saturated rockfill to be considered
 - Some evidence of lateral displacement at depth within foundation materials at the Seep 10 bench
 - Evidence of high temperature zones (to be evaluated further)

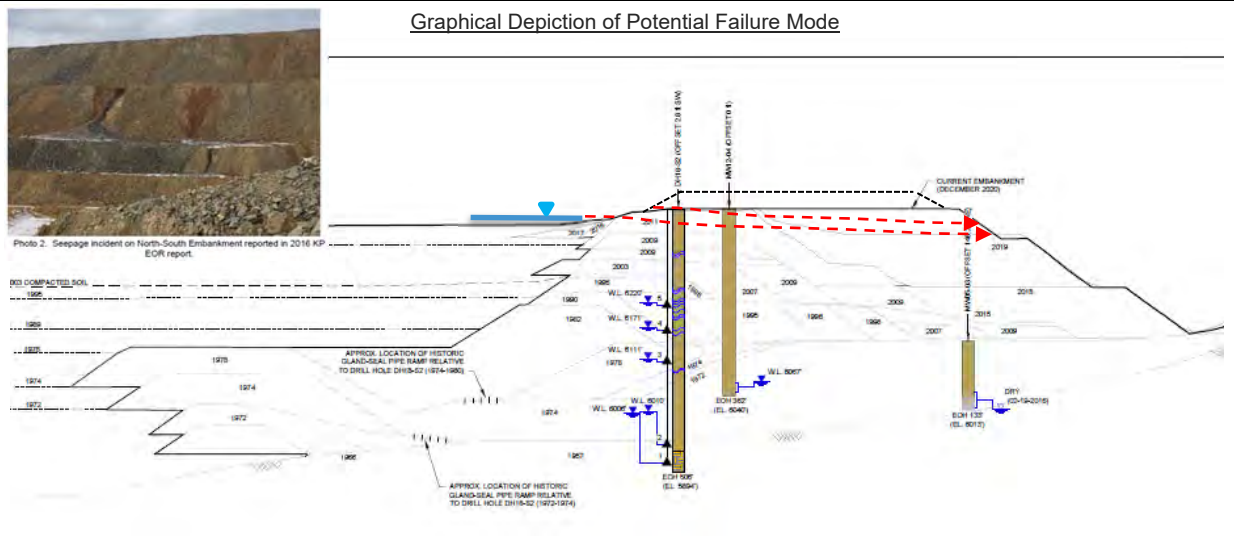
- (1) Flood water hydraulically connects with existing seepage paths that have been observed to daylight on the downstream slope.
- (2) Results in piping.

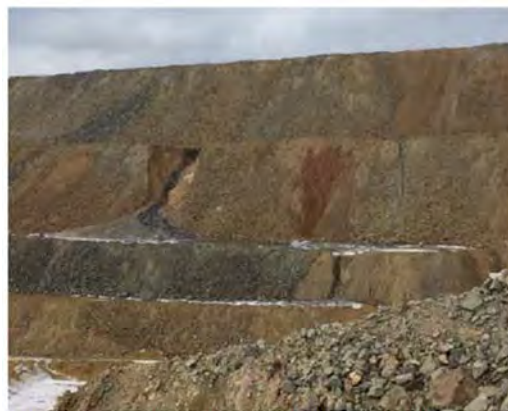
Photo 2. Seepage incident on North-South Embankment reported in 2016 KP EOR report.

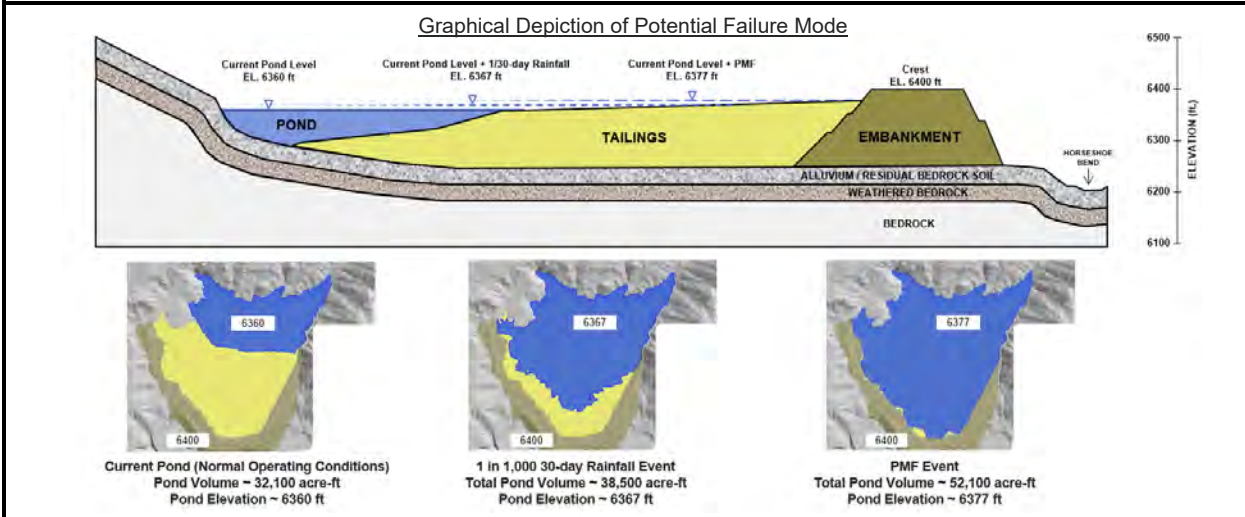
- (1) Flood occurs causing rise in pond.
- (2) Overtops lowest point on the N-S Embankment.
- (3) Results in erosion of embankment fill and breach of facility.

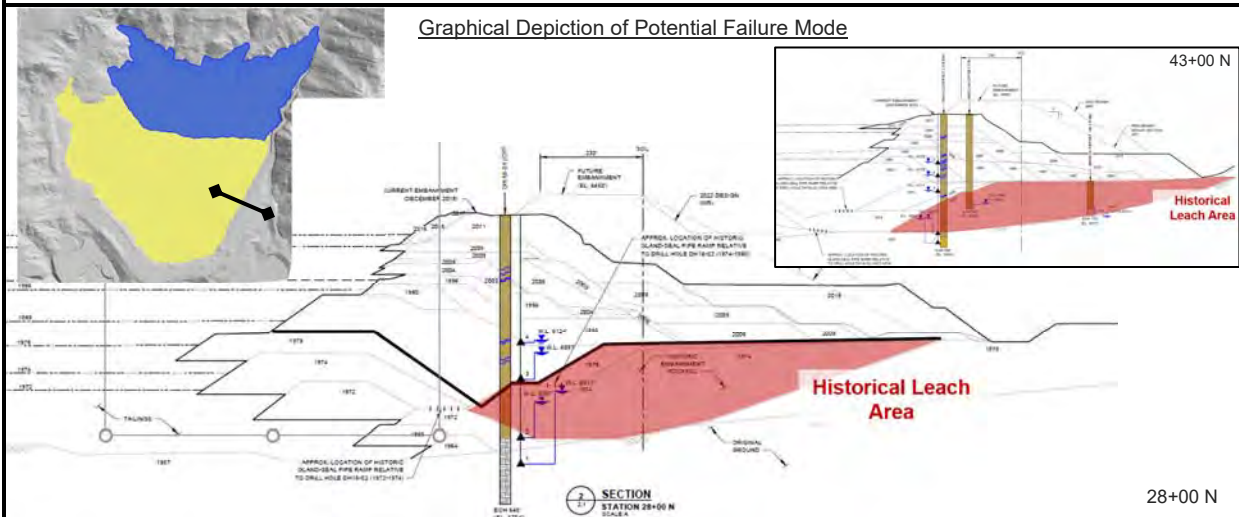
- (1) Severe earthquake occurs.
- (2) Response to earthquake results in compression of the buried leach materials on the downstream side of the embankment.
- (3) Undesirable embankment crest settlement.
- (4) Results in overtopping of supernatant pond and breach of the facility.

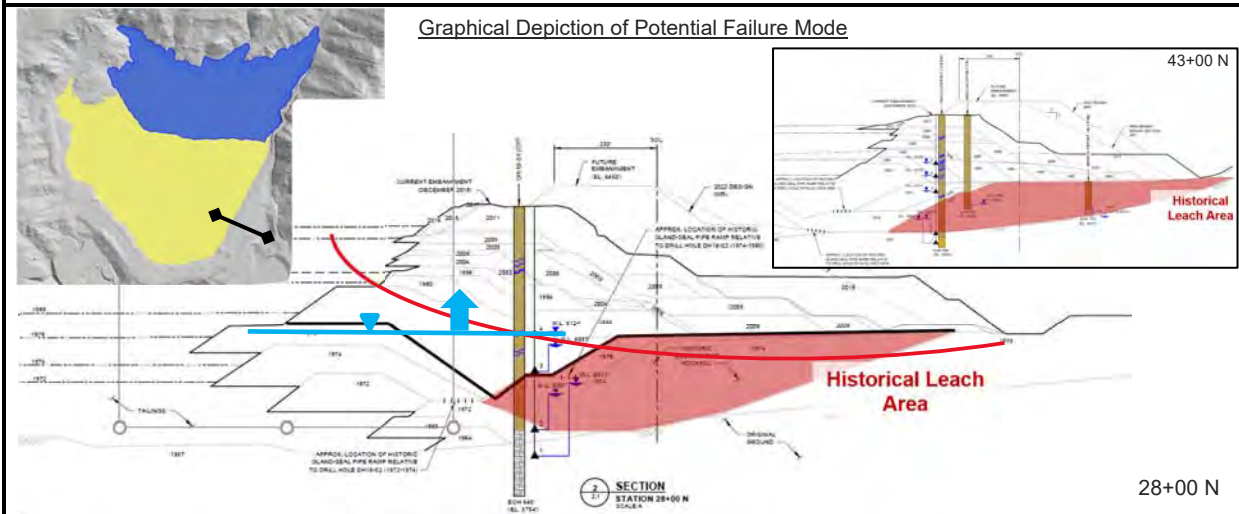
- (1) Severe earthquake occurs.
- (2) Seismic loading results in excess pore pressure development within critical resisting areas of the embankment or foundation soils.
- (3) Increasing pore pressures result in decreasing shear resistance leading to slope instability.
- (4) Embankment instability occurs through a deeply seated slip surface impacting the full embankment height.

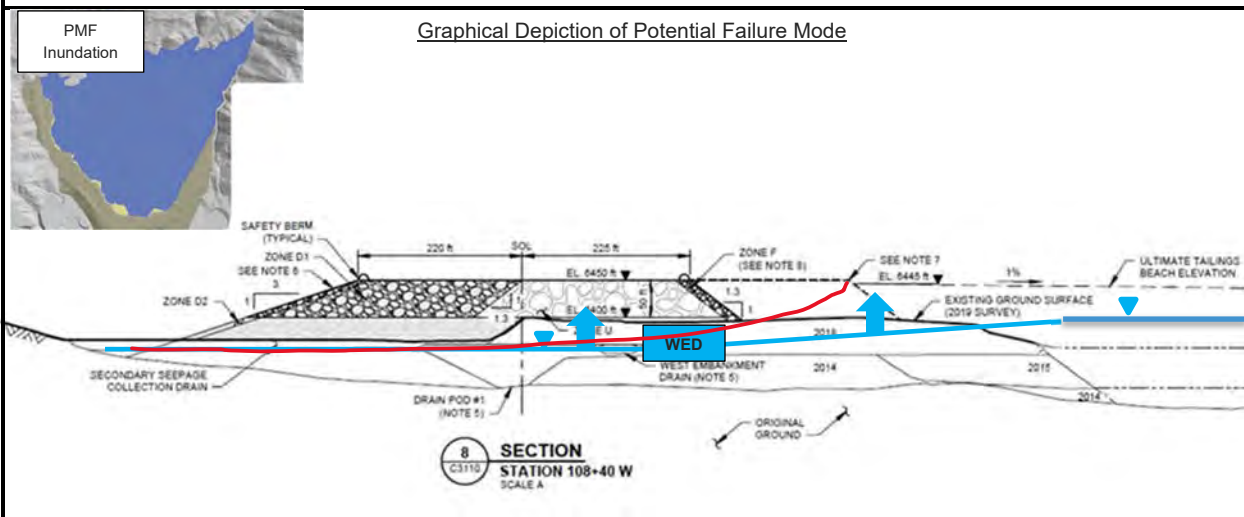
- (1) Severe natural flooding occurs resulting from some combination of extreme rainfall and snowpack.
- (2) Flood waters lead to rising pond surface inundating the long, drained tailings beaches and flooding the upstream facing of the embankment.
- (3) Seepage overwhelms capacity of the West Embankment Drain (WED).
- (4) Rise in pore pressures within the embankment rockfill is sufficient to decrease effective stress in critical resisting areas near the downstream side of the embankment resulting in slope instability.

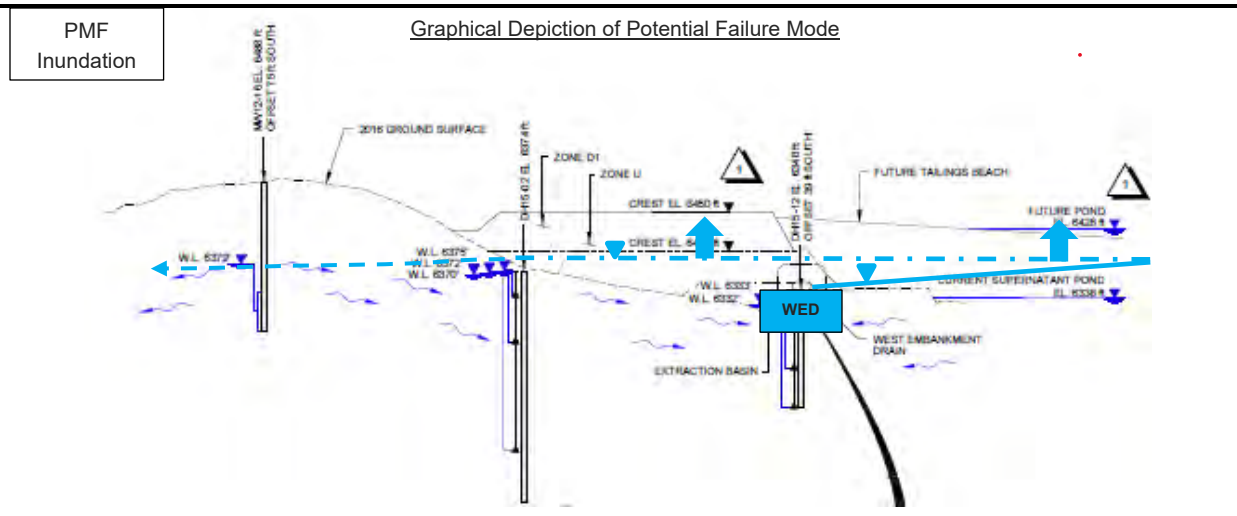
- (1) Severe natural flooding occurs resulting from some combination of extreme rainfall and snowpack.
- (2) Flood waters lead to rising pond surface inundating the long, drained tailings beaches and flooding the upstream facing of the embankment.
- (3) Seepage overwhelms capacity of the West Embankment Drain (WED).
- (4) Rise in pore pressures within the embankment rockfill and foundation materials increases to above Potentiometric Low (PL) or Deep Isolated Failure System (DIFS) in the West Ridge.
- (5) Elevated pore pressures within the PL or DIFS are sustained for sufficient period of time, such that uncontrolled seepage from the YDTI occurs towards/beyond the West Ridge.
