VA101-126/29-4

MONTANA RESOURCES

YANKEE DOODLE TAILINGS IMPOUNDMENT - 2023 ANNUAL INSPECTION REPORT

EXECUTIVE SUMMARY

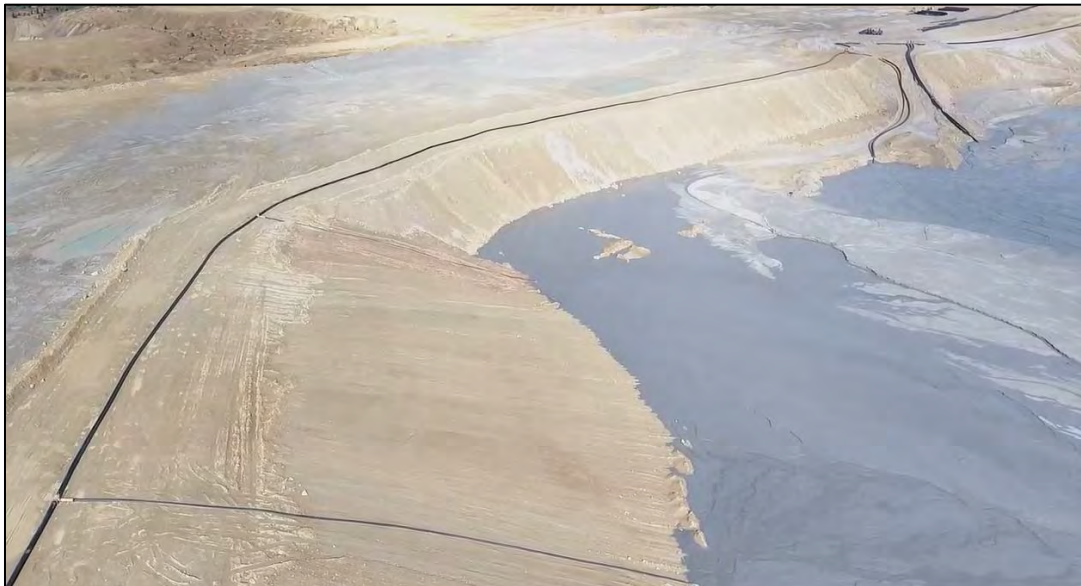
PHOTO 10 – East-West Embankment upstream side near limit of upstream regrading work at Section 23+00NW. Differential settlement cracking observed along tailings discharge corridor from Section 23+00NW to 33+00NW near the tailings discharge point (at top right corner).

- 3. Regrade the upstream slope of East-West Embankment between approximately Sections 33+00NW (Discharge 2-1) and 23+00NW from the tailing discharge corridor to the tailings beach surface to mitigate the differential settlement cracking currently observed along the tailings discharge corridor in this area. Tie in the regraded slope neatly with the upstream embankment slope east of Section 23+00NW. Reapply alluvium facing with a minimum nominal thickness of 3 ft to the regraded slope in this area to enhance continuity of the upstream alluvium facing layer along the center part of the dam.**

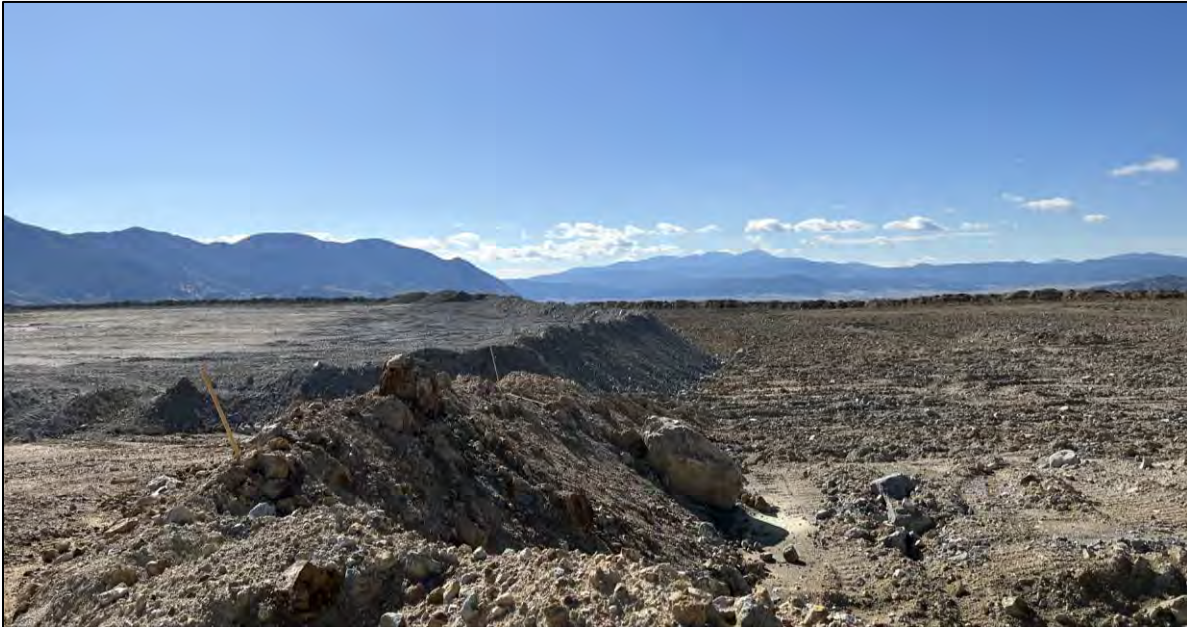
PHOTO 39 – Central Pedestal Area final grading lift progress to the east of Section 0+00, facing south. Cross ripped area on right side of image was where transverse cracking was remediated. No crack re-expression observed.

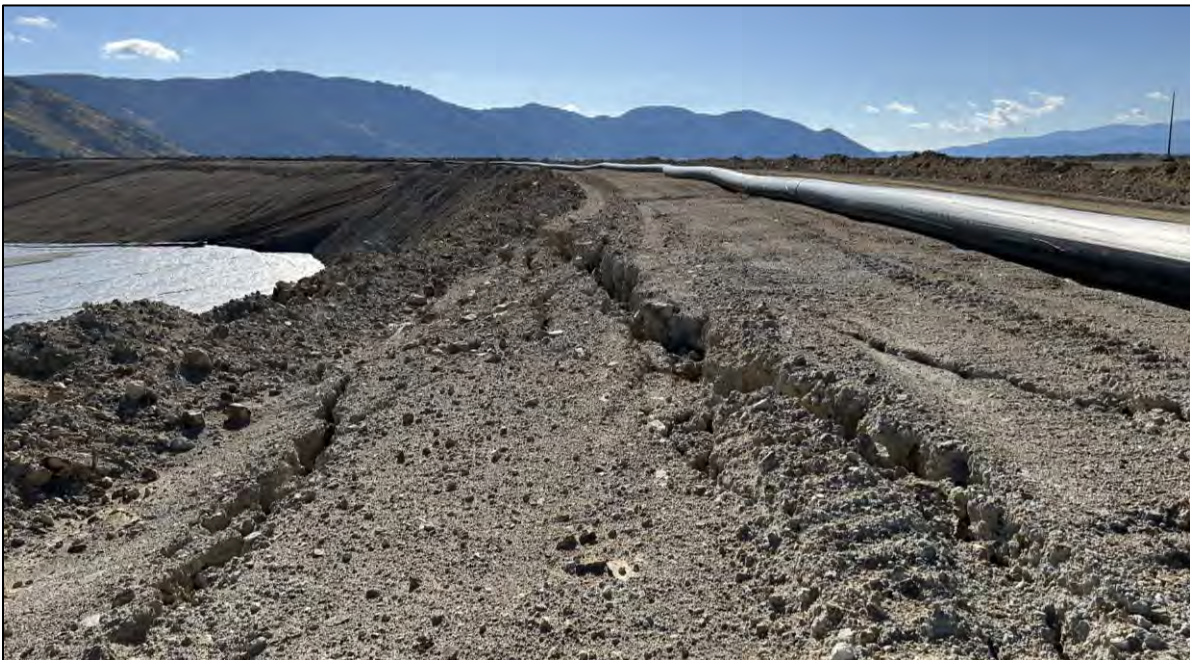
PHOTO 44 – East-West Embankment upstream side near limit of upstream regrading work at Section 23+00NW. Differential settlement cracking observed along tailings discharge corridor from Section 23+00NW to 33+00NW, facing southeast.

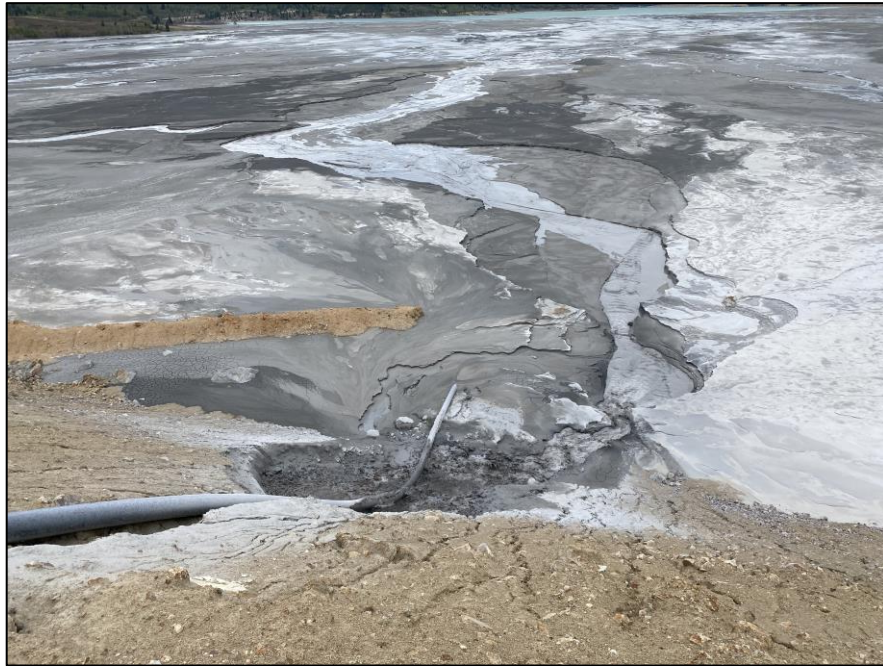
Spigot, valve, and pipeline operating conditions were reviewed. Spigot pipe leaks were observed at various locations along tailings Pipeline 1, with an example shown on Photo 2.1. Appendix B further outlines the valve, spigot pipe and discharge condition of each spigot.

Photo 2.1 EL. 6,450 ft West Embankment Discharge Spigot 1-2B 12" Valve Leaking

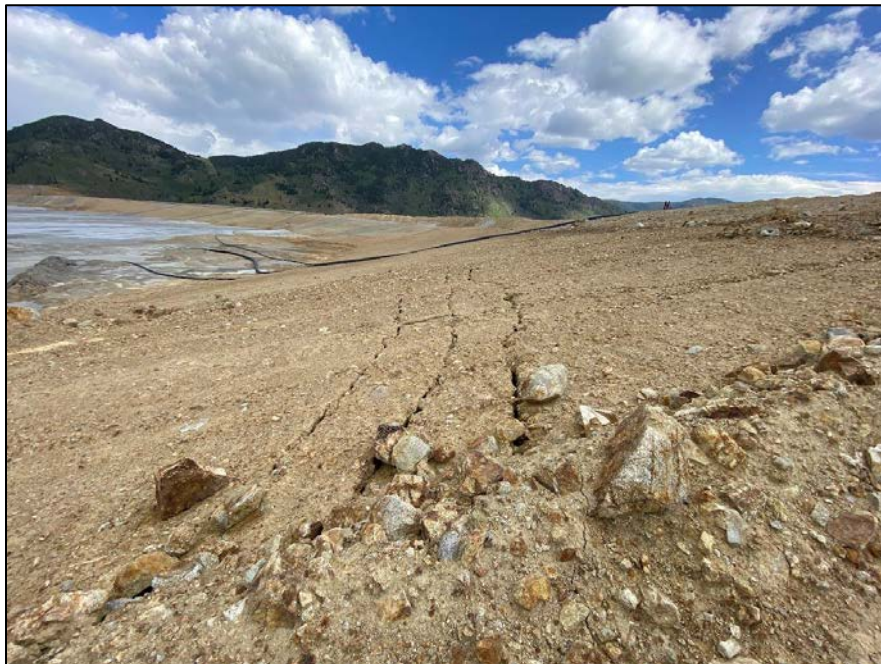
Cracking was observed along the recently placed alluvium upstream of the East-West Embankment. Alluvium facing was placed between March and May 2023 and Photo 2.3 shows an example of cracking perpendicular to the slope. Settlement cracking is inferred to be due to differential settlement of the alluvium material placed above the tailings surface and freeze-thaw processes in this area.

Photo 2.3 EL. 6,450 ft East-West Embankment Upstream Alluvium Facing Slope Cracking

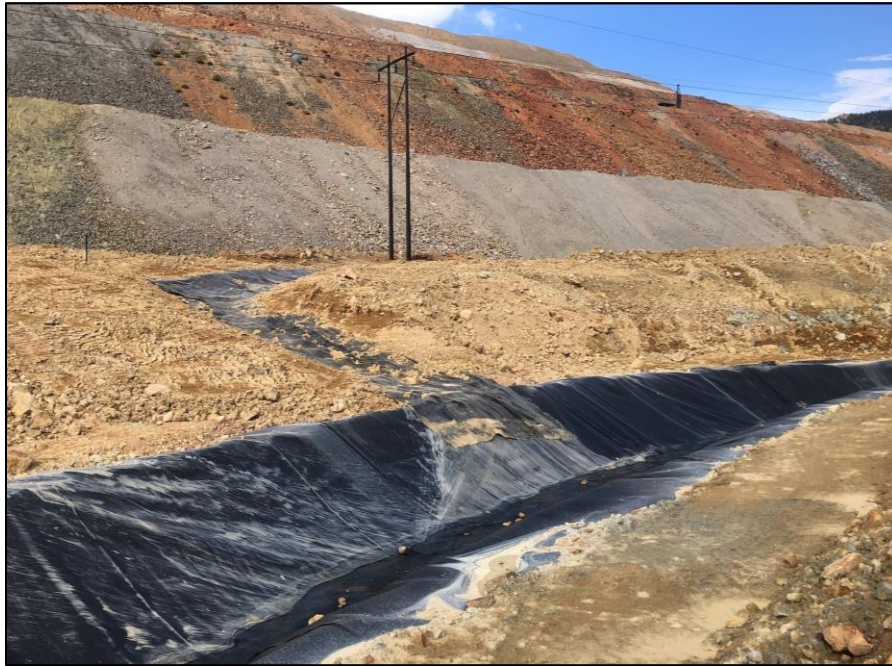
Photo 2.8 Geotextile Added North of SWD#10 to Prevent Sediment Erosion into Ditch

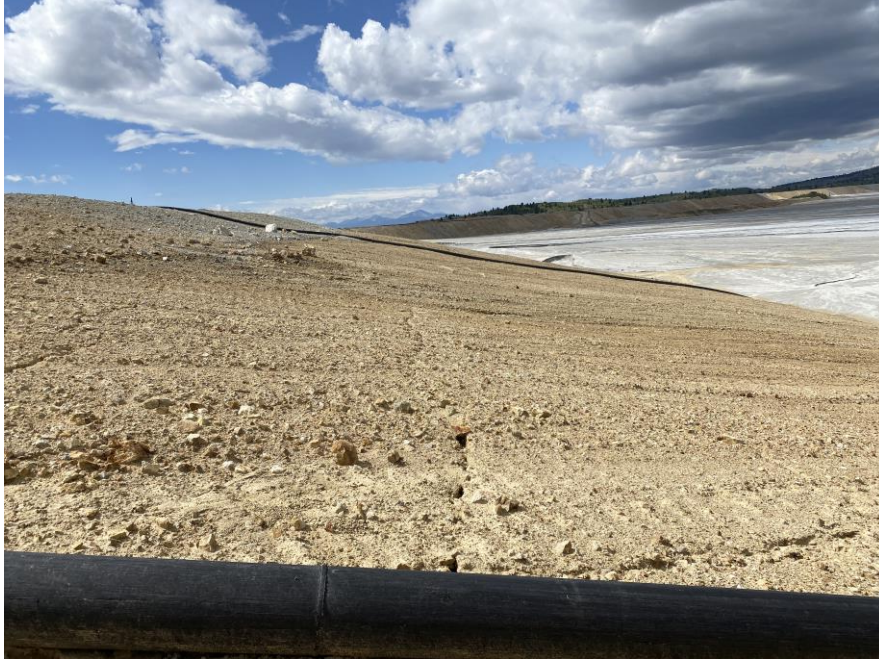
PHOTO 9 – East-West Embankment – Settling cracks noticed within the upstream face with the Zone F facing

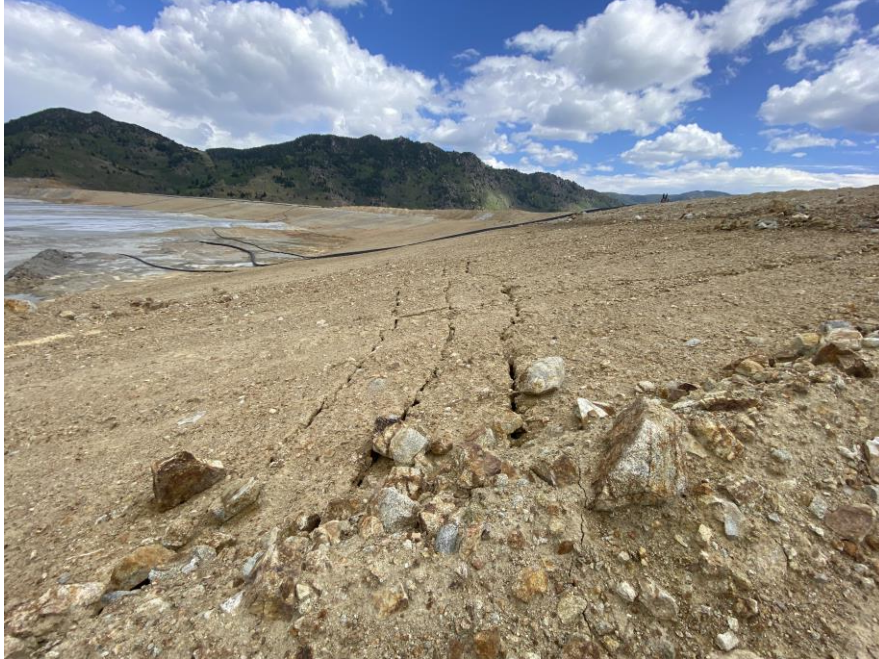
PHOTO 11 – East-West Embankment – Settling cracks noticed within the upstream face with the Zone F facing

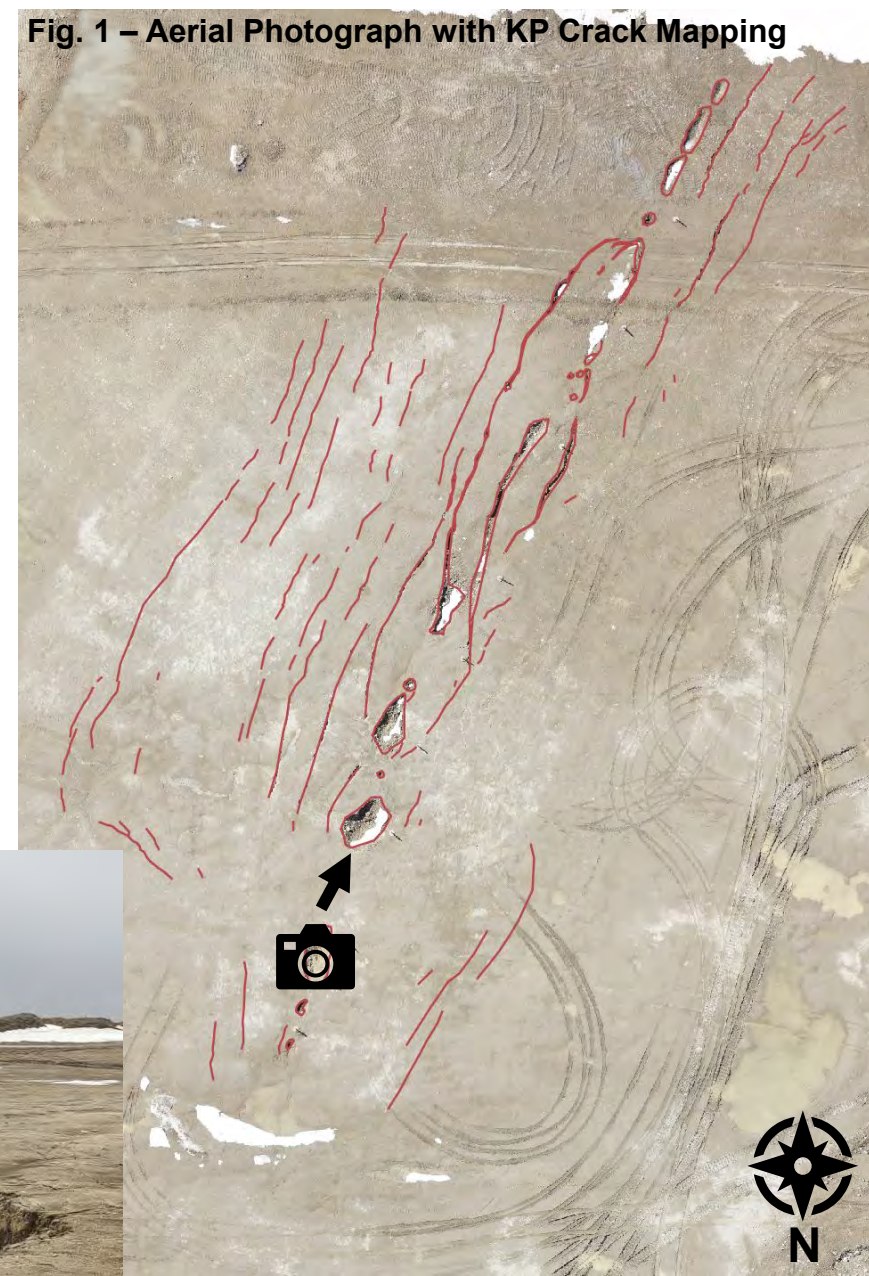
- Significant transverse cracking and depressions were observed along the EL. 6,450 ft crest near Section 0+00 on April 27, 2023, which triggered a Level 1 Unusual Occurrence response that comprised on-site inspections (completed by MR and KP), a targeted monitoring campaign (developed by KP and the YDTI Engineer of Record (EOR)), and remedial activities completed by MR operations (reported previously in VA23-01198)
 - A detailed summary of the observed cracking and monitoring analyses was reviewed with the Independent Review Panel (IRP) on June 13, 2023
 - The response comprised:
 - EOR notification by MR
 - Heightened monitoring of cracking and deformation in the area.
 - Investigation of the cause
 - Test trenching/pitting within main cracking area
 - Review with ITRB
 - Implementation of remedial activities
 - Follow-up inspection following remediation

Fig. 2 – Observed Cracking and Depressions (photo provided by MR)
