**MONTANA DEPARTMENT OF ENVIRONMENTAL QUALITY  
HARD ROCK MINING SECTION, MINING BUREAU  
OPERATING PERMIT – FIELD INSPECTION REPORT**

Permittee: Montana Resources, LLC			Inspection Date: June 25, 2024		
Operating Permit #: 00030		Project: Montana Resources- Continental Mine Complex		County: Butte-Silver Bow	
Nearest City or Town(s): Butte					
Inspector(s): Conor Fox and Ben Johnson (AQB), Garrett Smith (MB)			Permittee Rep(s): Jeremy Fleege		
Agencies w/overlapping permit jurisdiction:		<input type="checkbox"/> USFS	<input type="checkbox"/> BLM	<input checked="" type="checkbox"/> Other (EPA)	<input type="checkbox"/> None
Minerals: Copper, molybdenum, minor silver					
Status:		<input checked="" type="checkbox"/> Active	<input type="checkbox"/> Inactive	<input type="checkbox"/> Suspended	<input type="checkbox"/> Other
Weather: Mostly sunny, high temp 84°F					
Type of Operation:			Purpose of Inspection:		
<input checked="" type="checkbox"/>	Open Pit		<input type="checkbox"/>	Initial (Pre-permitting)	
<input type="checkbox"/>	Underground		<input checked="" type="checkbox"/>	Regular Compliance

Hard Rock Mining Section Inspection  
Photo Log

Permit: 00030 2024-06-25-inspect

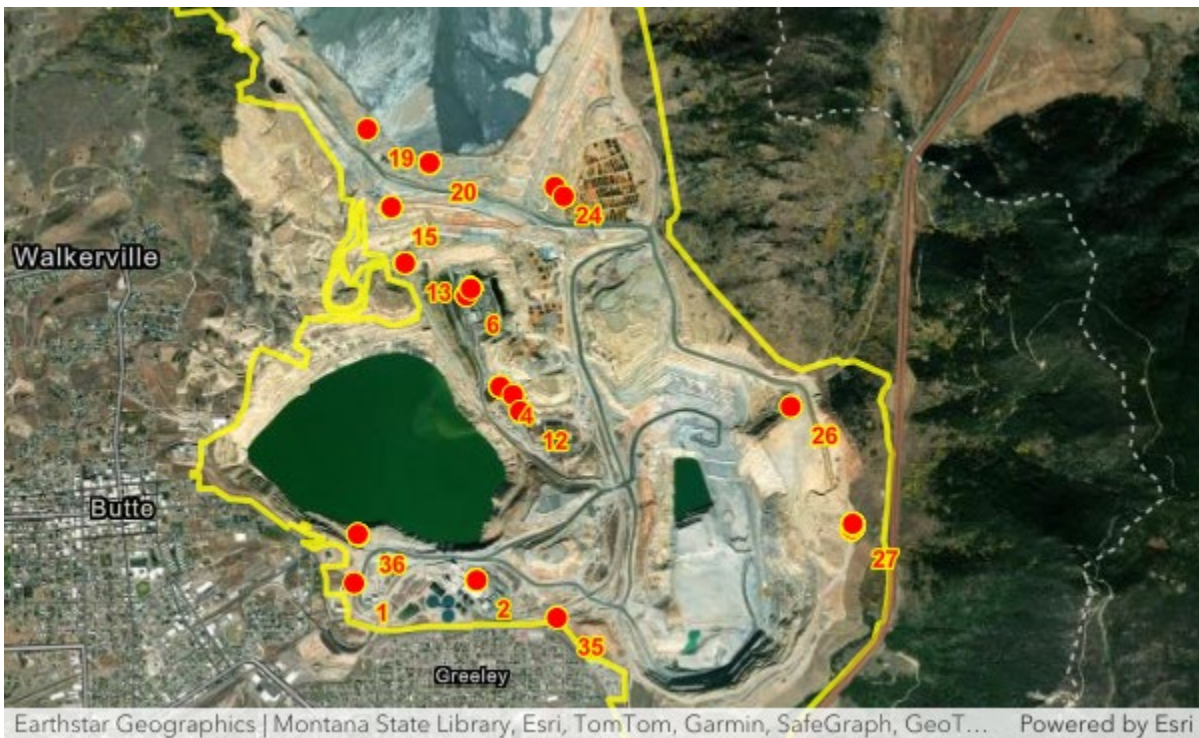
Photo #: 1

The inspection began around the crushing, milling, and concentrator facilities located on the southern end of the site (Photos 1 through 3). Although the facilities are critical for mining operations, these are pre-1971 processing facilities that are exempt from the Hard Rock Mining Operating Permit (Attorney General Opinion, 1977). However, the MAQP includes these facilities and the permit requires that emission sources be tested on a 4-year interval. Bison Engineering was contracted to conduct sampling over multiple days. Two baghouses associated with the fine ore bins were being tested during this inspection, so the sampling was focused on particulate matter and the efficiency of filtration systems. Additional details are provided in a separate inspection report issued by DEQ-AQB.

Description: View of crusher facility from office access road

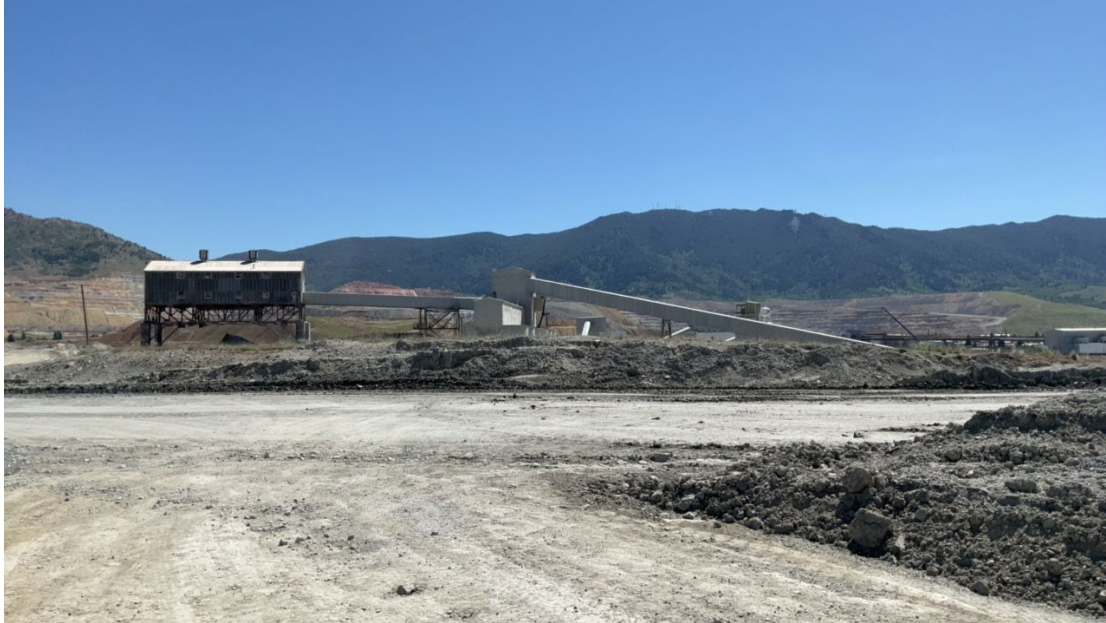
Photo #: 2

Description: Source testing is being conducted for Air Quality Permit

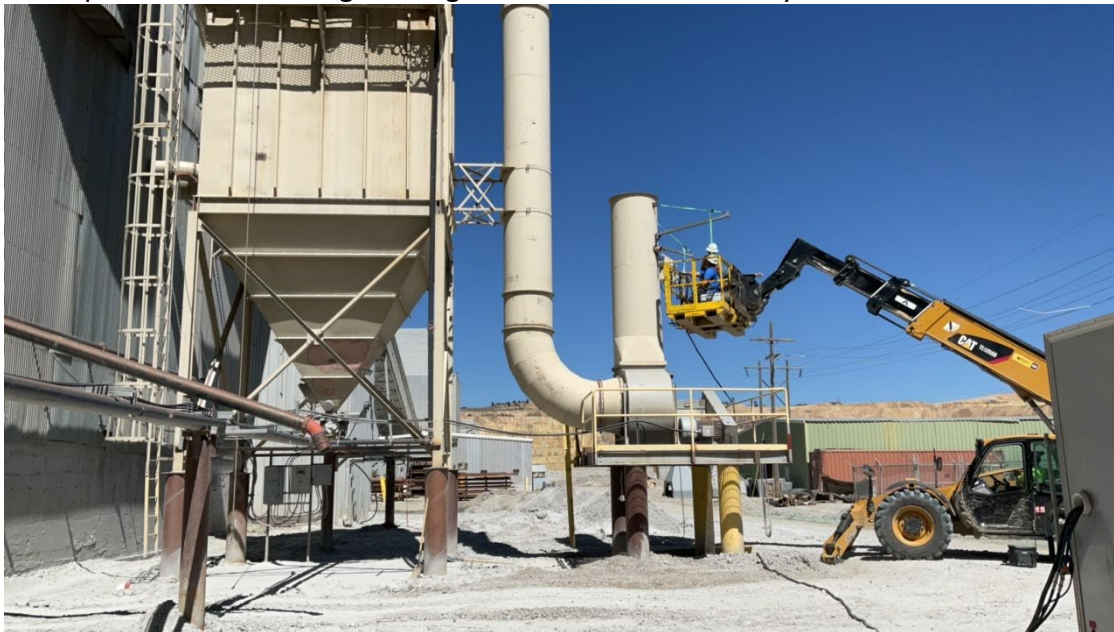
Photo #: 3

Description: Two stacks/filtration systems are being tested simultaneously.

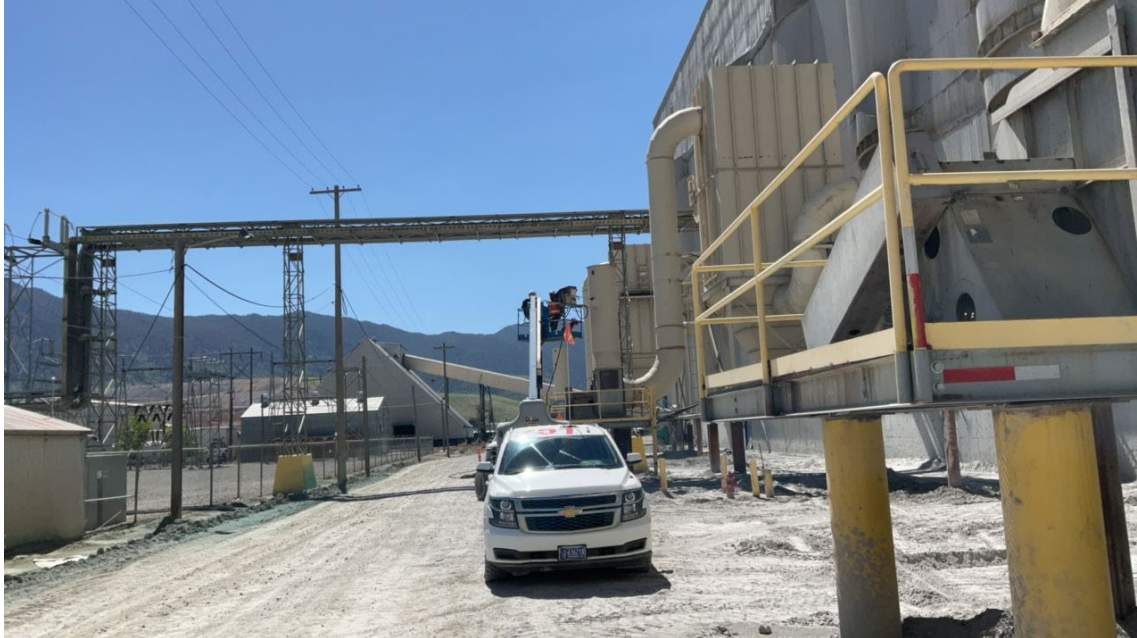
Photo #: 4

On the way to the HSB area, the new copper precipitation plant was observed (Photos 4 and 5). This plant was approved as permit revision 22-001 on 10/26/2022, and MR noted that it was commissioned in late spring 2024. The new plant is functioning well, operating on a similar scale as the old plant that was recently demolished and removed from the HSB footprint. The process of cementing copper on scrap iron is not technically sophisticated, but it remains effective to remove copper from water in the Berkeley Pit and HSB seepage sources, before the water is treated or managed in other ways.

Description: The new copper precipitation plant is operational

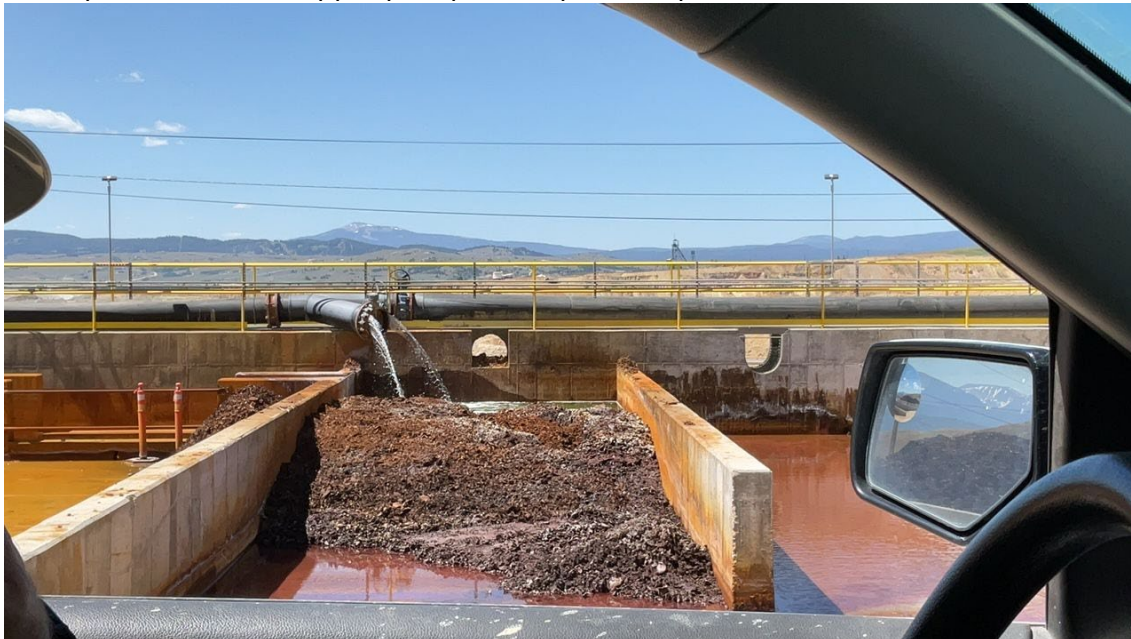
Photo #: 5

Description: The new copper precipitation plant is operational

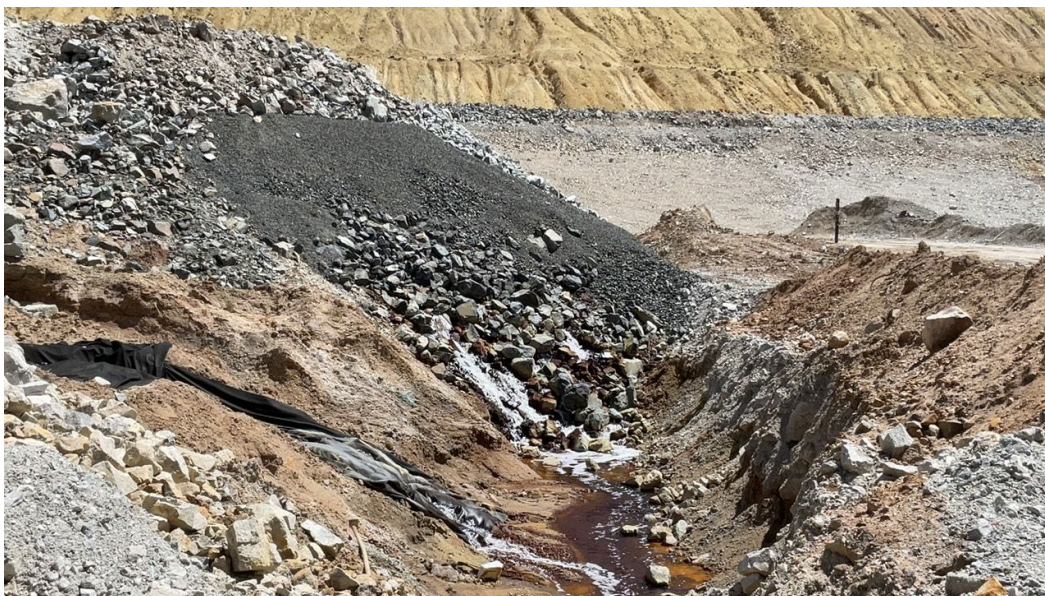
Photo #: 7

The construction of layered rock drains and seepage conveyance features continues in the HSB area (Photos 6 through 10). DEQ approved Minor Amendment 011 on 7/14/2022 for the construction of the HSB Rock Disposal Site (RDS) at the southern toe of the Yankee Doodle TSF. The RDS design includes a foundation drainage layer and engineered rock drains to capture and convey seepage flows from underneath the RDS, through a conveyance channel, and then to the management and treatment systems required under the Butte Mine Flooding Operable Unit (BMFOU) remedy. The old precipitation plant has been completely demolished and removed (Photos 15 and 16), but the placement of non-ore rock into the RDS will not occur until drain construction is complete (likely by 2025). As a component of Minor Amendment 011, the "Seep 10" that emanates on a bench above HSB has also been diverted into a channel, pond, and pipeline, to be routed around the future HSB RDS (Photos 13, 14, and 17). The outlet weir connected to a pipeline is continuously monitored for flow and sampled semi-annually for water quality.

Description: Construction of rock drains in the Horseshoe Bend area is ongoing

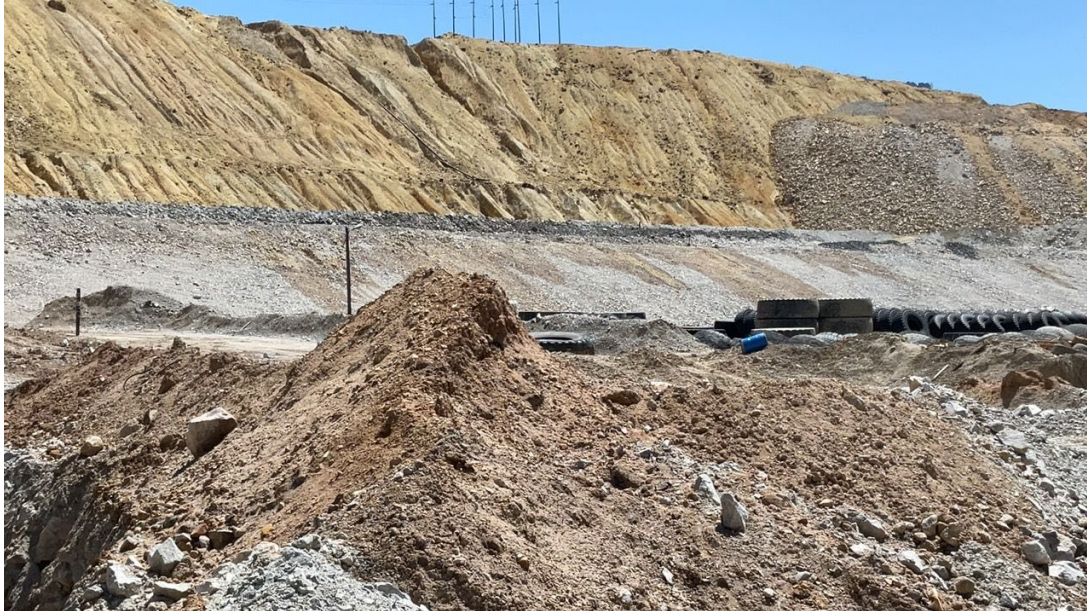
Photo #: 8

Description: Construction of rock drains in the Horseshoe Bend area is ongoing

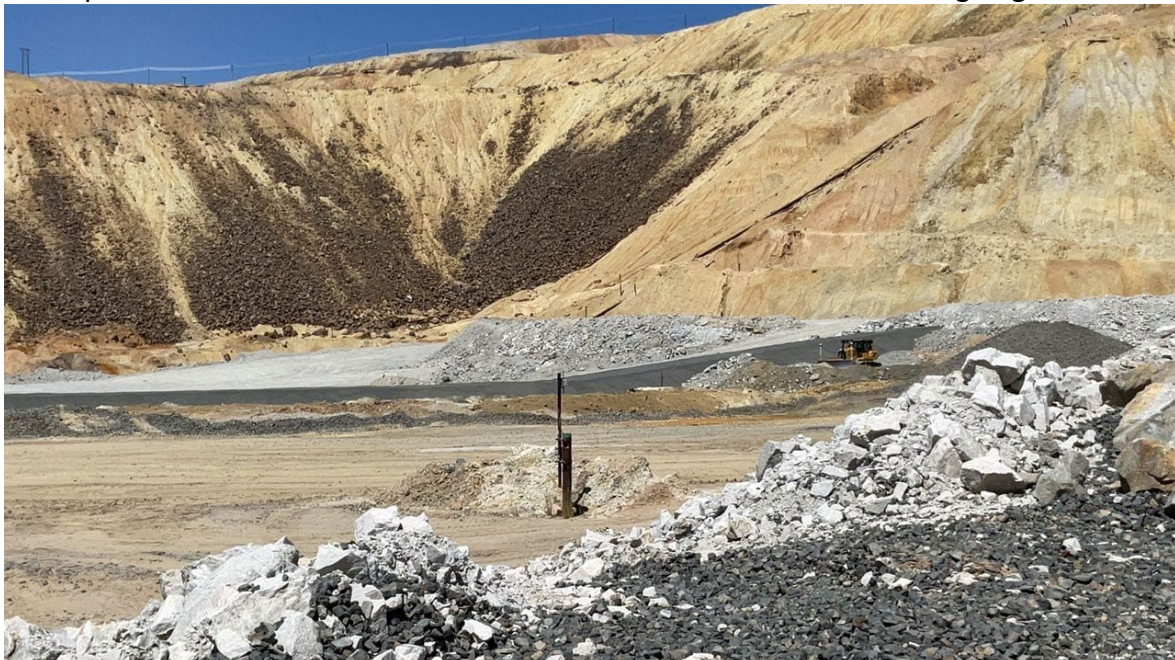
Photo #: 9

Description: Construction of rock drains in the Horseshoe Bend area is ongoing, this shows a cross-section of the drain layers

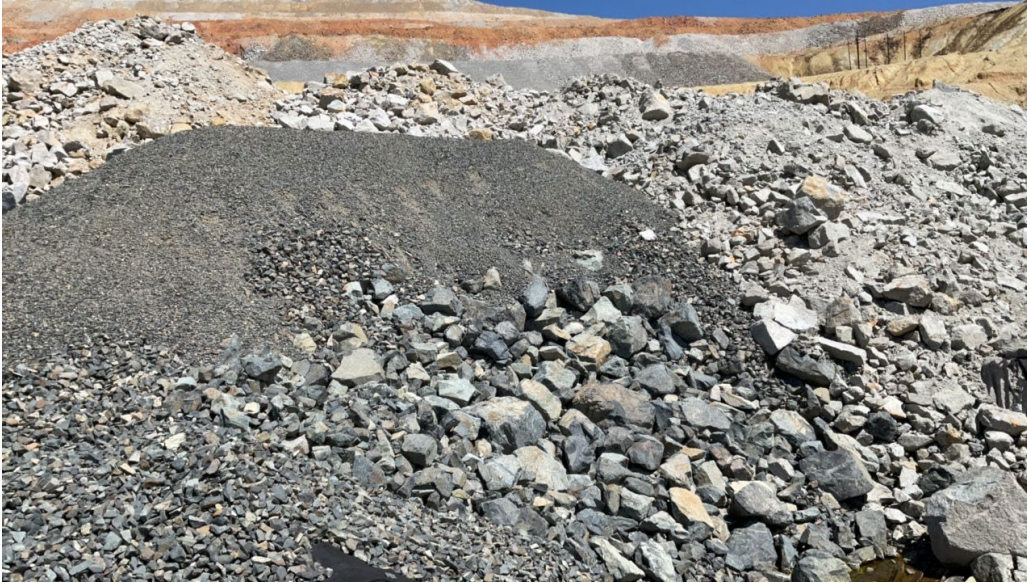
Photo #: 10

Description: Seepage from the rock drains is conveyed away from the Horseshoe Bend area through a channel

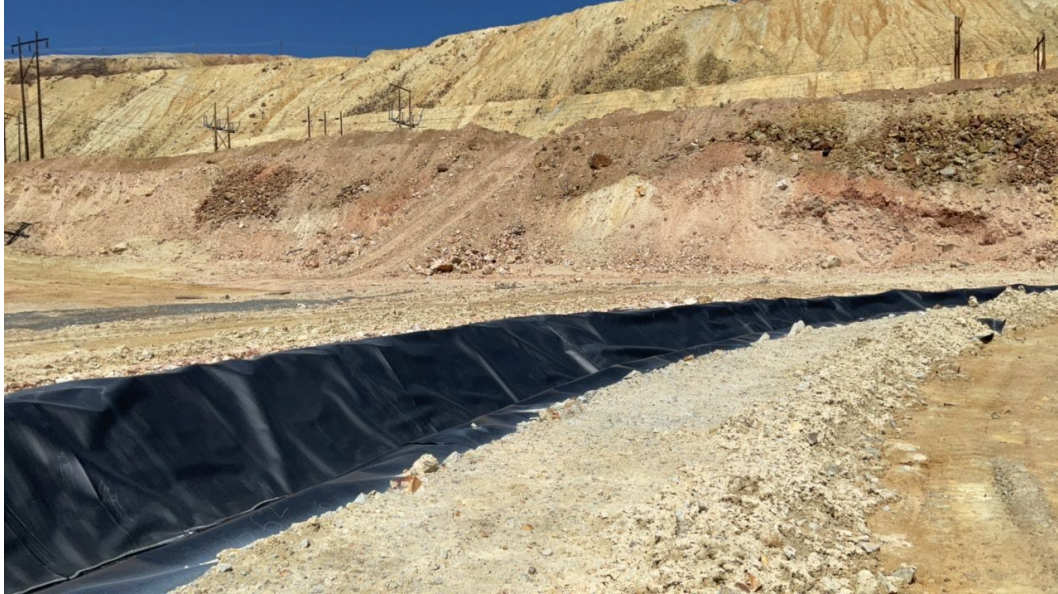
Photo #: 14

Description: A newly constructed lined channel conveys flow away from the Seep 10 bench, flow is measured at the outlet to this collection pond

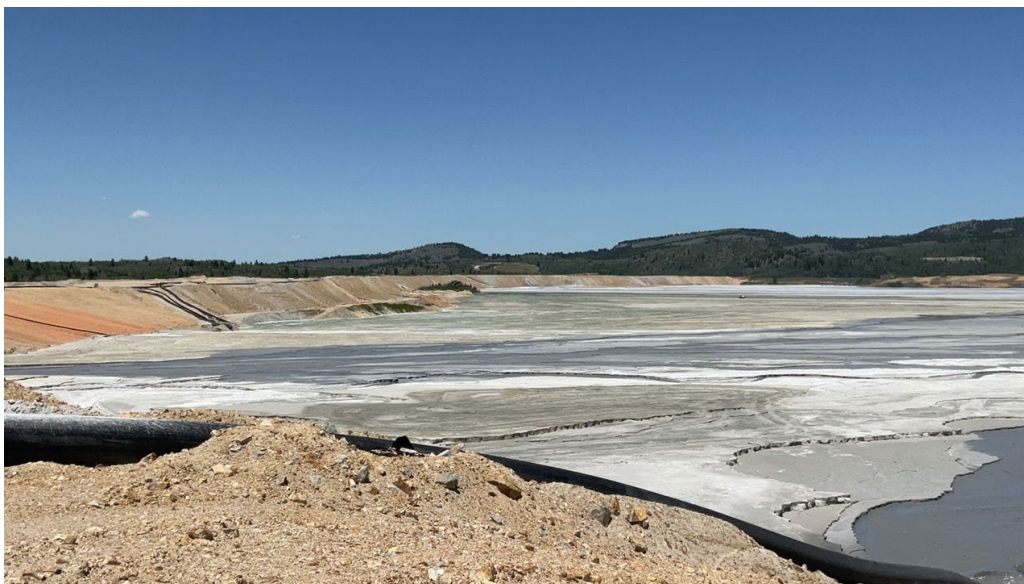
Photo #: 20

Description: TSF- the upstream faces of embankments have been graded and covered with alluvium/fine material. View of the West Embankment, with two tracked vehicles on the beach surface to apply dust suppressant

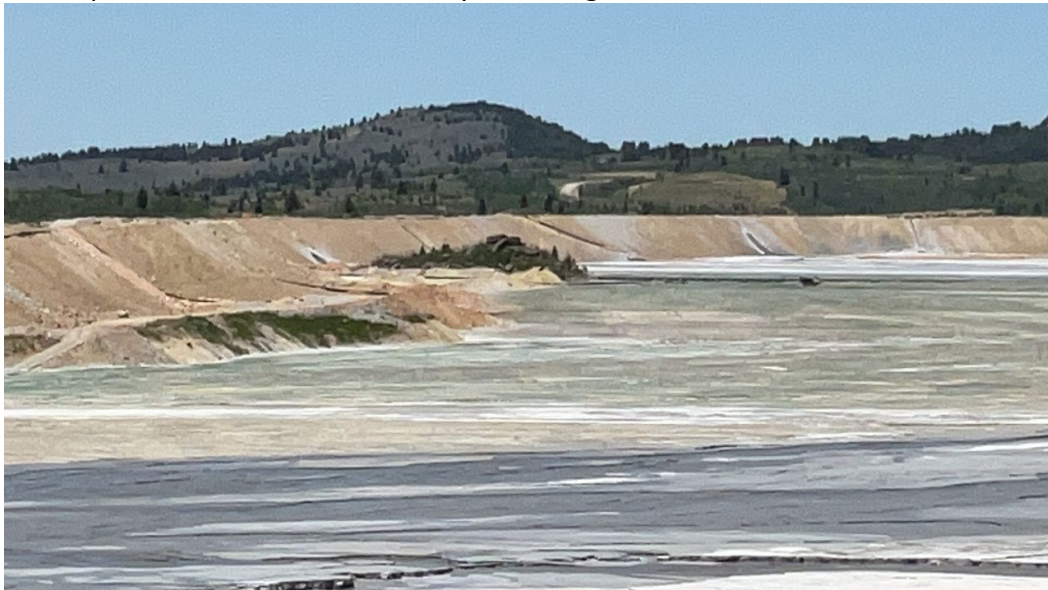
Photo #: 22

Description: TSF- the upstream faces of embankments have been graded and covered with alluvium/fine material. Multiple discharge locations are effective at wetting the tailings beach surfaces. View of the North/South Embankment and the barge access road.

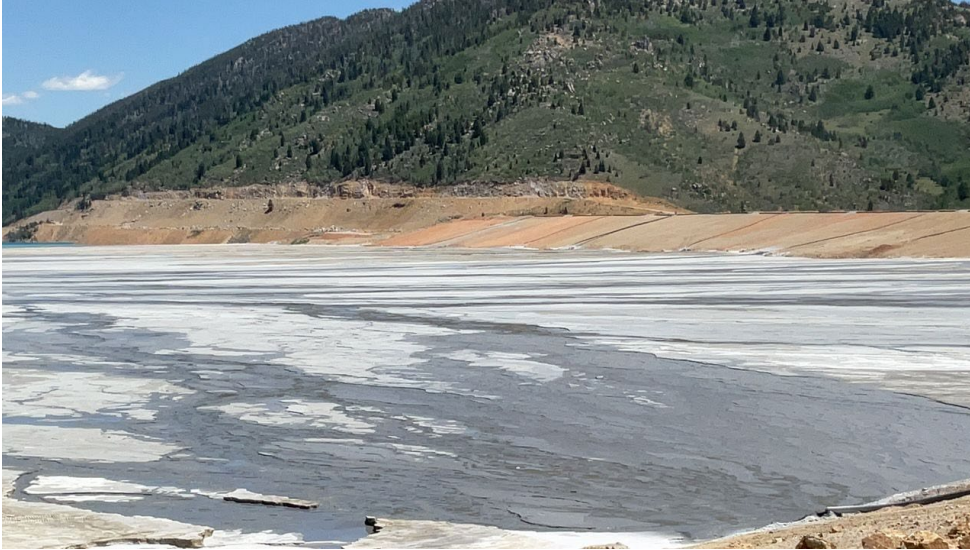
Photo #: 23

Description: Multiple discharge locations are effective at wetting the tailings beach surfaces. The supernatant pond is visible in the distance

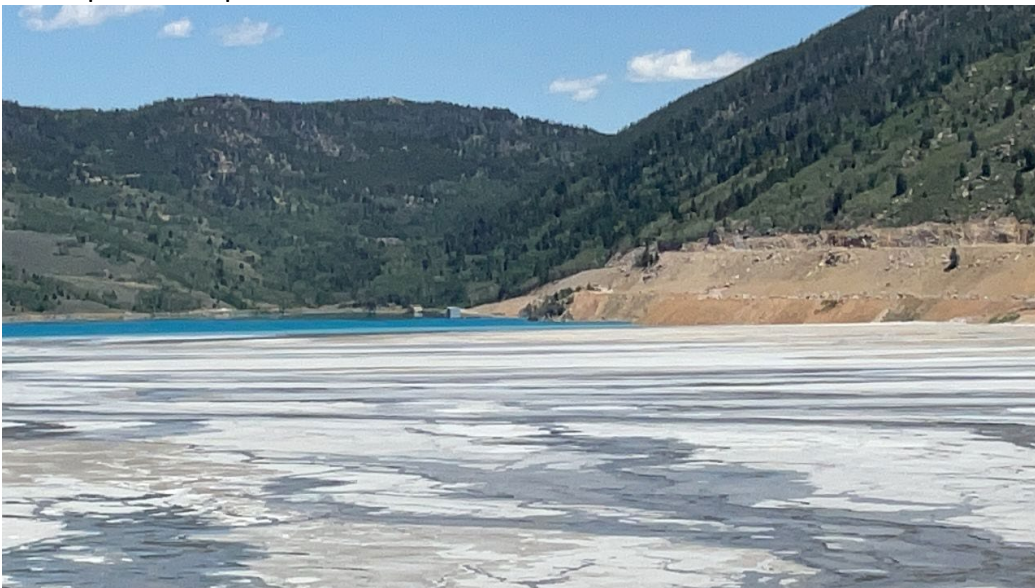
Photo #: 24

The TSF was accessed near Booster Station 3, along a portion of the East-West Embankment. A wide beach area is important to separate the tailings pond from the embankments, thus contributing to the safety and stability of the facility. There are now 28 tailings discharge points around the TSF perimeter, which allow greater flexibility for selectively applying slurry in areas that might become dry and prone to blowing dust, and to control the sequential development of the beach and pond areas (Photos 19 through 23). During this site visit, there were very few surfaces across the beach that were not saturated, and no blowing dust was observed. The placement of magnesium chloride storage tanks and bladders around the TSF also allows for more rapid filling and deployment of the tracked vehicles used for dust suppression (Photos 20 and 21). The new access road to the pond and pumping barge is being utilized (Photos 22 and 23) and the placement of rock along the North-South Embankment to construct a "step-out" and access ramp is ongoing (Photo 24).

Description: Step out and access ramp construction on the North/South Embankment

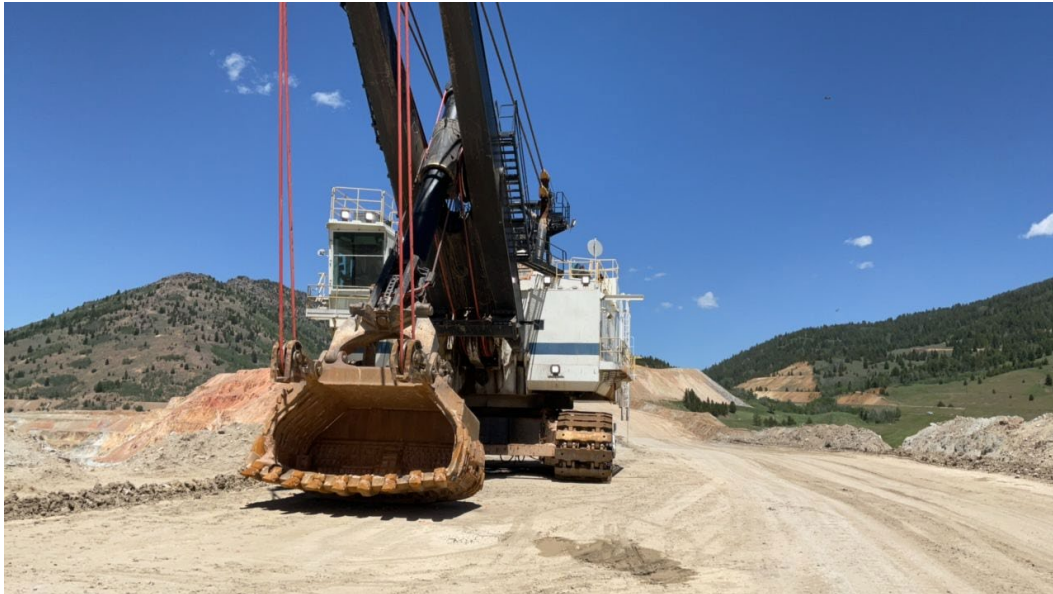
Photo #: 29

As documented in 2022 and 2023 inspections, MR observed areas of instability on the D East highwall in the Continental Pit during fall 2022. Revision MR22-002 was approved on 10/26/2022 for additional disturbance and overburden removal to the east of the highwall (termed "E East"), to create a shallower slope on the rock face and limit future instability (Photos 25 and 26). The blasting plan was later modified in revision 23-003 (approved 9/27/2023) to state that no blasting would occur within 500 feet of the Interstate 15 right-of-way without prior approval from DEQ in consultation with the Montana Department of Transportation (MDT). Disturbance and overburden removal have expanded in this area, but blasting has not yet occurred within a distance that requires additional coordination and approval from DEQ and MDT (Photos 27 through 34). **MR anticipates that blasting within this buffer distance may occur within the next year, so DEQ recommends proactive communication and preparation for any modified blasting methods or traffic control that may be needed.**

Description: Progress of E East layback

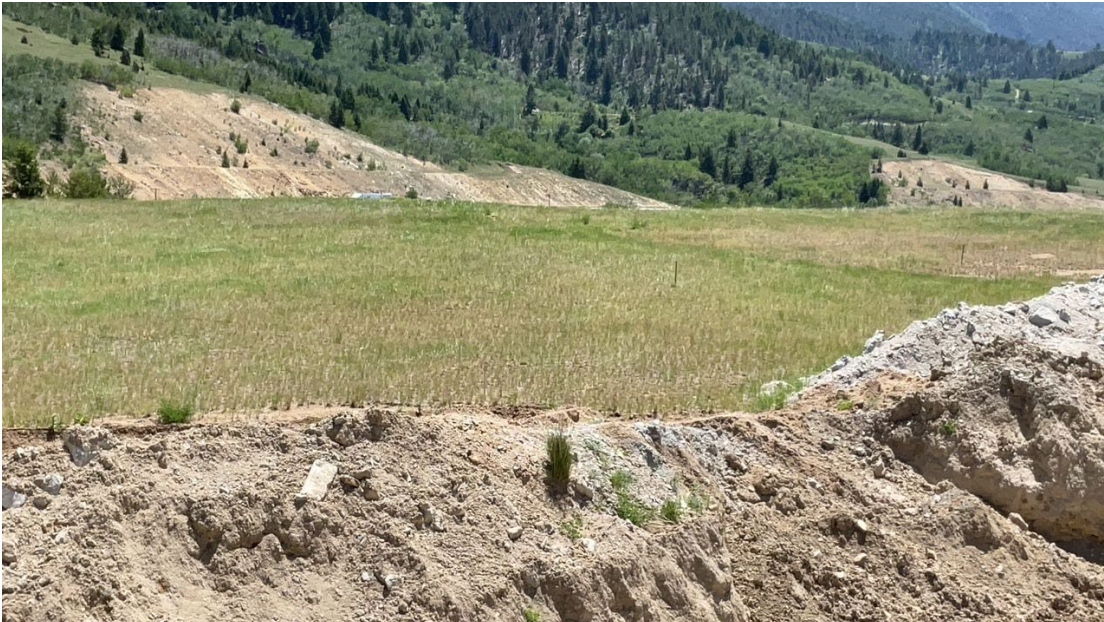
Photo #: 34

Description: Progress of E East layback

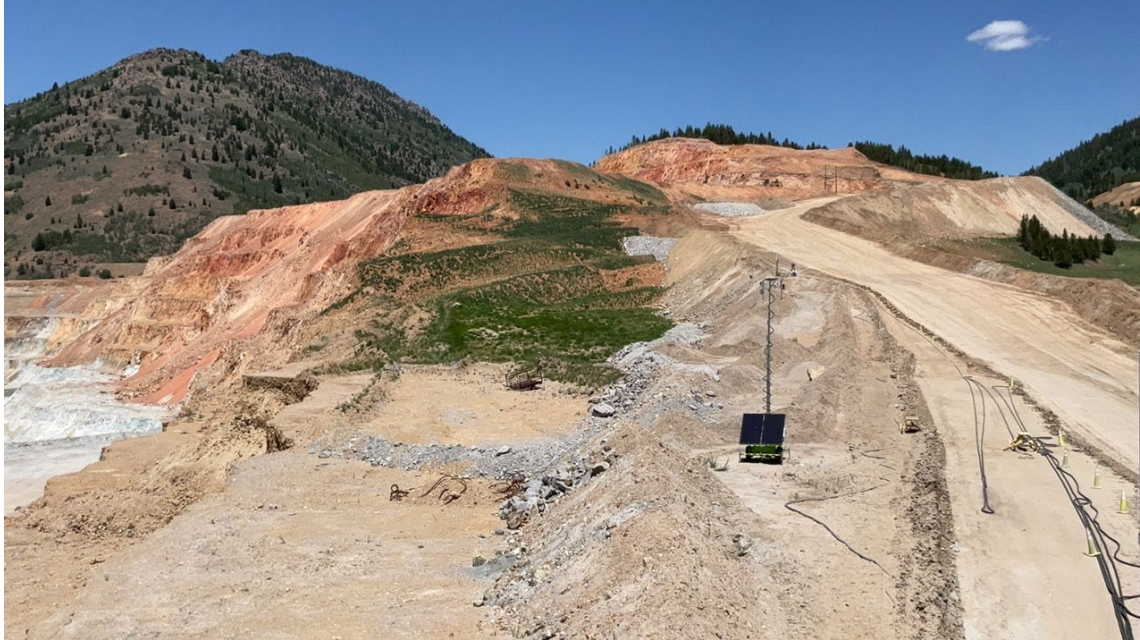
Photo #: 35

Description: Constructed berm and pipeline corridor to maintain storm water and/or process solution capture (see 11/29/2023 inspection for details)
