MONTANA DEPARTMENT OF ENVIRONMENTAL QUALITY  
HARD ROCK MINING BUREAU  
OPERATING PERMIT – FIELD INSPECTION REPORT

Operator: Montana Resources, LLP				Inspection Date: July 18, 2022			
Operating Permit #: 00030			Project: Montana Resources-Continental Mine Complex			County: Silver Bow	
Nearest City or Town(s): Butte							
DEQ Staff: Garrett Smith				Company Representative(s): Mark Thompson			
Agencies w/overlapping Jurisdiction:			USFS		BLM		Other <input checked="" type="checkbox"/> None
Minerals: Copper, molybdenum, minor silver							
Status:		<input checked="" type="checkbox"/>	Active		Inactive		Suspended <input type="checkbox"/> Other <input type="checkbox"/>
Weather: Mostly sunny, windy, high temp 82°F							
Type of Operation:				Purpose of Inspection:			
<input checked="" type="checkbox"/>	Open Pit				Initial (Pre-permitting)		
	Underground			<input checked="" type="checkbox"/>	Regular Compliance		
	Placer				Amendment #		
<input checked="" type="checkbox"/>	<i>Heap Leach- Leach pads near HSB no longer receiving solution</i>				Complaint Received

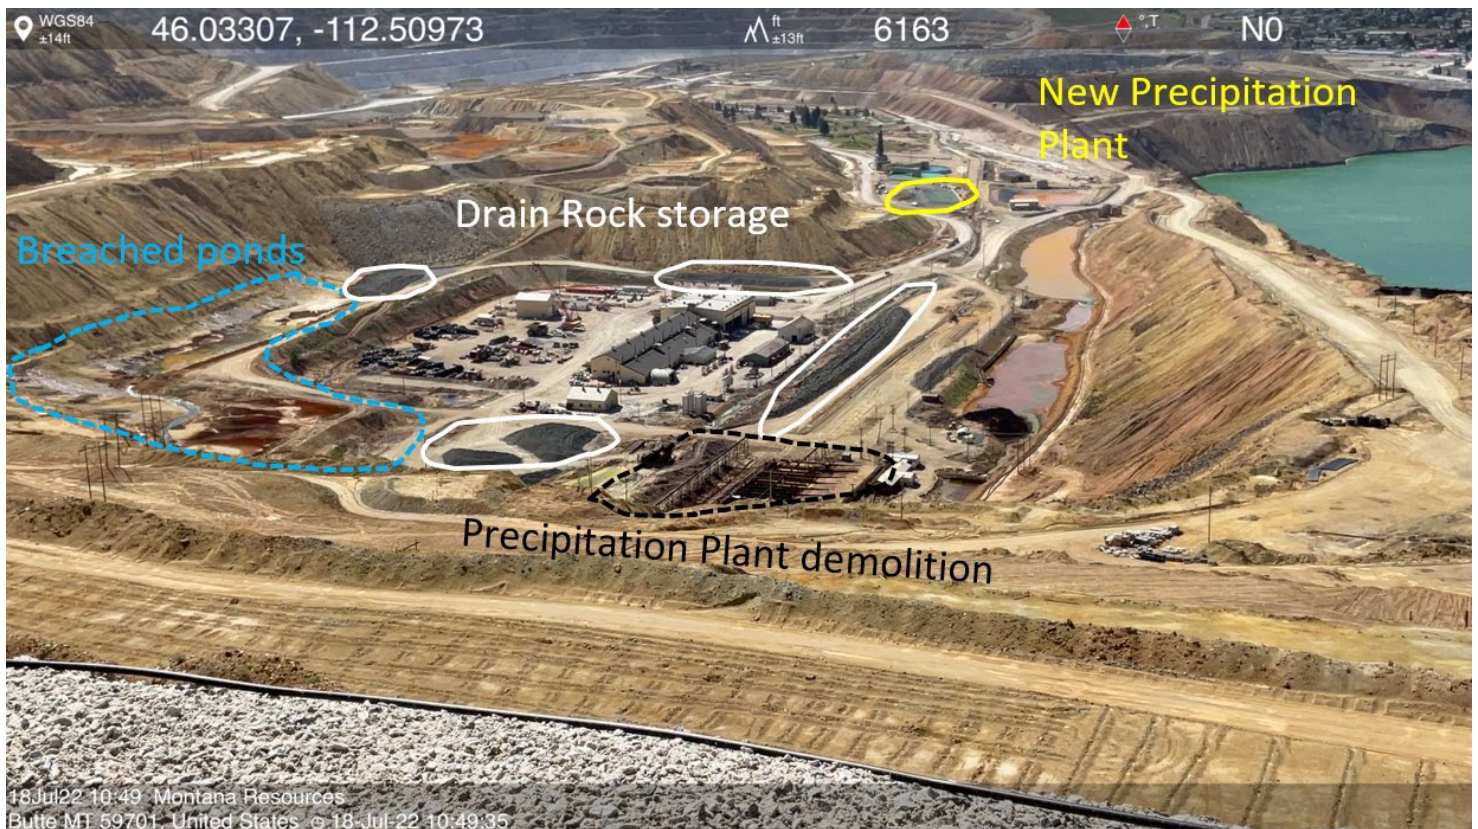
On June 14, 2022, MR submitted a permit modification application to DEQ to allow the construction of a rock disposal site (RDS) within the HSB area, at the southern toe of the YDTI (Photo 1). The feature would include a foundation drainage layer and engineered rock drains to capture and convey seepage flows from underneath the RDS, eventually reaching the management and treatment systems required under the Superfund remedy. Reclamation of the RDS would involve grading the surface to a stable slope, covering with soil, and reseeded. The designs for the RDS and underlying drainage system were certified by the designated Engineer of Record (EOR). Even though the project does not constitute an expansion of a tailings storage facility (as defined in 82-4-303, MCA), the Independent Review Panel (IRP) for the YDTI also reviewed the project plans and provided supportive feedback.

**Photo 1-** Looking south over the HSB area: the former Precipitation Plant is being demolished (lower center, black); water collection ponds at the toe of adjacent leach pads have been breached and drained (left, blue); drain rock from Pipestone Quarry has been placed in stockpiles around the area (white); the construction of the new Precipitation Plant near the HSB Water Treatment Plant (yellow); Berkeley Pit to the distant right.

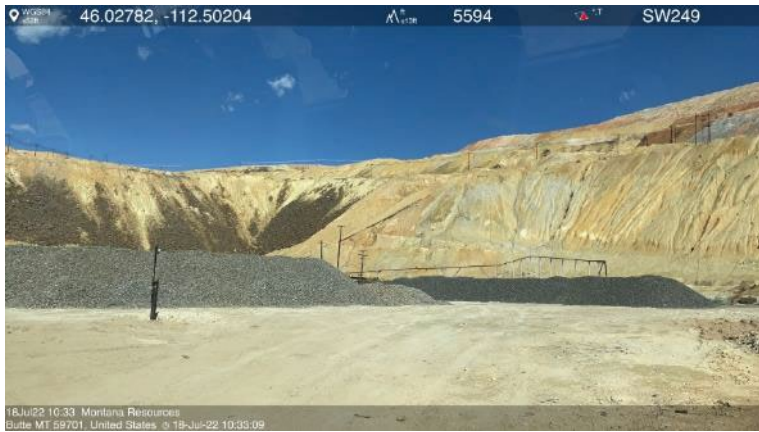
The rock drains underneath the HSB RDS would be constructed with layers of durable rock from the Pipestone Quarry, using similar methods as the WED within the West Embankment. As observed on the site tour, stockpiles of drain rock have been staged around the HSB area (Photo 2). Some fill material and drain rock have also been placed around the east side of HSB, to assist with compaction and drainage of the collection ponds at the toe of adjacent leach pads (Photo 3). The former ponds have been drained and residual seepage flows are being collected and conveyed to the primary HSB Pond through diversion ditches (Photos 4, 5, and 6).

**Photo 2-** Stockpiles of drain rock from the Pipestone Quarry have been staged around the HSB area for future construction of a foundation drainage layer and engineered rock drains. **Photo 3-** Some fill material and drain rock have also been placed around the east side of HSB, to assist with compaction and drainage of the collection ponds at the toe of adjacent leach pads.

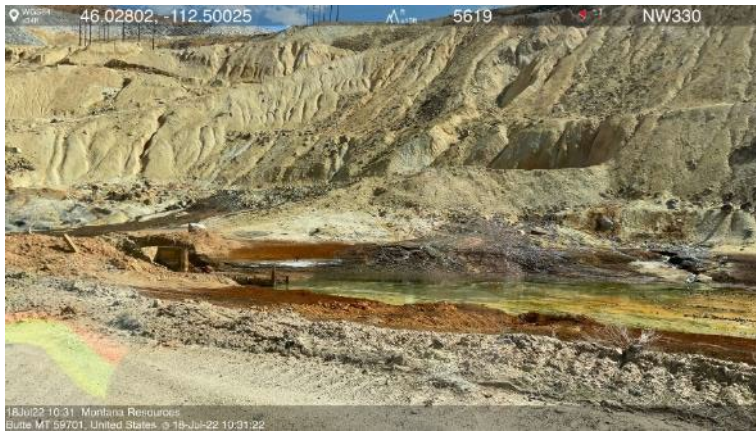
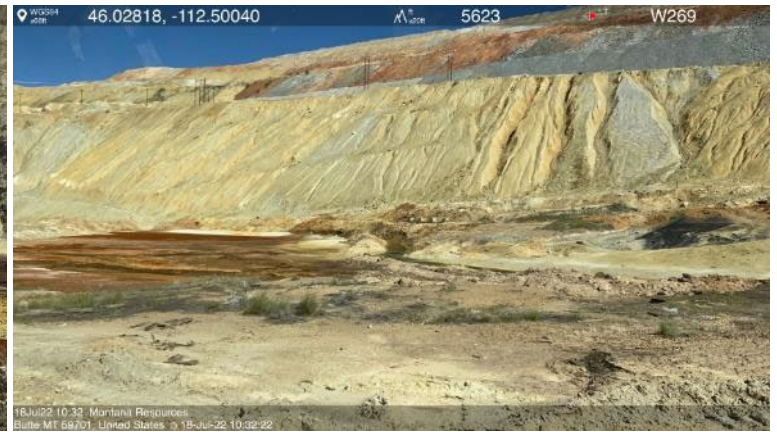
**Photos 4 and 5-** The former collection ponds have been drained and residual seepage flows are being collected and conveyed to the primary HSB Pond through diversion ditches

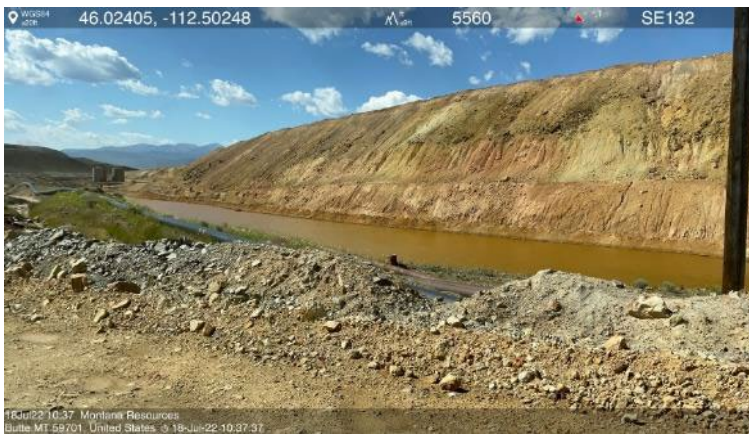
**Photo 6-** The primary HSB Pond, which contains the multiple sources of seepage that emanate from HSB. From this holding pond, water may be diverted to the HSB Water Treatment Plant or pumped into the YDTI. **Photo 7-** The old Precipitation Plant is in the process of being demolished, a few components still remain.

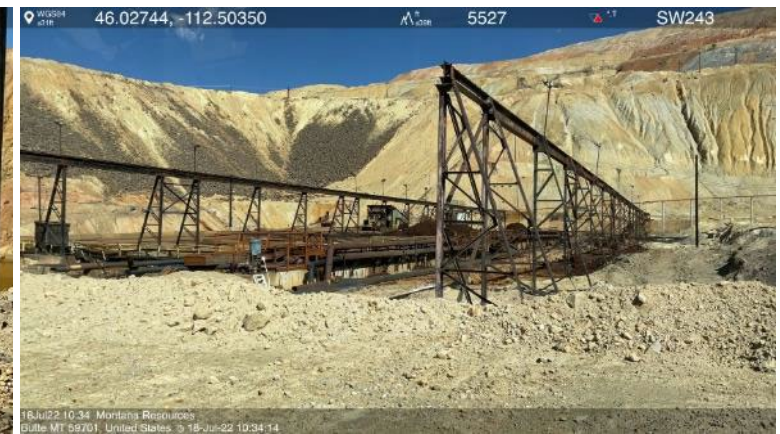
area” footprint of 73 acres within the permit boundary. The approved permit modification for the HSB RDS requires demolition of the old Precipitation Plant, thus eliminating the pre-1971 processing facility that retained the exempt status (Photo 7). The exemption from permitting and bonding requirements would no longer apply to the area, as the remaining buildings and infrastructure are not processing facilities. **The obligated bond required for the permit modification is \$36,500 (73 acres x \$500/acre), consistent with the bonding level for pre-1974 disturbance areas surrounding the HSB. Pending an adjustment of the obligated bond amount held by DEQ, the approved amendment allows MR to proceed with the activities associated with the construction and eventual reclamation of the HSB RDS.**

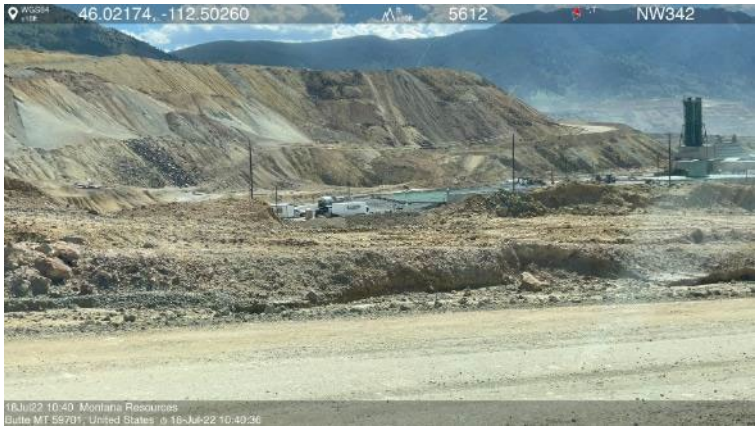
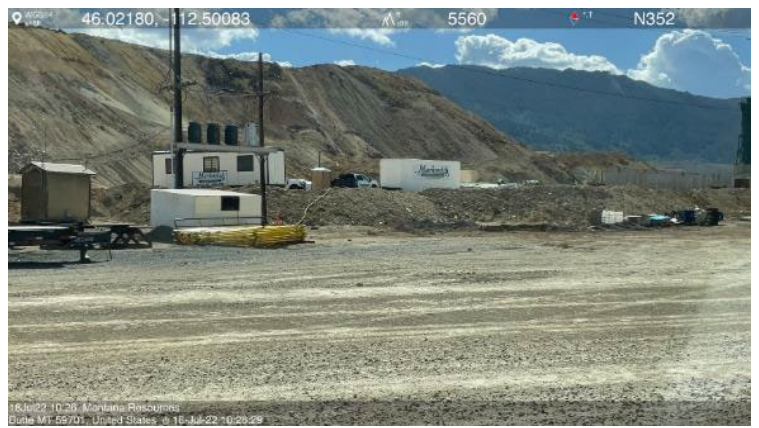
MR submitted a request for permit revision MR22-001 on April 13, 2022 to construct a new Precipitation Plant, approximately 0.5 mile to the south of the old plant within HSB. DEQ provided a deficiency letter on May 3, 2022 with questions about the construction, operation, and reclamation of the plant, as well as the location of the plant in relation to pre-1974 disturbance areas. MR has not responded to the deficiency comments at the time of this inspection, although construction of concrete structures and foundations at the new facility have progressed beyond the ground preparation that was observed on the June 7, 2022 site inspection (Photos 8 and 9).

The new plant location is no longer within the exempt HSB footprint, it is located on previously disturbed ground where no structures exist in the currently approved permit. **Although the precipitation process would continue in a similar manner at the relocated plant, an entirely new facility constructed in a new location constitutes a change to the details of the approved Operations and Reclamation plans. Additional bond may also be required to address reclamation for portions of the facility that occur outside of the pre-1974 disturbance area (82-4-338, MCA and ARM 17.24.141). DEQ contacted MR on July 19, 2022 and explained that this activity is considered a violation of 82-4-336(4), MCA, for departing from an approved plan without obtaining department approval for the proposed change. DEQ will soon provide additional correspondence regarding this noncompliance.**

**Photos 8 and 9-** Construction continues at the proposed location for the new Precipitation Plant, to the north of the HSB Water Treatment Plant. Concrete structures and foundations have been created, although the associated permit revision (MR22-001) has not been approved and a bond adjustment may be necessary.

- Precipitation Plant Relocation- Application for permit revision was submitted on April 13, 2022. Responses are pending from MR to the deficiency comments DEQ provided on May 3, 2022. Construction of the new plant has continued without DEQ’s authorization, and potentially without being adequately bonded. DEQ will provided additional correspondence about noncompliance.

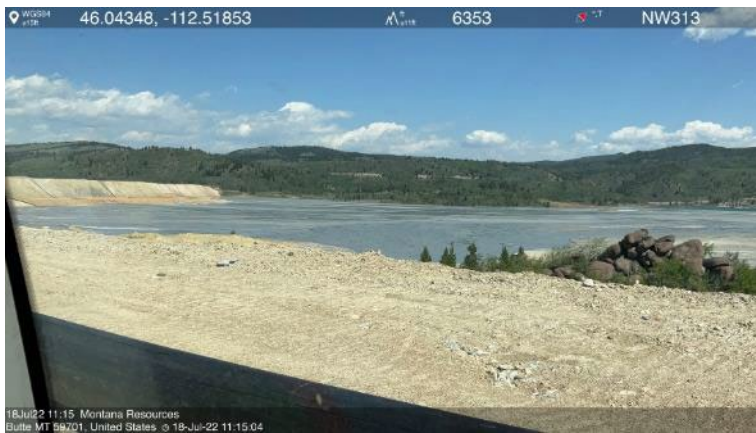
The site tour continued to the YDTI, where the crest elevations are being constructed to an elevation of 6,450 feet. Tailings discharge along the west side of YDTI continues to develop a wide beach between the West Embankment and the supernatant pond (Photos 10 and 11). As the beach surface area increases, additional measures are needed to reduce the potential for blowing dust. MR has installed storage bladders for magnesium chloride around the YDTI, to speed up the process to deploy and refill tracked vehicles onto the beach (Photo 12). During this site visit, wind gusts began around 10:00 AM and exceeded 40 mph through midday. Proactive application of magnesium chloride on the beach took place earlier in the day, although the high winds resulted in fugitive dust blowing from the beach (Photos 13 and 14). The severity of blowing dust would likely have been worse in the absence of the mitigation methods being employed. MR reported that the volume of magnesium chloride used in the first 6 months of 2022 (>600,000 gallons) has exceeded the annual totals used in 2020 and 2021.

**Photo 10-** The interior/upstream face of the West Embankment, with tailings discharge lines across the slope. **Photo 11-** The extraction pond at the south end of the WED, where a pump barge is used to circulate water back into the YDTI.

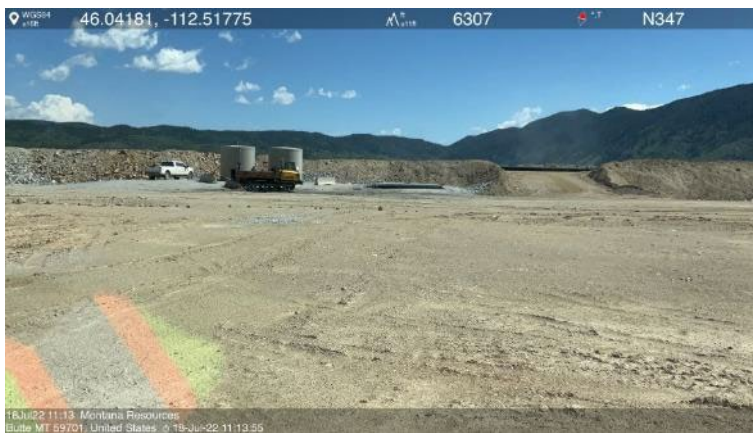
**Photo 12-** MR has installed storage bladders for magnesium chloride around the YDTI, to speed up the process to deploy and refill tracked vehicles onto the beach. **Photo 13-** Tracks across the tailings beach and darkened surfaces indicate the proactive efforts to apply magnesium chloride and limit the potential for fugitive dust.

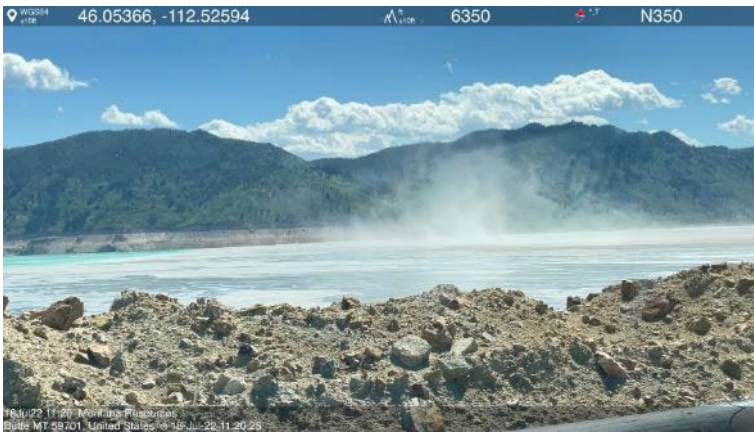
**Photo 14:** Wind gusts began around 10:00 AM and exceeded 40 mph through midday. The severity of blowing dust would likely have been worse in the absence of the application of magnesium chloride. **Photo 15:** At the south end of the West Embankment, the lined extraction pond continues to receive the outflow from the WED installed within the embankment's foundation.

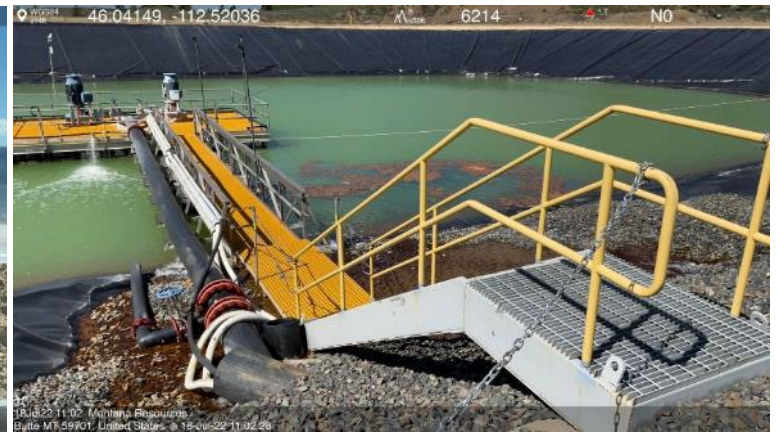
At the south end of the West Embankment, the lined extraction pond continues to receive the outflow from the WED installed within the embankment’s foundation (Photo 15). The drain also collects a lesser amount of groundwater, which generally follows topography and flows eastward from the West Ridge to the West Embankment. The flow rate into the WED extraction pond was typically between 300 and 450 gpm during 2019-2021, but the rate has increased from 450 to 575 gpm in the first quarter of 2022. This increase is likely due to additional tailings discharge along the West Embankment and rapid/direct infiltration of water into the coarse tailings that are adjacent to the WED. The measured flows remain below the design capacity of the WED (4,500 gpm).

Water quality monitoring results from the extraction pond are provided in the 2021 Annual Progress Report. Although the TSF pond had an average pH of 10.3, the water reporting to the extraction pond had an average pH of 3.31 and the concentration of sulfate and some metals (Al, Cd, Cu, Fe, Mn, Pb, U, Zn) are enriched in the extraction pond as

compared to the tailings pond. This indicates the current level of reactivity of the materials that are encountered by water entering the WED. **Monitoring the WED water quality and flow rates should continue as specified in the Operating Plan. The monitoring results should also be compared to the modeling assumptions that were included in Amendment 010. This information will further inform the development of future plans to expand the TSF, with respect to evaluating the performance of the WED and the potential options to manage the long-term outflow.**

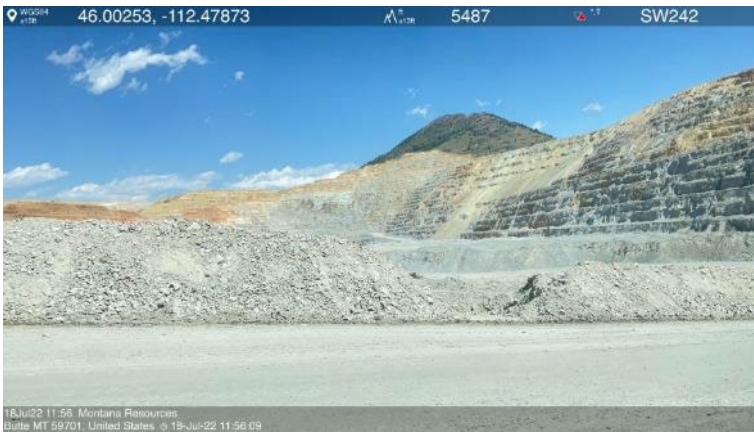
The tour concluded with the Continental Pit, where mining continues within the D East, D North, and C Block portions of the pit (Photo 16). This also provided a good view of the west highwall, which reveals the Central Zone alluvium above an iron-rich oxidized cap, which occurs above an enriched ore zone that occurs in the area between the Berkeley and Continental Pits (Photo 17). This area may be developed as part of future mining, which would likely be a component of a pending major amendment.

**Photo 16-** Mining continues within the D East, D North, and C Block portions of the Continental Pit. **Photo 17-** The west highwall of Continental Pit, which reveals the Central Zone alluvium (brown) above an iron-rich oxidized cap (red), which occurs above an enriched ore zone.
