**MONTANA DEPARTMENT OF ENVIRONMENTAL QUALITY  
HARD ROCK MINING SECTION, MINING BUREAU  
OPERATING PERMIT – FIELD INSPECTION REPORT**

Permittee: Montana Resources, LLC				Inspection Date: September 4, 2024					
Operating Permit #: 00030			Project: Montana Resources- Continental Mine Complex			County: Butte-Silver Bow			
Nearest City or Town(s): Butte									
Inspector(s): Garrett Smith				Permittee Rep(s): Jeremy Fleege, Mark Thompson					
Agencies w/overlapping permit jurisdiction:		USFS		BLM		X	Other (EPA)	None	
Minerals: Copper, molybdenum, minor silver									
Status:		X		Active		Inactive		Suspended	Other
Weather: Mostly sunny and smoky, high temp 81°F									
Type of Operation:				Purpose of Inspection:					
X	Open Pit				Initial (Pre-permitting)				
	Underground			X	Regular Compliance				
	Placer				Amendment #      MR#				
X	<i>Leach- Leach pads near HSB not receiving solution</i>				Complaint Received				
X	Tailings Storage Facility: [ X ] Active or [ ] Inactive				Bond Release				
	Mill			X	Other (tour, data collection, baseline, TSF, etc.)- <i>TSF records review is attached</i>

Hard Rock OP Mining Section  
Inspection Photo Log  
Permit: 00030 Montana Resources  
In

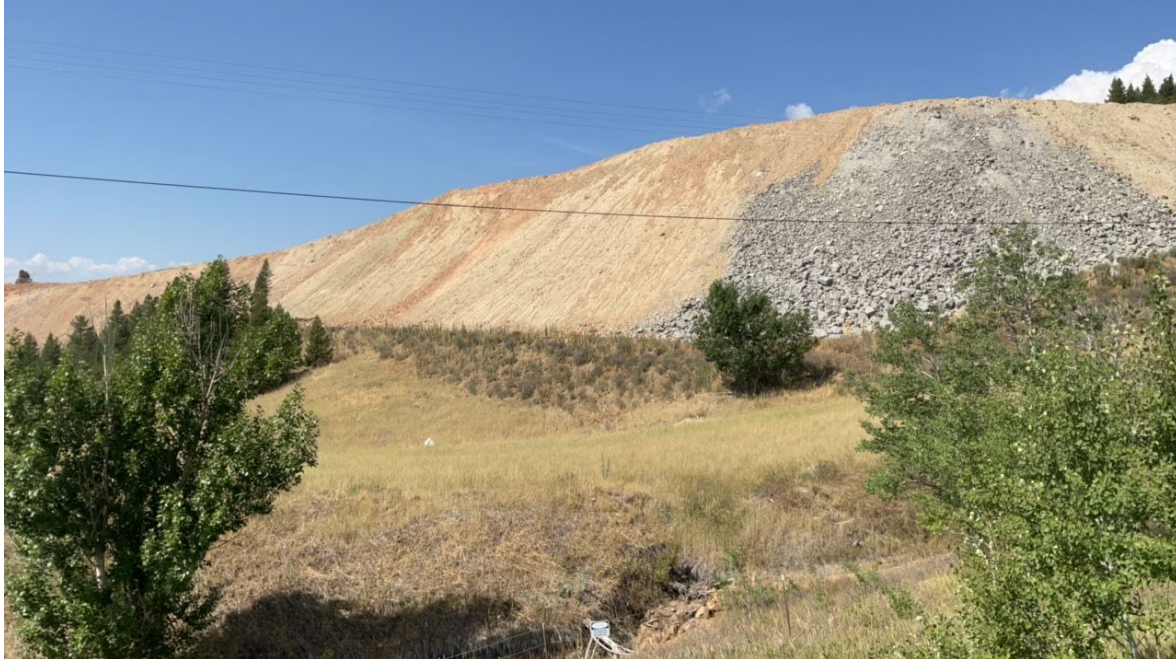
Photo #: 2

Description: Disturbance associated with the E East layback area, reclamation on grassy slopes below.

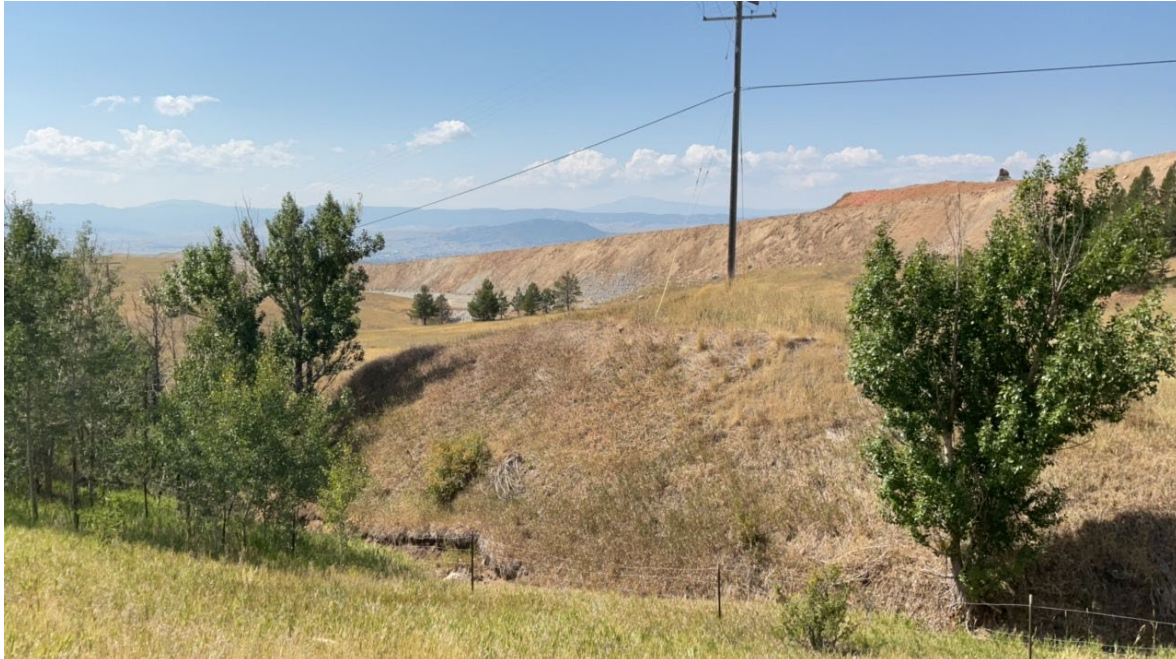
Photo #: 3

Description: Disturbance associated with the E East layback area, larger areas of reclamation to the south.

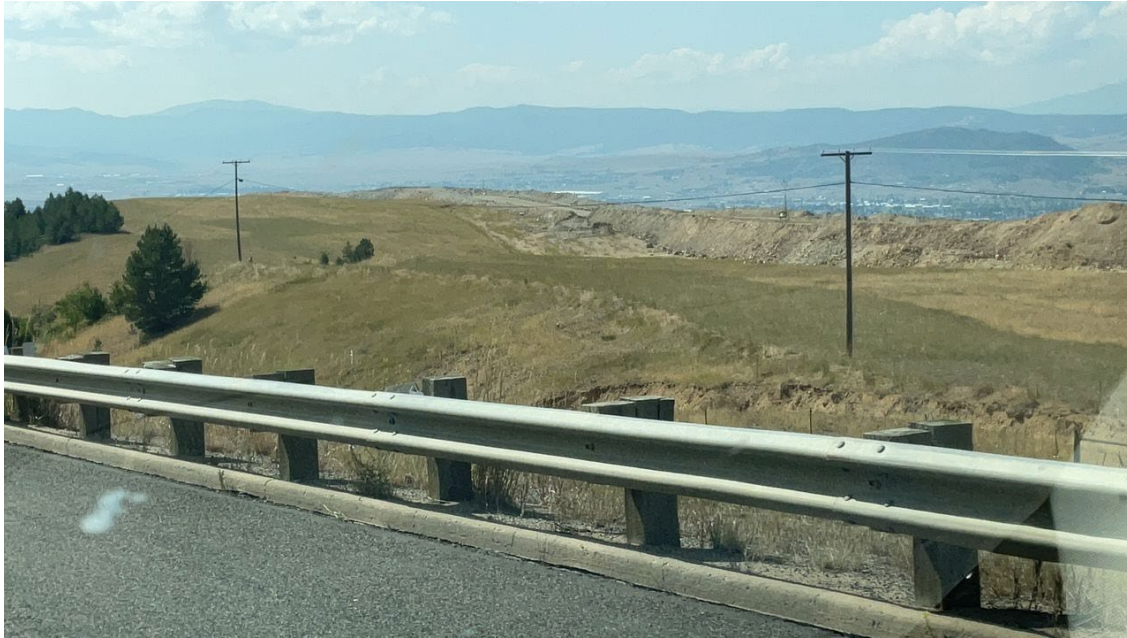
Photo #: 4

Description: Reclamation on the East Dump Complex appears stable, with only minor areas of erosion.

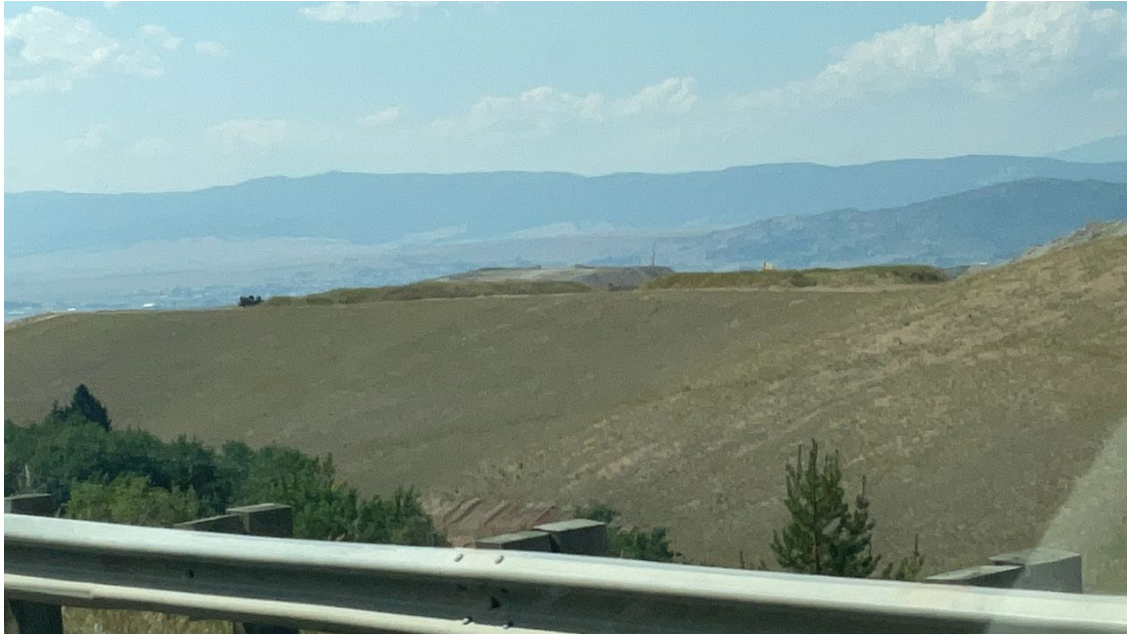
Photo #: 5

Description: Reclamation on the East Dump Complex appears stable, with only minor areas of erosion.

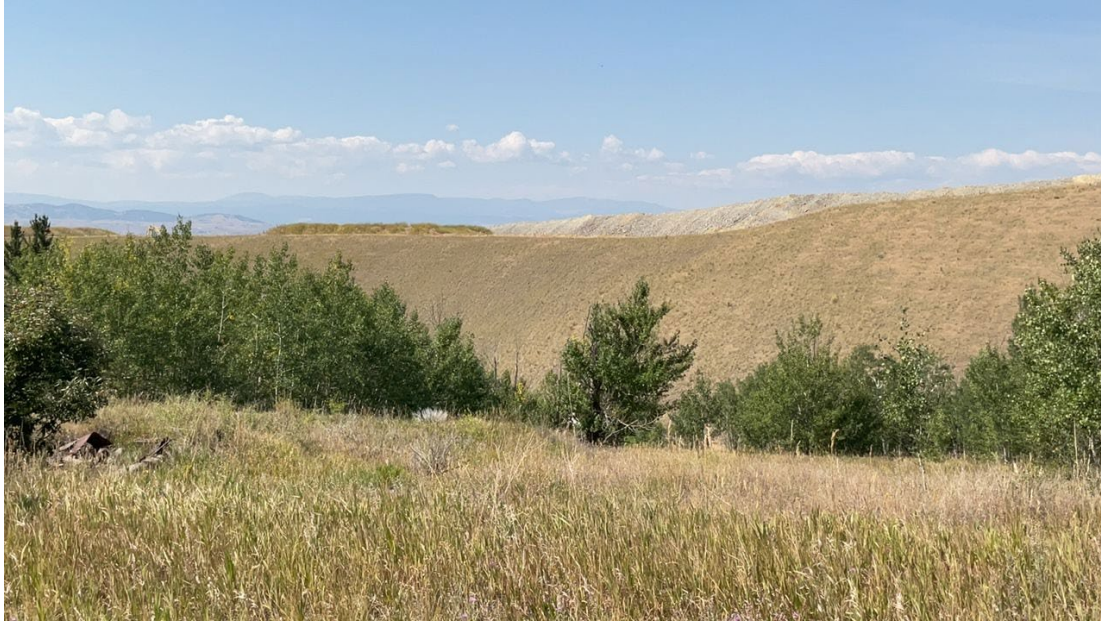
Photo #: 6

Description: Reclamation on the East Dump Complex appears stable (distant), with only minor areas of erosion.

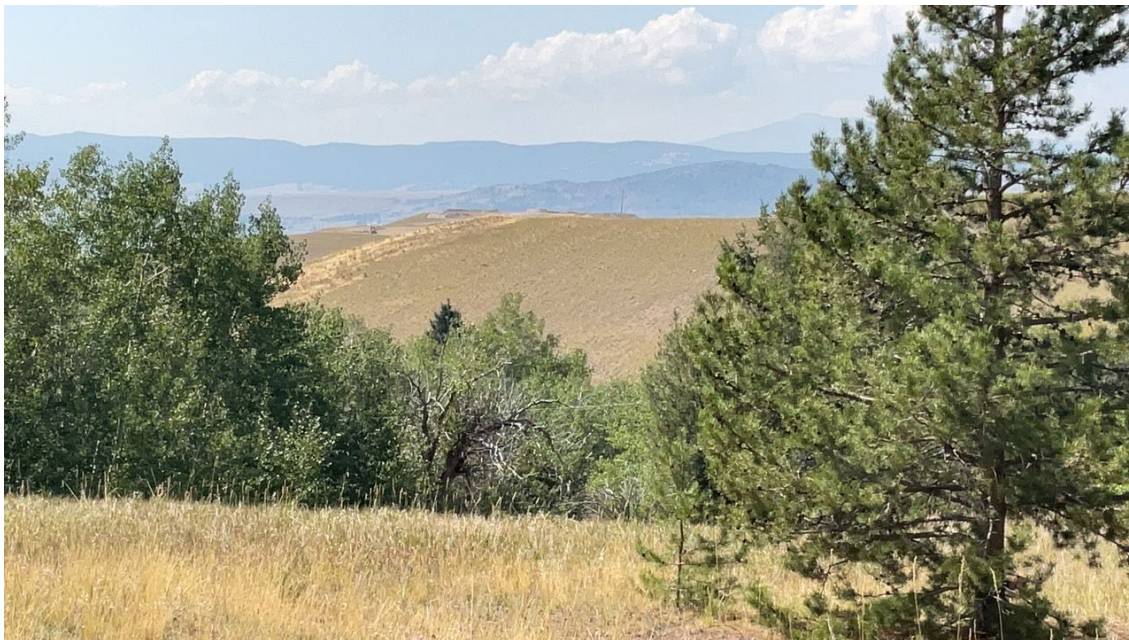
Photo #: 7

Description: The access road leading to Clear Water Ditch and East Dump reclamation has minor erosion.

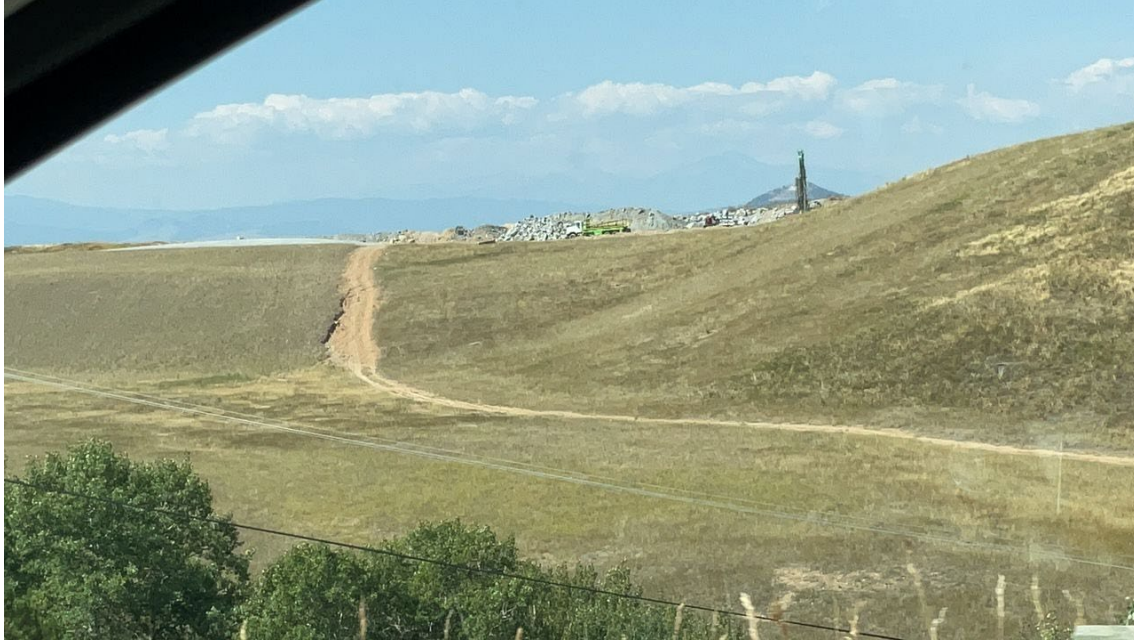
Photo #: 8

Description: Reclamation on the East Dump Complex appears stable, with only minor areas of erosion.

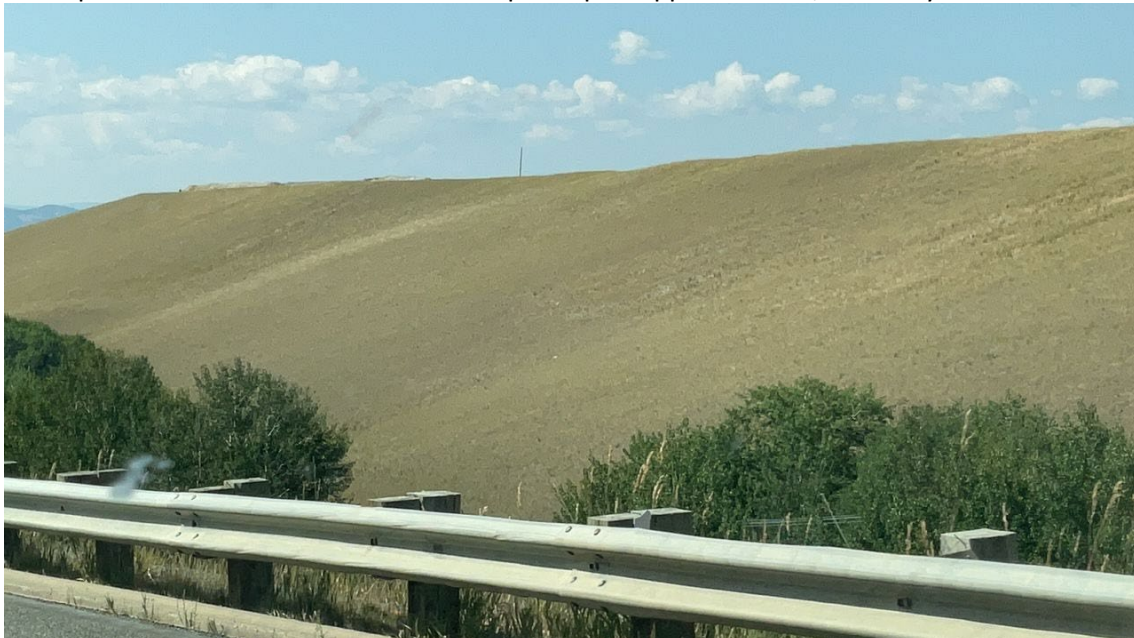
Photo #: 9

Disturbance and overburden removal has continued in the E East area (Photos 9 through 14). The blasting plan was modified through revision 23-003 to state that no blasting would occur within 500 feet of the Interstate 15 right-of-way

Description: The layback around E East is ongoing, creating a shallower angle in the overall highwall configuration. Interstate is beyond the right margin of photo.

without prior approval from DEQ in consultation with the Montana Department of Transportation (MDT). However, blasting has not yet occurred within a distance that requires additional coordination and approval from DEQ and MDT. **MR anticipates that blasting within this buffer distance may occur over the next year, so DEQ recommends proactive communication and preparation for any modified blasting methods or traffic control that may be needed.**

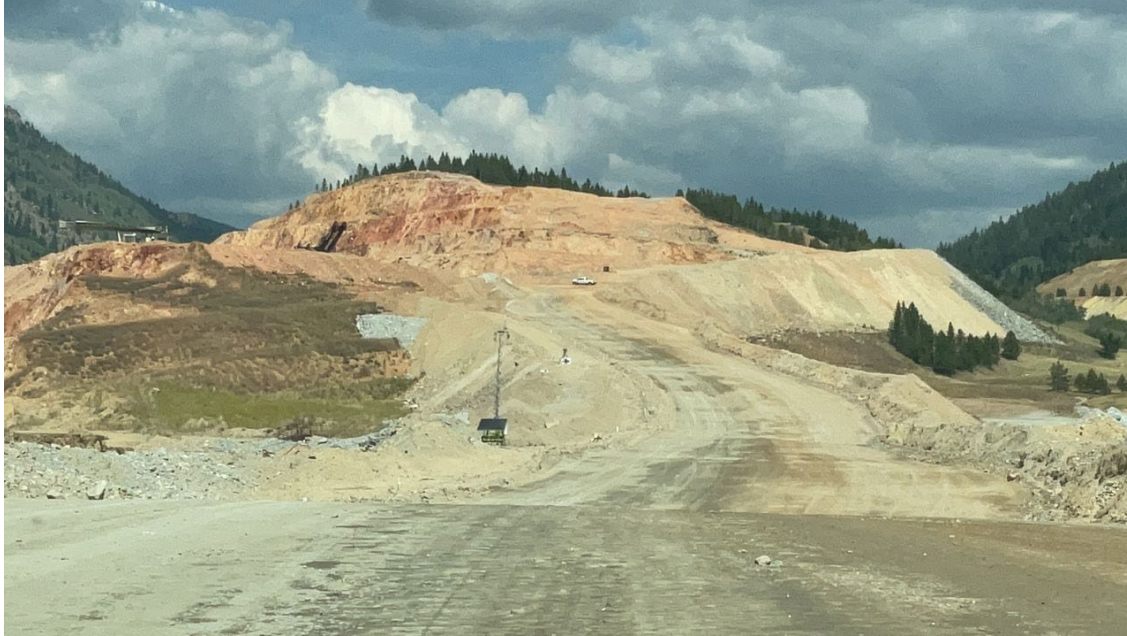
Photo #: 10

Description: Drilling, blasting, and hauling material from layback area.

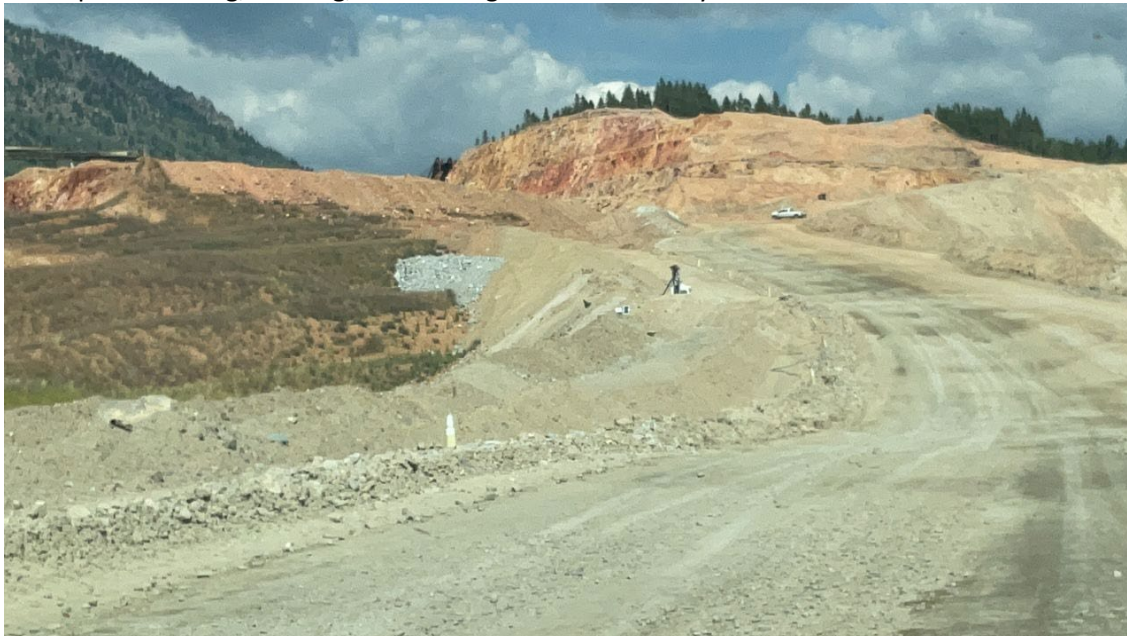
Photo #: 11

Description: Drilling, blasting, and hauling material from layback area.

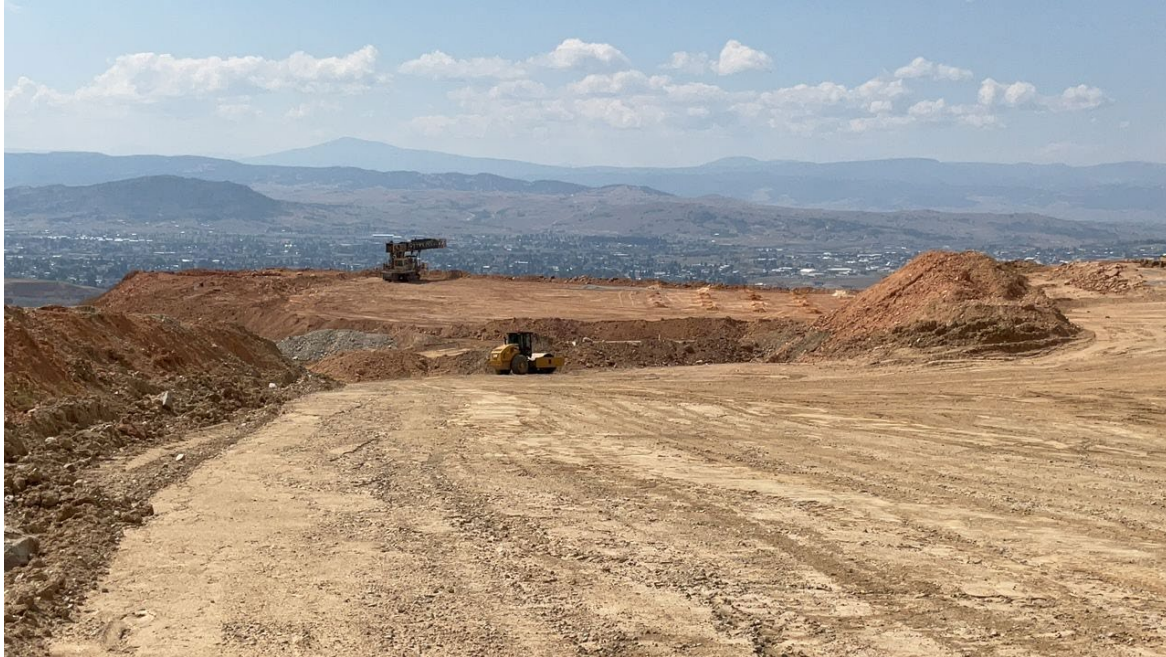
Photo #: 12

Description: Drilling, blasting, and hauling material from layback area.

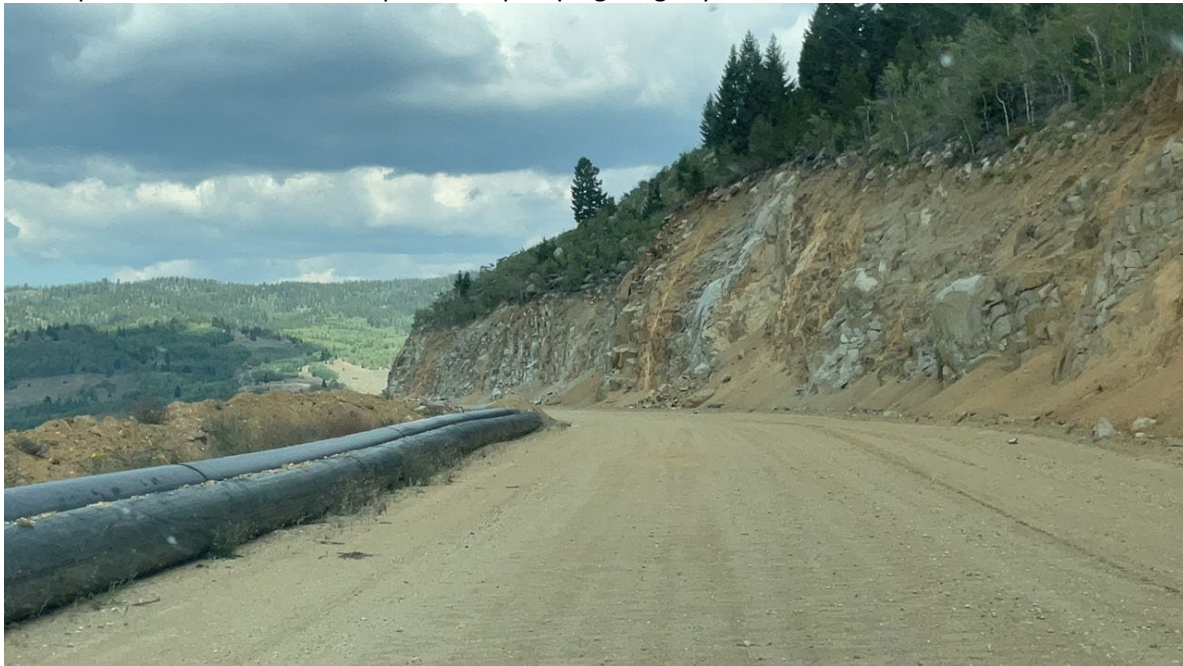
Photo #: 23

After passing by the ongoing construction of the “mega ramp” along the southeast side of the TSF (Photo 21), the TSF beach and pond were accessed along the barge access road (Photos 22, 27, and 28). Grading and alluvium placement have occurred on the upstream faces of the embankments, in accordance with Engineer of Record (EOR) recommendations (Photos 23, 29, and 30). The EOR will be conducting the annual facility inspection during the week of September 23<sup>rd</sup>. Construction of the embankment crests to an elevation of 6,450 feet has occurred across the facility, with the exception of a small area in the northwest corner (construction pending). Other aspects of construction, monitoring, and maintenance are being conducted in accordance with the Design Document, Tailings Operation Maintenance and Surveillance (TOMS) Manual, and annual recommendations from the EOR. See TSF Addendum for additional details.

Description: Grading and alluvium placement have occurred on the upstream face of the North-South embankment, in accordance with EOR recommendations.

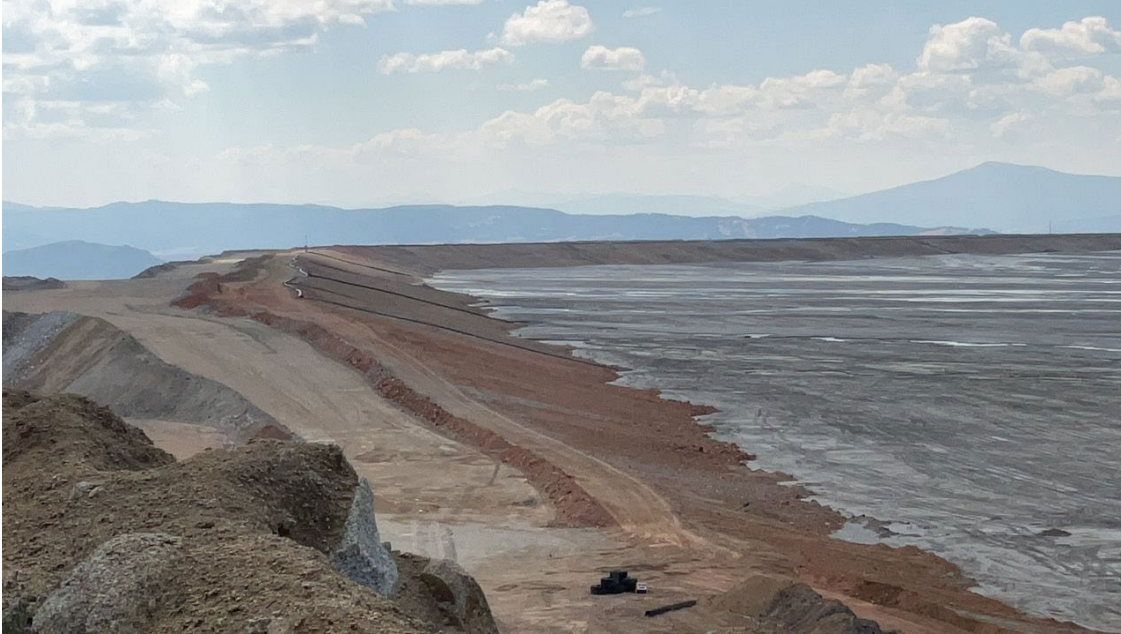
Photo #: 24

A wide beach area is important to separate the tailings pond from the embankments, thus contributing to the safety and stability of the facility. There are 28 tailings discharge points around the TSF perimeter, which allow greater flexibility for selectively applying slurry in areas that might become dry and prone to blowing dust, and to control the sequential development of the beach and pond areas (Photos 24 through 26, 29 through 33). The tailings beach is saturated in many places and tracks are visible from vehicles spraying magnesium chloride for dust control, there was no blowing dust observed on this site inspection.

Description: The tailings beach is saturated in many places and tracks are visible from vehicles spraying magnesium chloride for dust control.

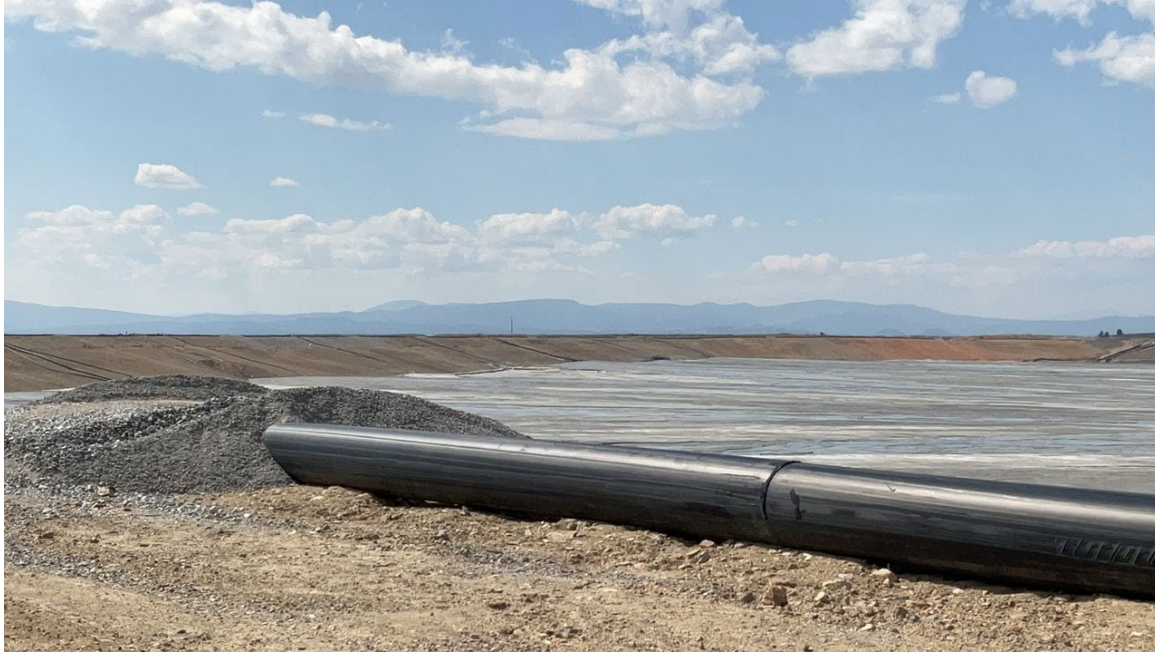
Photo #: 30

Description: Grading and alluvium placement on the upstream face of the East-West Embankment.

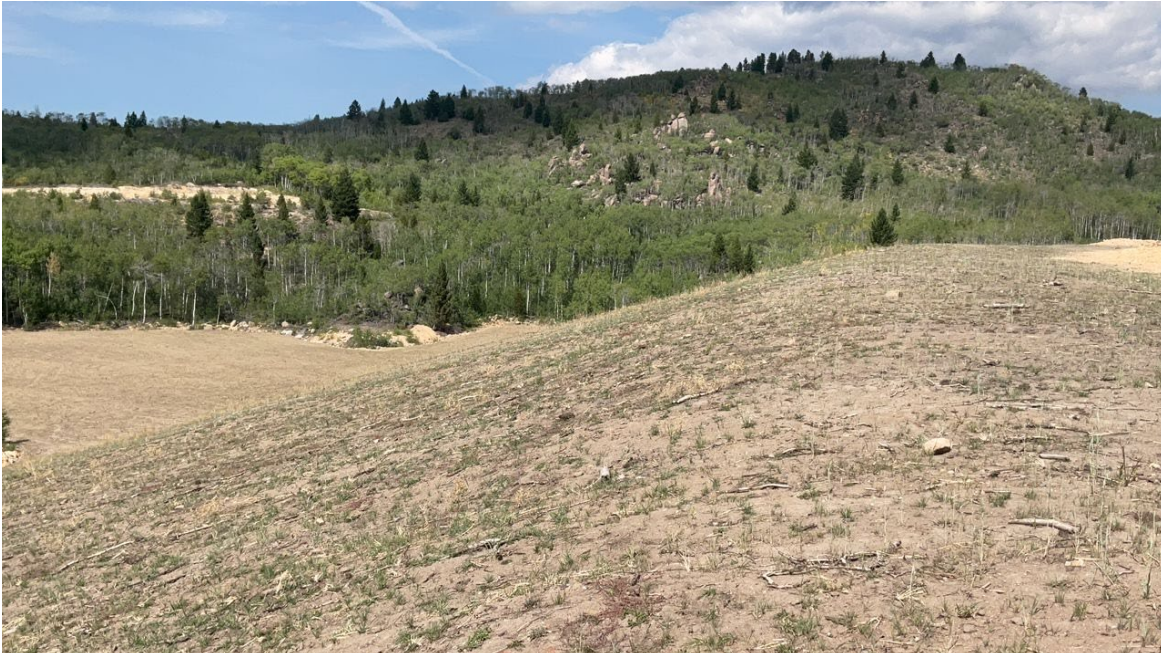
Photo #: 35

In late 2023, grading and soil placement occurred over approximately 21.7 acres on the downstream face of the West Embankment. These areas were seeded in early June 2024 and the initial vegetation has started to grow (Photos 34 through 36). The coverage looks good at this point, with very few weeds observed. The level of germination is a bit surprising, given the hot and dry conditions in the past few months. A small portion of the area (2.7 acres) was covered with variable depths of topsoil and organic amendments, as test plots for investigating alternative reclamation strategies (Photos 38 through 42). The test plot areas show comparable growth at this point and all areas will be monitored over the upcoming growing seasons. **If new methods are ultimately identified and proposed for completing the final reclamation, the Reclamation Plan must be revised accordingly. If test plot areas fail to meet the requirements for comparable stability and utility to adjacent lands (82-4-336(9), MCA), then additional reclamation work would be required (i.e. alluvium or soil placement) in order to comply with the approved Reclamation Plan and to be eligible for bond release.**

Description: Early growth on West Embankment slopes, seeded in early June 2024.

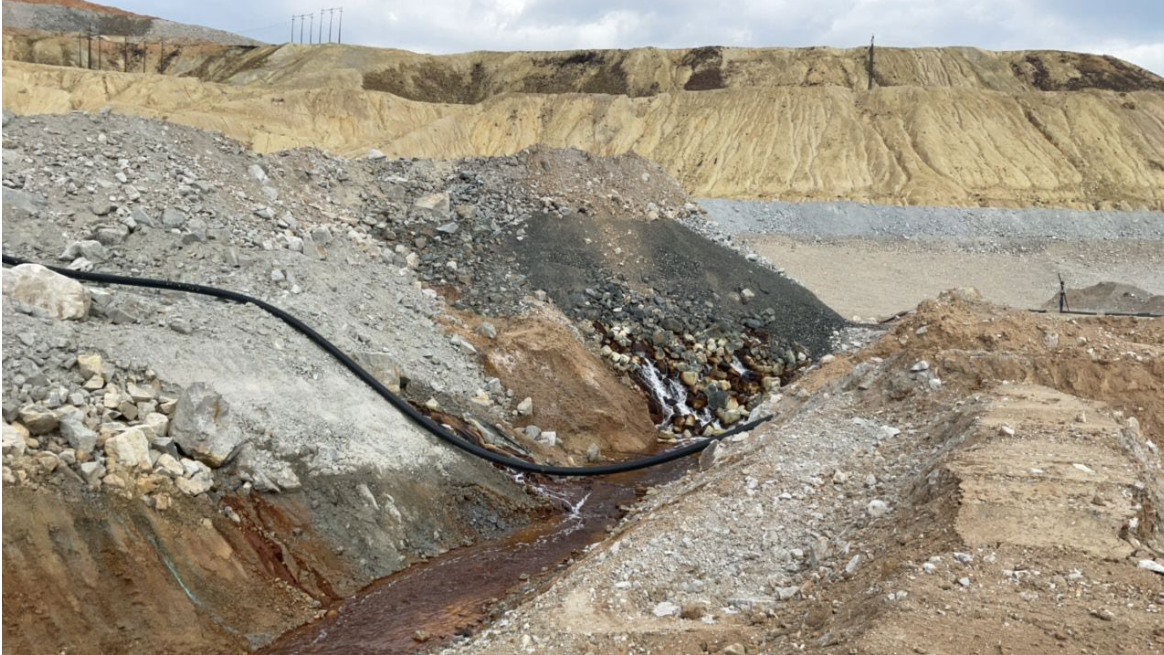
Photo #: 52

The construction of layered rock drains and seepage conveyance features continues, and the old precipitation plant has been completely demolished and removed (Photos 48 through 52). In some areas, a cross section of the multi-layer drain was visible, in addition to seepage emanating from the contact of the rock drain and underlying ground surface.

Description: Contact of rock drain and underlying surface, zones within the drain are visible.
