**MONTANA DEPARTMENT OF ENVIRONMENTAL QUALITY
HARD ROCK MINING BUREAU
OPERATING PERMIT – FIELD INSPECTION REPORT**

| Operator: Montana Resources, LLC | | | | Inspection Date: September 6, 2023 | | | | |
| Operating Permit #: 00030 | | | Project: Montana Resources- Continental Mine Complex | | | County: Silver Bow | | |

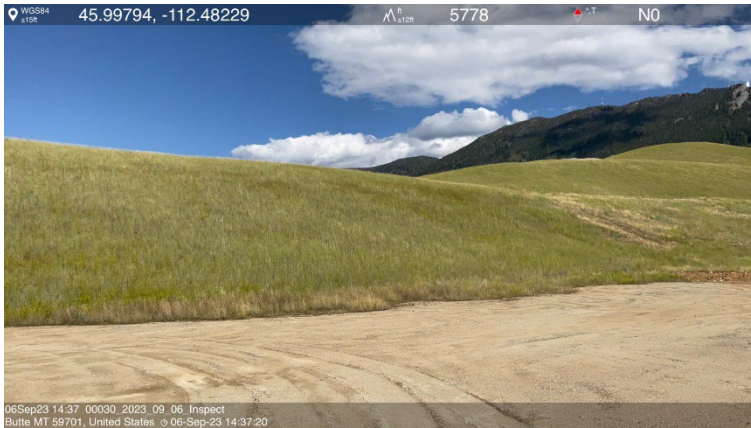
The inspection began on the southeast portion of the permit area, where the south end of the East RDS has been reclaimed and revegetated within the past 5 to 6 years. As noted through monitoring conducted by Westech (2021 and 2022 Annual Reports), the vegetation is establishing well in most areas (Photo 1). There are a few areas of minor rilling and erosion on the slopes that do not appear to be expanding from year to year. There are also some “hot spots” where the vegetation is sparse, particularly on portions of the southern Hillcrest RDS slope that were reclaimed and vegetated decades ago (Photo 2). As described by Westech, “Hot spots are small areas without typical reclamation, although they are surrounded by typical reclamation at the Hillcrest RDS. Hot Spots contain high metal concentrations, have low pH, and support very little vegetation. It is unclear what created these features and whether any reclamation occurred on them; hot spots may be the result of uneven coversoil distribution over acidic alluvium, a past disturbance that removed the coversoil and vegetation, or some other activity.”

Photo 1- Revegetation on the southern slopes of the East RDS is looking good. **Photo 2-** A “hot spot” on the Hillcrest RDS shows less vegetation than surrounding slopes with more recent reclamation, although the soil is not completely bare. Sampling and monitoring indicate some test plot areas received atypical reclamation in the 1990s, rather than hot spots being a failure of current reclamation practices.

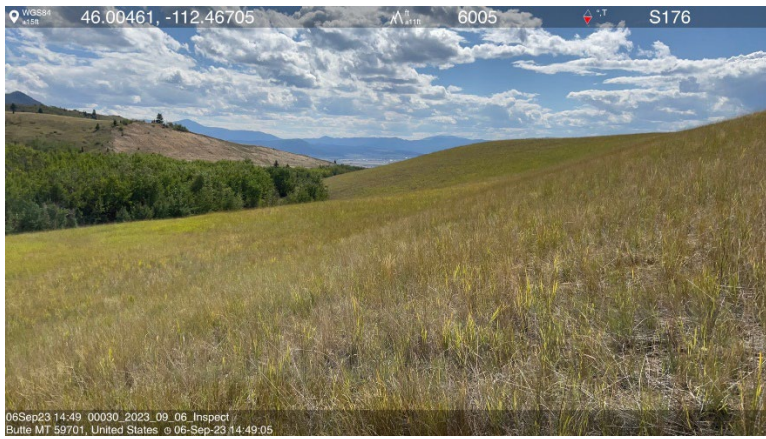
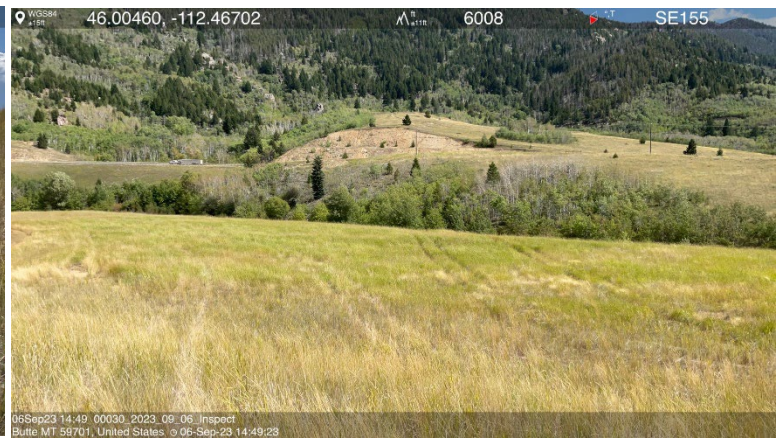
The next stop was the east slope of the East RDS which faces Interstate 15. Like much of the south end of the complex, vegetation is looking good across this area (Photos 3 and 4). There are a few areas of rilling and erosion on the slopes that do not appear to be expanding, repair activities are not yet warranted. A variety of perennial species continue to establish across the slopes, following a reduction in some interim/pioneer species (e.g. sterile triticale). Previous inspections noted abundant knapweed in some areas near the primary access road down the East RDS slope, but control efforts appear to have reduced the extent of weeds. This access road has been damaged with recent storm runoff, preventing further travel by a light vehicle (Photo 5). **Monitoring should continue in the future to document the progression of vegetation and identify any maintenance work that may be needed for areas of erosion, poor soil quality, or other growth-limiting factors. Weed control and other vegetation and soil maintenance activities should continue across the East RDS when necessary. Repairs to the access road are recommended to limit further degradation and water infiltration into the waste rock below the road.**

Photos 3 and 4- The eastern slopes of the East RDS are showing good vegetation establishment, with few erosional features observed. Weed control has reduced knapweed that was previously observed in this area, but spraying should continue as needed.

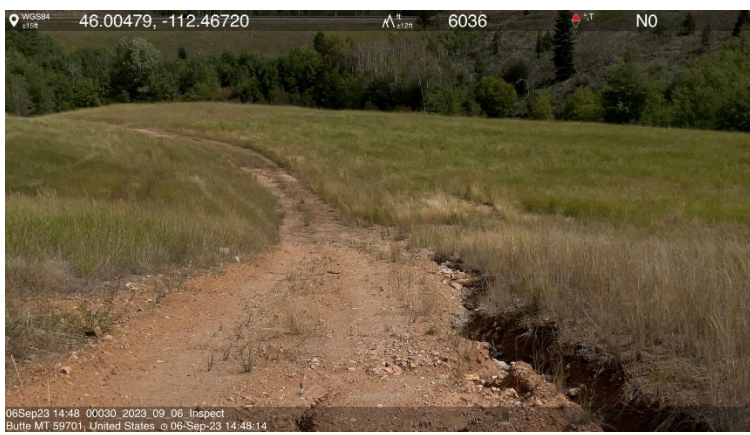
Photo 5- The primary access road on the East RDS has been eroded by recent storm events, preventing light vehicle traffic. When practicable, this feature should be repaired to restore access. **Photo 6-** A failure occurred in the central portion of the D East highwall in 2022, vegetation removal and soil salvage has occurred to the east (right) of the highwall as part of constructing an access ramp for the layback.

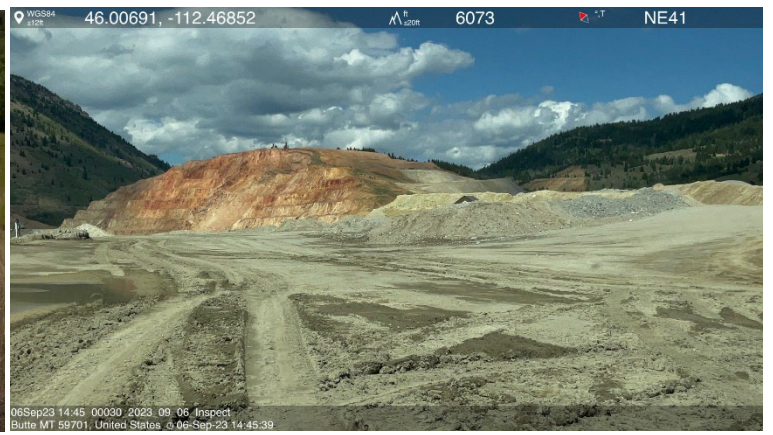
MR observed areas of instability on the D East highwall in the Continental Pit during fall 2022. Revision 22-002 was approved on 10/26/2022 for additional disturbance and overburden removal to the east of the current extent of the highwall, to create a shallower slope on the rock face and limit future instability (Photo 6). Vegetation removal and soil salvage has occurred to the east of the highwall as part of constructing an access ramp and this material is stockpiled in other locations along the East RDS. No changes were made to the current provisions in the Operating Plan about blasting within the Continental Pit, which state:

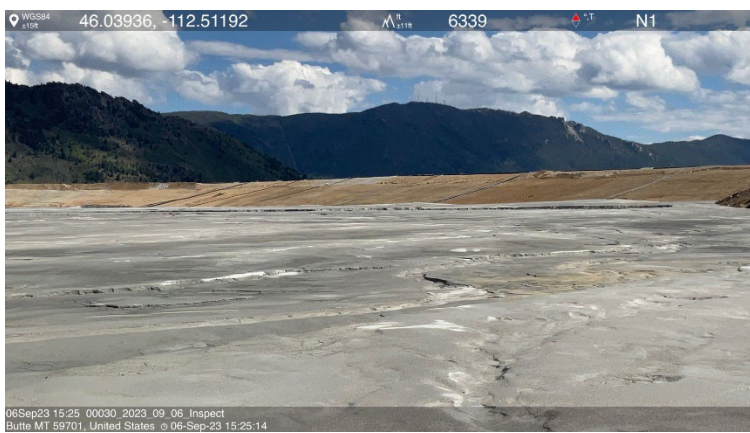
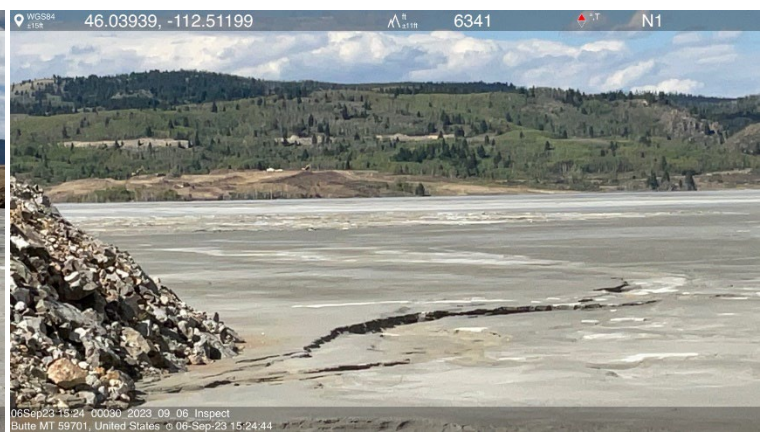
Photo 7- Additional tailings discharge lines allow greater flexibility for selectively applying tailings slurry in areas that might become dry and prone to blowing dust, and to control the uniform development of the beach and pond areas. The internal face of the embankment has been covered with alluvium and graded. **Photo 8-** As seen across the extent of the tailings beach, soil salvage is occurring along the north end of the West Embankment.

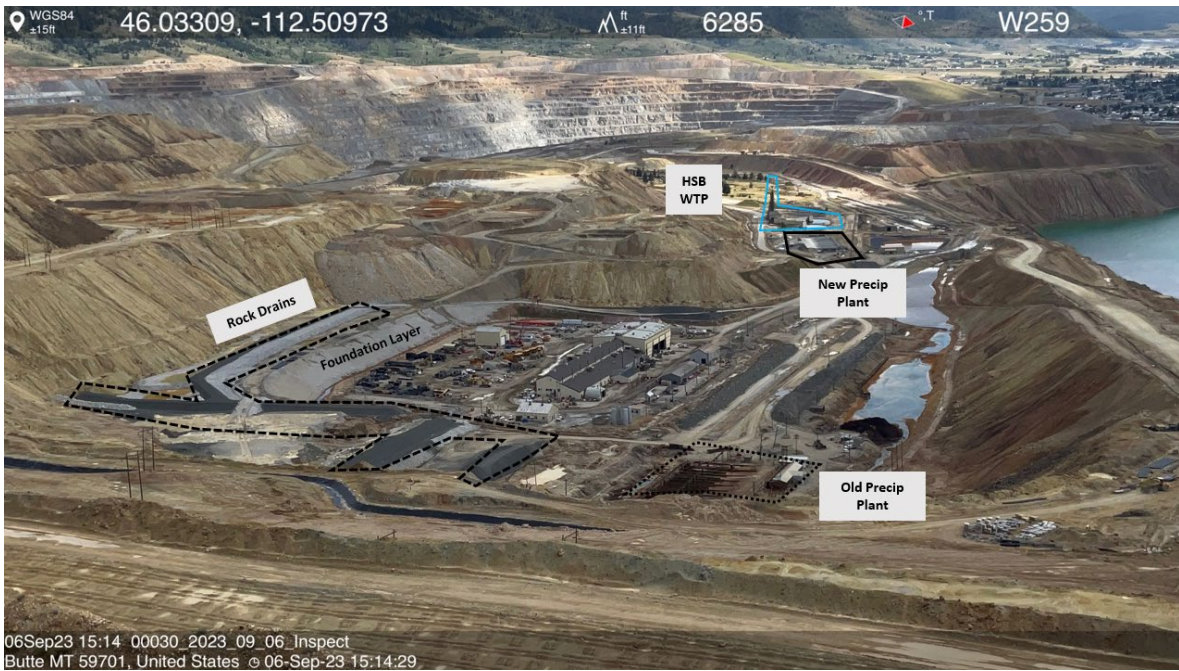
The inspection continued to the HSB overlook near Tailings Booster Station #3. DEQ approved Minor Amendment 011 on 7/14/2022 for the construction of the HSB RDS at the southern toe of YDTI. The RDS design includes a foundation drainage layer and engineered rock drains to capture and convey seepage flows from underneath the RDS, through a conveyance channel, and then to the management and treatment systems required under the BMFOU remedy. Construction of the foundation drainage layer and rock drains is ongoing, while the old precipitation plant is being decommissioned (Photo 9). The new precipitation plant near the HSB Water Treatment Plant (MR22-001) is still under construction and not yet operational (Photo 10). As a component of Minor Amendment 011, the seepage that emanates on a bench above HSB (“Seep 10”) will eventually be diverted around the future HSB RDS. Instead of flowing directly to the HSB area, seepage will be routed into a lined channel and pipe system that is currently being constructed (Photos 11 and 12). This configuration may also improve the accuracy of monitoring flow rates from Seep 10.

Photo 9- The HSB overlook near Tailings Booster Station #3, major features from the report are outlined and labeled.

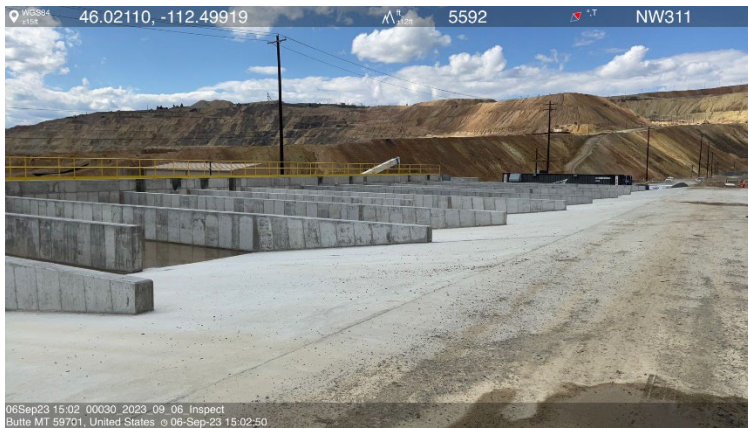
Photo 10- A new precipitation plant is being constructed to the south of HSB, near the HSB Water Treatment Plant. This facility was approved as revision MR 22-001. **Photo 11-** A lined channel and pipeline system is being constructed to divert Seep 10 flows around the future HSB RDS area.

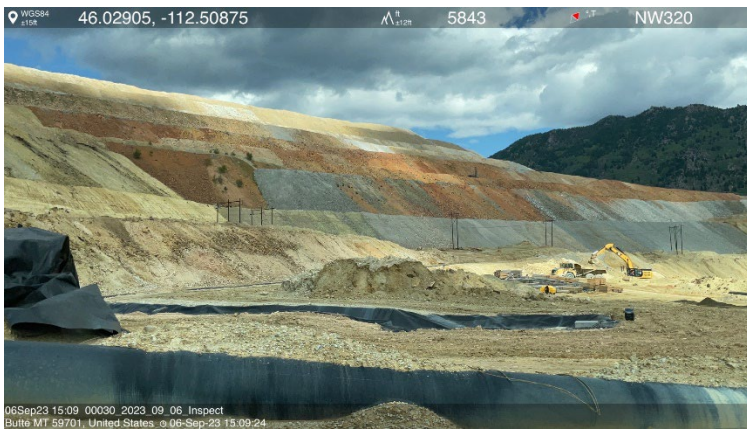
Photo 12- A lined channel and pipeline system is being constructed to divert Seep 10 flows around the future HSB RDS area. **Photo 13-** Pilot scale testing for REE/CM recovery will begin later in September 2023, which would involve the placement of “geotubes” on a gravel pad area that is adjacent to the current plant facility.

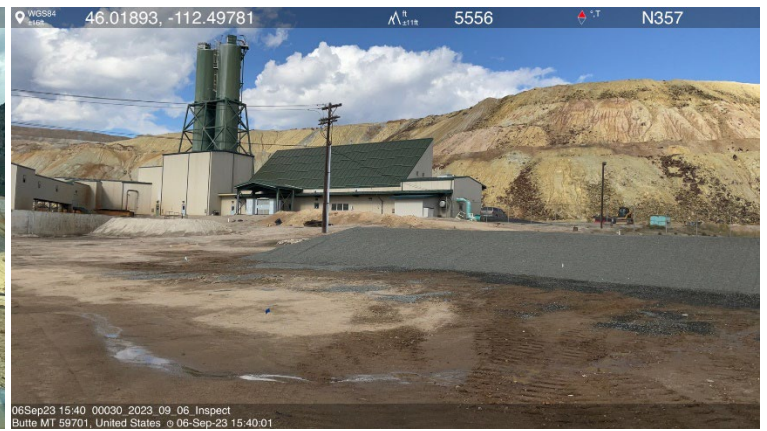
MR is currently coordinating with a research group through the University of West Virginia to evaluate the potential to recover rare earth elements (REE) and other critical metals (CM) from the sludge produced by water treatment at the HSB plant being operated under the BMFOU remedy. MR anticipates that pilot scale testing will begin in late September 2023, which would involve the placement of “geotubes” (permeable material tubes) in a flat area adjacent to the current plant facility (Photo 13). Following a two-stage pH adjustment, the resulting sludge would be dewatered within the geotubes until the moisture content is ~40%, and then shipped off-site for further analysis and processing to separate the elements of interest. **Similar to the recovery of precipitated copper, the extraction of REE/CM from water treatment sludge would constitute the production of “minerals in commercial quantities for sale, beneficiation, refining, or other processing or disposition” (definition of mining, 82-4-301, MCA).** DEQ requests updates on the timeline for this project and it may be appropriate to schedule a focused site tour for others in the department. DEQ would like to further discuss potential permit implications for such a recovery system, as the operation, reclamation, and financial assurance for the system may also be addressed through BMFOU water treatment agreements.
