**MONTANA DEPARTMENT OF ENVIRONMENTAL QUALITY  
HARD ROCK MINING BUREAU  
OPERATING PERMIT – FIELD INSPECTION REPORT**

Operator: Montana Resources, LLC				Inspection Date: September 28, 2023					
Operating Permit #: 00030			Project: Montana Resources- Continental Mine Complex			County: Silver Bow			
Nearest City or Town(s): Butte									
DEQ Staff: Tommy Butler, Eric Dahlgren, Wayne Jepson, Tim Matthews, Garrett Smith; Dan Seifert (BLM)				Company Representative(s): Mark Thompson					
Agencies w/overlapping permit jurisdiction:		USFS		BLM		Other	X	None	
Minerals: Copper, molybdenum, minor silver									
Status:		X		Active		Inactive		Suspended	Other
Weather: Partly cloudy, high temp 60°F									
Type of Operation:				Purpose of Inspection:					
X	Open Pit				Initial (Pre-permitting)				
	Underground			X	Regular Compliance				
	Placer				Amendment #				
X	Leach- <i>Leach pads near HSB not receiving solution</i>				Complaint Received				
X	Tailings Storage Facility: [X] Active or [ ] Inactive				Bond Release				
X	Mill			X	Other (tour, data collection, baseline, TSF, etc.)

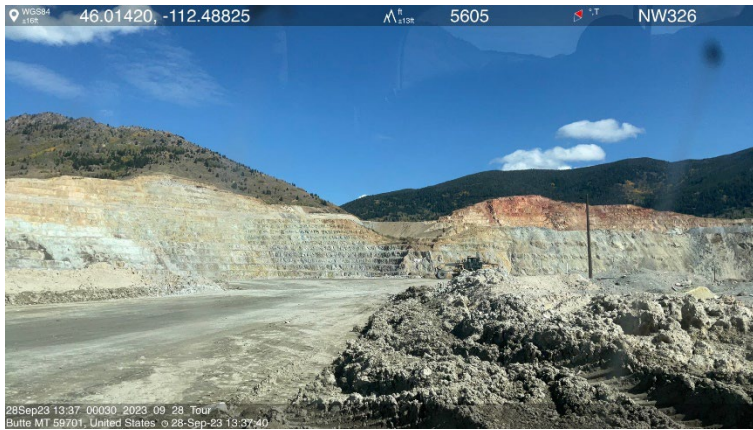
**Photo 1-** Around the Continental Pit, graders and other equipment engaged in haul road maintenance. **Photo 2-** The geotubes are being tested near the HSB water treatment plant.

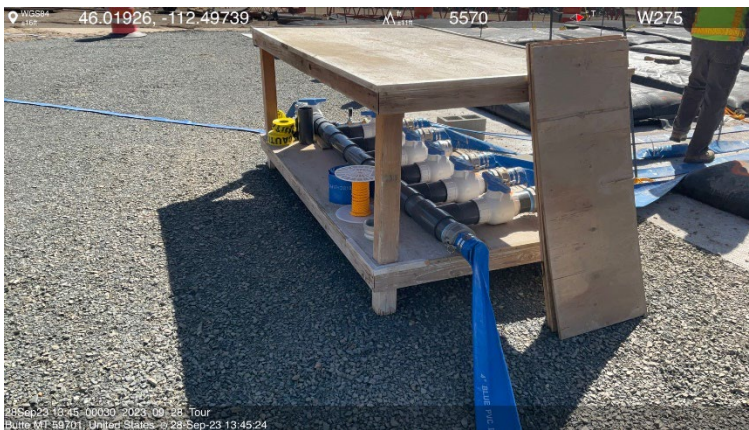
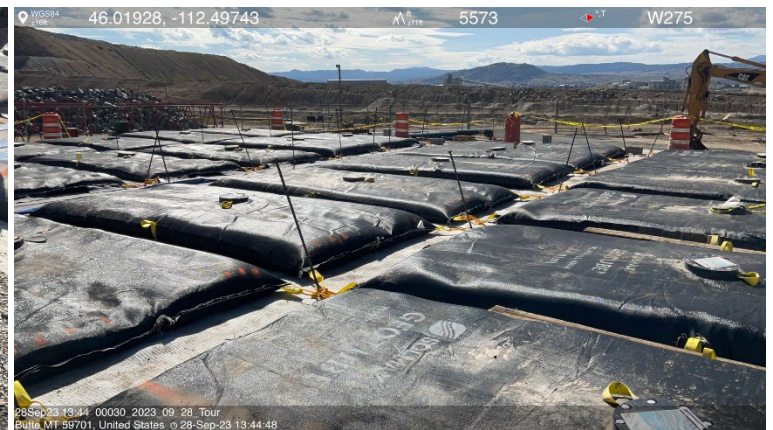
**Photos 3 and 4-** The piping and valve system used to discharge precipitated sludge into the geotubes, which are made of woven synthetic materials.

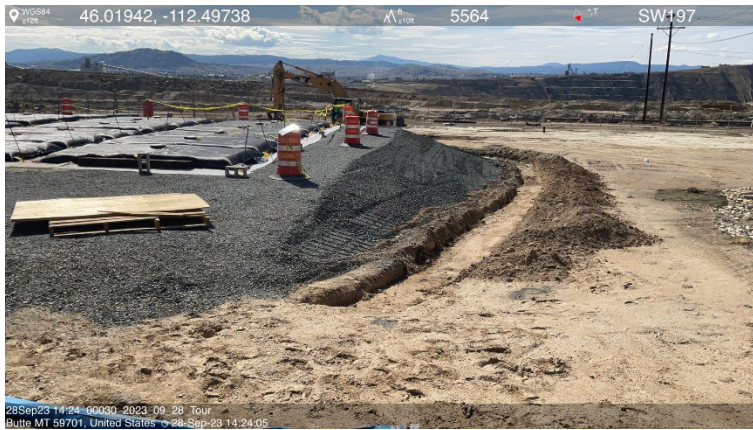
Seepage from the area was collected in a perimeter ditch and directed back toward the Berkeley Pit (Photo 5). Filling the geotubes occurred more quickly than anticipated and the material has already reached approximately 30-50% solids, with about 140 tons located on the drainage pad. The geotubes will be cut open to obtain samples that will be contained in barrels and transported to West Virginia (Photo 6). In addition to analyzing the bulk composition of the material, it is important to better understand the processing methods necessary to separate the various REE/CM components. Further testing and conclusions are pending.

**Photo 5-** A drainage ditch was constructed around the gravel pad to contain water seeping out the geotubes. **Photo 6-** Sludge samples will be taken out of the geotubes and transported to West Virginia for further analysis.

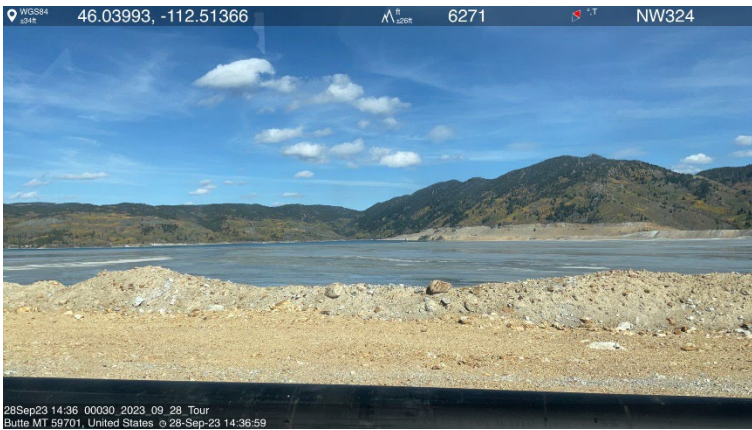
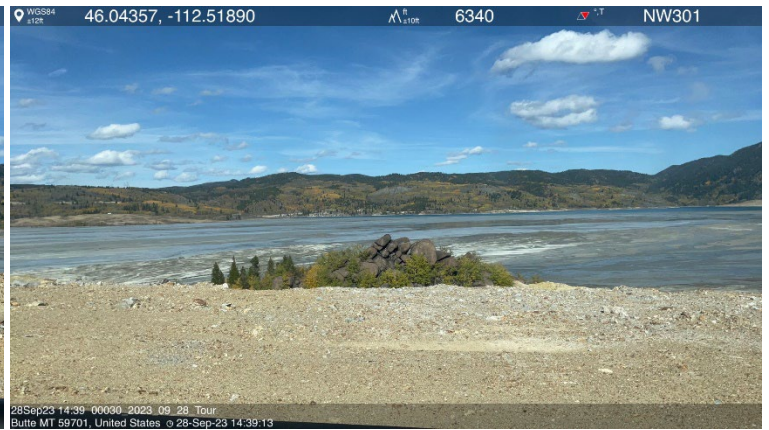
**Photos 7 and 8-** Additional tailings discharge lines allow greater flexibility for selectively applying tailings slurry in areas that might become dry and prone to blowing dust, and to control the uniform development of the beach and pond areas. The internal face of the embankment has been covered with alluvium and graded. The rocks and vegetation in Photo 8 are the remaining exposure of “Rocky Knob.”

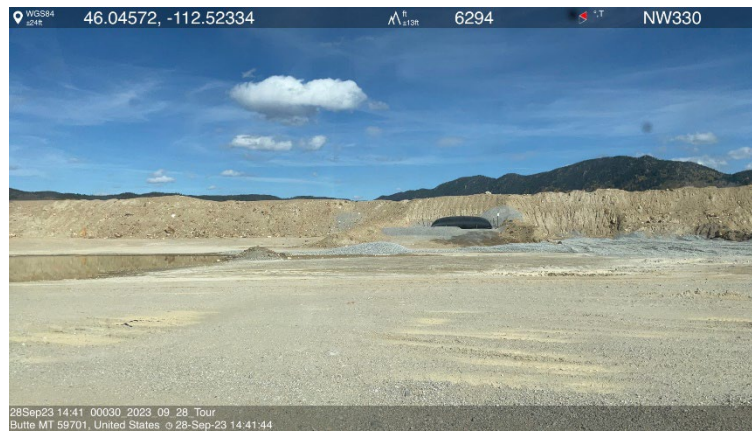
The YDTI was accessed near Booster Station 3, along a portion of the East-West Embankment. A wide beach area is important for separation of the tailings pond from the embankments, thus contributing to the safety and stability of the facility. There are now 28 tailings discharge points around the facility, which allow greater flexibility for selectively applying tailings slurry in areas that might become dry and prone to blowing dust, and to control the development of the beach and pond areas (Photos 7 and 8). During this site visit, there were very few surfaces across the beach that were not saturated and no fugitive dust was observed. The placement of magnesium chloride storage tanks and bladders positioned around YDTI also allows for more rapid filling and deployment of the tracked vehicles used for dust suppression (Photo 9).

**Photo 9-** Storage bladders for magnesium chloride are placed around YDTI to allow rapid filling and deployment for tracked vehicles as part of dust suppression efforts. **Photo 10-** Soil has been salvaged from the north end of the West Embankment and it’s being placed on the downstream face of the embankment.

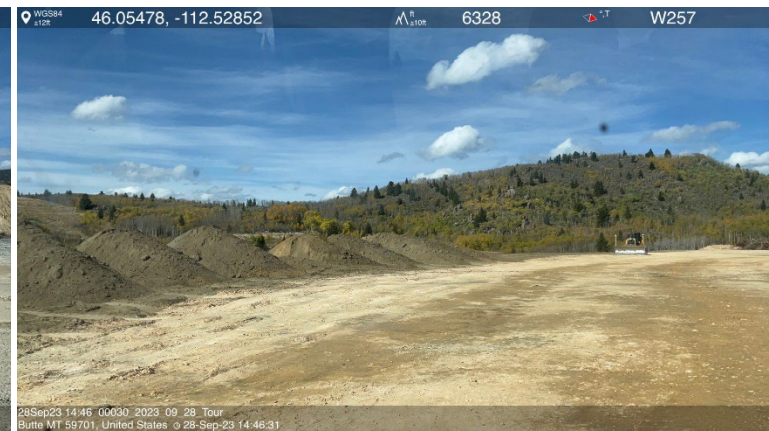
Along the northwest part of the permit area, contractors for Butte-Silver Bow have finished relocating a pipeline that conveys water from Moulton Reservoir to the municipal water treatment plant to the north of Walkerville. MR contractors were salvaging soil along the northwest portion of YDTI, at the north end of the West Embankment. This material is being staged for placement along the downstream (west) slope of the West Embankment (Photos 10-12). Vegetation and organic debris that was removed during soil salvage has been placed in large piles and will be converted into mulch to be used as compost or organic soil amendment (Photo 11). As concurrent reclamation occurs, MR would like to implement different test plots to evaluate methods for the placement and amendment of cover soil and the success of revegetation. **DEQ requests more information about the proposed test plots and the variables to be evaluated. If new methods are ultimately identified and proposed for completing the final reclamation, the Reclamation Plan must be revised accordingly. If test plot areas fail to meet the requirements for comparable stability and utility to adjacent lands (82-4-336(9), MCA), then additional reclamation work would**

be required prior to bond release and closure. The testing regime for coversoil should be implemented for this material during placement (see Reclamation Plan, 2023), rather than the details specified for Central Zone alluvium. Testing would indicate whether any soil amendments may be necessary to support revegetation (e.g. lime, compost, fertilizer).

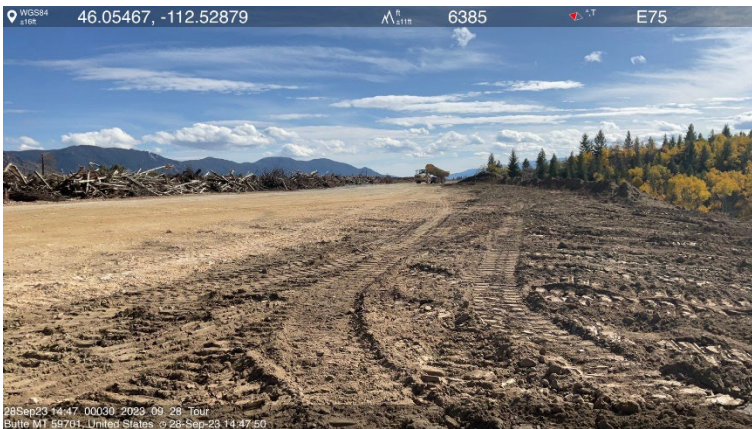
**Photo 11-** Equipment is placing and pushing soil along the West Embankment. **Photo 12-** Looking at the outer slope of the West Embankment, drain rock is visible at the bottom. Soil stockpiles in the distance have vegetation established and serve as visual barriers.

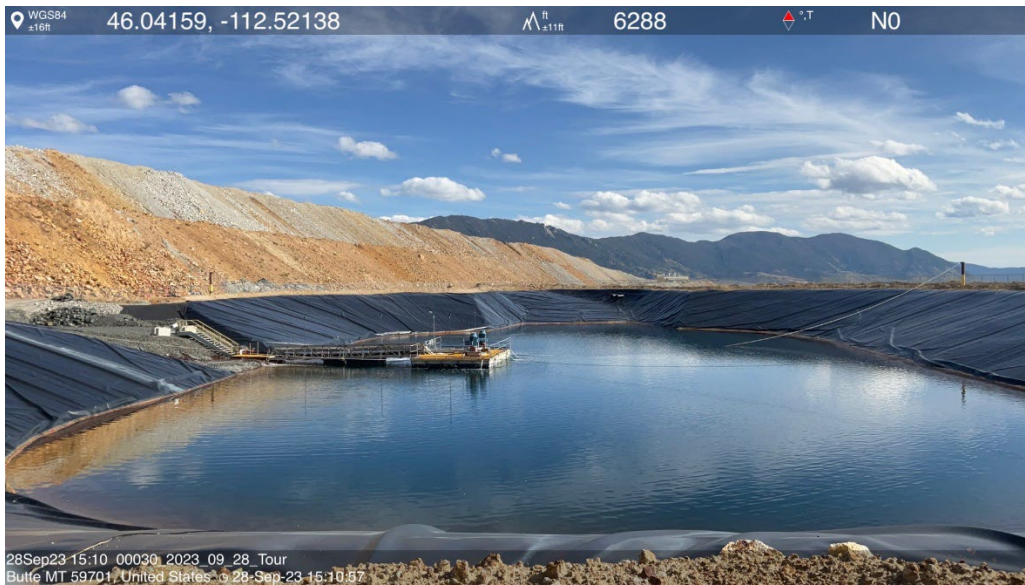
While leaving the YDTI, the West Embankment Drain (WED) extraction pond was observed (Photo 13). This water is pumped back into YDTI through a floating barge. As part of resolving a stipulation for Amendment 010, MR engaged with BMFOU parties to evaluate the post-mining management of this seepage. In consultation with DEQ, EPA provided a letter on September 12, 2022 which confirms that the water collected by the WED after the cessation of mining would occur within the East Camp system and the agencies agreed that this water would be managed as part of the BMFOU remedy, rather than under the operating permit and reclamation bond.

**Photo 13-** The extraction pond at the end point of the WED. This seepage from the West Embankment is being pumped back into YDTI during operations (via floating barge), and during post-closure conditions it will be managed with other water under BMFOU requirements.
