**MONTANA DEPARTMENT OF ENVIRONMENTAL QUALITY
HARD ROCK MINING SECTION, MINING BUREAU
OPERATING PERMIT – FIELD INSPECTION REPORT**

Permittee: Montana Resources, LLC				Inspection Date: November 8, 2024					
Operating Permit #: 00030			Project: Montana Resources- Continental Mine Complex			County: Butte-Silver Bow			
Nearest City or Town(s): Butte									
Inspector(s): Shanna Law, Garrett Smith				Permittee Rep(s): Jeremy Fleege					
Agencies w/overlapping permit jurisdiction:		USFS		BLM		X	Other (EPA)	None	
Minerals: Copper, molybdenum, minor silver									
Status:		X		Active		Inactive		Suspended	Other
Weather: Mostly sunny, high temp 56°F									
Type of Operation:				Purpose of Inspection:					
X	Open Pit				Initial (Pre-permitting)				
	Underground			X	Regular Compliance				
	Placer				Amendment # MR#				
X	<i>Leach- Leach pads near HSB not receiving solution</i>				Complaint Received				
X	Tailings Storage Facility: [X] Active or [] Inactive				Bond Release				
	Mill				Other (tour, data collection, baseline, TSF, etc.)-

Hard Rock OP Mining Section Inspection Photo Log

Permit: 00030 Montana Resources, LLC

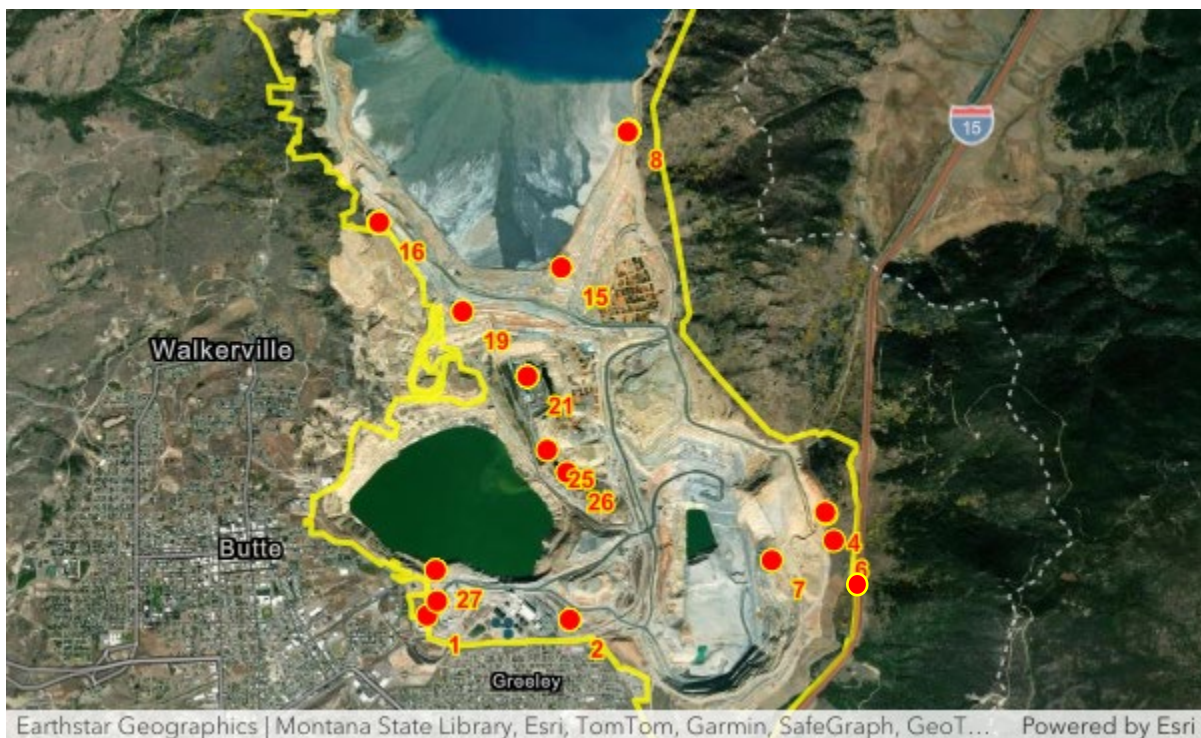
Photo #: 1

Description: The haul route and pipelines near the office, previously used for conveying Parrot Tailings for on-site disposal. Depending on the location determined for BPSOU waste, this route could potentially be used for conveying other off-site waste to the Berkeley Pit.

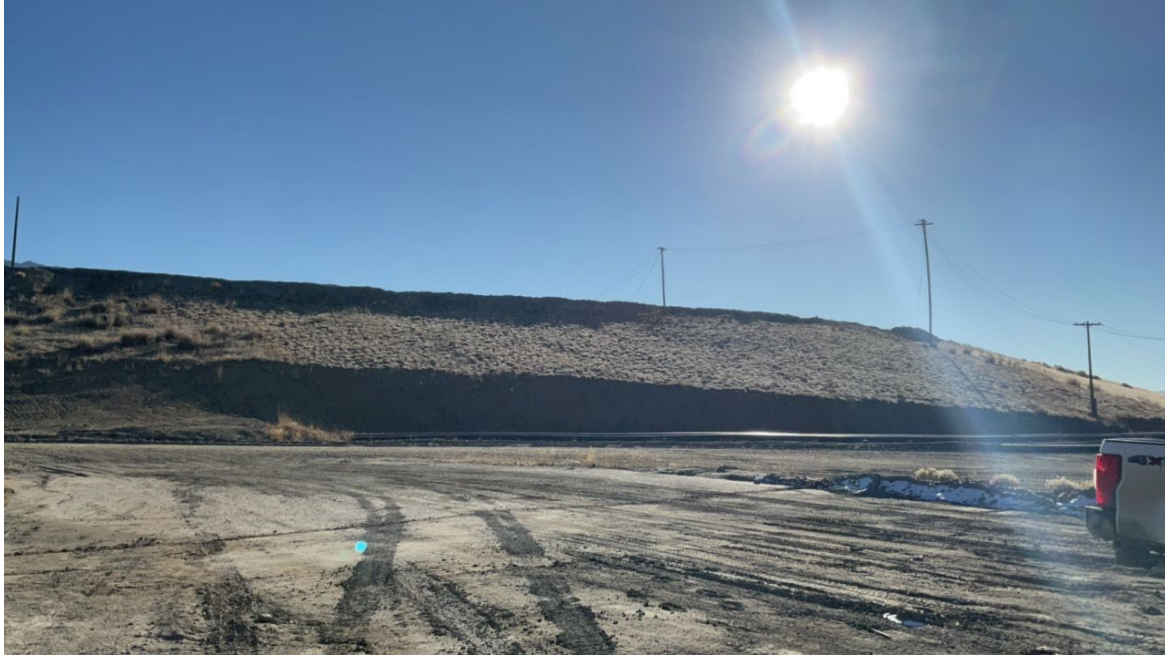
Photo #: 2

<u>Concurrent Reclamation</u>							
Reclamation activities are ongoing for an area directly north/northeast of the guard shack entrance gate (~20 acres). The area has been graded and most of the soil has been placed, although some soil hauling and pushing remains to be completed (Photos 2 and 3). The area will then be seeded and revegetation will be monitored periodically in the coming years. A small area (~1 acre) is being used as a test plot for incorporating biochar into the soil cover, which will be compared to another small plot using only compost as an amendment to the soil.							
As noted in previous inspections, another concurrent reclamation project is along the downstream face of the West Embankment (21.7 acres, not observed on this trip). The early vegetation establishment looked good on the

Description: This area near the guard shack (approx. 20 acres) is being reclaimed, with completed grading and soil placement in most areas.

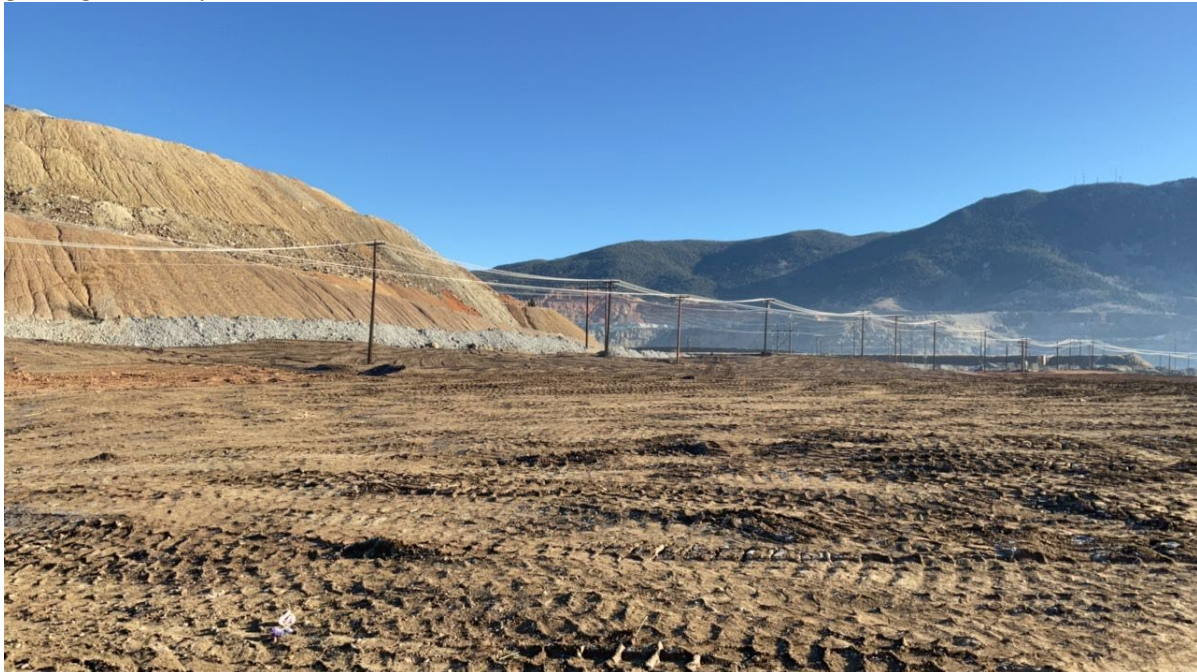
Photo #: 3

Description: Reclamation area north east of the guard shack

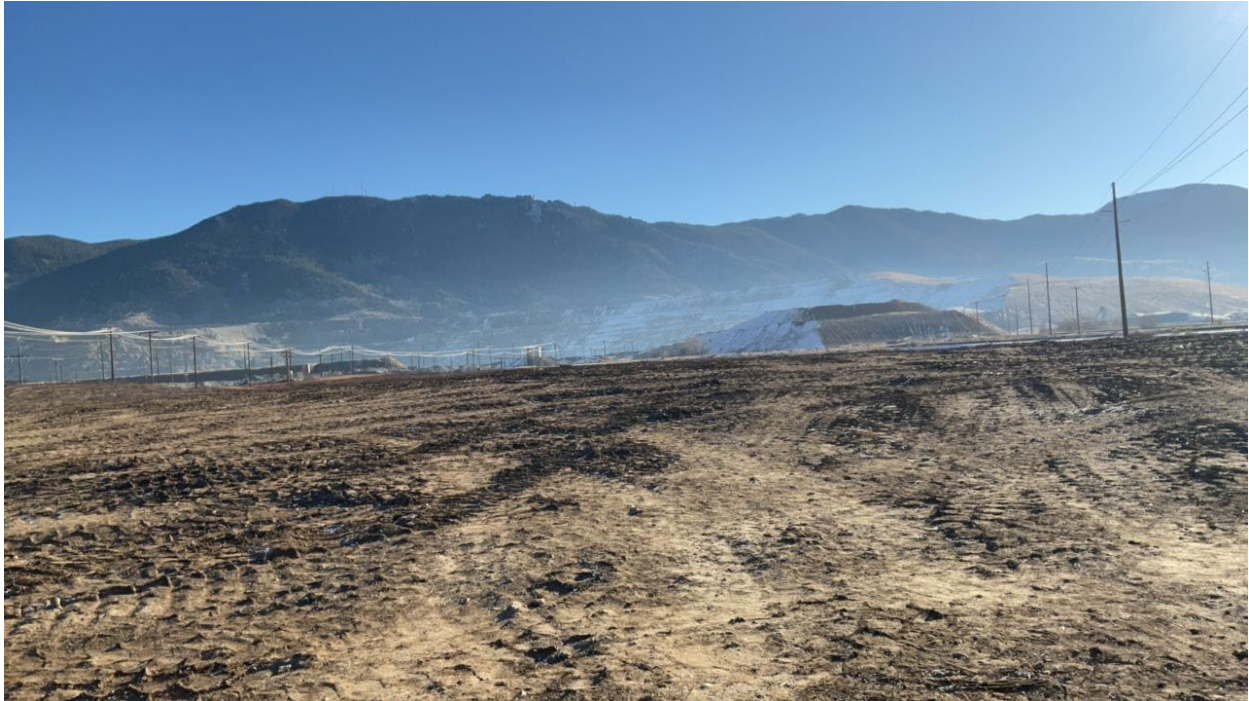
Photo #: 4

As documented in 2022 and 2023 inspections, MR observed areas of instability on the D East highwall in the Continental Pit during fall 2022. Revision MR22-002 allowed for additional disturbance and overburden removal to the east of the highwall (termed “E East”), to create a shallower slope on the rock face and limit future instability. Disturbance and overburden removal continues in the E East area (Photos 4, 5, and 6).

Description: Mining continues in the E East layback of the Continental Pit

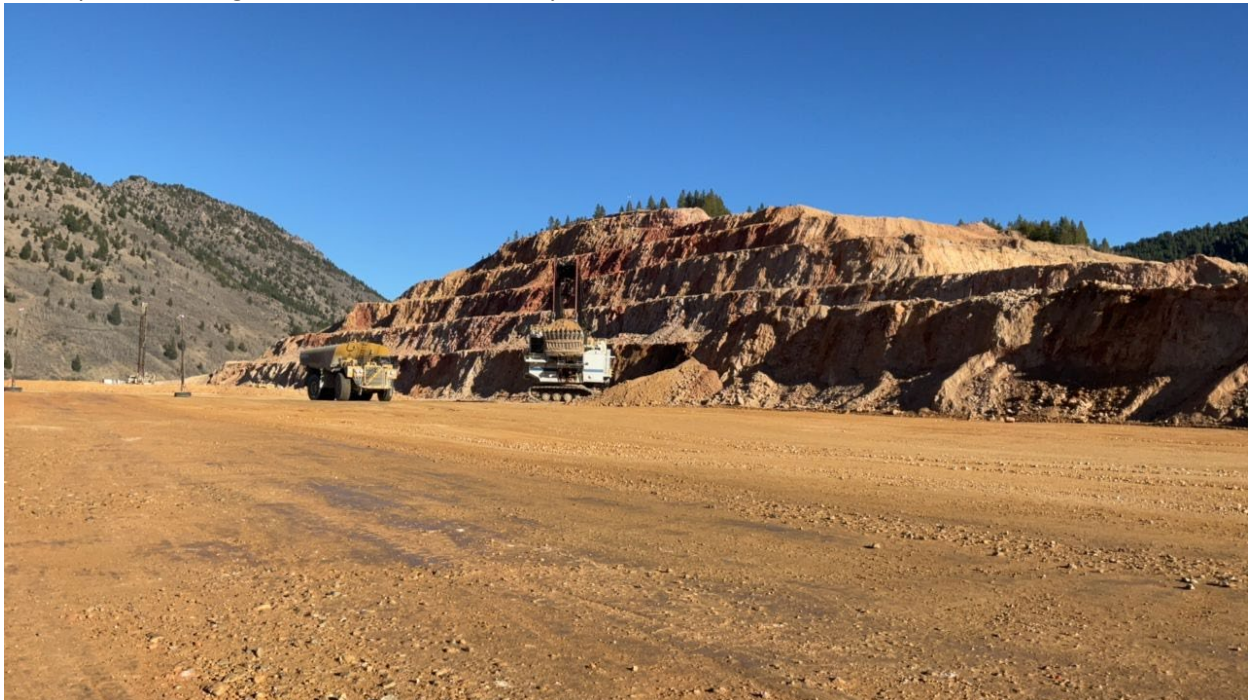
Photo #: 5

Description: Mining continues in the E East layback of the Continental Pit

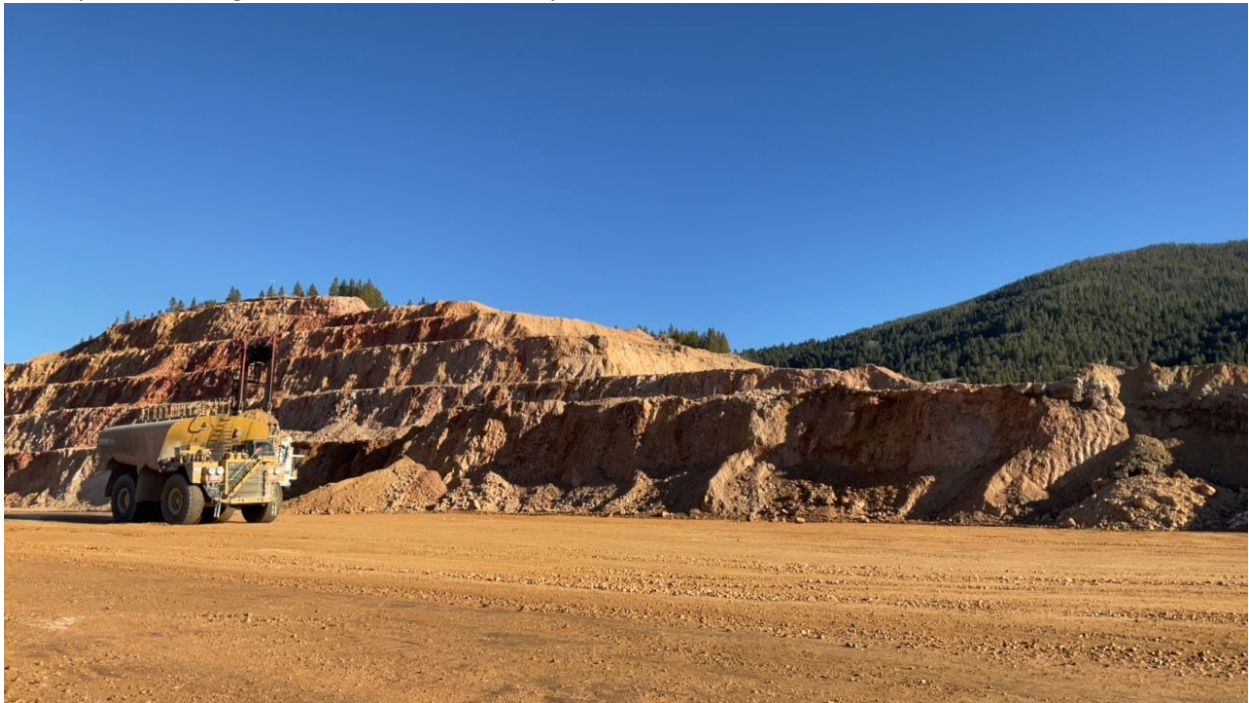
Photo #: 6

Description: Mining continues in the E East layback of the Continental Pit (distance)

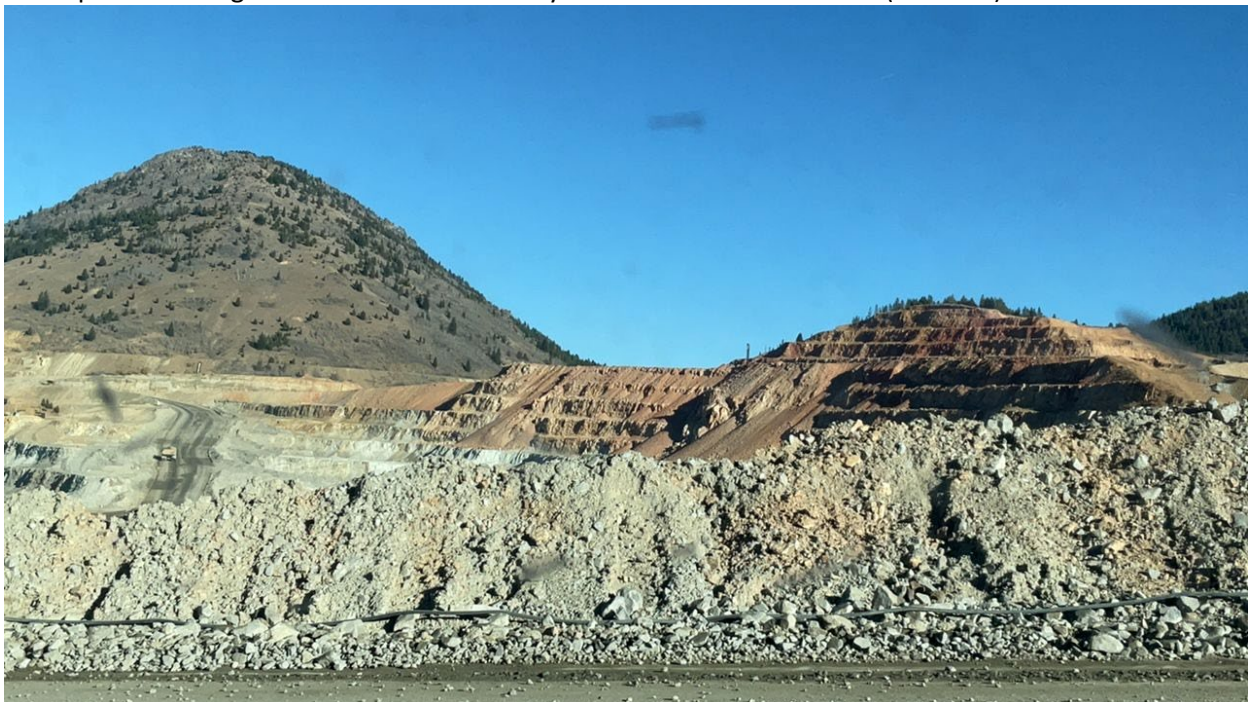
Photo #: 7

The progress of mining across the Continental Pit and the exposure of a pronounced area of supergene enrichment in the D East area were observed on the way to the TSF barge access road (Photos 6 and 7). Two drill rigs were also observed along the east side of the Continental Pit, presumably for reserve characterization and mine sequence planning (Photos 31 and 32). **DEQ recommends additional discussion about ongoing drilling and monitoring programs, in relation to the details provided in the Operations and Reclamation Plans and the Tailings Operation Maintenance and Surveillance (TOMS) Manual.**

Description: Clear contact between leached and enriched zone, area of high wall movement in 2022 is on the left side

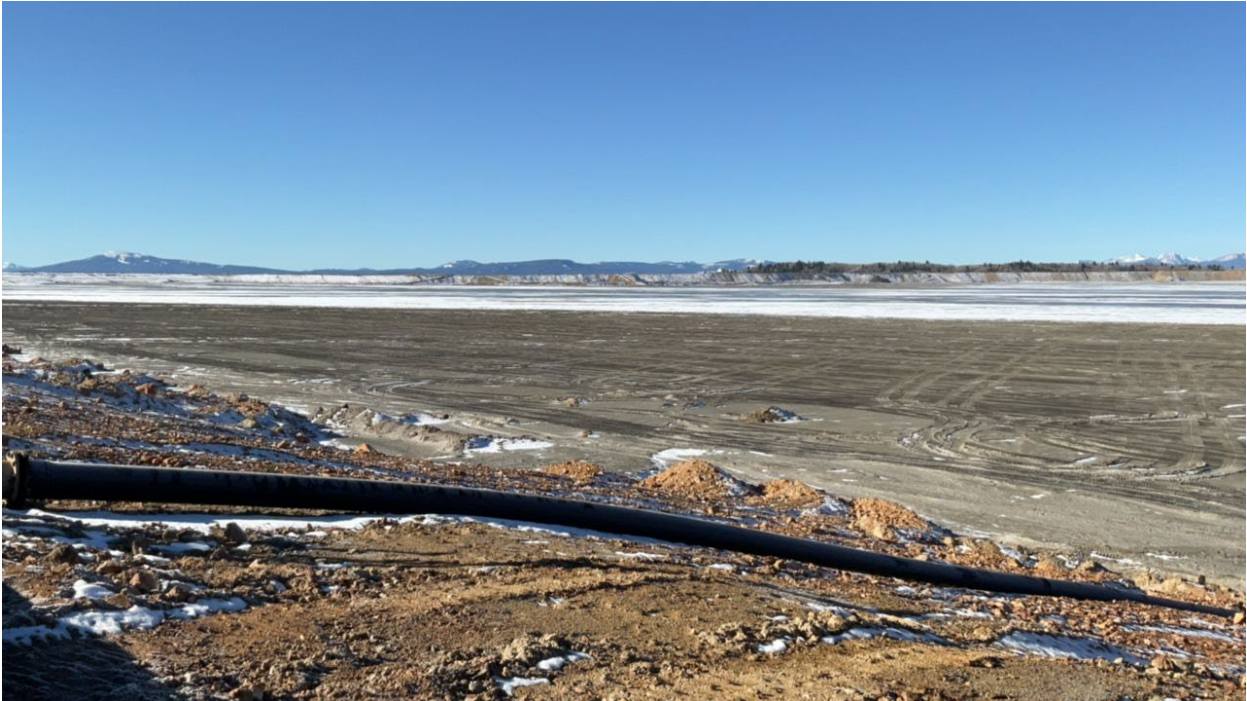
Photo #: 12

Construction of the embankment crests to a design elevation of 6,450 feet has occurred across the facility, with the exception of a small area along the North-South Embankment (Photo 12). The former low point in the northwest corner of the West Embankment has recently been raised to the design crest elevation (Photo 14). Having multiple tailings discharge points allows greater flexibility for selectively applying slurry in areas that might become dry and prone to blowing dust, and to control the sequential development of the beach and pond areas. The tailings beach is saturated in many places or covered in snow and ice, and tracks are visible from vehicles spraying magnesium chloride for dust control (Photos 10, 11, and 14). There was no blowing dust observed on this site inspection. In general, construction, monitoring, and maintenance are being conducted in accordance with the Design Document, TOMS Manual, and annual recommendations from the EOR.

Description: Looking along the North-South Embankment, from the vantage of a low point that has not yet been raised to an elevation of 6450 ft

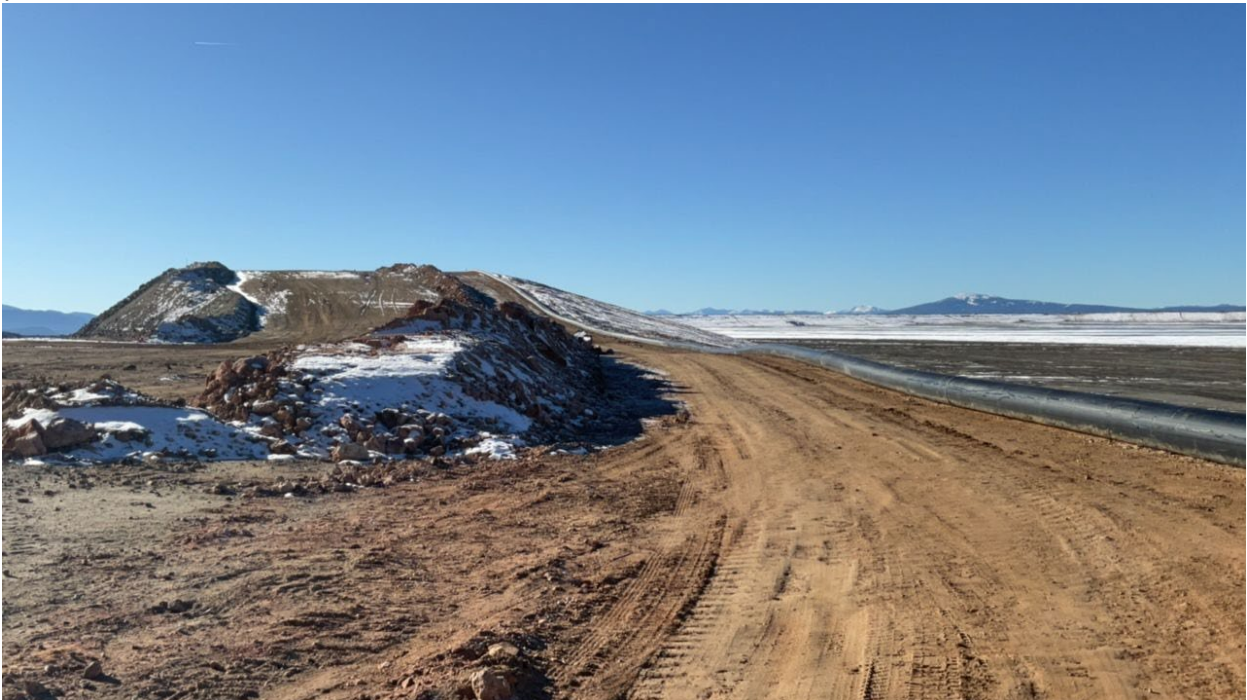
Photo #: 13

Description: Pipeline and tailings beach on the North-South Embankment

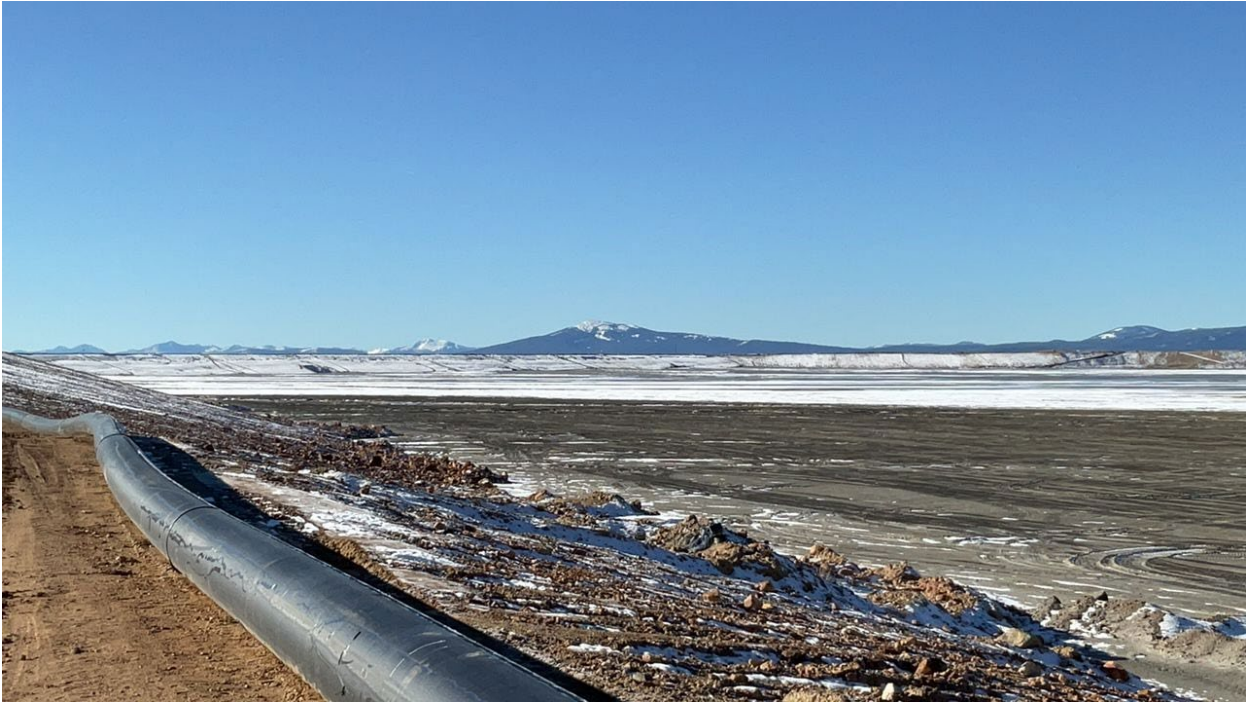
Photo #: 14

Description: View across the TSF, the northwest corner of the West Embankment has been raised to an elevation of 6450 ft (bright/orange-tan lift)

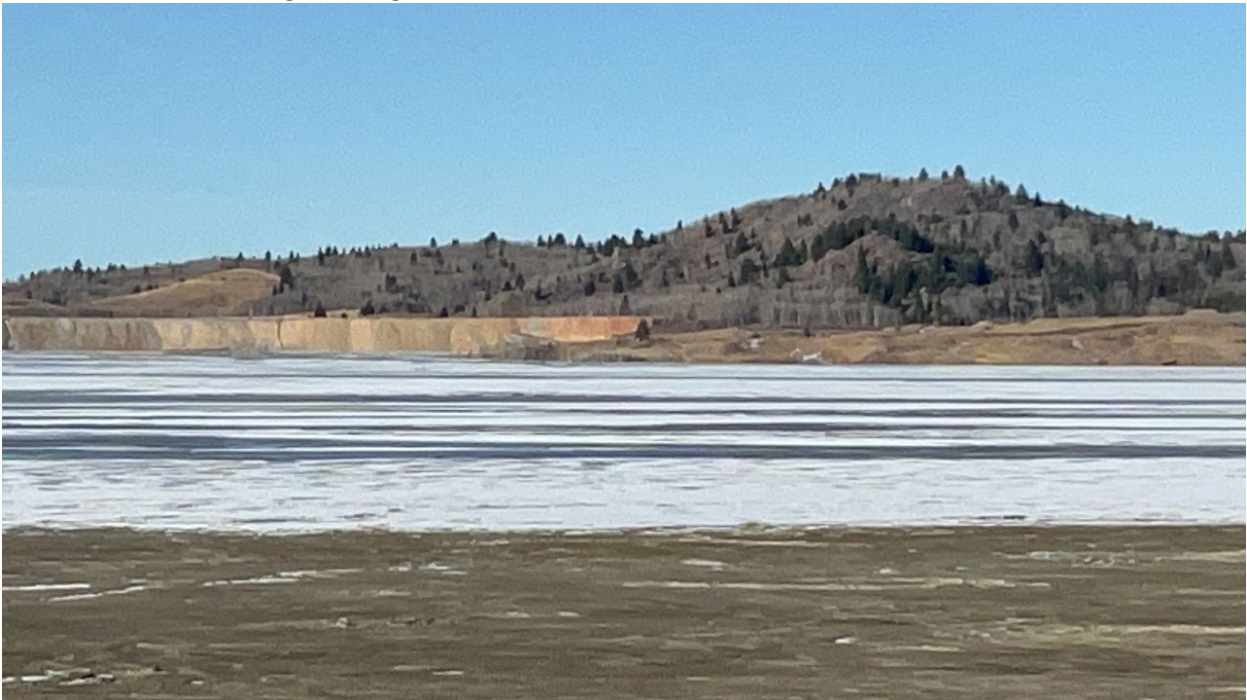
Photo #: 15

Description: Much of the tailings beach appears saturated or covered in snow/ice, no blowing dust was observed on this trip

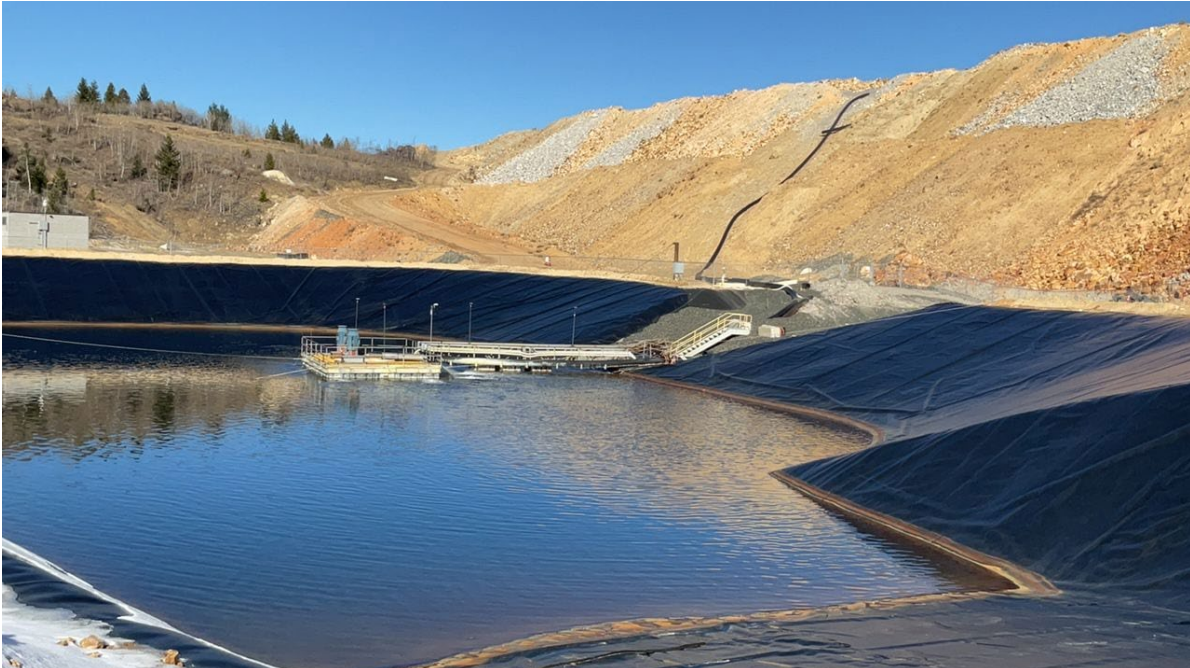
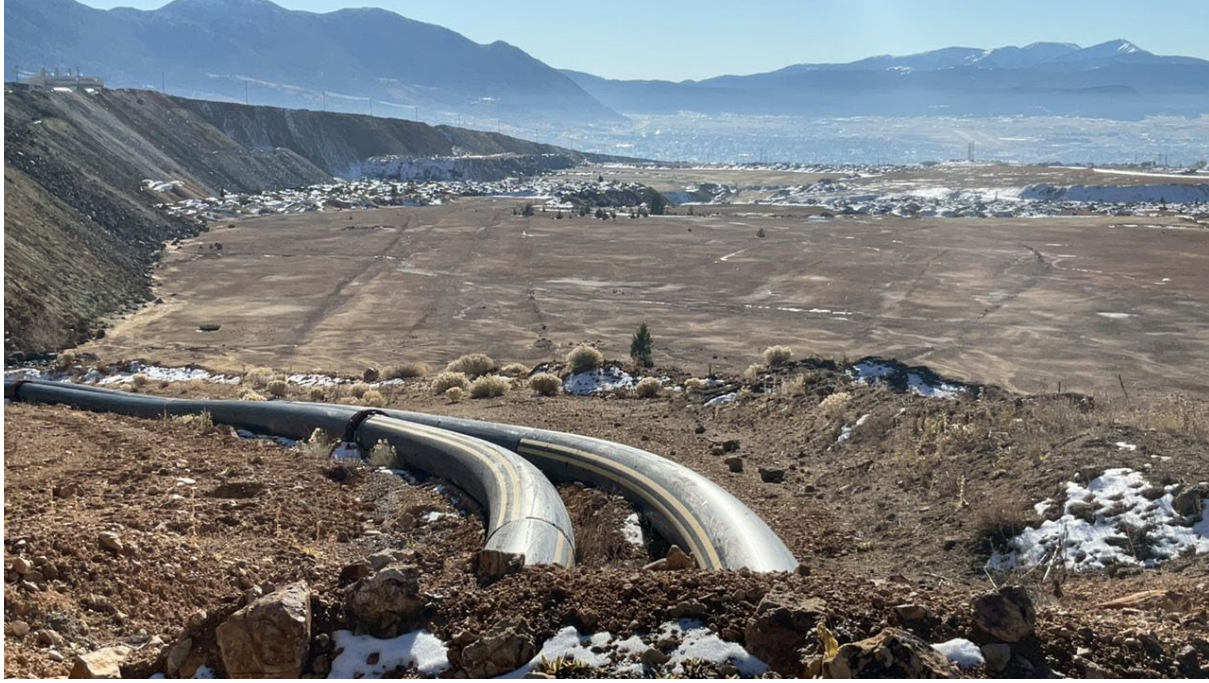
Description: Looking down at the Northwest Dumps from the WED Extraction Pond, a portion of this land was acquired from Atlantic Richfield Co. (potential expansion of embankment footprint)

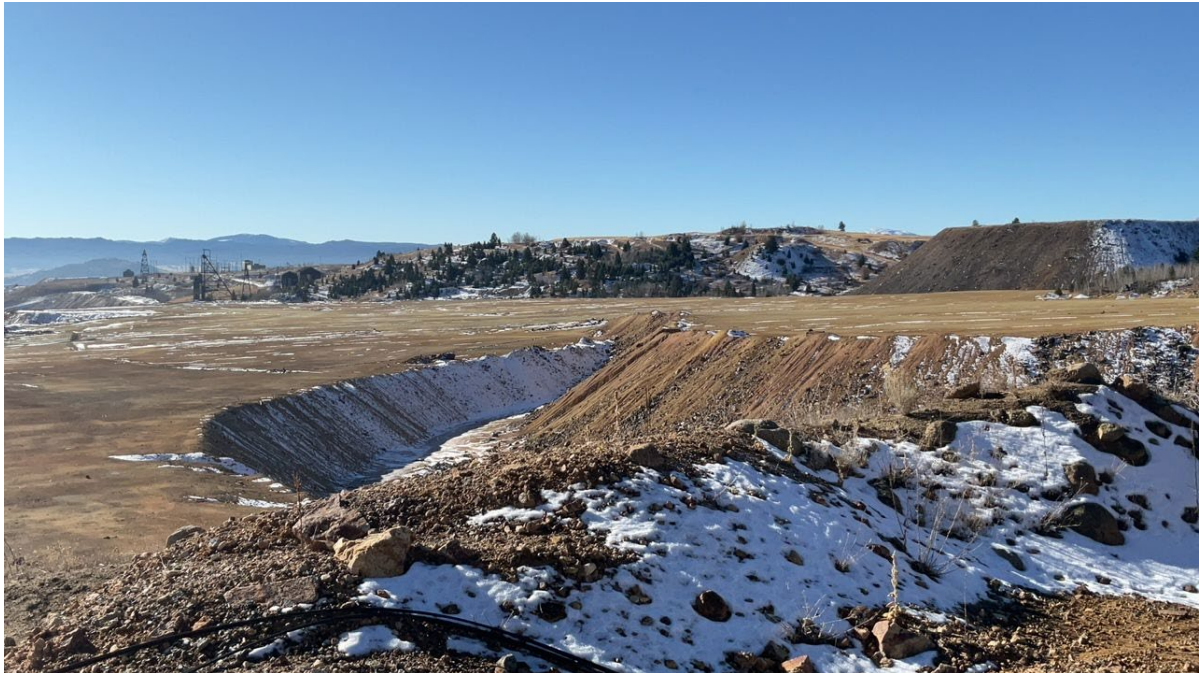
Photo #: 19

Description: Looking down at Horseshoe Bend area from Tailings Booster Station #3

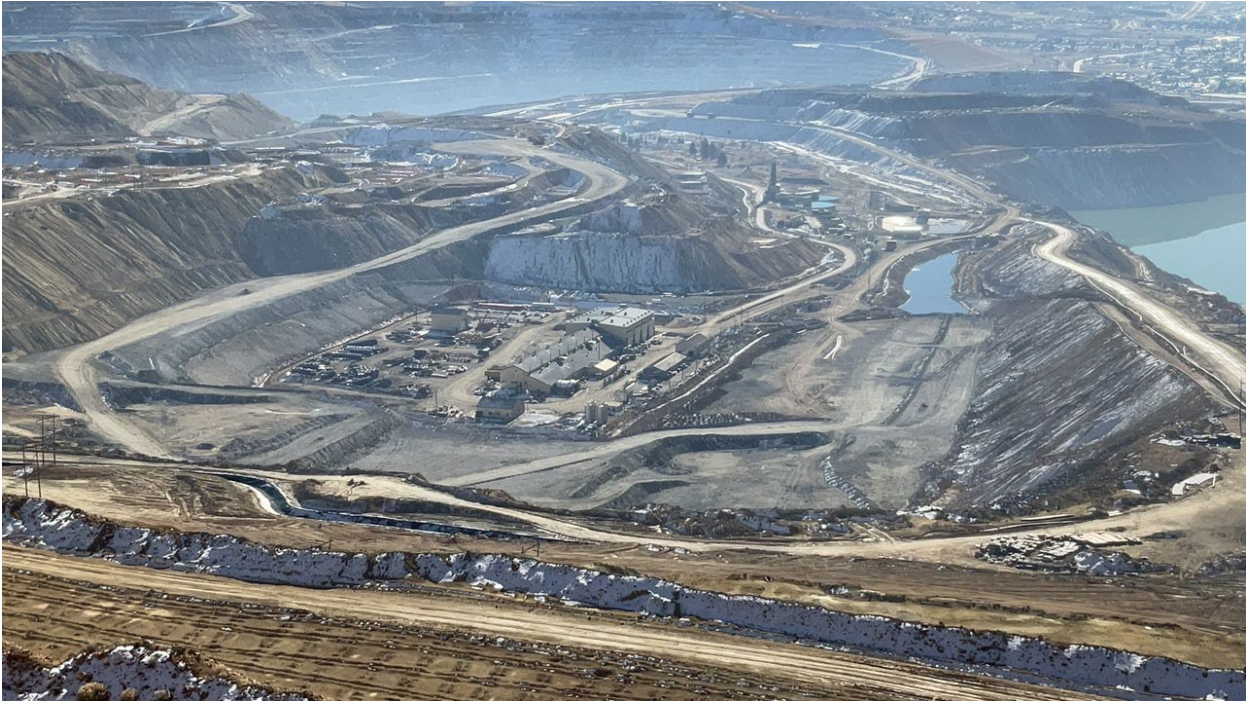
Photo #: 20

Description: Looking down at Horseshoe Bend area and inactive leach pads, from Tailings Booster Station #3

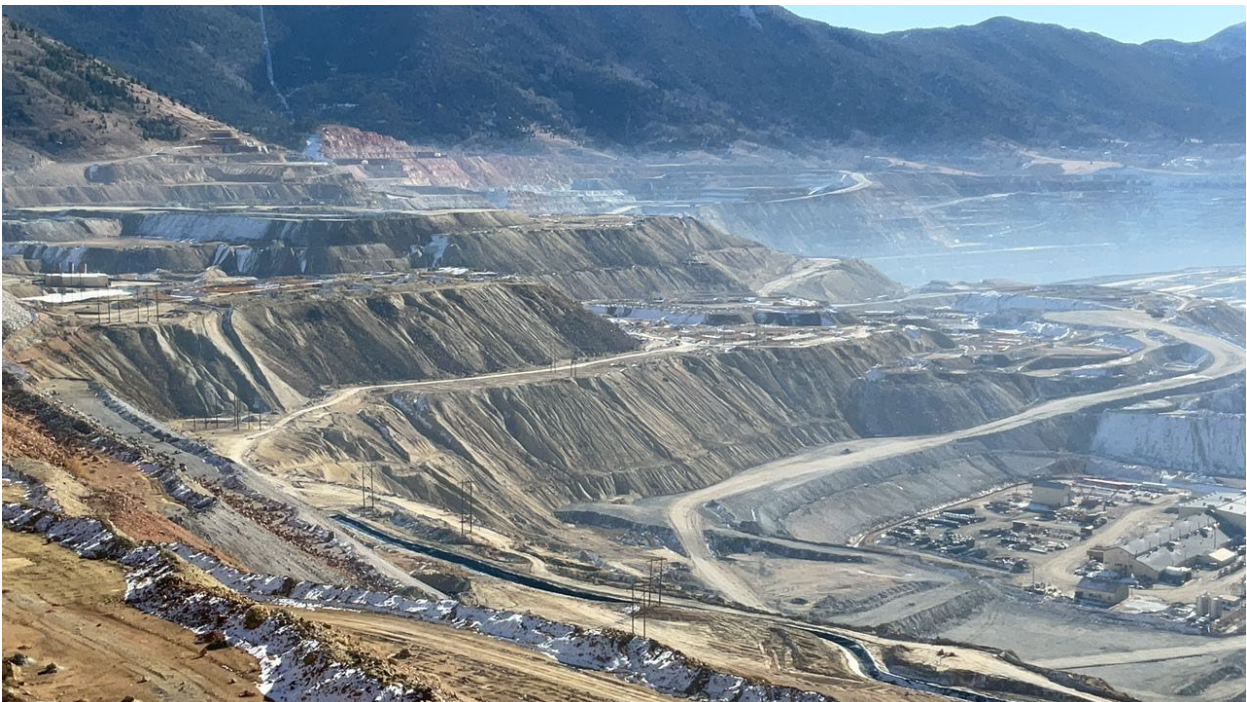
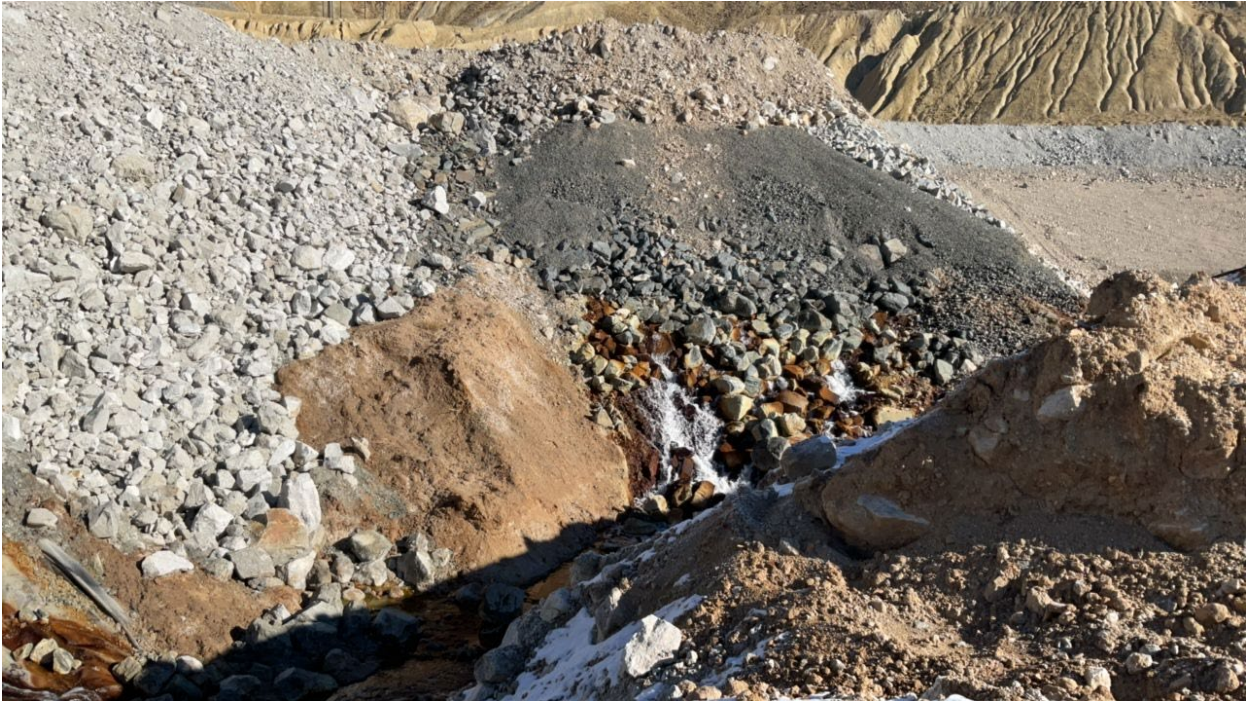
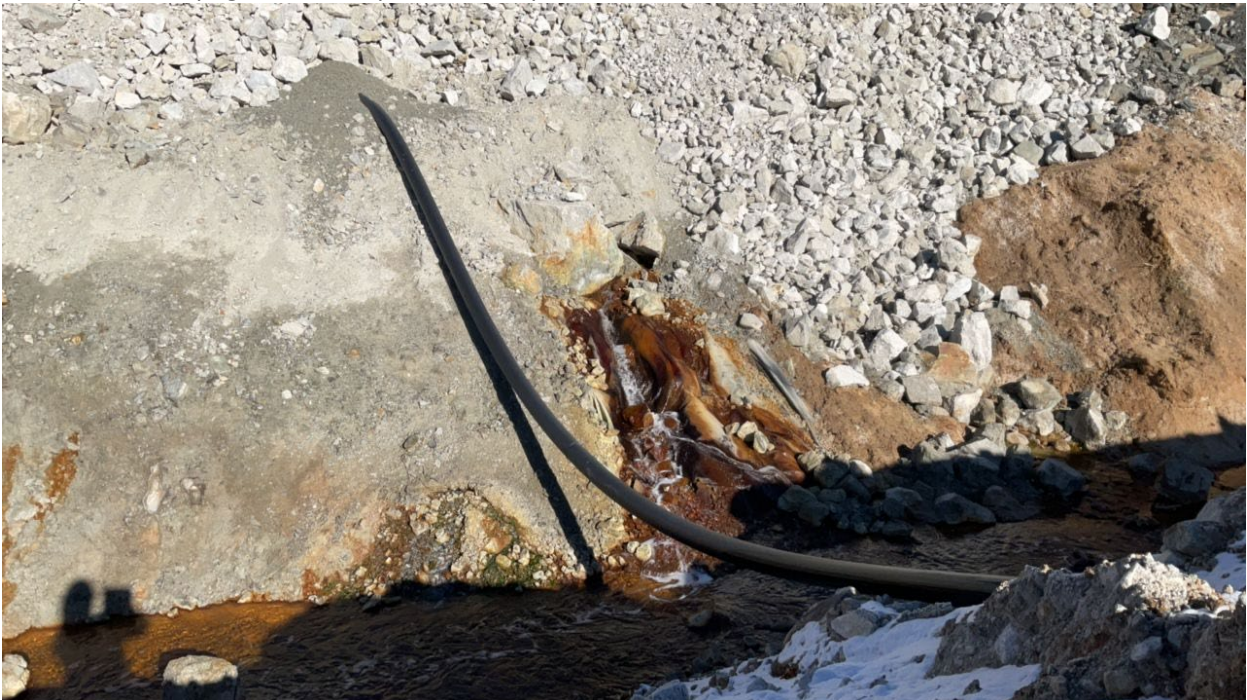
Since the last inspection, the construction of layered rock drains has concluded (Photos 19 and 24). The placement of non-ore rock into the RDS will likely commence in 2025 (see preliminary EOR recommendation above). In some areas, a cross section of the multi-layer drain was visible, in addition to seepage emanating from the contact of the rock drain and underlying ground surface (Photos 21 through 23).

Description: Seepage from one portion of exposed rock drain in the Horseshoe Bend area

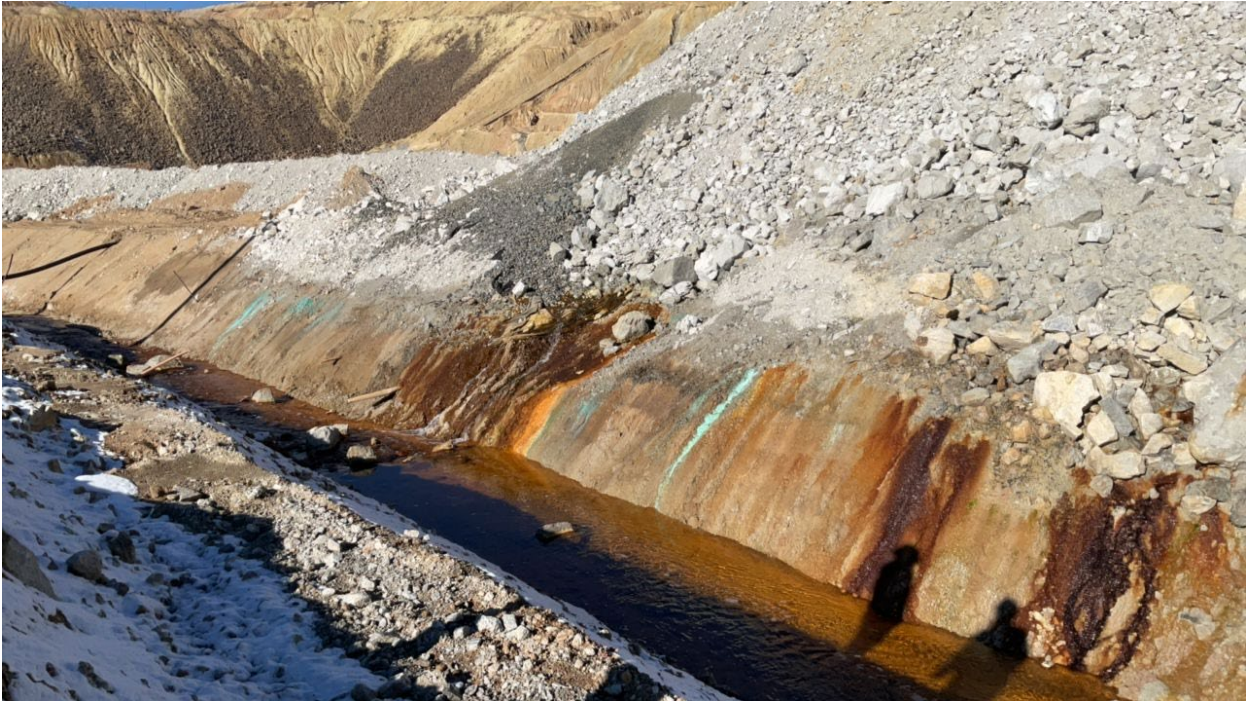
Photo #: 24

Description: Looking at the east side of Horseshoe Bend, former pond areas have been backfilled with drainage blanket layer and rock drains.

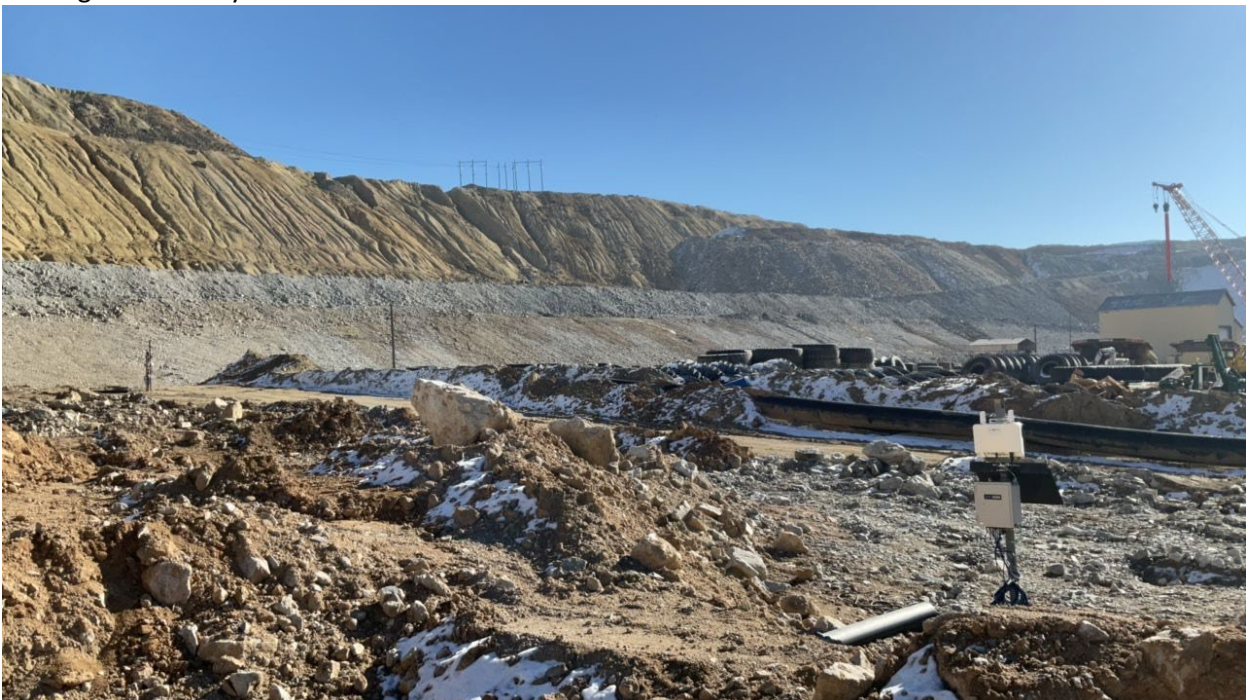
Photo #: 25

Description: New copper precipitation plant, to the south of Horseshoe Bend

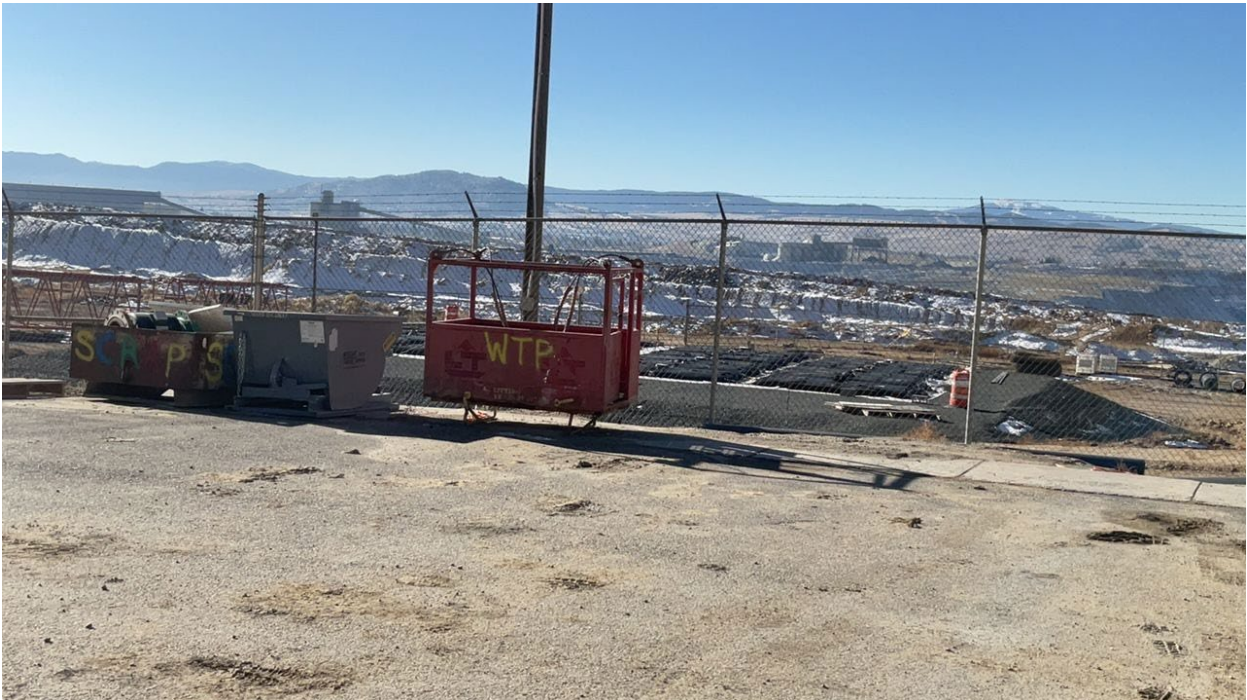
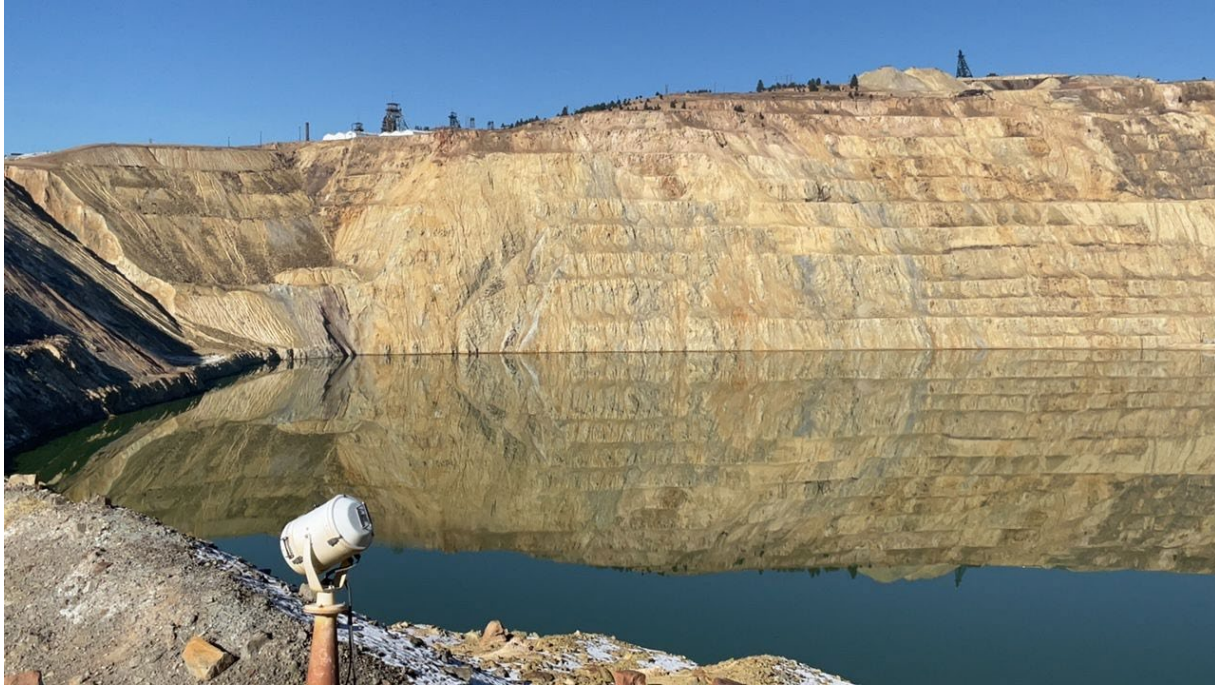
Description: View of Berkeley Pit from bird shack, migratory bird monitoring and mitigation program is underway for the season

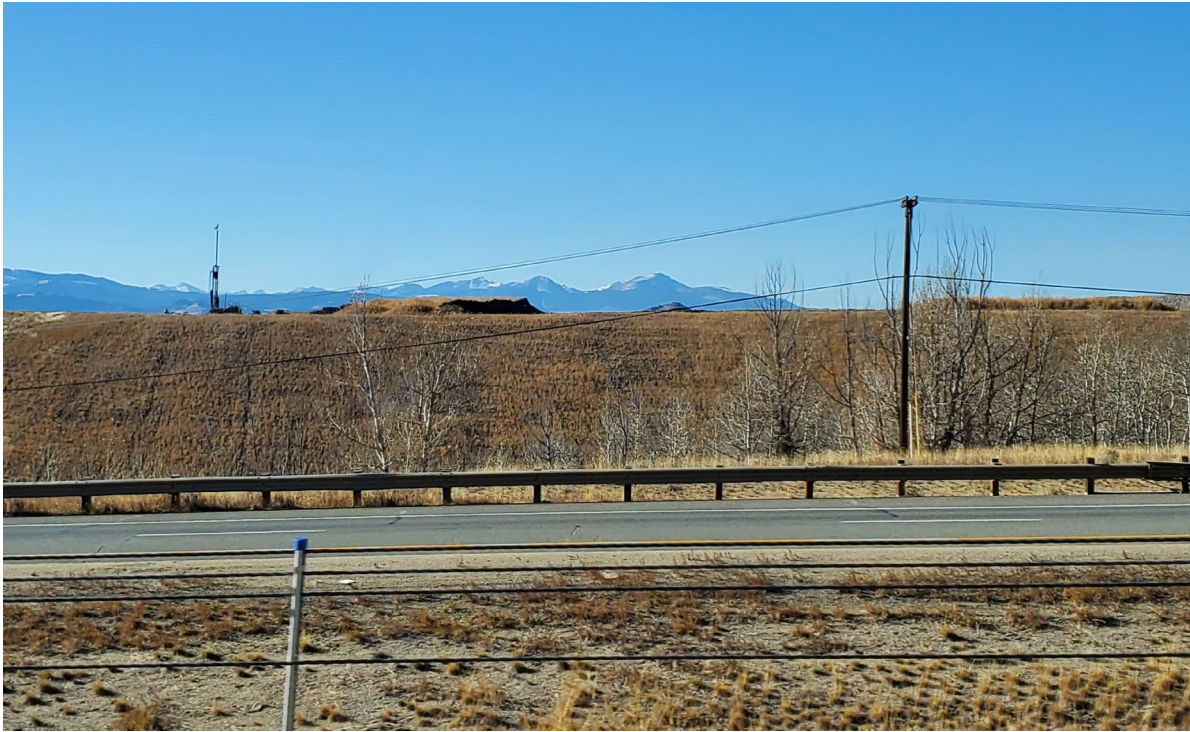
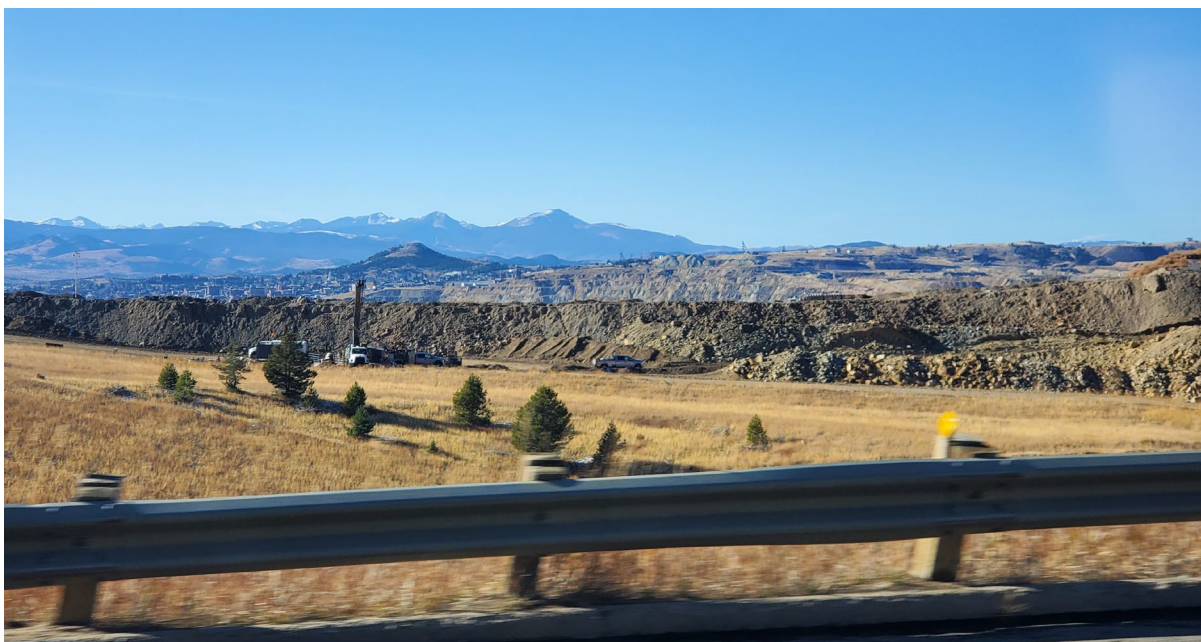
Photos #: 31 and 32

Description: View from the adjacent interstate- two drill rigs on the east side of the Continental Pit, within the disturbance area. Ongoing drilling programs provide information for mine sequence planning and reserve characterization.
