MONTANA DEPARTMENT OF ENVIRONMENTAL QUALITY
HARD ROCK MINING BUREAU
OPERATING PERMIT – FIELD INSPECTION REPORT

Operator: Montana Resources, LLC				Inspection Date: November 22, 2022			
Operating Permit #: 00030			Project: Montana Resources- Continental Mine Complex			County: Silver Bow	
Nearest City or Town(s): Butte							
DEQ Staff: Macy Livesay, Tim Matthews, Mark Odegard, Garrett Smith				Company Representative(s): Mark Thompson, Jeremy Fleege			
Agencies w/overlapping Jurisdiction:		USFS		BLM		Other	X None
Minerals: Copper, molybdenum, minor silver							
Status:		X Active		Inactive		Suspended	Other
Weather: Partly cloudy, high temp 40°F							
Type of Operation:				Purpose of Inspection:			
X	Open Pit				Initial (Pre-permitting)		
	Underground			X	Regular Compliance		
	Placer				Amendment #		
X	<i>Heap Leach- Leach pads near HSB no longer receiving solution</i>				Complaint Received		
	Vat Leach				Bond Release		
X	Mill				Other		
	Other:				NON issued

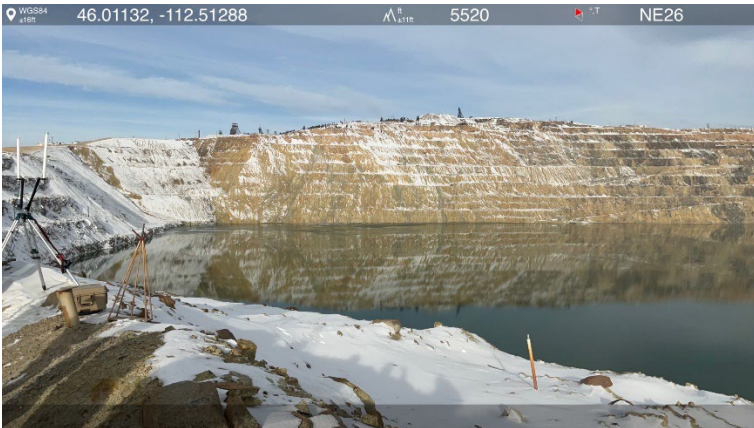
The fall monitoring program for migratory birds typically runs from August 15 through December 31 each year. The methods used to identify and deter birds that land on the Berkeley Pit Lake are continuously improving (Photo 1). Although the water quality is not acutely/immediately toxic, prolonged exposure can lead to increased bird mortality. Based upon the characteristics and habits of each species, MR staff have been trained to implement different methods during different times of the day to prevent the birds from staying on the pit lake for extended periods of time. The methods used to deter birds have included noise machines, lasers, spotlights, aerial or aquatic drones, rifles, propane cannons, and fireworks. During the inspection, a contractor was conducting tests with a new type of autonomous aquatic drone that would continuously circulate around the lake surface. MR reported that the mitigation program continues to be successful. Two weeks prior to this inspection, there were approximately 2,000 birds that landed temporarily on the pit lake, no mortalities were reported.

Photo 1- The methods used to identify and deter birds that land on the Berkeley Pit lake are continuously improving. During the inspection, a contractor was conducting tests with a new type of autonomous aquatic drone that would continuously circulate around the lake surface. **Photo 2-** A failure occurred in the central portion of the D East highwall on November 1, 2022. Although an estimated 1 million tons of rock were displaced along a series of benches, there were no employee injuries or damage to equipment.

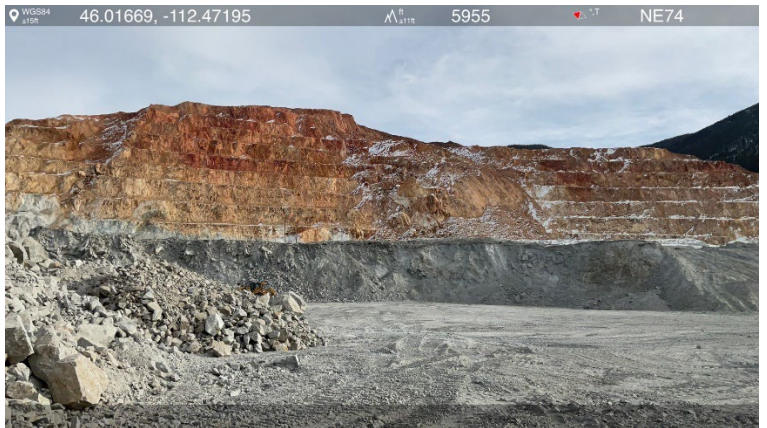
As predicted by the pit monitoring system, a failure occurred in the central portion of the D East highwall in the middle of the night on November 1, 2022 (Photos 2 and 3). Although an estimated 1 million tons of rock were displaced along a series of benches, there were no employee injuries or damage to equipment. Vegetation removal and soil salvage are ongoing to the east of the highwall and this material is being stockpiled in other locations along the East Dump Complex, where it may be more easily accessed for future use during reclamation (Photo 4). MR currently estimates that the removal of overburden and displaced rock may take approximately two years to complete. Mining continues in other portions of the Continental Pit, with little influence from the recent failure.

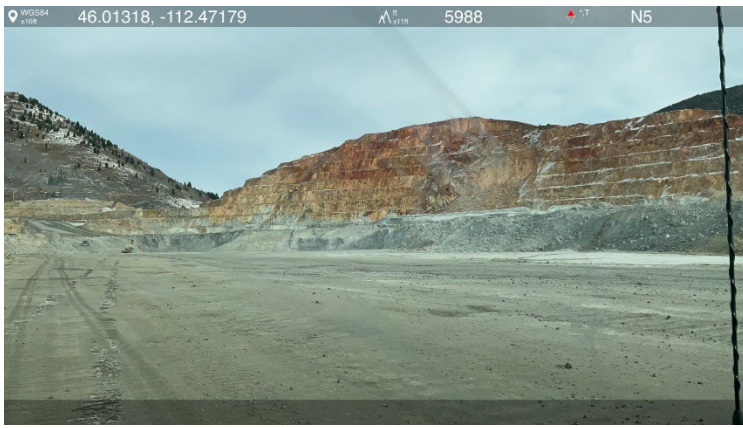
Photo 3- Note that the lateral extent of the failure was limited by a wide access road which separates the D East area from the deeper portions of the Continental Pit (to the left of this view). **Photo 4-** Vegetation removal and soil salvage are ongoing to the east of the highwall and this material is being stockpiled in other locations along the East Dump Complex, where it may be more easily accessed for future use during reclamation.

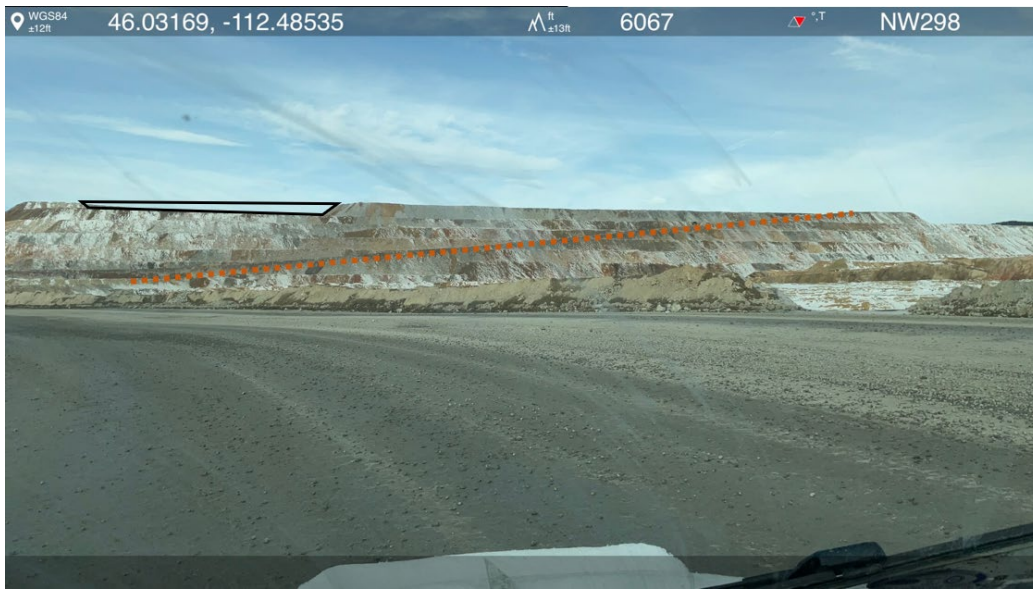
constructed to this elevation, near the juncture between N-S and E-W Embankments (Photo 5). The primary haul route now follows along the ramp constructed on the N-S Embankment.

Photo 5- Only a portion of the crest has not been constructed to this elevation, near the juncture between N-S and E-W Embankments (outlined in black). The primary haul route now follows along the ramp constructed on the N-S Embankment (orange dashes).

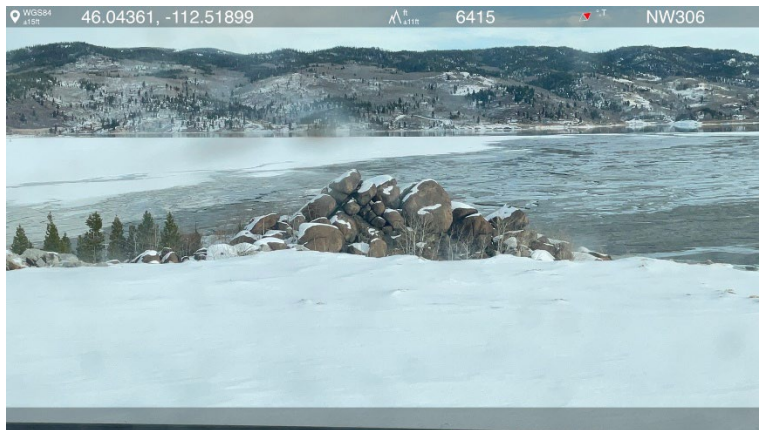
Photo 6- Additional tailings discharge lines have been installed around the perimeter embankments of YDTI. Note the diminishing remnants of the “Rocky Knob” granite outcrop, which used to be a prominent topographic feature above the beach. **Photo 7-** Additional tailings discharge lines will allow greater flexibility for selectively applying tailings slurry in areas that might become dry and prone to blowing dust, and to control the development of the beach and pond areas.

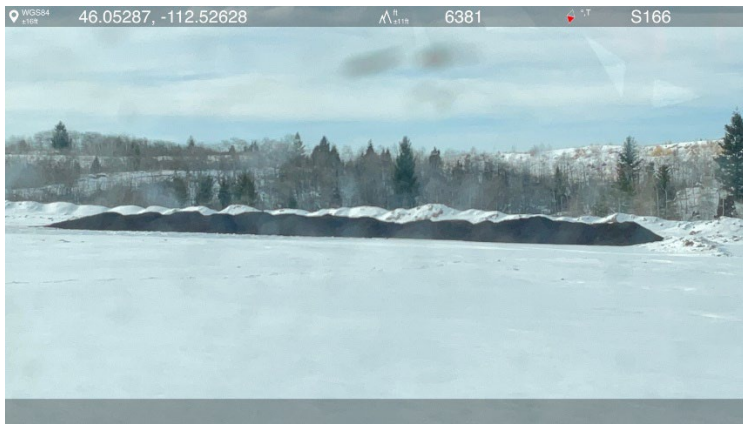
Photo 8- Compost is being stockpiled along a portion of the West Embankment, to be mixed with soil during concurrent reclamation. **Photo 9-** The interior/upstream face of the West Embankment, with tailings discharge lines across the slope.

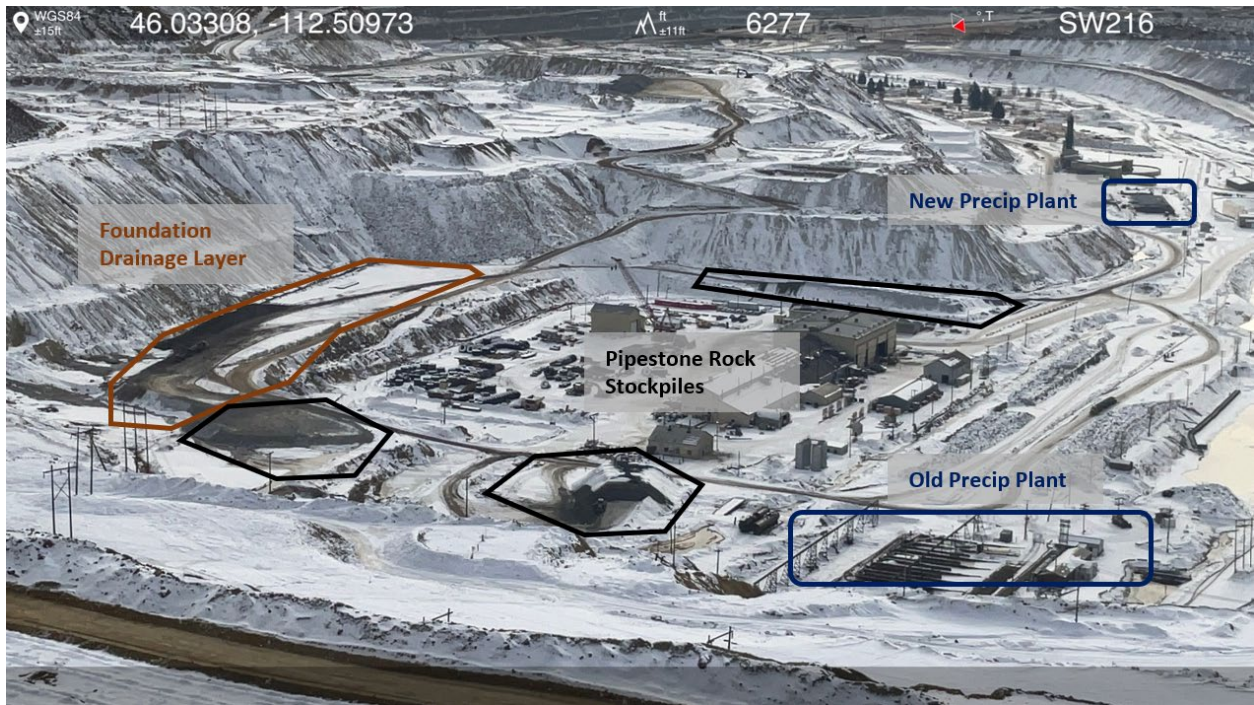
The inspection continued to the HSB overlook near Tailings Booster Station #3, before going through the HSB area (Photo 10). On July 14, 2022, DEQ approved Minor Amendment 011 for the construction of a rock disposal site (RDS) within the HSB area, at the southern toe of YDTI. The RDS would include a foundation drainage layer and engineered rock drains to capture and convey seepage flows from underneath the RDS, through a conveyance channel, and then to the management and treatment systems required under the Superfund remedy. Stockpiles of rock from the Pipestone Quarry have been placed within the HSB area, awaiting placement and drain construction (Photo 11). Three different size fractions of rock would be used to create the layered drains, similar in construction to the WED. The foundation drainage layer was being placed during the inspection and based on the rapid infiltration of seepage that was observed, it seems likely that most of the seepage that emanates in HSB would be conveyed within this layer, beneath the layered rock drains (Photos 12 through 14). The HSB Weir provides monitoring data for the total flow leaving the HSB area. The average flow measured in the HSB Weir during Q3 was approximately 3,220 gpm, which is comparable to the average flows observed since the recirculation of leach pad solutions was stopped in July 2021.

Photo 10- The HSB overlook near Tailings Booster Station #3, major features from the report are outlined and labeled.

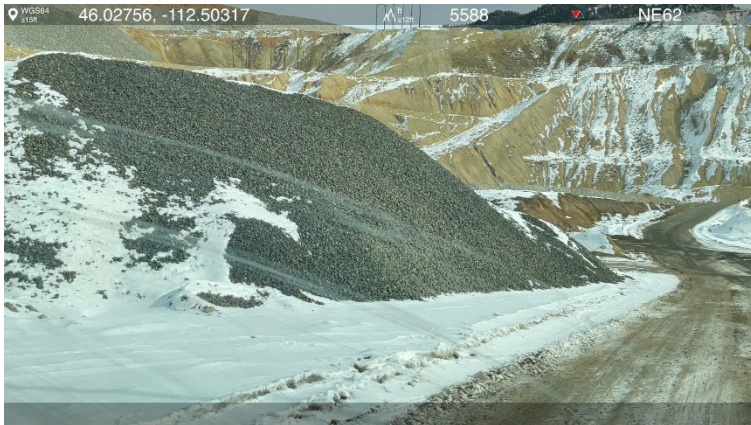
Photo 11- Stockpiles of rock from the Pipestone Quarry have been placed within the HSB area, awaiting placement and drain construction. **Photo 12-** The foundation drainage layer was being placed during the inspection, prior to the construction of rock drains.

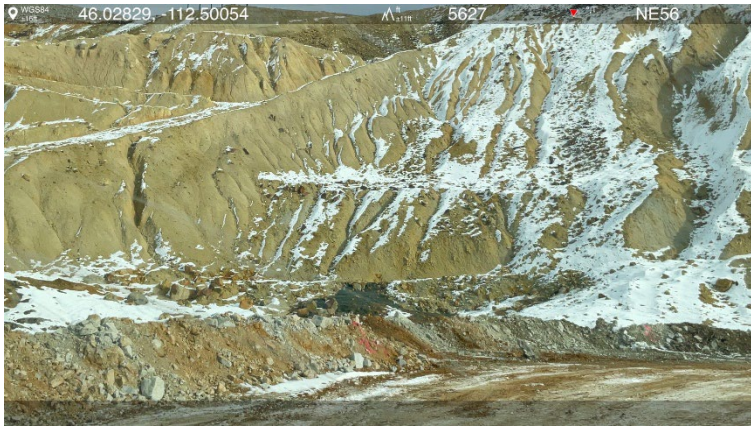
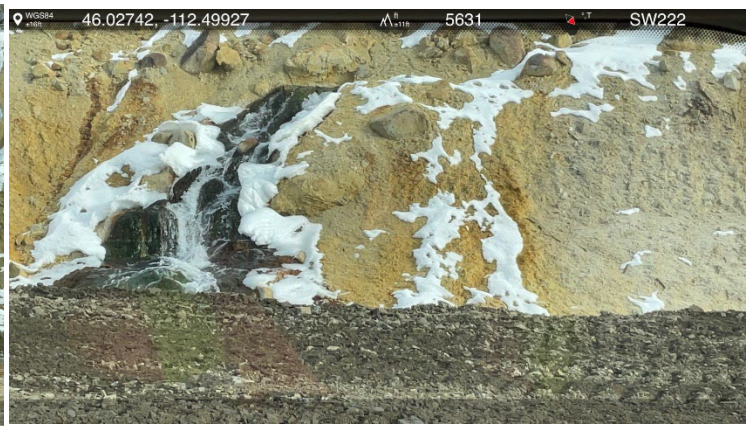
Photos 13 and 14- Based on the rapid infiltration of seepage that was observed going directly into the foundation drainage layer, it seems likely that most of the seepage that emanates in HSB would be conveyed within this layer, beneath the layered rock drains.

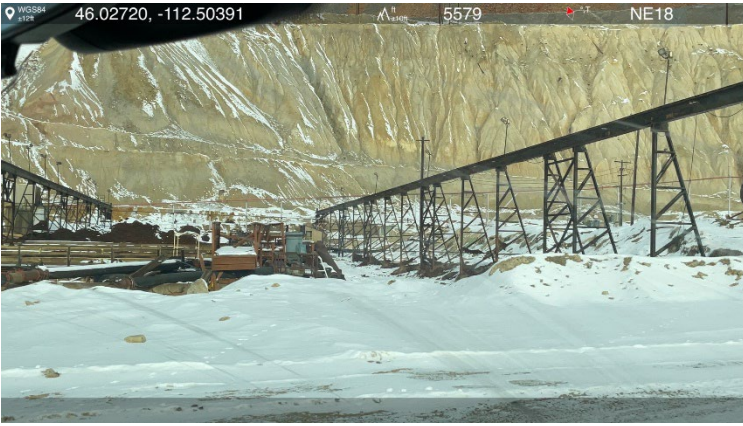
The historical copper precipitation plant has been undergoing demolition in preparation for the RDS construction, though some portions of the plant are still operational at decreased capacity (Photo 15). Copper is being recovered from water pumped out of the Berkeley Pit, when not disrupted by freezing conditions. A new precipitation plant is being constructed to the south of HSB, near the HSB Water Treatment Plant (Photo 16). This facility was approved on October 26, 2022 as revision MR 22-001. MR reported that the facility would be operational in 2023, although some aspects of construction (particularly electrical work) have recently been delayed. The site inspection concluded with an overview of the milling and concentrating facilities as an orientation for new DEQ staff. These pre-1971 processing facilities are exempt from the permitting and bonding requirements of the MMRA.

Photo 15- The historical copper precipitation plant has been undergoing demolition in preparation for the RDS construction, though some portions of the plant are still operational at decreased capacity. Copper is being recovered from water pumped out of the Berkeley Pit, when not disrupted by freezing conditions. **Photo 16-** A new precipitation plant is being constructed to the south of HSB, near the HSB Water Treatment Plant. This facility was approved as revision MR 22-001.
