**MONTANA DEPARTMENT OF ENVIRONMENTAL QUALITY
HARD ROCK MINING SECTION, MINING BUREAU
OPERATING PERMIT – FIELD INSPECTION REPORT**

Operator: Montana Resources, LLC				Inspection Date: November 29, 2023			
Operating Permit #: 00030		Project: Montana Resources- Continental Mine Complex		County: Butte-Silver Bow			
Nearest City or Town(s): Butte, Walkerville							
Inspector(s): Don Danesi, Chris Romankiewicz, Garrett Smith				Company Rep(s): Mark Thompson, Jeremy Fleege			
Agencies w/overlapping permit jurisdiction:		<input type="checkbox"/> USFS	<input type="checkbox"/> BLM	<input type="checkbox"/> Other (EPA)	<input checked="" type="checkbox"/> None		
Minerals: Copper, molybdenum, minor silver							
Status:		<input checked="" type="checkbox"/> Active	<input type="checkbox"/> Inactive	<input type="checkbox"/> Suspended	<input type="checkbox"/> Other		
Weather: Mostly sunny, high temp 42°F							
Type of Operation:				Purpose of Inspection:			
<input checked="" type="checkbox"/>	Open Pit				Initial (Pre-permitting)		
	Underground				Regular Compliance

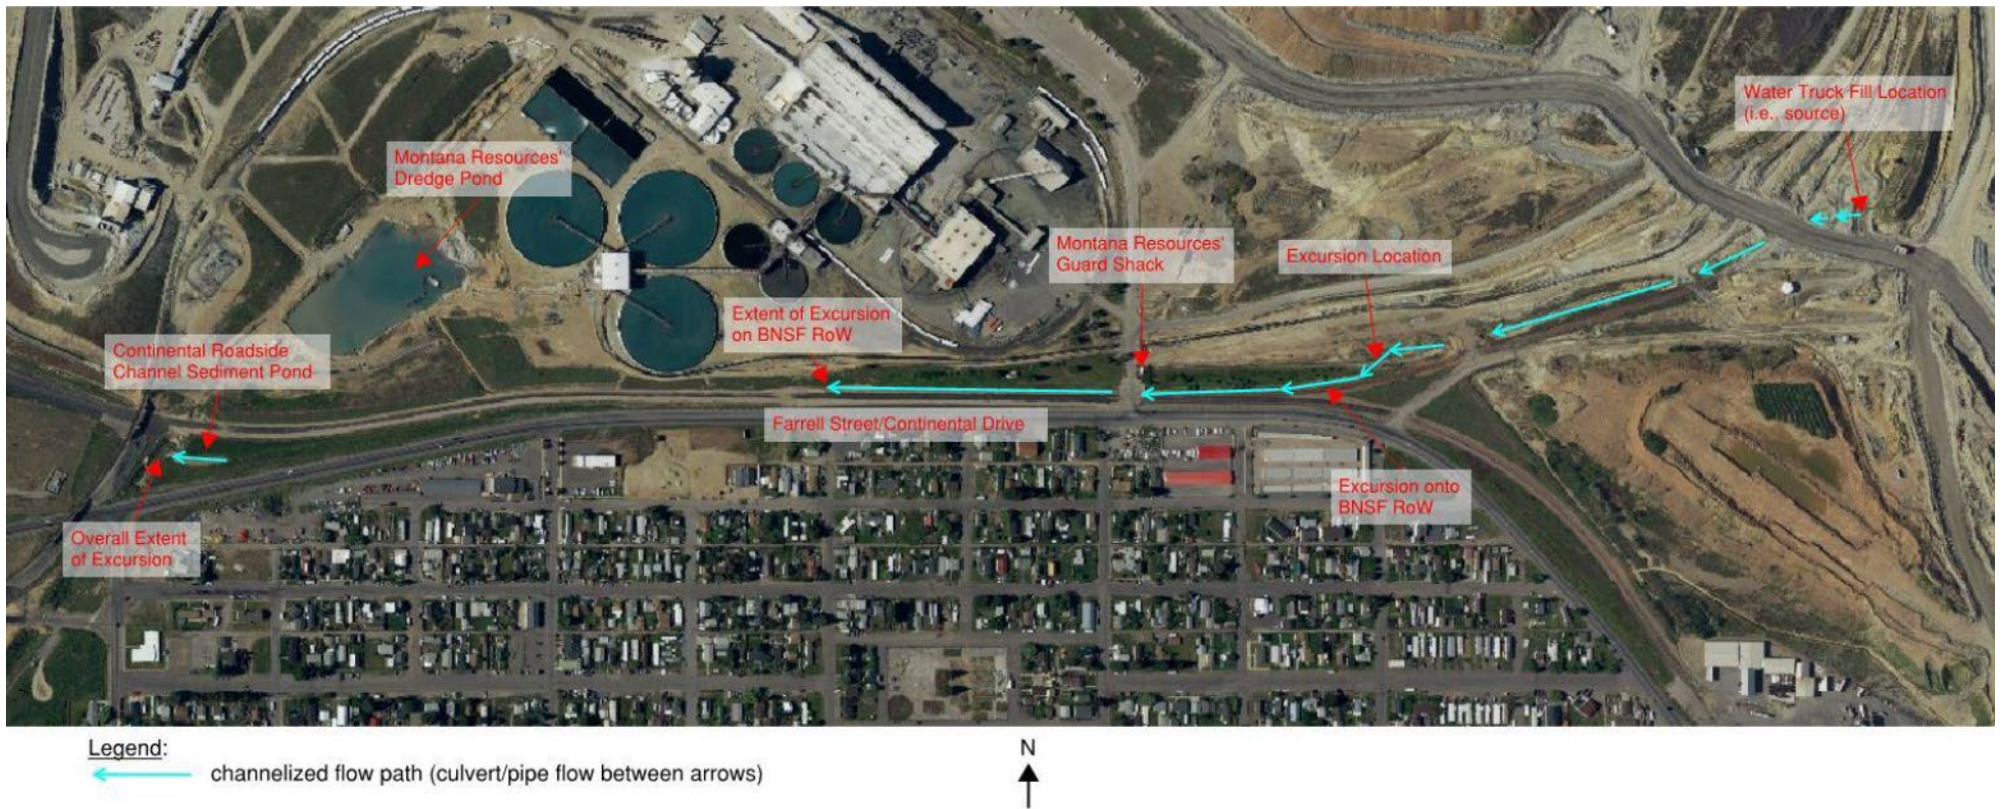
Figure 1: Provided by MR on 12/8/2023, this depicts the water's flowpath and the segments that consist of open channels or buried culverts.

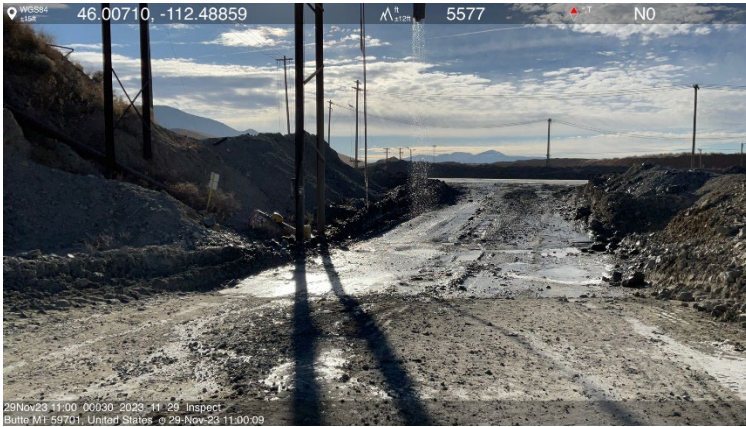
Photo 1: The source location of the process solution release was a truck fill station that is used for water trucks (52,000 gallons) conducting fugitive dust management. **Photo 2:** The flowing water entered a culvert near the fill station and was diverted beneath the nearby haul road.

SUMMARY: The inspection ended by 12:30 PM, with a brief meeting to recap the site observations and next steps. As observed on this inspection, MR will continue working on the diversion channel and berm features in this portion of the site to ensure that future runoff or process solutions are contained within the permitted area under unforeseen circumstances. In addition to further personnel training, MR may also evaluate other operational control measures to ensure that the filling station valve can be fully closed or potentially relocate the filling station.

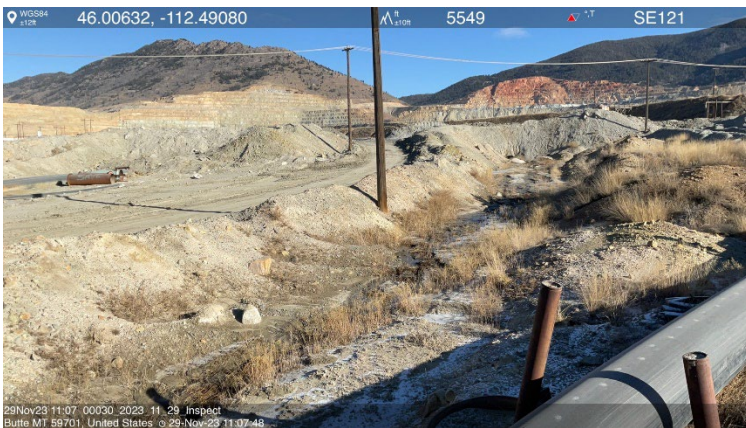
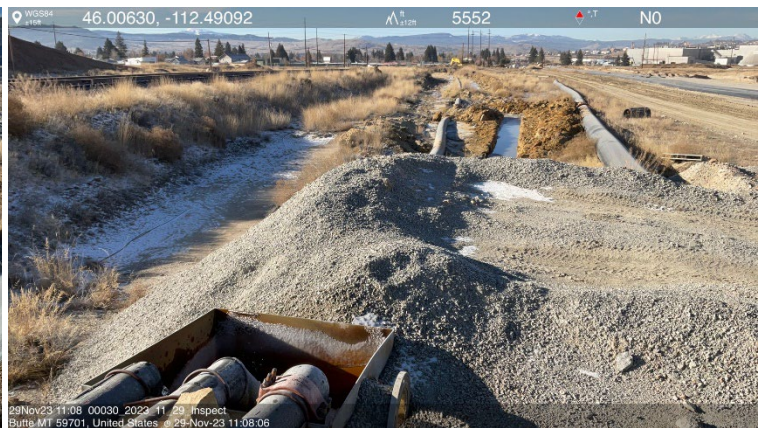
The flowing water entered a culvert near the fill station and was diverted beneath the nearby haul road (Photo 2). The water then continued to the south/southwest within existing channels and a series of culverts (Photo 3 and 4). To the east of the guard shack, the water escaped containment and flowed across the rail line and a flat area along the fence line. Within hours of discovery of the release, MR began implementing mitigation measures. MR mobilized equipment to excavate a trench to prevent any additional water from going outside of the mine permit boundary. During this inspection, additional earthwork was being performed to expand the trench and channel system and to raise the elevation of the adjacent berm/bank (Photos 5 through 7). The water observed during this inspection may have included remaining flow from the day of the release, but it also includes water that is routinely conveyed through the Clearwater Ditch (inside permit area) to the dredge pond near the mill.

Photos 3 and 4: The water continued to the south/southwest within existing channels and a series of culverts.

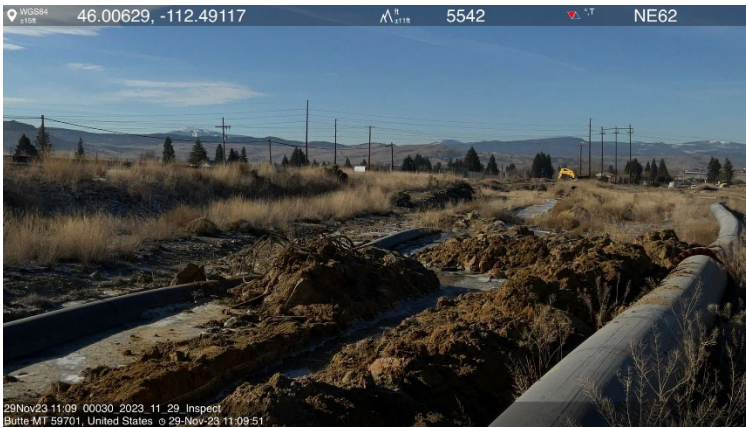
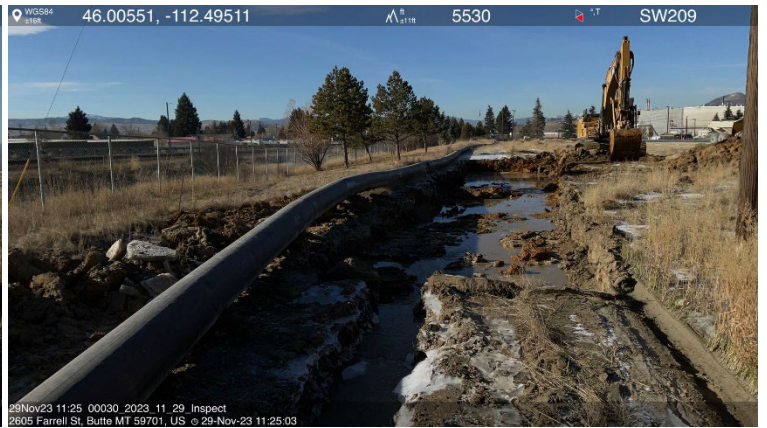
Photos 5 and 6: In addition to the immediate response measures, further earthwork was being performed to expand the trench and channel system and to raise the elevation of the adjacent berm/bank (Photos 5 through 7).

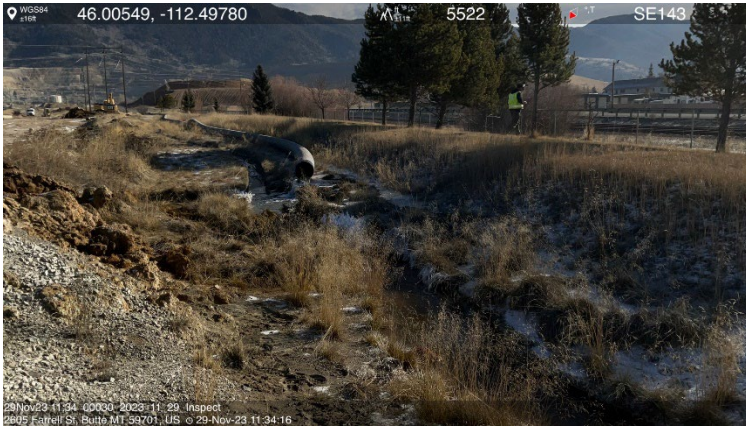
Photo 7: Flows continue within the Clearwater Ditch as part of operational water controls. **Photo 8:** Near the guard shack on Continental Avenue, the water flowed within the CRC along the railroad right-of-way outside of the permit area.

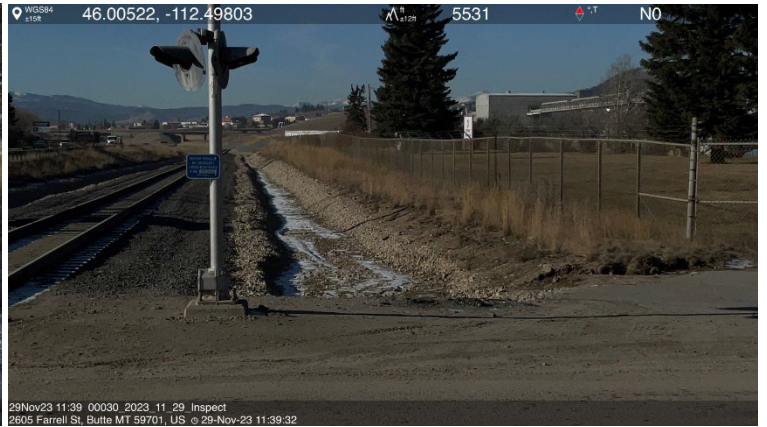
Near the guard shack on Continental Avenue, the water flowed within the CRC along the railroad right-of-way outside of the permit area. The flow was contained within the open channel and segments that consist of culverts or concrete channels (Photos 8 through 11). The flowing water ultimately ended with pooling in the sediment pond located at the western end of the CRC. This location is the northern extent of the upper Silver Bow Creek channel, formerly known as Metro Storm Drain (Photos 12 and 13). This feature conveys runoff from the area but does not contain perennial flow.

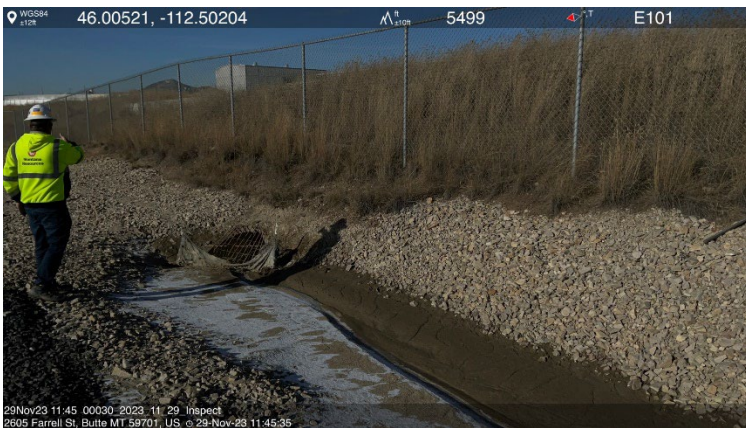
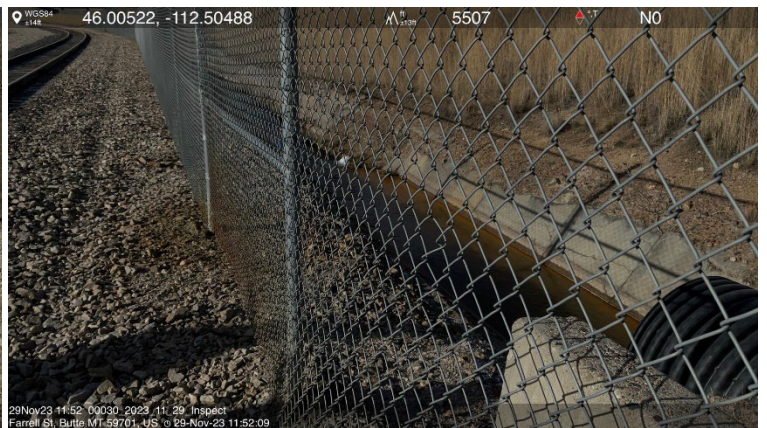
Photos 9 and 10: The flow was contained within the open channel of the CRC and segments that consist of culverts or concrete channels.

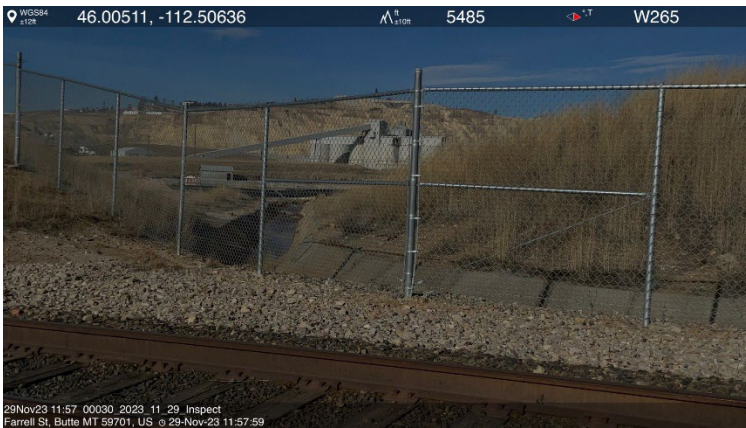
Photo 11: The flow was contained within the open channel of the CRC and segments that consist of culverts or concrete channels. **Photo 12:** The flowing water ultimately ended with pooling in the sediment pond located at the western end of the CRC.

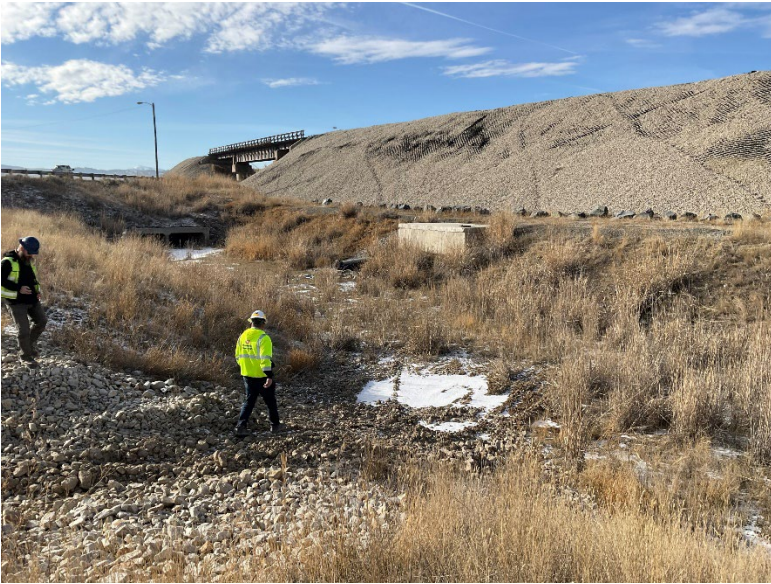
Photo 13: This location is the northern extent of the upper Silver Bow Creek channel, formerly known as Metro Storm Drain. This feature conveys runoff from the area but does not contain perennial flow.
