**MONTANA DEPARTMENT OF ENVIRONMENTAL QUALITY
HARD ROCK MINING BUREAU
OPERATING PERMIT – FIELD INSPECTION REPORT**

Operator: Montana Resources, LLC				Inspection Date: June 20, 2023			
Operating Permit #: 00030			Project: Montana Resources- Continental Mine Complex			County: Silver Bow	
Nearest City or Town(s): Butte							
DEQ Staff: Christine Abelmann, Derrek Schultz, Garrett Smith				Company Representative(s): Mark Thompson, Jeremy Fleege			
Agencies w/overlapping Jurisdiction:			USFS		BLM		Other <input checked="" type="checkbox"/> None
Minerals: Copper, molybdenum, minor silver							
Status:		<input checked="" type="checkbox"/>	Active		Inactive		Suspended <input type="checkbox"/> Other <input type="checkbox"/>
Weather: Partly cloudy, high temp 55°F							
Type of Operation:				Purpose of Inspection:			
<input checked="" type="checkbox"/>	Open Pit				Initial (Pre-permitting)		
	Underground			<input checked="" type="checkbox"/>	Regular Compliance		
	Placer				Amendment #		
<input checked="" type="checkbox"/>	<i>Heap Leach- Leach pads near HSB no longer receiving solution</i>				Complaint Received

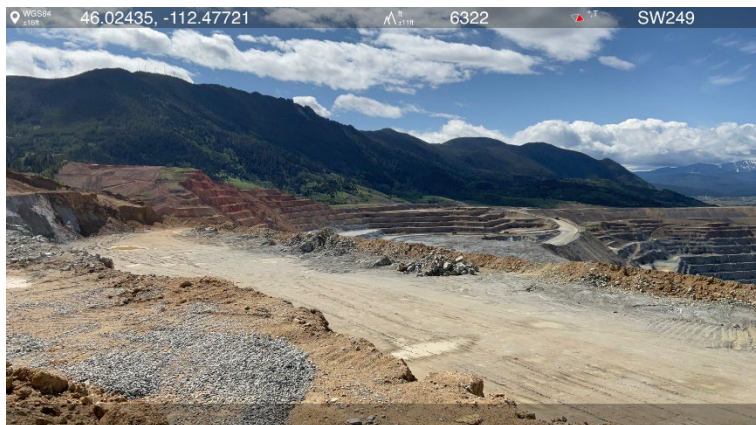
MR began proactive communication and planning with DEQ and Dept. of Transportation in case blasting would be necessary less than 1,000 feet from the interstate right-of-way. As predicted by the pit monitoring system, a failure occurred in the central portion of the D East highwall in early November 2022 (Photos 1 and 2). Although an estimated 1 million tons of rock were displaced along a series of benches, there were no employee injuries or damage to equipment. Vegetation removal and soil salvage has occurred to the east of the highwall as part of constructing an access ramp and this material is stockpiled in other locations along the East Dump Complex (Photo 3). Mining continues in other portions of the Continental Pit, with little influence from the failure area.

Photo 1- A failure occurred in the central portion of the D East highwall on November 1, 2022, which is a relatively small area in the Continental Pit (left side of photo). **Photo 2-** Vegetation removal and soil salvage has occurred to the east of the highwall as part of constructing an access ramp.

MR anticipates that blasting within 1,000 feet of the interstate will be necessary in the future, so geotechnical investigations are ongoing, and a risk evaluation report will be available later this summer. MR has also been drilling modified patterns with smaller holes in the current pit to better understand how those changes might better control disturbance with future blasting for the highwall layback. **Any activities that may impact Interstate-15 should be coordinated with MDT, but DEQ would like to be included for opportunities to collect seismic data. MR is evaluating whether any additional disturbance boundary adjustment may be necessary as part of the layback in this area now called “E East,” which would be addressed as a permit revision. The language about blasting in the Operating Plan may also need to be modified to reflect updated strategies.**

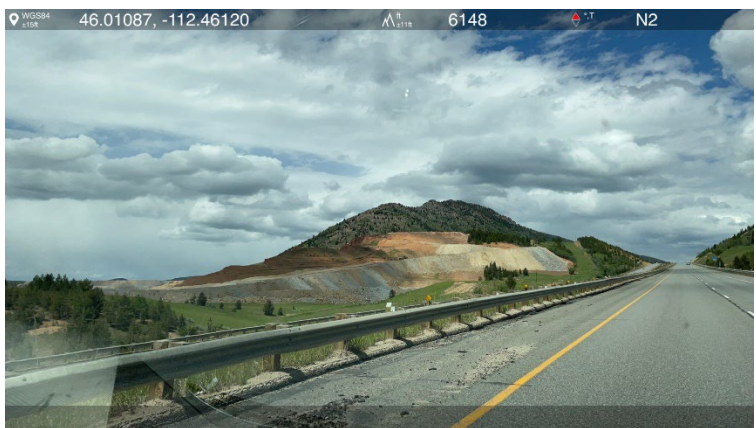
Photo 3- The backside of the highwall and soil salvage area in Photo 2 (from Interstate 15, northbound). **Photo 4-** Haul trucks moving non-ore rock, only small portions of the YDTI embankment crests have not been constructed to the 6,450 ft elevation.

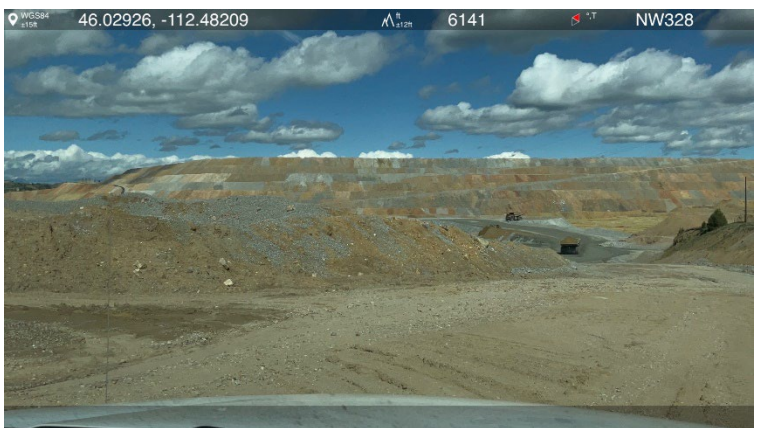
Non-ore rock is being used as construction material to expand the capacity of the Yankee Doodle Tailings Impoundment (YDTI) by raising the embankment crests to 6,450 feet (Amendment 010). Very few portions of the YDTI have not been constructed to this elevation. The primary haul route now follows along the ramp constructed on the N-S Embankment, rock placement is occurring on top of the former leach pads adjacent to this embankment slope (Photos 4 and 5). In late April 2023, small transverse cracks were observed along the Crest in areas of recent rock placement. The engineer of record was notified and focused monitoring was implemented, consistent with the requirements of the TOMS Manual for Level 1 events. Monitoring and trenching investigations demonstrated that the cracks were shallow and limited in extent. Mapping of recent rock fill sequences confirmed that the cracks

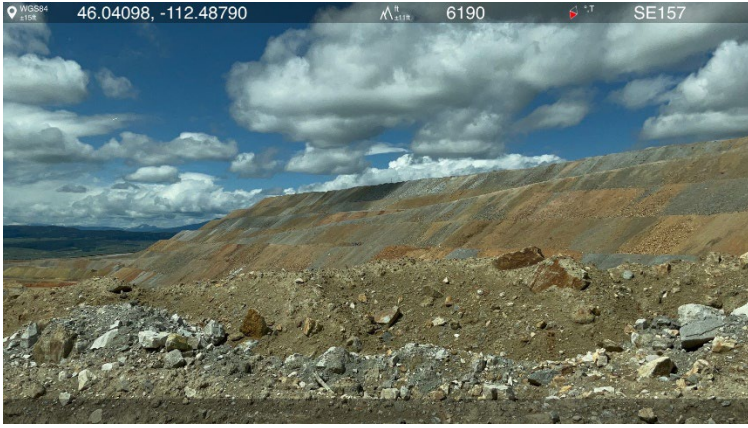
Photo 5- The primary haul route now follows along the ramp constructed on the N-S Embankment. **Photo 6-** The return water lines are functioning along the new barge access road (east side of YDTI), the former road will be decommissioned as the tailings and pond elevations rise.

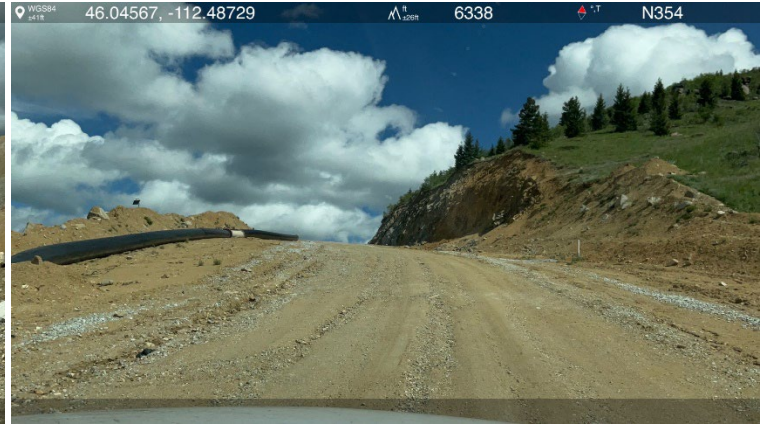
An overlook for the tailing storage facility was reached by the barge access road on the eastern margin, along the path of the return water lines (Photo 6). A wide beach area is important to separate the tailings pond from the embankments, thus contributing to the safety and stability of the facility. There are now 28 tailings discharge points around the facility, which allow greater flexibility for selectively applying tailings slurry in areas that might become dry and prone to blowing dust, and to control the development of the beach and pond areas (Photo 7). In addition to site specific weather forecasting, there is a dedicated crew for tailings monitoring and dust management. The placement of magnesium chloride storage tanks and bladders positioned around YDTI allow for more rapid filling and deployment of the tracked vehicles used for dust suppression.

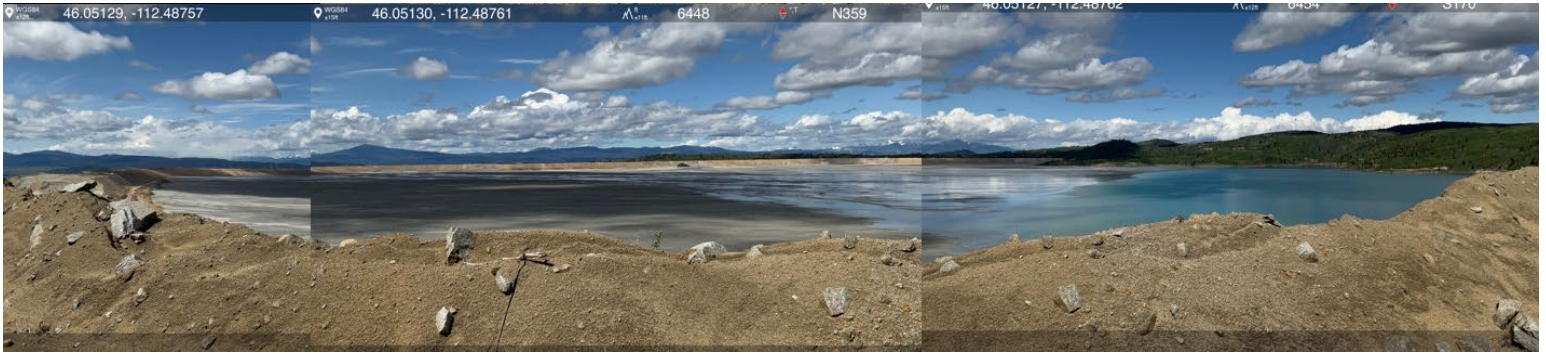
Photo 7- Additional tailings discharge lines allow greater flexibility for selectively applying tailings slurry in areas that might become dry and prone to blowing dust, and to control the uniform development of the beach and pond areas.

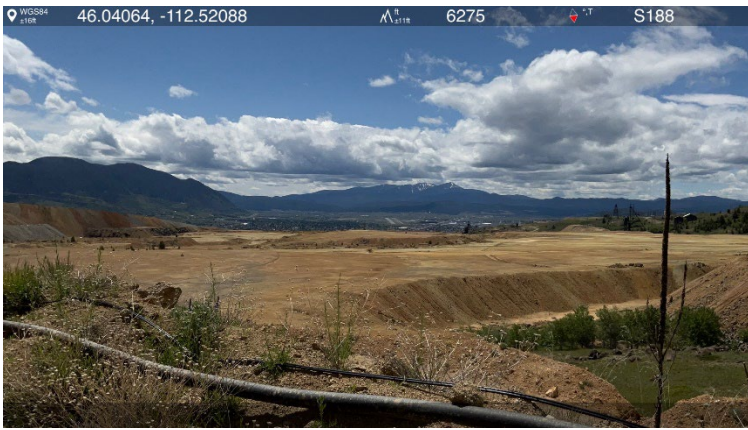
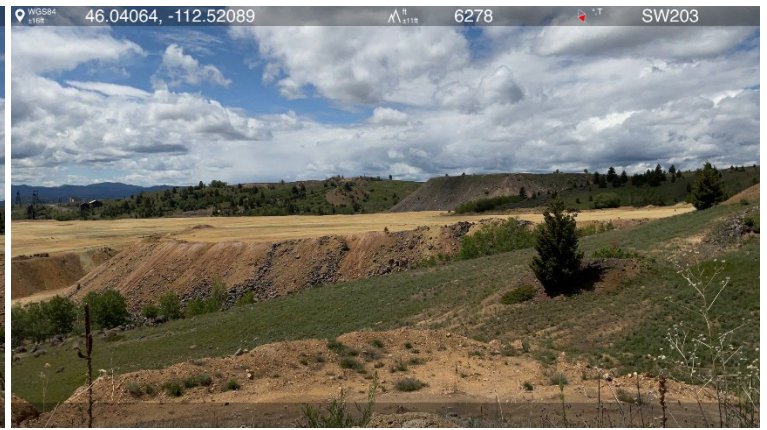
While leaving the YDTI, the area known as the Northwest Dumps was observed (Photos 9 and 10). This area was removed from the operating permit approximately 20 years ago, as it was incorporated into a historic preservation area within the BMFOU and Butte Priority Soils Operable Unit (BPSOU). MR is currently acquiring this land from Atlantic Richfield, anticipating that this location may be needed for rock placement and expansion of the YDTI in the future. **The operating permit must be modified to incorporate any disturbance and expansion of the permit boundary in this area prior to any activity occurring.**

Photos 9 and 10- Looking south/southwest from the WED Extraction Pond area. The disturbed areas and flat waste rock are called the Northwest Dumps. MR is acquiring this land from Atlantic Richfield.

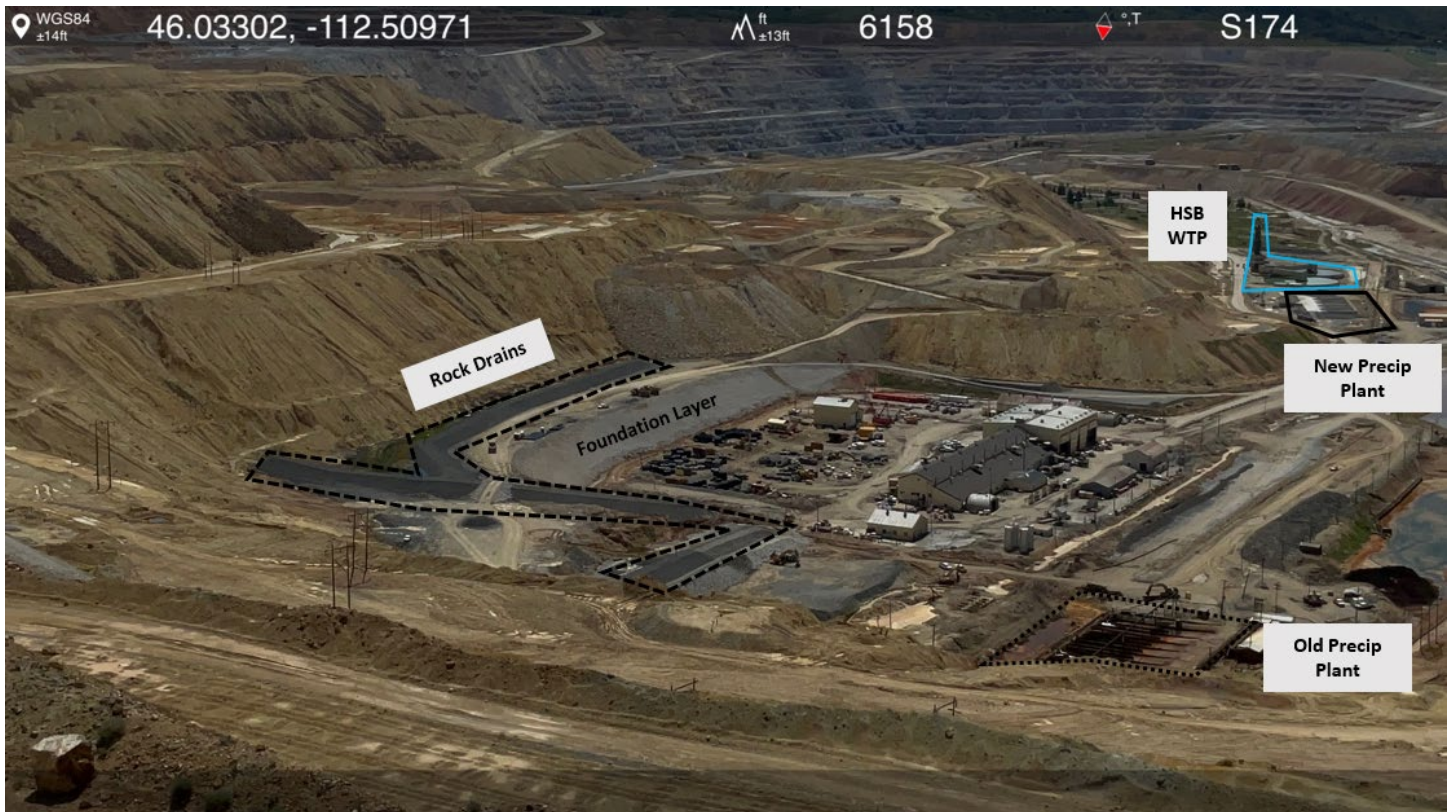
The inspection continued to the HSB overlook near Tailings Booster Station #3, before going through the HSB area (Photo 11). DEQ approved Minor Amendment 011 on 7/14/2022 for the construction of a rock disposal site (RDS) within the HSB area, at the southern toe of YDTI. The RDS would include a foundation drainage layer and engineered rock drains to capture and convey seepage flows from underneath the RDS, through a conveyance channel, and then to the management and treatment systems required under the Superfund remedy. The foundation drainage layer has been placed in some areas and based on the rapid infiltration of seepage that has been observed, it seems likely that much of the seepage that emanates in HSB would be conveyed within this layer, beneath the layered rock drains. Portions of the rock drains have also been constructed and that work is ongoing, using 3 different size fractions of Pipestone rock, similar in design and construction to the WED (Photos 12 and 13).

Photo 11- The HSB overlook near Tailings Booster Station #3, major features from the report are outlined and labeled.

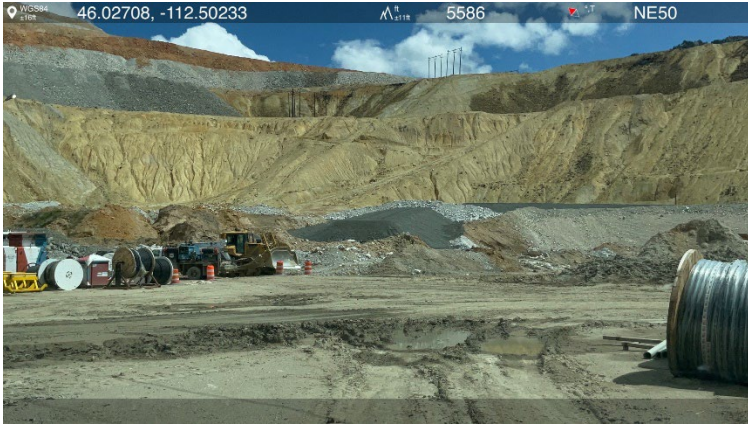
Photo 12- The 3-layer rock drains are being constructed on top of the foundation drainage layer, some portions have not yet been constructed. **Photo 13-** The foundation drainage layer continues to be constructed prior to placement of Pipestone drain rock.

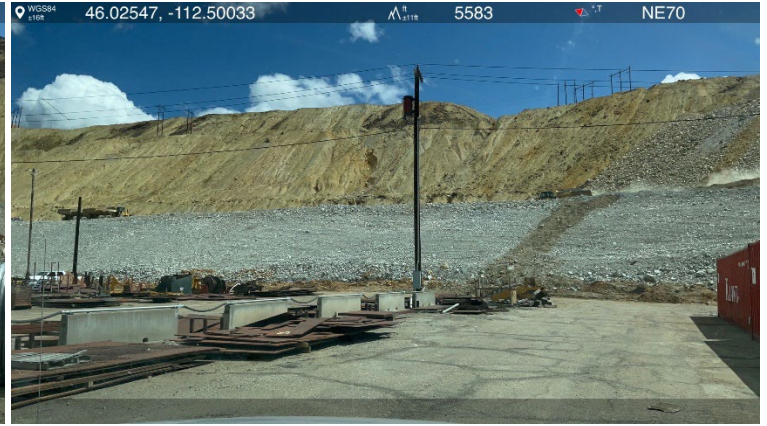
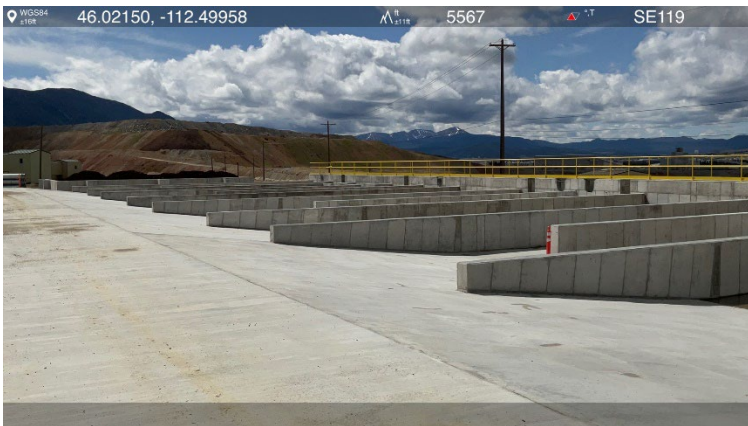
Photos 14 and 15- A new precipitation plant is being constructed to the south of HSB, near the HSB Water Treatment Plant. This facility was approved as revision MR 22-001.

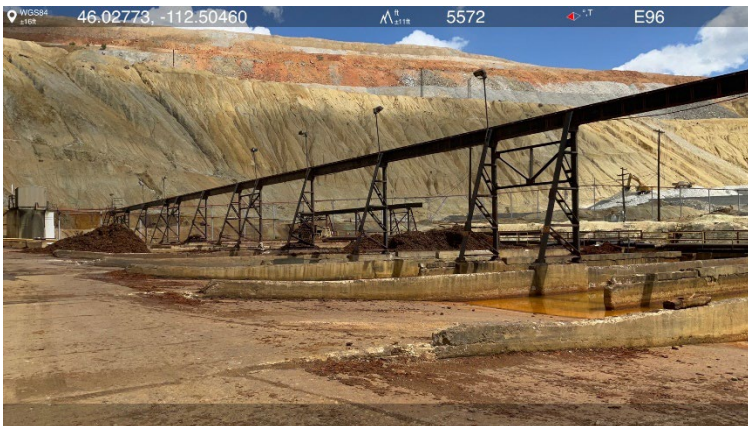
precipitation plant has been undergoing demolition in preparation for the RDS construction, though some portions of the plant are still operational at decreased capacity (Photo 16). Copper is being recovered from water pumped out of the Berkeley Pit and the HSB seepage.

Photo 16- The historical copper precipitation plant has been undergoing demolition in preparation for the RDS construction, though some portions of the plant are still operational at decreased capacity. **Photo 17-** Pilot scale testing for REE/CM recovery may begin later in 2023, which would involve the placement of “geotubes” in a flat area adjacent to the current plant facility (inside fence, other side of road berm).

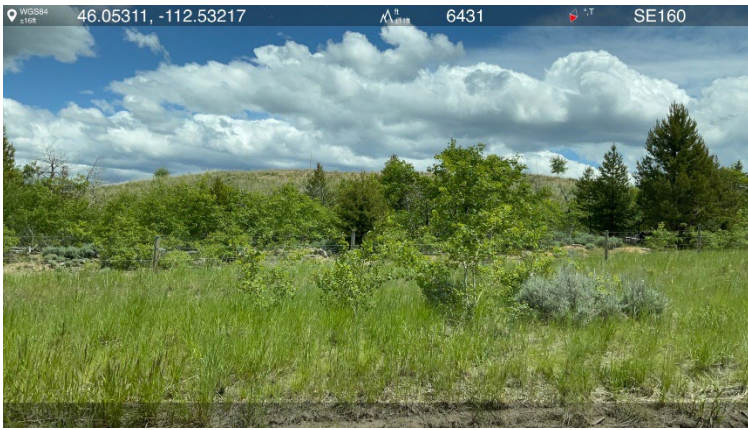
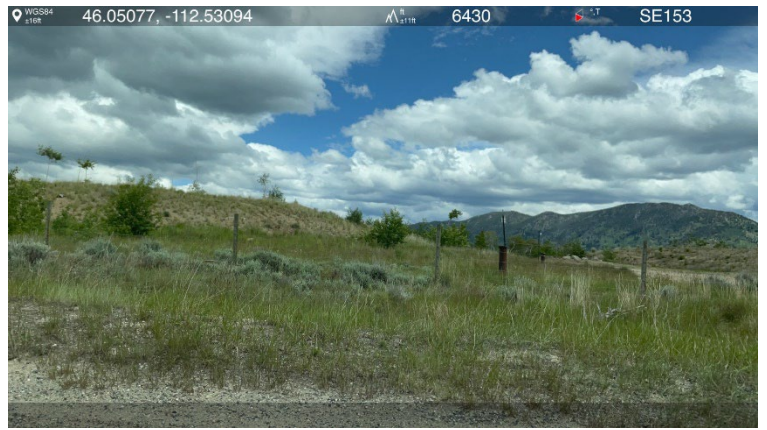
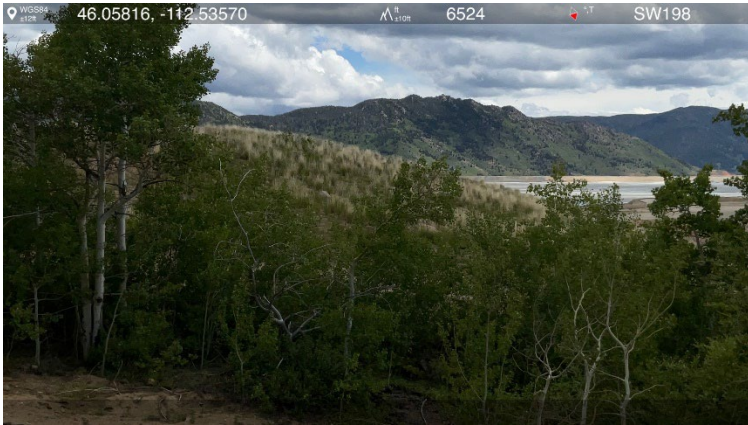
After the on-site inspection concluded, DEQ traveled along the Moulton Reservoir Road to evaluate the establishment of vegetation on stockpiles, which also serve as visual barriers along the public access road (Photos 18 through 20). The stockpile topography and surrounding native vegetation generally provide an effective barrier from most vantage points along the road. In most places, the establishment of grass and forb species on the piles is looking good and only minor erosion has occurred on the stockpile surface. A few of the aspen trees that were

Photos 18, 19, 20- Vegetated soil stockpiles along the Moulton Reservoir Road. The stockpile topography and surrounding native vegetation generally provide an effective visual barrier from most vantage points along the road. In most places, the establishment of grass and forb species on the piles is looking good and only minor erosion has occurred on the stockpile surface. A few of the aspen trees that were planted on top of the piles have survived, although most of them have not.

planted on top of the piles have survived, although most of them have not. There may be sufficient tree growth along the undisturbed margins of the piles to promote encroachment and further tree growth in the future. **The West Ridge stockpiles should continue to be monitored and any maintenance of soil surfaces and vegetation (e.g. supplemental seeding, planting, weed control) should be completed as needed.**
