June 5, 2023

Knight Piésold Ltd.

RE: Q1 2023 – YDTI Quarterly Water Data Summary

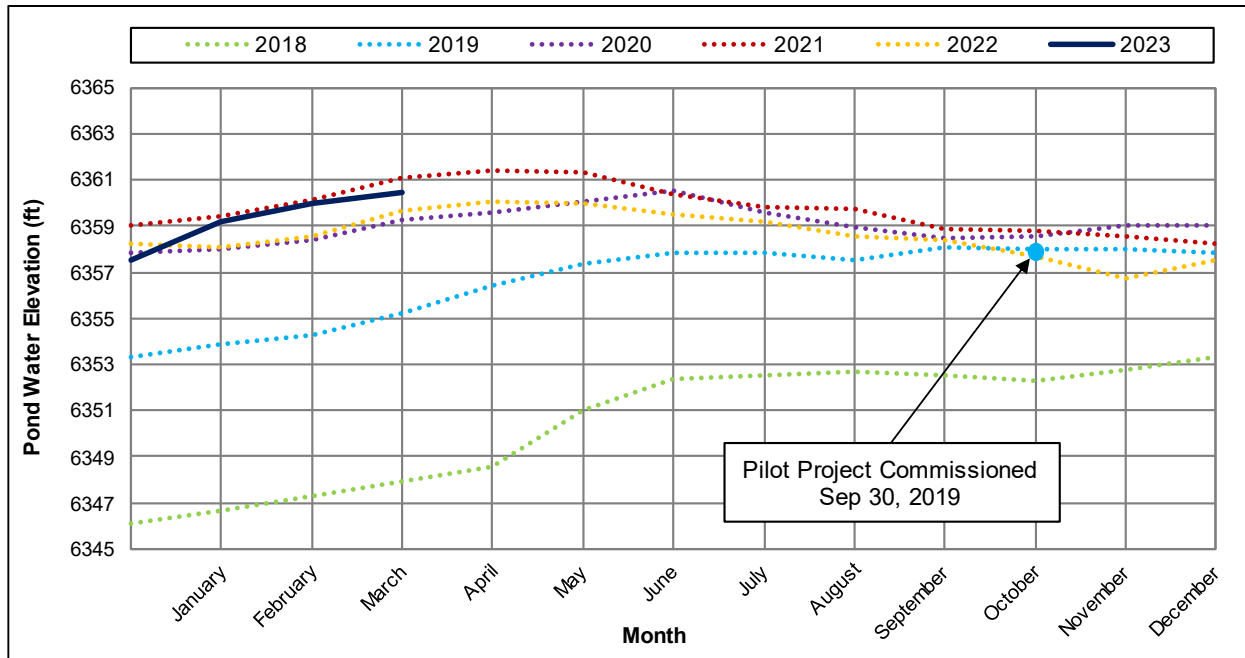
Figure 2.1 Monthly YDTI Pond Water Elevation

MR manually measures the YDTI supernatant pond elevation on a weekly basis. The final pond water elevation recorded during the Q1 monitoring period was 6,360.44 ft on March 23, 2023. This measurement equates to a pond elevation increase of approximately 2.9 ft during Q1 2023. The monthly pond water elevations from 2018 through Q1 2023 are presented on Figure 2.1. The supernatant pond elevation rate of rise (or decrease) is currently affected by MR discharging YDTI water off-site via the Polishing Plant as part of their commitment to reducing the YDTI pond volume to approximately 15,000 acre-ft. A more detailed description of the Pilot Project and Polishing Plant is presented in the Tailings Operations, Maintenance and Surveillance Manual (MR/KP, 2022).

The Q1 supernatant pond elevation increase is approximately 1.3 ft greater than the average increase observed in Q1 over the past three years. This increased rate of elevation increase is mainly attributed to

a reduction in the Pilot Project discharge flowrate as detailed in Section 2.2. The monthly pond water elevations from 2018 through Q1 2023 are presented on Figure 2.1.

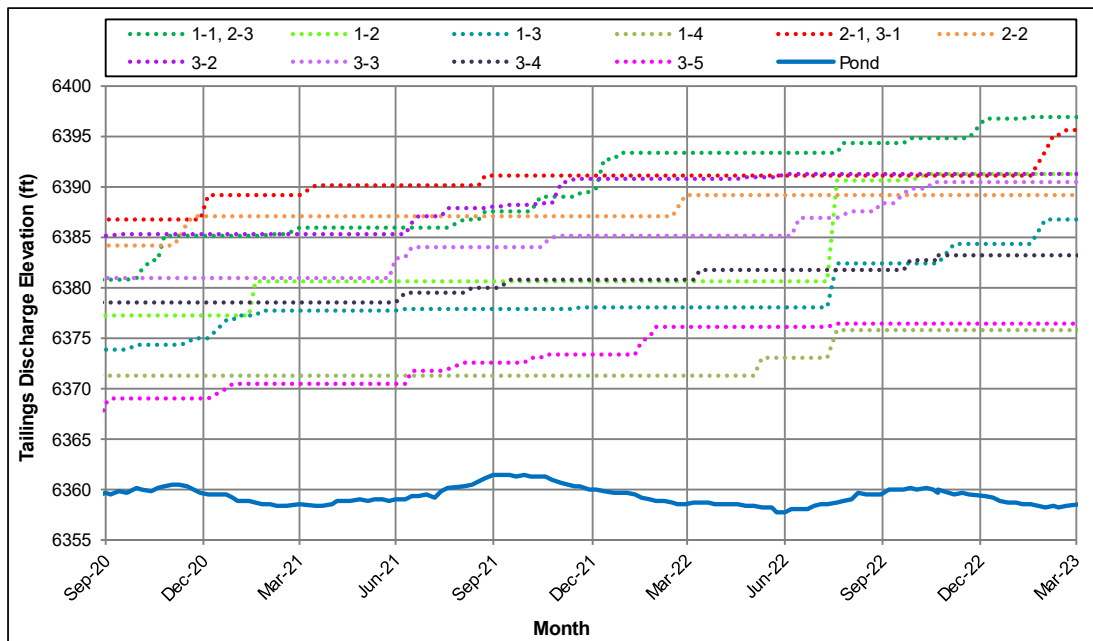
Figure 3.2 Tailings Discharge Elevations

The discharge spigot with the lowest beach elevation was 1-4 throughout Q1 2023. The elevation difference between 1-4 and the supernatant pond surface was approximately 15.3 ft at the end of Q1 2023. The location of the lowest discharge point identifies the general area of the facility where the pond may initially contact the embankment in the event the pond elevation rises due to an increase in pond volume (e.g., flooding).

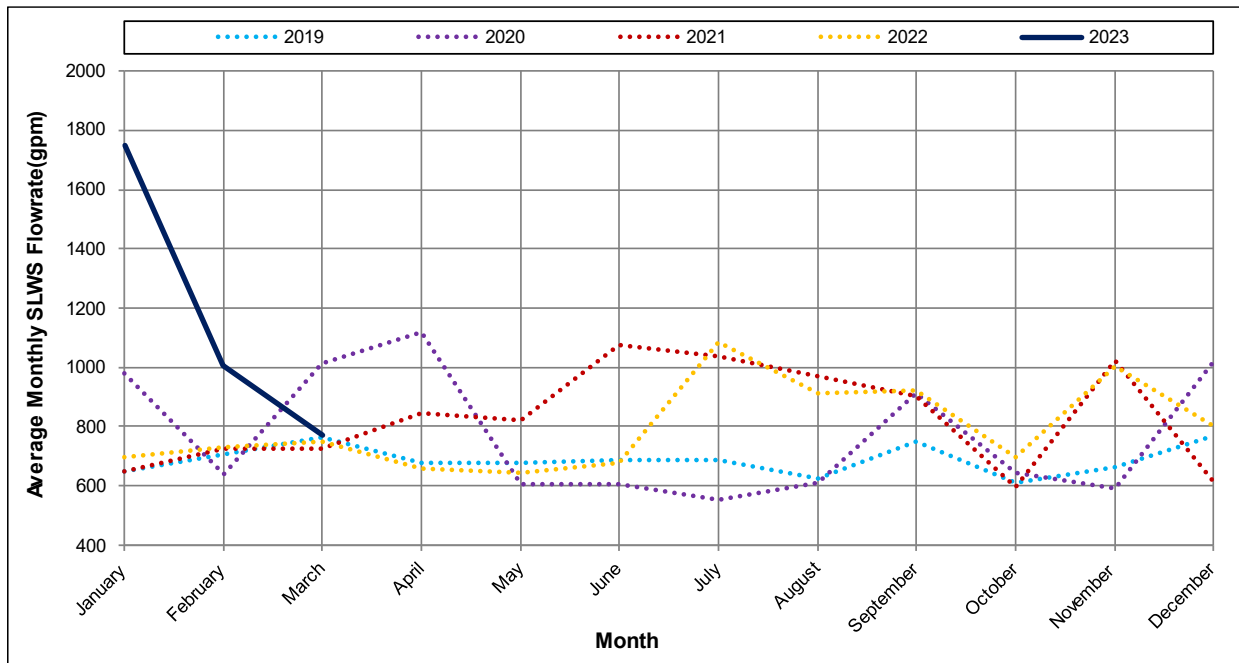
Figure 4.1 Average Monthly SLWS Flowrate

Water from the Silver Lake Water System (SLWS) is used to meet both the operational freshwater and make-up water requirements. SLWS flows in Q1 2023 averaged approximately 1,174 gpm (1.7 Mgalpd), which is a 0.7 Mgalpd (67%) increase compared to the average Q1 flowrate over the past five years. The increase in SLWS usage is mainly attributed to the following:

- Power issues at the Return Water barges in early January 2023
- Preparation for a ‘down day’ on March 15, 2023
- Increased operation of the molybdenum plant throughout Q1, which requires approximately 800 gpm (1.2 Mgalpd)

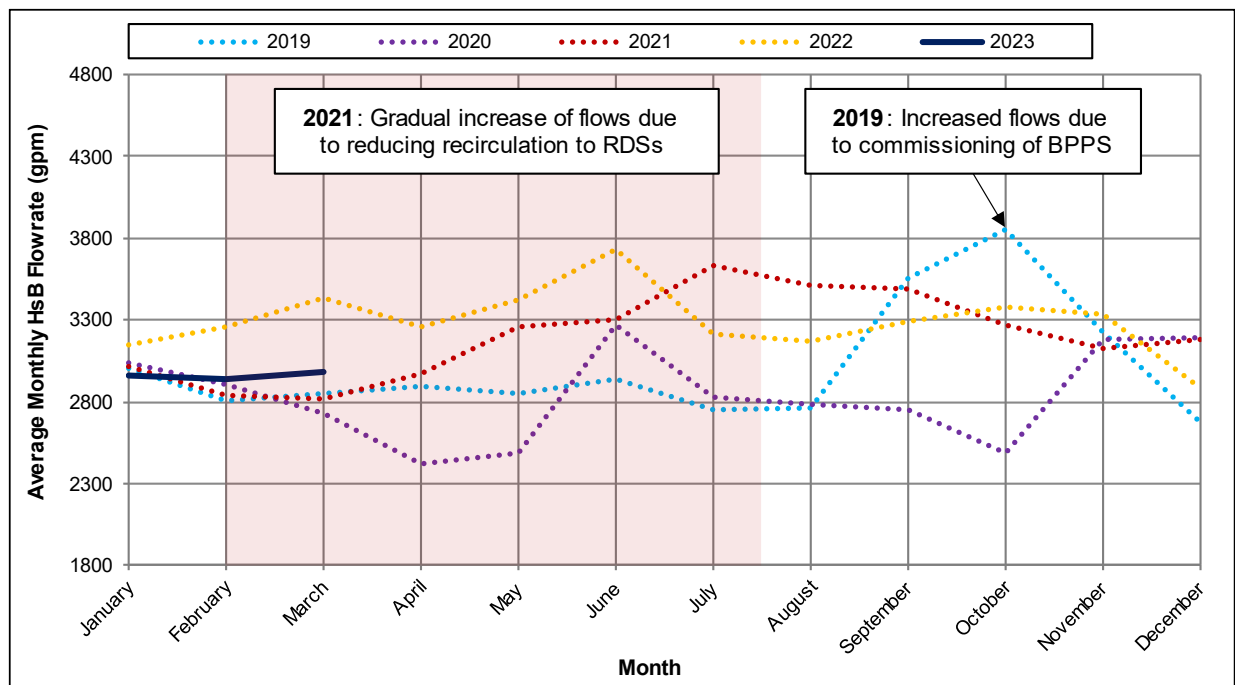
Figure 5.1 Average Monthly HsB Weir Flowrate

The average flowrate during Q1 2023 was approximately 2,960 gpm, which is approximately 310 gpm (9%) lower than the average flowrate since recirculation of leach solutions flows to the rock disposal sites (RDSs) ceased in Q3 2021. This decrease in flowrate is inferred to be caused by freezing temperatures during Q1. Average monthly HsB Weir flowrates are presented on Figure 5.1.

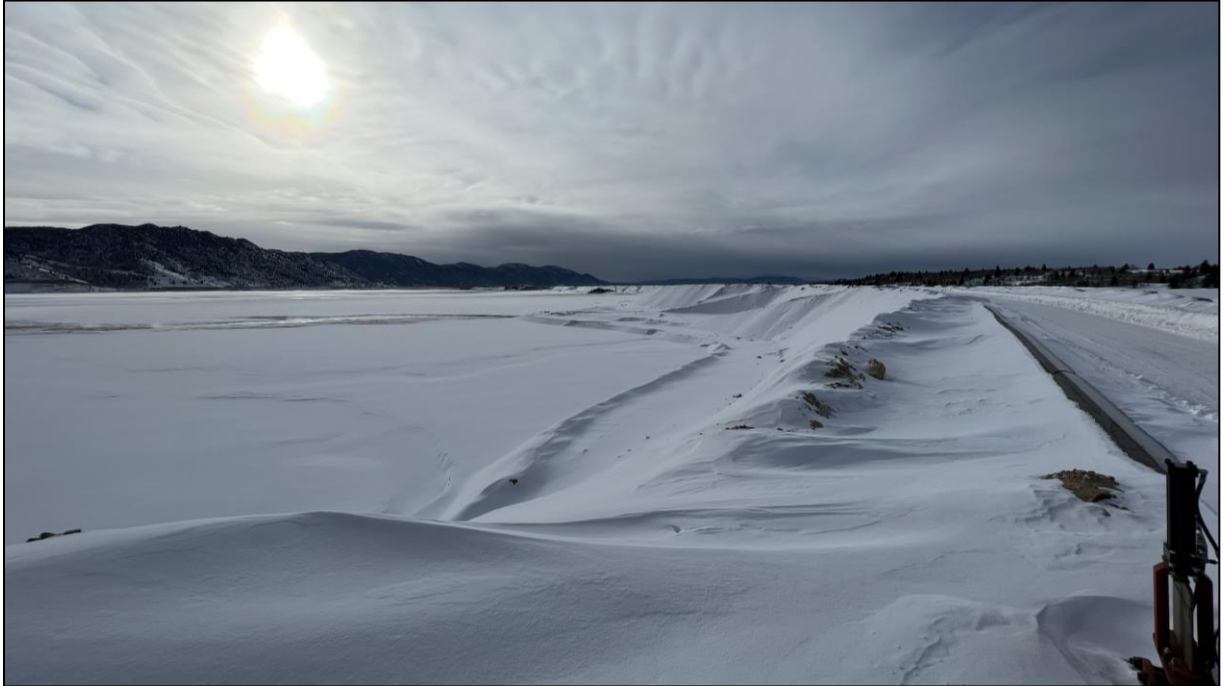
The increased flowrates recorded since early to mid-2022 are attributed to the discharge of tailings overtop of the historical tailings pipeline corridor for the EL. 6,400 ft lift of the West Embankment. The tailings were initially discharged onto the pipeline corridor bench due to the rising tailings beach in the facility, which was inferred to cause increased infiltration of tailings water into the WED. Photo 7.1 shows the discharges adjacent to the West Embankment in March 2023. MR and KP anticipate the WED pumping rates will vary throughout the year depending on tailings discharge practices and may slowly decrease over time as the tailings beach thickness increases above the EL. 6,400 ft pipeline corridor bench. MR have been closely monitoring the daily pump data records and conducting regular visual inspections of the tailings beach adjacent to the West Embankment. No signs of tailings slurry flowing directly into the embankment or other

adverse conditions have been observed to date. MR will continue to regularly monitor the tailings discharges in this area and associated increases in pumping rates required to maintain dewatering of the Extraction Pond.

Photo 7.1 Tailings discharge adjacent to the West Embankment – March 1, 2023.

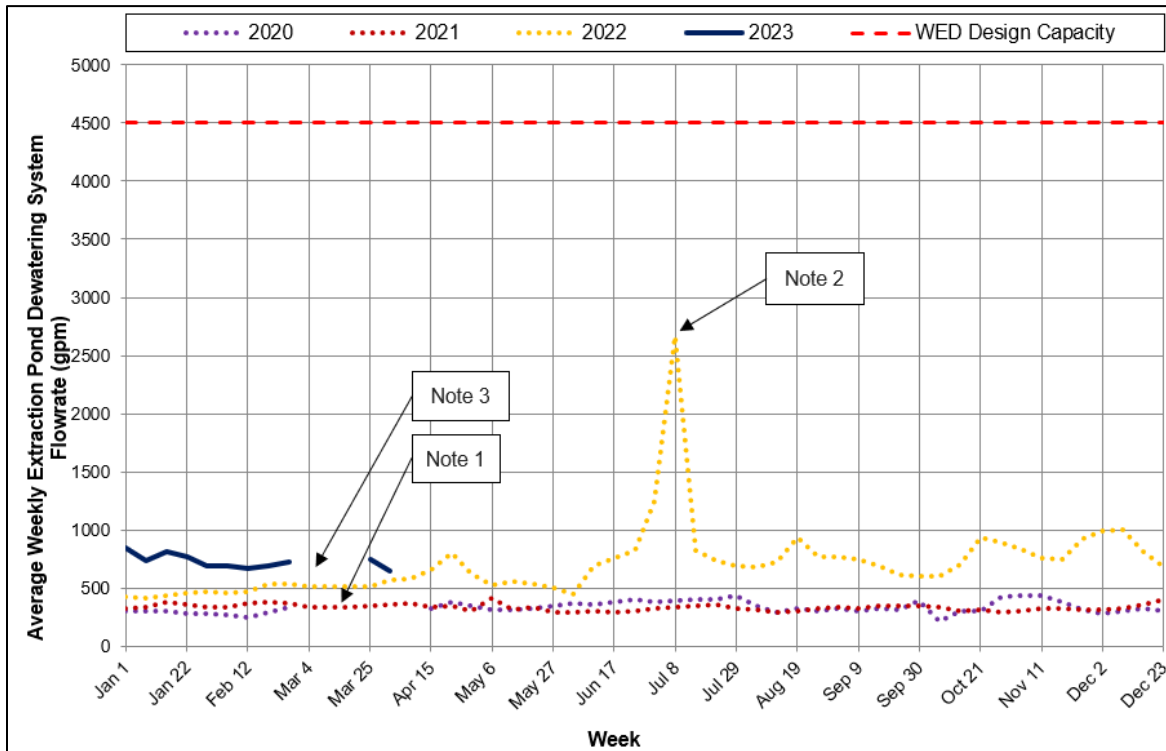
Figure 7.1 Average Weekly Extraction Pond Dewatering System Flowrate

The average weekly flowrates for the Extraction Pond Dewatering System since it began operating on November 20, 2019, are presented on Figure 7.1. The WED average weekly pumping rate increased above historical values beginning in February 2022. The pumping rates have since ranged from approximately 600 to 1,000 gpm. A peak of approximately 2,000 gpm was observed in July 2022 due to power outages; another peak of approximately 3,000 gpm was observed in March 2023 and is attributed to a flowmeter error.

1. Erroneous data caused by pump cycling from March to April 2020 were removed.
2. The average weekly Extraction Pond Dewatering System flowrate peaked July 9 to 15, 2022. This high flowrate is attributed to a single event on July 9 associated with power outages and increased infiltration of tailings water into the WED.
3. Erroneous data suspected to be due to a flowmeter error from March 4 to 18, 2023 were removed.

- WED Extraction Pond Dewatering System flowrates continued to be elevated above historical pumping rates during Q1, which is attributed to the rising tailings level and increased tailings slurry water being collected by the WED. MR and KP continue to monitor these flows closely.

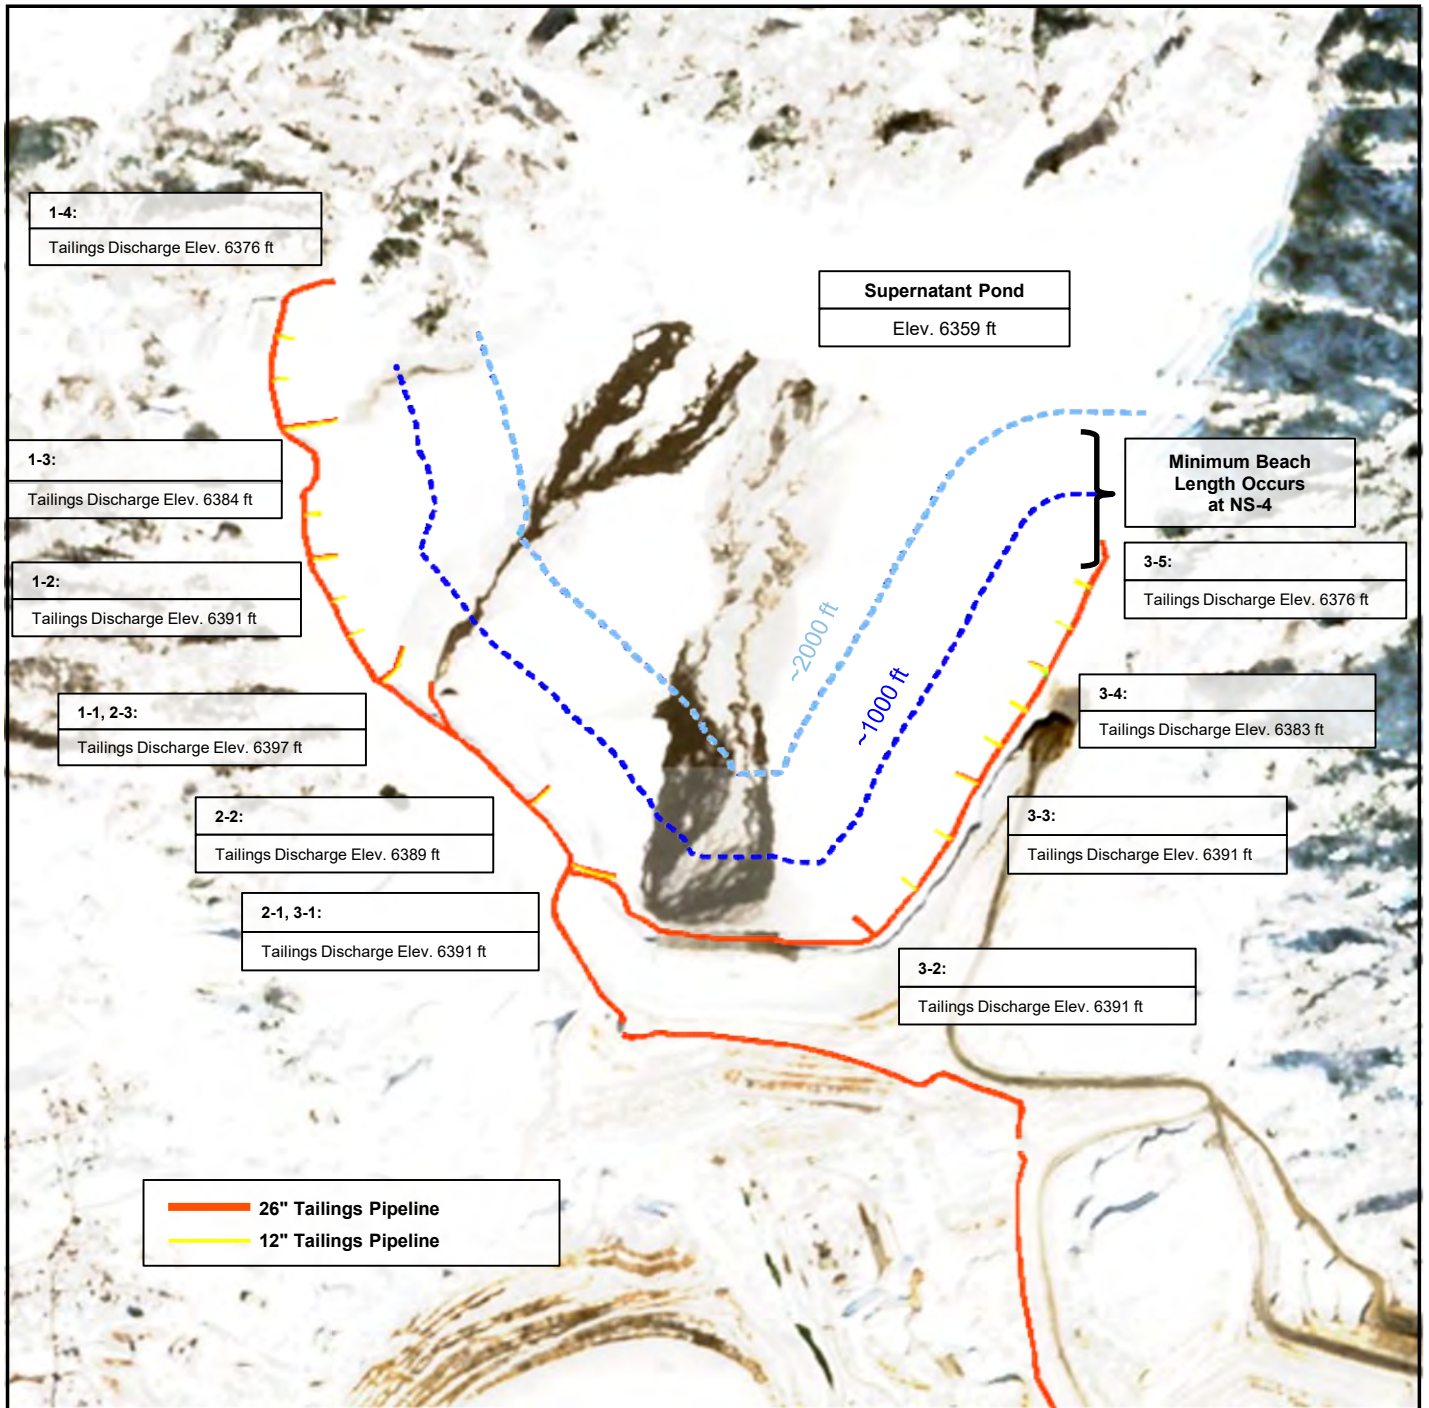
MONTANA RESOURCES, LLC.	
YANKEE DOODLE TAILINGS IMPOUNDMENT	
SENTINEL-2 SATELLITE IMAGERY TAILINGS BEACH ASSESSMENT JANUARY 27, 2023	
Knight Piesold CONSULTING	P/A NO. VA101-126/29
	REF. NO. VA23-00585
FIGURE A.1	
REV 0

Images captured by the Sentinel-2 satellite are reviewed twice per month to remotely observe the shape of the tailings beach and position of the supernatant pond relative to the embankments. The shortest beach length was observed at the northern end of the North-South Embankment and estimated to be approximately 1,450 ft at the end of Q1, which is approximately 100 ft shorter than the Q4 2022 beach length. This beach length was also observed in Q1 2021 when the supernatant pond water was at a similar elevation. The decreased beach length is attributed to the pond water elevation increasing and less beach being exposed as the beach/pond interface extends to the south. The pond/beach interface was partially obscured by snow and an ice cap, which may affect the minimum beach length estimation.

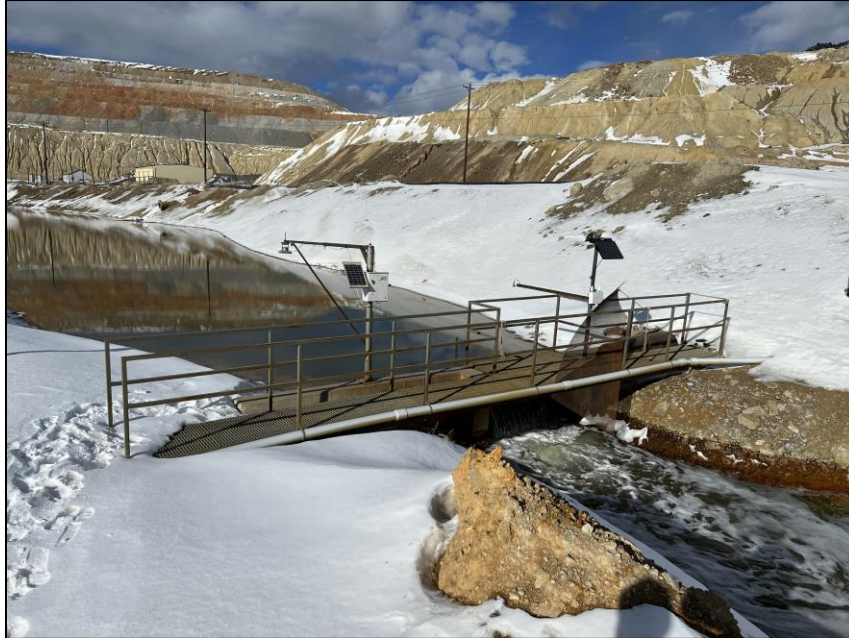
The HsB Weir records the flow of surface water discharging from the HsB area via the HsB Pond. The flows include YDTI seepage, meteoric inputs from the contributing catchment areas, and any drain down from leach pads. Seepage from the YDTI flows south through the HsB area and joins with localized surface runoff in the HsB Pond before passing over the HsB Weir. The flow depth over the weir is measured continuously using an ultrasonic lookdown level sensor located upstream of the weir. An image of the flow through the HsB Weir on March 1, 2023, is presented in Appendix A – Photo 1.

PHOTO 1 – March 1, 2023 – Flow through HsB Weir.

A new level sensor that records the flow depth passing over the HsB Weir was connected to MR’s remote monitoring system (Sensemetrics) in December 2022. Calibration of the sensor with the Sensemetrics software and program is ongoing. MR will begin using this data as the primary flow monitoring device once calibration is complete.

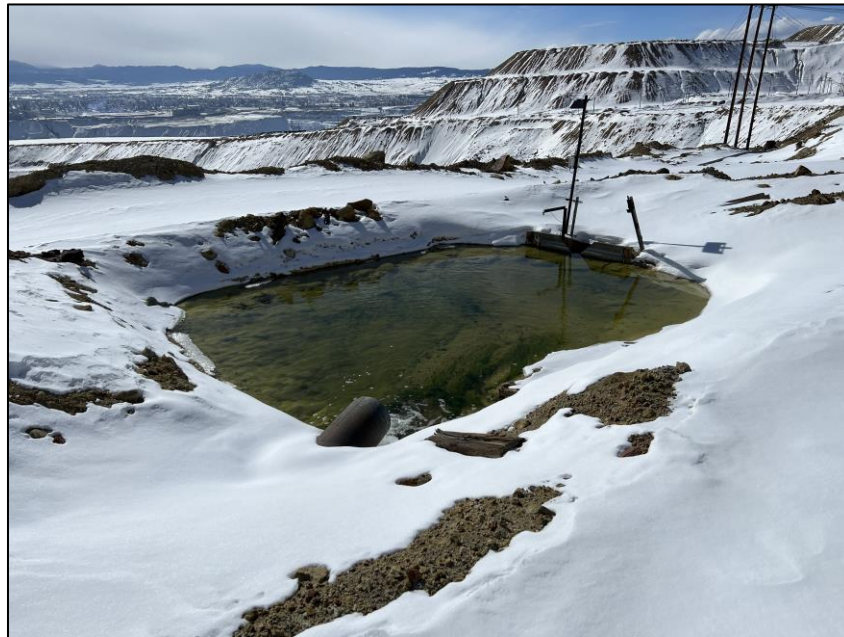
The Number 10 Seeps (Seep 10) daylight on the EL. 5,900 ft bench above the HsB seepage collection area. The seepage is collected in a small pond on the top of the EL. 5,900 ft bench and is routed to the HsB seepage collection area via a pipe. The Seep 10 flows are measured using an ultrasonic lookdown level sensor that automatically measures the stilling pond level near the weir. Images of the Seep 10 stilling pond taken on March 1, 2023, are presented in Appendix A – Photos 2 and 3.

PHOTO 2 – March 1, 2023 – Seep 10 Stilling Pond.

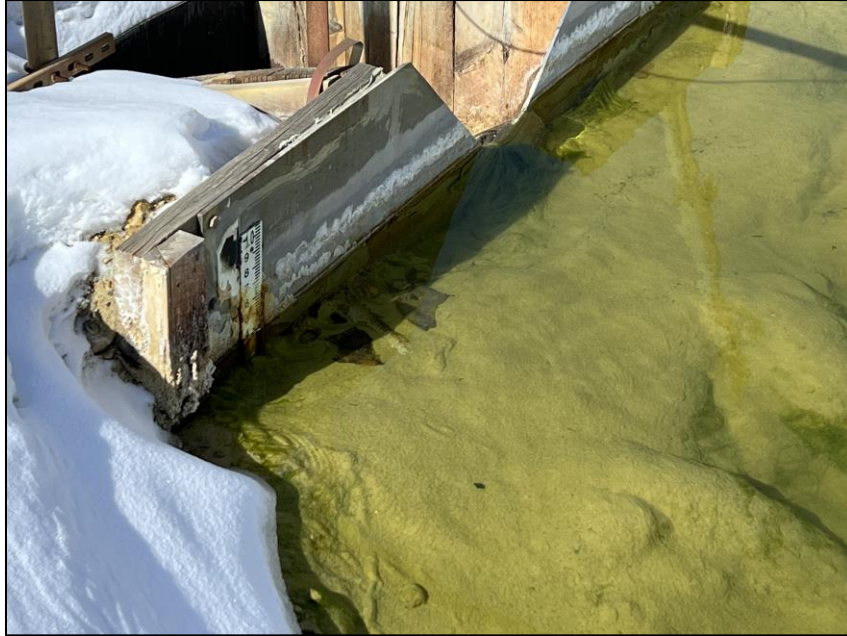
PHOTO 3 – March 1, 2023 – Seep 10 Weir and Staff Gauge, reading slightly below 0.4.

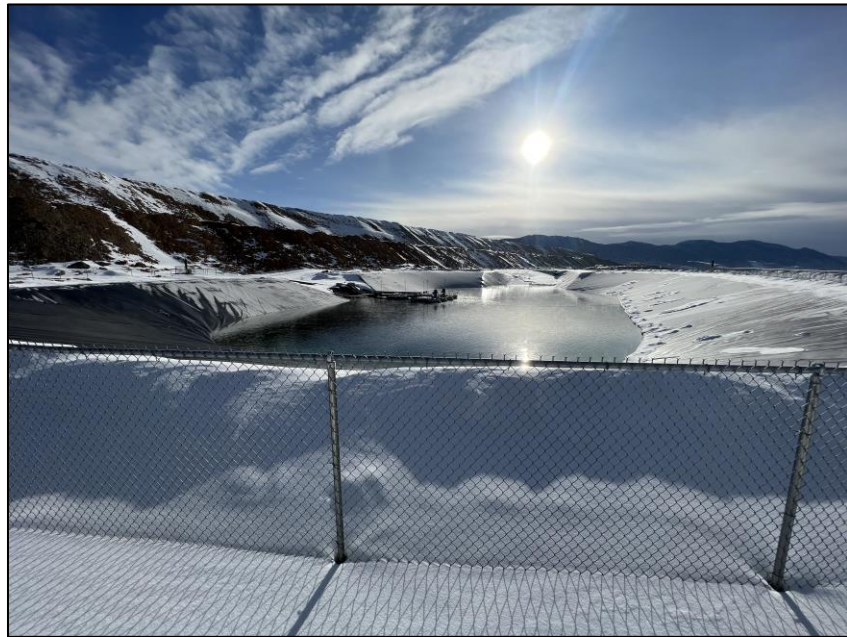
The WED and several other seepage control features of the West Embankment are designed to maintain hydrodynamic containment of the YDTI seepage as the supernatant pond elevation rises. Water collected in the WED flows by gravity into the Extraction Pond and is pumped to the YDTI via the Extraction Pond Dewatering System. The flows are measured using an inline totalizing flowmeter. An image of the WED Extraction Pond and Dewatering System taken on March 1, 2023, is presented in Appendix A – Photo 4.

PHOTO 4 – March 1, 2023 – WED Extraction Pond and Dewatering System.
