July 30, 2024

Mr. Mike Harvie
Manager of Engineering and Geology
Montana Resources, LLC
600 Shields Avenue
Butte, Montana
USA, 59701

RE: Q1 2024 – YDTI Quarterly Piezometric and Deformation Monitoring Update

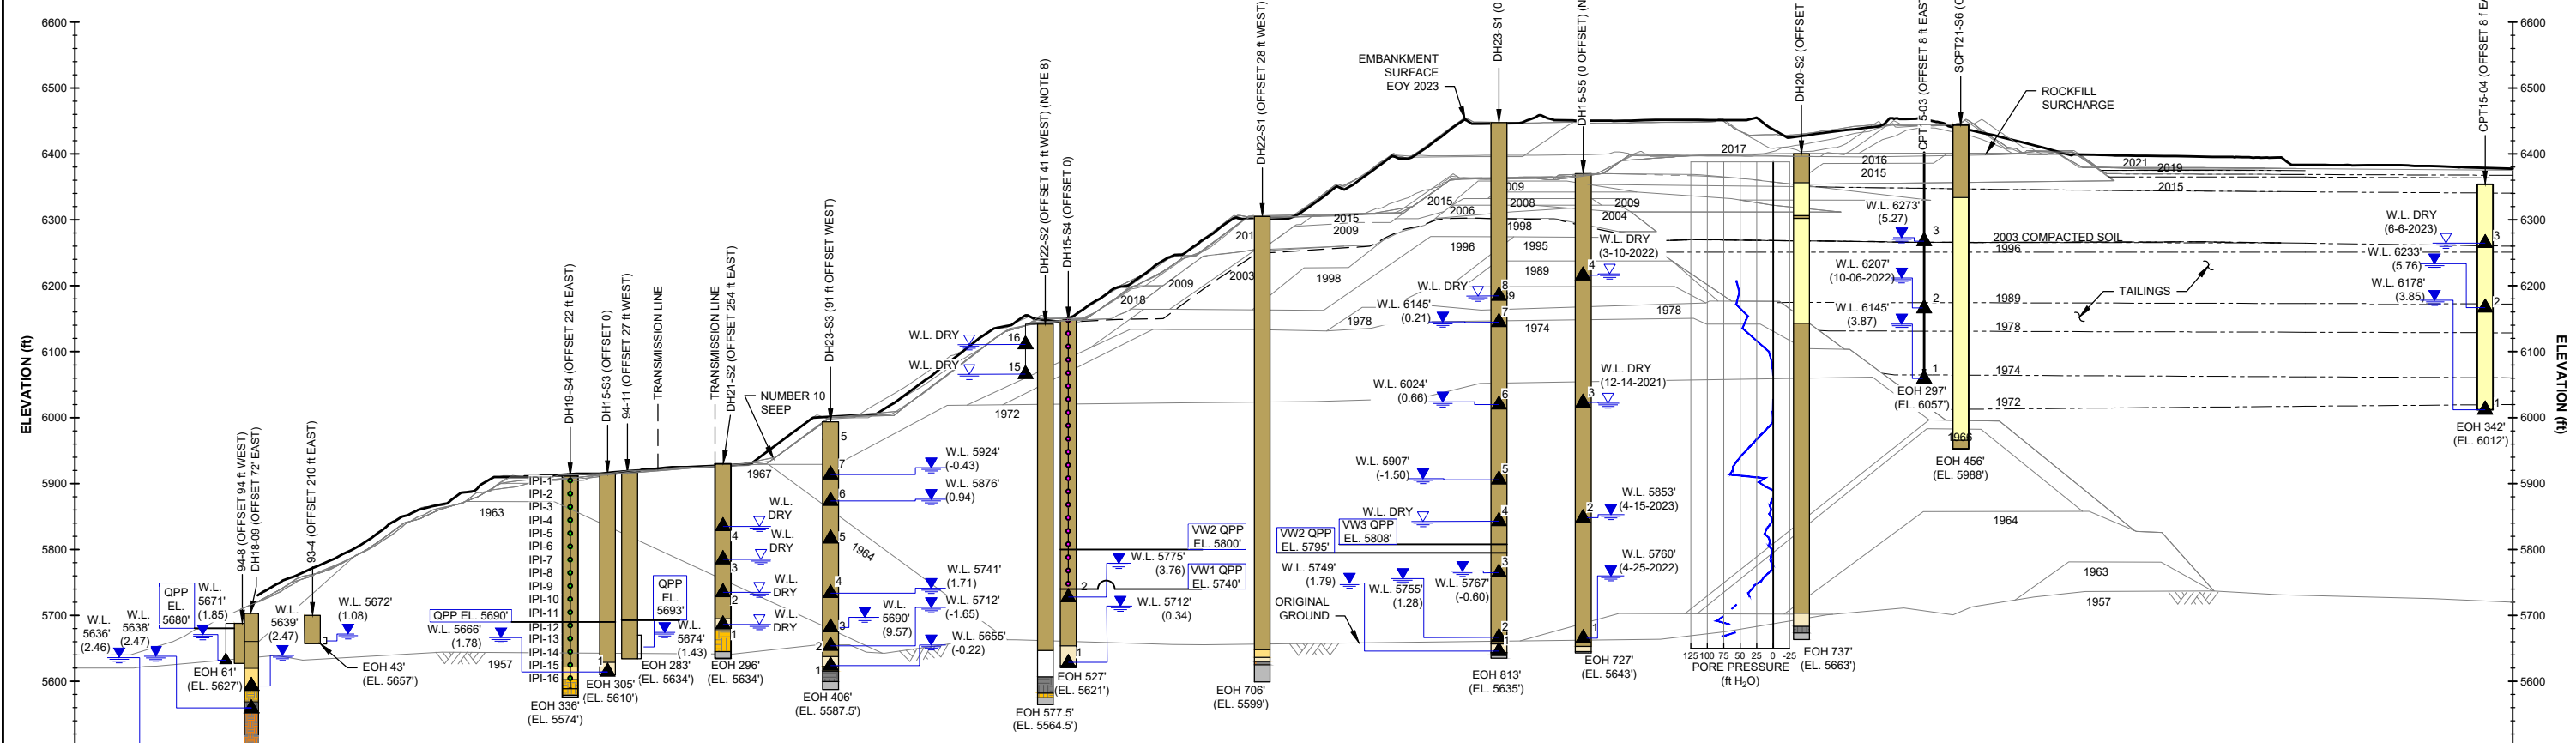
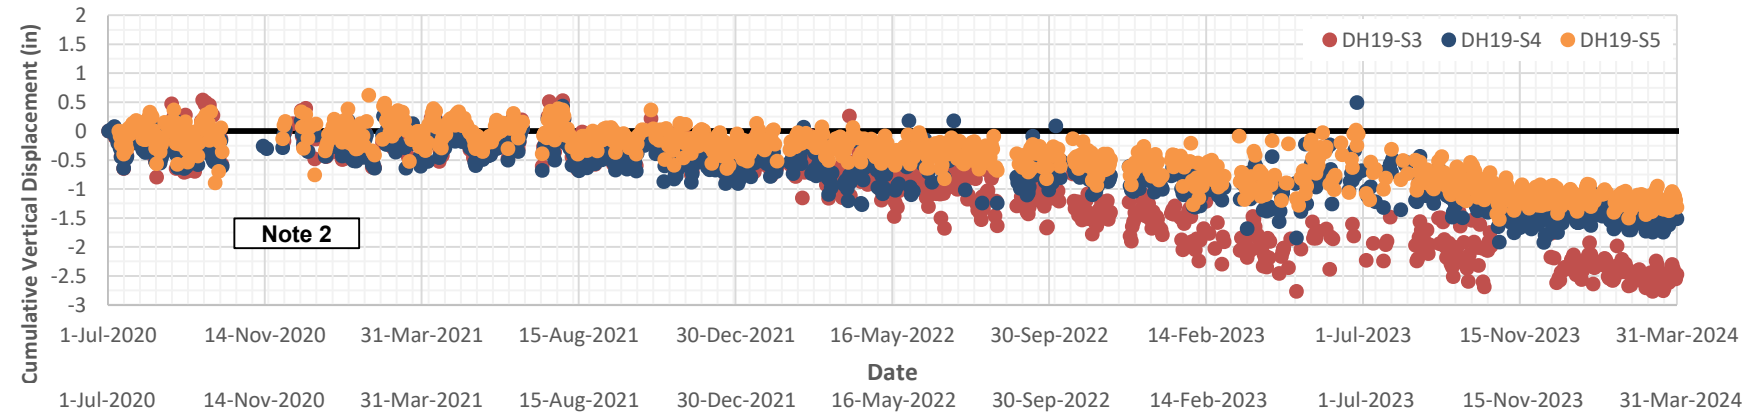
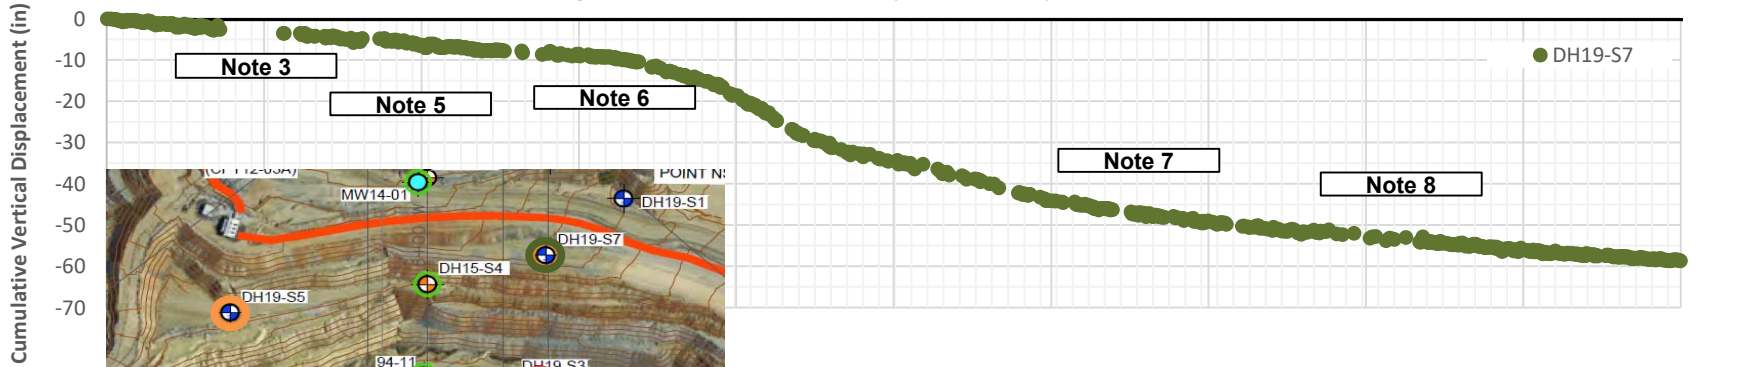
MONTANA RESOURCES, LLC	
MONTANA RESOURCES	
YDTI PIEZOMETRIC CONDITIONS EAST-WEST EMBANKMENT SECTION 8+00W (LOOKING WEST)	
Knight Piésold CONSULTING	P/A NO. VA101-126/31 REF. NO. VA24-00764 FIGURE 7
0 30JUL'24 ISSUED WITH LETTER CNN RMM KTD DESIGNED DRAWN REVIEWED	REV 0

Piezometric monitoring within the Central Pedestal Area (East-West and North-South Embankments between Section 12+00NW and 8+00N) observed slightly increasing pore water pressures within the basal saturated zone along Sections 8+00W and 0+00 during Q1 2024. Pore water pressures monitored within the overlying embankment remained relatively constant. Notable piezometric trends observed are summarized below.

- QPP monitoring sites installed in the basal rockfill monitored slightly increasing piezometric conditions throughout Q1 2024. This includes DH15-S4 VW2 (3.8 ft increase), MW94-11 (1.4 ft increase), MW94-08 (1.9 ft increase). QPP monitoring site DH23-S1 VW3 monitored relatively stable pore water pressures (decrease of approximately 0.6 ft).

- Non-QPP sensor DH23-S3 VW3 (installed downstream of DH15-S4) continued to monitor gradually increasing pore water pressures during Q1 2024; a trend which was been observed at this sensor since it was installed in Q4 2023. The sensor observed a 9.2 ft piezometric increase during Q1 2024.

- Non-QPP sensors DH21-S4 VW6 and VW7 monitored increasing pore pressures during Q1 2024 (approximately 6.3 ft and 5 ft, respectively) within the embankment rockfill. These appear to be associated with the pore water pressure increases observed at CPT14-02 (see Section 2.3.6).
- Non-QPP sensors DH23-S4 VW6, VW7, and VW8 monitored slightly decreasing (1 to 2 ft decrease) pore pressures beneath the embankment crest during Q1 2024.
- Non-QPP sensor SCPT21-S9 VW6 monitored slightly decreasing conditions (approximately 1.7 ft) beneath the downstream slope during Q1 2024.
- Non-QPP sensors DH19-S7 VW3 through VW6 monitored relatively stable pore water pressures (changes less than +/- 1 ft) beneath the downstream slope during the quarter.

- DH19-S7 VW7 observed an overall quarterly pore water pressure decrease of approximately 12 ft during Q1 2024. Two fluctuations (increases followed by subsequent dissipation) were observed between January 28th to February 2nd (approximately 5 ft increase) and March 16th to March 21st (approximately 16 ft increase). No corresponding pore pressure trends or fluctuations of similar magnitude are discernable at adjacent piezometric monitoring sites (i.e., DH21-S1, SCPT21-S9, DH23-S2, other DH19-S7 sensors).
- The cause of the fluctuating trend at DH19-S7 VW7 is uncertain and may indicate an instrumentation issue. Additional monitoring and assessment are recommended.
