Mr. Mike Harvie
Manager of Engineering and Geology
Montana Resources, LLC
600 Shields Avenue
Butte, Montana
USA, 59701

Knight Piésold Ltd.

RE: Q2 2023 – YDTI Quarterly Piezometric and Deformation Monitoring Update

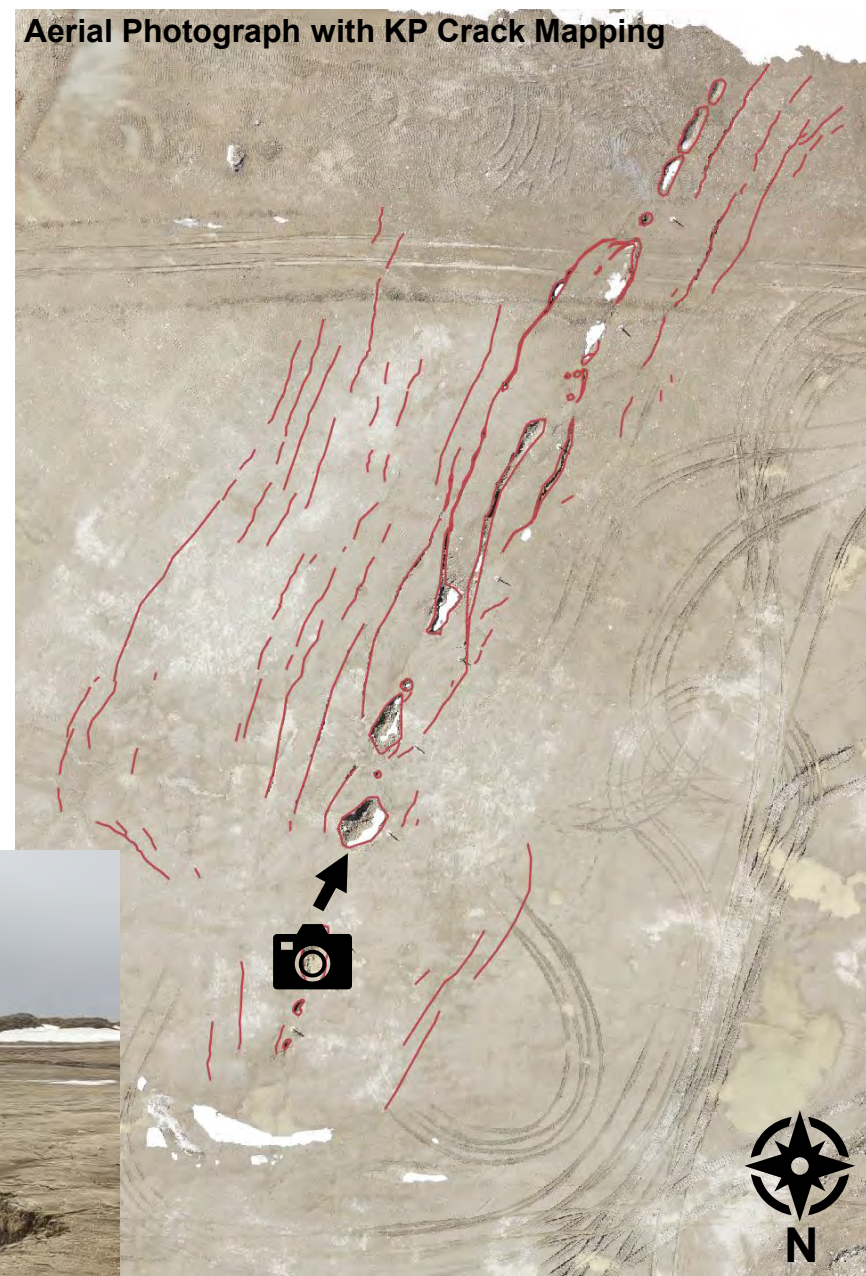
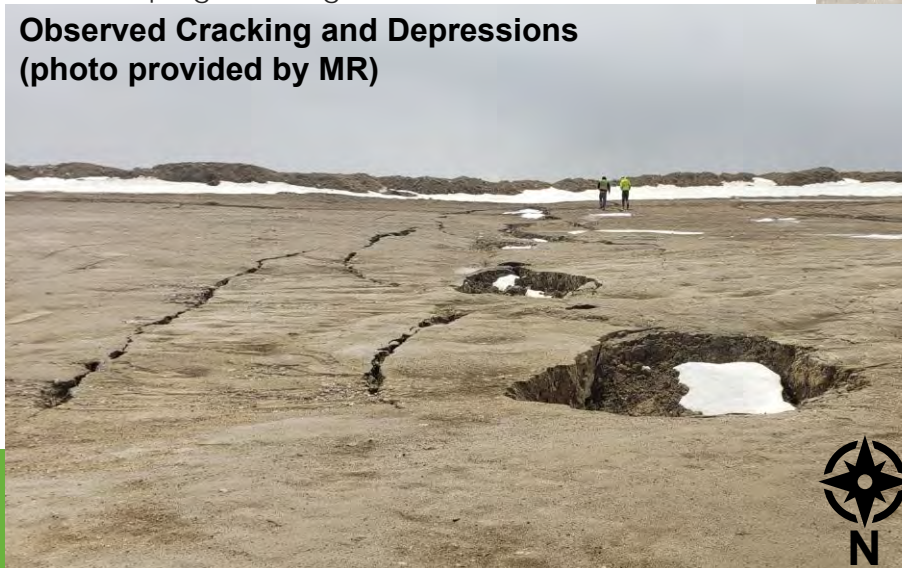
**Observed Cracking and Depressions
(photo provided by MR)**

- Montana Resources notified KP on April 27, 2023 that new transverse cracking and depressions had been observed by a dozer operator along the EL 6,450 ft crest near Section 0+00. MR Observations:
 - The depressions/cracks run transverse to the downstream face around the Section 0+00 area but do not extend to the upstream face
 - The cracks appear to be in a low spot where significant amt. ponded water had infiltrated into the cracks
 - MR looked at the downstream face directly below the settlement and cracks and there was no evidence of water seepage along the face.
 - MR also drove along the pipe ramp to see any evidence of erosion or seepage was discernable, none was found.

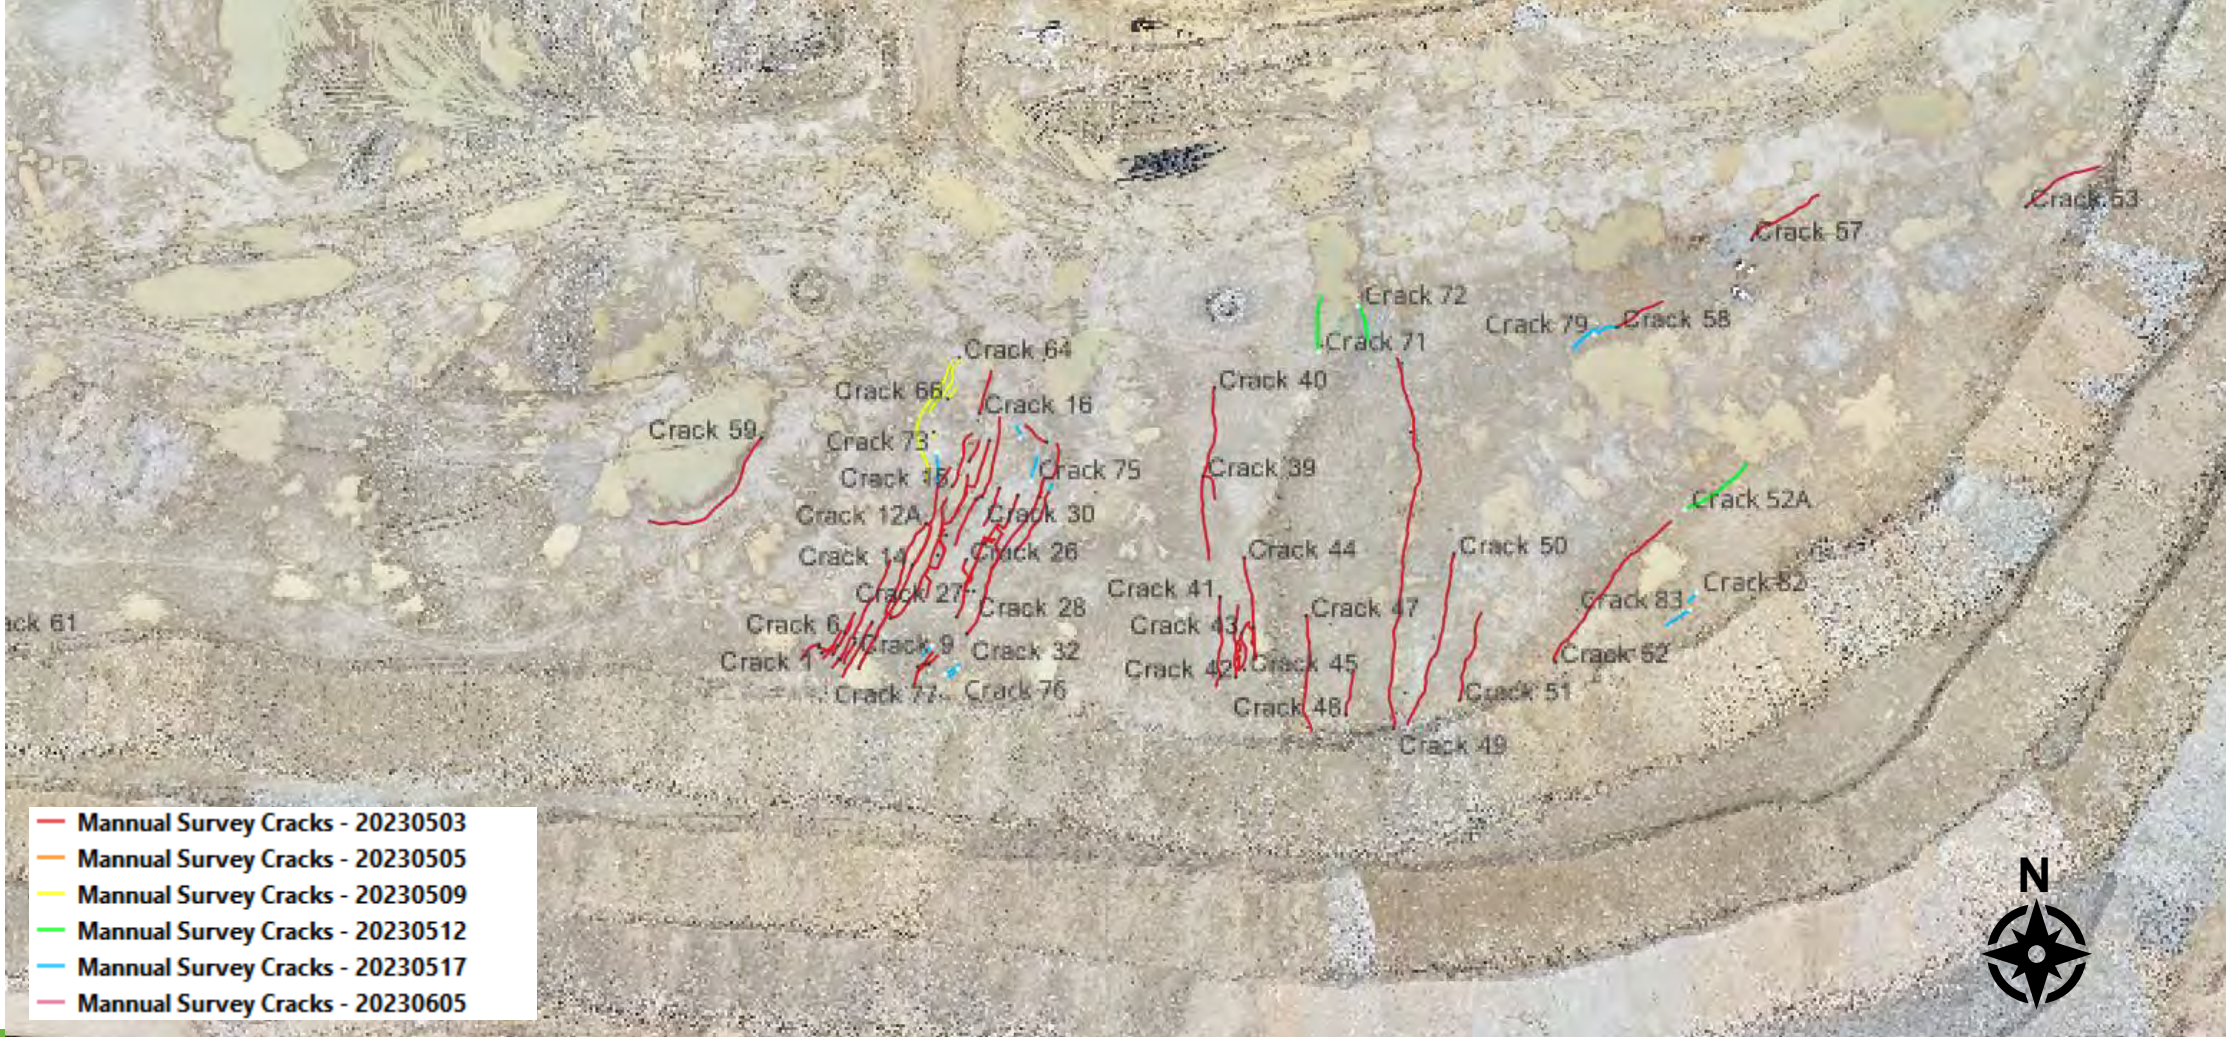
Aerial Photograph with KP Crack Mapping (updated through early-June)

- Inspections have identified some additional cracking that was not surveyed initially.
- These appear to be minor cracks or those outside of the main area
- Do not appear to indicate progression

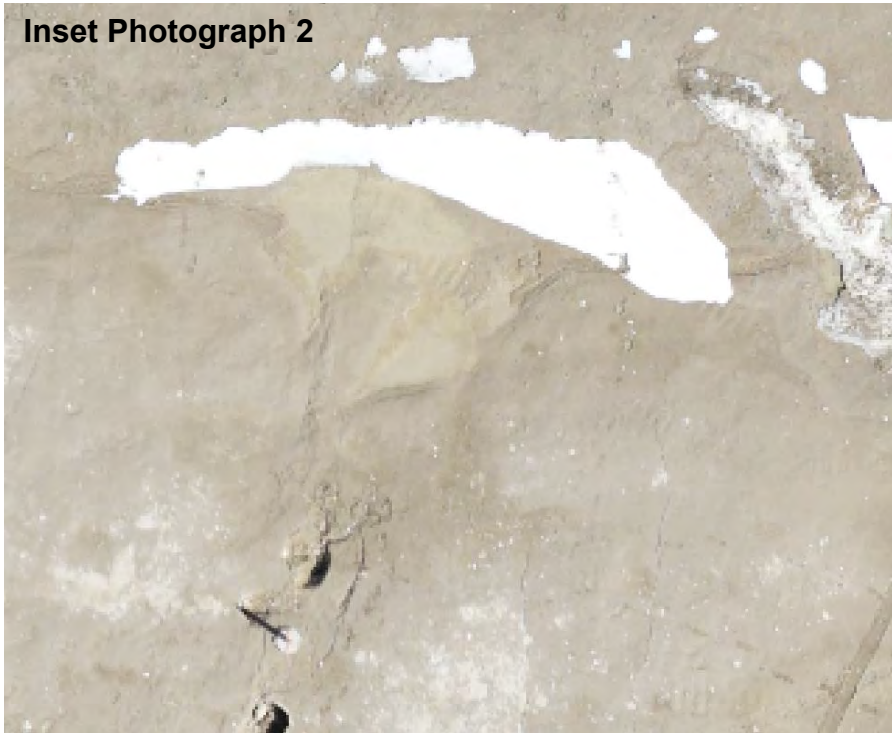
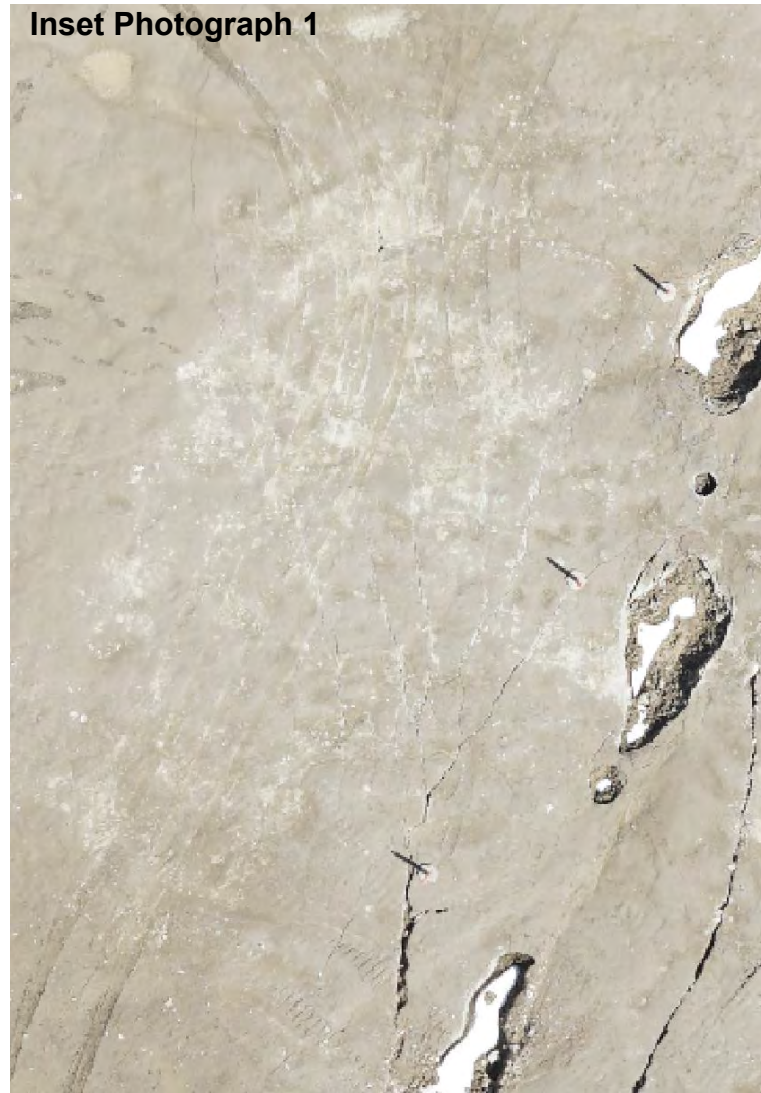
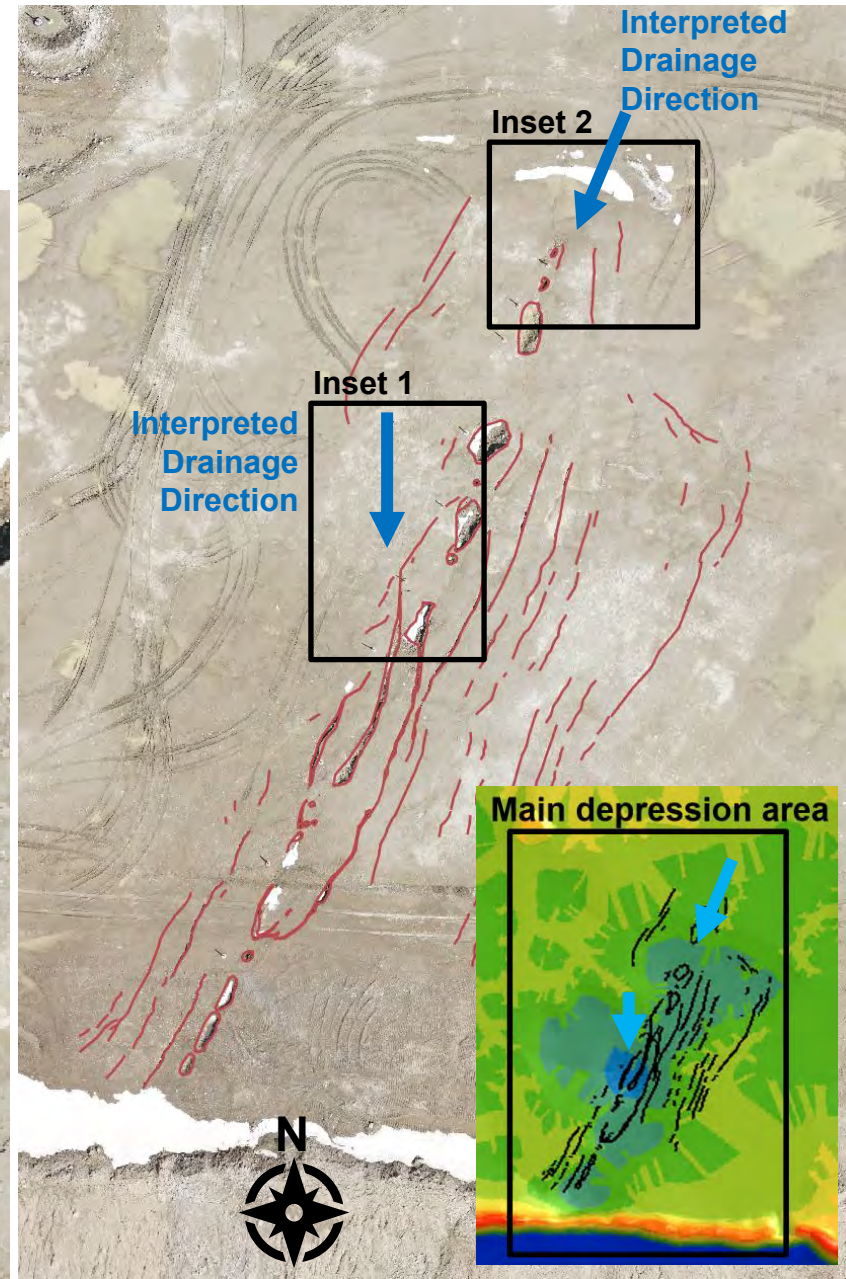
- Surface expressions of drainage towards cracks to south visible in some areas

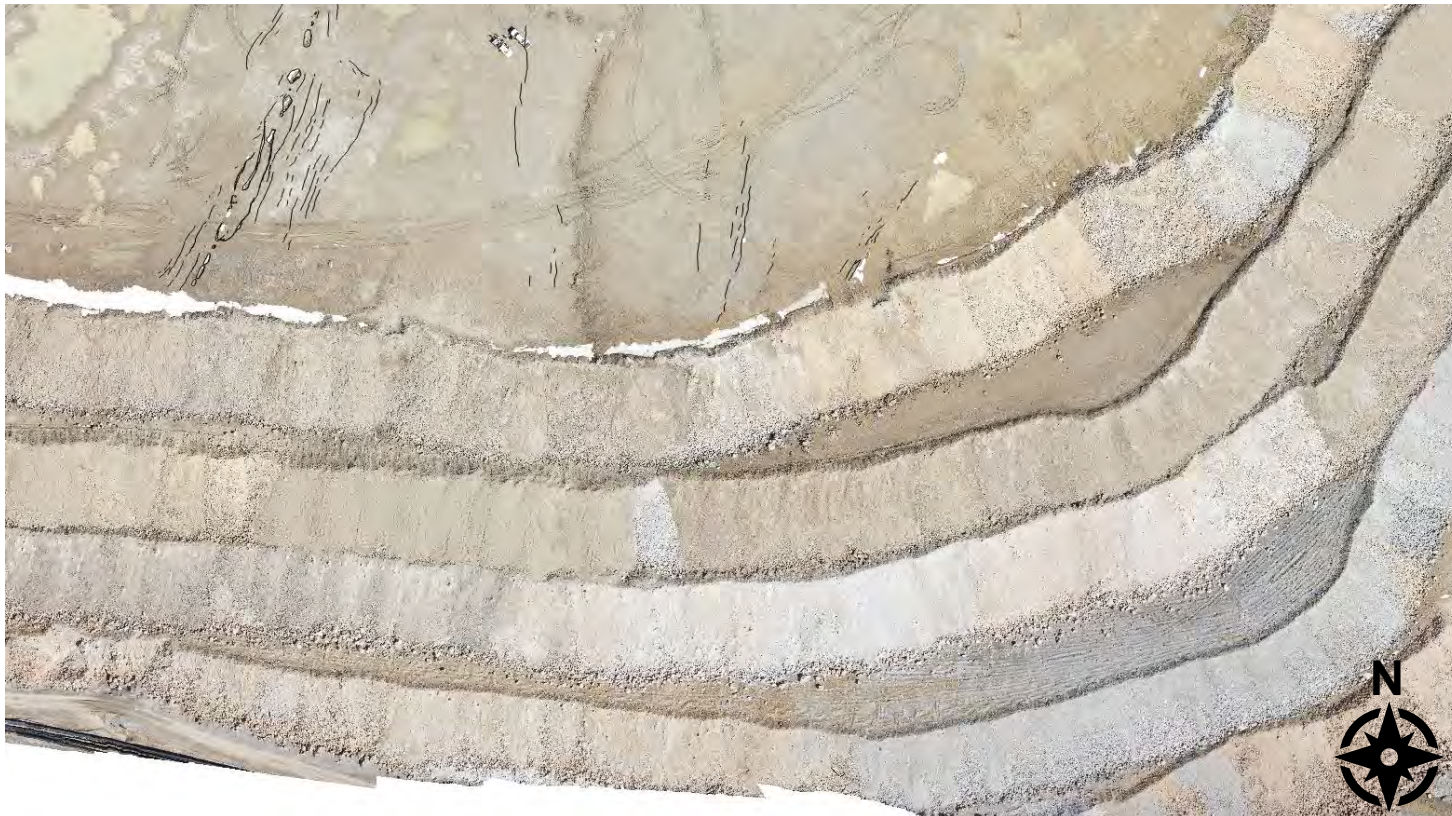
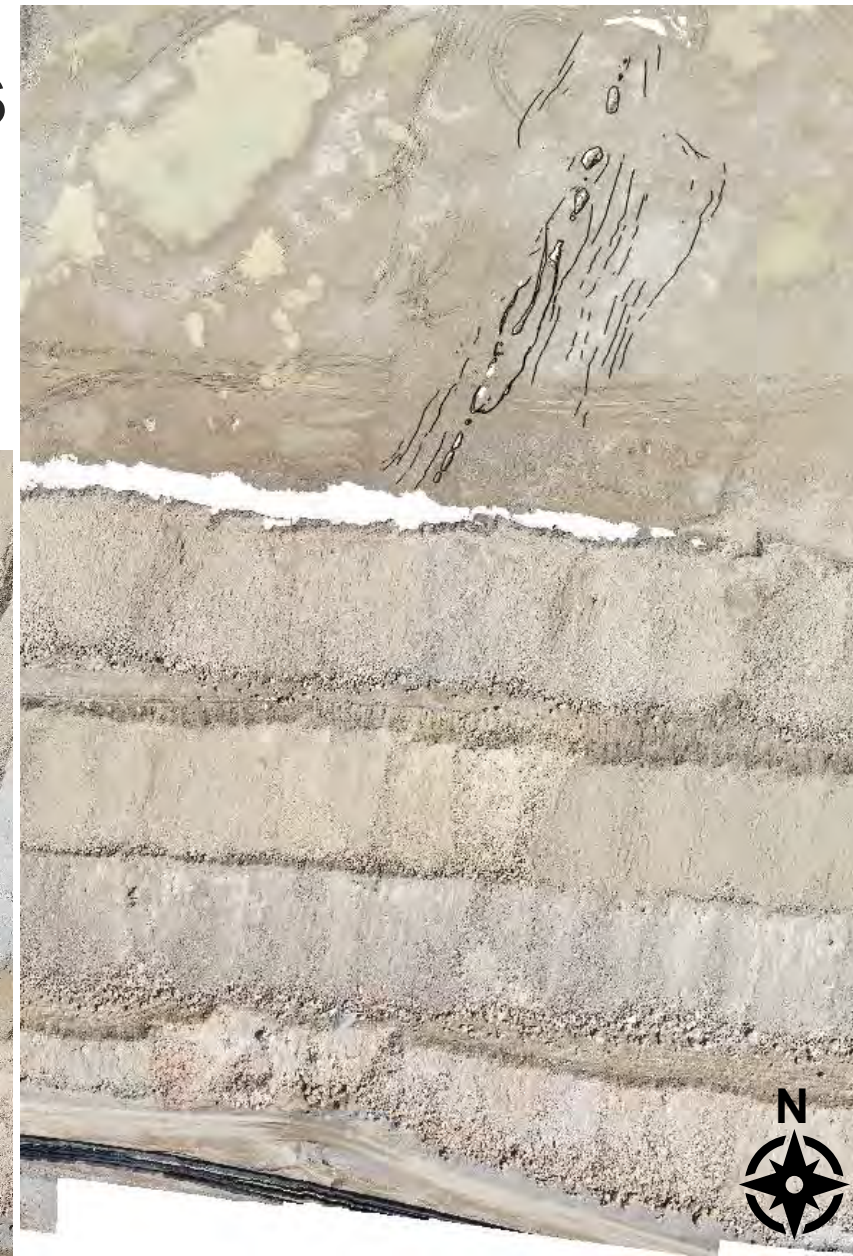
Downstream Slope of CPA Embankment (April 28, 2023)

- No discernable cracking or seepage discharge on DS embankment slope below cracking
 - MR inspections, review of aerial photographs, and KP on-site presence

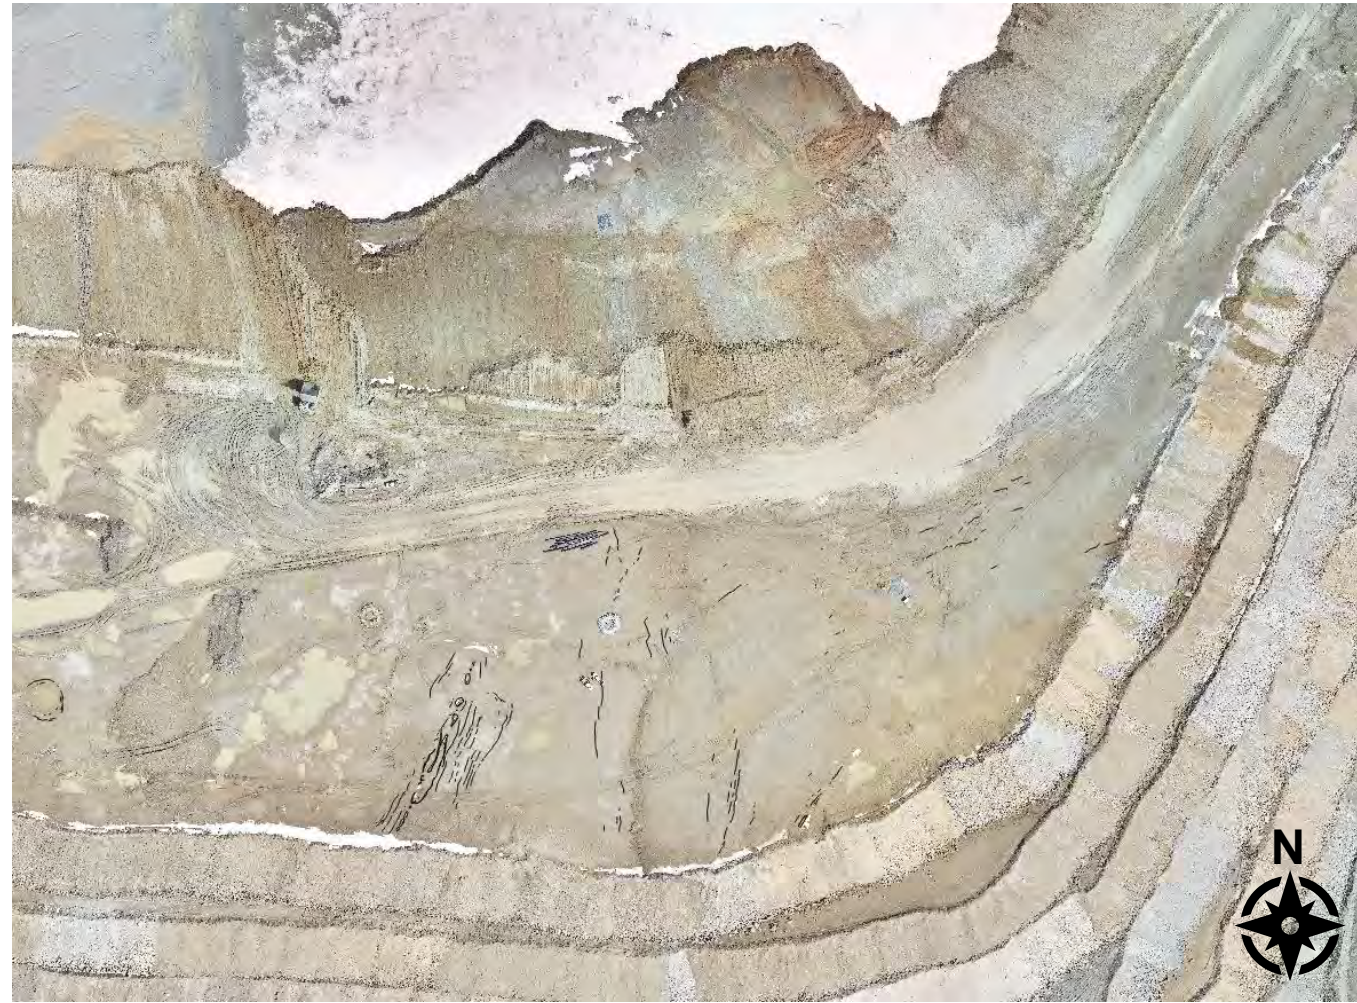
Upstream Slope of Rockfill Surcharge (April 28, 2023)

- No discernable evidence of cracking or seepage through US rockfill surcharge slope
 - Cracking does not appear to extend to the US surcharge
 - Recently re-sloped and faced with alluvium

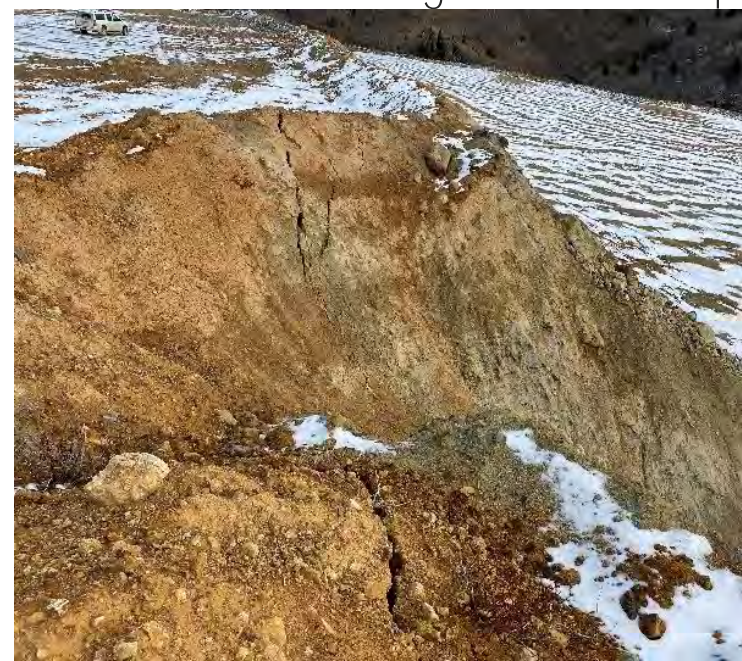
North-South Embankment Crest Cracking (2019)

- Cracking of newly placed rockfill has been observed previously along the North-South Embankment:
 - Attributed to differential settlement within the 50 ft thick rockfill lifts
 - No significant crack progression/deformation observed

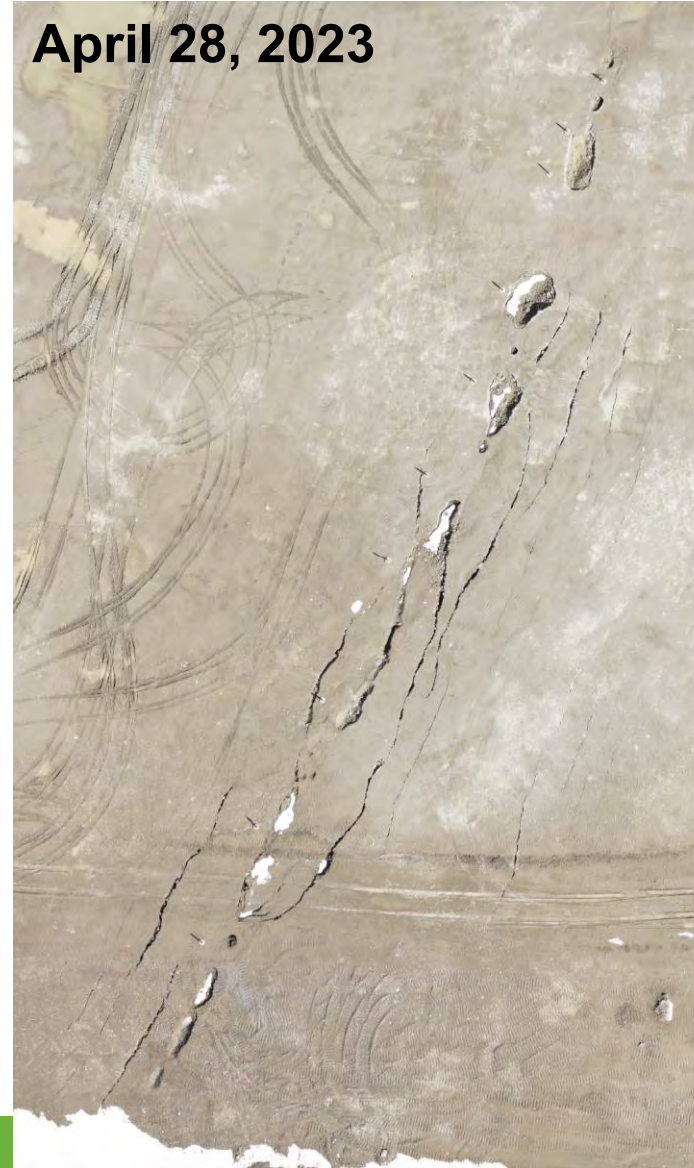
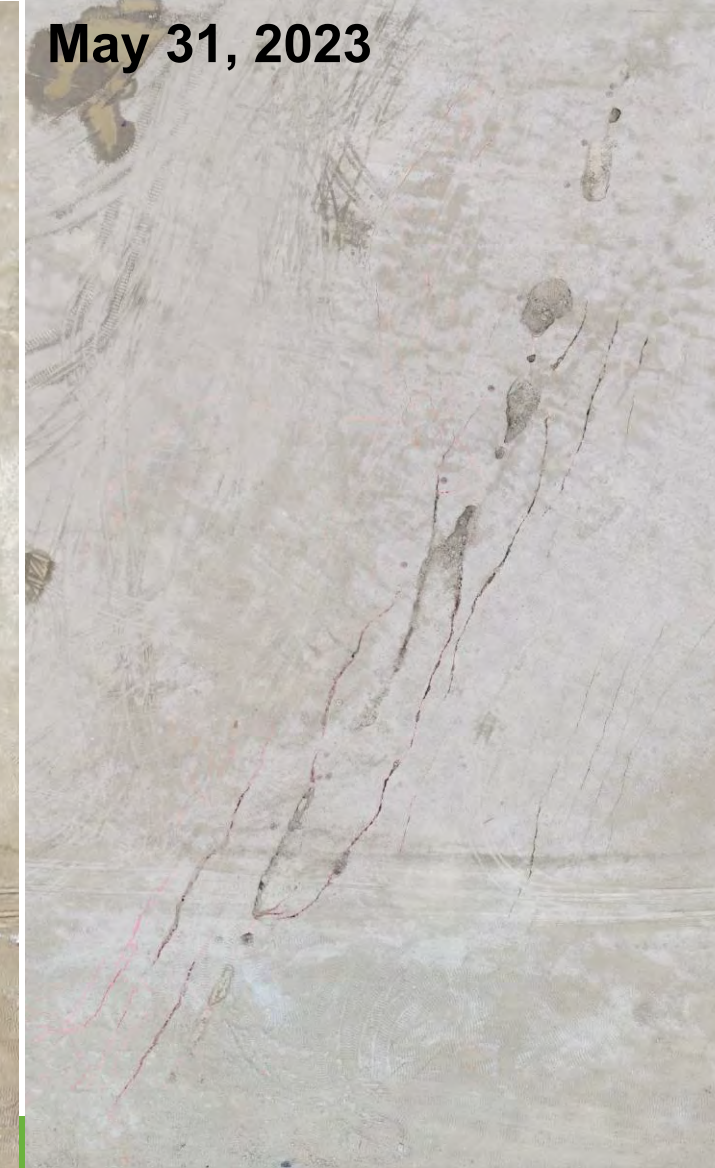
- Visual inspections have not identified significant progression of cracking/depressions within the Main Cracking Area
 - Minor precipitation-driven erosion of existing cracks and depressions
 - No discernable lengthening or development of increasing vertical offsets (consistent with pin extenso.)

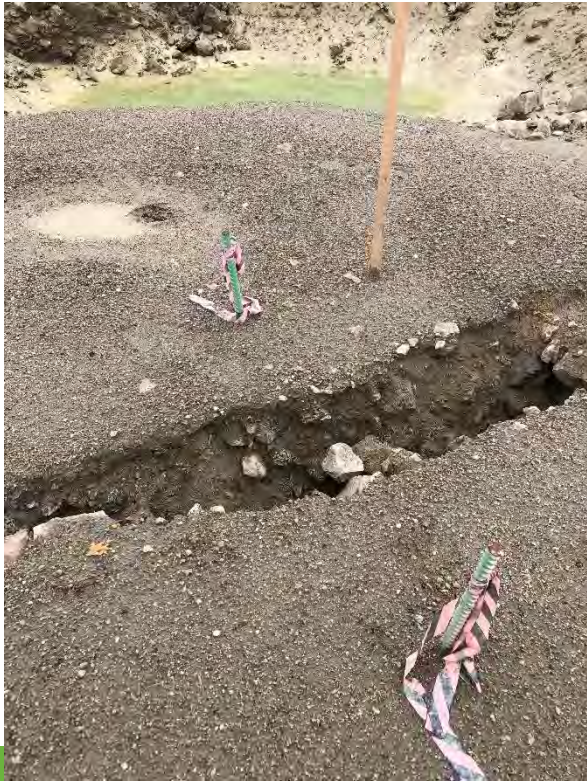
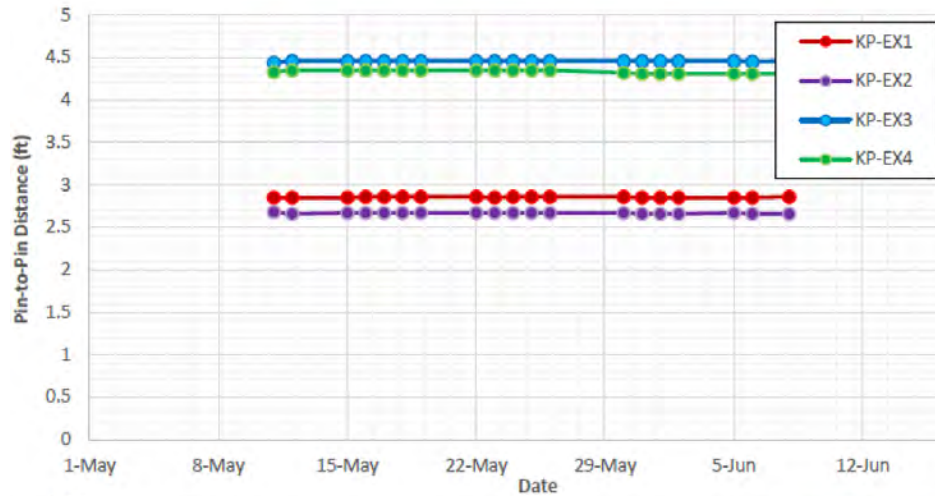
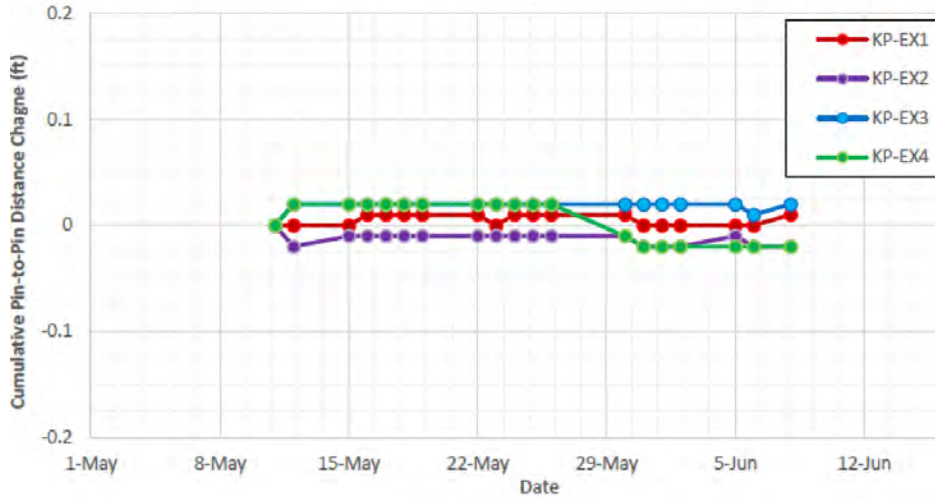
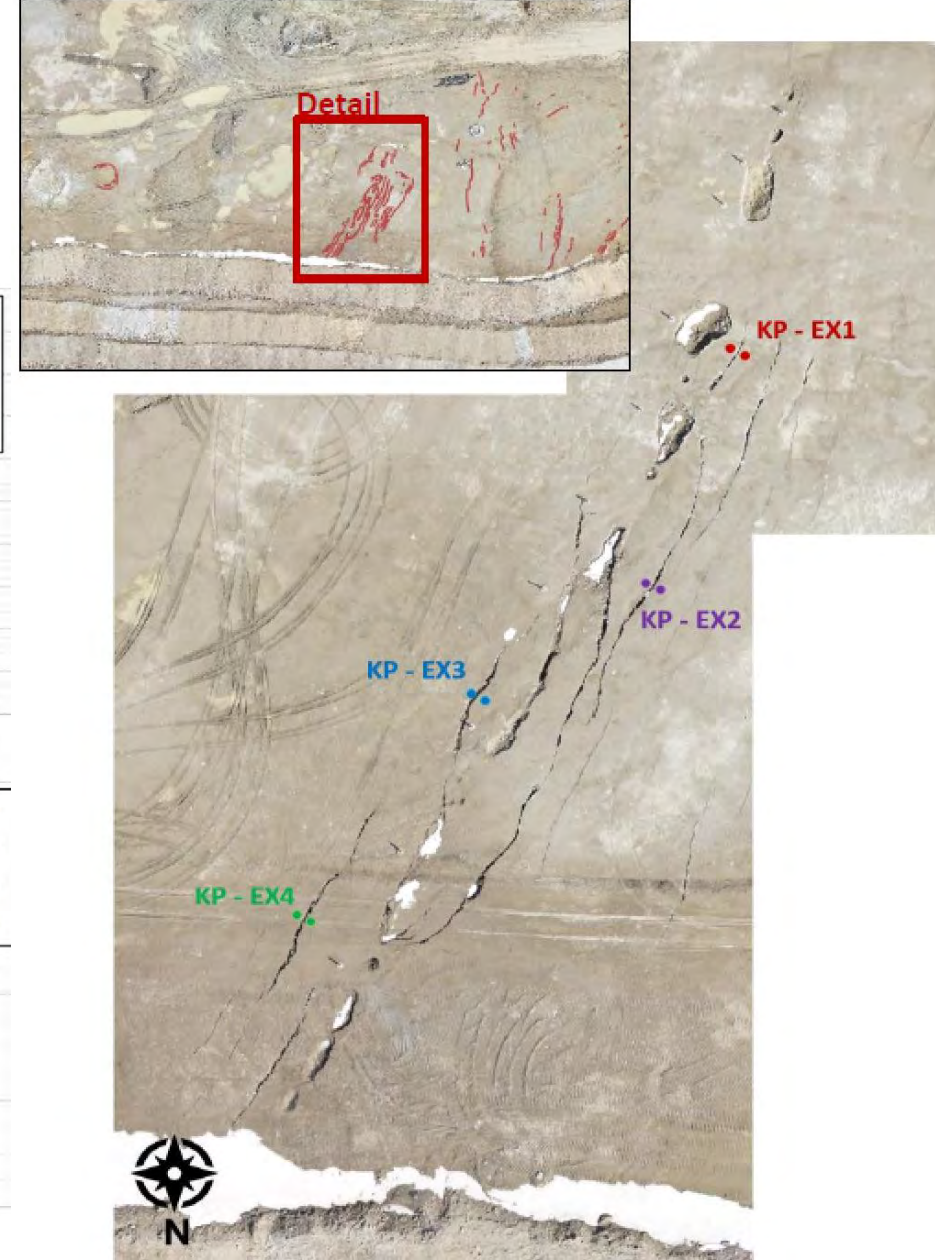
- No significant progression identified.

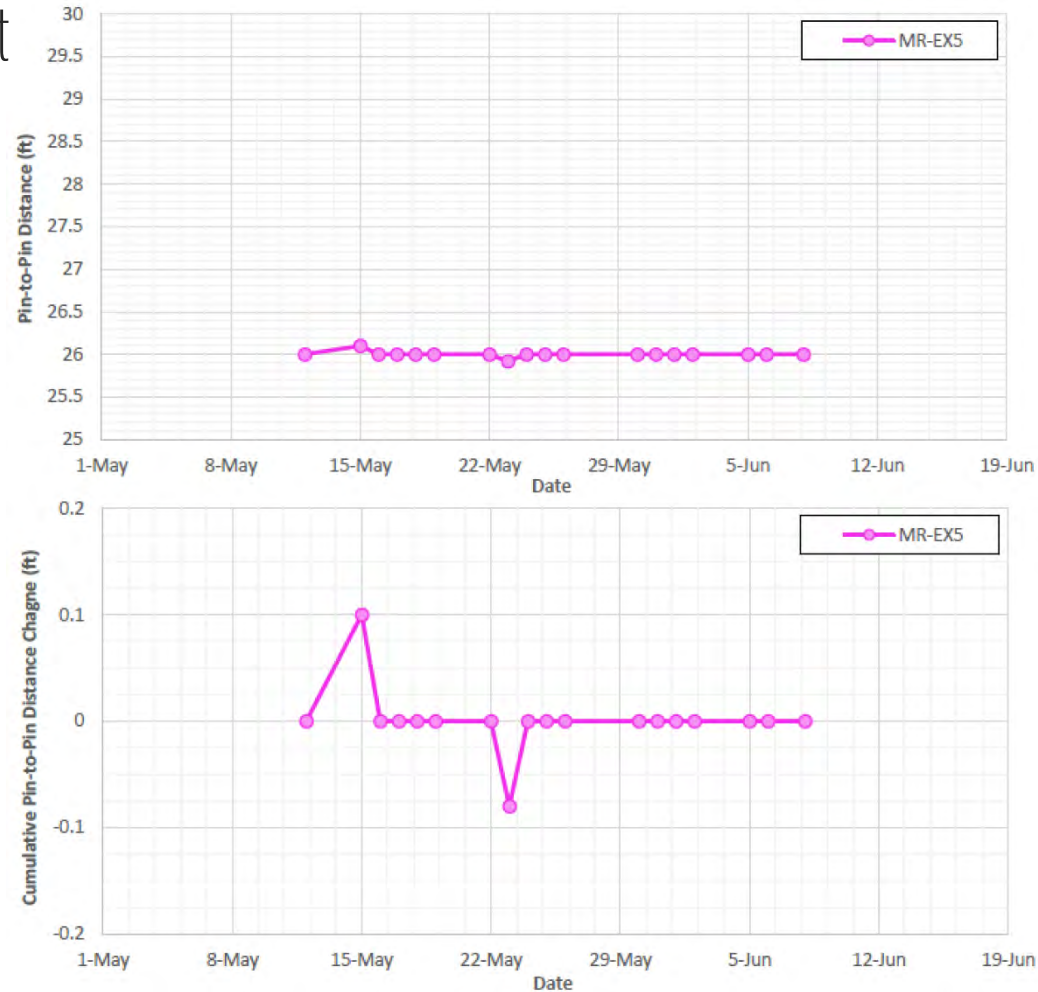
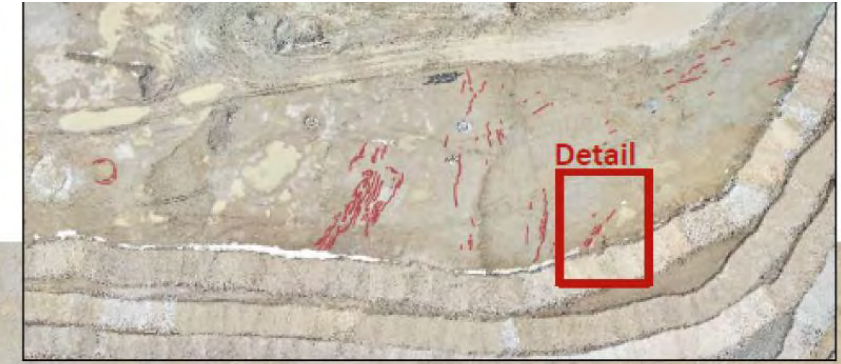
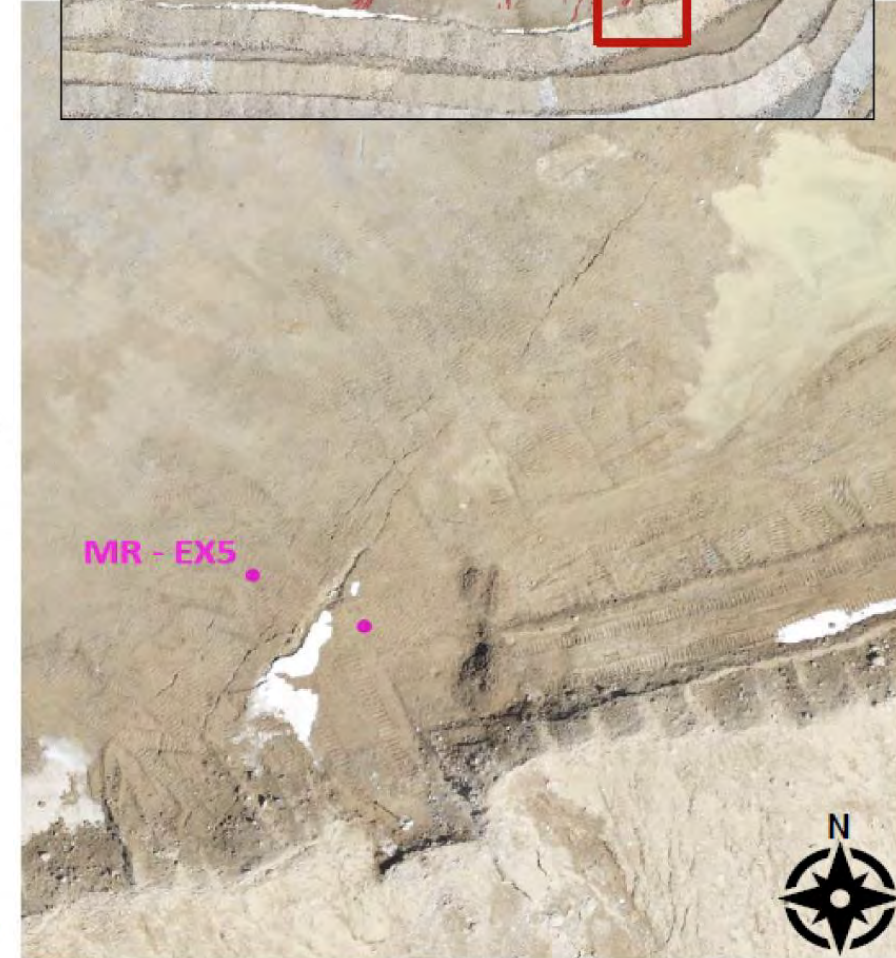
- No significant progression identified.

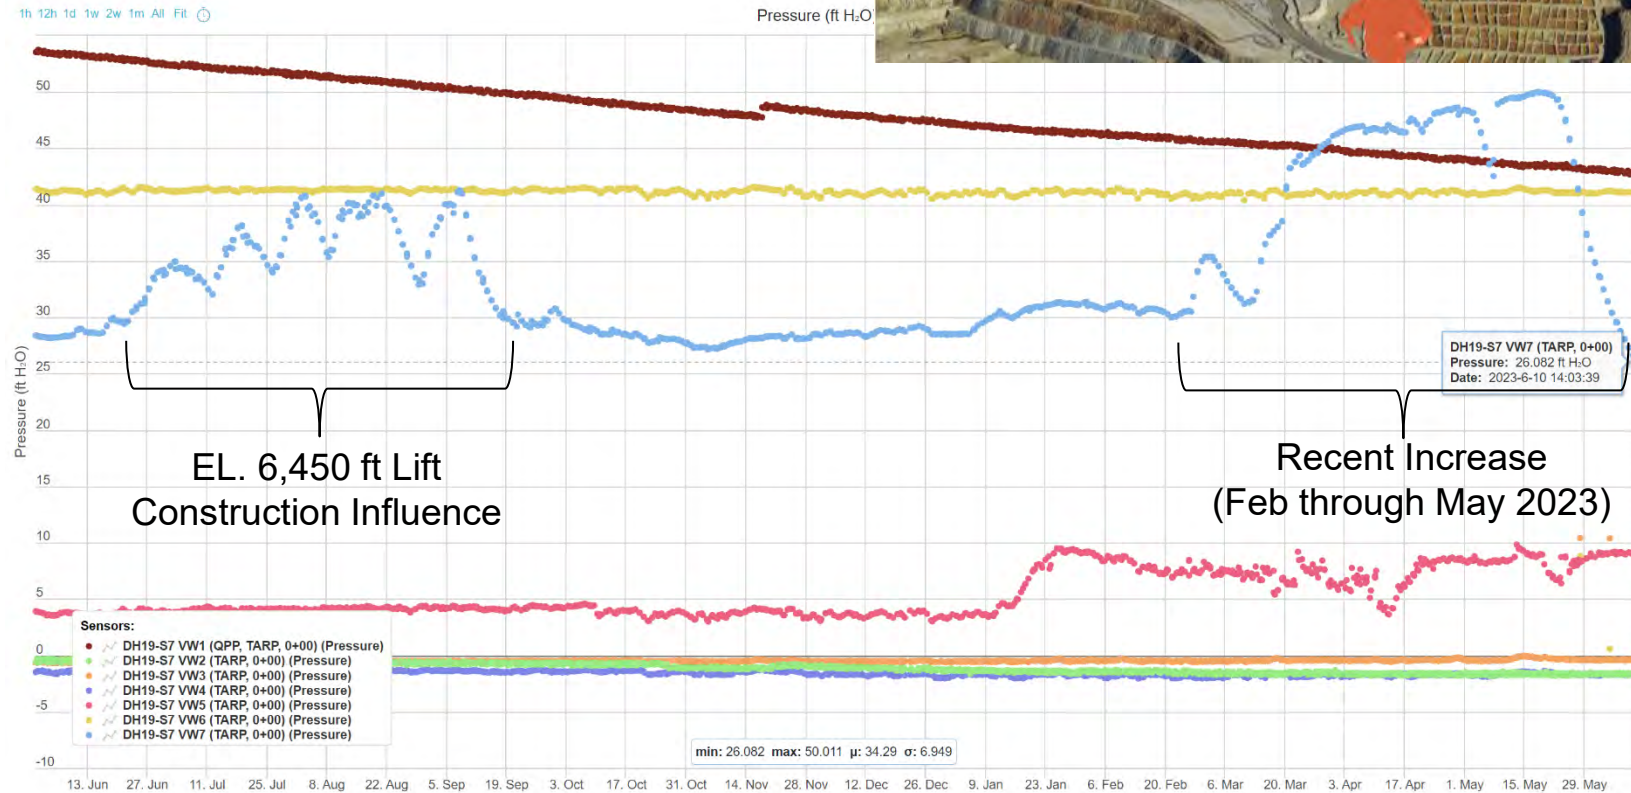
Fig. 15 – DH19-S7 Pore Water Pressure (June 10, 2023)

- Non-QPP sensor DH19-S7 VW7 observed an overall minor quarterly pore water pressure increase (approximately 3 ft) during Q2 2023; however, a significant fluctuation was observed during the monitoring period. A large pore water pressure decrease was monitored between May 19th and June 19th, 2023 (approximately 25 ft) followed by a rapid return to conditions observed prior to the fluctuation. Slightly increasing pore pressures were observed through the end of Q2 2023. The cause of this trend is currently uncertain and additional monitoring is recommended. This sensor has previously observed increasing pore water pressures resulting from nearby El. 6,450 ft lift construction during mid- to late-2022 within the historical 1982 lift-top interval (relatively finer grained, saturated zone); however, no significant construction occurred during Q2 2023.

- Pore water pressures within DH19-S7 VW7 increased during March 2023; has continued to increase slightly during May 2023
 - Sensor installed within the historical 1982 lift-top interval
 - Previously observed a pore water pressure increase during EL. 6,450 ft lift, followed by dissipation
 - Recent increase (approx. 25 ft) occurred after large-scale completion of EL. 6,450 ft lift.
 - Primarily inferred to be associated with alluvial facing along the upstream central rockfill surcharge
 - Precipitation and snowmelt may also contribute
