**November 8, 2023**

**RE: Q3 2023 – YDTI Quarterly Piezometric and Deformation Monitoring Update**

Montana Resources, LLC (MR) operates an open pit copper and molybdenum mine in Butte, Montana. Tailings produced from ore processing are stored within the Yankee Doodle Tailings Impoundment (YDTI), which is a valley-fill style impoundment contained within rockfill embankments. Knight Piésold Ltd. (KP) supports MR to routinely monitor hydrogeological and geotechnical conditions as part of their operational surveillance plan for the tailings facility, as described in the Tailings Operations, Maintenance and Surveillance (TOMS) Manual (MR/KP, 2022). Monitoring data are comprehensively reviewed on a quarterly basis to evaluate the performance of the YDTI in conjunction with observations made during periodic inspections.

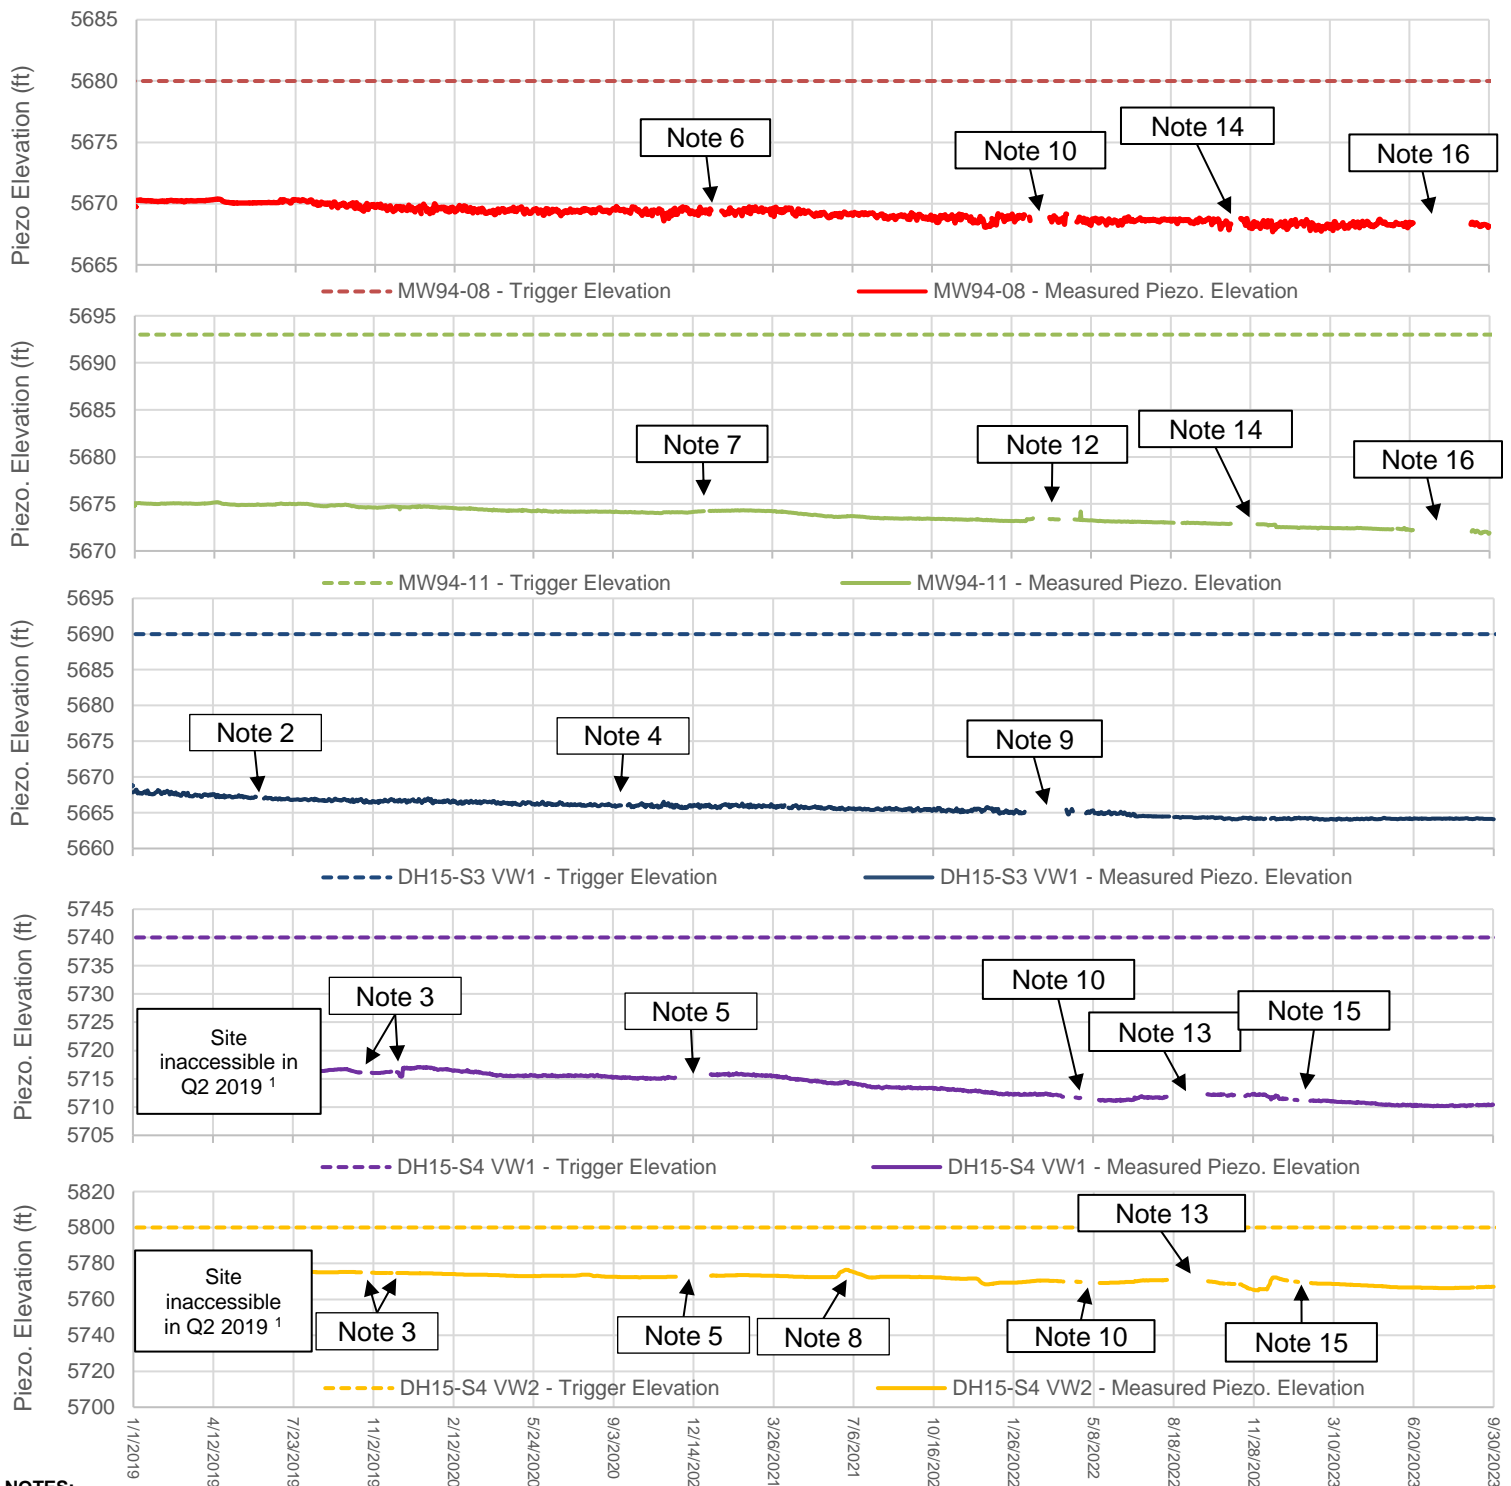
- QPP sensor DH15-S4 VW2 (Section 8+00W) observed slightly increasing pore pressures (approximately 0.6 ft) during Q3 2023.
- Non-QPP Geo4Sight instrumentation within drillholes DH20-S2 and DH21-S1 (beneath the rockfill surcharge on Sections 8+00W and 0+00, respectively) monitored relatively stable pore pressures during Q3 2023.

1. NO DATA ARE SHOWN FROM DEC 20, 2017 TO JULY 25, 2019 FOR DH15-S4 VW1 AND VW2 AS MR STAFF WERE UNABLE TO CONNECT THE INSTRUMENTATION WITH THE REMOTE MONITORING SYSTEM DUE TO SITE INACCESSIBILITY.

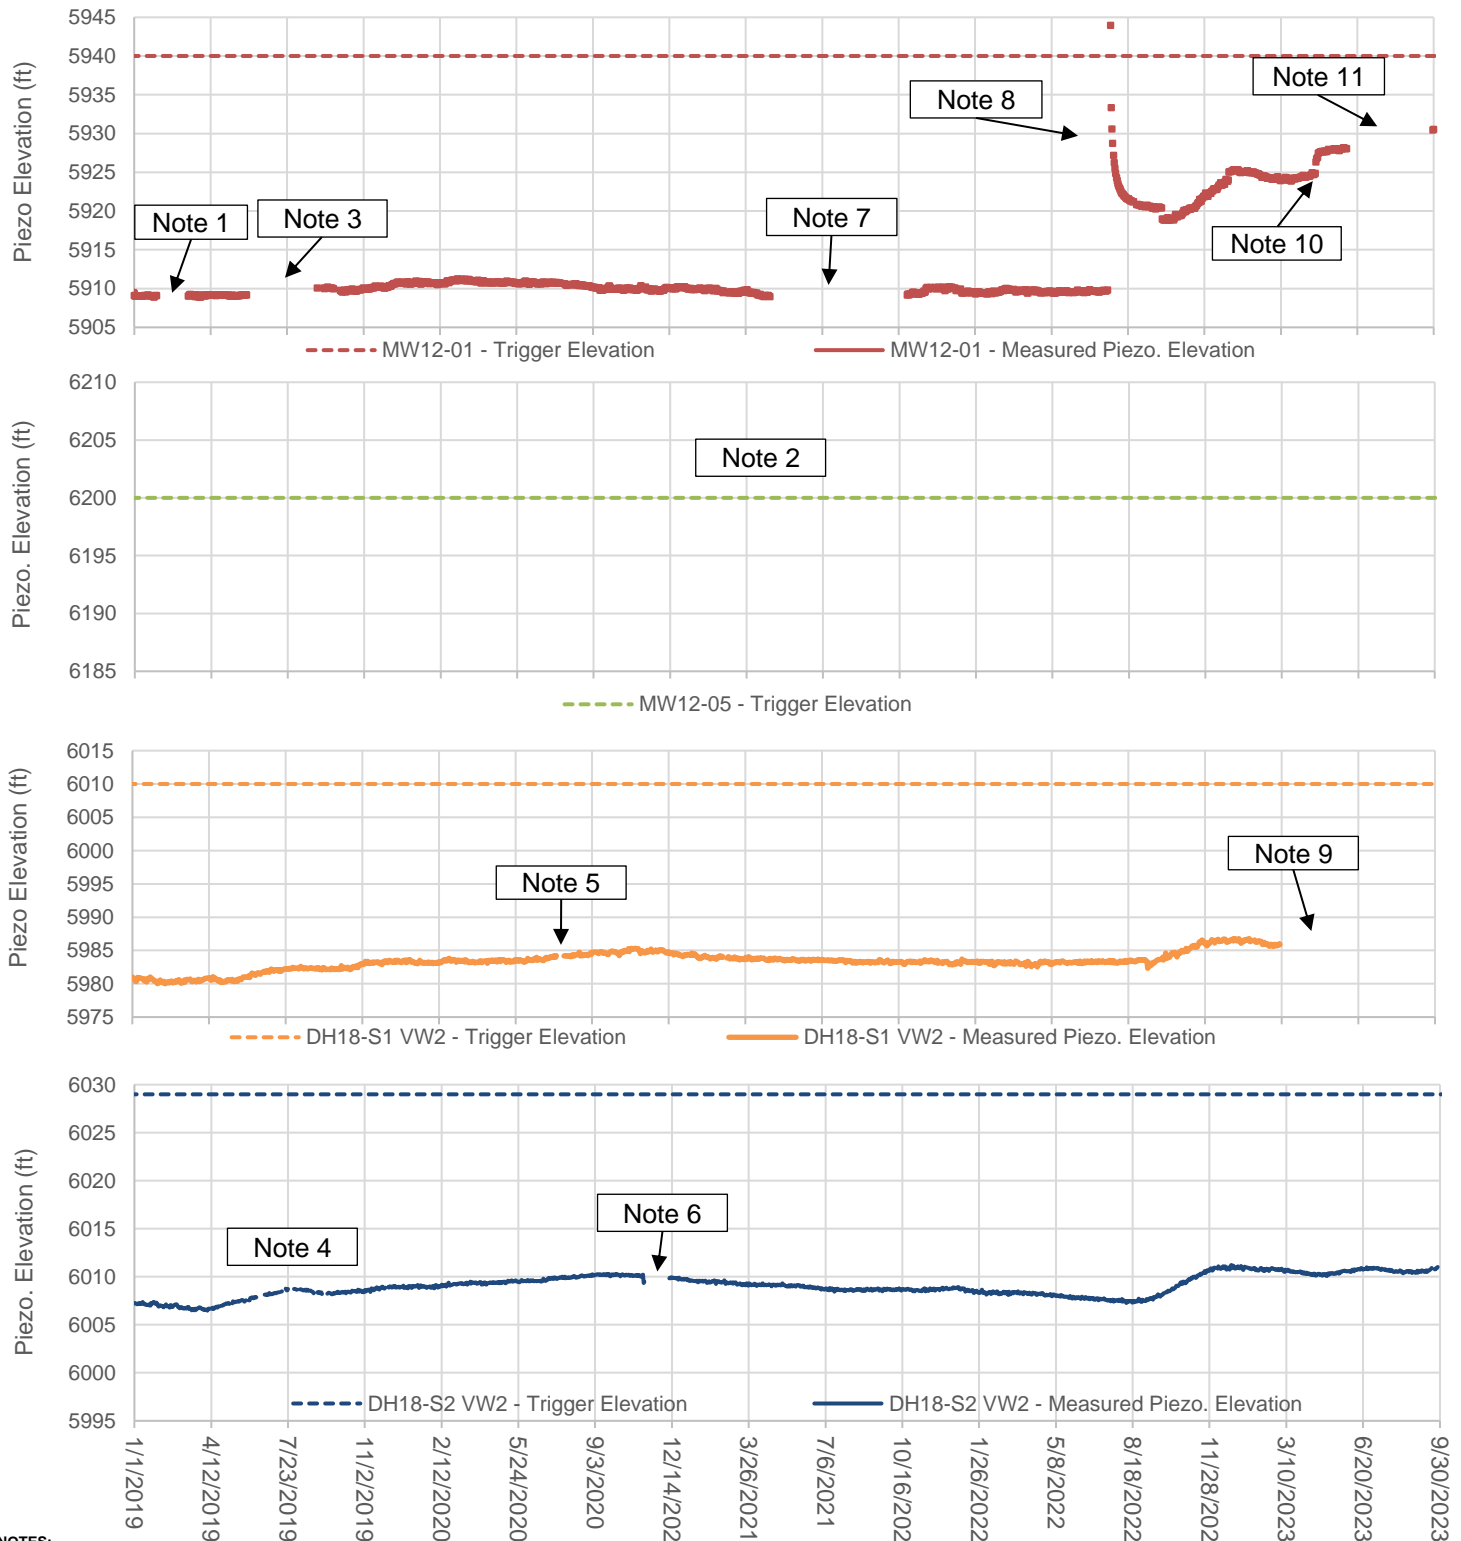
- Monitoring well MW12-05 has historically been unsaturated and remained unsaturated through August 8, 2023, after which the sensor stopped recording due to suspected cable or sensor damage.

1. MW12-01 BECAME UNSATURATED FROM FEBRUARY 1 TO MARCH 13, 2019.
2. NO DATA WERE COLLECTED BY MW12-05. THE STANDPIPE WAS UNSATURATED (DRY) UNTIL IT BECAME DAMAGED ON MARCH 8, 2023 BY CONSTRUCTION.

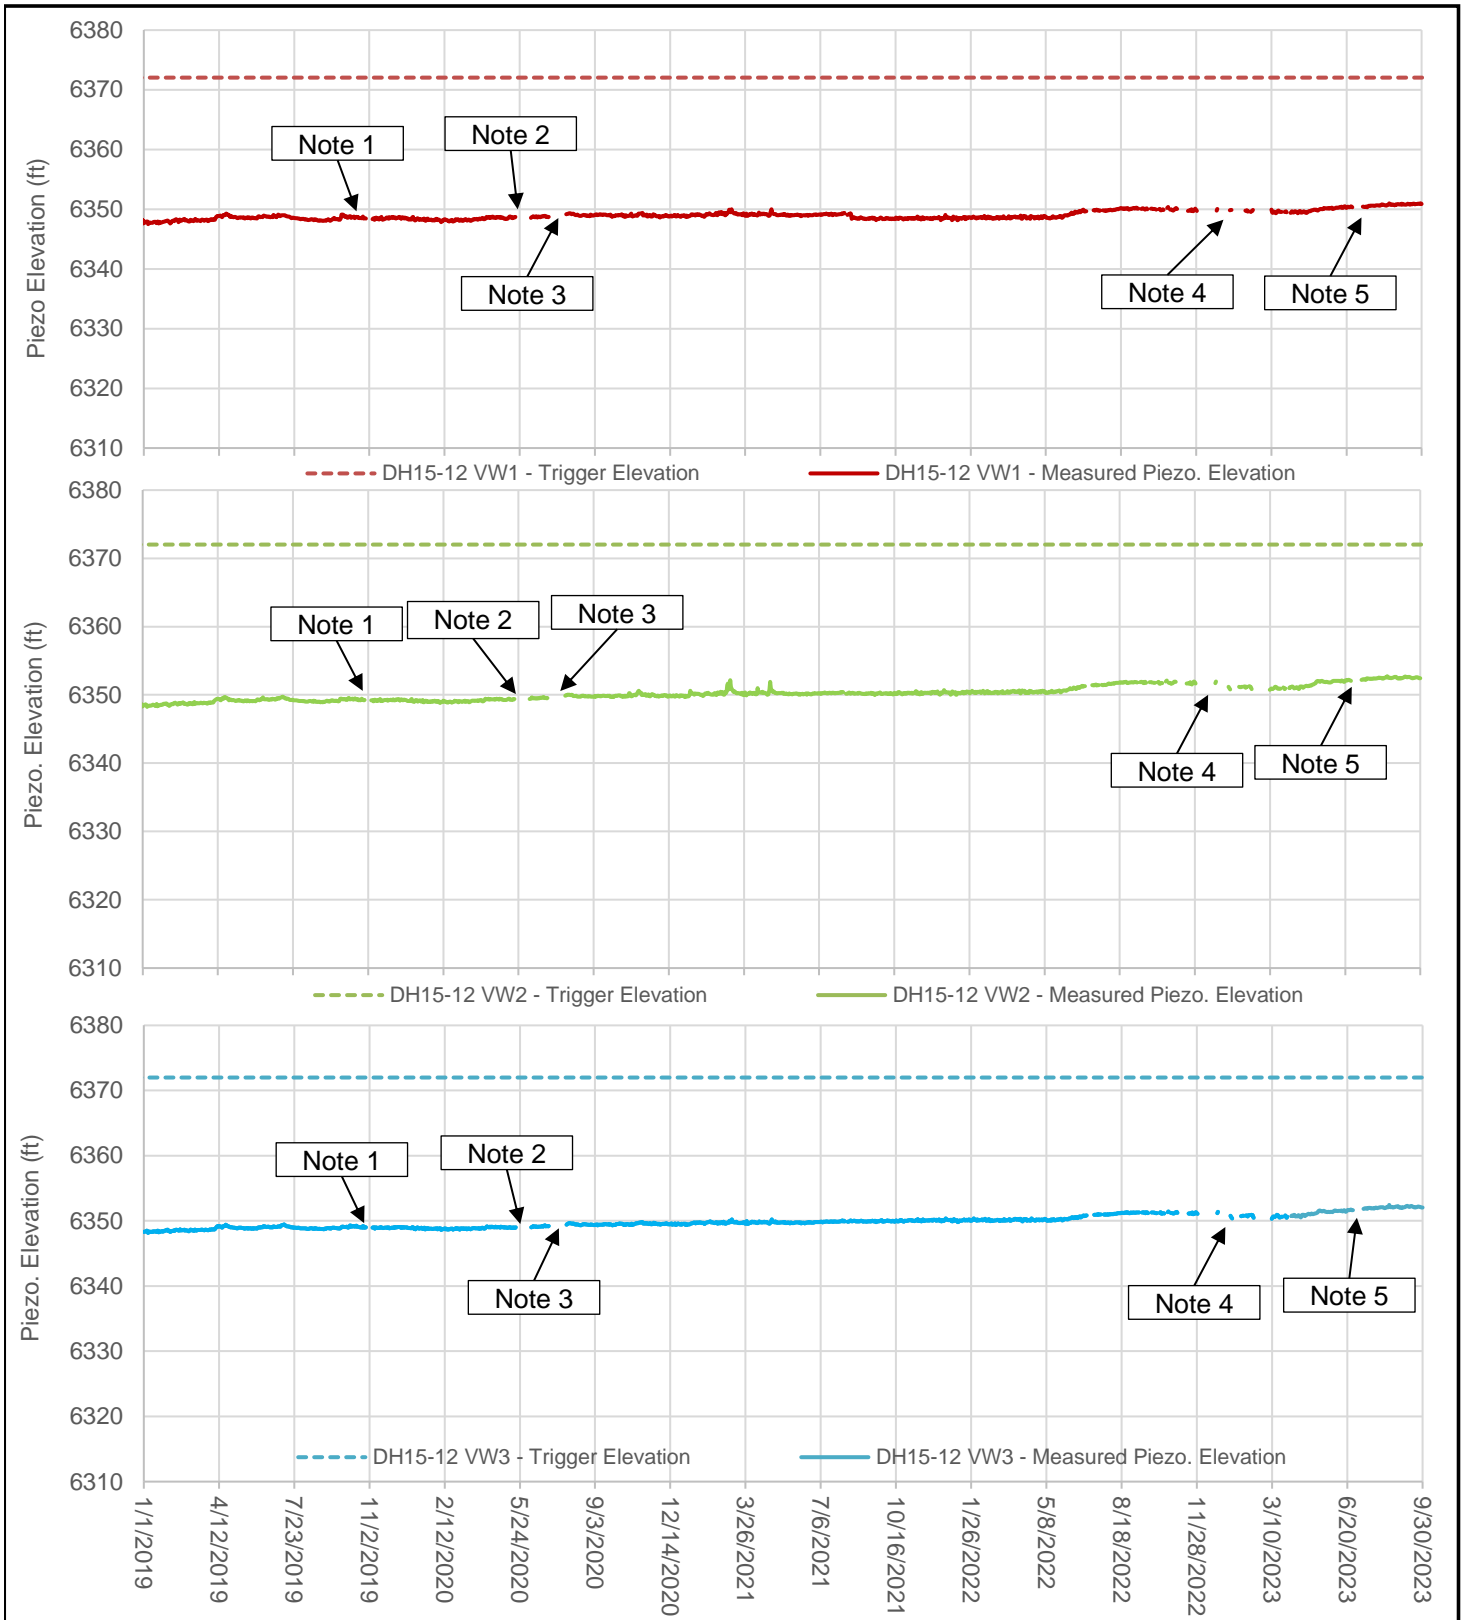
P/A NO. VA101-00126/29
	REF. NO. VA23-01703
<b>FIGURE A.1</b>	
REV 0

- QPP sensors in drillhole DH15-12 (VW1, VW2, and VW3), installed within the West Embankment foundation, monitored slightly increasing pore water pressures (approximately 0.2 to 0.5 ft). Sensors VW1, VW2, and VW3 remained approximately 20 ft below their QPP trigger thresholds.
- Pore water pressures monitored by QPP sensors installed in WED Drain Pods 1 and 2 (VWP-DP1 and VWP-DP2, respectively) indicate constant or slightly increasing pore pressures (decrease of 0.3 and increase 0.9 ft, respectively). The sensors remain approximately 30 ft below their respective QPP trigger thresholds.
- The piezometric elevation monitored by the non-QPP sensor in the WED Extraction Basin (VWP-EB1) monitored a minor pore water pressure increase (approximately 0.5 ft).

- NOTES:**
1. NO DATA WERE COLLECTED BY DH15-12 VW1, VW2, AND VW3 FROM OCTOBER 30, 2019 TO NOVEMBER 6, 2019 DUE TO A CONNECTIVITY ISSUE.
  2. NO DATA WERE COLLECTED BY DH15-12 VW1, VW2, AND VW3 FROM MAY 19 TO JUNE 9, 2020 DUE TO A SUSPECTED LOGGER CONNECTIVITY ISSUE.
  3. NO DATA WERE COLLECTED BY DH15-12 VW1, VW2, AND VW3 FROM JULY 3 TO JULY 26, 2020 DUE TO A CONNECTIVITY ISSUE.
  4. ALL SENSORS IN DRILLHOLE DH15-12 EXPERIENCED INTERMITTENT OUTAGES BETWEEN NOVEMBER 2, 2022 AND APRIL 15, 2023.
  5. NO DATA WERE COLLECTED BY DH15-12 VW1, VW2 AND VW3 FROM JUNE 29 TO JULY 12, 2023 DUE TO A CONNECTIVITY ISSUE.

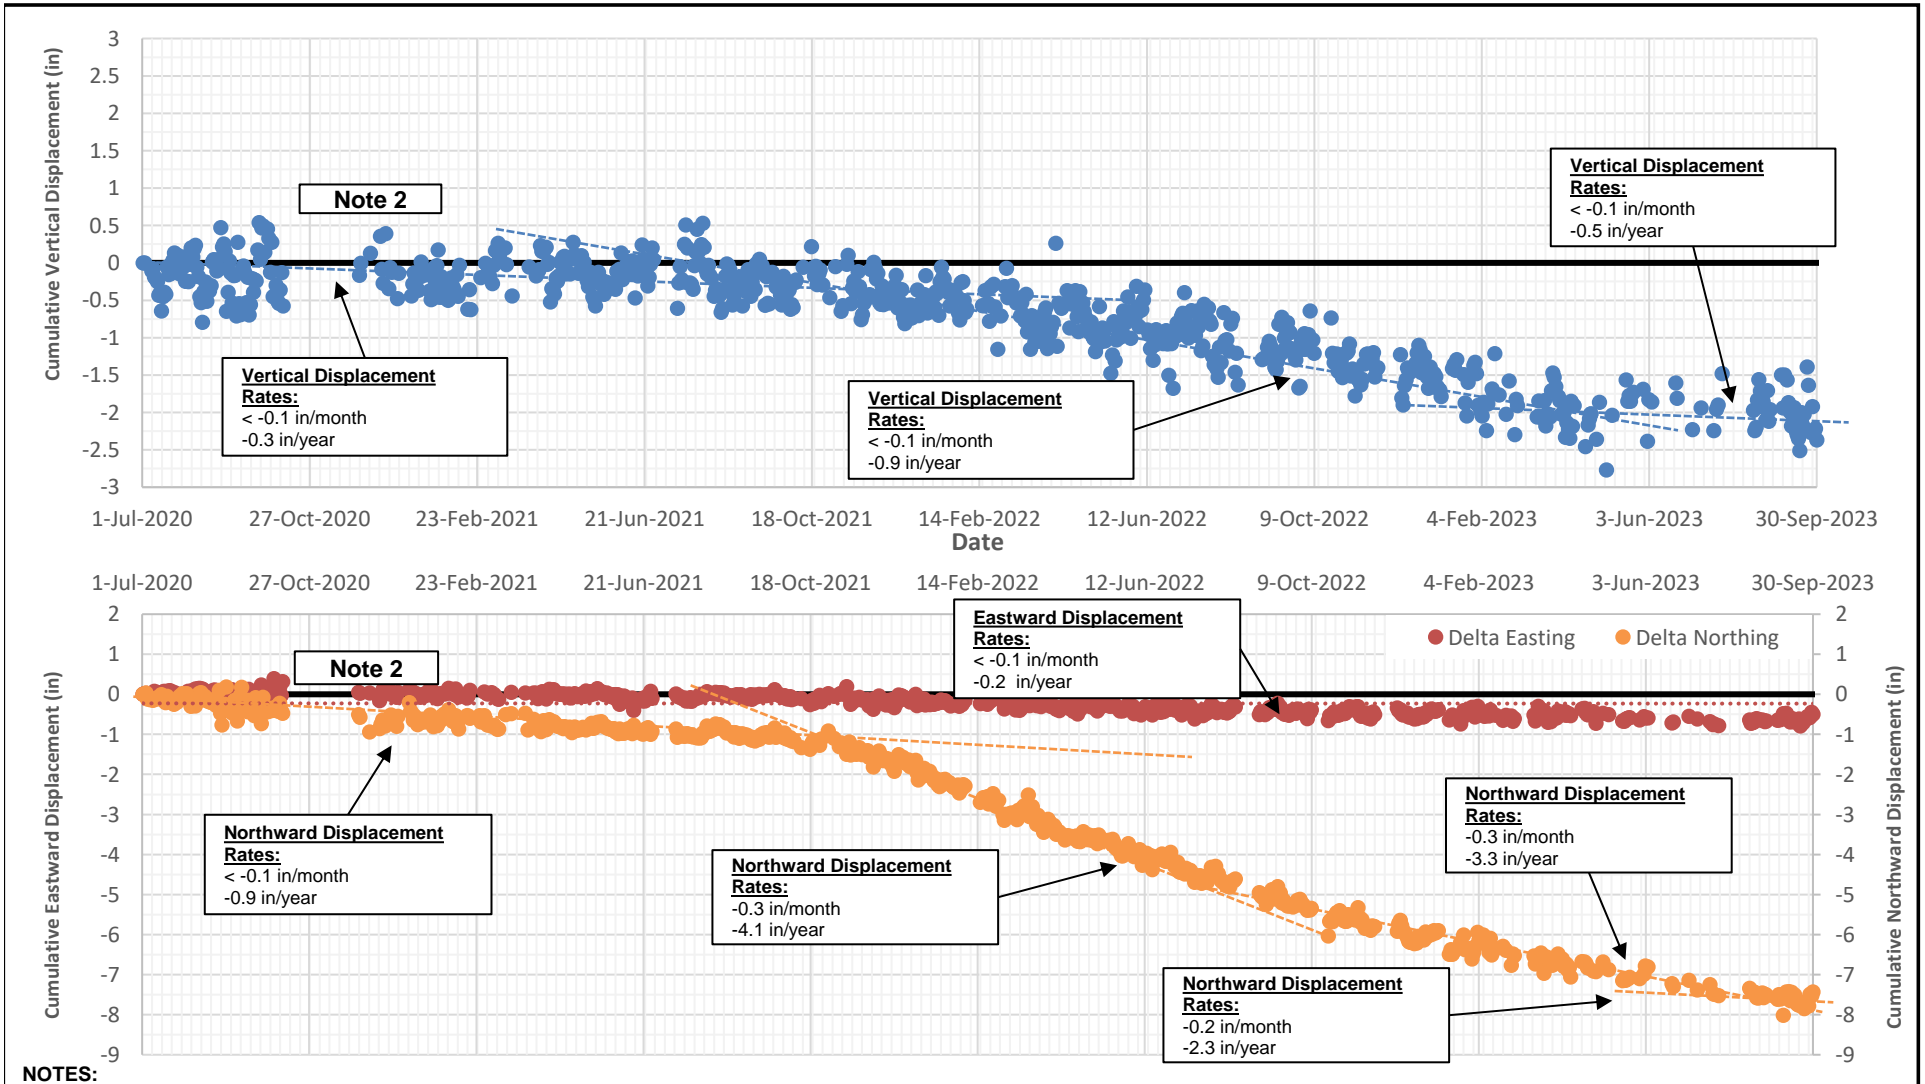
MONTANA RESOURCES LLC.	
YANKEE DOODLE TAILINGS IMPOUNDMENT	
<b>CUMULATIVE VERTICAL &amp; LATERAL DISPLACEMENTS MONITORED AT DH19-S3 (JULY 1, 2020 THROUGH SEPTEMBER 30, 2023)</b>	
	P/A NO. VA101-00126/29
	REF. NO. VA23-01703
<b>FIGURE A.2</b>	
REV 0

- Survey-monuments (GNSS DH19-S3, GNSS DH19-S4, SB-1, SB-2, and SB-3) installed along the Seep 10 Bench have previously observed slightly elevated surface deformation rates interpreted as construction influence. Monitoring during Q3 2023 appear to continue to indicate stable or slowing deformation rates.
