Prepared for
Montana Resources, LLP
600 Shields Avenue
Butte, Montana
USA, 59701

Prepared by
Knight Piésold Ltd.
Suite 1400 - 750 West Pender Street
Vancouver, British Columbia
Canada, V6C 2T8

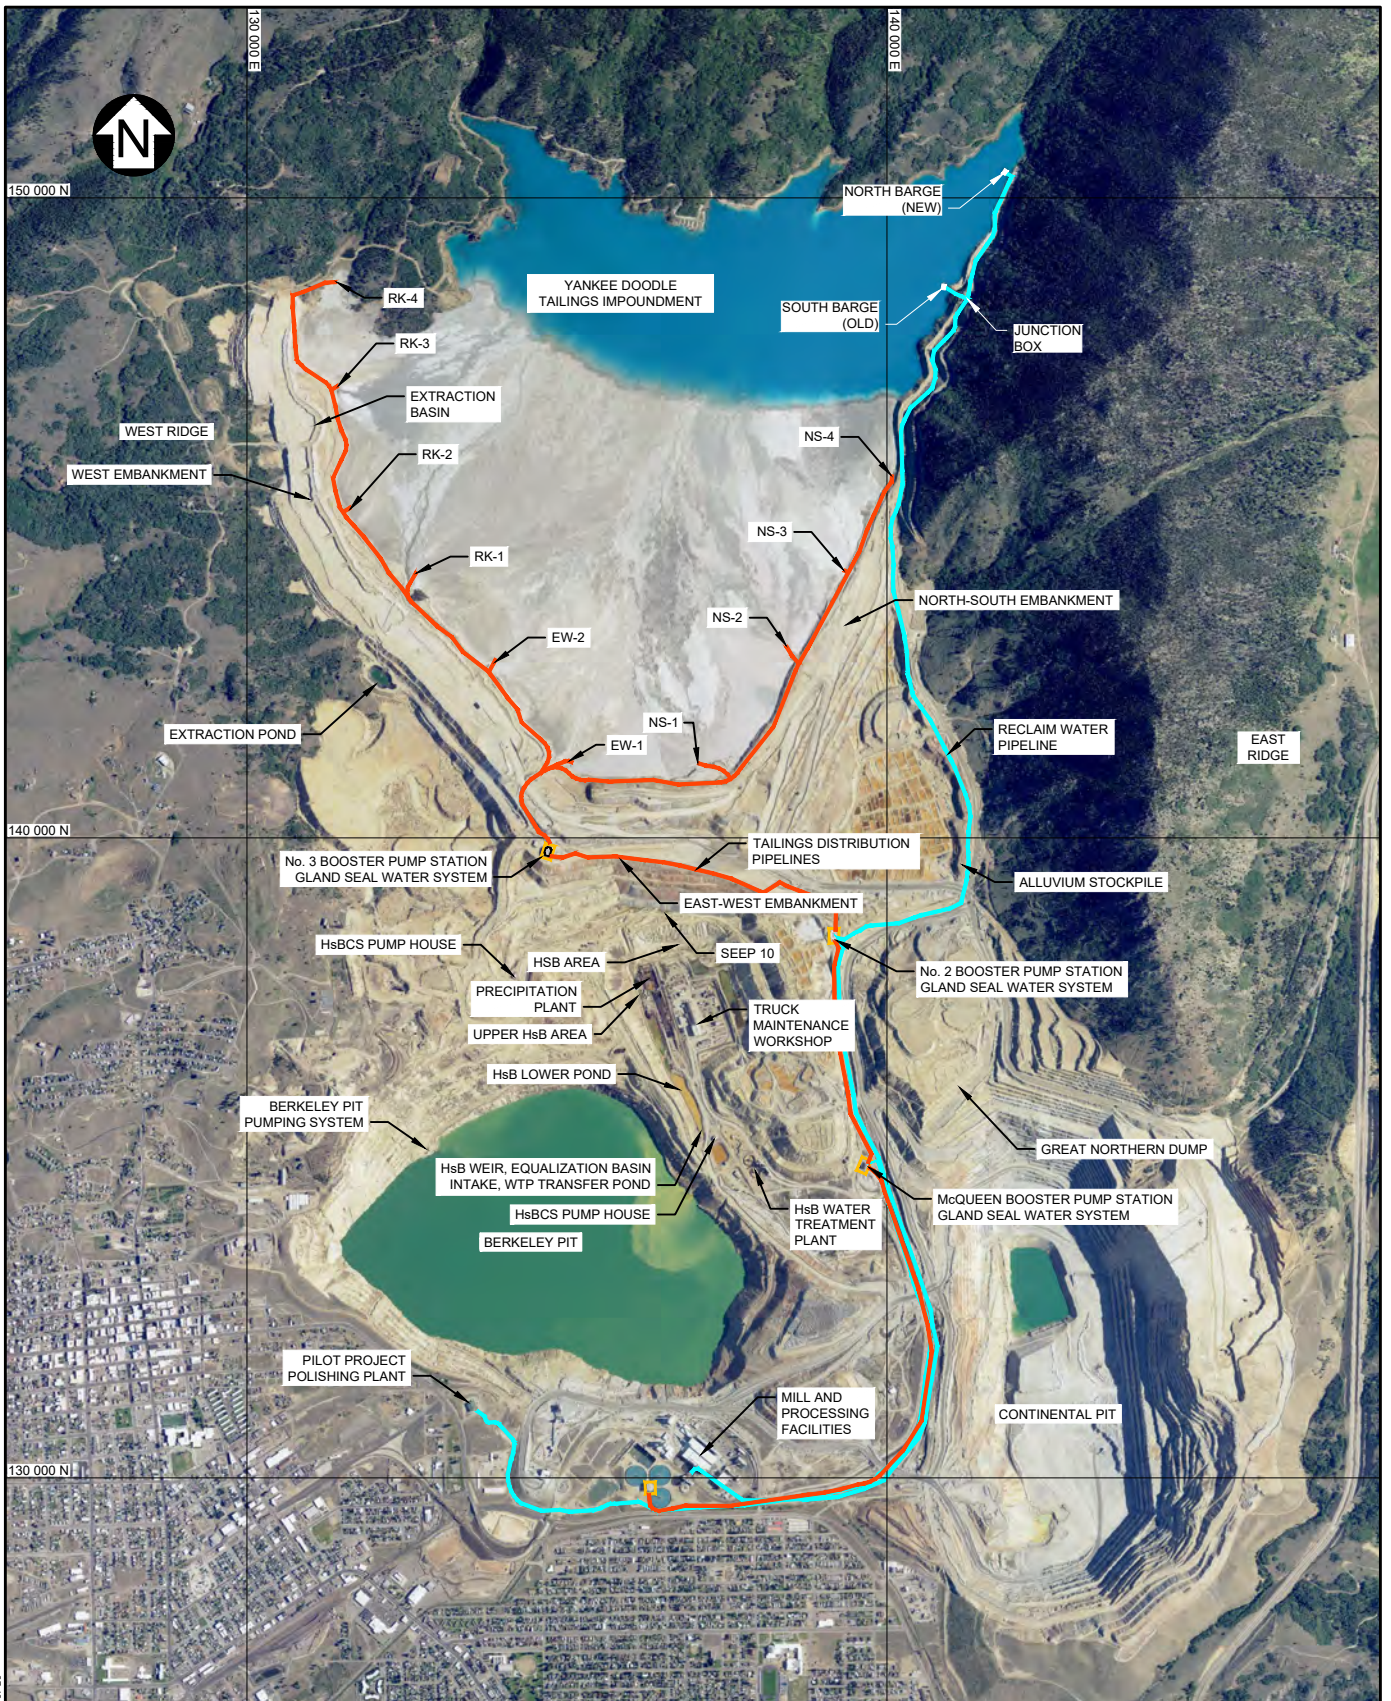
SAVED: M:\110012625\A\Aca\FIGSA16_12222021 2:54:41 PM, RMCLELLAN PRINTED: 1/10/2022 2:52:21 PM, FIG 1.1, RMCLELLAN
 XREF FILE(S): SR_01_2021-07-29 IMAGE FILE(S): SR_01_2021-07-29

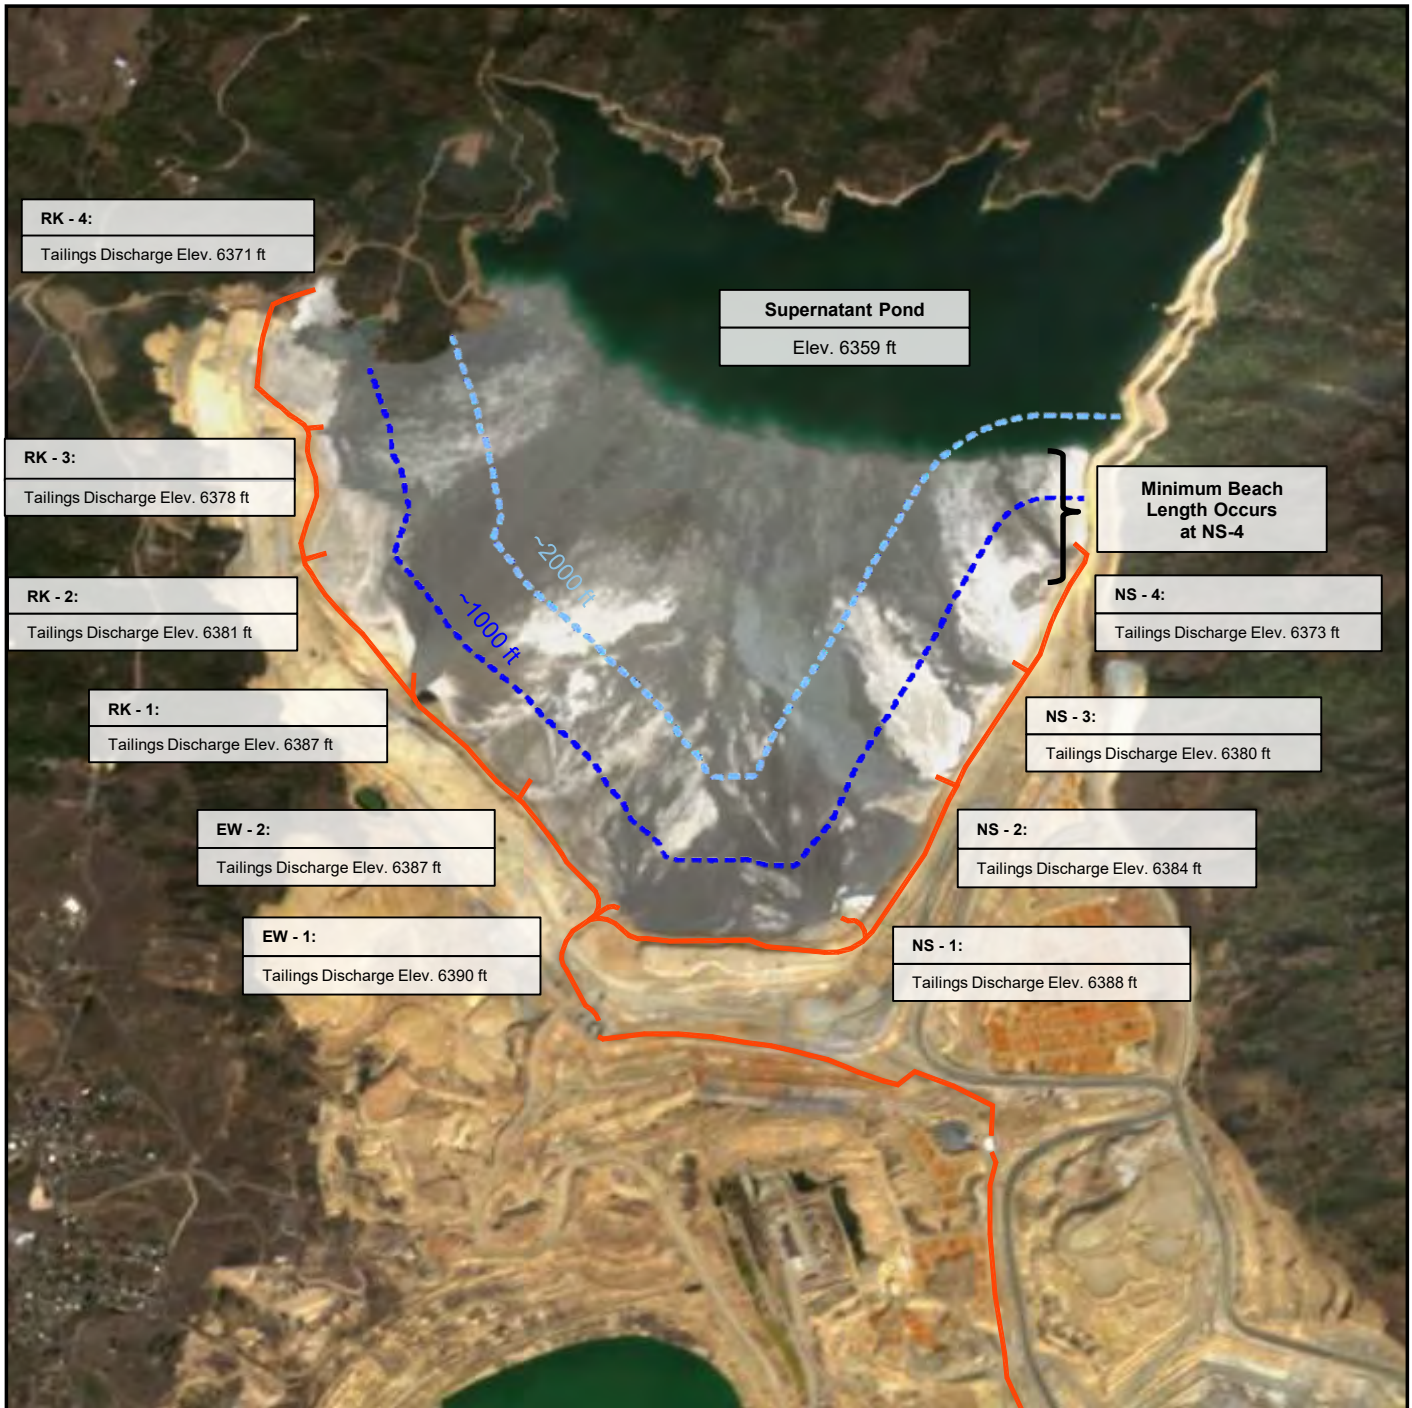
The Q3 (August 18, 2021) (KP, 2021l) and Q4 (November 17, 2021) field reviews were completed by Mr. Fontaine and Mr. Jason Gillespie, P.Eng. of KP, respectively. The format of the field review summary letter was revised by KP starting with the Q3 period. The quarterly summary letters now include a more detailed construction summary, including end of quarter progress images and placement tonnages provided by MR, along with the observations and recommendations from the field review. The 2021 Q3 Construction Summary and Field Review (KP, 2021l) is included as Appendix B. The Q4 summary letter is in progress and will be completed by KP in early 2022 once end of year construction data is available.

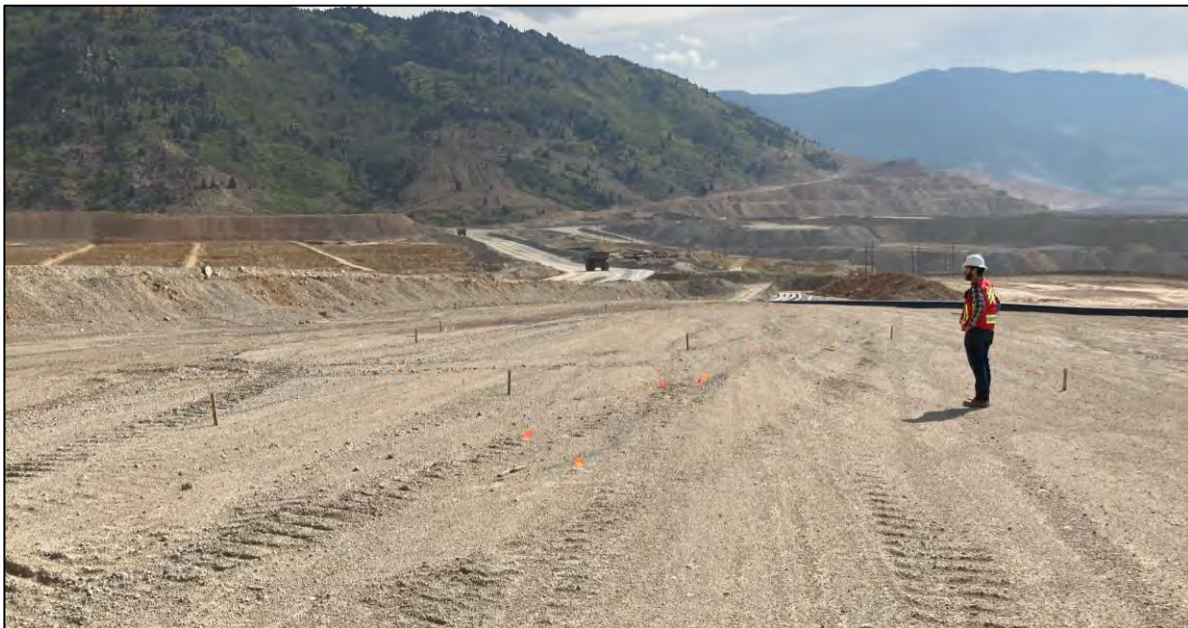
PHOTO 42 – Cracks monitored along the upstream side of the East-West pipeline ramp by the eastern toe of the EL. 6,250 ft lift, facing east.

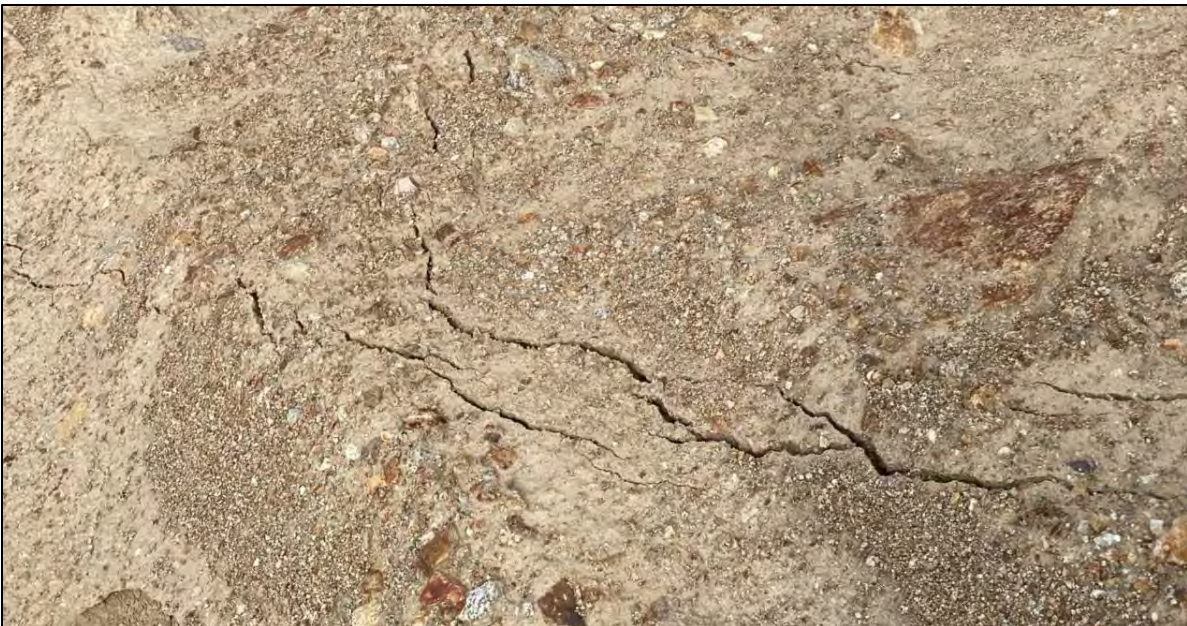
PHOTO 50 – Cracking observed along recently placed areas of the EL. 6,450 ft lift on the West Embankment.

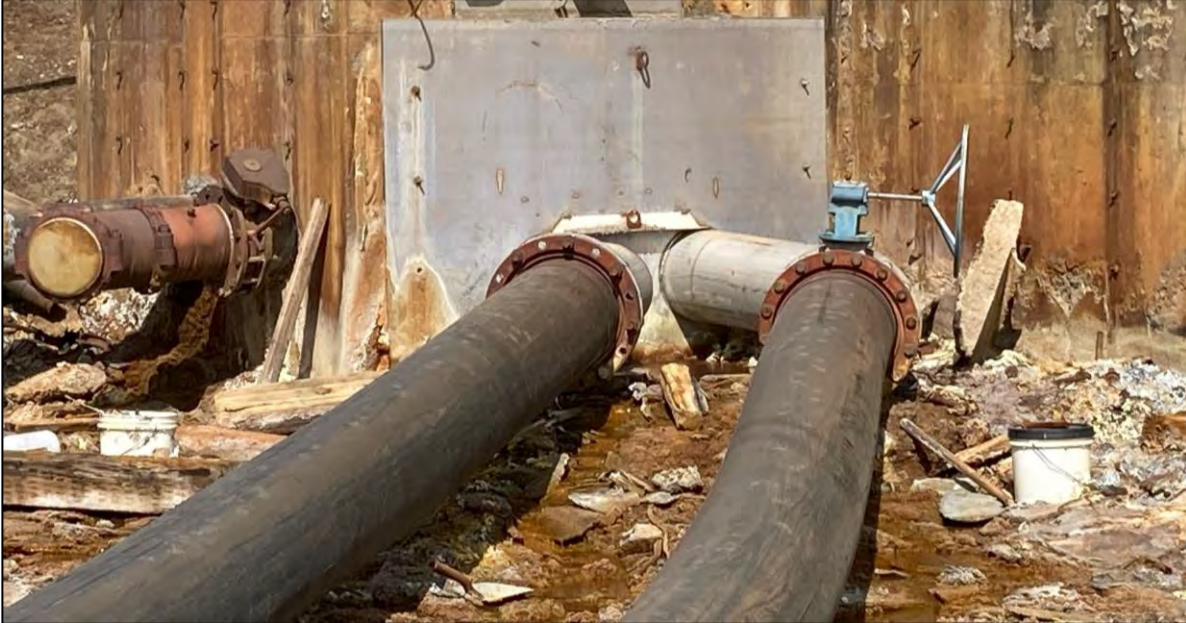
PHOTO 63 – Bulkhead replacement for discharge lines from the #5 and #6 Cells.

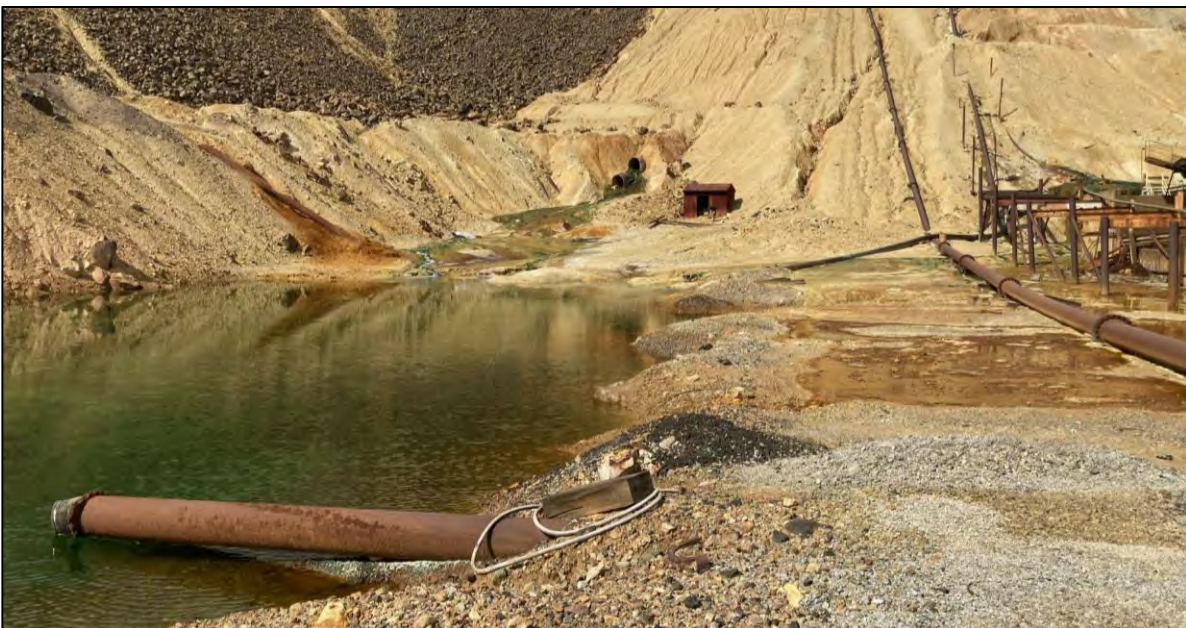
PHOTO 64 – Seepage collection area at the west side of the Upper HsB Area.

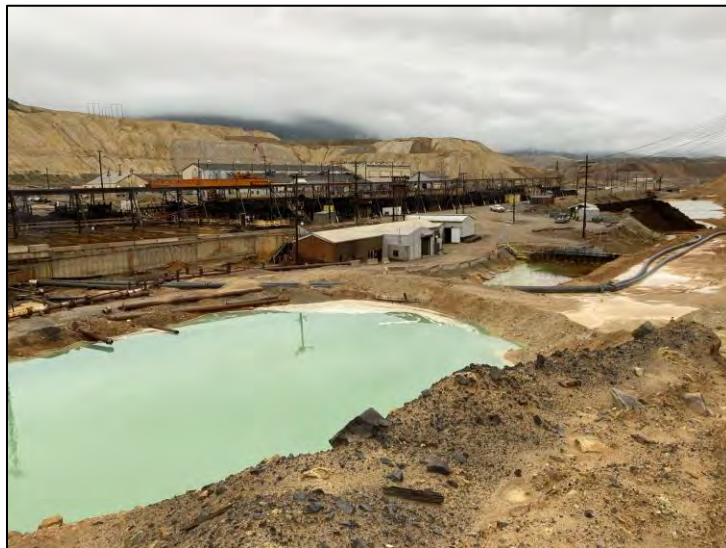
Photo 3.1 Water ponding within the upper HsB Area

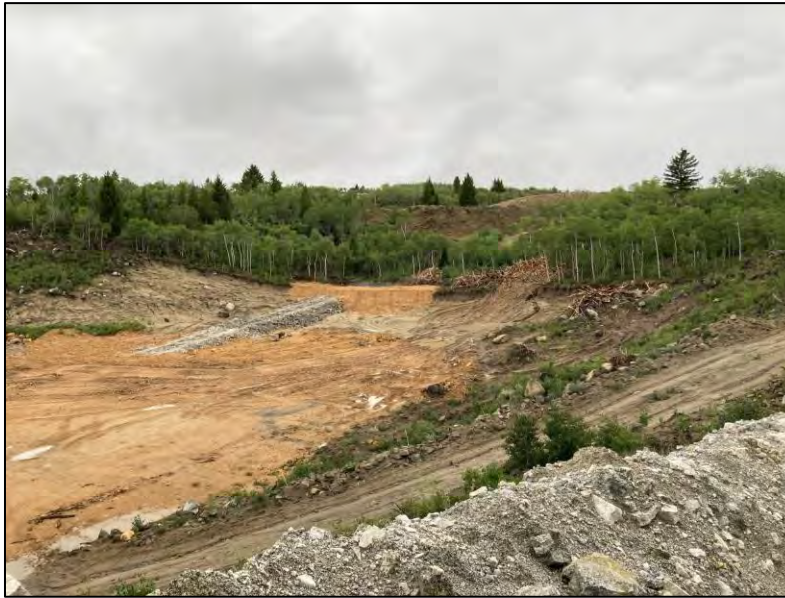
Photo 3.2 Example of slash piles pushed up to the tree line along the West Embankment

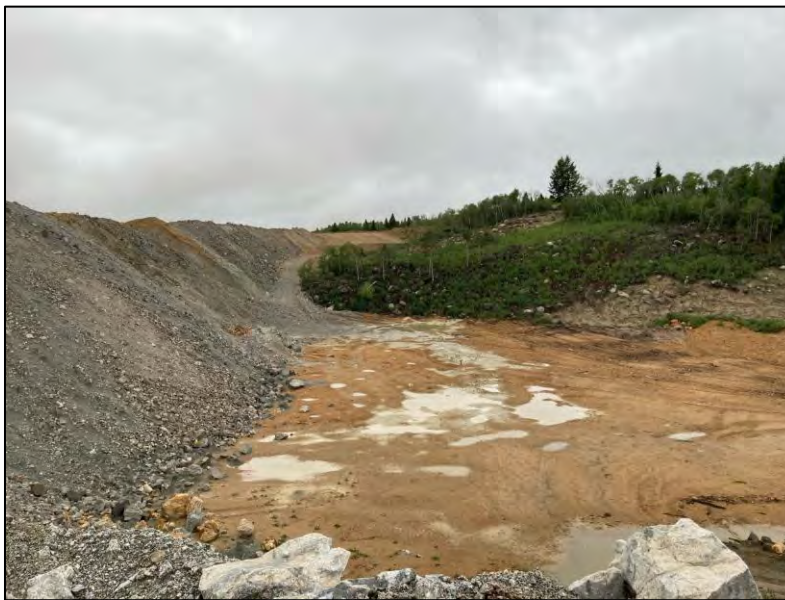
Photo 3.3 Incomplete D1 material placement at Ridge Road facing South

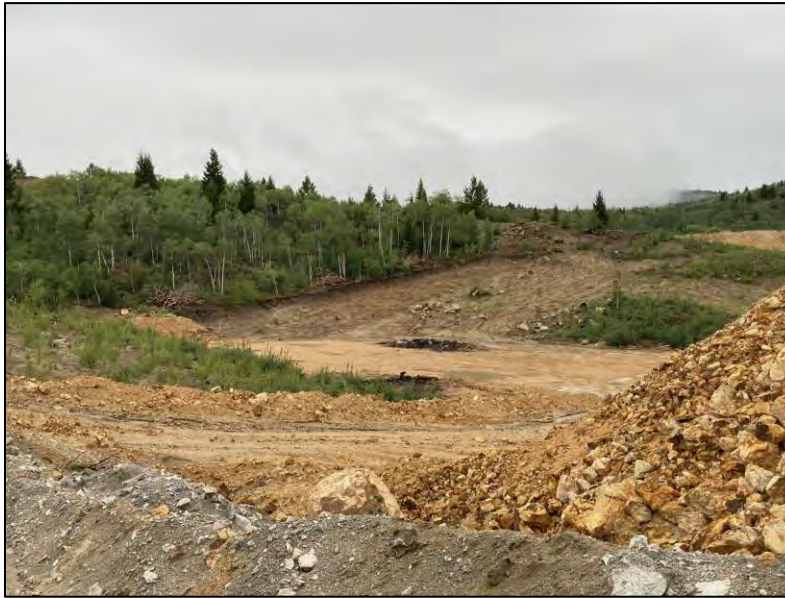
Photo 3.4 Incomplete D1 material placement at Ridge Road facing North

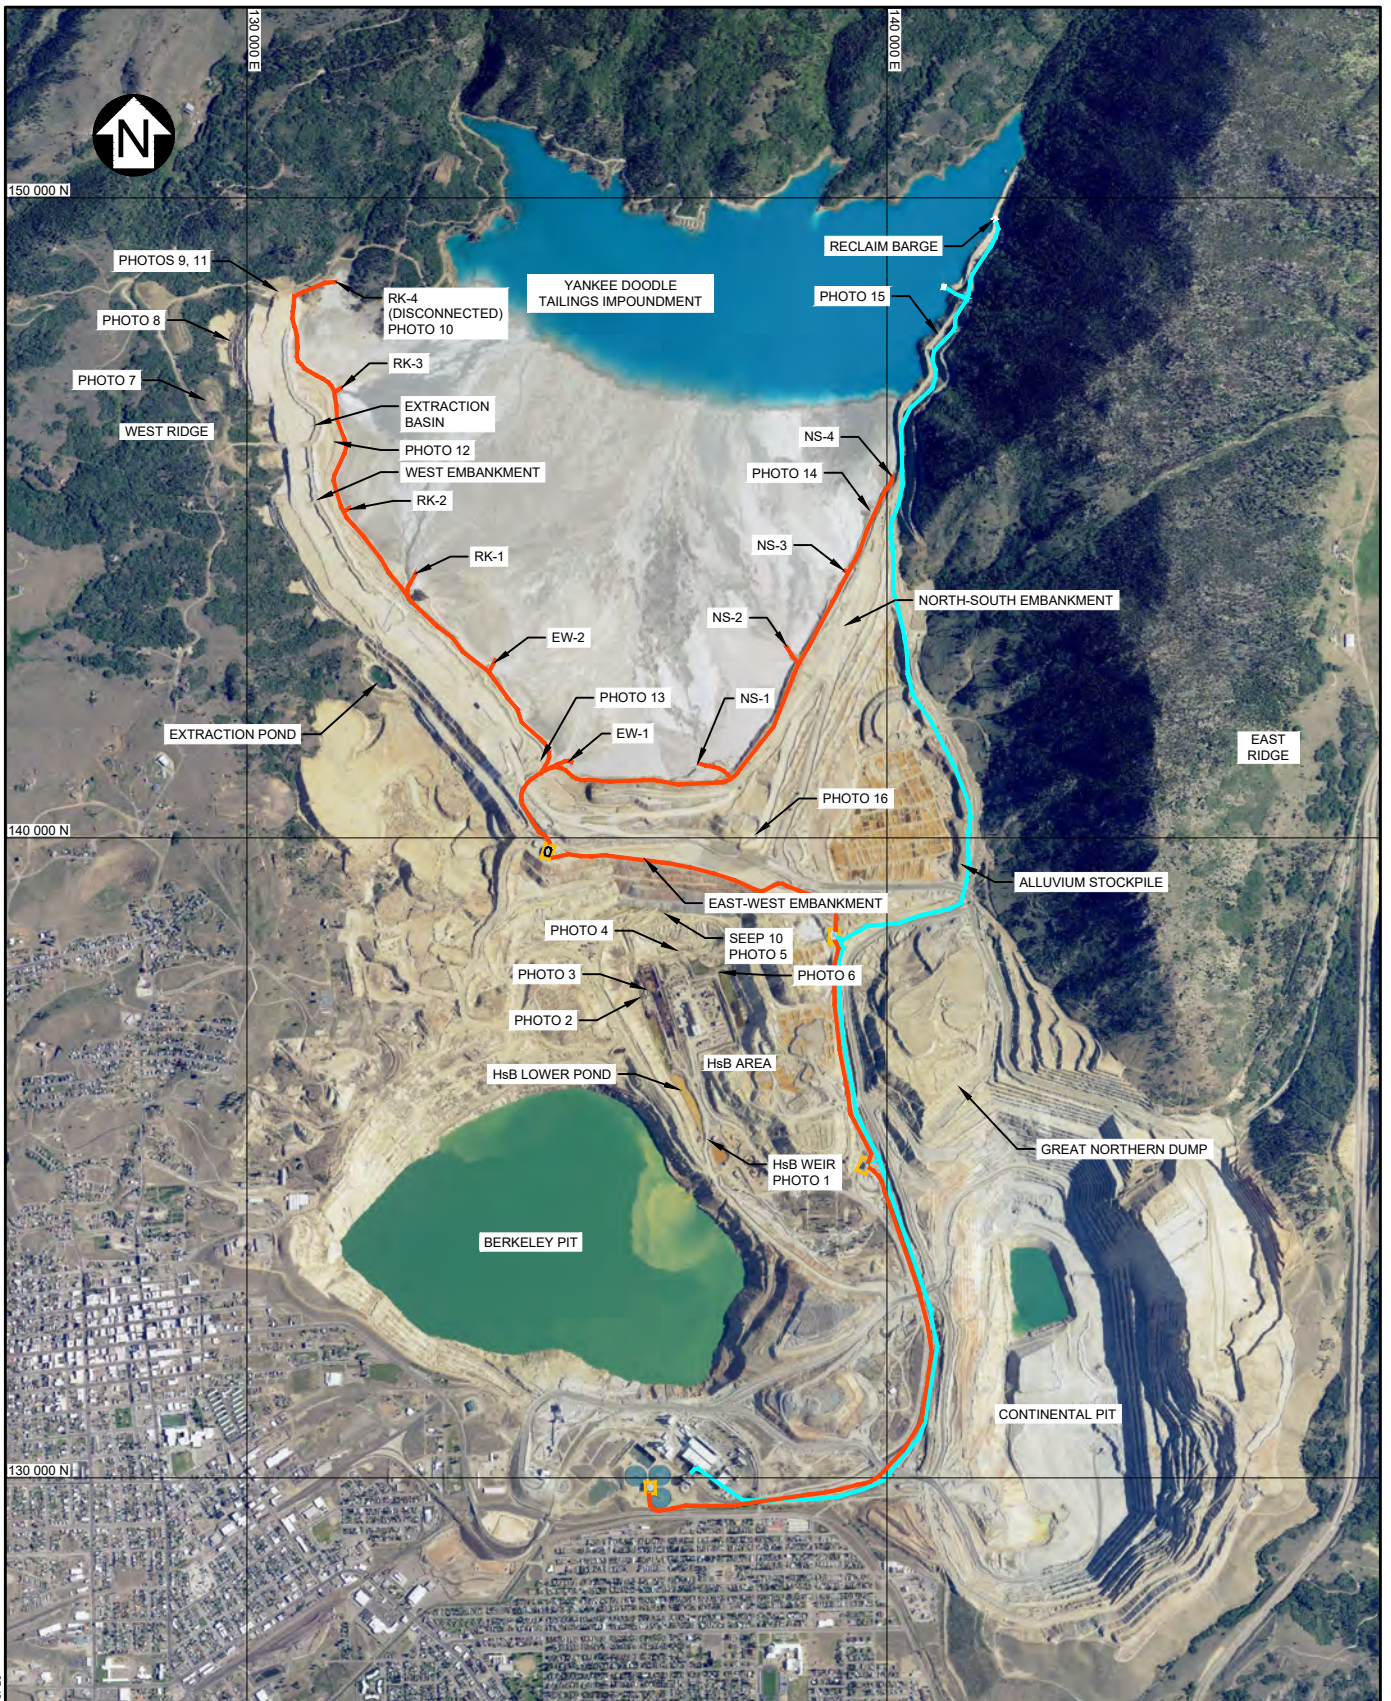
Construction along the new reclaim water pipeline corridor was observed during the inspection. The work comprises a substantial bedrock cut along Rampart Mountain at approximately EL. 6,500 ft above the existing reclaim pipeline access road connecting to a rockfill ramp located adjacent to and downstream of the North-South Embankment. A contractor is responsible for the cut portions of the reclaim corridor with MR constructing the rockfill ramp. Construction is nearly complete with only minor work required along the cut and at the interface to tie into the rockfill ramp. The newer reclaim barge was observed to be disconnected and relocated further to the north in preparation for realignment of the reclaim pipeline along this new corridor.

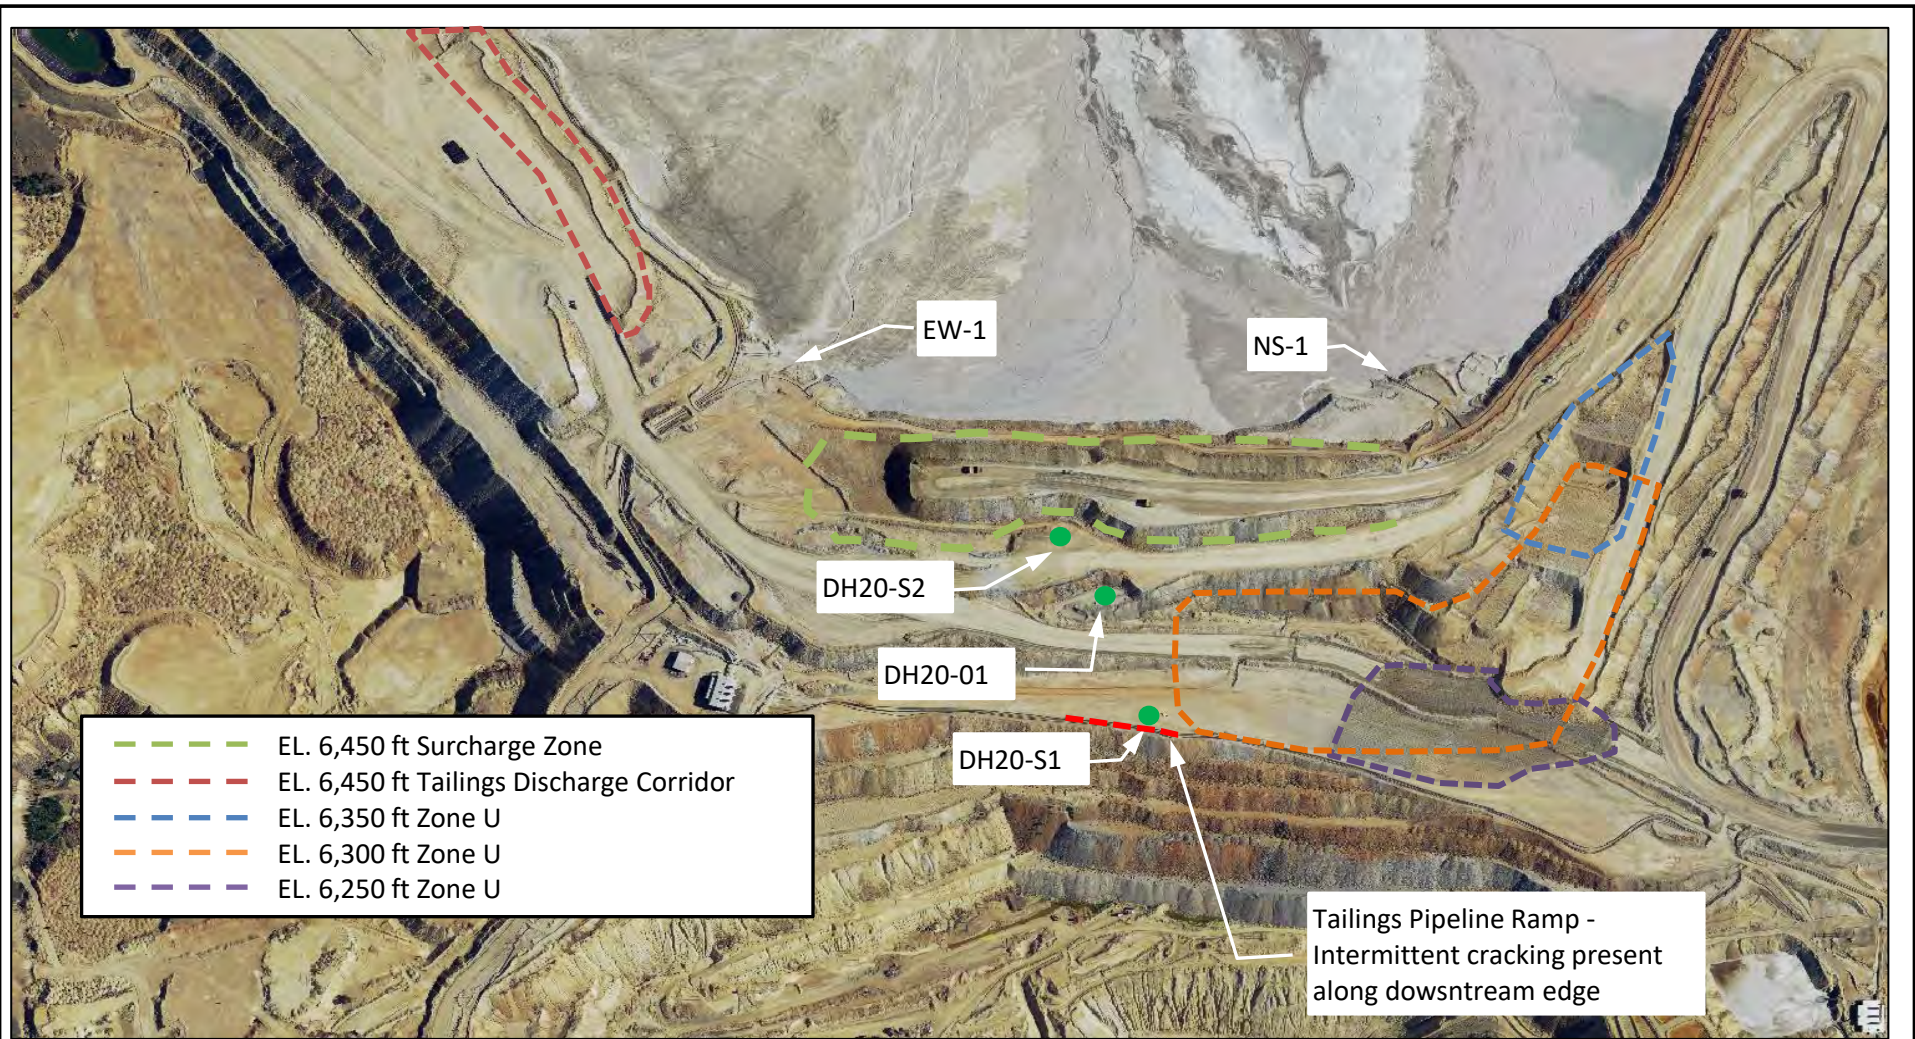
- EL. 6,450 ft Surcharge Zone
- EL. 6,450 ft Tailings Discharge Corridor
- EL. 6,350 ft Zone U
- EL. 6,300 ft Zone U
- EL. 6,250 ft Zone U

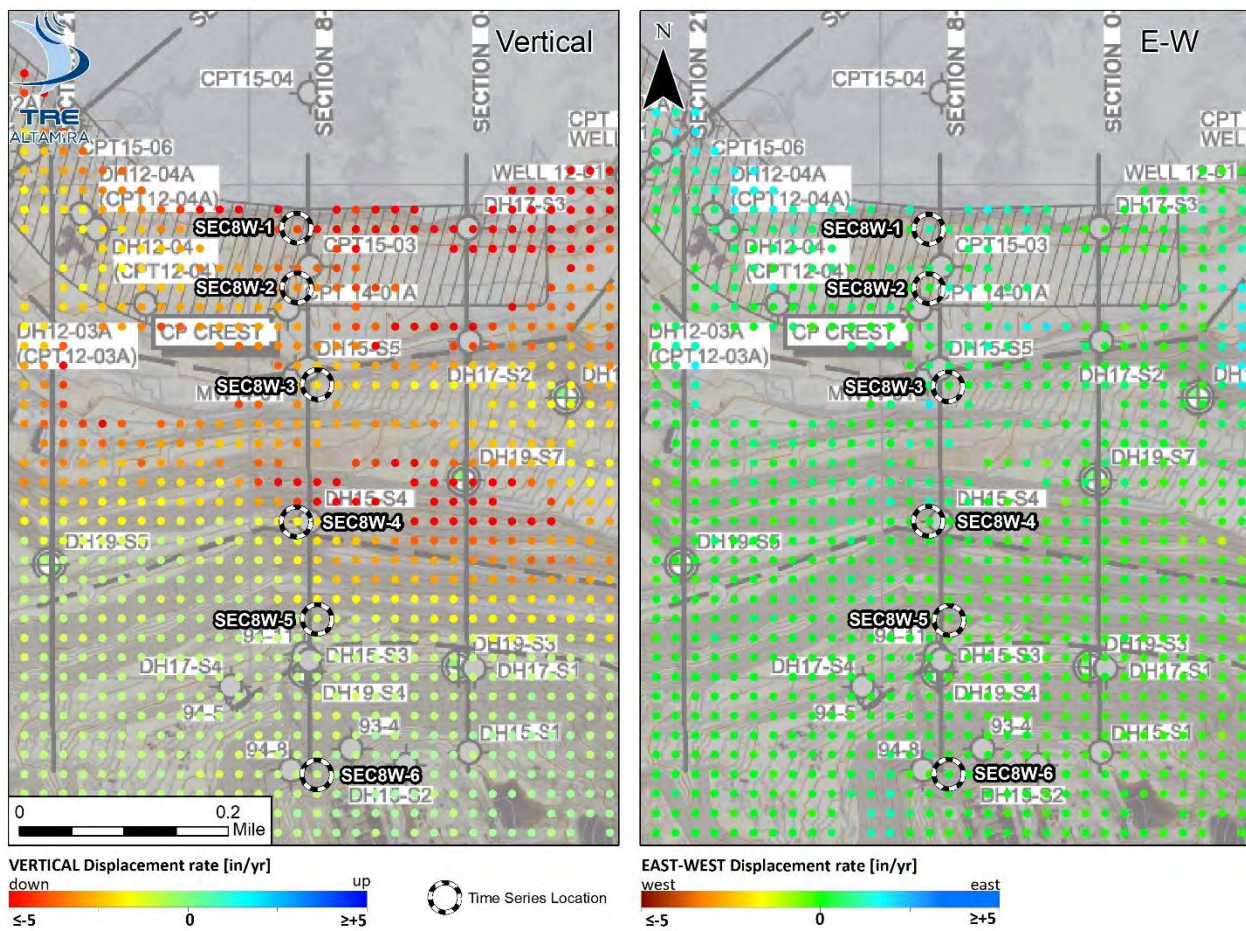
Figure 22: Location of TS analyzed along the Sec 8+00 W transect. Vertical displacement is represented in the left panel while the right panel shows the East-West movement.

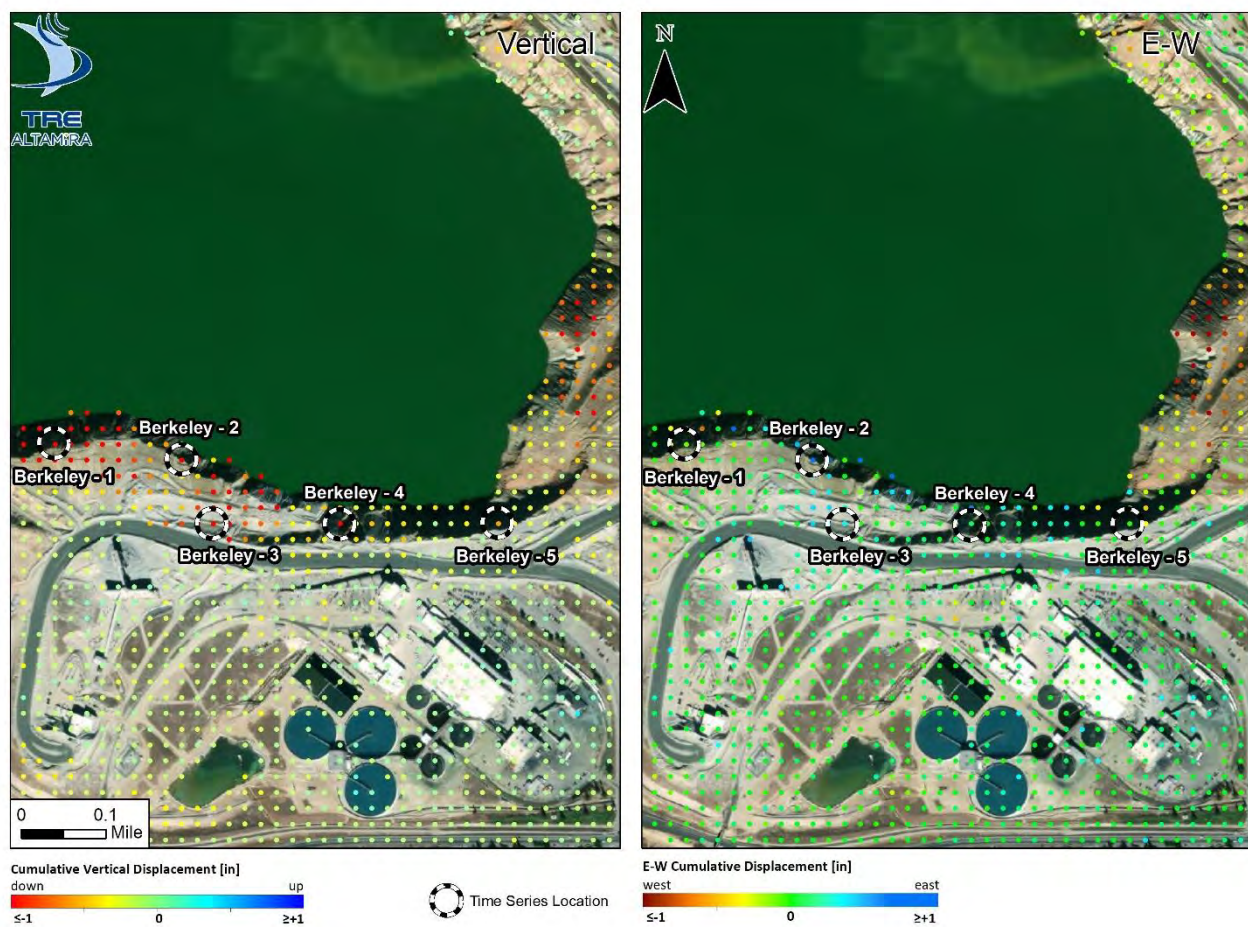
Figure 32: Location of TS analyzed at Berkeley Pit. Vertical displacement is represented in the left panel while the right panel shows the East-West movement.

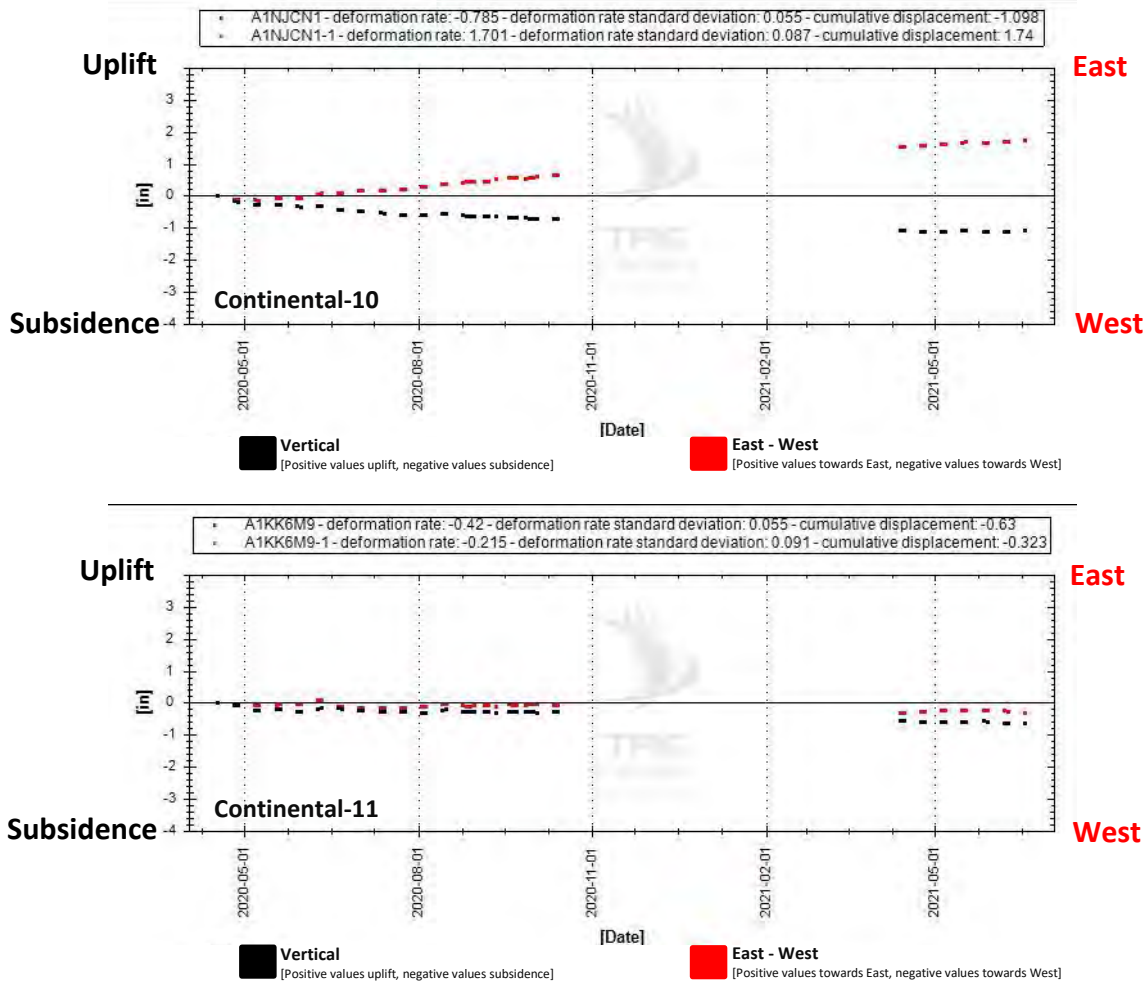
Figure 39: Continental-10 and Continental-11 displacement time series. Black dots represent the vertical displacement while red dots represent the E-W horizontal component of the motion.

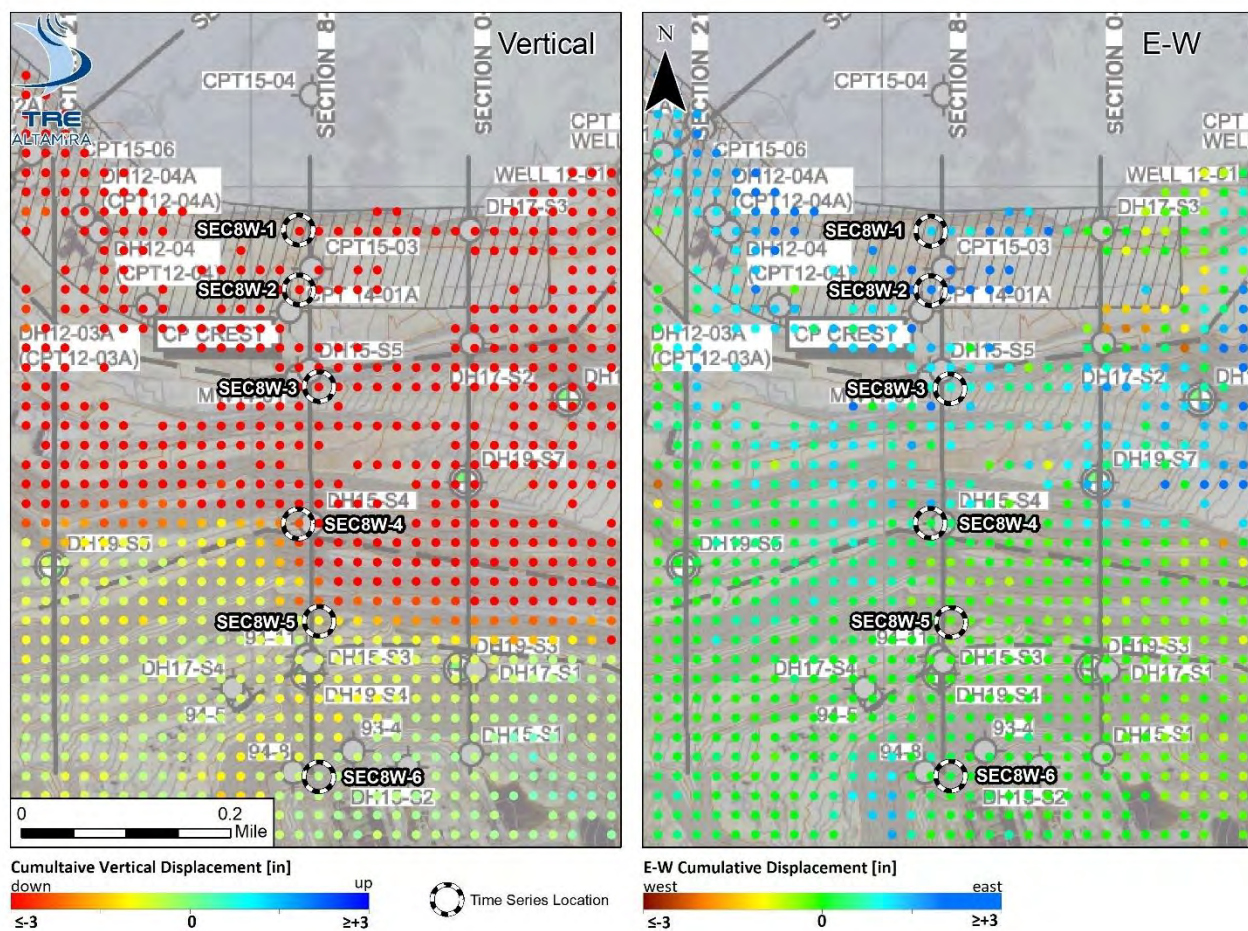
Figure 20: Location of TS analyzed along the Sec 8+00 W transect. Vertical displacement is represented in the left panel while the right panel shows the East-West movement.

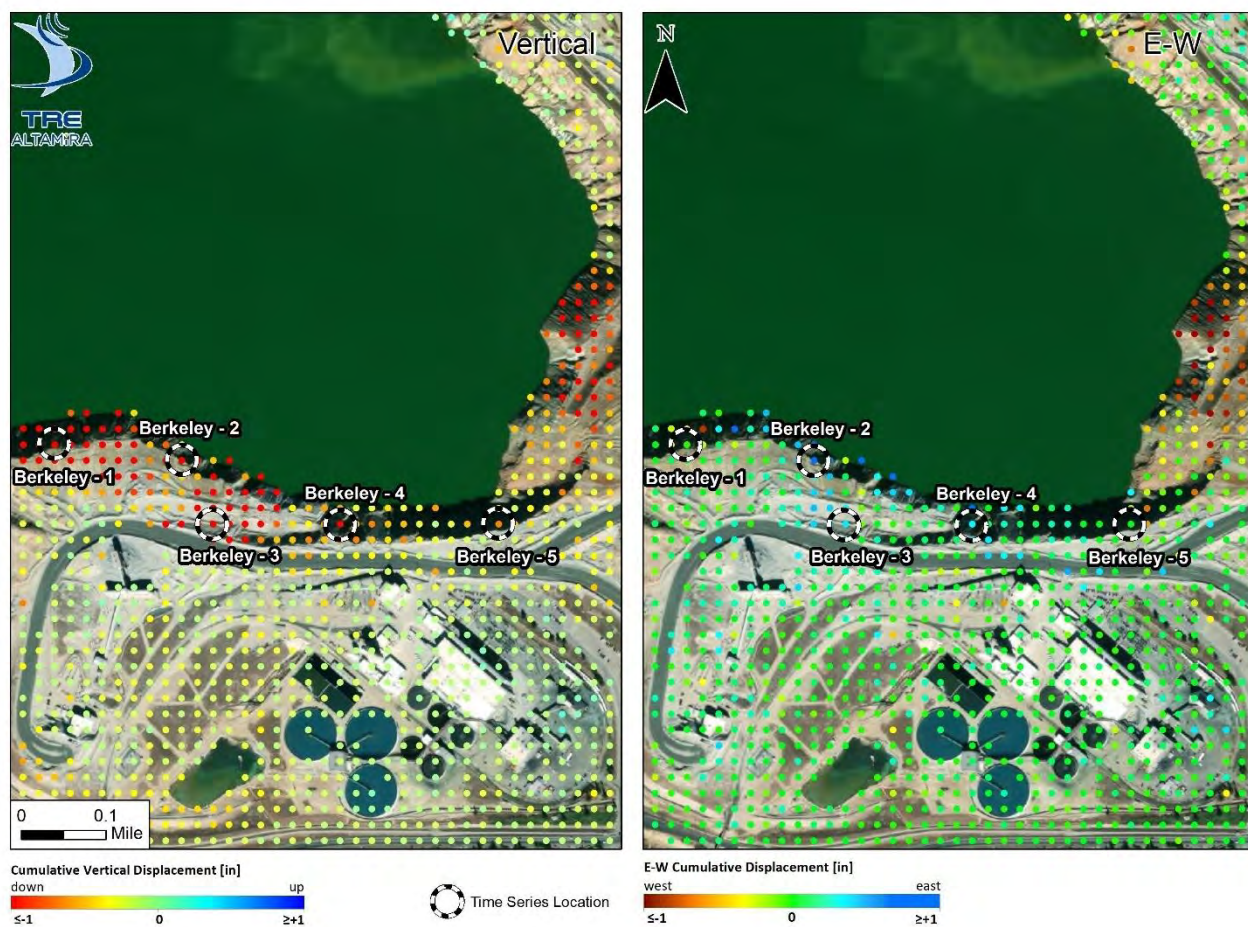
Figure 30: Location of TS analyzed at Berkeley Pit. Vertical displacement is represented in the left panel while the right panel shows the East-West movement.

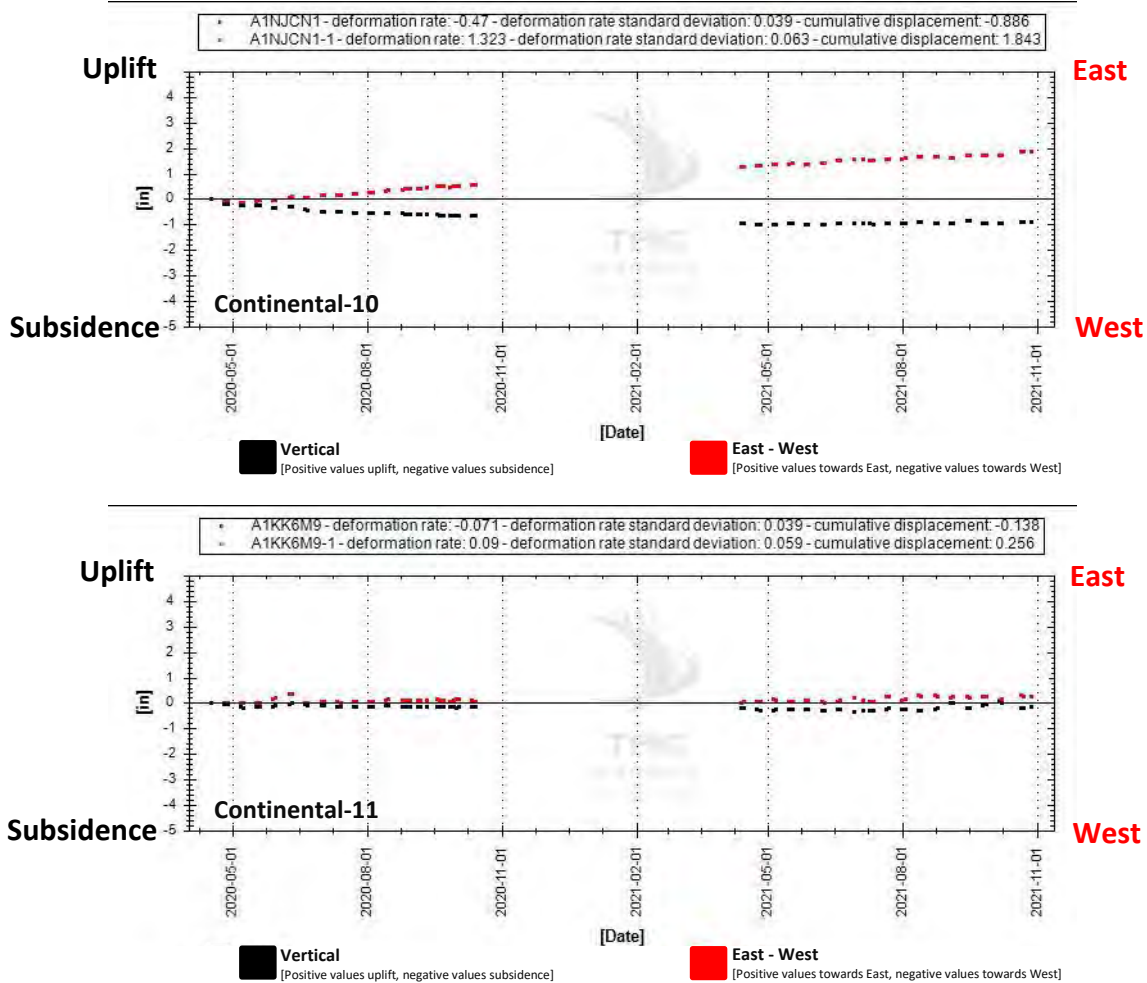
Figure 37: Continental-10 and Continental-11 displacement time series. Black dots represent the vertical displacement while red dots represent the E-W horizontal component of the motion.
