Prepared for
Montana Resources, LLP
600 Shields Avenue
Butte, Montana
USA, 59701

Prepared by
Knight Piésold Ltd.
Suite 1400 - 750 West Pender Street
Vancouver, British Columbia
Canada, V6C 2T8

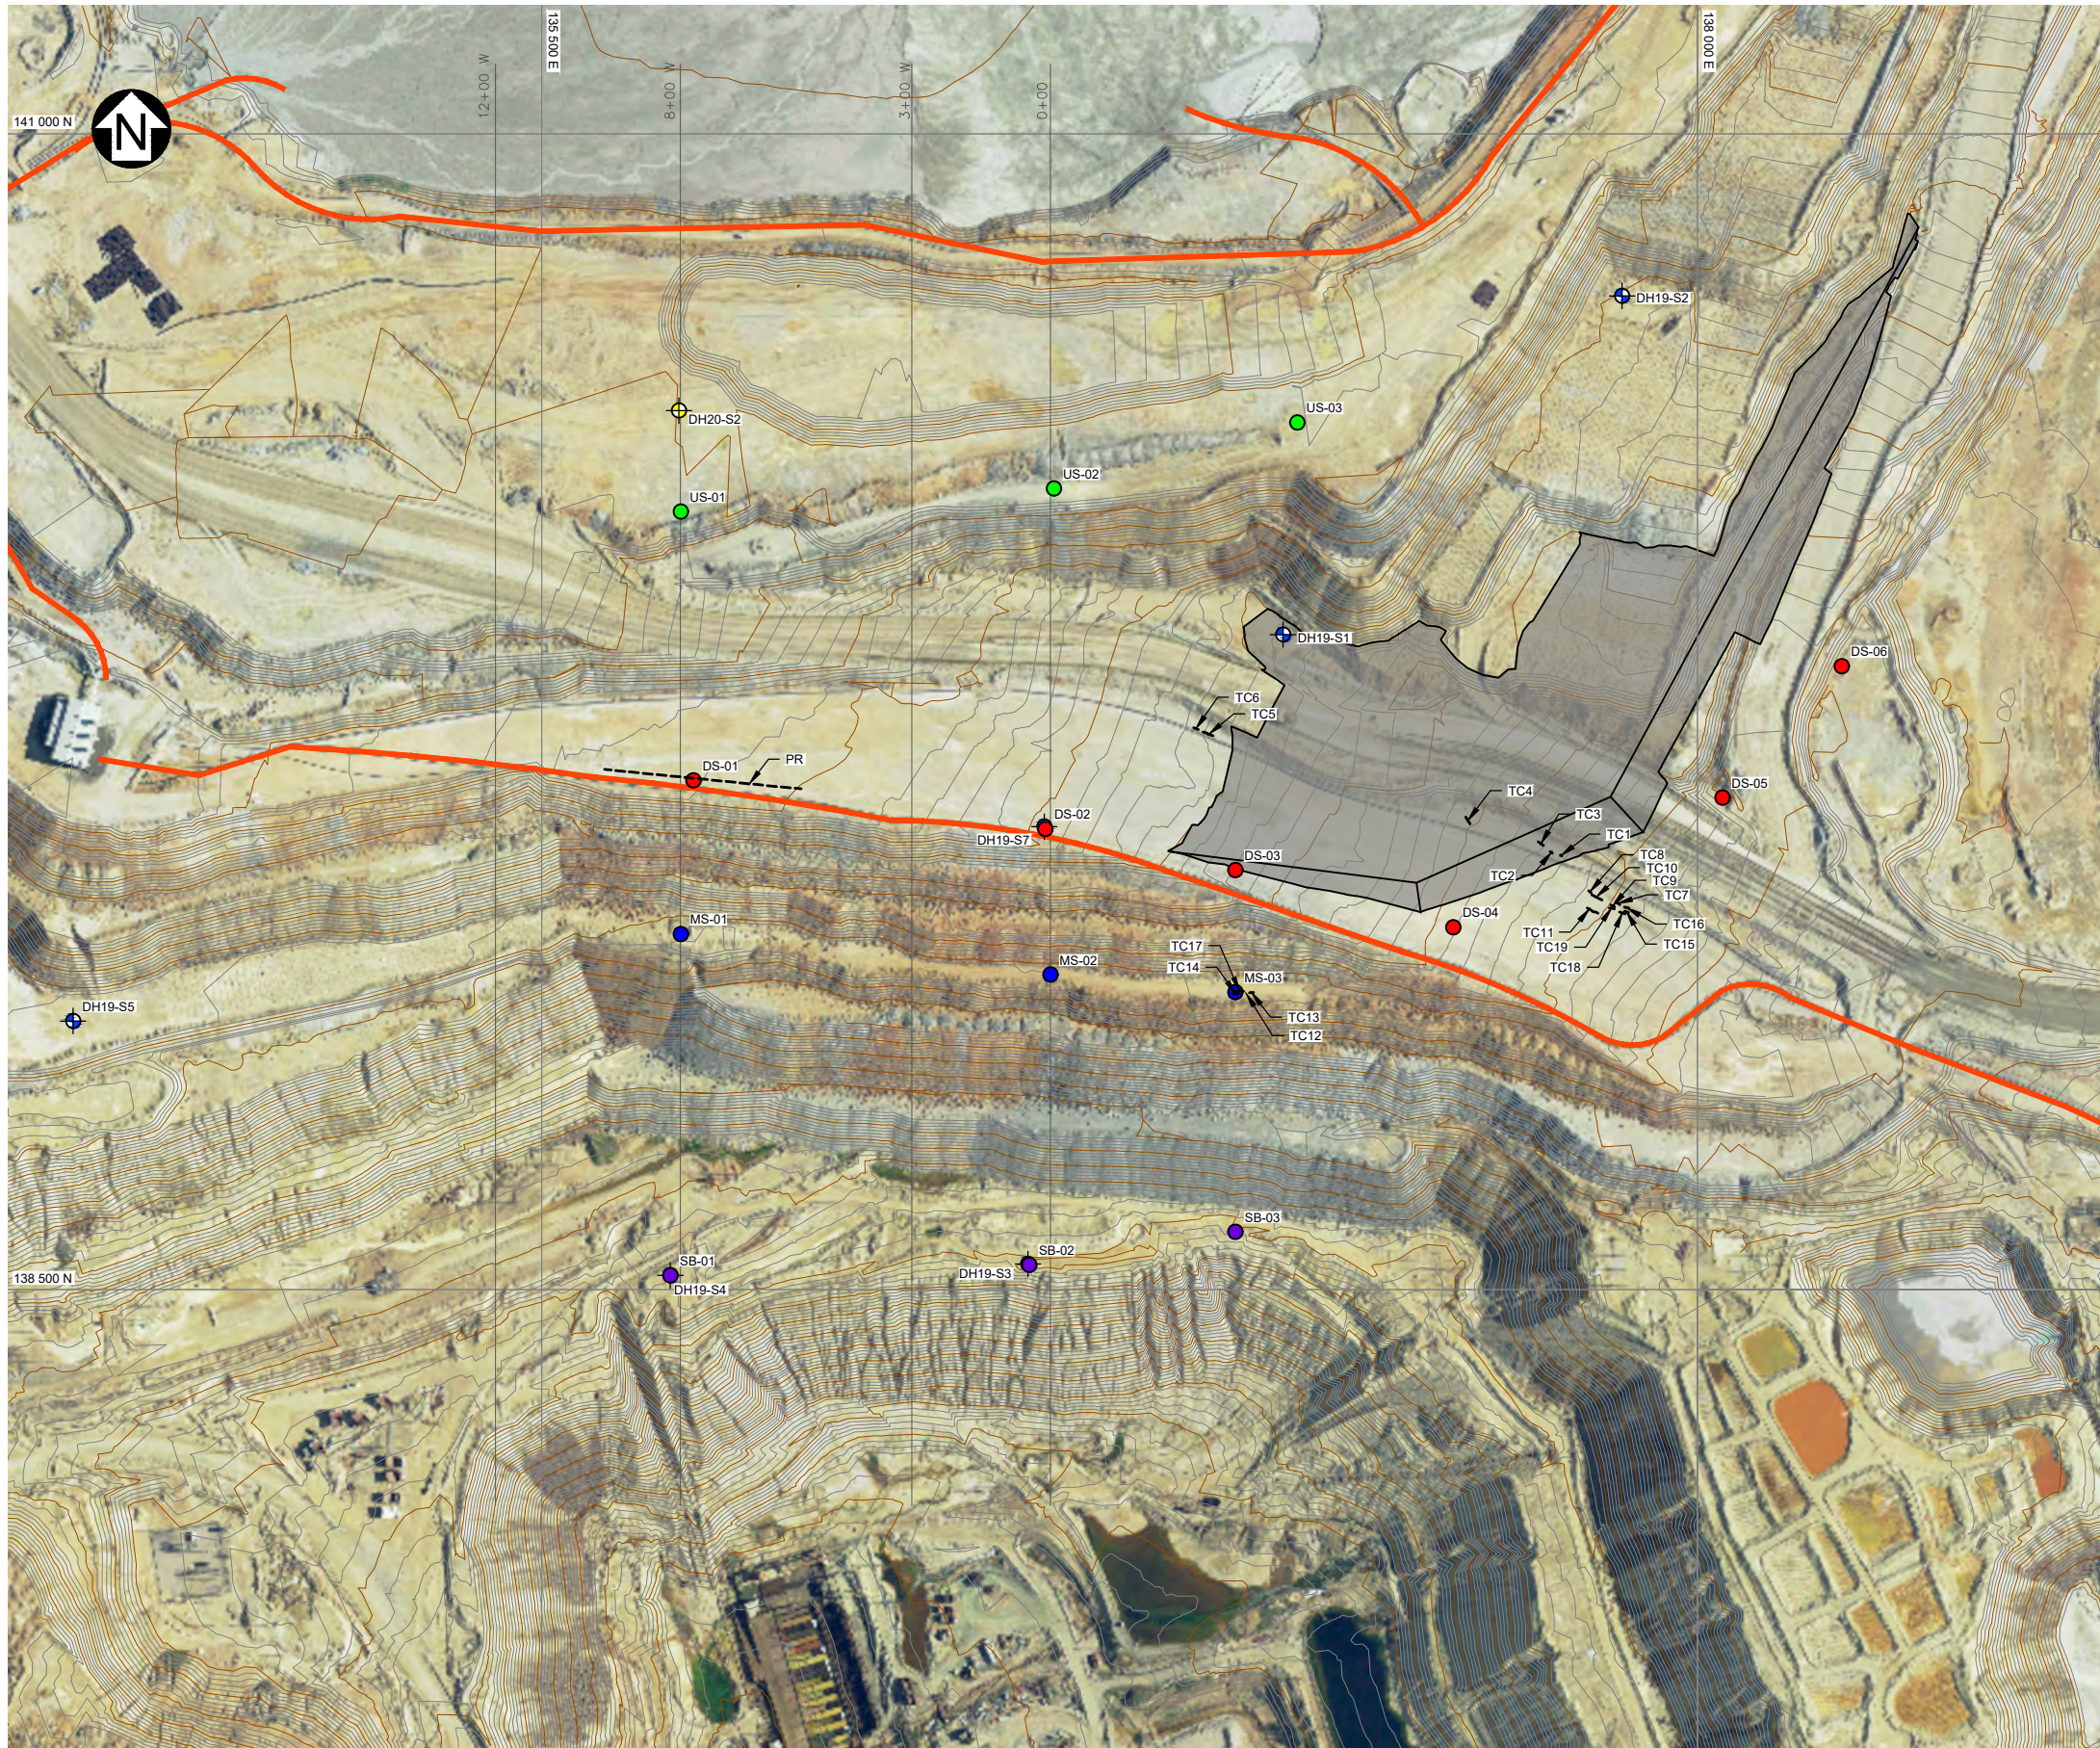
SAVED: M:\110100\126\05\AAAcara\FIGS\B15_9\24\2021 2:32:57 PM - RMCI LLELAN PRINTED: 10/5/2021 2:47:13 PM - FIG 1 - RMCI LLELAN
 REV: 0 05OCT21 ISSUED WITH LETTER SY3 RMM KTD
 REV DATE DESCRIPTION DESIGNED DRAWN REVIEWED

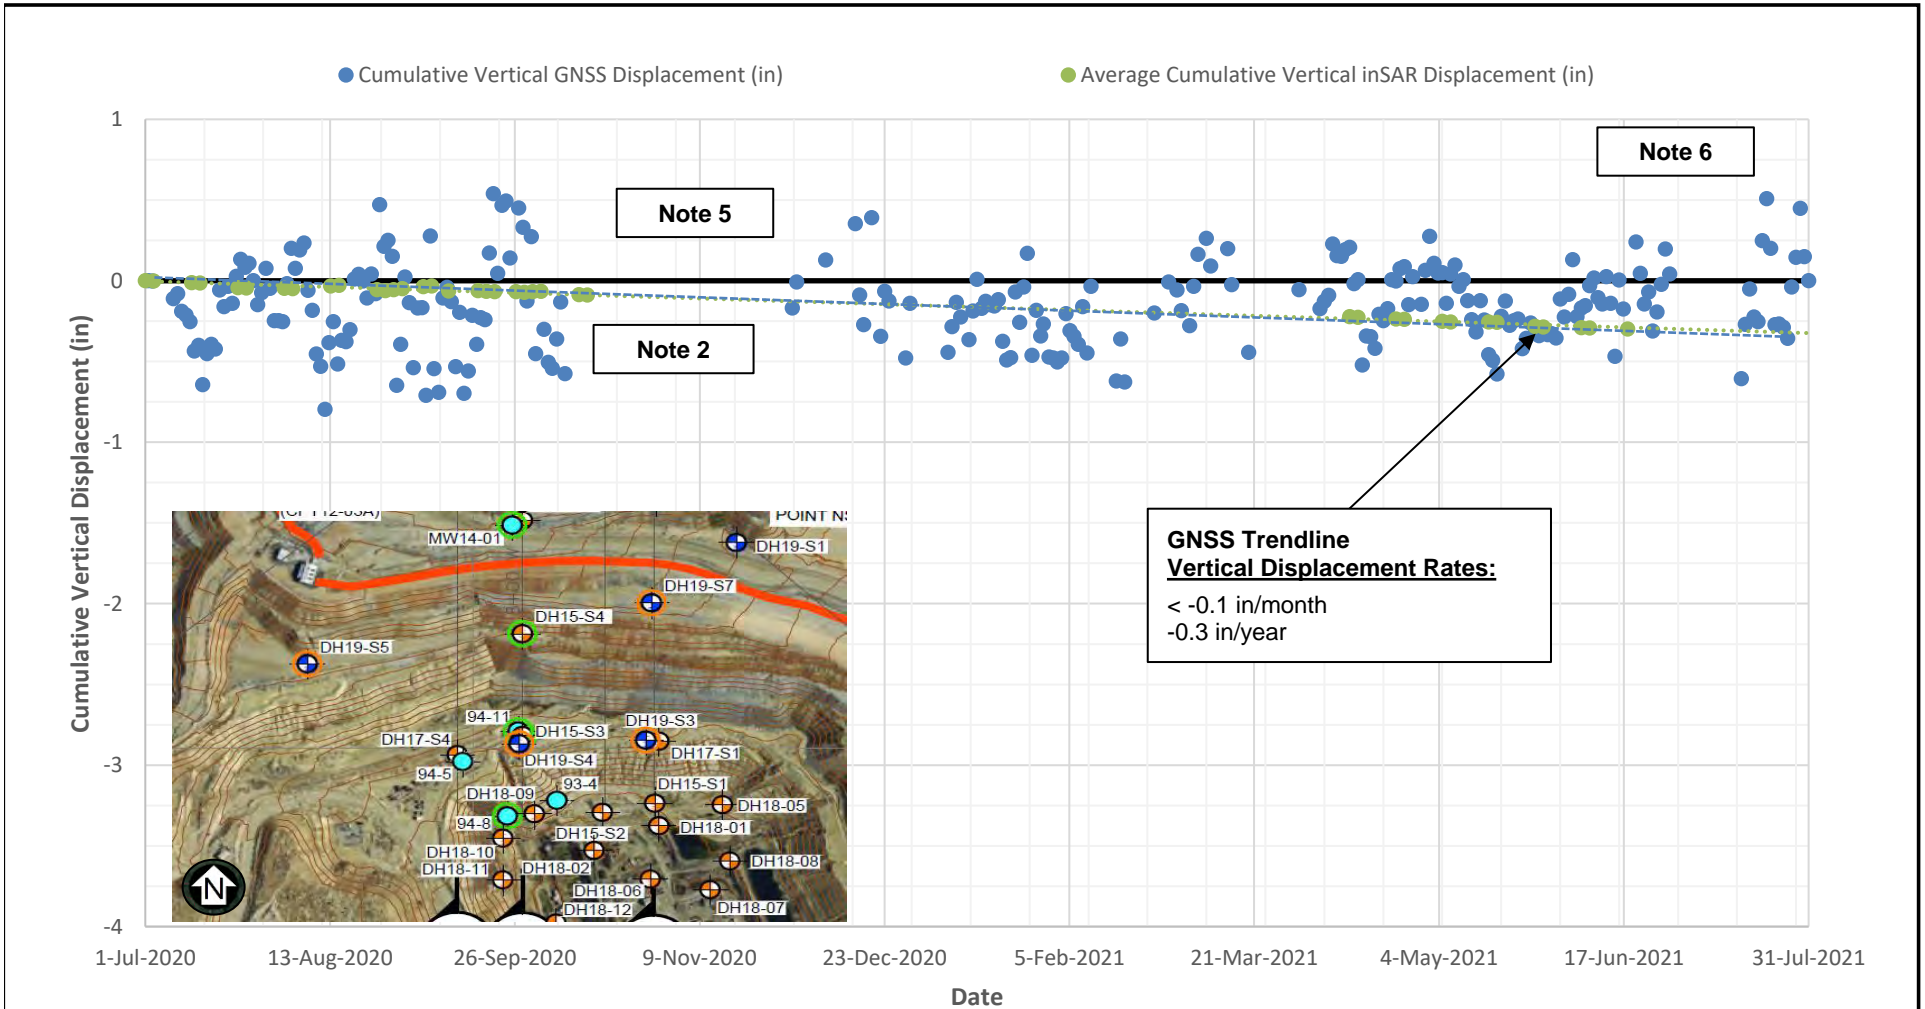
(Figures C2.1 to C2.8)

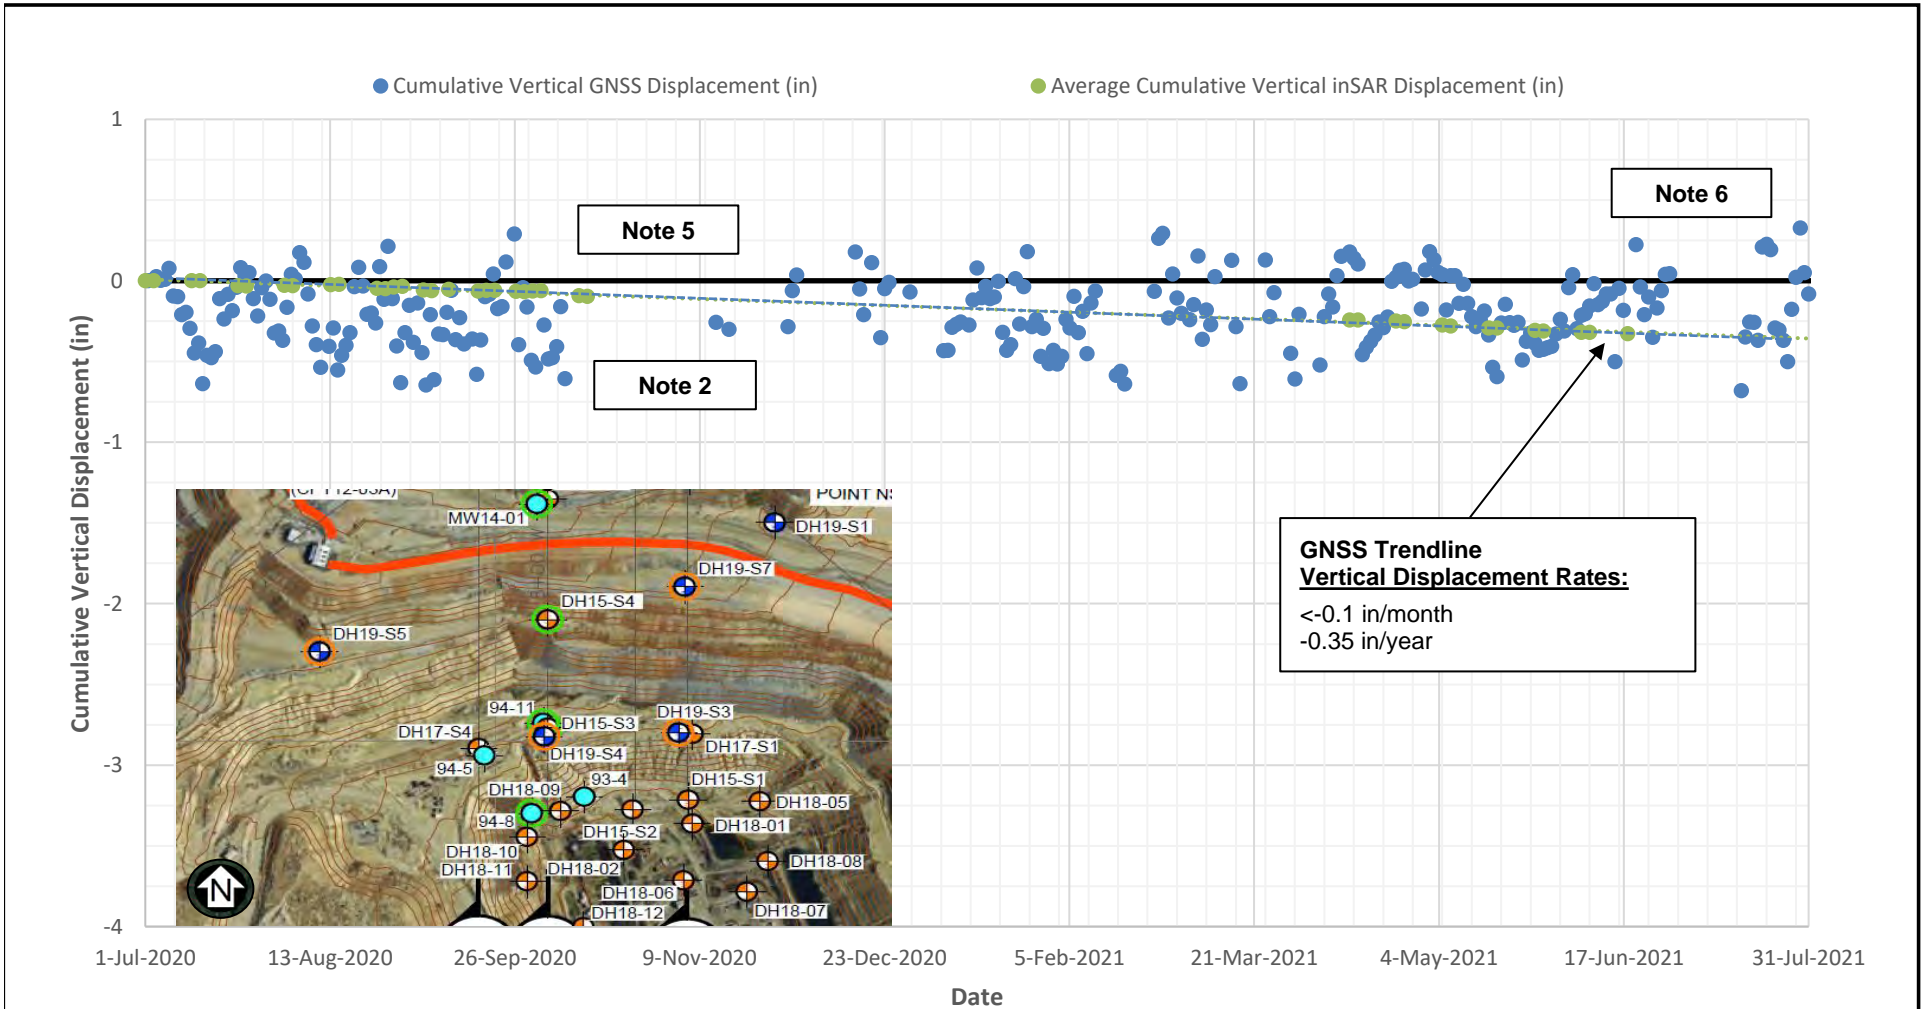
MONTANA RESOURCES LLP.		
YANKEE DOODLE TAILINGS IMPOUNDMENT		
CUMULATIVE VERTICAL & LATERAL DISPLACEMENTS MONITORED AT DH19-S3 (JULY 1, 2020 THROUGH JULY 31, 2021)		
	P/A NO. VA101-00126/25	REF. NO. VA21-01362
	FIGURE C2.2	
		REV 0

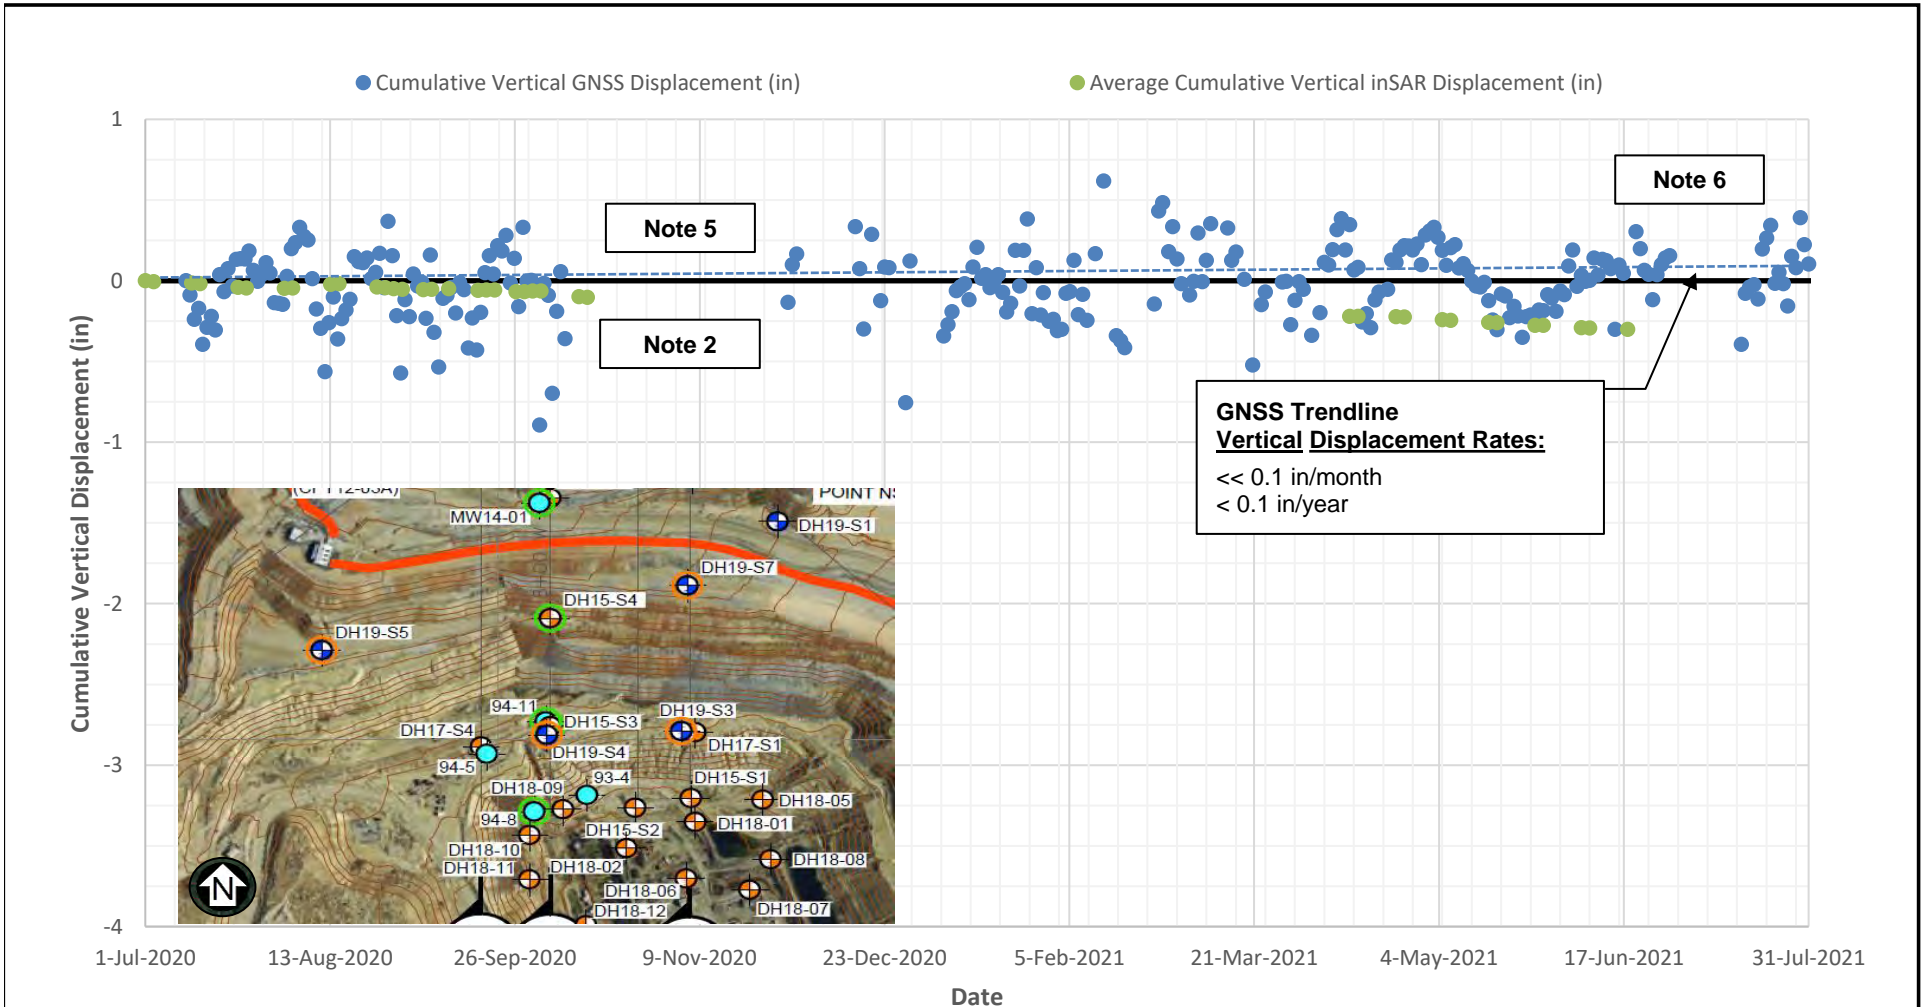
P/A NO. VA101-00126/25 REF. NO. VA21-01362
FIGURE C2.4	
REV 0

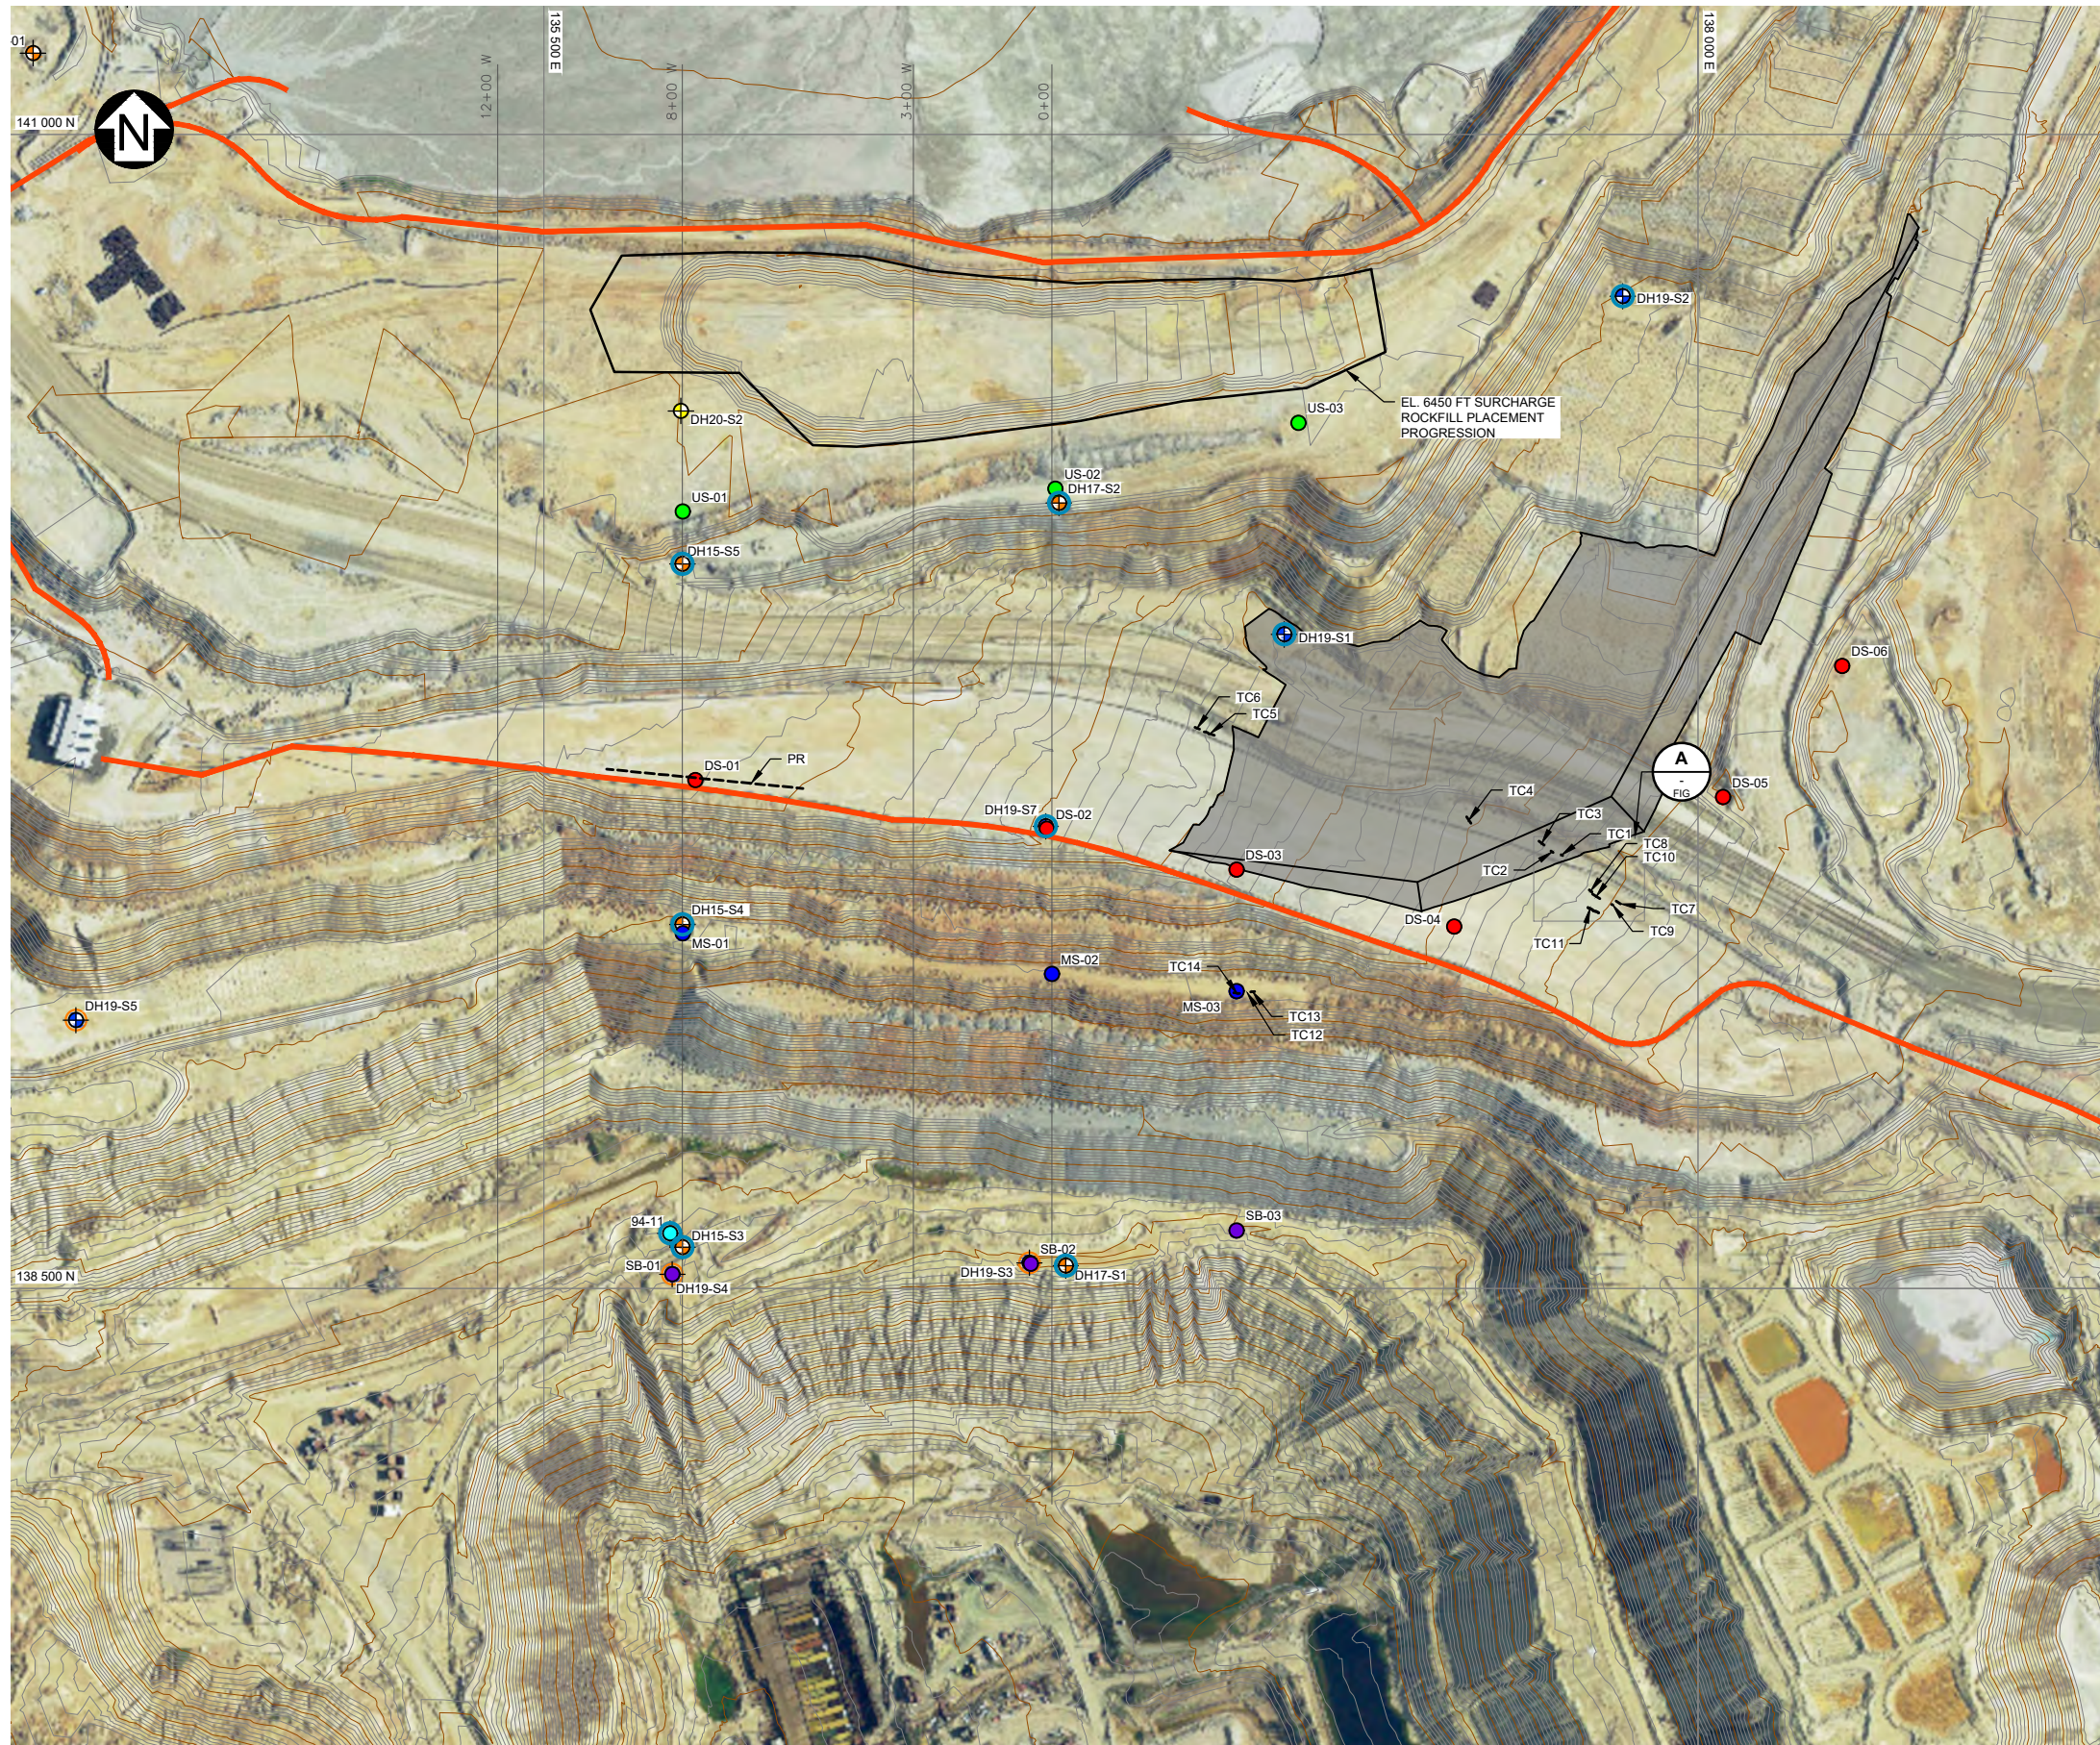
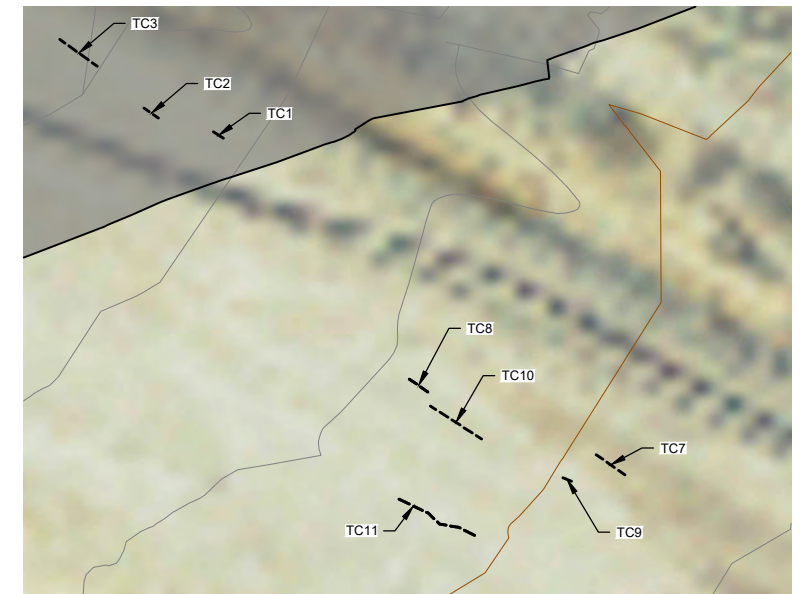
A **DETAIL**
SCALE B

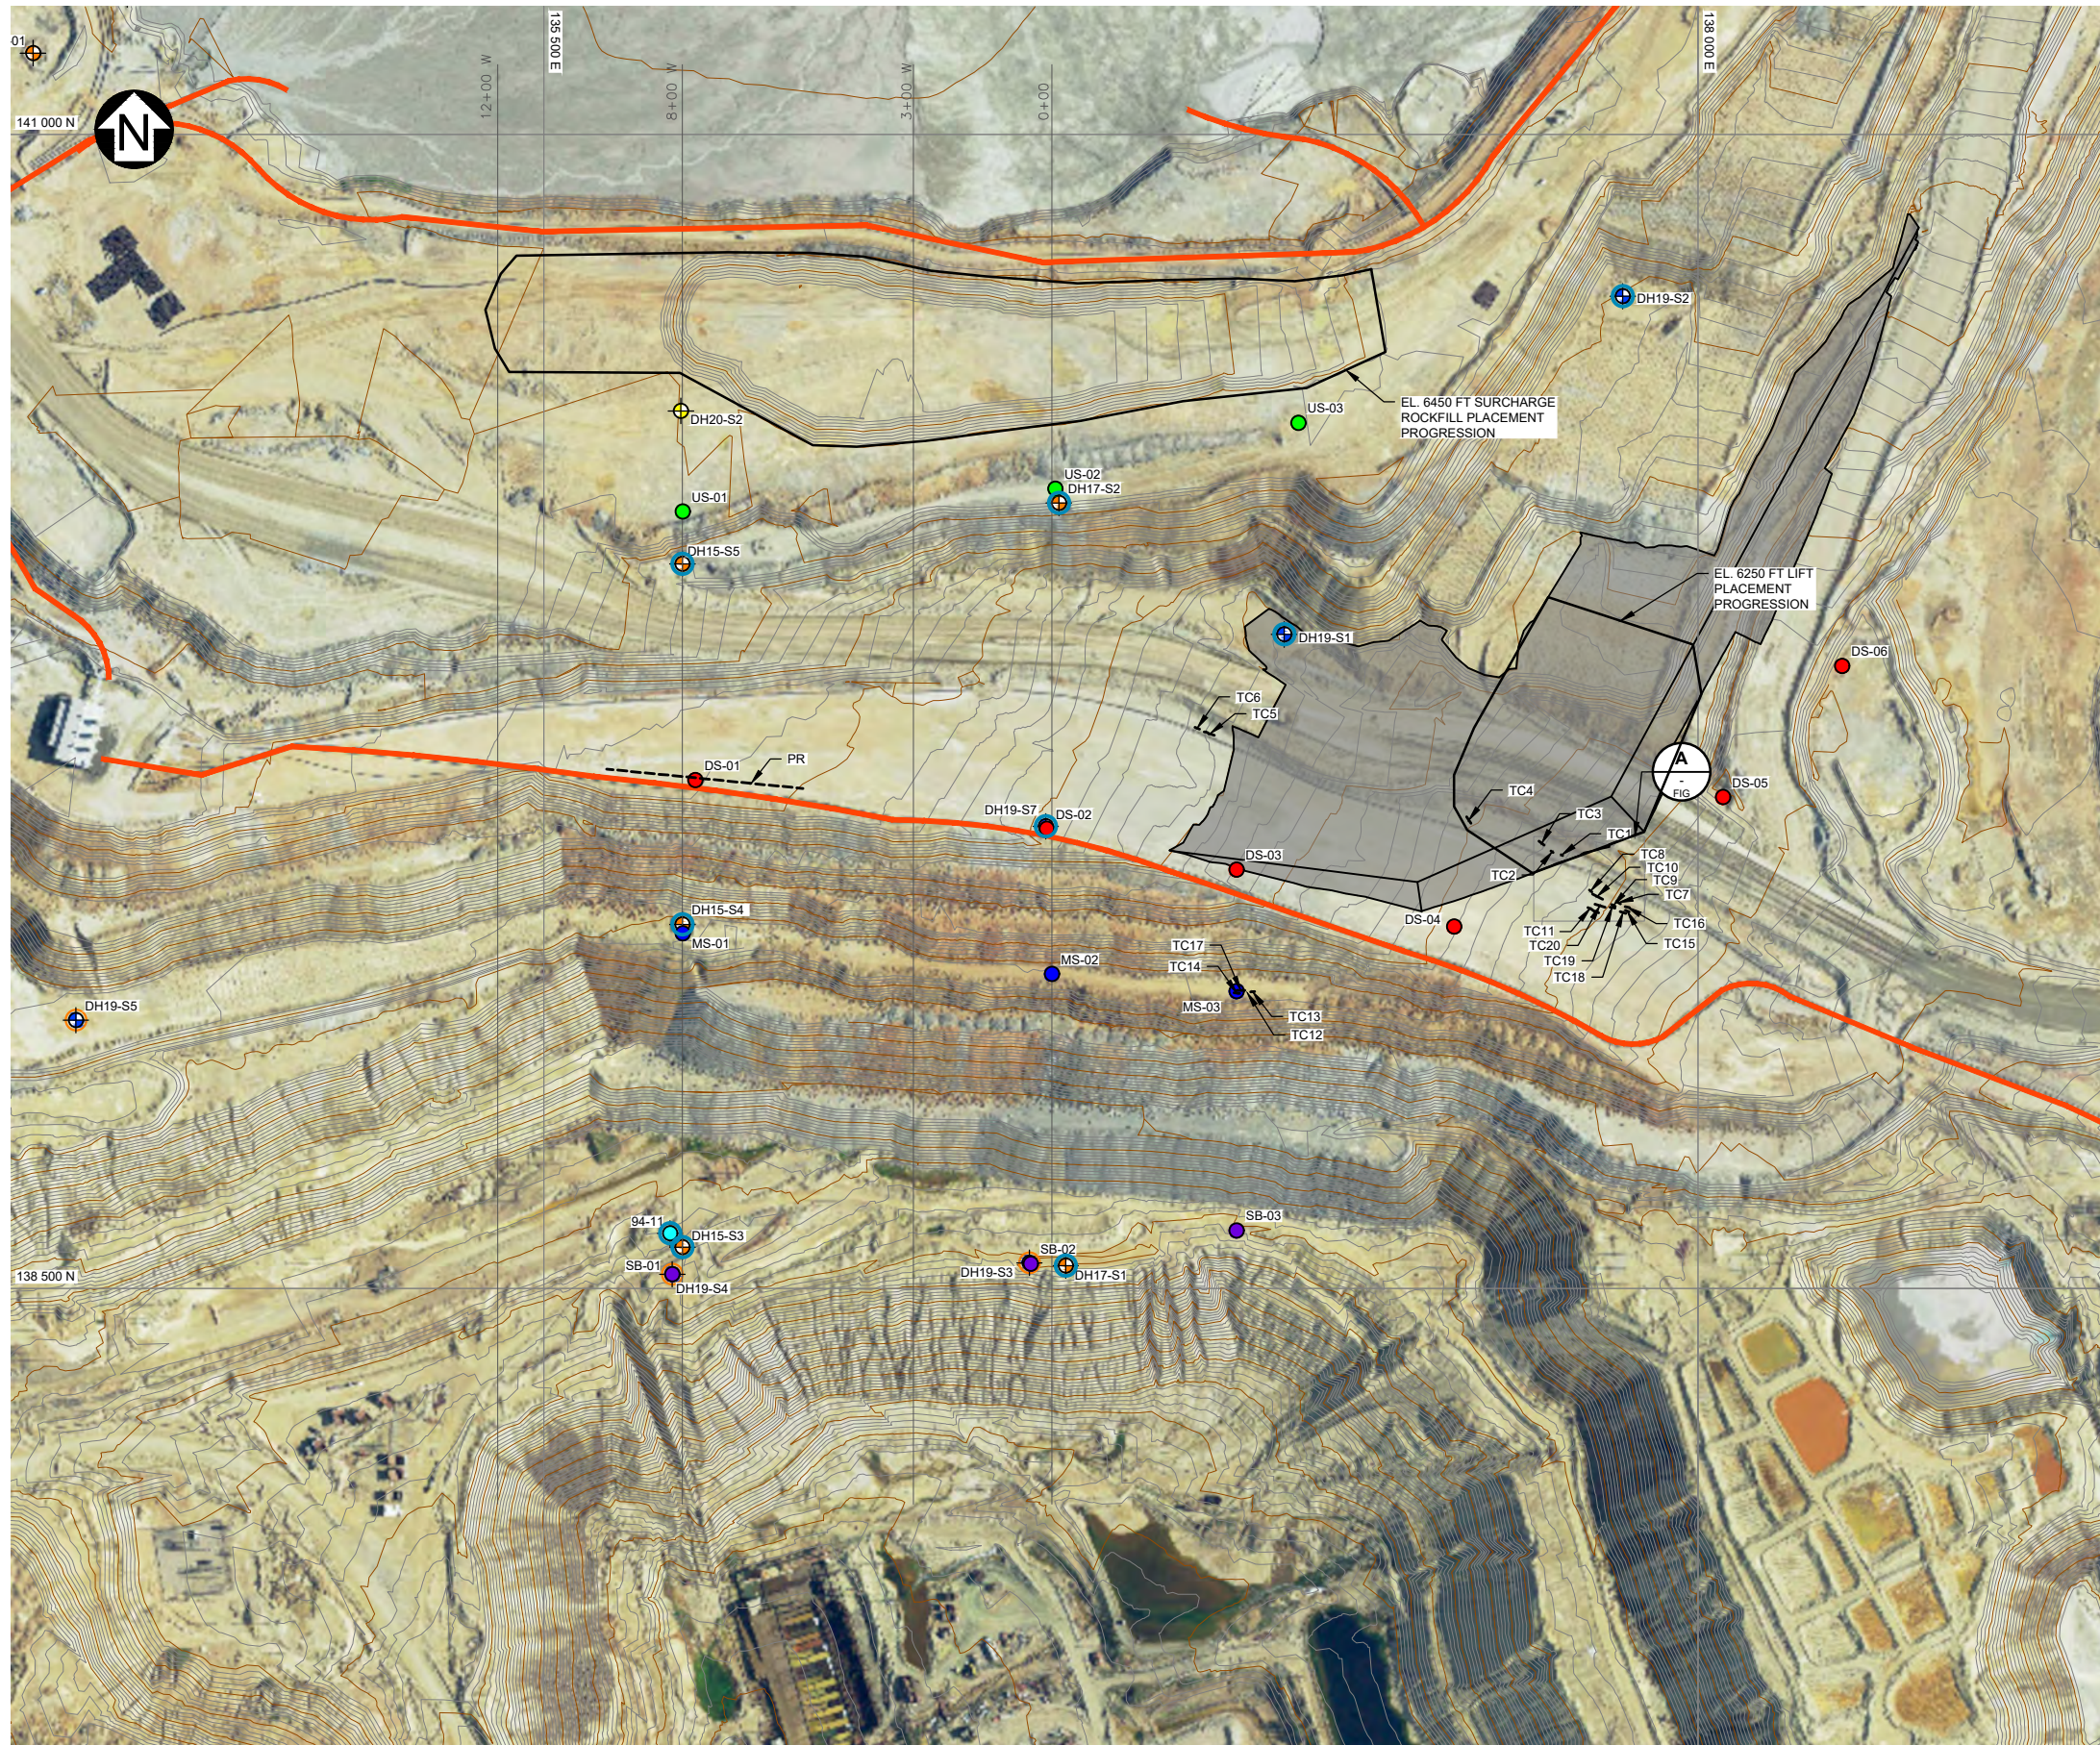
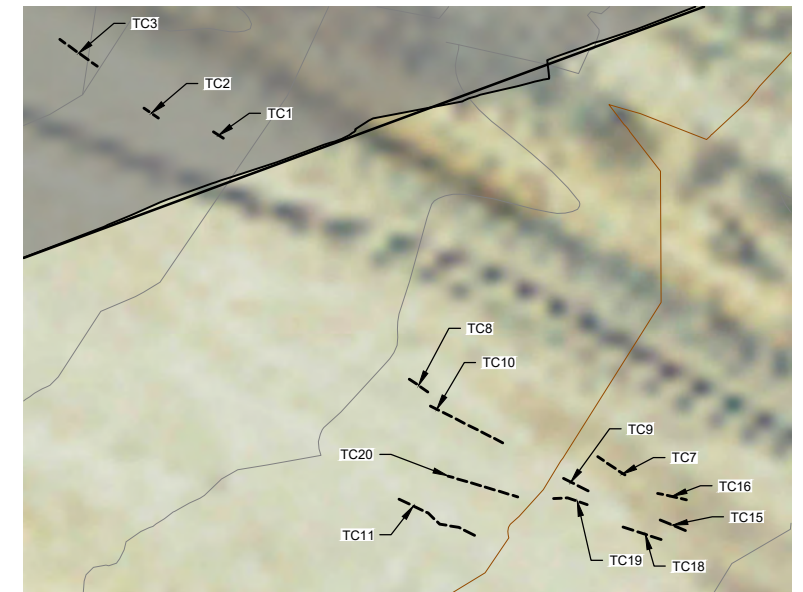
A **DETAIL**
SCALE B
FIG.

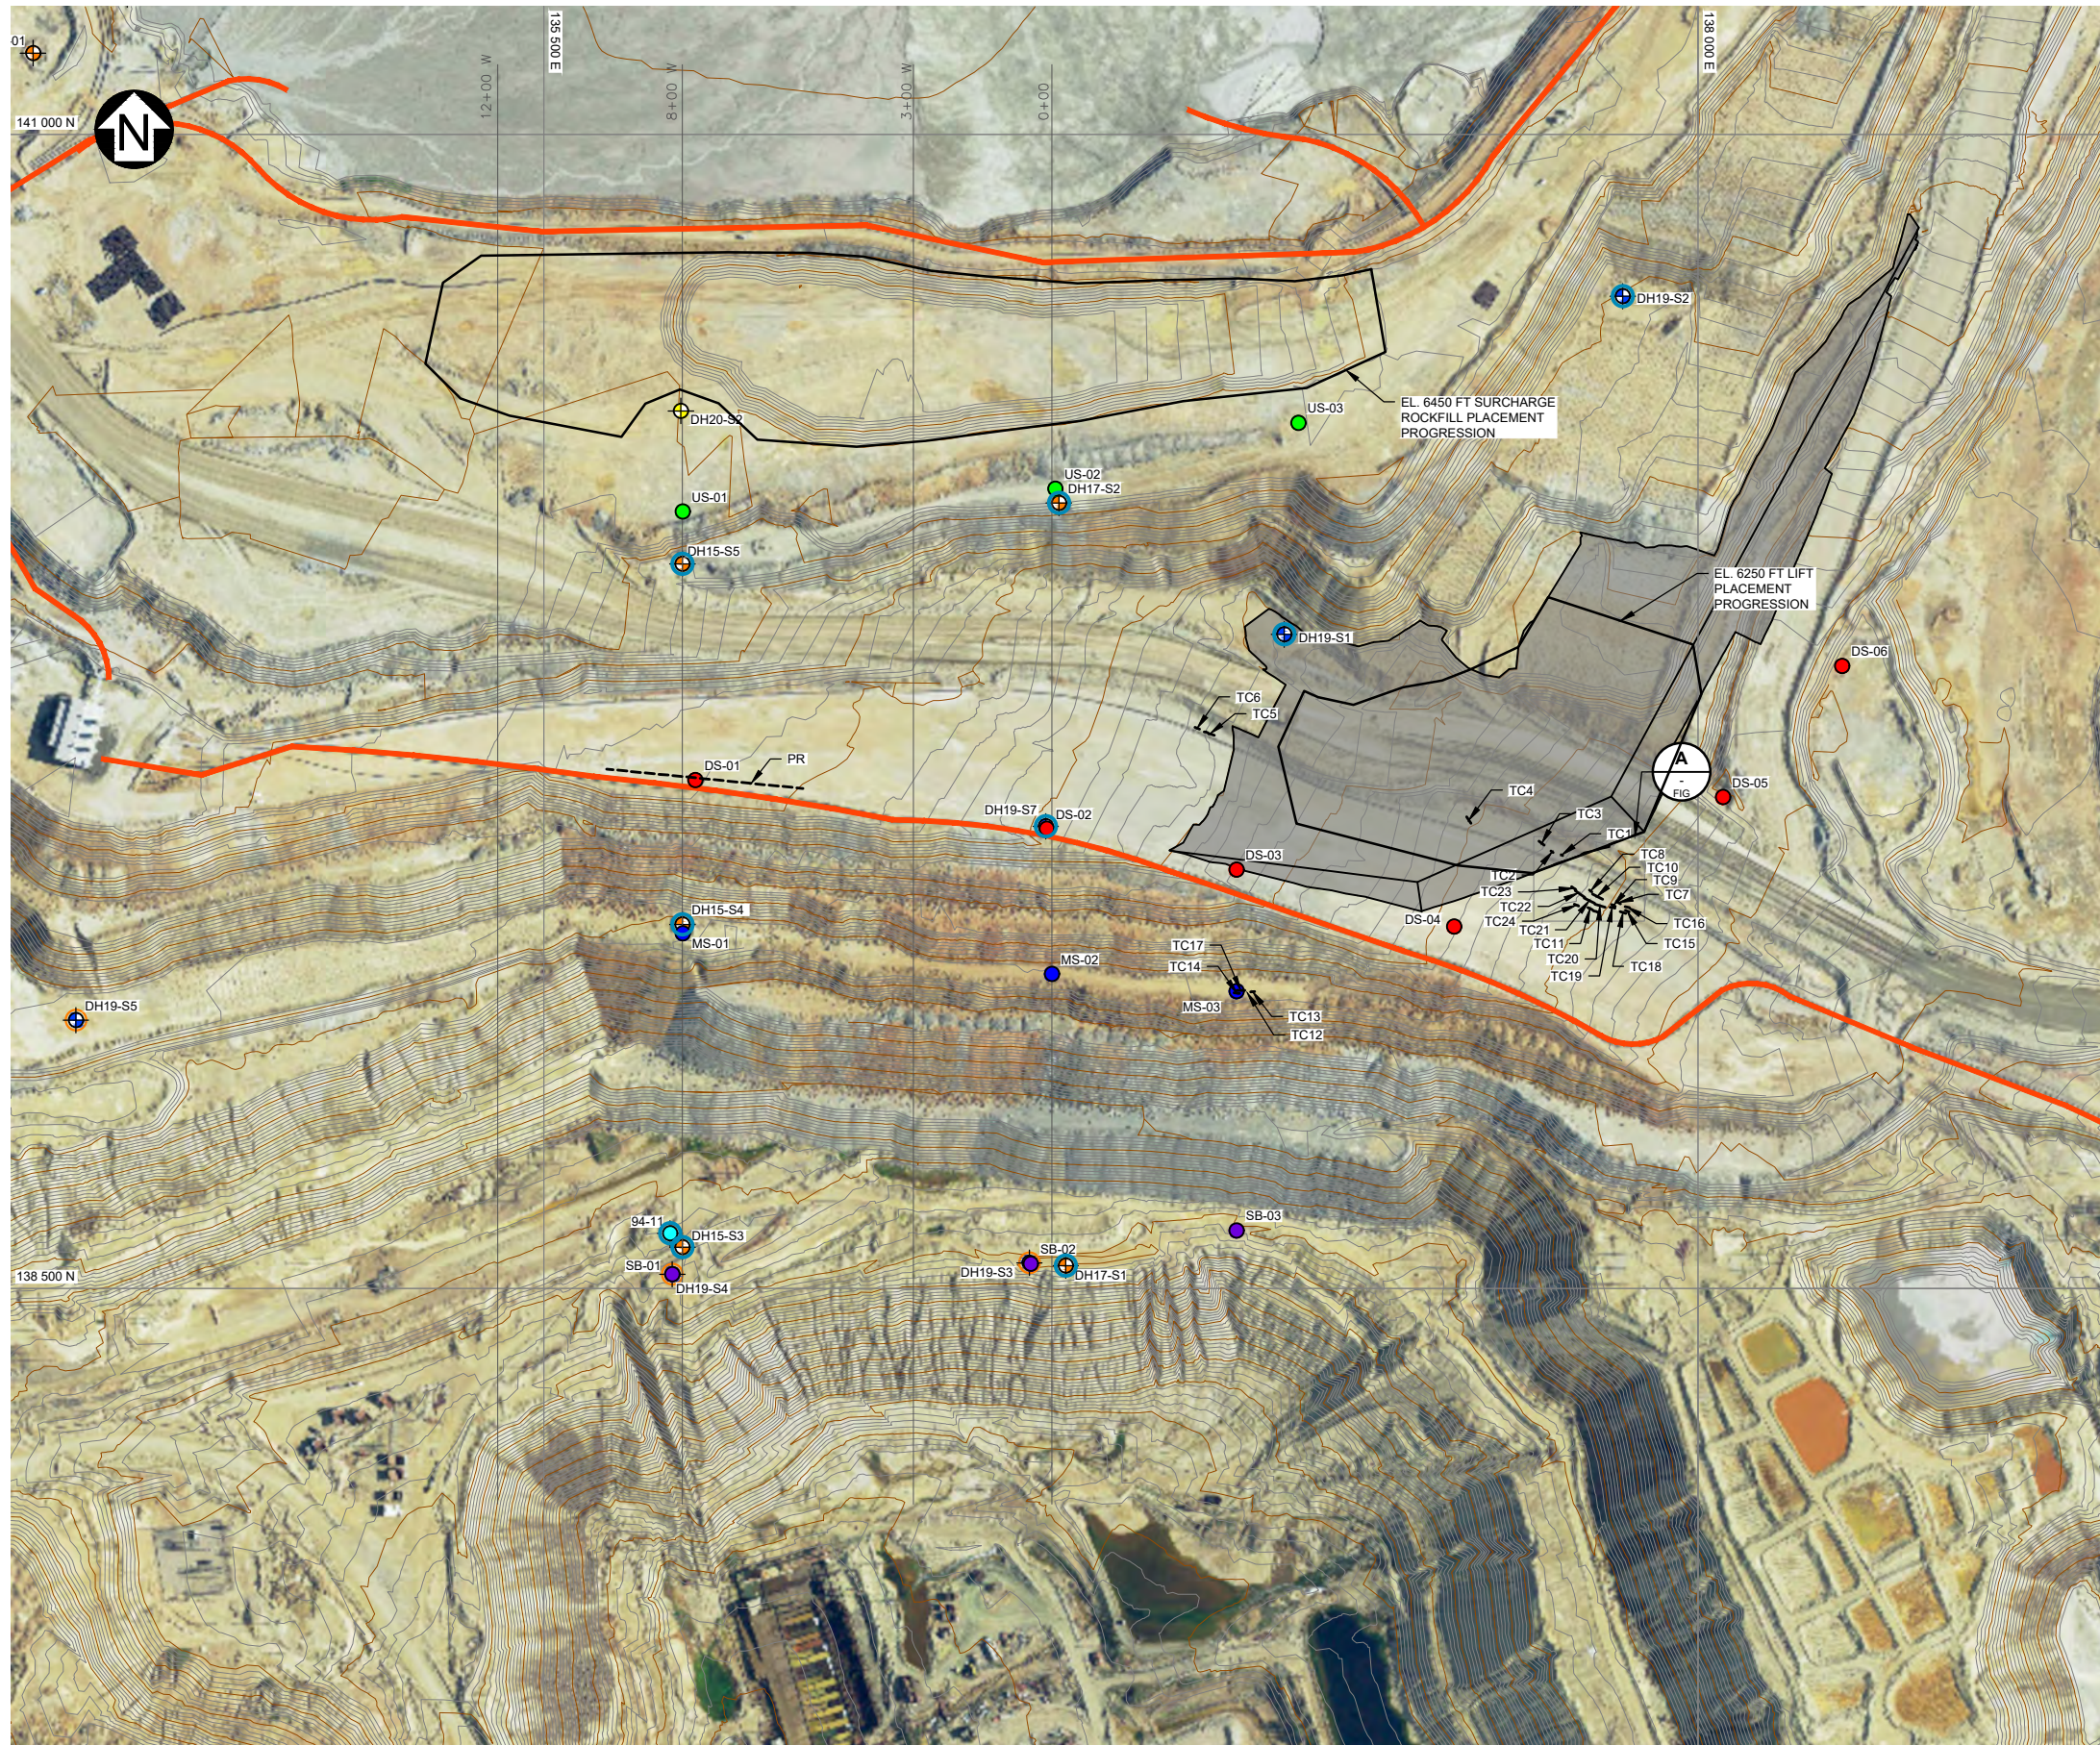
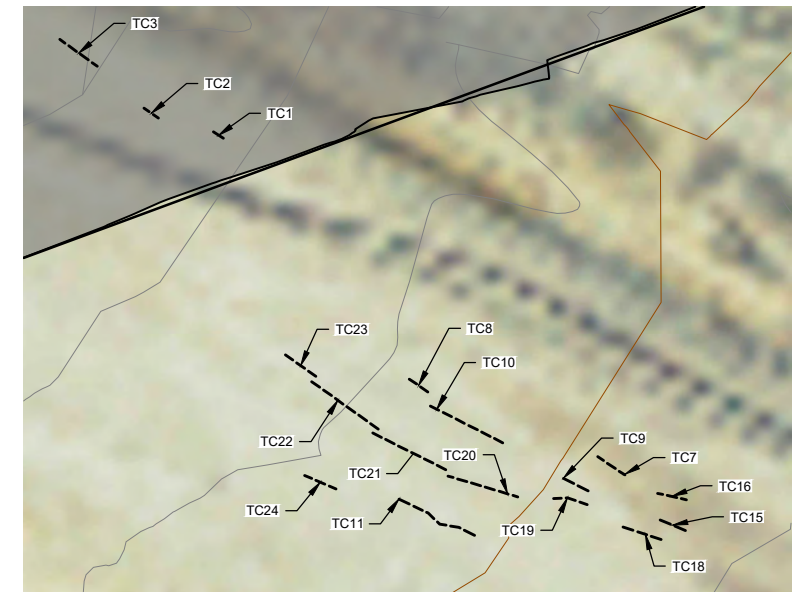
A **DETAIL**
SCALE B
