Prepared for
Montana Resources, LLP
600 Shields Avenue
Butte, Montana
USA, 59701

Prepared by
Knight Piésold Ltd.
Suite 1400 - 750 West Pender Street
Vancouver, British Columbia
Canada, V6C 2T8

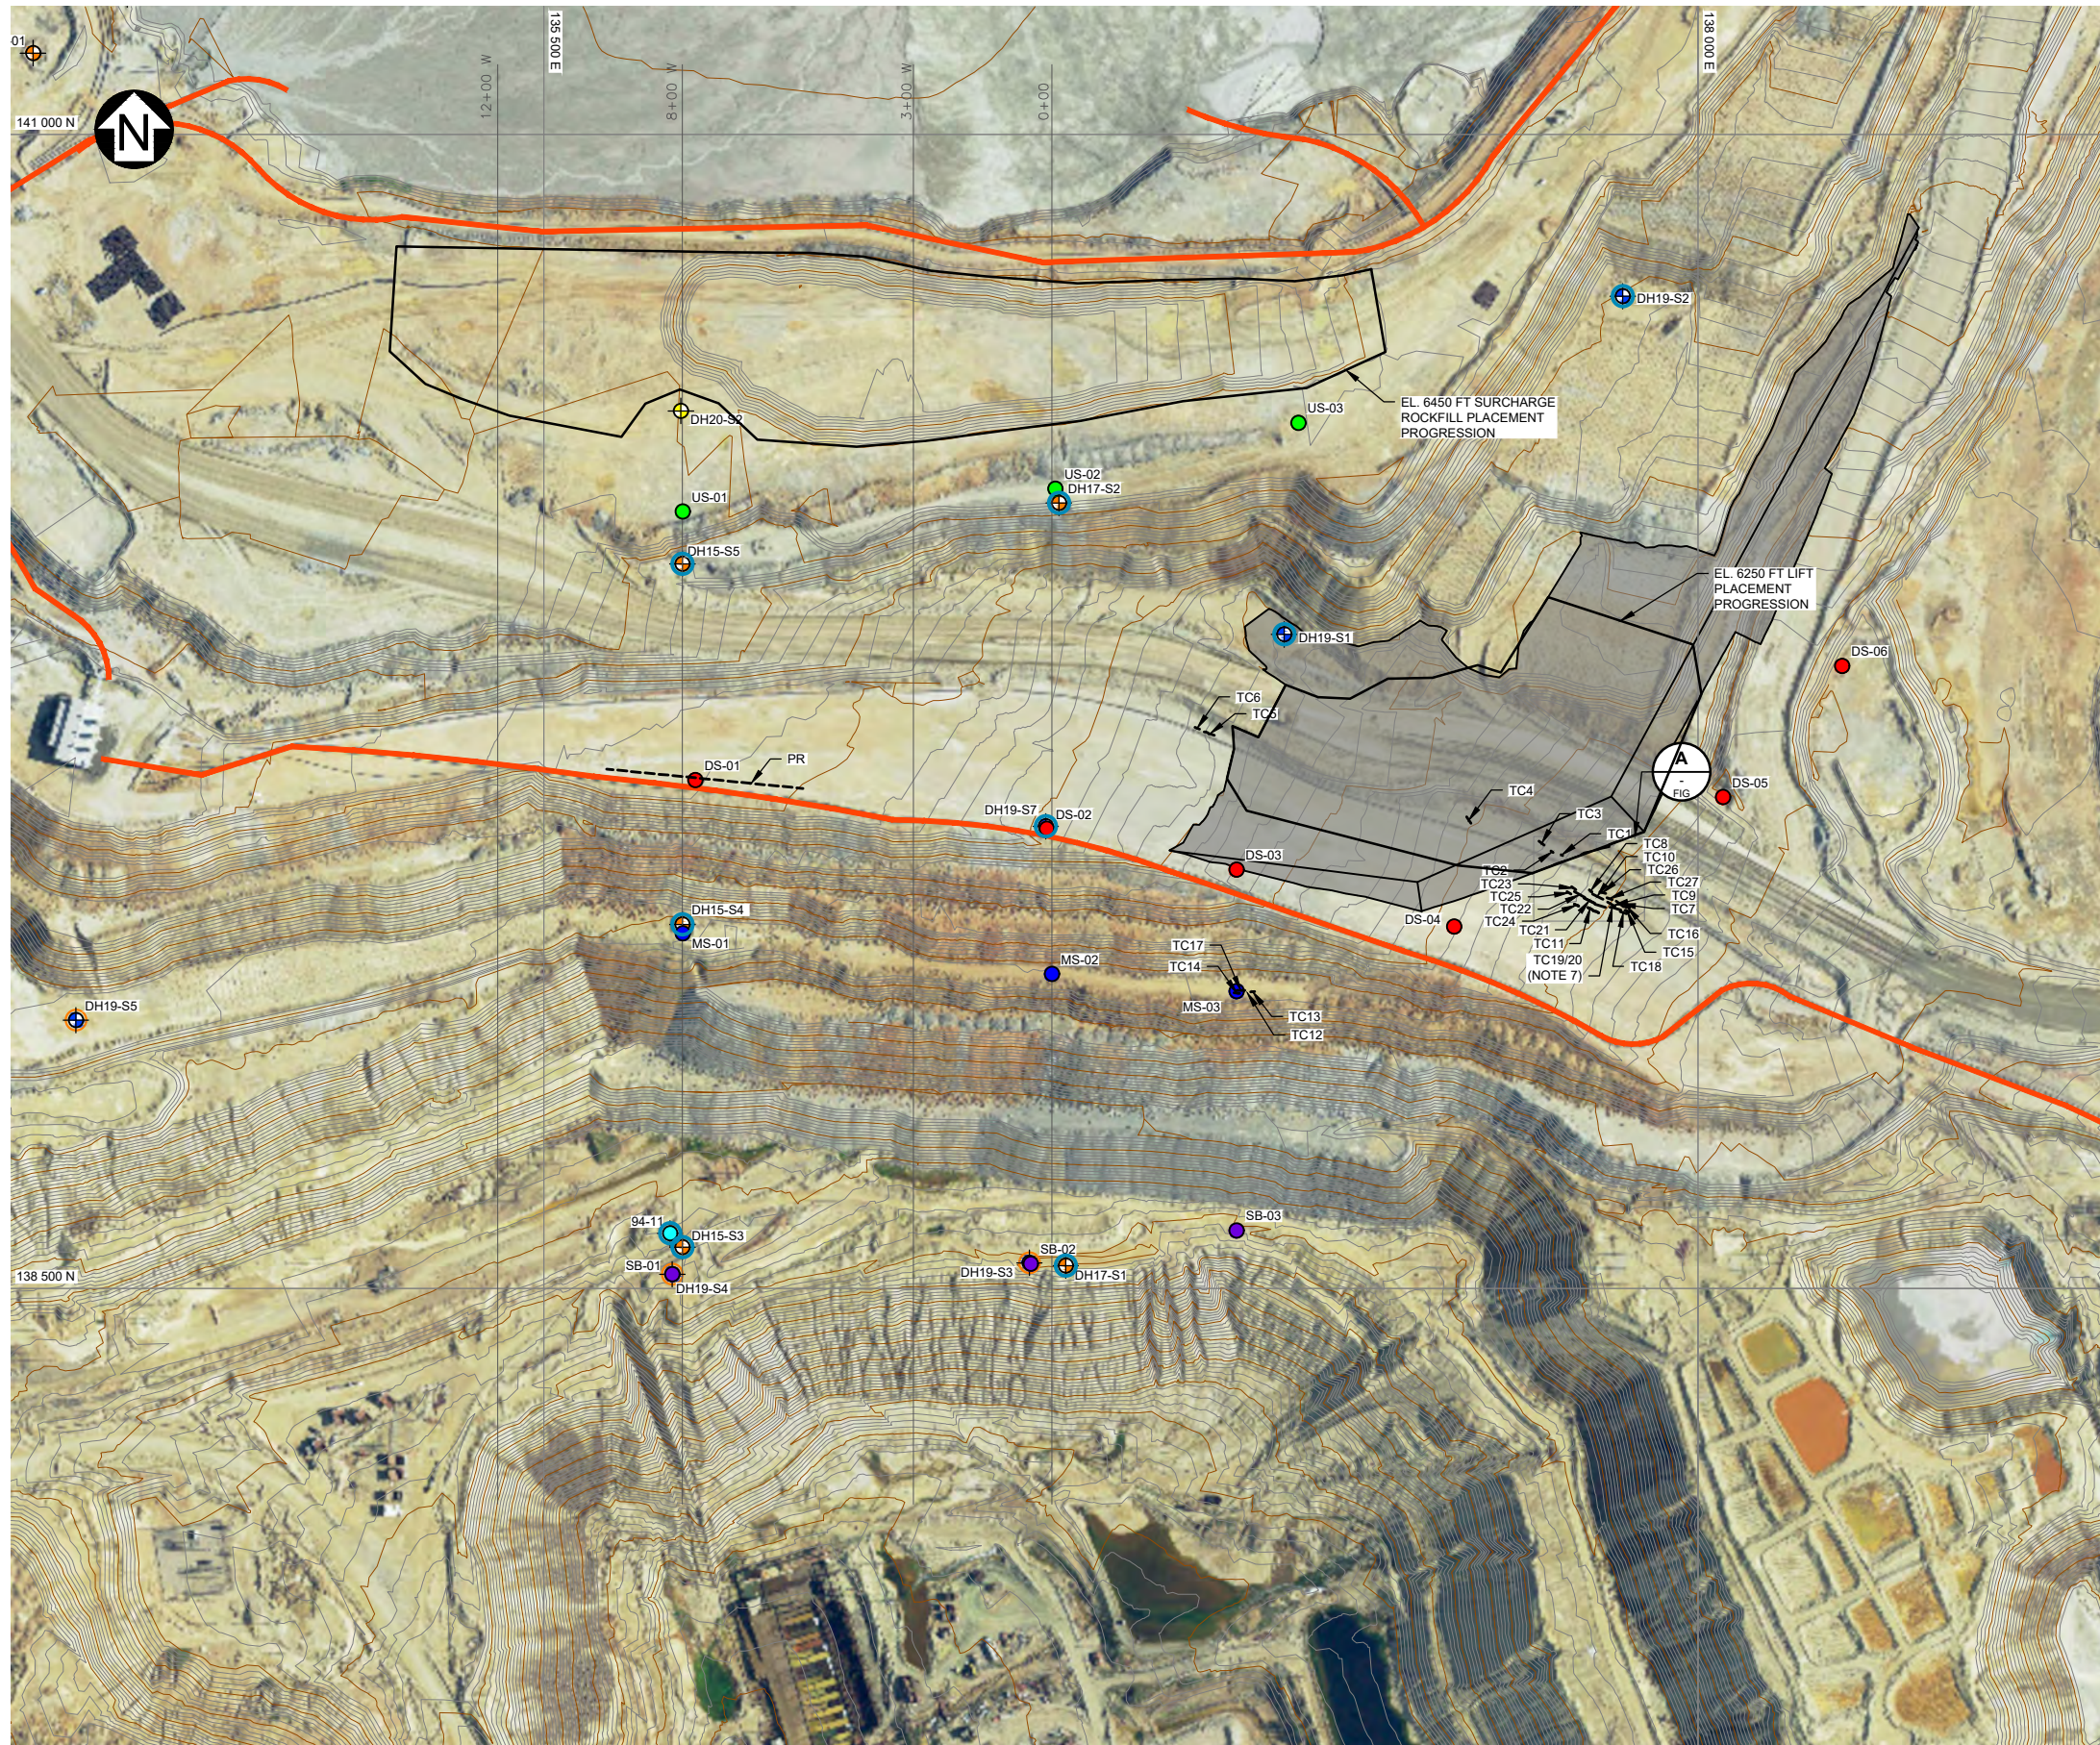
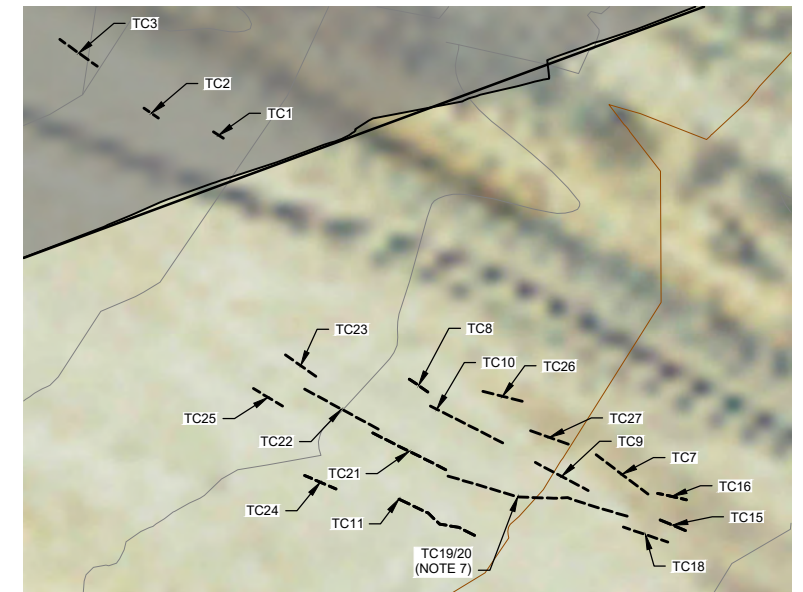
A **DETAIL**
SCALE B

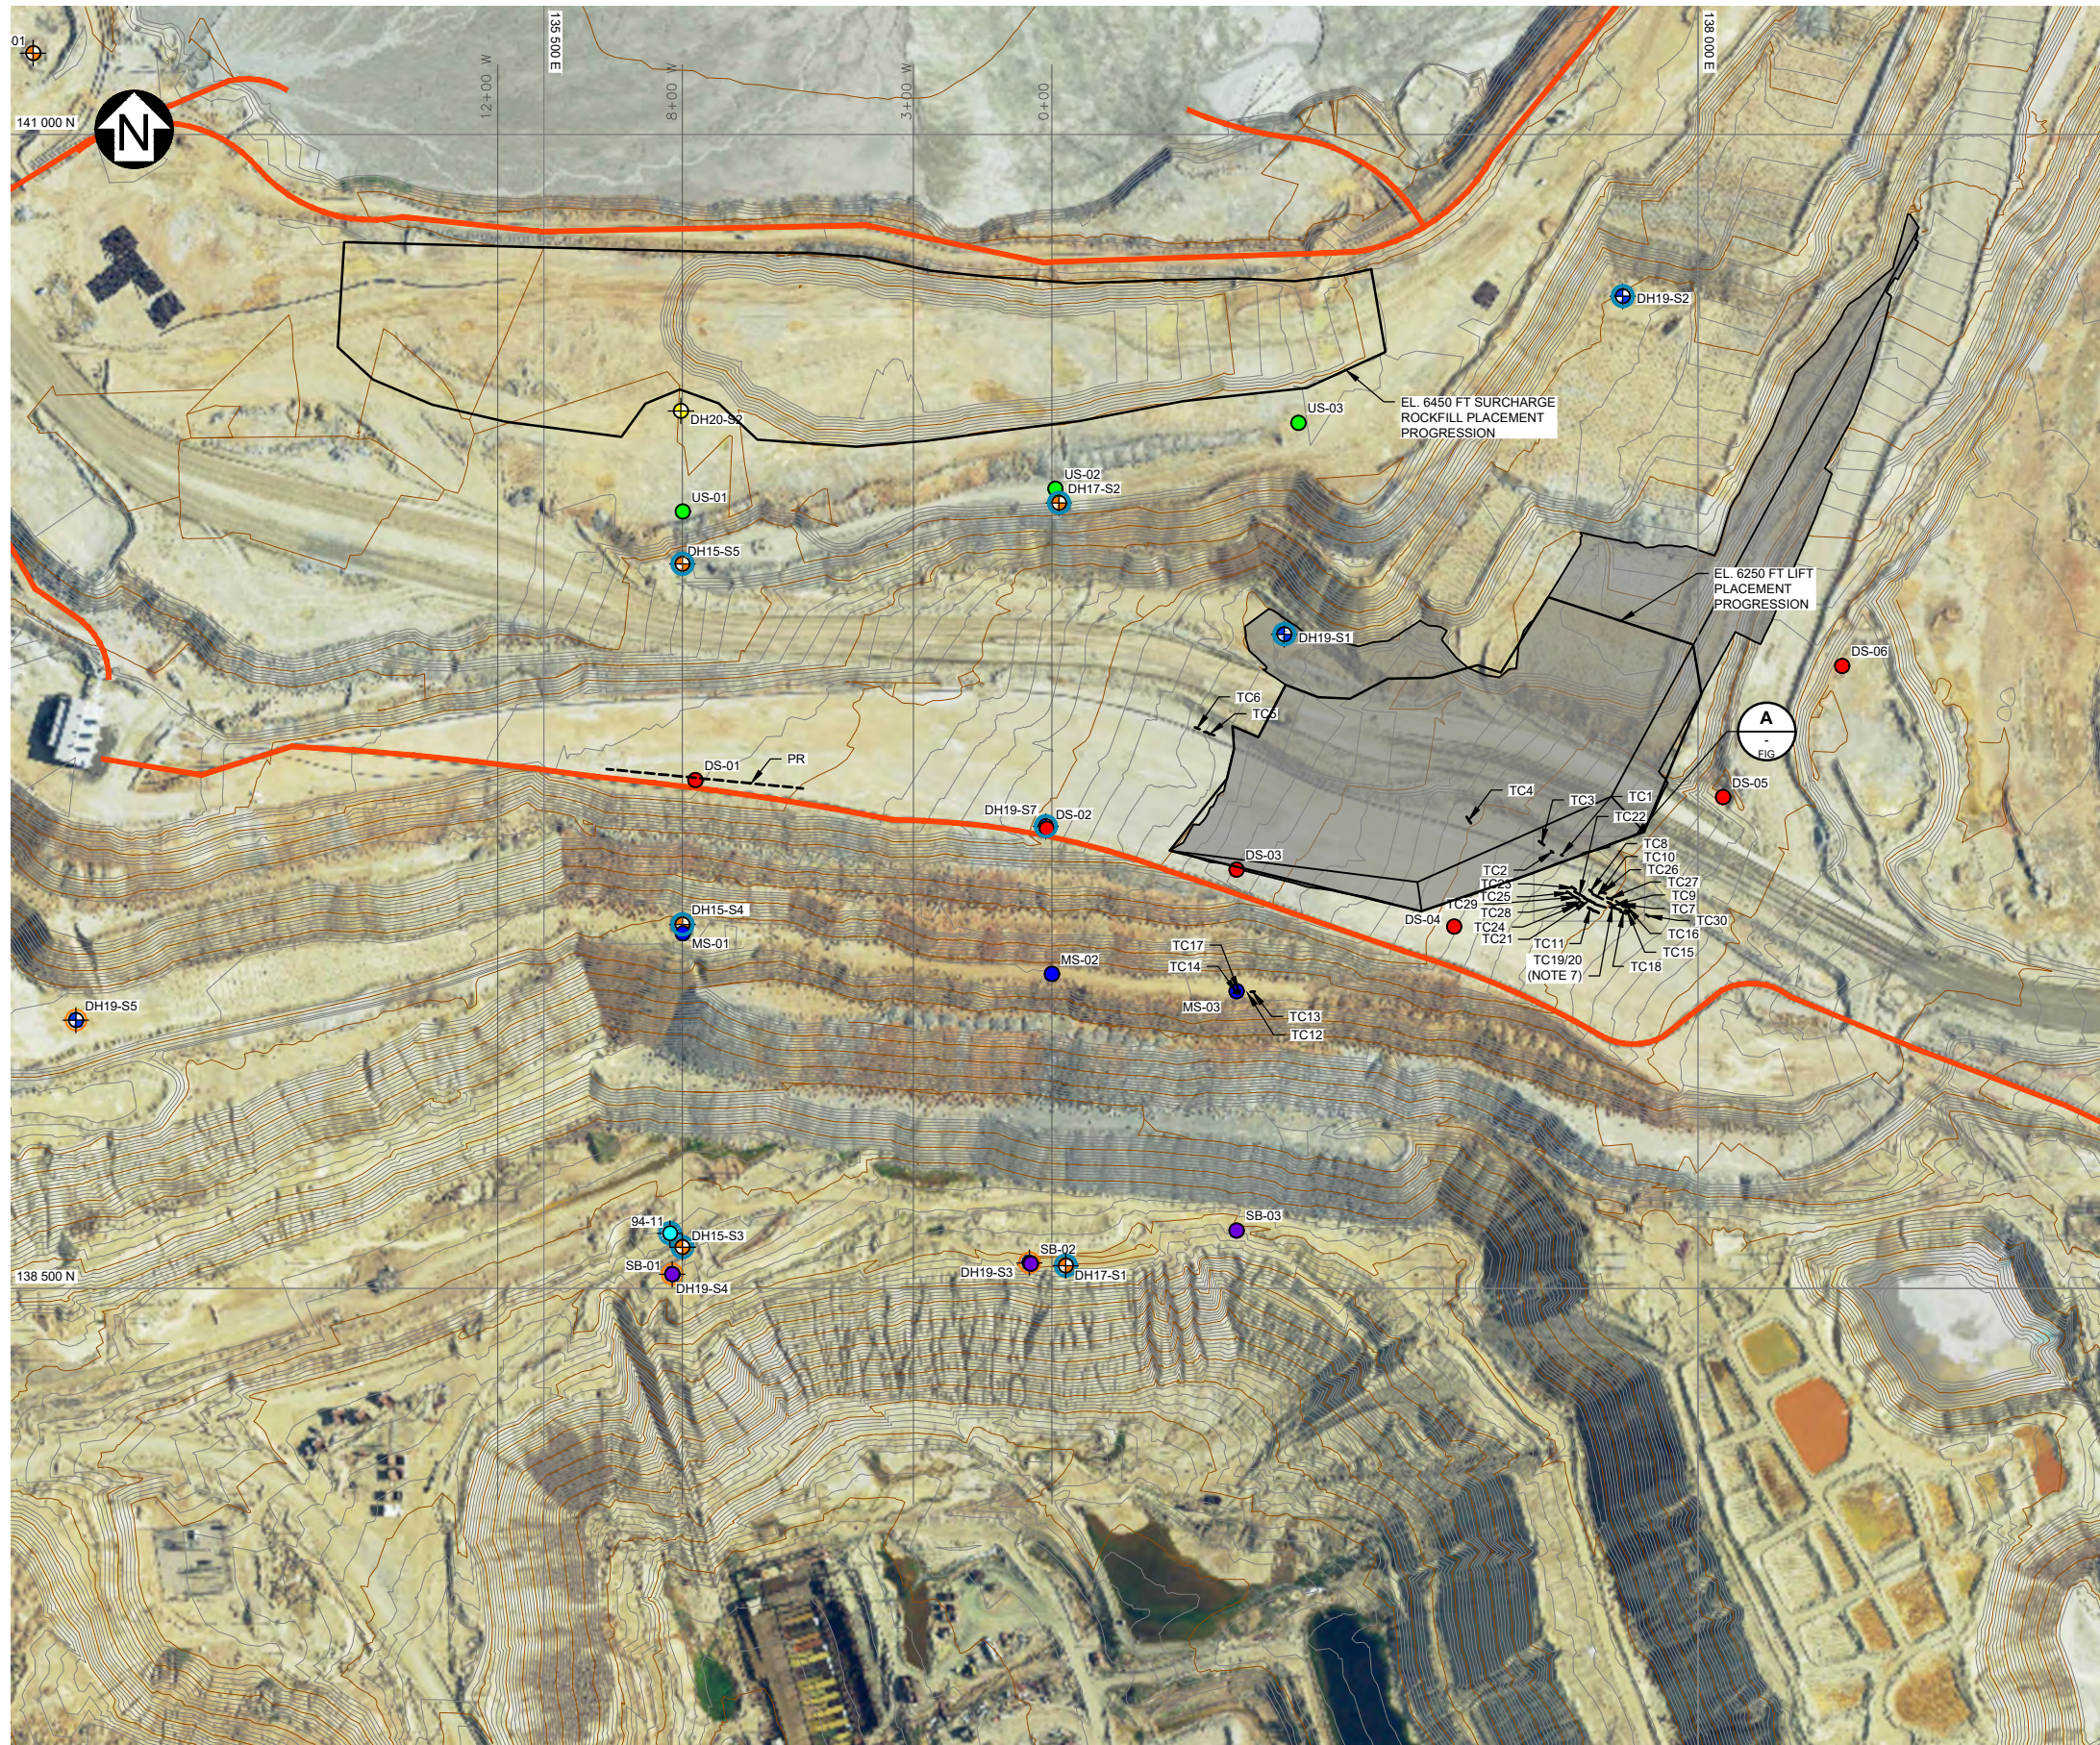
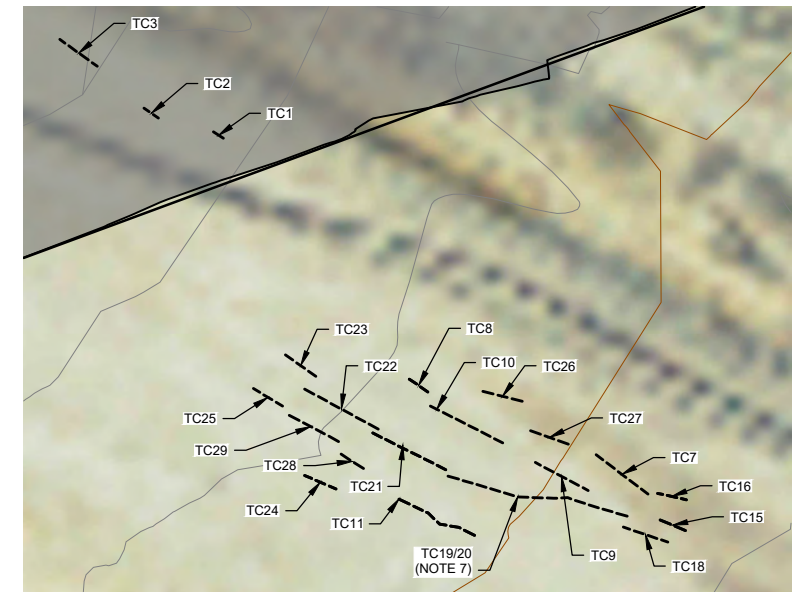
A **DETAIL**
SCALE B
FIG.

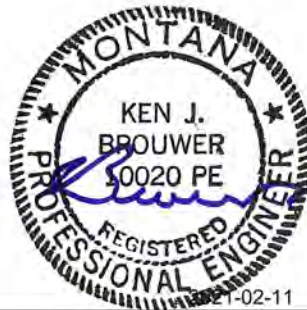
I have reviewed and verify that the corrective actions proposed by MR should reasonably be expected to effectively address the recommendations contained in the 2020 Annual Inspection Report.
