May 23, 2024

RE: Q1 2024 – YDTI Quarterly Tailings and Water Management Summary

Q1 2024 – YDTI QUARTERLY WATER DATA SUMMARY PHOTO LOG

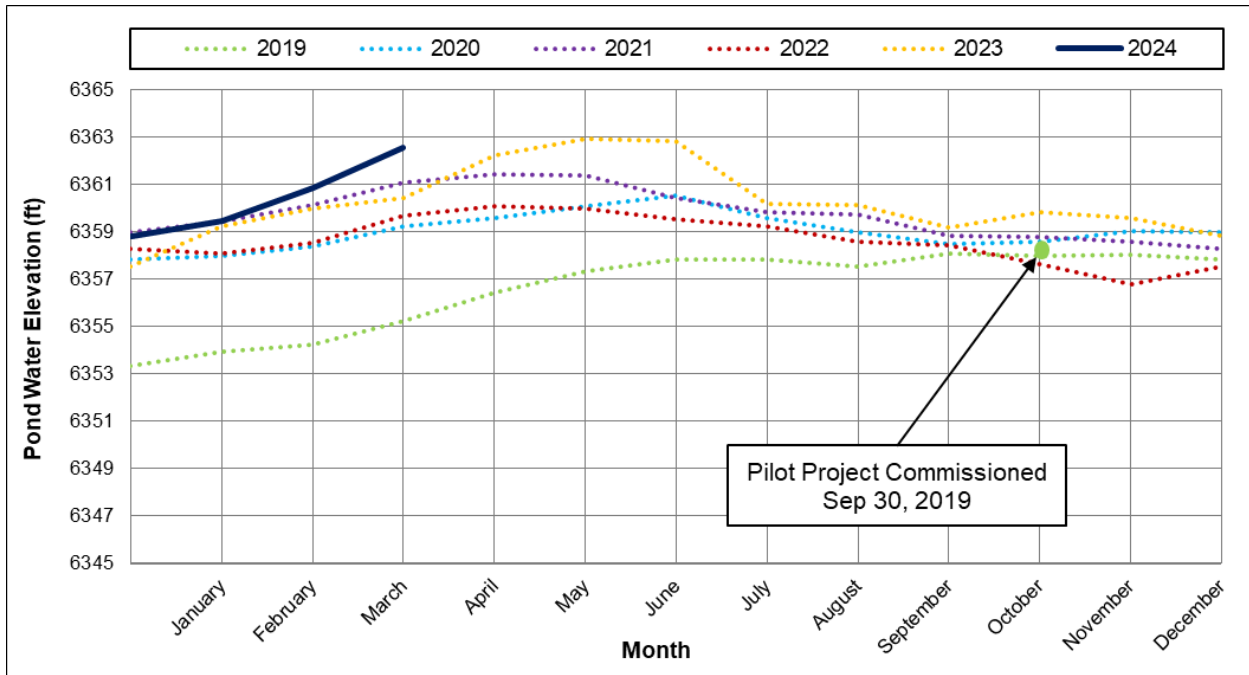
Figure 2.1 Monthly YDTI Pond Water Elevation

MR manually measures the YDTI supernatant pond elevation on a weekly basis. The final pond water elevation recorded during the Q1 monitoring period was 6362.6 ft on March 25, 2024. This measurement equates to a pond elevation increase of approximately 3.8 ft during Q1 2024. Monthly pond water elevations from 2019 through Q1 2024 are presented on Figure 2.1.

The water levels measured during Q1 increased each month, which is consistent with previous Q1 seasonal trends as the winter ice cap over the beach and pond melts. The water level increase recorded in Q1 was slightly larger than the water level increases measured during the same period in recent years. The larger increase in the water level rate of rise is attributed to changes in the operational philosophy of the Polishing Plant operations, which are described in more detail in the following section.

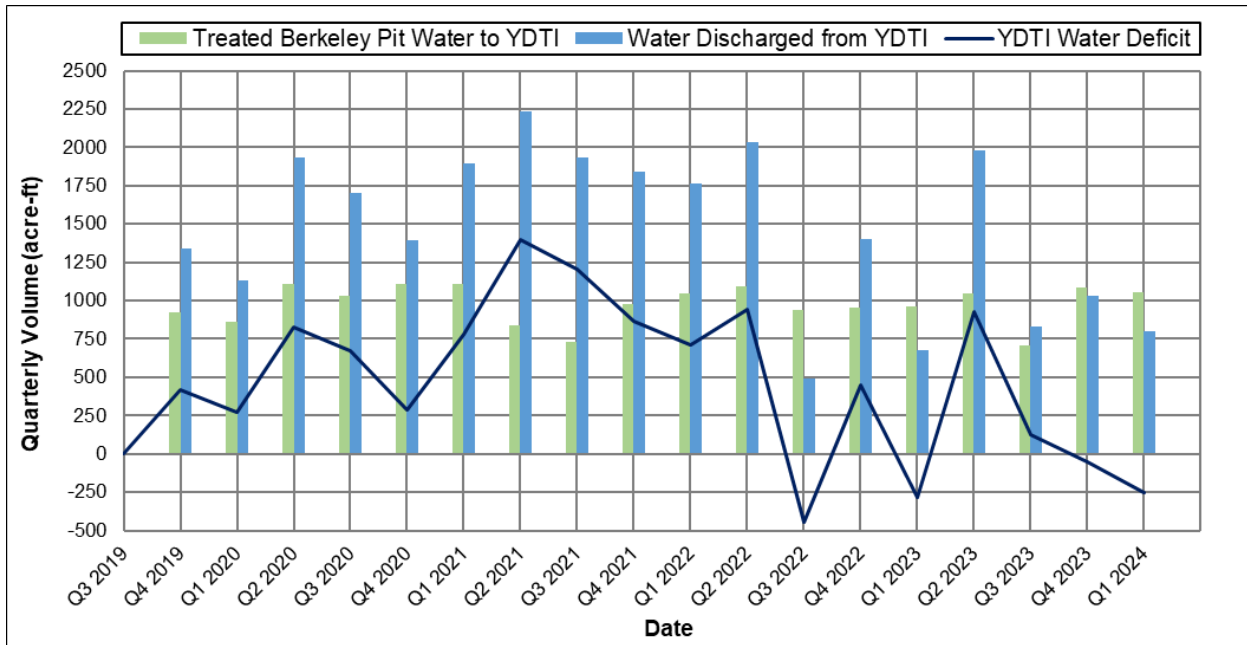
Figure 2.2 Berkeley Pit Pumping System and Polishing Plant Flows - Quarterly Summary

The quarterly flow records for the Berkeley Pit Pumping System, Polishing Plant discharge, and associated YDTI deficit since off-site discharge via the Polishing Plant began in 2019 are shown on Figure 2.2. The YDTI supernatant pond had a net gain of approximately 83 million gallons (255 acre-ft) of water in Q1 2024. Approximately 343 million gallons (1,054 acre-ft) of treated Berkeley Pit water was discharged into the YDTI and 260 million gallons (800 acre-ft) of YDTI water was discharged off-site during Q1. The net YDTI water deficit between Berkeley Pit inflows and Polishing Plant off-site discharge since 2019 is approximately 2,880 million gallons (8,850 acre-ft).

MR have been discharging YDTI water off-site via the Polishing Plant since September 2019 in effort to draw the stored volume of the YDTI down to a recommended target of approximately 15,000 ac-ft. An estimated supernatant pond volume of approximately 17,100 acre-ft was achieved as of mid-July 2023, which is within the estimated normal seasonal fluctuations of the recommended target of approximately 15,000 acre-ft. The YDTI Engineer of Record identified in the 2023 Annual Inspection Report (KP, 2024) that the active drawdown of the pond inventory was therefore completed in 2023. A revised operating philosophy for the Polishing Plant discharge to actively maintain the pond water inventory within seasonal fluctuations is now being applied as recommended in the 2023 Annual Inspection Report. The net balance of ‘Water from the Berkeley Pit to the YDTI’ and ‘Water discharged from the YDTI’ will be adjusted as required to maintain the pond water inventory within a target normal operating range of 12,000 to 18,000 acre-ft.

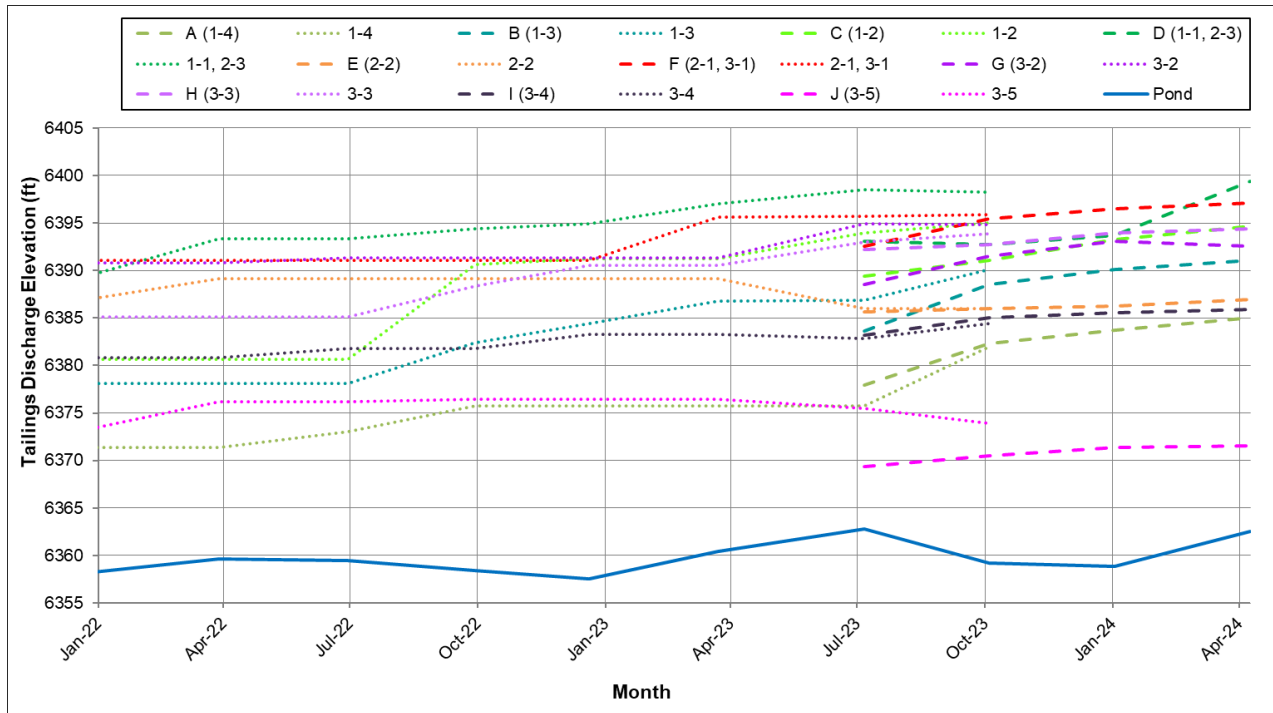
Figure 3.2 Tailings Discharge Elevations

The discharge location with the lowest beach elevation was 3-5 throughout Q1 2024. The elevation difference between the tailings beach at 3-5 and the supernatant pond surface was approximately 9.0 ft at the end of Q1 2024. The location of the lowest discharge point identifies the general area of the facility where the pond may initially contact the embankment in the event the pond elevation rises due to an increase in pond volume (e.g. flooding). The next lowest discharge point was 1-4, which was approximately 22.4 ft higher than the supernatant pond surface at the end of Q1 2024.

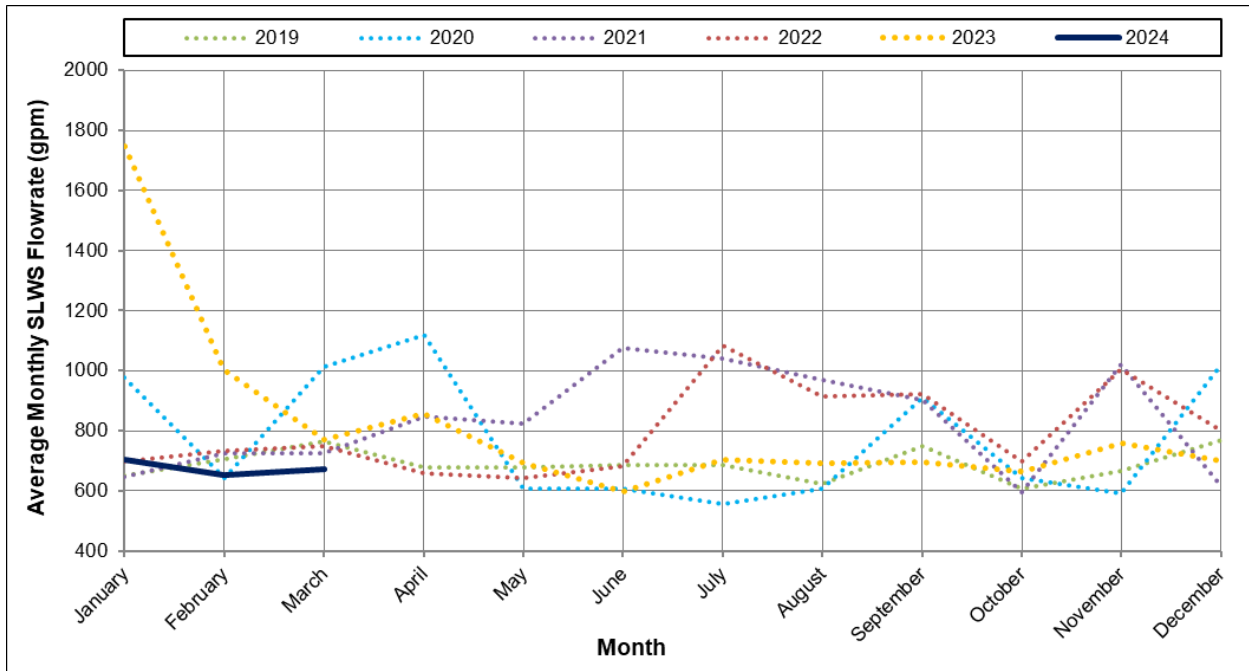
Figure 4.1 Average Monthly SLWS Flowrate

Water from the Silver Lake Water System (SLWS) is used to meet the operational freshwater and make-up water requirements. The average SLWS flow in Q1 2024 was approximately 680 gpm (1.0 Mgd), which is the target SLWS flowrate. Average monthly SLWS flowrates from 2019 through Q1 2024 are shown on Figure 4.1.

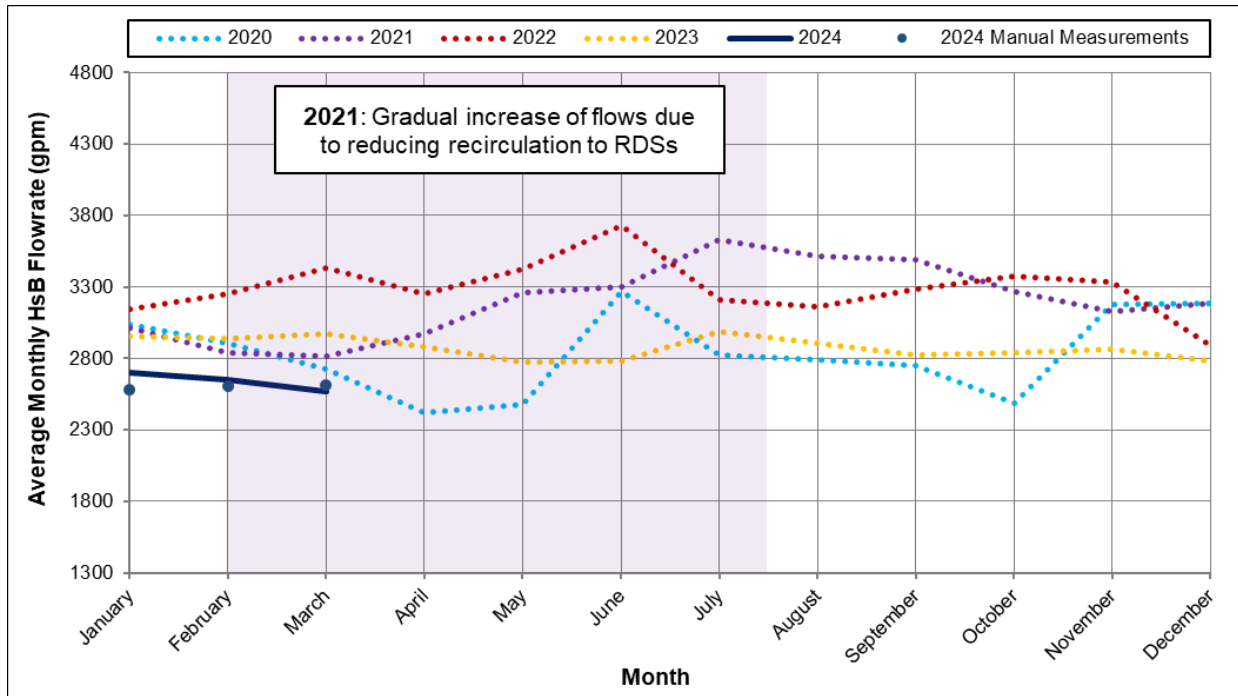
Figure 5.1 Average Monthly HsB Weir Flowrate

The MR sensor was problematic in Q3 and Q4 2023. MR replaced their sensor in mid-Q1 2024; however, when comparison was performed against the MBMG sensor data and manual measurements, the analysis showed that the MBMG sensor data corresponded with the manual readings, and there was no correlation between the MR sensor and the manual readings. The Q1 HsB Weir flowrate analysis therefore continues to evaluate data solely from the MBMG sensor.

The average monthly HsB Weir flowrates measured by the MBMG sensor are presented on Figure 5.1. The average flowrate from the MBMG data throughout Q1 2024 was approximately 2,640 gpm. The average monthly flowrates observed during Q1 were generally stable and slightly lower than the previous four years.

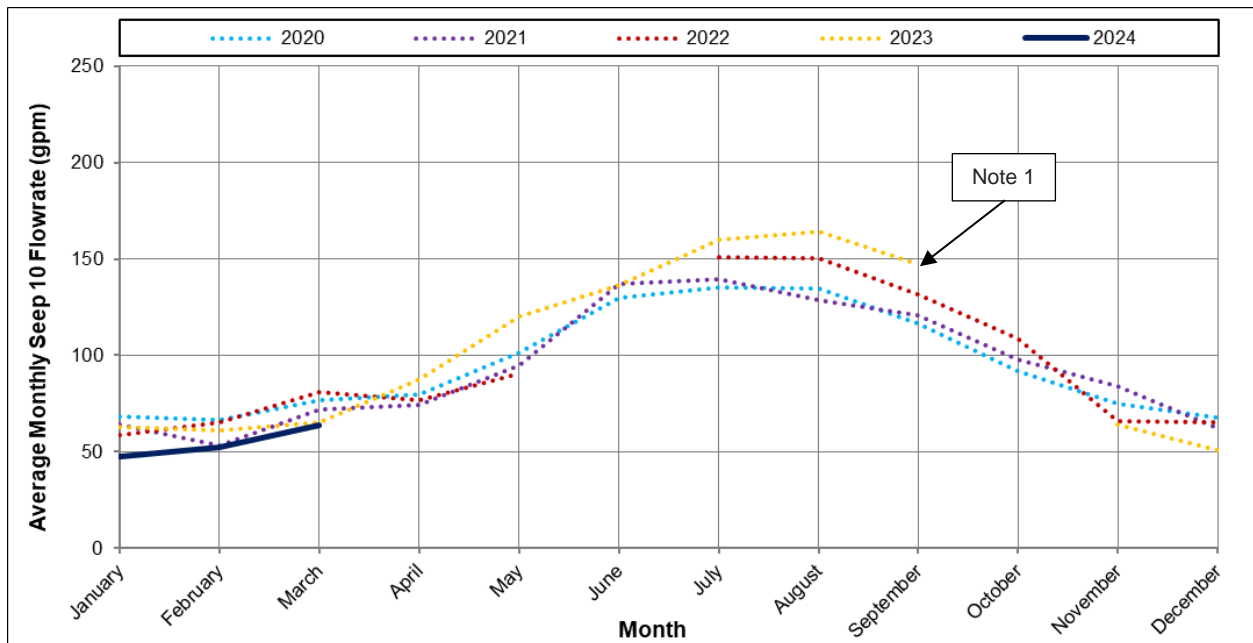
Figure 6.1 Average Monthly Seep 10 Weir Flowrate

The average monthly Seep 10 flowrates from 2020 through Q1 2024 are presented on Figure 6.1. The flowrates during the monitored period in Q1 2024 were on average approximately 55 gpm. Flowrate trends throughout Q1 2024 were consistent with seasonal trends observed in previous years.

2. Data collection was suspended from September 8, 2023 to October 31, 2023 for the construction and commissioning of the new Seep 10 system.

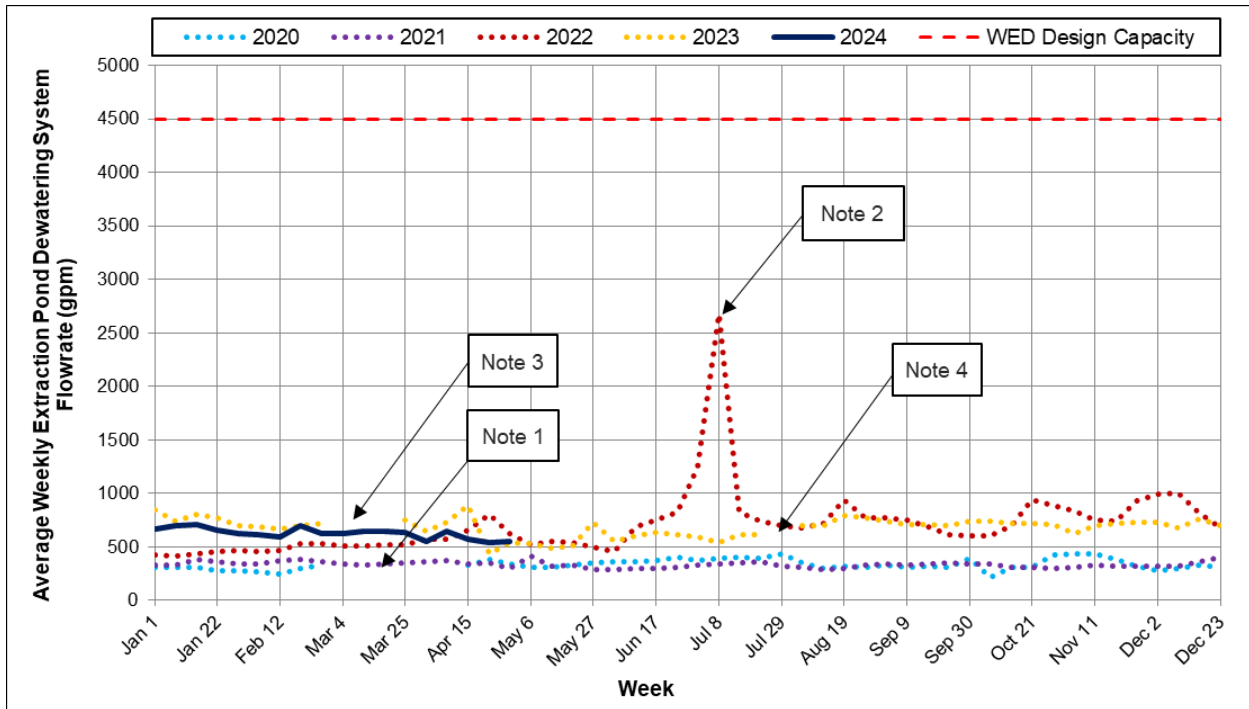
Figure 7.1 Average Weekly Extraction Pond Dewatering System Flowrate

Water collected in the WED flows by gravity into the Extraction Pond and is pumped to the YDTI via the Extraction Pond Dewatering System. The flows are measured using an inline totalizing flowmeter. An image of the WED Extraction Pond and Dewatering System taken on March 13, 2024 is presented in Appendix A – Photo 4. The average weekly flowrates for the Extraction Pond Dewatering System, since it began operating in November 2019, are presented on Figure 7.1. The average daily flowrate during Q1 2024 was 642 gpm, which is comparable to the flowrates recorded since mid-2022.

1. Erroneous data caused by pump cycling from March to April 2020 were removed.
2. The average weekly Extraction Pond Dewatering System flowrate peaked between July 9 to 15, 2022. This high flowrate is attributed to a single event on July 9 associated with power outages and subsequent increase in pumping rate to reduce the WED pond elevation.
3. Erroneous data suspected to be due to a flowmeter error from March 4 to 18, 2023 were removed.
4. Erroneous data suspected to be due to maintenance downtime from July 28 to 30, 2023 were removed.

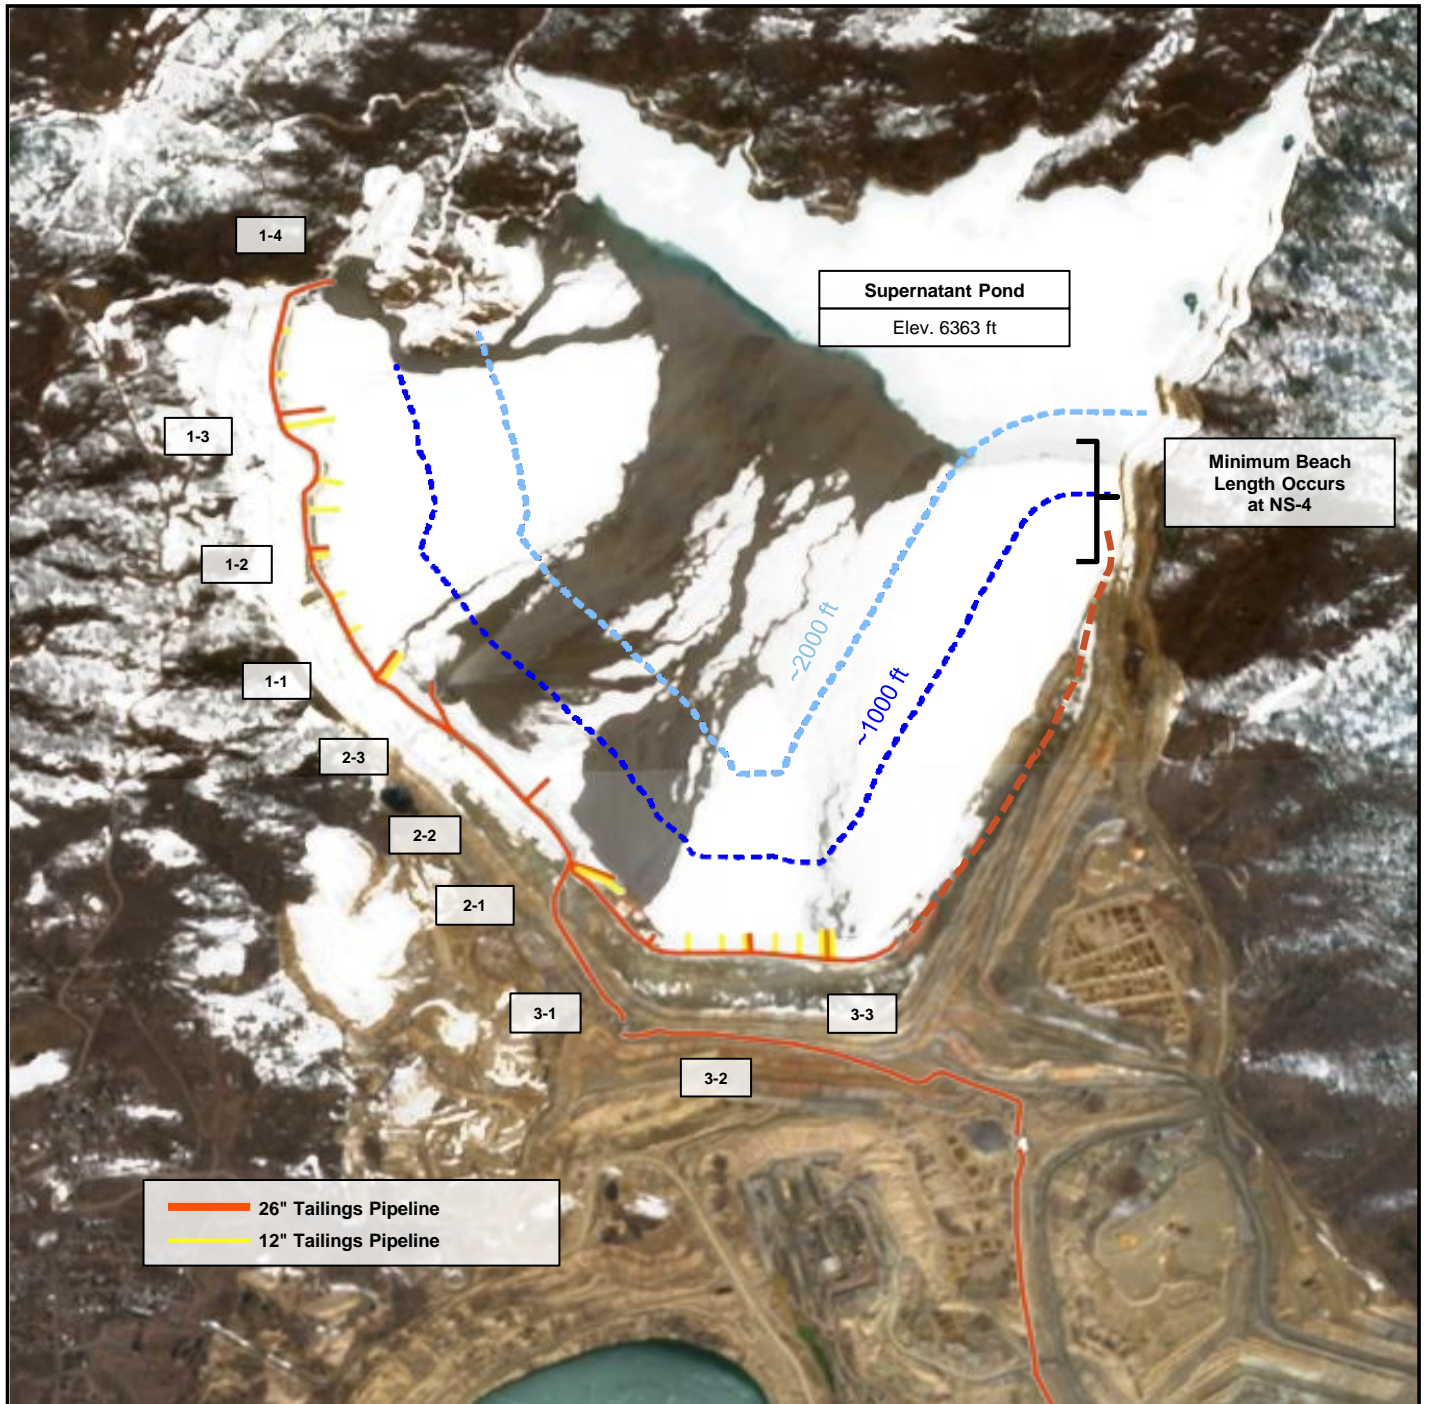
Knight Piésold CONSULTING	FIGURE A.3
REV 0	RSD 0

Images captured by the Sentinel-2 satellite are reviewed twice per month to remotely observe the shape of the tailings beach and position of the supernatant pond relative to the embankments. The shortest beach length was observed at the northern end of the North-South Embankment and estimated to be approximately 1,450 ft at the end of Q1. The beach length during Q1 was obscured by the snow and ice cap on top of the YDTI beach and supernatant pond. An overview of the facility observed from the Sentinel-2 satellite images at the end of January, early March, and beginning of April are presented in the attached Figures A.1 to A.3.

1. TAILINGS DISCHARGE AND SUPERNATANT POND ELEVATION WAS SURVEYED BY DRONE FLYOVER ON MARCH 25, 2024. ALL ELEVATIONS ARE RELATIVE TO THE ANACONDA DATUM.
2. THE MINIMUM BEACH LENGTH AT THE NORTHERN EXTREMITY OF THE N-S EMBANKMENT IS MEASURED FROM THE TAILINGS BEACH AND UPSTREAM EMBANKMENT INTERFACE, AT THE INTERSECTION OF THE N-S EMBANKMENT AND NATURAL TOPOGRAPHY OF RAMPART MOUNTAIN, TO THE TAILINGS BEACH AND POND SURFACE INTERFACE.
3. SENTINEL-2 VISIBLE SATELLITE IMAGE TAKEN ON APRIL 2, 2024
4. TAILINGS PIPELINE 3 ALONG THE NORTH-SOUTH EMBANKMENT WAS DISCONNECTED DURING Q1 2024.

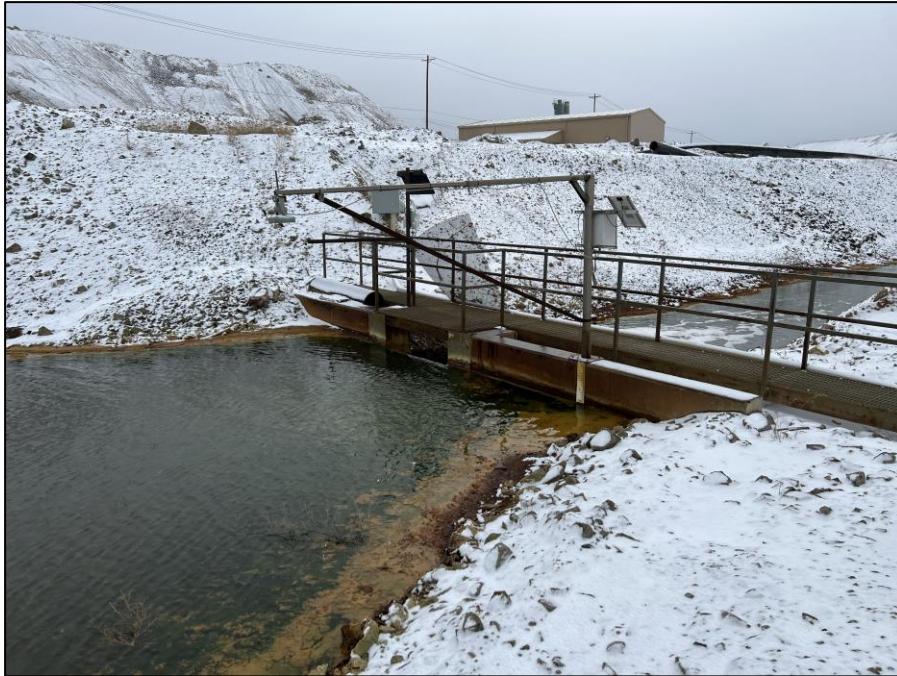
The HsB Weir records the flow of surface water discharging from the HsB area via the HsB Pond. The flows include YDTI seepage and meteoric inputs from the contributing catchment areas. Seepage from the YDTI flows south through the HsB area and joins with localized surface runoff in the HsB Pond before passing over the HsB Weir. The flow depth over the weir is measured continuously using two independent ultrasonic lookdown sensors located upstream of the weir. One sensor is maintained by the Montana Bureau of Mines and Geology (MBMG) and the second sensor is maintained by MR. MR installed their sensor to enable remote continuous monitoring of the HsB flow data. A photo of the flow conditions observed at the HsB Weir on March 13, 2024 is presented in Appendix A in Photo 1.

PHOTO 1 – March 13, 2024 –HsB Weir

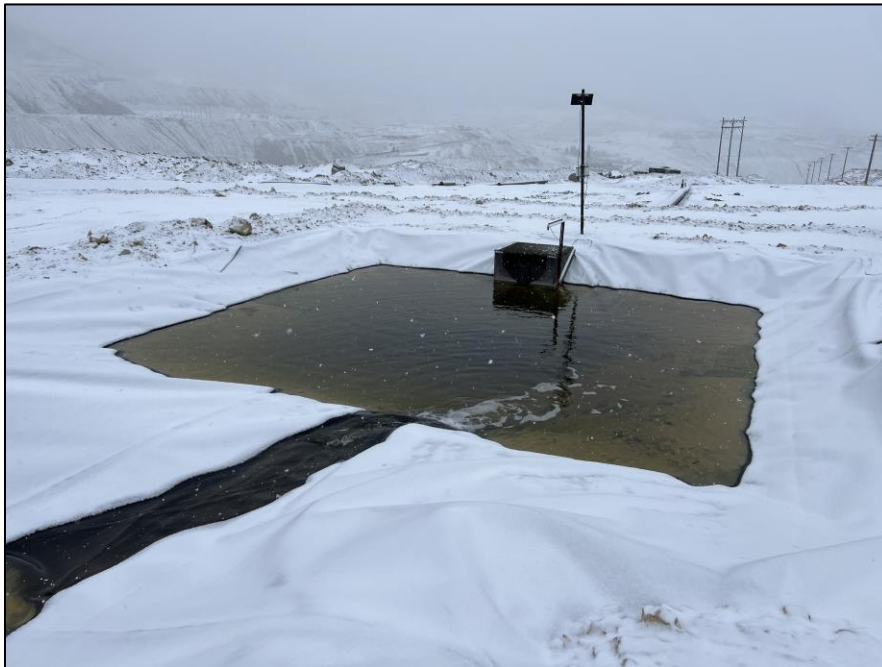
The Seep 10 flows are measured using an ultrasonic lookdown level sensor (the previous sensor was relocated to the new pond). The sensor automatically measures the stilling pond level immediately upstream of the weir. Images of the new Seep 10 pond on March 13, 2024 are presented in Appendix A in Photos 2 and 3.

PHOTO 2 – March 13, 2024 – Seep 10 Stilling Pond

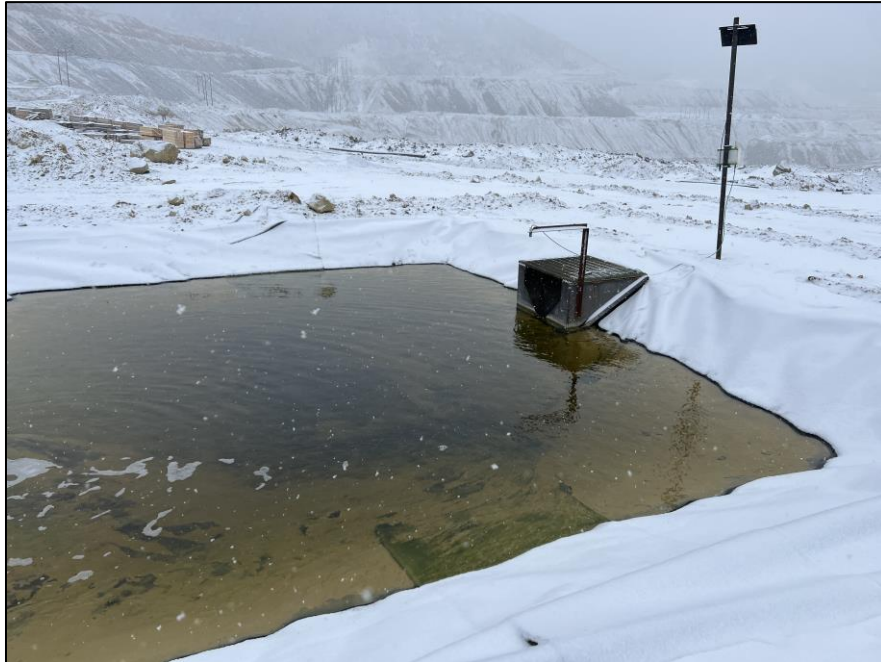
PHOTO 3 – March 13, 2024 – Seep 10 Weir.

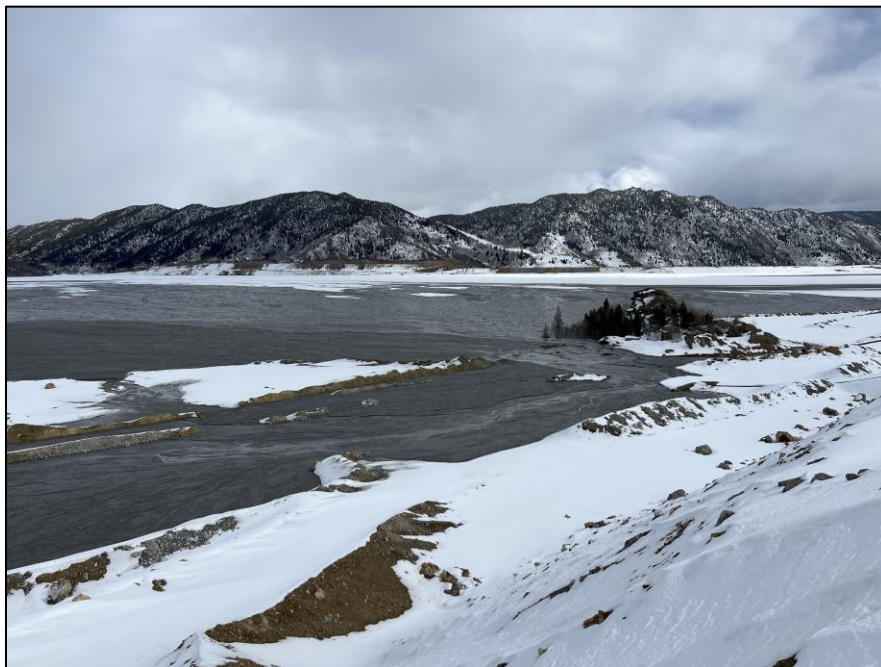
PHOTO 4 – March 13, 2024 – Discharge from West Embankment (looking south)
