November 21, 2023

Mr. Mark Thompson
Vice President - Environmental Affairs
Montana Resources, LLC
600 Shields Avenue
Butte, Montana
USA, 59701

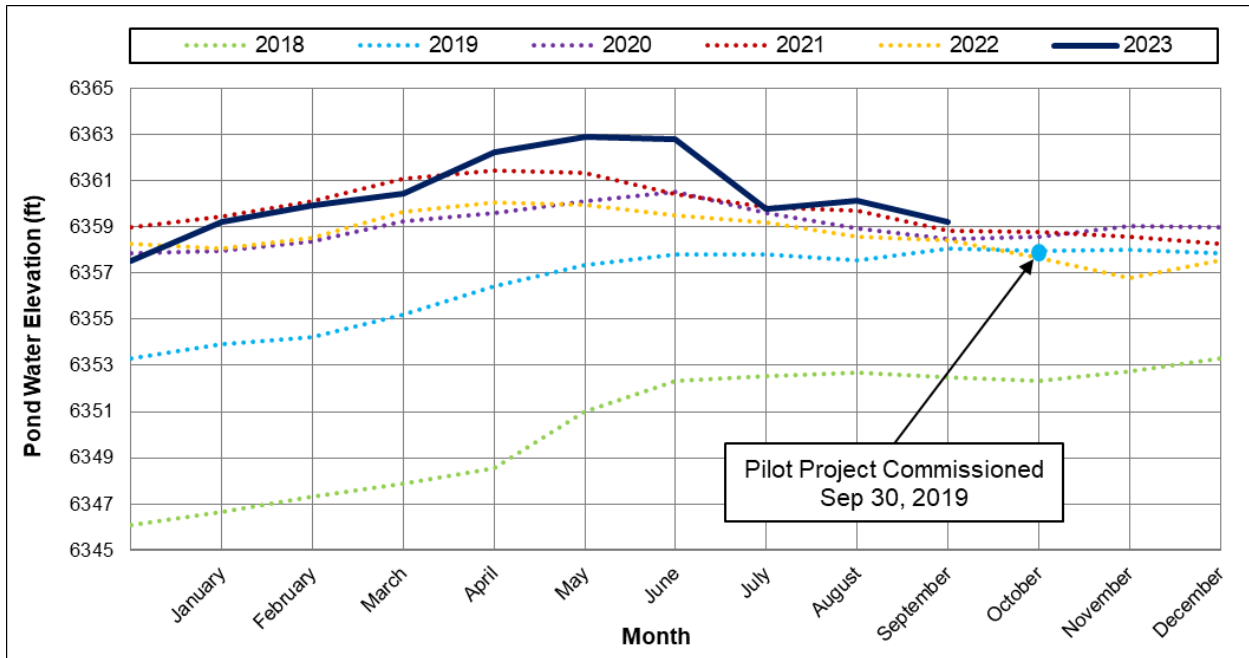
Figure 2.1 Monthly YDTI Pond Water Elevation

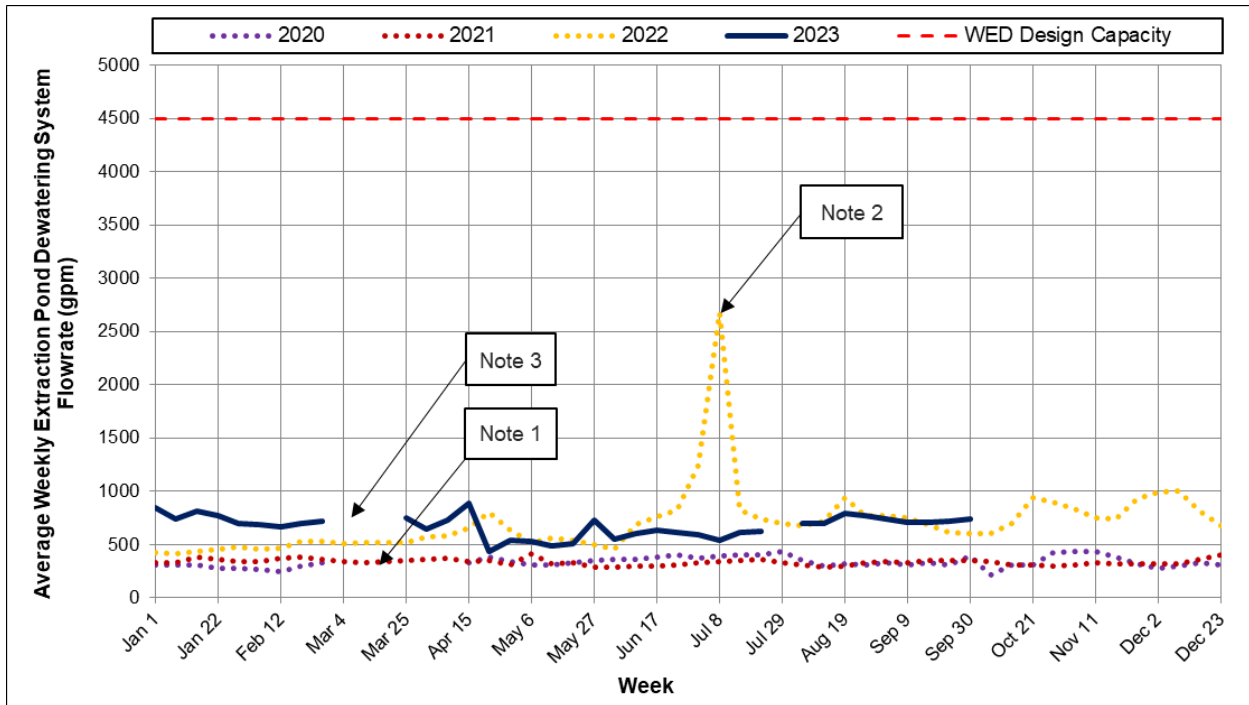
MR and KP anticipate the WED pumping rates will continue to vary throughout the year in the short-term depending on tailings discharge practices and may slowly decrease over time as the tailings beach thickness increases above the EL. 6,400 ft pipeline corridor bench. MR have been closely monitoring the daily pump data records and conducting regular visual inspections of the tailings beach adjacent to the West Embankment. No adverse conditions have been observed to date. MR will continue to regularly monitor the tailings discharges in this area and associated changes in pumping rates required to maintain dewatering of the Extraction Pond.
