Prepared for
Montana Resources, LLP
600 Shields Avenue
Butte, Montana
USA, 59701

Prepared by
Knight Piésold Ltd.
Suite 1400 - 750 West Pender Street
Vancouver, British Columbia
Canada, V6C 2T8

VA101-126/23-2

YANKEE DOODLE TAILINGS IMPOUNDMENT 2020 ANNUAL INSPECTION REPORT

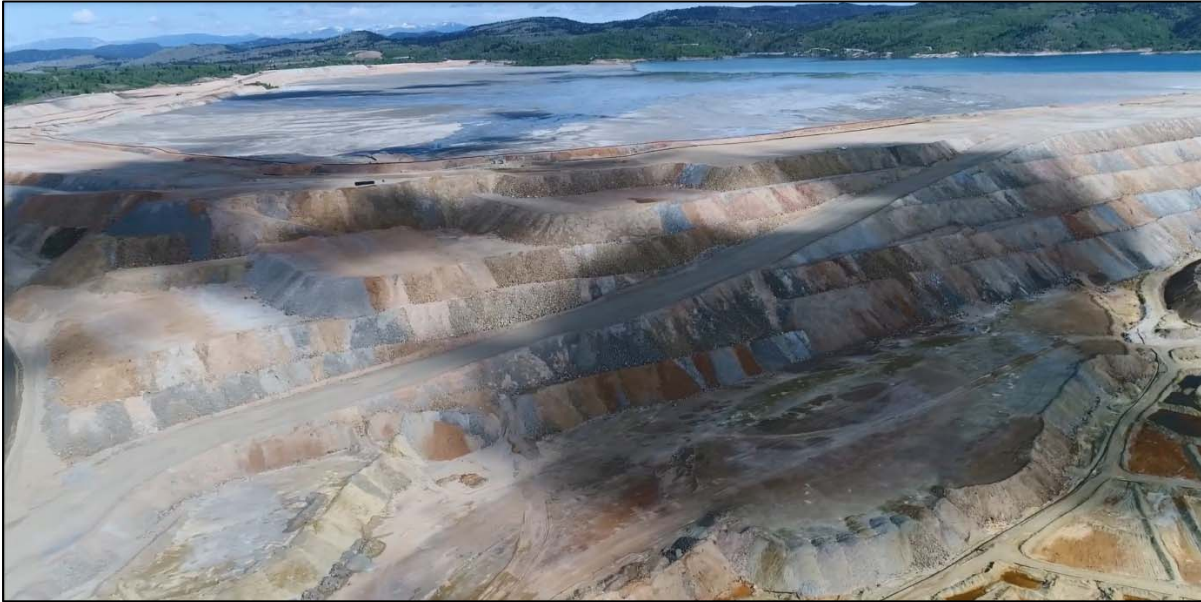
PHOTO 1 – North-South Embankment downstream shell, looking northwest from southeast end of YDTI at the new mine haul ramp.

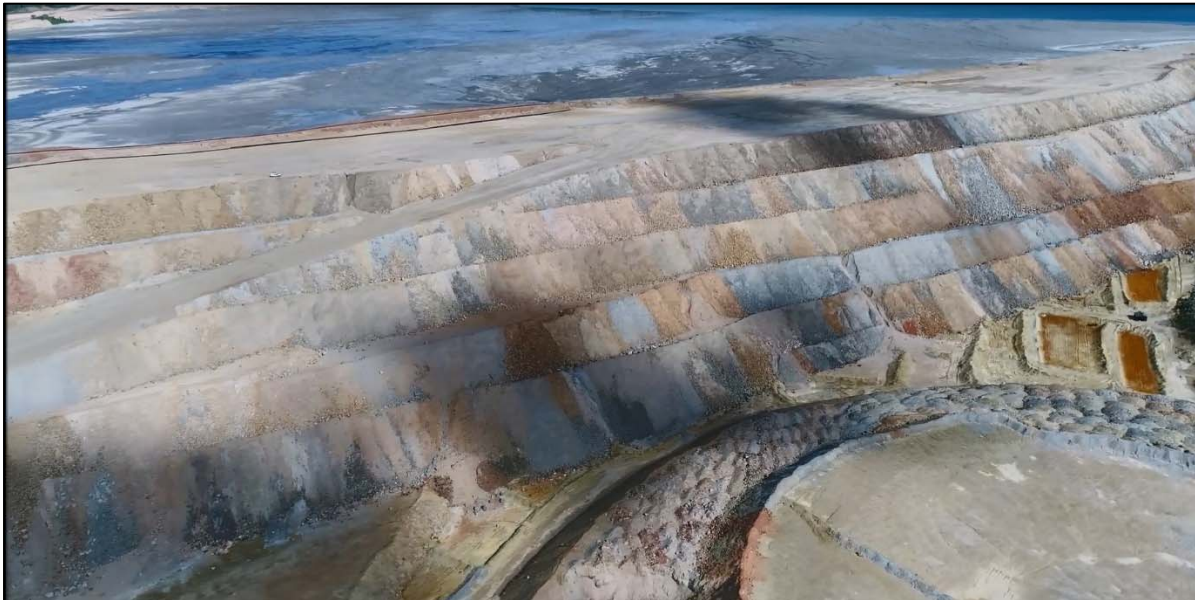
PHOTO 2 – North-South Embankment downstream shell, looking northwest towards the top of the new mine haul ramp at EL. 6,400 ft

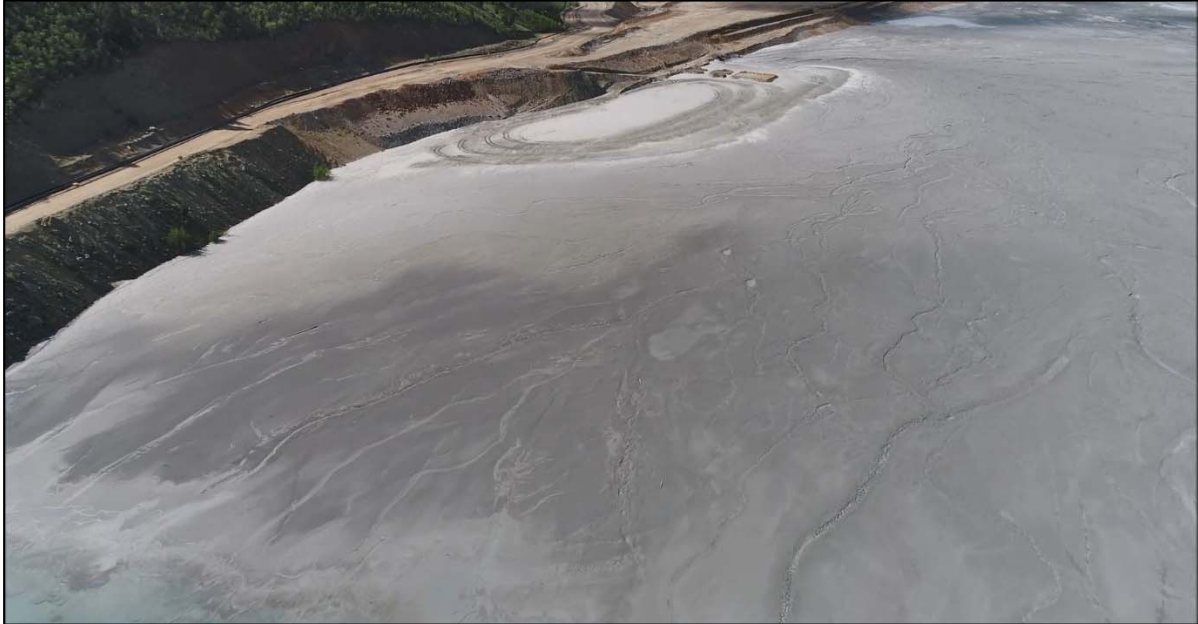
PHOTO 5 – Tailings beach beyond the northern end of the North-South Embankment near former position of tailings discharge location, NS-3, looking southeast.

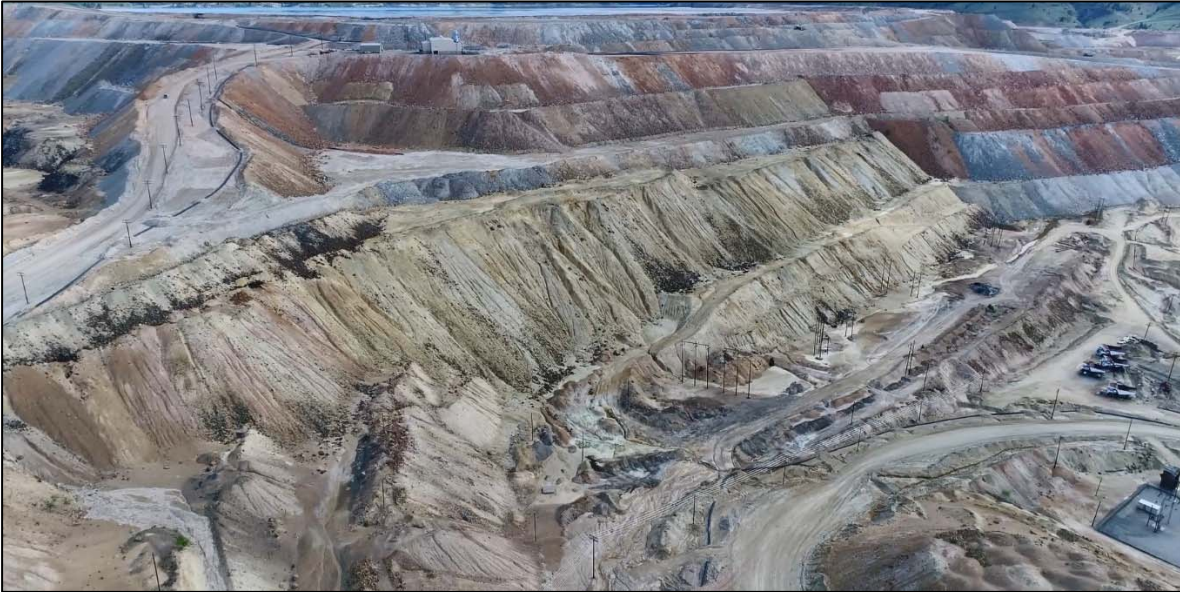
PHOTO 9 – Central pedestal area of the East-West Embankment, looking northeast.

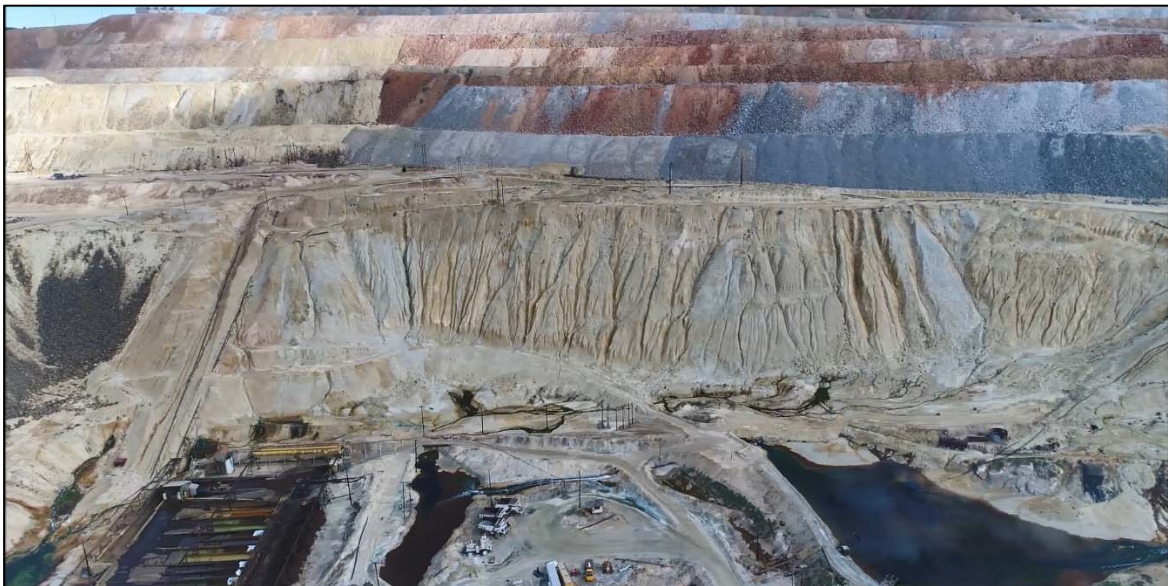
PHOTO 10 – East-West Embankment downstream slope, Number 10 Seep bench area, HsB and Leach Seeps area, looking north.

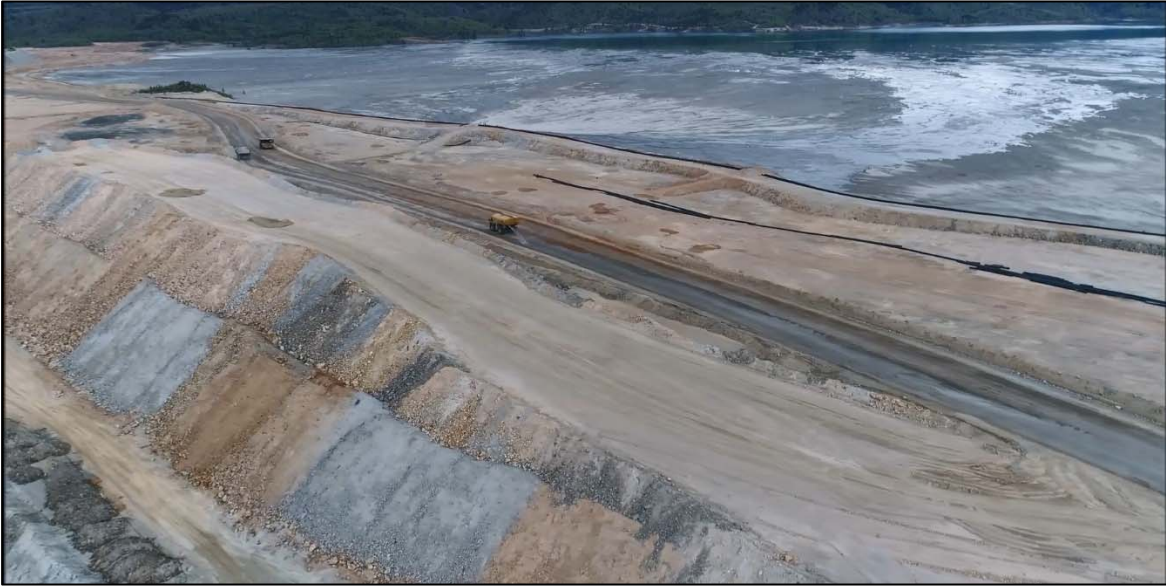
PHOTO 11 – East-West Embankment and rockfill surcharge near discharge location EW-2, looking north.

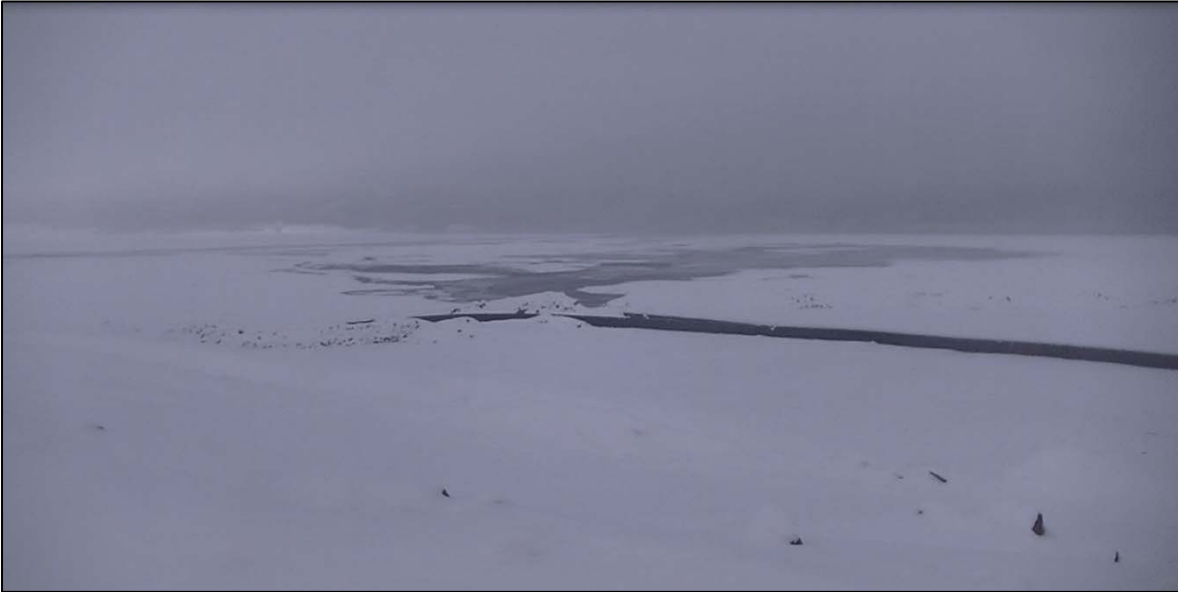
PHOTO 28 – Tailings flow over snow-covered tailings beach between the North-South and East-West Embankments.

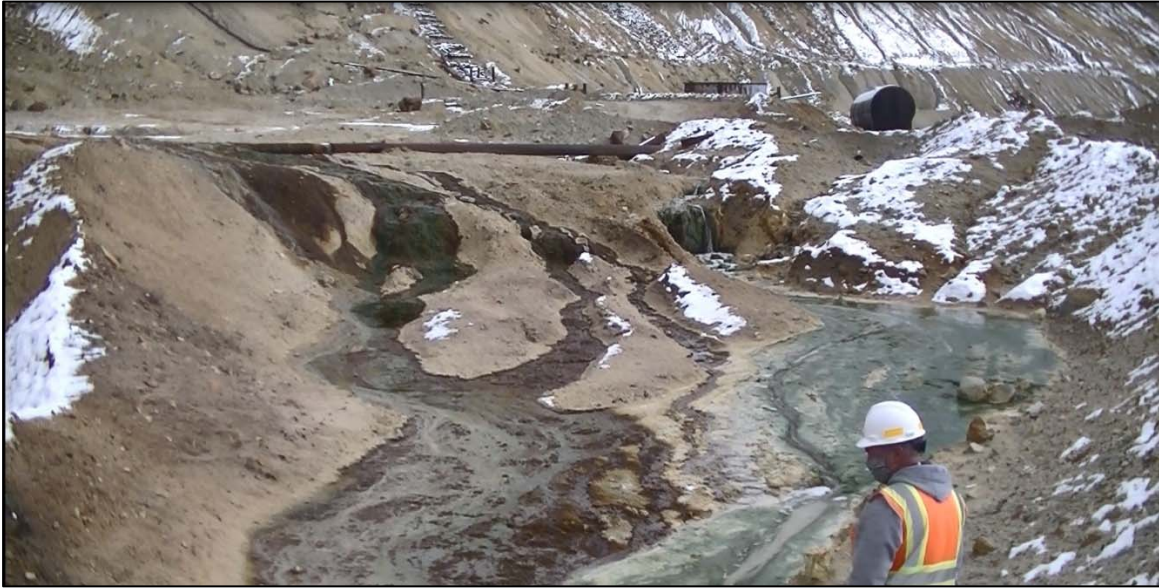
PHOTO 30 – Seepage (leach seeps) along the downstream toe of the East-West Embankment in HsB Area, looking east.

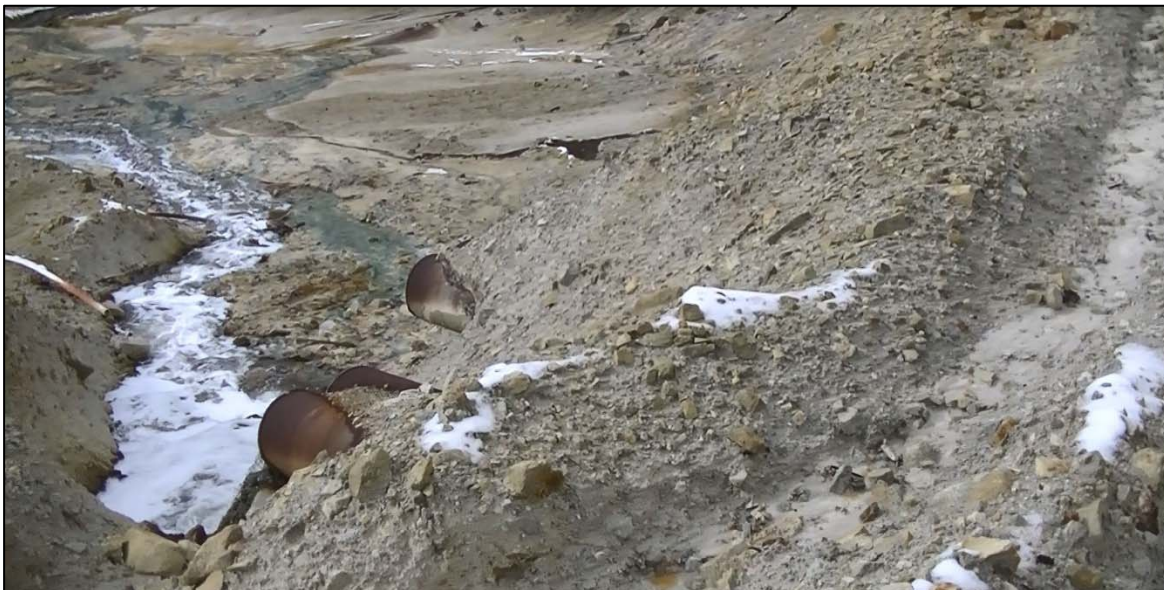
PHOTO 31 – Combined seepage (leach seeps) going towards Precipitation Plant in HsB Area at downstream toe of East-West Embankment maximum section, looking west.

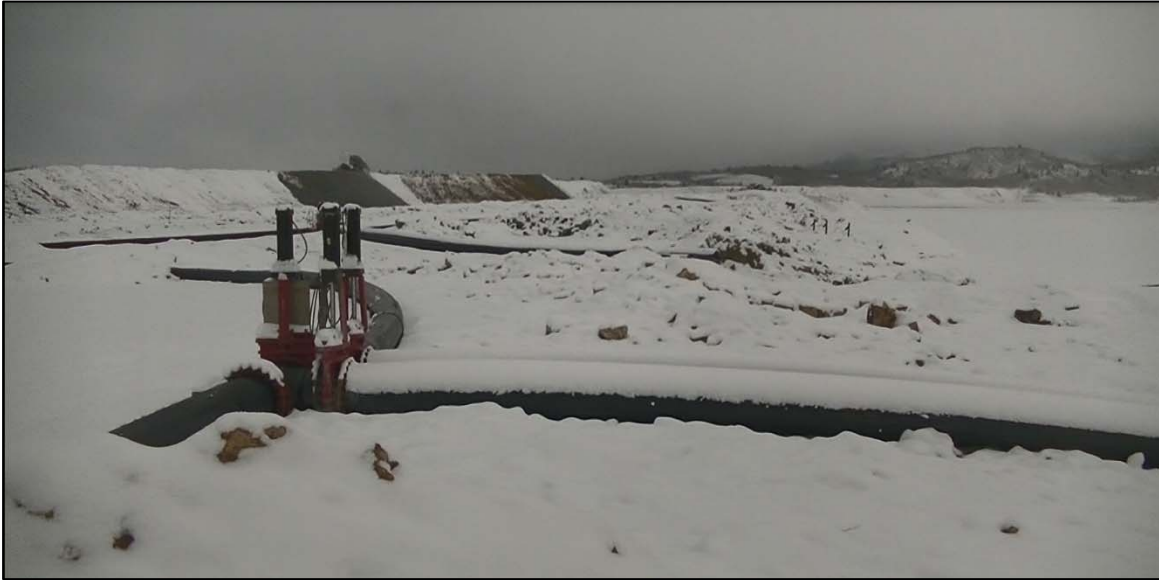
PHOTO 32 – Snow-covered tailings discharge pipeline valve near discharge location EW-1, and construction of a new EL. 6,450 ft lift on East-West Embankment near discharge location EW-2.

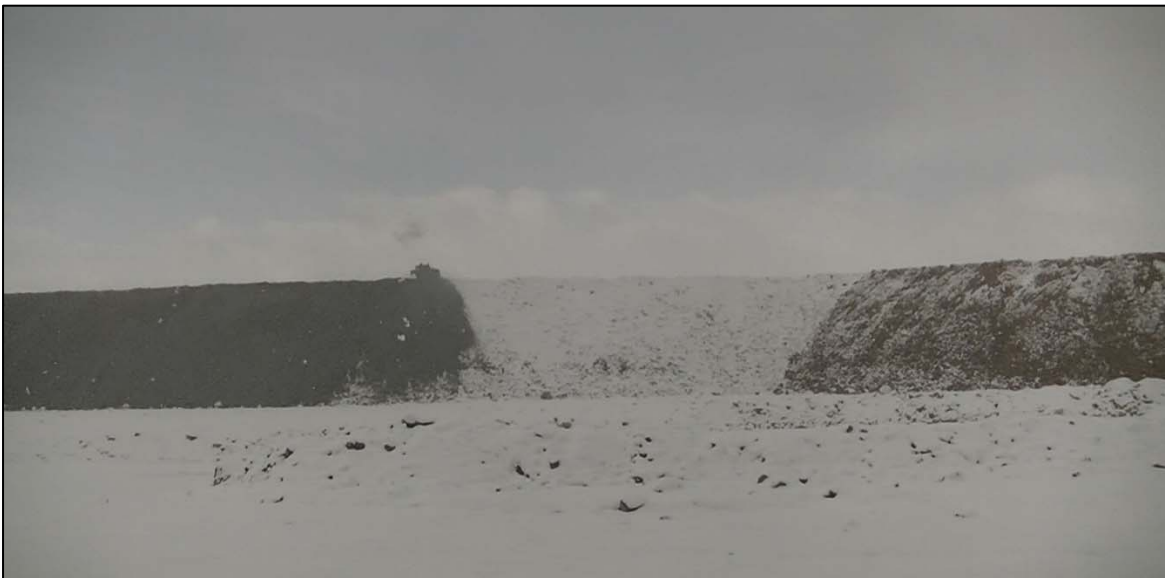
PHOTO 33 – Close-up of construction of EL. 6,450 ft lift on East-West Embankment near discharge location EW-2.

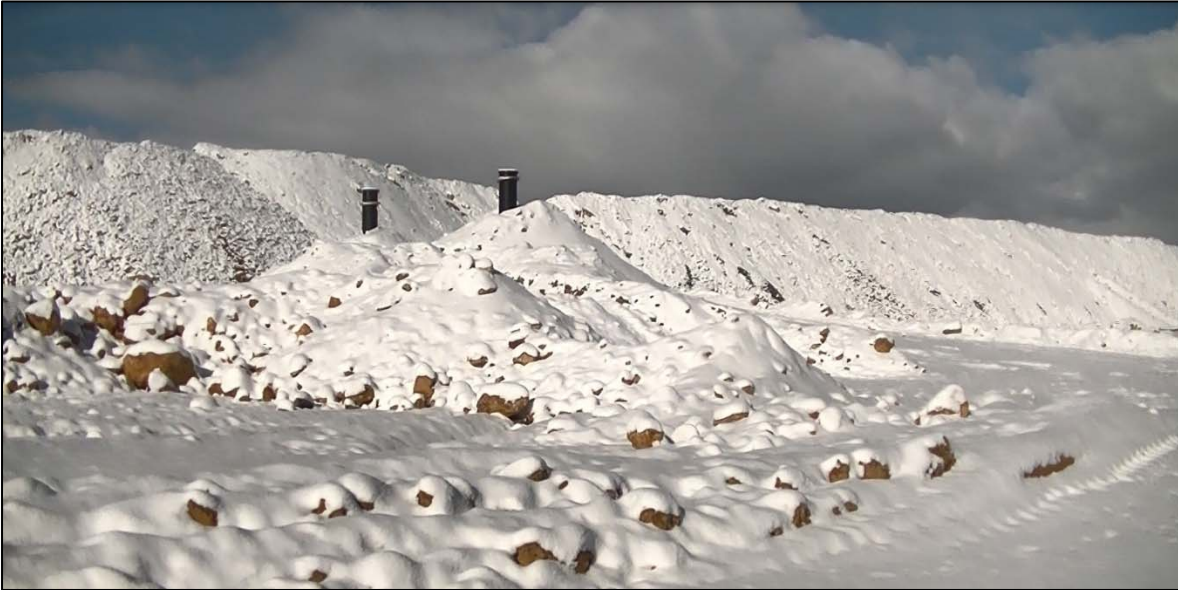
PHOTO 36 – Riser pipes from the Extraction Basin along the West Embankment, EL. 6,450 ft lift construction in the background.

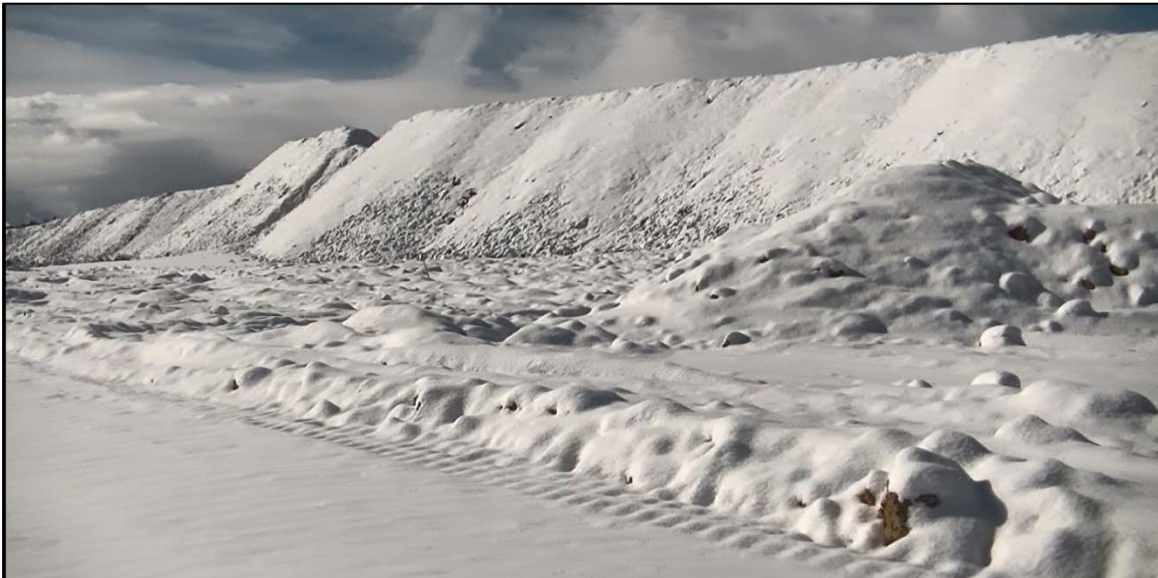
PHOTO 37 – Upstream face of recently construction EL. 6,450 ft lift along the West Embankment.

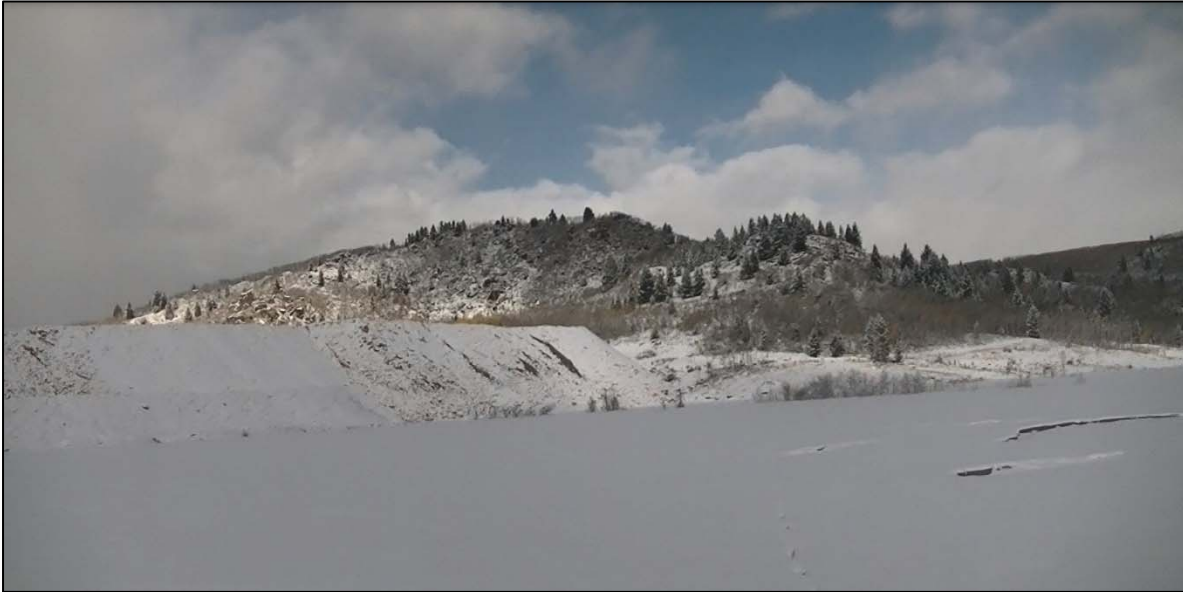
PHOTO 38 – Recently constructed EL. 6,450 ft lift at northern end of West Embankment.

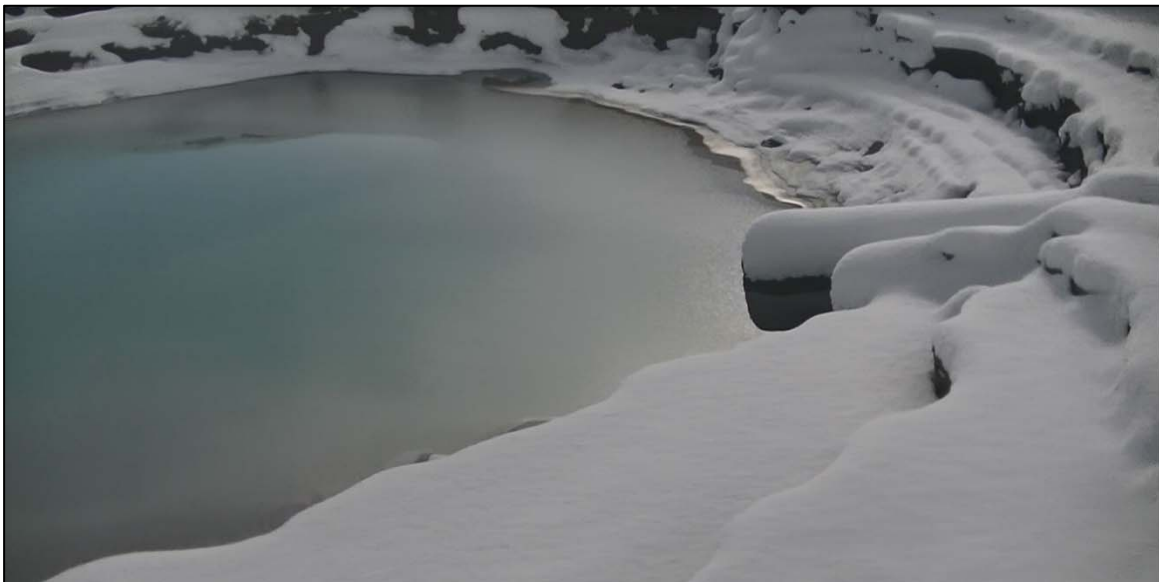
PHOTO 39 – Discharge location RK-4.

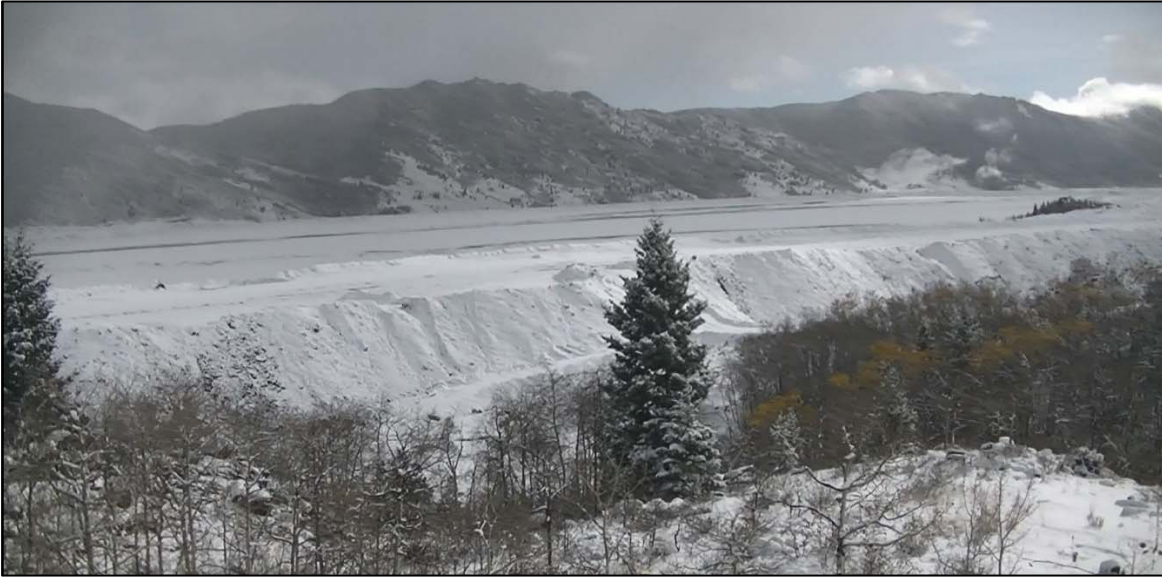
PHOTO 40 – Overview of the snow-covered West Embankment from the West Ridge topsoil stockpile.

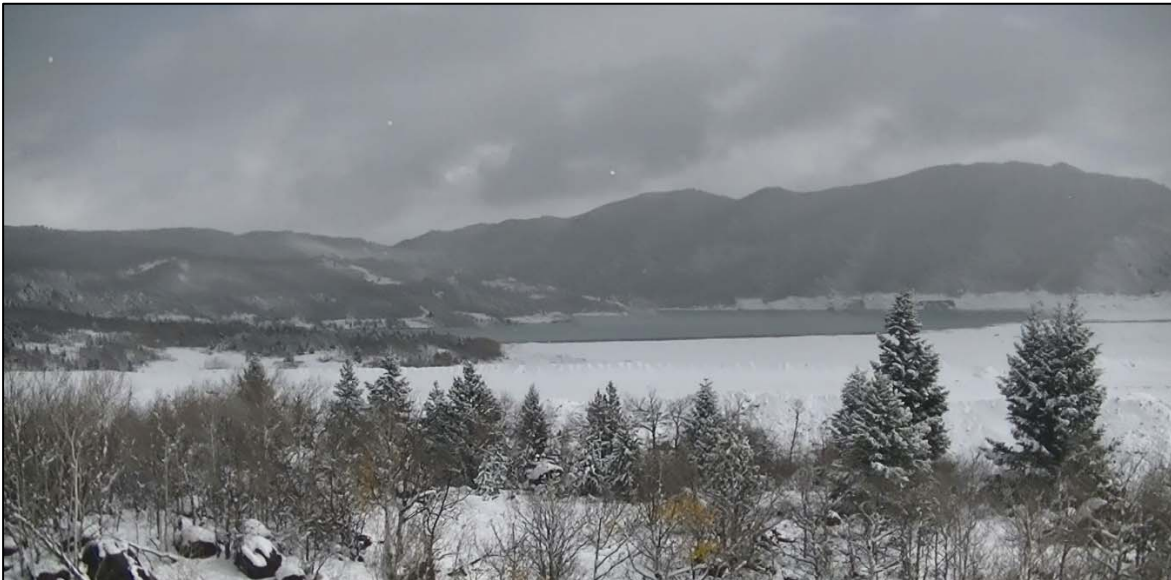
PHOTO 41 – Overview of the YDTI supernatant pond from the West Ridge topsoil stockpile.

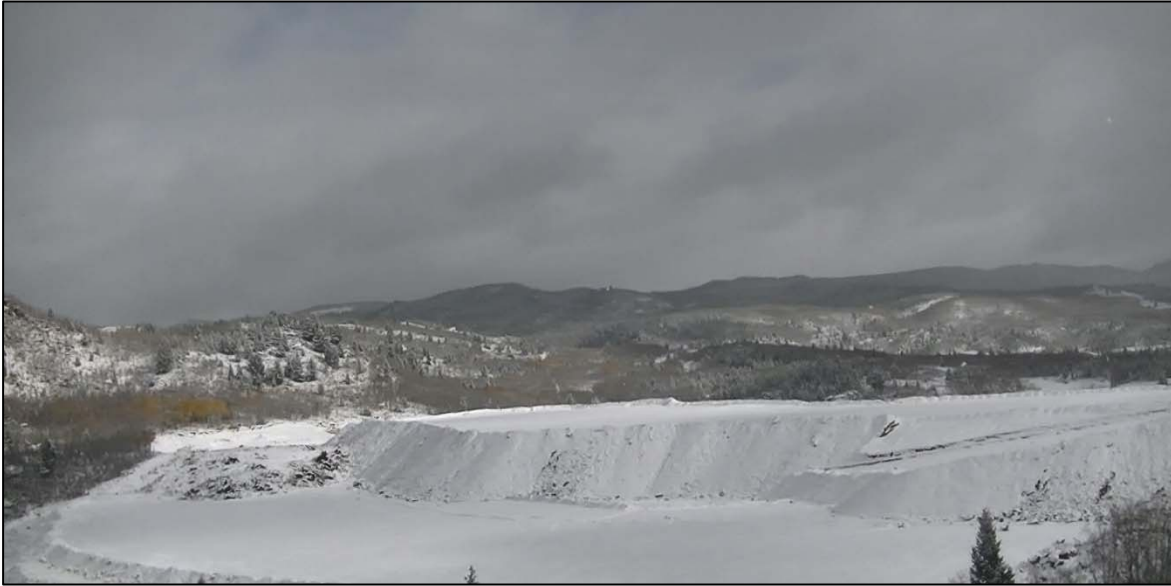
PHOTO 42 – Downstream side of the West Embankment at the northern end looking northeast. Zone U fill placement to EL. 6,450 ft completed; Zone D1 remains to be placed on the downstream side.

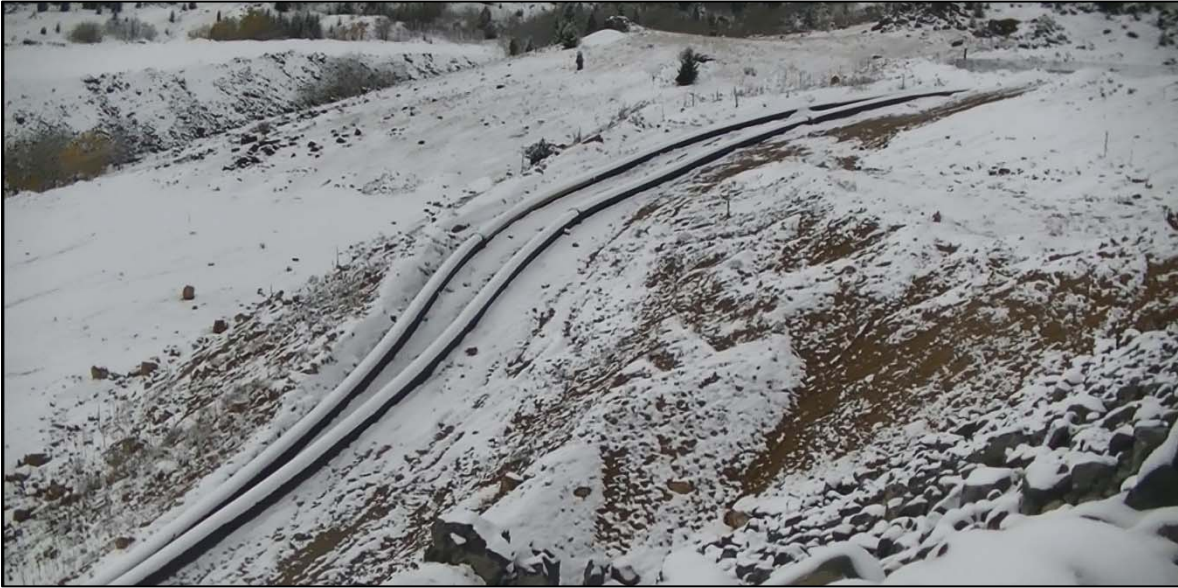
PHOTO 44 – Snow-covered WED Extraction Pond emergency overflow pipelines.

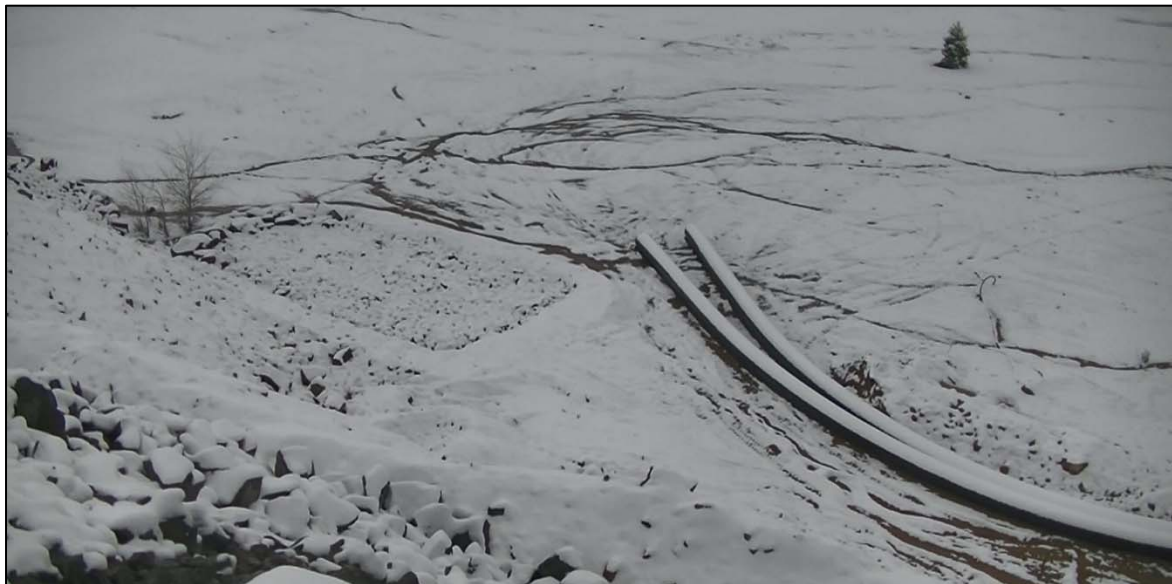
PHOTO 45 – Snow-covered WED Extraction Pond emergency overflow pipelines, boulders for energy dissipation and final alignment of pipeline discharge remains to be completed.

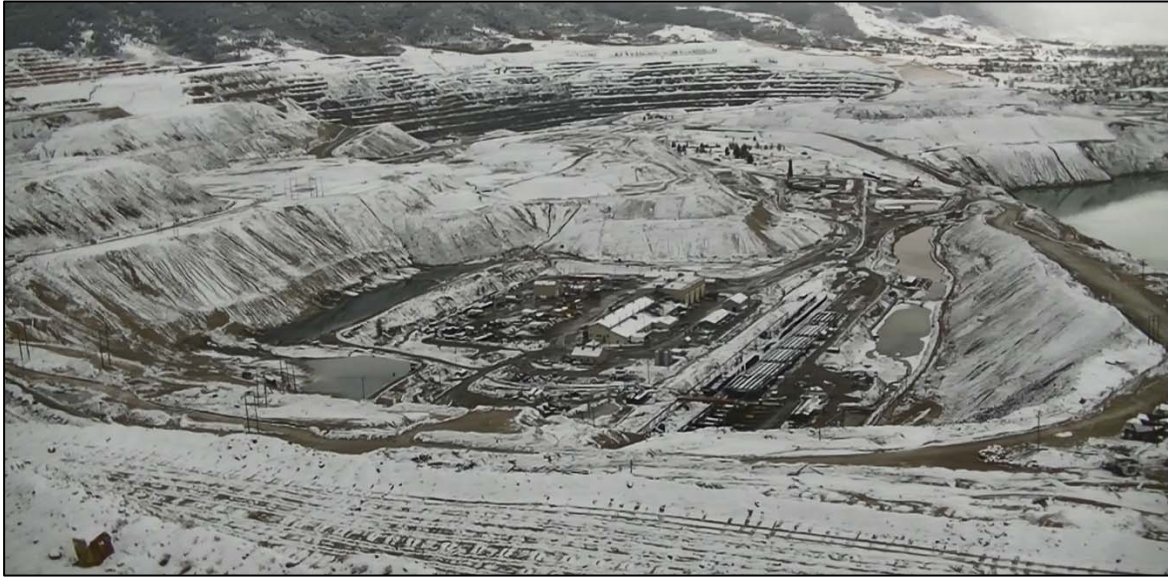
PHOTO 46 – Overview of the HsB Area, looking south from No. 3 (Tailings) Booster Pump House viewpoint.

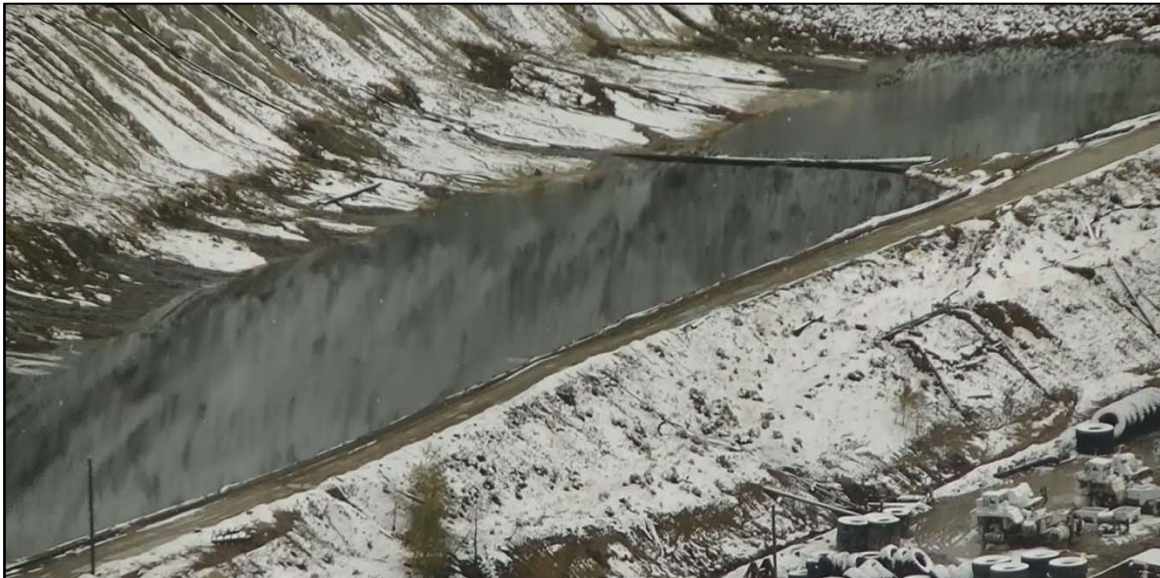
PHOTO 47 – Holding Pond in the HsB Area, looking southeast from No. 3 (Tailings) Booster Pump House viewpoint.

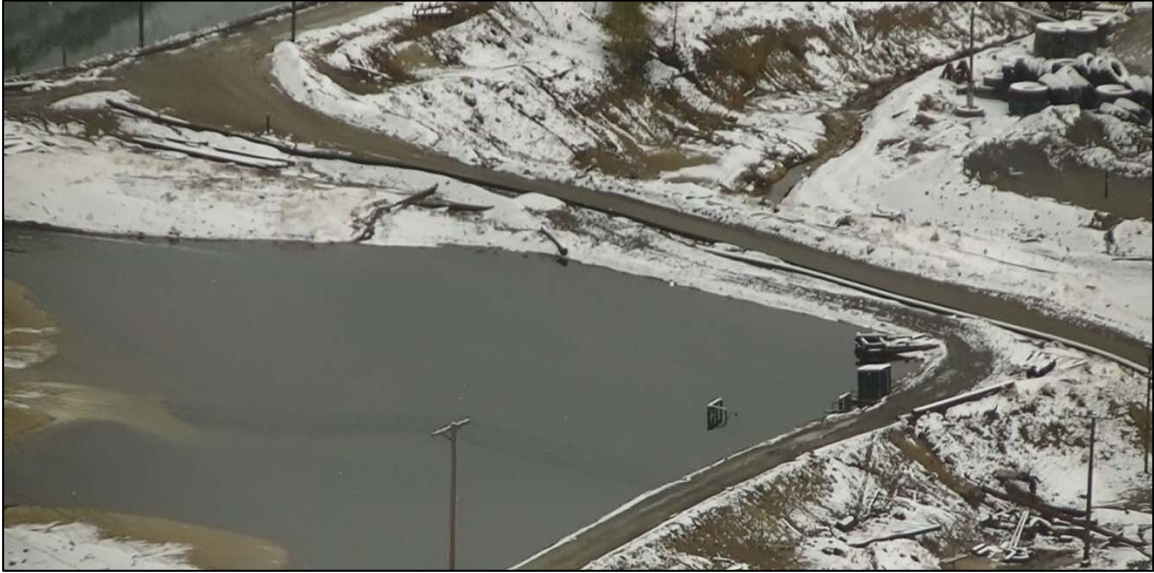
PHOTO 48 – Surge Pond in the HsB Area, looking southeast from No. 3 (Tailings) Booster Pump House viewpoint.

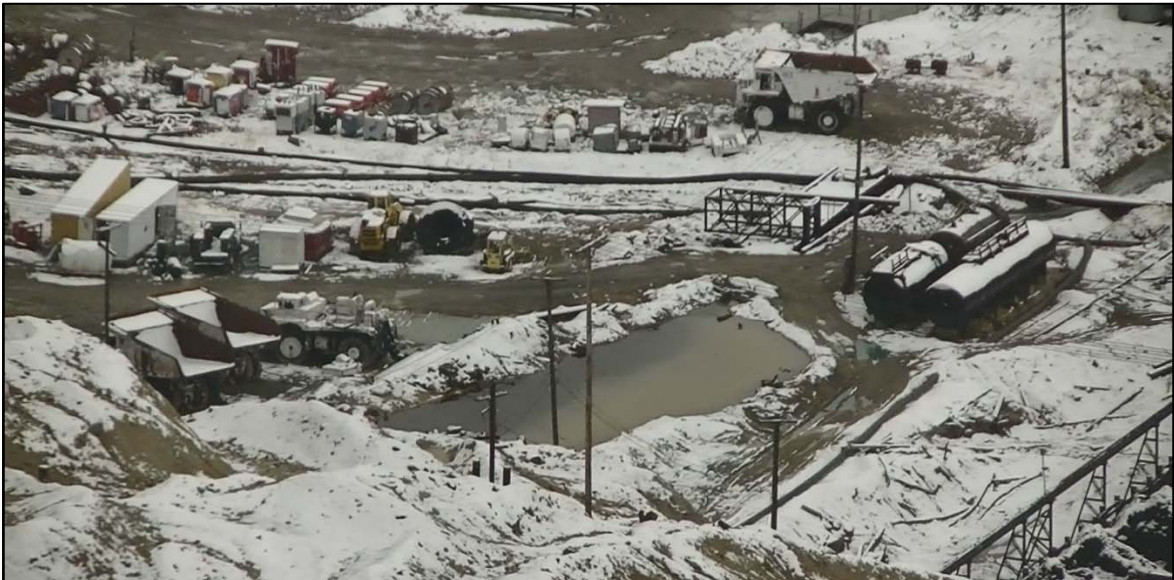
PHOTO 49 – Houligan Pond in the HsB Area, looking south from No. 3 (Tailings) Booster Pump House viewpoint.

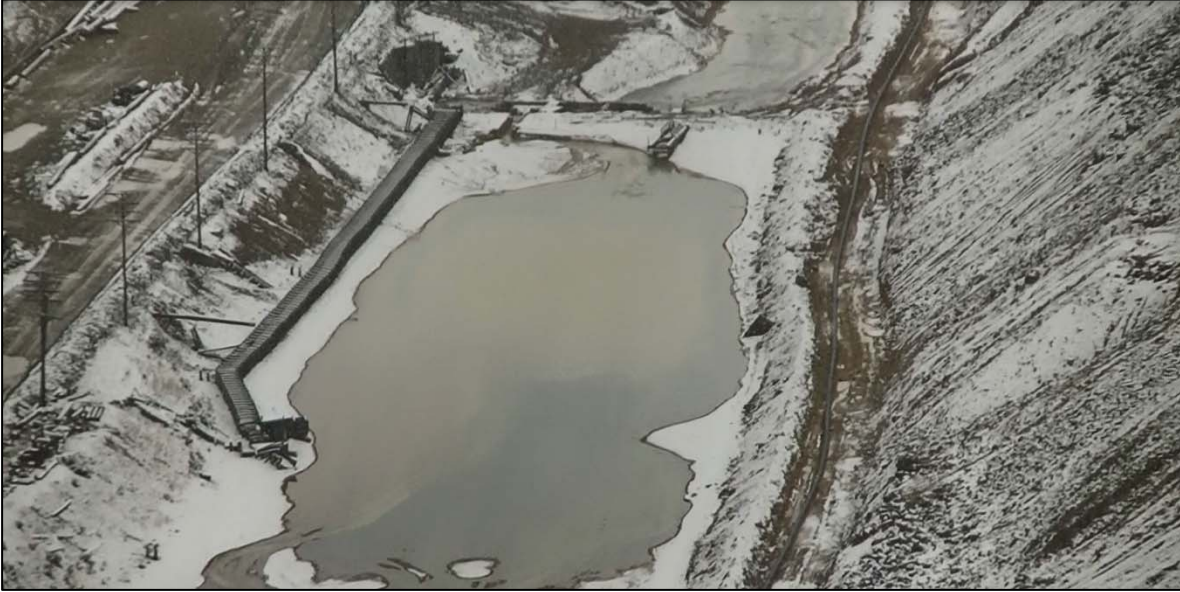
PHOTO 50 – Upper HsB Pond in the HsB Area, looking south from No. 3 (Tailings) Booster Pump House viewpoint.

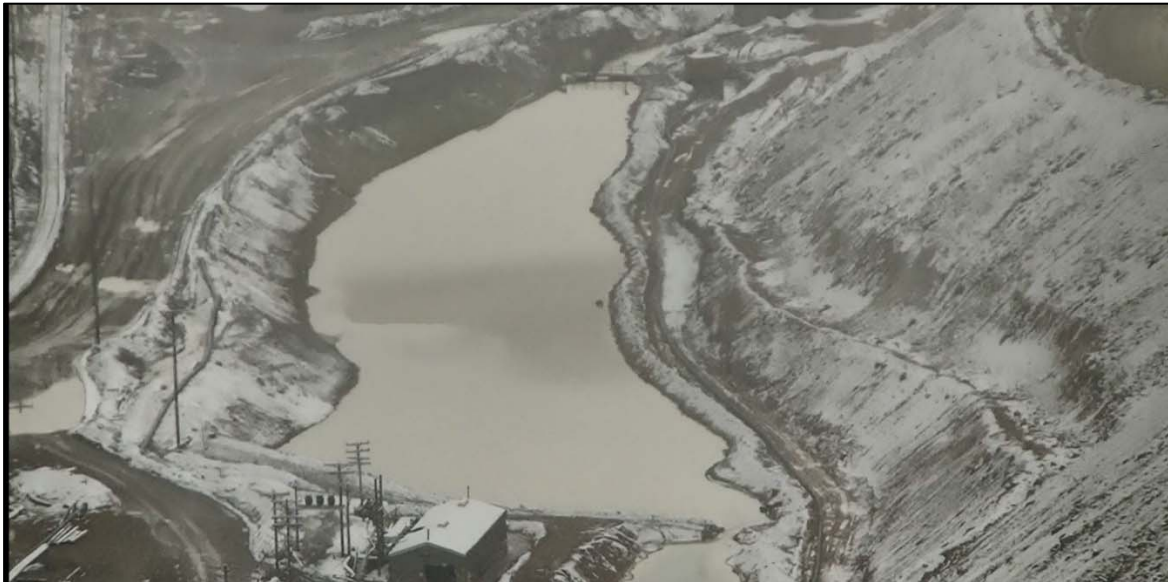
PHOTO 51 – HsB Pond in the HsB Area, looking south from No. 3 (Tailings) Booster Pump House viewpoint.

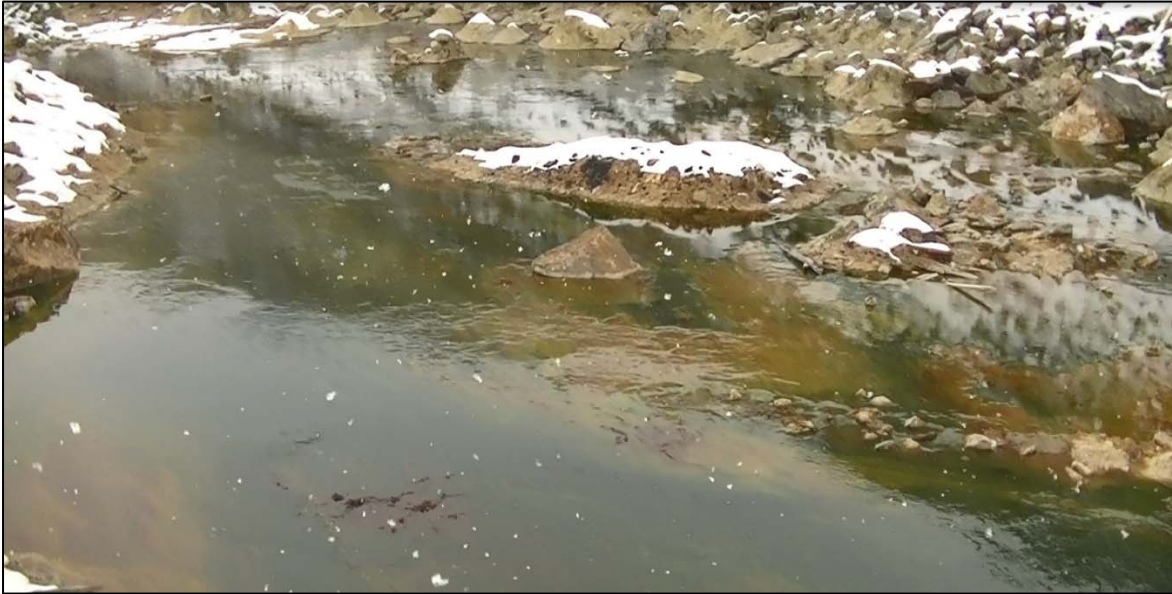
PHOTO 52 – Seepage at the Number 10 Seep bench area, looking northwest.

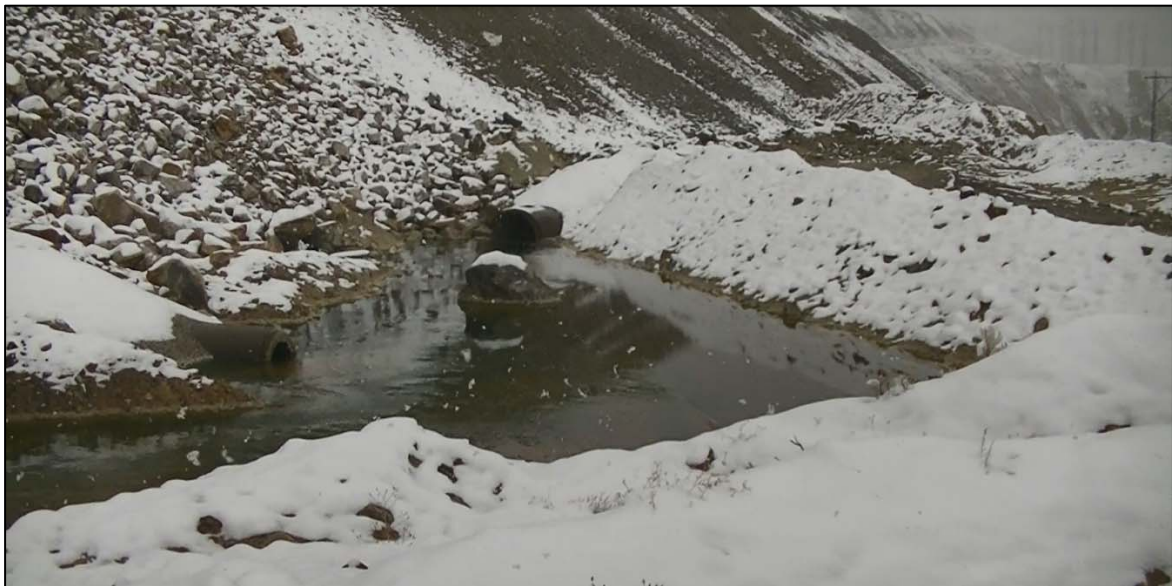
PHOTO 53 – Seepage at the Number 10 Seep bench area, looking east.

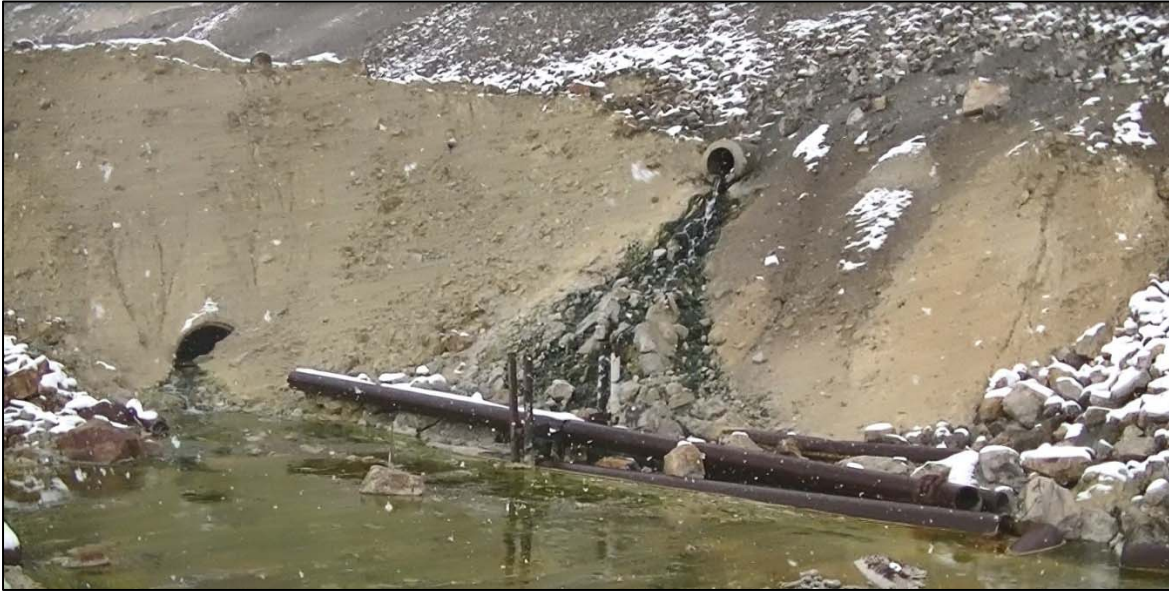
PHOTO 54 – Number 10 Seep collection area inflow.

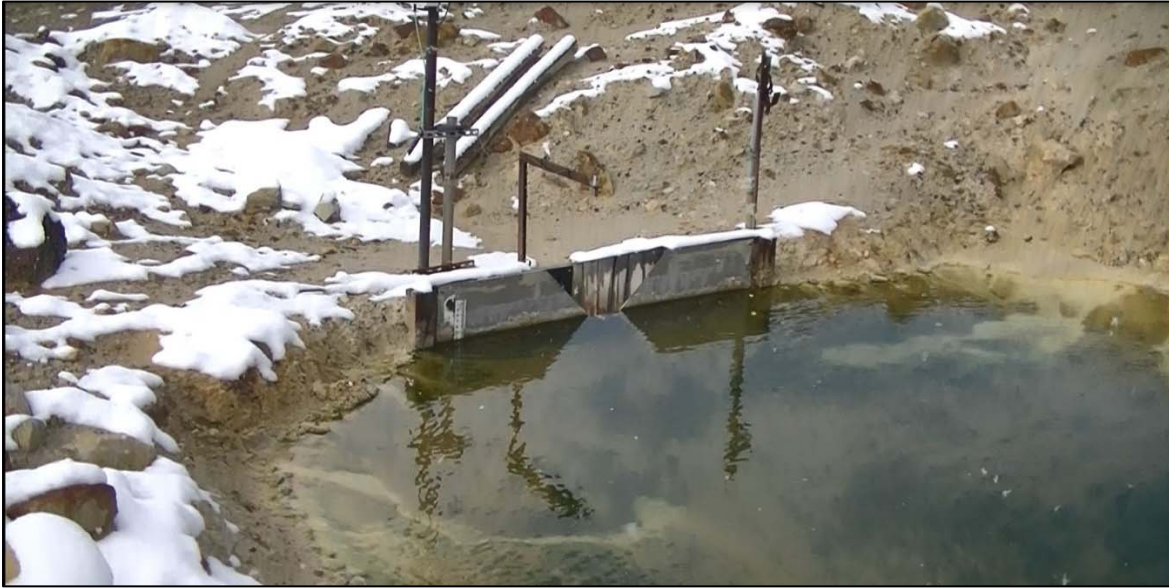
PHOTO 56 – Number 10 Seep V-notch weir and automated level sensor connected to the RMS.

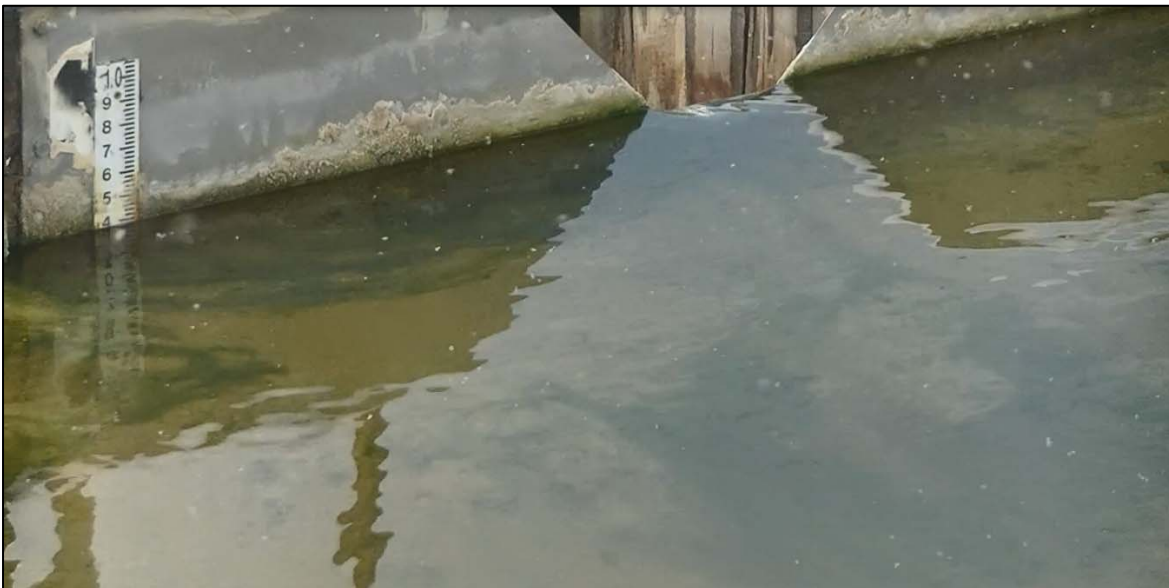
PHOTO 57 – Number 10 Seep V-notch weir staff gauge reading slightly below 0.4.

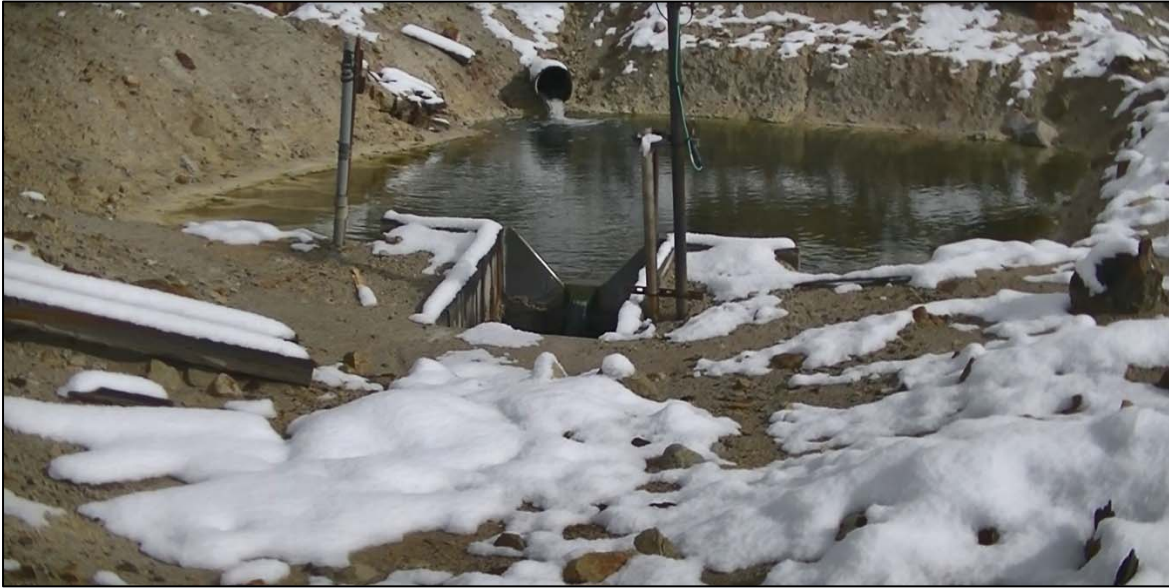
PHOTO 58 – Overview of Number 10 Seep stilling pond.
