Prepared for
Montana Resources, LLP
600 Shields Avenue
Butte, Montana
USA, 59701

Prepared by
Knight Piésold Ltd.
Suite 1400 - 750 West Pender Street
Vancouver, British Columbia
Canada, V6C 2T8

VA101-126/23-2

YANKEE DOODLE TAILINGS IMPOUNDMENT 2020 ANNUAL INSPECTION REPORT

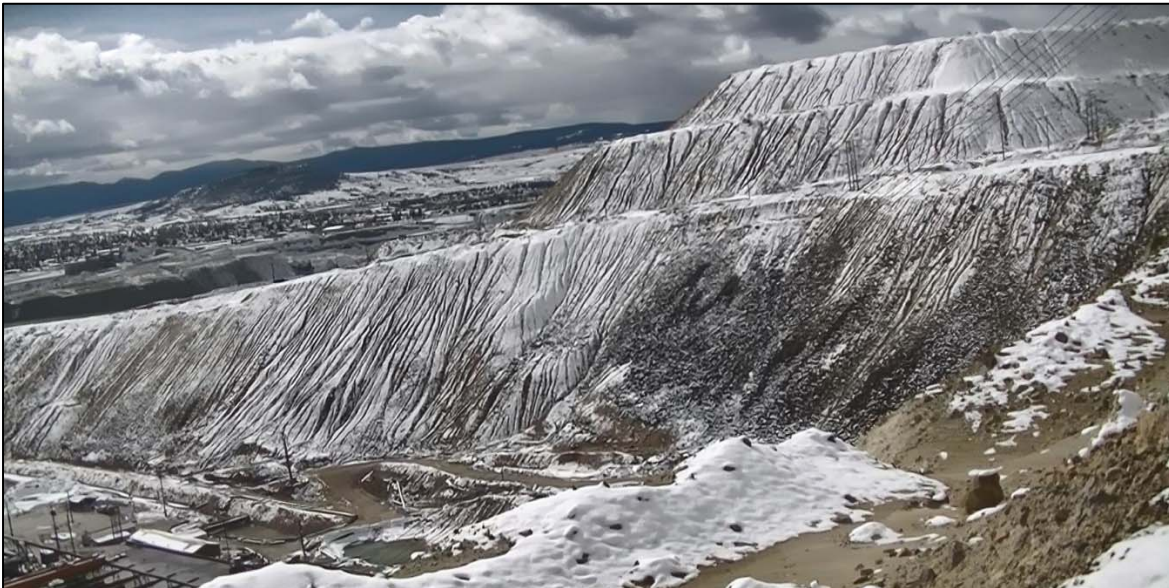
PHOTO 59 – Slope at northwest corner of HsB Area, looking east from Number 10 Seep area.

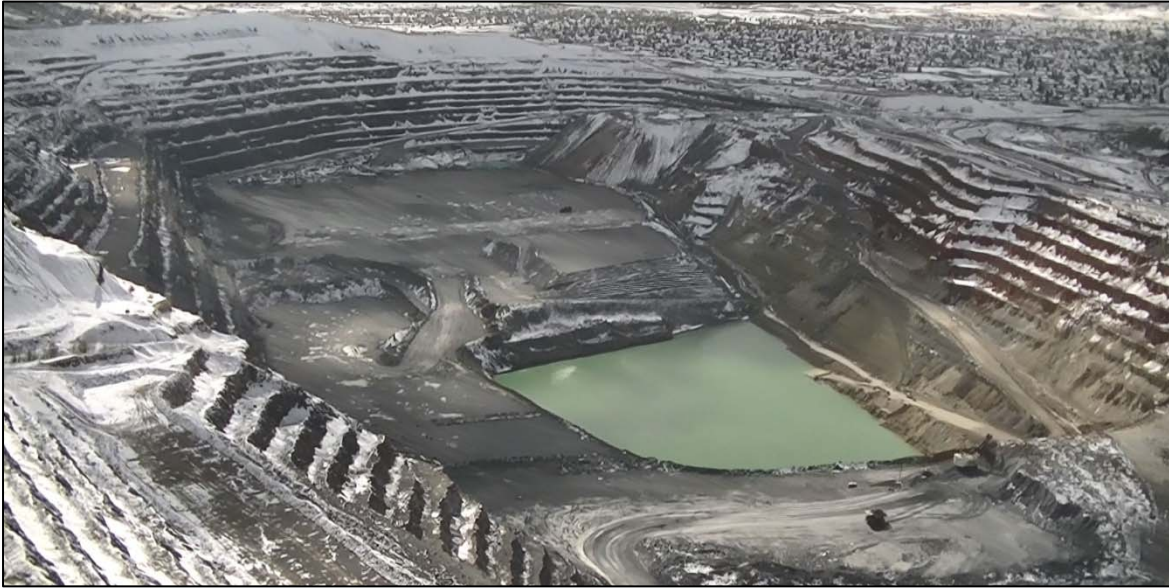
PHOTO 60 – Continental Pit, looking southeast from Sunflower Hill repeater.

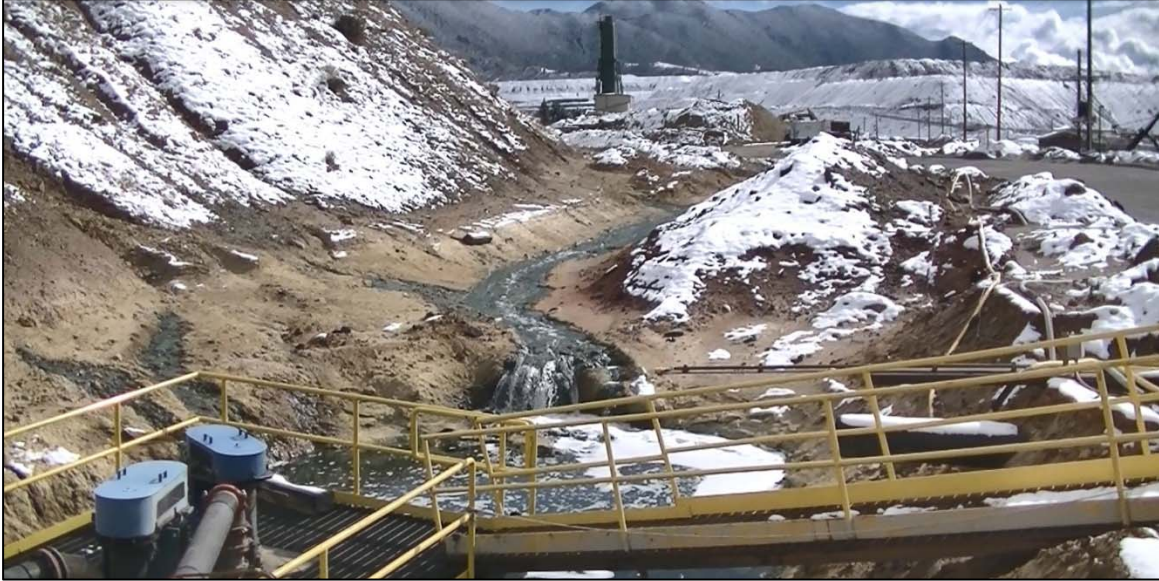
PHOTO 62 – Muddler Pump operating with a small overflow to the HsB Pond.

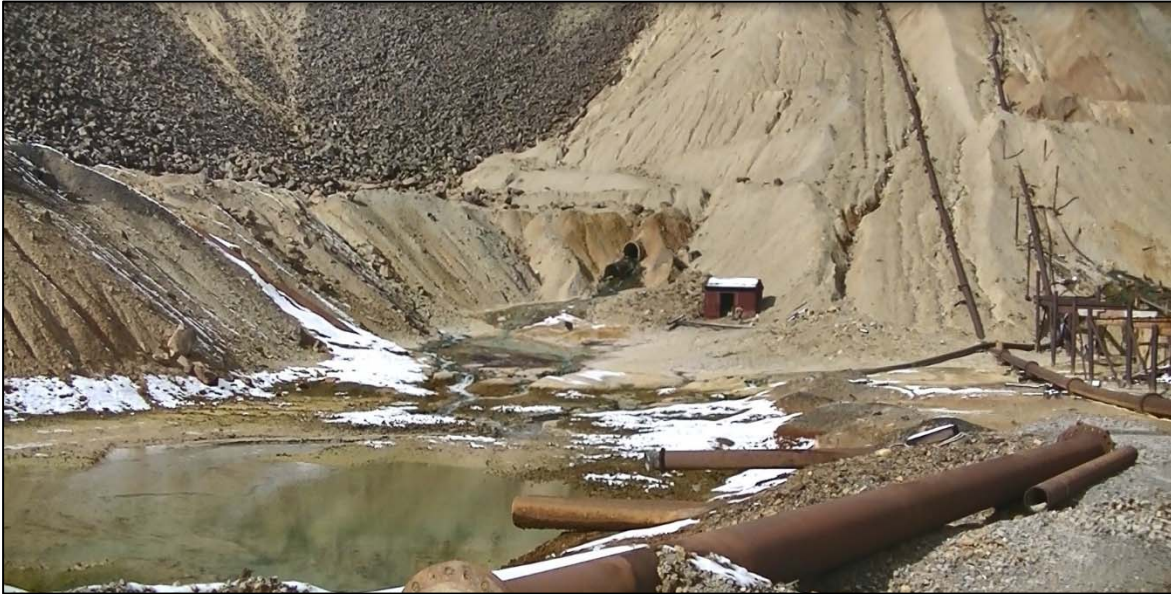
PHOTO 64 – Seepage collection area at the west side of the Upper HsB Area.

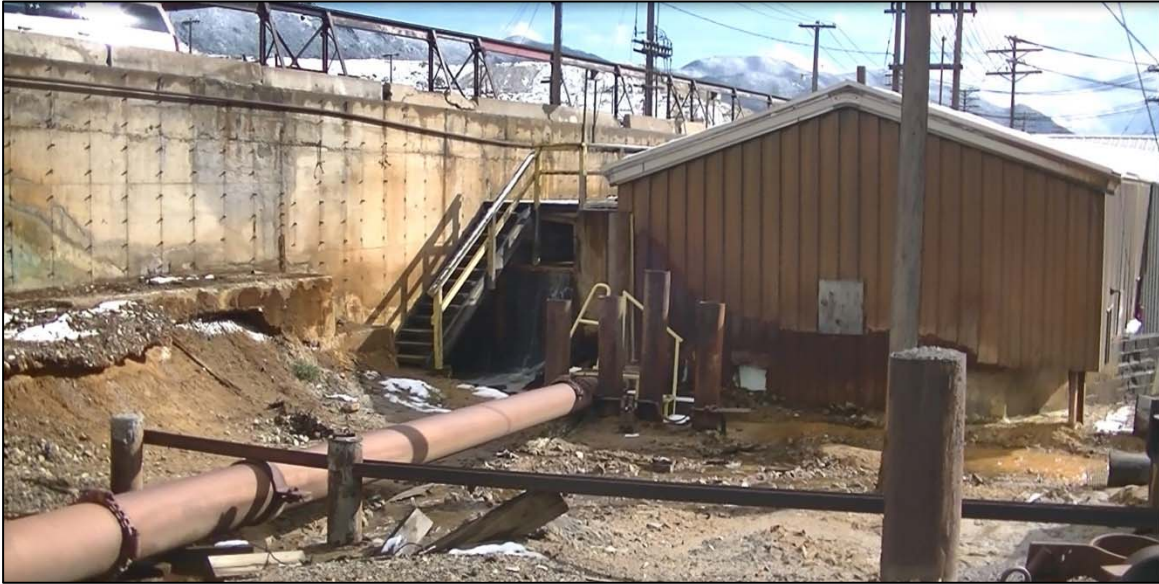
PHOTO 66 – Precipitation Plant Recirculation Pump House. There is overflow seen at the head tank under the stairs.

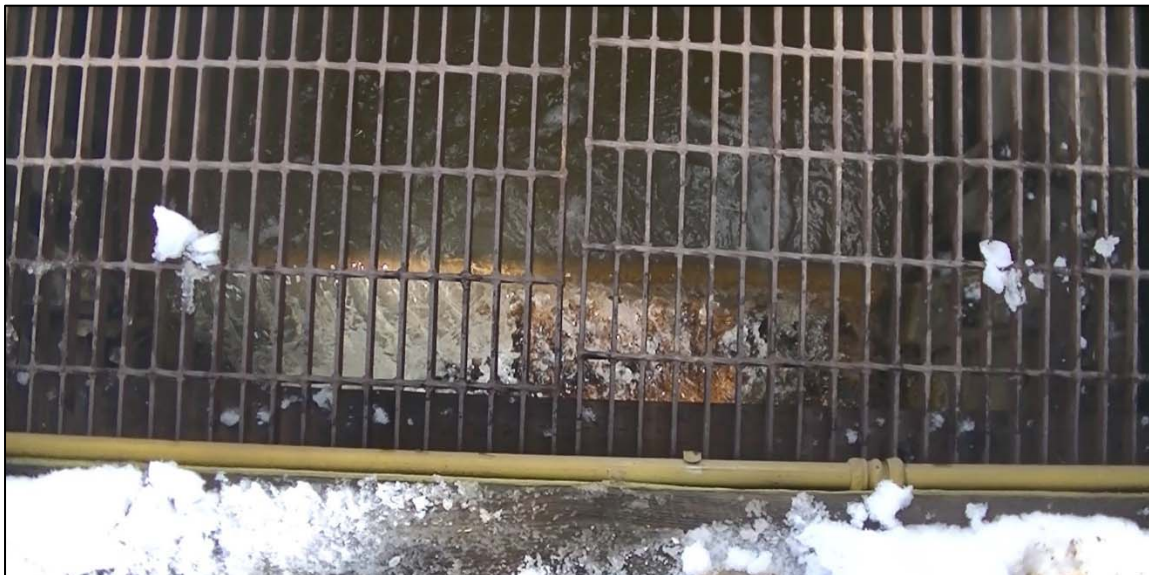
PHOTO 67 – Precipitation Plant overflow weir.

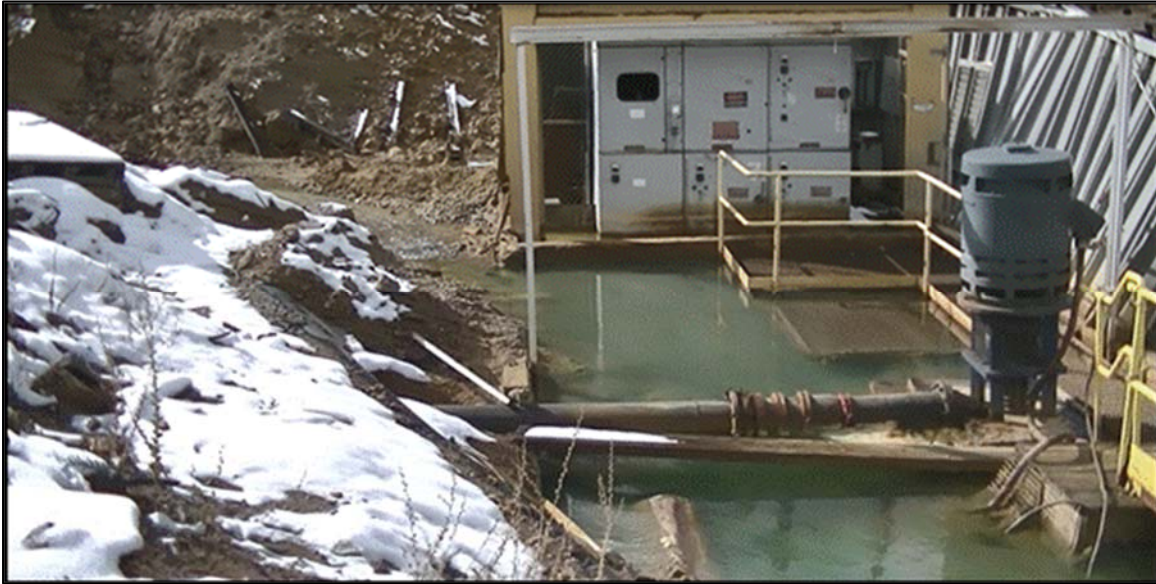
PHOTO 68 – Cell 10 Pump with overflow bypassing.

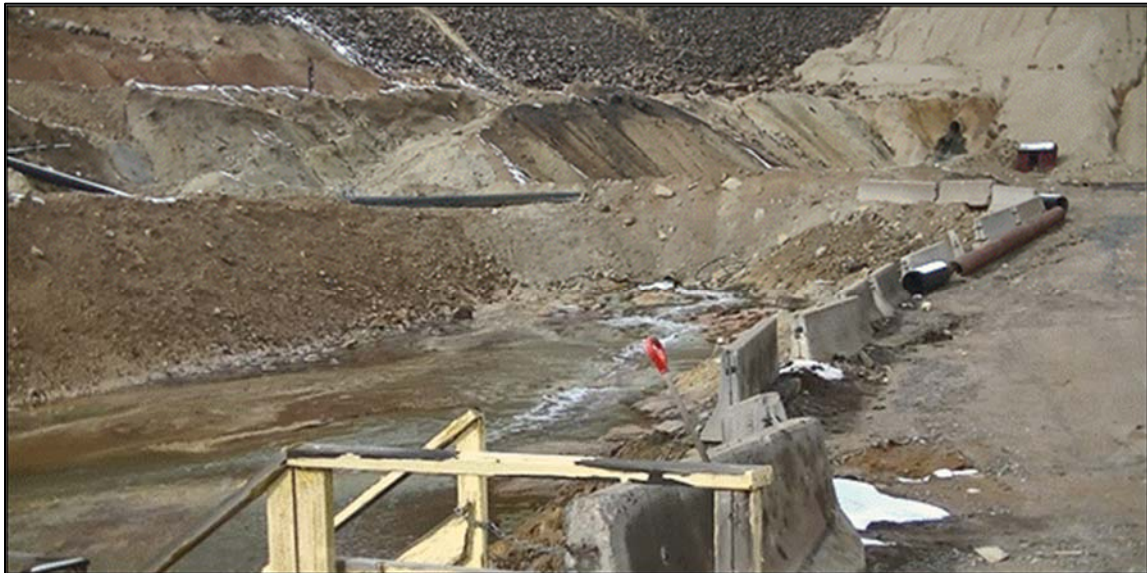
PHOTO 69 – Culvert discharging flow from Upper HsB area to Cell 10 pump area.

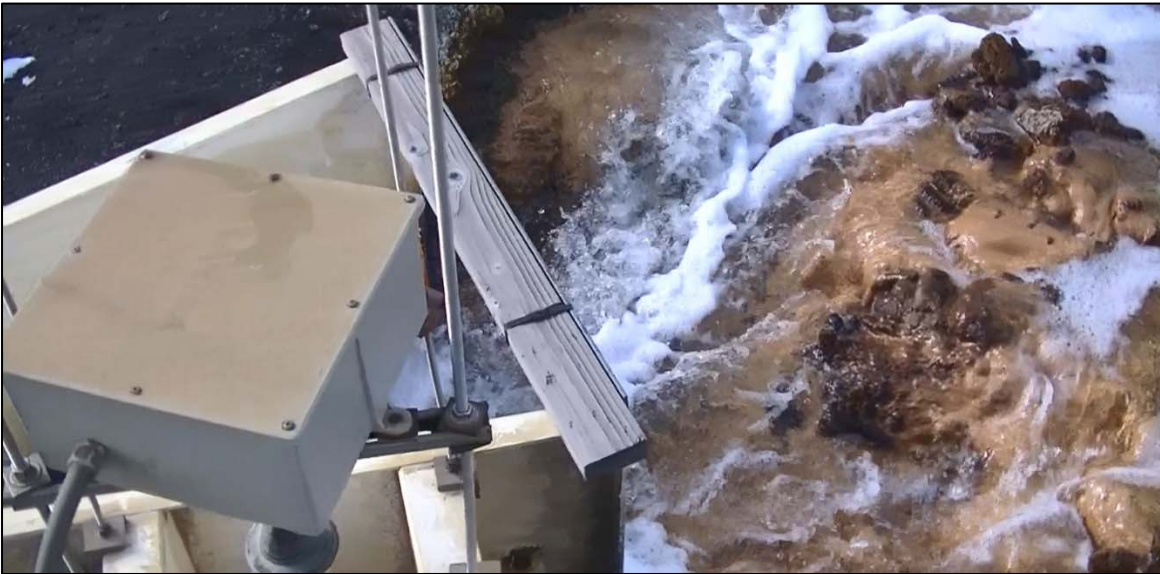
PHOTO 70 – Inlet of Parshall flume providing measurement of Cell 10 discharge flow.

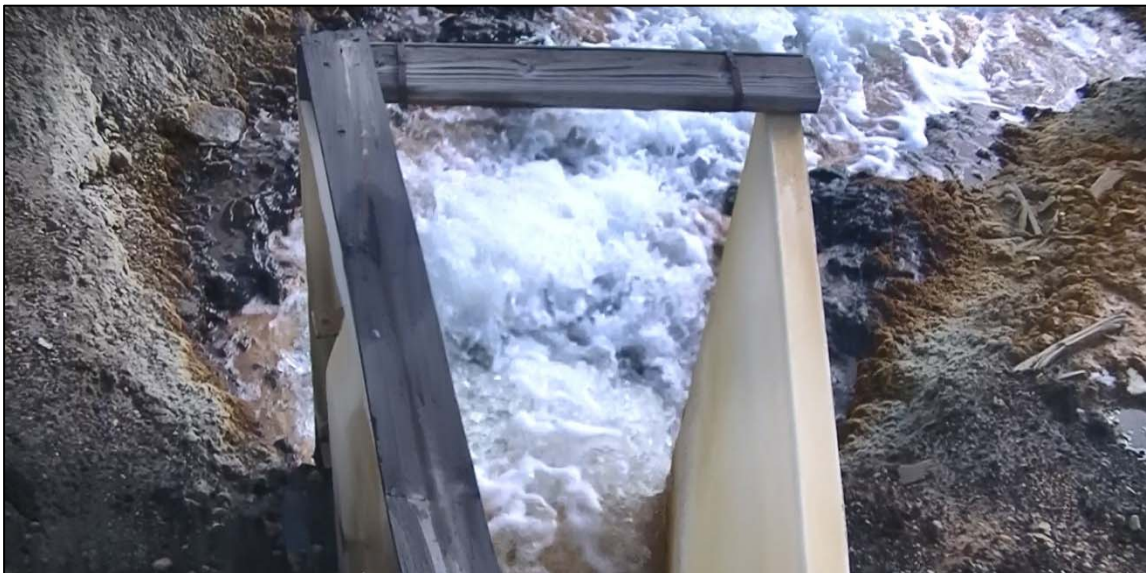
PHOTO 71 – Outlet of Parshall flume providing measurement of Cell 10 discharge flow.

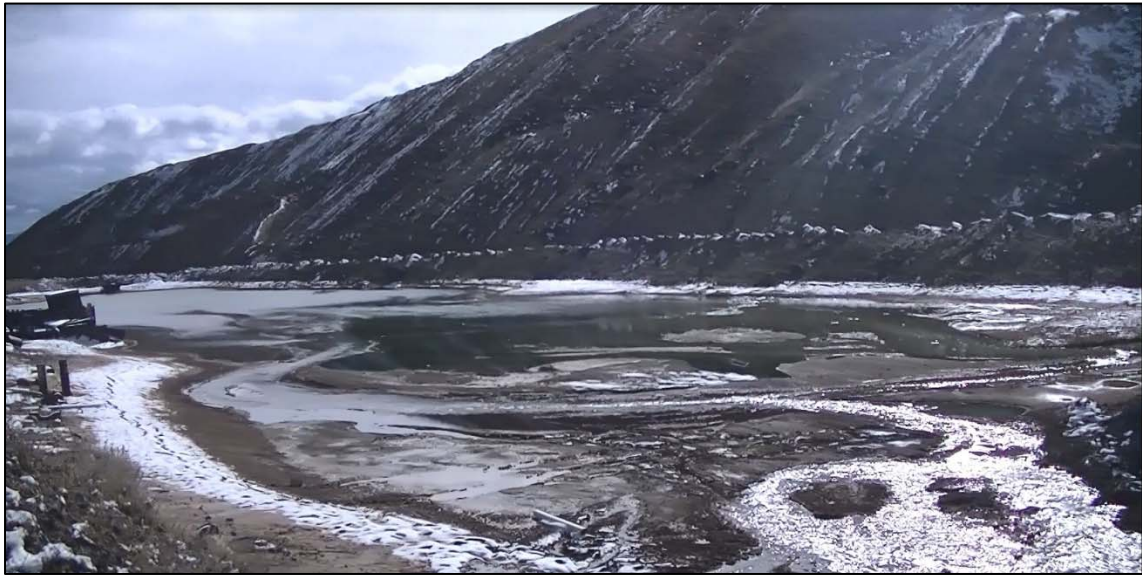
PHOTO 72 – West side of the Upper HsB Pond.

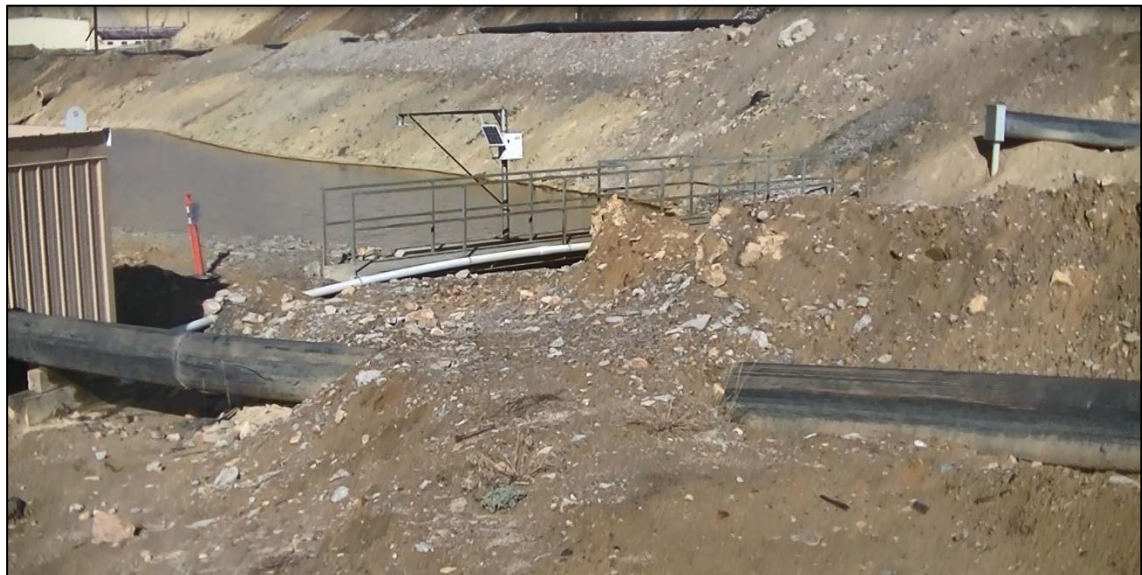
PHOTO 73 – HsB Pond and Weir.

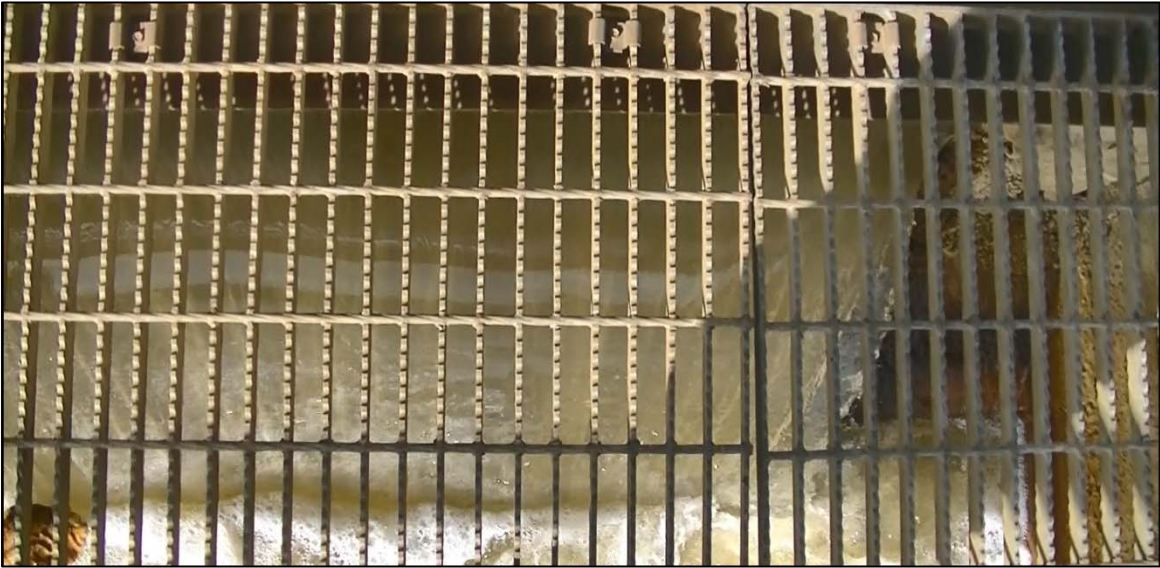
PHOTO 74 – Flow through the HsB Weir.

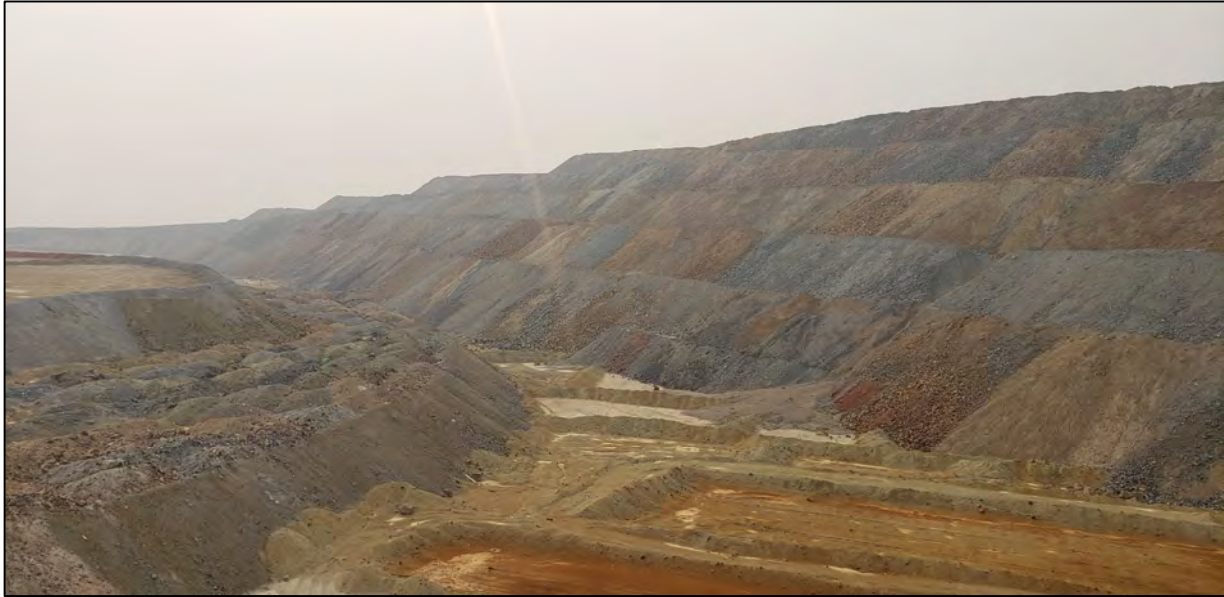
PHOTO 1 – North-South Embankment – Downstream step-out overview

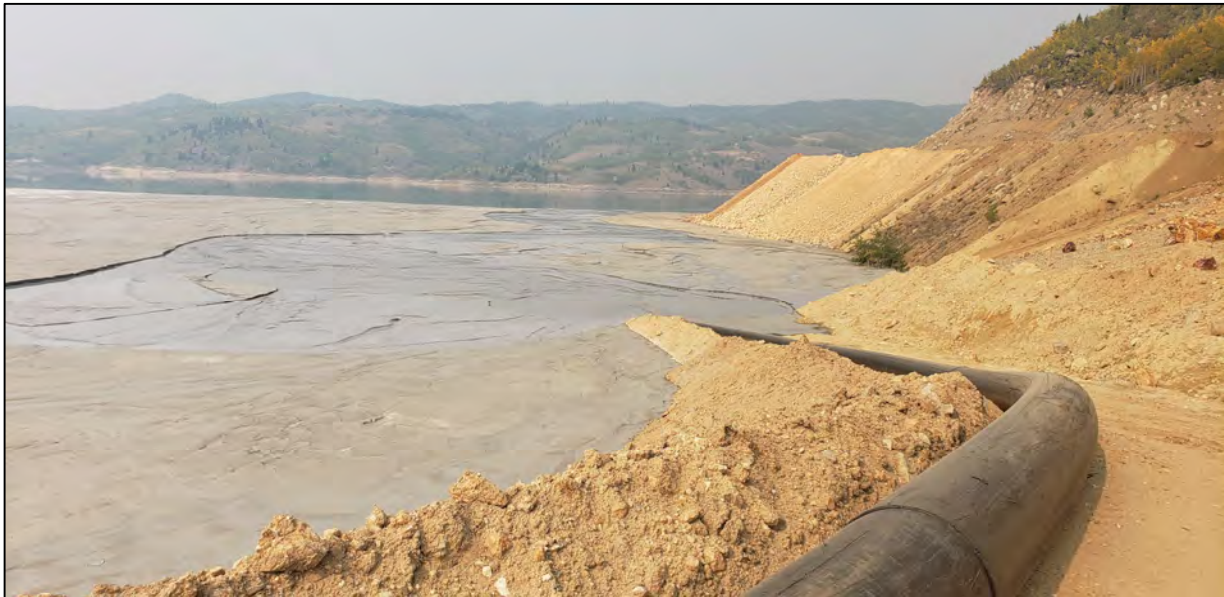
PHOTO 2 – North-South Embankment – Tailings discharge NS-4 and supernatant pond location

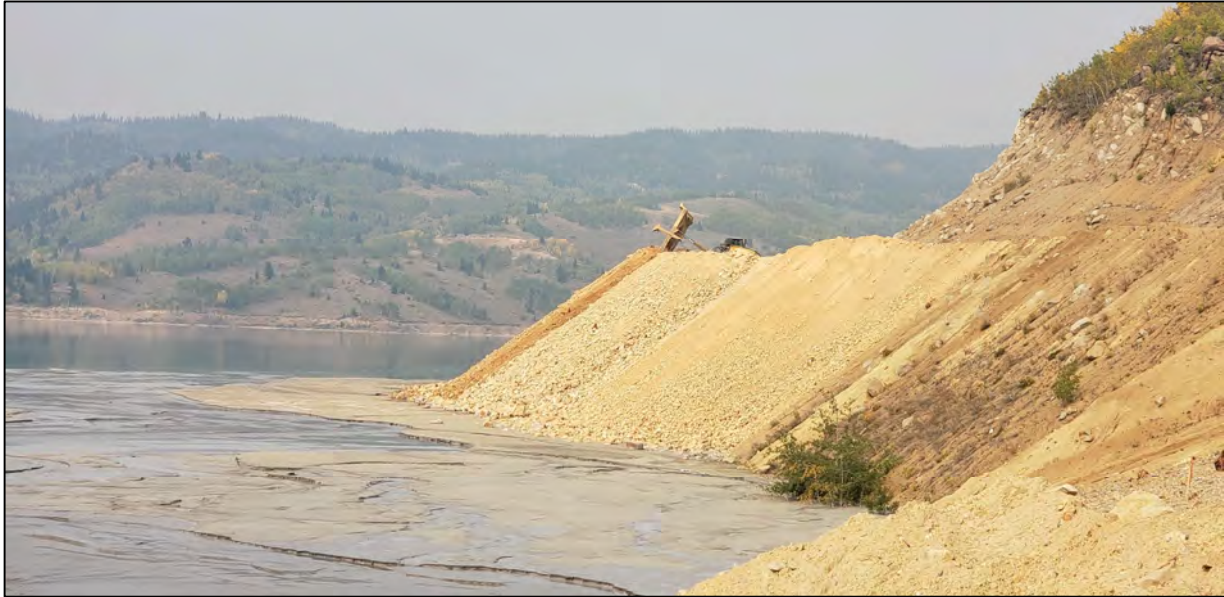
PHOTO 3 – North-South Embankment – Road widening to accommodate realignment of the Reclaim Water Pipeline

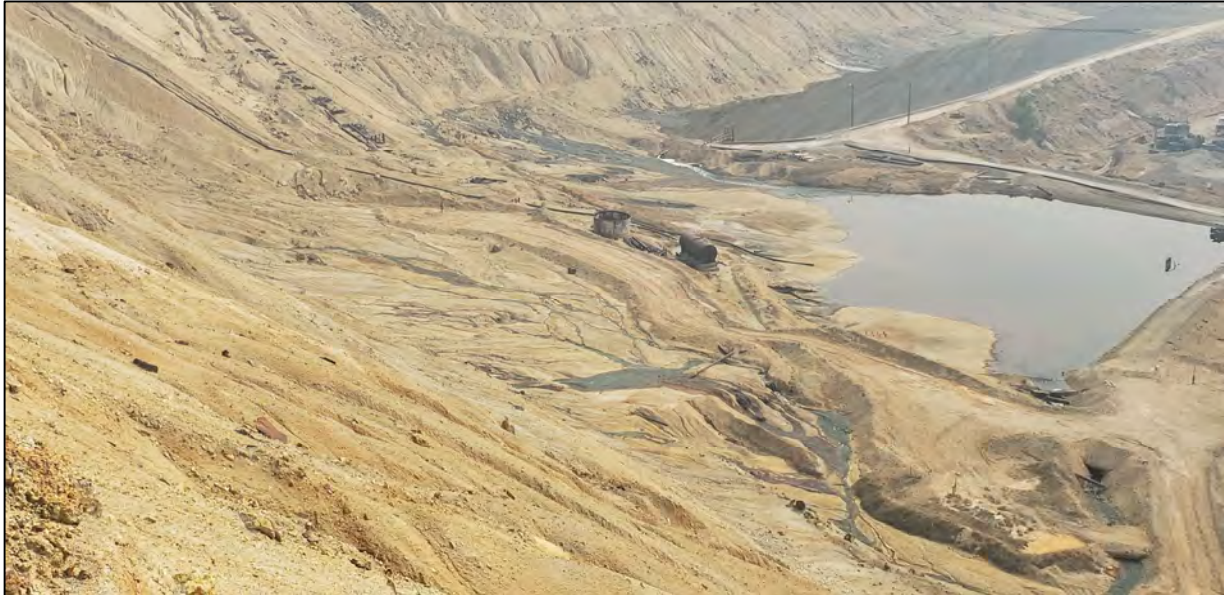
PHOTO 17 – HsB Area – Leach seeps along toe of East-West Embankment viewed from Seep 10 bench

MR is to continue to monitor the flow conditions adjacent to the Precipitation Plant and at the HsB Pond areas for any changes in flows or new seepage locations.

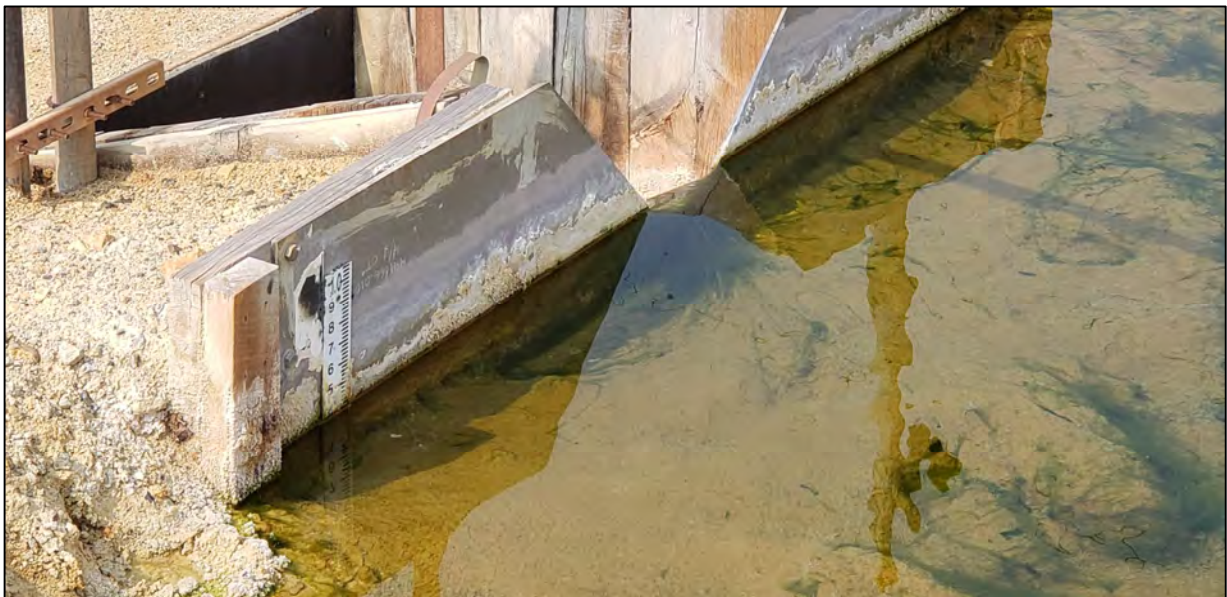
PHOTO 22 – Seep 10 Weir Staff Gauge reading approximately 0.4

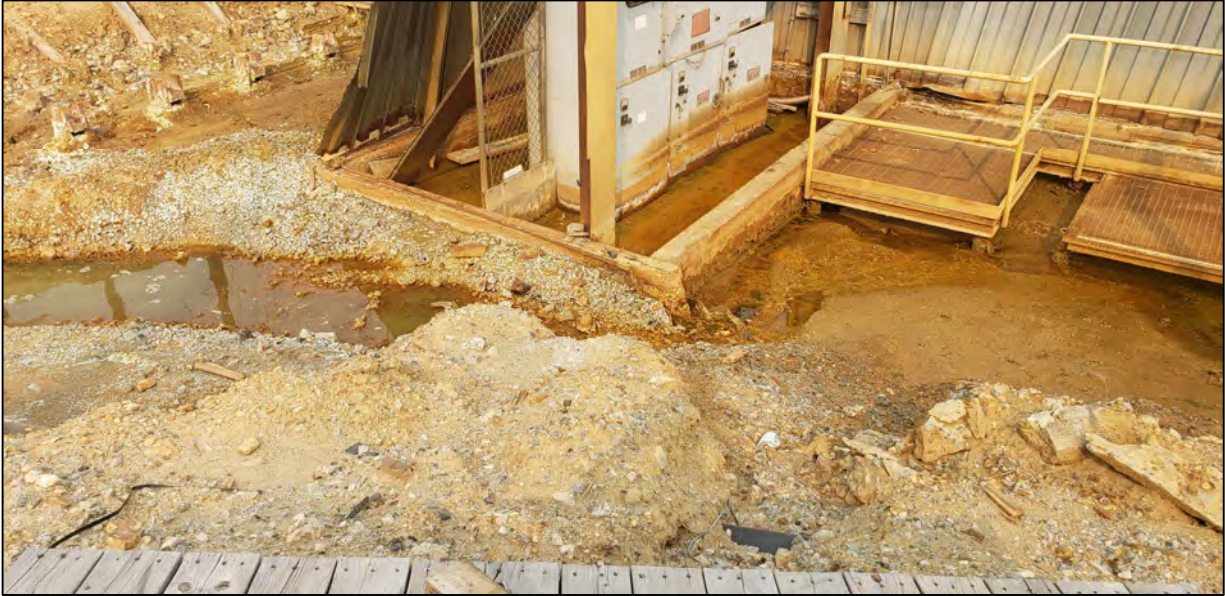
PHOTO 25 – HsB Area – Cell #10 Pump, minor overflow to HsB Lower Pond

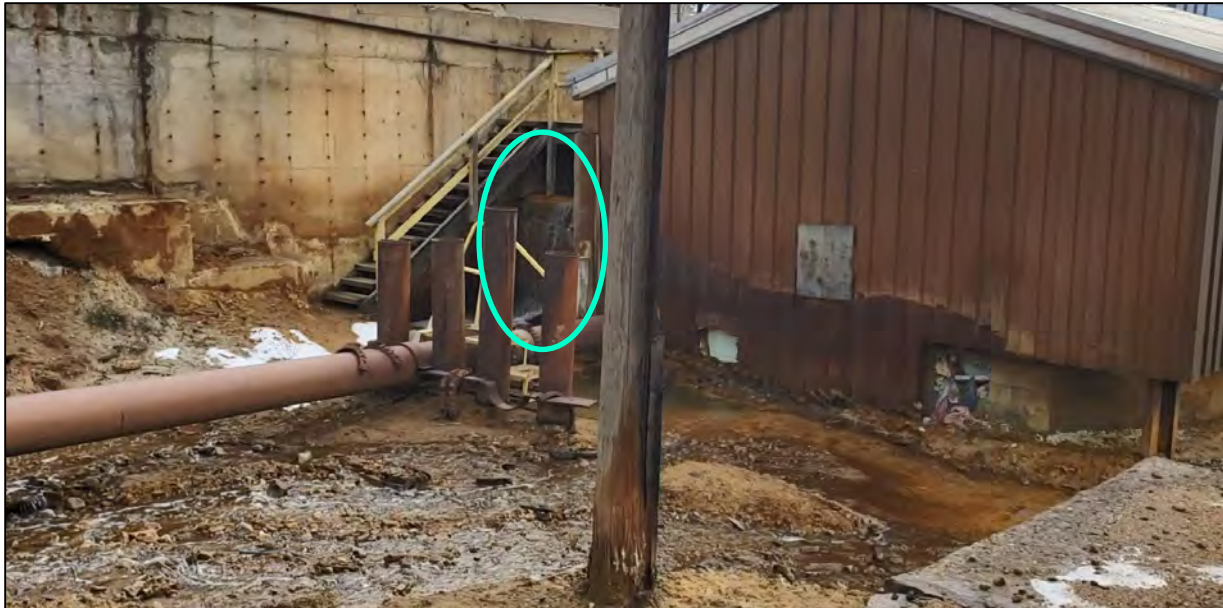
Water was also observed during Q3 2020 overflowing from the Precipitation Plant recirculation pump house head tank and draining to the adjacent HsB Pond (Photo 7.3). This unmeasured flow also reduces the contributing flows to the precipitation plant recirculation pump and overflow. Overflow at this location has been observed intermittently since Q4 2019.

Photo 7.3 Precipitation Plant Recirculation Pump House. Water is overflowing from the head tank under the stairs.

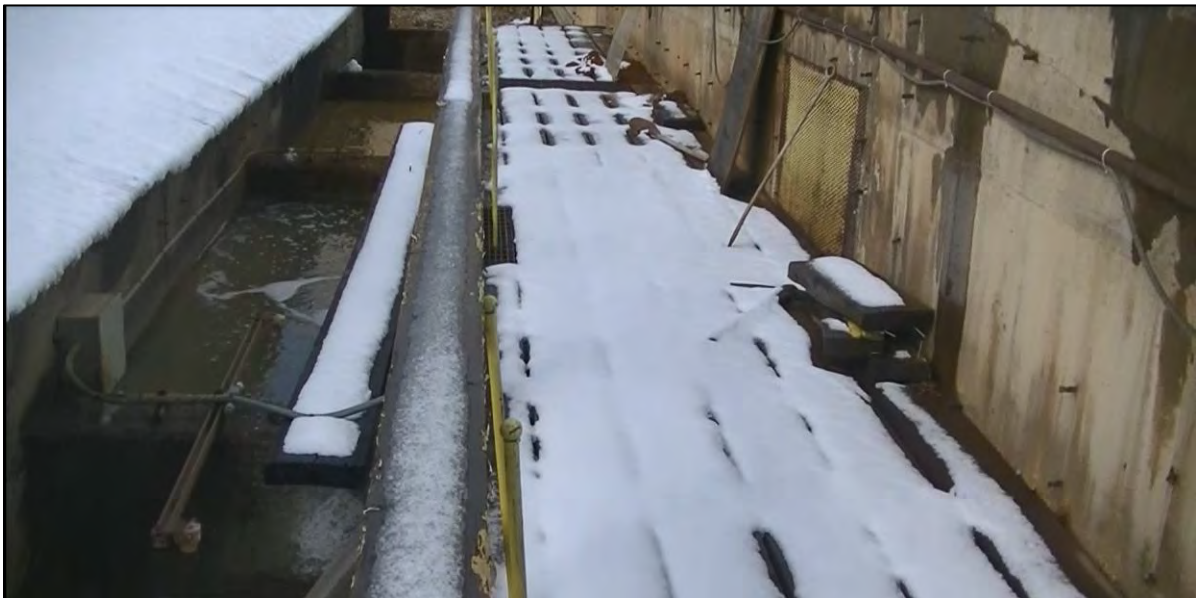
PHOTO 6 – Oct 15, 2020 – Precipitation Plant Recirculation Pump House head tank water level. Water is approximately 1 ft below the top of the concrete separators.
