Prepared for
Montana Resources, LLC
600 Shields Avenue
Butte, Montana
USA, 59701

Prepared by
Knight Piésold Ltd.
Suite 1400 - 750 West Pender Street
Vancouver, British Columbia
Canada, V6C 2T8

VA101-126/27-2

YANKEE DOODLE TAILINGS IMPOUNDMENT 2022 ANNUAL INSPECTION REPORT

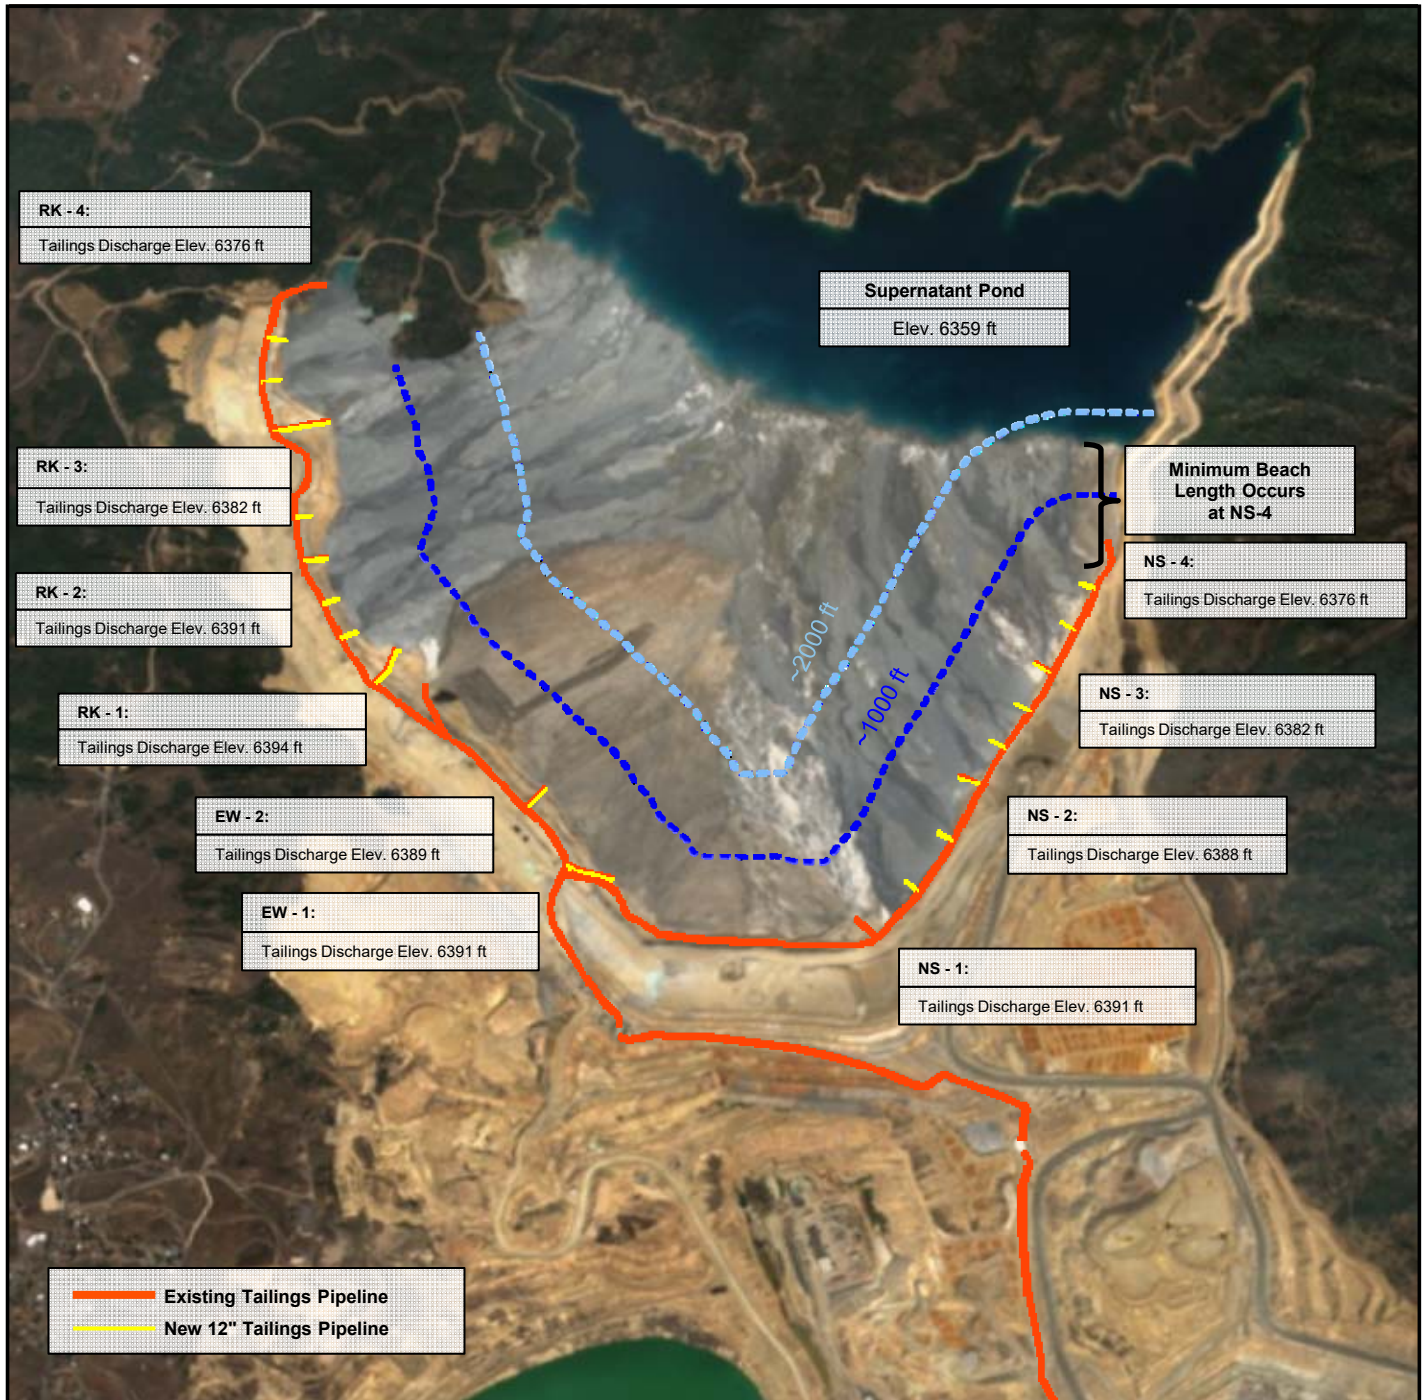
The tailings beach continued to be well managed in 2022 with the shortest beach length (of approximately 1,500 ft) typically observed at the northern end of the North-South Embankment, consistent with previous years. The tailings beach remains well drained and firm where tailings are not being actively discharged, consistent with the key performance objectives for the impoundment.

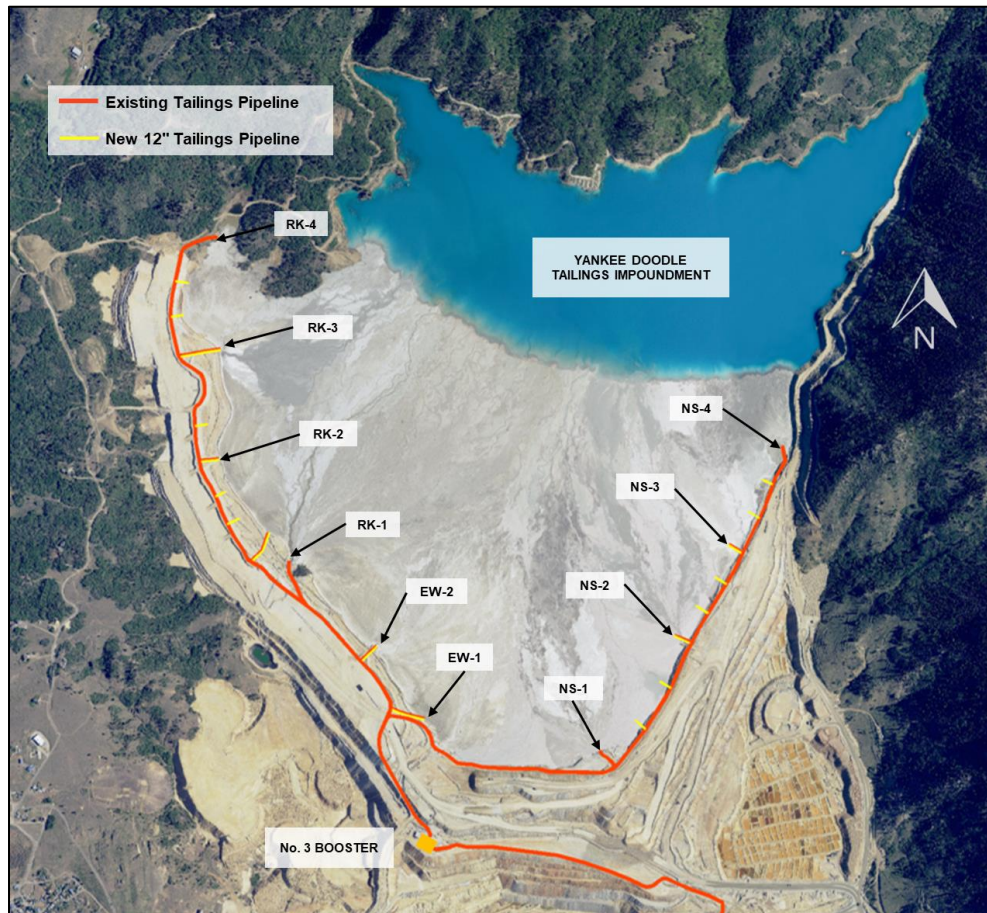
Figure 3.5 YDTI Tailings Discharge Locations

MR completed the installation of 18 new discharge locations, comprising single or twinned 12-inch pipelines, during Q2 and Q3 2022. The 12-inch discharge lines are distributed along the YDTI embankments as shown on Figure 3.5. The new smaller diameter discharge lines are typically operated to enhance beach wetting (to help limit the potential for blowing tailings) with discharge occurring at several locations along the line concurrently. This discharge strategy provides additional flexibility to maintain beach wetting in broad areas without cycling discharge locations, while leaving other beach areas exposed longer to improve trafficability for application of dust suppressants (e.g. magnesium chloride) using MR's track mounted Terramac units. Field observations from the site inspections and remote sensing data indicates that this approach appears to be very effective. The satellite image included on Figure 2.1 provides a good example of the effectiveness.

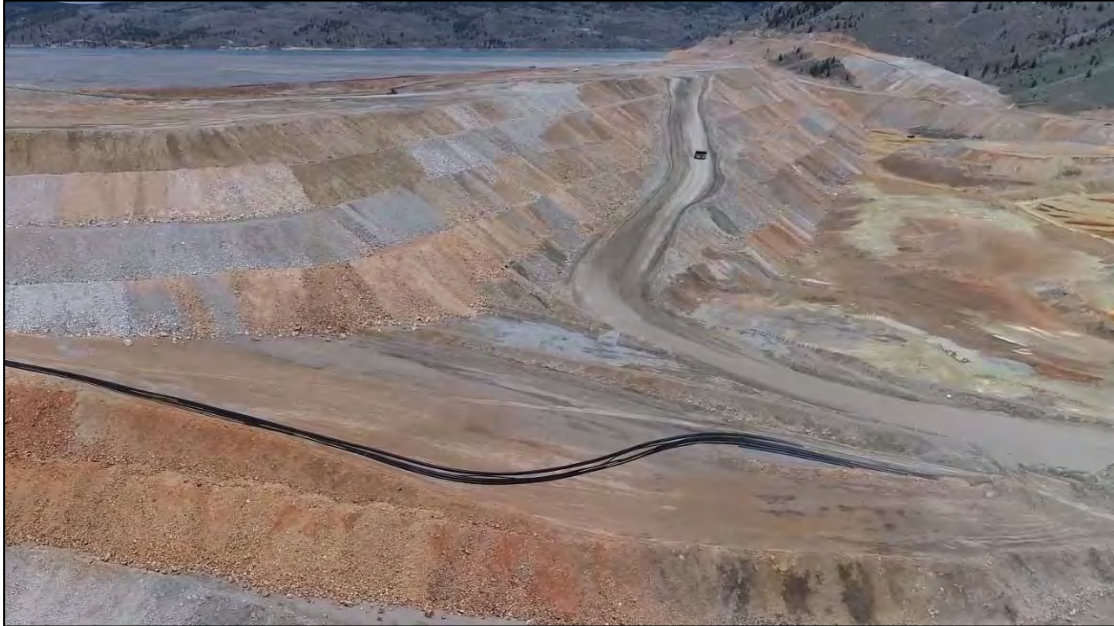
PHOTO 1 – North-South Embankment downstream shell, facing north from southeast end of YDTI.

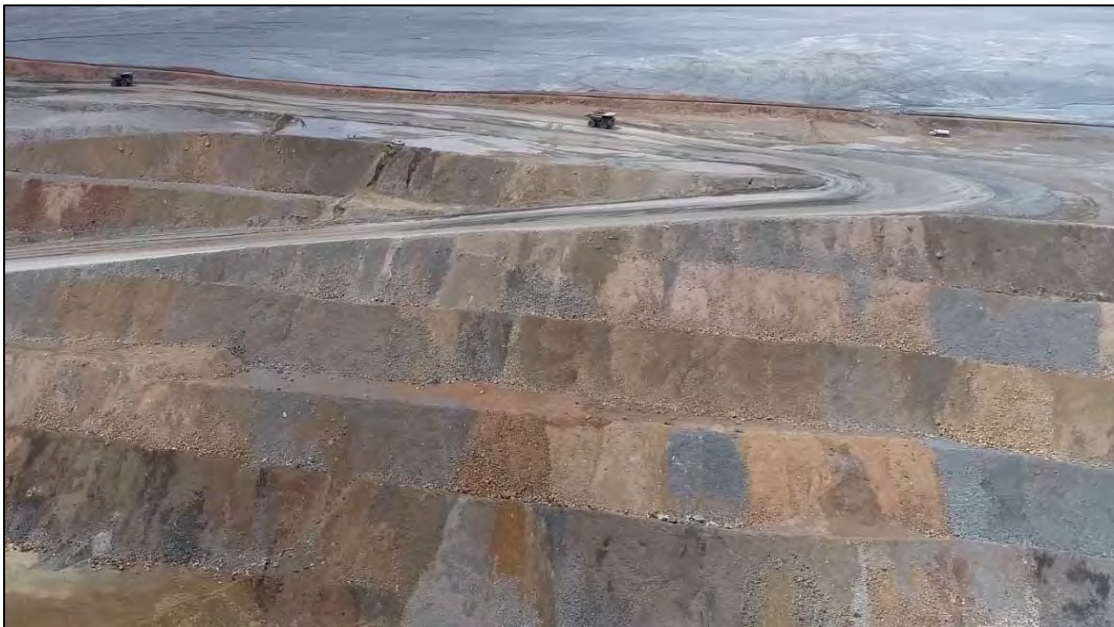
PHOTO 2 – North-South Embankment downstream shell, facing west towards the top of the mine haul ramp at EL. 6,400 ft.

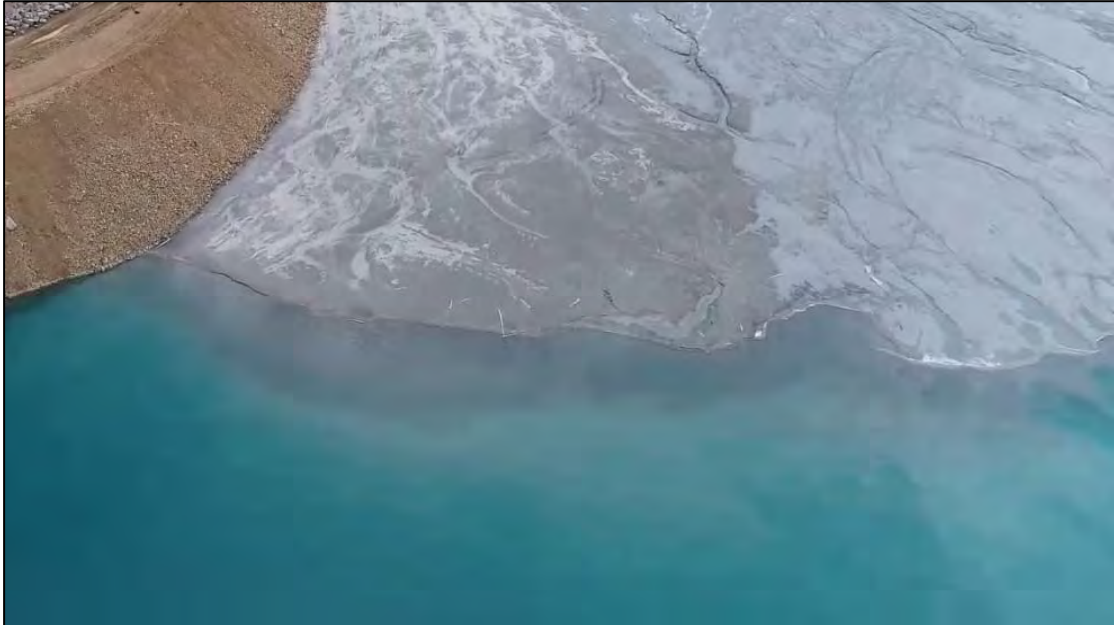
PHOTO 5 – Tailings beach and supernatant pond interface, looking south from the supernatant pond.

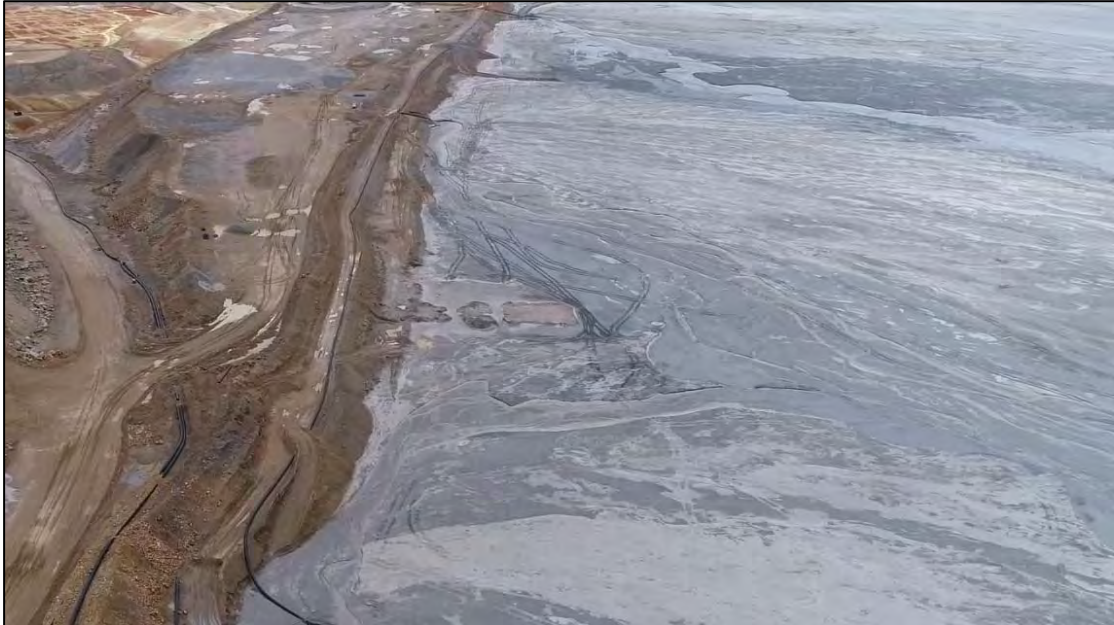
PHOTO 7 – North-South Embankment crest (left), tailings discharge corridor, and tailings beach (right) near tailings discharge NS-4.

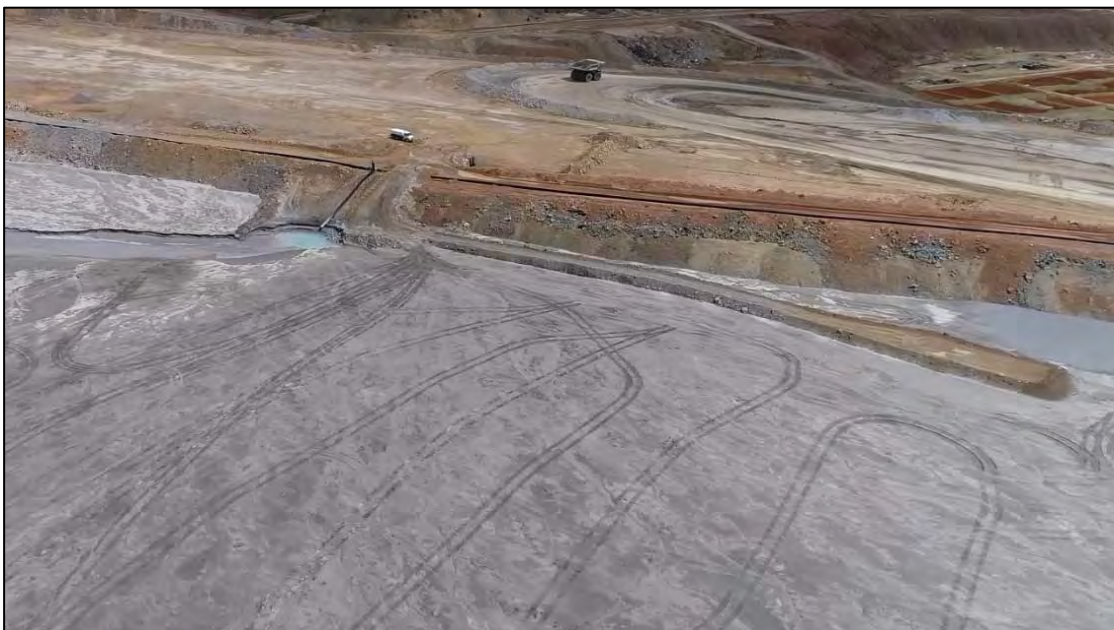
PHOTO 8 – Upstream side of the North-South Embankment by tailings discharge location NS-2, facing east.

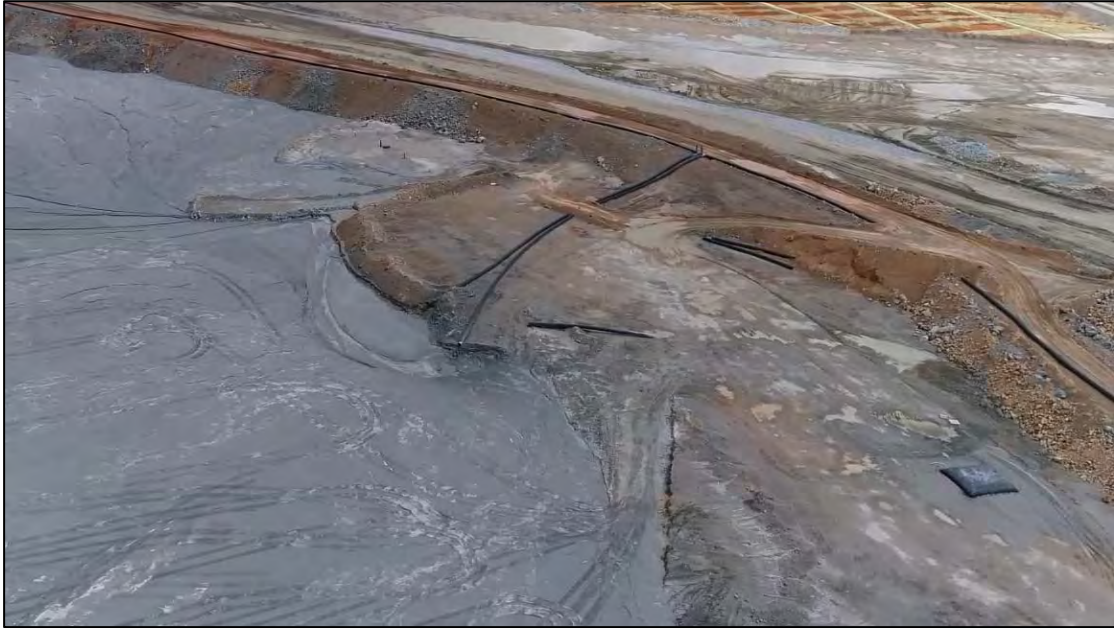
PHOTO 9 – Discharge location NS-1 along the North-South Embankment, facing east.

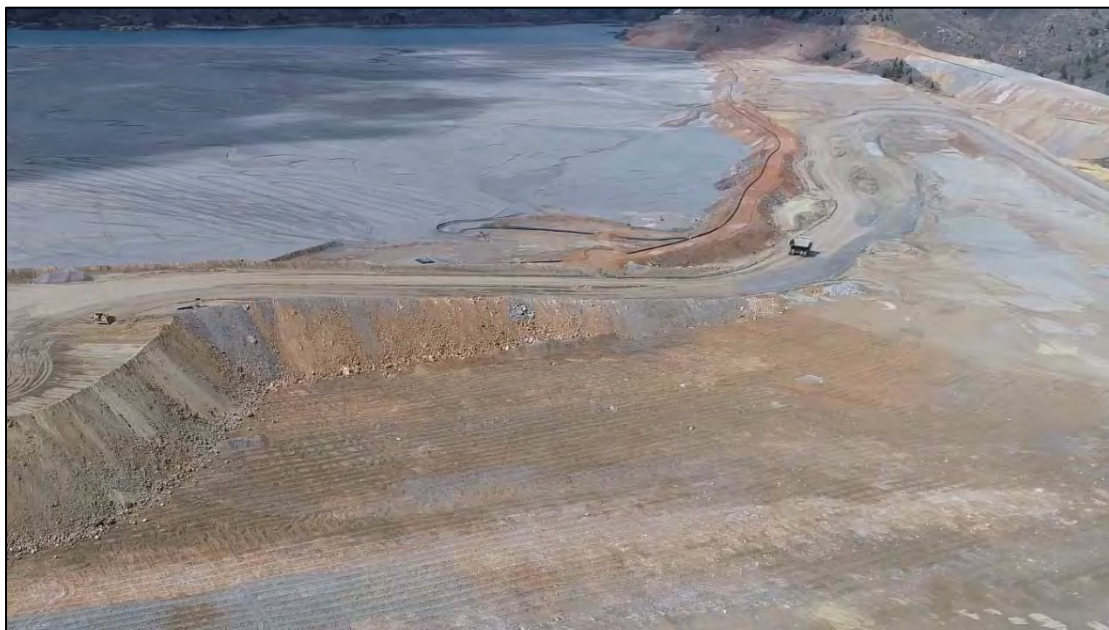
PHOTO 10 – Tailings beach (left), EL. 6,450 ft rockfill surcharge placement progress (left), North-South Embankment crest (right), and subgrade preparation at the North-South Embankment and East-West Embankment tie-in area, facing north.

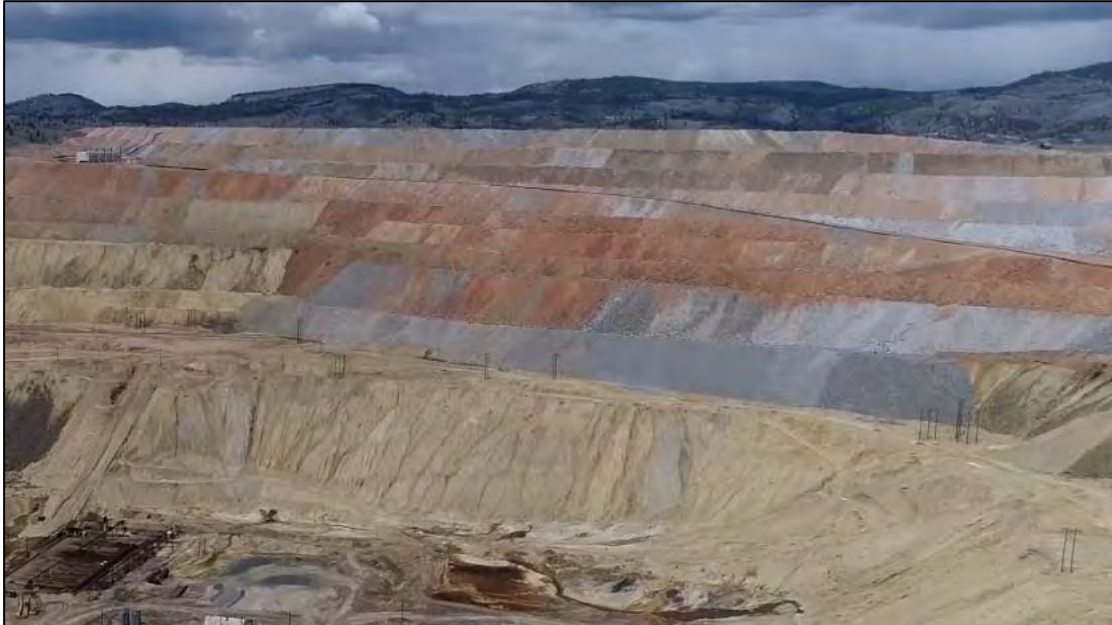
PHOTO 11 – East-West Embankment downstream slope and Number 10 Seep bench area, facing north.

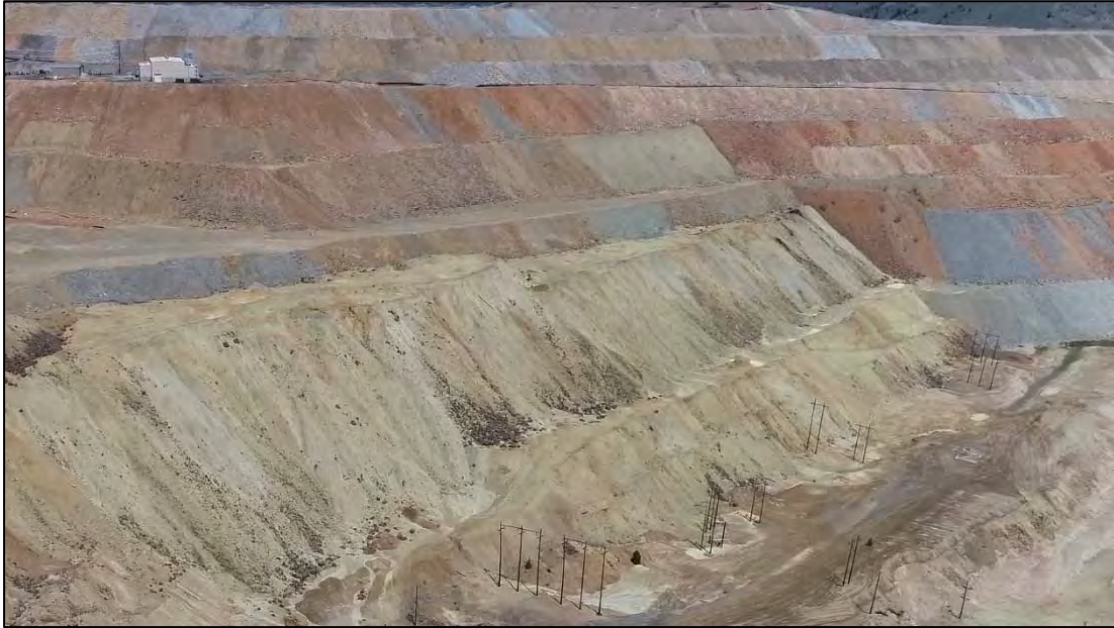
PHOTO 13 – Central pedestal area of the East-West Embankment, looking northeast.

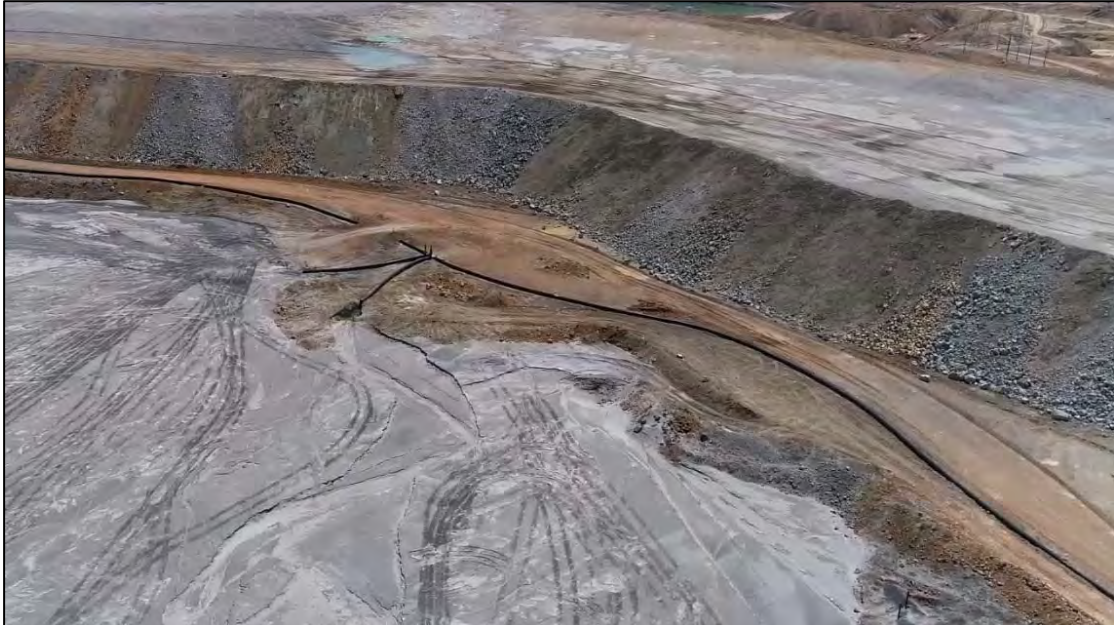
PHOTO 17 – East-West Embankment upstream face at discharge location EW-1, facing south.

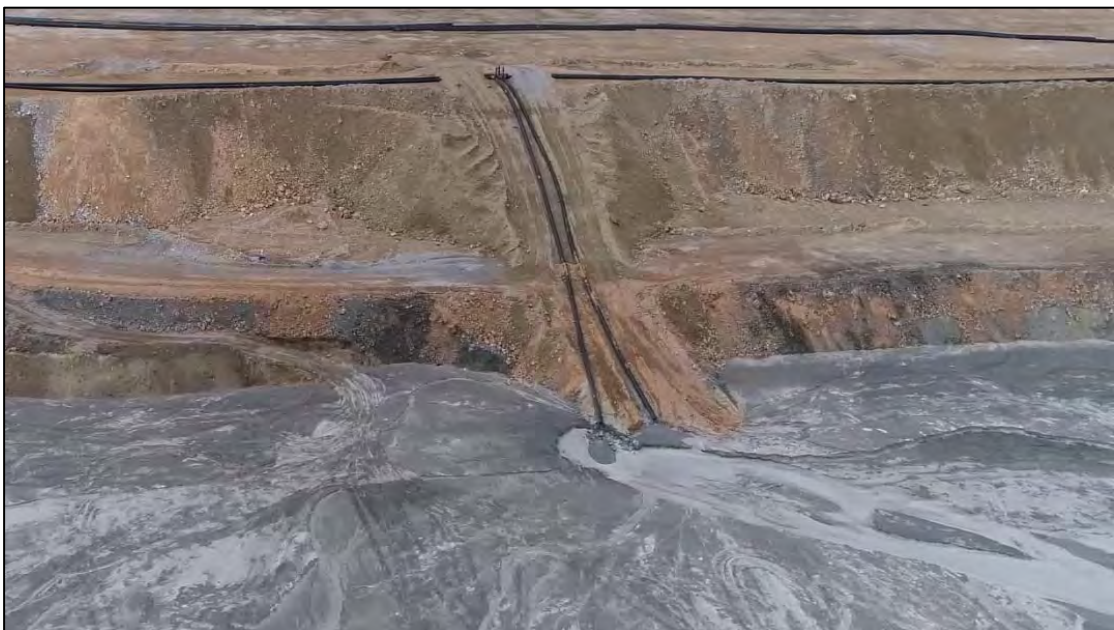
PHOTO 20 – East-West Embankment upstream side at discharge location EW-2, facing southwest.

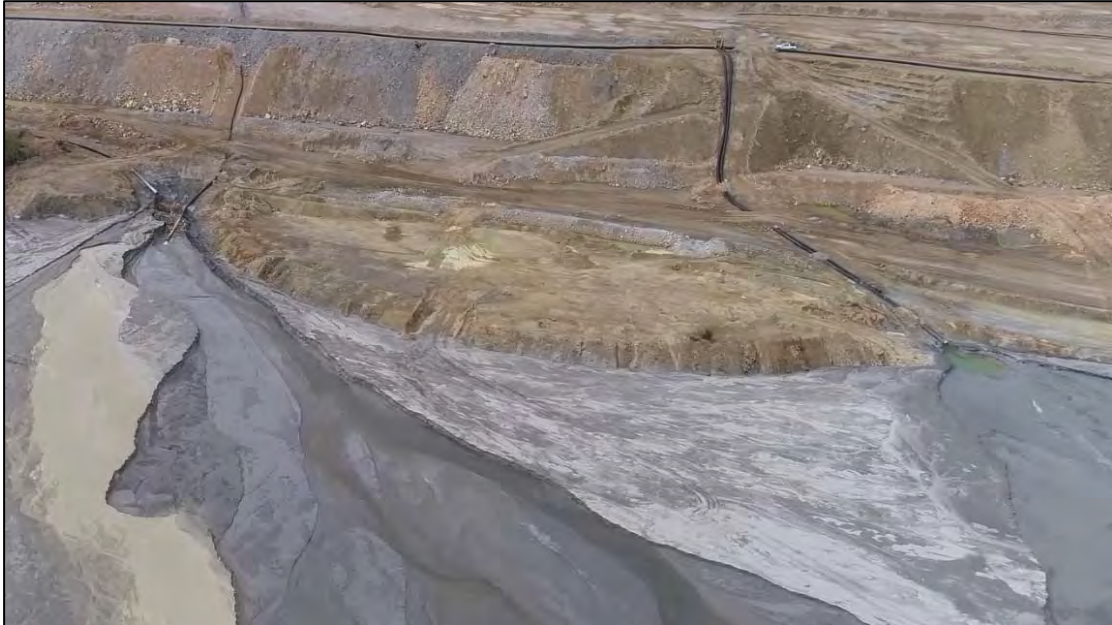
PHOTO 21 –West Embankment upstream interface near Rocky Knob, with view of discharge location RK-1 and an adjacent, recently installed 12” discharge, facing south.

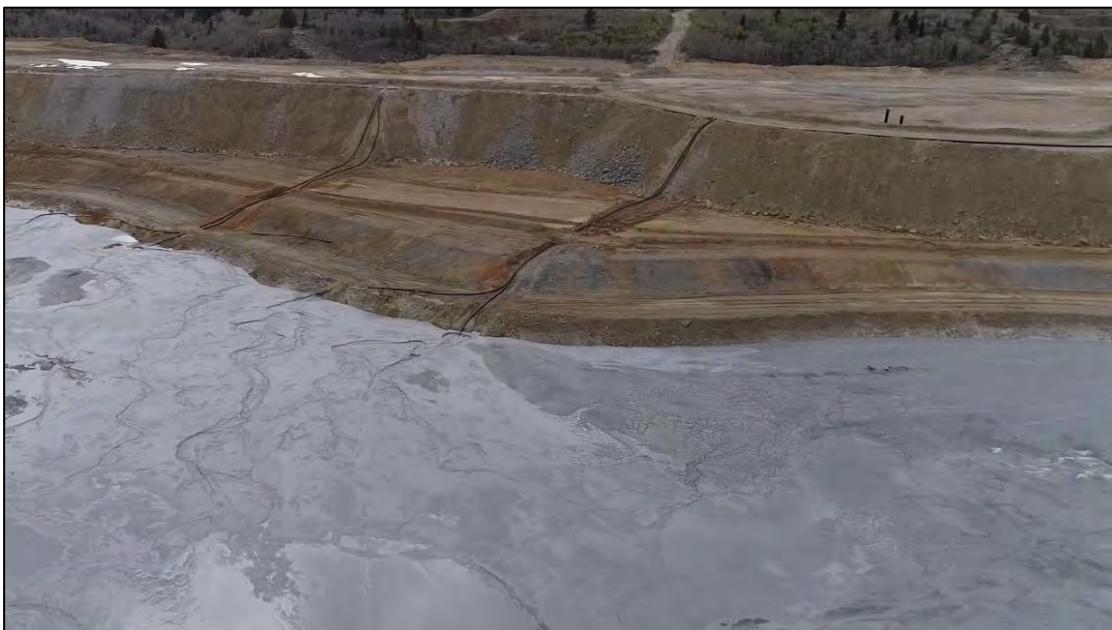
PHOTO 22 – West Embankment upstream interface with view of recently installed 12” discharges between discharge locations RK-2 and RK-3, facing west.

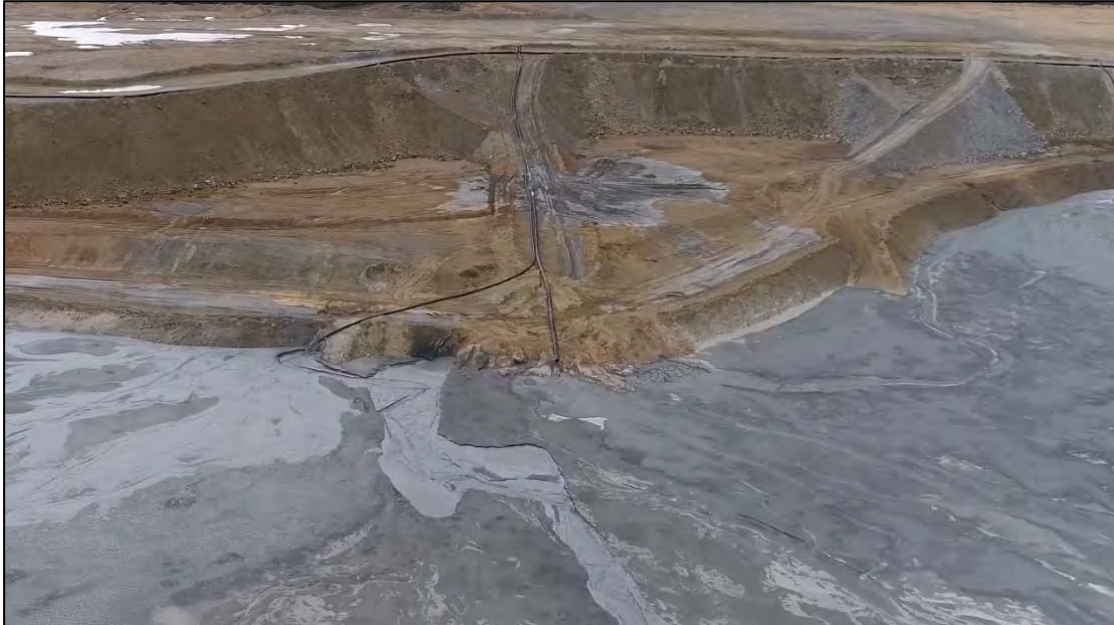
PHOTO 23 – West Embankment upstream interface and discharge location RK-3, facing west.

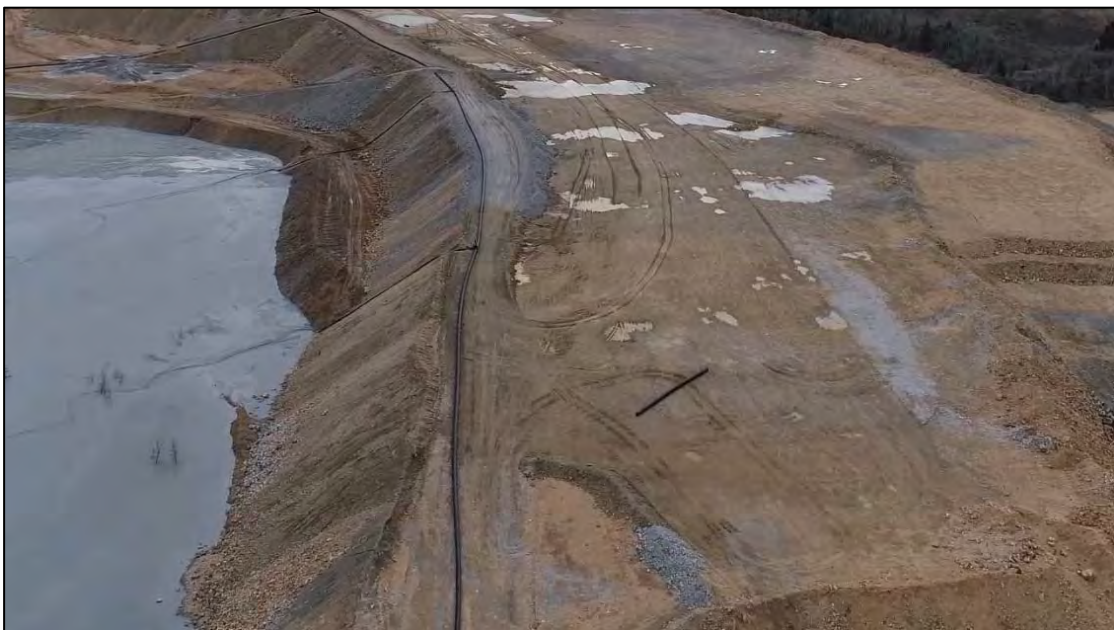
PHOTO 24 – Northern end of West Embankment with view of upstream interface and EL. 6,450 ft crest, facing south near discharge location RK-4.

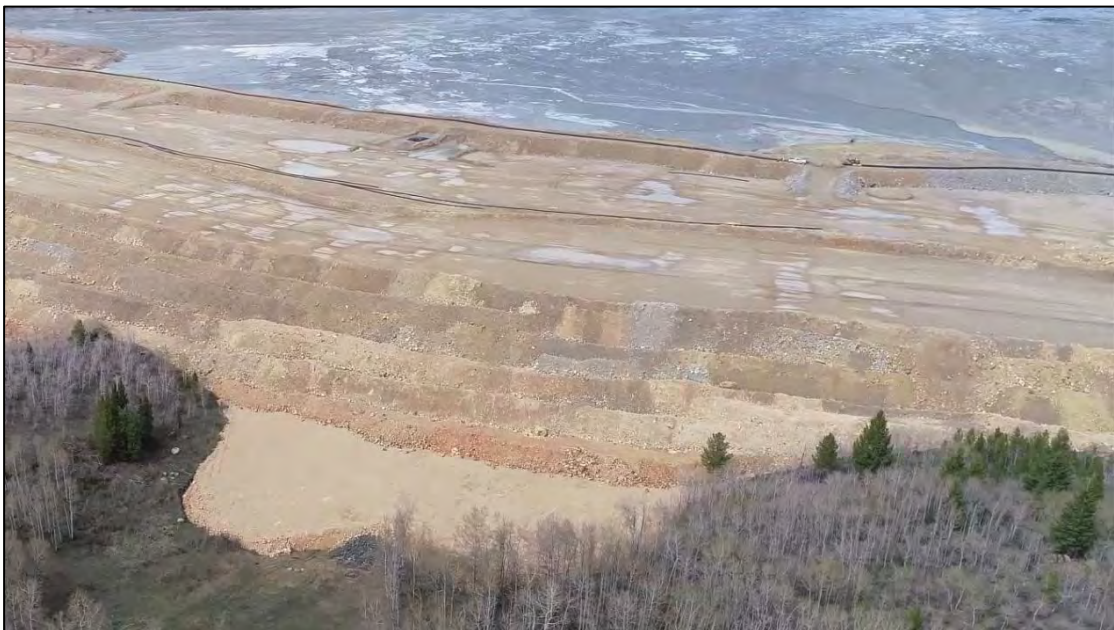
PHOTO 26 – West Embankment downstream shell, northwest of Rocky Knob and Extraction Pond, looking northeast.

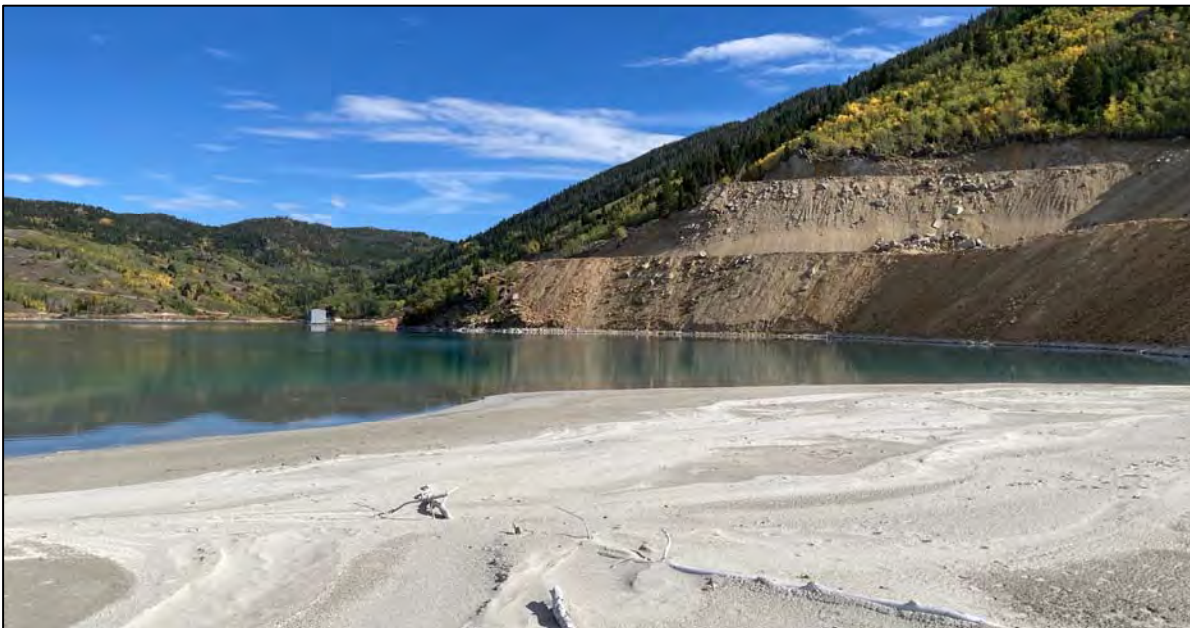
PHOTO 32 – YDTI tailings beach and supernatant pond interface, facing north.

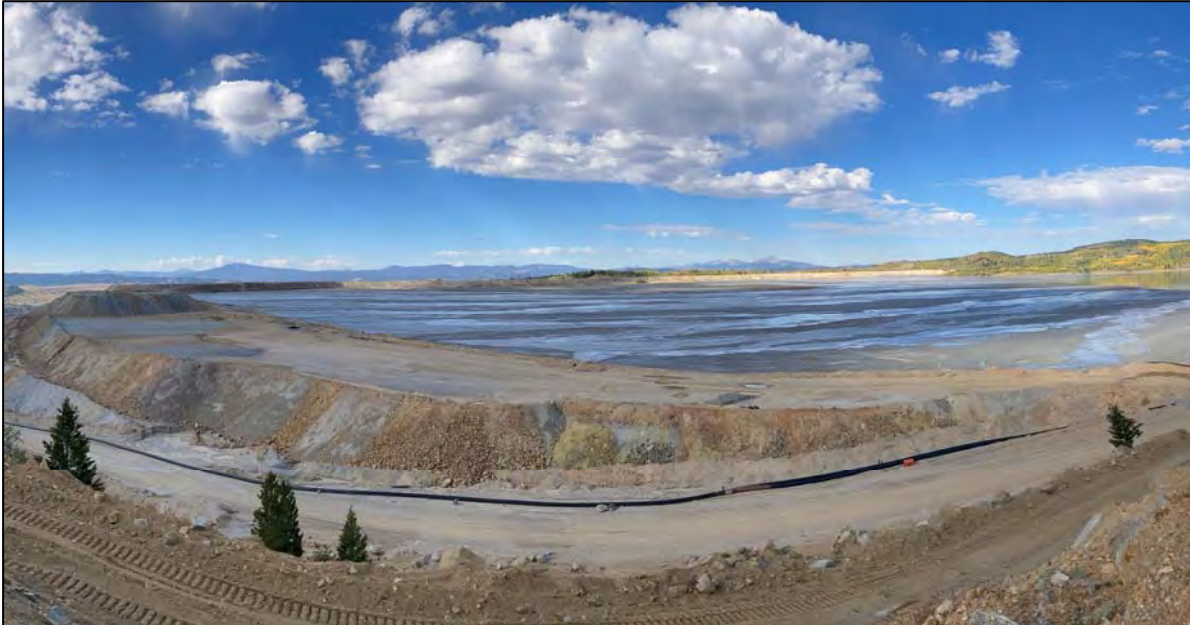
PHOTO 33 – North-South Embankment and beach, looking west from the New Reclaim Water Pipeline ramp.

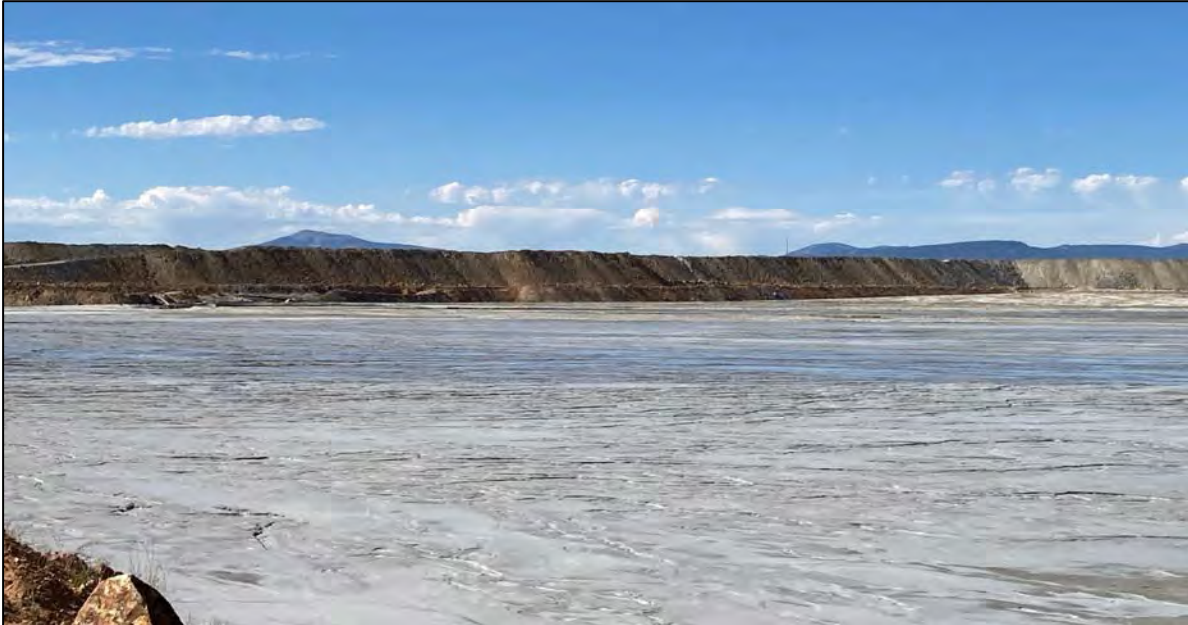
PHOTO 41 – East-West Embankment EL. 6,450 ft surcharge zone upstream shell and adjacent tailings beach in between tailings discharge locations EW-1 and EW-2, facing south from the North-South Embankment.

The interface of the tailings beach and rockfill surcharge between discharge locations 3-1 and 3-2 upstream of the Central Pedestal Area of the embankment remains relatively low when compared to the beach elevation at the adjacent discharge locations, consistent with the observations from the field reviews completed since Q3 of 2021. The recommendation to introduce an additional discharge in this location was included in the 2021 EOR Annual Inspection Report (KP, 2022c) and was scheduled in the 2021 Corrective Action Plan (CAP) (MR, 2022) to be completed in Q3 or Q4 of 2022. This was not completed in Q3 of 2022. MR indicated the installation of the additional discharge is expected to be in Q1 of 2023, once the tailings discharge corridor is constructed.

- 2. Modify the tailings distribution system by extending Line 2 to allow discharge at location Discharge 3-2 (NS-1) and add a discharge location between the current locations of Discharge 3-1 (EW-1) and Discharge 3-2 (NS-1) when the EL. 6,450 ft raise of the embankment is completed. Use of 12-inch discharge lines along the extension of Line 2 to location Discharge 3-2 (NS-1) would satisfy the recommendation (modification of 2021 recommendation).**

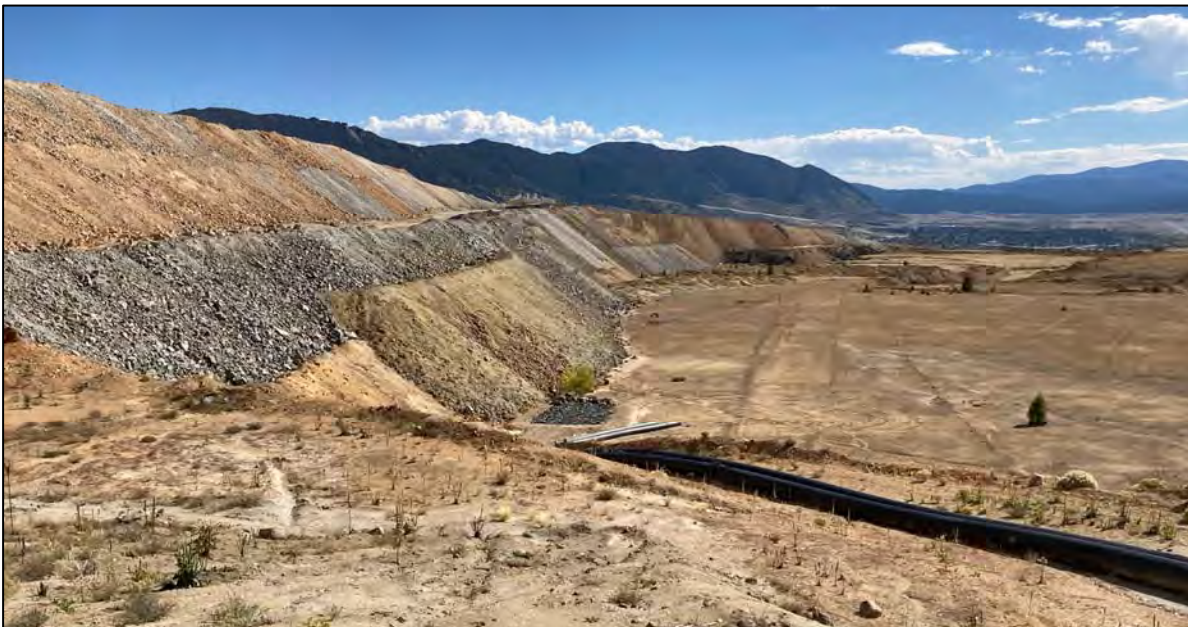
PHOTO 44 – East-West Embankment downstream slopes and WED Extraction Pond emergency overflow pipelines, west of Booster Station #3, facing southeast near Extraction Pond. Boulders for energy dissipation and final alignment of pipeline discharge remains to be completed.

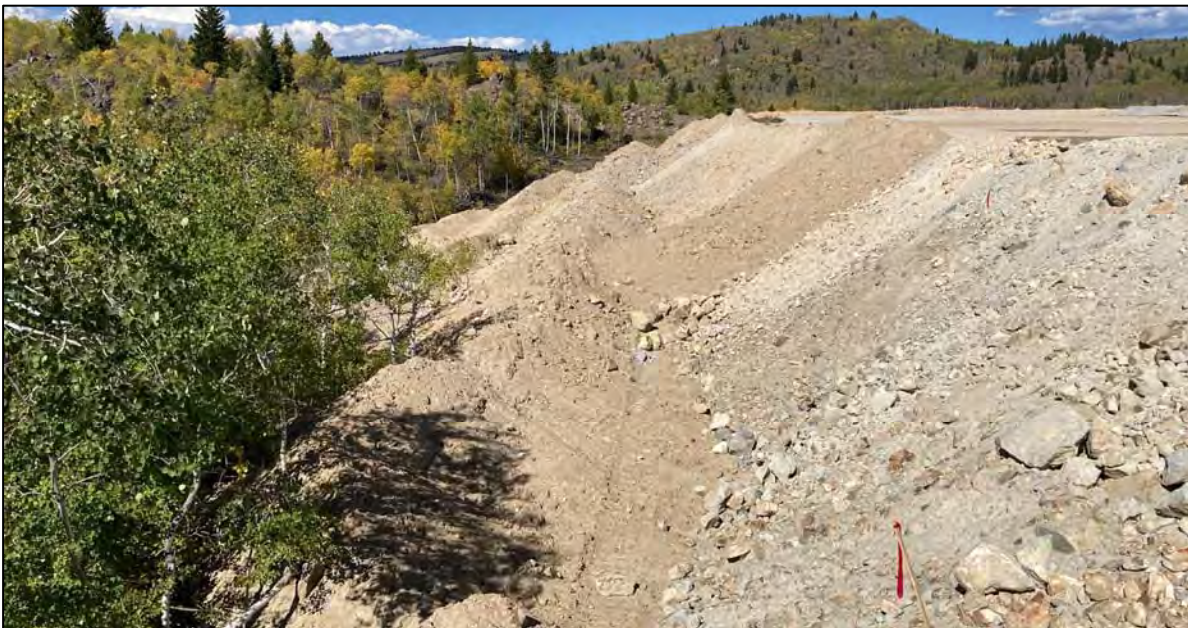
PHOTO 48 – Downstream side of West Embankment south of the Ridge Road. Completed D1 material placement in benches pending final grading and trimming to 3H:1V slope angle, facing north.

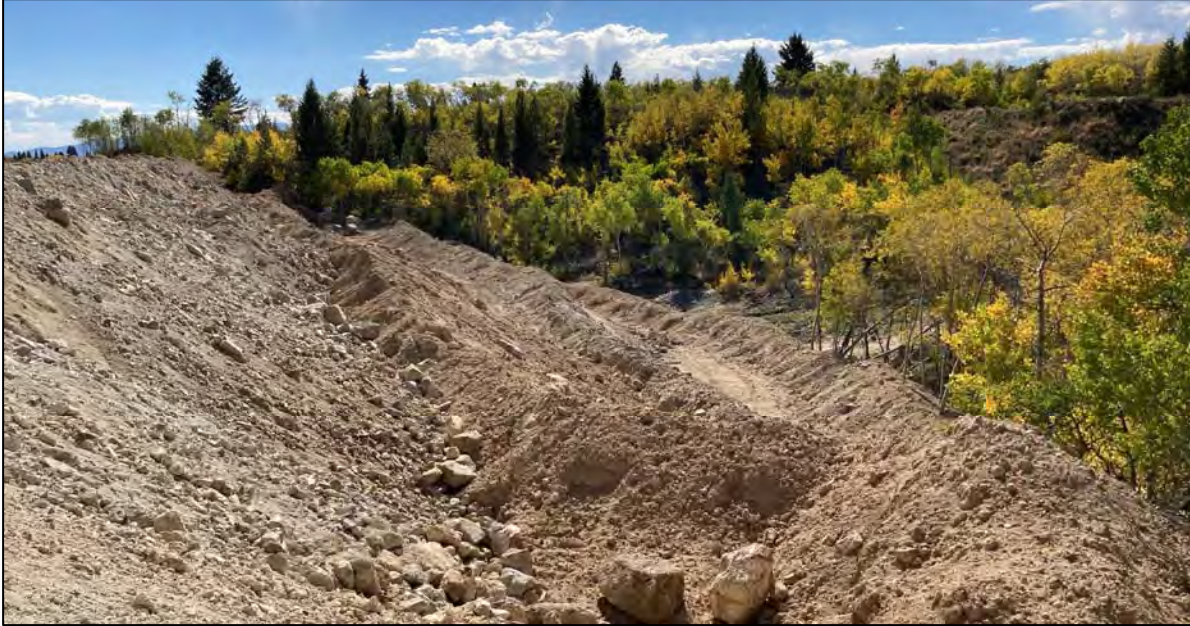
PHOTO 49 – Downstream side of West Embankment south of the Ridge Road. Completed D1 material placement in benches pending final grading and trimming to 3H:1V slope angle, facing north.

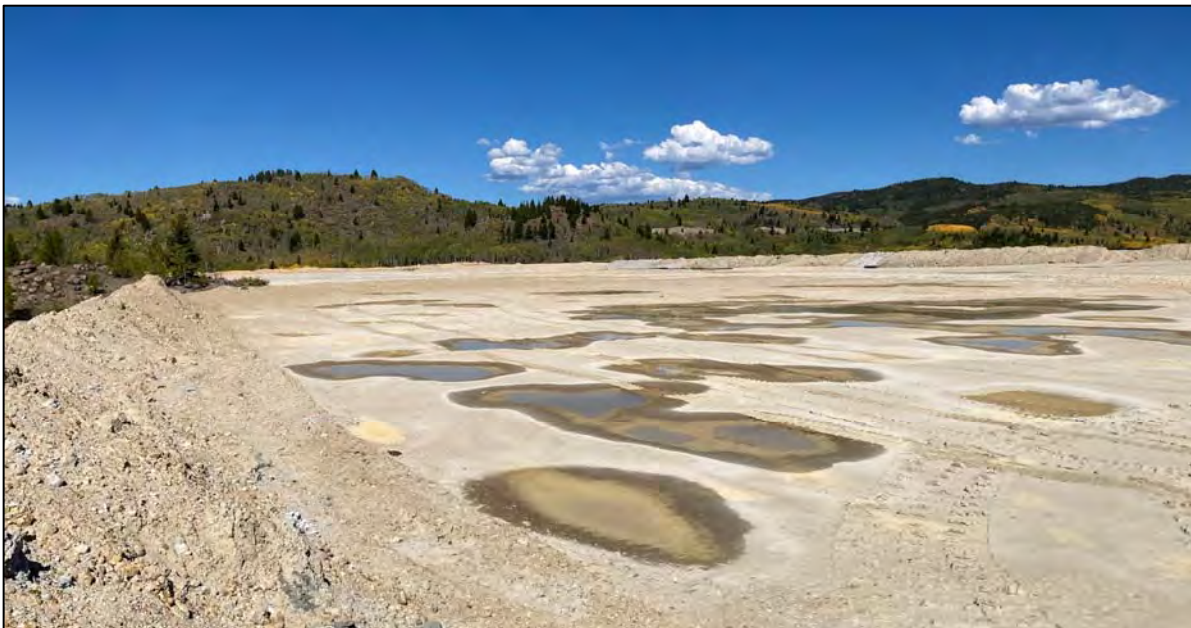
PHOTO 50 – Minor depressions and ponded water on downstream side of West Embankment crest, facing north at EL. 6,450 ft.

Several crest depressions and areas of settlement were observed along the EL. 6,450 ft West and East-West Embankments, as well as the EL. 6,400 ft North-South Embankment as described above and in the Q2 Field Review (KP, 2022b). A recommendation of the Q2 Field Review was to consider additional grading and/or infilling in areas that did not meet the allowable embankment crest grade tolerance of 24 inches (2 ft) as outlined in Table 3.3 of the CMP.

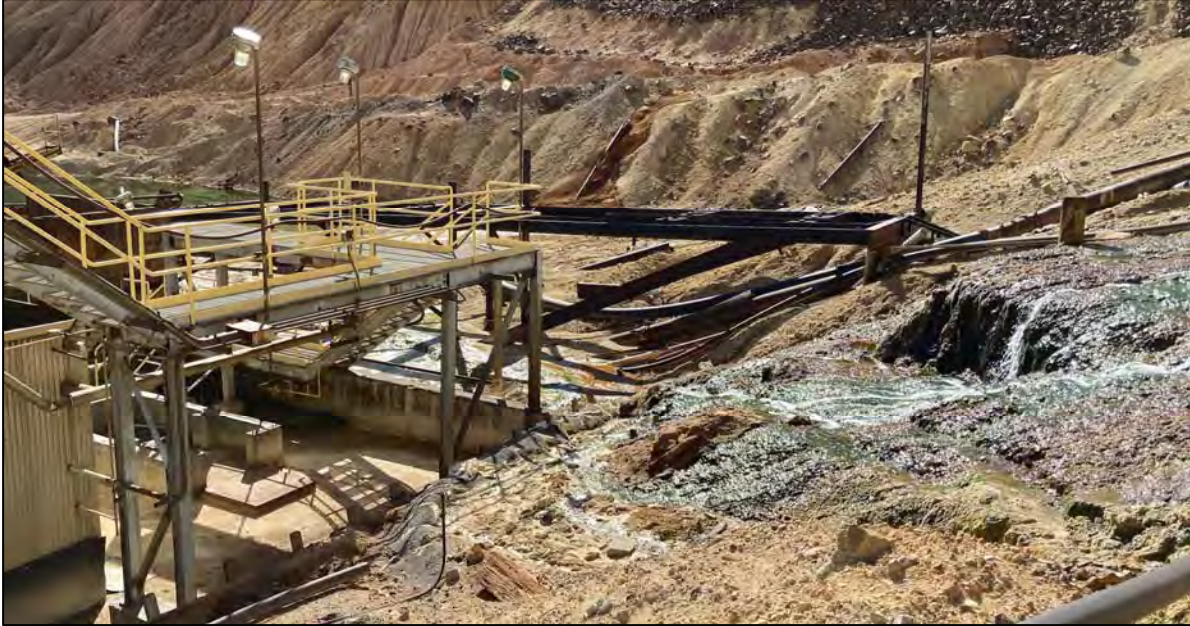
PHOTO 65 – Embankment toe seepage (right) flowing into Upper HsB Pond, facing west.

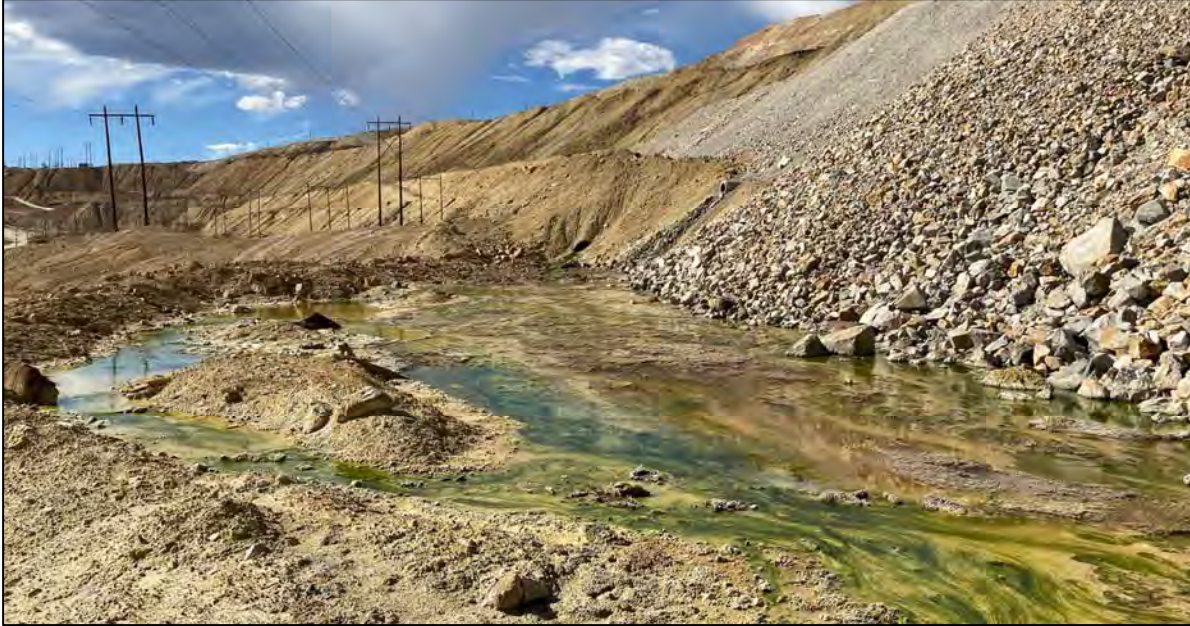
PHOTO 71 – Seepage at the Number 10 Seep bench area, looking west.

- 4. Develop and implement a new system to collect flows along the Seep 10 bench and convey these flows to the HsB Pond (continuation of 2021 recommendation).**
