Prepared for
Montana Resources, LLC
600 Shields Avenue
Butte, Montana
USA, 59701

Prepared by
Knight Piésold Ltd.
Suite 1400 - 750 West Pender Street
Vancouver, British Columbia
Canada, V6C 2T8

VA101-126/27-2

YANKEE DOODLE TAILINGS IMPOUNDMENT 2022 ANNUAL INSPECTION REPORT

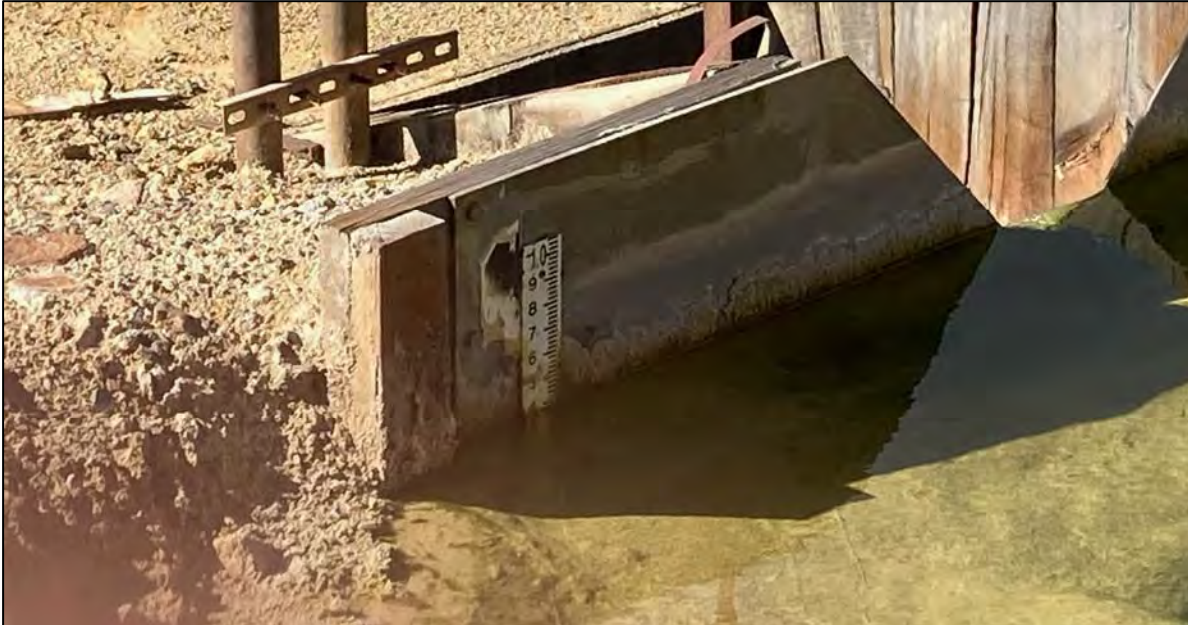
PHOTO 73 – Number 10 Seep V-notch weir staff gauge reading 0.38.

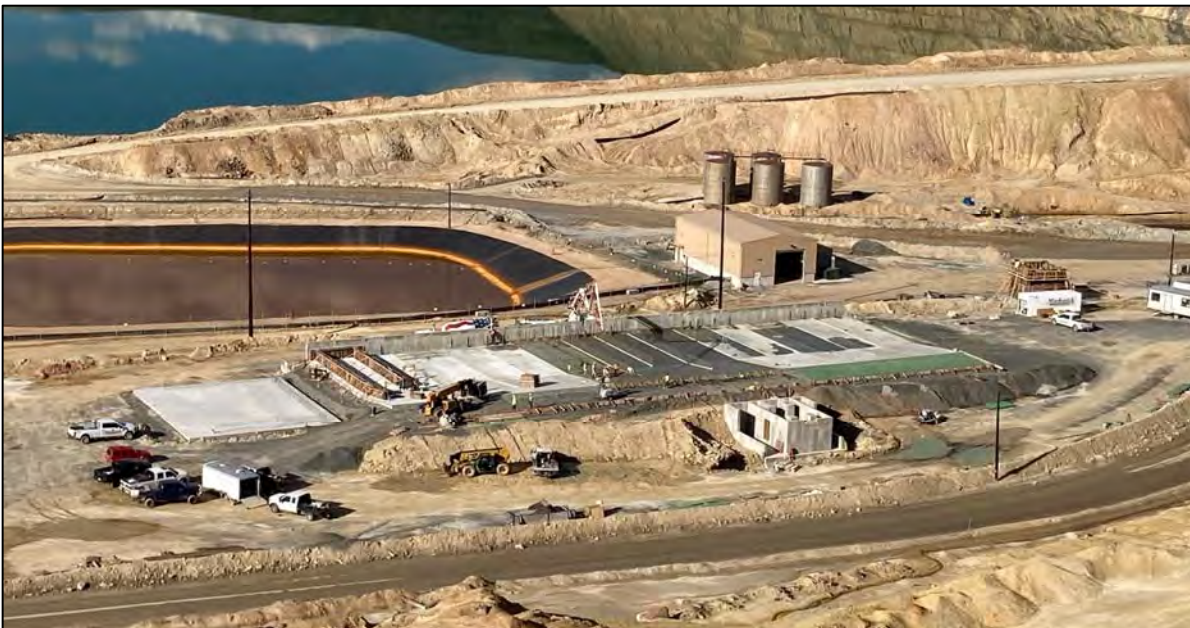
PHOTO 76 – New Precipitation Plant construction, facing west.

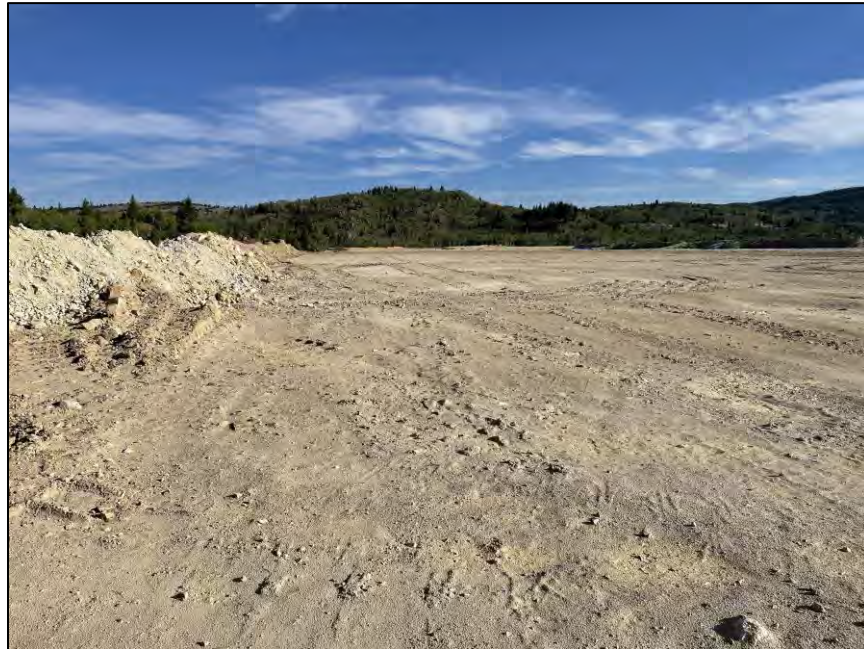
Zone D1 construction progress along the downstream edge of the embankment in the draws north and south of the Ridge Road was viewed during the field review. Zone D1 has been completed to EL. 6,450 ft in these areas and surface preparation was completed as per the CMP prior to each lift of D1 materials being placed.

Photo 3.2 Completed Zone D1 – North of the Ridge Road at EL. 6,450 ft

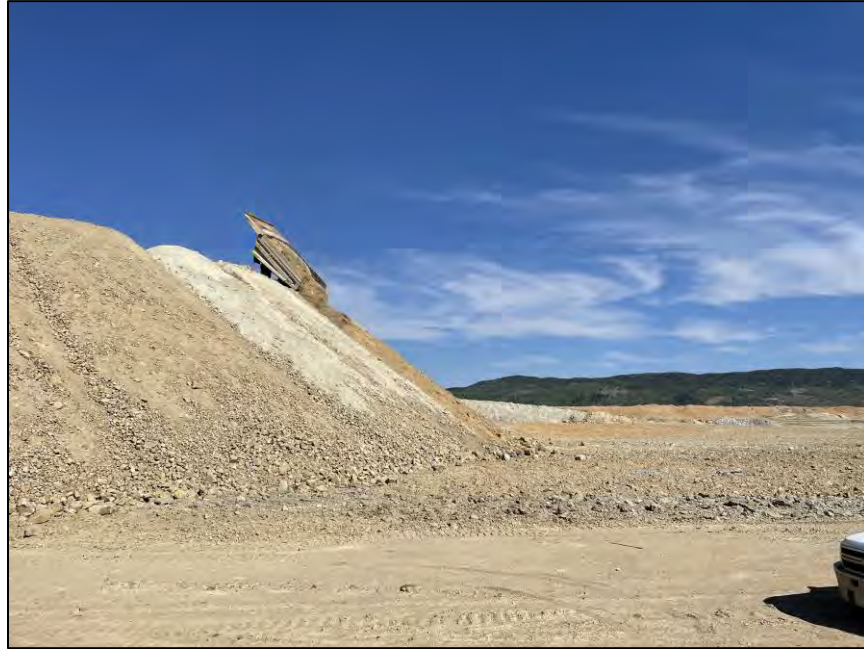
Areas of interest examined during the field review along East-West Embankment are outlined on Figure 3.3. MR continued construction of the EL. 6,450 ft Zone U lift of the East-West Embankment during the quarter and construction was ongoing at the time of the field review between approximately Section 3+00W and 8+00N of the Central Pedestal Area. Construction was progressing in an easterly direction as shown on Photo 3.3. The lift subgrade surface, comprising the previously placed U material of the EL. 6,400 ft lift, had been cross ripped in preparation for the advancing lift above.

Photo 3.3 EL. 6,450 ft East-West Embankment Construction Near Section 0+00

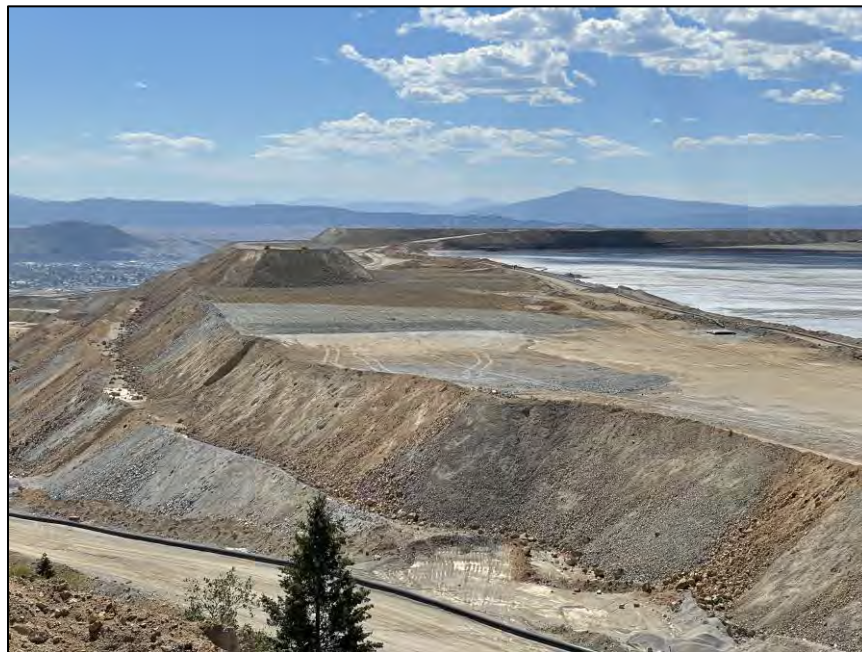
Areas of interest observed during the field review along the North-South Embankment are outlined on Figure 3.4. MR commenced and progressed construction of the EL. 6,450 ft Zone U lift along the North-South Embankment, between Sections 28+00N and 43+00N during Q3. Construction was progressing northwards near Section 38+00N, as shown on Photo 3.5, during the field review. The lift subgrade surface, comprising the previously placed U material of the EL. 6,400 ft lift, had been cross ripped in preparation for the advancing lift above.

Photo 3.5 EL. 6,450 ft North-South Embankment Construction

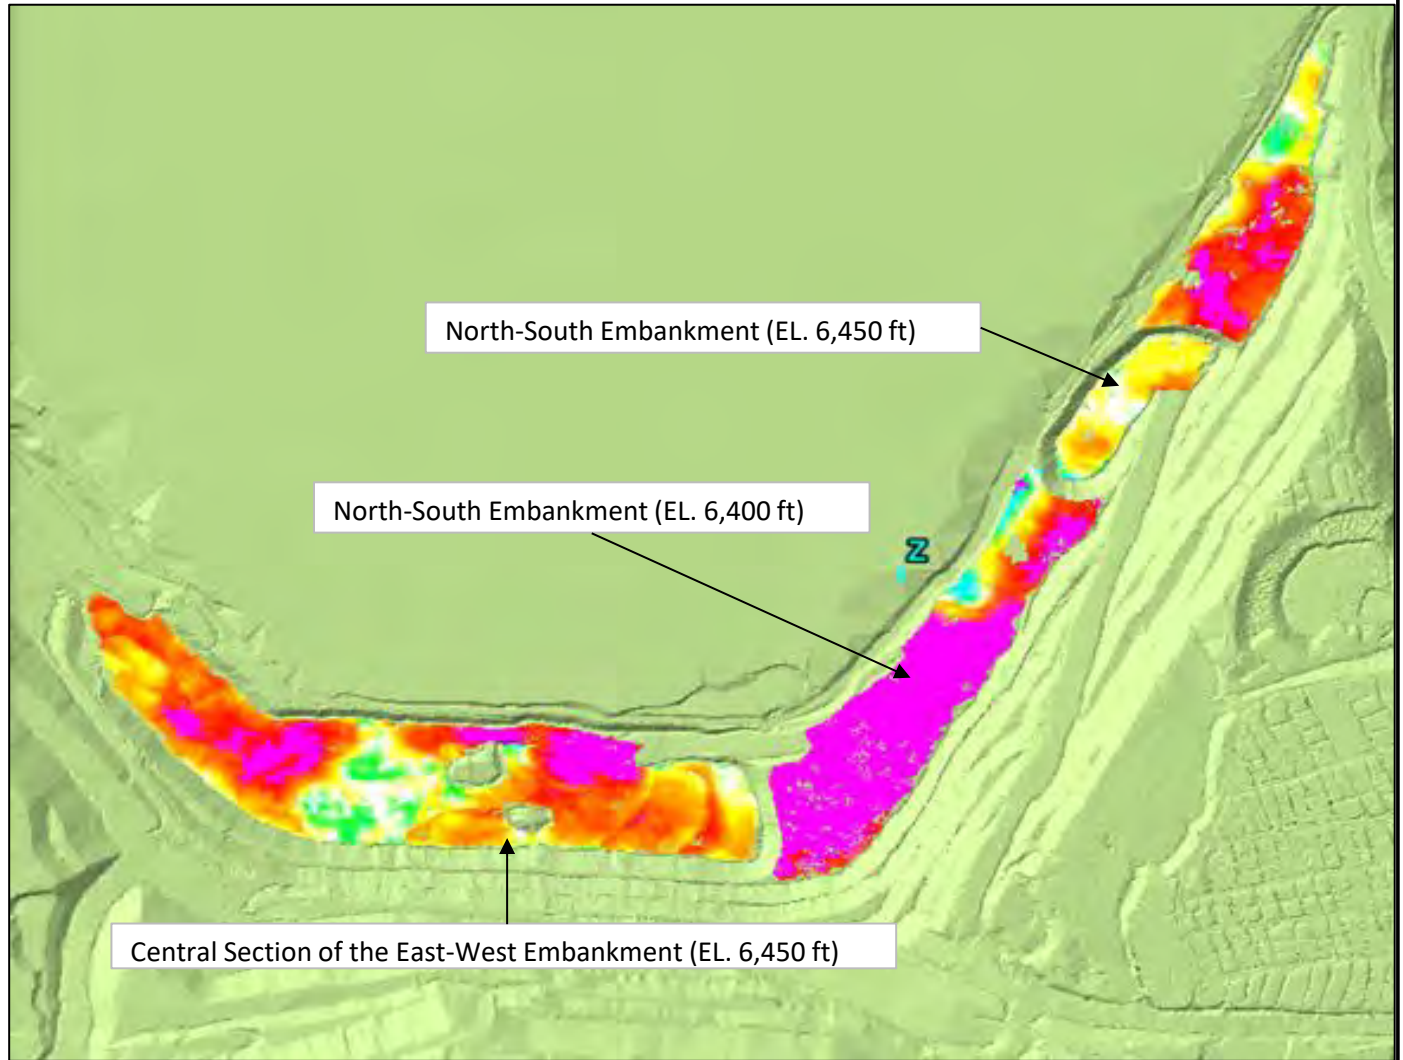
P/A NO. VA101-126/27
FIGURE 3.5	
REV 0	REF. NO. VA22-01895

Several crest depressions and areas of settlement were observed along the EL. 6,450 ft West and East-West Embankments, as well as the EL. 6,400 ft North-South Embankment as described above and in the Q2 Field Review (KP, 2022b). A recommendation of the Q2 Field Review was to consider additional grading and/or infilling in areas that did not meet the allowable embankment crest grade tolerance of 24 inches (2 ft) as outlined in Table 3.3 of the CMP.

MR provided end of Q3 survey information for the East-West Embankment Central Pedestal Area and North-South Embankment to present the varying embankment crest elevations using a hot/cool map, similar to the survey information provided for Q2. The end of Q3 maps are presented on Figure 3.5. The updated maps show that some infilling and regrading work was completed along the North-South Embankment, north of Section 43+00N, during Q3; however, the surfaces provided and presented on Figure 3.5 continue to show areas of variance in excess of 5 ft in this area and throughout the East-West and North-South Embankments. Continued grading and/or infilling should be considered within these areas to manage ponding water and promote surface runoff following construction of the EL. 6,450 ft lift to maintain the crest surface within the grade tolerances outlined in the CMP.

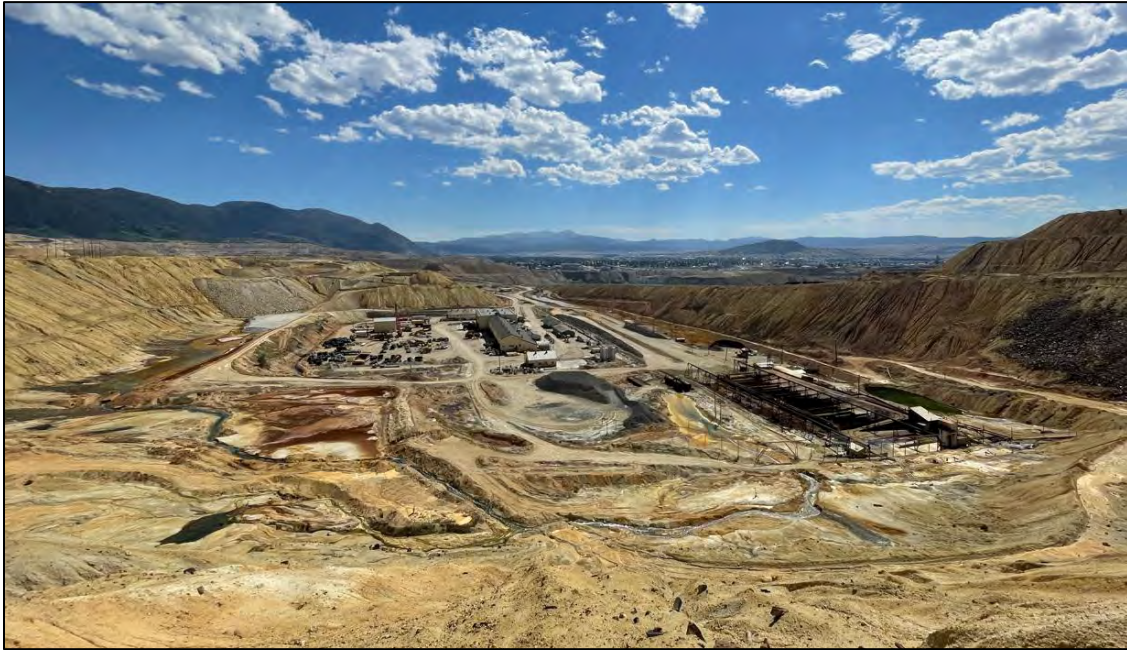
Photo 3.7 HsB Area Overview

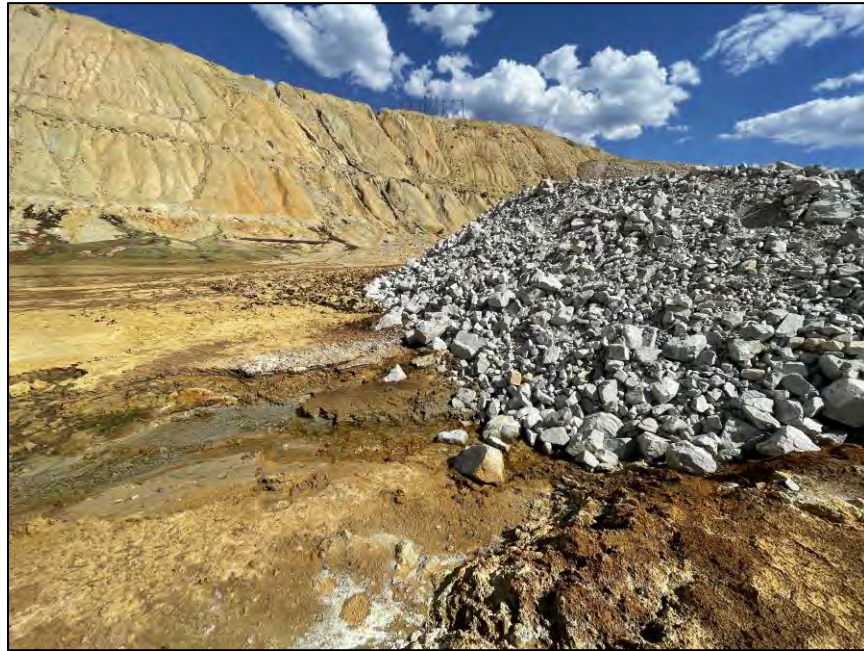
- The displaced material at the toe of the placed UF material at the south end of the Holding Pond are relatively dry, friable, and stable enough to walk on except for the area along a localized depression consisting of a minor stream flow concentrated at the base of the placed material, shown on Photo 3.8.

Photo 3.8 Placed UF Material in the Southern End of the Holding Pond

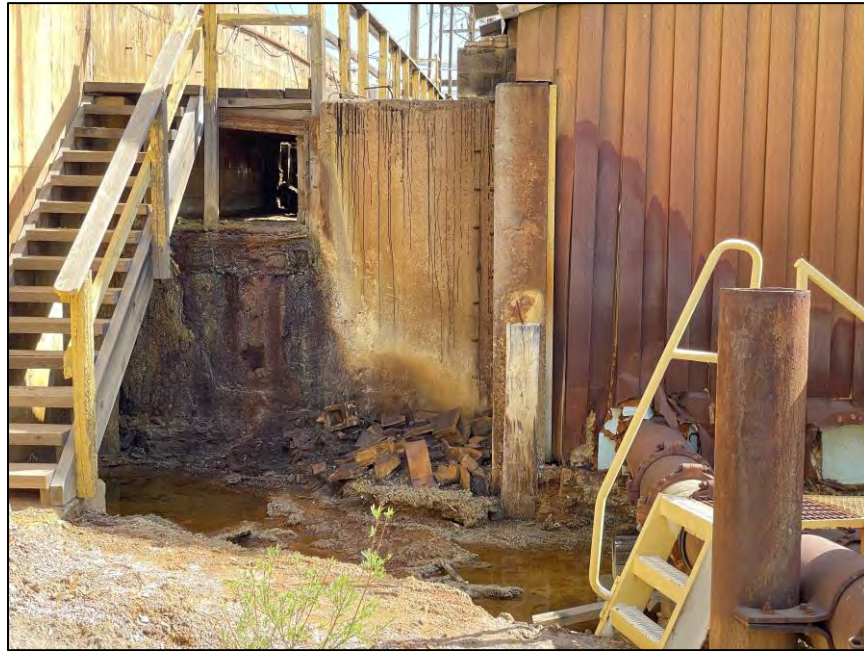
- There were no signs of overflow/leakage from the recirculation pumphouse head tank (reporting to the former Cell 10 Pump area) as shown on Photo 3.9.

Photo 3.9 Recirculation Pumphouse Head Tank

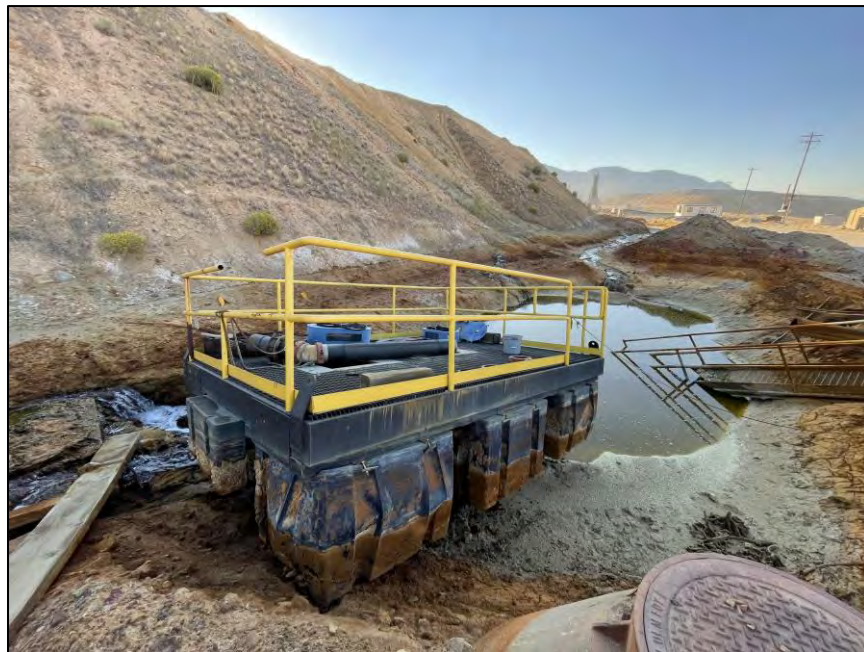
- Seepage flows collecting in the decommissioned Muddler Pump area were overflowing to the lower HsB Pond. The decommissioned Muddler Pump housing structure was moved to the perimeter of the standing pond area as shown on Photo 3.10.

Photo 3.10 Decommissioned Muddler Pump Area

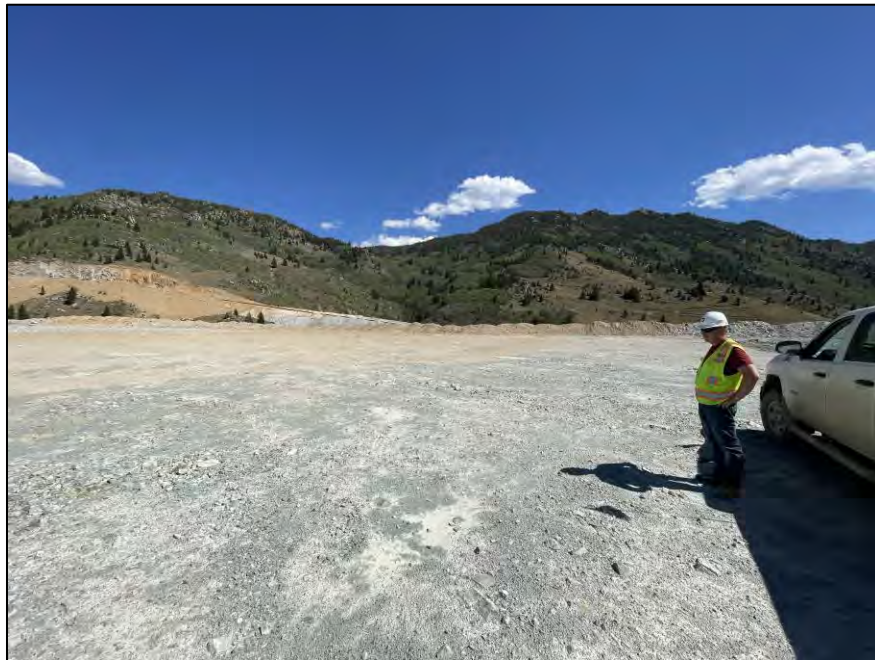
No obvious signs of ponding were observed in areas that were infilled and regraded along the EL. 6,400 ft crest north of Section 43+00N in Q2 of 2022 as per the 2021 EOR AIR and CAP. Several undulations and depressions were observed in the area between Sections 28+00N and 38+00N, similar to the conditions described above along the West and East-West Embankment crest and in the Q2 Field Review (KP, 2022b), with an example shown on Photo 3.6.

PHOTO 8 – North-South Embankment – EL. 6,400 ft crest in area that underwent CAP recommended re-grading, looking northeast

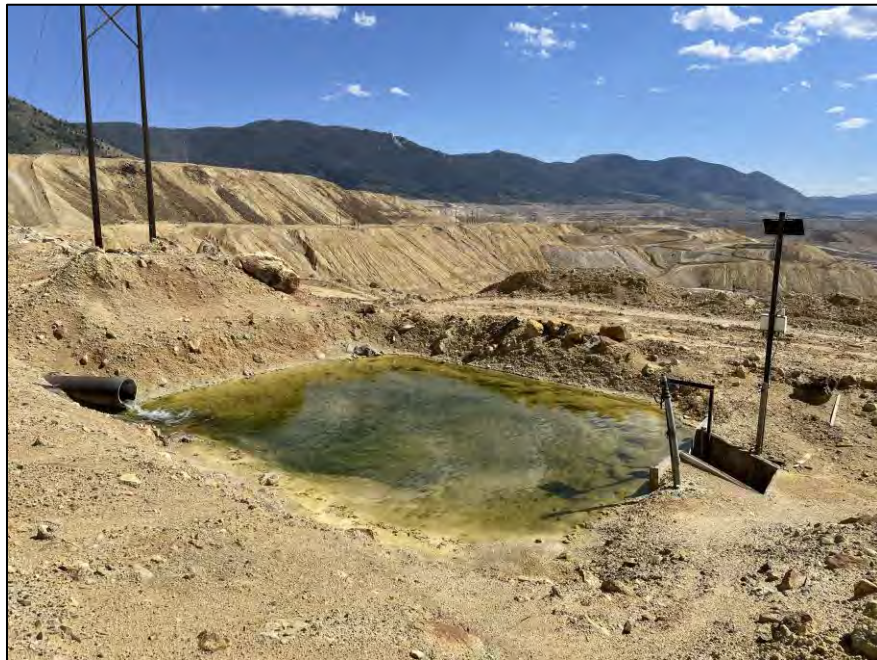
- The Seep 10 flow paths, surface collection ditches, and stilling pond appear generally consistent with previous reviews. The reading on the staff gauge installed at the stilling pond was observed to be approximately 0.38. No additional grading was completed in the Seep 10 area since Q2.

PHOTO 12 – Seep 10 Stilling Pond

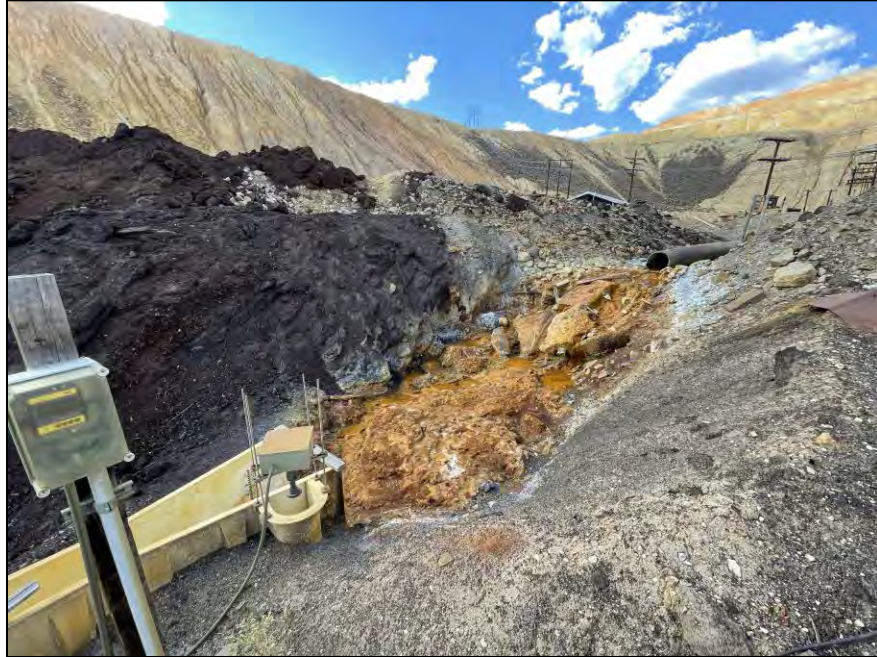
- Minor flow was observed to be passing the decommissioned Precipitation Flume (previously monitoring the outflow from Cell 10 of the Precipitation Plant).

PHOTO 13 – Horseshoe Bend – Minor flows passing through the Precipitation Flume from the former Cell 10 Pump area

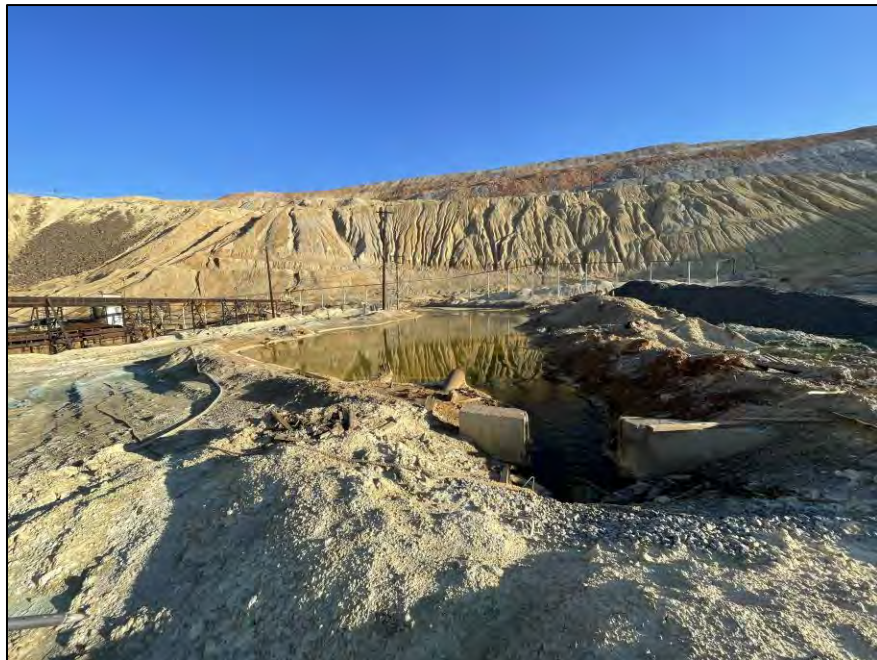
- The Houligan Pond continues to operate at near full capacity and overflows to the lower HsB pond via a pipeline and ditch.

PHOTO 16 – Horseshoe Bend – Houligan Pond and overflow, looking north

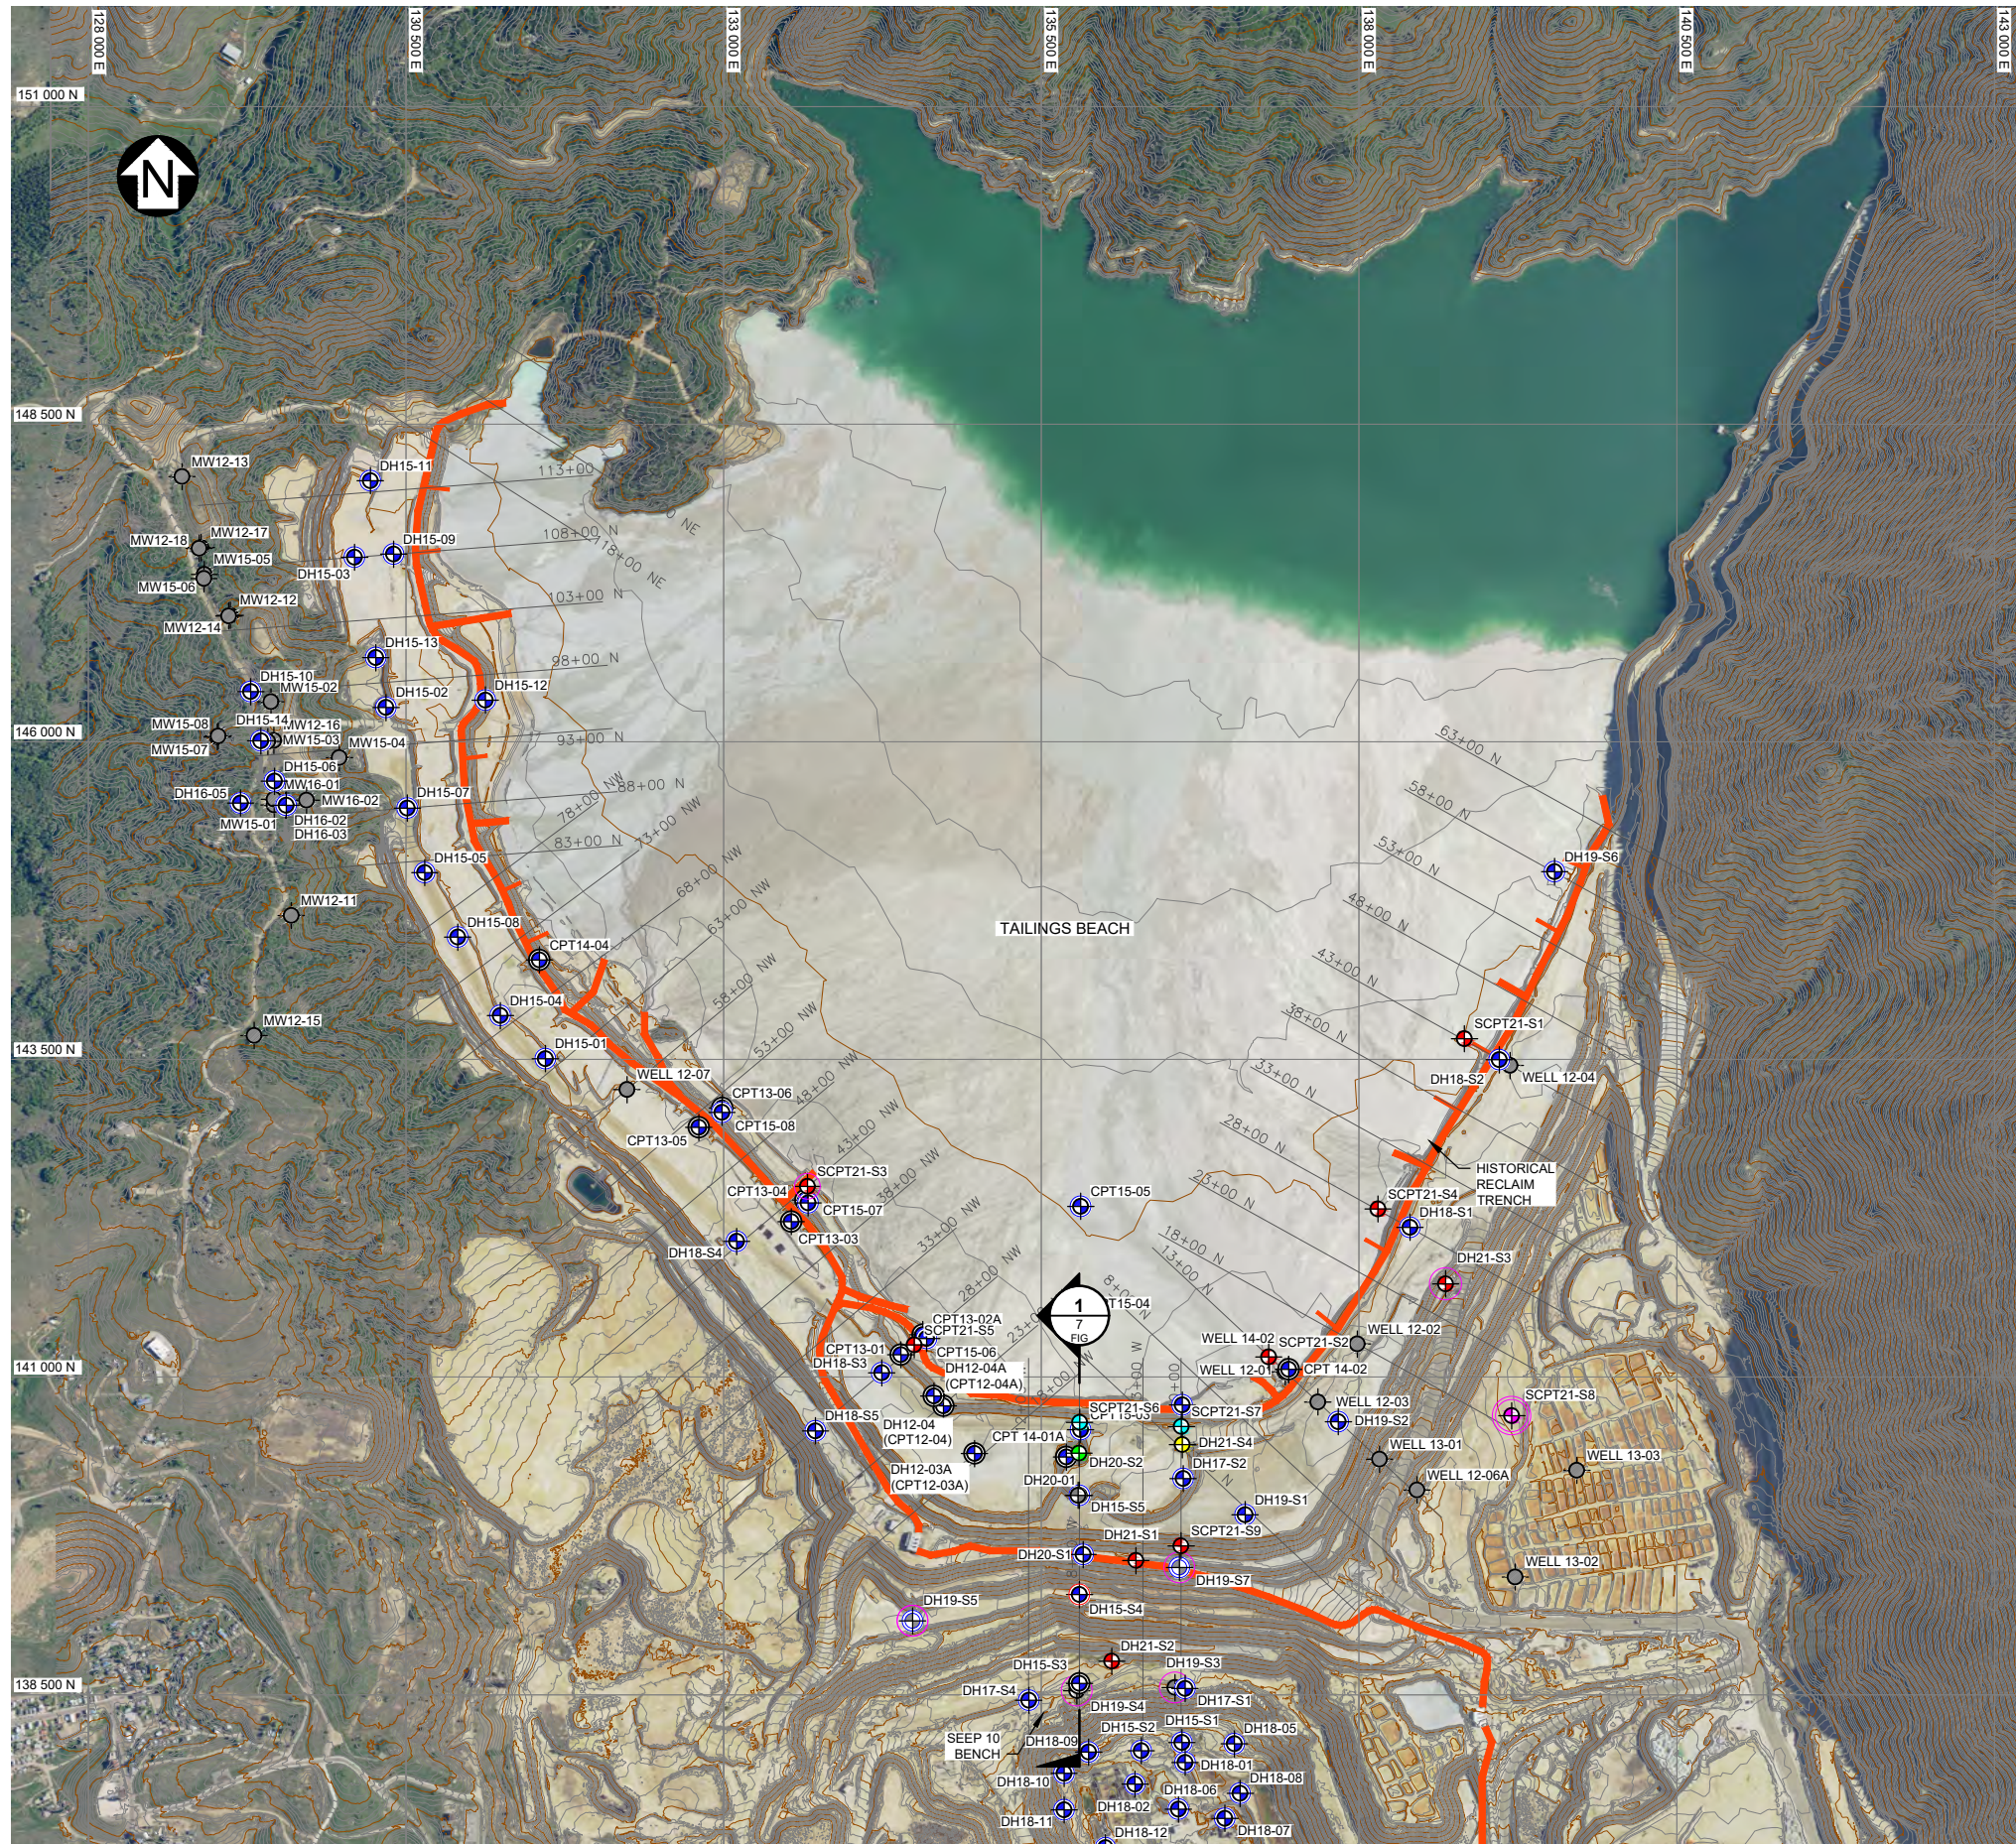
MONTANA RESOURCES, LLP	
YANKEE DOODLE TAILINGS IMPOUNDMENT	
ACTIVE PIEZOMETRIC INSTRUMENTATION AND MONITORING SITE	
	<small>P/A NO.</small> VA101-126/27 <small>REF NO.</small> VA22-01888 FIGURE 1
REV 0	<small>REV 0</small>

5. SENSOR DH15-S5 VW1 IS POTENTIALLY DAMAGED DUE TO THE RECENT COLLAR RAISE AND HAVE BEEN ABANDONED. THIS SENSOR WAS RETIRED FROM THE QPPS AND REPLACED WITH DH15-S5 VW2 ON OCTOBER 3, 2022.

6. DATA LOGGERS INSTALLED FOR SENSORS DH15-S4 VW1 AND VW2 BECAME DAMAGED ON AUGUST 10, 2022 AND HAVE REPORTED ERRONEOUS VALUES SUBSEQUENTLY. VALUES HAVE BEEN OMITTED FOR CLARITY. TROUBLESHOOTING AND MANUAL DATA COLLECTION IS ONGOING.

7. SENSOR MW12-01 HAS BEEN REPORTING ERRONEOUS VALUES DUE TO A SUSPECTED DATA LOGGER ISSUE SINCE JULY 23, 2022. TROUBLESHOOTING IS ONGOING.

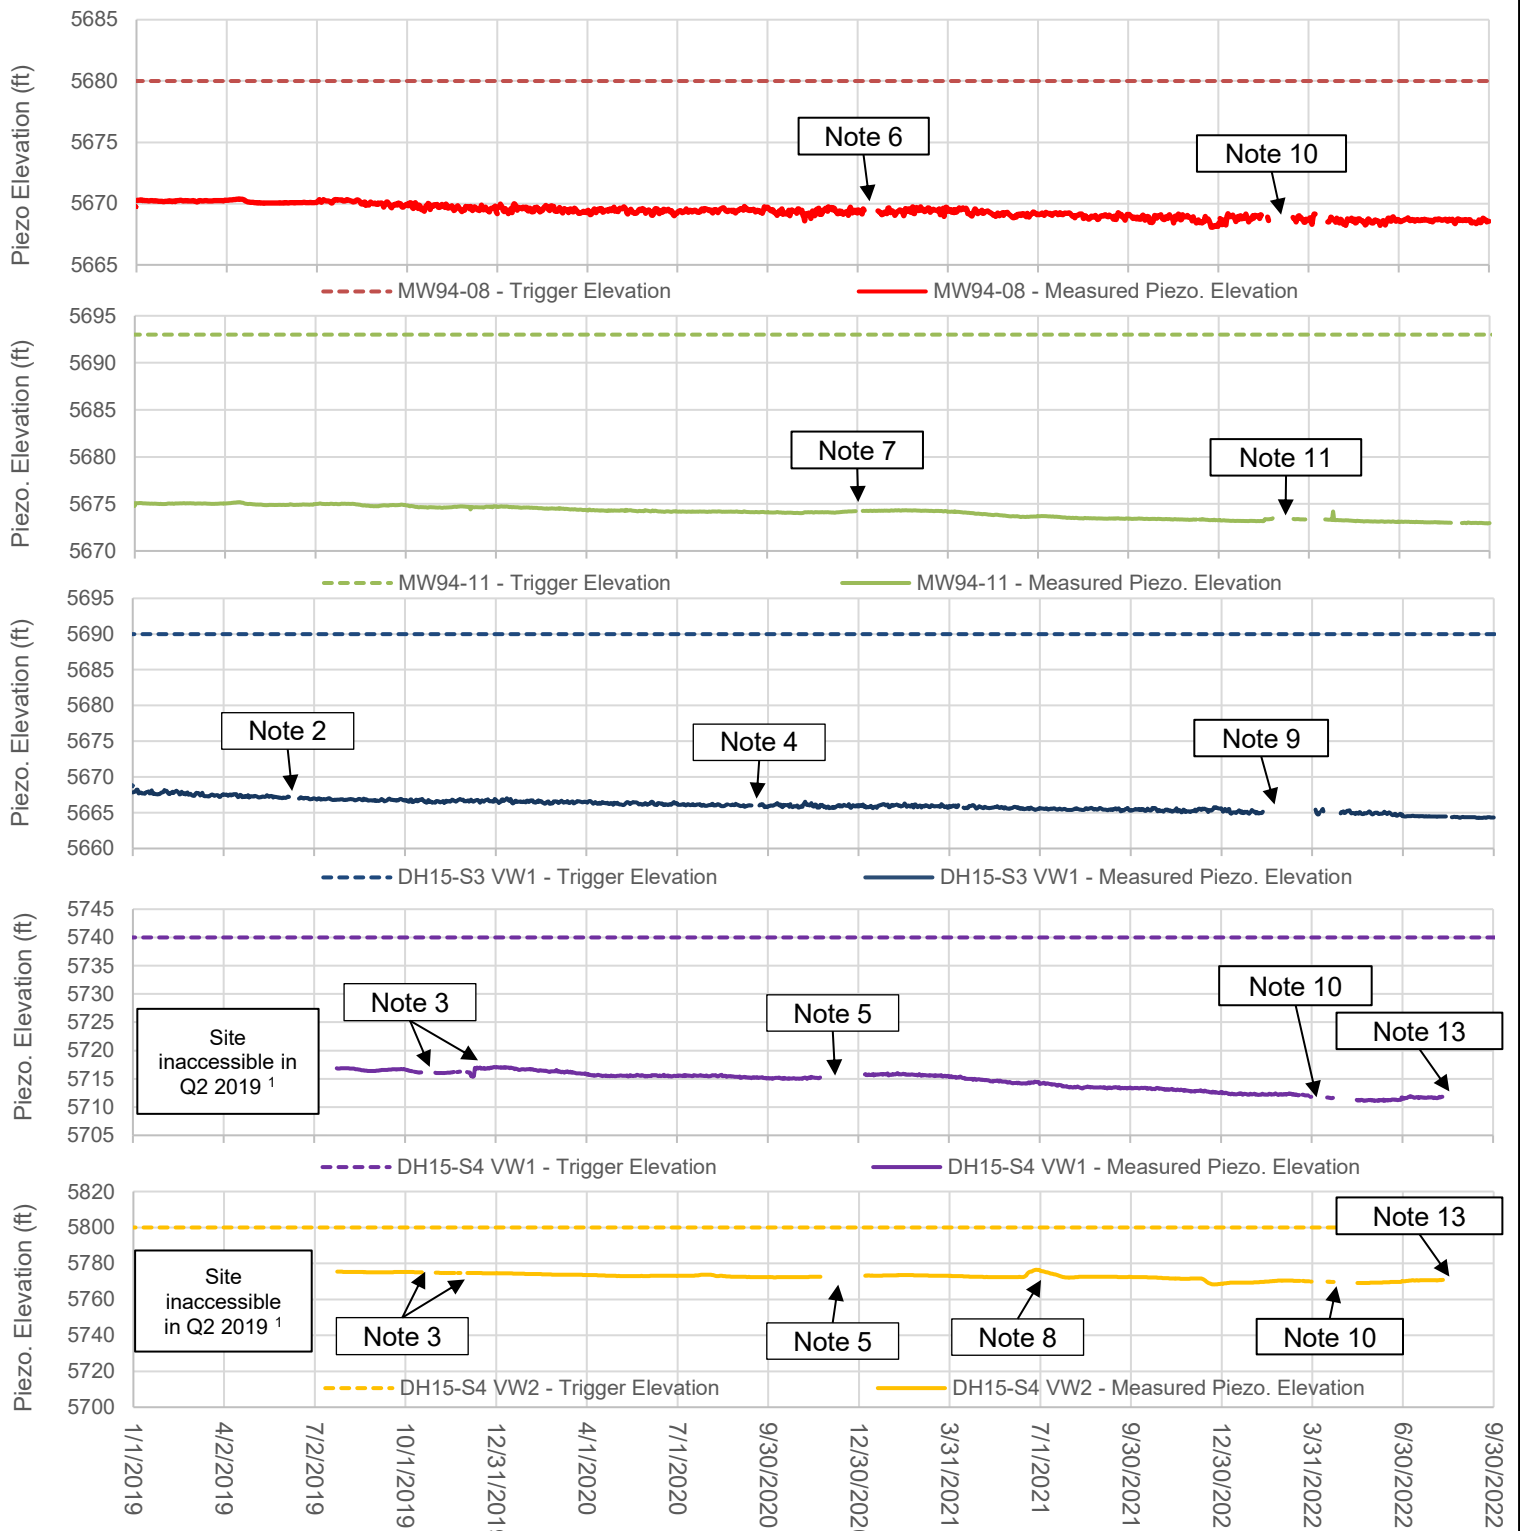
P/A NO. VA101-126/27 REF. NO. VA22-01888
FIGURE 2	
REV 0	0

4. NO DATA WERE COLLECT BY DH15-S3 VW1 FROM SEPTEMBER 15 TO SEPTEMBER 21, 2020 DUE TO DEPLETED GEONET BATTERY WHICH WAS SUBSEQUENTLY REPLACED.
5. NO DATA WERE COLLECTED BY DH15-S4 VW1 AND VW2 DUE TO SUSPECTED LOGGER ISSUE FROM NOVEMBER 22, 2020. FUNCTIONALITY WAS RESTORED USING A REPLACEMENT LOGGER IN Q1 2021.

8. PIEZOMETRIC ELEVATION INCREASED IN RESPONSE TO OBSERVED INFILTRATION OF TAILINGS SLURRY WATER INTO THE CENTRAL ROCKFILL SURCHARGE FROM JUNE 14 TO JUNE 28, 2021 AS DESCRIBED IN VA21-01320.

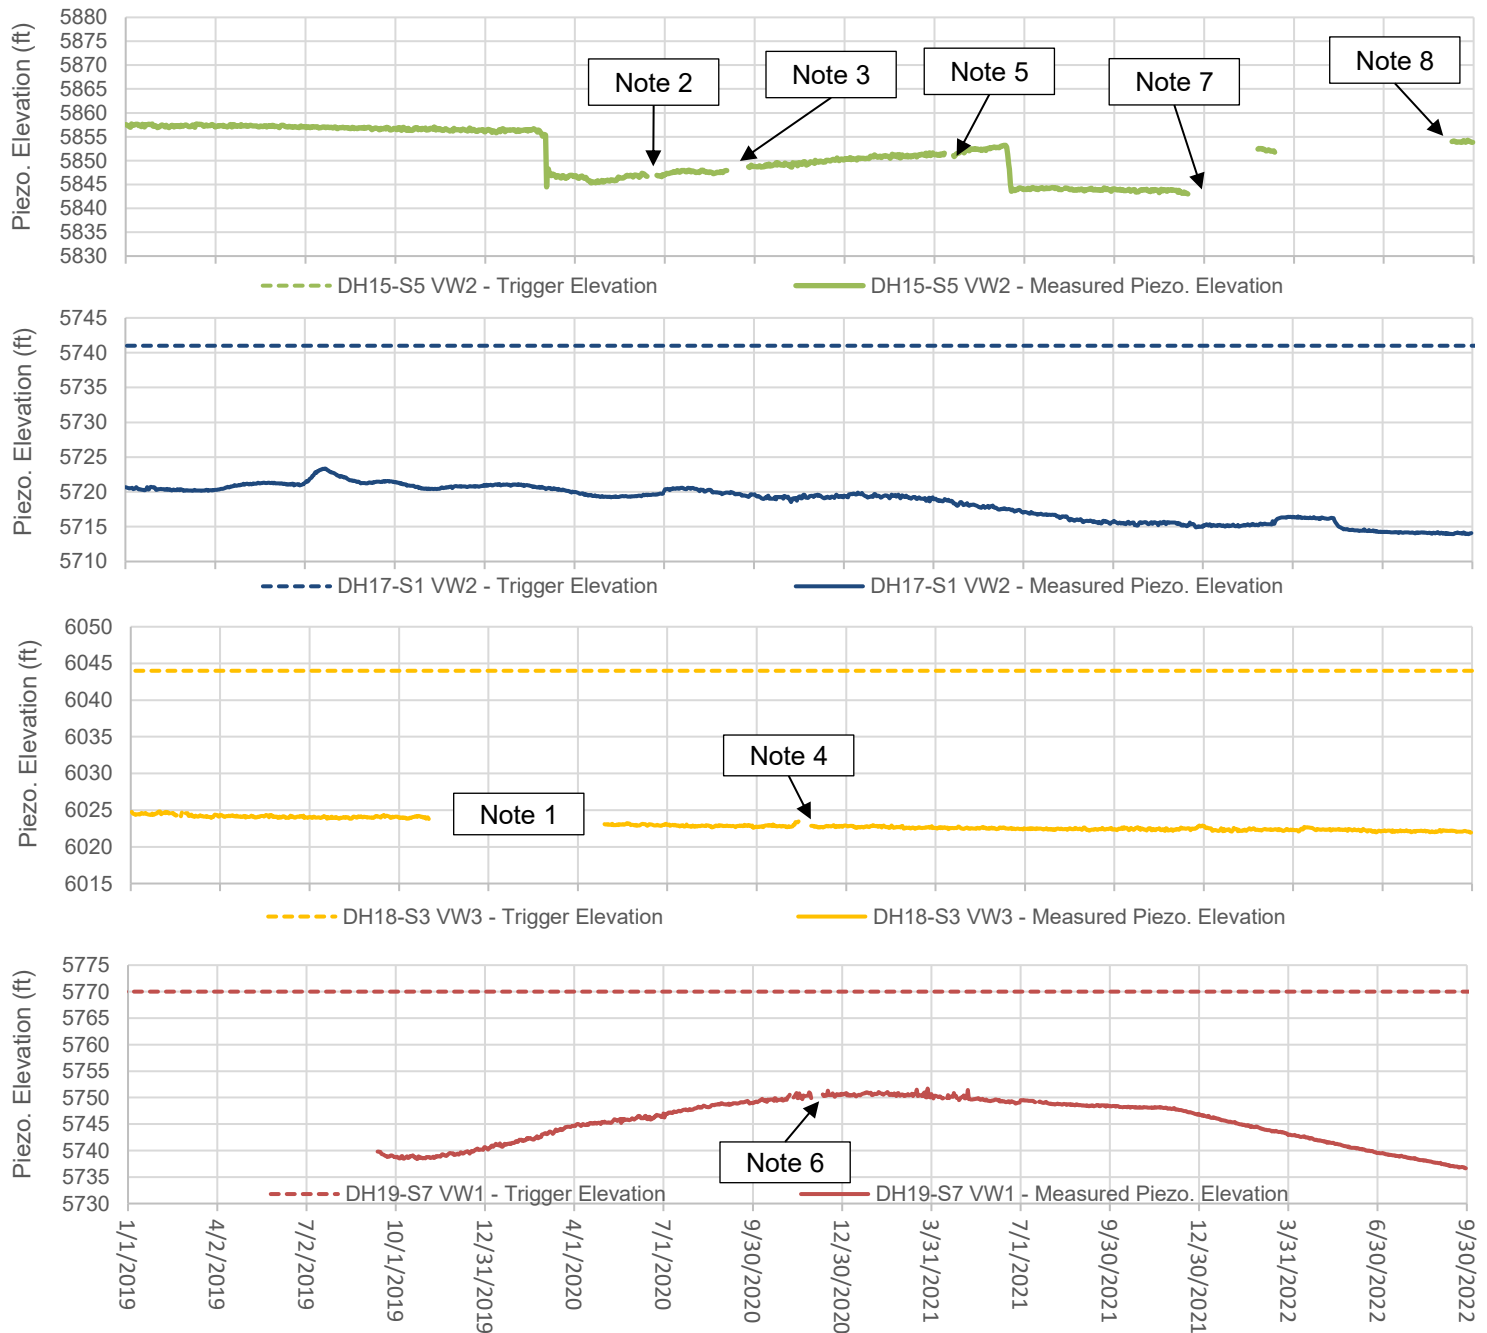
P/A NO. VA101-126/27 REF. NO. VA22-01888
FIGURE 3	REV 0

1. NO DATA WERE COLLECTED BY DH18-S3 VW1 FROM NOVEMBER 1, 2019 TO FEBRUARY 3, 2020 AND FEBRUARY 4 TO APRIL 30, 2020 DUE TO SUSPECTED HARDWARE DAMAGE.
2. NO DATA WERE COLLECTED BY DH15-S5 VW2 DUE TO LOGGER POWER SUPPLY ISSUES FROM JUNE 13 TO 23, 2020.

3. NO DATA WERE COLLECTED BY DH15-S5 VW2 DUE TO WATER DAMAGED LOGGER FROM SEPTEMBER 2 TO 24, 2020. THE LOGGER WAS SUBSEQUENTLY REPLACED.
4. NO DATA WERE COLLECTED BY DH18-S3 DUE TO A DEPLETED DATA LOGGER BATTERY FROM NOVEMBER 12 TO 25, 2020.

8. QPP SENSOR DH15-S5 VW1 WAS DAMAGED DURING EL. 6450 ft LIFT CONSTRUCTION AND HAS BEEN ABANDONED. KP HAVE ELECTED SENSOR DH15-S5 VW2 AS A REPLACEMENT QPP.

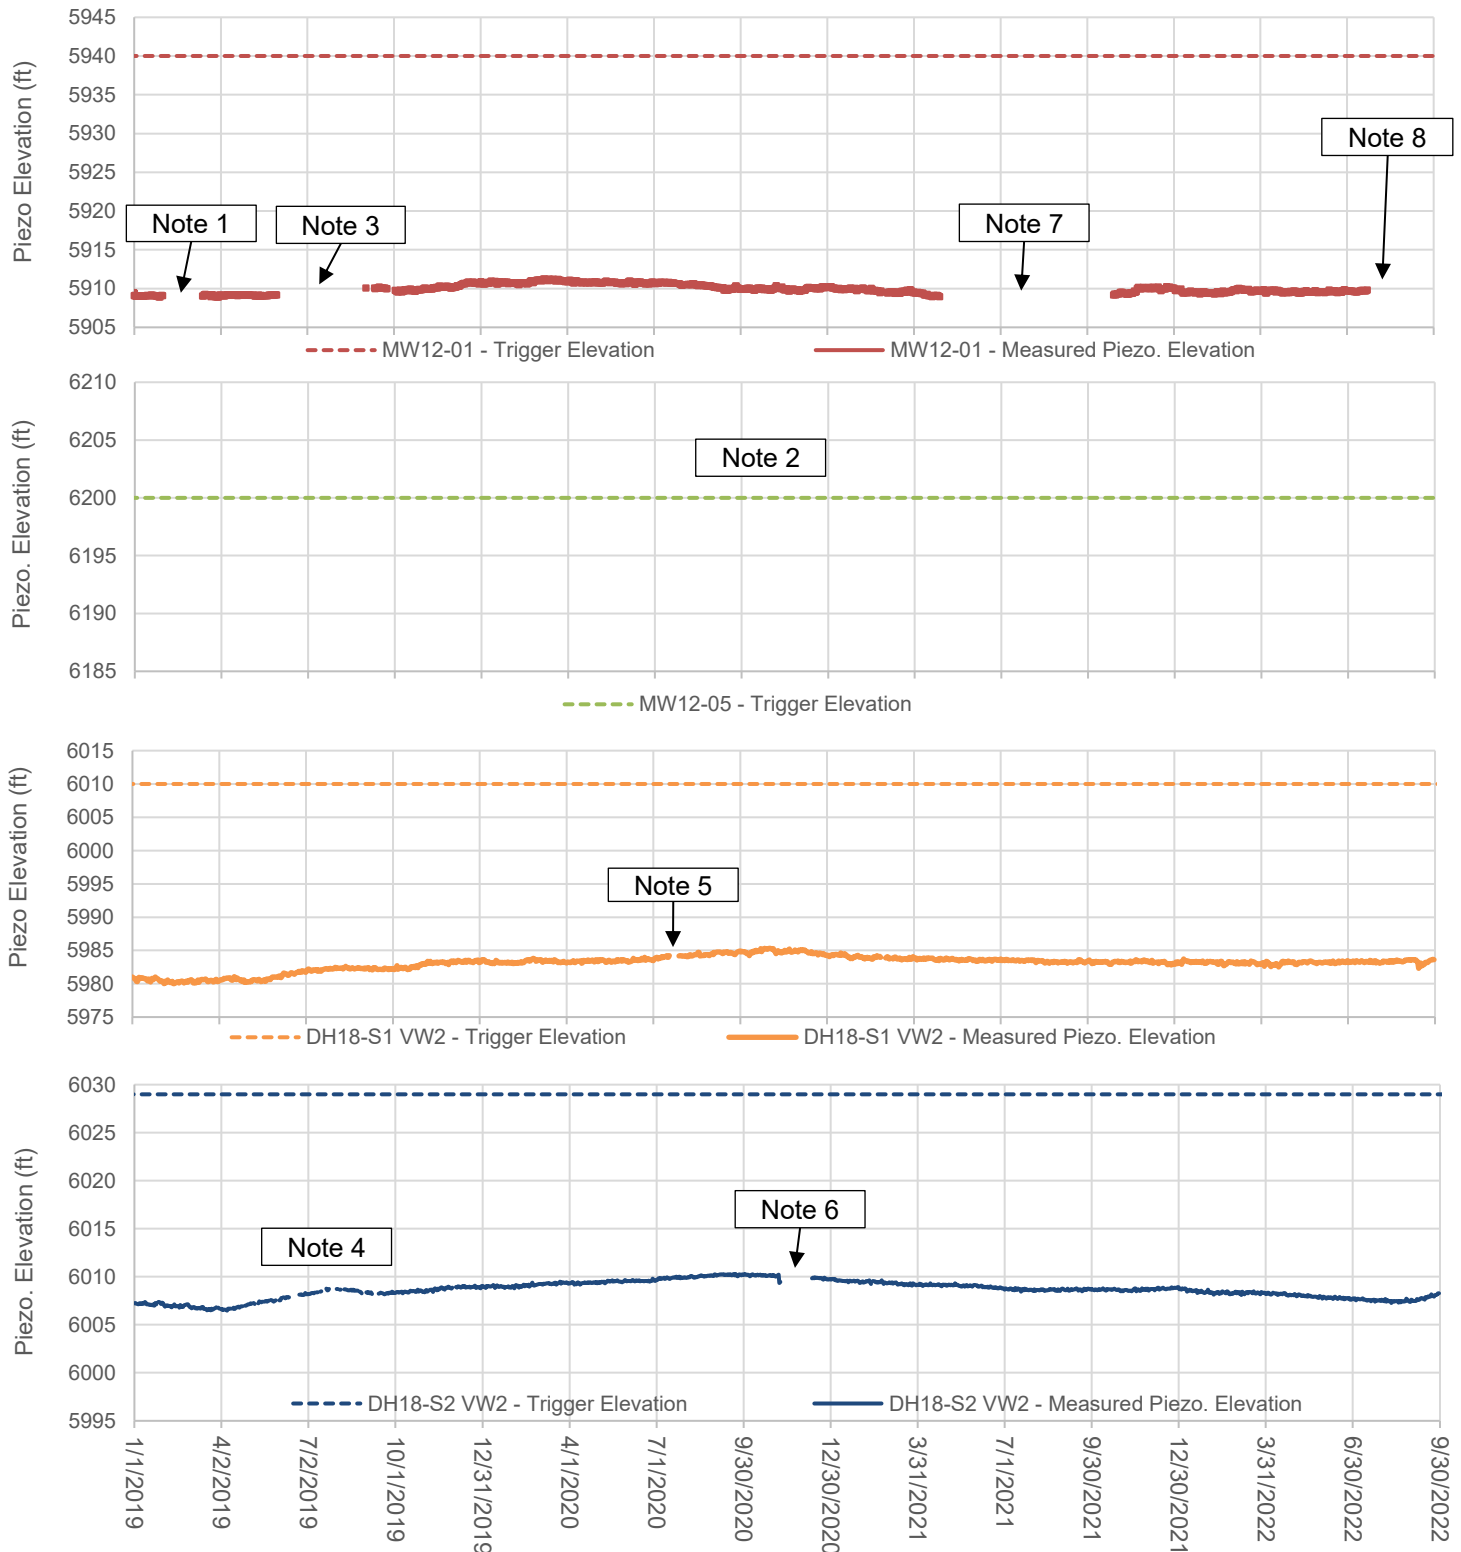
P/A NO. VA101-126/27	REF. NO. VA22-01888	FIGURE 4		REV 0	
P/A NO. VA101-126/27	REF. NO. VA22-01888						
FIGURE 4							
REV 0

1. MW12-01 BECAME UNSATURATED FROM FEBRUARY 1 TO MARCH 13, 2019. NO DATA WERE COLLECTED BY MW12-01.
2. NO DATA WERE COLLECTED BY MW12-05. THE STANDPIPE WAS AND REMAINS UNSATURATED (DRY).

3. NO DATA WERE COLLECTED BY MW12-01 FROM MAY 31 TO SEPTEMBER 11, 2019 DUE TO DATA LOGGER FAILURE.
4. ERRONEOUS NOISE WAS RECORDED IN THE DATA BY DH18-S2 VW2. THESE DATA HAVE BEEN OMITTED FOR CLARITY.
