Prepared for
Montana Resources, LLC
600 Shields Avenue
Butte, Montana
USA, 59701

Prepared by
Knight Piésold Ltd.
Suite 1400 - 750 West Pender Street
Vancouver, British Columbia
Canada, V6C 2T8

VA101-126/27-2

YANKEE DOODLE TAILINGS IMPOUNDMENT 2022 ANNUAL INSPECTION REPORT

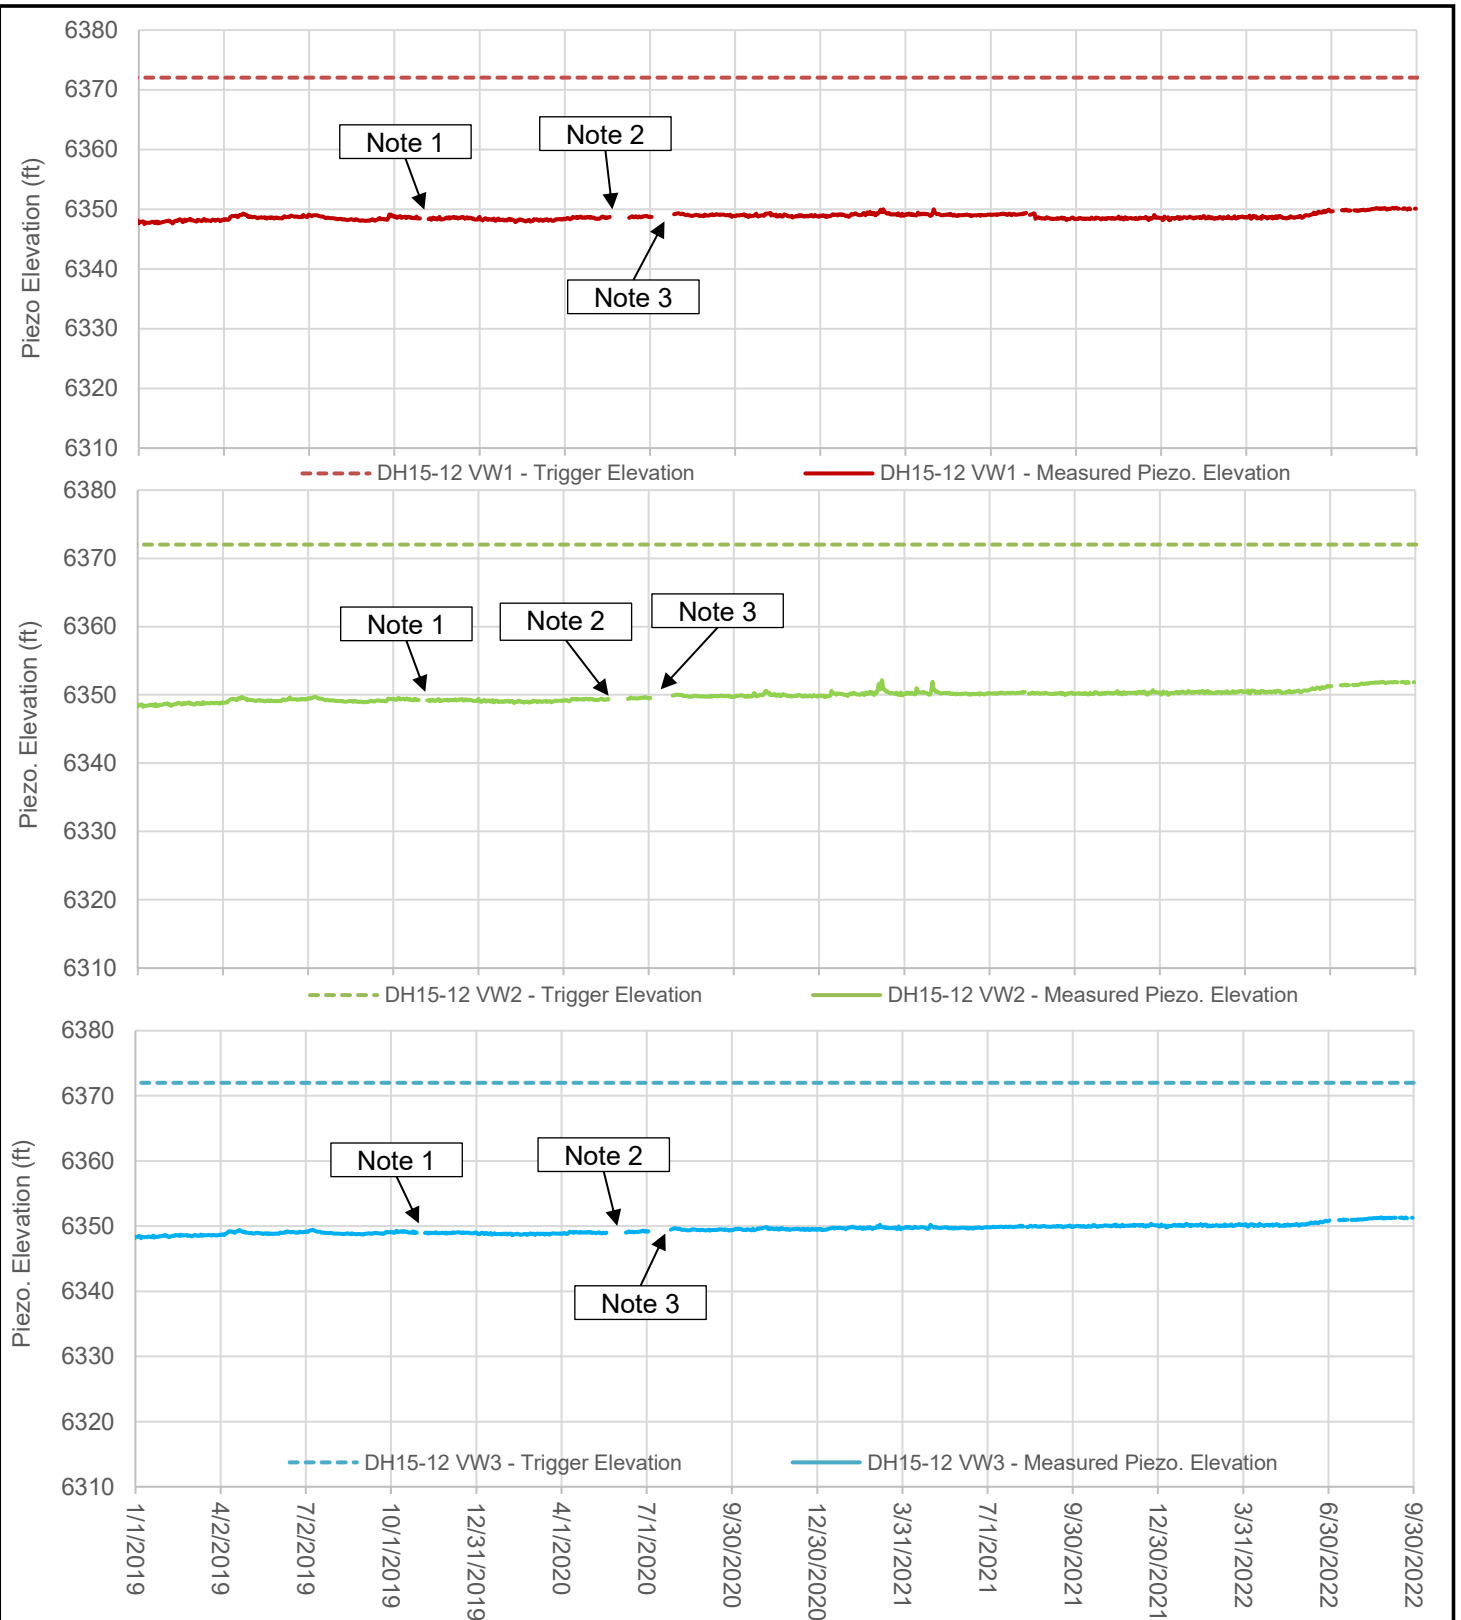
MONTANA RESOURCES, LLP	
YANKEE DOODLE TAILINGS IMPOUNDMENT	
SUMMARY OF MEASURED VS. QPP TRIGGER PIEZOMETRIC ELEVATIONS WEST EMBANKMENT	
Knight Piesold CONSULTING	P/A NO. VA101-126/27 REF. NO. VA22-01888
FIGURE 5	REV 0

- NOTES:**
1. NO DATA WERE COLLECTED BY DH15-12 VW1, VW2, AND VW3 FROM OCTOBER 30, 2019 TO NOVEMBER 6, 2019 DUE TO A CONNECTIVITY ISSUE.
 2. NO DATA WERE COLLECTED BY DH15-12 VW1, VW2, AND VW3 FROM MAY 19 TO JUNE 9, 2020 DUE TO A SUSPECTED LOGGER CONNECTIVITY ISSUE.
 3. NO DATA WERE COLLECTED BY DH15-12 VW1, VW2, AND VW3 FROM JULY 3 TO JULY 26, 2020 DUE TO A CONNECTIVITY ISSUE.

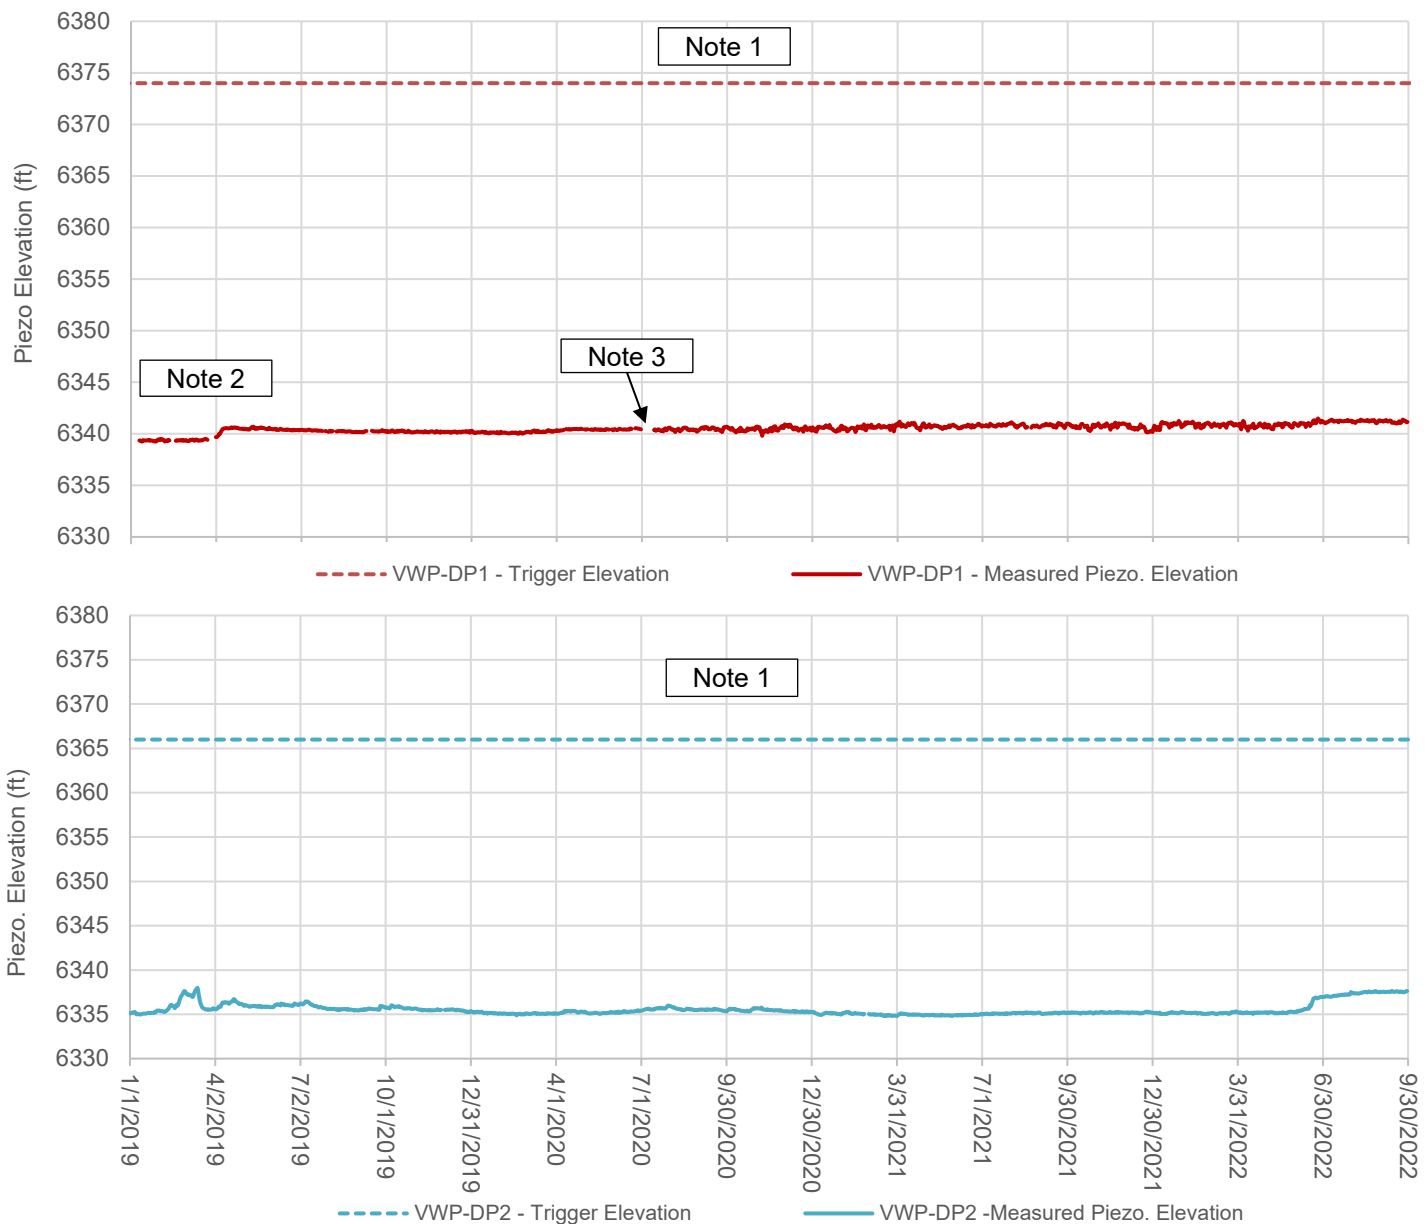
MONTANA RESOURCES, LLP	
YANKEE DOODLE TAILINGS IMPOUNDMENT	
SUMMARY OF MEASURED VS. QPP TRIGGER PIEZOMETRIC ELEVATIONS WEST EMBANKMENT	
Knight Piesold CONSULTING	P/A NO. VA101-126/27 REF. NO. VA22-01888
FIGURE 6	
REV 0

- NOTES:**
1. TRIGGER ELEVATIONS FOR SENSORS INSTALLED IN THE DRAIN PODS HAVE BEEN SPECIFIED AT THE ALLOWABLE HYDRAULIC GRADE LINE.
 2. PERIODIC OUTAGES OCCURED AT VWP-DP1 DUE TO INTERMITTENT BATTERY VOLTAGE ISSUES.
 3. NO DATA WERE RECORDED BY VWP-DP1 FROM JULY 1 TO 14, 2020 DUE TO A COMMUNICATION OUTAGE. A REPLACEMENT DATA LOGGER WAS SUBSEQUENTLY INSTALLED TO RESOLVE THE ISSUE.

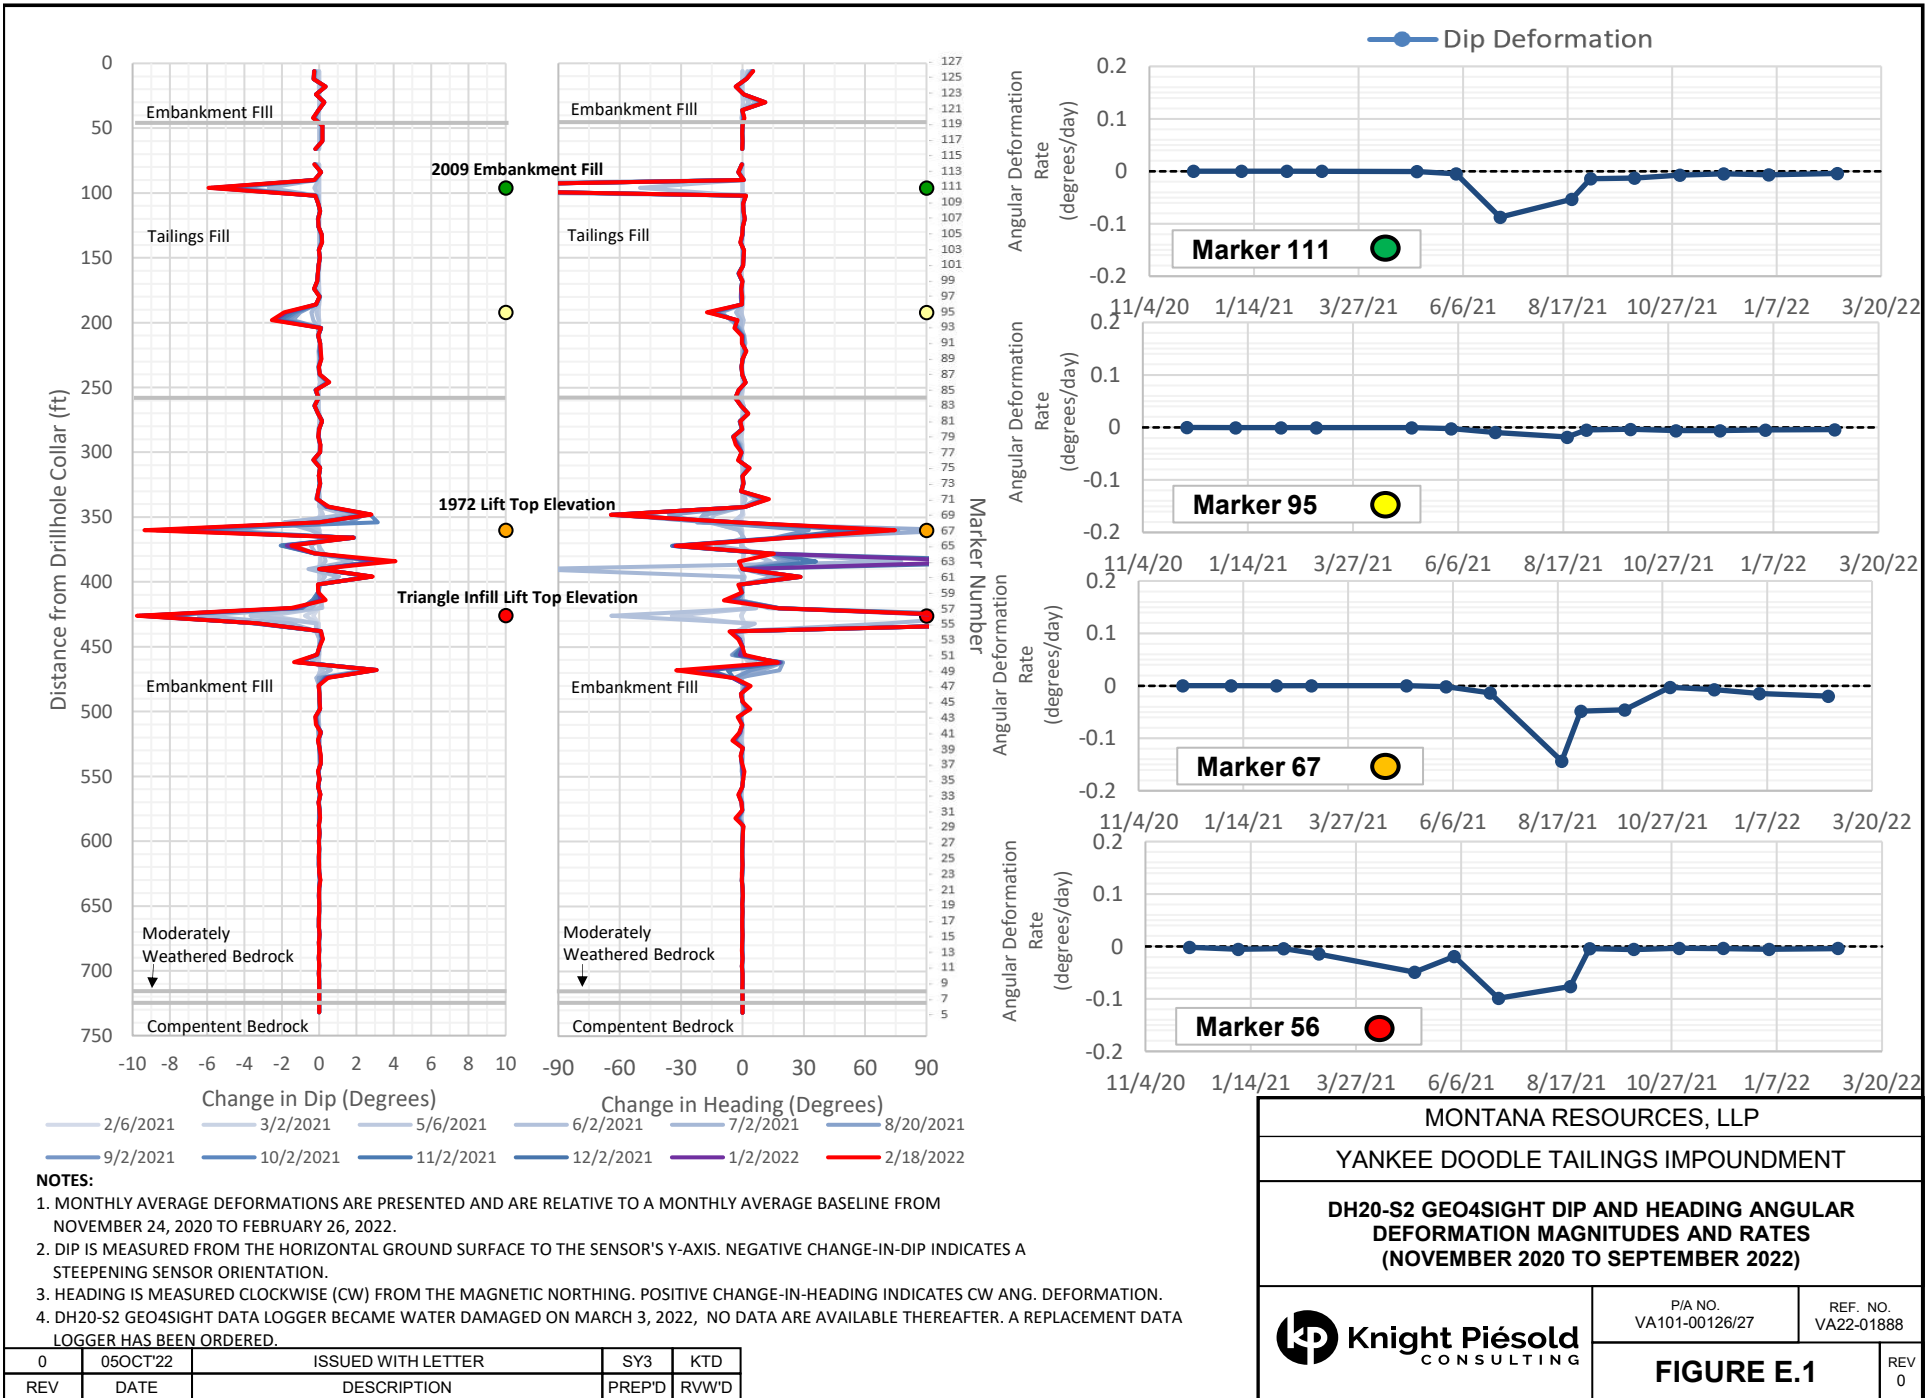
Knight Piésold CONSULTING	P/A NO. VA101-00126/27 REF. NO. VA22-01888
FIGURE E.1	
REV 0

- NOTES:**
1. MONTHLY AVERAGE DEFORMATIONS ARE PRESENTED AND ARE RELATIVE TO A MONTHLY AVERAGE BASELINE FROM NOVEMBER 24, 2020 TO FEBRUARY 26, 2022.
 2. DIP IS MEASURED FROM THE HORIZONTAL GROUND SURFACE TO THE SENSOR'S Y-AXIS. NEGATIVE CHANGE-IN-DIP INDICATES A STEEPENING SENSOR ORIENTATION.
 3. HEADING IS MEASURED CLOCKWISE (CW) FROM THE MAGNETIC NORTHING. POSITIVE CHANGE-IN-HEADING INDICATES CW ANG. DEFORMATION.
 4. DH20-S2 GEO4SIGHT DATA LOGGER BECAME WATER DAMAGED ON MARCH 3, 2022, NO DATA ARE AVAILABLE THEREAFTER. A REPLACEMENT DATA LOGGER HAS BEEN ORDERED.
