VA101-126/29-4

MONTANA RESOURCES

YANKEE DOODLE TAILINGS IMPOUNDMENT - 2023 ANNUAL INSPECTION REPORT

EXECUTIVE SUMMARY

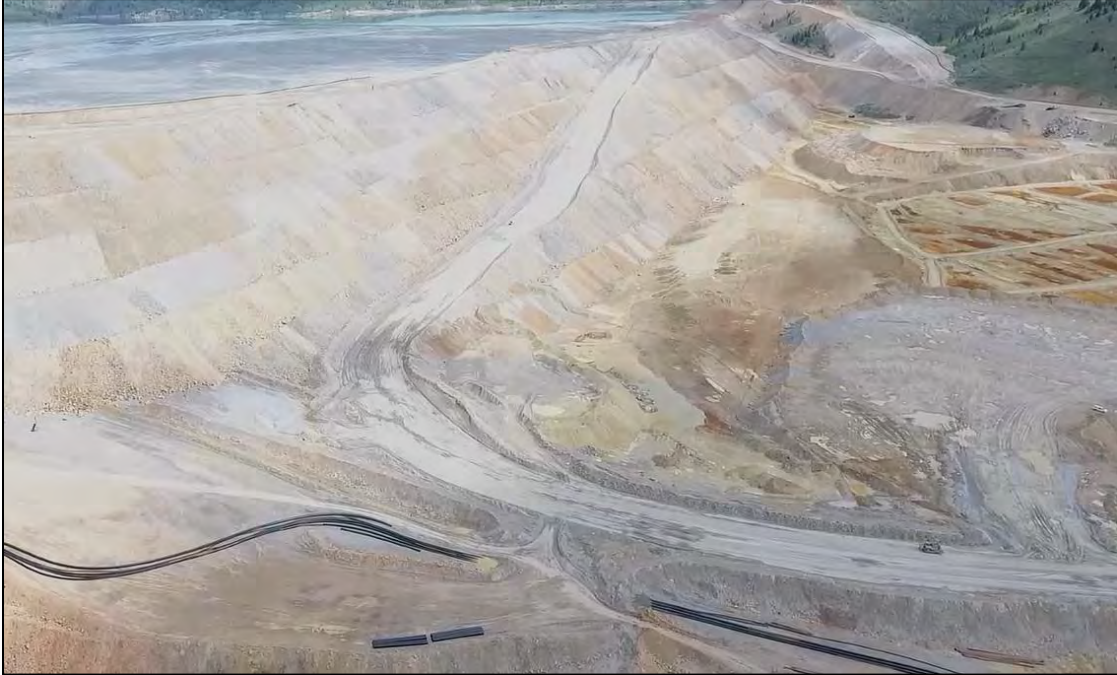
PHOTO 1 – North-South Embankment downstream shell, facing north from southeast end of YDTI.

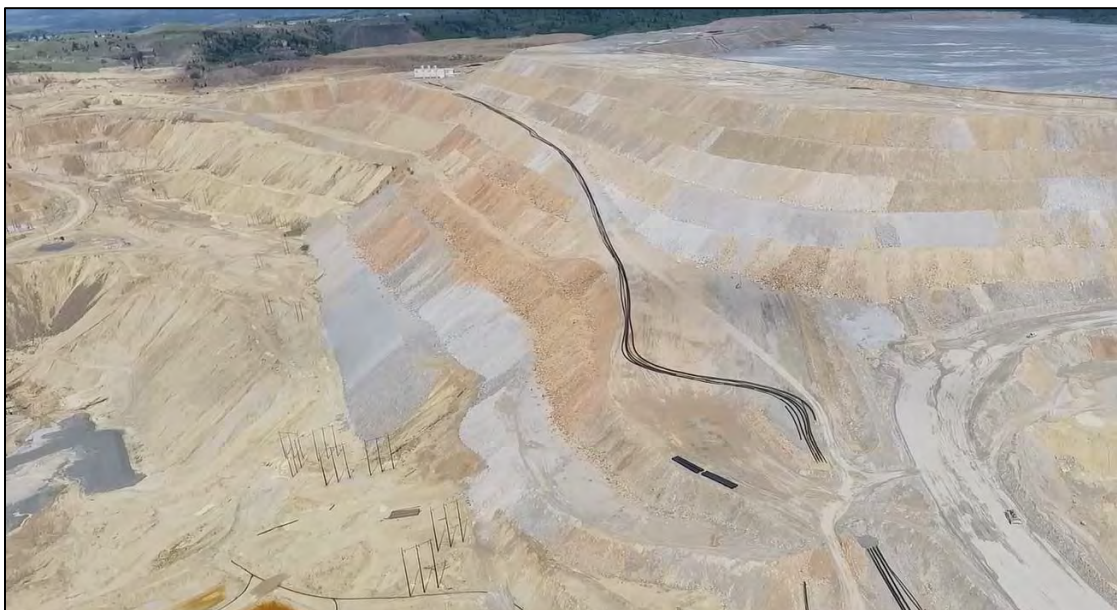
PHOTO 2 – Central Pedestal Area downstream shell, facing west.

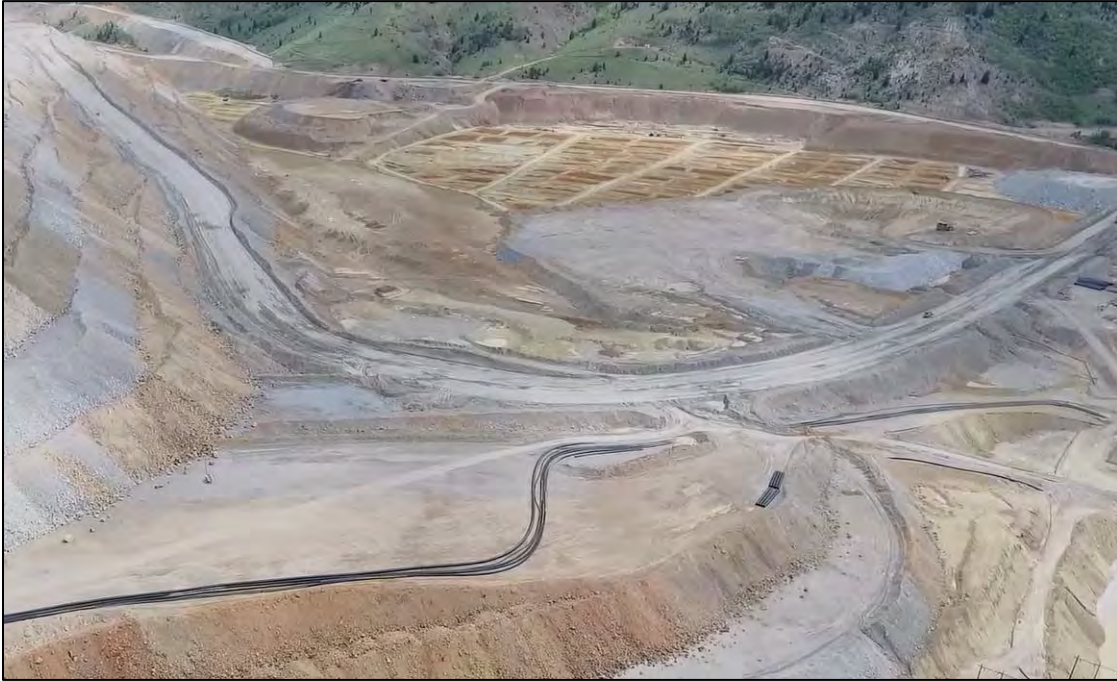
PHOTO 3 – North RDS construction with initial haul ramp lifts, facing northeast

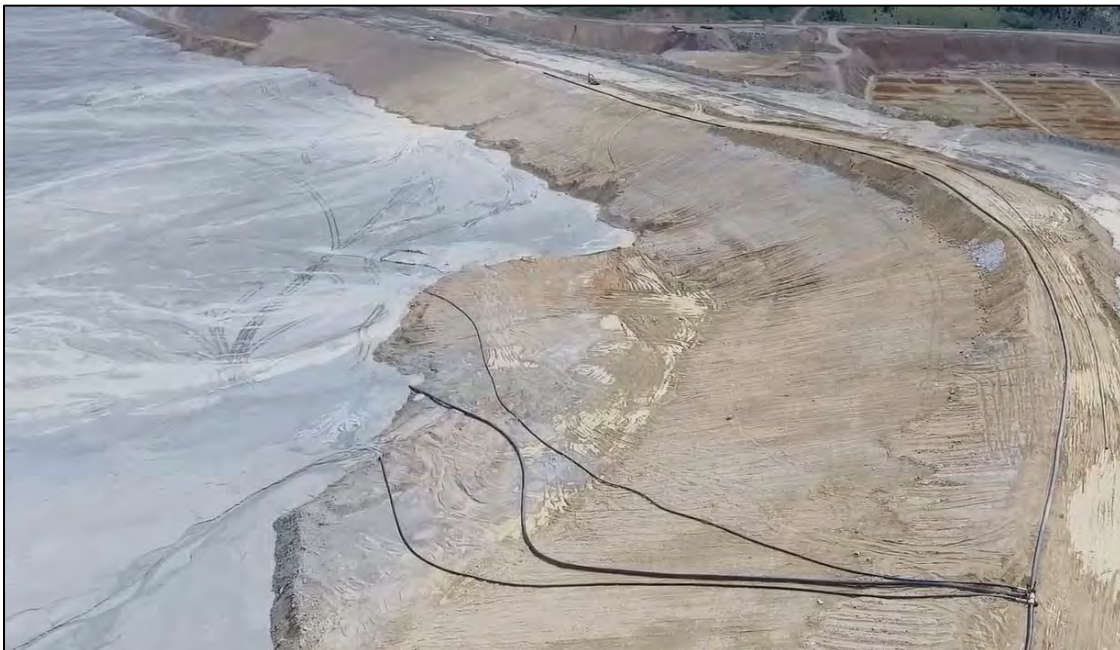
PHOTO 4 – North-South Embankment upstream regrading and alluvium facing completed up to approximately Section 28+00N, facing northeast.

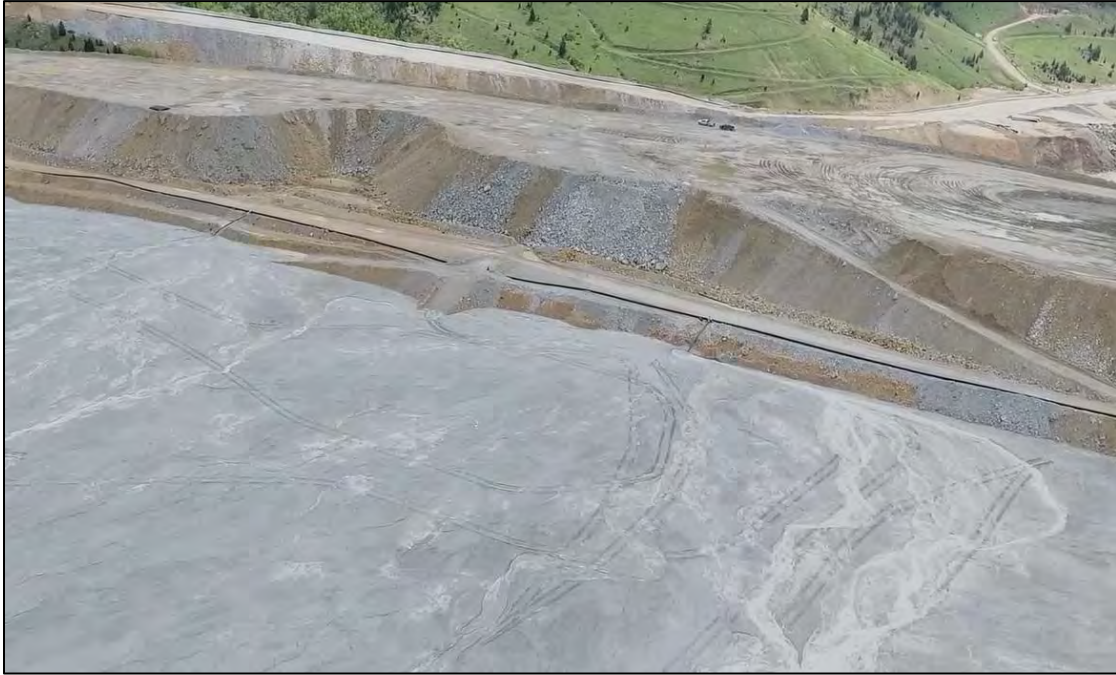
- The upstream slope of the embankment between approximately 0+00 and 28+00N was regraded and alluvium facing placed along the regraded slope as recommended in the 2022 AIR. The remaining regrading and facing work is scheduled for early 2024 as per the 2022 Corrective Action Plan (CAP).

PHOTO 5 – North-South Embankment upstream regrading remains to be completed beyond approximately Section 28+00N, facing east.

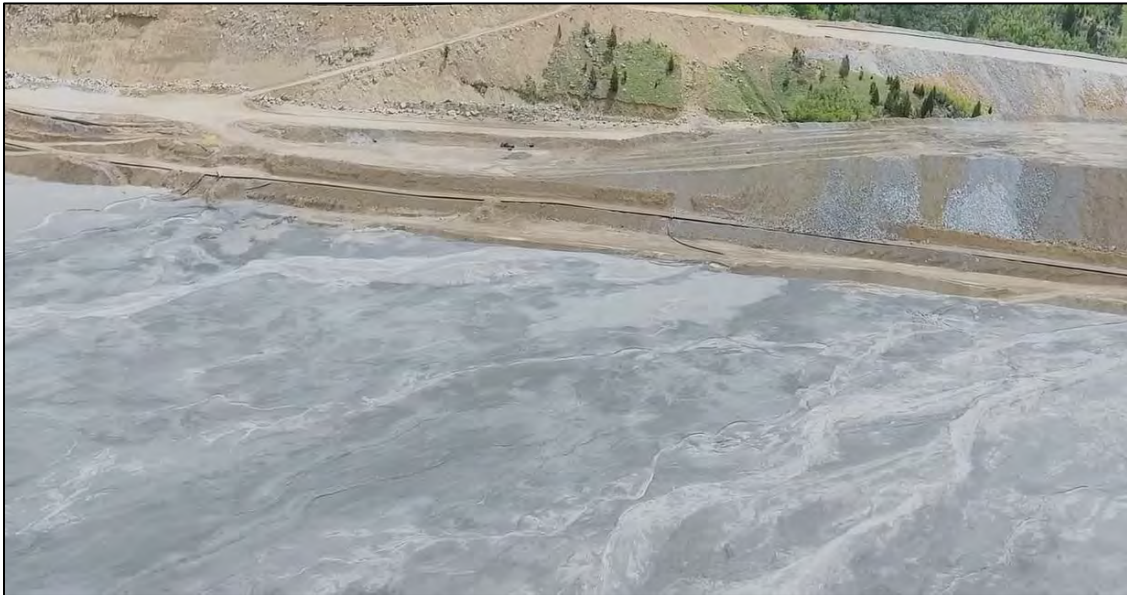
PHOTO 6 – North-South Embankment deferred fill placement area beyond approximately Section 50+00N, facing east.

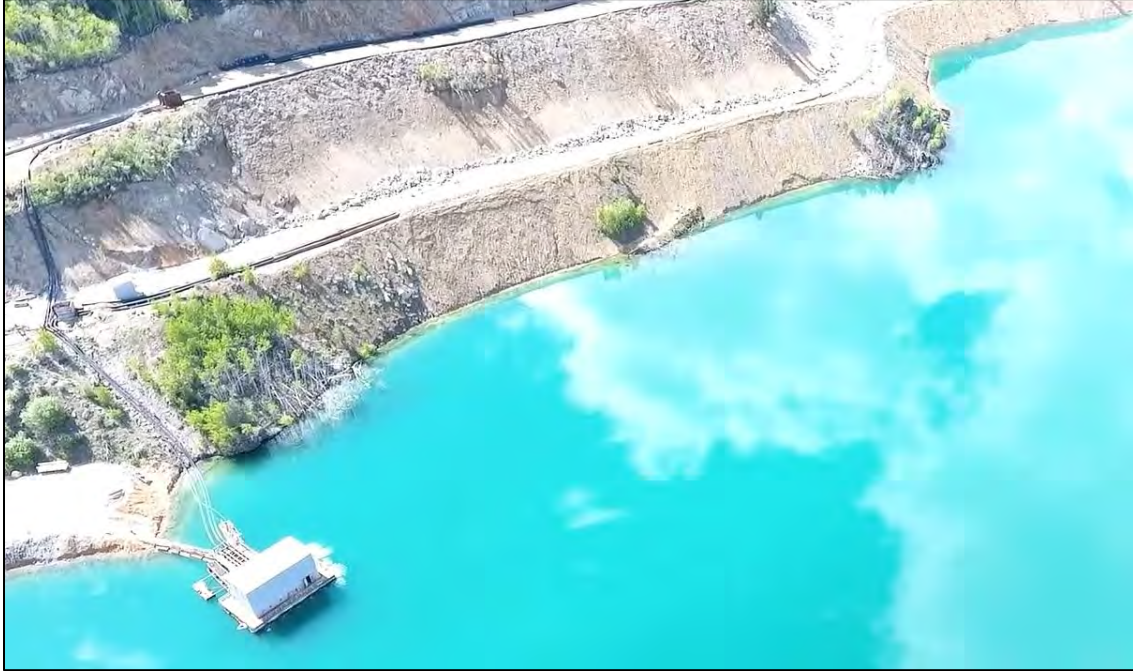
PHOTO 7 – Older Reclaim Barge connected to reclaim pipeline along the EL. 6,500 ft road.

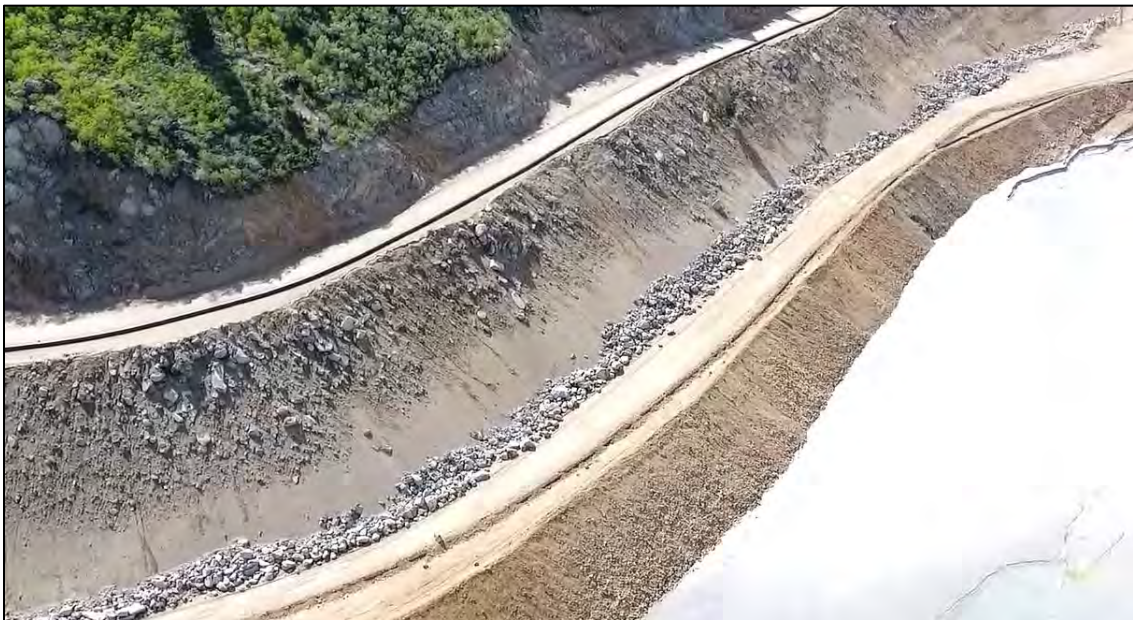
PHOTO 8 – Relocated reclaim water pipeline along the EL. 6,500 ft road.

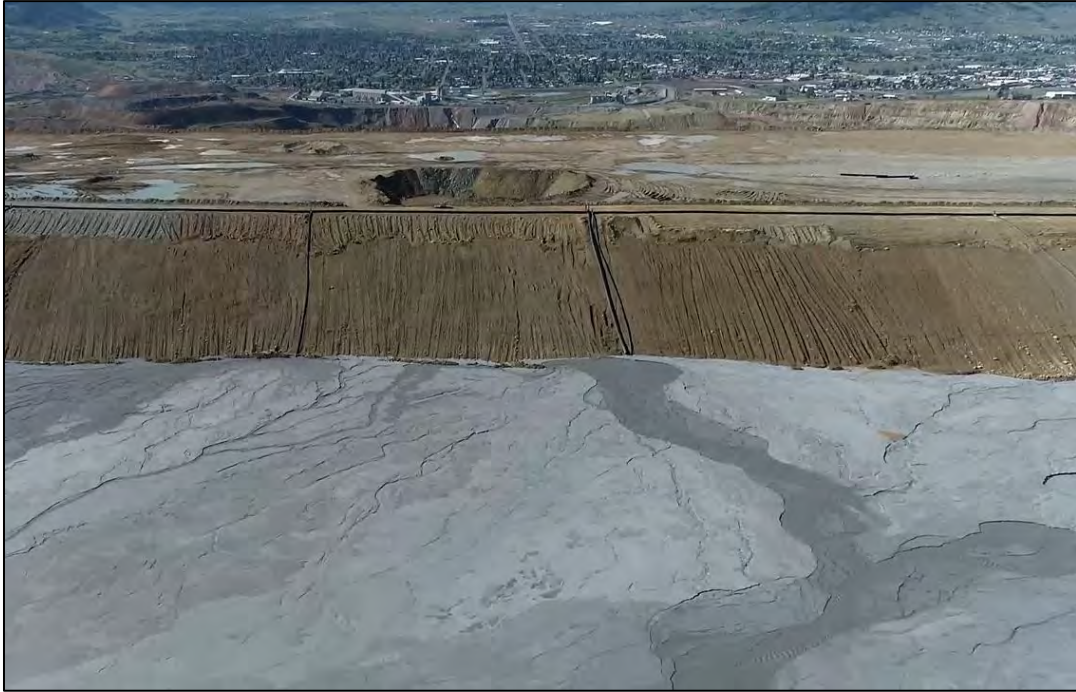
PHOTO 9 – East-West Embankment upstream regrading and alluvium facing completed in Central Pedestal Area, facing south.

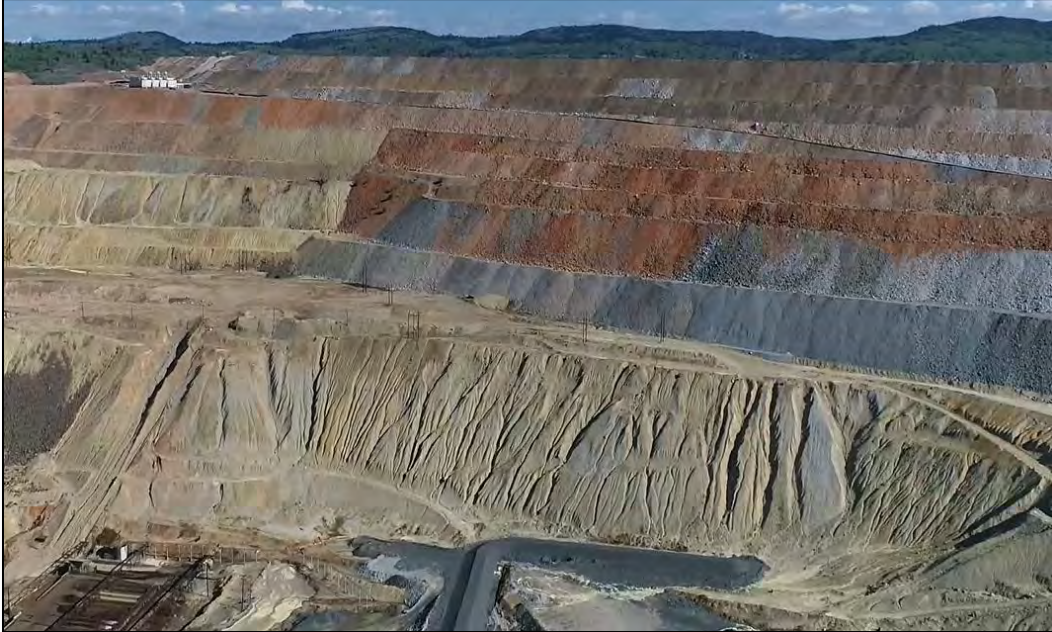
PHOTO 11 – East-West Embankment downstream slope and Number 10 Seep bench area, facing north.

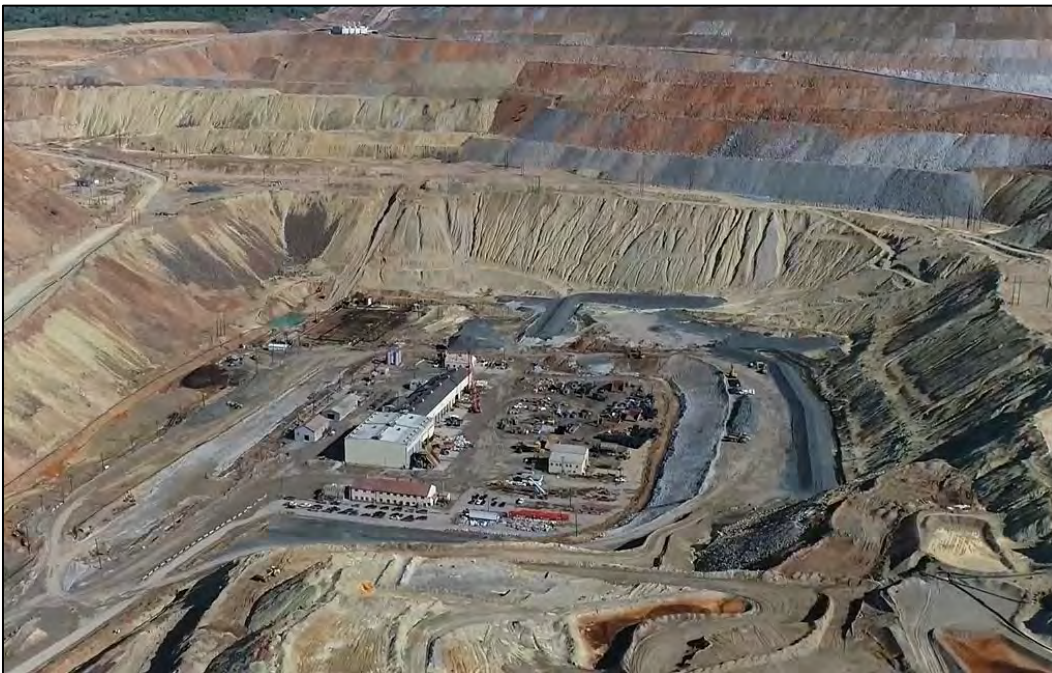
PHOTO 12 – Overview of Central Pedestal Area of the East-West Embankment, Seep 10 Bench, and HsB Area, facing north.

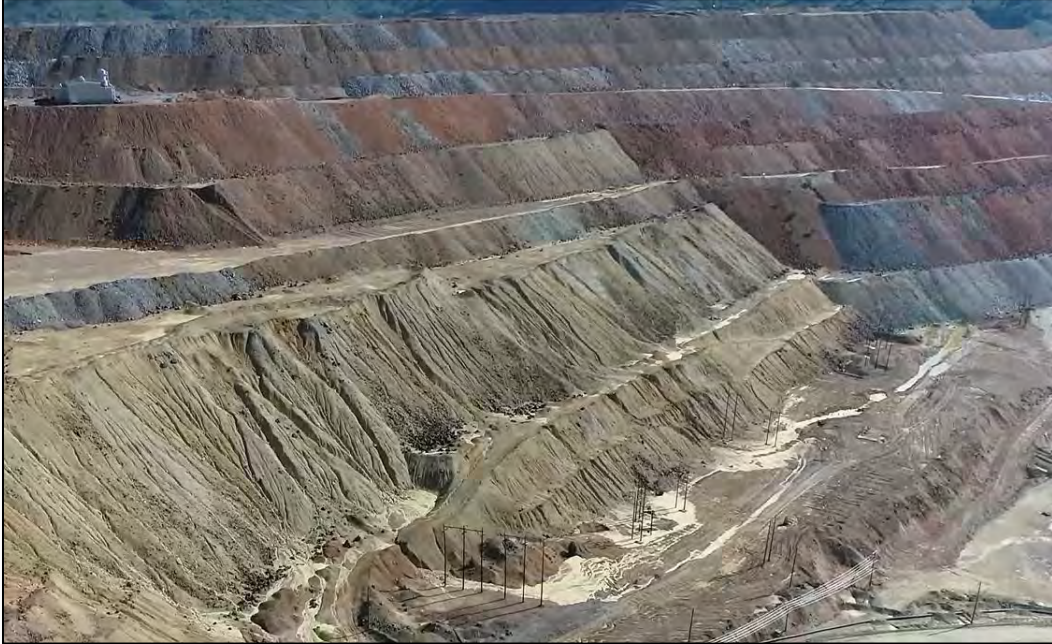
PHOTO 13 – Central Pedestal Area of the East-West Embankment, looking northeast.

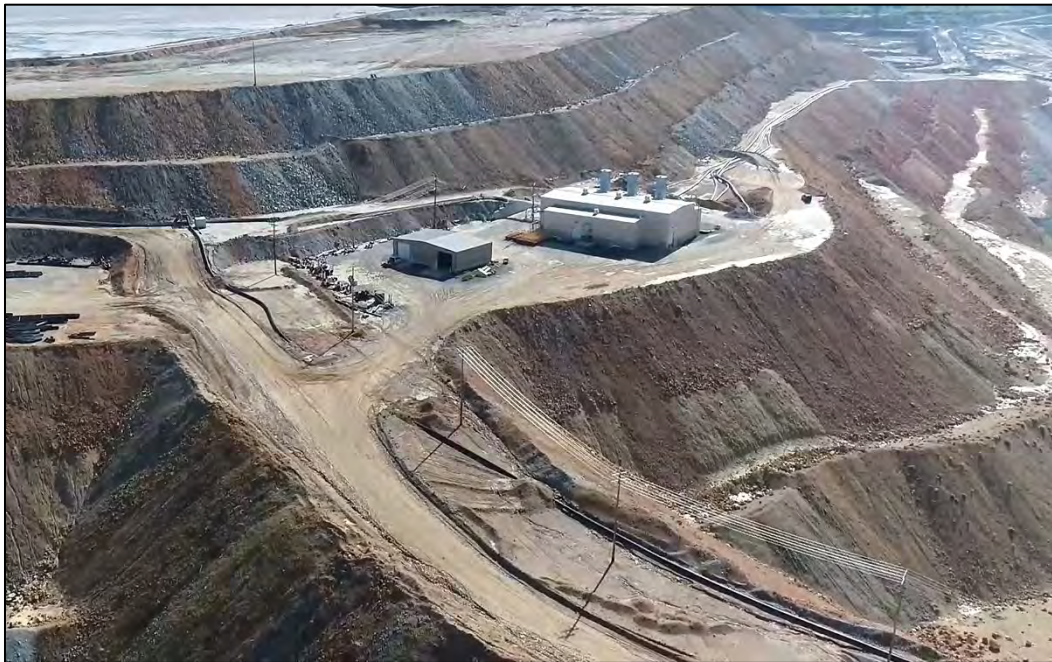
PHOTO 14 – EL. 6,450 ft lift placement complete, No. 3 Booster Pump House, and East-West pipeline ramp in Central Pedestal Area of the East West Embankment, facing east.

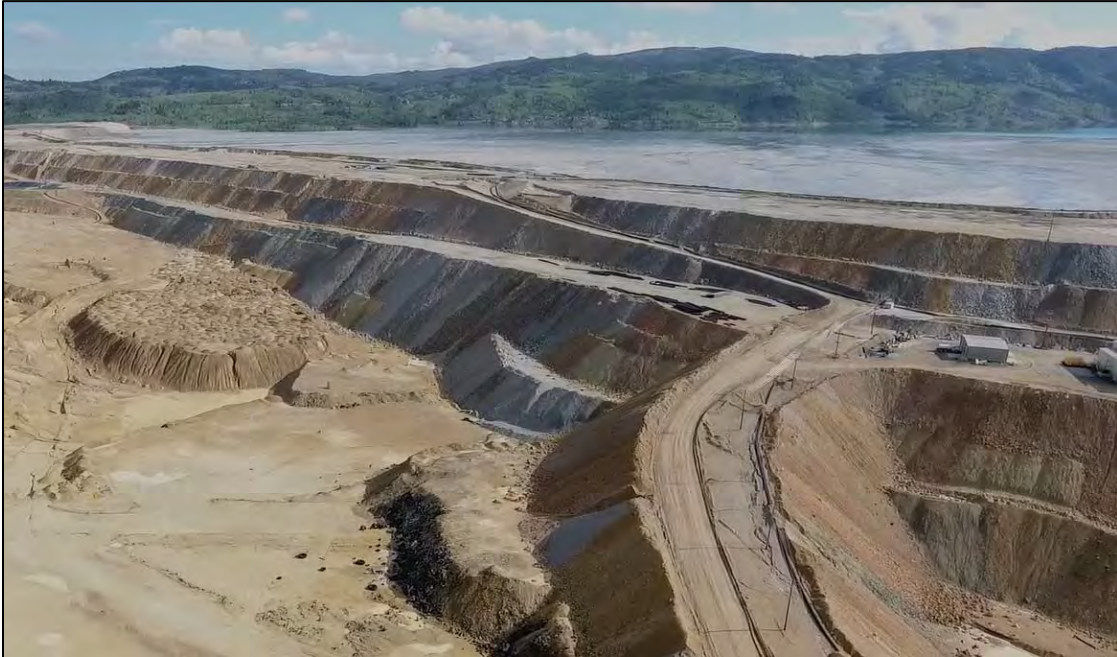
PHOTO 15 – East-West Embankment downstream side along northwest trending limb with No. 3 Booster Pump House on right hand side, looking north.

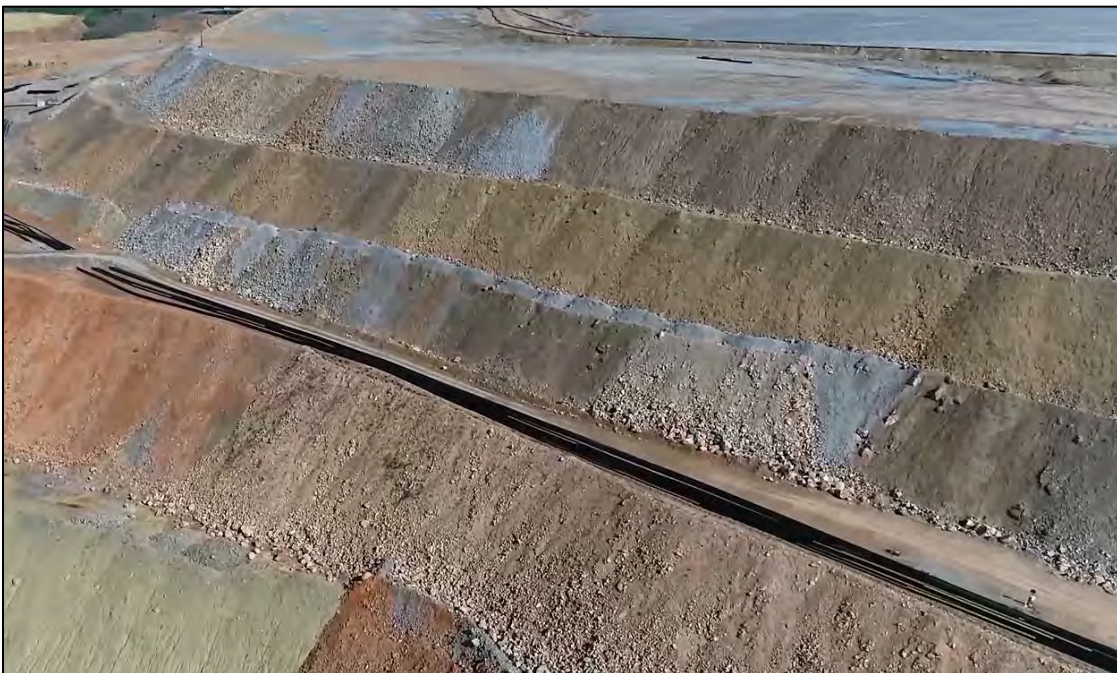
PHOTO 16 – East-West Embankment pipeline ramp with EL. 6,450 ft lift and surcharge zone placement complete, facing northwest from east of No. 3 Booster Pump House.

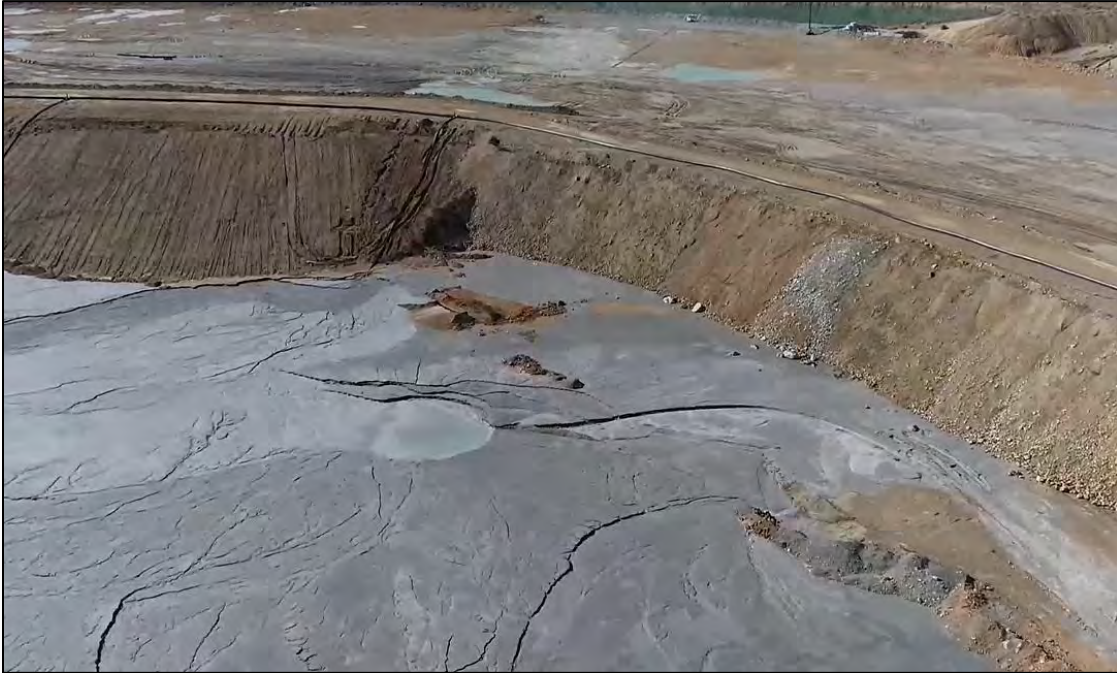
PHOTO 17 – East-West Embankment upstream face at discharge location EW-1, facing south.

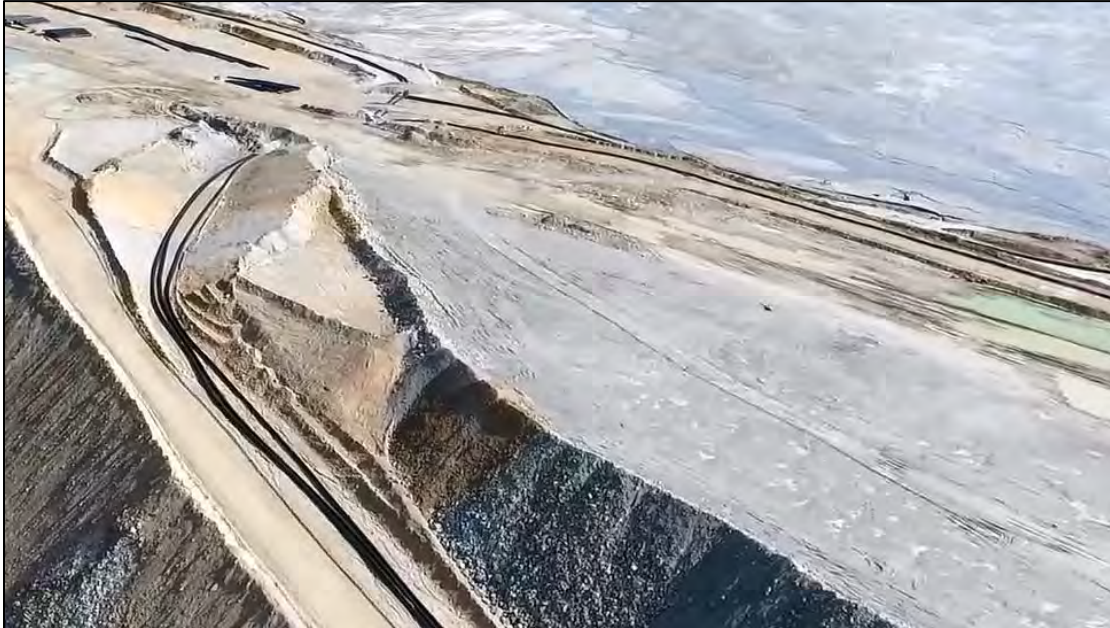
PHOTO 19 – East-West Embankment EL. 6,450 ft lift and surcharge zone, with view of adjacent tailings beach and Line 3, recently routed over the EL. 6,450 ft lift.

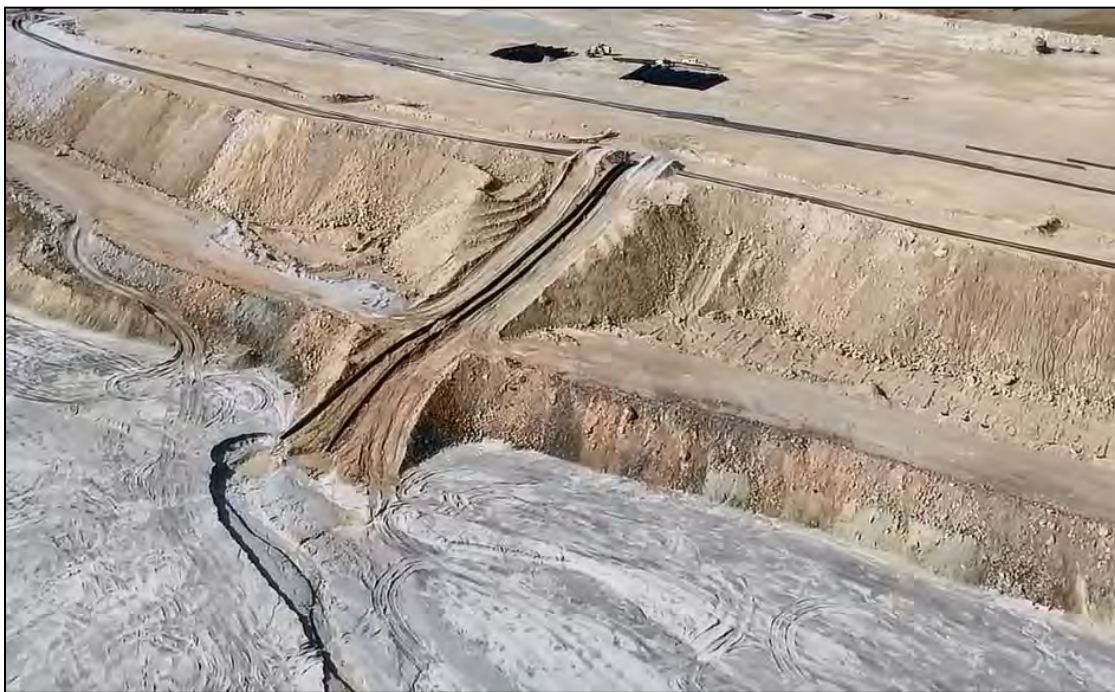
PHOTO 20 – East-West Embankment upstream side at discharge location EW-2, facing southwest.

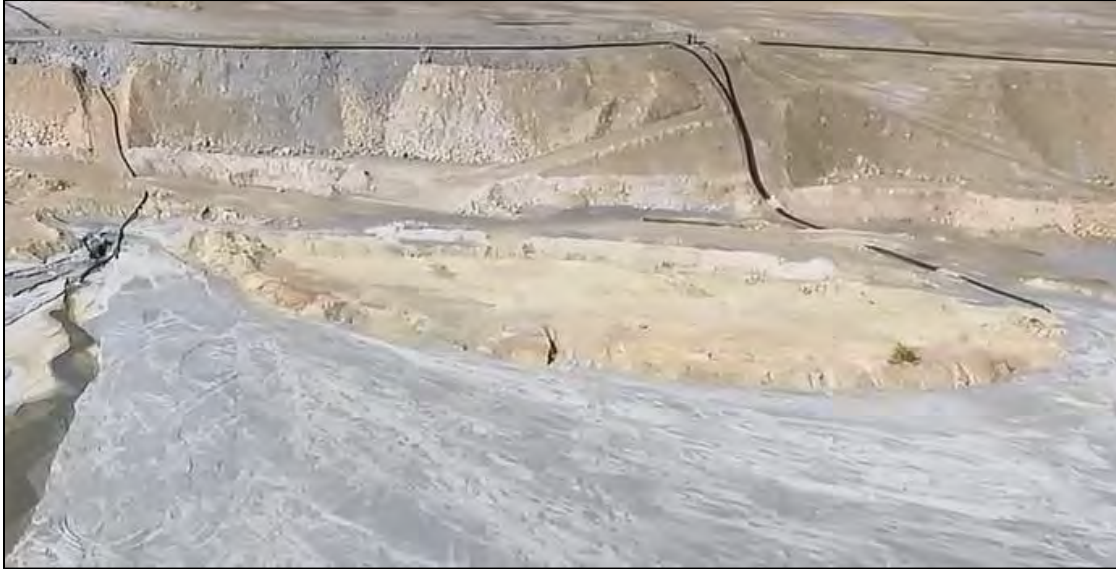
PHOTO 21 –West Embankment upstream interface near Rocky Knob, with view of discharge location RK-1 and an adjacent 12-inch discharge, facing south.

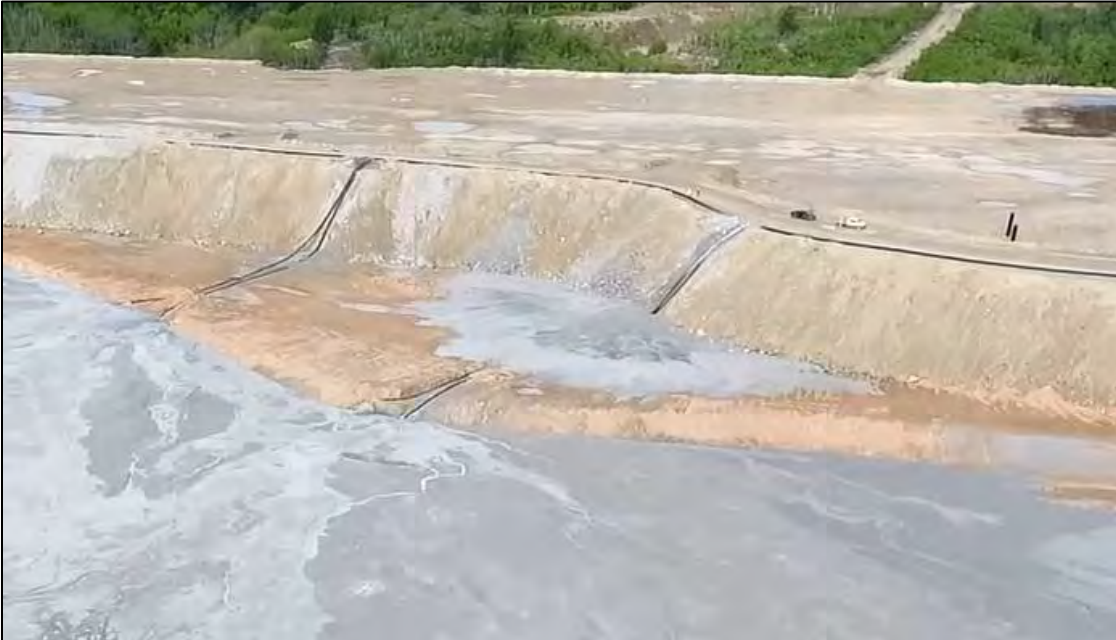
PHOTO 22 – West Embankment upstream interface with view of 12-inch discharges between discharge locations RK-2 and RK-3, facing west.

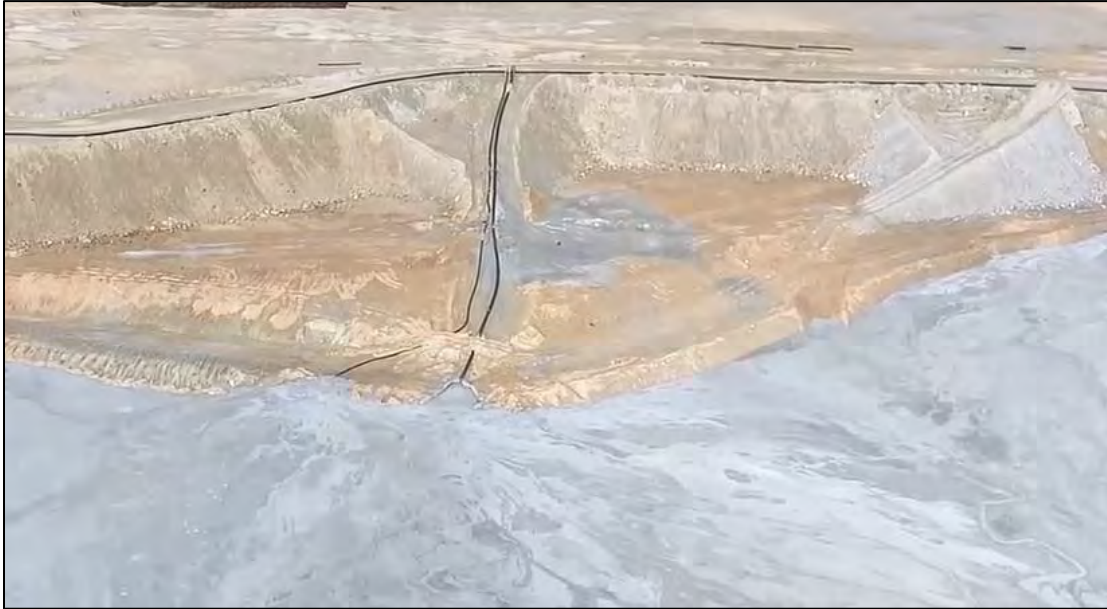
PHOTO 23 – West Embankment upstream interface and discharge location RK-3, facing west.

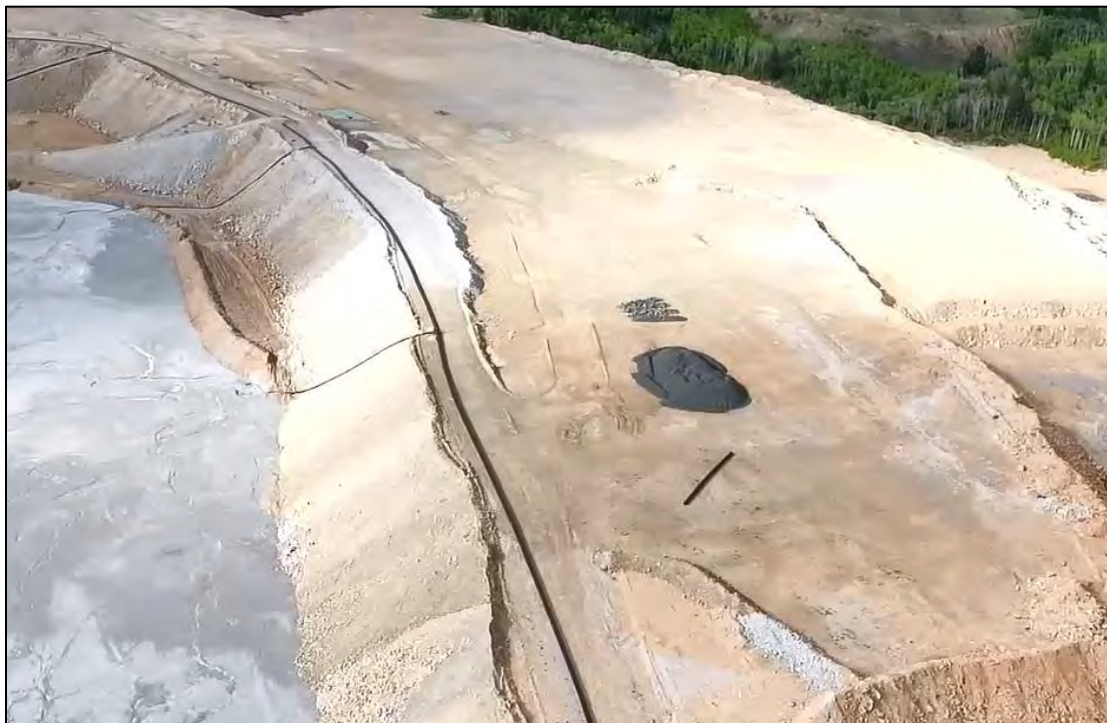
PHOTO 24 – West Embankment with view of upstream interface and EL. 6,450 ft crest, facing south near discharge location RK-4.

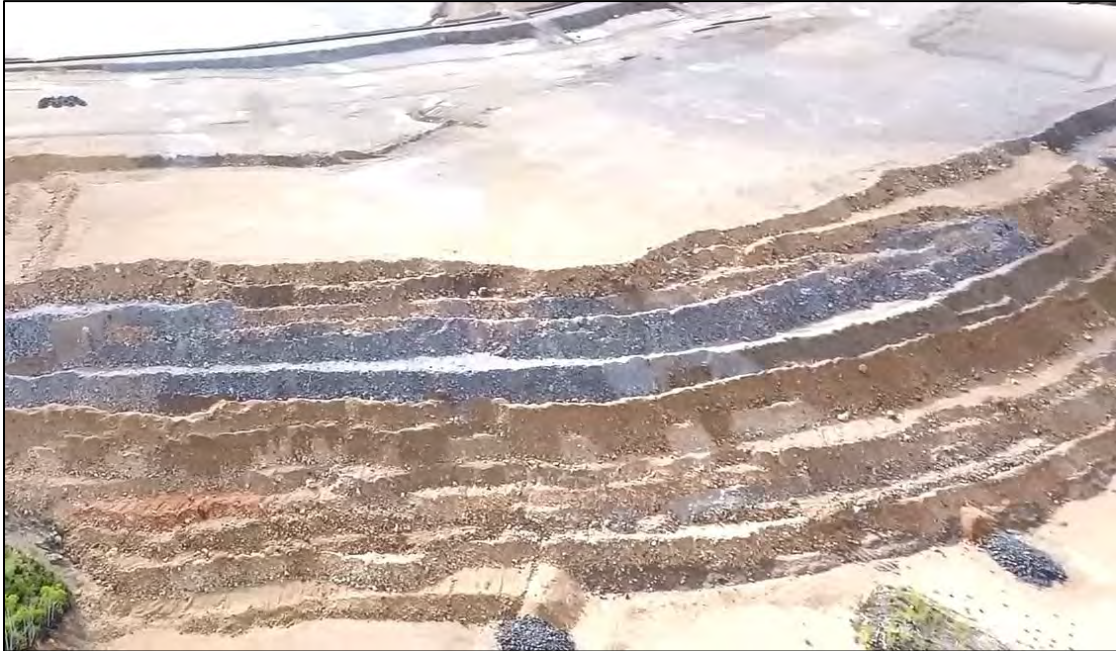
PHOTO 25 – West Embankment crest and downstream shell before final grading and trimming at northern end of West Embankment, facing east.

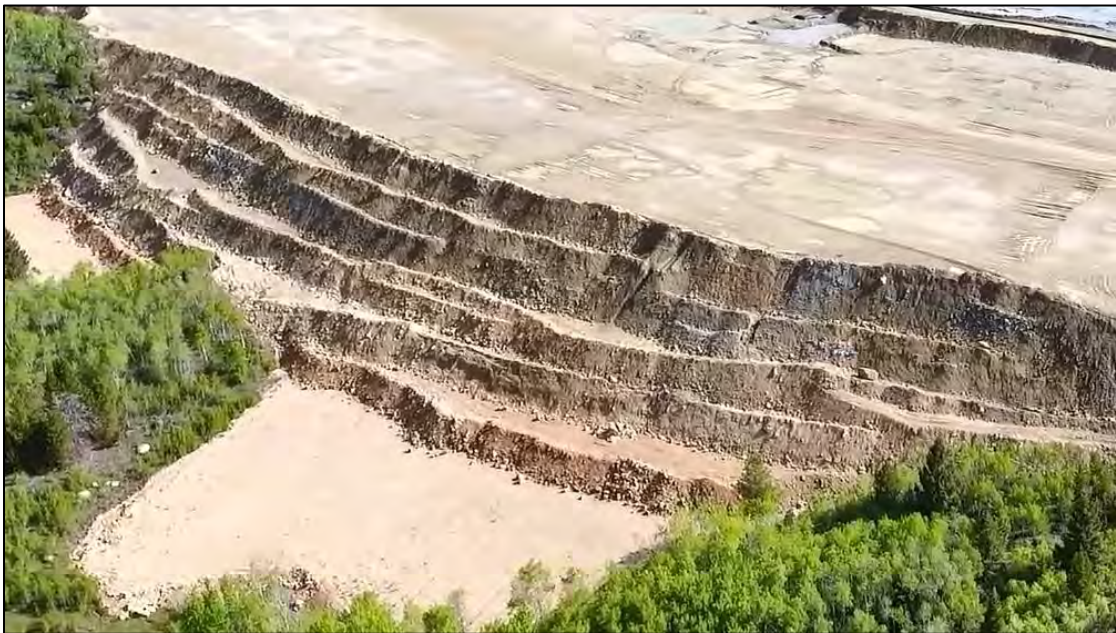
PHOTO 26 – West Embankment downstream shell before final grading and trimming, northwest of Rocky Knob and Extraction Pond, looking northeast.

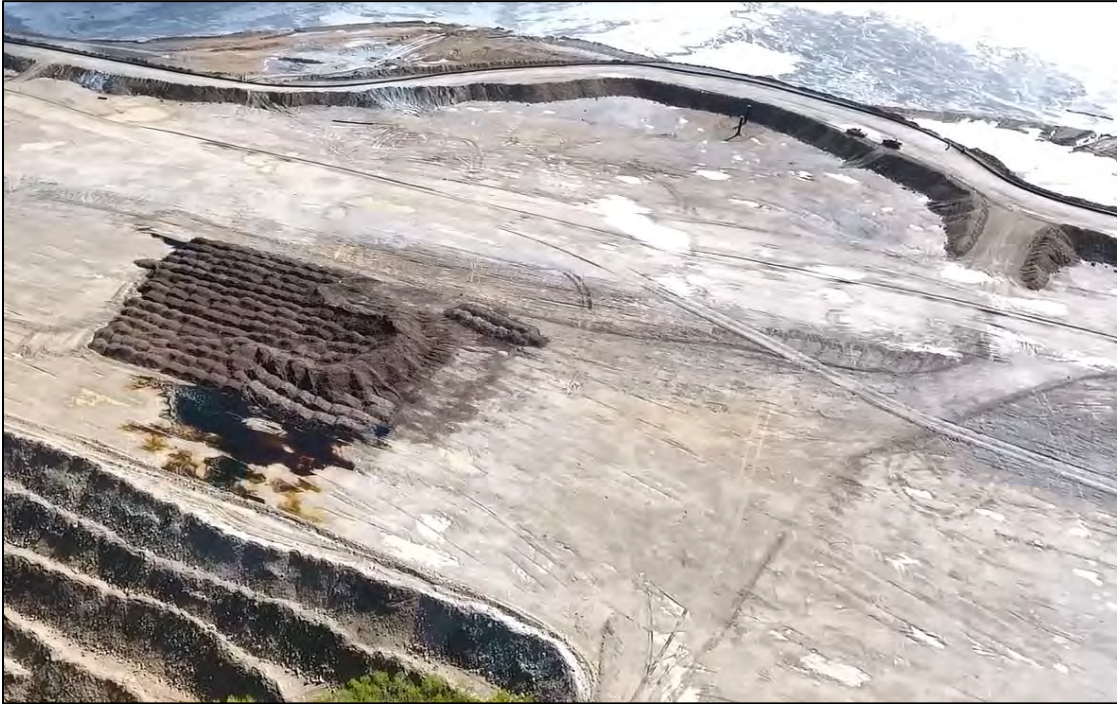
PHOTO 27 – West Embankment – organics stockpile on EL. 6,450 ft crest for use in downstream slope progressive reclamation.

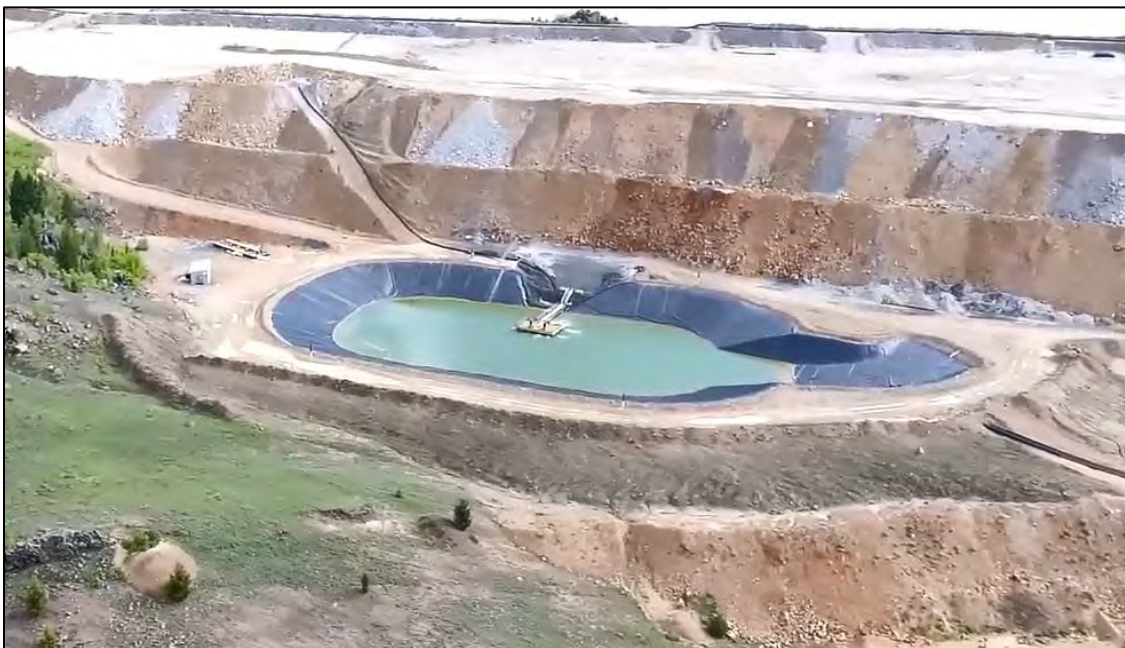
PHOTO 28 – Overview of WED Extraction Pond.

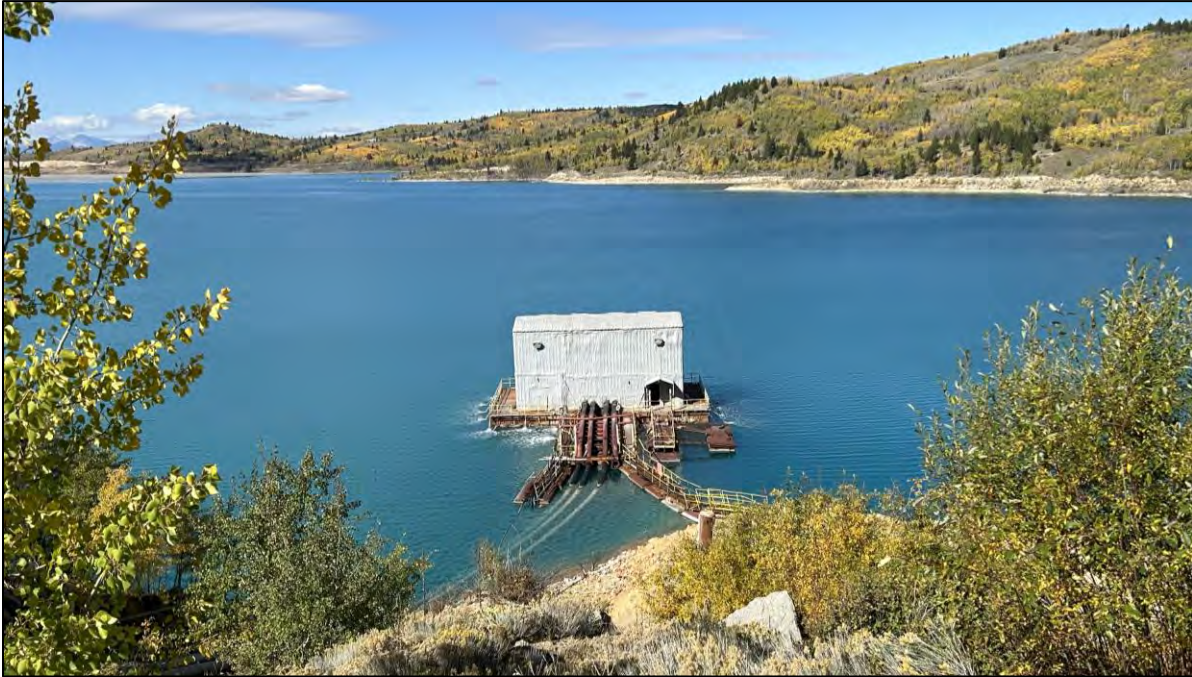
PHOTO 29 – Older (southern) Reclaim Barge and YDTI supernatant pond, facing west from the new reclaim water pipeline road.

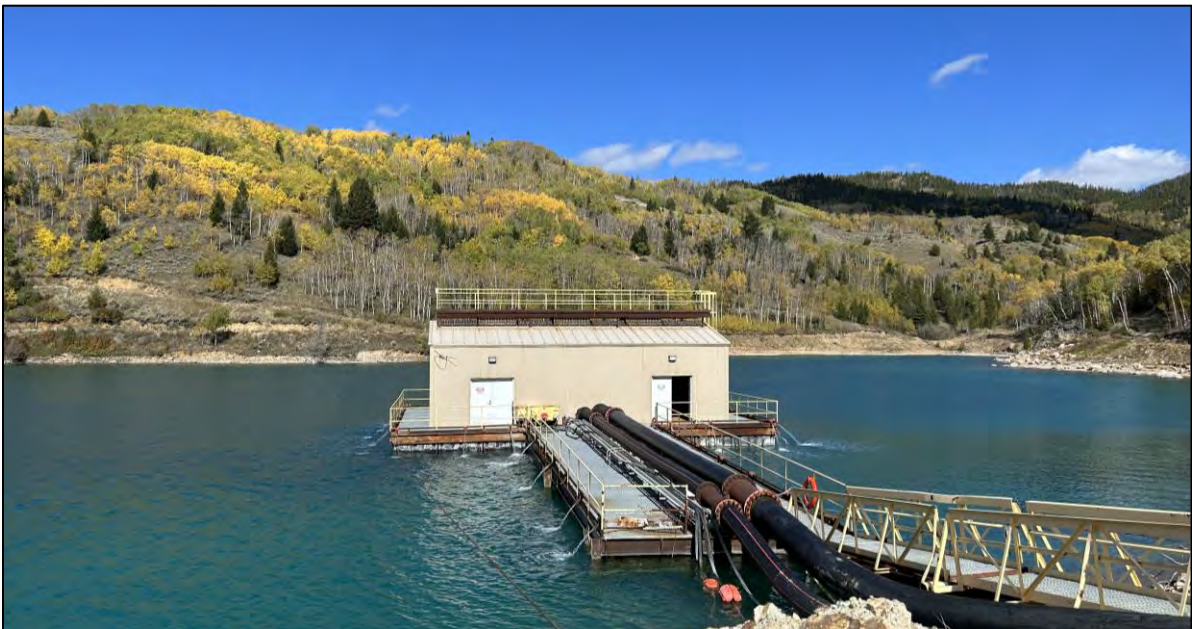
PHOTO 30 – Newer (northern) Reclaim Barge, facing north

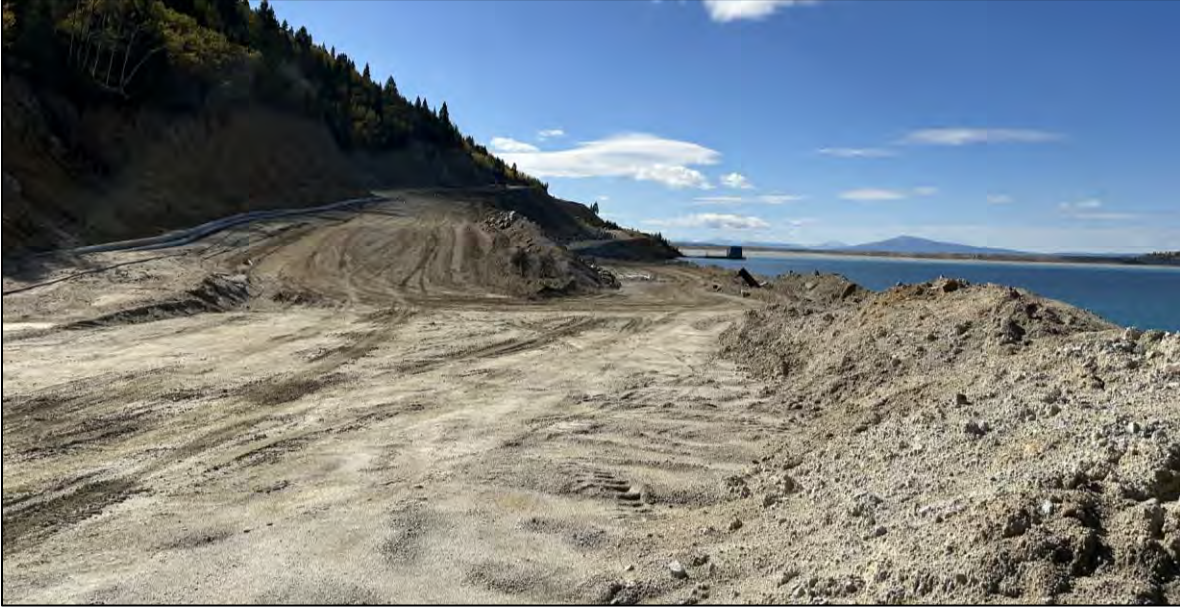
PHOTO 31 – Completed new reclaim pipeline road (left) and YDTI supernatant pond (right), facing south from northern reclaim barge.

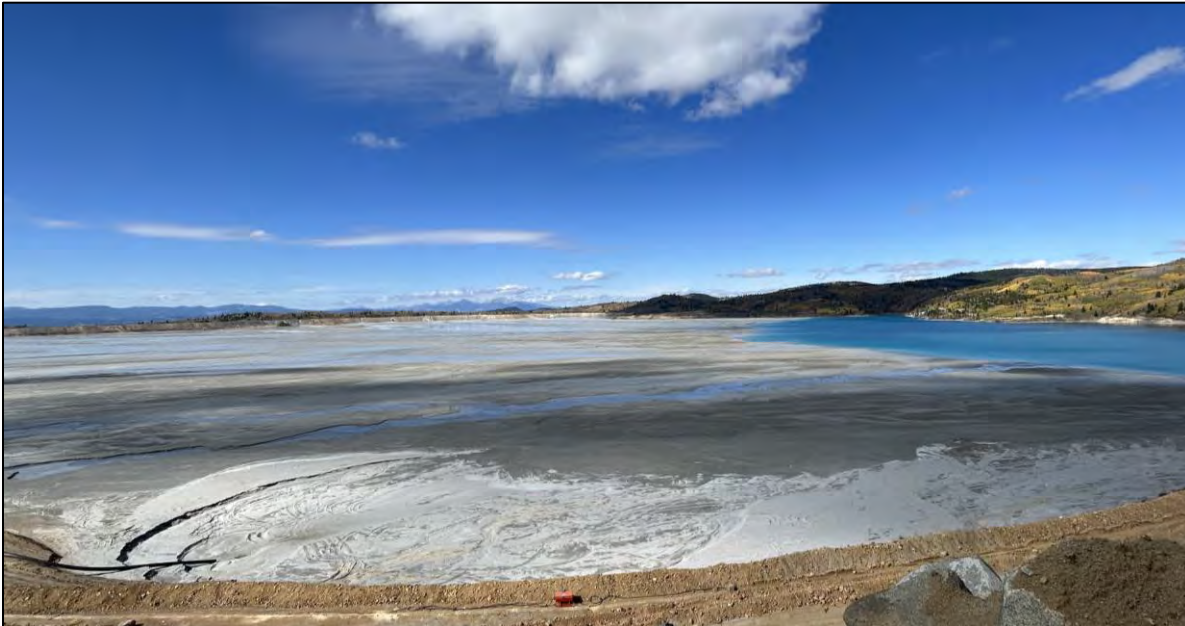
PHOTO 32 – YDTI tailings beach and supernatant pond interface, facing west from the new reclaim pipeline road.
