VA101-126/29-4

MONTANA RESOURCES

YANKEE DOODLE TAILINGS IMPOUNDMENT - 2023 ANNUAL INSPECTION REPORT

EXECUTIVE SUMMARY

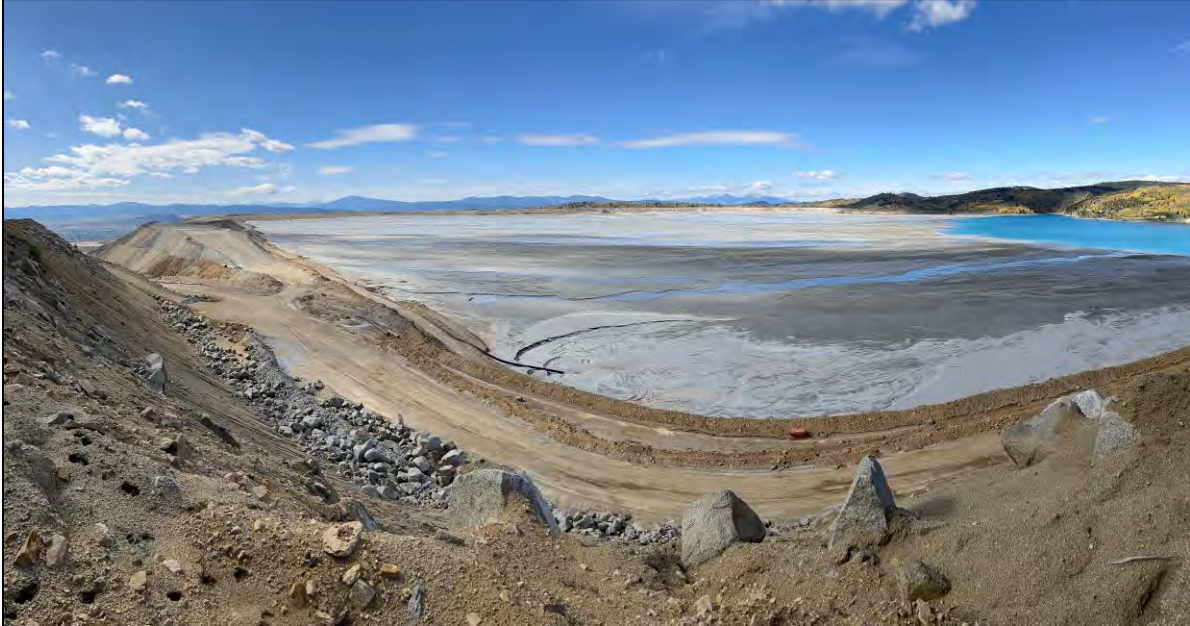
PHOTO 33 – North-South Embankment and beach, looking west from the new reclaim water pipeline road.

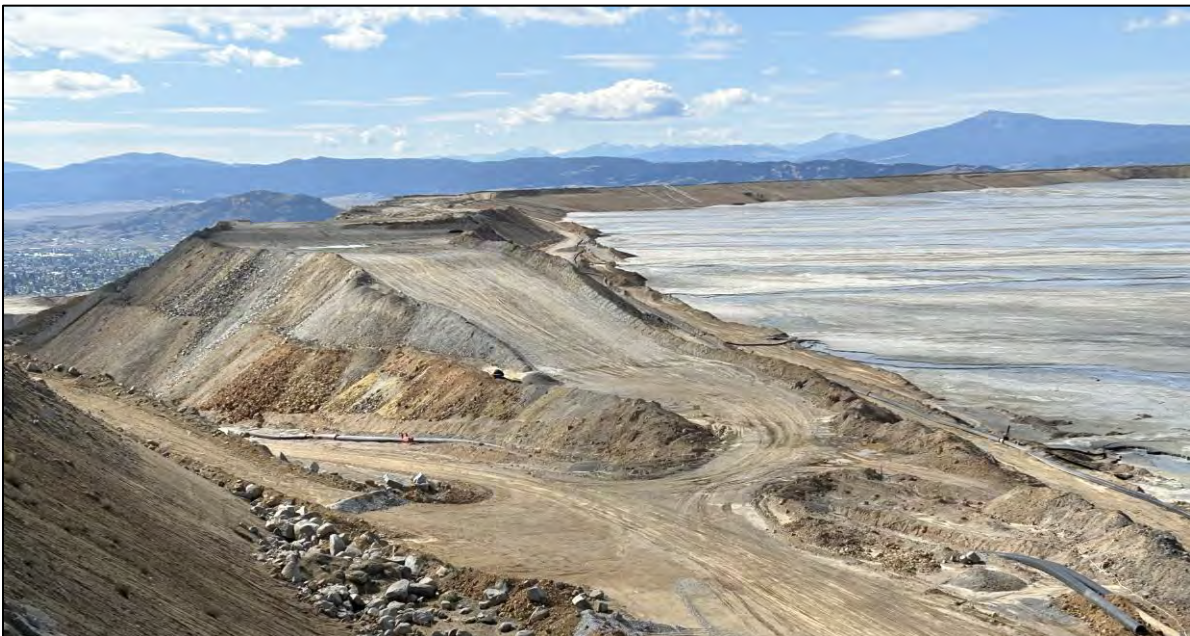
PHOTO 34 – North-South Embankment northern abutment at deferred fill placement area, looking southwest from the new reclaim pipeline road.

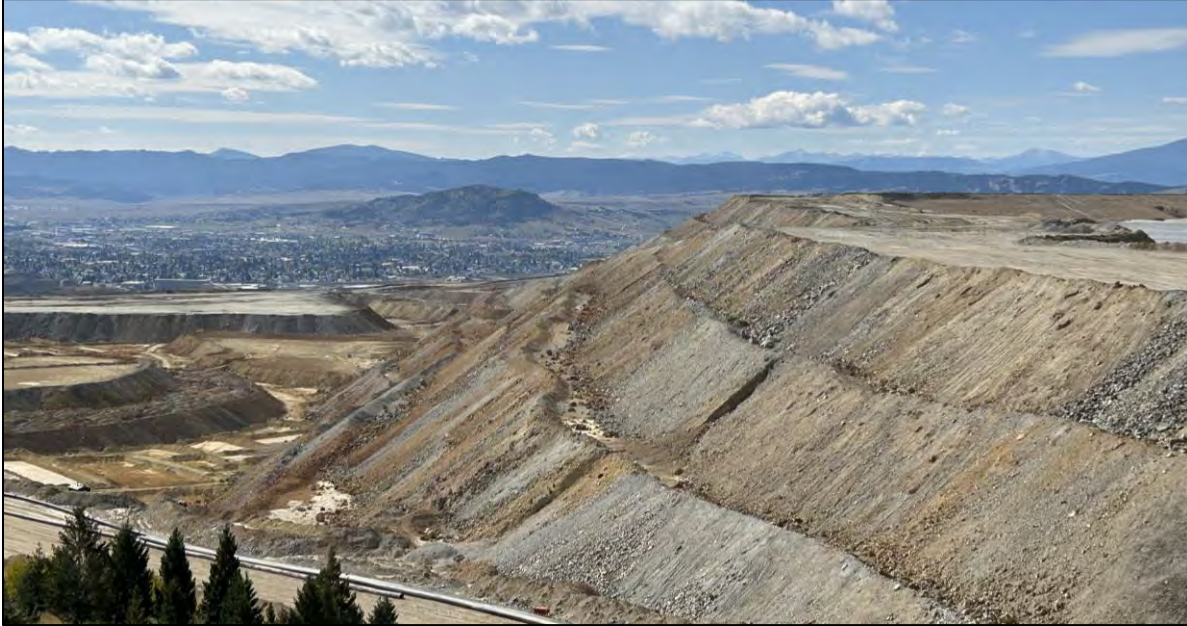
PHOTO 35 – North-South Embankment downstream slope with visible North RDS fill placement for the Mega Ramp, facing southwest.

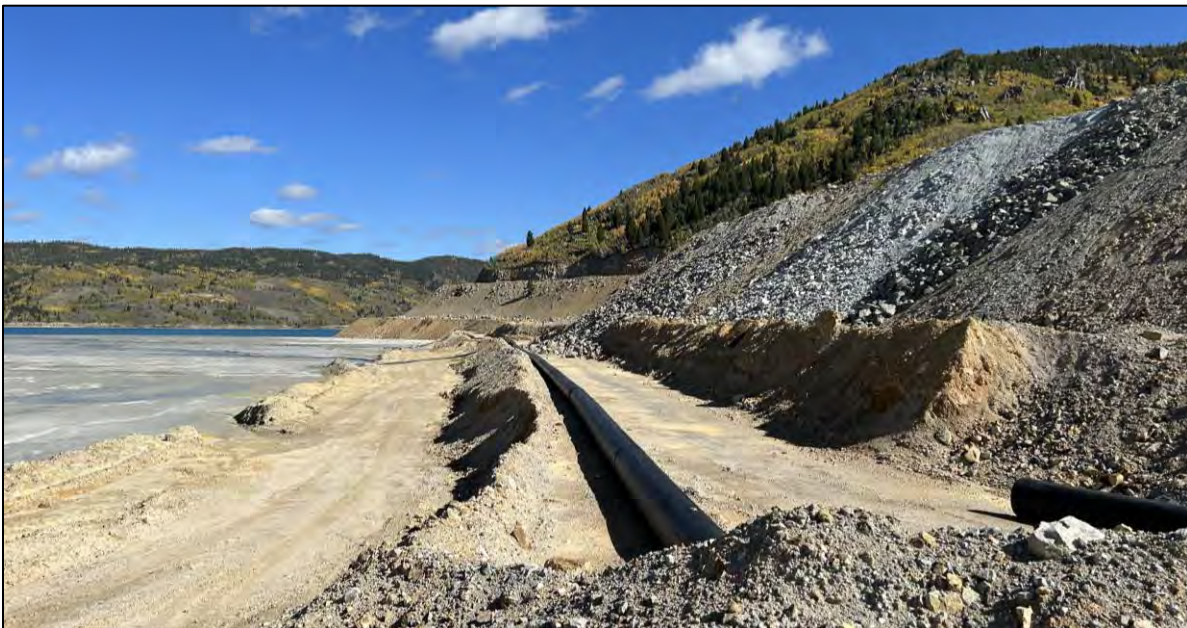
PHOTO 36 – North-South Embankment upstream side along EL. 6,400 ft tailings discharge corridor and EL. 6,450 ft lift placement near Discharge 3-4, facing northeast.

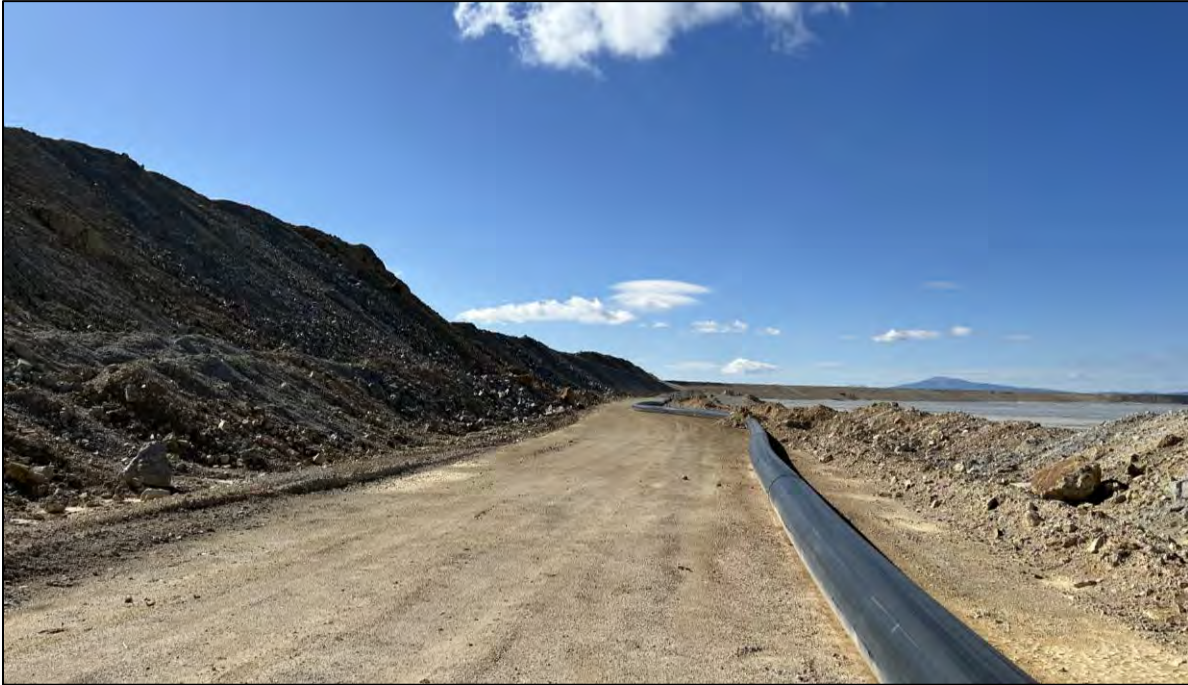
PHOTO 37 – North-South Embankment upstream side along EL. 6,400 ft tailings discharge corridor and EL. 6,450 ft lift placement near Discharge 3-4, facing southwest.

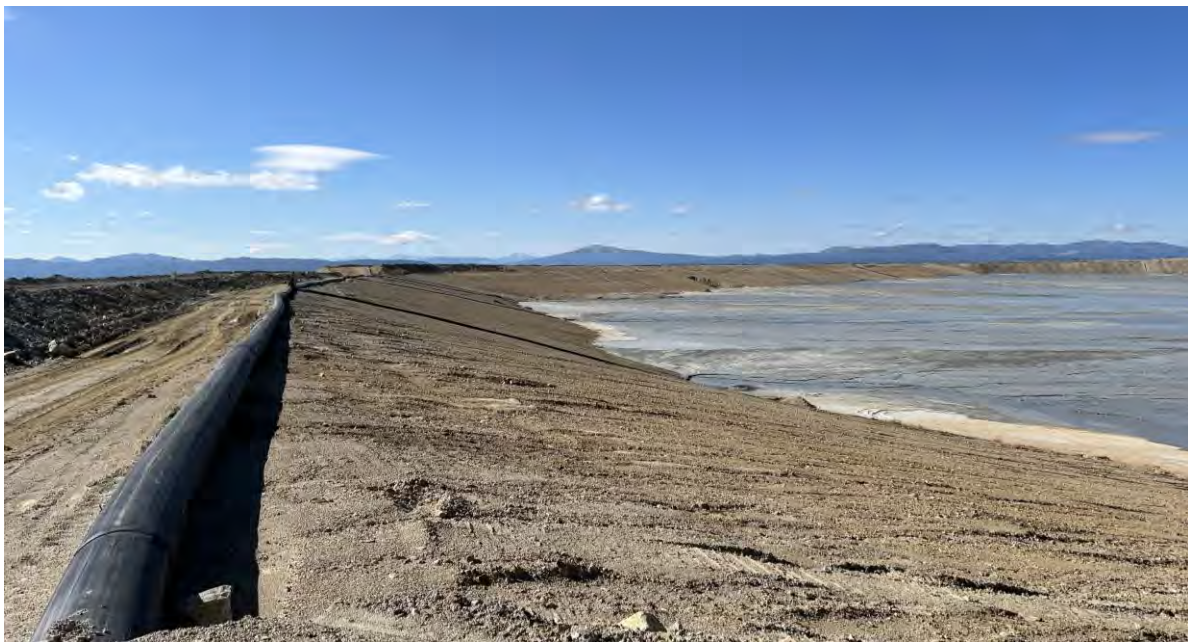
PHOTO 38 – North-South Embankment upstream side along EL. 6,450 ft tailings discharge corridor near Section 28+00N looking towards Central Pedestal Area, facing southwest.

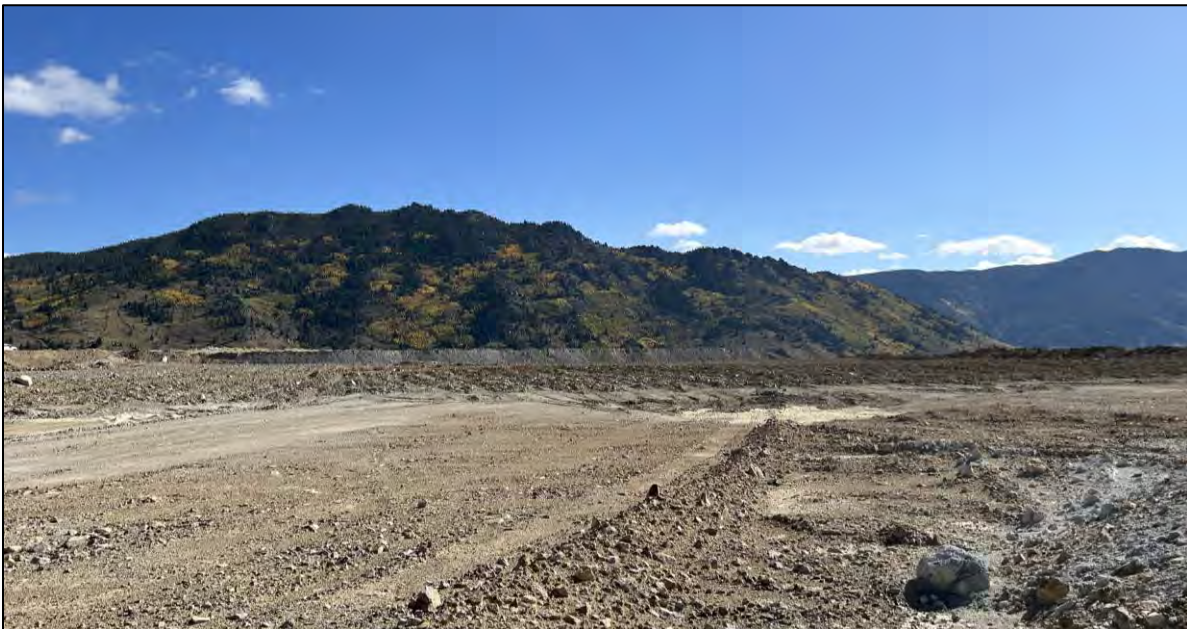
PHOTO 40 – Central Pedestal Area final grading lift progress, looking towards Section 0+00, facing east.

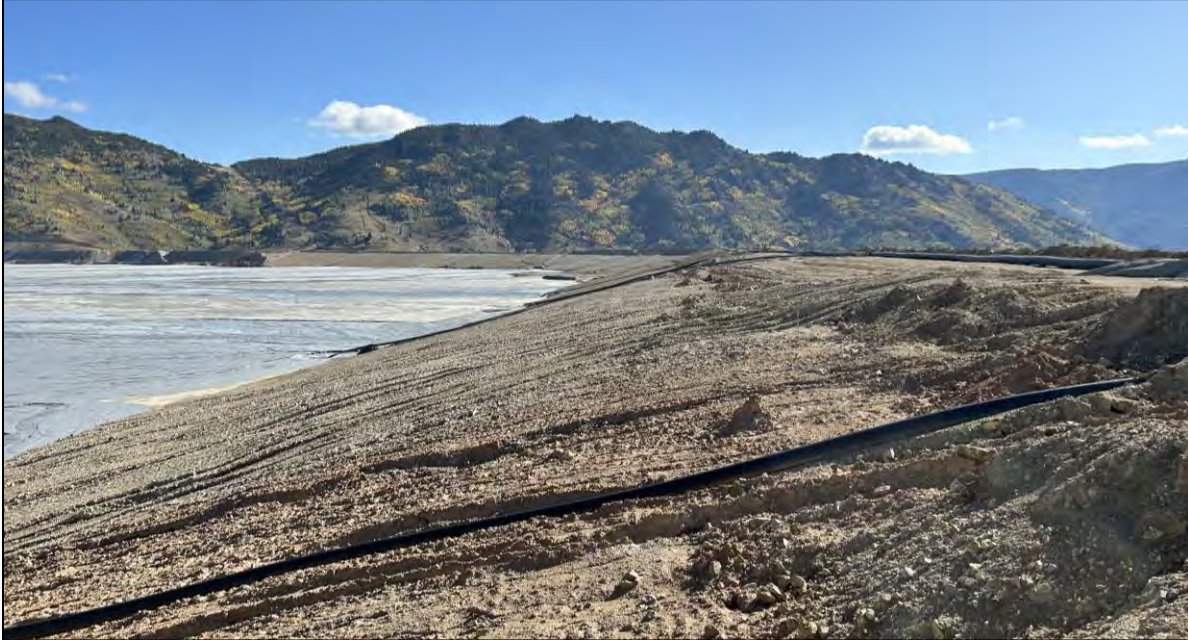
PHOTO 41 – East-West Embankment upstream regrading and alluvium facing completed in Central Pedestal Area, facing east from Section 23+00NW.

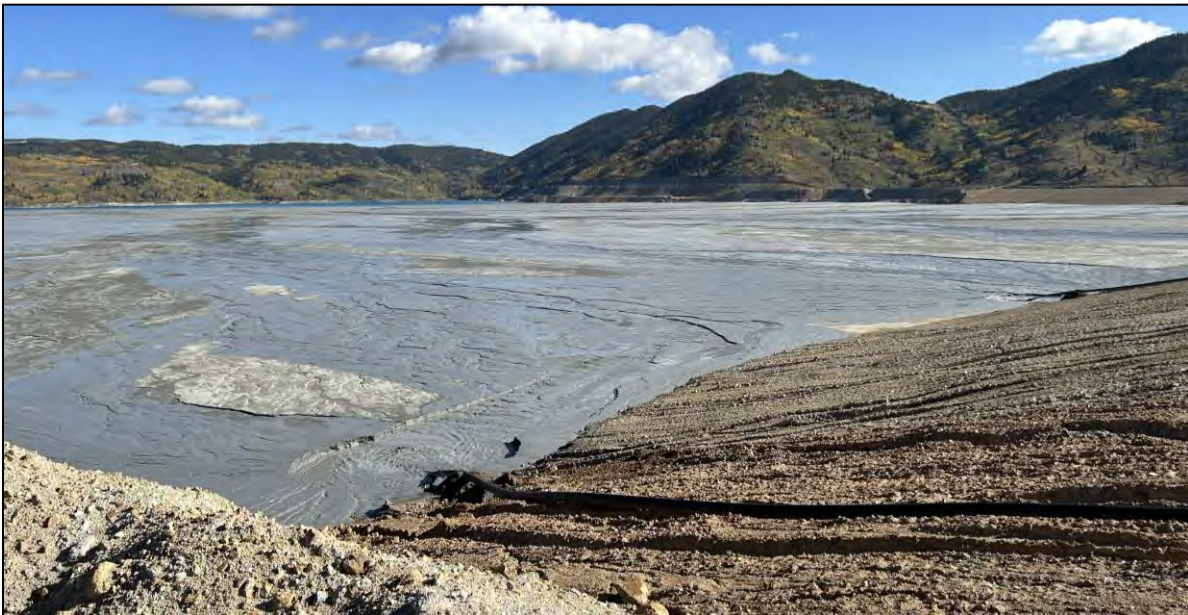
PHOTO 42 – East-West Embankment limit of upstream regrading and alluvium facing completed in Central Pedestal Area, facing northeast at Section 23+00NW.

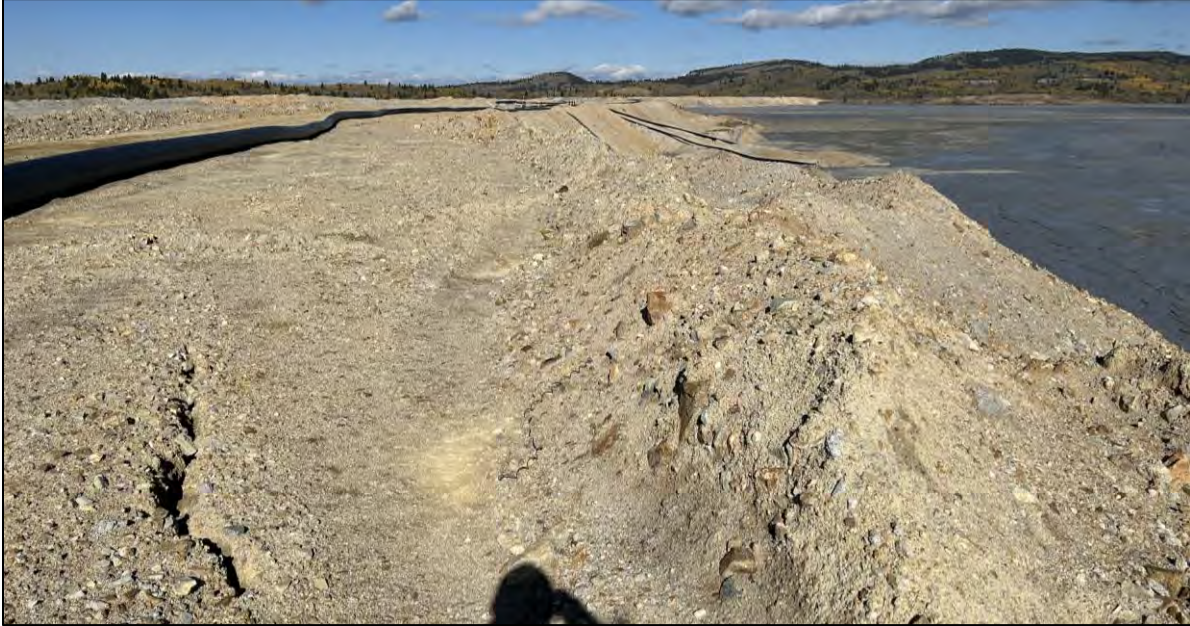
PHOTO 43 – East-West Embankment end of upstream regrading and alluvium facing completed in Central Pedestal Area, facing northwest at Section 23+00NW.

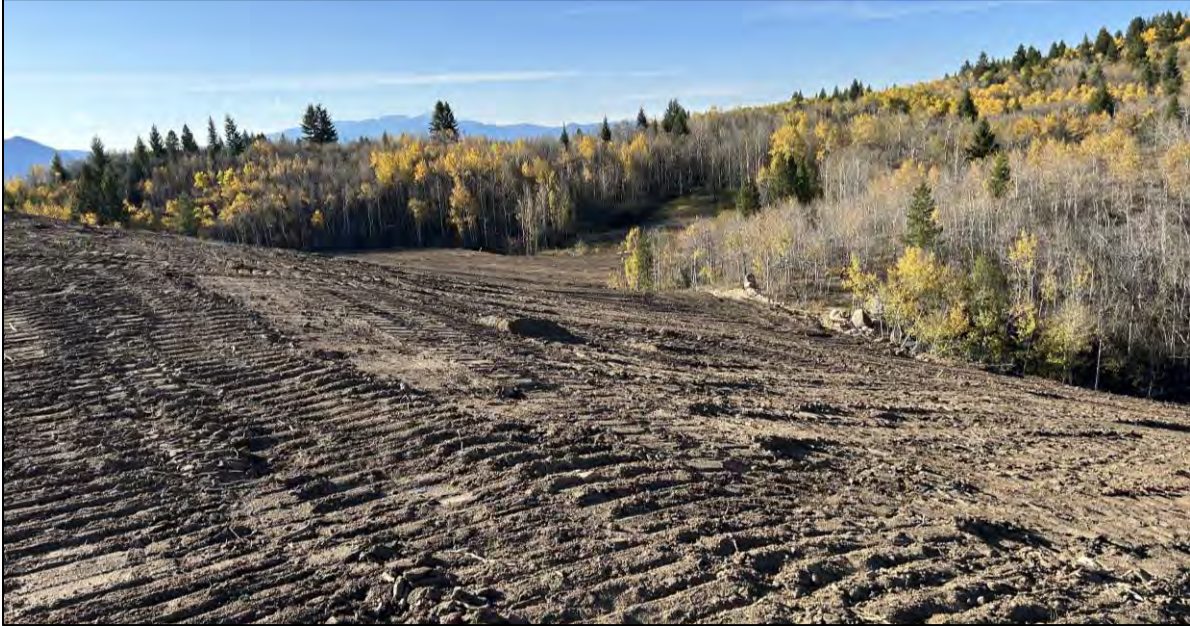
PHOTO 47 – Downstream side of West Embankment near Section 70+00W. Final grading and trimming to 3H:1V slope angle with topsoil placement completed, facing southwest.

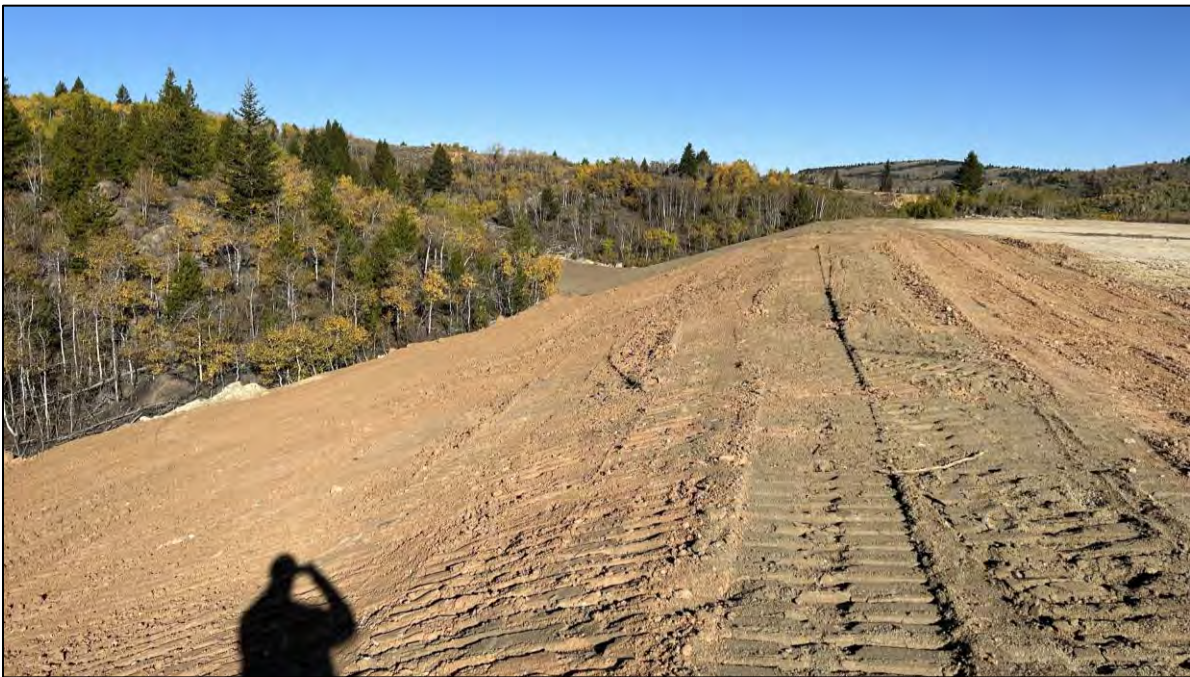
PHOTO 48 – Downstream side of West Embankment near Section 83+00W. Final grading and trimming to 3H:1V slope angle with topsoil placement completed, facing north.

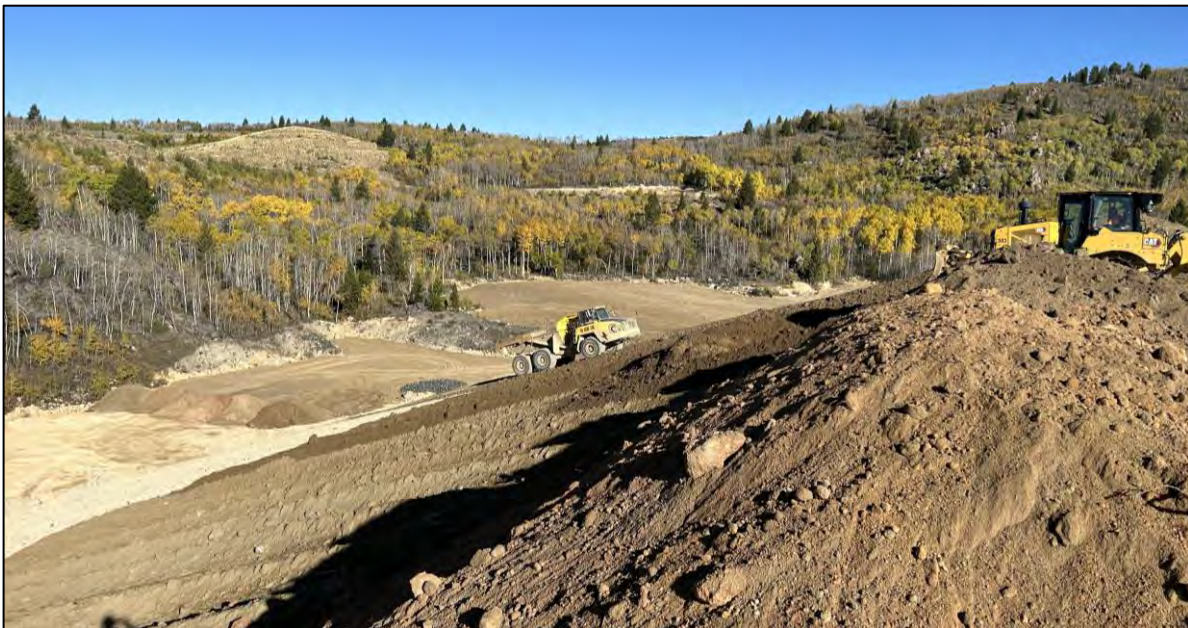
PHOTO 50 – Downstream side of West Embankment near Section 105+00W. Final grading and trimming to 3H:1V slope angle completed with topsoil placement in progress, facing westnorth.

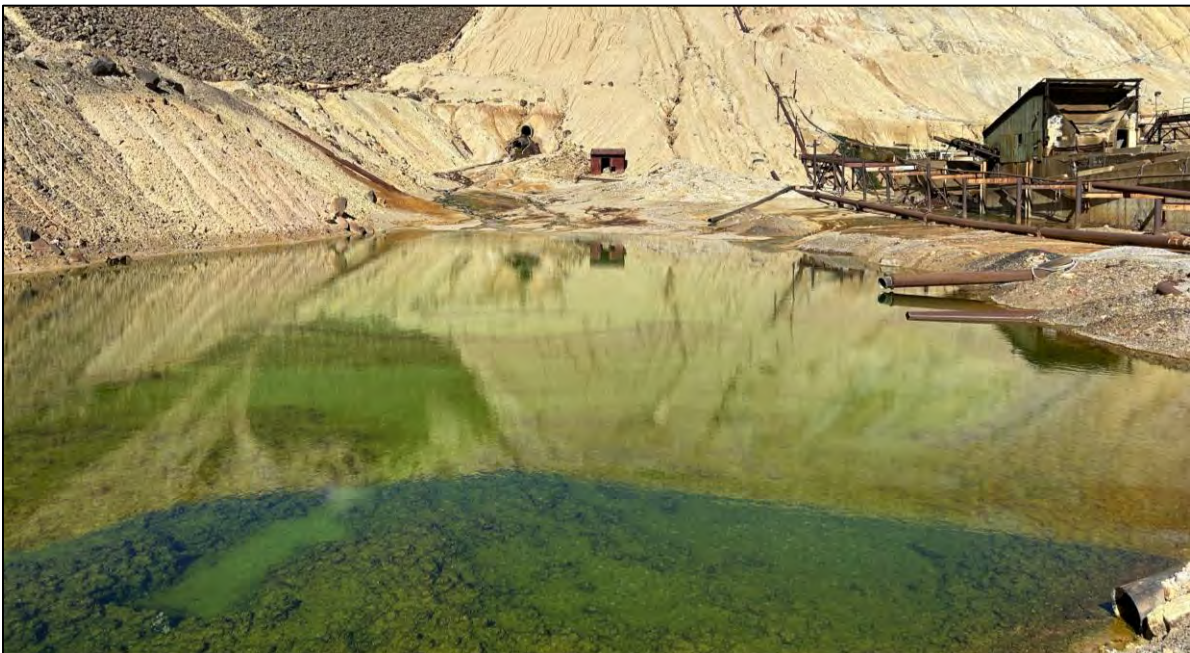
PHOTO 66 – Upper HsB Pond prior to breaching and drain down, facing north.

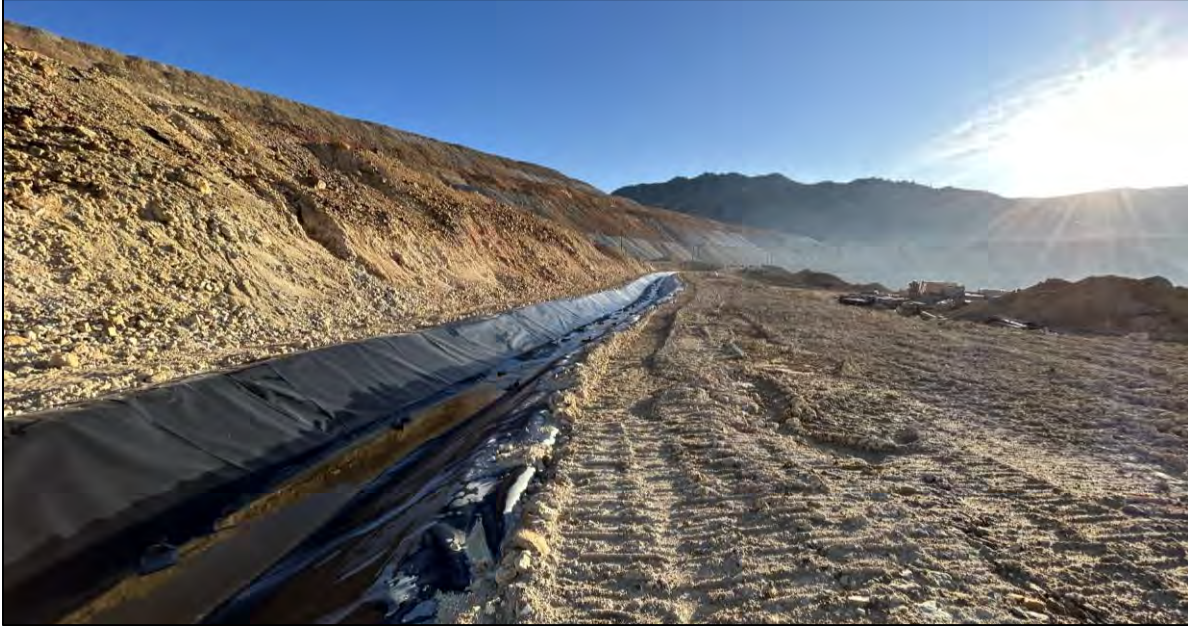
PHOTO 75 – Seep 10 bench SWD #10 conditions near Station 1+400, facing northeast.

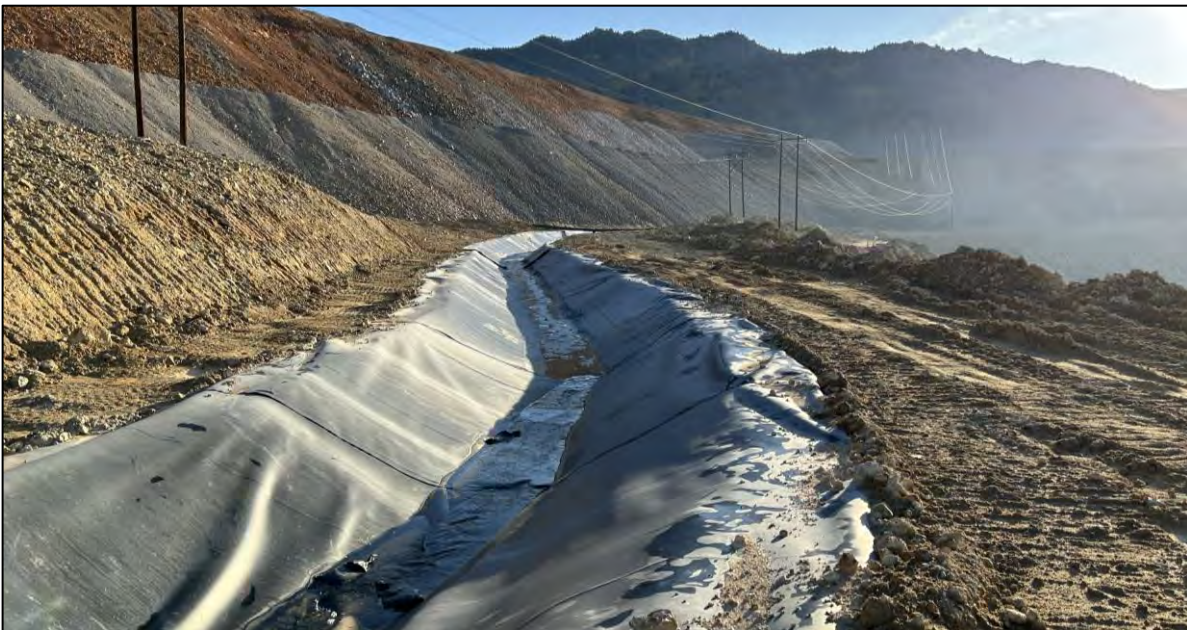
PHOTO 76 – Seep 10 bench SWD #10 conditions near Station 0+700, facing northeast.

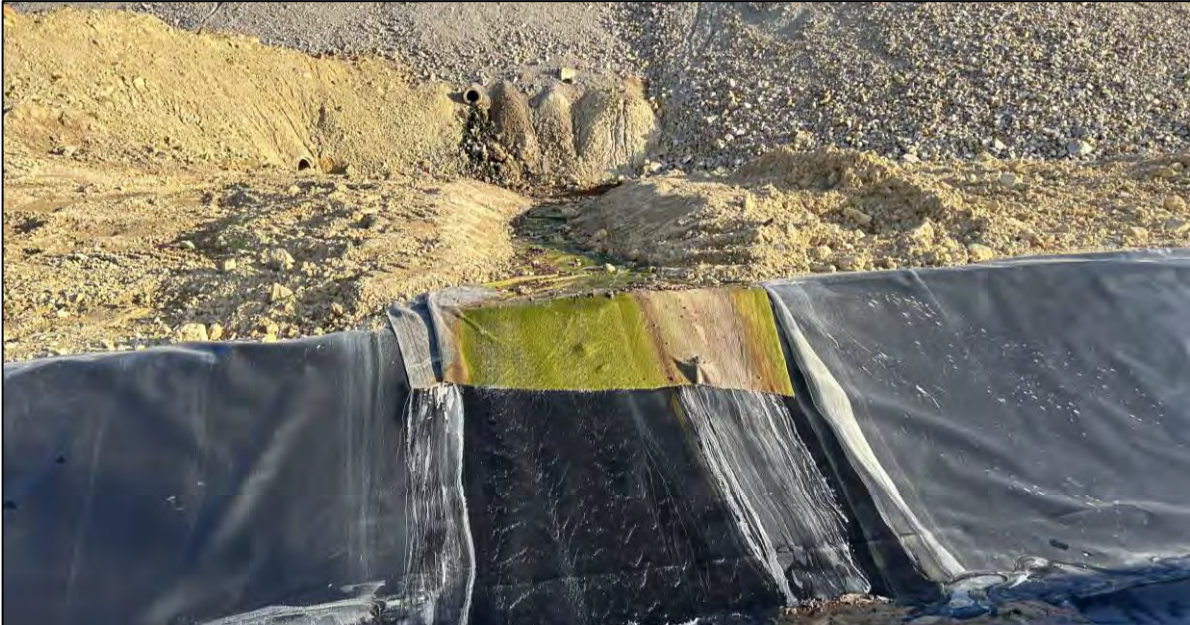
PHOTO 77 – Seep 10 bench SWD #10 conditions near Station 0+300 at Seep 10 inflow, facing north.

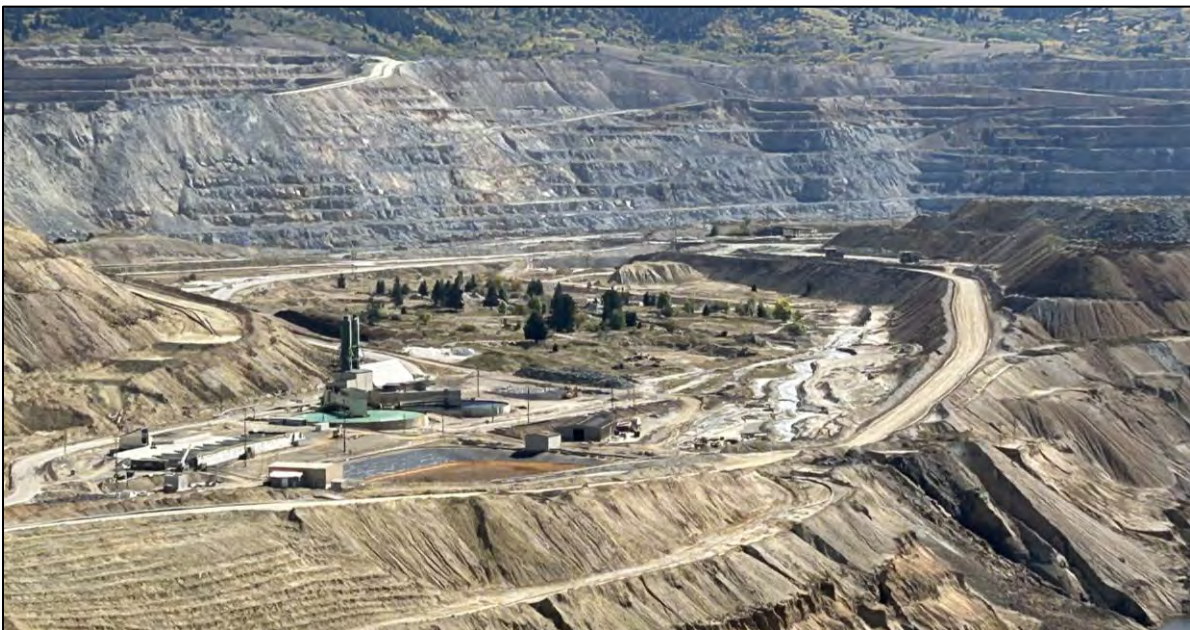
PHOTO 80 – Scalper Road On-site Containment Project visible with Continental Pit in background, facing southeast.

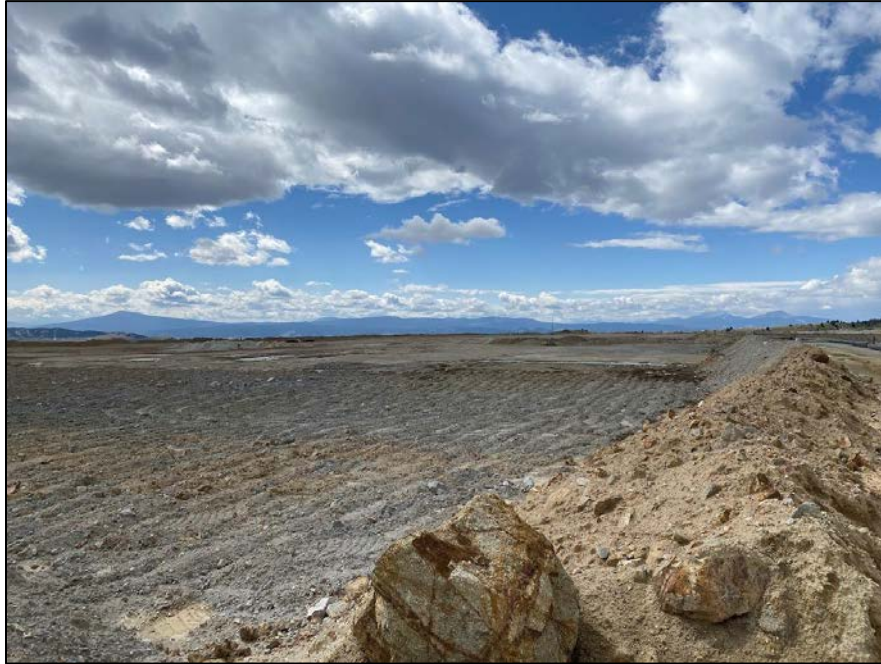
Construction continued along the East-West and North-South embankments during Q3 with infilling and regrading of the crest to the design elevation EL. 6,450 ft. Infilling and regrading activities are a result of a June 2023 meeting between MR and KP to discuss a plan to remediate the areas of cracking and crest depressions. MR began cross ripping existing ground and placing material for crest regrading in July 2023. The regrading began at approximately Section 0+00 and continued towards the West Embankment throughout Q3 as shown on Photo 2.2. MR will continue regrading activities along the East-West Embankment during Q4.

Photo 2.2 EL. 6,450 ft East-West Embankment Ripping for Fill Placement and Regrading

- MR is recommended to continue grading and infilling of the EL. 6,450 ft embankment crest to reduce the potential for ponding water and promote surface runoff. Table 3.3 of the CMP outlines the allowable embankment crest grade tolerance to be +24 inches / -0 inches. Remedial actions should be considered to remain within this allowable tolerance. **Ongoing. MR has advanced regrading activities as described in Section 2.2.**

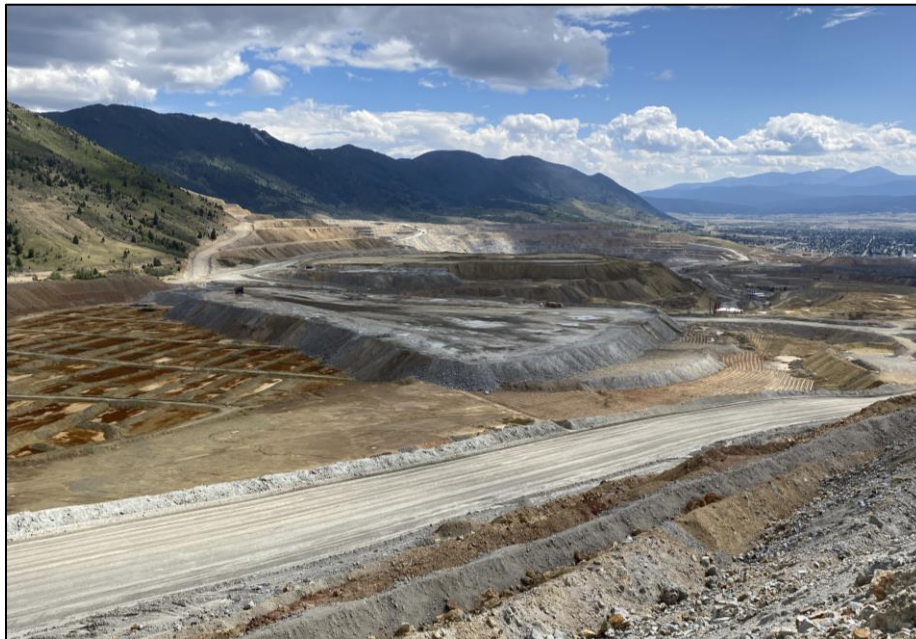
MR initiated construction activities for the North RDS, located over the historical leach pad areas at the downstream toe of the North-South Embankment, in March 2023. MR continued to advance the EL. 6,150 ft lift of the RDS in the westward direction towards the North-South Embankment haul ramp throughout Q3, as shown on Figure 2.5. Construction progress at the time of the field review is shown on Photo 2.4. Lift subgrade preparation, material placement, and material testing in this area are being completed by MR as per the KP letter outlining the construction practices for the RDS (KP, 2023f).

Photo 2.4 EL. 6,150 ft North RDS and Future Haul Ramp Construction

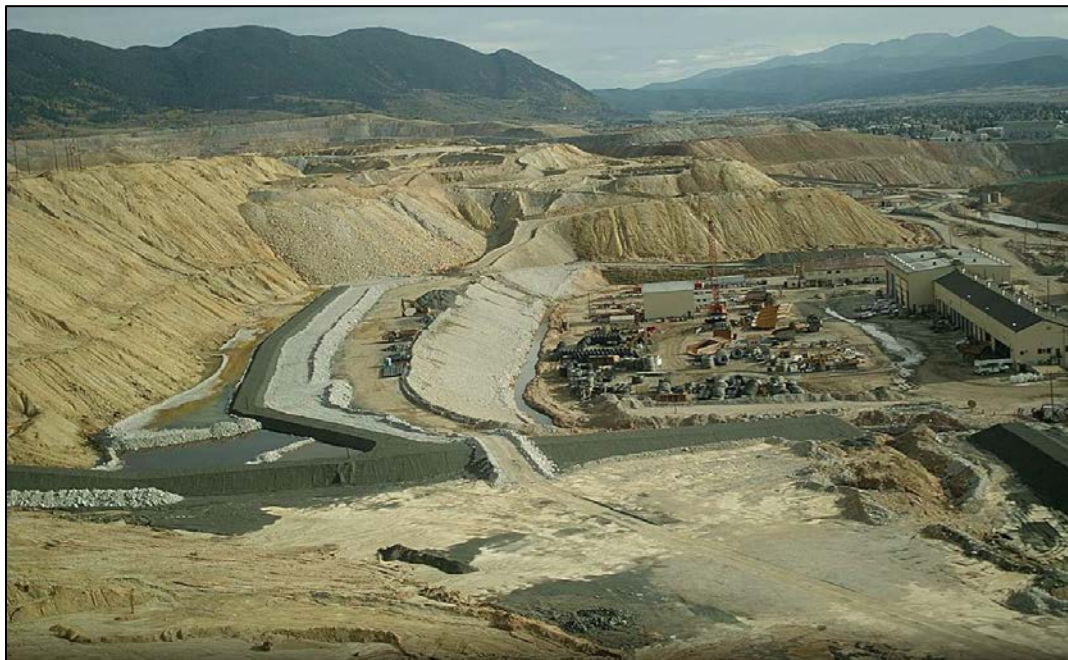
Rock drain construction progress slowed in Q3 while ICS focused on SWD #10 and construction activities along the West Embankment; however, ICS began placing UF overtop and around drains D4, D5, D6 and D7, as shown on Photo 2.5. UF material placement is expected to continue in Q4 with available UF Aplite (sourced from the Continental Pit) and imported Pipestone material. Quarterly and total material volumes for each zone within the HsB area are summarized in Table 2.2.

Photo 2.5 Zone UF Placement along Drain D6

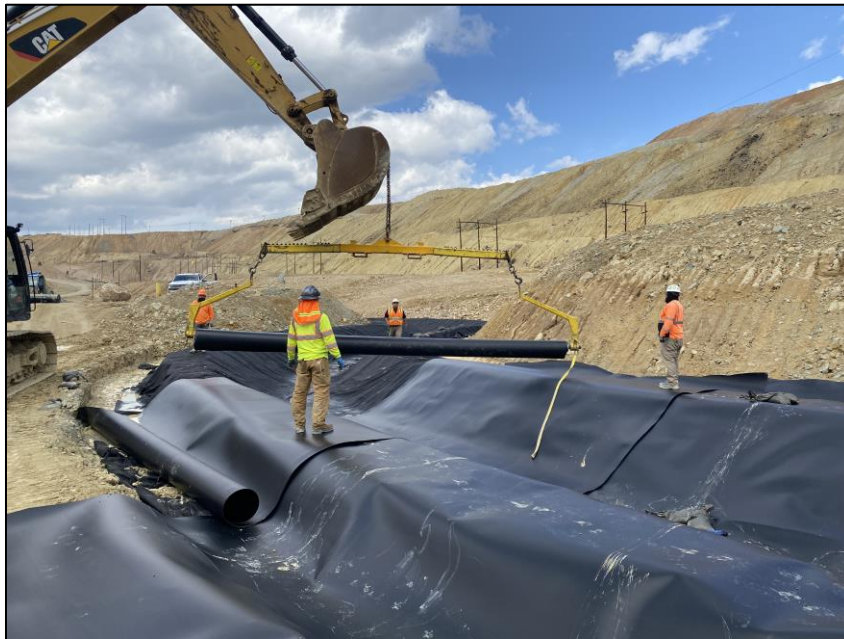
Excavation and shaping of SWD #10 and the Transition Pond along the Seep 10 bench was completed and installation of geosynthetic materials was completed by Northwest Linings and Geotextile Products Inc. (Northwest) between August 29th to 31st, 2023. Installation was completed in general accordance with the requirements of the Drawings, HsB CMP and manufacturer requirements. The installation of the 80-mil geomembrane above the non-woven geotextile is shown on Photo 2.6. Additional photos from the installation are included in the Photo Log in Appendix C.

Photo 2.6 Seep 10 SWD #10 Geomembrane Install – Looking West

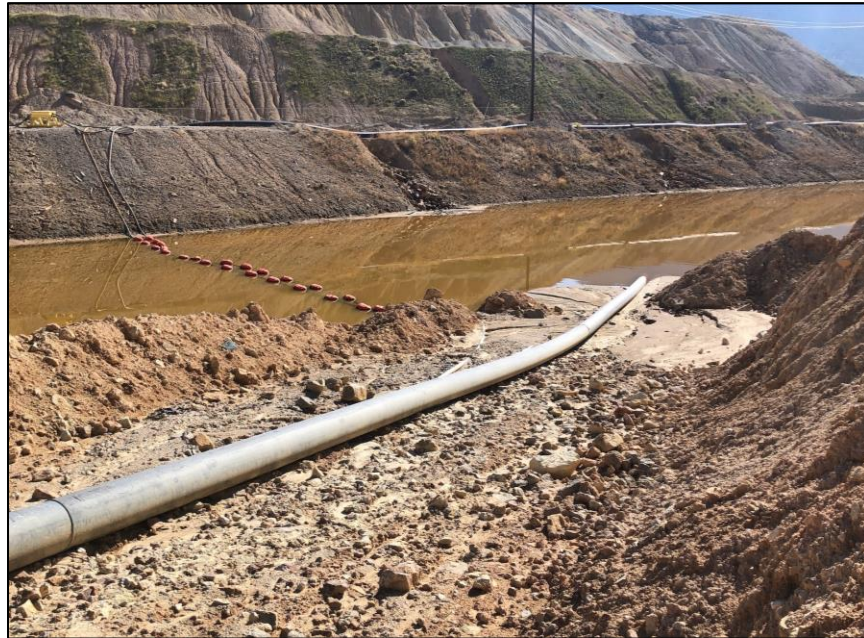
Installation of the collection box and weir within the Transition Pond was completed during Q3. Pipeline 1 has been connected to the collection box and discharges to the HsB pond; however, the installation of air relief valves and completion of the diffusion structure at the HsB pond is still to be completed. The current discharge of Pipeline 1 into the HsB Pond is shown on Photo 2.7.

Photo 2.7 Pipeline 1 Discharge into HsB Pond

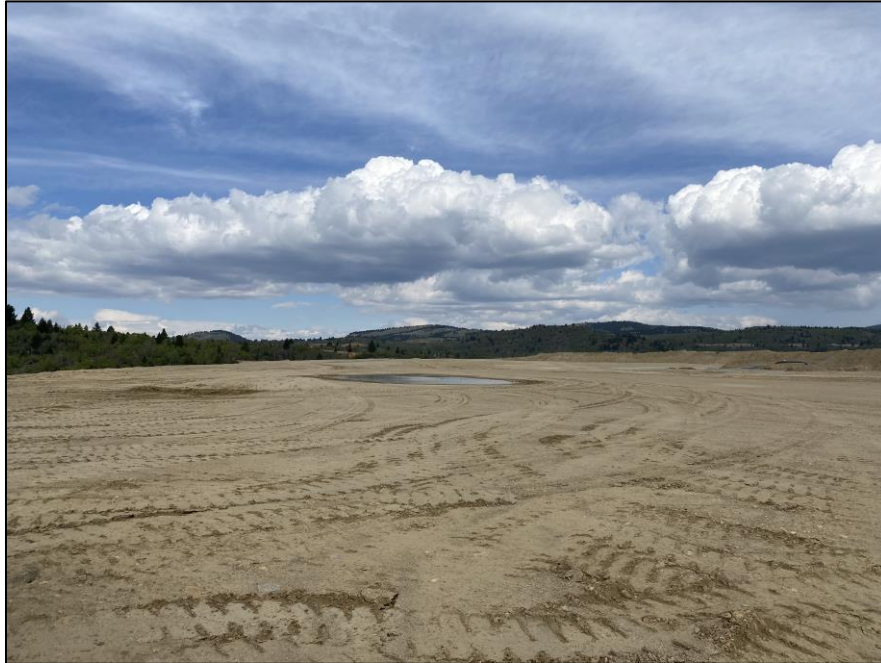
PHOTO 1 – West Embankment – Crest of Dam well graded with minimal depressions

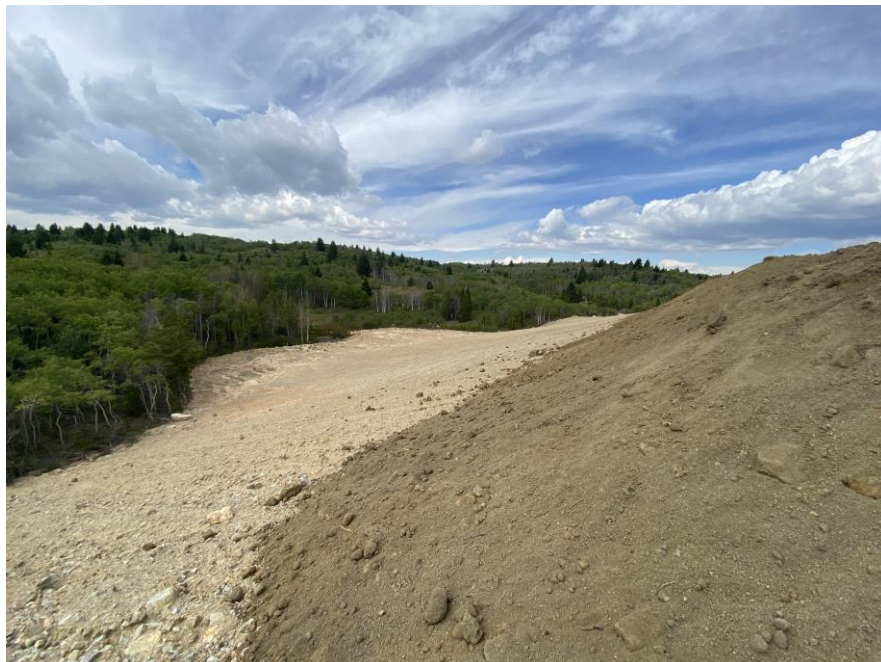
PHOTO 2 – West Embankment – Downstream face of dam receiving topsoil for reclaiming and revegetating surface

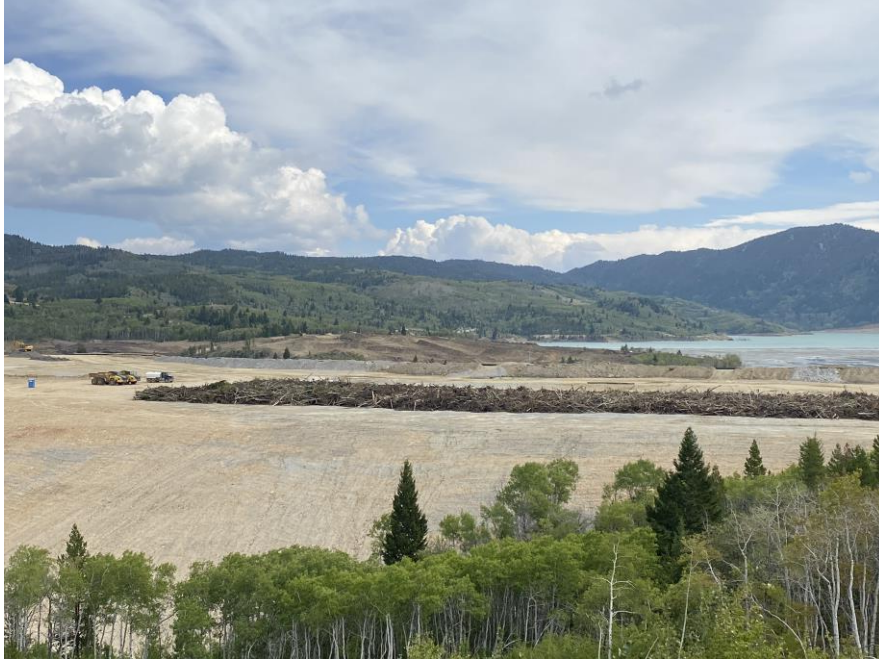
PHOTO 3 – West Embankment – EL. 6,450 ft lift crest – Organics stockpile

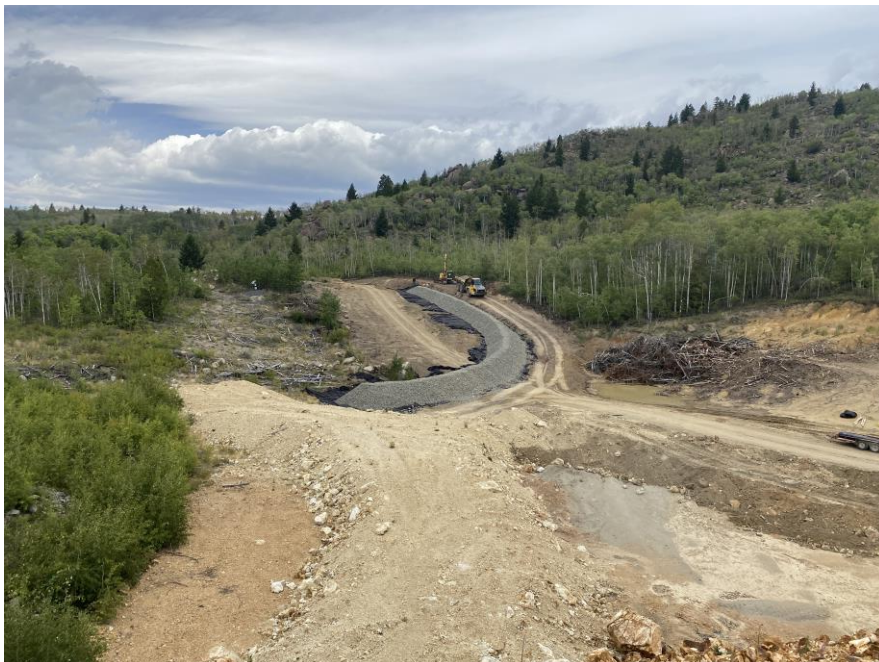
PHOTO 4 – West Embankment – Drain located at the north abutment

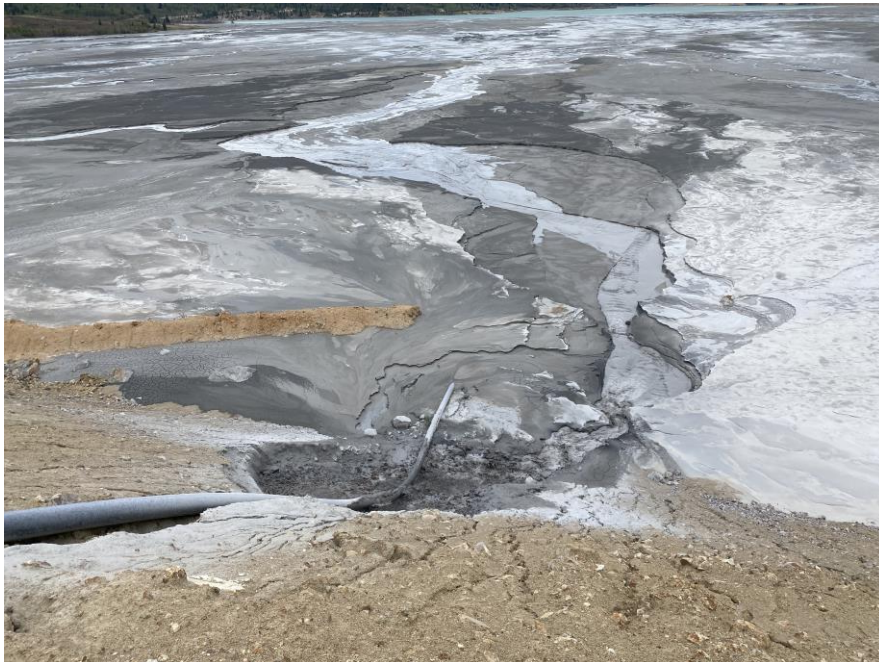
Erosion	X		X	Tailings have eroded through the 12 inch spigot pipe at approx. EL. 6,410 ft. Tailings observed running down the 6,450 ft upstream face causing erosion to embankment Zone U.
		Pipeline Corridor	X			Intermittent cracking present along the loosely placed berm, consistent with past field reviews.
Downstream Face	✓	Cracking, Subsidence, Depressions		X		
		Seeps, Damp or Soft areas		X		
Extraction Pond	✓	General Review	X		X	Pump system was operating at the time of the field review. Seeps into the pond are as expected.
Active Embankment Construction	✓	Material Placement	X		X	Downstream slope trimming and regrading was completed. Placement and stockpiling of topsoil material ongoing during review.
		Drain Construction	X		X	Secondary collection drain construction ongoing at north extent of embankment.
		Surface Preparation		NA		
		Other	X			Organics stockpile for reclamation currently being stored on embankment crest.

PHOTO 6 – West Embankment – Upstream face discharge 1-2B causing erosion to the embankment due to eroded discharge pipe.

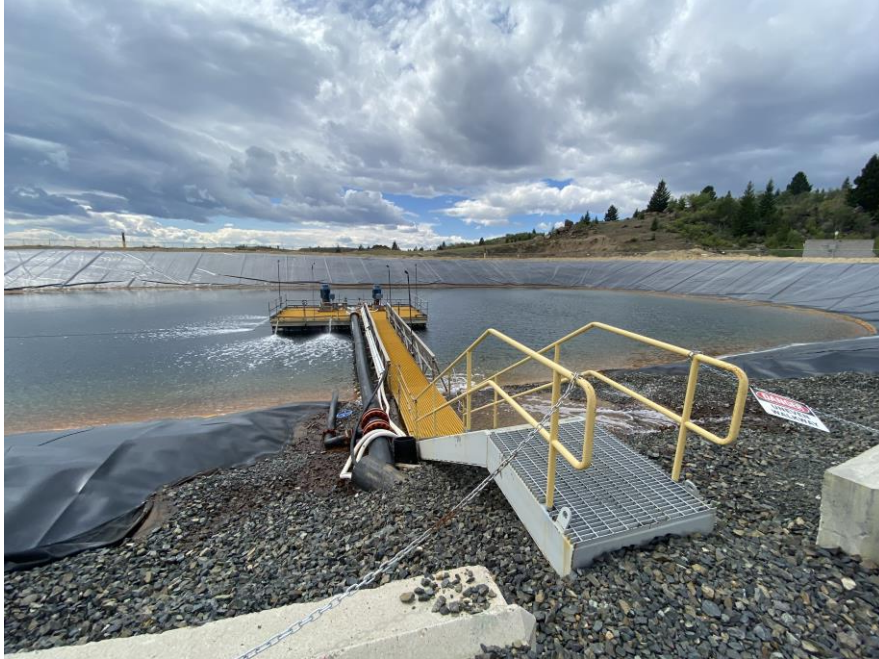
PHOTO 7 – Extraction Pond – Pumping system operating as normal

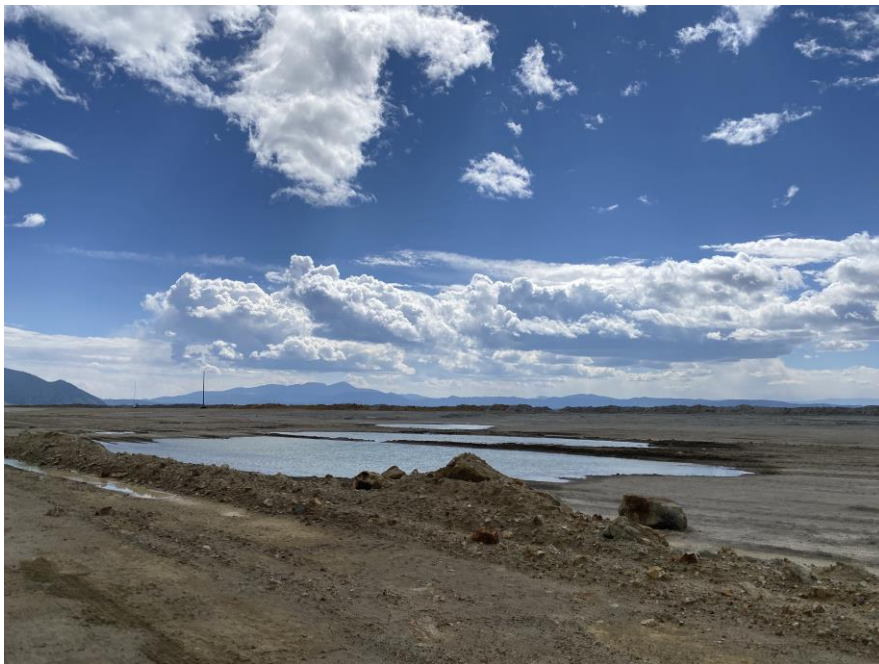
PHOTO 8 – East-West Embankment - Undulations/depressions visible along surface grade of the embankment crest due to settlement – Puddling formed after storm event
