VA101-126/29-4

MONTANA RESOURCES

YANKEE DOODLE TAILINGS IMPOUNDMENT - 2023 ANNUAL INSPECTION REPORT

EXECUTIVE SUMMARY

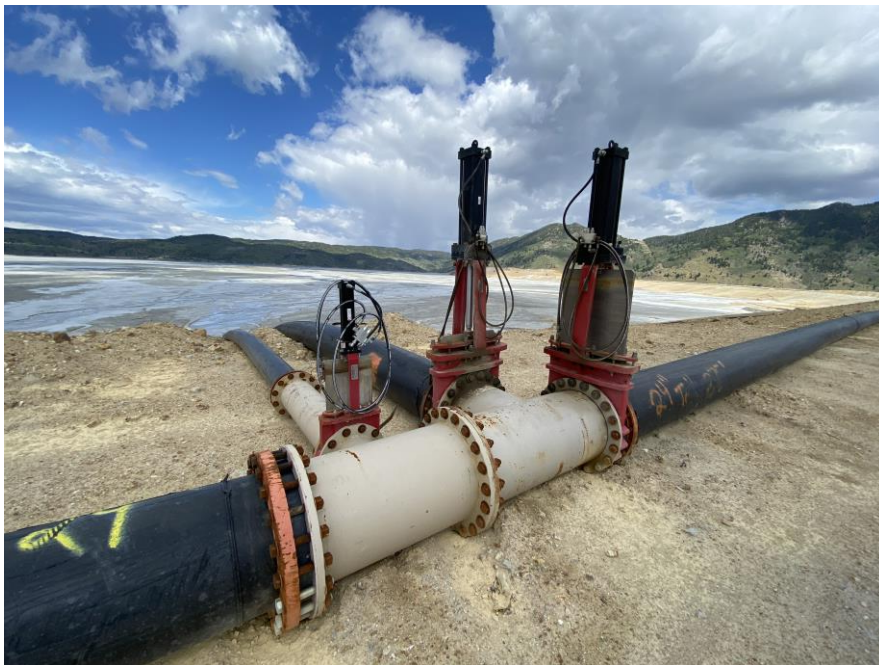
PHOTO 10 – East-West Embankment – Spigot 3-2 and 3-2A

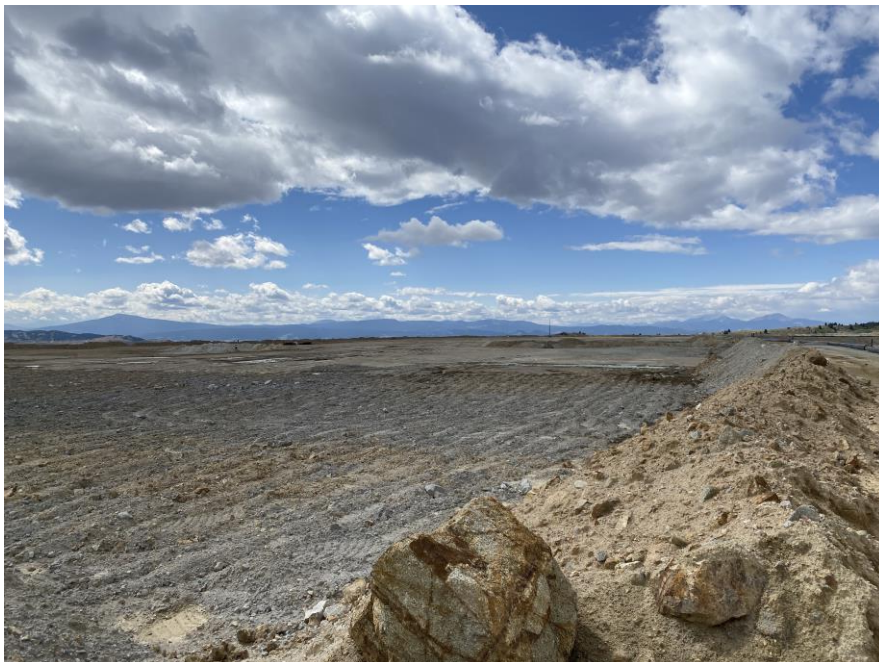
PHOTO 12 – East-West Embankment – Ripping of embankment crest for placement of material for regrading

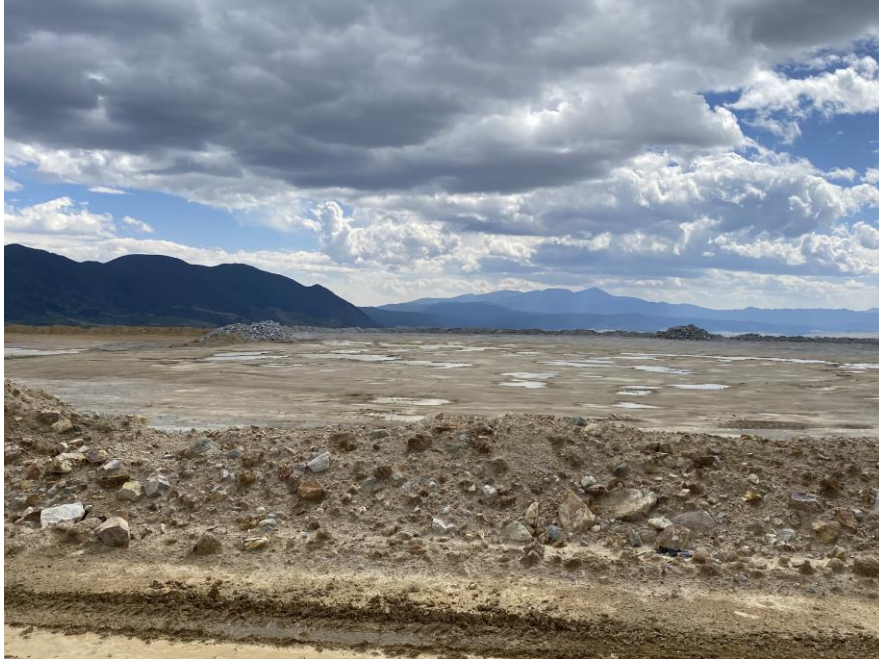
PHOTO 13 – East-West Embankment - Undulations/depressions visible along crest

- MR is recommended to continue grading and infilling of the EL. 6,450 ft embankment crest to reduce the potential for ponding water and promote surface runoff. Table 3.3 of the CMP outlines the allowable embankment crest grade tolerance to be +24 inches / -0 inches. Remedial actions should be considered to remain within this allowable tolerance. **Ongoing. MR has advanced regrading activities as described in Section 2.2.**

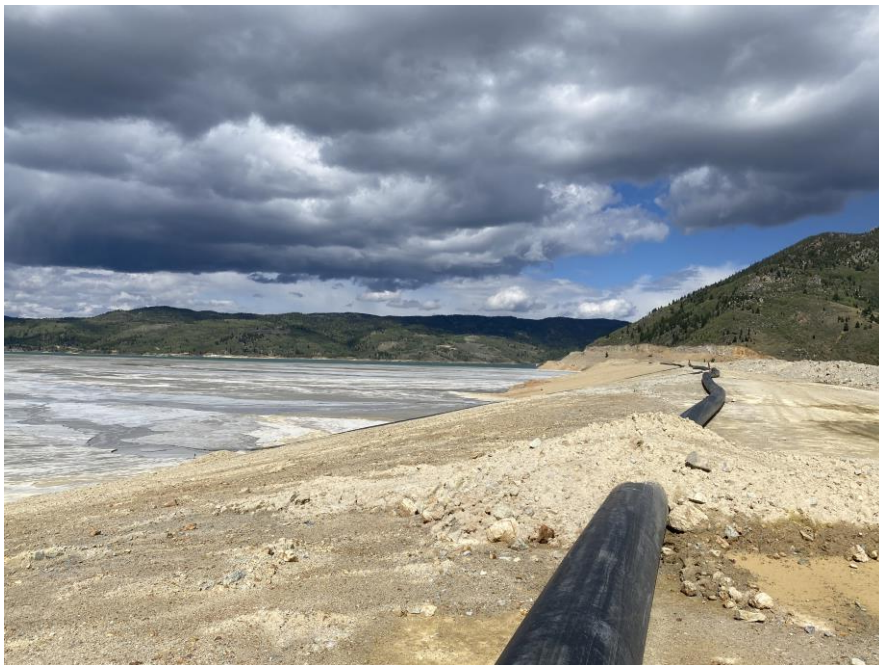
PHOTO 14 – North-South Embankment – Pipeline corridor – Tailings Pipeline 3

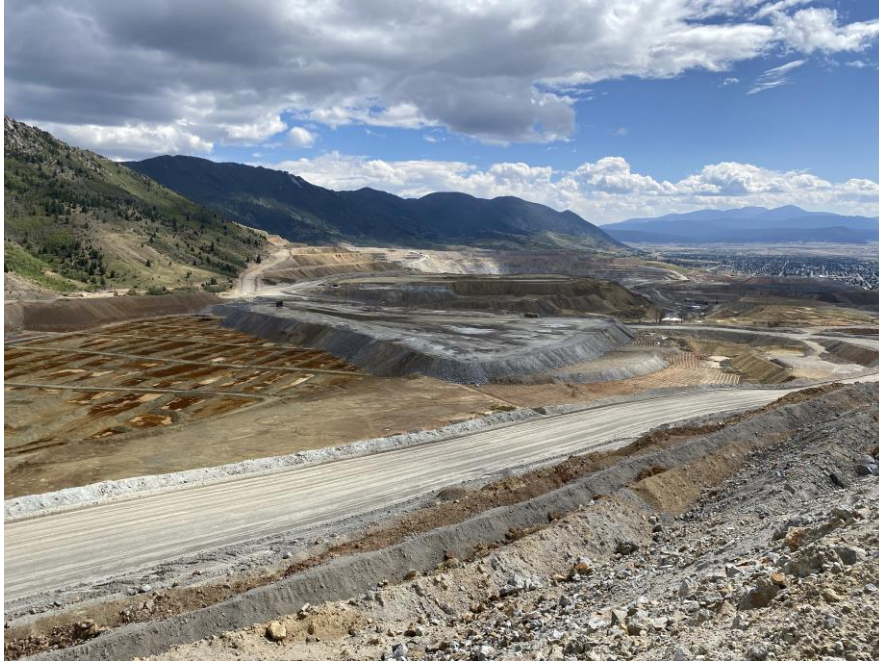
PHOTO 15 – North RDS – Active 6,150 ft dumping operations ongoing

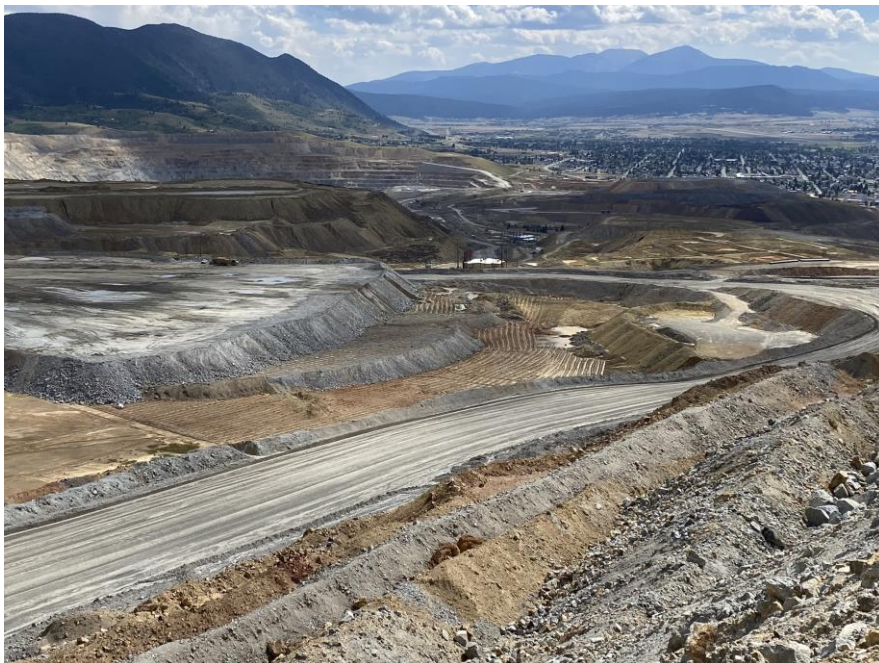
PHOTO 16 – North RDS – Ripping of existing ground for future expansion of RDS

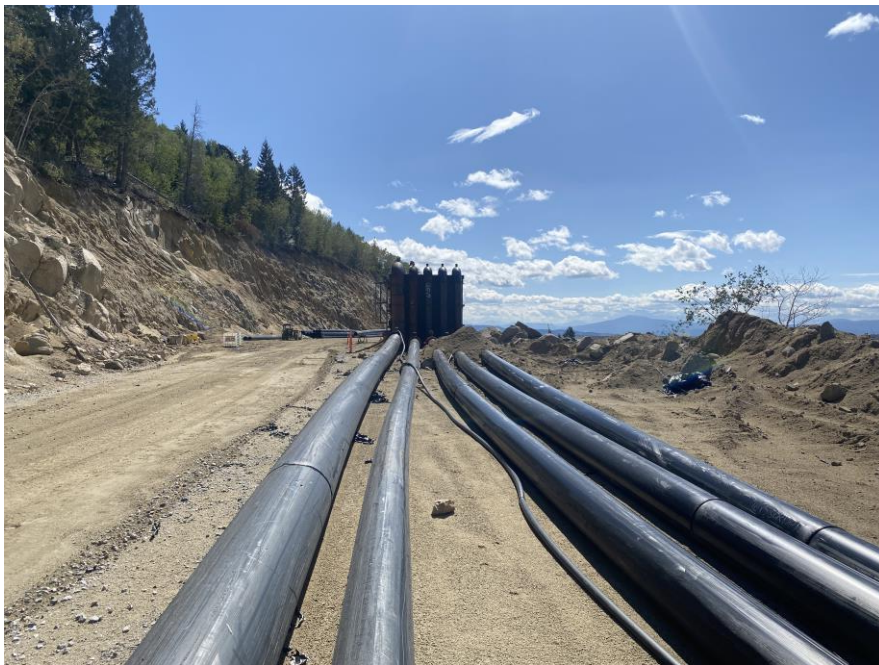
PHOTO 18 – Reclaim Road - Looking South at 5 reclaim pipes coming from the two reclaim barges

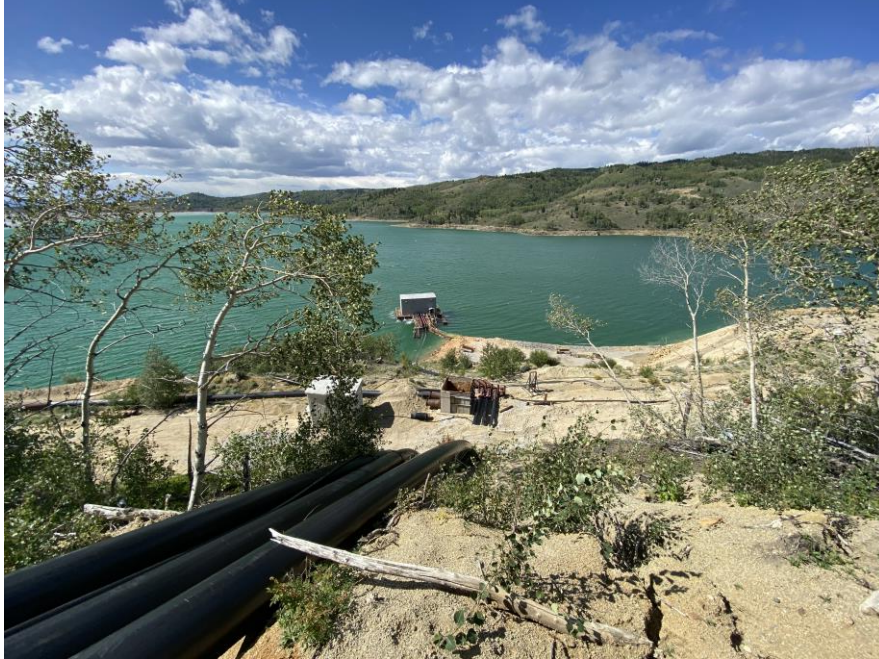
PHOTO 19 – Old reclaim barge – Outlet pipes now routed up to 6,450 ft reclaim road

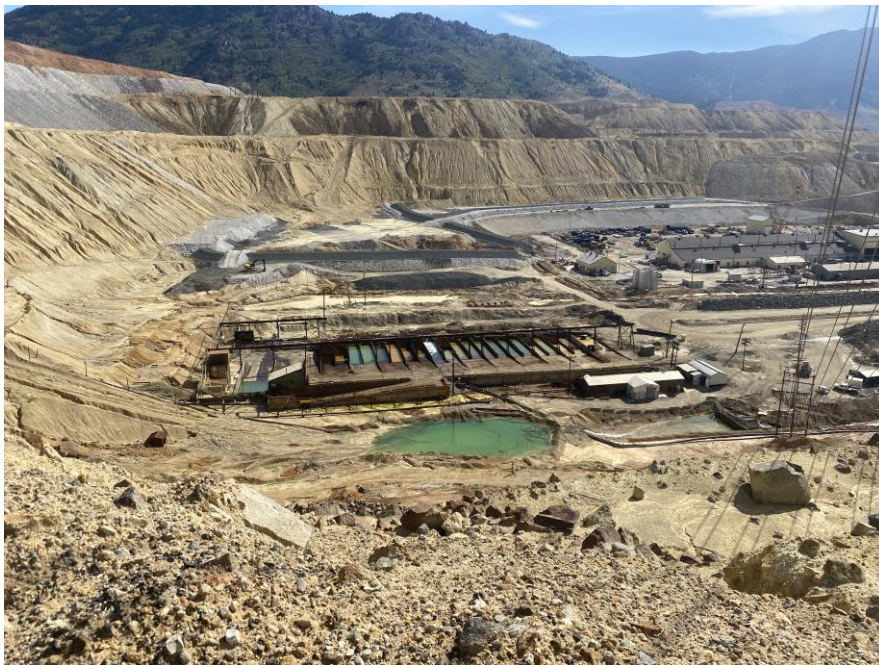
PHOTO 20 – Stage 1 HsB RDS – Overlook – Looking East

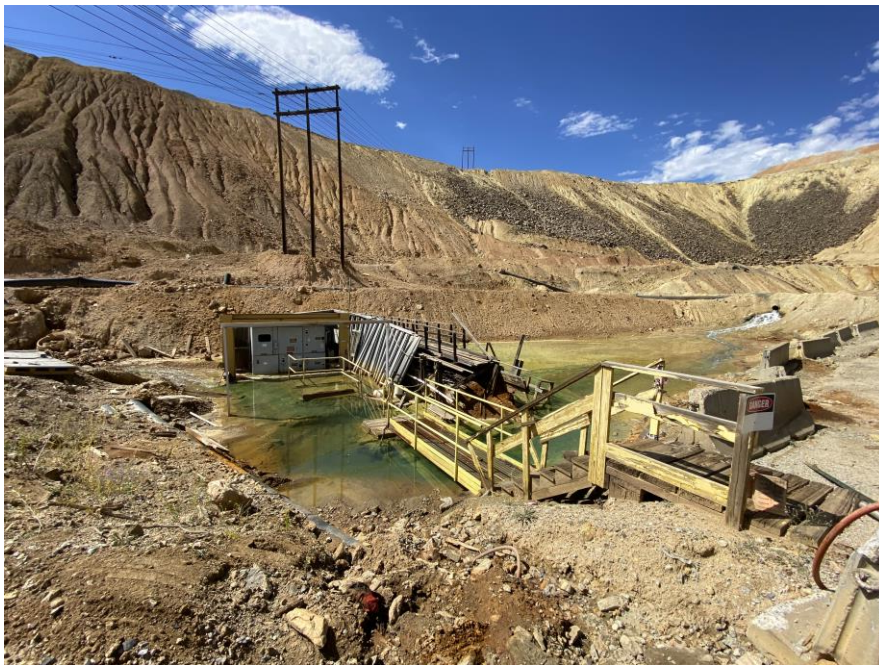
PHOTO 22 – Stage 1 HsB RDS – Old Precip Plant Cell 10 Pump Area

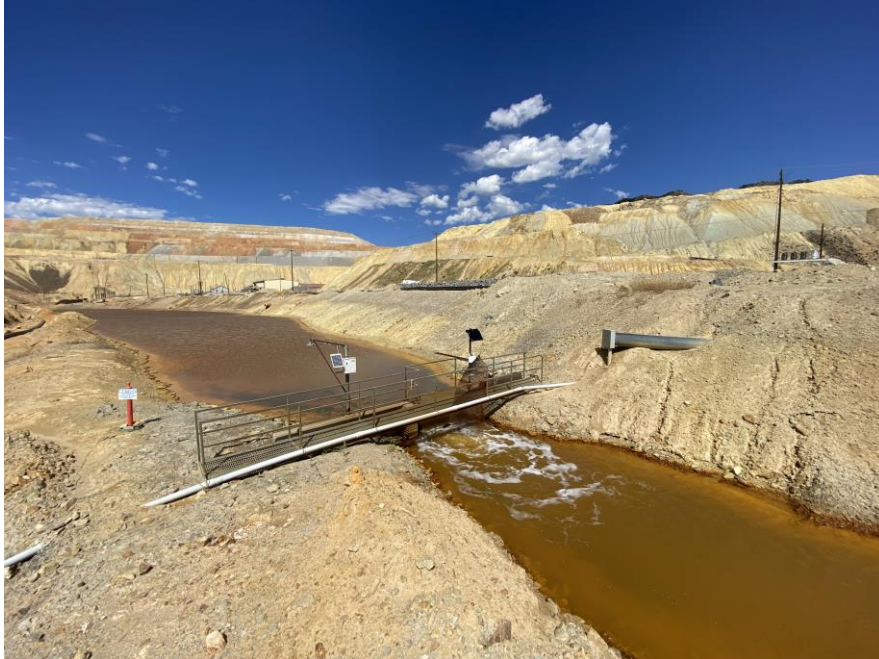
PHOTO 23 – HsB Weir – Looking North

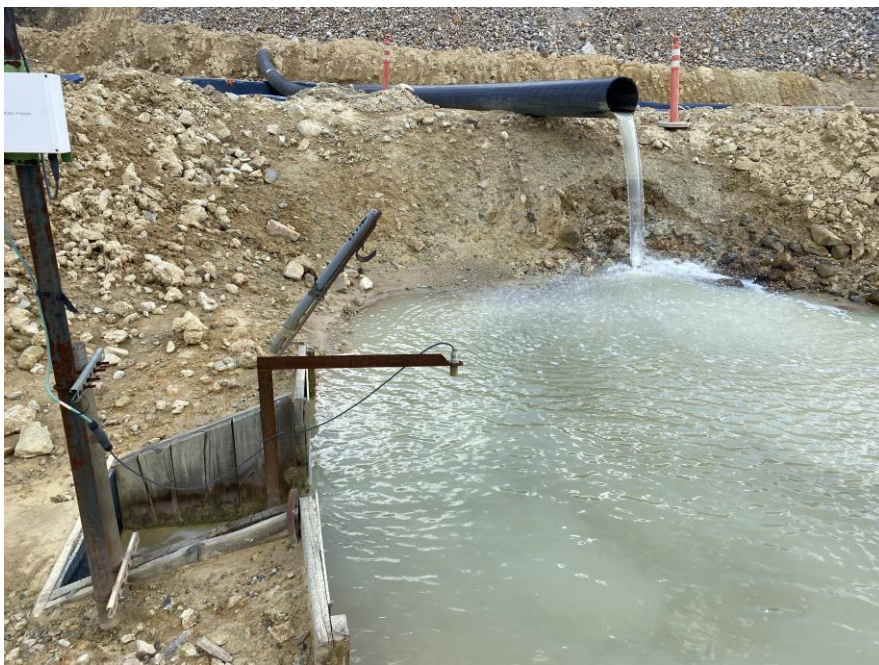
PHOTO 24 – Seep 10 – Pond inflows

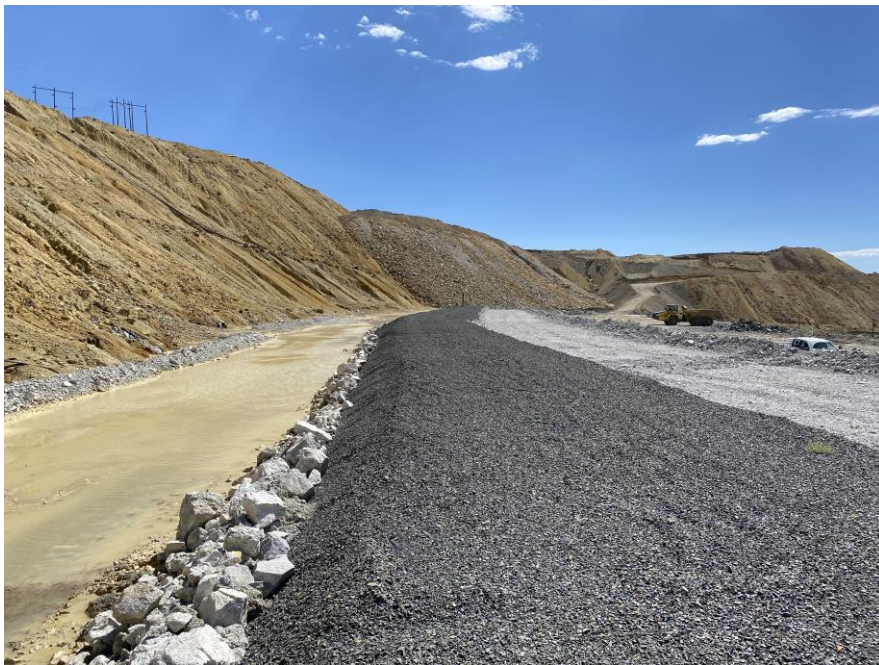
PHOTO 26 – Stage 1 HsB RDS – D6 STA 0+600 ft looking south

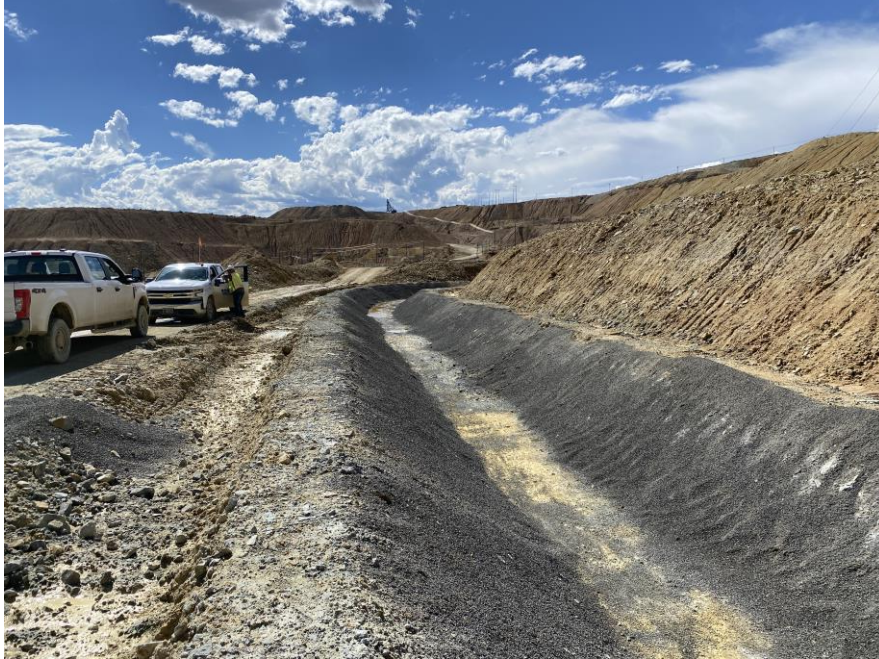
PHOTO 27 – Seep 10 – SWD#10 STA 0+500 ft looking west – 3/8" minus material placed along side slopes

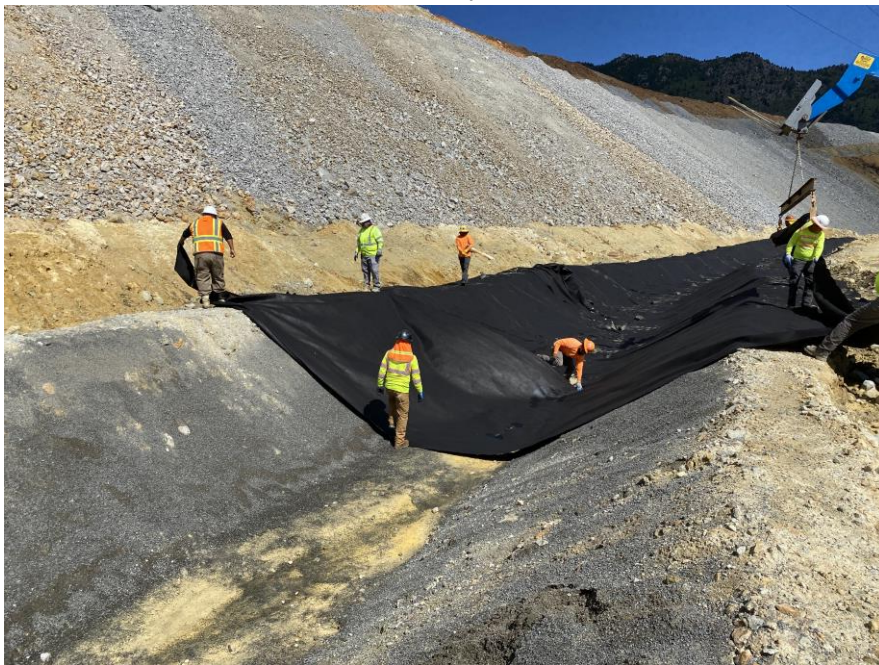
PHOTO 28 – Seep 10 – SWD#10 geotextile install by Northwest Linings

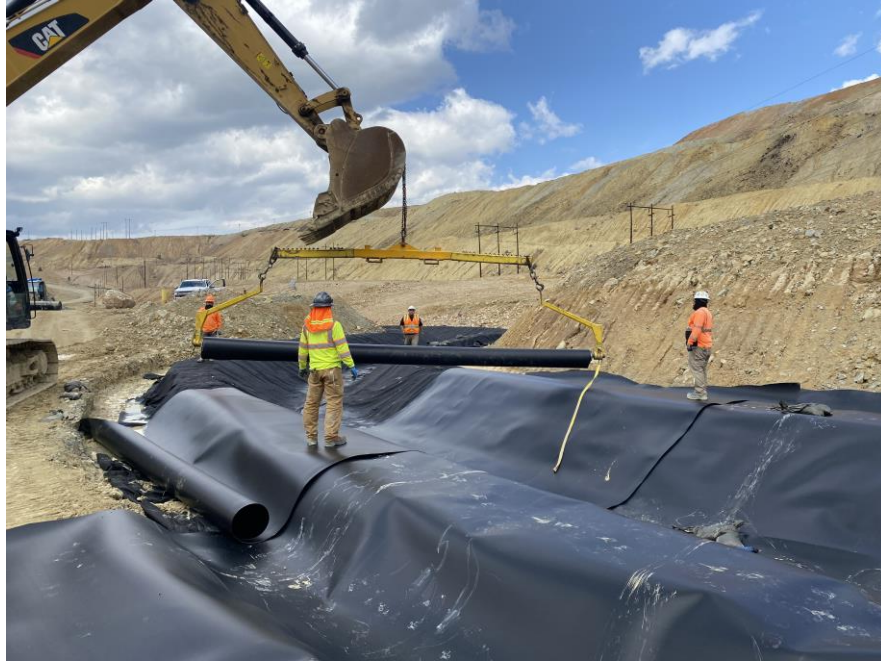
PHOTO 29 – Seep 10 – SWD#10 geomembrane install by Northwest Linings
