**MONTANA DEPARTMENT OF ENVIRONMENTAL QUALITY
HARD ROCK MINING SECTION, MINING BUREAU
OPERATING PERMIT – FIELD INSPECTION REPORT**

Permittee: Montana Resources, LLC				Inspection Date: November 8, 2024					
Operating Permit #: 00030			Project: Montana Resources- Continental Mine Complex			County: Butte-Silver Bow			
Nearest City or Town(s): Butte									
Inspector(s): Shanna Law, Garrett Smith				Permittee Rep(s): Jeremy Fleege					
Agencies w/overlapping permit jurisdiction:		USFS		BLM		X	Other (EPA)	None	
Minerals: Copper, molybdenum, minor silver									
Status:		X		Active		Inactive		Suspended	Other
Weather: Mostly sunny, high temp 56°F									
Type of Operation:				Purpose of Inspection:					
X	Open Pit				Initial (Pre-permitting)				
	Underground			X	Regular Compliance				
	Placer				Amendment # MR#				
X	<i>Leach- Leach pads near HSB not receiving solution</i>				Complaint Received				
X	Tailings Storage Facility: [X] Active or [] Inactive				Bond Release				
	Mill				Other (tour, data collection, baseline, TSF, etc.)-

Hard Rock OP Mining Section Inspection Photo Log

Permit: 00030 Montana Resources, LLC

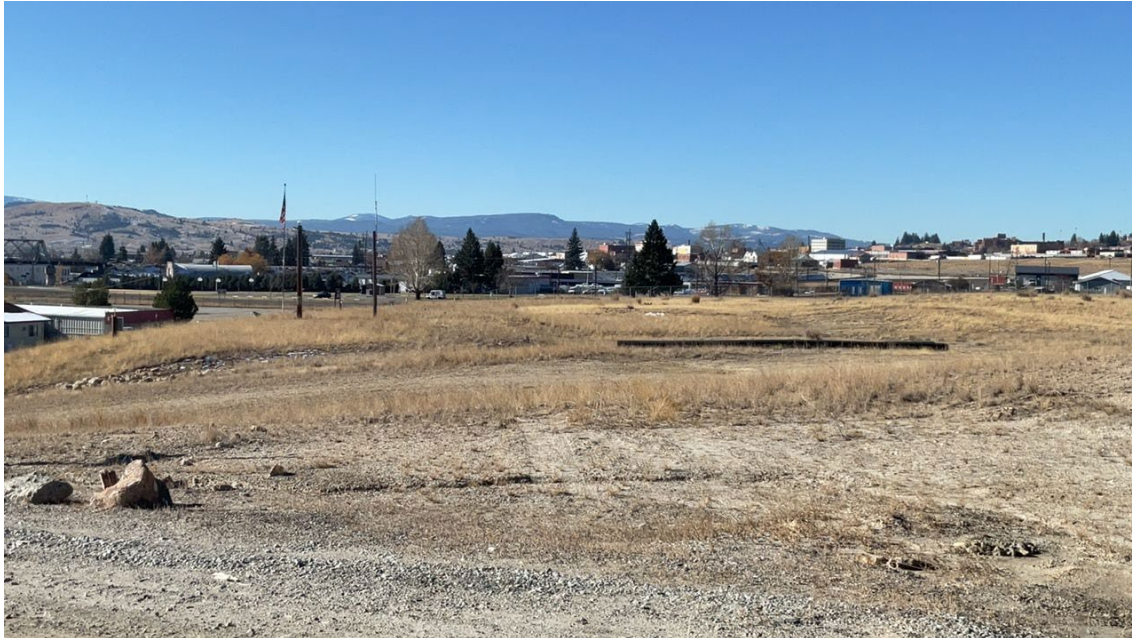
Photos #: 31 and 32

Description: The parcel between the MR office and the polishing plant may be used for a future repository, pending approval through BPSOU parties and a revision to the mine permit to remove these acres from the permit area.
