**MONTANA DEPARTMENT OF ENVIRONMENTAL QUALITY
HARD ROCK MINING BUREAU
OPERATING PERMIT – FIELD INSPECTION REPORT**

Operator: Montana Resources, LLC				Inspection Date: June 20, 2023			
Operating Permit #: 00030			Project: Montana Resources- Continental Mine Complex			County: Silver Bow	
Nearest City or Town(s): Butte							
DEQ Staff: Christine Abelmann, Derrek Schultz, Garrett Smith				Company Representative(s): Mark Thompson, Jeremy Fleege			
Agencies w/overlapping Jurisdiction:			USFS		BLM		Other <input checked="" type="checkbox"/> None
Minerals: Copper, molybdenum, minor silver							
Status:		<input checked="" type="checkbox"/>	Active		Inactive		Suspended <input type="checkbox"/> Other <input type="checkbox"/>
Weather: Partly cloudy, high temp 55°F							
Type of Operation:				Purpose of Inspection:			
<input checked="" type="checkbox"/>	Open Pit				Initial (Pre-permitting)		
	Underground			<input checked="" type="checkbox"/>	Regular Compliance		
	Placer				Amendment #		
<input checked="" type="checkbox"/>	<i>Heap Leach- Leach pads near HSB no longer receiving solution</i>				Complaint Received

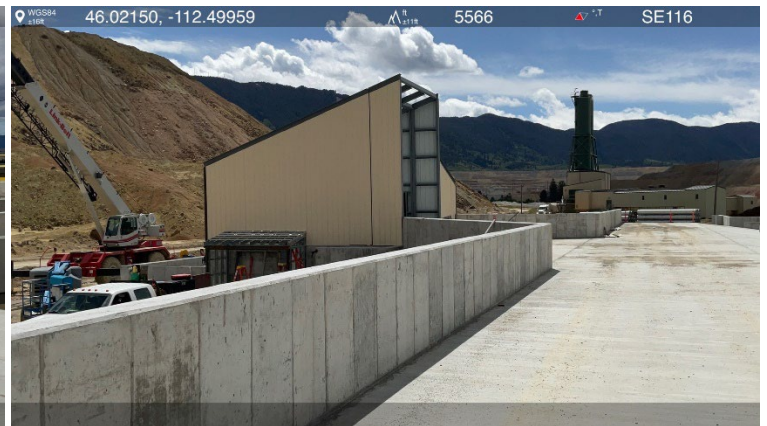
The average flow measured in the HSB Weir through the end of 2022 was approximately 3,200 gpm, which is comparable to the average flows observed since the recirculation of leach pad solutions was stopped in July 2021. A new precipitation plant continues to be constructed to the south of HSB, near the HSB Water Treatment Plant (Photos 14 and 15), as approved through revision MR22-001 on 10/26/2022. MR reported that the facility would likely be operational later in 2023, although some aspects of construction have been delayed. The historical copper

Photos 14 and 15- A new precipitation plant is being constructed to the south of HSB, near the HSB Water Treatment Plant. This facility was approved as revision MR 22-001.

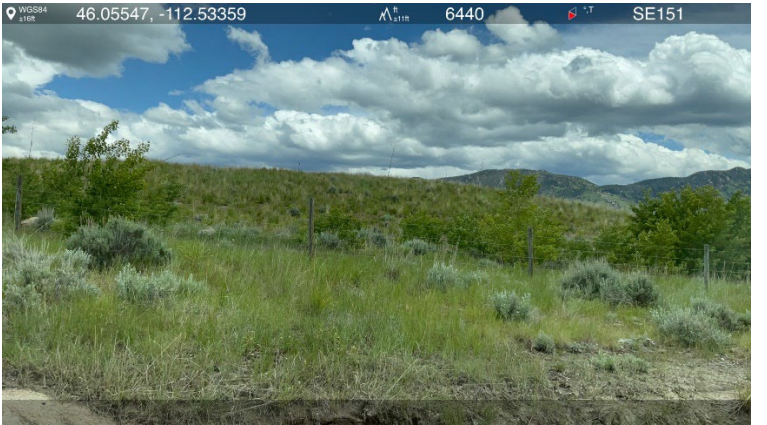
After the on-site inspection concluded, DEQ traveled along the Moulton Reservoir Road to evaluate the establishment of vegetation on stockpiles, which also serve as visual barriers along the public access road (Photos 18 through 20). The stockpile topography and surrounding native vegetation generally provide an effective barrier from most vantage points along the road. In most places, the establishment of grass and forb species on the piles is looking good and only minor erosion has occurred on the stockpile surface. A few of the aspen trees that were

Photos 18, 19, 20- Vegetated soil stockpiles along the Moulton Reservoir Road. The stockpile topography and surrounding native vegetation generally provide an effective visual barrier from most vantage points along the road. In most places, the establishment of grass and forb species on the piles is looking good and only minor erosion has occurred on the stockpile surface. A few of the aspen trees that were planted on top of the piles have survived, although most of them have not.
