June 5, 2023

Knight Piésold Ltd.

RE: Q1 2023 – YDTI Quarterly Water Data Summary

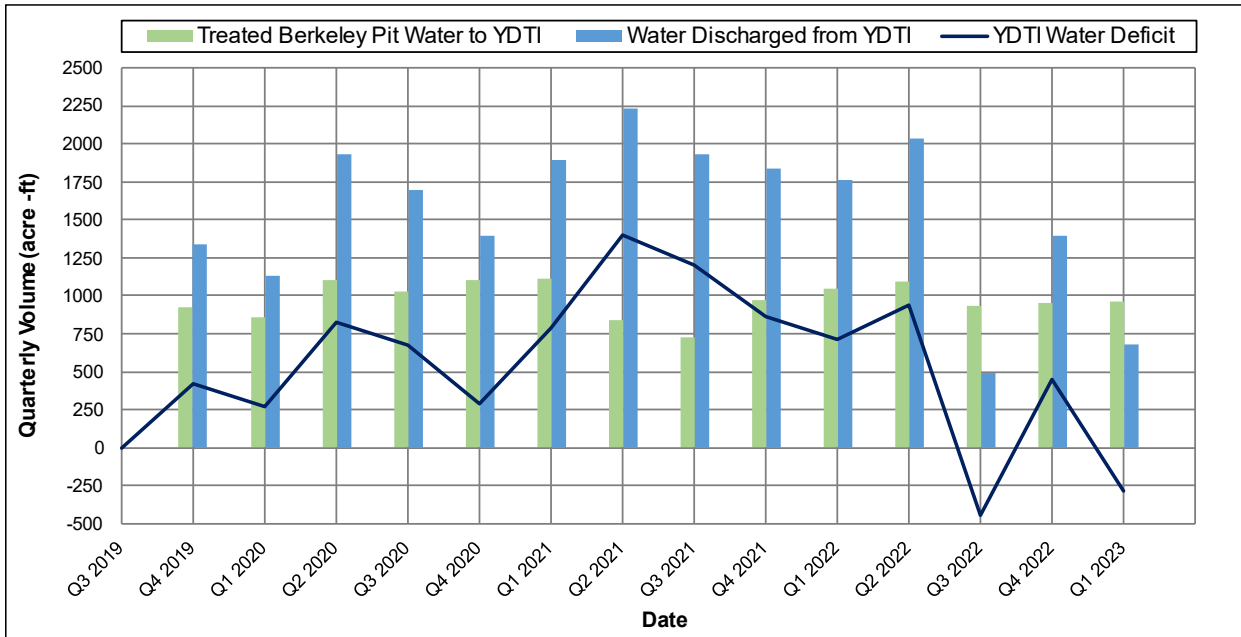
Figure 2.2 Berkeley Pit Pilot Project Flows – Quarterly Summary

The YDTI supernatant pond had a net gain of approximately 93 million gallons (284 acre-ft) of water in Q1. Approximately 313 million gallons (960 acre-ft) of treated Berkeley Pit water were discharged into the YDTI and 220 gallons (676 acre-ft) of YDTI water were discharged off-site during Q1. This is the second quarter since the Pilot Project commissioning during which the YDTI experienced a net volume gain instead of a volume deficit. The amount of water discharged is less than the amount of water introduced during Q1 because of issues with the Reclaim Water pumps, which were not able to provide enough water to meet Mill and Polishing Plant demands.

The quarterly flow records for the Berkeley Pit Pumping System, Polishing Plant discharge, and YDTI quarterly balance since the Pilot Project commissioning in 2019 are shown on Figure 2.2.

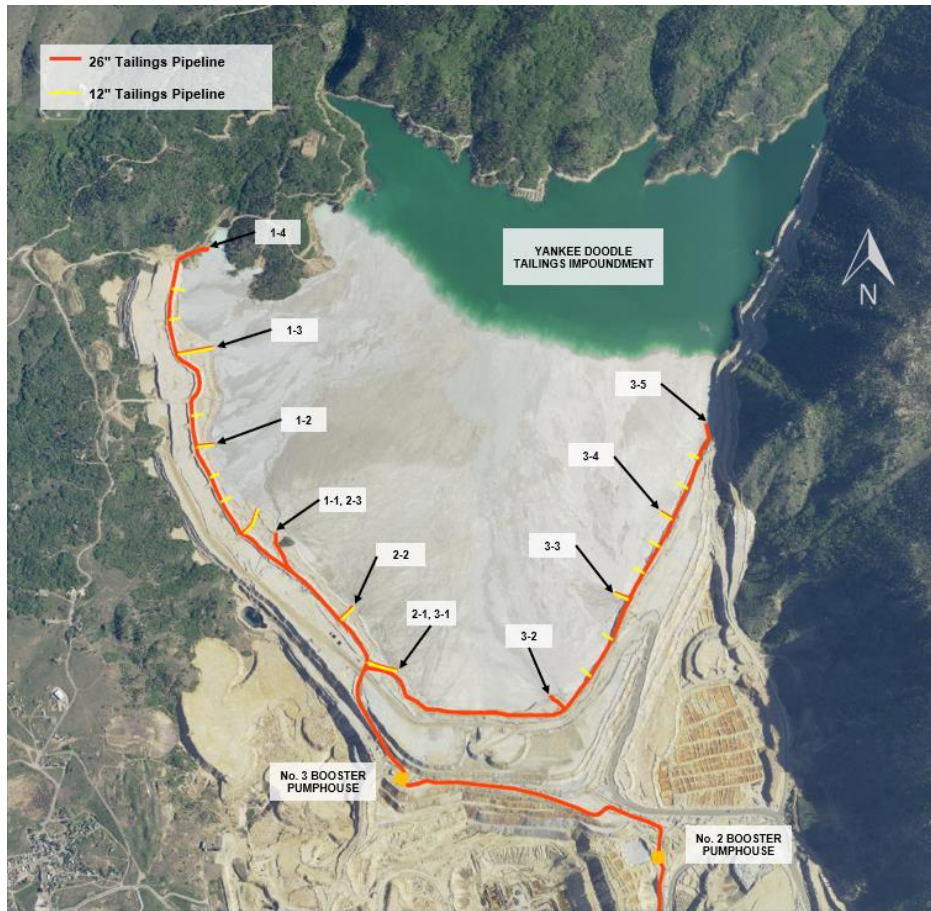
Figure 3.1 YDTI Tailings Discharge Locations

Tailings discharge records indicate that tailings were distributed from all three YDTI embankments during Q1 2023, with six of the ten 26-inch discharge locations and none of the 12-inch discharge lines being used. The tailings discharge locations are shown on Figure 3.1, and the tailings beach elevations at each of the discharge locations are shown on Figure 3.2.

The discharge spigot with the lowest beach elevation was 1-4 throughout Q1 2023. The elevation difference between 1-4 and the supernatant pond surface was approximately 15.3 ft at the end of Q1 2023. The location of the lowest discharge point identifies the general area of the facility where the pond may initially contact the embankment in the event the pond elevation rises due to an increase in pond volume (e.g., flooding).

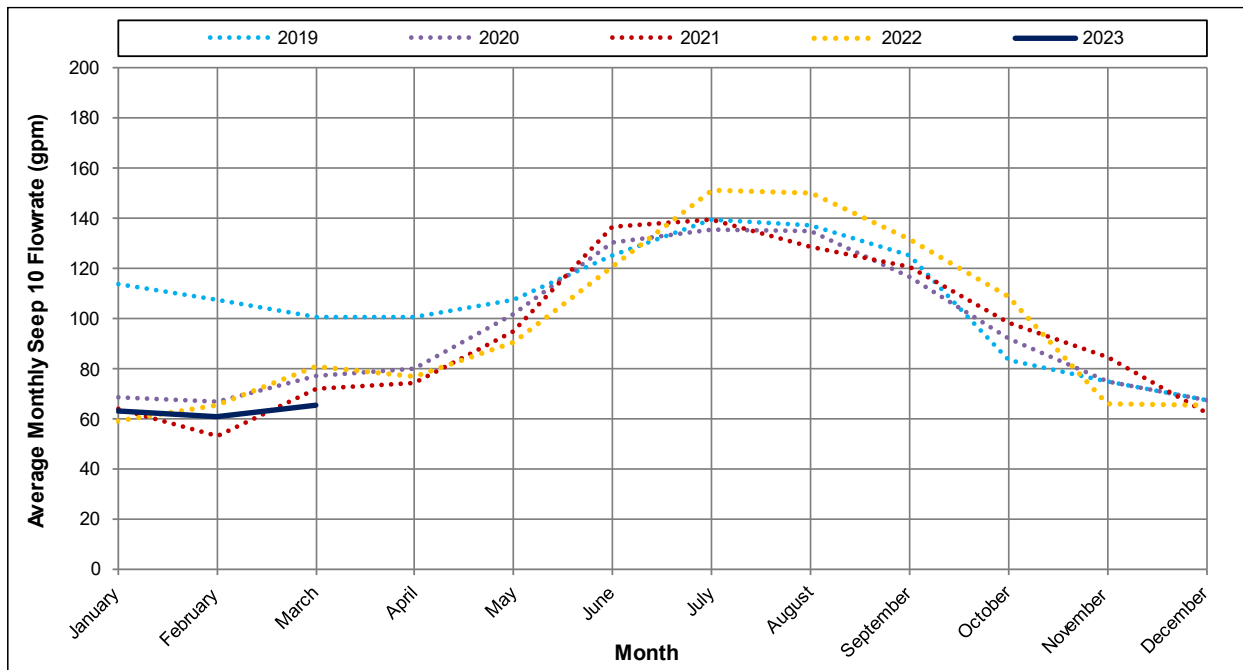
Figure 6.1 Average Monthly Seep 10 Weir Flowrate

The average monthly Seep 10 flowrates from 2019 through Q1 2023 are presented on Figure 6.1. The average flowrate during Q1 2023 follows the Q1 trend observed over the past three years.

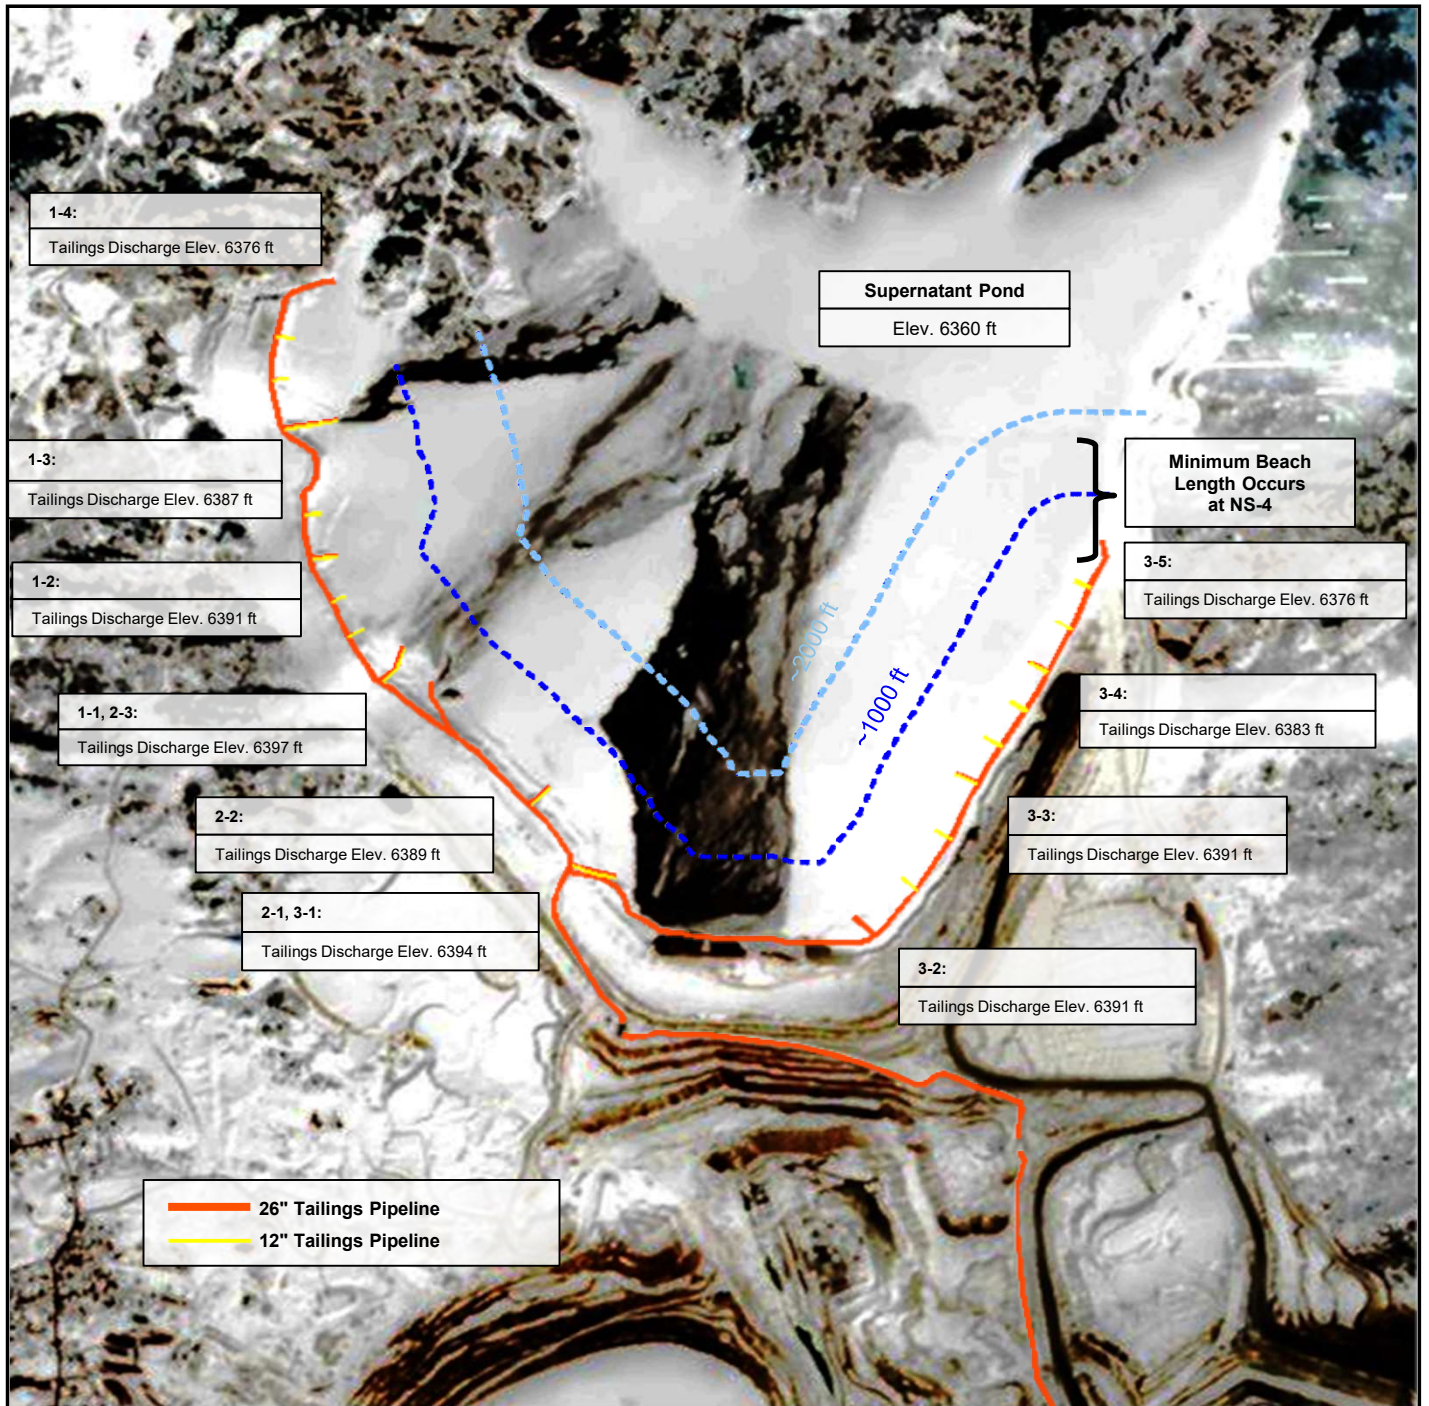
Images captured by the Sentinel-2 satellite are reviewed twice per month to remotely observe the shape of the tailings beach and position of the supernatant pond relative to the embankments. The shortest beach length was observed at the northern end of the North-South Embankment and estimated to be approximately 1,450 ft at the end of Q1, which is approximately 100 ft shorter than the Q4 2022 beach length. This beach length was also observed in Q1 2021 when the supernatant pond water was at a similar elevation. The decreased beach length is attributed to the pond water elevation increasing and less beach being exposed as the beach/pond interface extends to the south. The pond/beach interface was partially obscured by snow and an ice cap, which may affect the minimum beach length estimation.
