July 30, 2024

Mr. Mike Harvie
Manager of Engineering and Geology
Montana Resources, LLC
600 Shields Avenue
Butte, Montana
USA, 59701

RE: Q1 2024 – YDTI Quarterly Piezometric and Deformation Monitoring Update

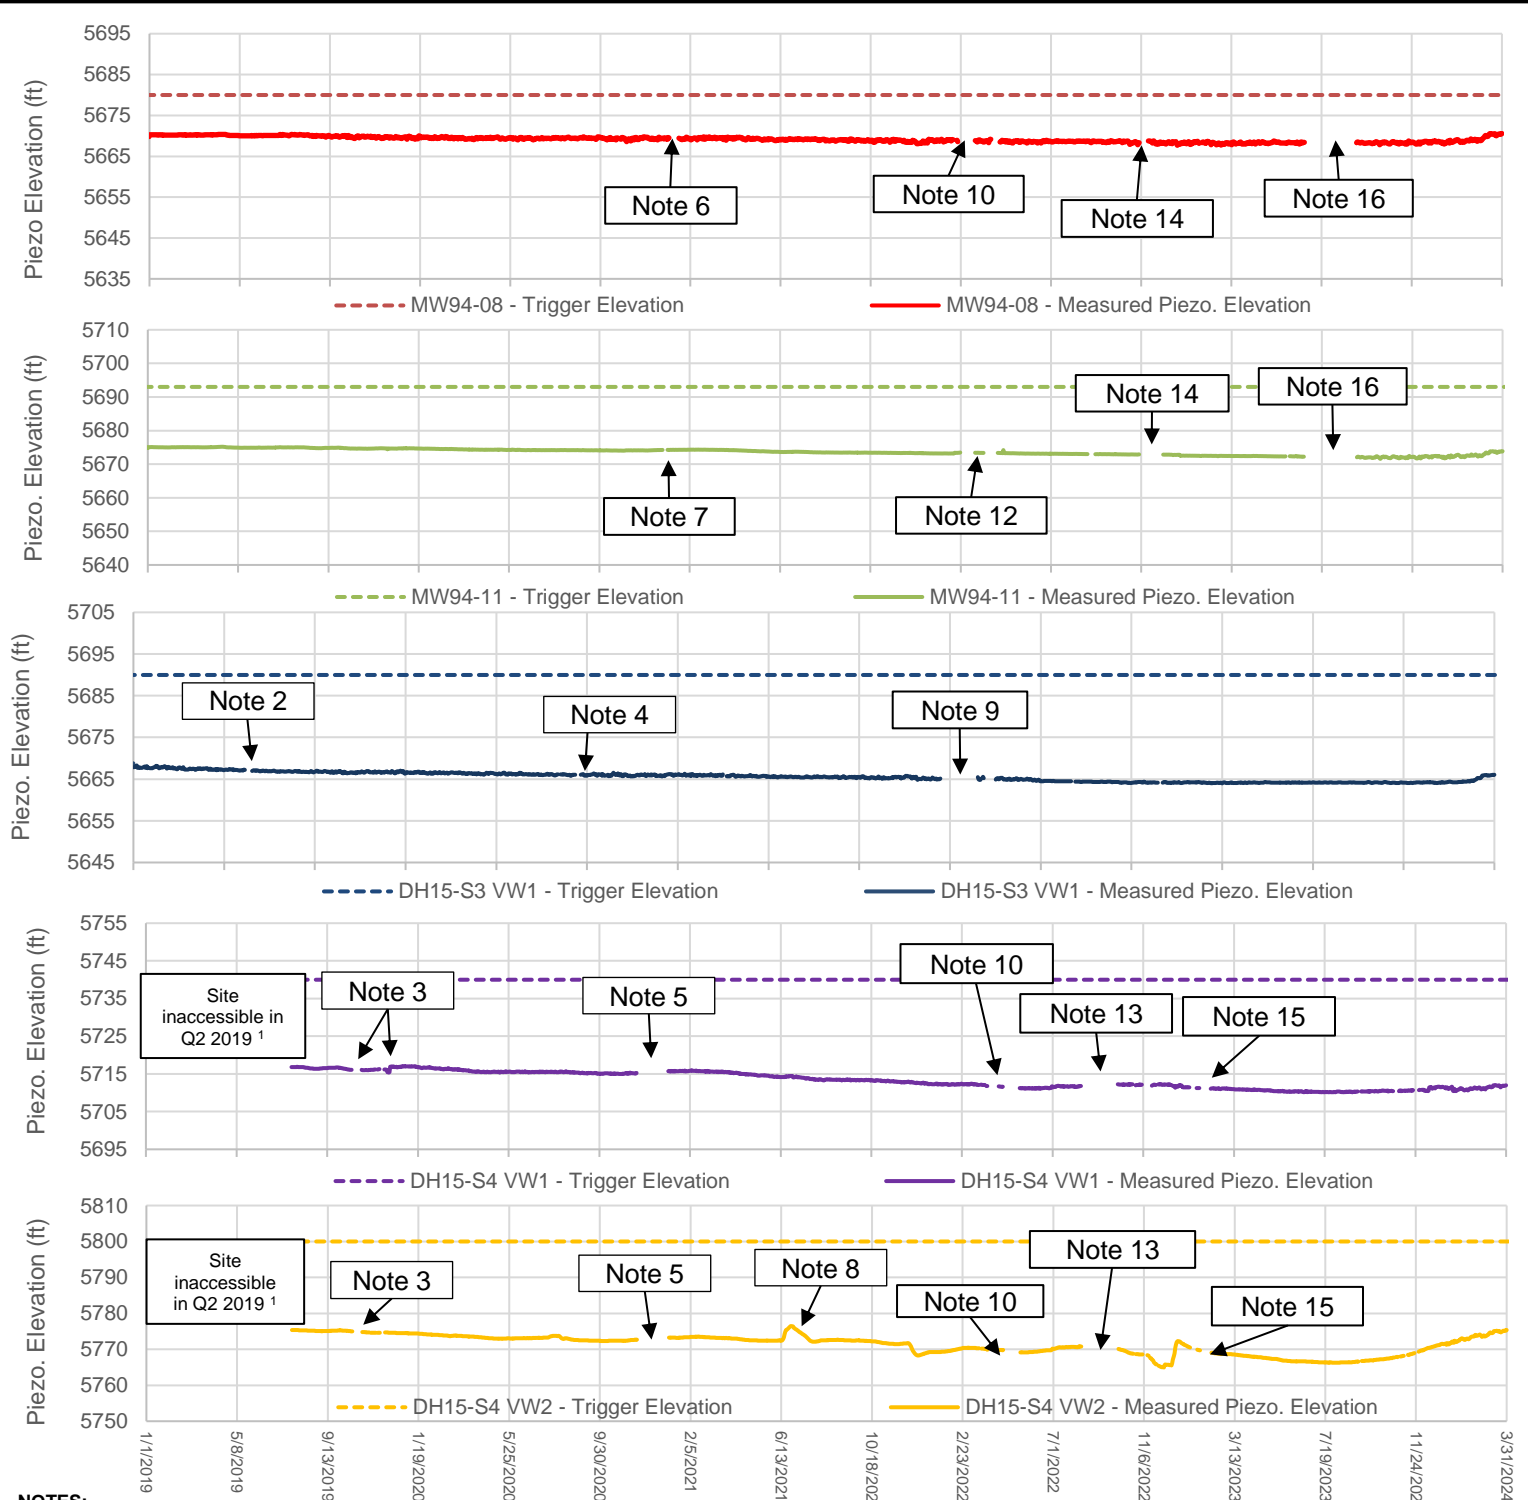
MONTANA RESOURCES, LLC	
MONTANA RESOURCES	
SUMMARY OF MEASURED VS. QPP TRIGGER PIEZOMETRIC ELEVATIONS EAST-WEST EMBANKMENT	
P/A NO. VA101-126/31	REF. NO. VA24-00764
FIGURE 2	
REV 0

8. PIEZOMETRIC ELEVATION INCREASED IN RESPONSE TO OBSERVED INFILTRATION OF TAILINGS SLURRY WATER INTO THE CENTRAL ROCKFILL SURCHARGE FROM JUNE 14 TO JUNE 28, 2021 AS DESCRIBED IN VA21-01320.

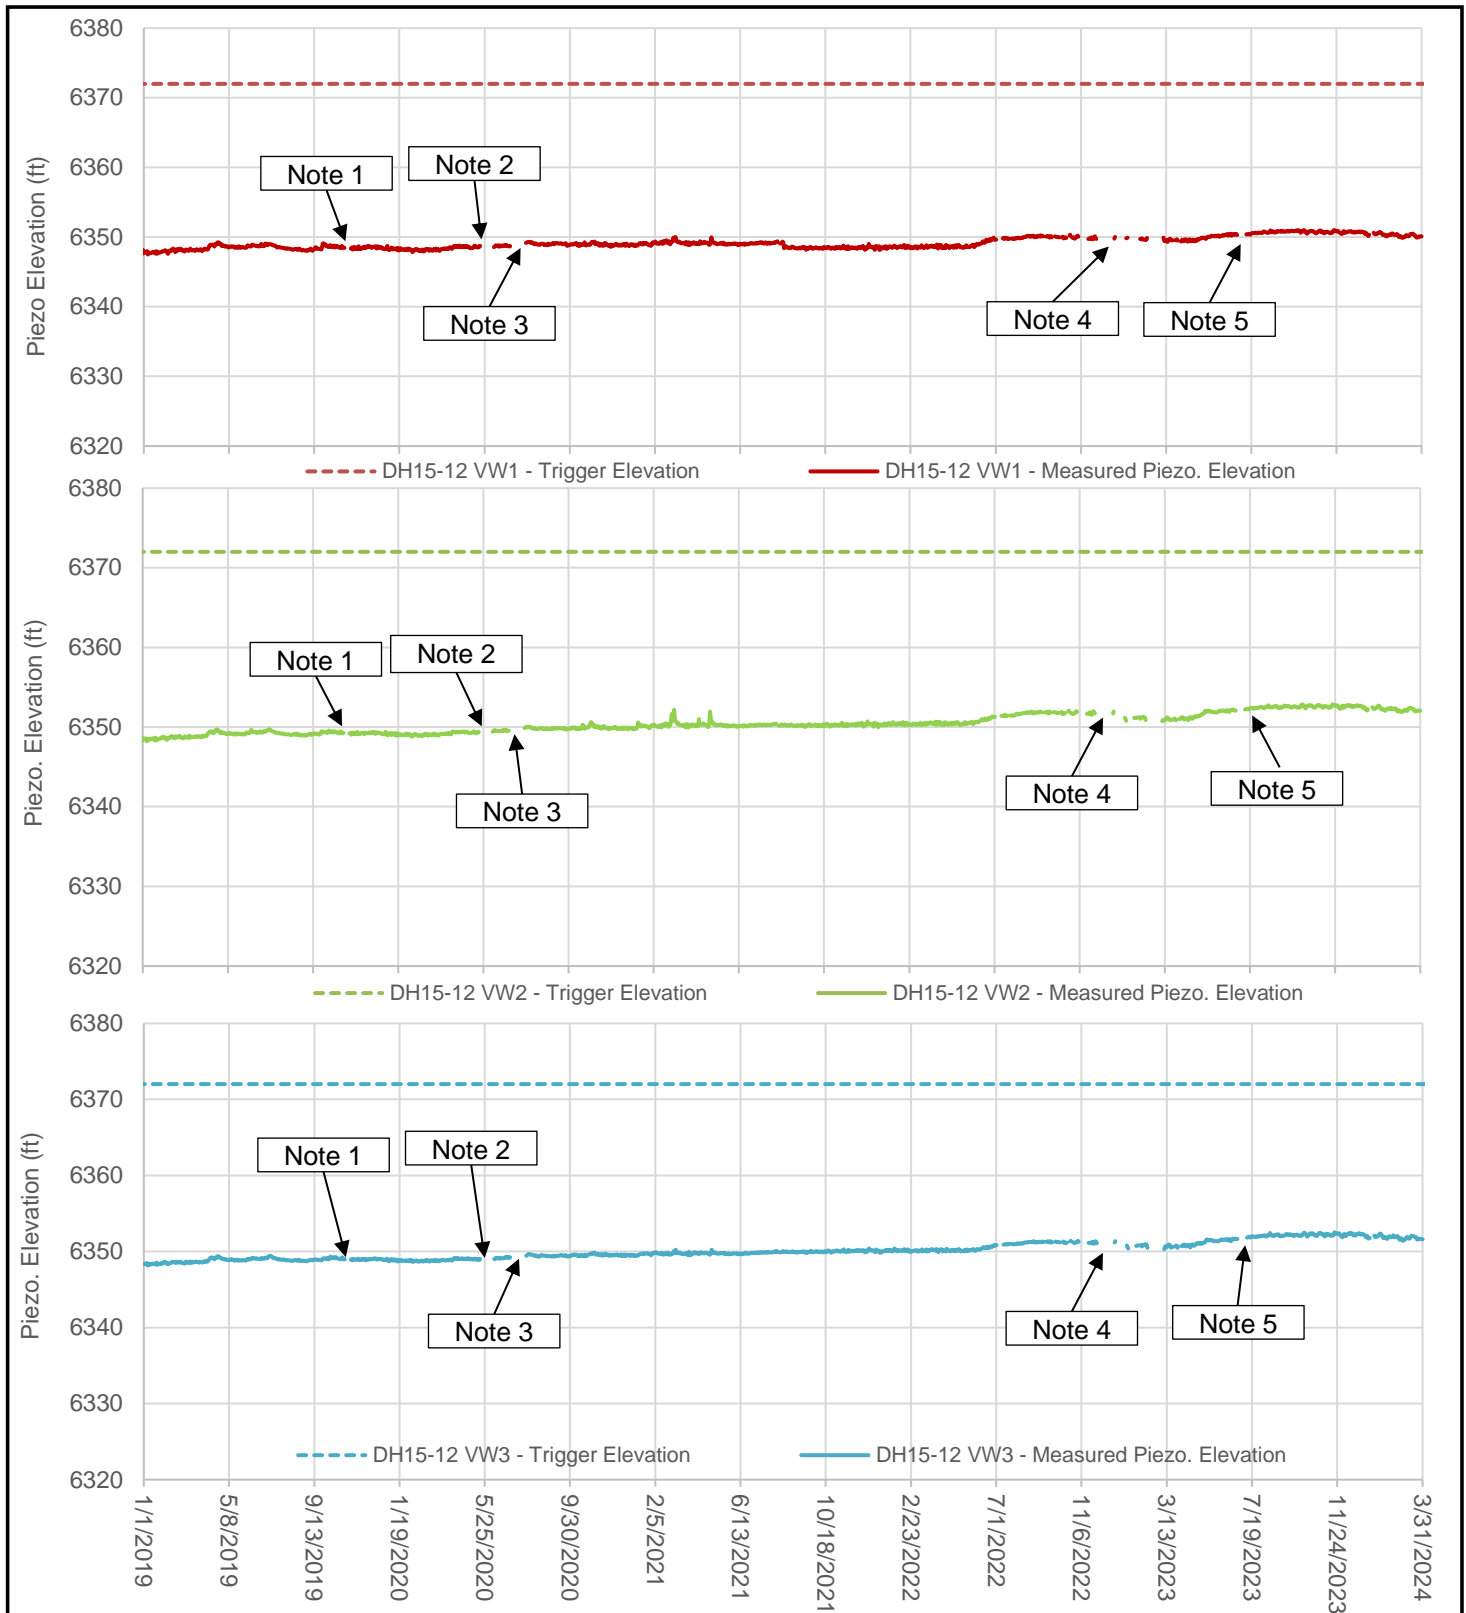
P/A NO. VA101-126/31 REF. NO. VA24-00764
FIGURE 5	REV 0

- QPP sensors in drillhole DH15-12 (VW1, VW2, and VW3), installed within the West Embankment, observed slightly decreasing pore water pressures (approximately 0.7 ft). All three sensors remained approximately 20 ft below their QPP trigger thresholds.
- Pore water pressures monitored by QPP sensors installed in WED Drain Pods 1 and 2 (VWP-DP1 and VWP-DP2, respectively) observed slightly decreasing pore pressures (approximately 0.4 ft and 0.3 ft, respectively). The sensors remain approximately 33 ft and 28 ft below their respective QPP trigger thresholds.
- The piezometric elevation monitored by the non-QPP sensor in the WED Extraction Basin (VWP-EB1) monitored a minor pore water pressure decrease (approximately 0.6 ft) during Q1 2024.

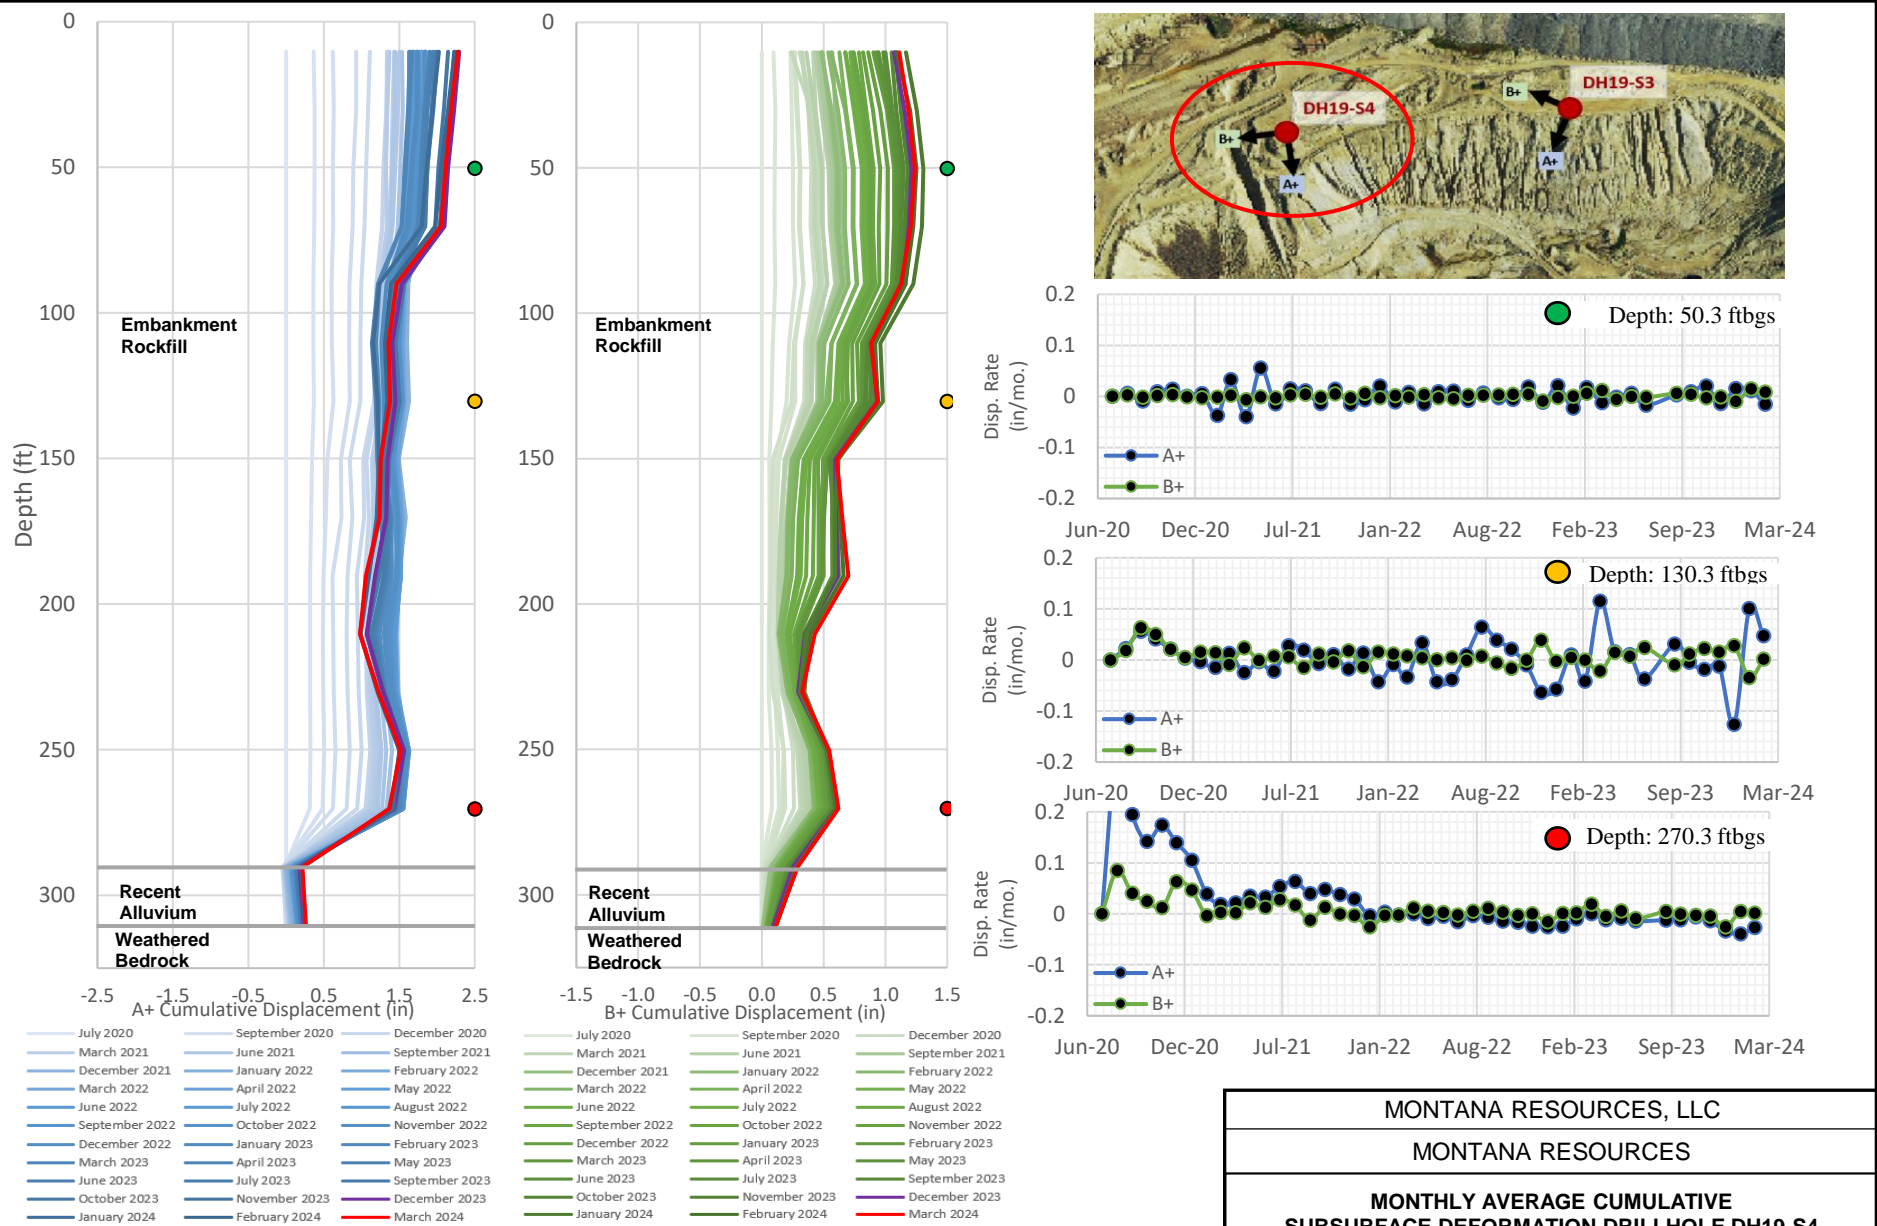
P/A NO. VA101-126/31
	REF. NO. VA24-00764
FIGURE B.4	
REV 0

- NOTES:**
1. CUMULATIVE DEFORMATION MAGNITUDES AND RATES ARE PRESENTED AS MONTHLY AVERAGES.
 2. POSITIVE A+ AND B+ DEFORMATIONS INDICATE SOUTHWARD AND WESTWARD DISPLACEMENTS, RESPECTIVELY.
 3. DEFORMATION MAGNITUDE BETWEEN 290 FTBG AND 310 FTBG IS INTERPRETED TO BE AN OVERESTIMATE DUE TO IPI CONNECTING ROD FLEXION.

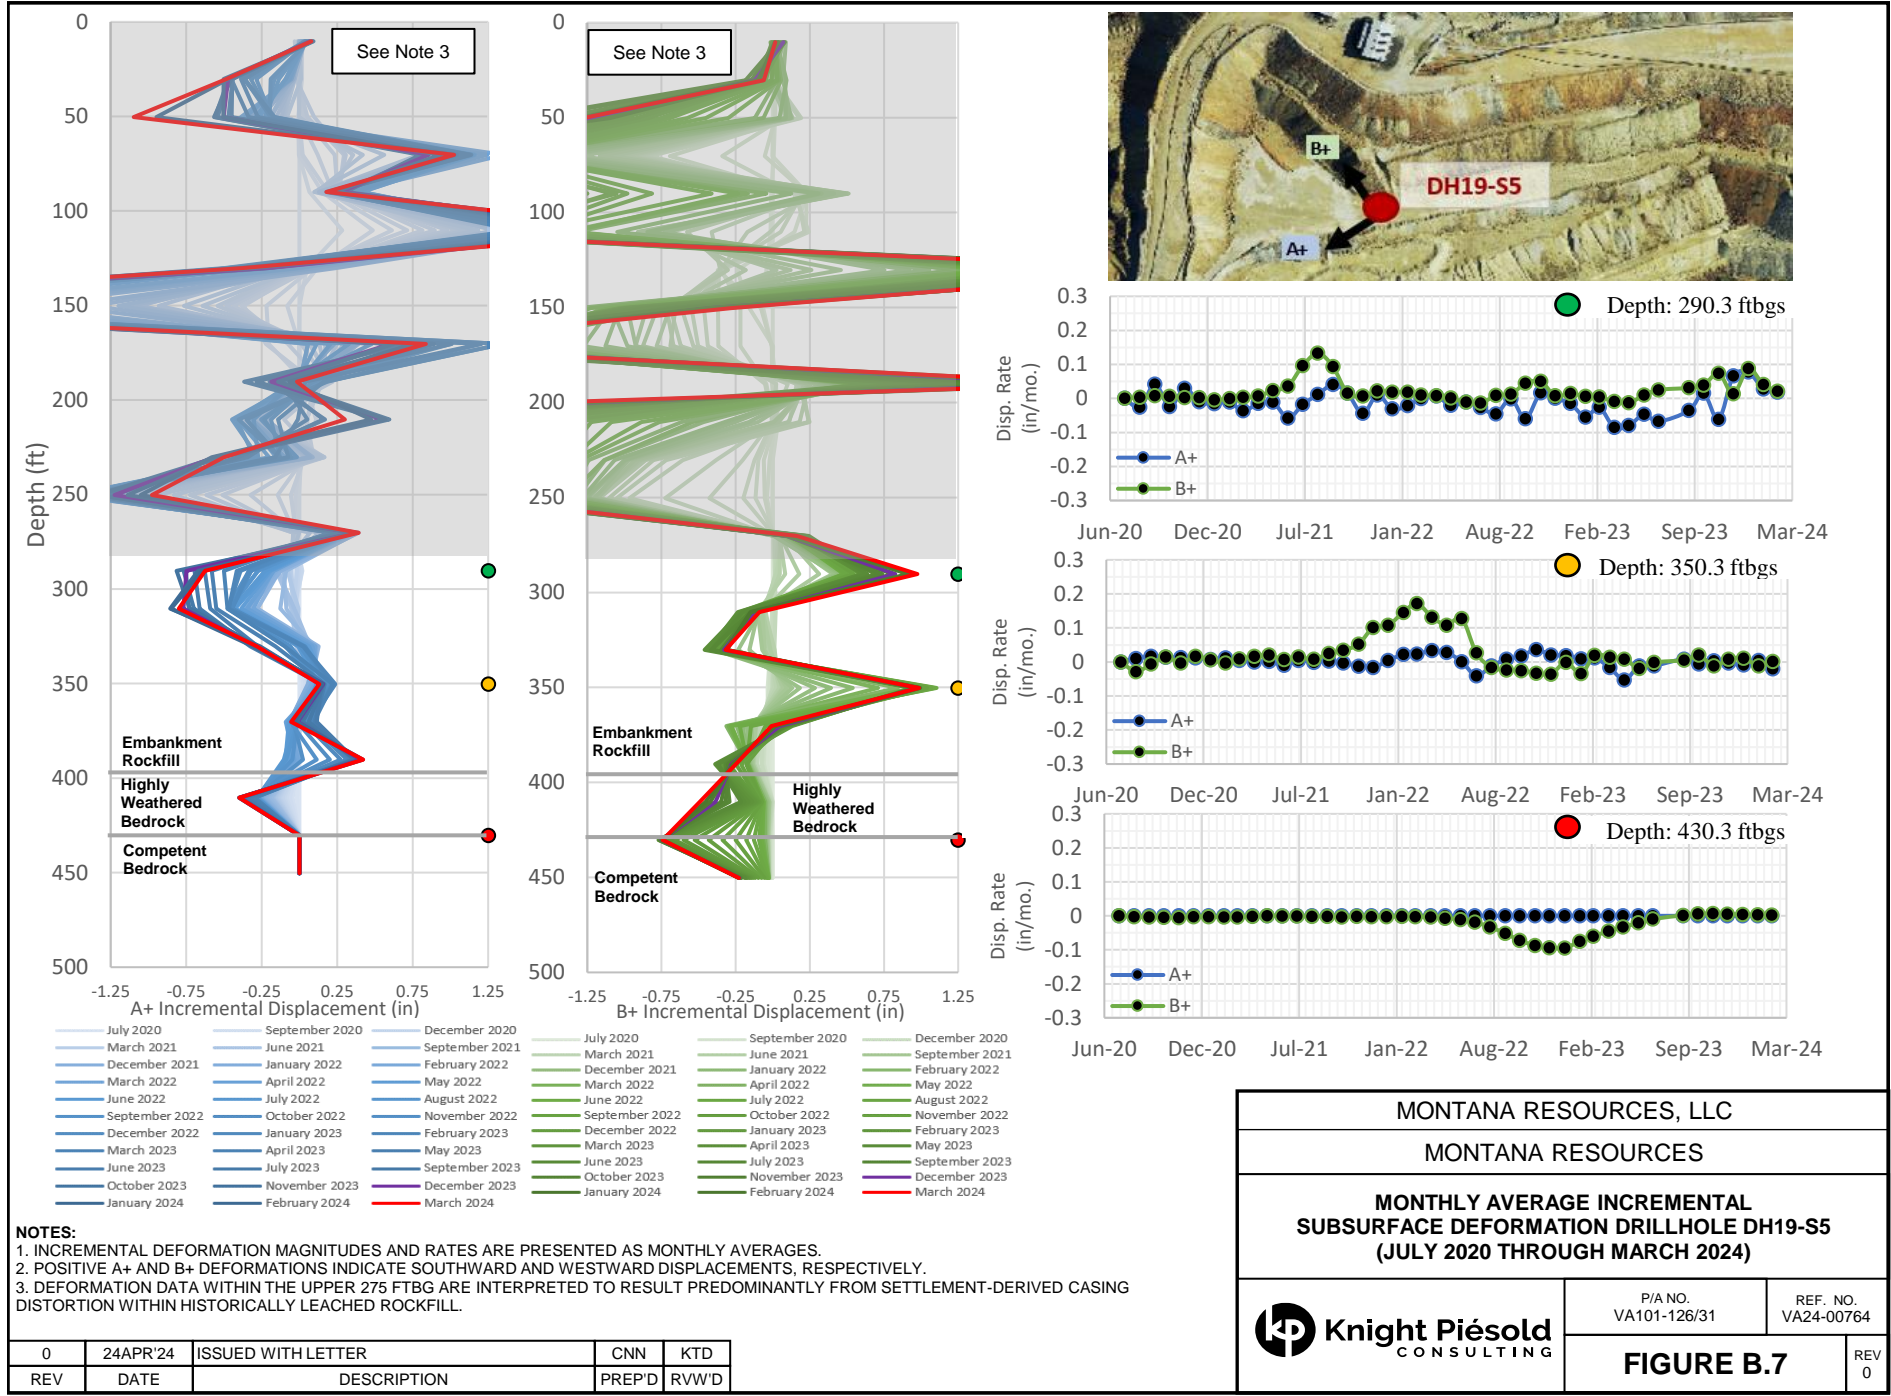
MONTANA RESOURCES, LLC	
MONTANA RESOURCES	
MONTHLY AVERAGE INCREMENTAL SUBSURFACE DEFORMATION DRILLHOLE DH19-S5 (JULY 2020 THROUGH MARCH 2024)

NOTES:
 1. INCREMENTAL DEFORMATION MAGNITUDES AND RATES ARE PRESENTED AS MONTHLY AVERAGES.
 2. POSITIVE A+ AND B+ DEFORMATIONS INDICATE SOUTHWARD AND WESTWARD DISPLACEMENTS, RESPECTIVELY.
 3. DEFORMATION DATA WITHIN THE UPPER 275 FTBG ARE INTERPRETED TO RESULT PREDOMINANTLY FROM SETTLEMENT-DERIVED CASING DISTORTION WITHIN HISTORICALLY LEACHED ROCKFILL.

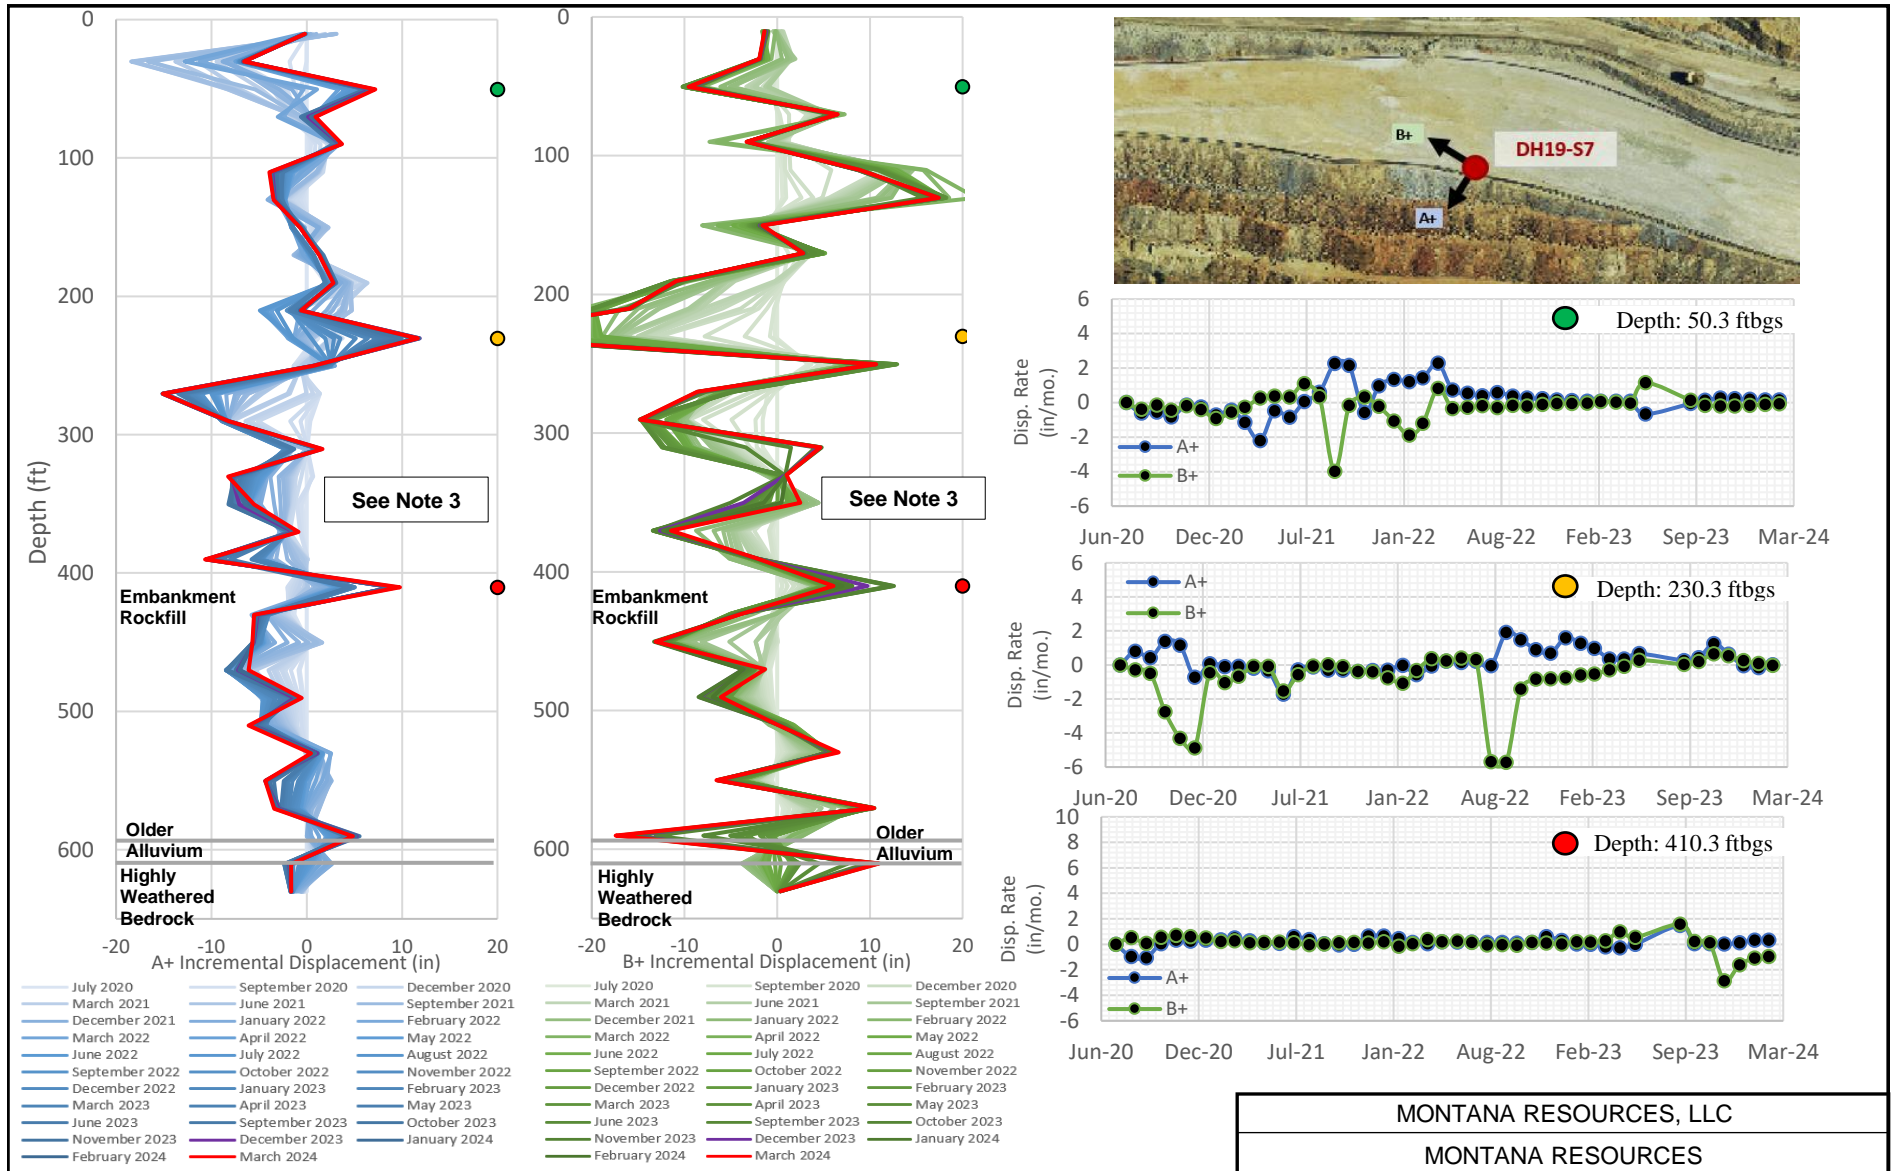
MONTANA RESOURCES, LLC	
MONTANA RESOURCES	
MONTHLY AVERAGE INCREMENTAL SUBSURFACE DEFORMATION DRILLHOLE DH19-S7 (JULY 2020 THROUGH MARCH 2024)	
	P/A NO. VA101-126/31
	REF. NO. VA24-00764
FIGURE B.9	
REV 0

NOTES:
 1. INCREMENTAL DEFORMATION MAGNITUDES AND RATES ARE PRESENTED AS MONTHLY AVERAGES.
 2. POSITIVE A+ AND B+ DEFORMATIONS INDICATE SOUTHWARD AND WESTWARD DISPLACEMENTS, RESPECTIVELY.
 3. DEFORMATION DATA THROUGHOUT THE EMBANKMENT ROCKFILL ARE INTERPRETED TO RESULT PREDOMINANTLY FROM SETTLEMENT-DERIVED CASING DISTORTION WITHIN THE ROCKFILL AND ARE NOT REPRESENTATIVE OF IN-SITU LATERAL DISPLACEMENT.

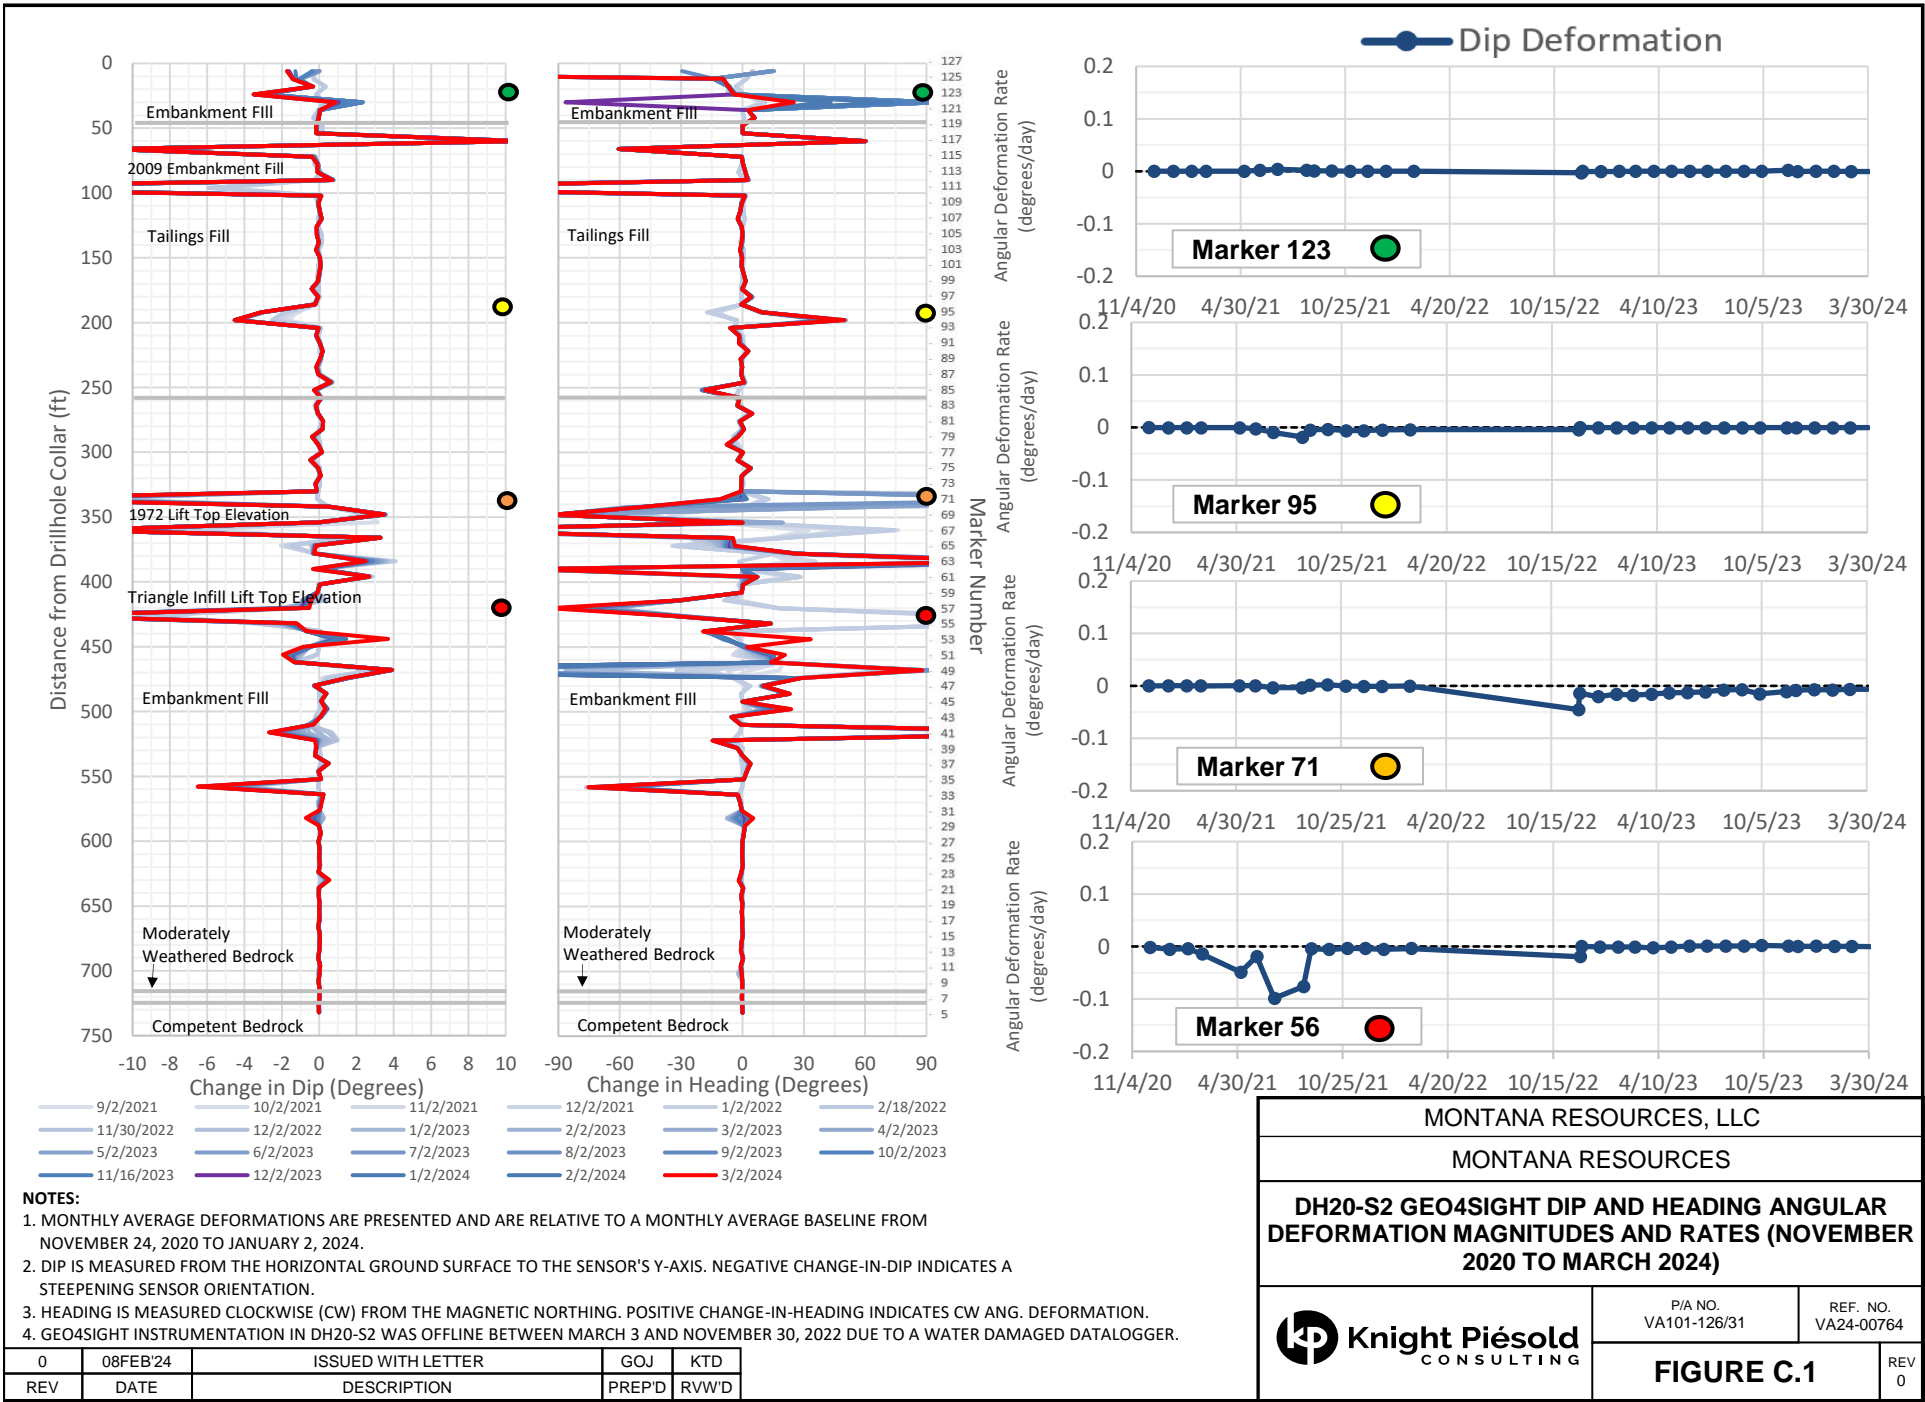
- NOTES:**
1. MONTHLY AVERAGE DEFORMATIONS ARE PRESENTED AND ARE RELATIVE TO A MONTHLY AVERAGE BASELINE FROM NOVEMBER 24, 2020 TO JANUARY 2, 2024.
 2. DIP IS MEASURED FROM THE HORIZONTAL GROUND SURFACE TO THE SENSOR'S Y-AXIS. NEGATIVE CHANGE-IN-DIP INDICATES A STEEPENING SENSOR ORIENTATION.
 3. HEADING IS MEASURED CLOCKWISE (CW) FROM THE MAGNETIC NORTHING. POSITIVE CHANGE-IN-HEADING INDICATES CW ANG. DEFORMATION.
 4. GEO4SIGHT INSTRUMENTATION IN DH20-S2 WAS OFFLINE BETWEEN MARCH 3 AND NOVEMBER 30, 2022 DUE TO A WATER DAMAGED DATALOGGER.
