Mr. Mike Harvie
Manager of Engineering and Geology
Montana Resources, LLC
600 Shields Avenue
Butte, Montana
USA, 59701

Knight Piésold Ltd.

RE: Q2 2023 – YDTI Quarterly Piezometric and Deformation Monitoring Update

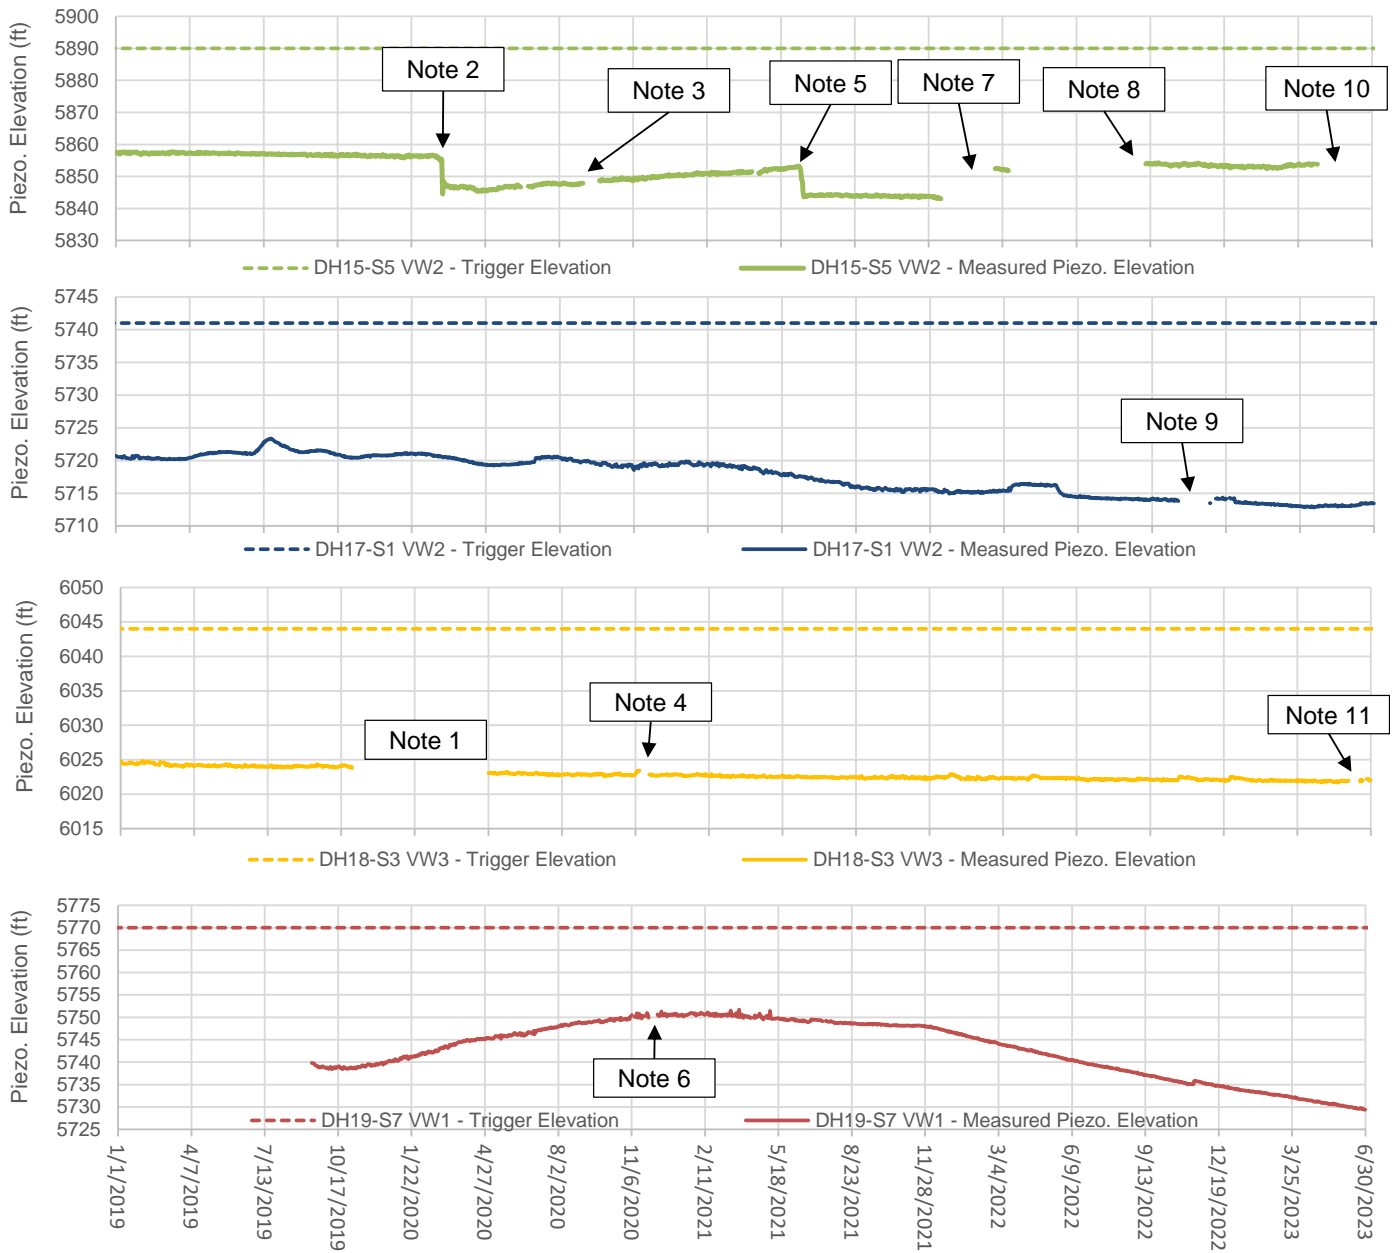
<table><tr> <td style="font-size: small;">P/A NO. VA101-126/29</td> <td style="font-size: small;">REF. NO. VA23-01198</td> </tr><tr> <td colspan="2" style="text-align: center;">FIGURE 3</td> </tr></table>

8. QPP SENSOR DH15-S5 VW1 WAS DAMAGED DURING EL. 6450 ft LIFT CONSTRUCTION AND HAS BEEN ABANDONED. KP HAVE ELECTED SENSOR DH15-S5 VW2 AS A REPLACEMENT QPP.

9. THE DATA LOGGER AT DH17-S1 WAS DAMAGED AND NO DATA WERE RECORDED BETWEEN OCTOBER 18, 2022 AND DECEMBER 9, 2022. FUNCTIONALITY HAS SUBSEQUENTLY BEEN RESTORED.

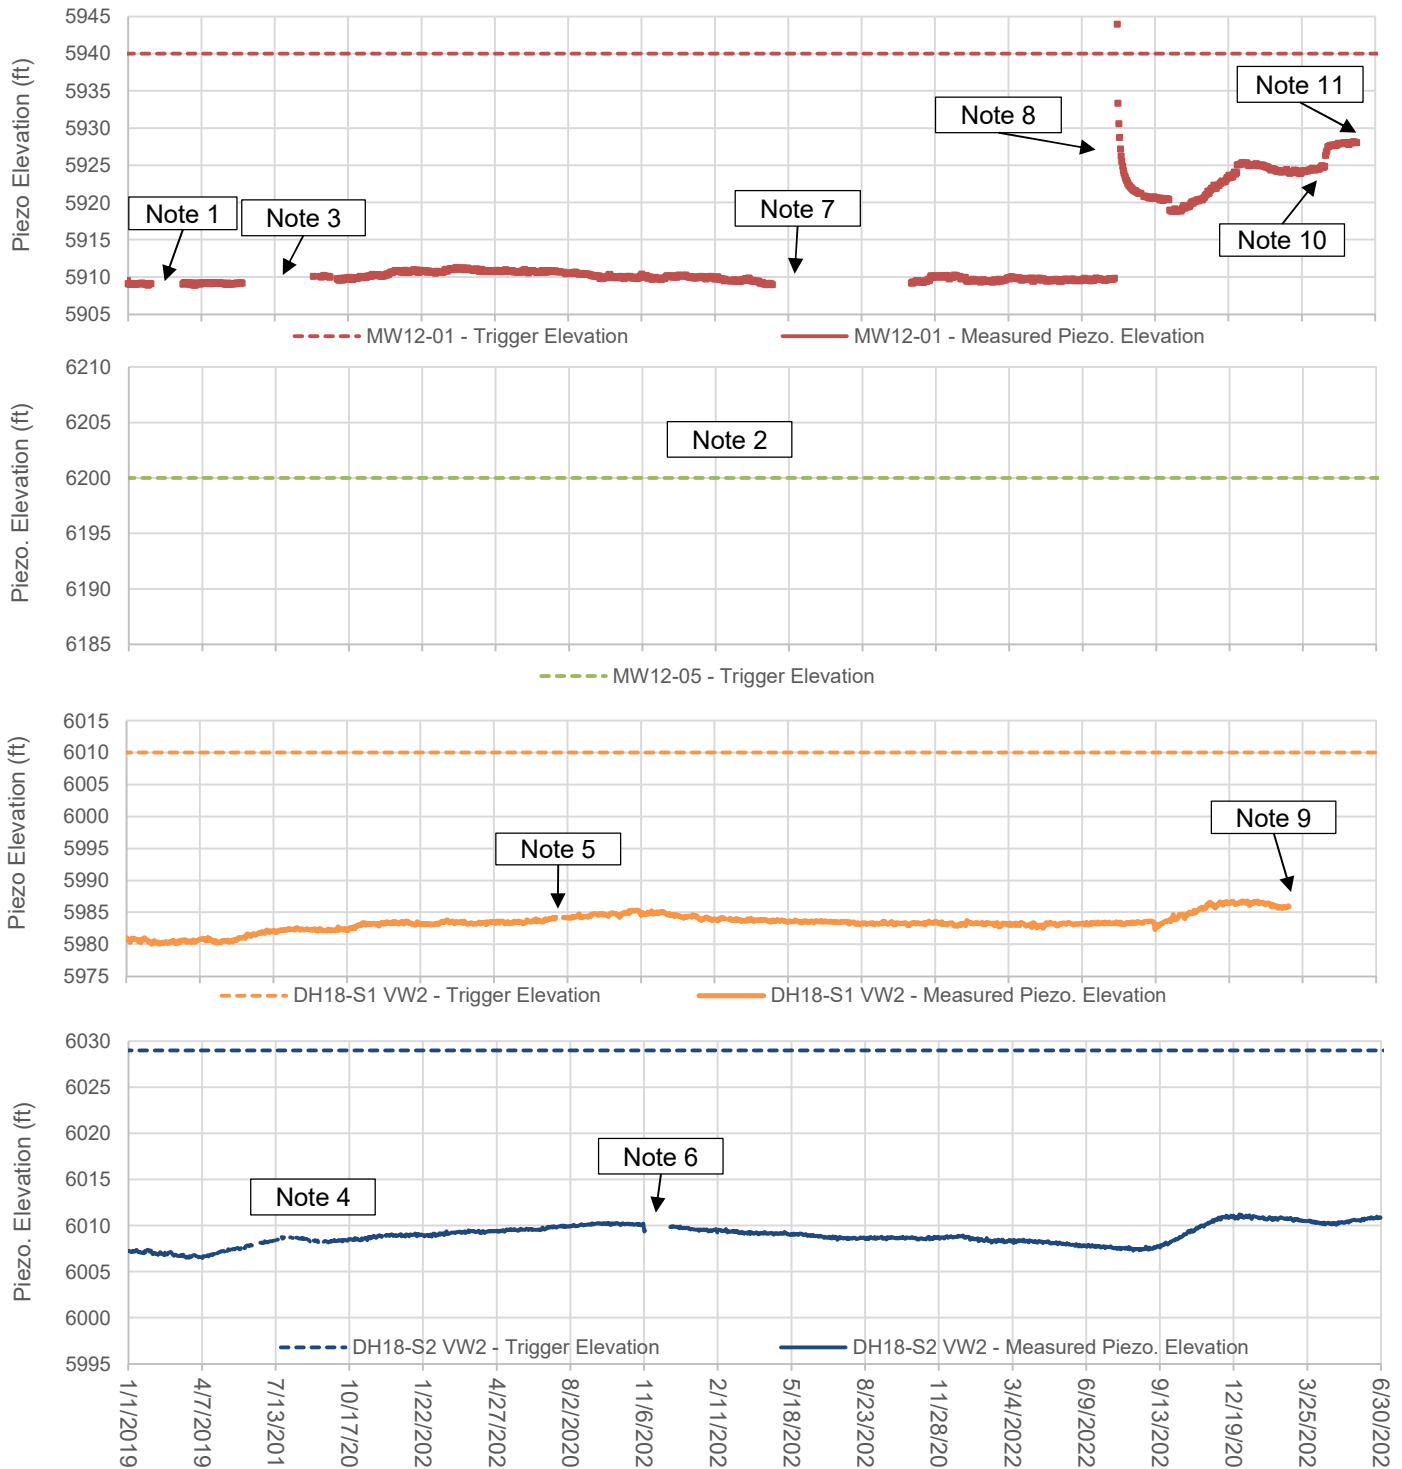
11. SENSOR MW12-01 STOPPED COLLECTING DATA ON JUNE 6, 2023 DUE TO SUSPECTED HARDWARE ISSUES.

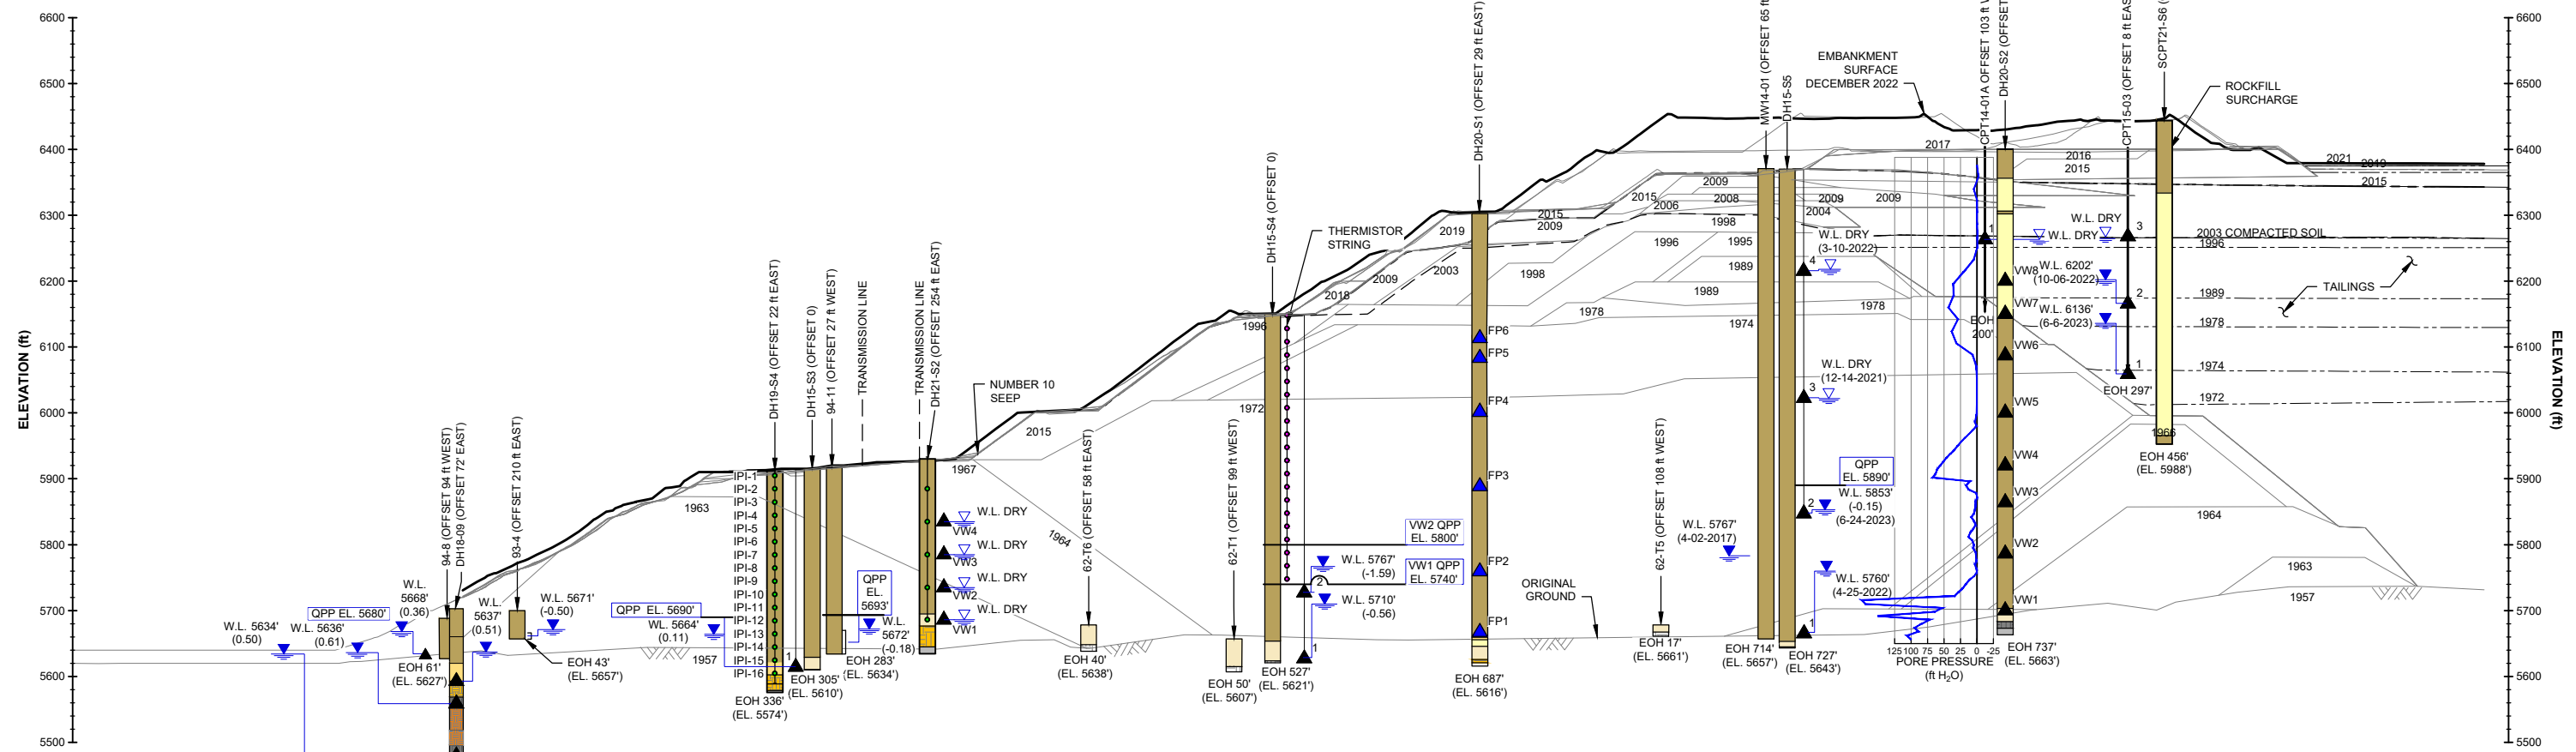
PIEZOMETRIC CONDITIONS ALONG EAST-WEST EMBANKMENT SECTION 8+00W (LOOKING WEST)

- NOTES:**
- COORDINATE SYSTEM IS ANACONDA MINE GRID.
 - DIMENSIONS AND ELEVATIONS ARE IN FEET, UNLESS NOTED OTHERWISE.
 - PIEZOMETRIC LEVELS (W.L.) SHOWN USING END OF Q2 2023 READINGS (JUNE 30, 2023), UNLESS OTHERWISE INDICATED.
 - CHANGE IN WATER LEVEL FOR QPP SITES IS RELATIVE TO END OF Q1 2023.
 - MONITORING WELL MW14-01 ABANDONED DUE TO RISER BLOCKAGE DURING Q4 2019, RESULTING IN ERRONEOUS DATA. DATA OMITTED FOR CLARITY.
 - QPP STANDS FOR QUANTITIVE PERFORMANCE PARAMETER.
 - NO PORE WATER PRESSURE DATA ARE AVAILABLE FROM DH20-S1 AS THE INSTRUMENTATION IS NOT FUNCTIONAL.
 - SENSORS DH15-S5 VWP1, VWP3, AND VWP4 WERE DAMAGED DURING A COLLAR RAISE AND HAVE BEEN ABANDONED.

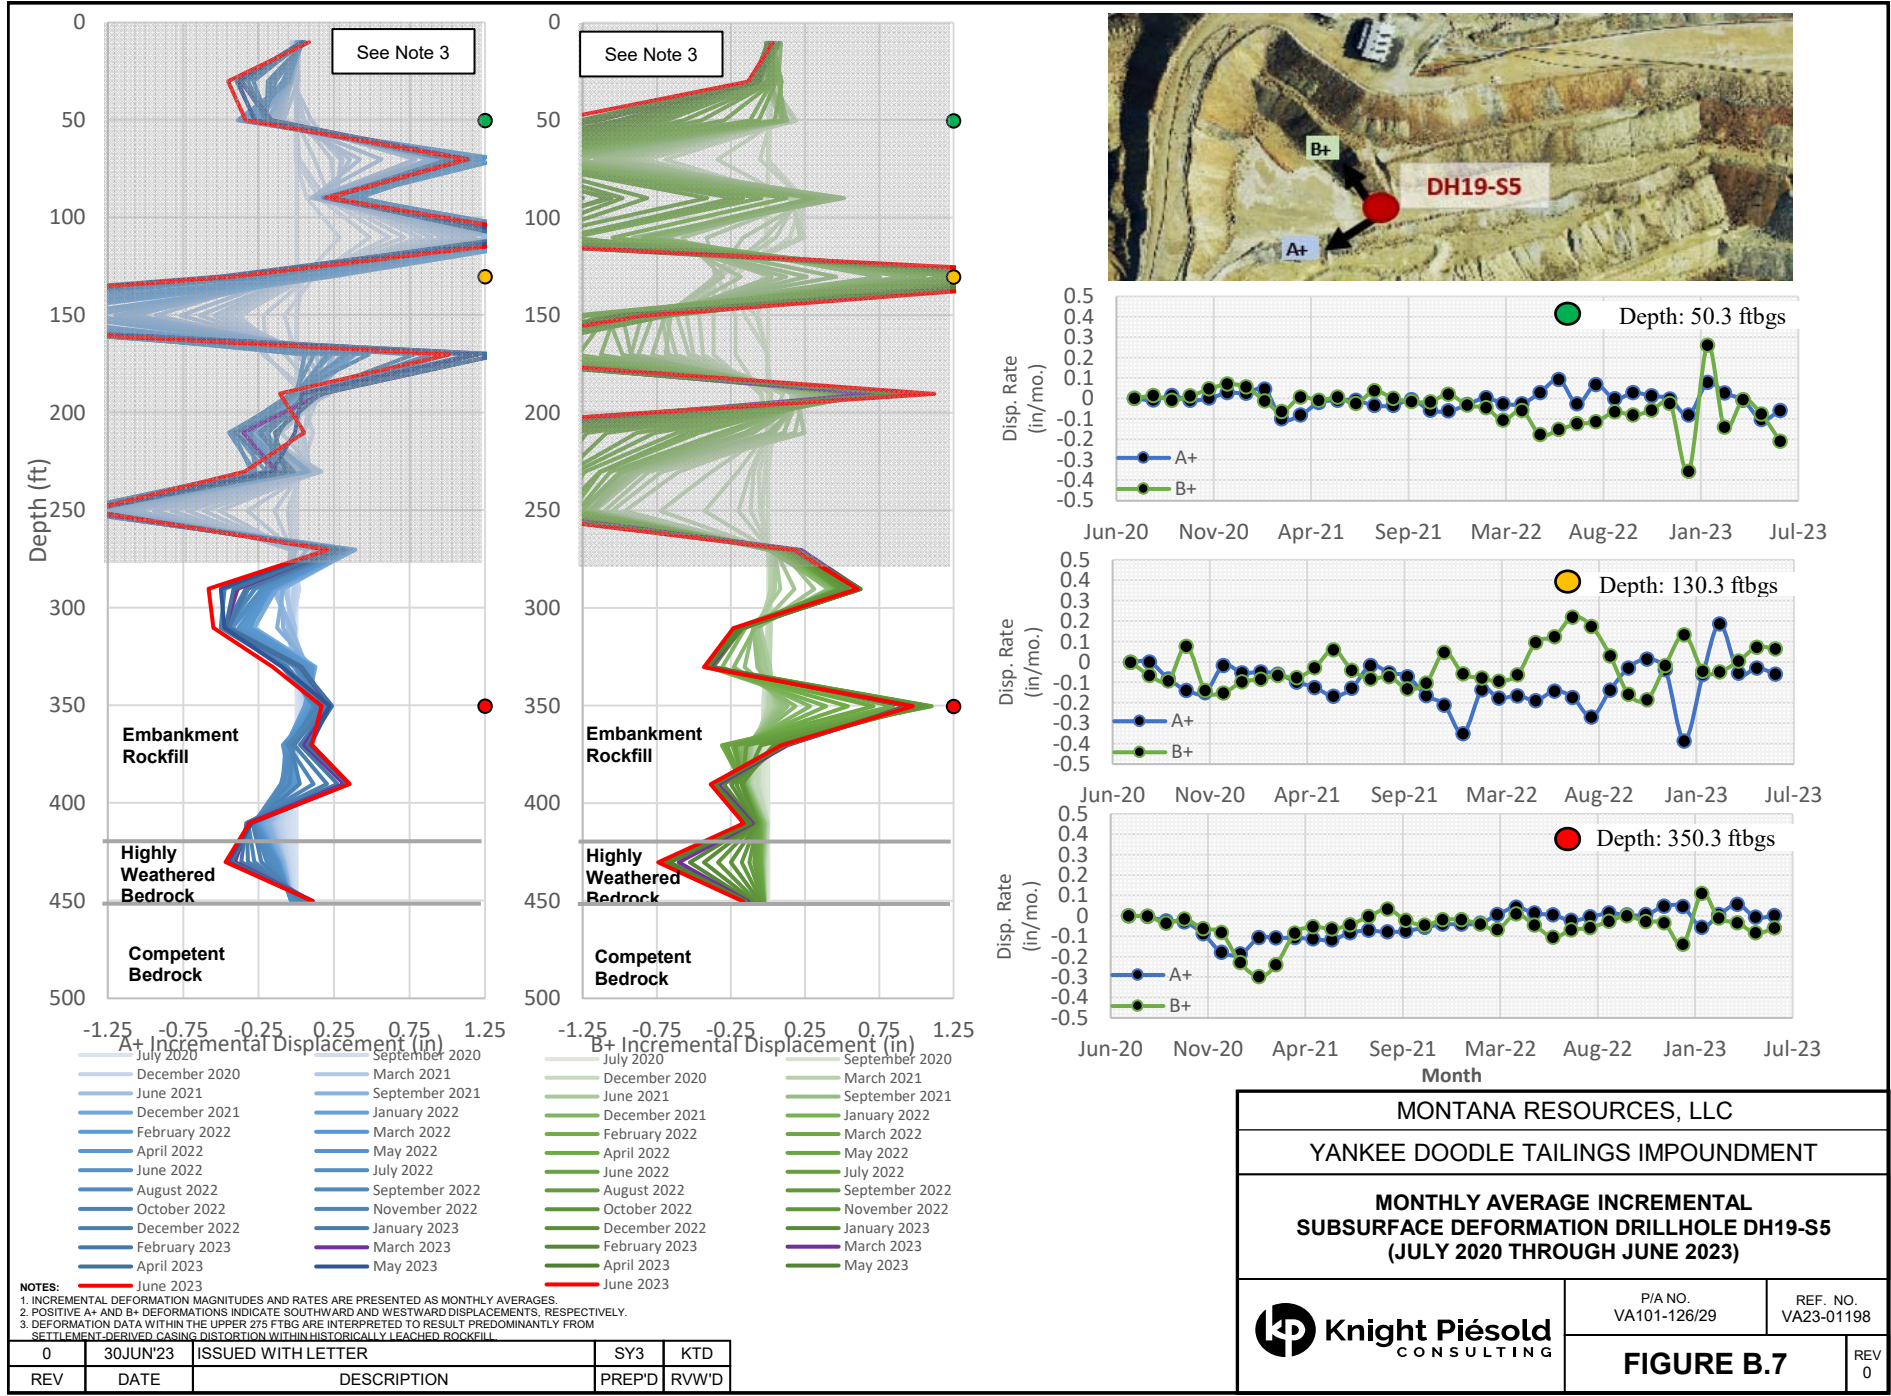
Knight Piesold CONSULTING	FIGURE B.7
P/A NO. VA101-126/29	REF. NO. VA23-01198
	REV 0

- INCREMENTAL DEFORMATION MAGNITUDES AND RATES ARE PRESENTED AS MONTHLY AVERAGES.
- POSITIVE A+ AND B+ DEFORMATIONS INDICATE SOUTHWARD AND WESTWARD DISPLACEMENTS, RESPECTIVELY.
- DEFORMATION DATA WITHIN THE UPPER 275 FTBGS ARE INTERPRETED TO RESULT PREDOMINANTLY FROM SETTLEMENT-DERIVED CASING DISTORTION WITHIN HISTORICALLY LEACHED ROCKFILL.

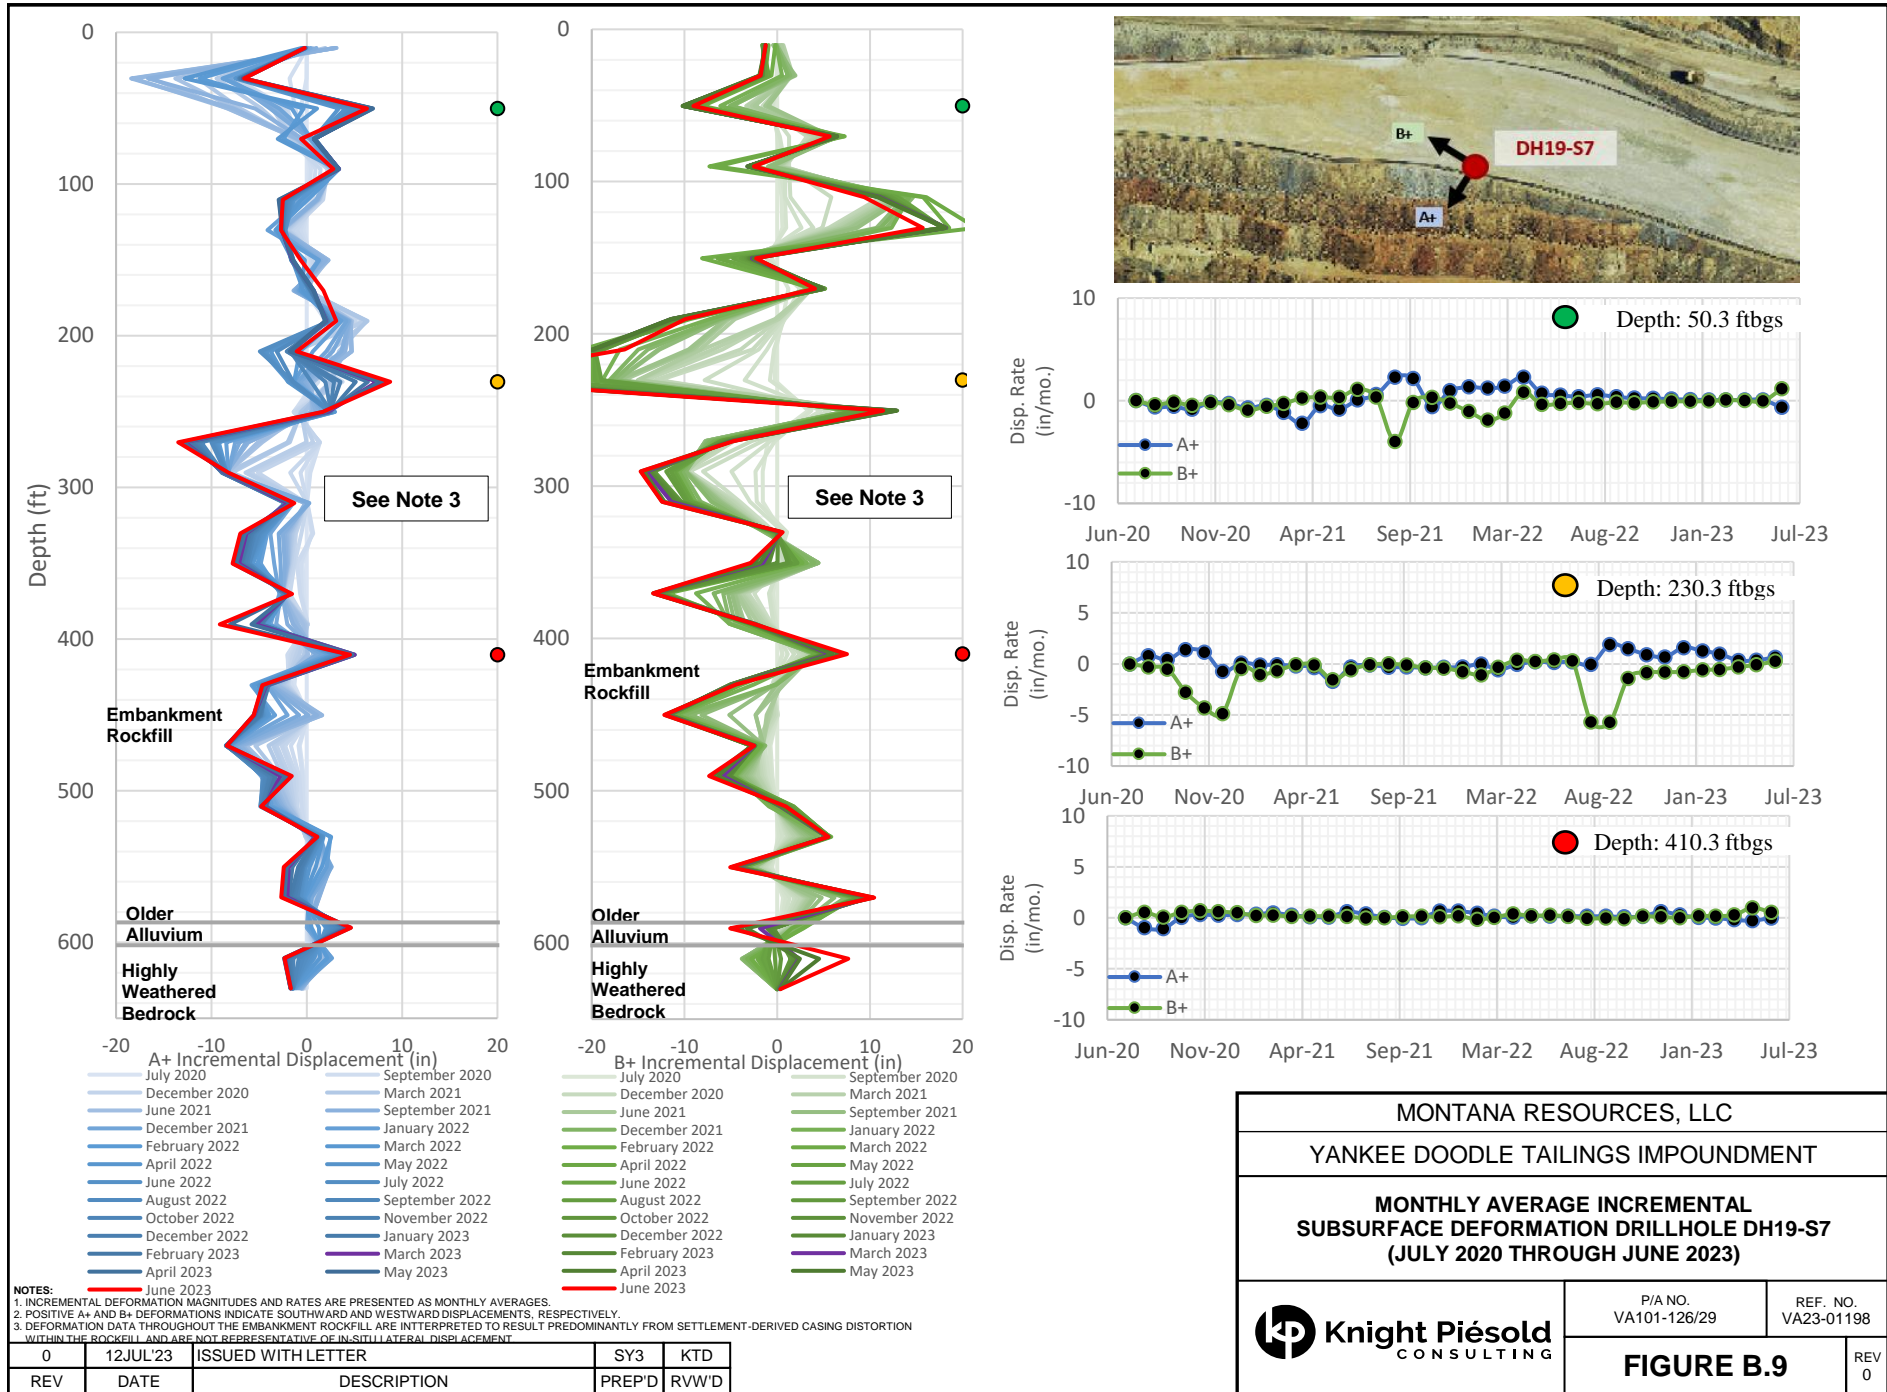
NOTES:
 1. INCREMENTAL DEFORMATION MAGNITUDES AND RATES ARE PRESENTED AS MONTHLY AVERAGES.
 2. POSITIVE A+ AND B+ DEFORMATIONS INDICATE SOUTHWARD AND WESTWARD DISPLACEMENTS, RESPECTIVELY.
 3. DEFORMATION DATA THROUGHOUT THE EMBANKMENT ROCKFILL ARE INTERPRETED TO RESULT PRIMARILY FROM SETTLEMENT-DERIVED CASING DISTORTION WITHIN THE ROCKFILL AND ARE NOT REPRESENTATIVE OF IN-SITU LATERAL DISPLACEMENT.

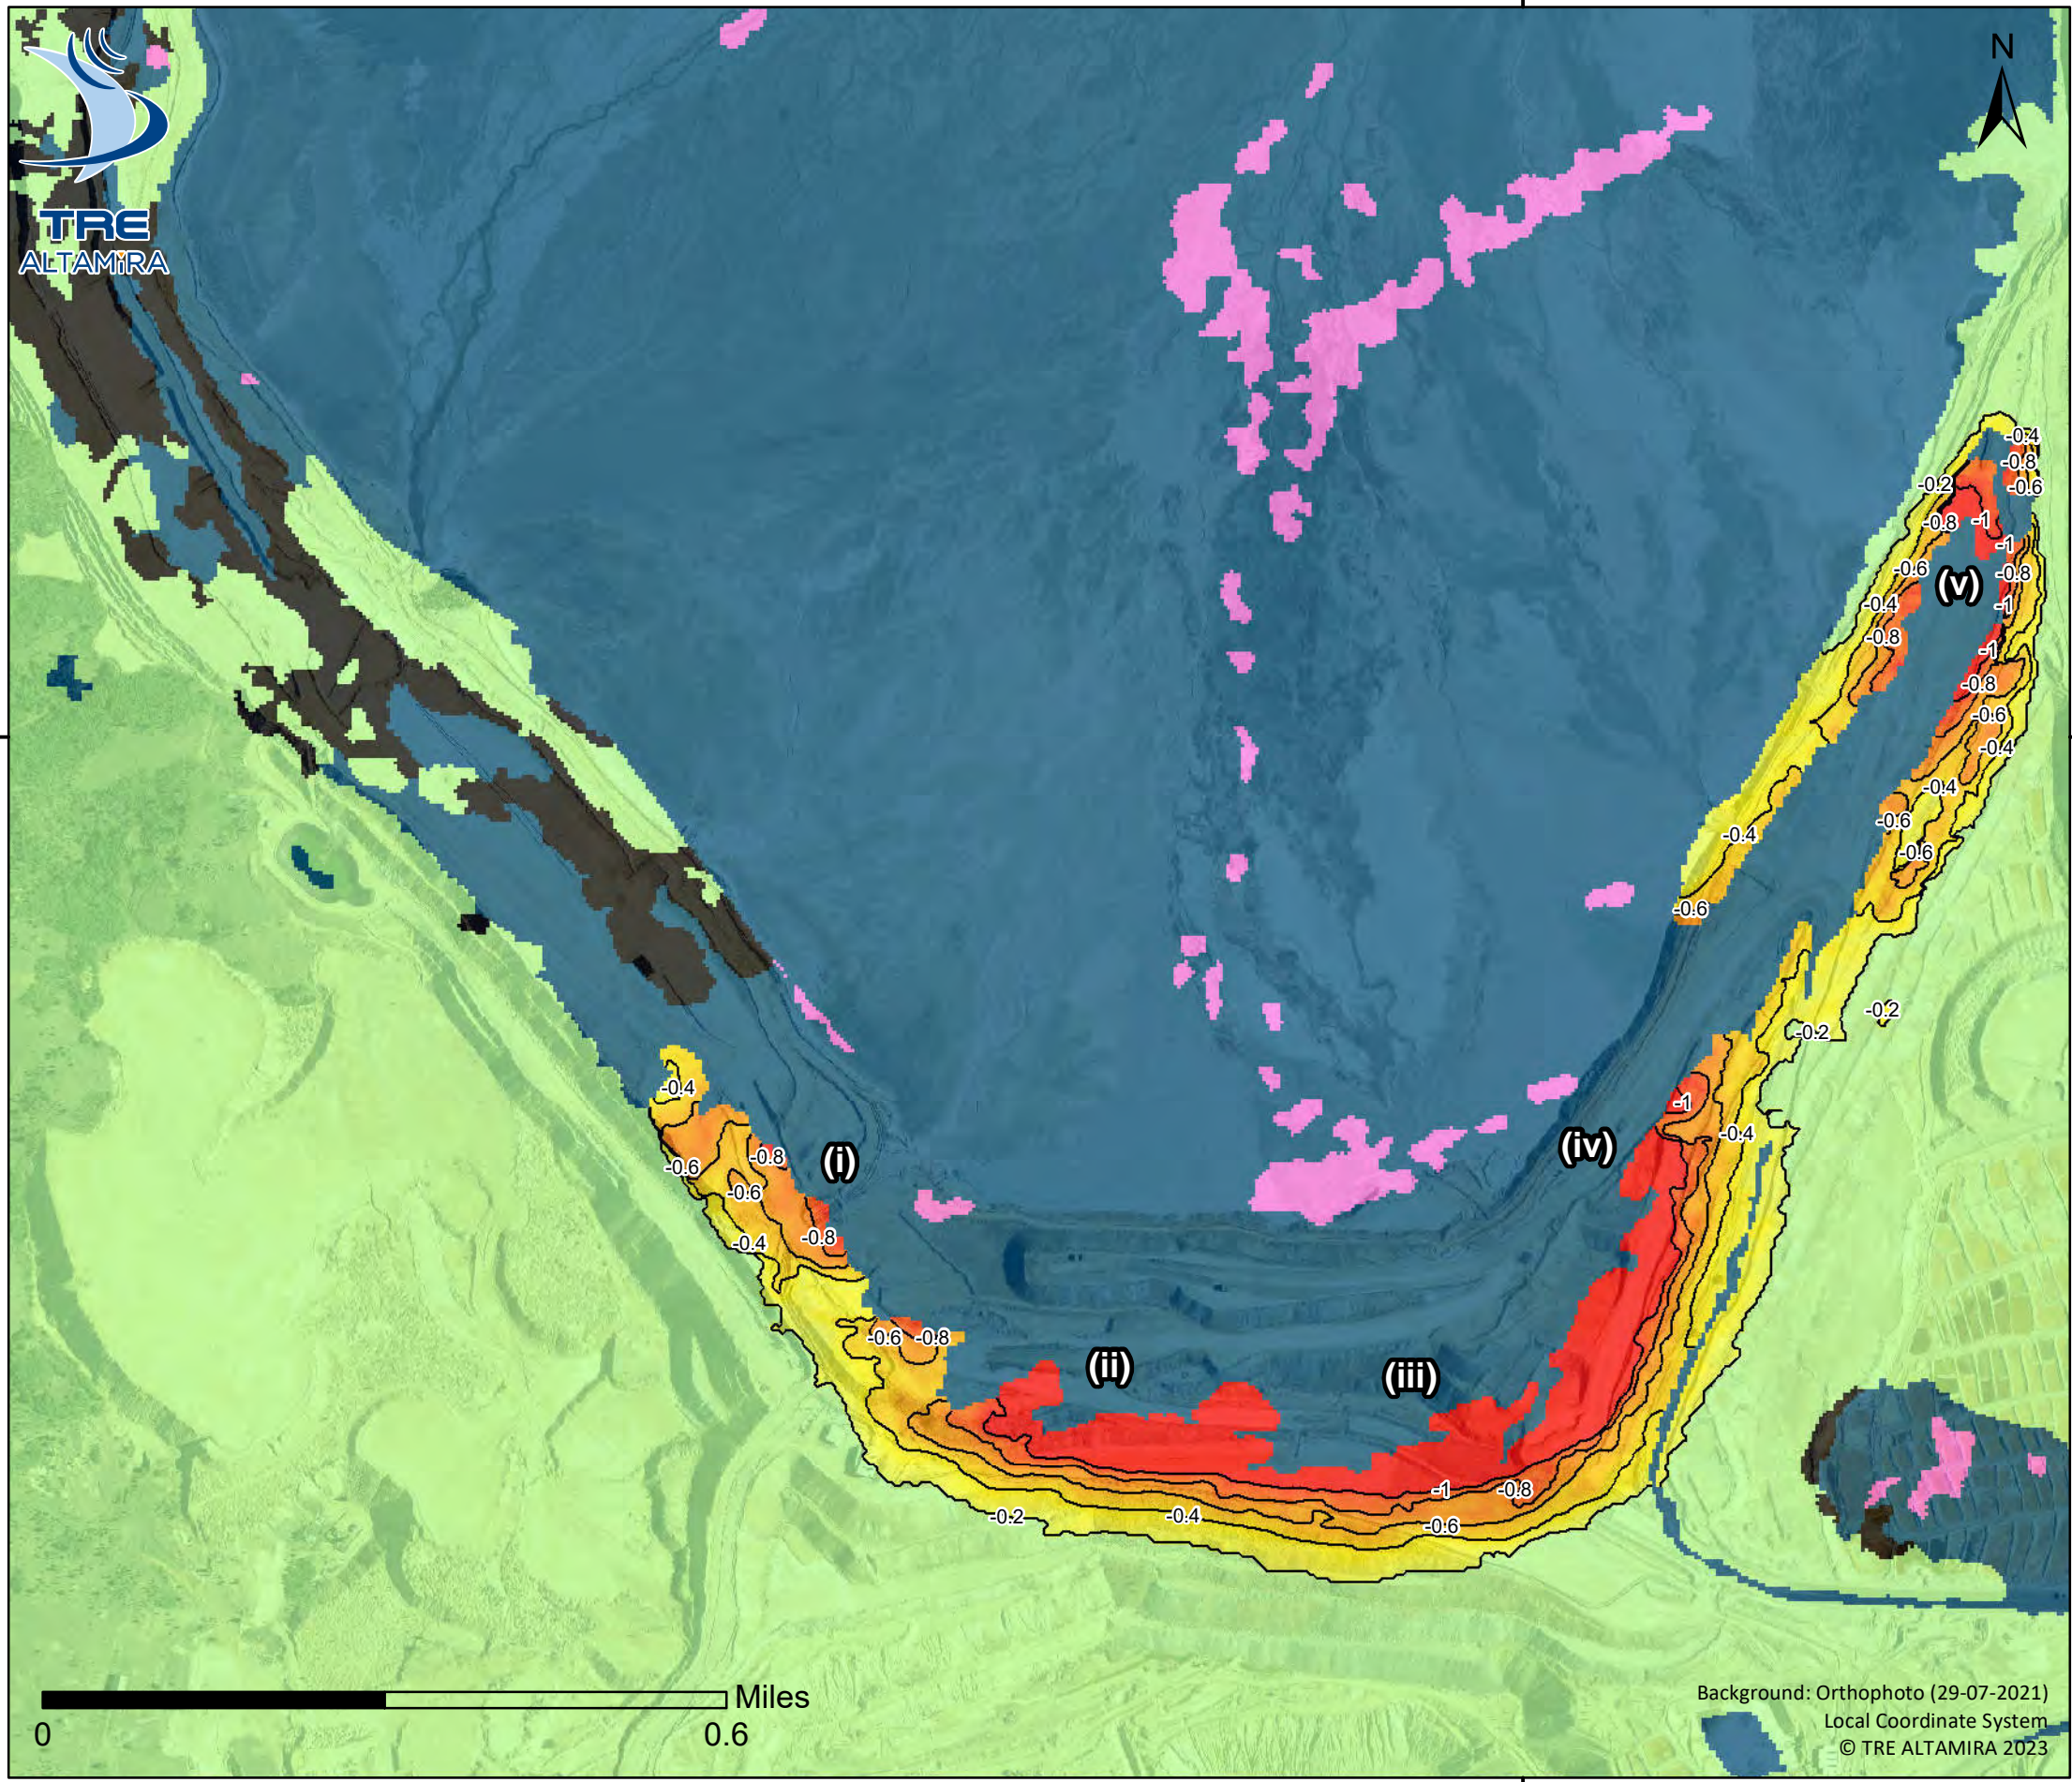
12 May 2023 - 03 Jun 2023

Further possible motion observed on the West Embankment

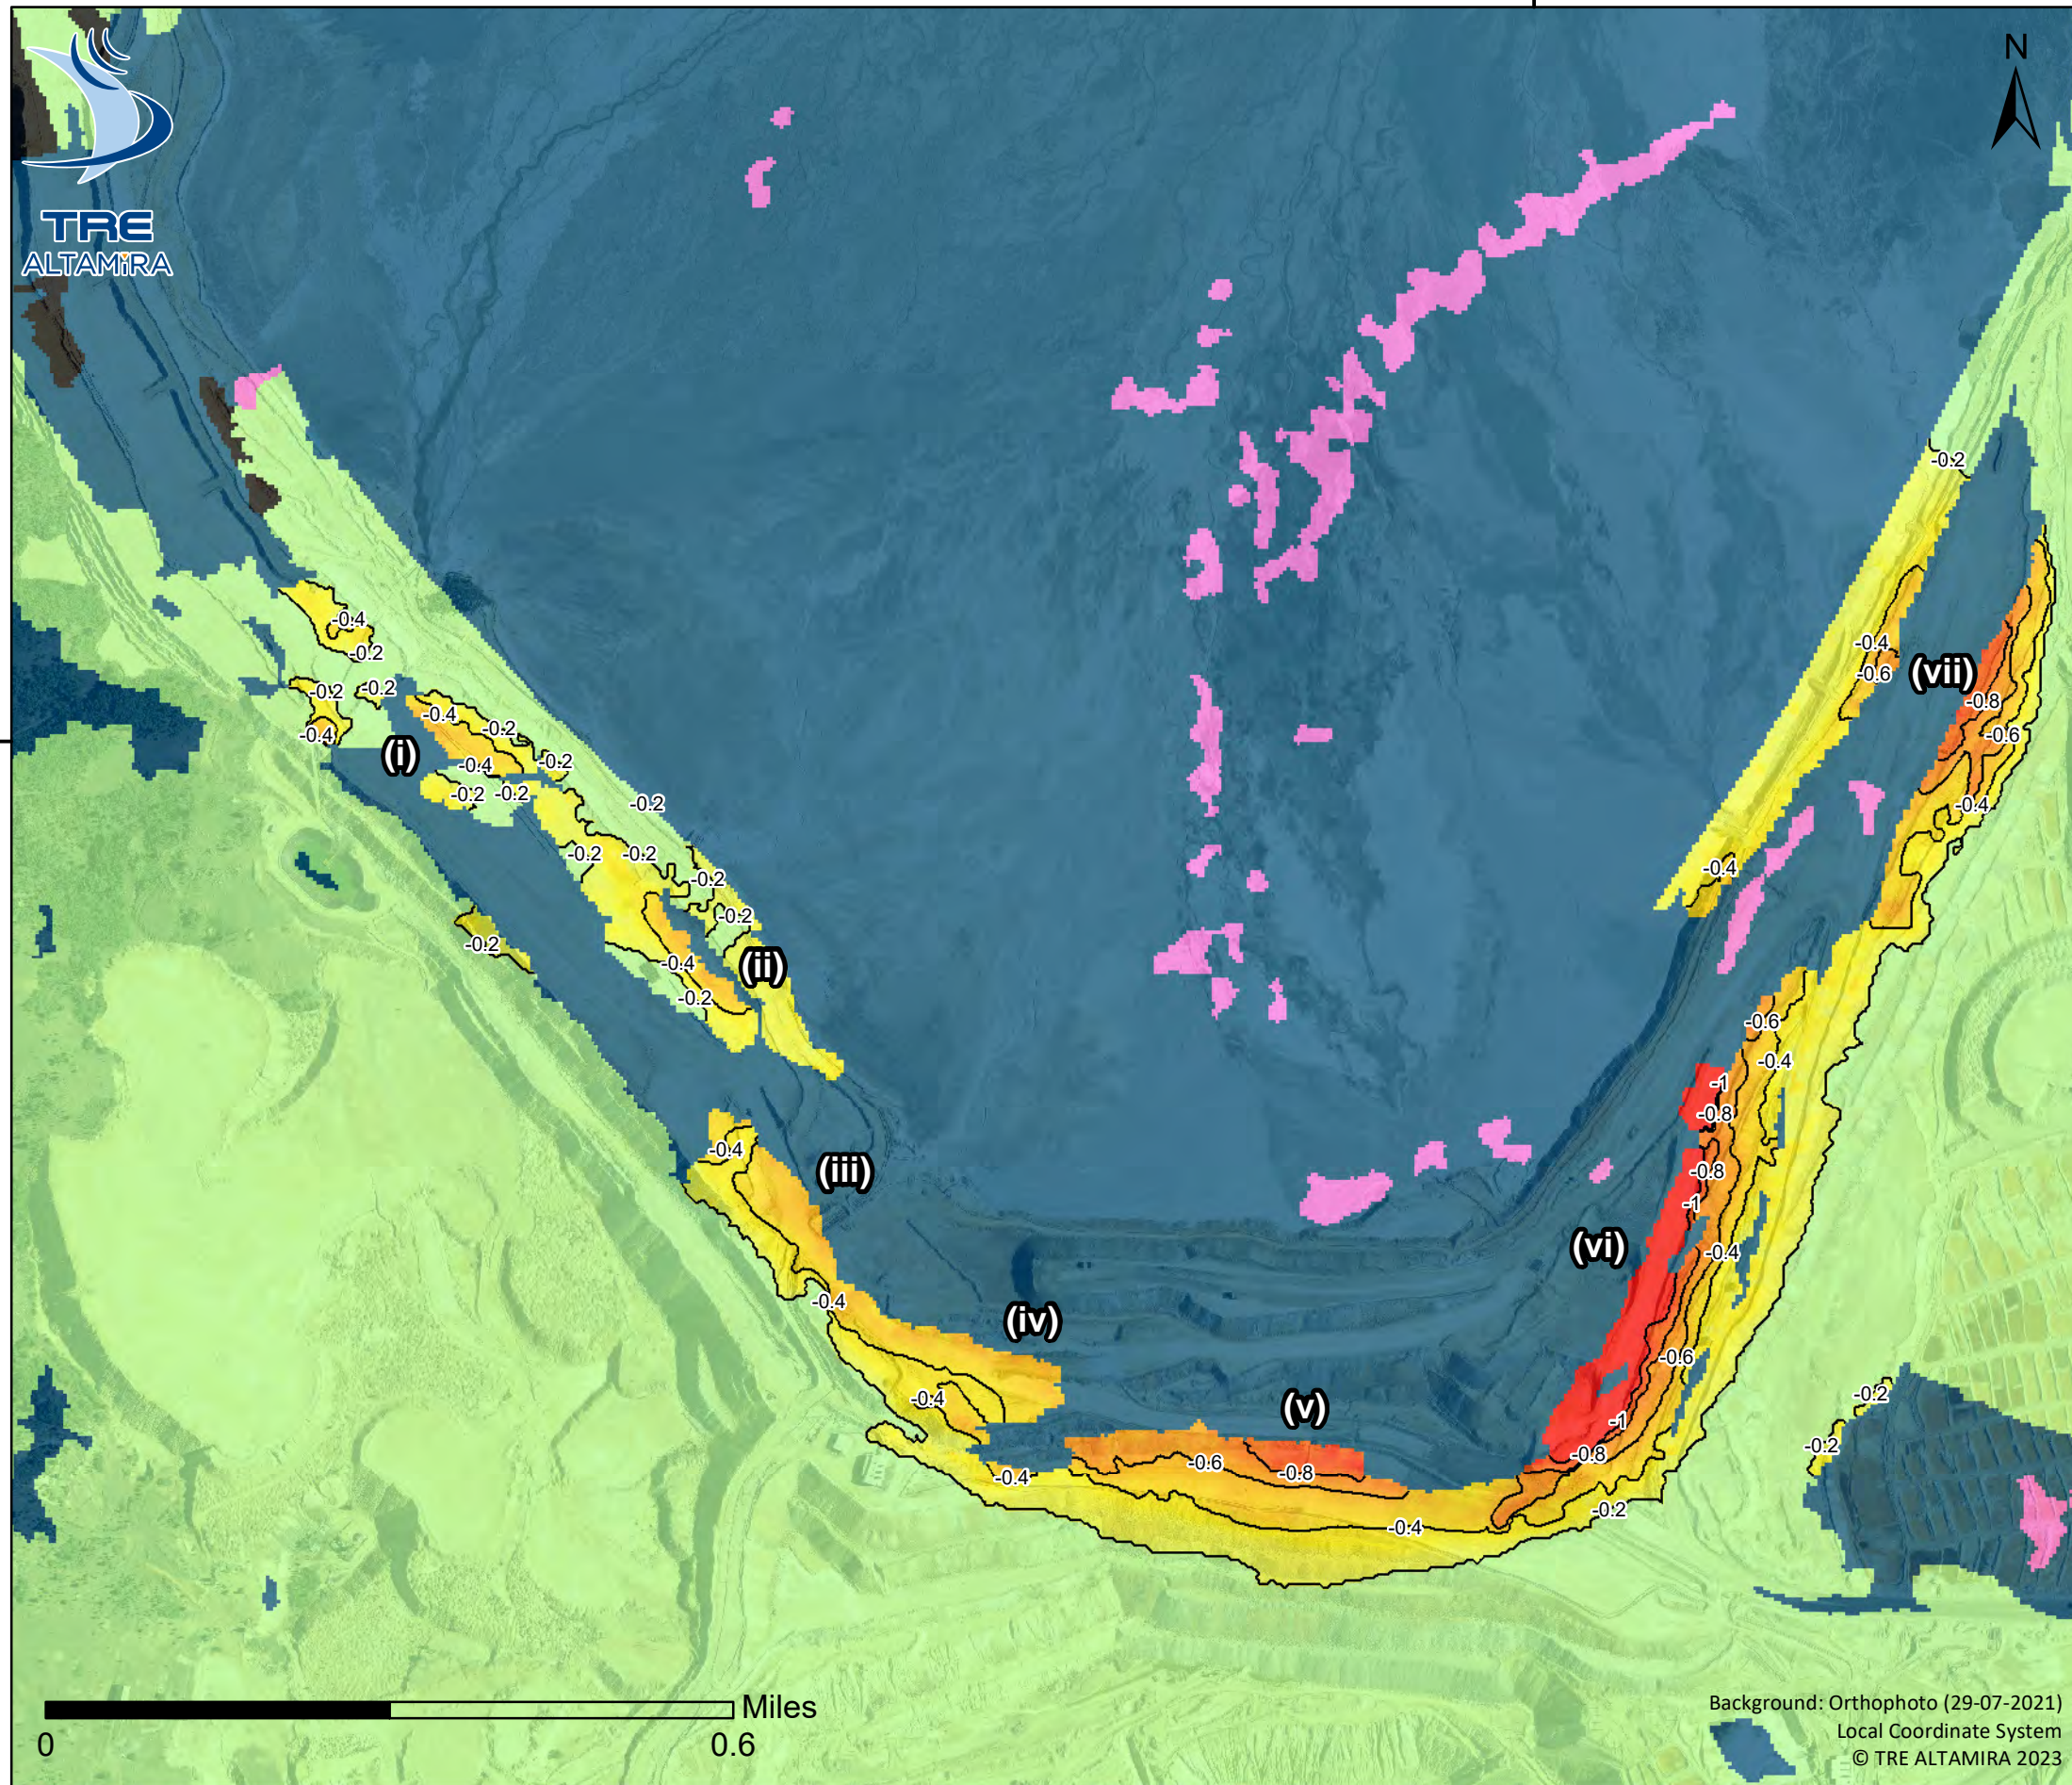
23 May 2023 - 14 Jun 2023

Further possible motion observed on the West Embankment

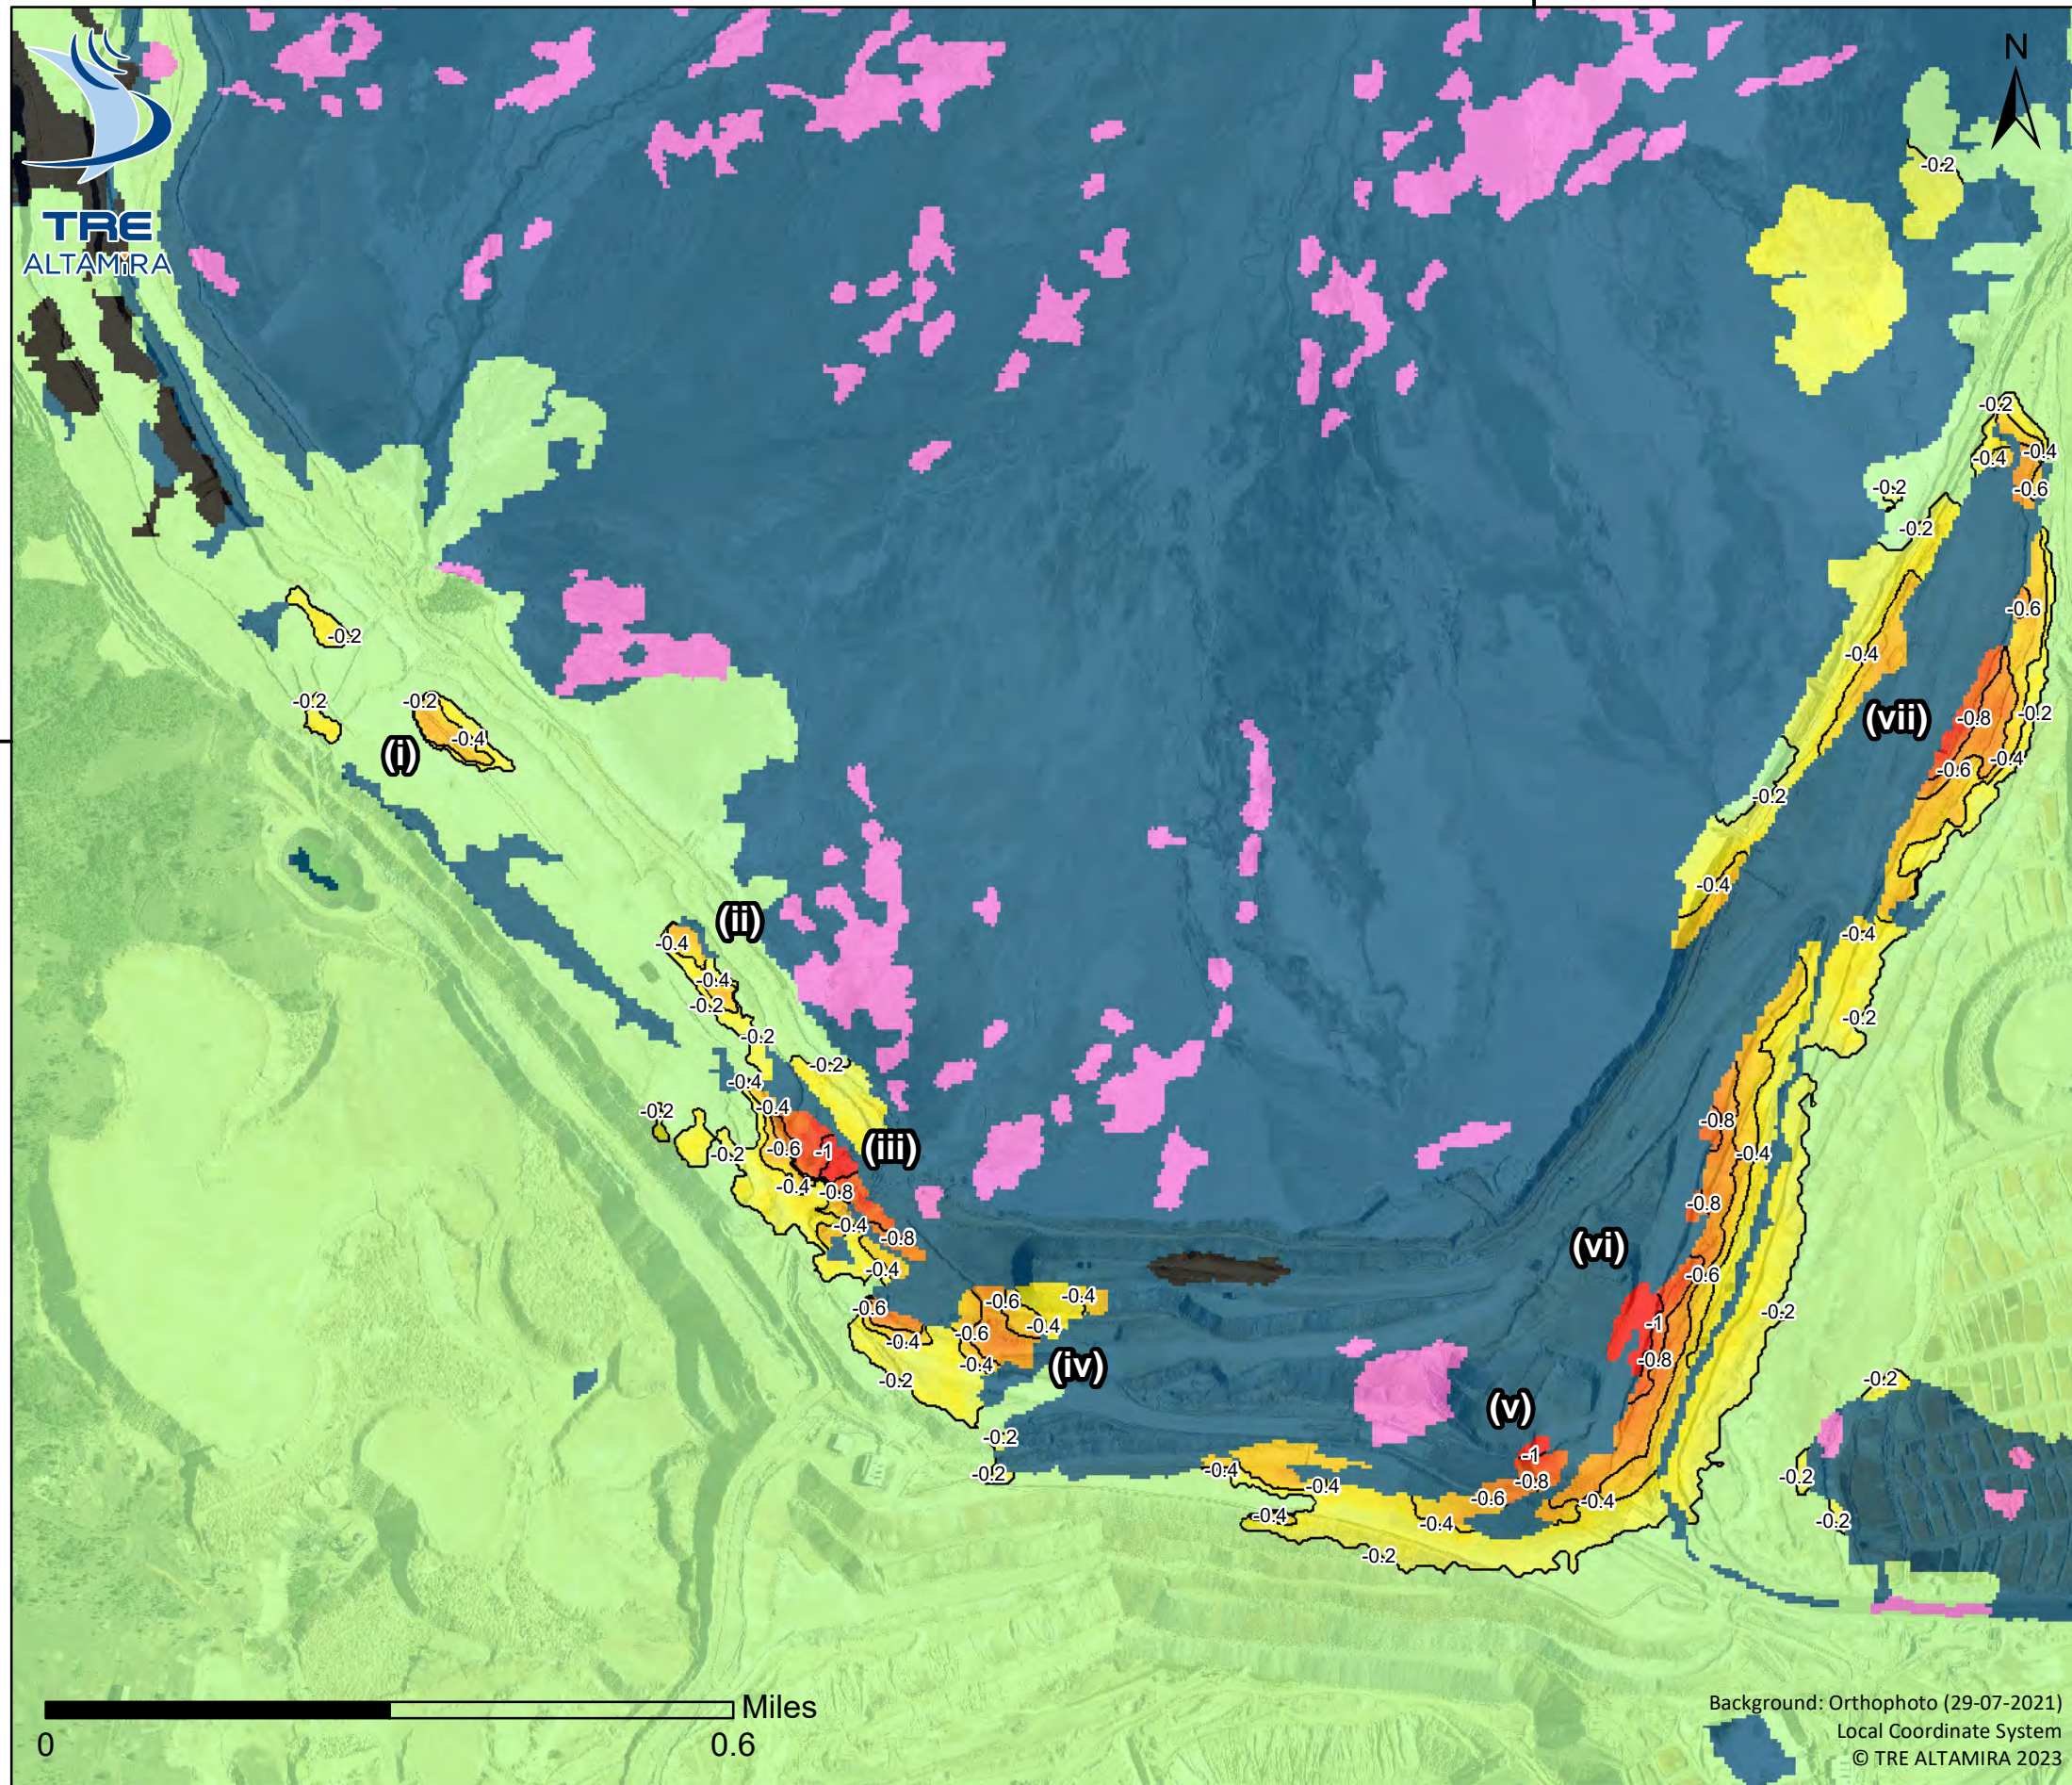
03 Jun 2023 - 25 Jun 2023

Further possible motion observed on the West Embankment and East-West Embankment
