Mr. Mike Harvie
Manager of Engineering and Geology
Montana Resources, LLC
600 Shields Avenue
Butte, Montana
USA, 59701

Knight Piésold Ltd.

RE: Q2 2023 – YDTI Quarterly Piezometric and Deformation Monitoring Update

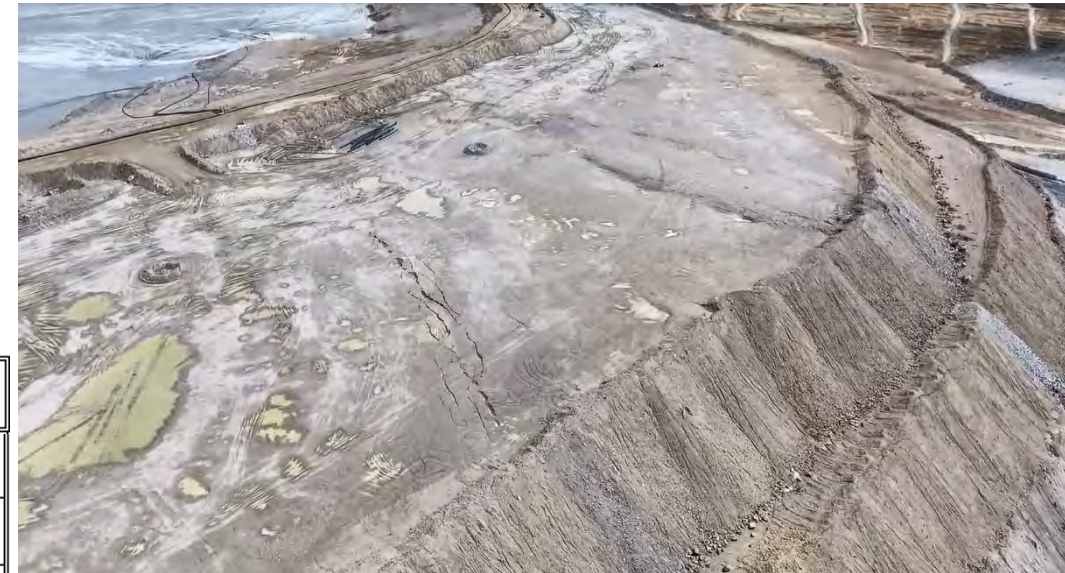
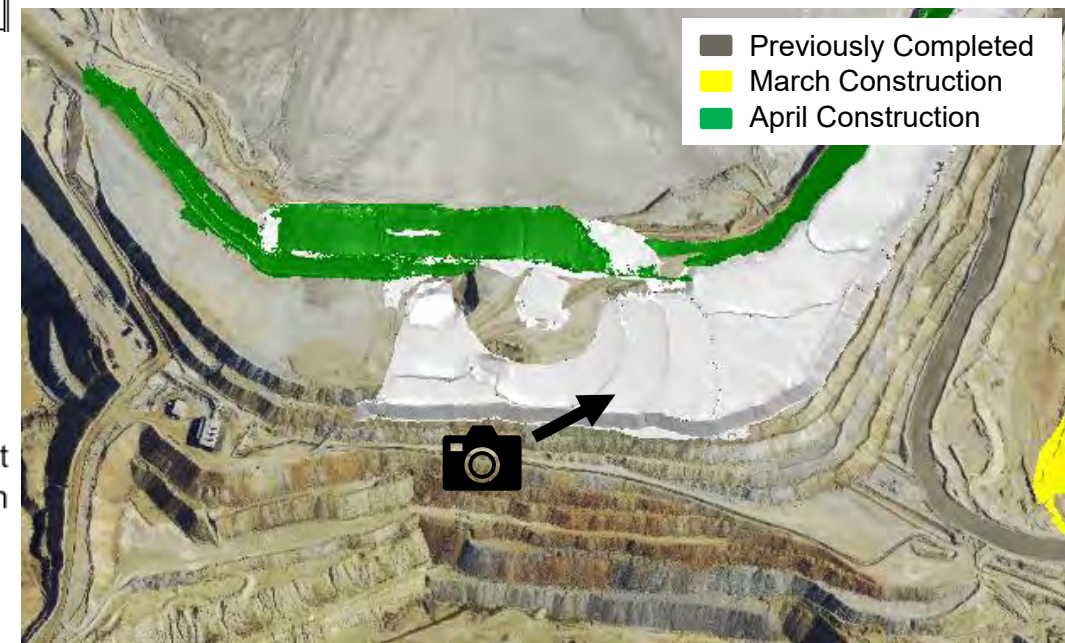
- Montana Resources notified KP on April 27, 2023 that new transverse cracking and depressions had been observed by a dozer operator along the EL 6,450 ft crest near Section 0+00. MR Observations:
 - The depressions/cracks run transverse to the downstream face around the Section 0+00 area but do not extend to the upstream face
 - The cracks appear to be in a low spot where significant amt. ponded water had infiltrated into the cracks
 - MR looked at the downstream face directly below the settlement and cracks and there was no evidence of water seepage along the face.
 - MR also drove along the pipe ramp to see any evidence of erosion or seepage was discernable, none was found.

**Observed Cracking and Depressions
(photo provided by MR)**

- Observed cracking constitutes a Level 1 Unusual Occurrence per the TOMS manual:

- The EOR and KP requested the following follow-up inspection and monitoring activities to be completed by Montana Resources:
 - Provide crack survey data and photogrammetry/imagery from crest drone survey completed April 28, 2023

- Initiate inspection and monitoring of cracking, including:
 - Daily inspection of known (photographs, inspection reports)
 - Paint and flag known cracks to monitor for length progression

- Install pin extensometers and initiate monitoring for aperture and/or offset progression
 - Provide minimum 3x per week DGPS data from existing survey-monuments within the Central Pedestal Area (CPA) to monitor deformations/scree for signs of instability in proximity and downstream of the main cracking area.

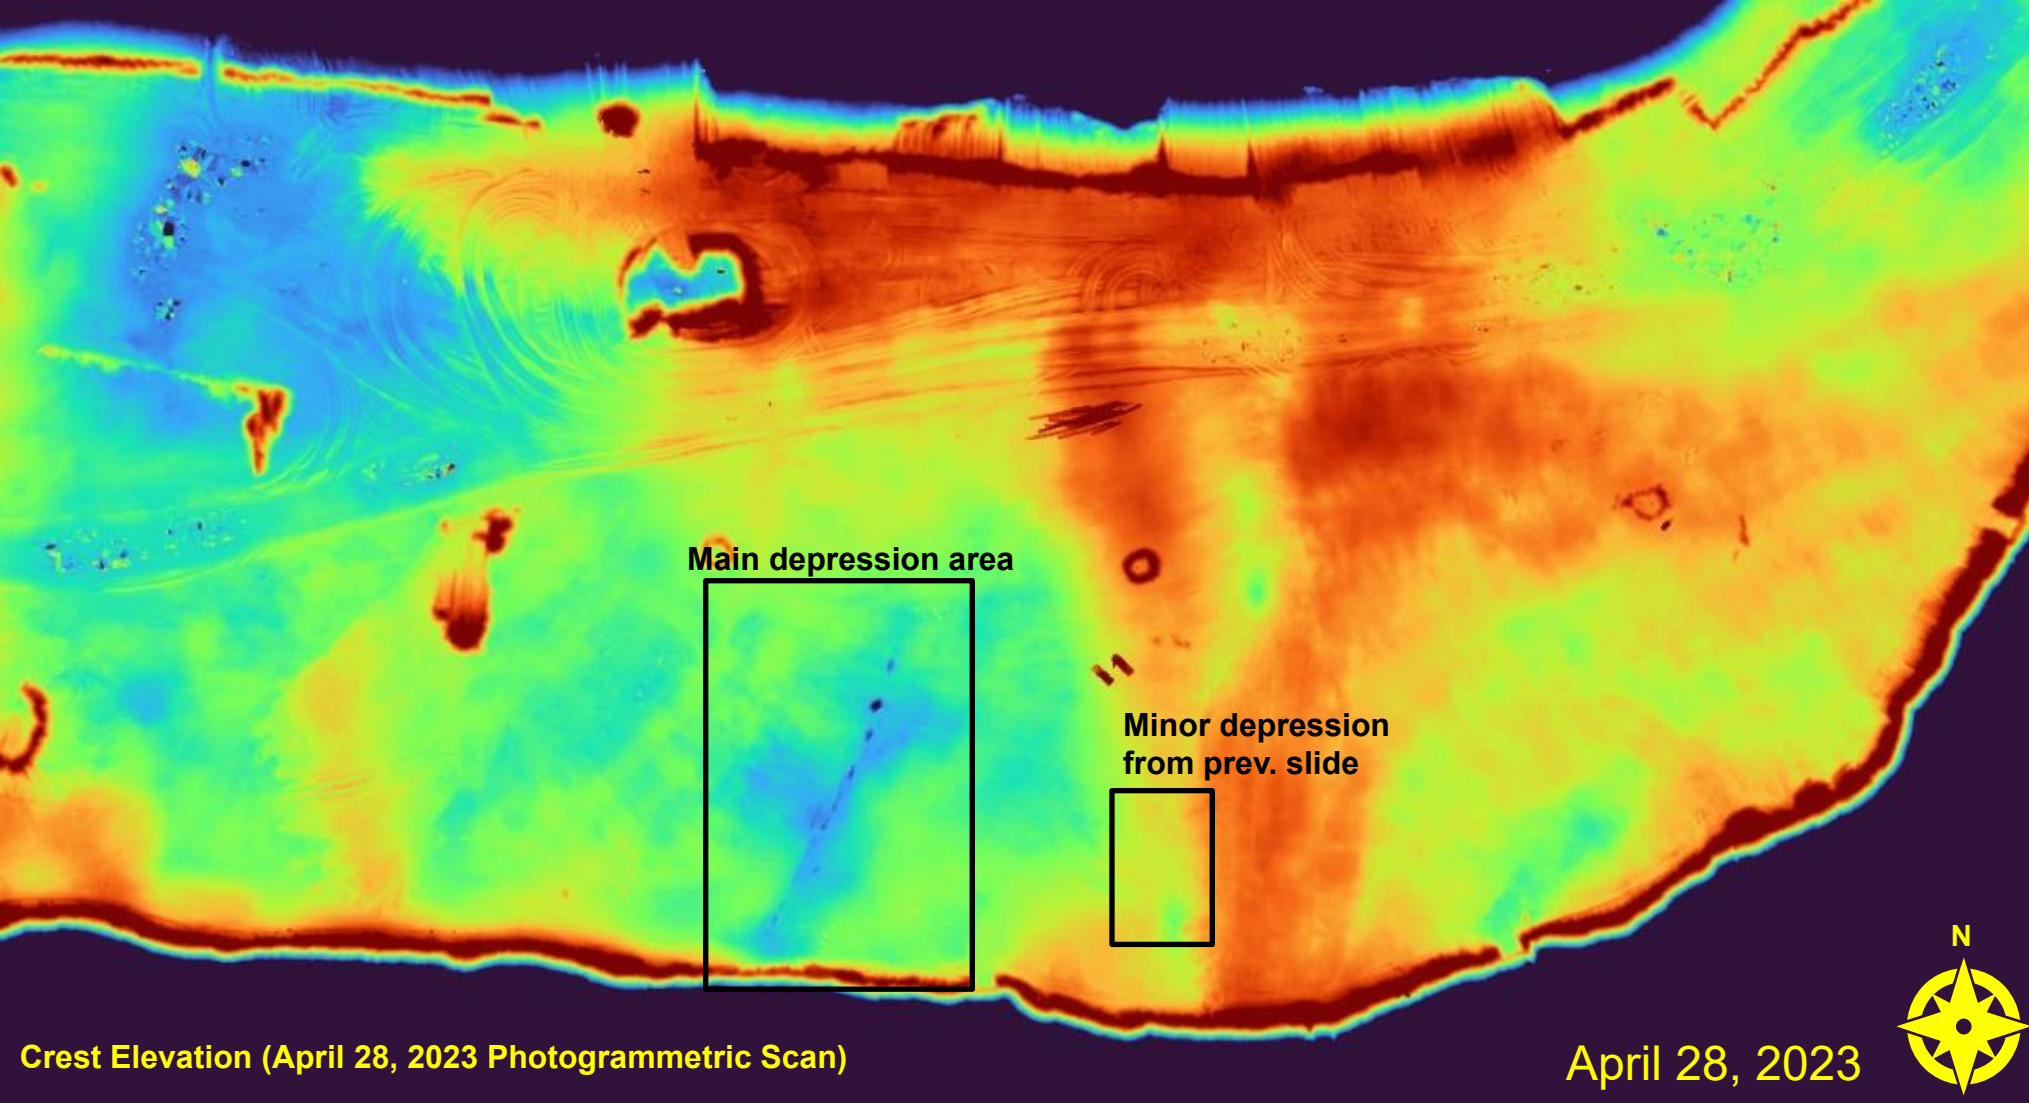
Crest Elevation (April 28, 2023 Photogrammetric Scan)

- Surface expressions of drainage towards cracks to south visible in some areas

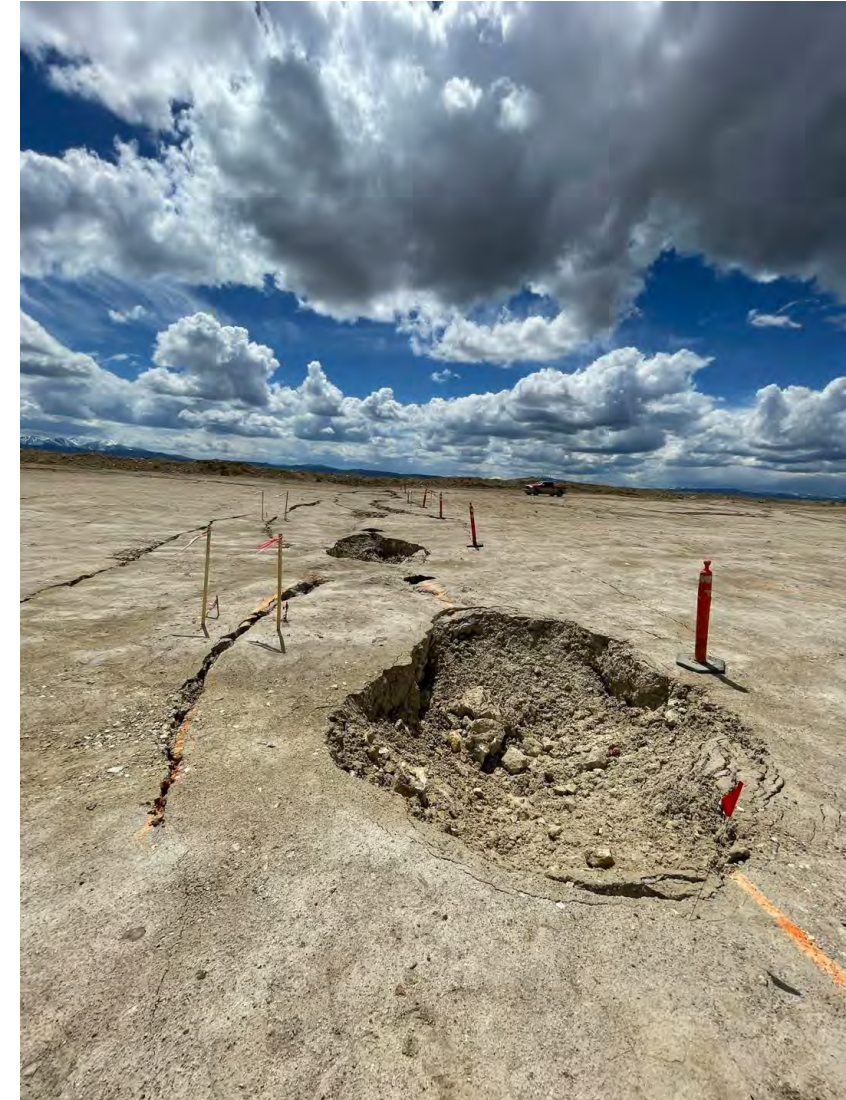
Cracking – Updated Crack Map

- Inspections have identified some additional cracking that was not surveyed initially.
- These appear to be minor cracks or those outside of the main area
- Do not appear to indicate progression

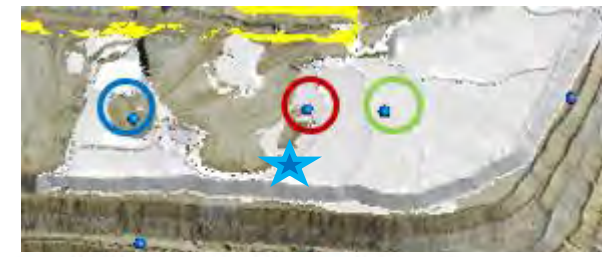
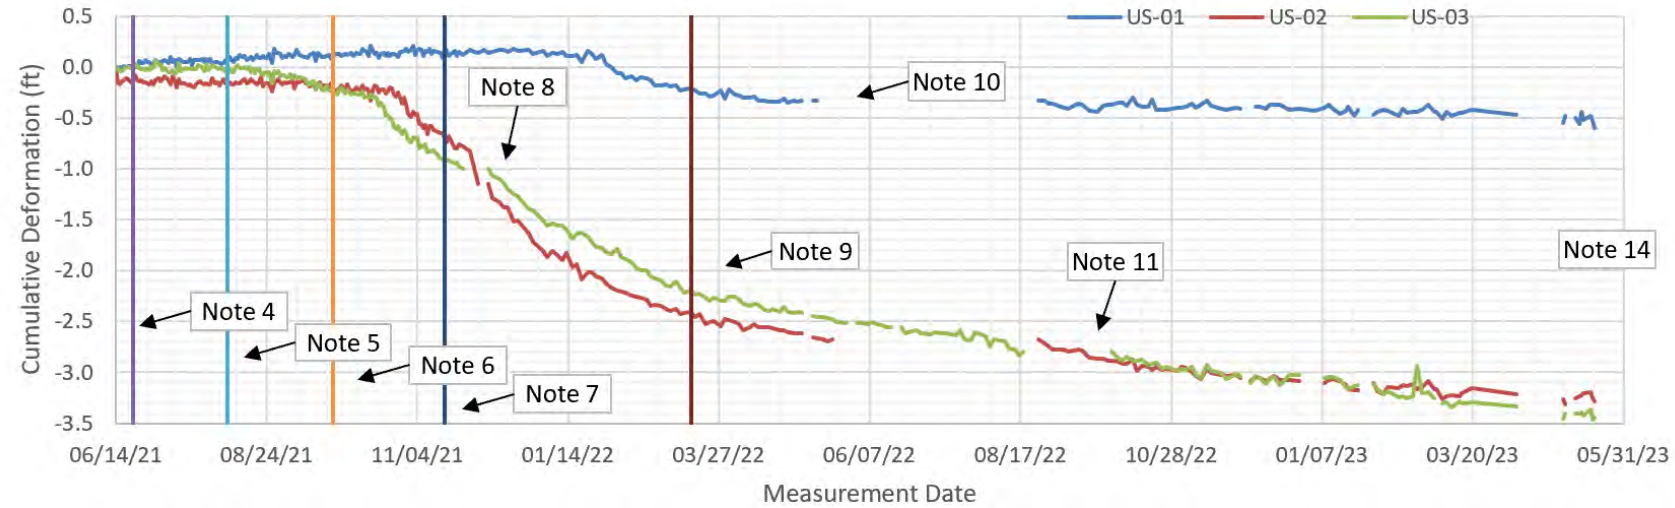
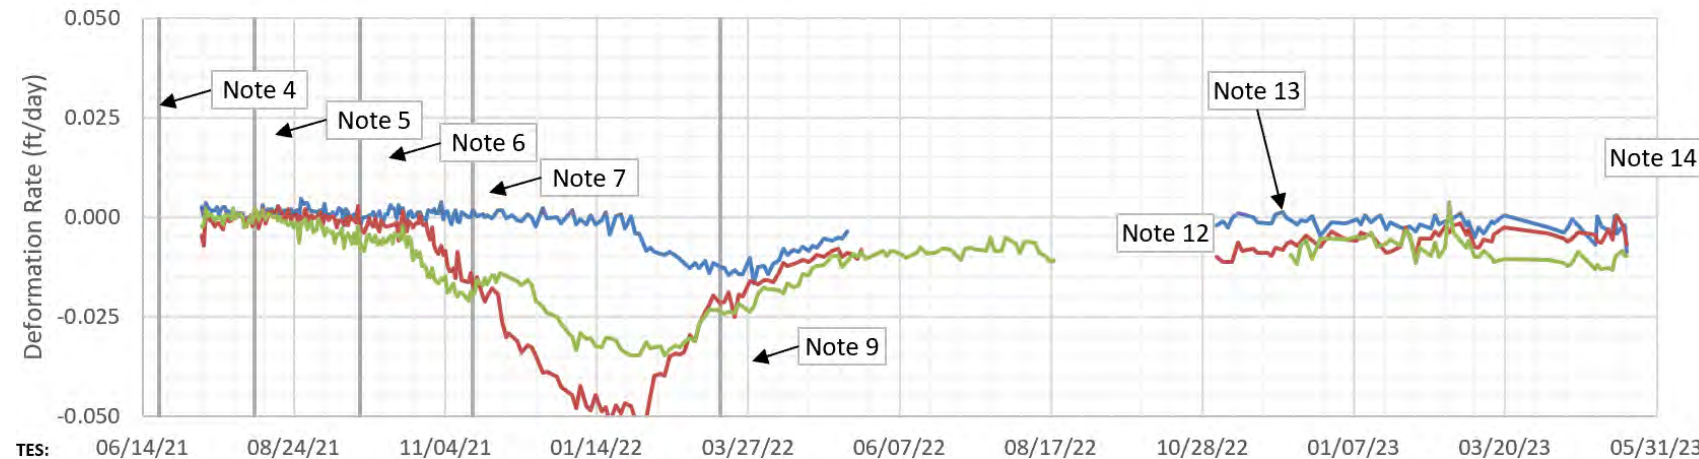
Surface Displacement – DGPS (Crest)

- Crest DGPS monument displacements have remained stable or slowed slightly.

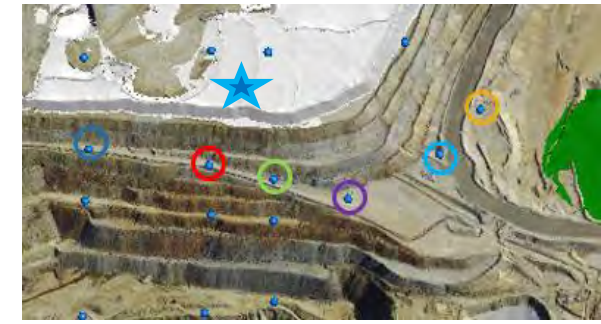
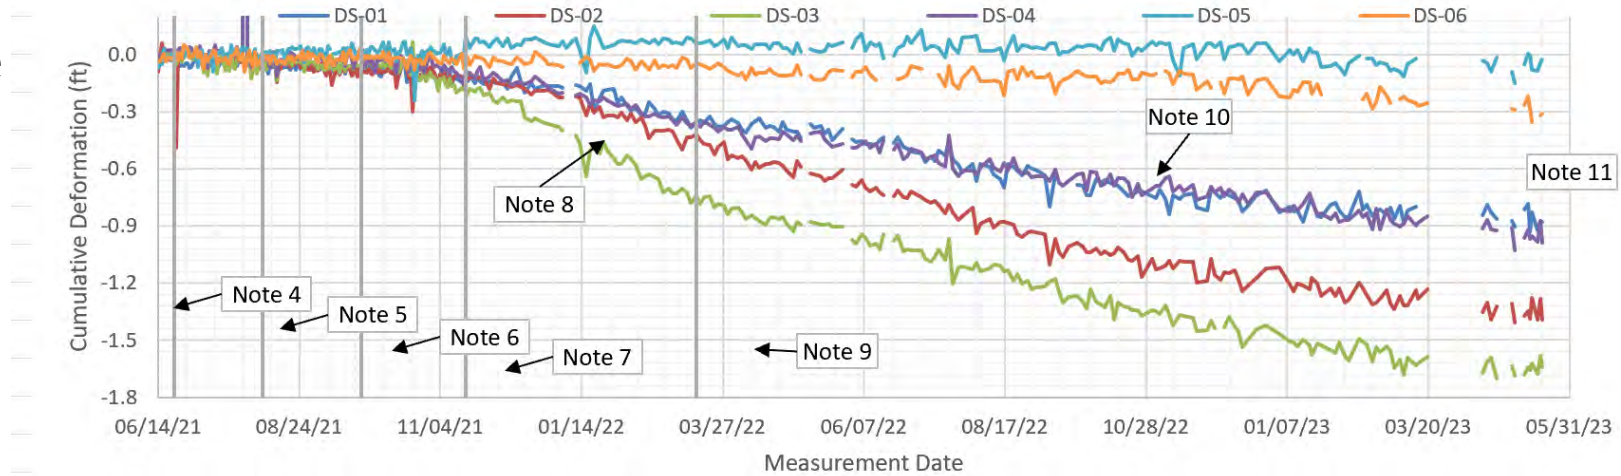
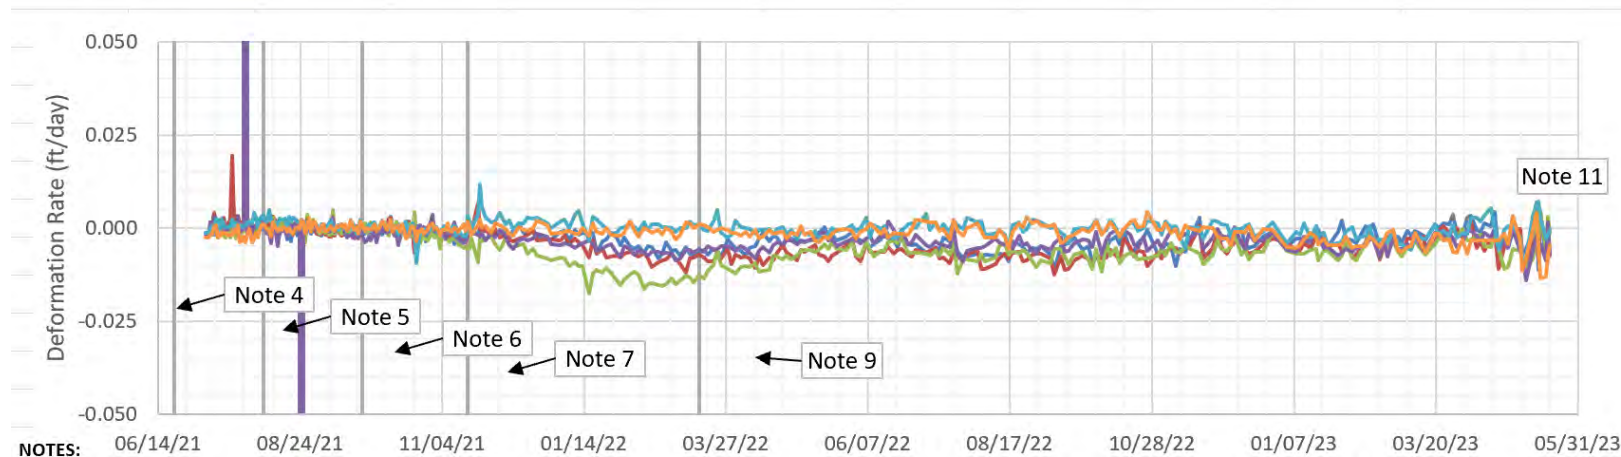
Fig. 13 – DGPS N-S Displacement Data; Pipeline Ramp (May 17, 2023)

Surface Displacement – DGPS (Pipeline Ramp)

- Tailings Pipeline Ramp DGPS monument deformations have continued to slow

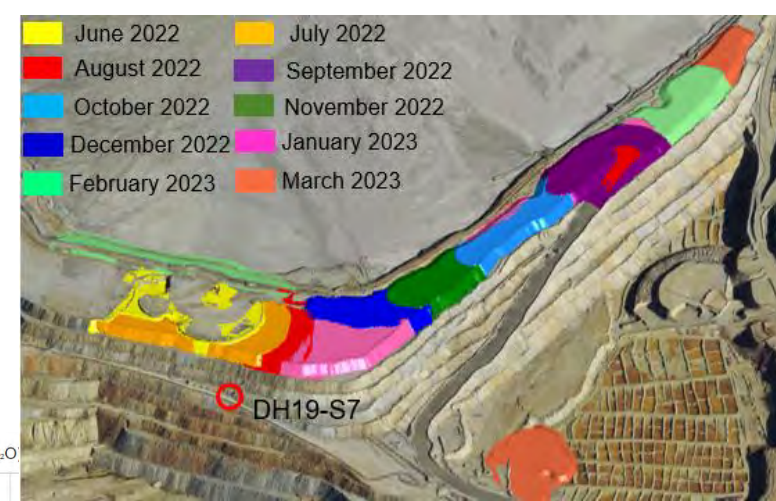
Fig. 15 – DH19-S7 Pore Water Pressure (June 10, 2023)

Pore Water Pressure – DH19-S7

- Pore water pressures within DH19-S7 VW7 increased during March 2023; has continued to increase slightly during May 2023
 - Sensor installed within the historical 1982 lift-top interval
 - Previously observed a pore water pressure increase during EL. 6,450 ft lift, followed by dissipation
 - Recent increase (approx. 25 ft) occurred after large-scale completion of EL. 6,450 ft lift.
 - Primarily inferred to be associated with alluvial facing along the upstream central rockfill surcharge
 - Precipitation and snowmelt may also contribute

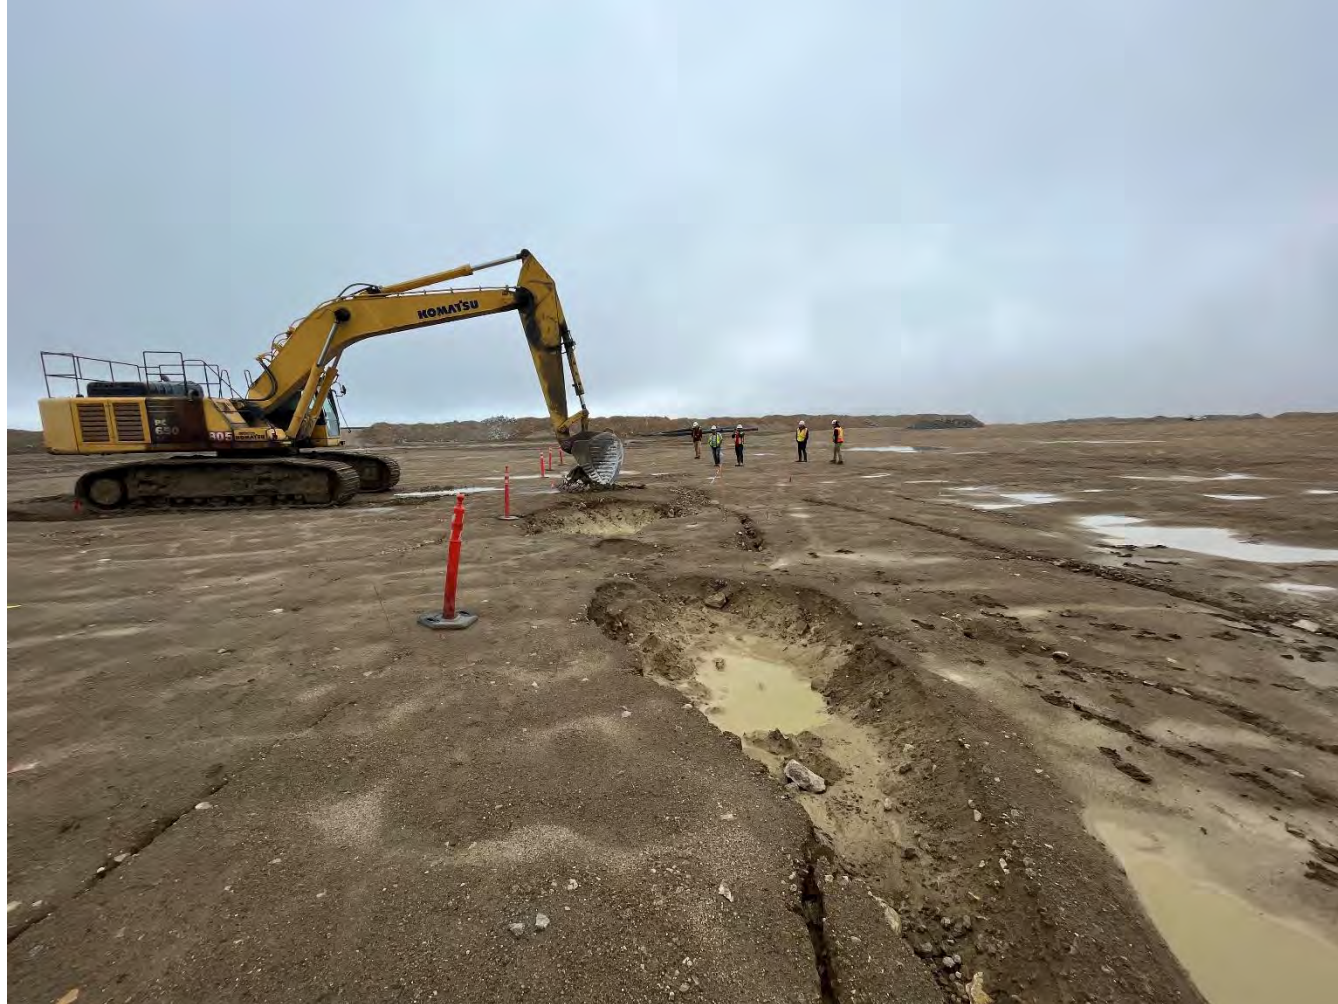
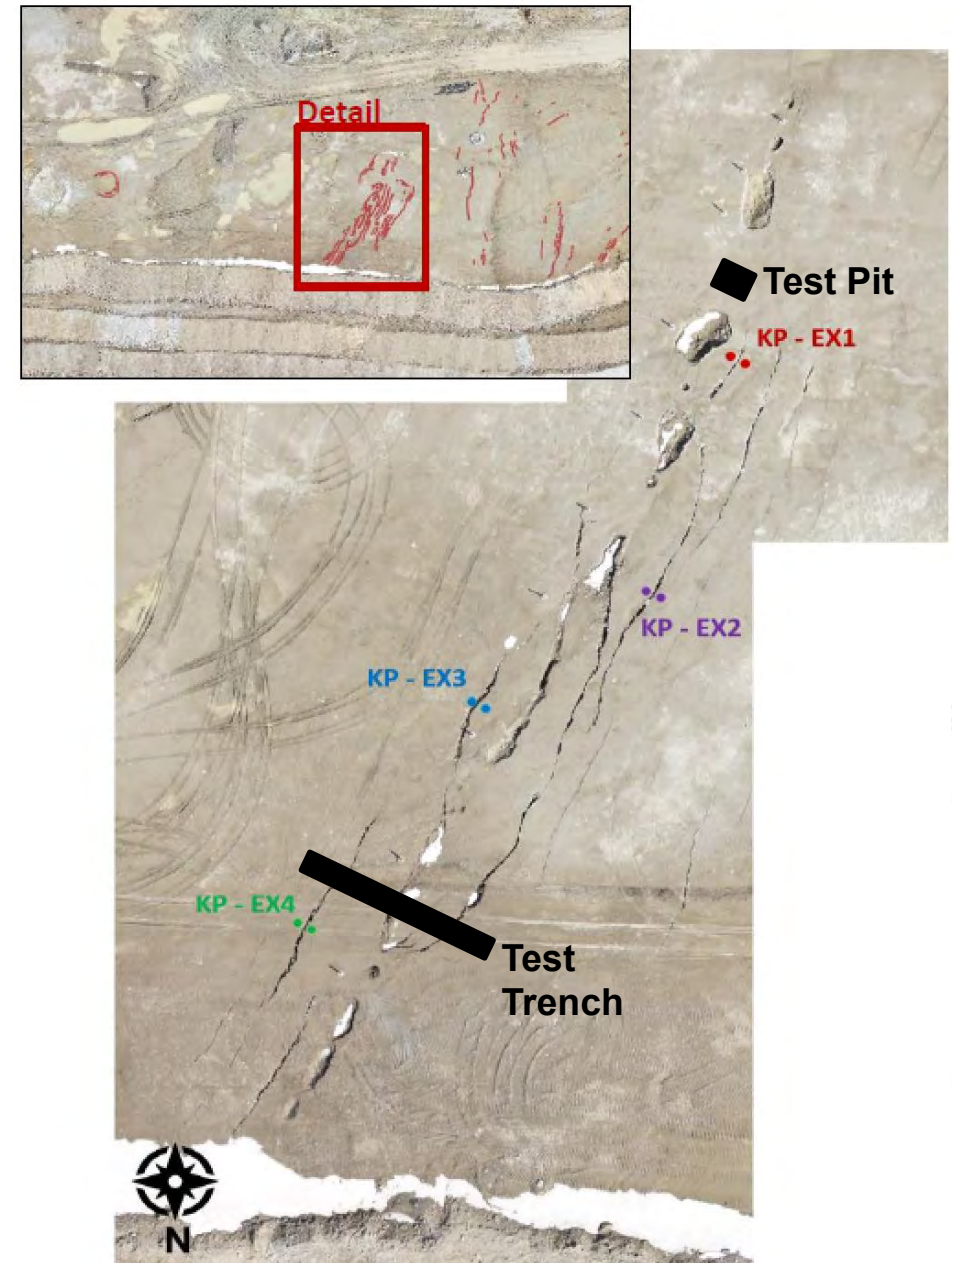
Test Pitting & Trenching

- Test pit and test trench were completed
 - Rockfill typical of 50 ft lift top material; minor cracks visible in trench (1-3 ft depth)
 - Remediation & continued monitoring (to be initiated imminently)

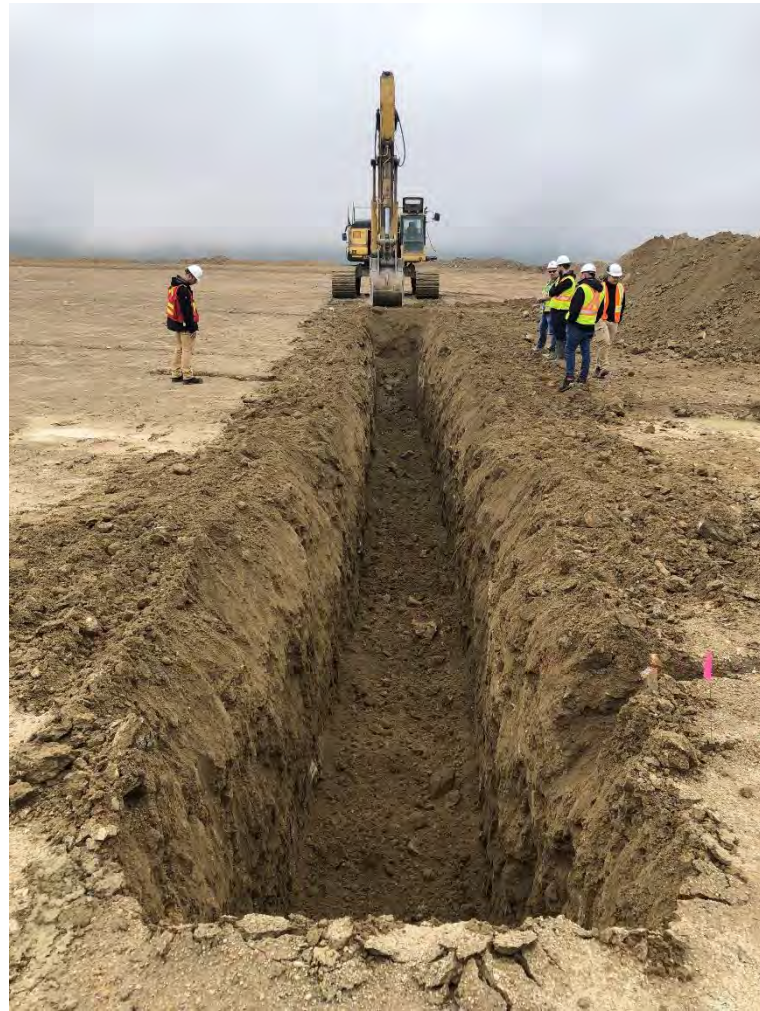
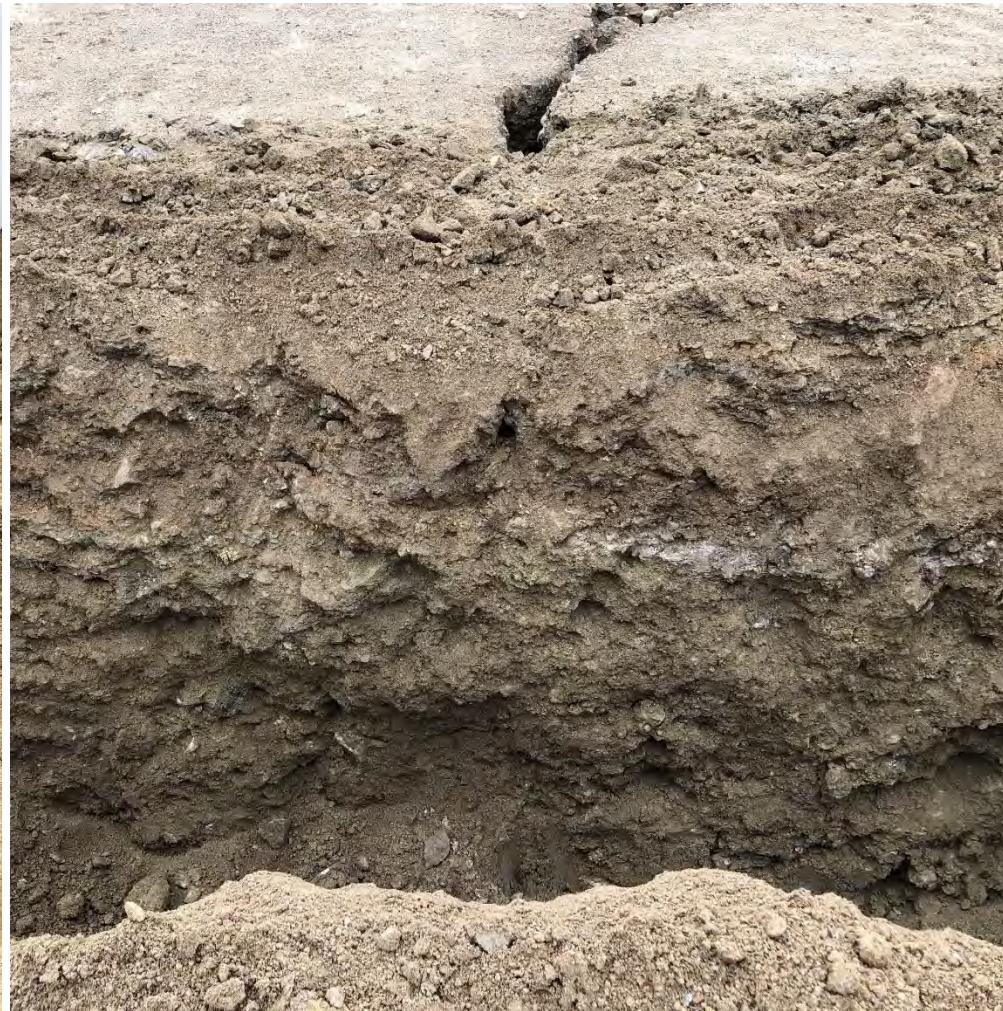
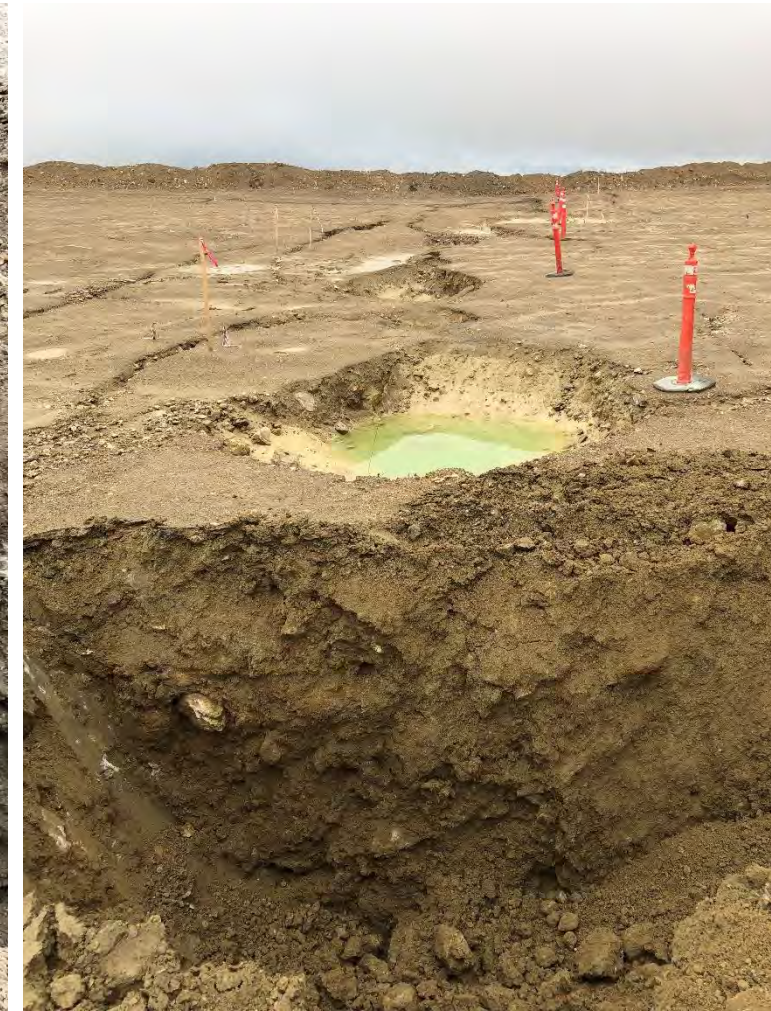
Test Pitting & Trenching

- KP are evaluating remedial measures, which will generally comprise:
 - Ripping/shallow excavation of existing cracked surface
 - Leveling/infilling low areas on embankment crest to reduce potential ponding
