**November 8, 2023**

**RE: Q3 2023 – YDTI Quarterly Piezometric and Deformation Monitoring Update**

Montana Resources, LLC (MR) operates an open pit copper and molybdenum mine in Butte, Montana. Tailings produced from ore processing are stored within the Yankee Doodle Tailings Impoundment (YDTI), which is a valley-fill style impoundment contained within rockfill embankments. Knight Piésold Ltd. (KP) supports MR to routinely monitor hydrogeological and geotechnical conditions as part of their operational surveillance plan for the tailings facility, as described in the Tailings Operations, Maintenance and Surveillance (TOMS) Manual (MR/KP, 2022). Monitoring data are comprehensively reviewed on a quarterly basis to evaluate the performance of the YDTI in conjunction with observations made during periodic inspections.

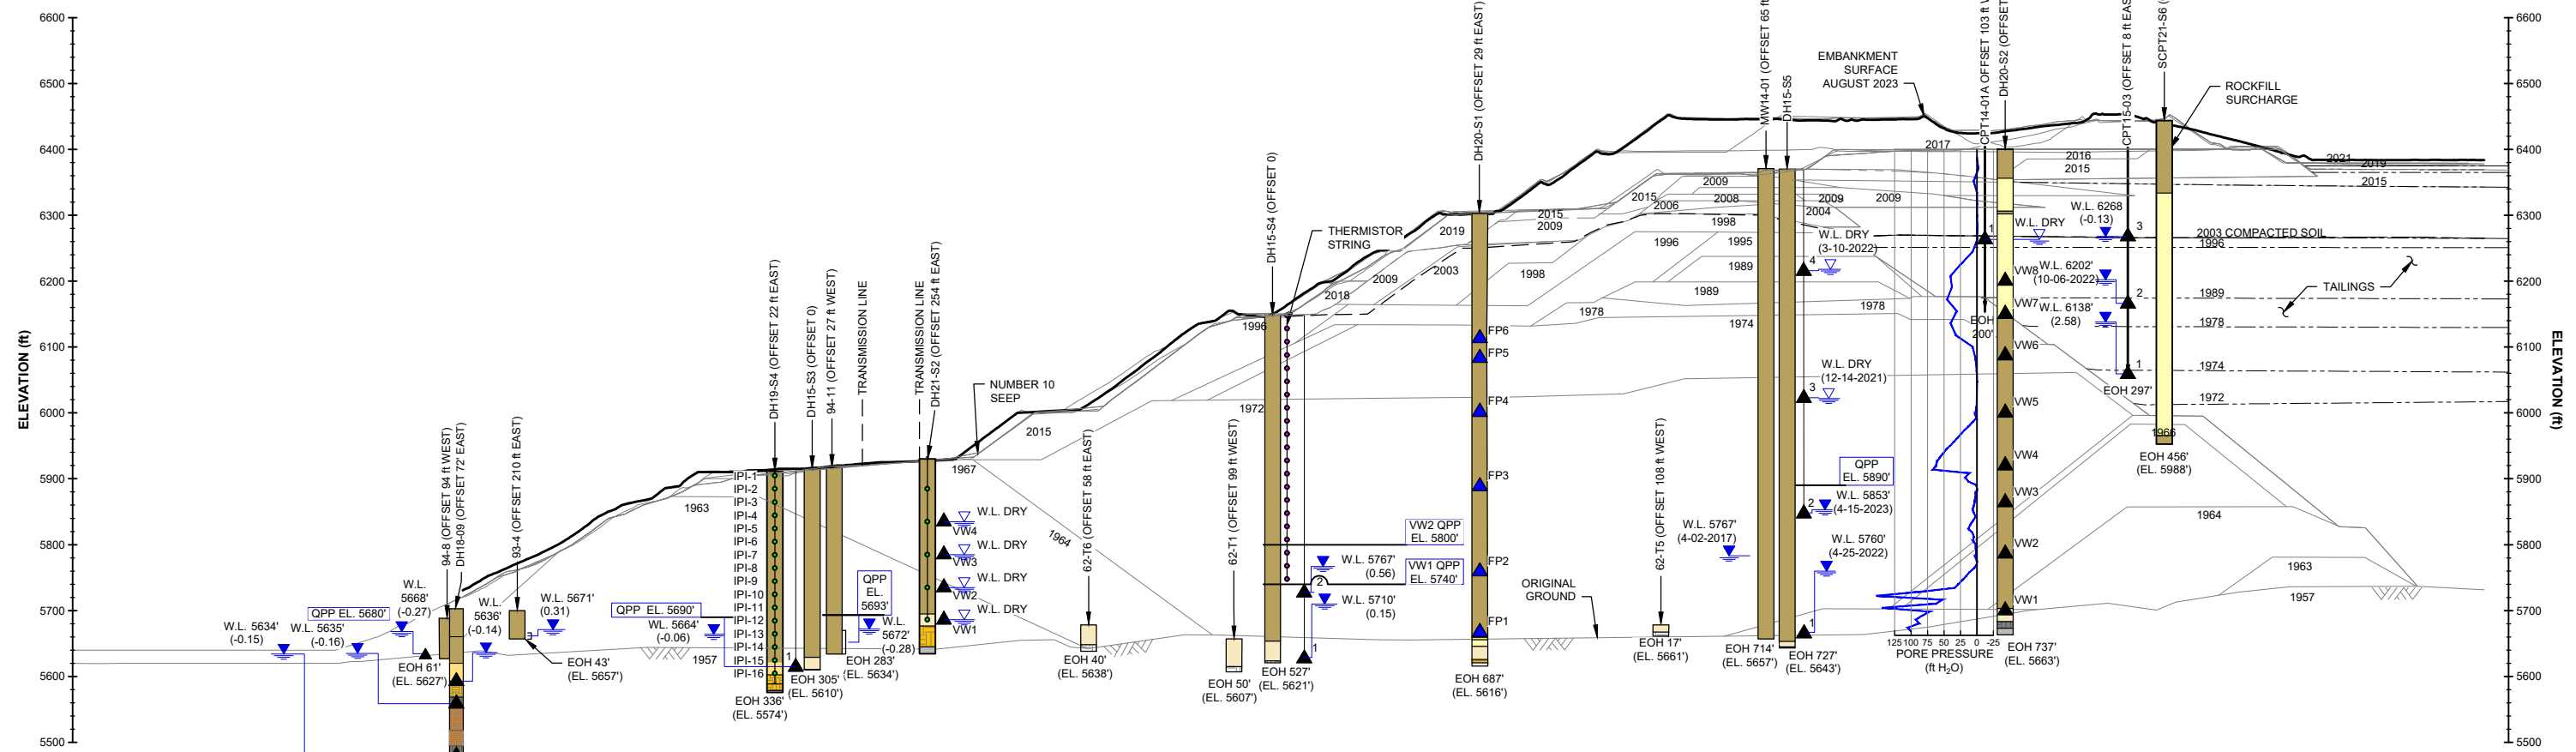
MONTANA RESOURCES, LLC	
YANKEE DOODLE TAILINGS IMPOUNDMENT	
<b>PIEZOMETRIC CONDITIONS ALONG EAST-WEST EMBANKMENT SECTION 8+00W (LOOKING WEST)</b>	
	P/A NO. VA101-126/29 REF. NO. VA23-01703
<b>FIGURE 7</b>	
REV 0	REV 0

No piezometric trigger elevation exceedances were observed at QPP monitoring sites during Q3 2023. A high-level summary of QPP piezometric data and instrumentation status is provided in Table 1. Piezometric data recorded at QPP sites within the East-West, North-South, and West Embankments are shown relative to the trigger elevations on Figures 2 through 6. Piezometric conditions and quarterly change in piezometric elevation for instruments installed along Section 8+00W of the East-West Embankment are presented graphically on Figure 7.

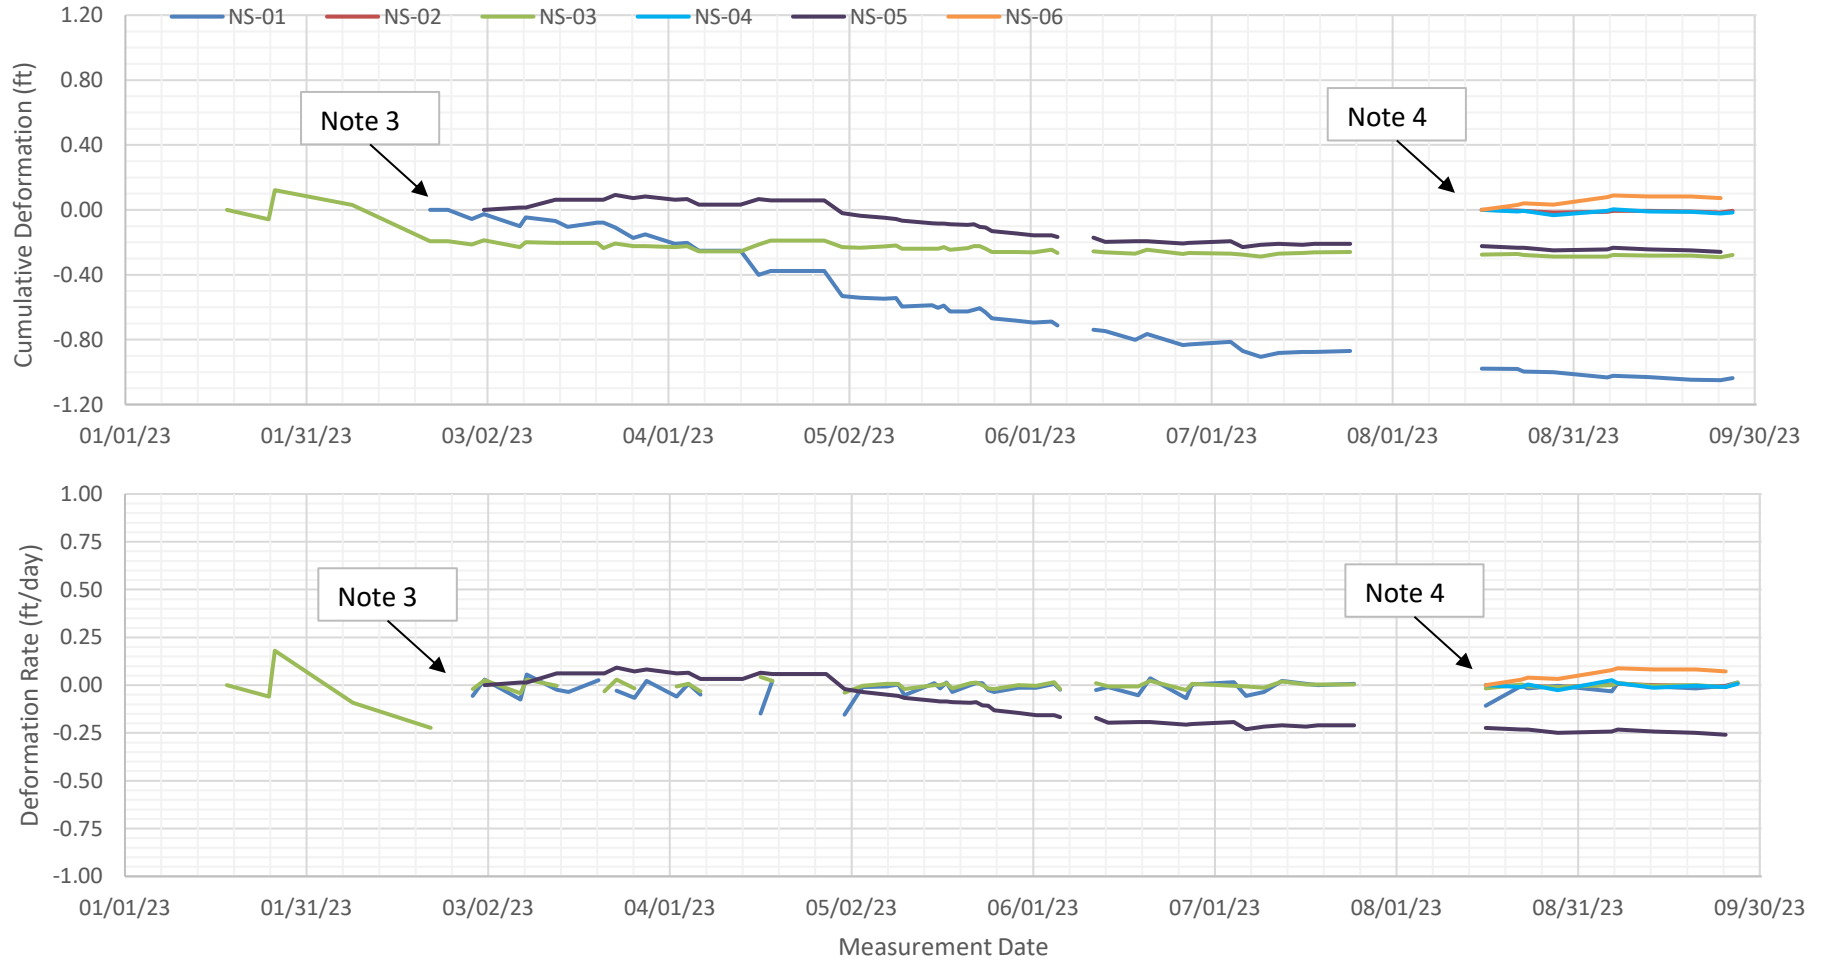
MONTANA RESOURCES LLC.	
YANKEE DOODLE TAILINGS IMPOUNDMENT	
<b>NS EMBANKMENT SURVEY MONUMENTS VERTICAL DEFORMATION</b>	
	P/A NO. VA101-126/29
	REF. NO. VA23-01703
<b>FIGURE A.21</b>	
REV 0

- Manual survey-monuments (NS-01, NS-02, NS-03, NS-04, NS-05, and NS-06) are installed along the North-South Embankment and have monitored deformations during and following EL. 6,450 ft crest construction using a total station. Available data indicate slightly elevated, generally slowing deformation rates following the substantial conclusion of EL. 6,450 ft lift construction in Q1 2023. The highest deformation rates are observed near to where the East-West and North-South Embankment join (NS-01) in the region where construction was most relatively recently active (January 2023). It is anticipated that these rates will continue to slow in Q4 2023.

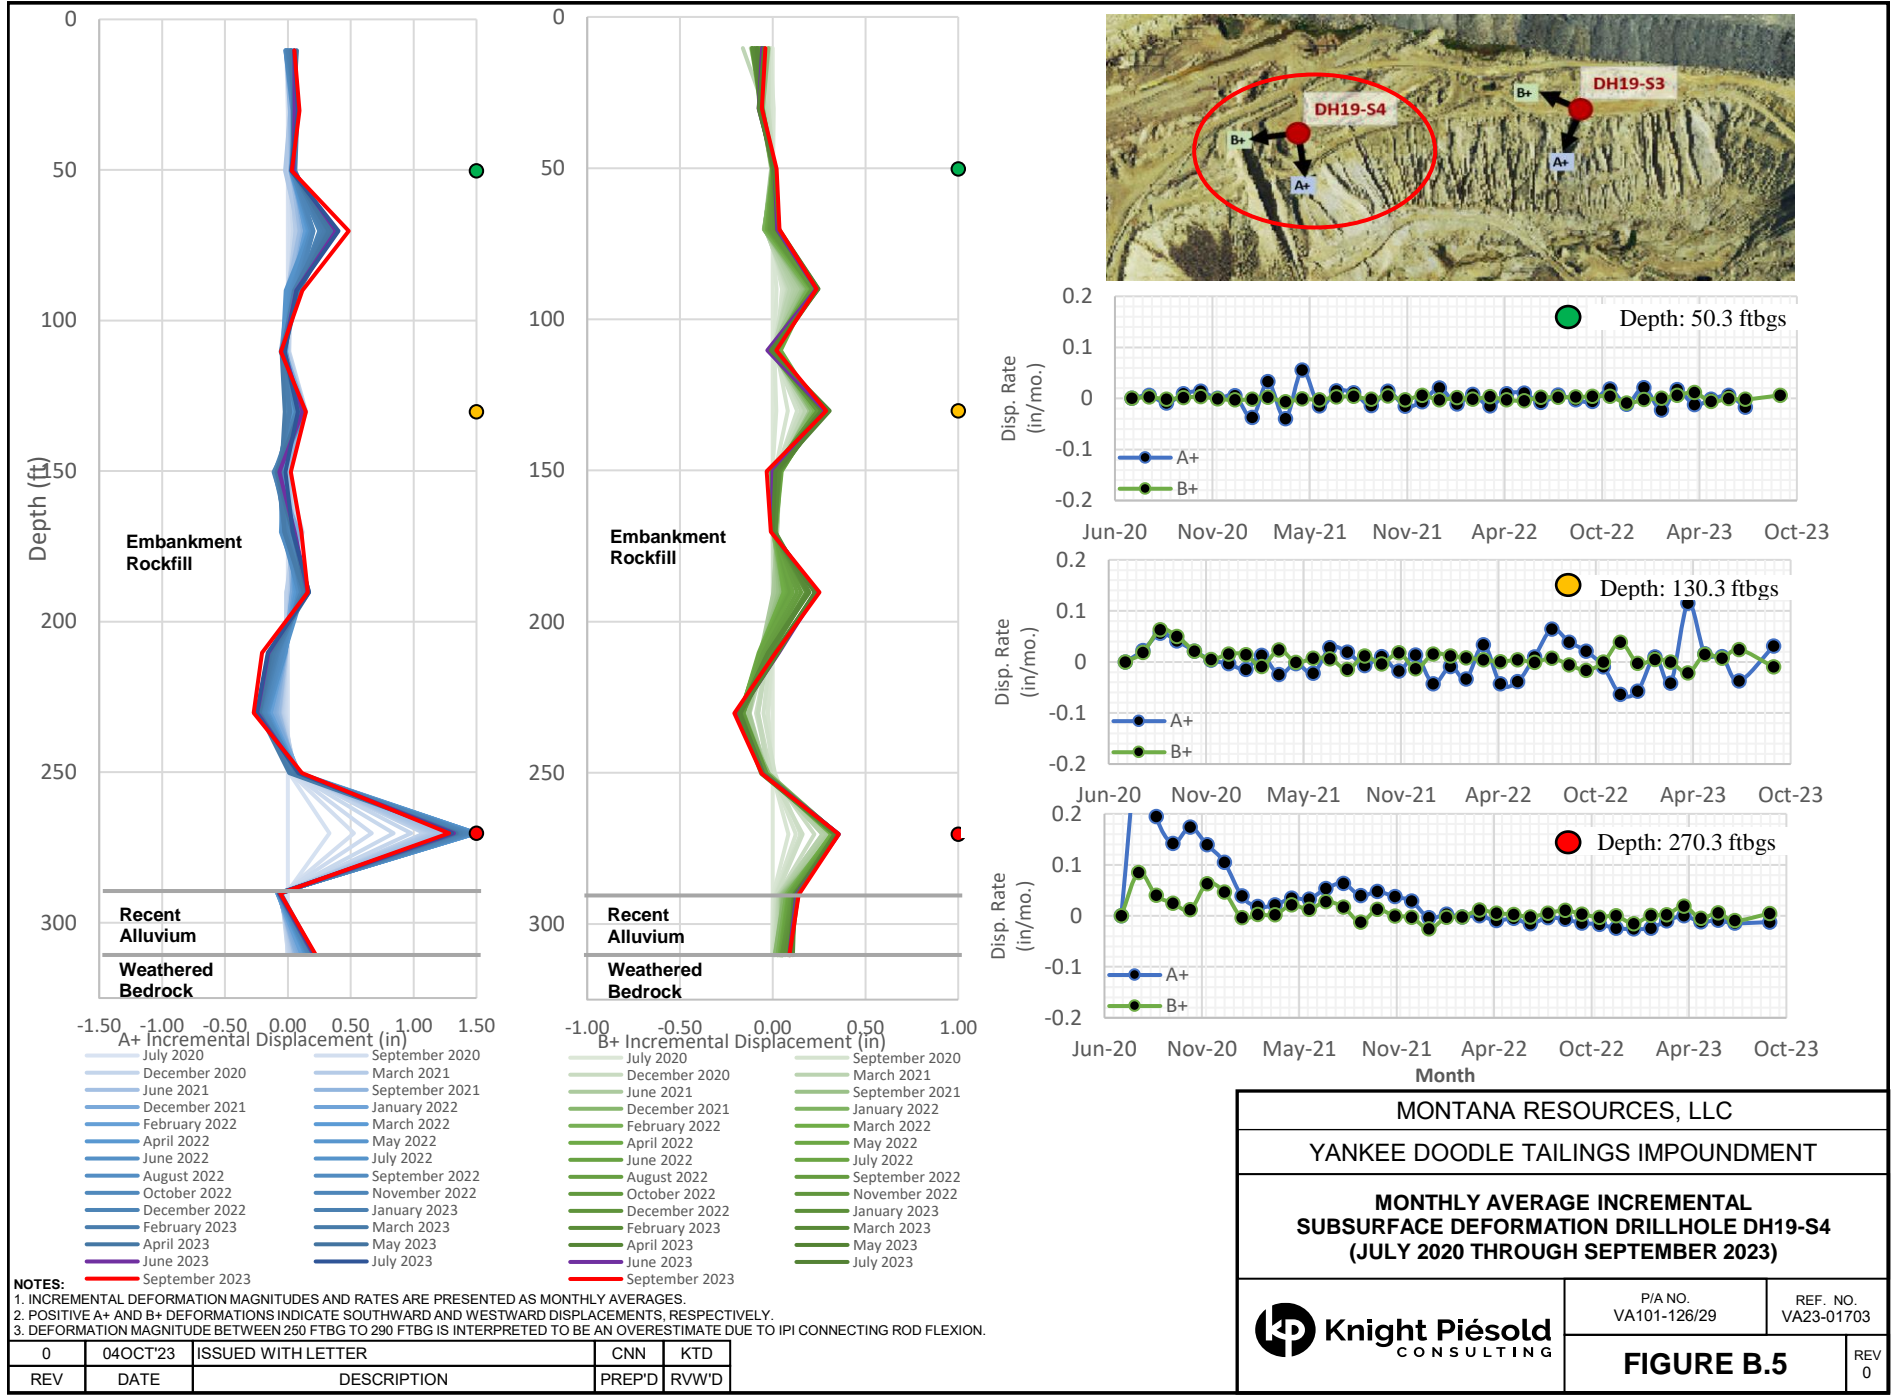
MONTANA RESOURCES, LLC	
YANKEE DOODLE TAILINGS IMPOUNDMENT	
<b>MONTHLY AVERAGE INCREMENTAL SUBSURFACE DEFORMATION DRILLHOLE DH19-S4 (JULY 2020 THROUGH SEPTEMBER 2023)</b>	
P/A NO. VA101-126/29	REF. NO. VA23-01703
	<b>FIGURE B.5</b>
	REV 0

**NOTES:**  
 1. INCREMENTAL DEFORMATION MAGNITUDES AND RATES ARE PRESENTED AS MONTHLY AVERAGES.  
 2. POSITIVE A+ AND B+ DEFORMATIONS INDICATE SOUTHWARD AND WESTWARD DISPLACEMENTS, RESPECTIVELY.  
 3. DEFORMATION MAGNITUDE BETWEEN 250 FTBG TO 290 FTBG IS INTERPRETED TO BE AN OVERESTIMATE DUE TO IPI CONNECTING ROD FLEXION.

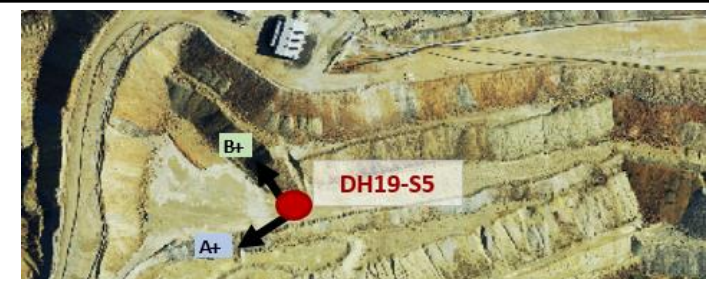
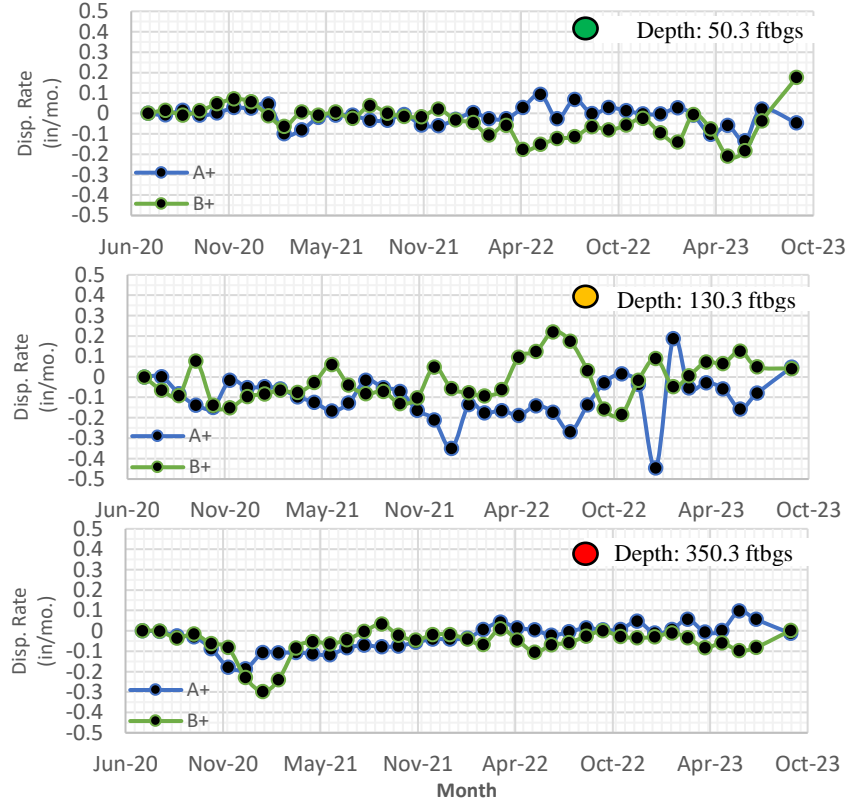
MONTANA RESOURCES, LLC	
YANKEE DOODLE TAILINGS IMPOUNDMENT	
<b>MONTHLY AVERAGE INCREMENTAL SUBSURFACE DEFORMATION DRILLHOLE DH19-S5 (JULY 2020 THROUGH SEPTEMBER 2023)</b>	
	P/A NO. VA101-126/29
	REF. NO. VA23-01703
<b>FIGURE B.7</b>	
REV 0

**NOTES:**  
 1. INCREMENTAL DEFORMATION MAGNITUDES AND RATES ARE PRESENTED AS MONTHLY AVERAGES.  
 2. POSITIVE A+ AND B+ DEFORMATIONS INDICATE SOUTHWARD AND WESTWARD DISPLACEMENTS, RESPECTIVELY.  
 3. DEFORMATION DATA WITHIN THE UPPER 275 FTBG ARE INTERPRETED TO RESULT PREDOMINANTLY FROM SETTLEMENT-DERIVED CASING DISTORTION WITHIN HISTORICALLY LEACHED ROCKFILL.

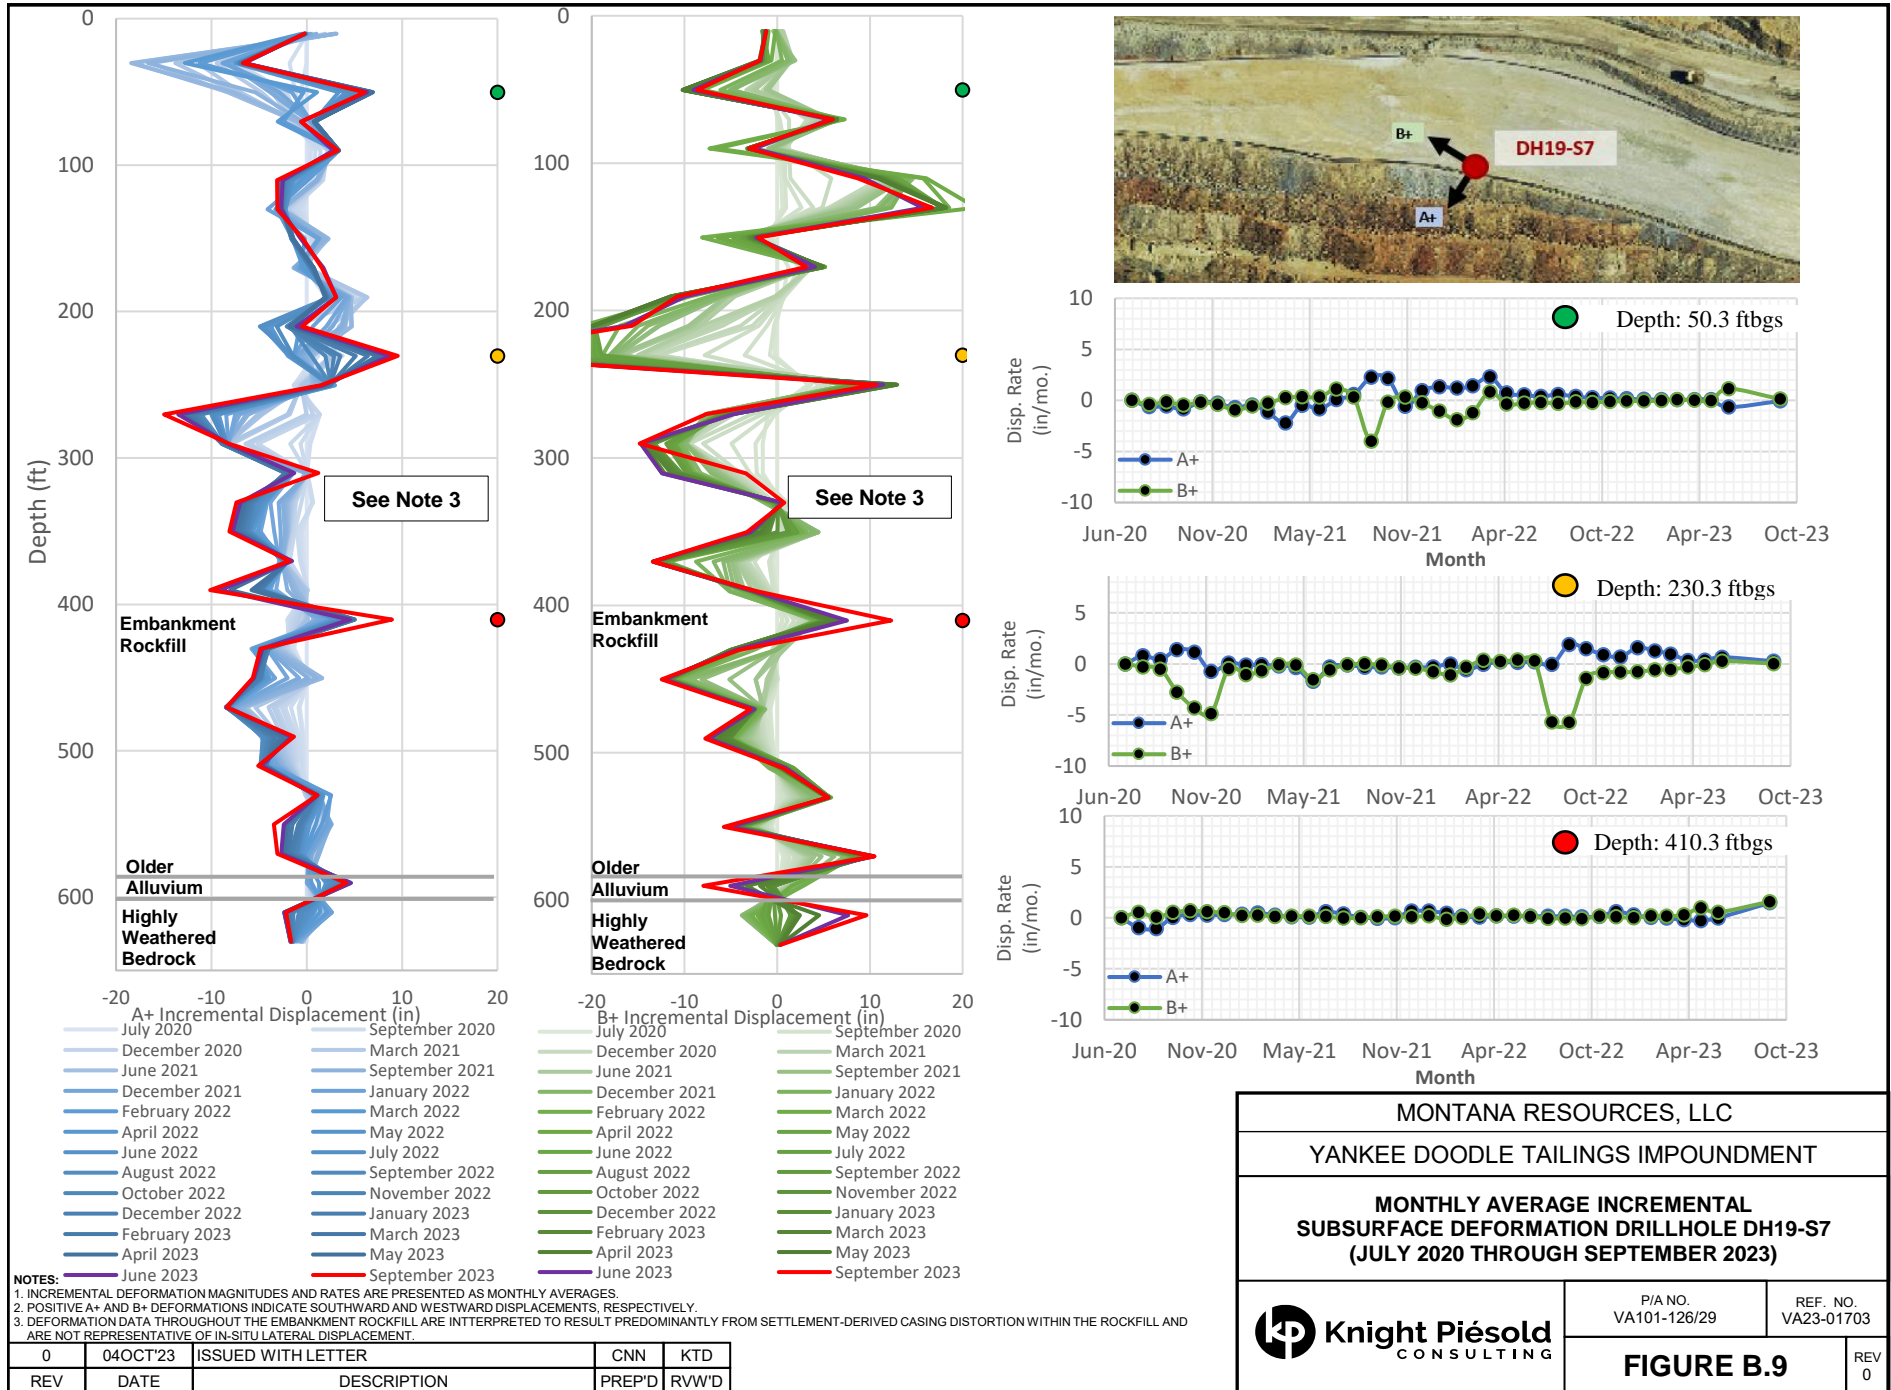
**NOTES:**  
 1. INCREMENTAL DEFORMATION MAGNITUDES AND RATES ARE PRESENTED AS MONTHLY AVERAGES.  
 2. POSITIVE A+ AND B+ DEFORMATIONS INDICATE SOUTHWARD AND WESTWARD DISPLACEMENTS, RESPECTIVELY.  
 3. DEFORMATION DATA THROUGHOUT THE EMBANKMENT ROCKFILL ARE INTERPRETED TO RESULT PREDOMINANTLY FROM SETTLEMENT-DERIVED CASING DISTORTION WITHIN THE ROCKFILL AND ARE NOT REPRESENTATIVE OF IN-SITU LATERAL DISPLACEMENT.

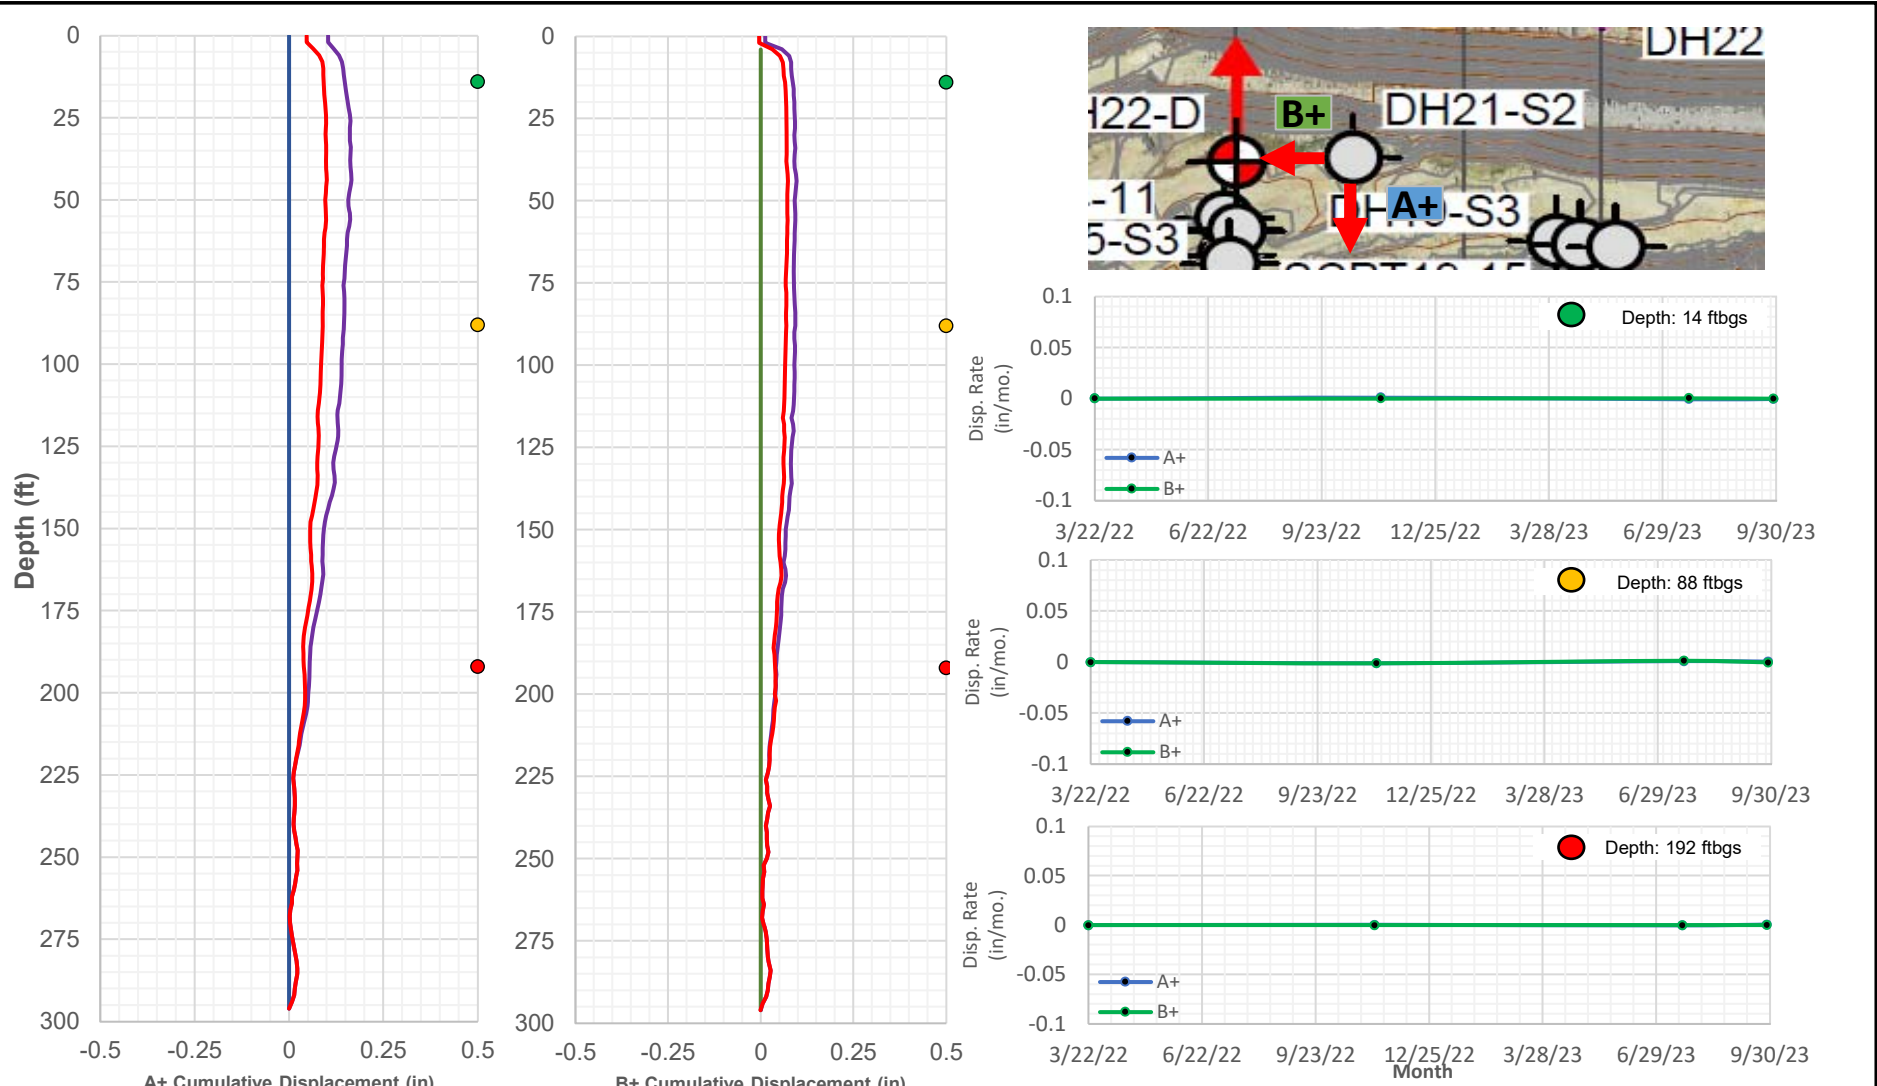
MONTANA RESOURCES, LLC	
YANKEE DOODLE TAILINGS IMPOUNDMENT	
<b>CUMULATIVE SUBSURFACE DEFORMATION DRILLHOLE DH21-S2 (MARCH 2022 THROUGH SEPTEMBER 2023)</b>	
	P/A NO. VA101-126/29
	REF. NO. VA23-01703
<b>FIGURE B.12</b>	
REV 0

1. CUMULATIVE DEFORMATION MAGNITUDES AND RATES ARE PRESENTED.
2. POSITIVE A+ AND B+ DEFORMATIONS INDICATE SOUTHWARD AND WESTWARD DISPLACEMENTS, RESPECTIVELY.
3. DEFORMATION DATA WITHIN THE UPPER 275 FTBG ARE INTERPRETED TO RESULT PREDOMINANTLY FROM SETTLEMENT-DERIVED CASING DISTORTION WITHIN HISTORICALLY LEACHED ROCKFILL.

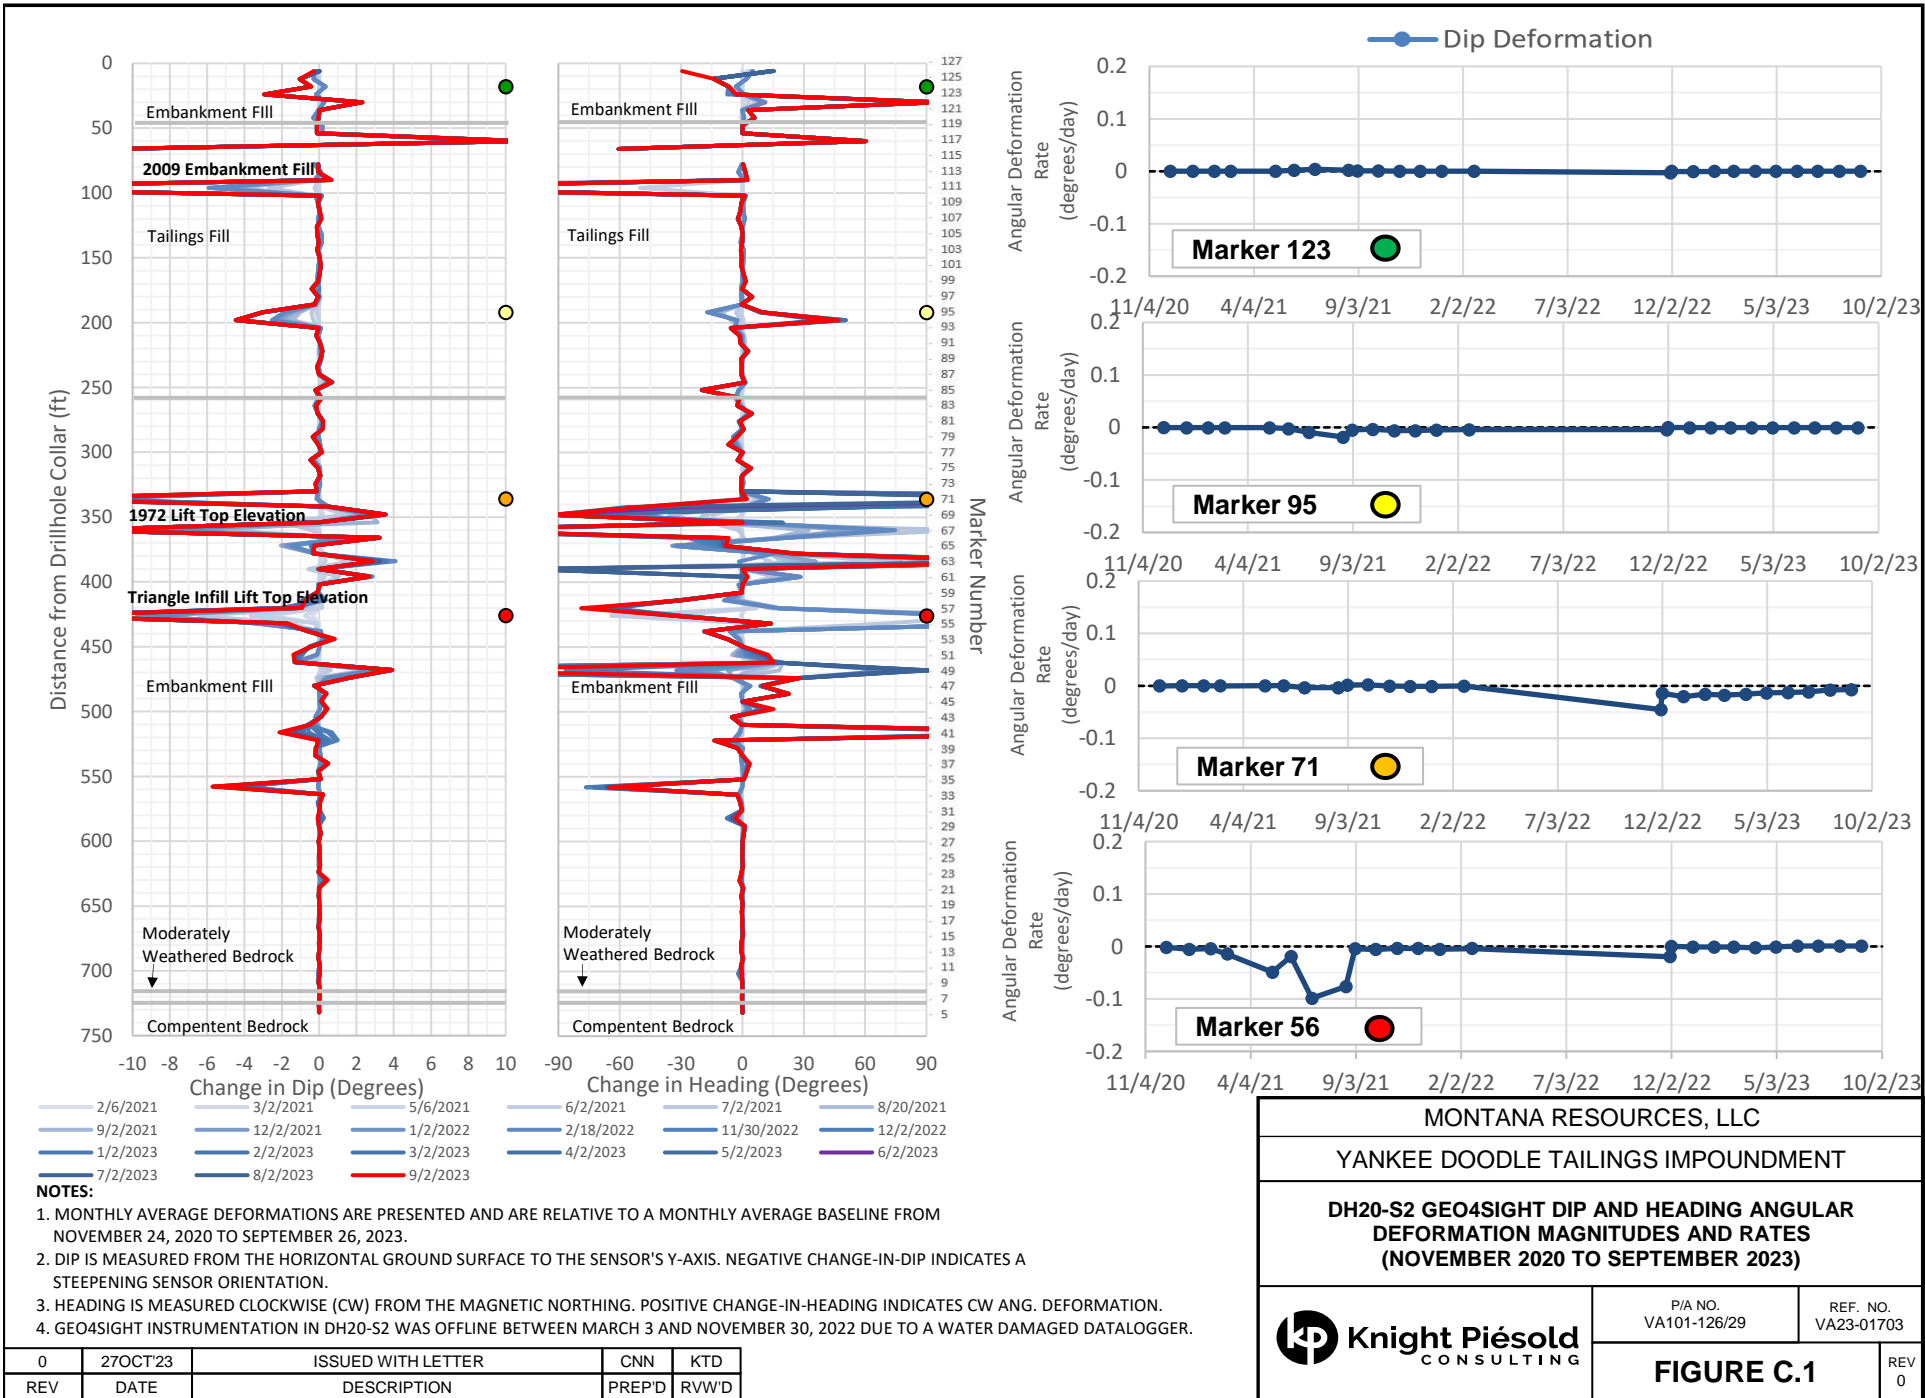
<b>MONTANA RESOURCES, LLC</b>		
<b>YANKEE DOODLE TAILINGS IMPOUNDMENT</b>		
<b>DH20-S2 GEO4SIGHT DIP AND HEADING ANGULAR DEFORMATION MAGNITUDES AND RATES (NOVEMBER 2020 TO SEPTEMBER 2023)</b>		
	P/A NO. VA101-126/29	REF. NO. VA23-01703
	<b>FIGURE C.1</b>	
		REV 0

- NOTES:**
- MONTHLY AVERAGE DEFORMATIONS ARE PRESENTED AND ARE RELATIVE TO A MONTHLY AVERAGE BASELINE FROM NOVEMBER 24, 2020 TO SEPTEMBER 26, 2023.
  - DIP IS MEASURED FROM THE HORIZONTAL GROUND SURFACE TO THE SENSOR'S Y-AXIS. NEGATIVE CHANGE-IN-DIP INDICATES A STEEPENING SENSOR ORIENTATION.
  - HEADING IS MEASURED CLOCKWISE (CW) FROM THE MAGNETIC NORTHING. POSITIVE CHANGE-IN-HEADING INDICATES CW ANG. DEFORMATION.
  - GEO4SIGHT INSTRUMENTATION IN DH20-S2 WAS OFFLINE BETWEEN MARCH 3 AND NOVEMBER 30, 2022 DUE TO A WATER DAMAGED DATALOGGER.
