Prepared for
Montana Resources, LLP
600 Shields Avenue
Butte, Montana
USA, 59701

VA101-126/23-5

YANKEE DOODLE TAILINGS IMPOUNDMENT

2020 DATA ANALYSIS REPORT

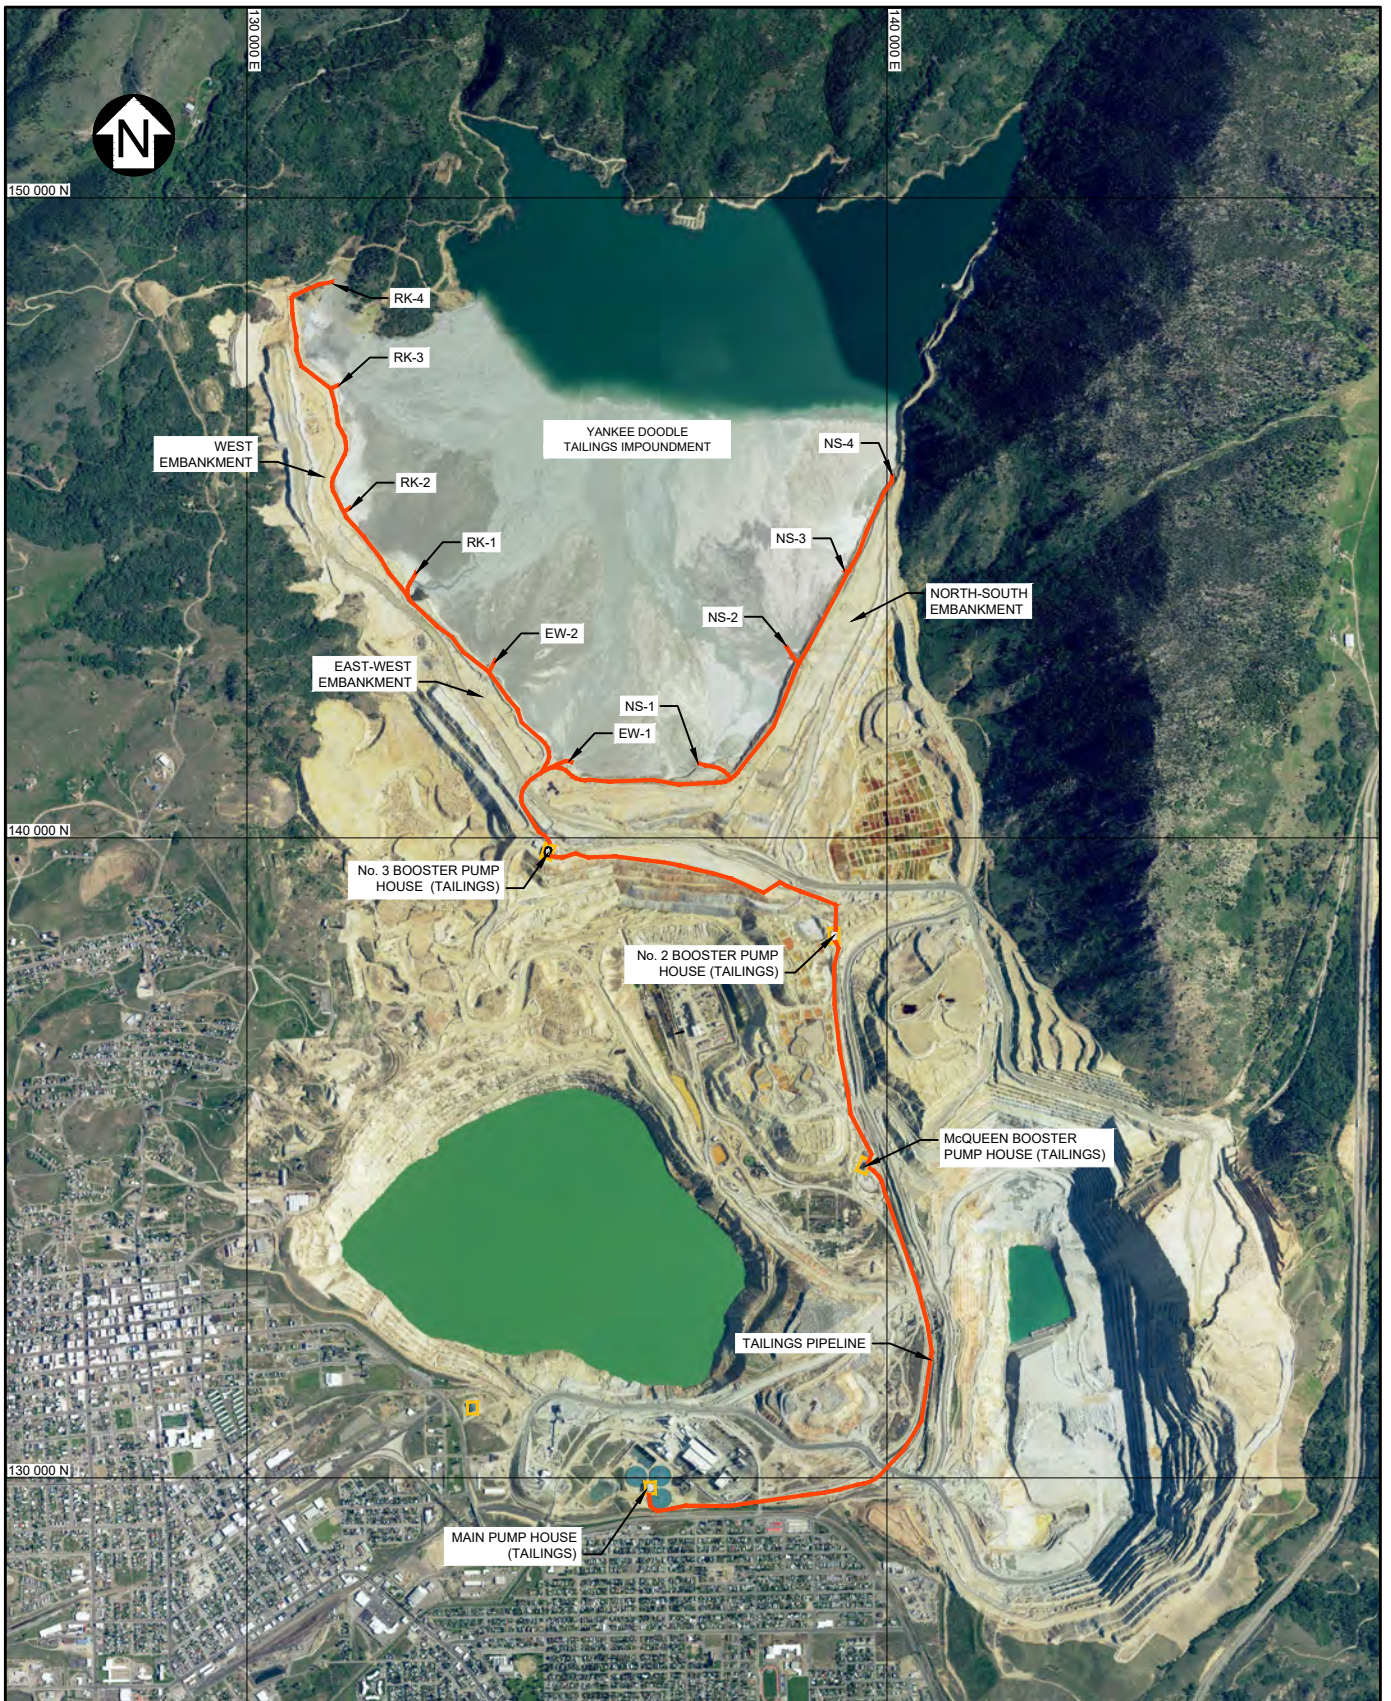
The total mass of tailings solids discharged into the YDTI in 2020 was calculated based on the Concentrator production data minus the concentrate produced. The tailings discharge mass typically represents 99% of the total Concentrator throughput. The average Concentrator throughput was 45,300 tons per day during 2020. This equates to an average production of 44,900 tons of tailings per day and a total annual tailings production of 16.4 million tons (Mt). The 2020 production rate was the lowest annual production total since 2004. The total annual tailings production has varied between 16.4 and 18.2 Mt since 2004. The production rate is determined by the mine operations and is dependent on ore quality, operations schedule, rock hardness, and other operational factors.

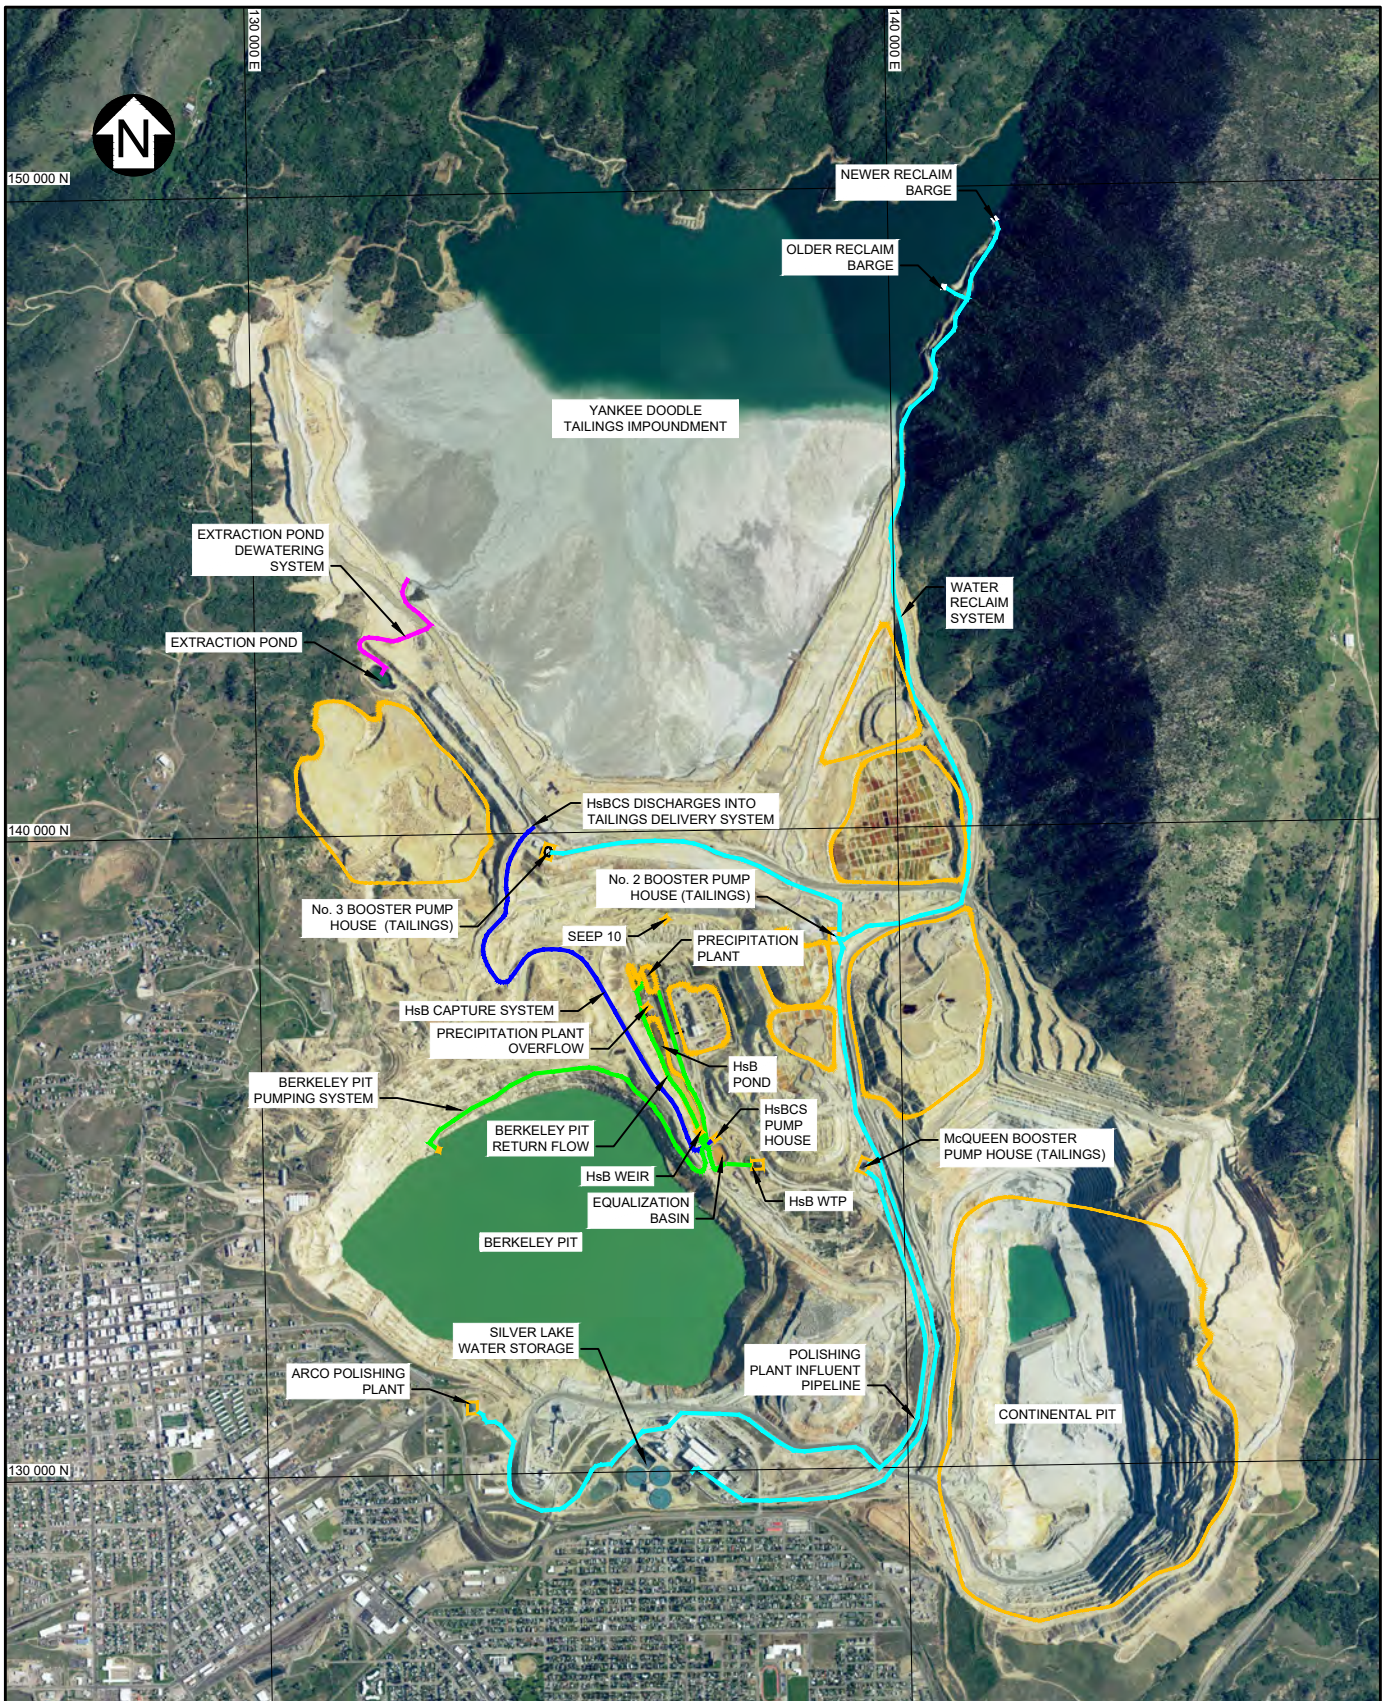
The off-site discharge of water from the Polishing Plant is a BMFOU activity and outside of the direct purview of the YDTI EOR. One goal of the Pilot Project is to reduce the supernatant pond volume to approximately 15,000 acre-ft over the next 3 to 5 years, provided there is no detrimental impact to operations. The Pilot Project is not entirely within MR's control and a variety of factors and interruptions are possible that could impact the timeline. The Pilot Project systems and Polishing Plant data are discussed in this report due to the effects these activities have on other mine water management systems, including the YDTI pond volume, pond elevation, and water reclaim system rates. A general arrangement of the Pilot Project components and other site water management systems relevant to this report are shown on Figure 3.5.

MONTANA RESOURCES, LLP													
YANKEE DOODLE TAILINGS IMPOUNDMENT													
WATER MANAGEMENT SYSTEMS GENERAL ARRANGEMENT													
Knight Piésold CONSULTING	P/A NO. VA101-126/23 REF NO. 5 FIGURE 3.5												
<table border="1" style="width: 100%; border-collapse: collapse;"> <tr> <td style="width: 33%;">0</td> <td style="width: 33%;">29JUN'21</td> <td style="width: 33%;">ISSUED WITH REPORT</td> </tr> <tr> <td>REV</td> <td>DATE</td> <td>DESCRIPTION</td> </tr> </table>	0	29JUN'21	ISSUED WITH REPORT	REV	DATE	DESCRIPTION	<table border="1" style="width: 100%; border-collapse: collapse;"> <tr> <td style="width: 33%;">KS1</td> <td style="width: 33%;">RMM</td> <td style="width: 33%;">DDF</td> </tr> <tr> <td>DESIGNED</td> <td>DRAWN</td> <td>REVIEWED</td> </tr> </table>	KS1	RMM	DDF	DESIGNED	DRAWN	REVIEWED
0	29JUN'21	ISSUED WITH REPORT											
REV	DATE	DESCRIPTION											
KS1	RMM	DDF

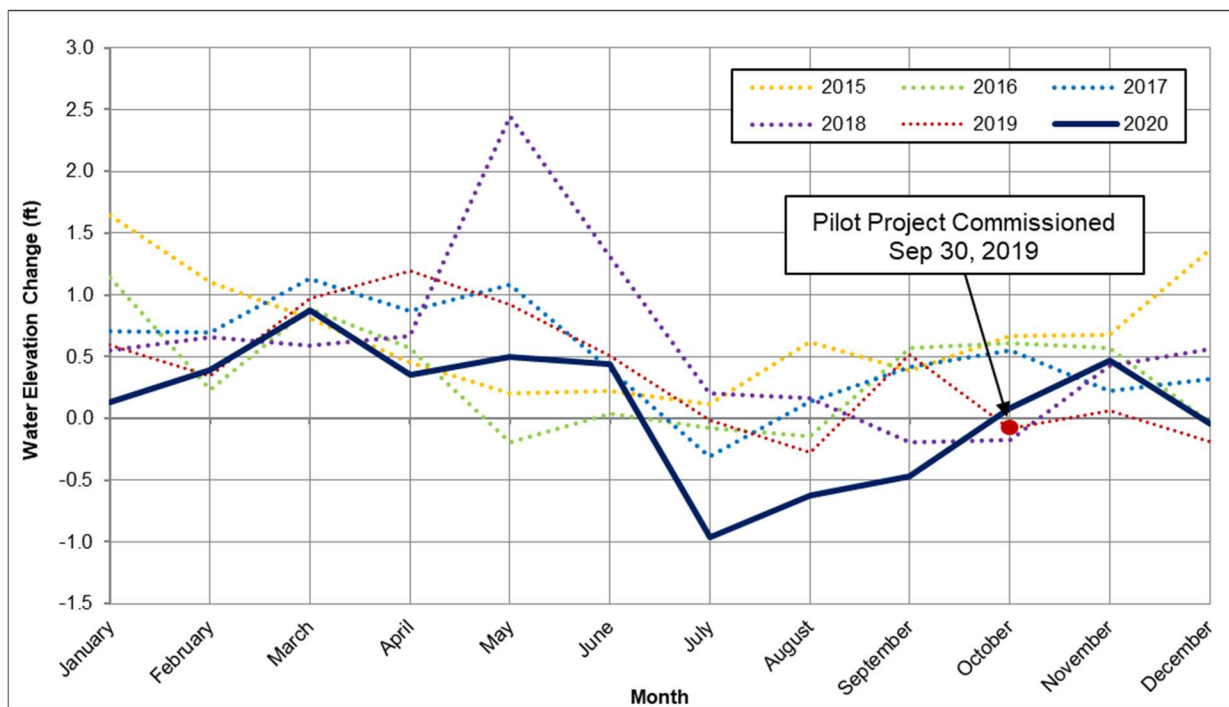
Figure 3.6 Monthly Supernatant Pond Elevation Change

The supernatant pond water elevation was recorded weekly during 2020. The monthly average pond elevation changes observed from 2015 through 2020 are shown on Figure 3.6. The trends illustrate the seasonal fluctuations at the site, with higher rates of rise in the spring and lower rates of rise or elevation decreases observed in the summer. The lower-than-usual elevation change observed during Q2 and Q3 are attributed to a delayed spring freshet in 2020 and operation of the Pilot Project. The elevation increase observed in November 2020 was greater than that of the previous year due to warmer-than-usual temperatures melting early season snowfall.

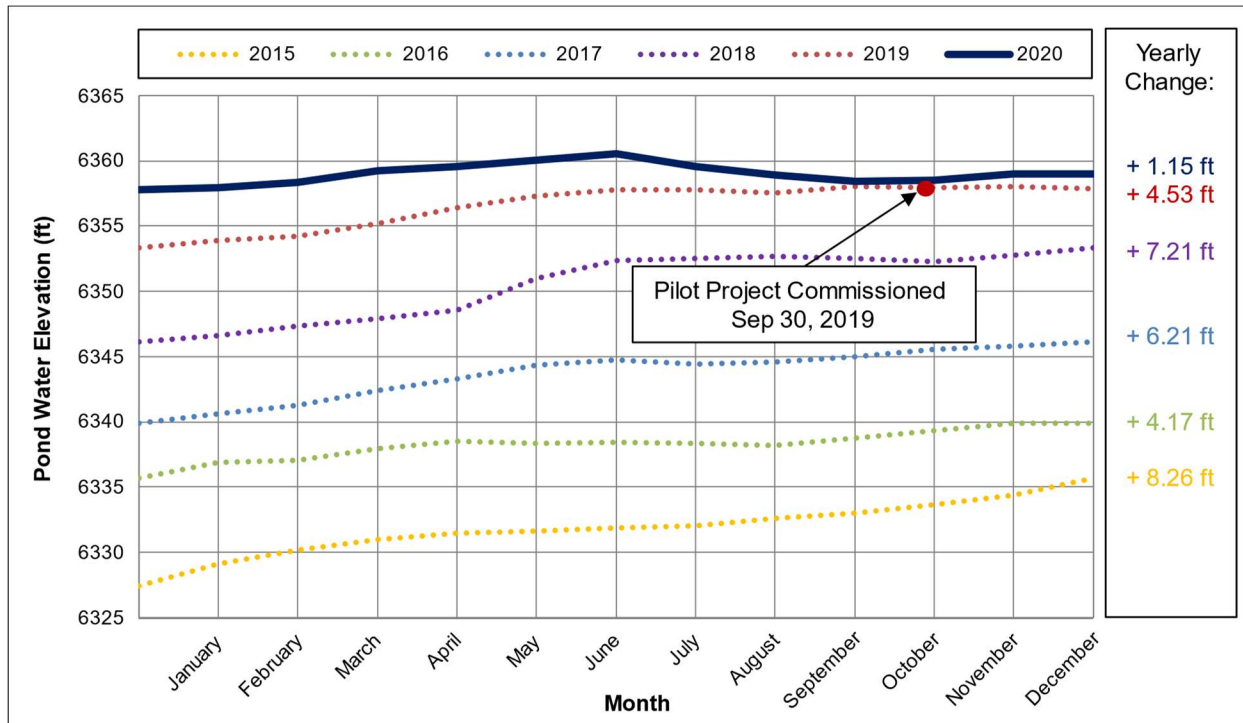
Figure 3.7 Monthly Supernatant Pond Elevation

The monthly pond elevations observed from 2015 through 2020 are shown on Figure 3.7. The supernatant pond elevation increased by approximately 1.2 ft in 2020, which was 81% less than the average annual pond rise measured during the previous five years. This net reduction in elevation was expected and is largely attributed to the operation of the Pilot Project and the associated off-site water discharge.

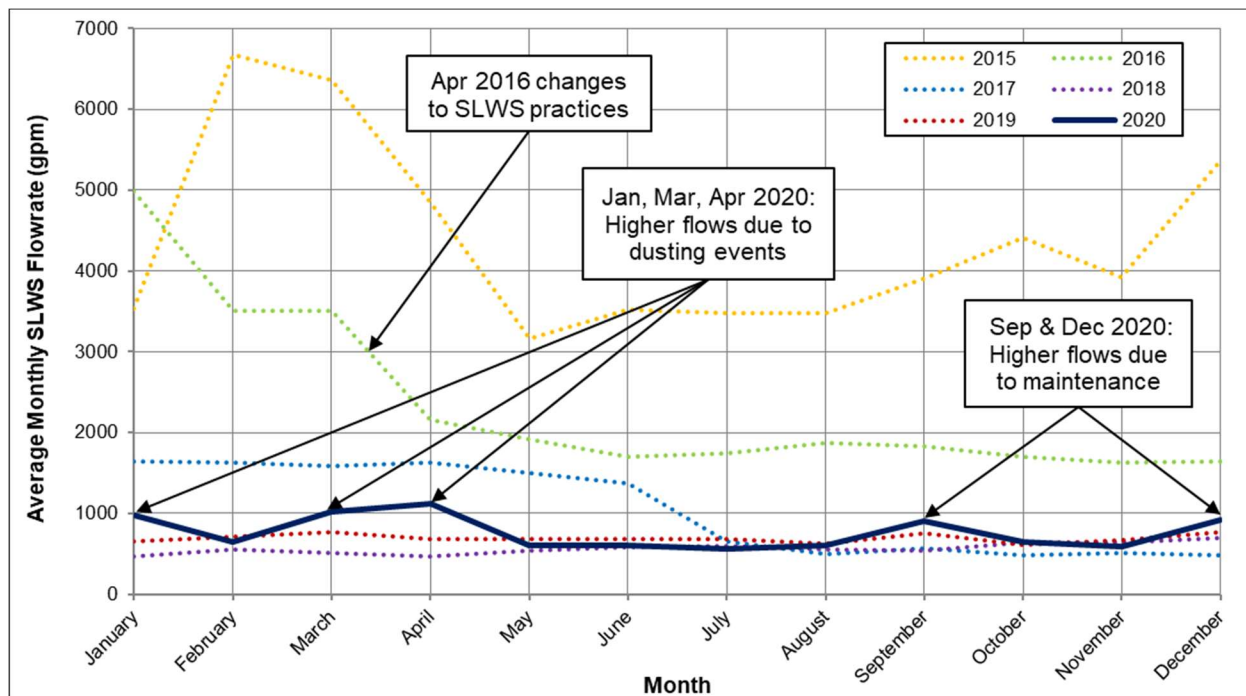
Figure 3.8 Average Monthly SLWS Flowrate

The average monthly flowrates from the SLWS from 2015 through 2020 are shown on Figure 3.8. The average 2020 flowrate for the SLWS was 770 gpm (1.1 MGD). This is slightly higher than the target annual average of 1 MGD and is attributed to increased water demand from dusting events in January, March, and April 2020, and from maintenance activities in September and December 2020.

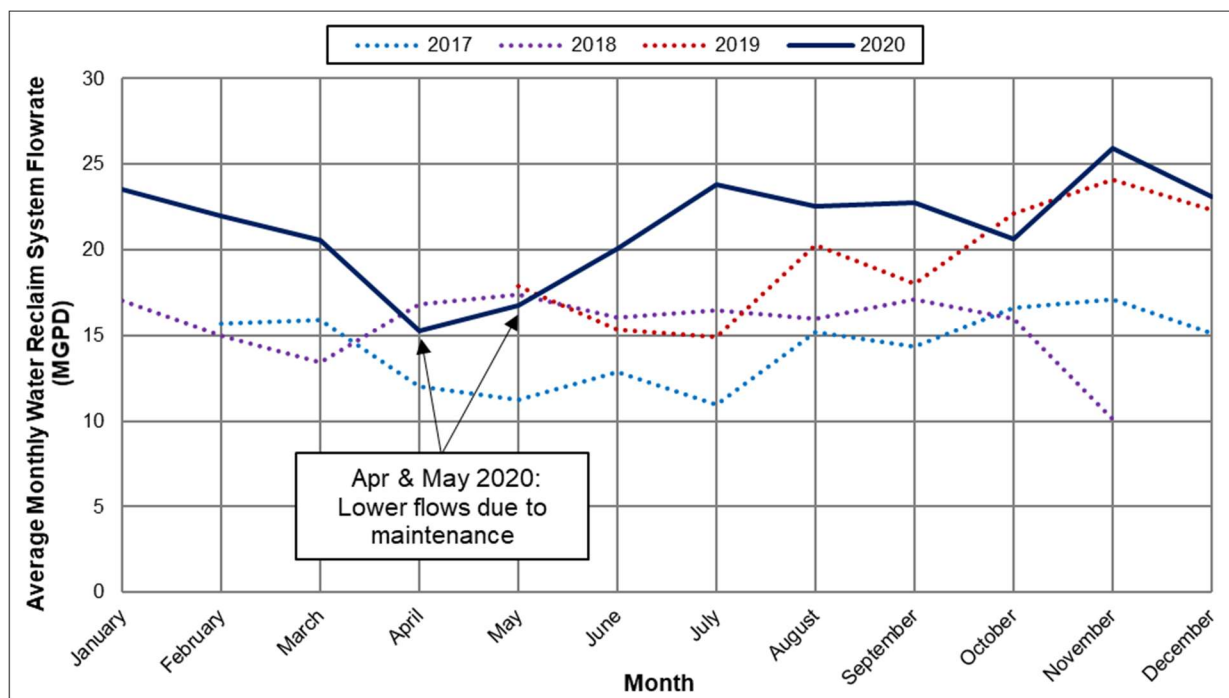
Figure 3.9 Average Monthly Water Reclaim Flowrates

The average monthly Water Reclaim System flowrates from February 2017 to December 2020 are shown on Figure 3.9. Erroneous data due to flowmeter malfunction from December 2018 through April 2019 is omitted. The average flowrate increased in August 2019 following commissioning of the Polishing Plant water off-take. The 2020 average flowrate was approximately 21 MGPD. The lower-than-usual averages measured in April and May 2020 were due to maintenance-related activities.

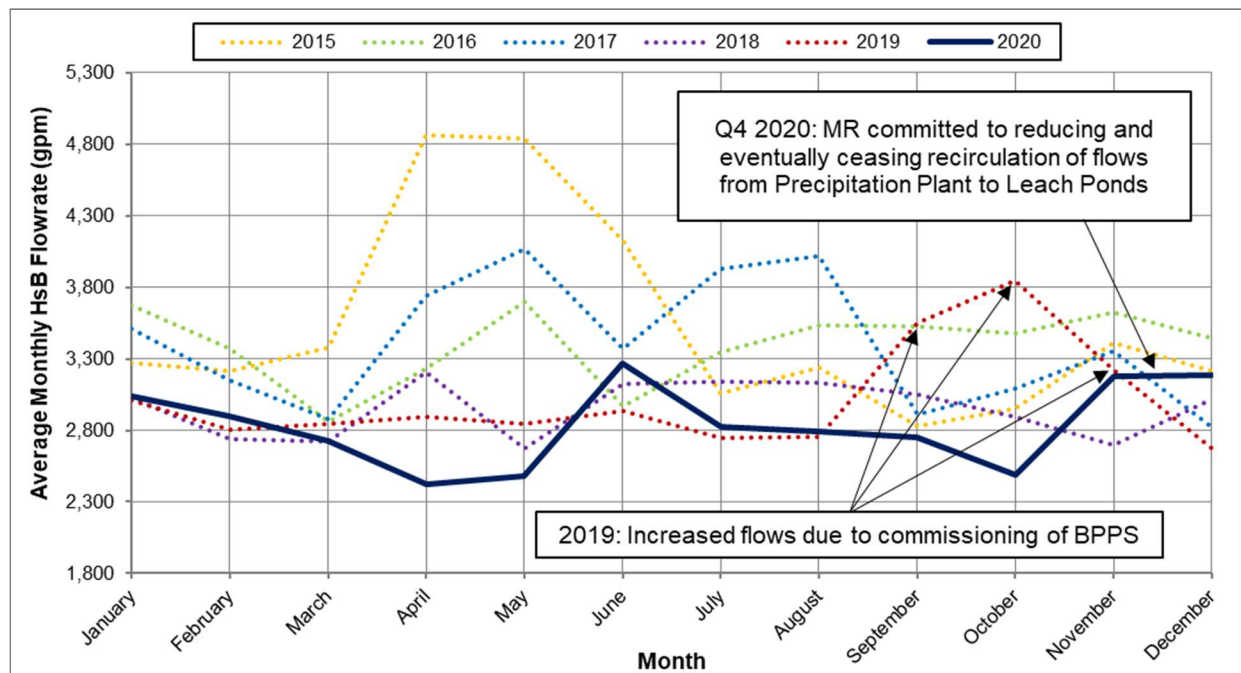
Figure 3.10 Monthly Average HsB Weir Flowrate

The monthly average flowrates measured at the HsB Weir from 2015 through 2020 are shown on Figure 3.10. The 2020 average annual flowrate was 2,840 gpm (4.1 MGPD), which is very similar to the 2019 annual average flowrate of 2,830 gpm, excluding data affected by the commissioning of the Pilot Project from September to November 2019.

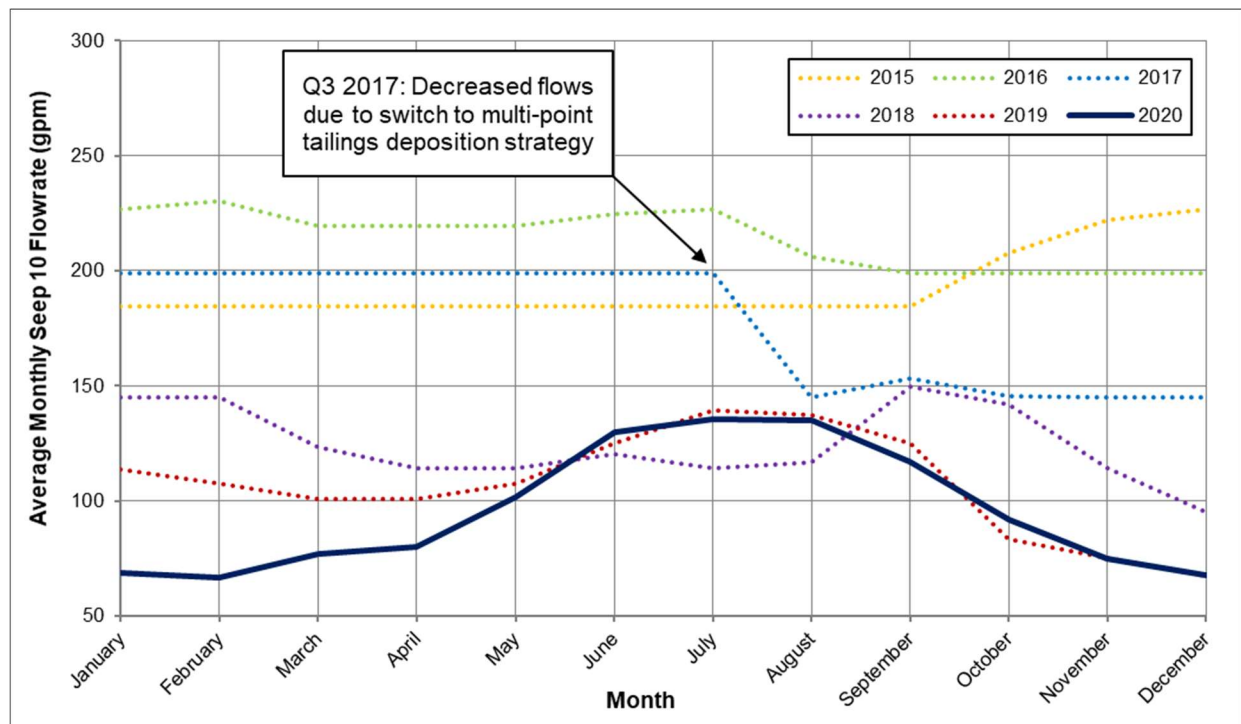
Figure 3.11 Monthly Average Seep 10 Flowrate

The Seep 10 monthly average flowrates from 2015 through 2020 are shown on Figure 3.11. The average measured flowrate at Seep 10 was 95 gpm in 2020, which is 11% (12 gpm) lower than the 2019 average. The average annual seepage flowrates have been generally decreasing since July 2017, which is attributed to the transition from a single tailings discharge point to a multi-point discharge strategy in the YDTI. The trend generally has lower flowrates during Q1 and Q4, and higher flowrates during Q2 and Q3. This trend is likely attributed to the increased flows during the freshet and the onset of warmer temperatures. The flows at Seep 10 are expected to continue to follow this trend in 2021.

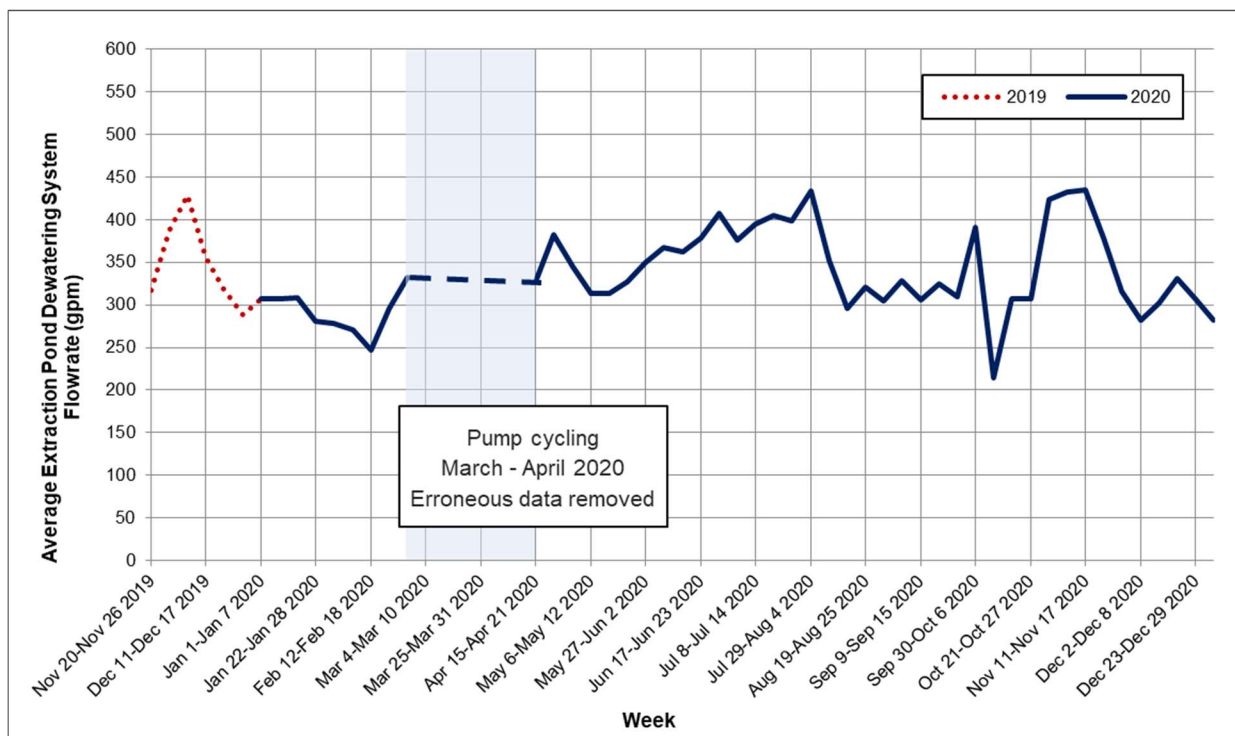
Figure 3.13 Extraction Pond Dewatering System Weekly Flowrate

The Extraction Pond forms the gravity outlet of the WED, and the Extraction Pond Dewatering System conveys water from the pond to the YDTI via a pipeline that discharges at tailings discharge location RK-1. The returned flows are measured using an inline totalizing flowmeter. The Extraction Pond and Extraction Pond Dewatering System, which includes a floating barge and pump system, was commissioned on November 20, 2019. The average weekly flowrates for the Extraction Pond Dewatering System since it began operating are presented on Figure 3.13. A period of erroneous data in March and April 2020 is omitted from the system flow analysis. The Extraction Pond Dewatering System recorded average weekly flowrates between 250 gpm and 450 gpm. A longer period of data collection is required before any trends or seasonal changes can be determined.

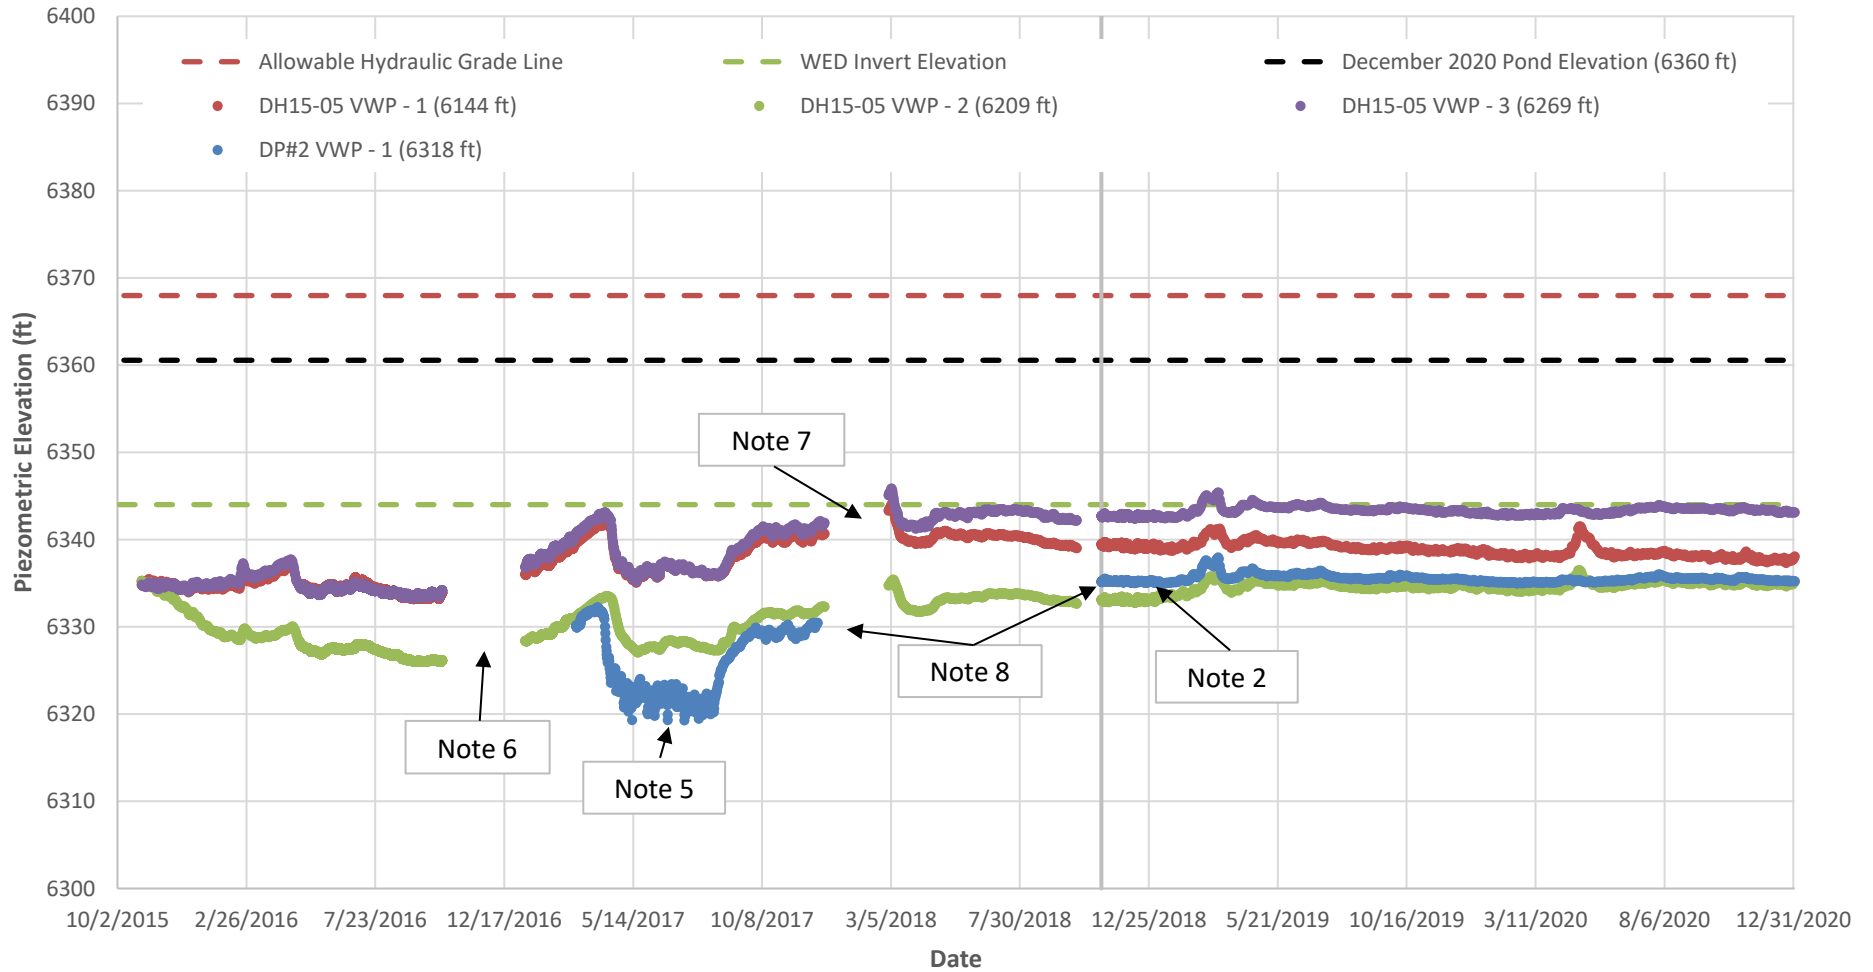
1. SENSOR ELEVATIONS SHOWN IN LEGEND ARE RELATIVE TO ANACONDA MINE GRID.
2. DP#2 VWP-1 IS INSTALLED IN THE BOTTOM OF DRAIN POD 2.
3. THE DH15-05 VWPS ARE INSTALLED IN A DRILLHOLE APPROXIMATELY 200 ft S OF DP#2.
4. SENSORS WERE INTEGRATED INTO THE REMOTE MONITORING SYSTEM BETWEEN NOVEMBER 1 AND 16, 2018.
5. WATER LEVEL DRAWDOWN IS ASSOCIATED WITH CONSTRUCTION RELATED DEWATERING OF THE SOUTH POND AREA AND FROM THE WEST EMBANKMENT DRAIN.
6. THE ALLOWABLE HYDRAULIC GRADE LINE REPRESENTS A 10 ft INCREASE IN HYDRAULIC HEAD ABOVE THE FILTER ZONE AND DRAIN CROWN OF THE WEST EMBANKMENT DRAIN AT DRAIN POD #2.
7. NO DATA RECORDED FROM DECEMBER 19, 2017 TO NOVEMBER 16, 2018 DUE TO A CONNECTIVITY ISSUE.
8. SENSORS STOPPED LOGGING DUE TO INSUFFICIENT BATTERY VOLTAGE.

MONTANA RESOURCES, LLP			
YANKEE DOODLE TAILINGS IMPOUNDMENT			
DRAIN POD #2 AREA PIEZOMETRIC ELEVATION RELATIVE TO WEST EMBANKMENT DRAIN AND MAXIMUM ALLOWABLE HYDRAULIC GRADE LINE			
	P/A NO. VA101-00126/23	REF. NO. 5	FIGURE 4.16 REV 0

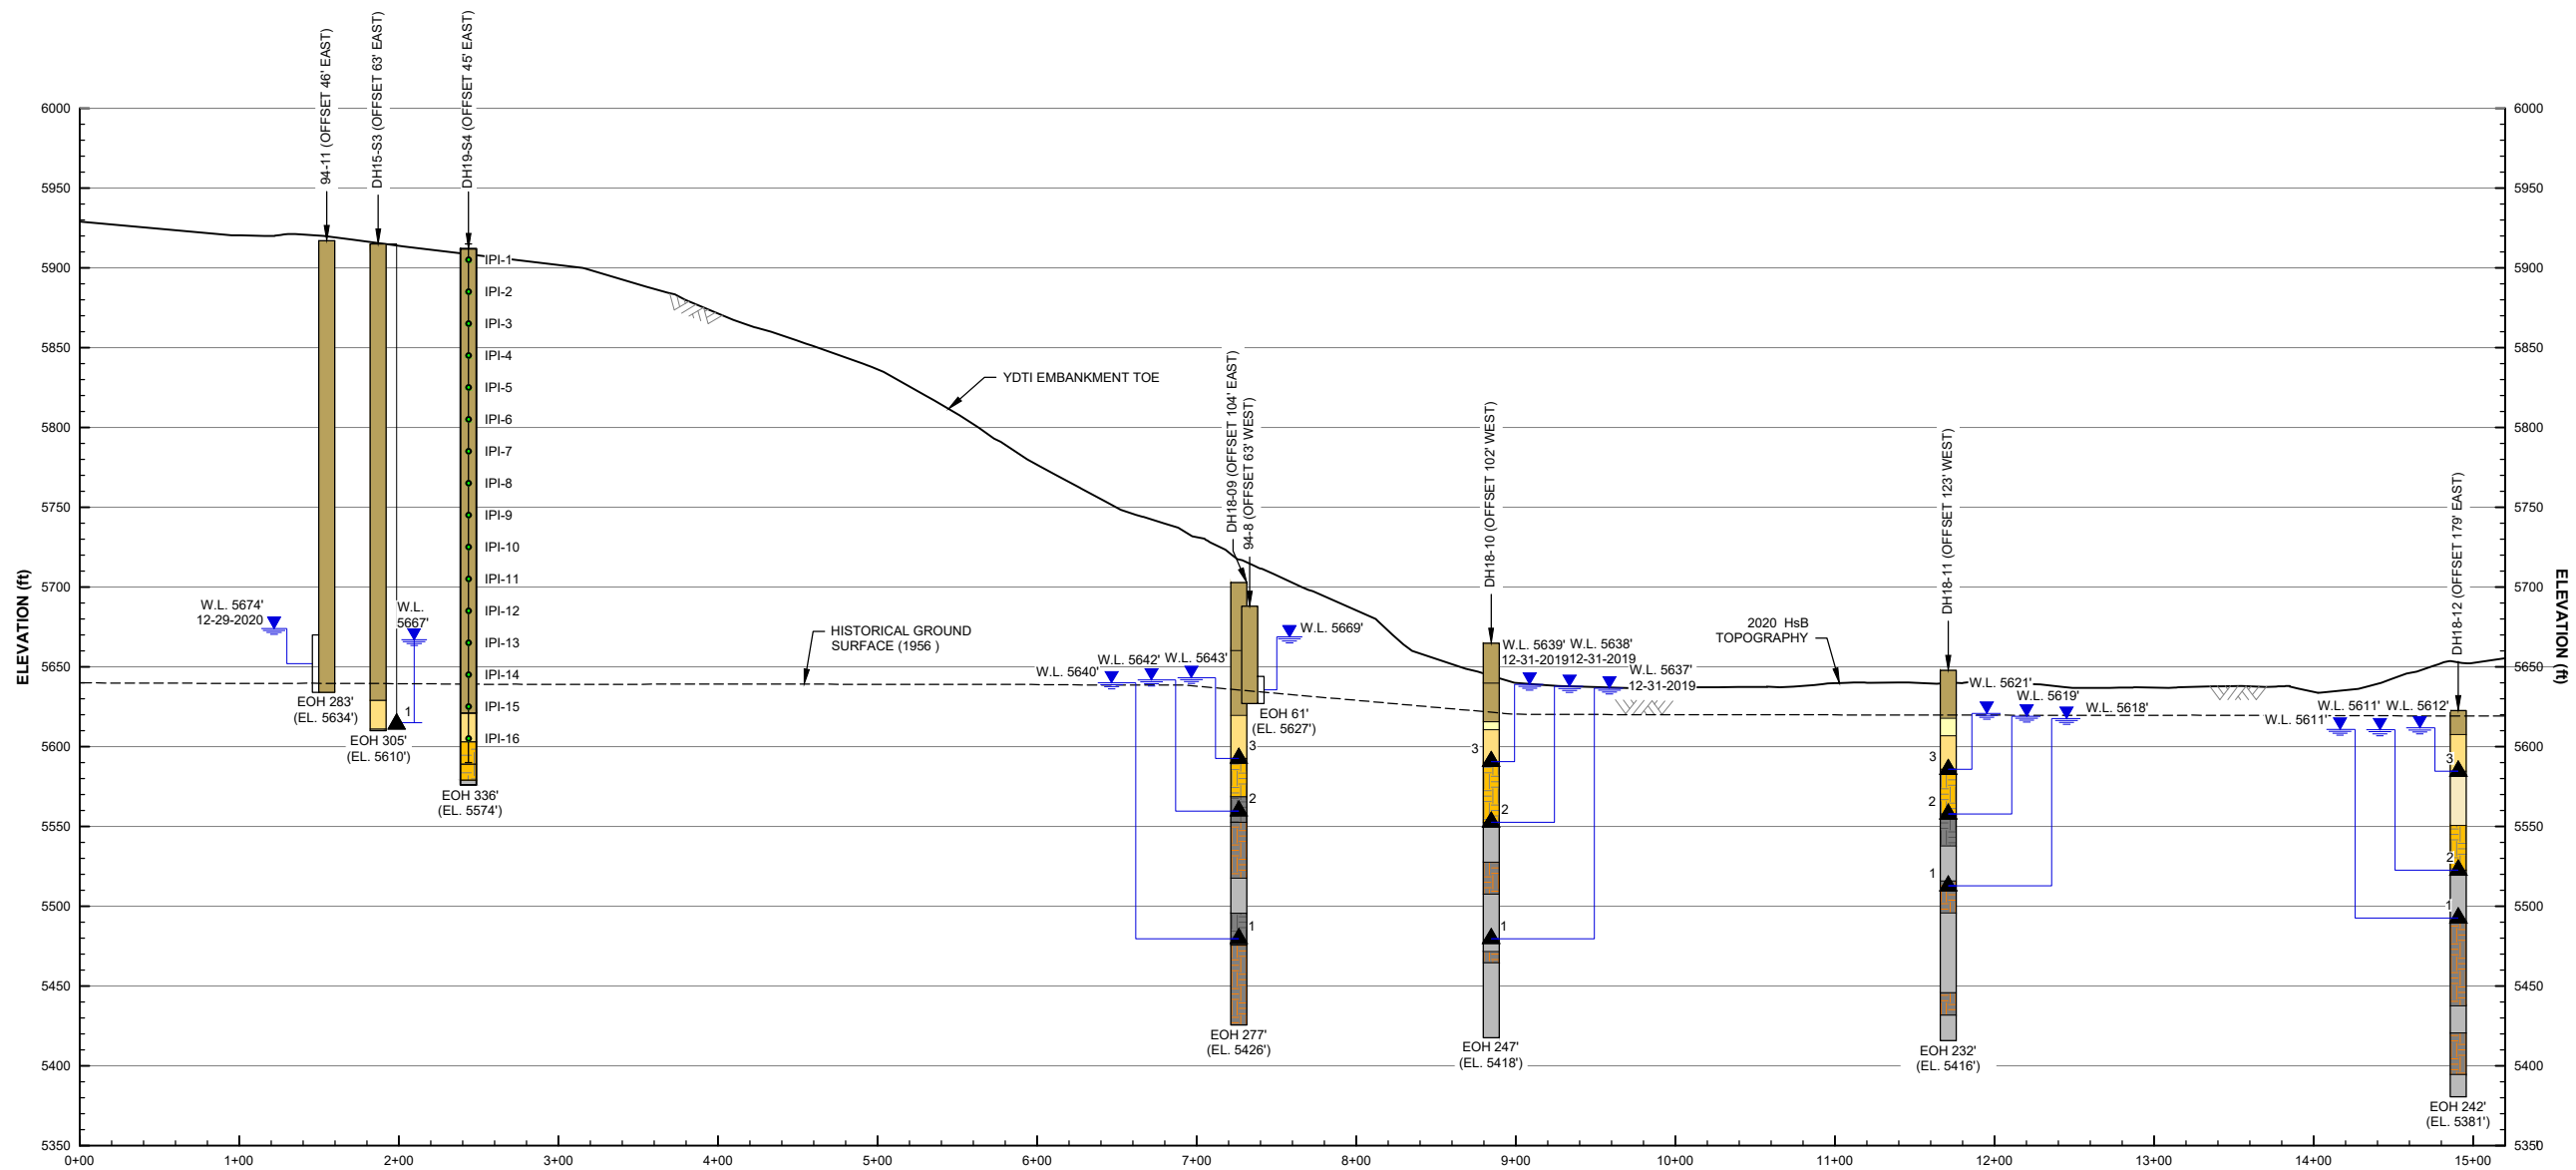
MONTANA RESOURCES, LLP	
YANKEE DOODLE TAILINGS IMPOUNDMENT	
PIEZOMETRIC CONDITIONS ALONG HISTORICAL SILVER BOW CREEK DIVERSION (HsB SECTION 1)	
P/A NO. VA101-126/23	REF NO. 5
FIGURE 4.21	
REV 0	KTD

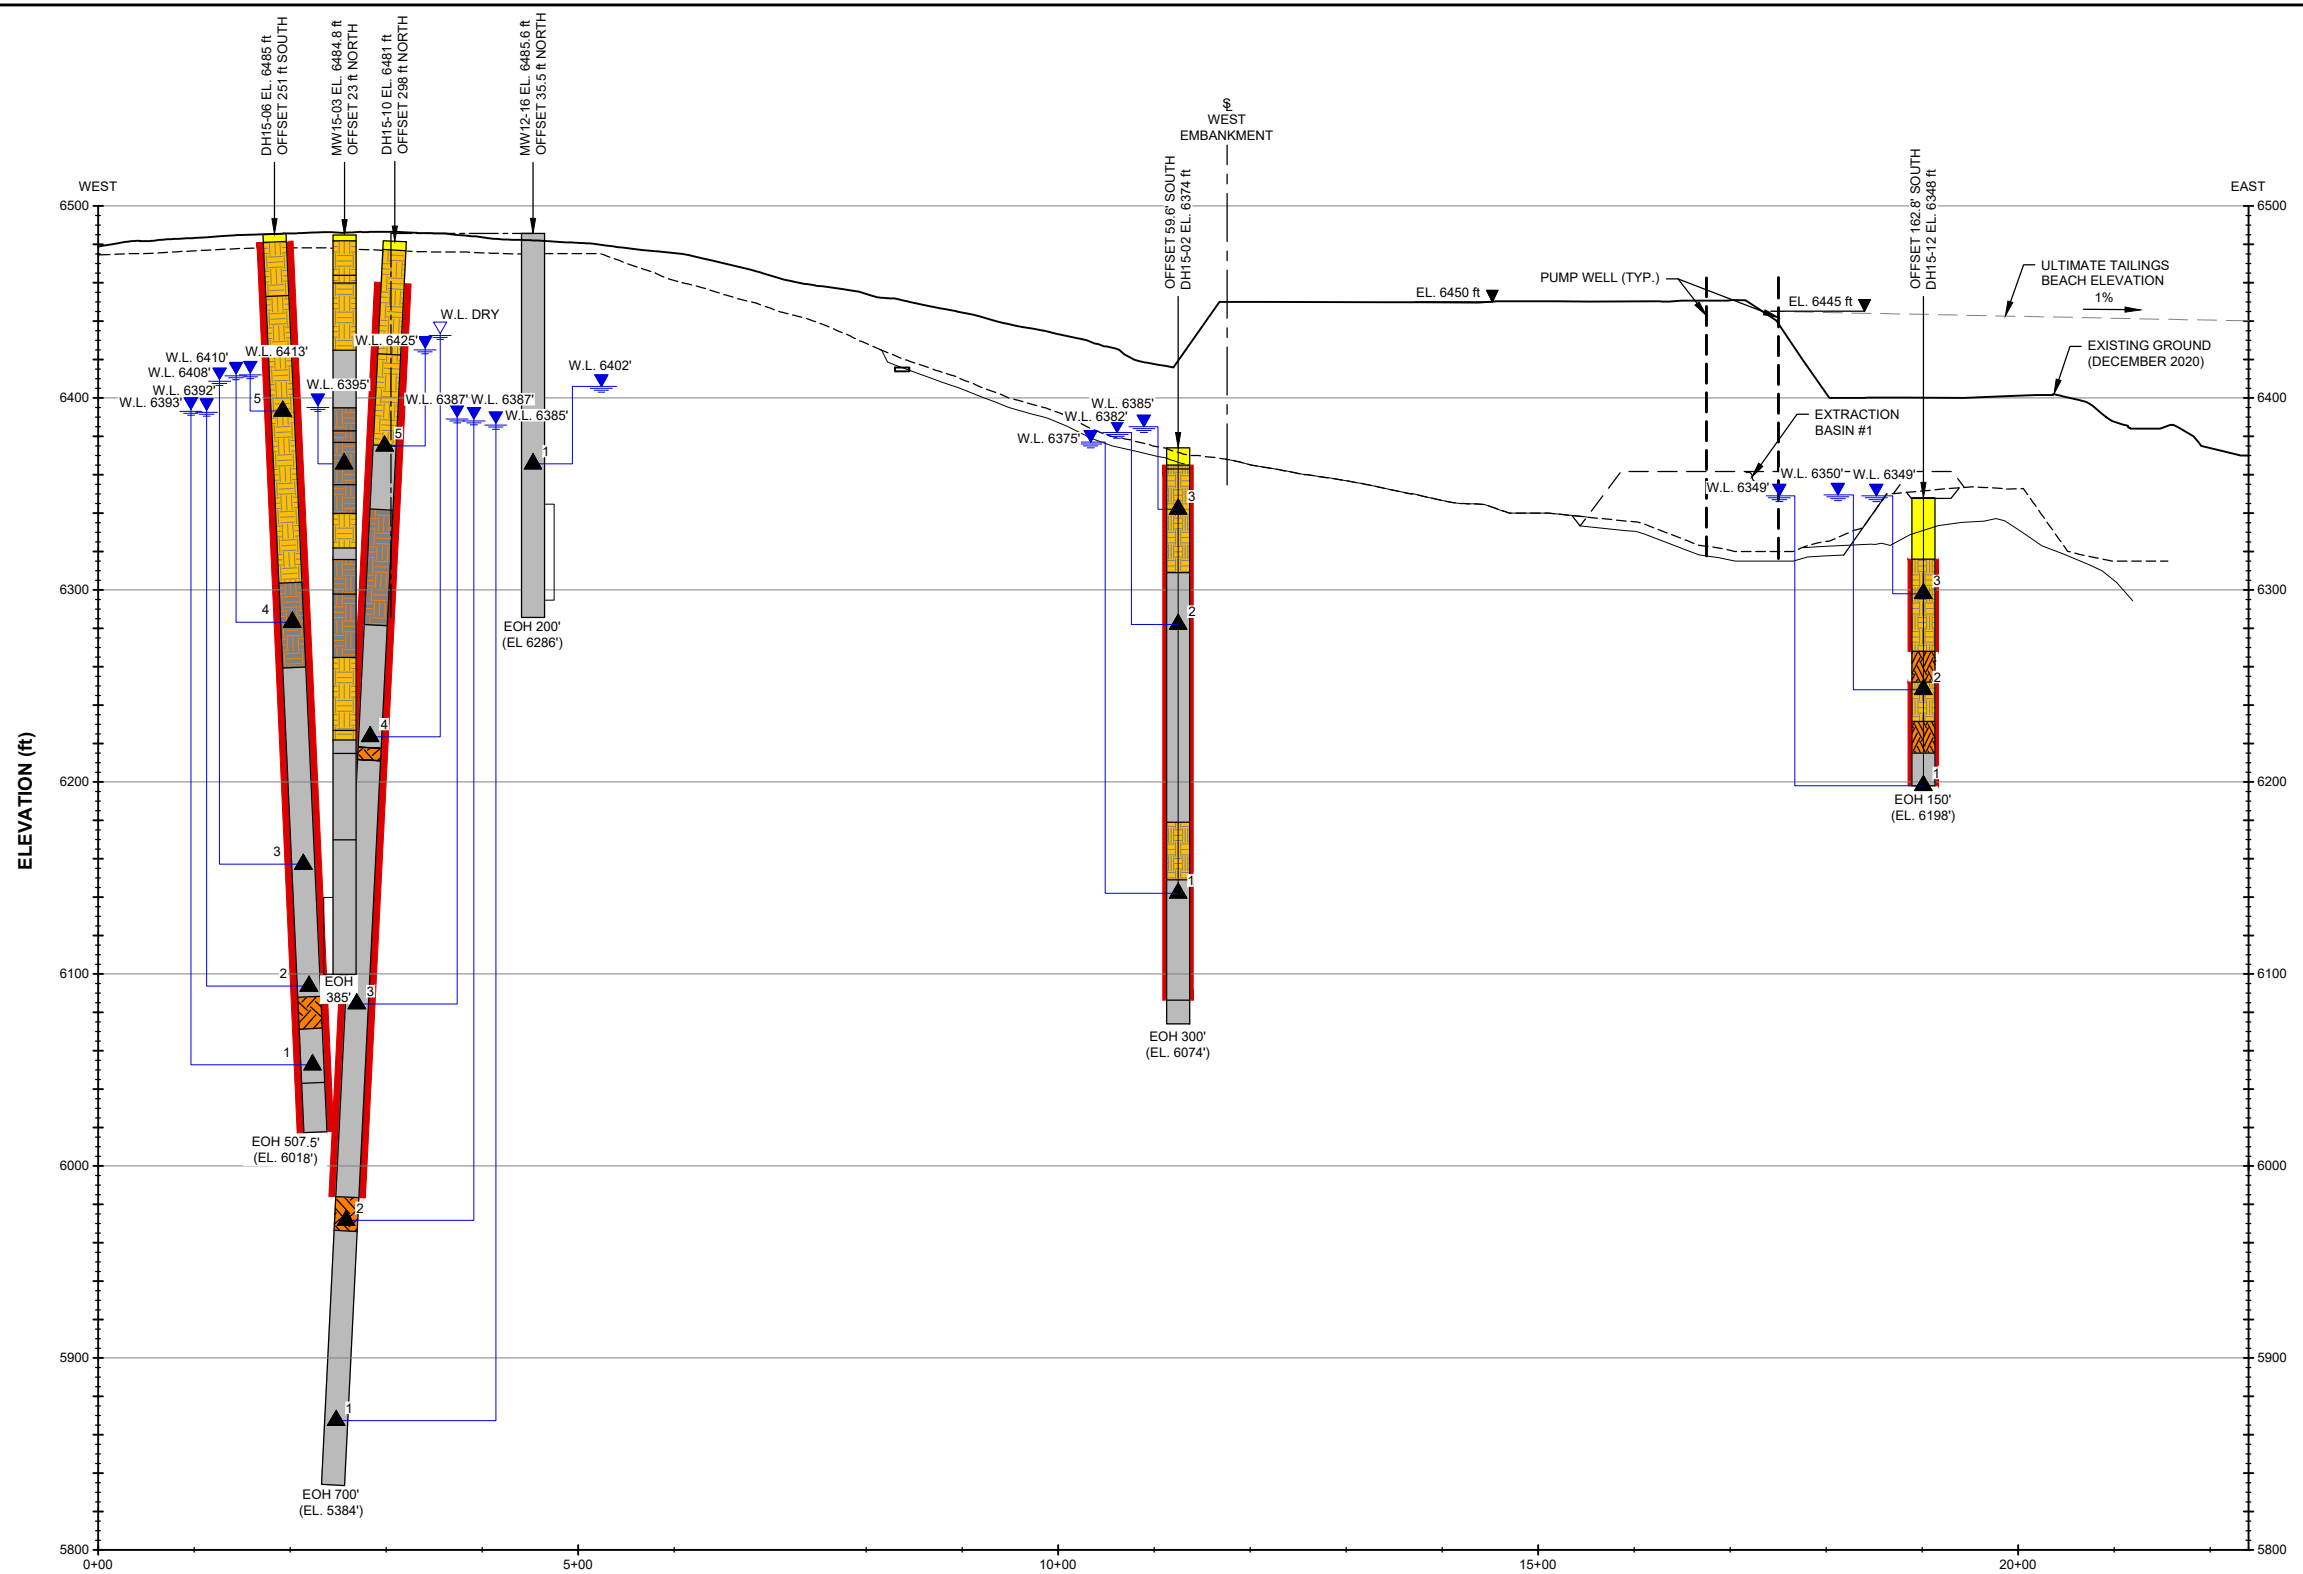
MONTANA RESOURCES, LLP	
YANKEE DOODLE TAILINGS IMPOUNDMENT	
WEST RIDGE HYDRAULIC CONTAINMENT POTENTIOMETRIC LOW (LOOKING NORTH)	
Knight Piésold CONSULTING	P/A NO. VA101-126/23 REF NO. 5 FIGURE 4.24 REV 0

It is important to note that the WED is presently not required to maintain hydrodynamic containment along the West Ridge since the current (December 2020) supernatant pond elevation remains below the piezometric elevations monitored along the ridgeline (ranging between approximately 6,385 and 6,450 ft) within both systems. A comparison of the historical and current YDTI supernatant pond elevations and West Ridge water levels measured in monitoring well MW12-16 are shown on Figure 4.25. This comparison indicates that the current YDTI pond level remains well below the design-basis water table within the Potentiometric Low (6,380 ft measured in MW12-16). The water table within the Potentiometric Low has increased by approximately 23 ft after the selection of the design basis level, resulting in a water table at approximately EL. 6,405 ft in December 2020. The December 2020 YDTI supernatant pond elevation is approximately 6,360 ft, which is approximately 45 ft below the current piezometric elevation at the ridge.

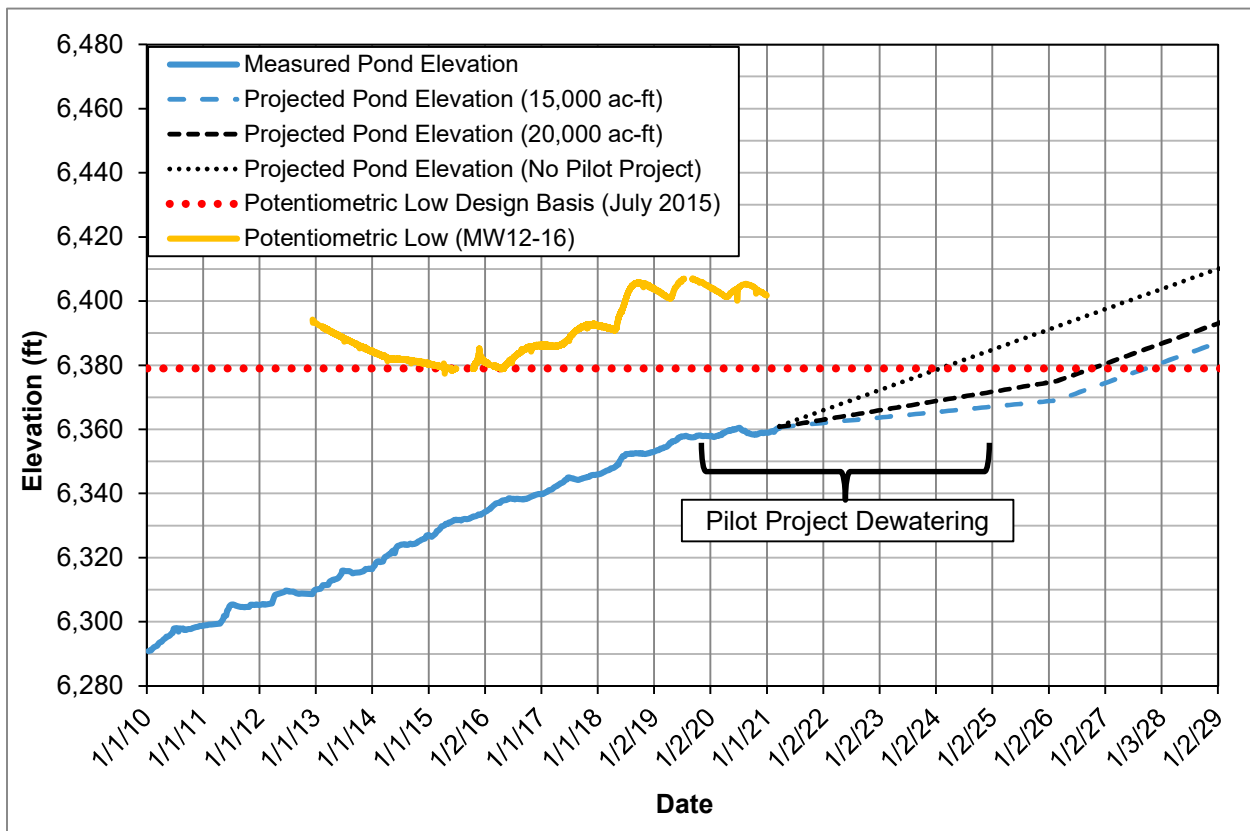
Figure 4.25 YDTI Pond Elevation vs. Piezometric Conditions within Potentiometric Low

Extrapolation of the current YDTI pond elevation trend suggests that the WED will not be required until January 2027 for the purpose of hydrodynamic containment so long as continued water management associated with the Berkeley Pit Pilot Project continues. Discontinuation of the Pilot Project may result in the need for the WED by January 2024 to maintain containment. However, it is also noted that the WED is currently operational, thus, it will continue to enhance the security of the hydrodynamic seepage containment system along the West Ridge during current and future operations.
