Prepared for
Montana Resources, LLP
600 Shields Avenue
Butte, Montana
USA, 59701

VA101-126/23-5

YANKEE DOODLE TAILINGS IMPOUNDMENT

2020 DATA ANALYSIS REPORT

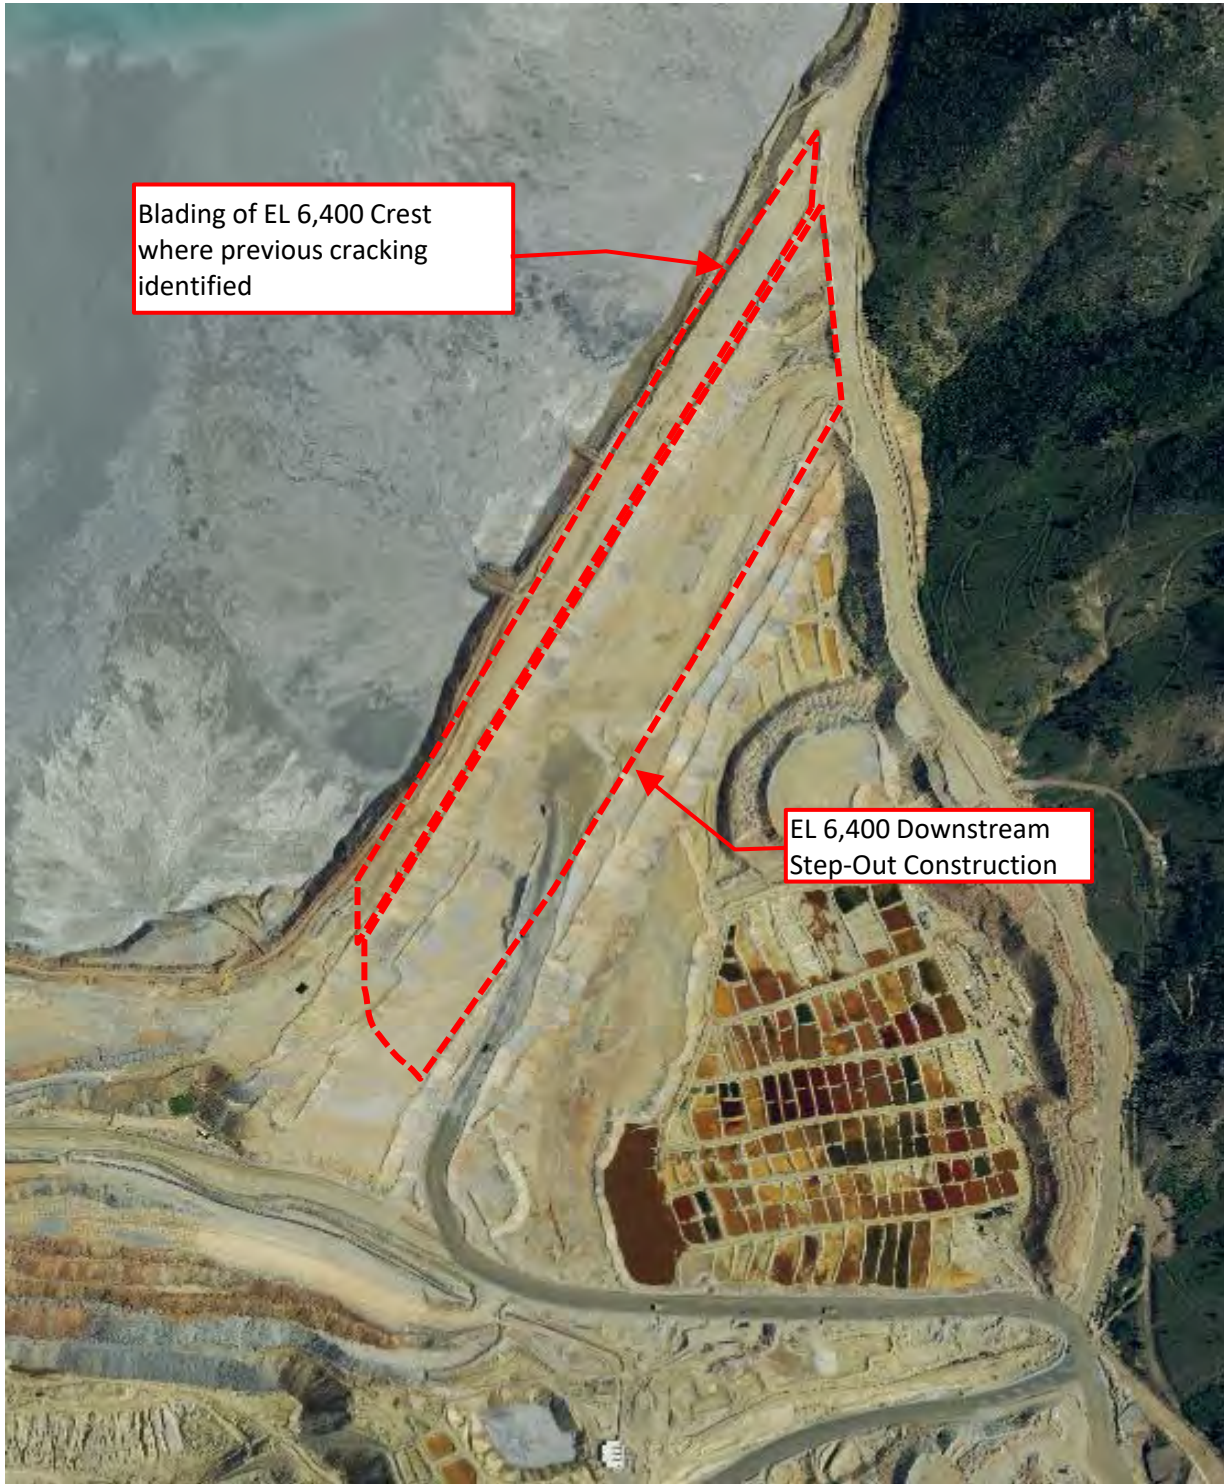
1. AERIAL IMAGERY FROM JULY 1, 2019 PROVIDED BY MONTANA RESOURCES, LLP.
2. CONSTRUCTION AREAS ARE ESTIMATED TO REPRESENT ACTIVE AREAS DURING Q1 OF 2020.

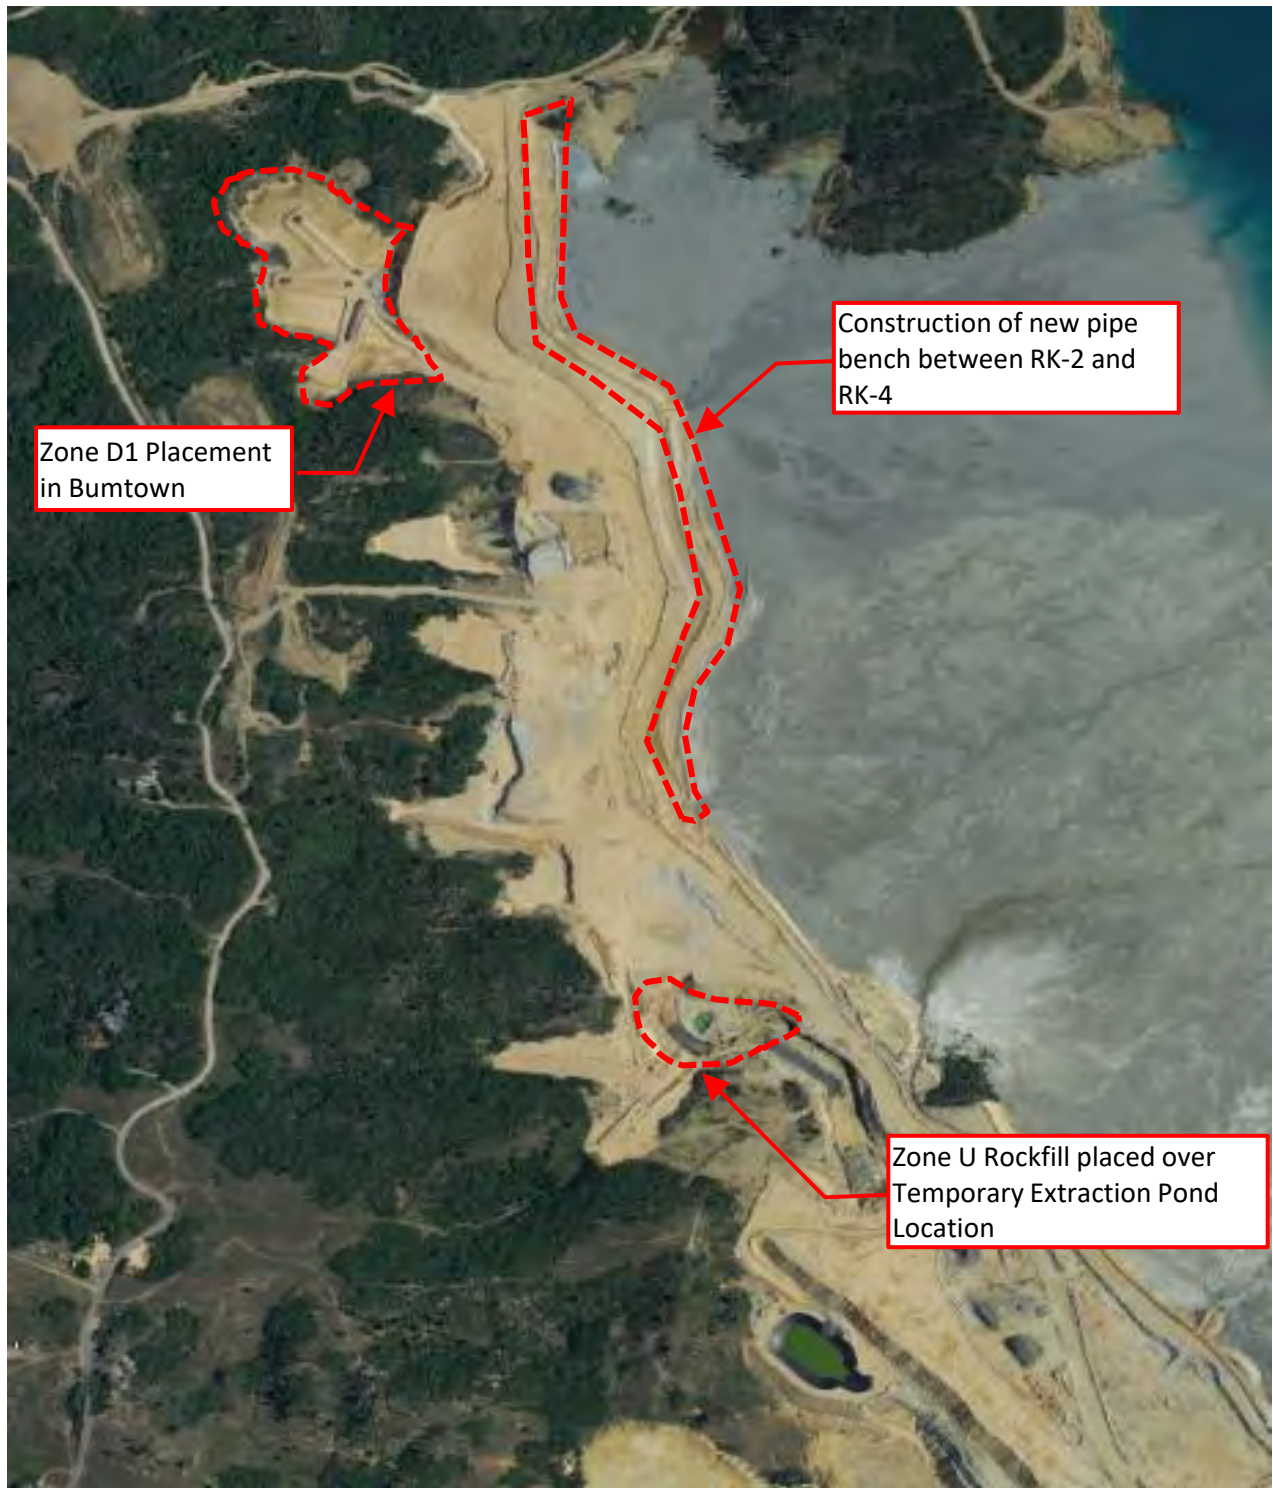
- 1. AERIAL IMAGERY FROM JULY 1, 2019 PROVIDED BY MONTANA RESOURCES, LLP.
- 2. CONSTRUCTION AREAS ARE ESTIMATED TO REPRESENT ACTIVE AREAS DURING Q1 OF 2020.

The area surrounding the Temporary Extraction Pond was filled in with Zone U material by MR as shown on Photo 9. The Zone D1 lifts along the western edge of this area still need to be placed. The MR haul fleet has continued to place Zone D1 in 5 ft lifts near the Drain Pod 1 area (Bumtown), which has reached approximately EL. 6,395 ft as shown in Photo 10. Areas of active construction along the West Embankment during Q1 are shown on Figure 3.

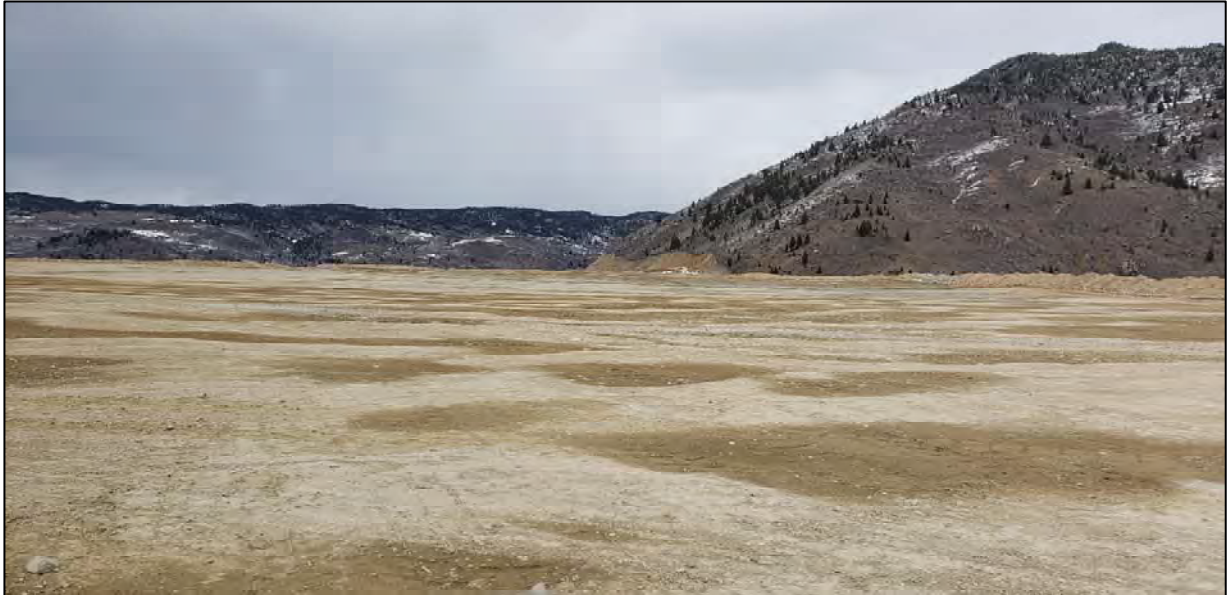
PHOTO 1 – North-South Embankment – Construction of the 6,400 ft lift. (March 30, 2020)

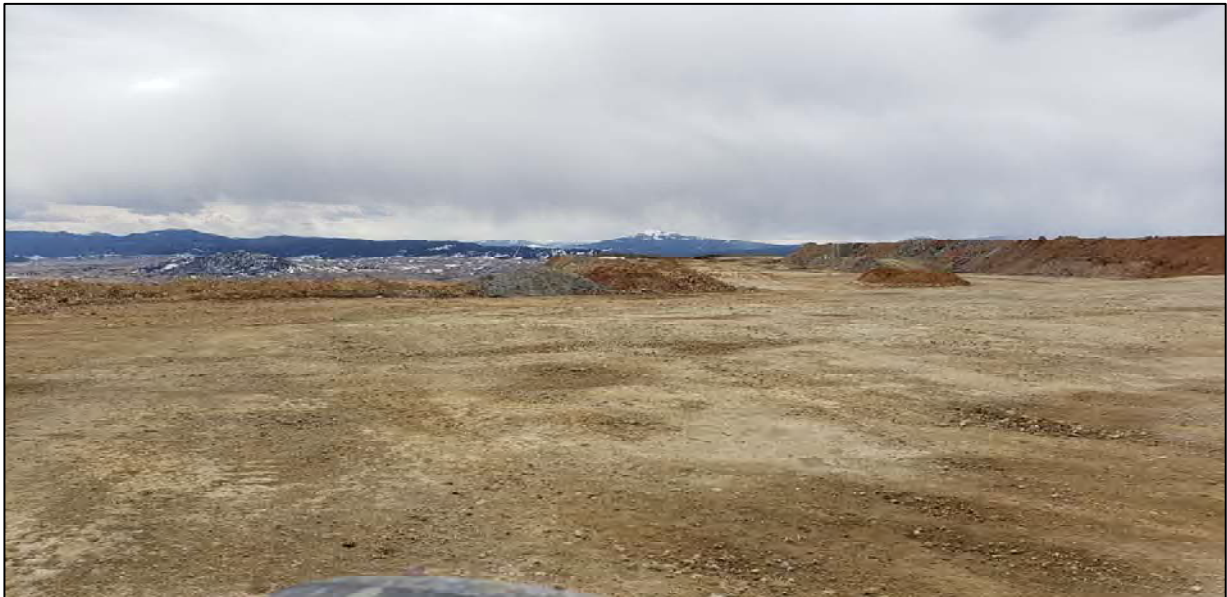
PHOTO 2 – North-South Embankment – Construction of the 6,400 ft lift nearly complete near the southern extent. (March 30, 2020)

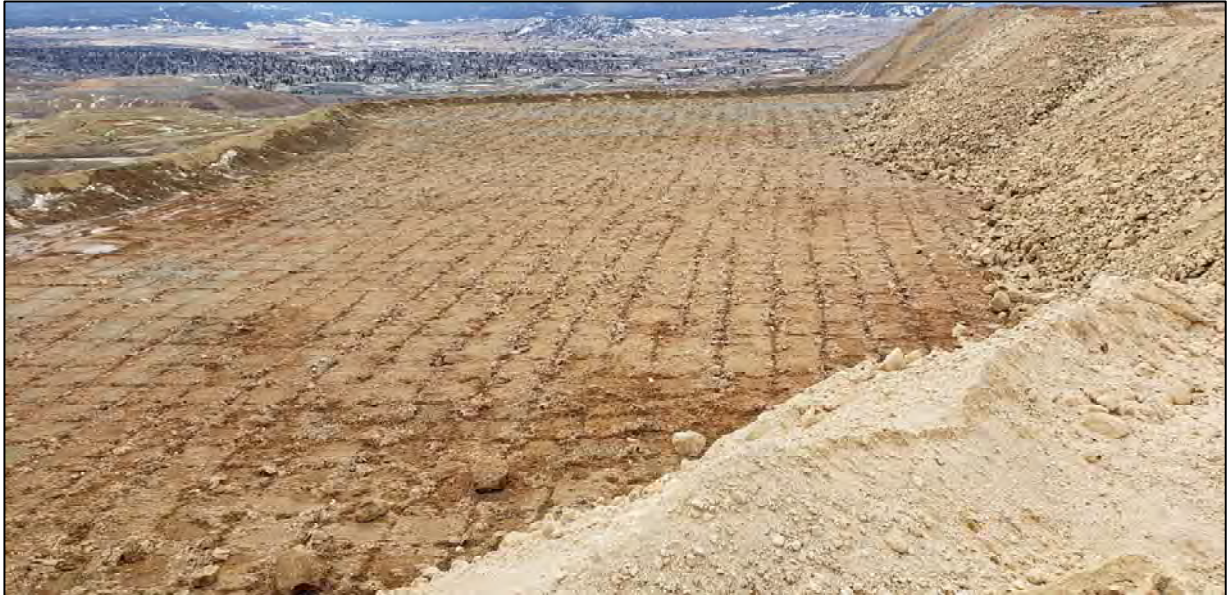
PHOTO 3 – North-South Embankment – Southern extent of 6,350 ft lift surface scarified prior to advancement of the 6,400 ft lift. (March 30, 2020)

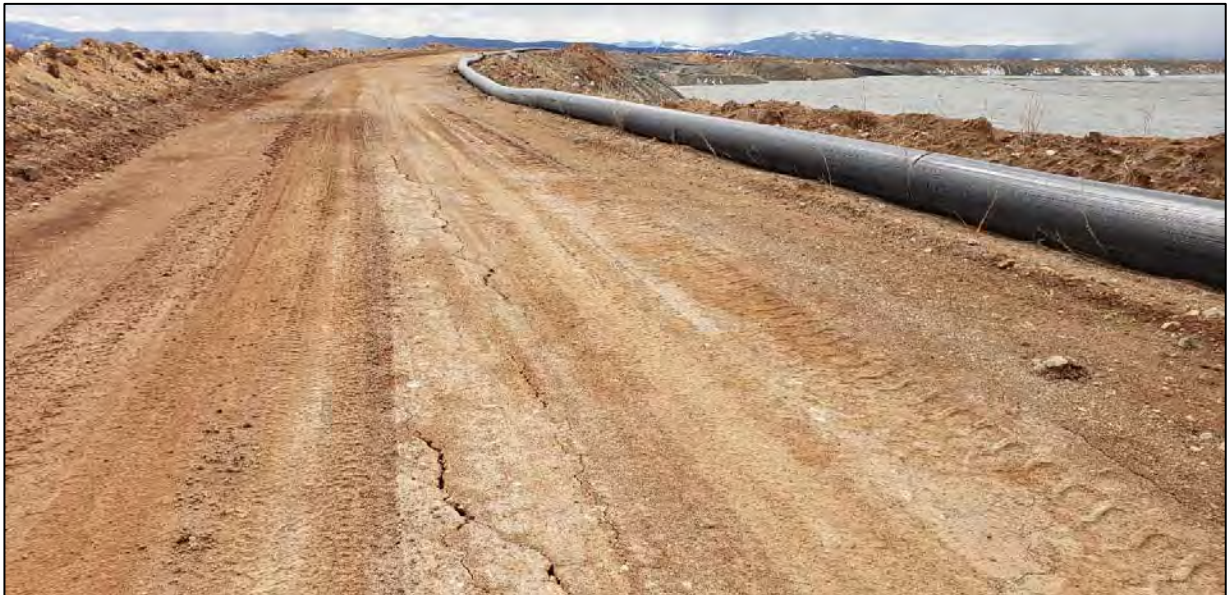
PHOTO 4 – North-South Embankment – Dormant cracking along the upstream pipe corridor near the NS-2 discharge location. (March 30, 2020)

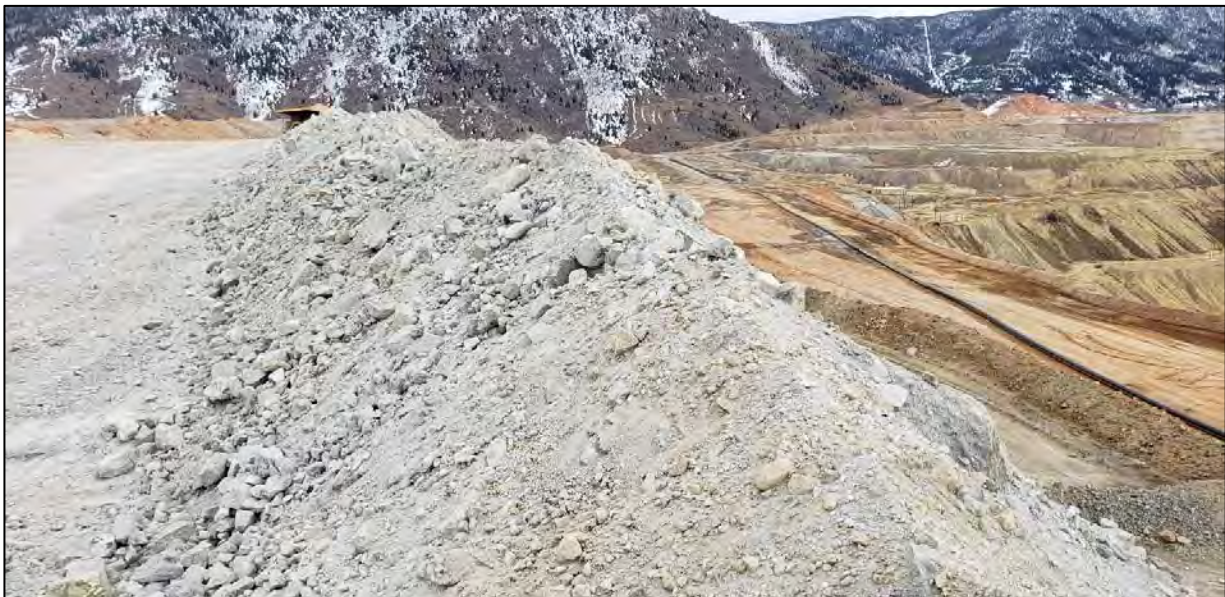
PHOTO 6 – East-West Embankment – New pipe bench and one tailings line moved beyond projected EL. 6,450 ft embankment toe. Additional dozer work needed above Booster Station #2 before remaining pipelines are relocated. (March 30, 2020)

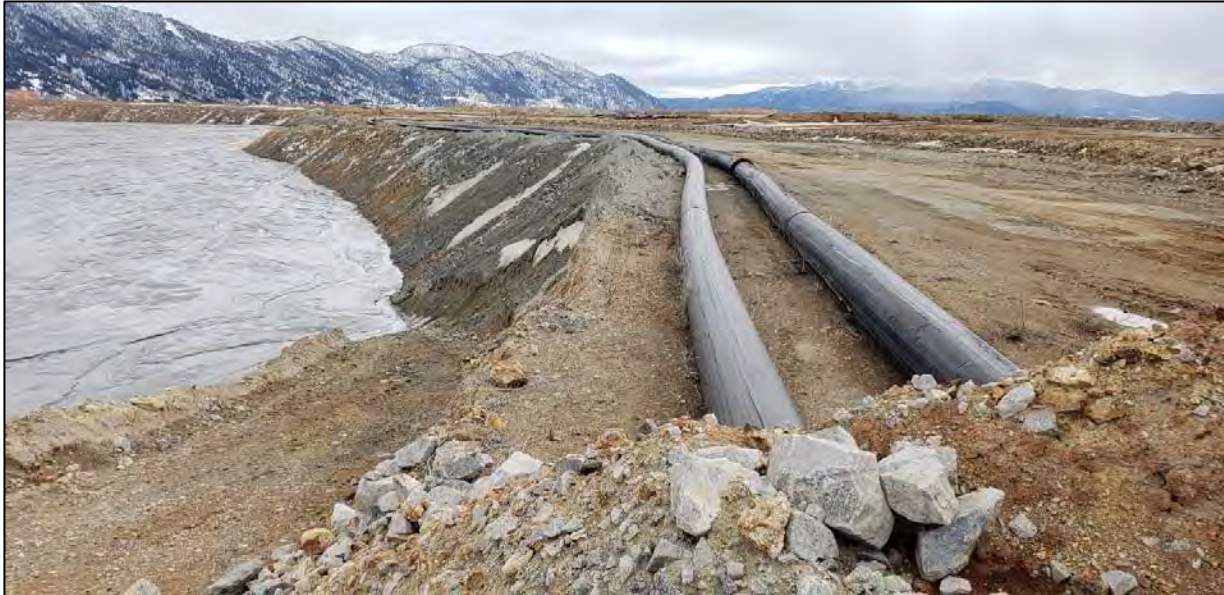
PHOTO 7 – East-West Embankment – Over steepened cut slopes on Terramac access ramp. (March 30, 2020)

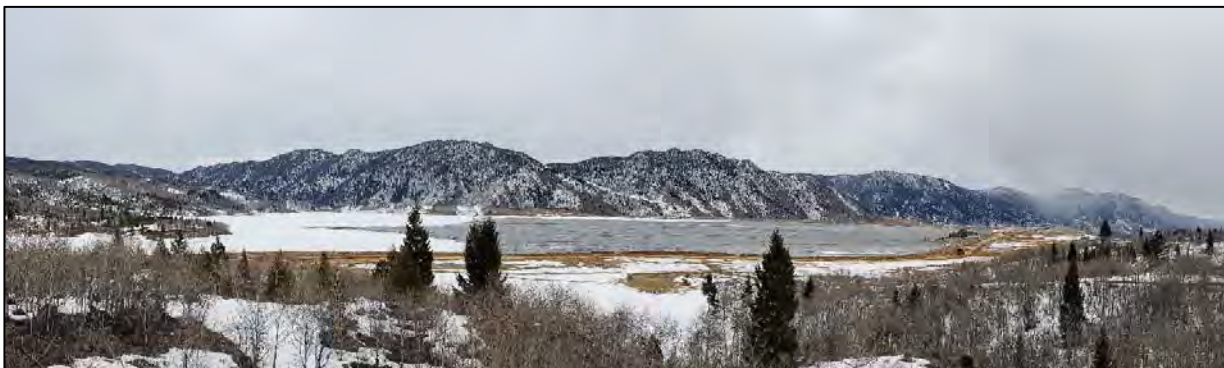
PHOTO 8 – West Embankment – Overview from the West Ridge Topsoil Stockpile. (March 30, 2020)

The majority of the West Embankment is constructed to EL. 6,400 ft and the West Embankment Drain (WED) has been completed. An overview of the West Embankment area as viewed from a topsoil stockpile on the West Ridge is shown on Photo 8. Mungas Construction Co. (Mungas) has completed their scope of work and are no longer on site.

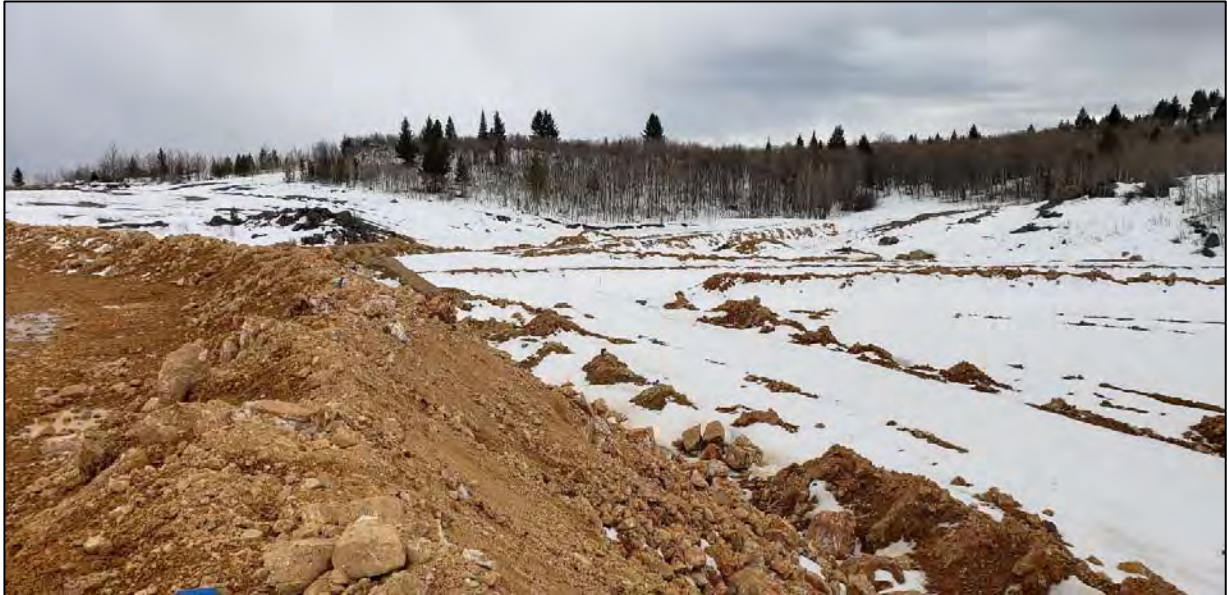
PHOTO 9 – West Embankment – Area above Temporary Extraction Pond filled in with U material, D1
5 ft lifts are planned to be placed in Q2. (March 30, 2020)

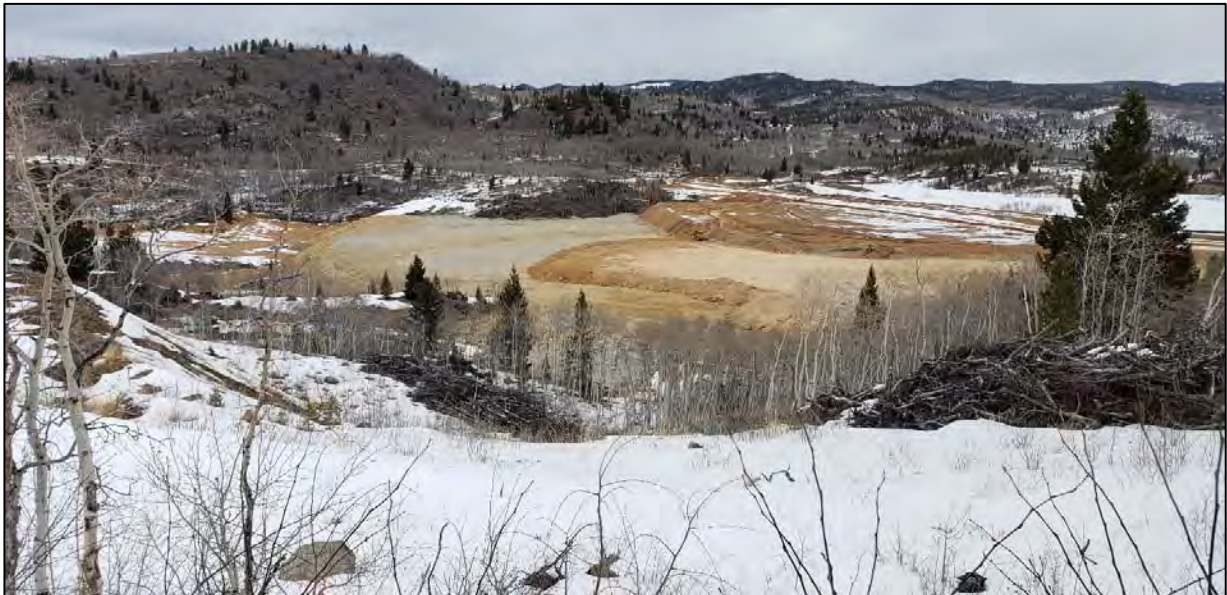
PHOTO 10 – West Embankment – Placement of the 6395 lift of Zone D1 Material near Drain Pod 1
(Bumtown). (March 30, 2020)

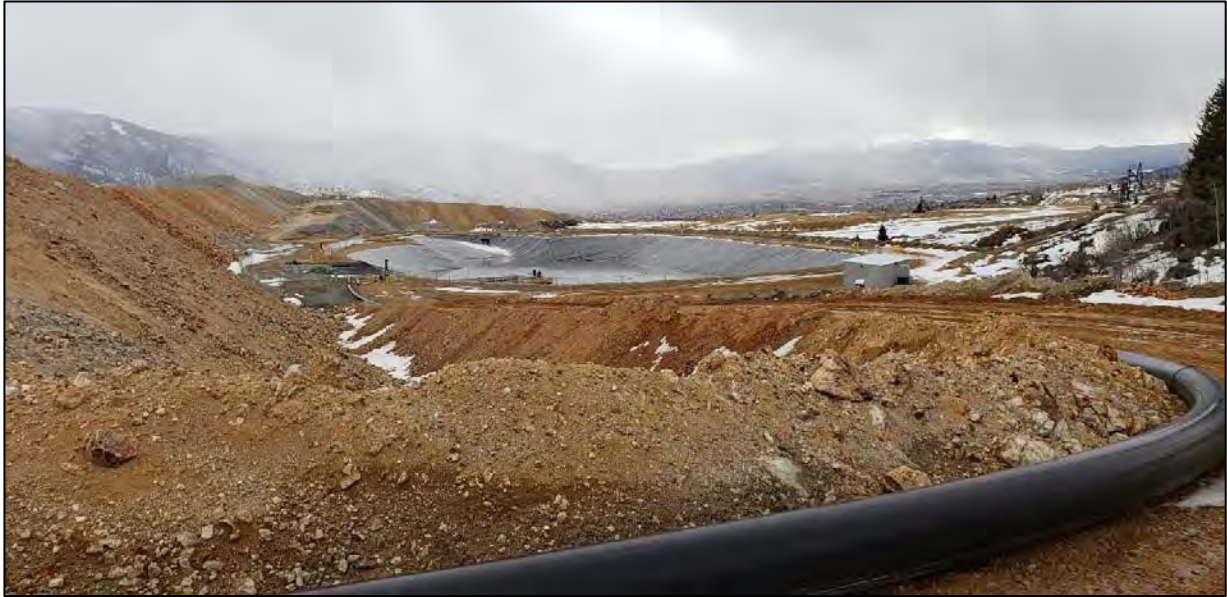
PHOTO 11 – West Embankment – WED Extraction Pond and Pump Station. (March 30, 2020)

The Extraction Pond pumps installed on the floating barge (Photo 11) are operating and were discharging at approximately 700 gpm at the time of the field review. The welding and placement of the emergency overflow pipelines from the Extraction Pond is still to be completed as shown on Photo 12. The emergency overflow discharge structure at the outlet of the emergency overflow pipelines has been constructed; however, additional large boulders for energy dissipation need to be placed after the pipeline installation is complete.

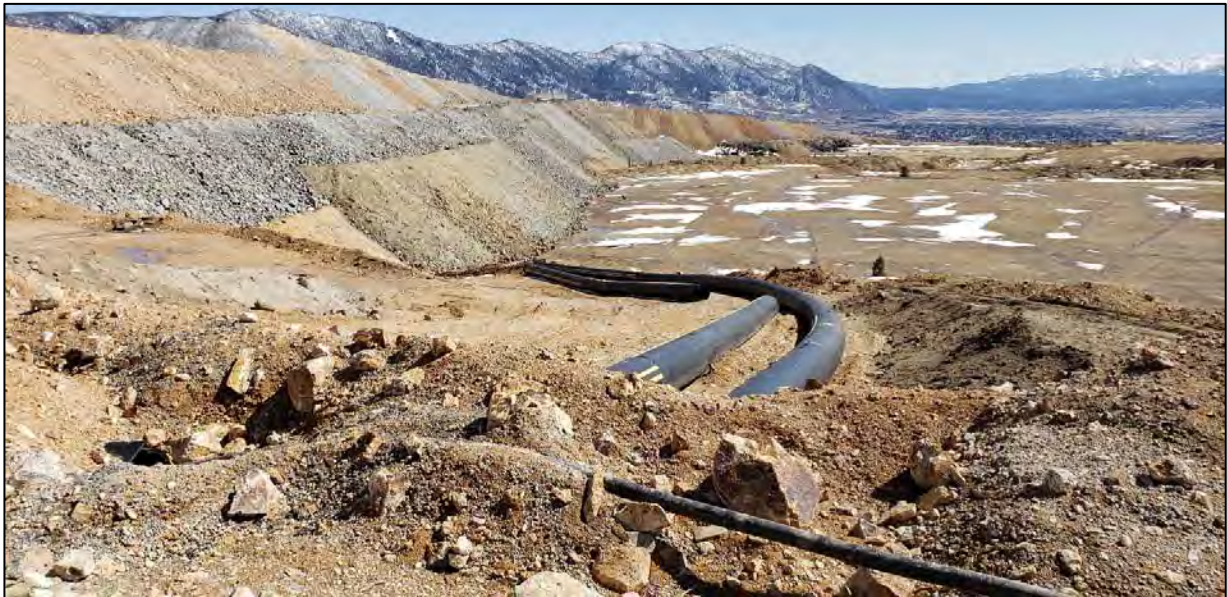
PHOTO 12 – West Embankment – Extraction Pond Emergency Pipelines, still under construction. (March 30, 2020)

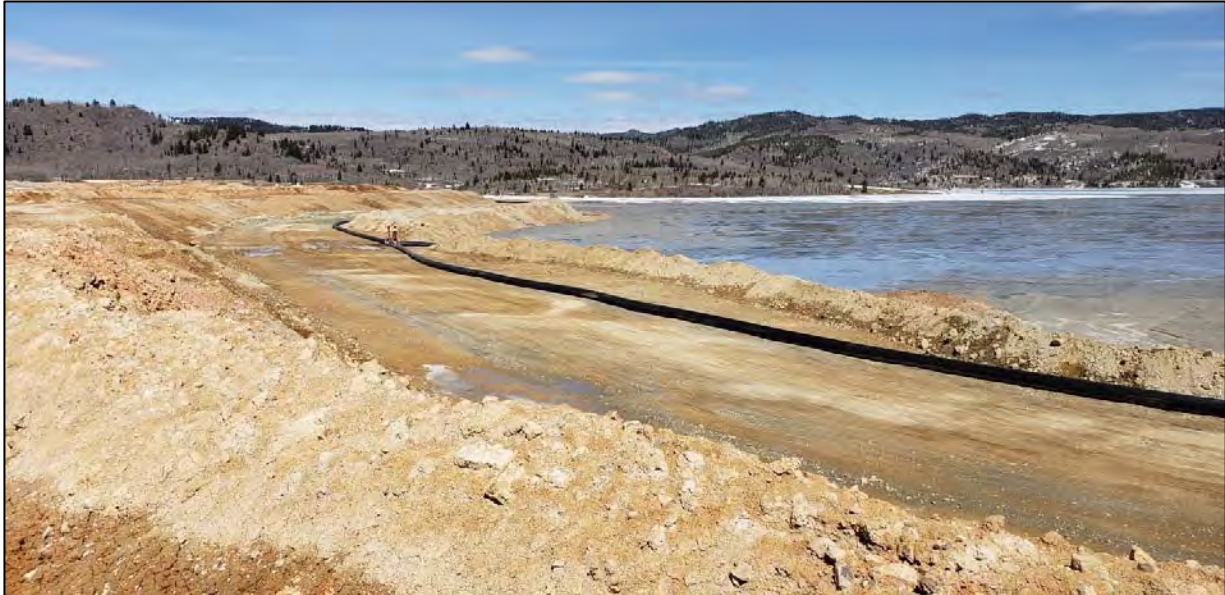
PHOTO 13 – West Embankment – Completed Pipe Bench Raise of Tailings Line #1 and Discharge Point RK-2 in use. (April 10, 2020)

Tailings Line 1 was inoperable from RK-2 to RK-4 from early January 2020 until mid March 2020 due to construction of a new pipe bench to raise the pipeline above current beach elevations. The line is now fully functional, as shown in Photo 13.

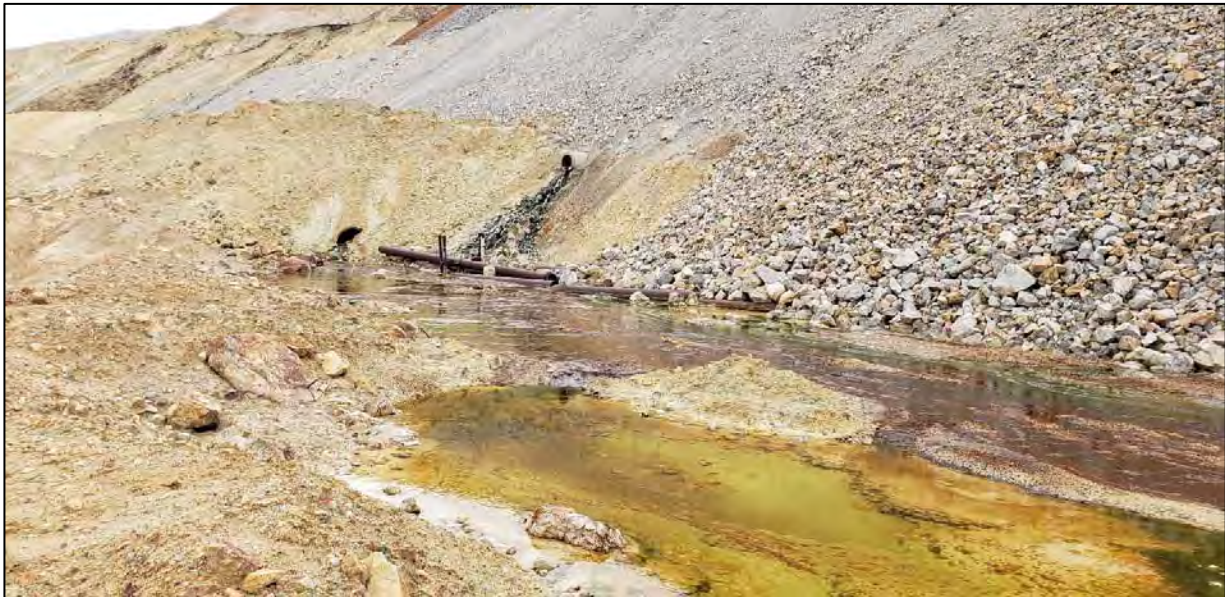
PHOTO 14 – Seep 10 Area. (March 30, 2020)

The condition of the Seep 10 flow paths, surface collection ditches, and stilling pond appear consistent with previous field reviews as shown in Photos 14 and 15. The ultrasonic lookdown level sensor installed at the Seep 10 weir was operating normally and the reading on the staff gauge at the time of the field review was approximately 0.38 as shown in Photo 16.

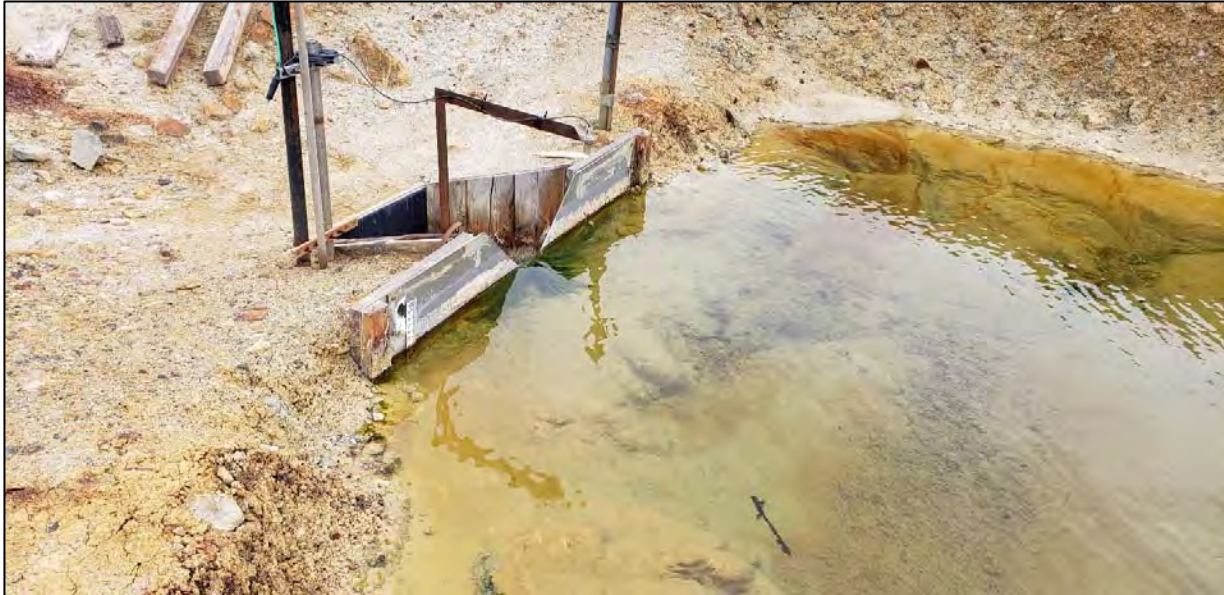
PHOTO 15 – Seep 10 Weir. (March 30, 2020)

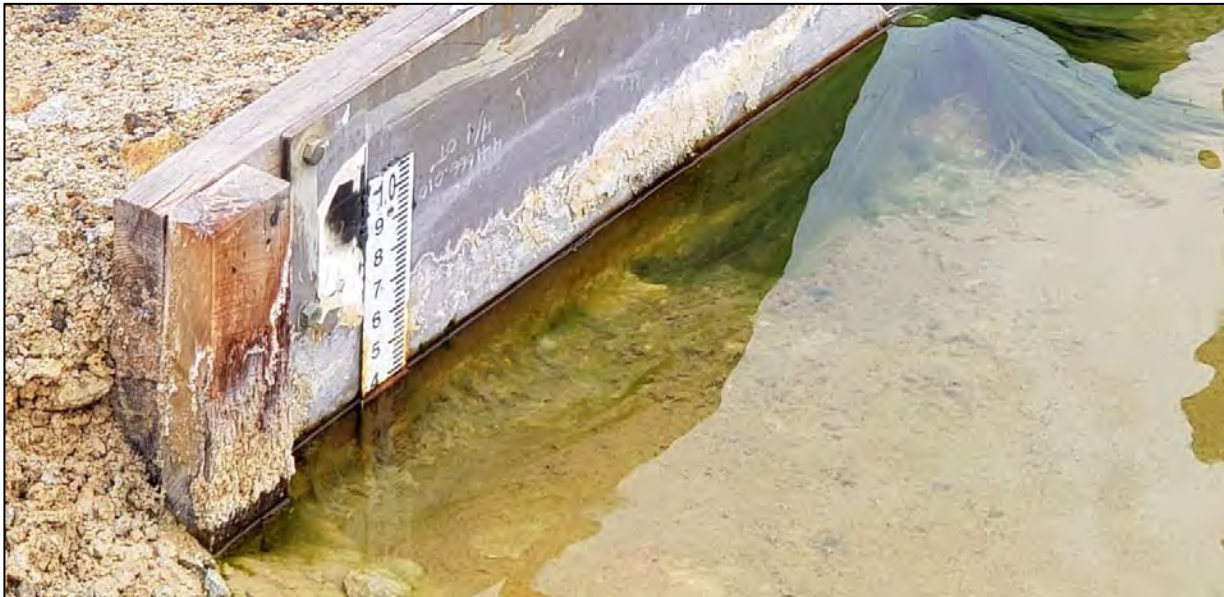
PHOTO 16 – Seep 10 Weir Staff Gauge reading approximately 0.38. (March 30, 2020)

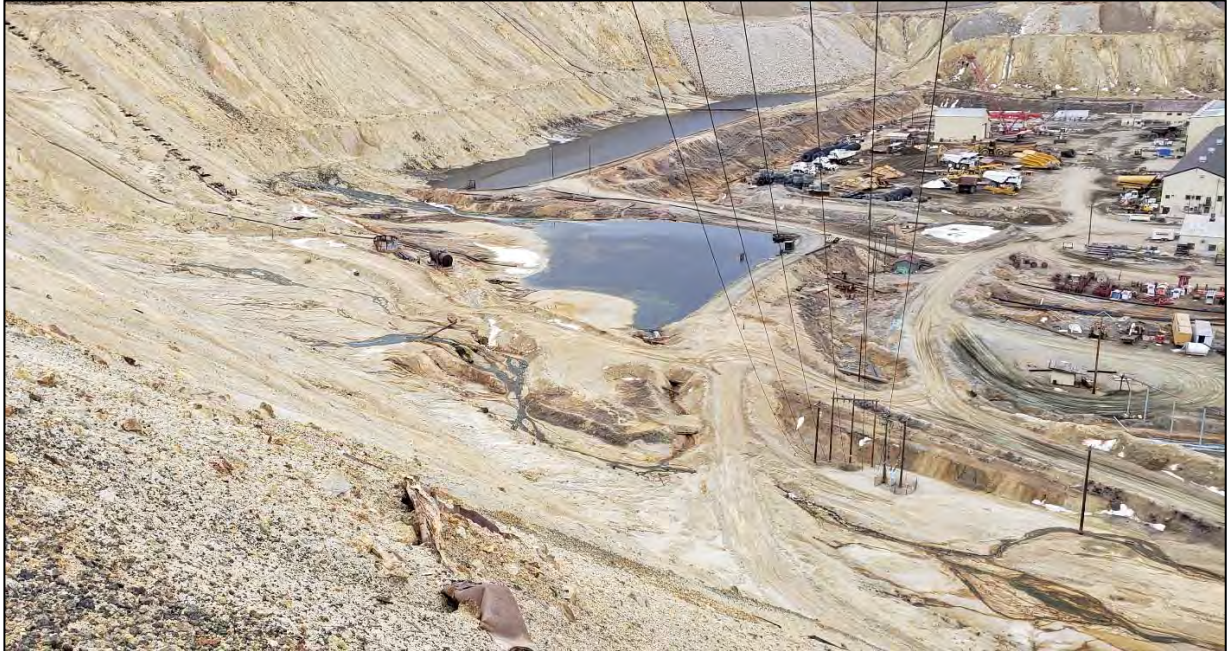
PHOTO 17 – Horseshoe Bend (HsB) Area – Leach seeps along toe of East-West Embankment viewed from Seep 10 bench. (March 31, 2020)

Horseshoe Bend (HsB) seepage flow paths and collection ditches at the toe of the East-West Embankment were generally consistent with previous field reviews as shown in Photos 17 and 18.

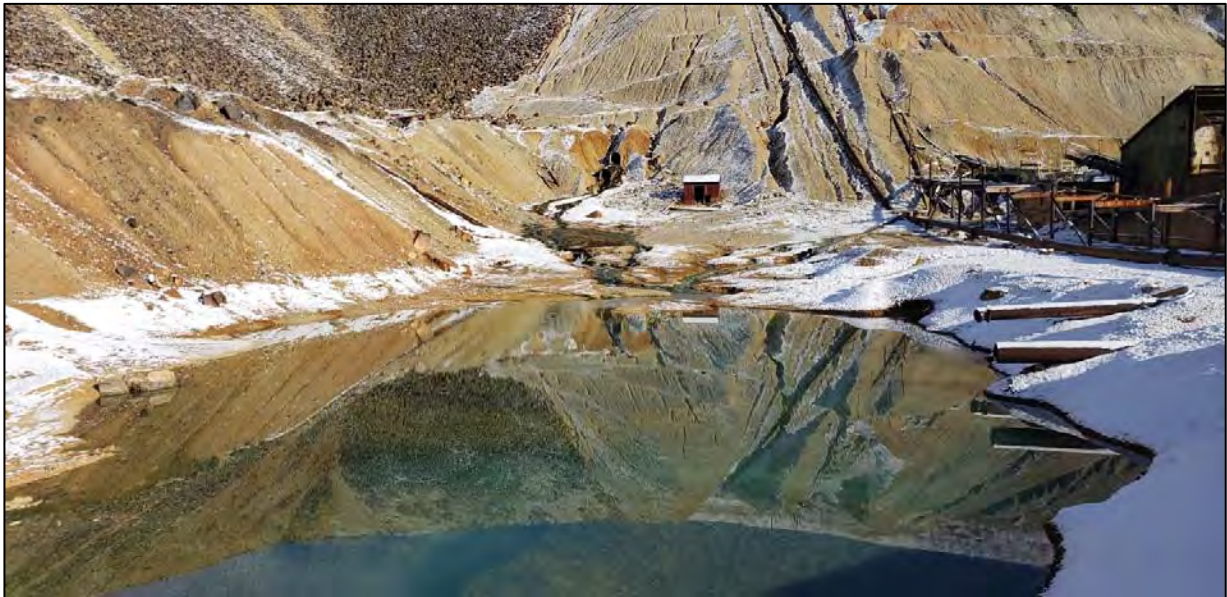
PHOTO 18 – HsB Area – Upper seepage collection area west of Precipitation Plant. (March 31, 2020)

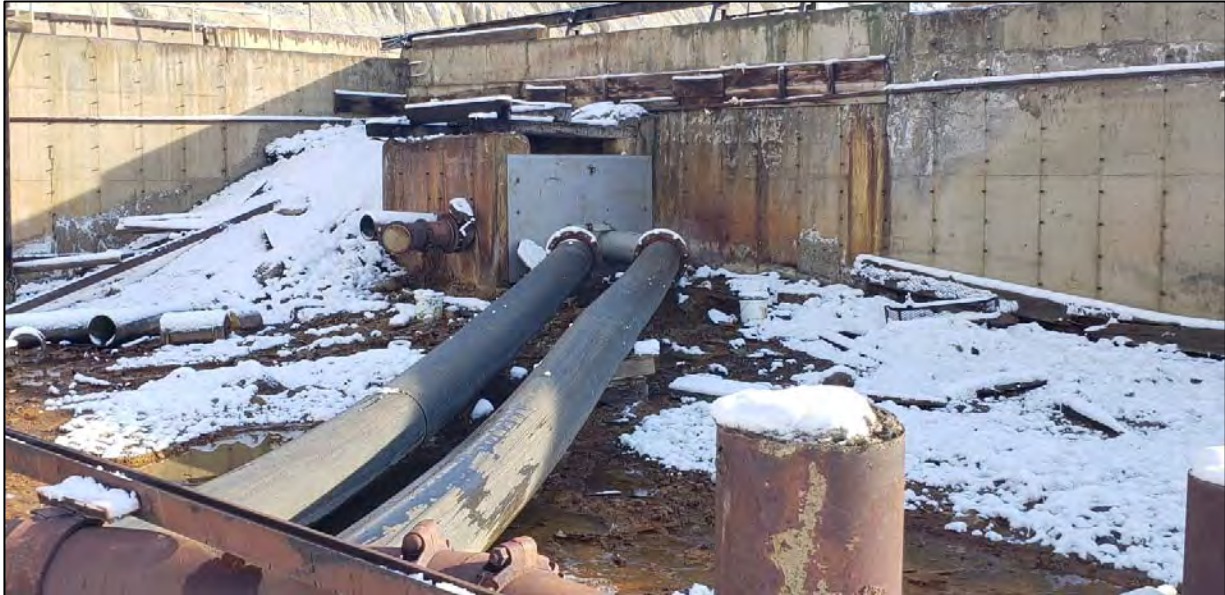
PHOTO 19 – HsB Area – Repair work done to discharge pipe bulkhead exiting #5 and #6 Cells of Precipitation Plant.

Various overflow or seepage flows were identified at the Precipitation Plant area during previous field review and EOR Annual Inspection, and corrective measures have been taken. Repairs were made to cracks in the bulkhead at the Precipitation Plant where the discharge pipelines exit the #5 and #6 Cells as shown in Photo 19. The water level at the Cell 10 pump located downstream of the HsB Upper Pond was lower than observed during previous field reviews as shown on Photo 20. The Cell 10 pump was replaced and effectively handles all incoming flows.

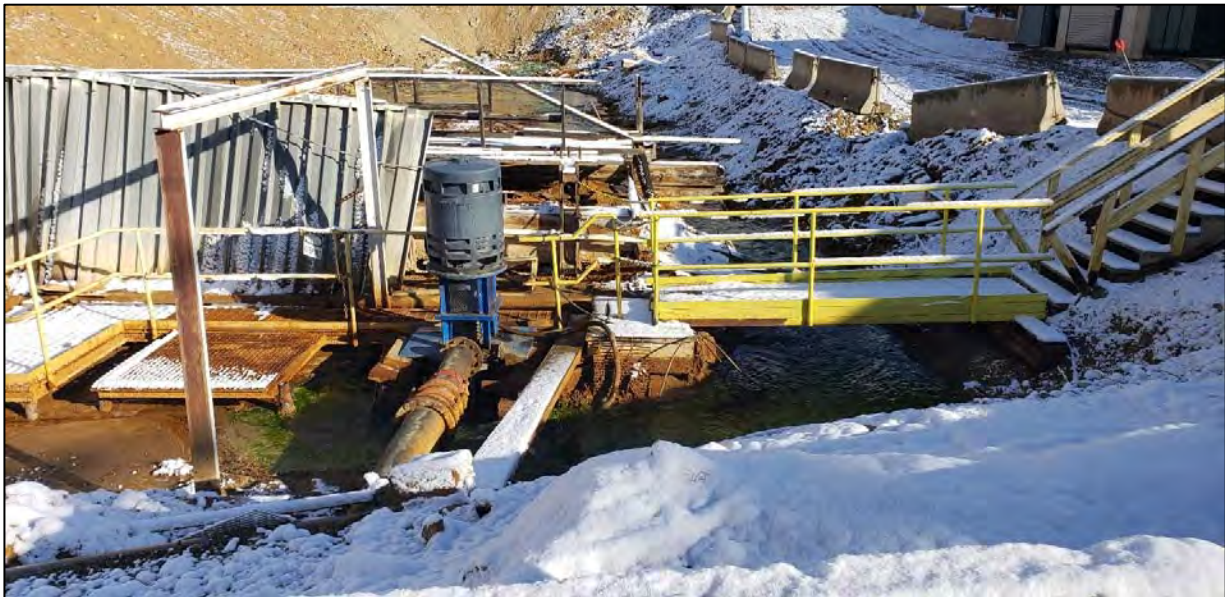
PHOTO 20 – HsB Area – Cell #10 Pump, new pump handling incoming flows, no overflowing water to HsB Lower Pond.

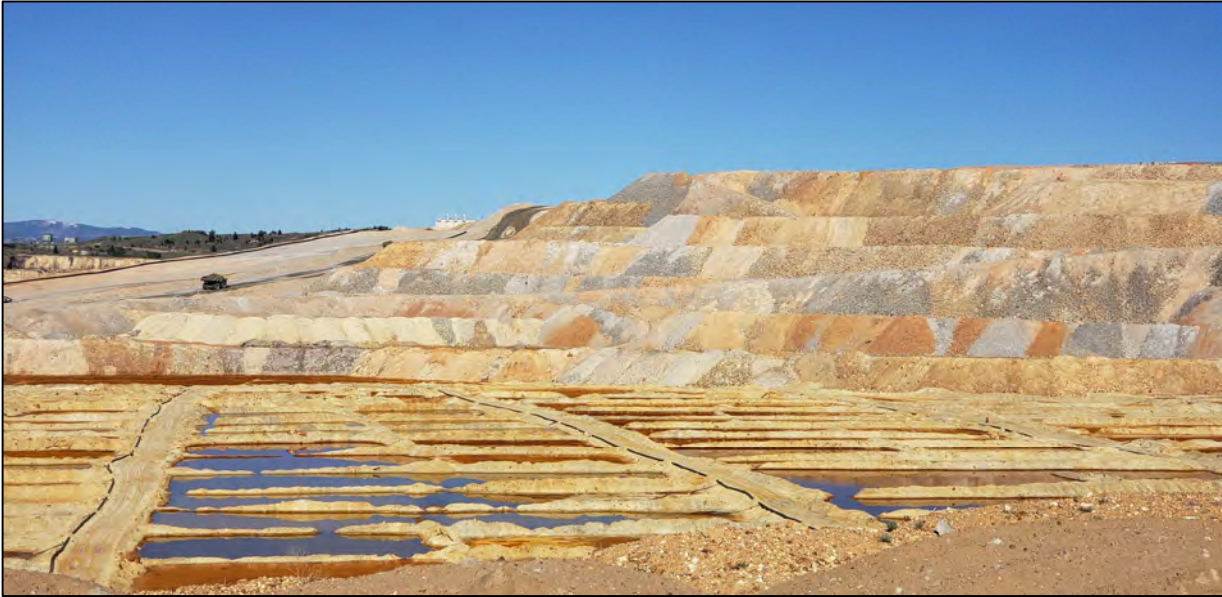
PHOTO 1 – North-South Embankment – Downstream step-out construction. (June 26, 2020)

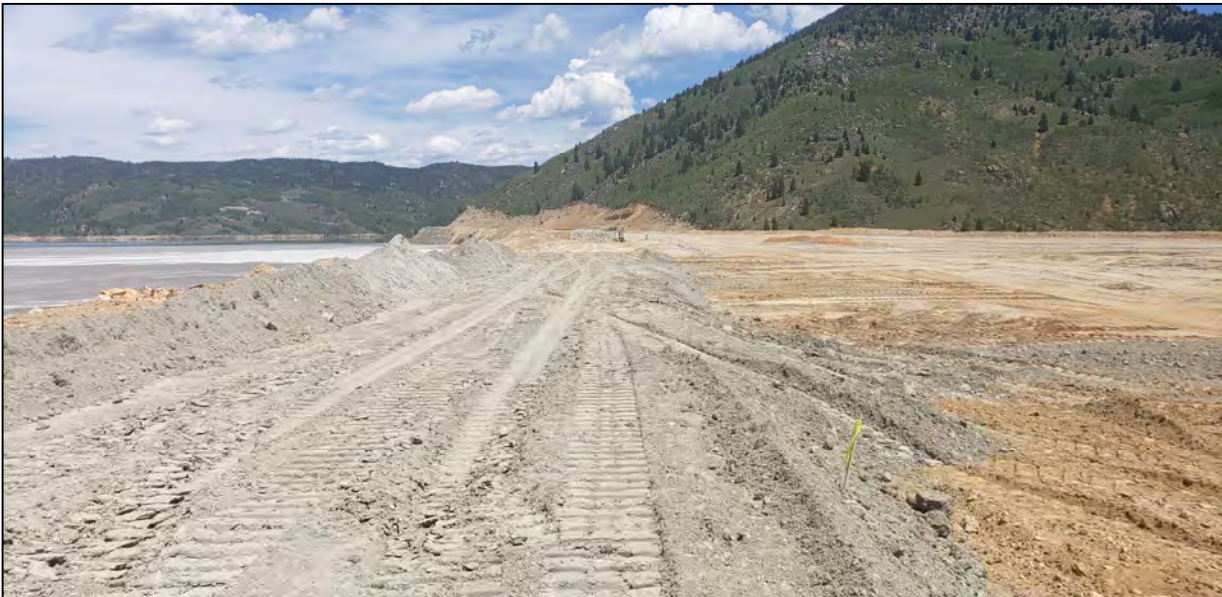
PHOTO 2 – North-South Embankment – Tailings discharge corridor construction, looking towards NS-3. (June 26, 2020)

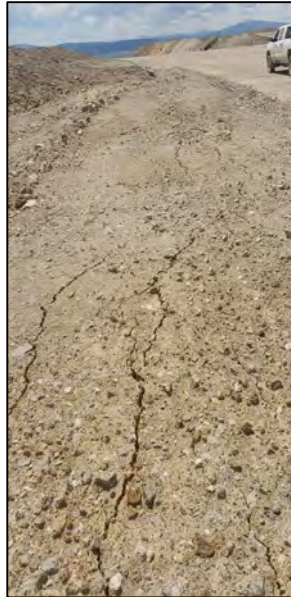
PHOTO 3 – North-South Embankment – Cracking along the downstream edge of the EL. 6,400 ft lift.
(June 26, 2020)

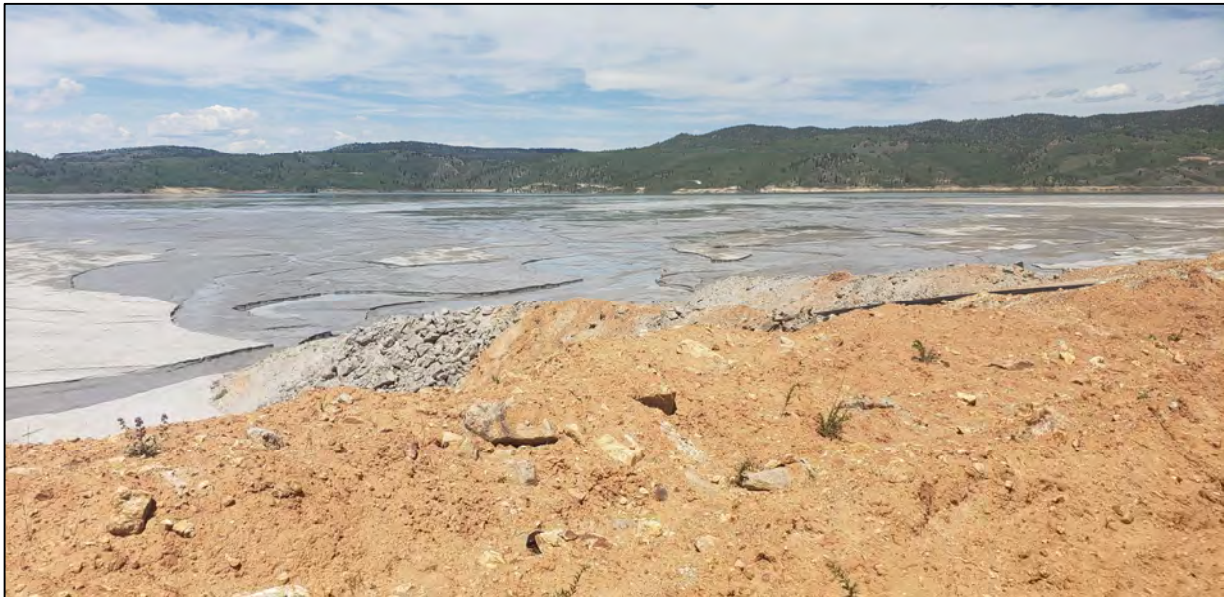
PHOTO 4 – North-South Embankment – Tailings beach and supernatant pond as viewed from the
NS-2 discharge location. (June 26, 2020)

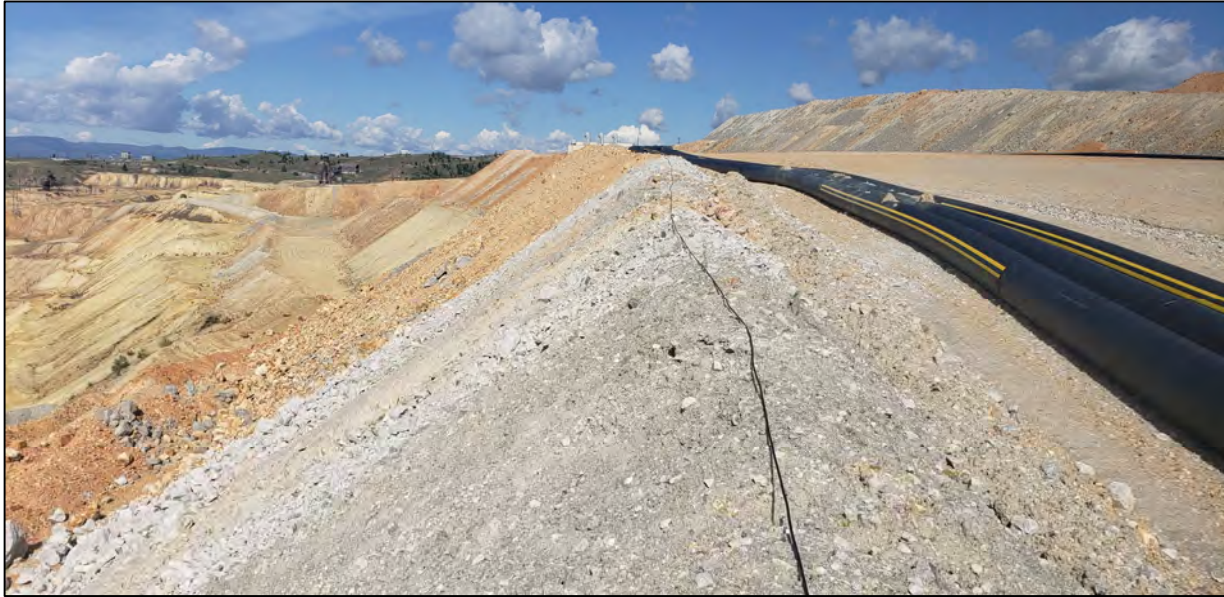
PHOTO 5 – East-West Embankment – Downstream edge of the pipe ramp. (June 26, 2020)

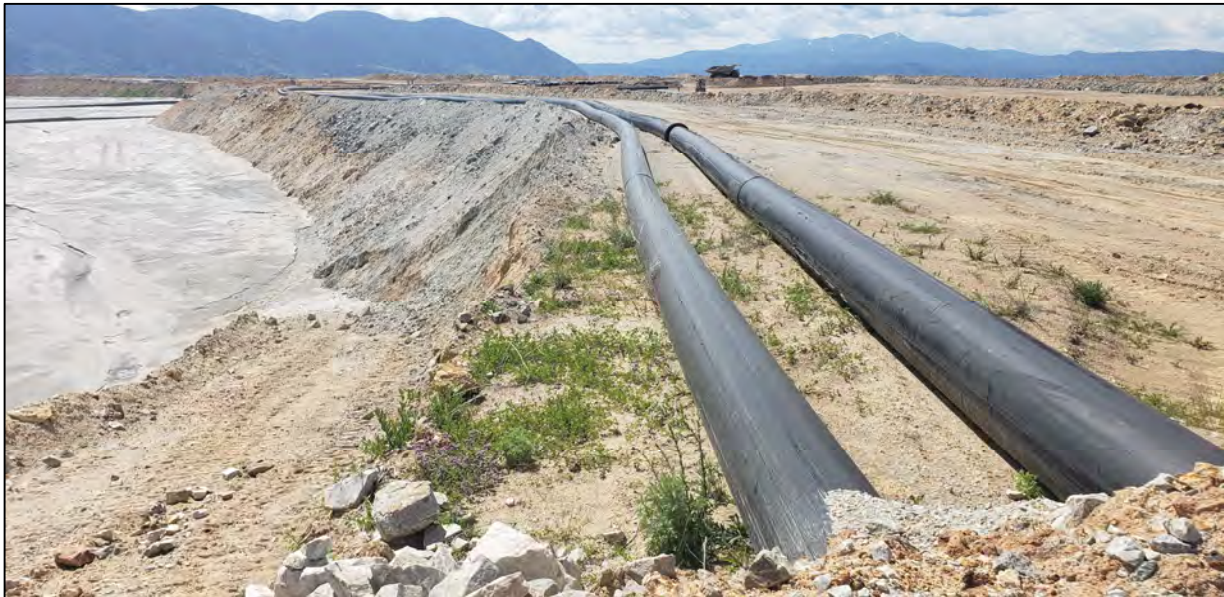
PHOTO 6 – East-West Embankment – Over steepened cut slopes on Terramac access ramp. (June 26, 2020)
