Prepared for
Montana Resources, LLP
600 Shields Avenue
Butte, Montana
USA, 59701

VA101-126/23-5

YANKEE DOODLE TAILINGS IMPOUNDMENT

2020 DATA ANALYSIS REPORT

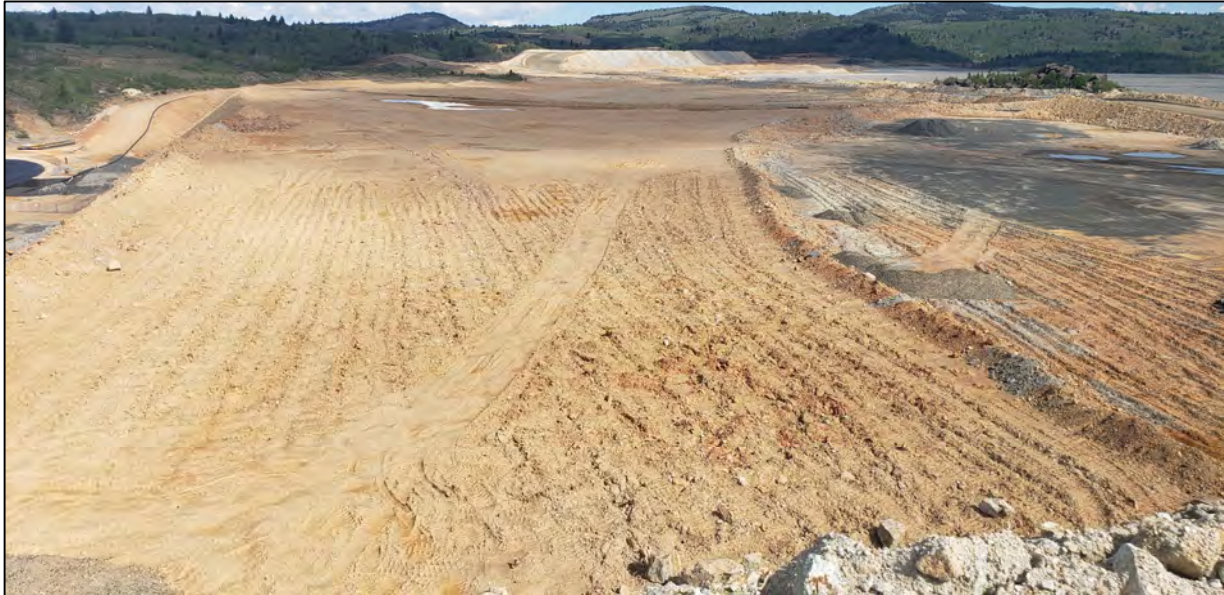
PHOTO 7 – West Embankment – EL. 6,400 ft surface scarified prior to EL. 6,450 ft lift placement (June 26, 2020)

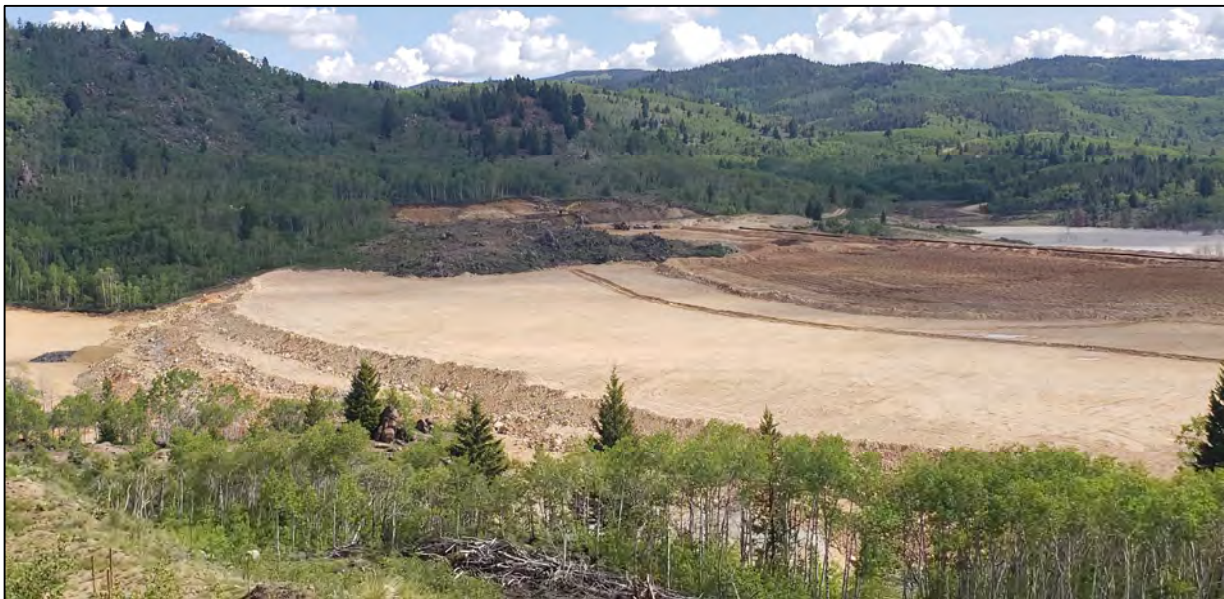
PHOTO 8 – West Embankment – Surface preparation of the EL. 6,400 ft. lift in advance of EL. 6,450 ft. construction.(June 26, 2020)

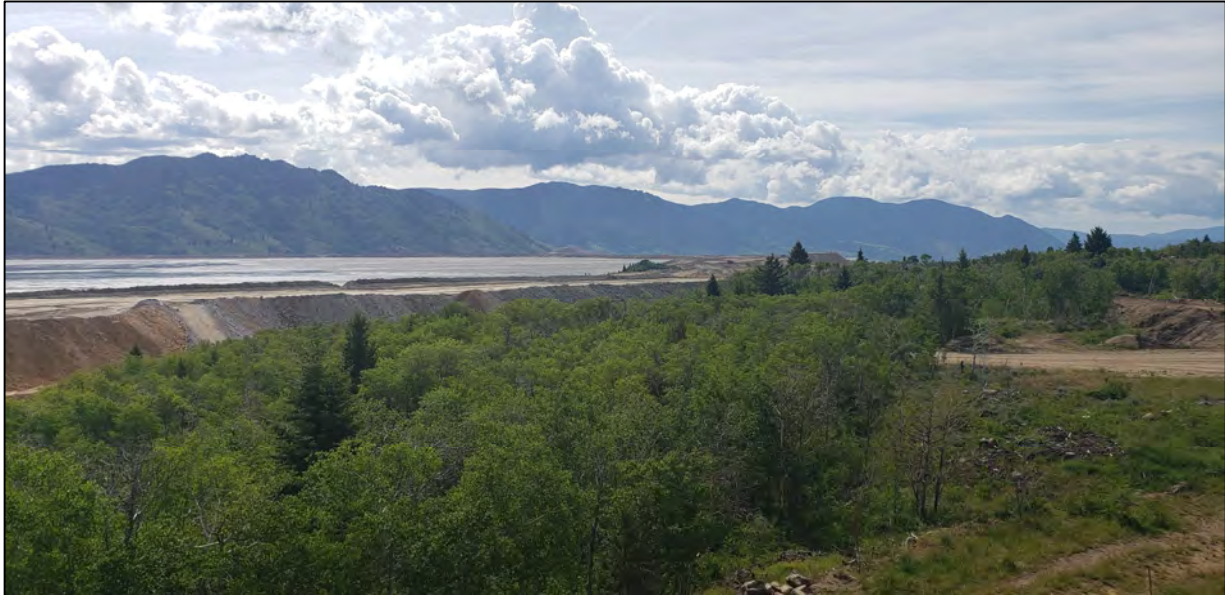
PHOTO 9 – West Embankment – Overview from the West Ridge Topsoil Stockpile showing EL. 6,450 ft. construction progress. (June 26, 2020)

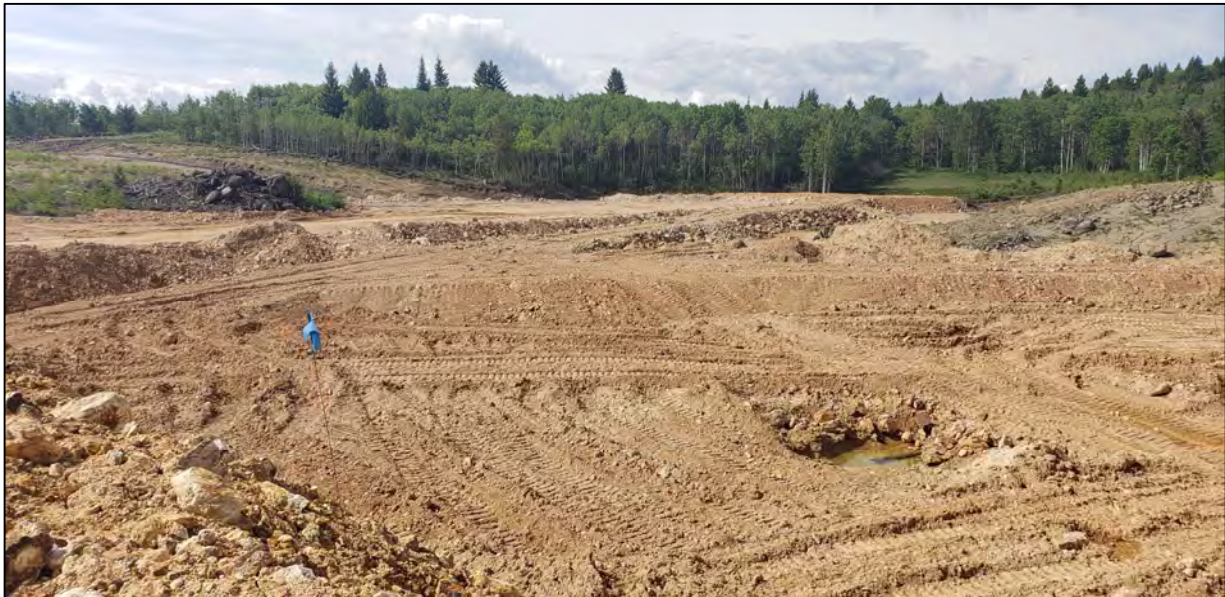
PHOTO 10 – West Embankment – EL. 6,405 ft. Zone D1 Material near Temporary Extraction Pond. (June 26, 2020)

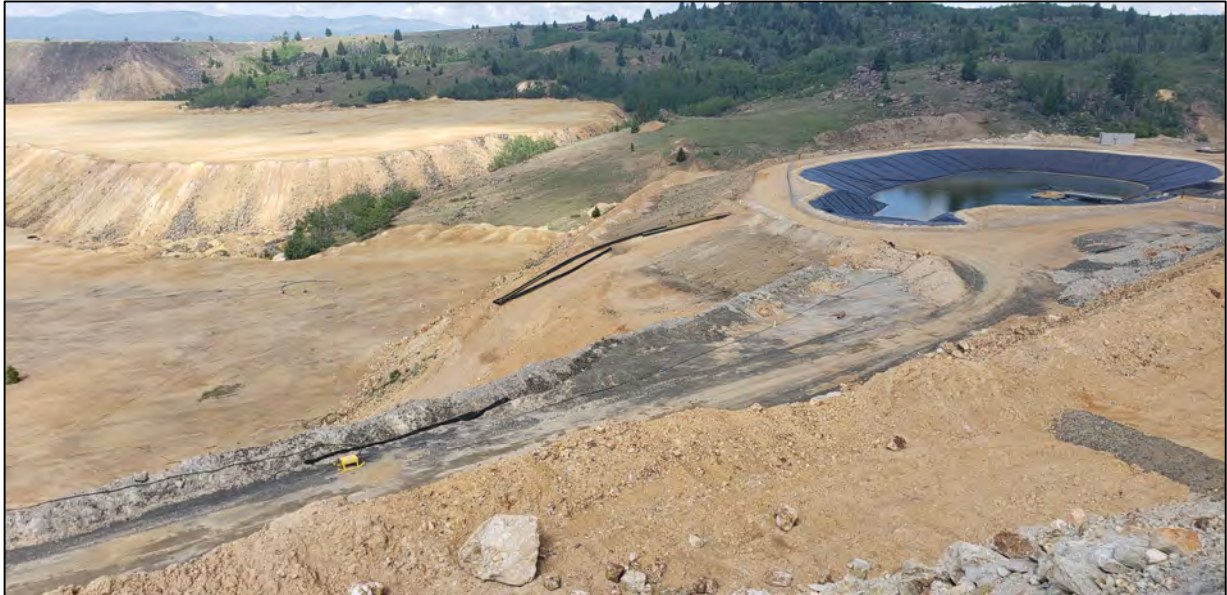
PHOTO 11 – West Embankment – WED Extraction Pond and emergency overflow pipelines. (June 26, 2020)

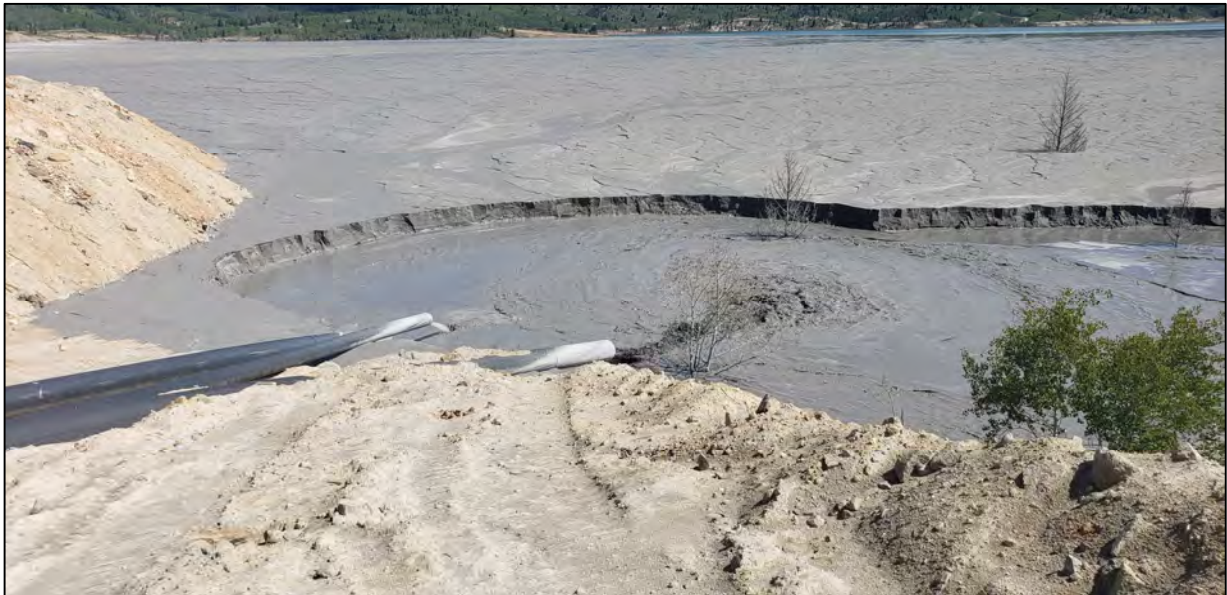
PHOTO 12 – West Embankment – RK-1 tailings discharge location. (June 26, 2020)

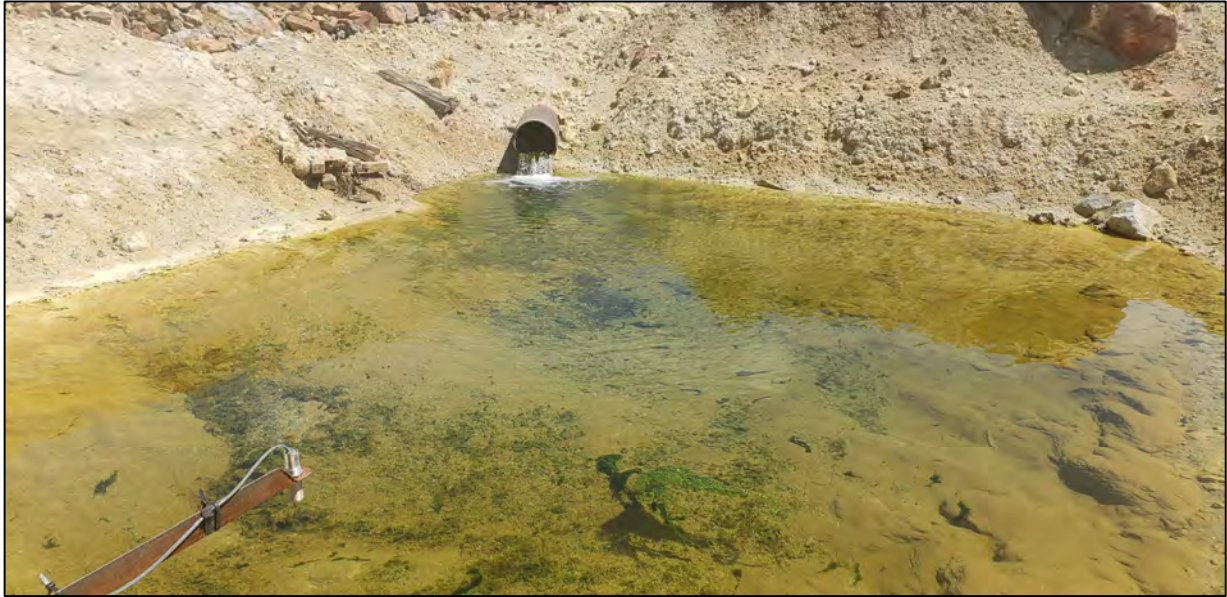
PHOTO 15 – Seep 10 Stilling Basin. (June 26, 2020)

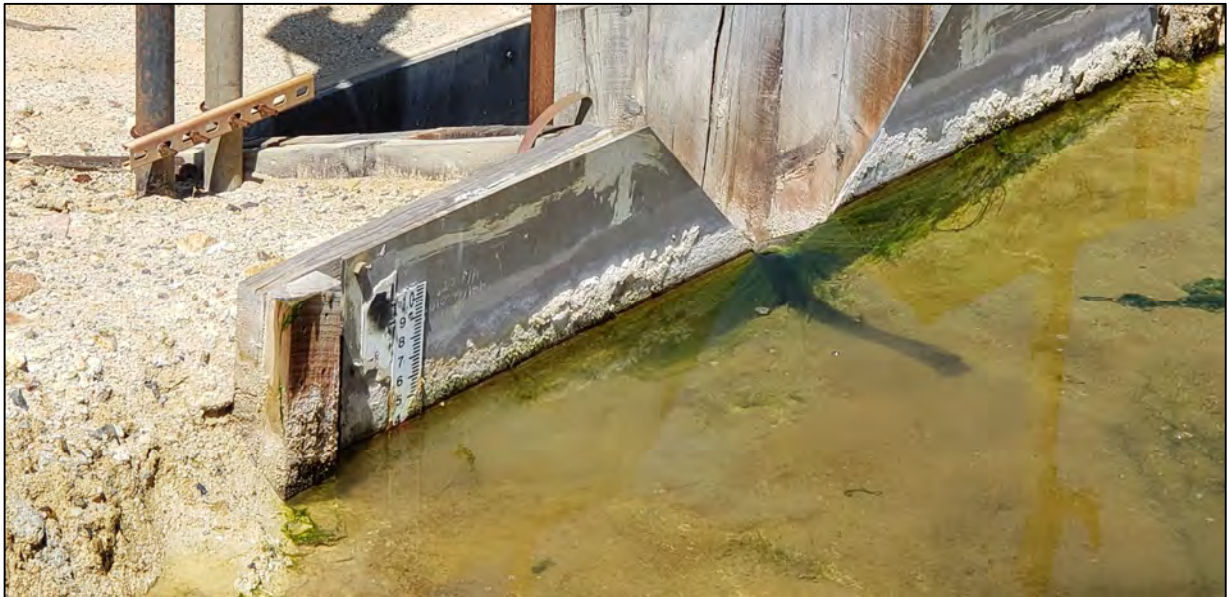
PHOTO 16 – Seep 10 Weir Staff Gauge reading approximately 0.4. (June 26, 2020)

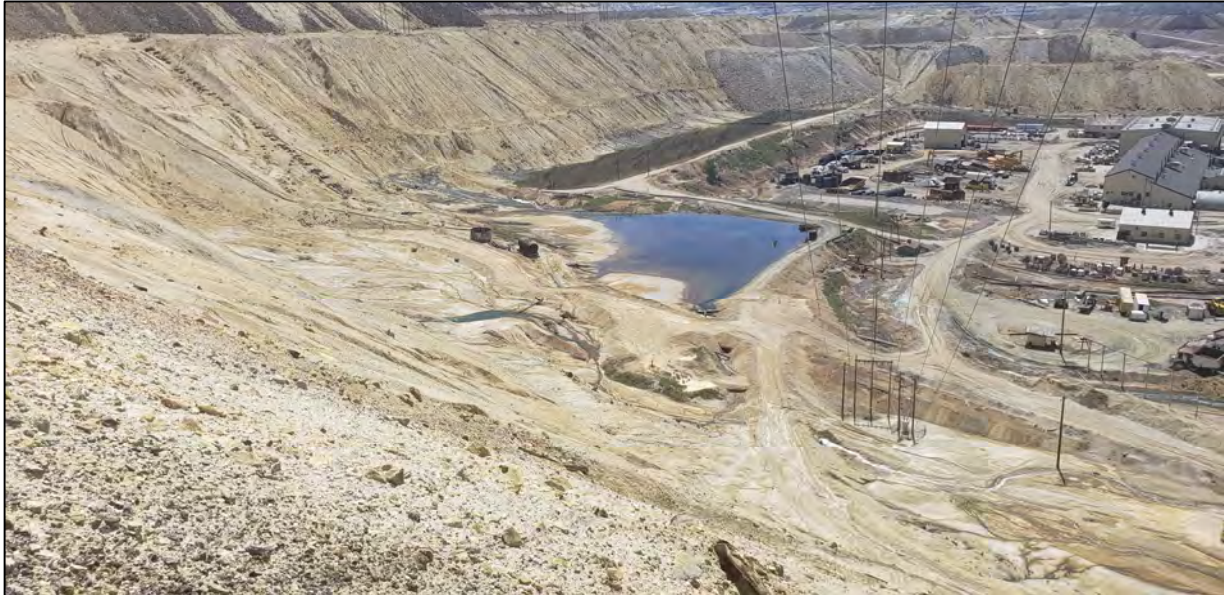
PHOTO 17 – Horseshoe Bend (HsB) Area – Leach seeps along toe of East-West Embankment viewed from Seep 10 bench. (June 26, 2020)

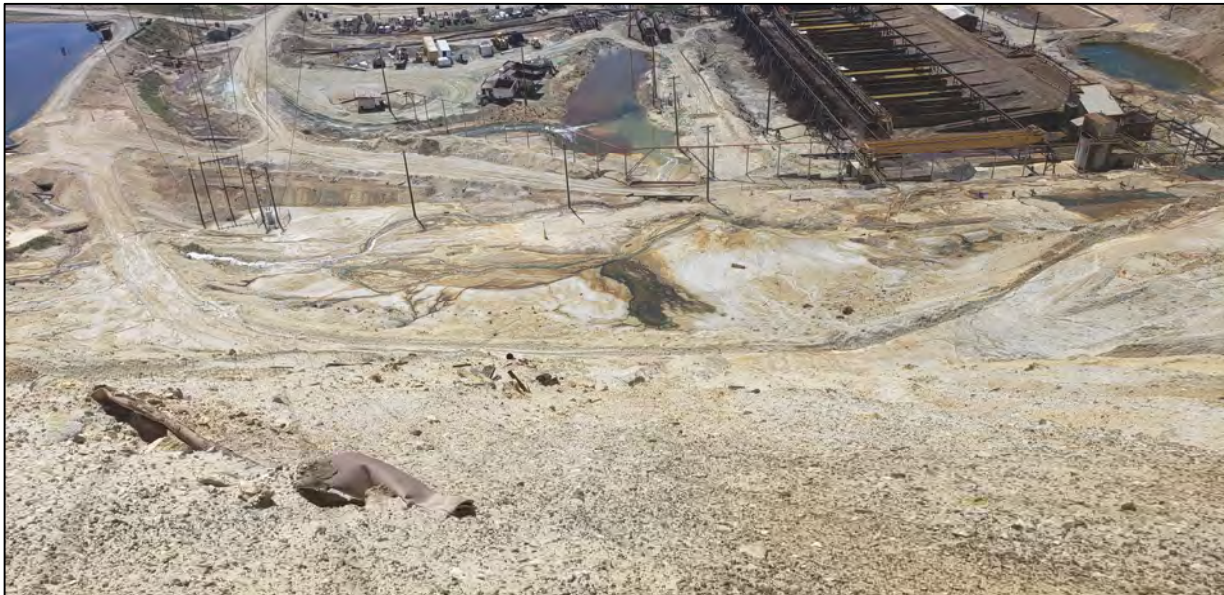
PHOTO 18 – HsB Area – Seeps along toe of East-West Embankment viewed from Seep 10 bench. (June 26, 2020)

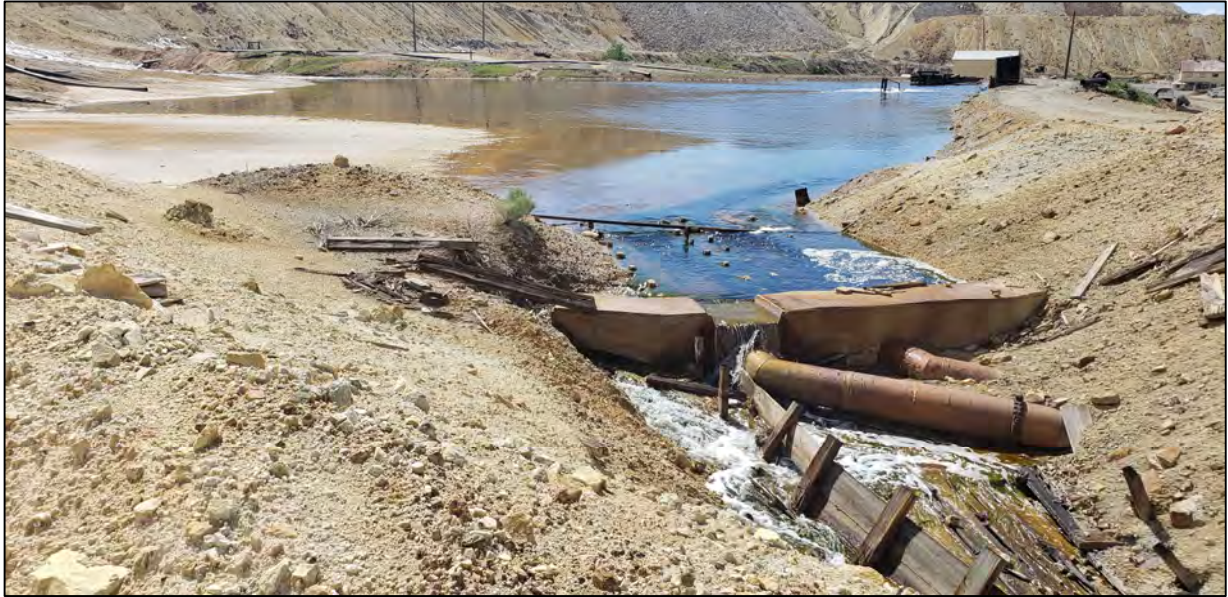
PHOTO 19 – HsB Area – Surge Pond overflow. (June 26, 2020)

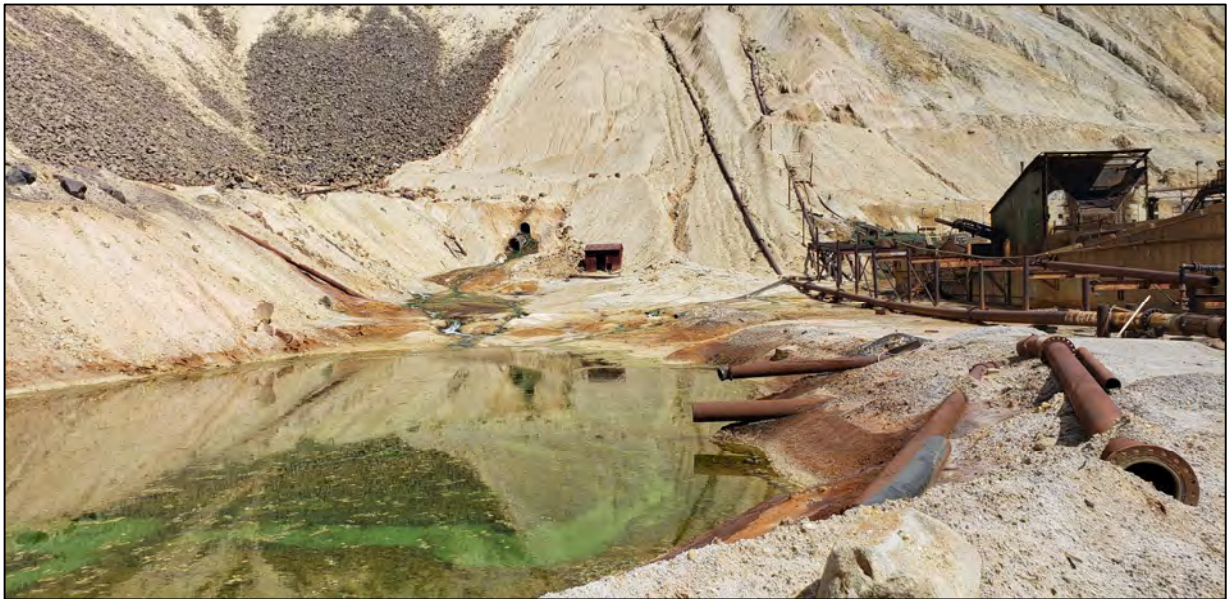
PHOTO 20 – HsB Area – Upper Pond and HsB seeps. (June 26, 2020)

Photos 20 through 23 show the Precipitation Plant and HsB Upper and Lower Pond areas, and indicate that the seep locations are generally consistent with past field reviews. The Cell 10 pump appears to function appropriately and was not overflowing towards the lower pond area at the time the provided video was recorded. The HsB Weir at the downstream end of the HsB Pond appears to be in good operating condition and is shown on Photo 24. These areas will continue to be monitored for any changes in flows or new seepage locations.

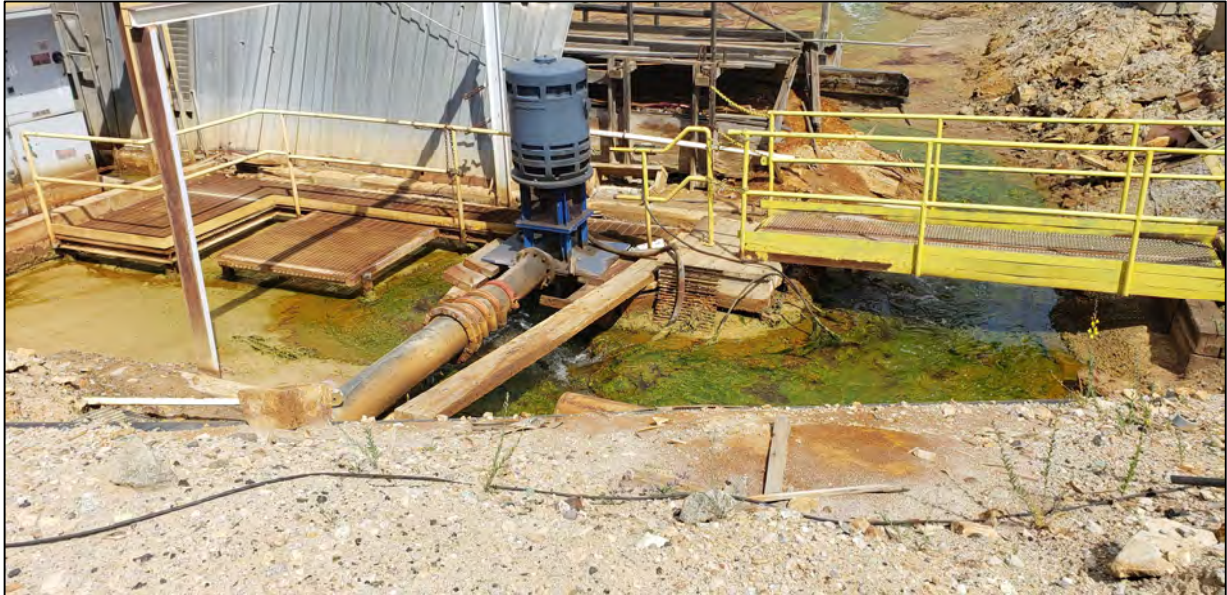
PHOTO 21 – HsB Area – Cell #10 Pump, no overflowing water to HsB Lower Pond. (June 26, 2020)

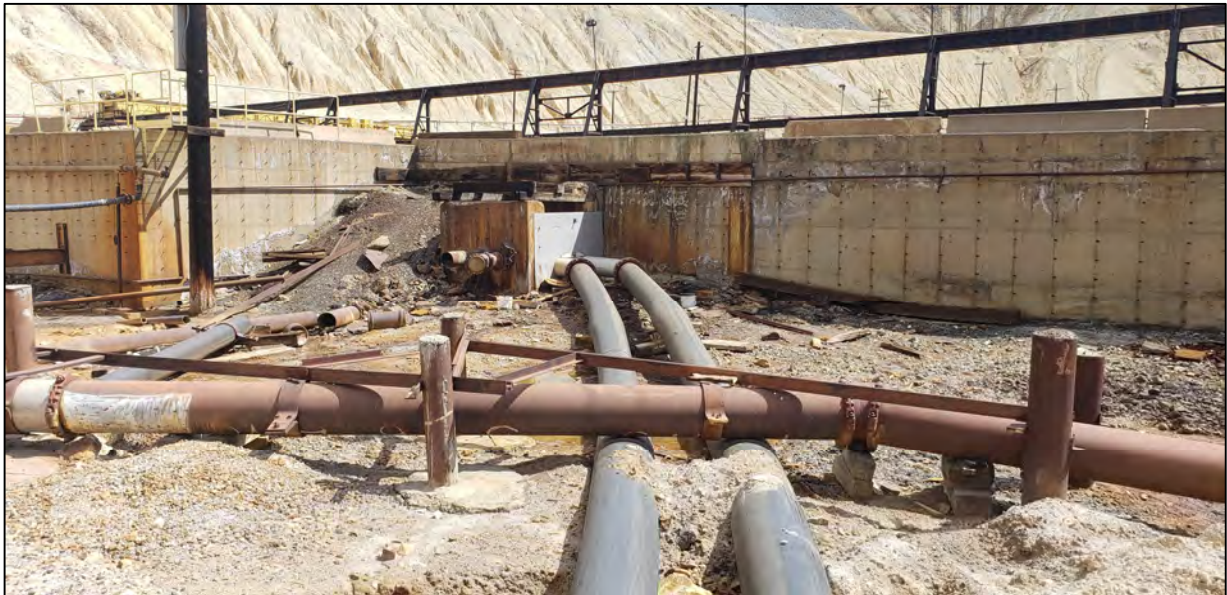
PHOTO 22 – HsB Area – Discharge pipe bulkhead exiting #5 and #6 Cells of Precipitation Plant. (June 26, 2020)

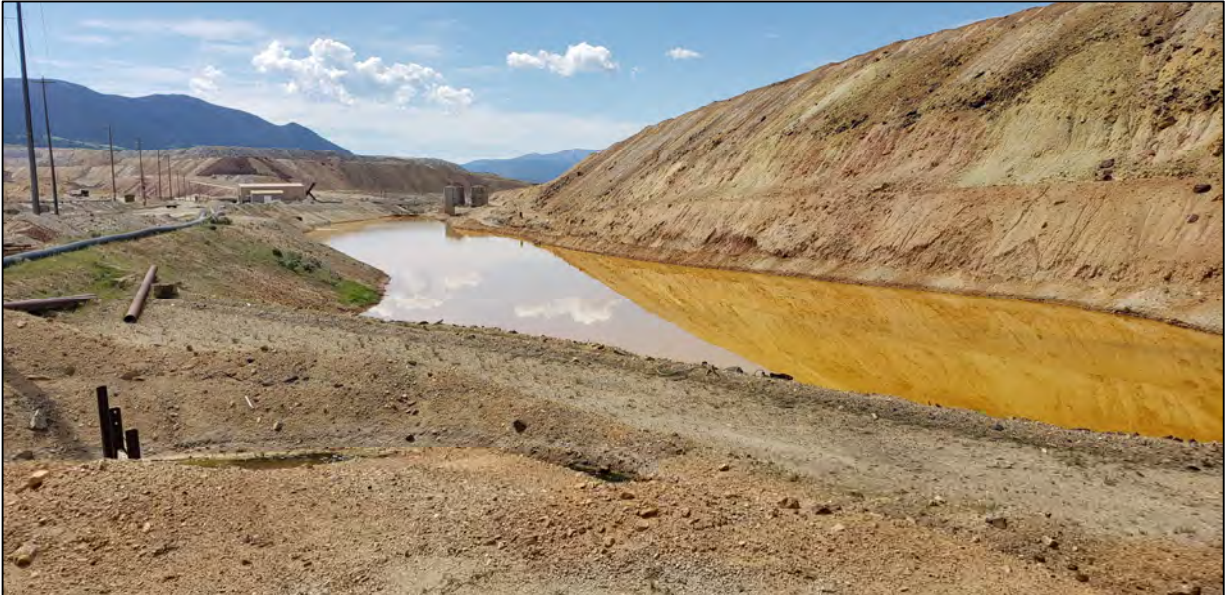
PHOTO 23 – HsB Area – HsB Lower Pond (June 26, 2020)

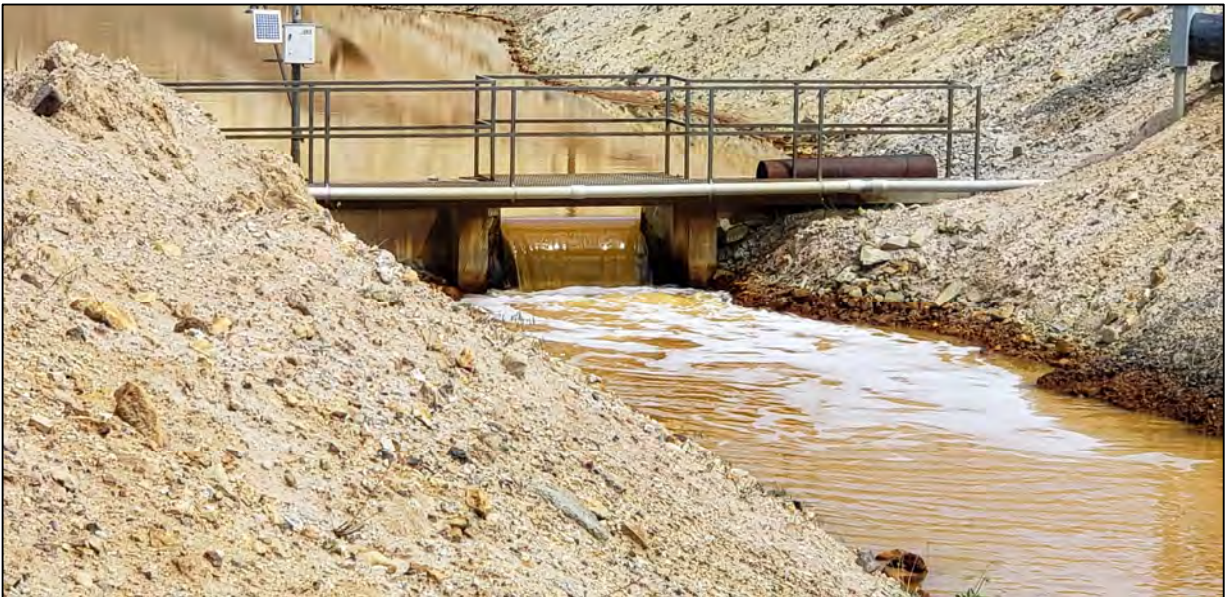
PHOTO 24 – HsB Area – HsB Weir. (June 26, 2020)

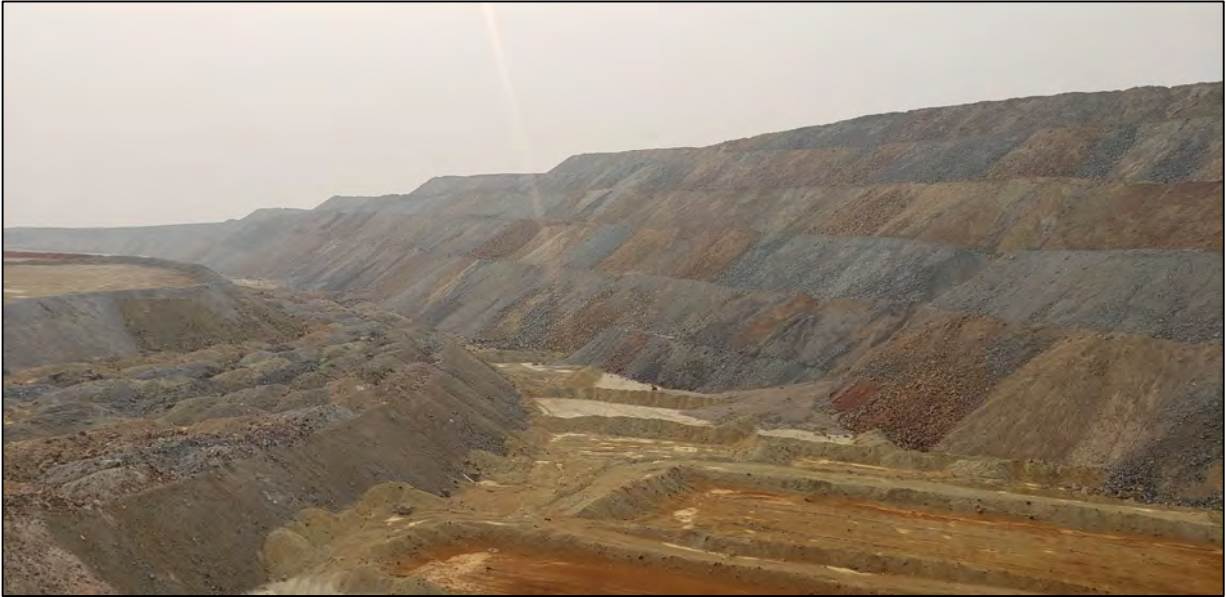
PHOTO 1 – North-South Embankment – Downstream step-out overview

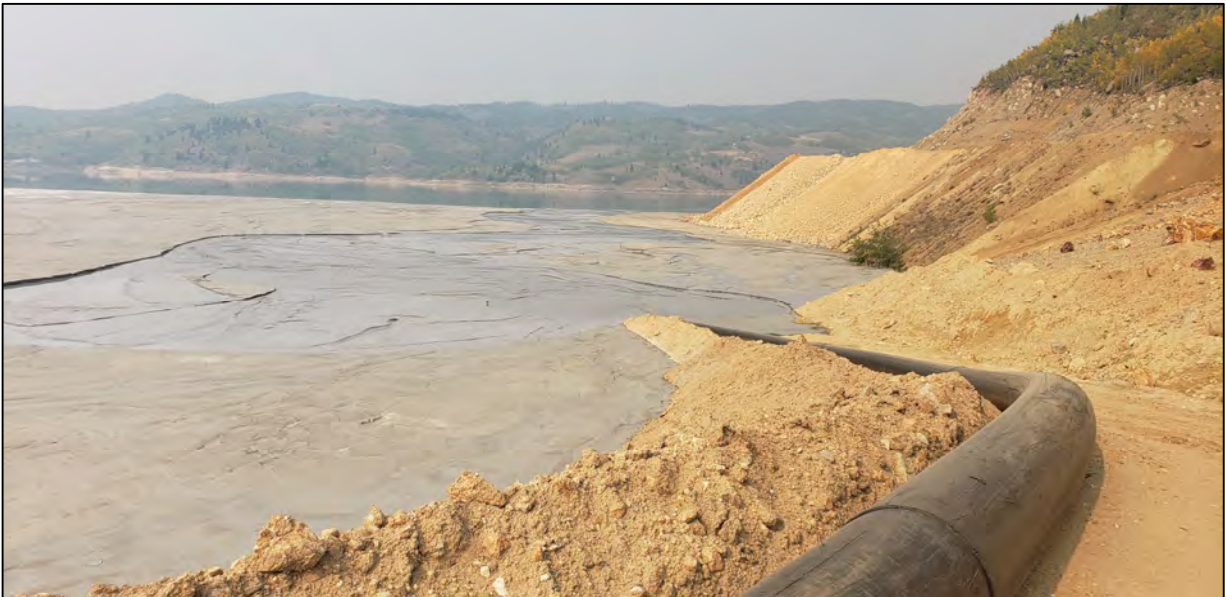
PHOTO 2 – North-South Embankment – Tailings discharge NS-4 and supernatant pond location

discharge NS-3 and implementation of the new discharge location NS-4. Photo 2 shows the beach conditions and supernatant pond location as viewed from the new NS-4 discharge location, which was active during the field review. The updated configuration of the tailings discharge locations is shown on Figures 1 and 2. The extension of Line 2 to NS-1 as recommended in the 2019 EOR AIR (KP, 2020c) is still to be completed.

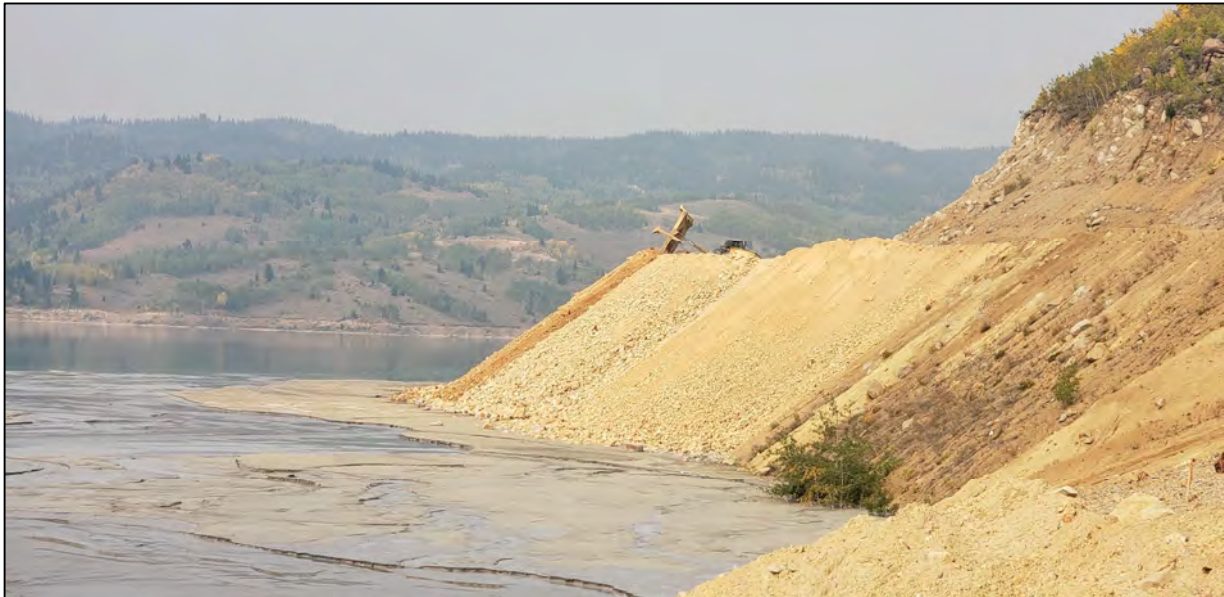
PHOTO 3 – North-South Embankment – Road widening to accommodate realignment of the Reclaim Water Pipeline

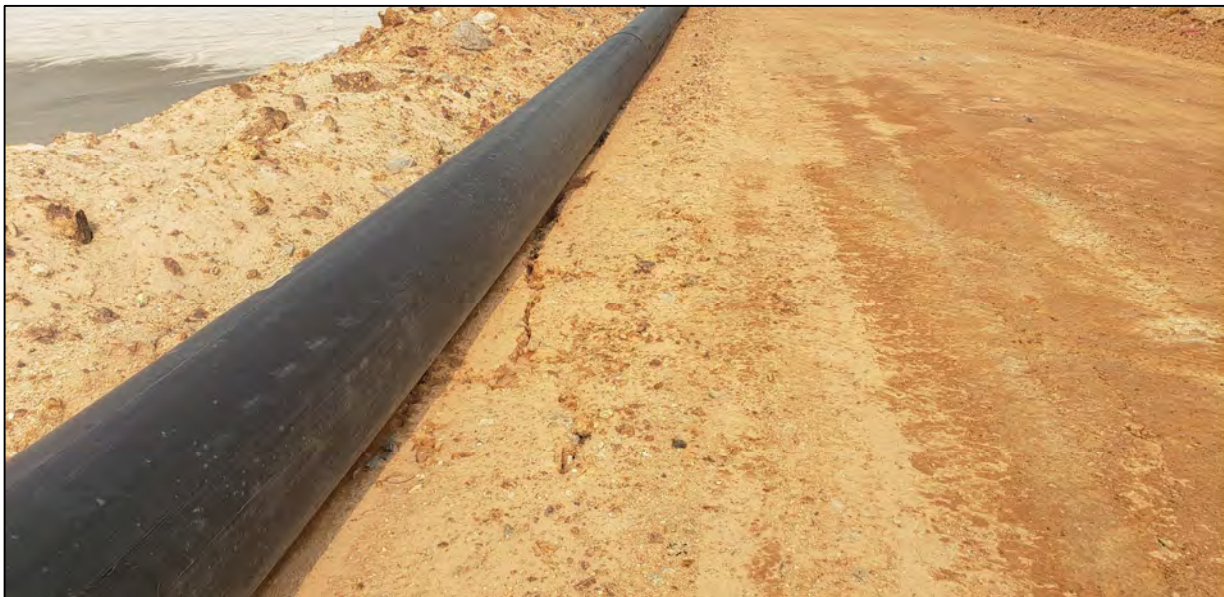
PHOTO 4 – North-South Embankment – Example of cracking along the upstream edge of the tailings discharge corridor

Dormant settlement cracking along the tailings discharge corridor along the upstream side of the embankment crest was reviewed and appears similar to the 2020 Q2 field review. An example of the settlement cracking is shown on Photo 4. Intermittent cracking along the downstream edge of the embankment crest, which is consistent with previously identified cracking as summarized in previous quarterly field reviews (2019, 2020a, 2020b) and 2019 EOR AIR (KP, 2020c), was observed, with an example shown on Photo 5. MR is to continue to monitor any additional cracking and/or propagation of the existing cracks. MR is to continue to inform KP of any changing conditions.

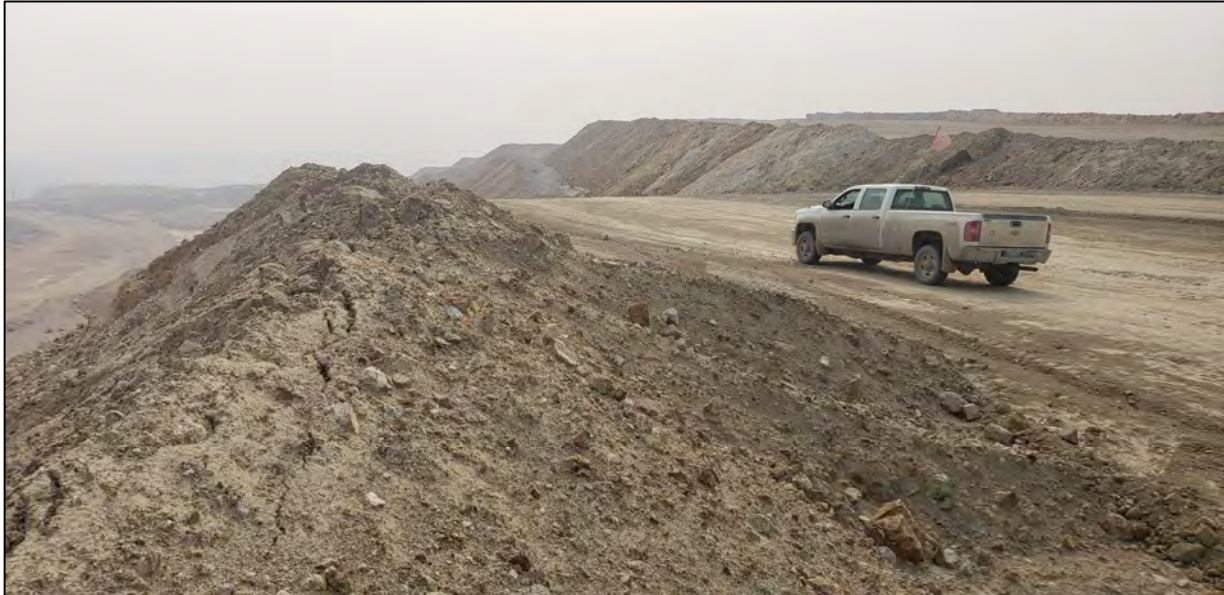
PHOTO 5 – North-South Embankment – Downstream edge of Haul Ramp showing minor settlement cracking along EL 6,400 lift

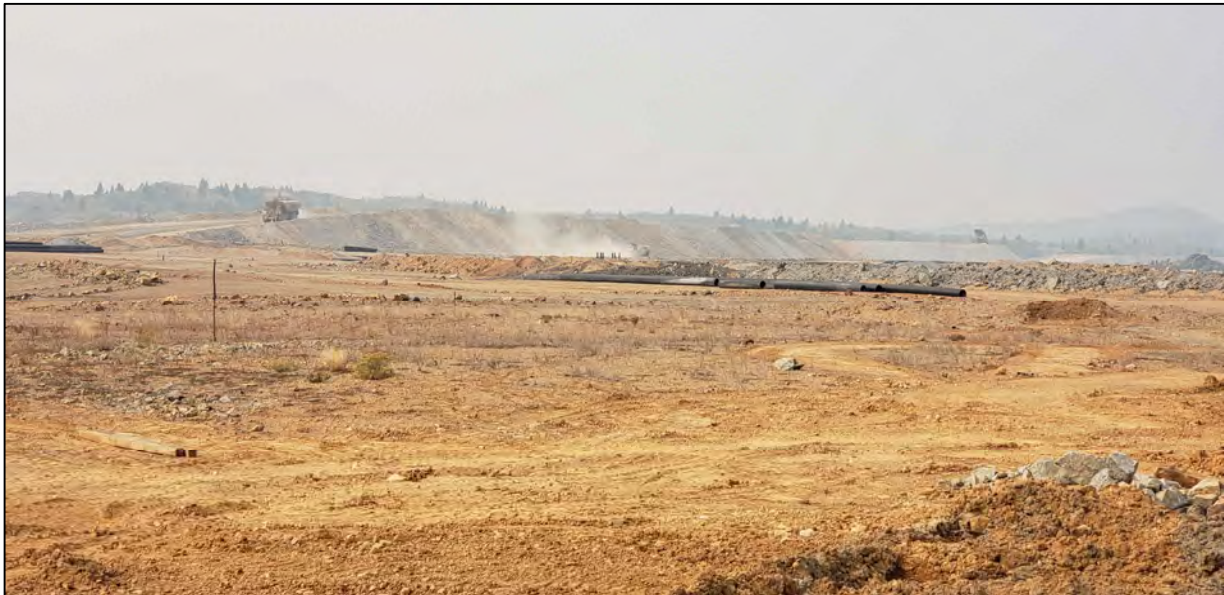
PHOTO 6 – East-West Embankment – EL 6,450 ft construction progress

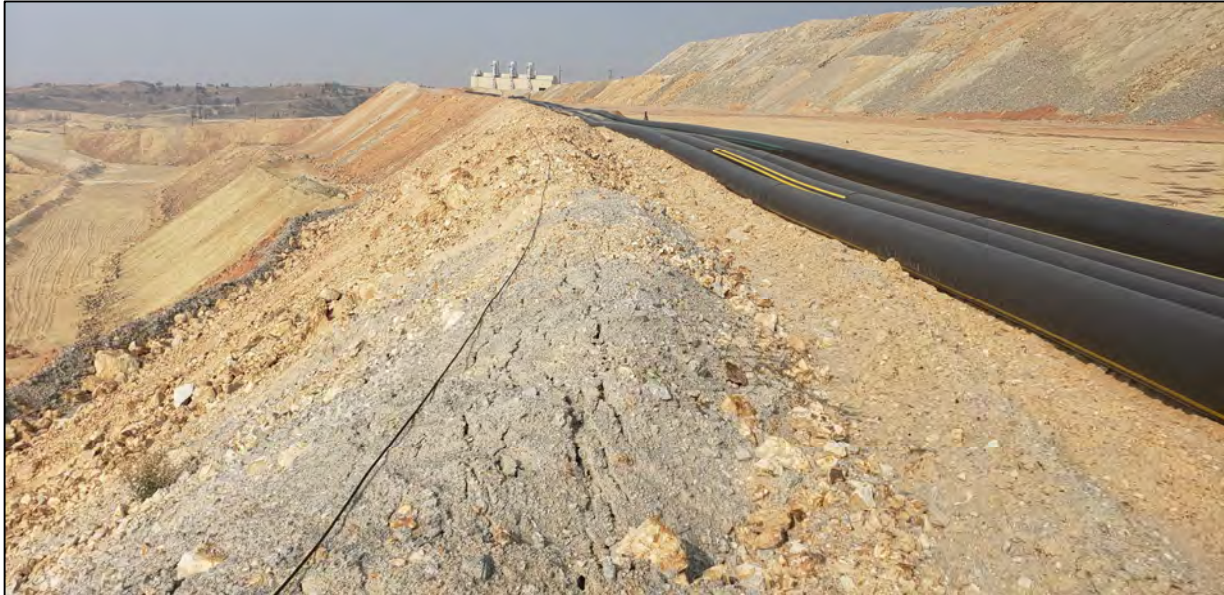
PHOTO 7 – East-West Embankment – Downstream edge of pipeline ramp showing minor settlement cracking

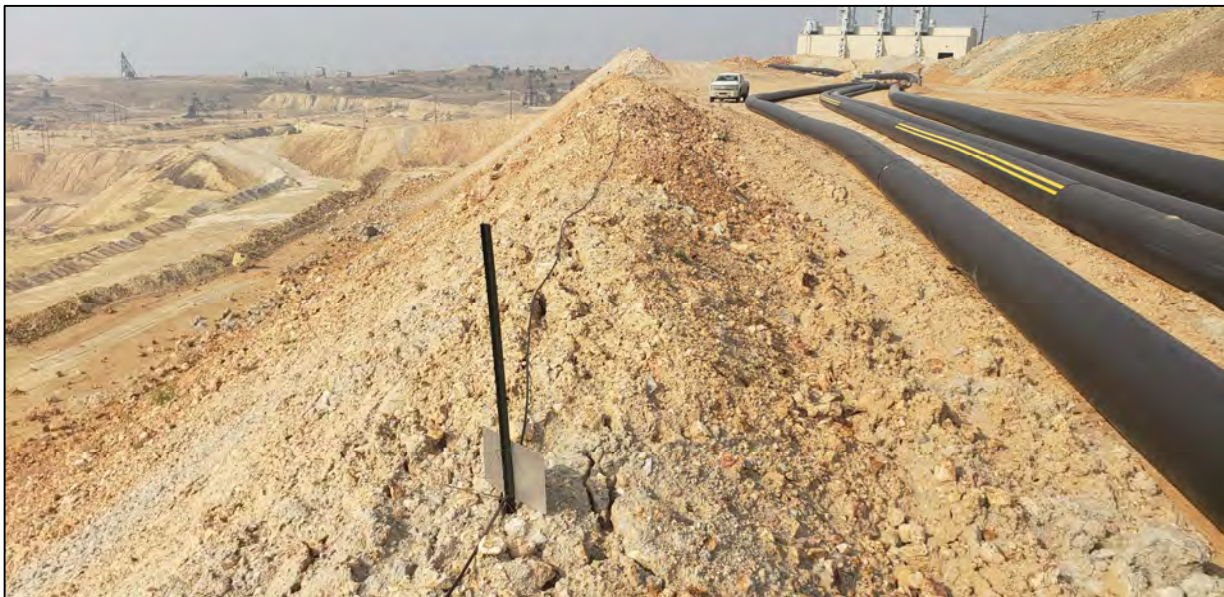
PHOTO 8 – East-West Embankment – Downstream edge of pipeline ramp showing minor settlement cracking

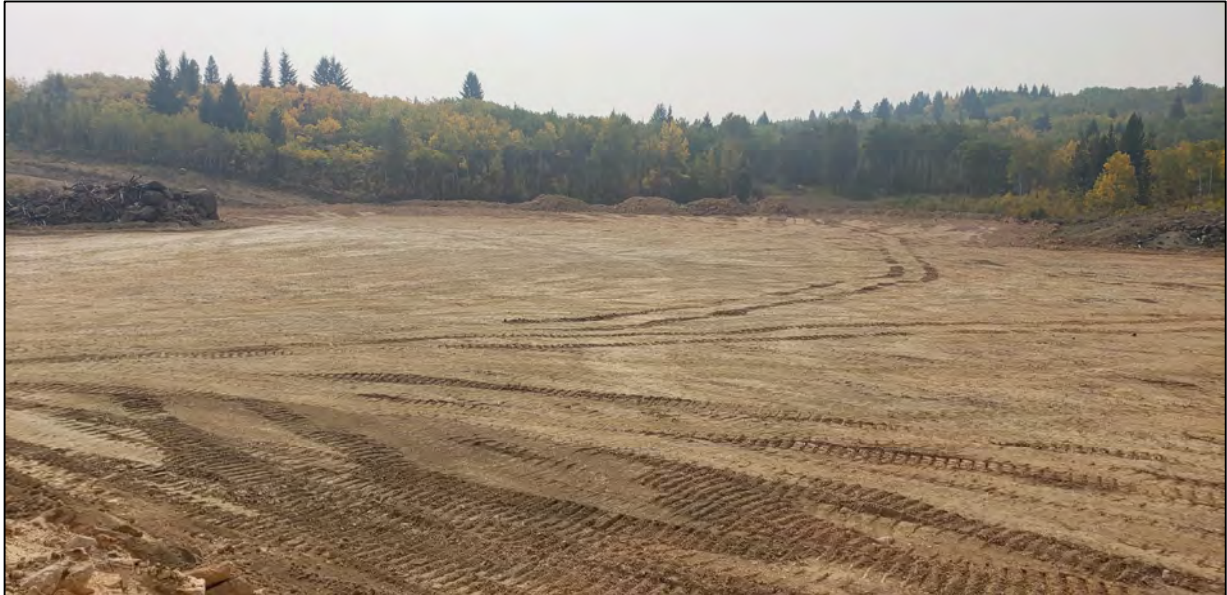
PHOTO 11 – West Embankment – EL 6,400 ft Zone D1 Material near Temporary Extraction Pond location

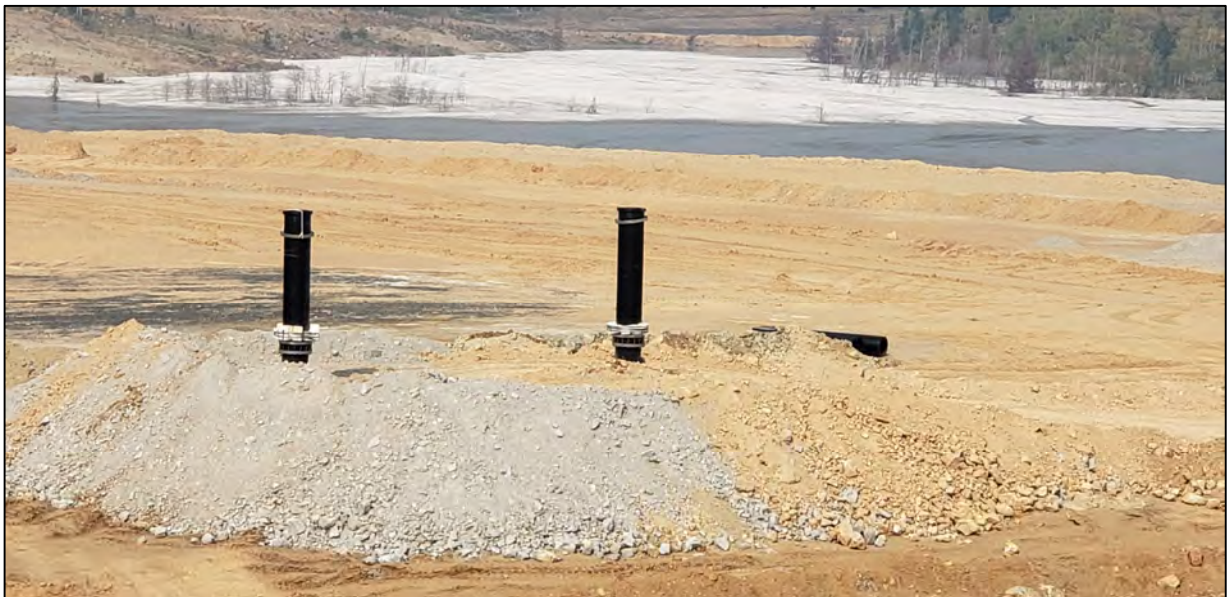
PHOTO 12 – West Embankment – Extraction Basin well risers

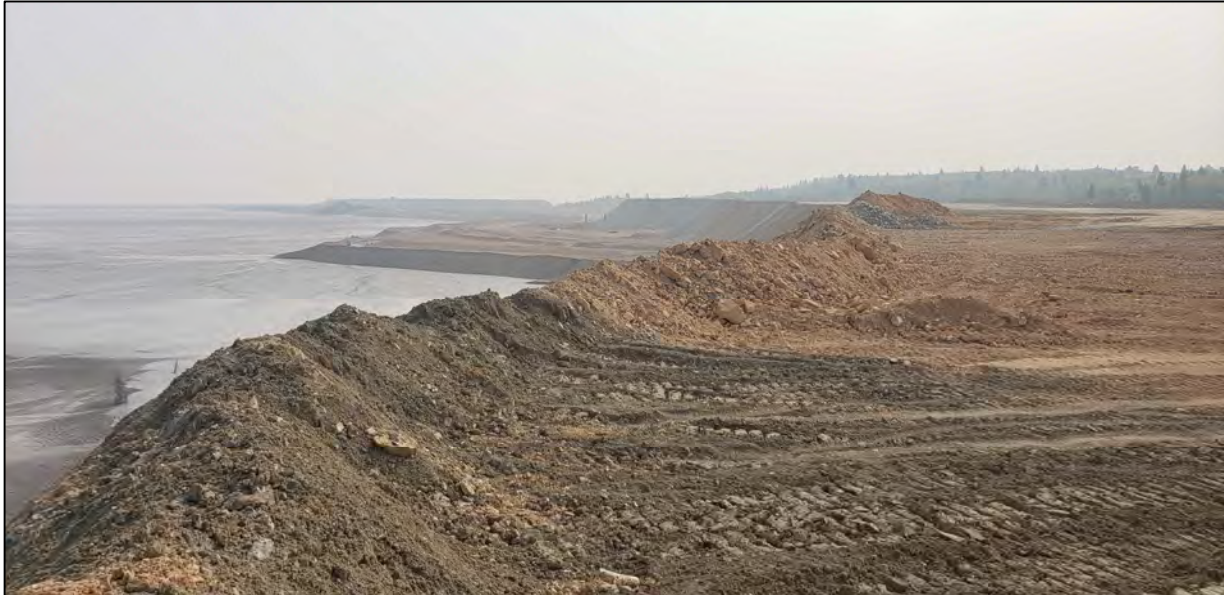
PHOTO 13 – West Embankment – EL 6,450 ft construction progress

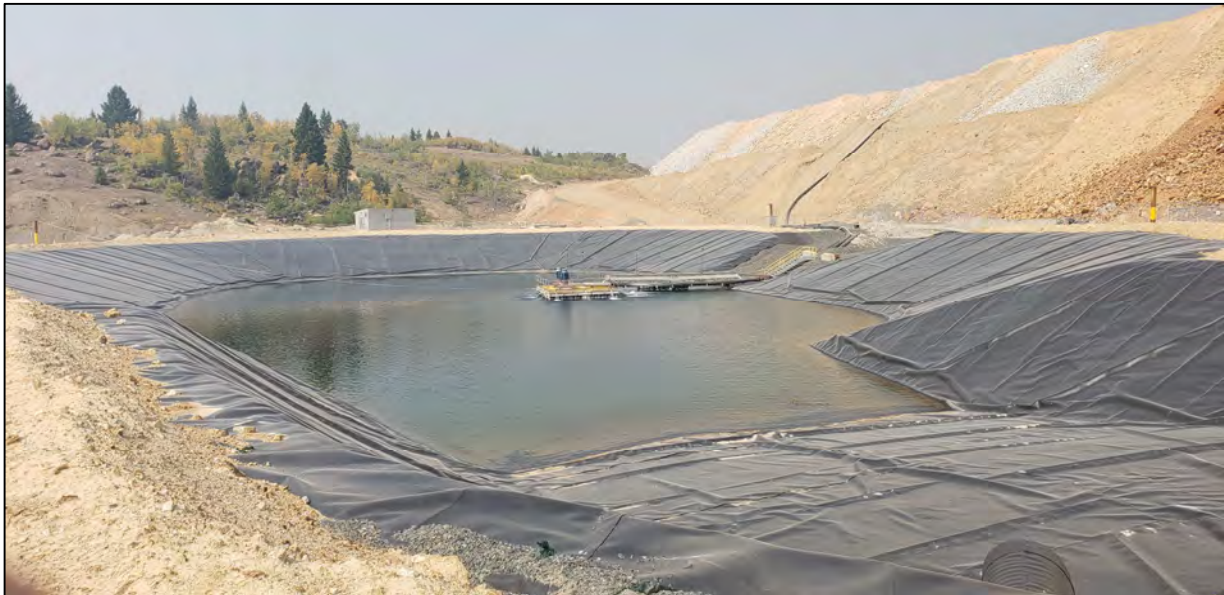
PHOTO 14 – West Embankment – Extraction Pond

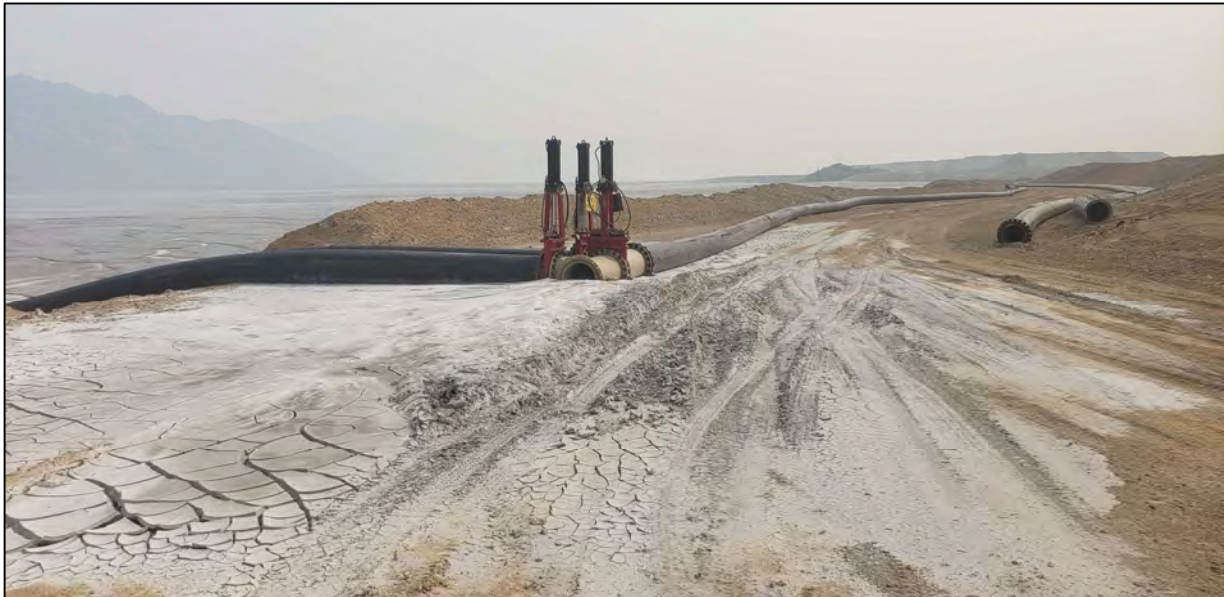
PHOTO 15 – West Embankment – Line 1, Valve 3 disconnected from RK-4 at RK-3 discharge location

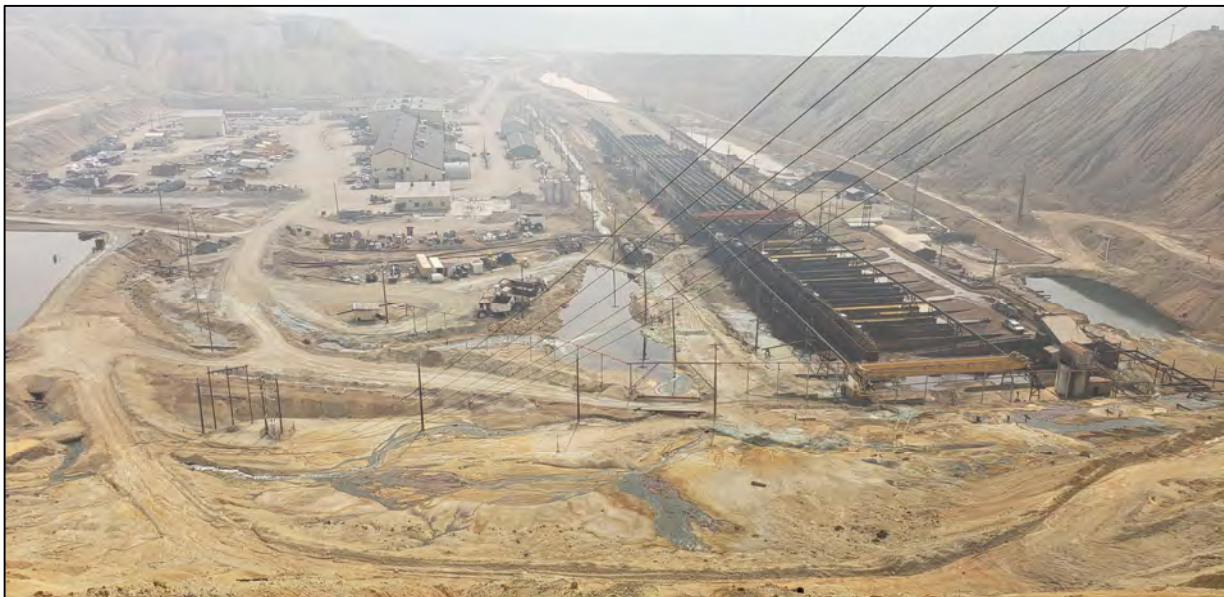
PHOTO 16 – Horseshoe Bend (HsB) Area – Leach seeps along toe of East-West Embankment viewed from Seep 10 bench.

The HsB seepage flow paths and collection ditches at the toe of the East-West Embankment viewed from the Seep 10 bench are shown on Photos 16 and 17. The conditions observed were generally consistent with previous field reviews. The overflow from the Surge Pond, shown on Photo 18, continues to flow and cut around the weir. This flow, along with the weir overflow, is collected in a pipe downstream of the weir and is discharged into the Houligan Pond.
