Prepared for
Montana Resources, LLP
600 Shields Avenue
Butte, Montana
USA, 59701

VA101-126/23-5

YANKEE DOODLE TAILINGS IMPOUNDMENT

2020 DATA ANALYSIS REPORT

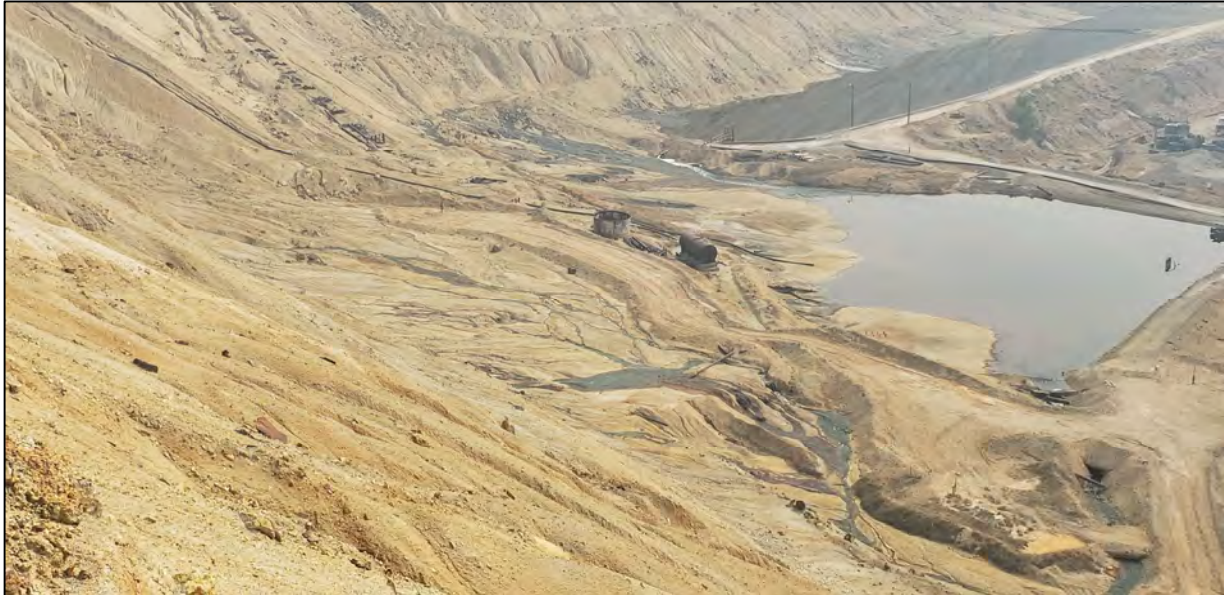
PHOTO 17 – HsB Area – Leach seeps along toe of East-West Embankment viewed from Seep 10 bench

The HsB seepage flow paths and collection ditches at the toe of the East-West Embankment viewed from the Seep 10 bench are shown on Photos 16 and 17. The conditions observed were generally consistent with previous field reviews. The overflow from the Surge Pond, shown on Photo 18, continues to flow and cut around the weir. This flow, along with the weir overflow, is collected in a pipe downstream of the weir and is discharged into the Houligan Pond.

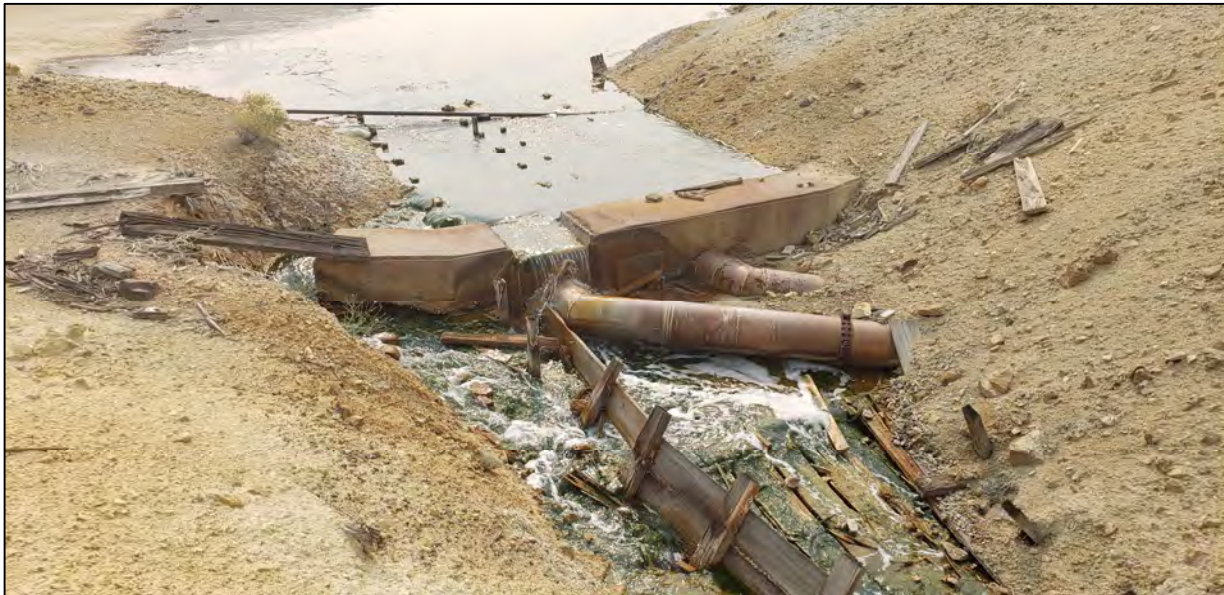
PHOTO 18 – HsB Area – Surge Pond overflow

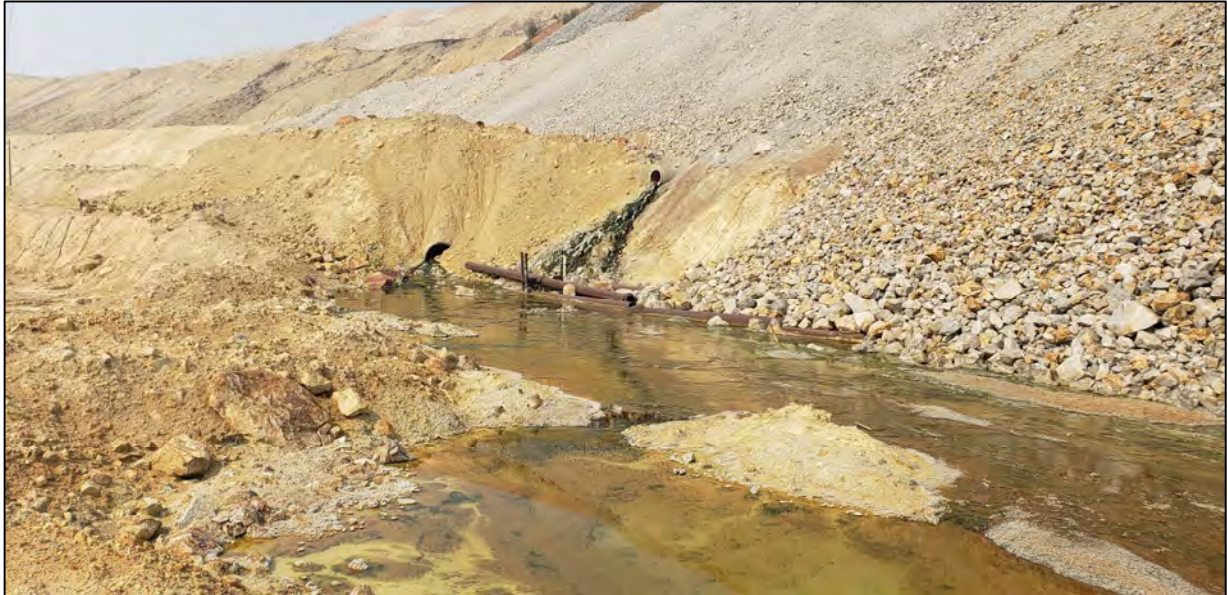
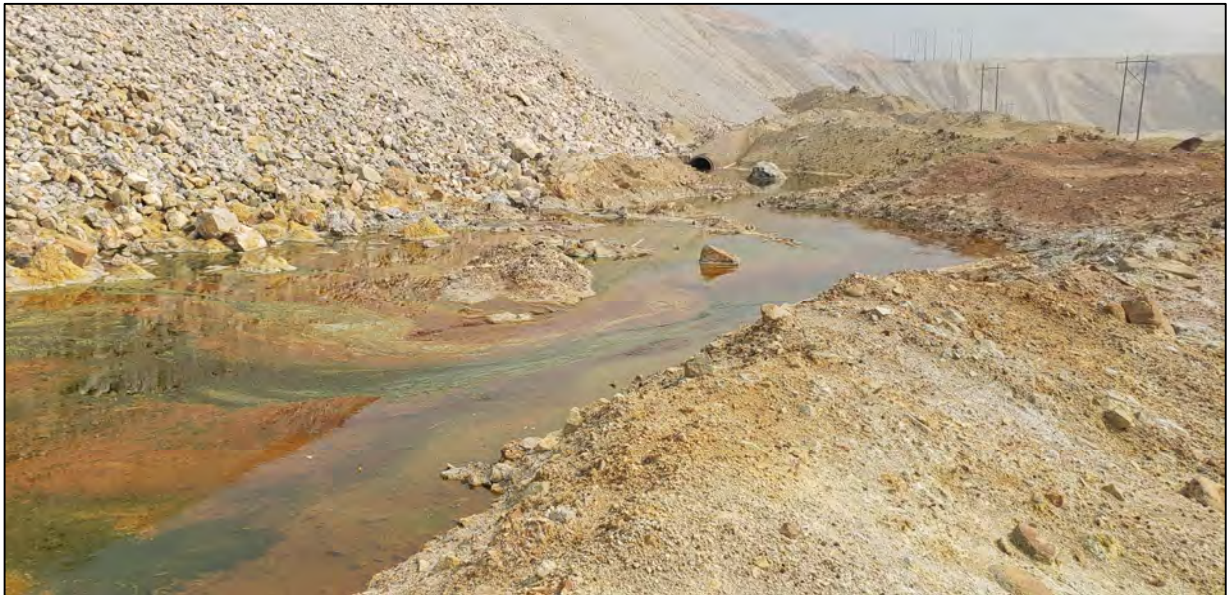
PHOTO 19 – Seep 10 area

PHOTO 20 – Seep 10 area

The condition of the Seep 10 flow paths, surface collection ditches, and stilling pond appear generally consistent with previous field reviews, as shown on Photos 19 through 21. The ultrasonic lookdown level sensor installed at the Seep 10 weir was reported to be operating normally and the reading on the staff gauge at the time of the field review was approximately 0.4 as shown on Photo 22.

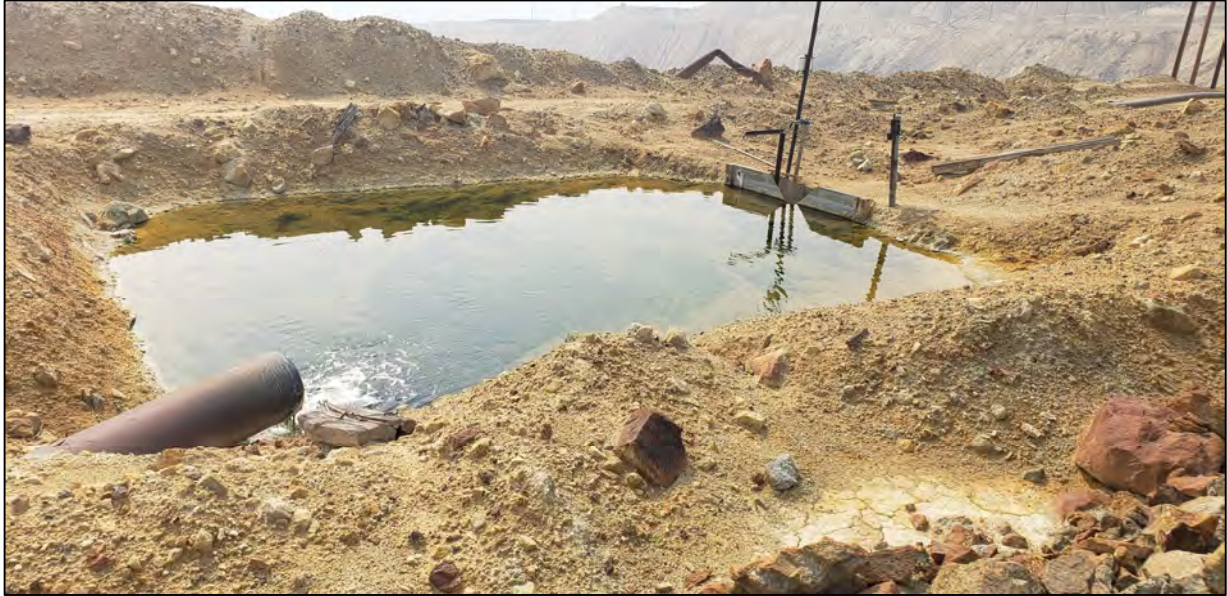
PHOTO 21 – Seep 10 Stilling Pond

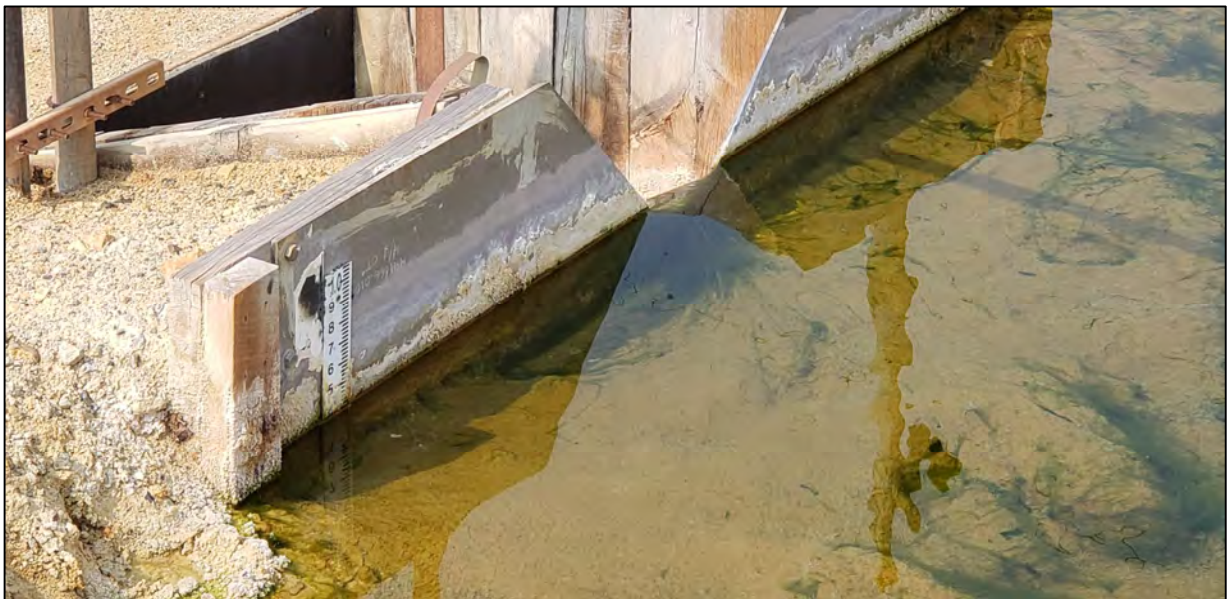
PHOTO 22 – Seep 10 Weir Staff Gauge reading approximately 0.4

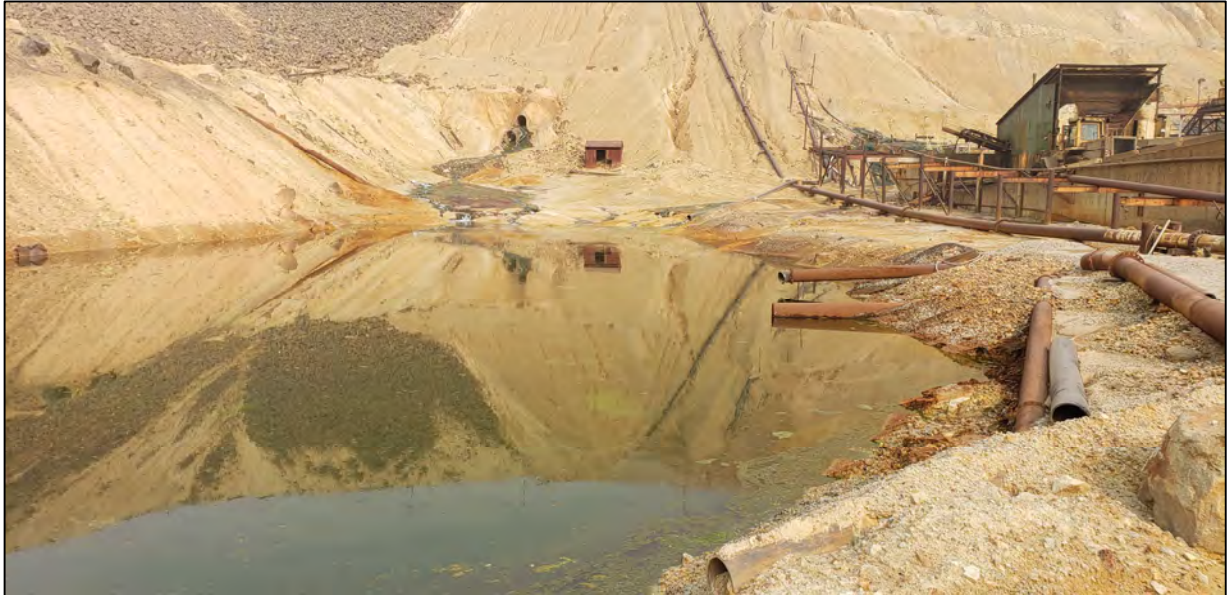
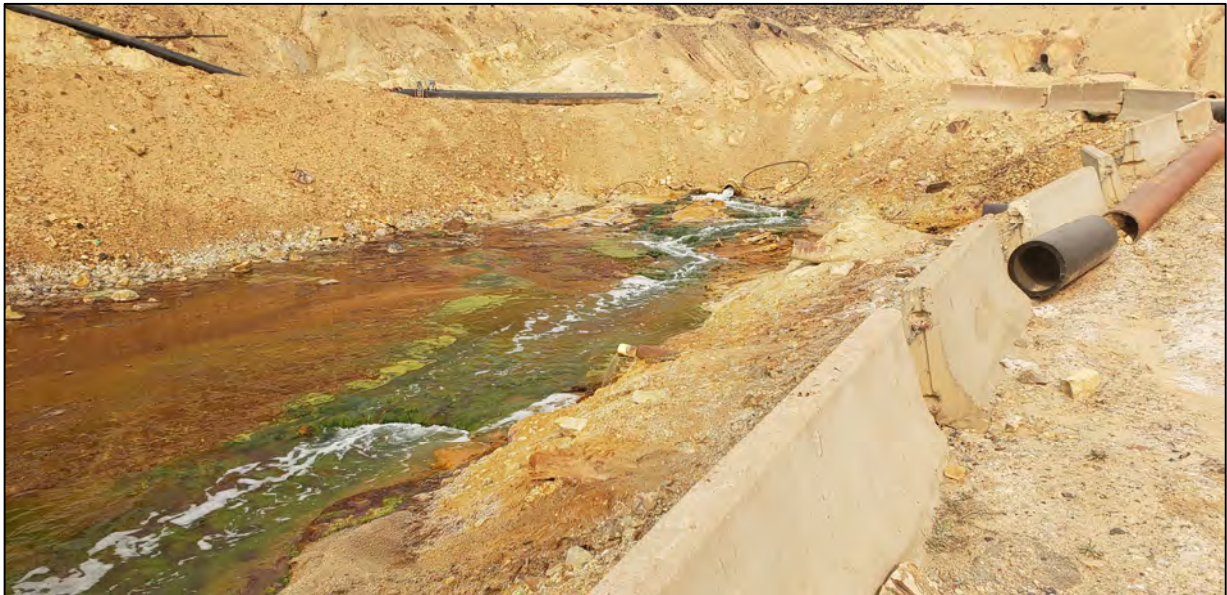
PHOTO 23 – HsB Area – HsB Upper Pond area

PHOTO 24 – HsB Area – HsB Upper Pond area

- The HsB Upper and Lower Pond areas and seepage inflows appear to be in similar condition as previous field reviews as shown on Photos 23 and 24.
- The Cell 10 pump area shows signs of a minor overflow towards the HsB Lower Pond at the time of the field review, as shown on Photo 25. Maintenance should be performed to stop this overflow bypass.

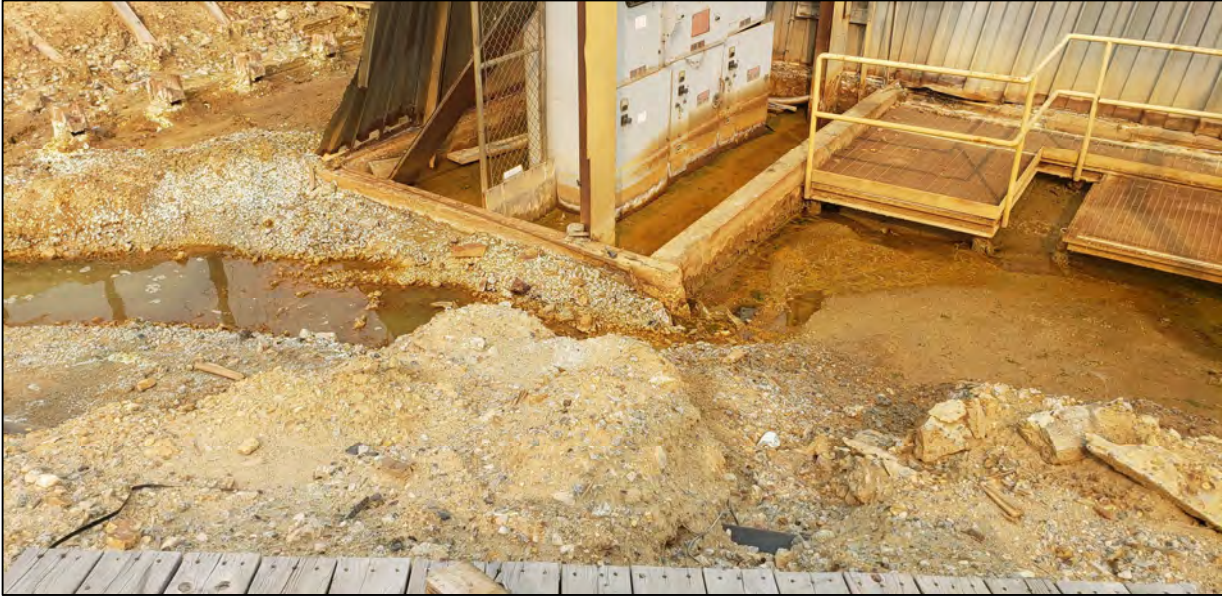
PHOTO 25 – HsB Area – Cell #10 Pump, minor overflow to HsB Lower Pond

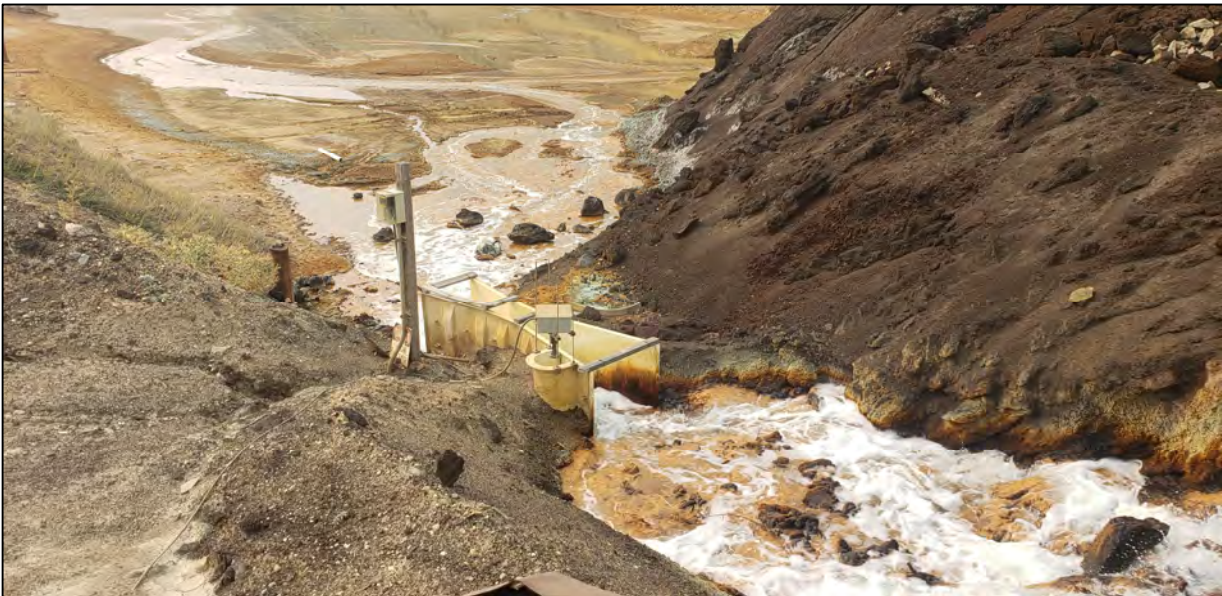
PHOTO 26 – HsB Area – Cell 10 Return Water Flume

- The Cell 10 return flow flume is shown on Photo 26 and appears to be operating normally.
- The HsB Weir at the downstream end of the HsB Pond, as shown on Photo 27, appears to be in good operating condition. The water level at the weir appears consistent with the level observed during the 2020 Q2 field review.

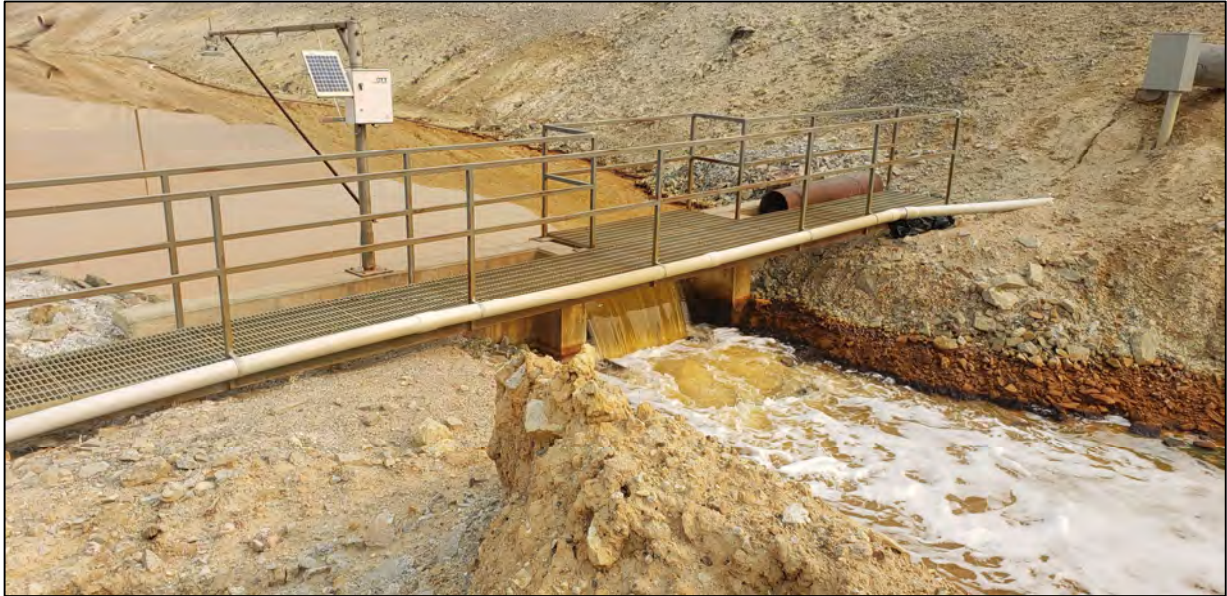
PHOTO 27 – HsB Area – HsB Weir

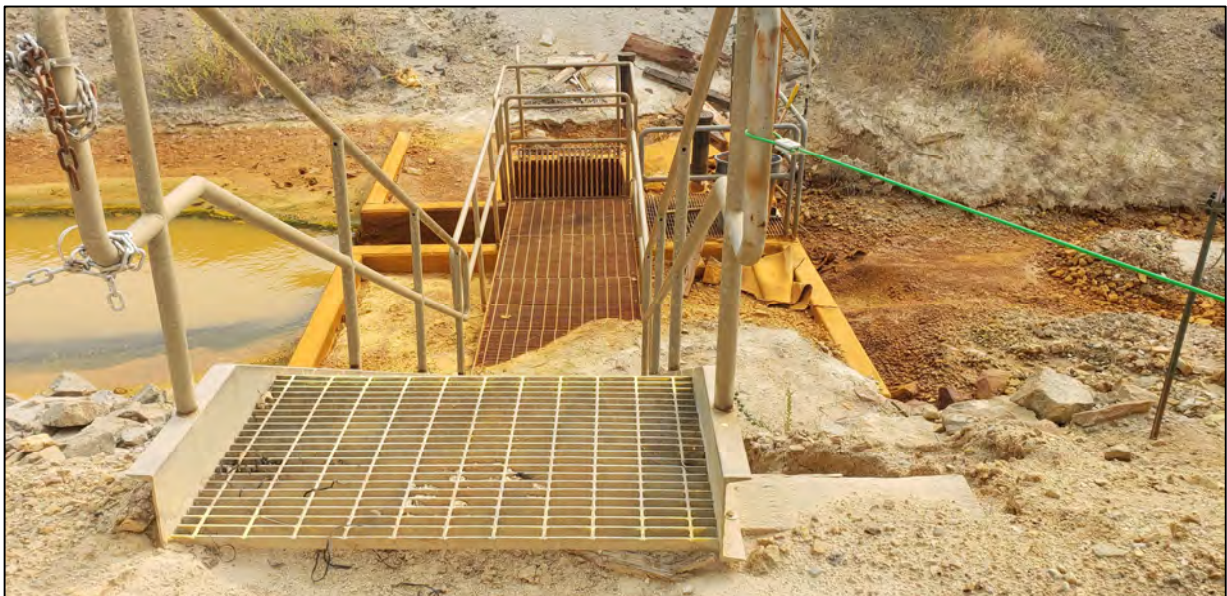
PHOTO 28 – HsB Area – Equalization Basin Intake

- The intake to the Equalization Basin, shown on Photo 28, appears to be operating normally and was not overflowing to the Berkeley Pit.
- The Berkeley Pit return flow pipeline was actively discharging to the HsB Water Treatment Plant Transfer Pond, as shown on Photo 29.

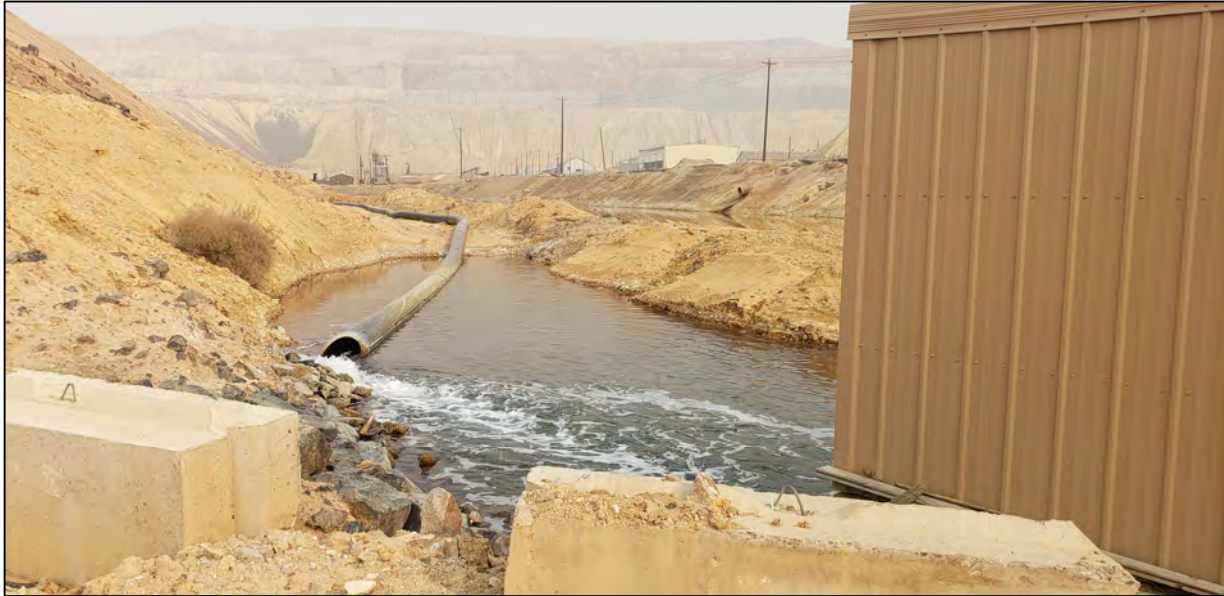
PHOTO 29 – HsB Area – HsB Water Treatment Plant Transfer Pond

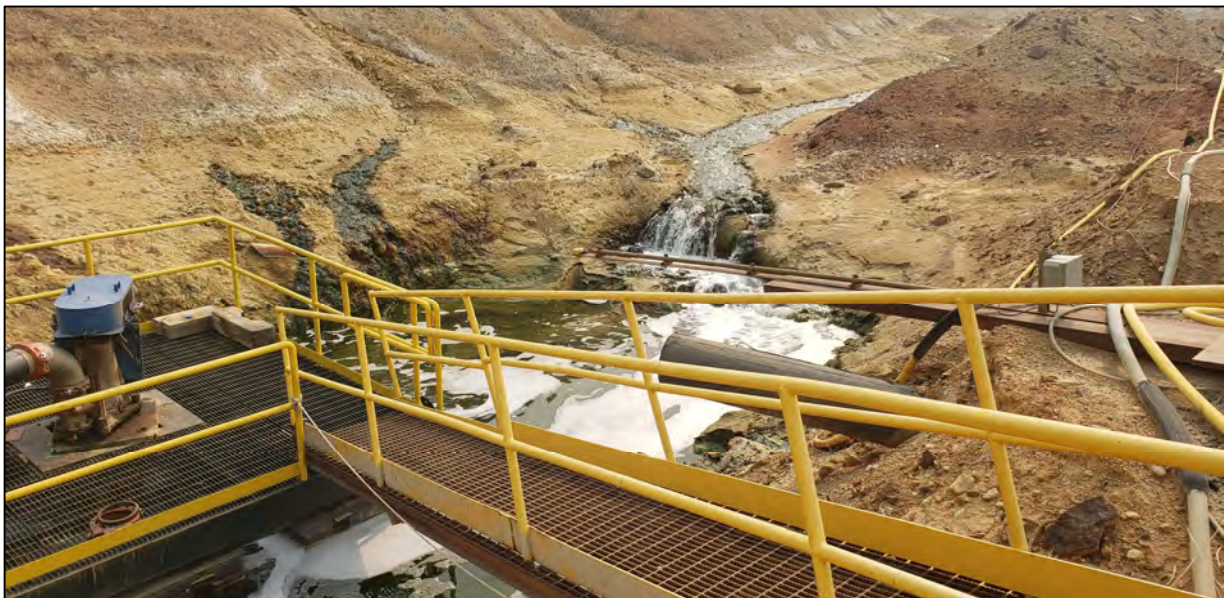
PHOTO 30 – HsB Area – Muddler Pump and overflow pipeline

- The Muddler Pump area, shown on Photo 30, appears to be operating normally with no overflow to the HsB Lower Pond.

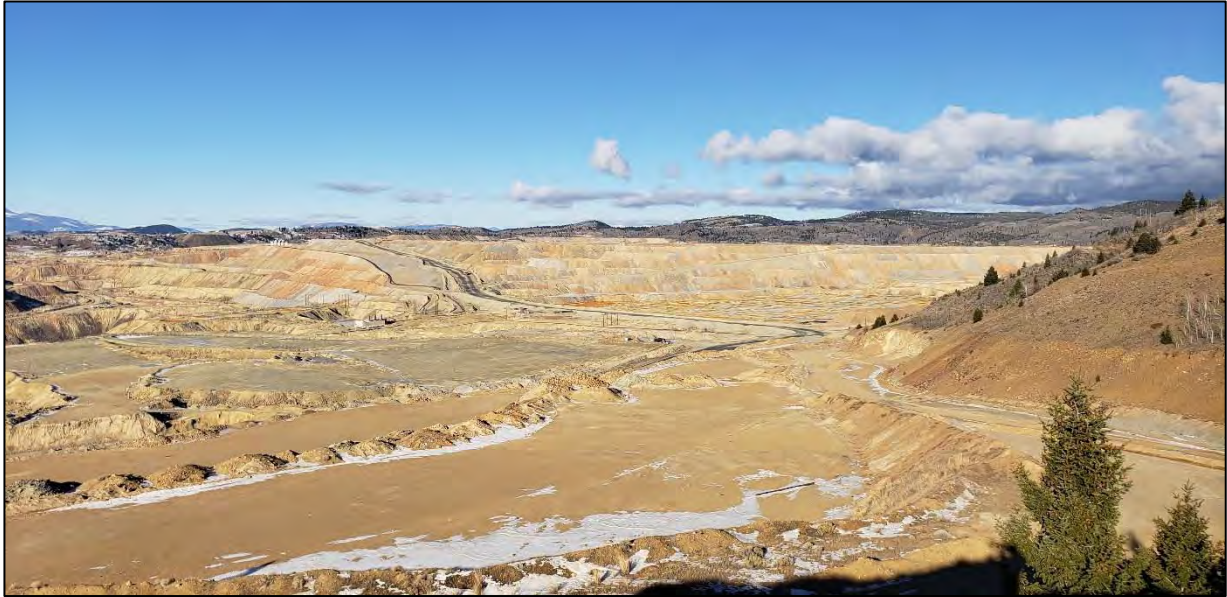
PHOTO 1 – North-South Embankment – Viewed from the Great Northern Dump

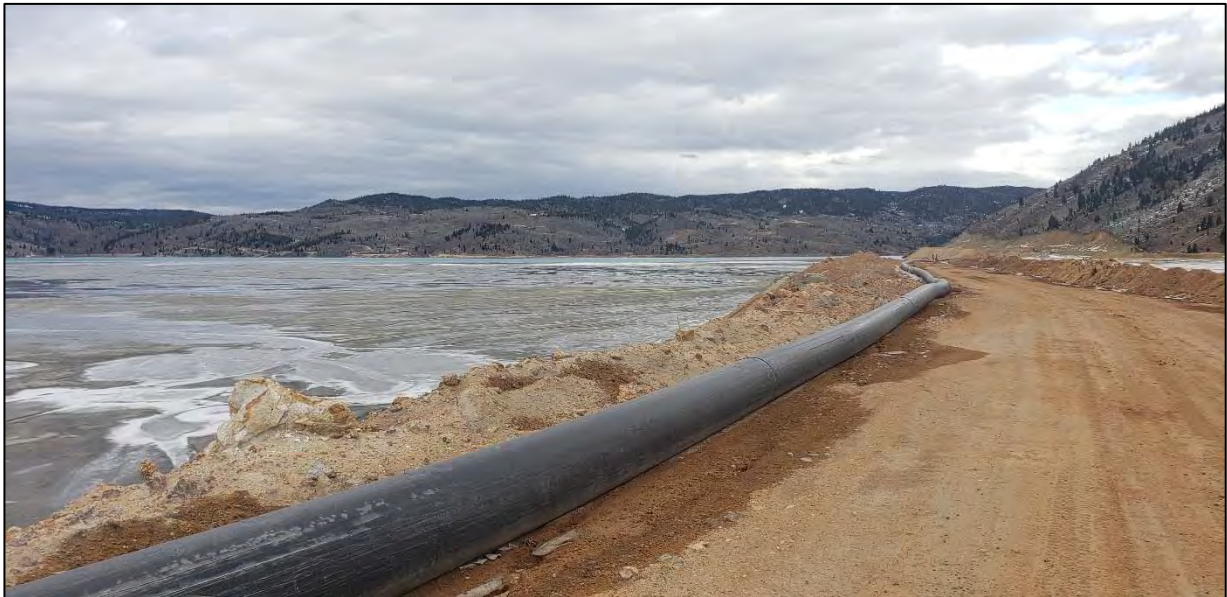
PHOTO 2 – North-South Embankment – Example of minor settlement cracking along the upstream edge of the tailings discharge corridor

Settlement cracking was observed to be present within the tailings discharge corridor along the upstream side of the embankment crest, similar to observations from previous 2020 field reviews. A photo of the tailings pipeline corridor and minor settlement cracking is shown on Photo 2. The provided photos and checklist indicate that the downstream edge of the embankment was reviewed, and no cracking, subsidence or depressions were identified by MR. Minor depressions were observed along the embankment access ramp as shown on Photo 3. It is unclear if these depressions are newly formed or a result of the construction and hauling patterns of the MR mine fleet. MR will continue to monitor any cracking and/or propagation of the existing cracks.

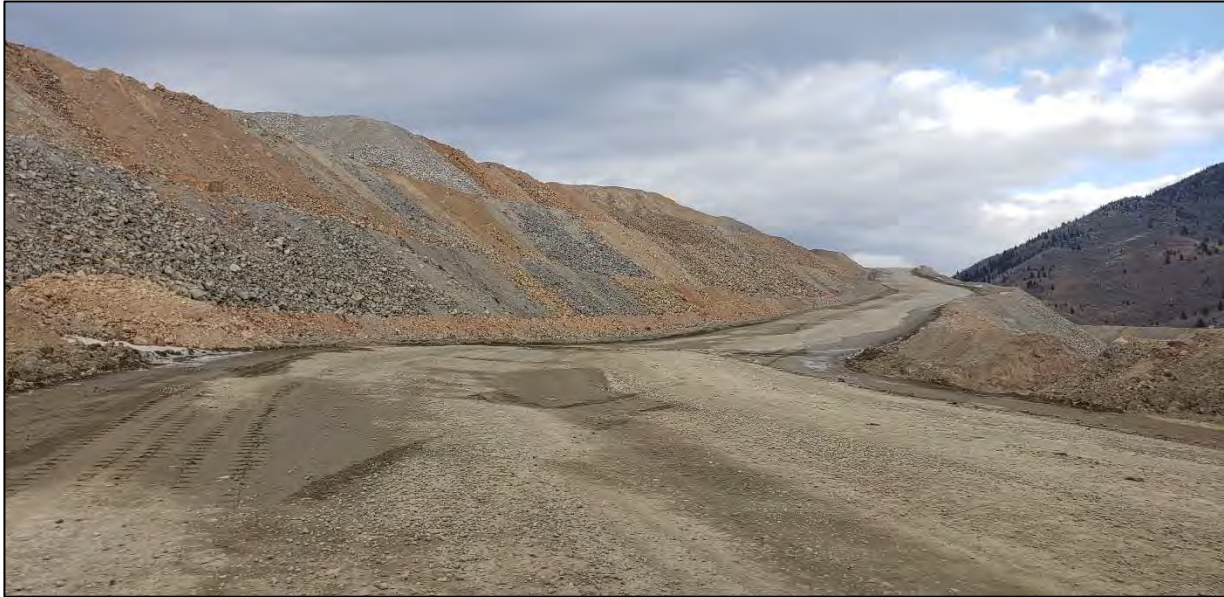
PHOTO 3 – North-South Embankment – Minor depressions in the access ramp

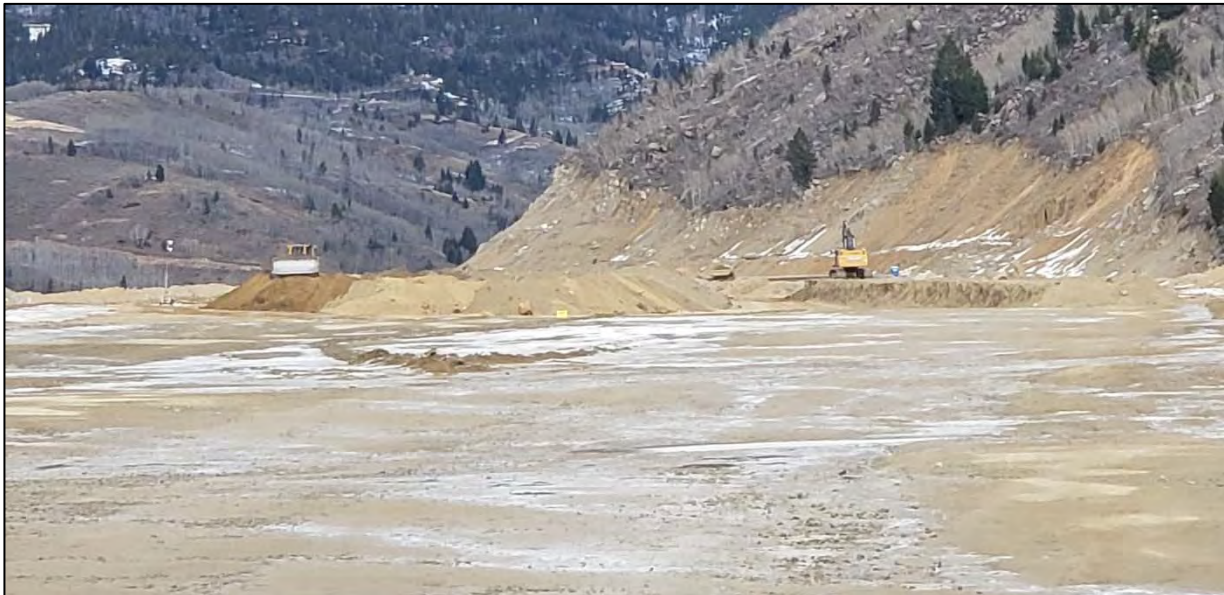
PHOTO 4 – North-South Embankment – Road widening to accommodate realignment of the Reclaim Water Pipeline

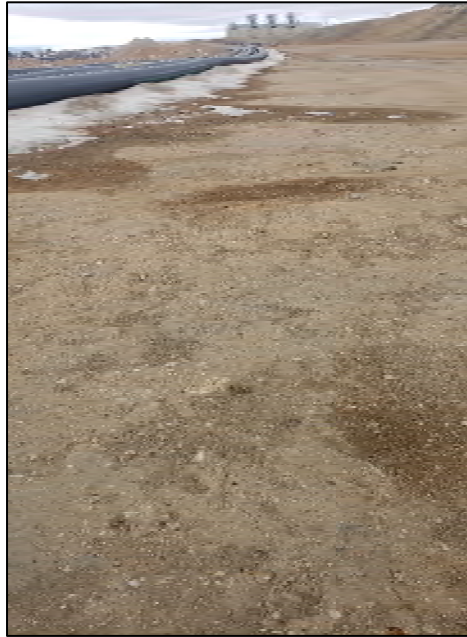
PHOTO 5 – East-West Embankment – Example of settlement cracking along the downstream edge of the tailings pipeline ramp

The downstream edge of the pipeline ramp shows signs of minor settlement cracking at intermittent locations along the ramp, including near DH20-S1. An example of the cracking is shown on Photo 5. MR is to continue to monitor the downstream edge of the pipeline ramp for any additional cracking or the propagation of existing cracks.

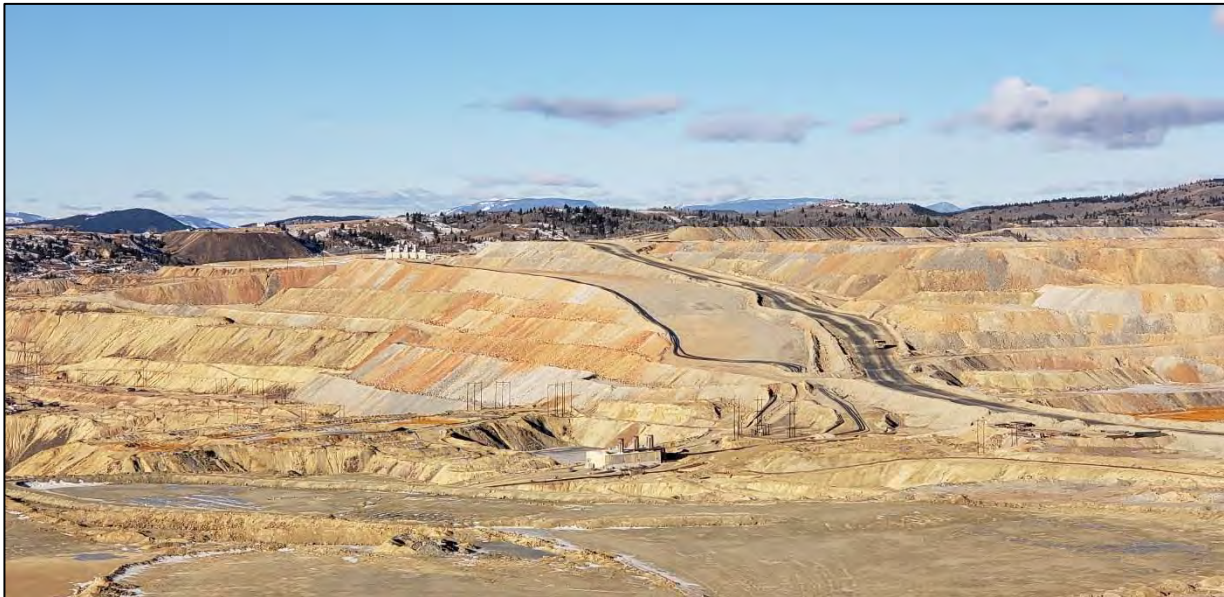
PHOTO 6 – East-West and North-South Embankment – Corner and central zone to be constructed

The connection of the East-West Embankment and North-South Embankment downstream step-outs is still to be completed (shown on Photo 6), as well as a portion of the central section along the East-West Embankment below EL. 6,450. The 2020 Annual Inspection Report (AIR) (KP, 2021a) includes a recommendation to provide a construction schedule outlining the planned dump sequencing with a focus on the next 12 to 24 months.

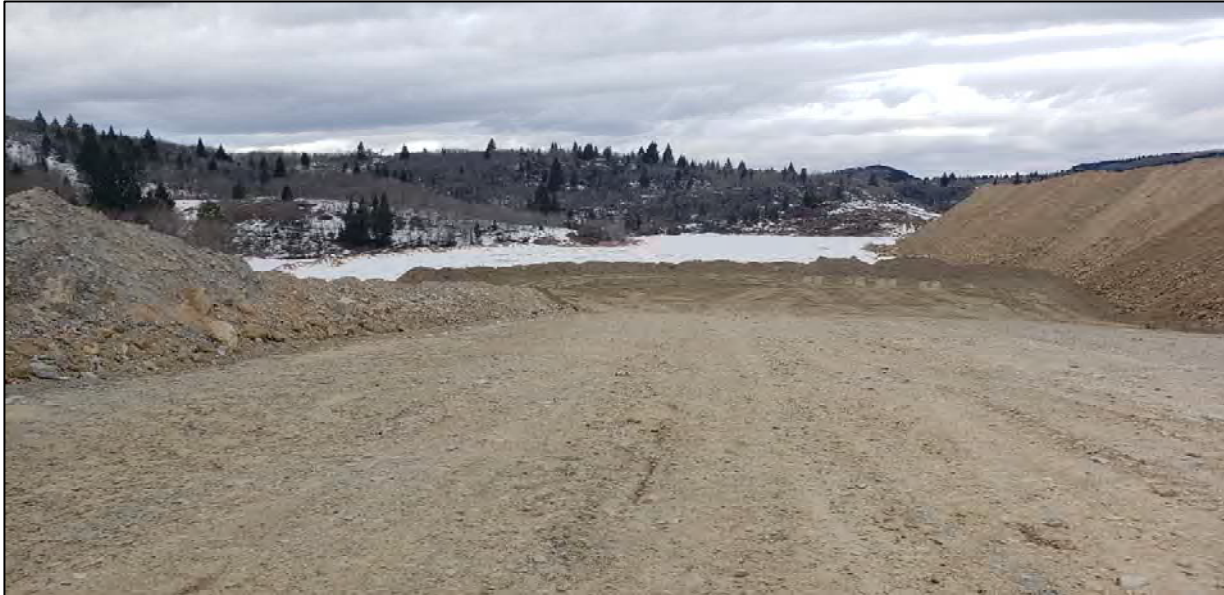
PHOTO 7 – West Embankment – Zone D1 construction west of the Temporary Extraction Pond location

Areas of interest along the West Embankment during Q4 are shown on Figure 4. Zone D1 construction continued along the western edge of the temporary sump (Photo 7) and in the area of Drain Pod 1 (Photo 8). Construction of Zone U for the EL. 6,450 lift of the West Embankment continued throughout Q4. An overview of the EL. 6,450 construction progress as viewed from the northern end of the West Embankment is shown on Photo 9. The EL. 6,400 ft surface was ripped prior to placement of the subsequent fill materials as presented in various weekly reports completed during Q4.

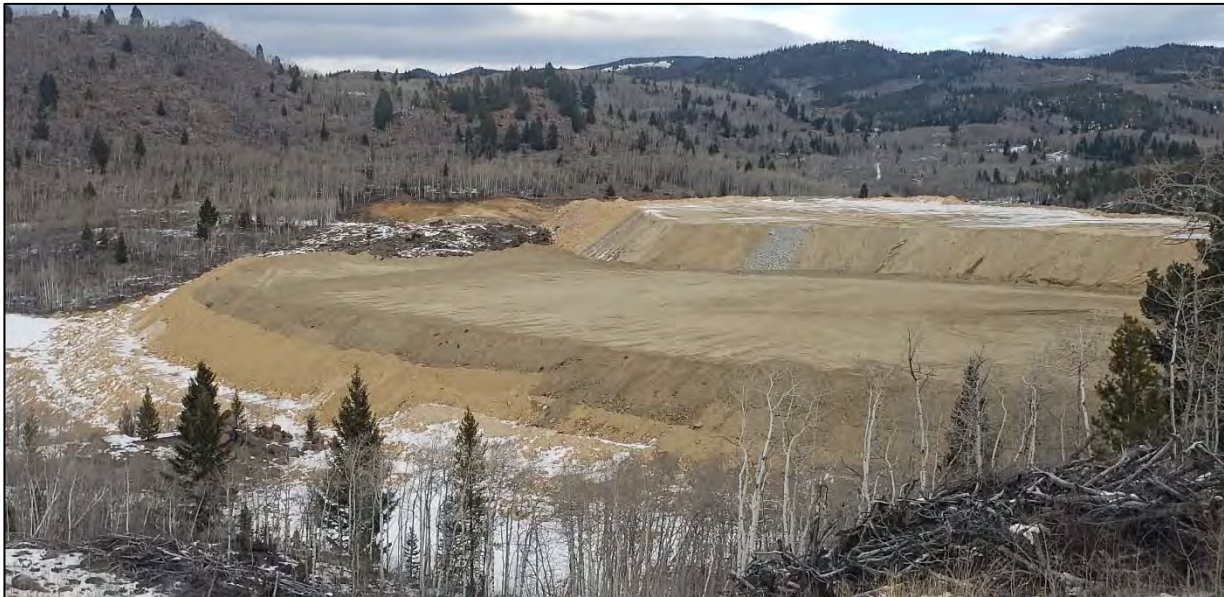
PHOTO 8 – West Embankment – Zone D1 construction at Drain Pod 1 location

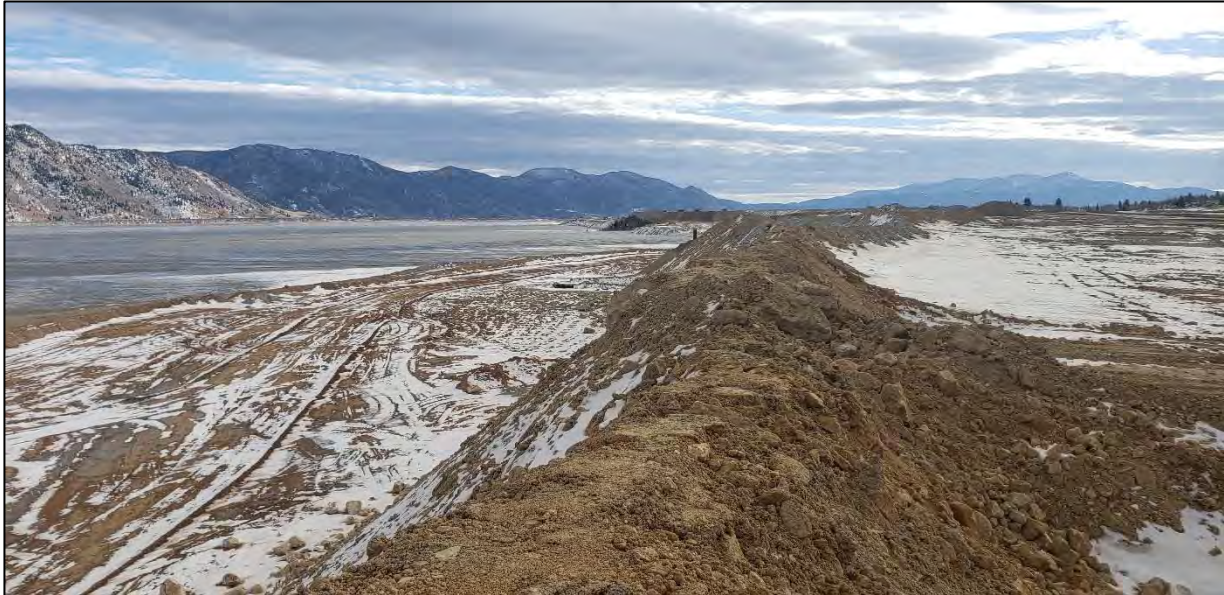
PHOTO 9 West Embankment – El. 6,450 ft construction progress, looking south from the northern end of the embankment

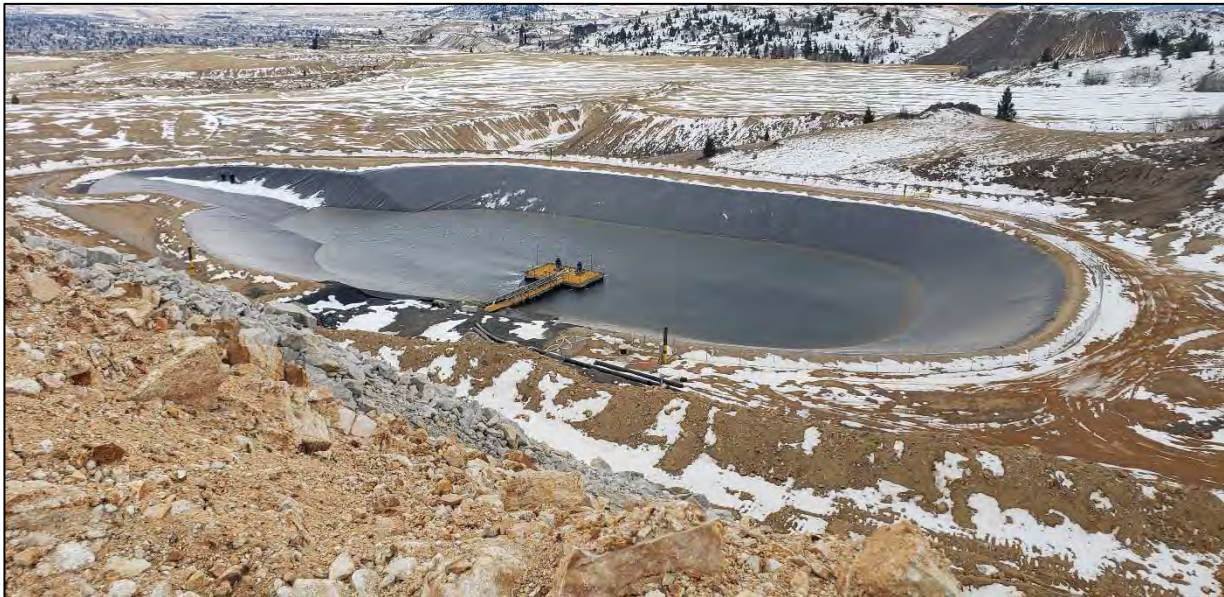
PHOTO 10 – West Embankment – Extraction Pond

An overview of the Extraction Pond is shown on Photo 10. The welding and placement of the emergency overflow pipelines from the Extraction Pond was completed in October and recorded in the appropriate weekly report (Photo 11). Additional large boulders for energy dissipation are still required at the emergency overflow discharge structure at the outlet of the emergency overflow pipelines.

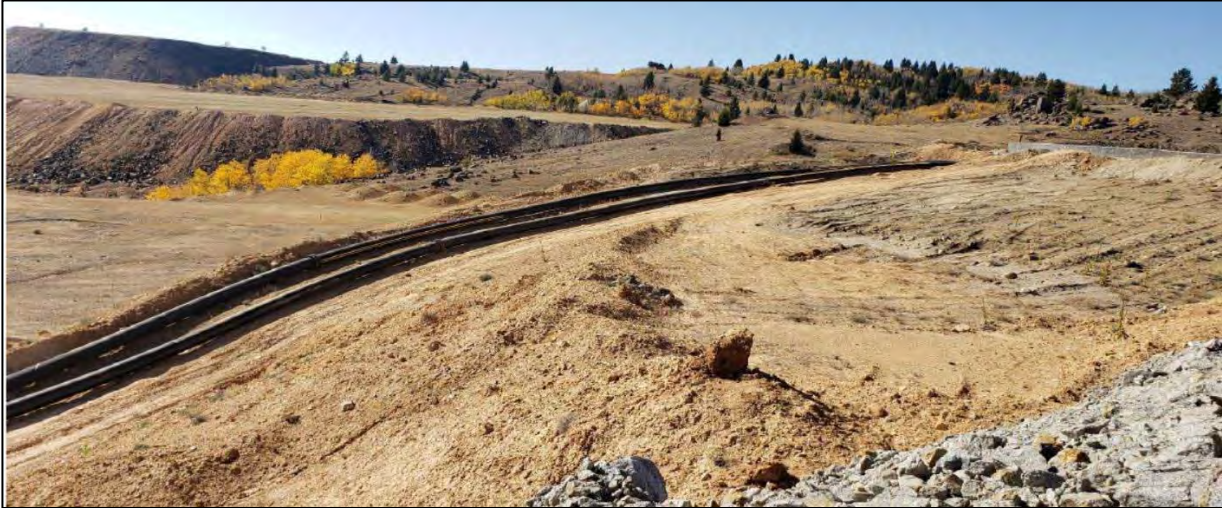
PHOTO 11 – West Embankment – Extraction Pond emergency overflow pipes fused

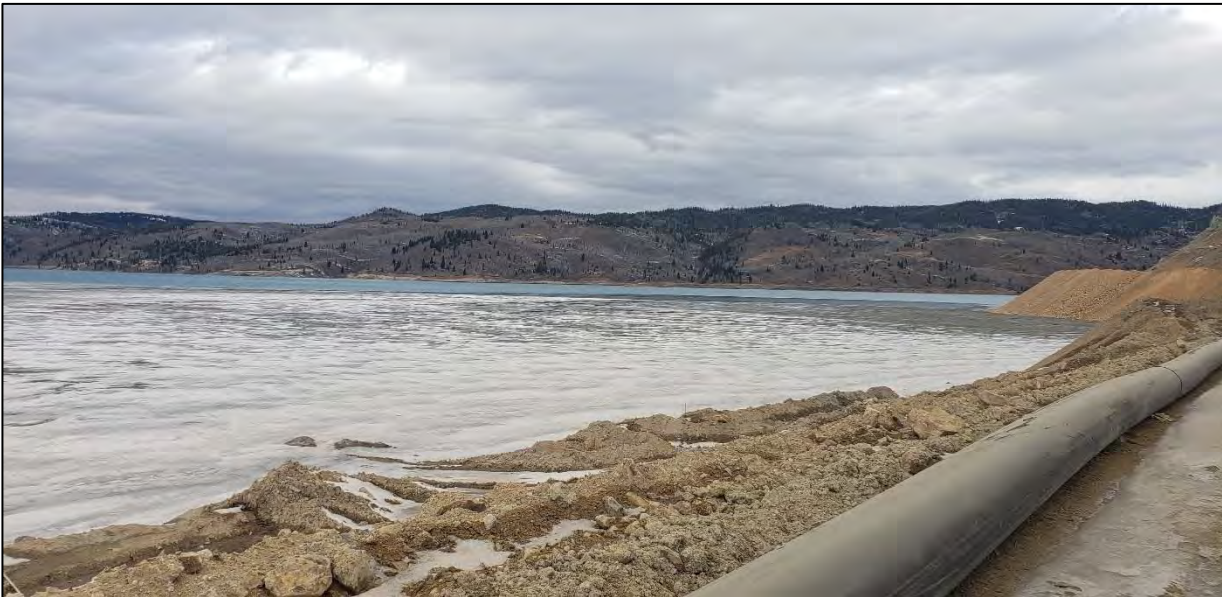
PHOTO 12 – Tailings Beach and Supernatant pond location – Viewed from the tailings discharge corridor near discharge location NS-4

The tailings beach conditions and supernatant pond location, observed from the tailings discharge corridor near discharge locations NS-4 and EW-2, and from the EL. 6,450 ft West Embankment near discharge location RK-3, are shown on Photos 12 through 14. Tailings discharge records indicate that nine of the ten discharge locations were active during Q4, with RK-4 being the only non-operational location. Discharge activity was inferred using the weekly tailings discharge elevations and daily discharge activity information provided by MR. The approximate beach elevations at each discharge location at the end of Q3 and Q4, along with the change in elevation over that time period, are summarized in the table below.

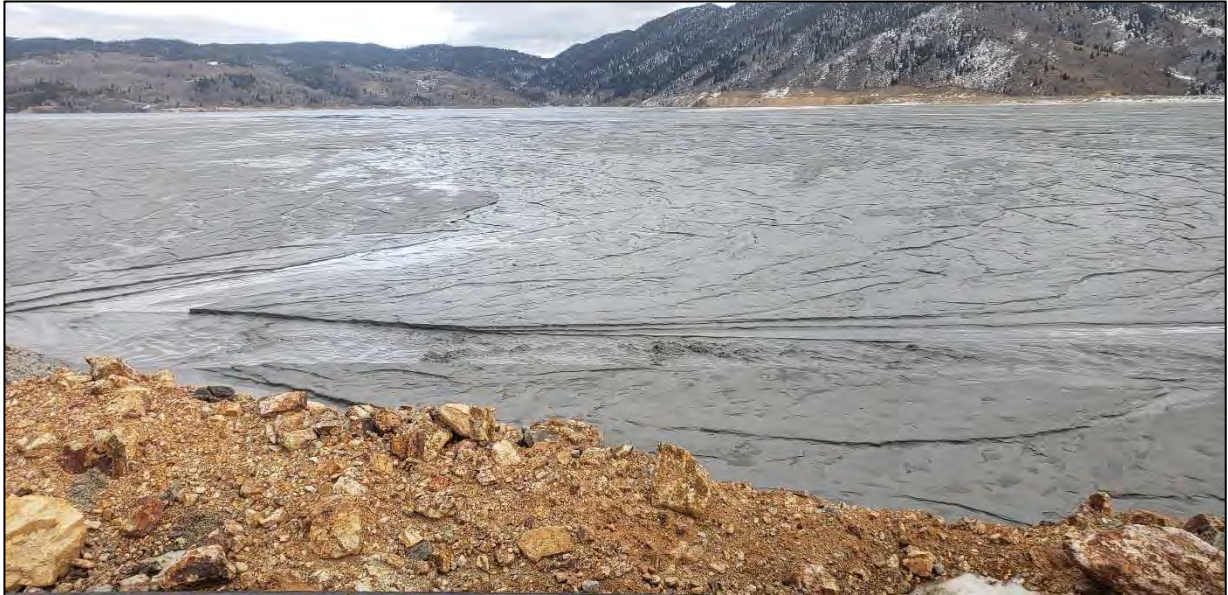
PHOTO 13 – Tailings Beach and Supernatant pond location – Viewed from the tailings discharge corridor near discharge location EW-2

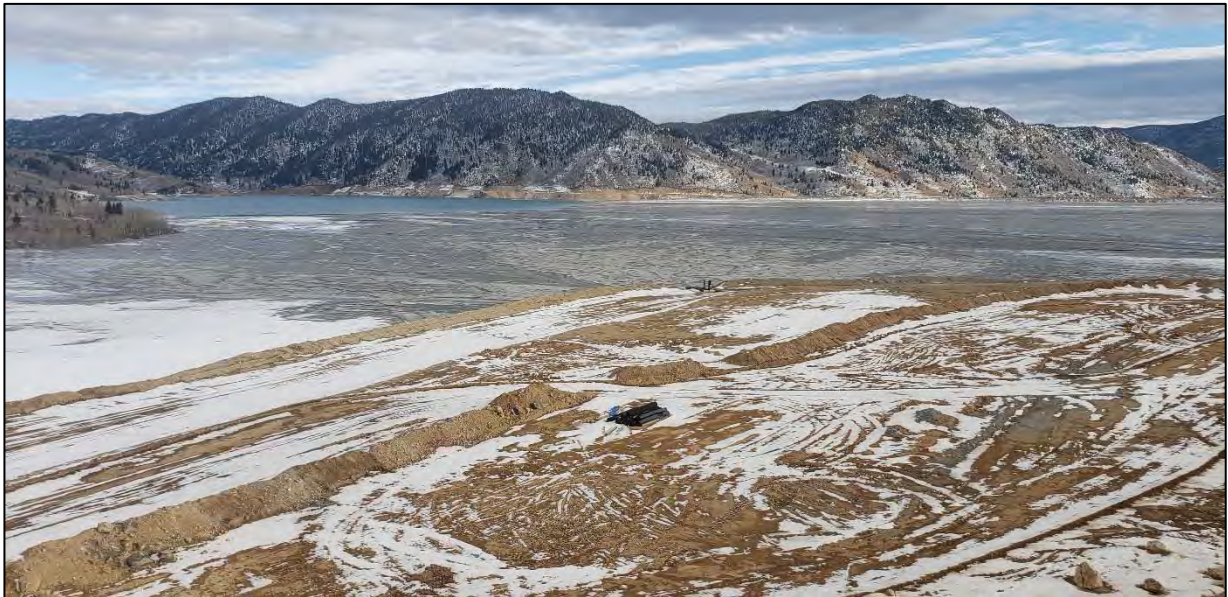
PHOTO 14 – Tailings Beach and Supernatant pond location – Viewed from EL 6,450 ft West Embankment near discharge location RK-3

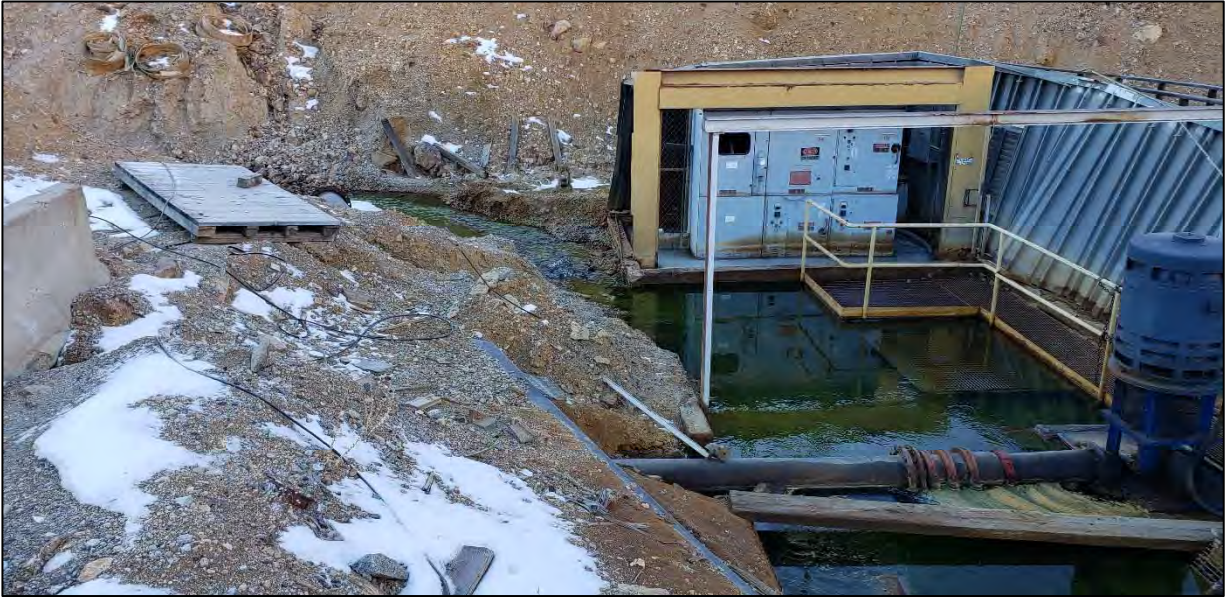
PHOTO 15 – Cell #10 Pump – Overflow to HsB Pond
