Prepared for
Montana Resources, LLP
600 Shields Avenue
Butte, Montana
USA, 59701

VA101-126/23-5

YANKEE DOODLE TAILINGS IMPOUNDMENT

2020 DATA ANALYSIS REPORT

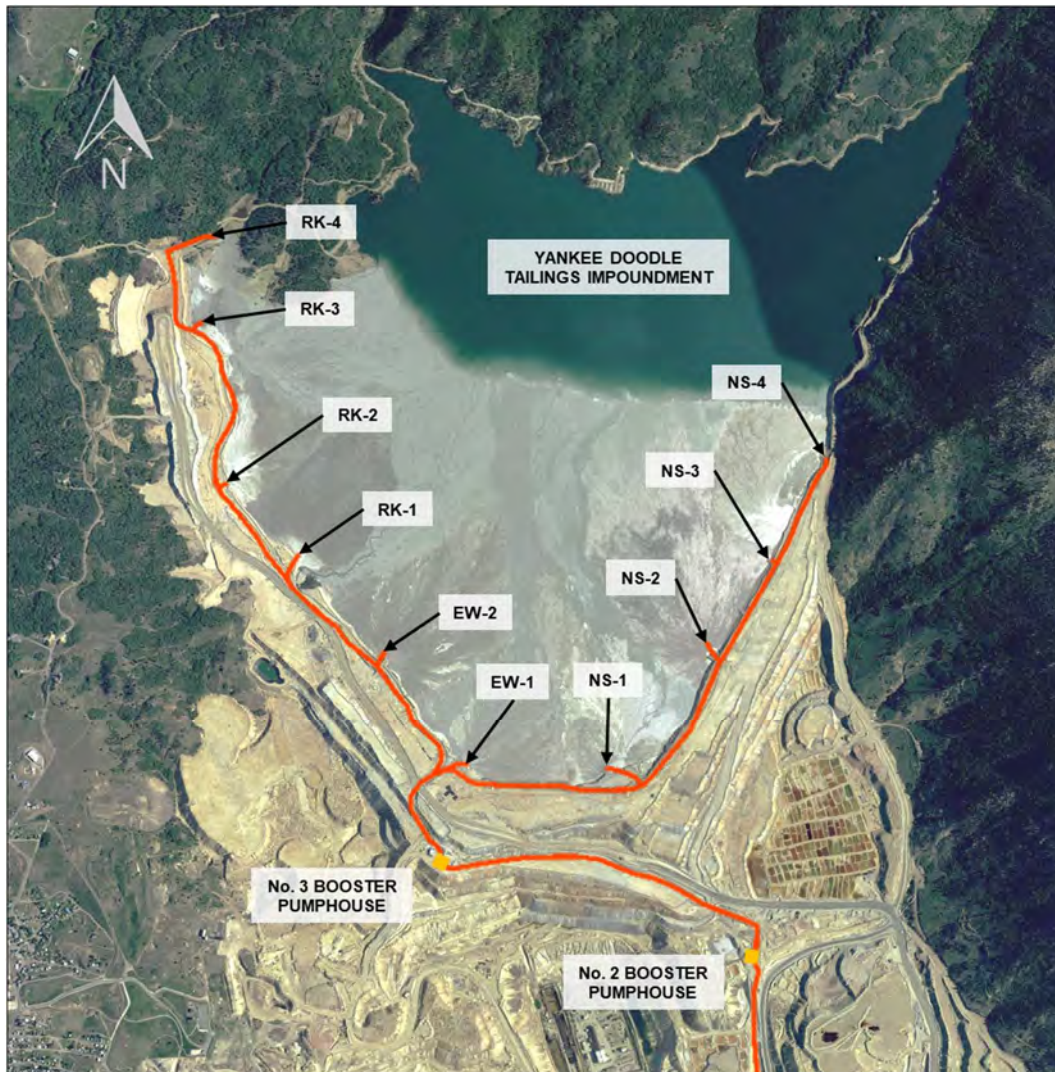
Figure 3.1 YDTI Tailings Discharge Locations

Several changes were made to Tailings Discharge Line 3 in Q3 2020; tailings discharge location NS-3 was relocated closer to NS-2 and a new discharge location NS-4 was added in August at the northern end of the North-South Embankment. The positions of the ten discharge locations at the end of Q3 are shown on Figure 3.1. Tailings discharge records indicate that tailings were distributed from all three YDTI embankments during Q3 2020, and all ten discharge locations were used.

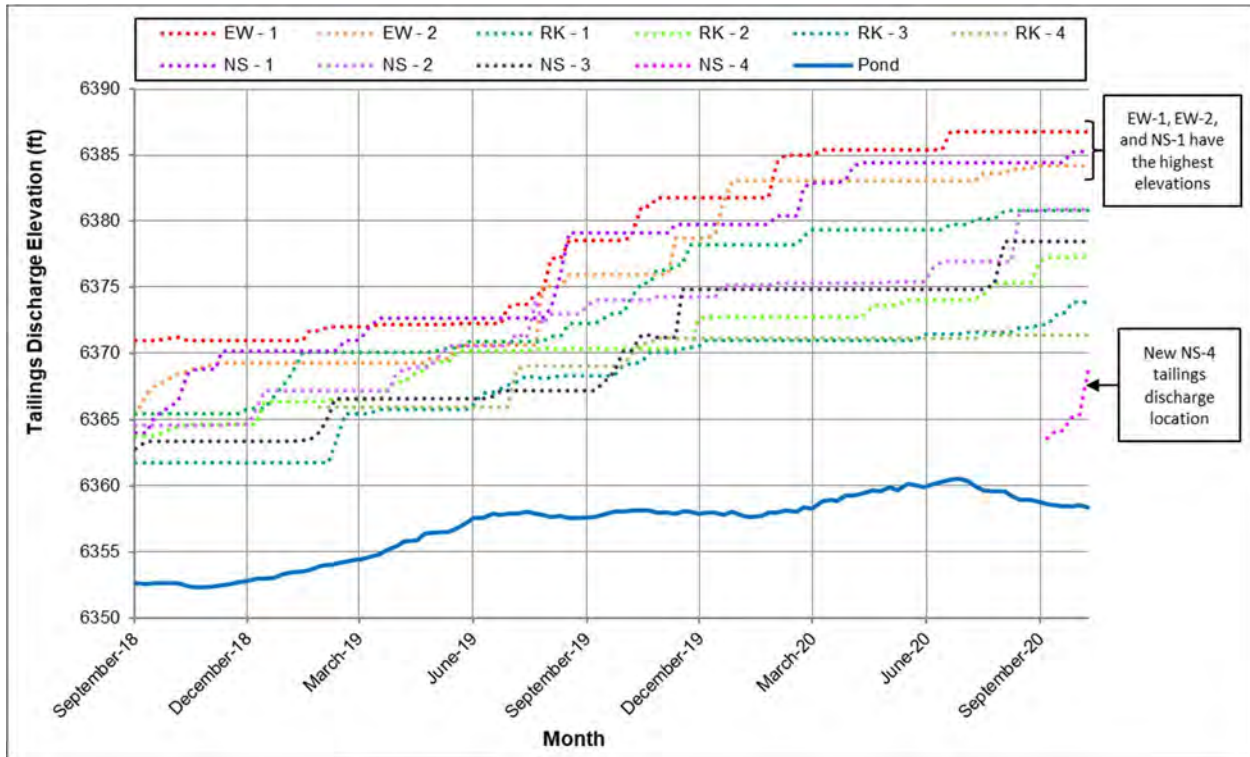
Figure 3.2 Tailings Discharge Elevations

The tailings beach elevations at each of the discharge locations are shown on Figure 3.2. The elevation difference between the lowest discharge elevation (NS-4) and the pond surface was approximately 11 ft at the end of Q3 2020. The lowest discharge elevation during Q3 was at the new NS-4 discharge location located at northern end of the North-South Embankment. The lowest discharge elevation prior to the installation of NS-4 was located at RK-3 and RK-4 at the northern end of the West Embankment. The location of the lowest discharge point identifies the area of the facility where the pond may initially contact the embankment in the event the pond elevation increases due to an increase in pond volume (e.g. flooding).

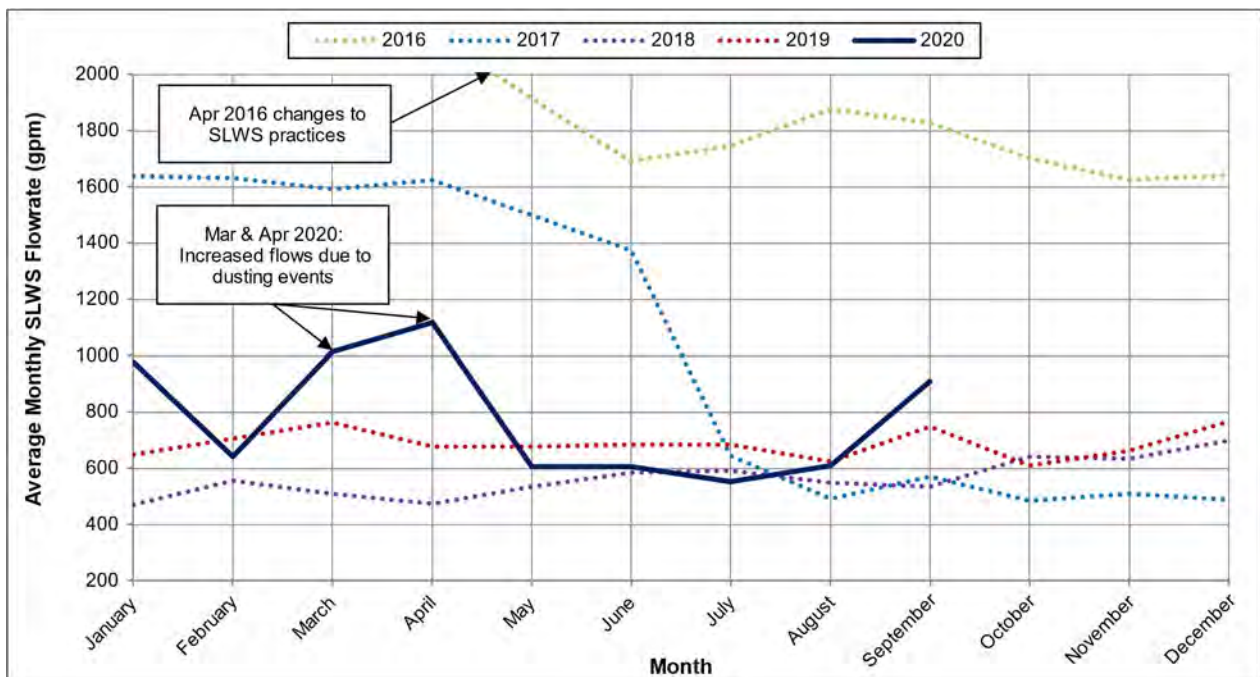
Figure 4.1 Average Monthly SLWS Flowrate

The flowrates since the implementation of the new SLWS practices are presented on Figure 4.1. SLWS flows in July and August 2020 were relatively constant at an average rate of 580 gpm (0.84 Mgalpd), which is comparable to the average Q3 flowrate from the previous 3 years. The September 2020 average flowrate was approximately 910 gpm (1.31 Mgalpd), which is a 34% increase compared to the average Q3 flowrate from the previous three years. This increase is due to a period of higher than usual SLWS usage from September 17 to 28, averaging approximately 1300 gpm (1.9 Mgalpd), when the SLWS was used for maintenance and filling the No. 3 thickener at the Concentrator. The average SLWS flowrate during Q3 remained below the target maximum flowrate of 1 Mgalpd even when considering the higher than usual flows in September.

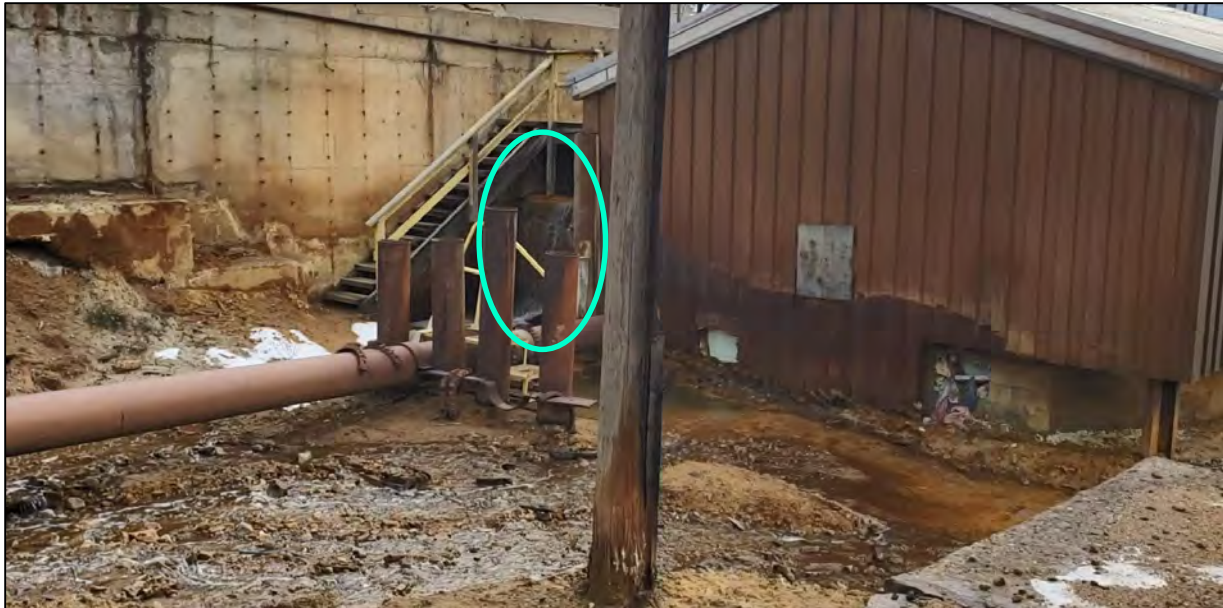
Photo 7.3 Precipitation Plant Recirculation Pump House. Water is overflowing from the head tank under the stairs.

Water was also observed during Q3 2020 overflowing from the Precipitation Plant recirculation pump house head tank and draining to the adjacent HsB Pond (Photo 7.3). This unmeasured flow also reduces the contributing flows to the precipitation plant recirculation pump and overflow. Overflow at this location has been observed intermittently since Q4 2019.

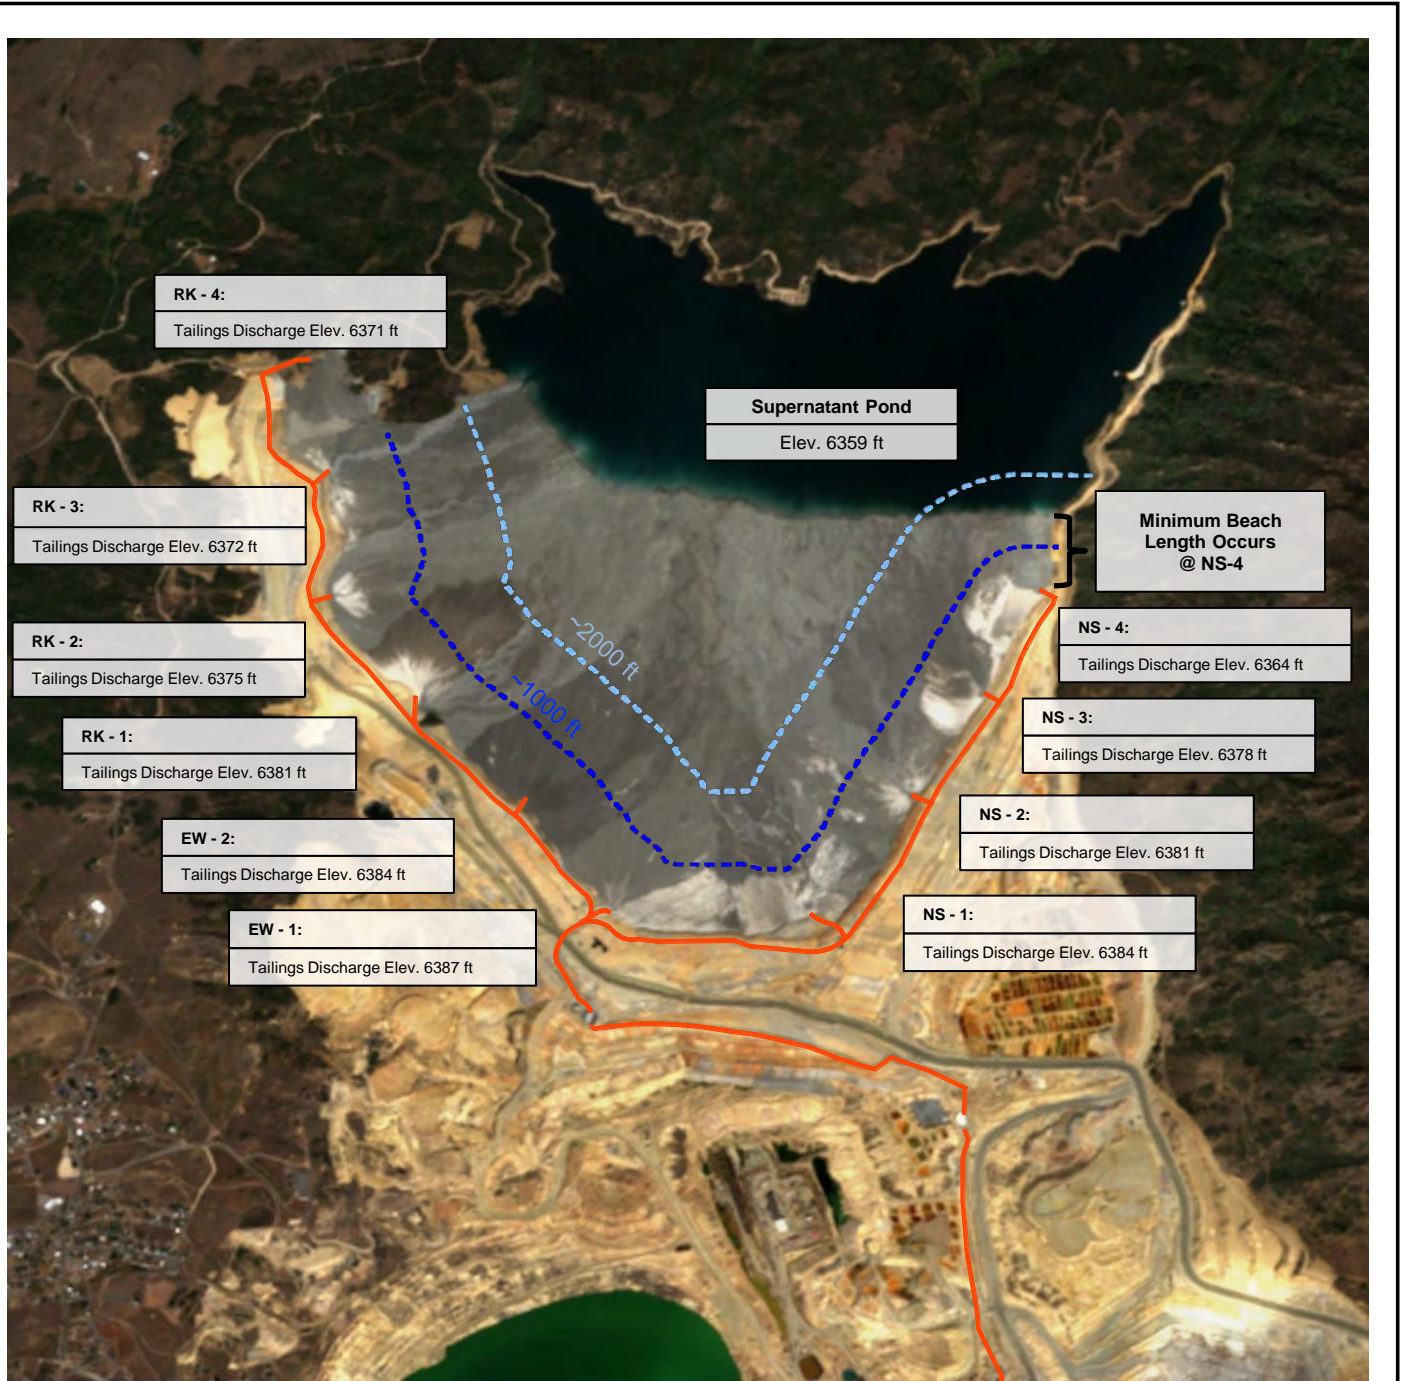
1. TAILINGS DISCHARGE AND SUPERNATANT POND ELEVATIONS WERE SURVEYED ON AUGUST 27, 2020. ALL ELEVATIONS ARE RELATIVE TO THE ANACONDA DATUM.
2. SENTINEL-2 VISIBLE SATELLITE IMAGE TAKEN ON AUGUST 28, 2020.
3. TAILINGS DISCHARGE LOCATION NS-3 WAS RELOCATED CLOSER TO NS-2.
4. TAILINGS DISCHARGE LOCATION NS-4 WAS ADDED AT THE END OF THE NORTH-SOUTH EMBANKMENT.

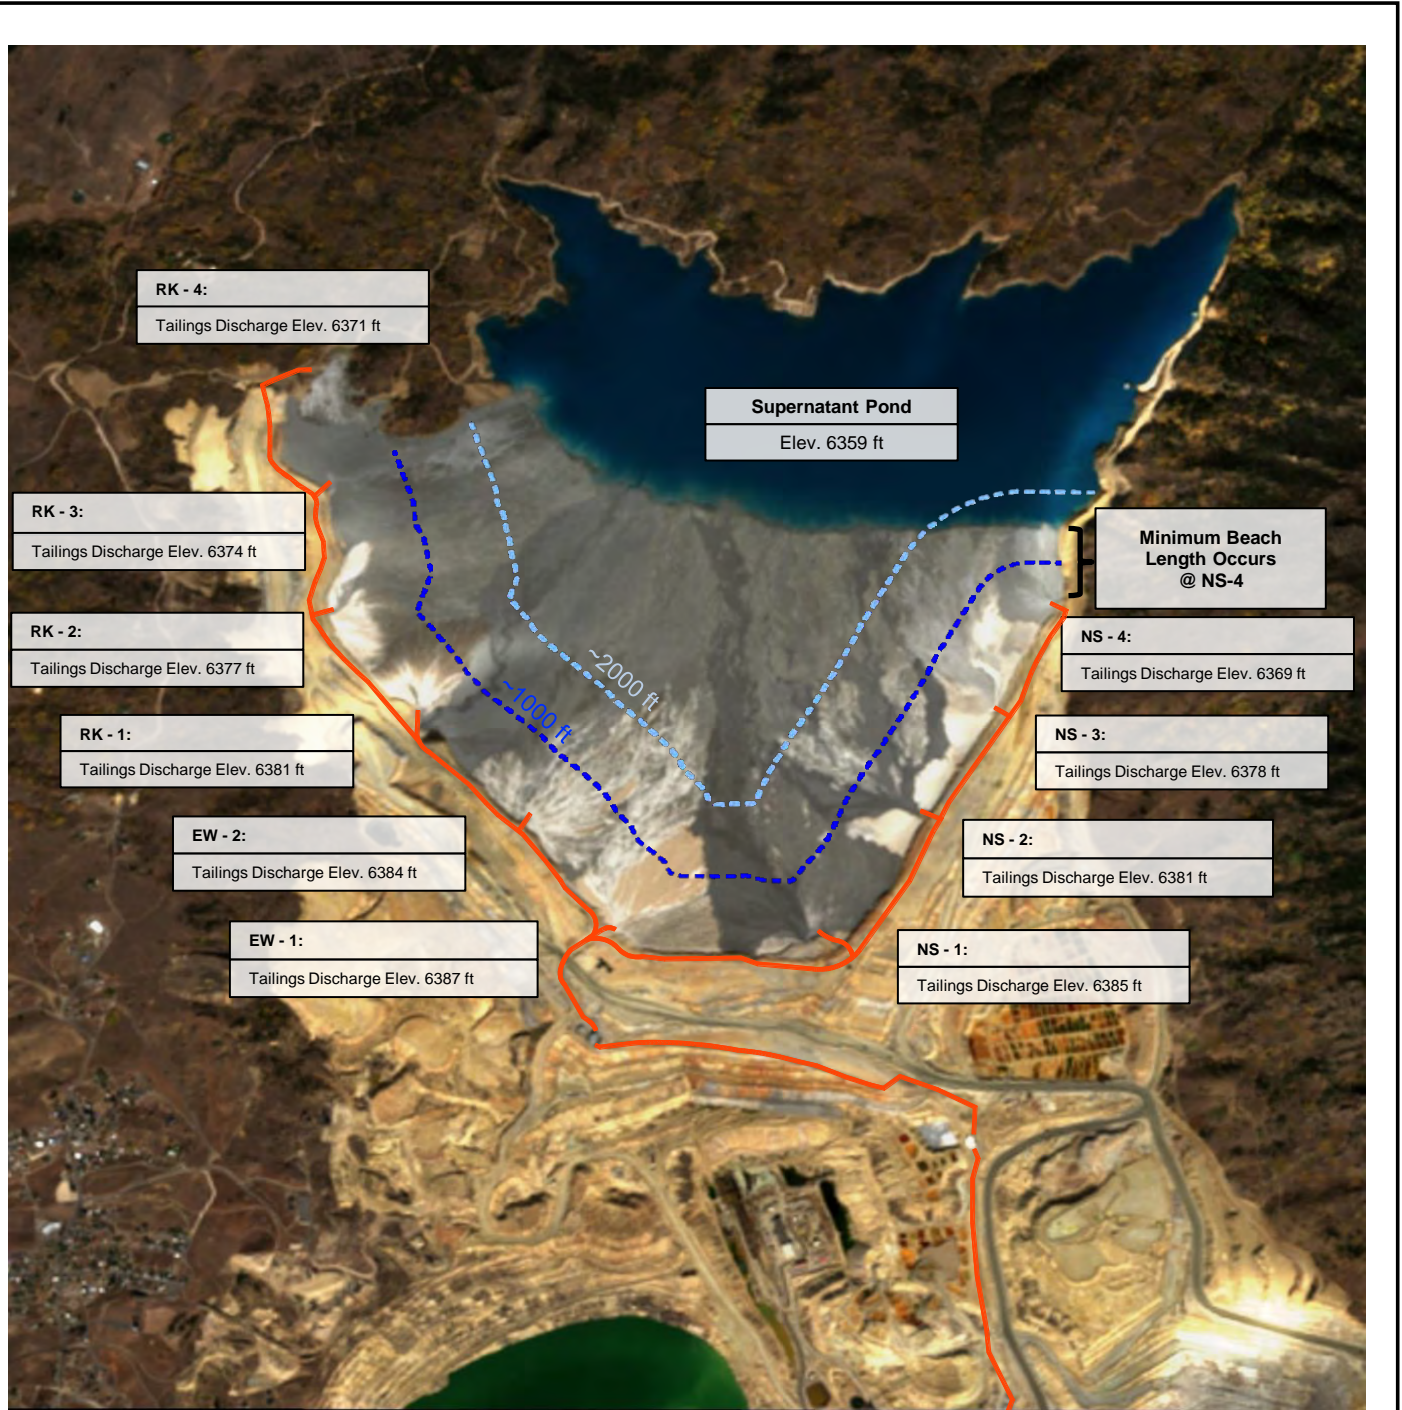
1. TAILINGS DISCHARGE AND SUPERNATANT POND ELEVATIONS WERE SURVEYED ON OCTOBER 5, 2020. ALL ELEVATIONS ARE RELATIVE TO THE ANACONDA DATUM.
2. SENTINEL-2 VISIBLE SATELLITE IMAGE TAKEN ON OCTOBER 7, 2020.

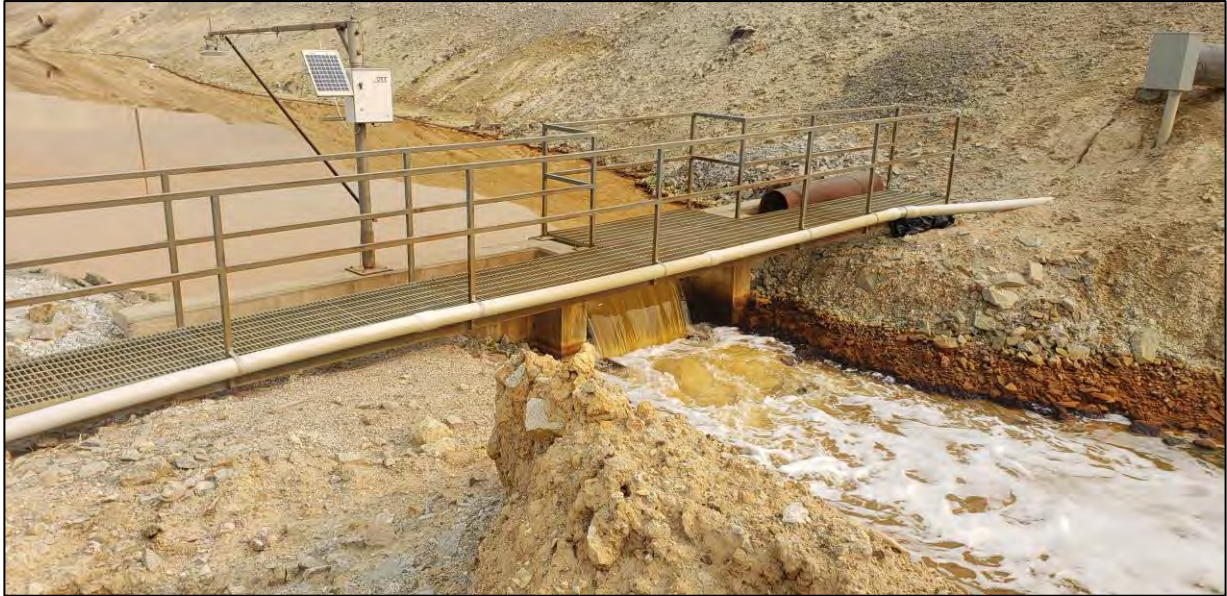
PHOTO 1 – Sep 16, 2020 – Flow through HsB Weir.

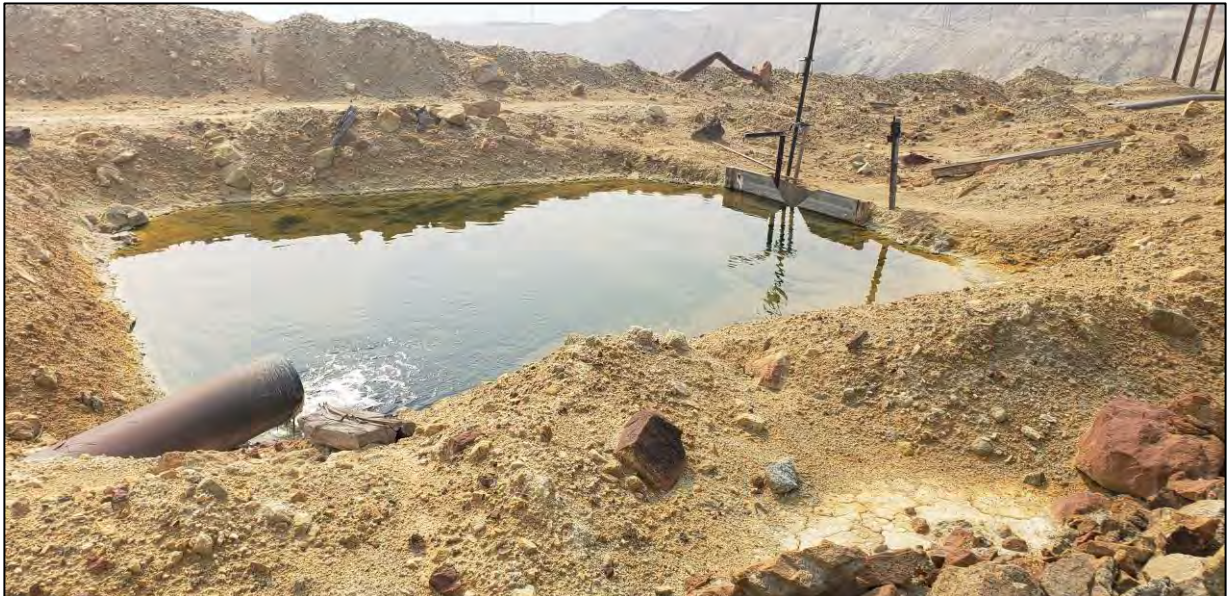
PHOTO 2 – Sep 16, 2020 – Seep 10 Stilling Pond.

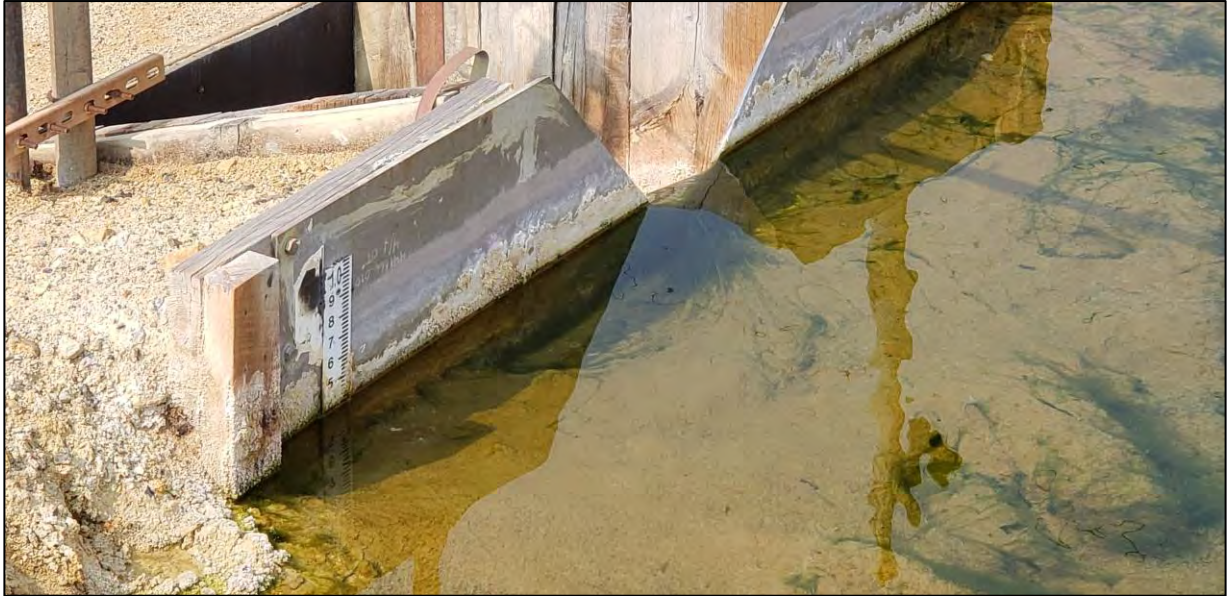
PHOTO 3 – Sep 16, 2020 – Seep 10 Weir and Staff Gauge.

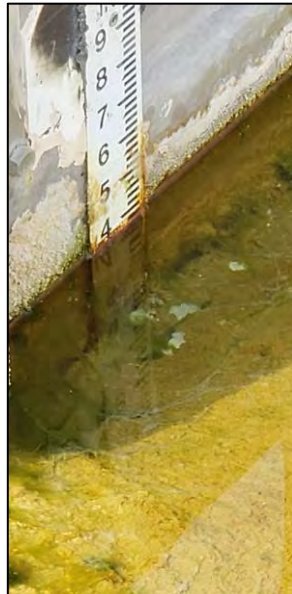
PHOTO 4 – Sep 16, 2020 – Seep 10 Staff Gauge reading slightly below 0.4.

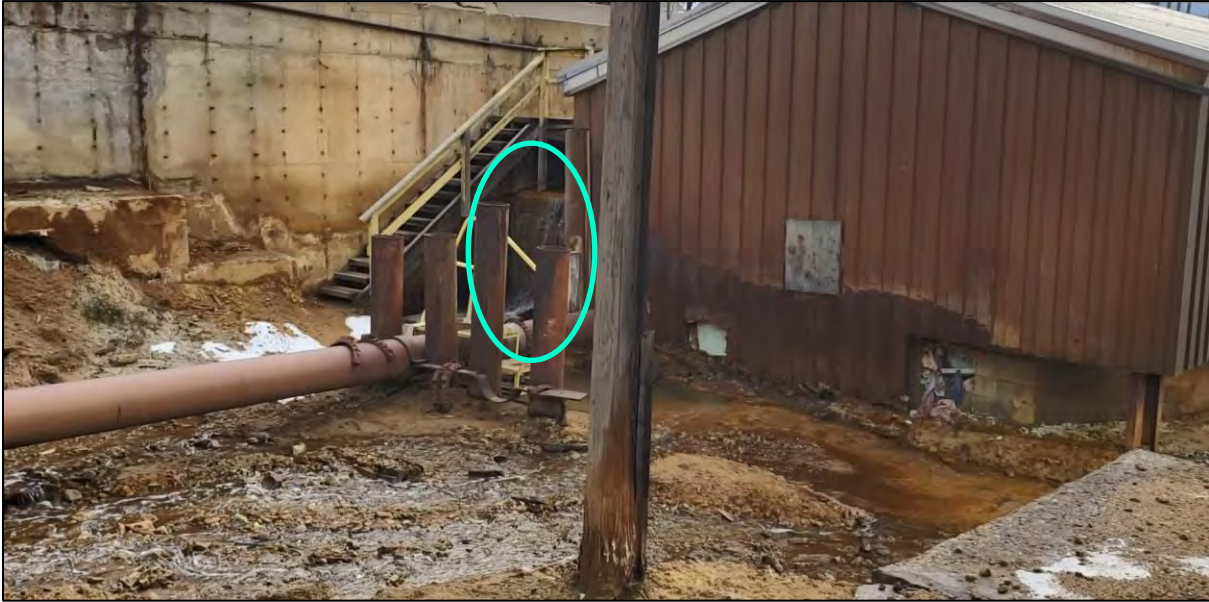
PHOTO 5 – Oct 30, 2020 – Precipitation Plant Recirculation Pump House. Water is overflowing from the head tank under the stairs.

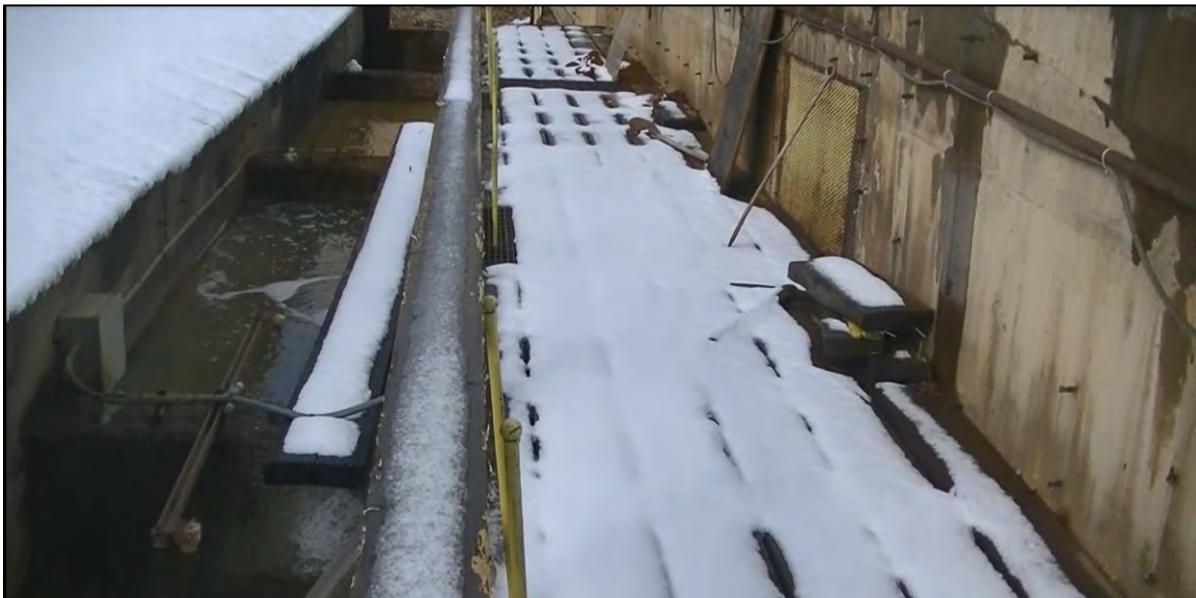
PHOTO 6 – Oct 15, 2020 – Precipitation Plant Recirculation Pump House head tank water level. Water is approximately 1 ft below the top of the concrete separators.

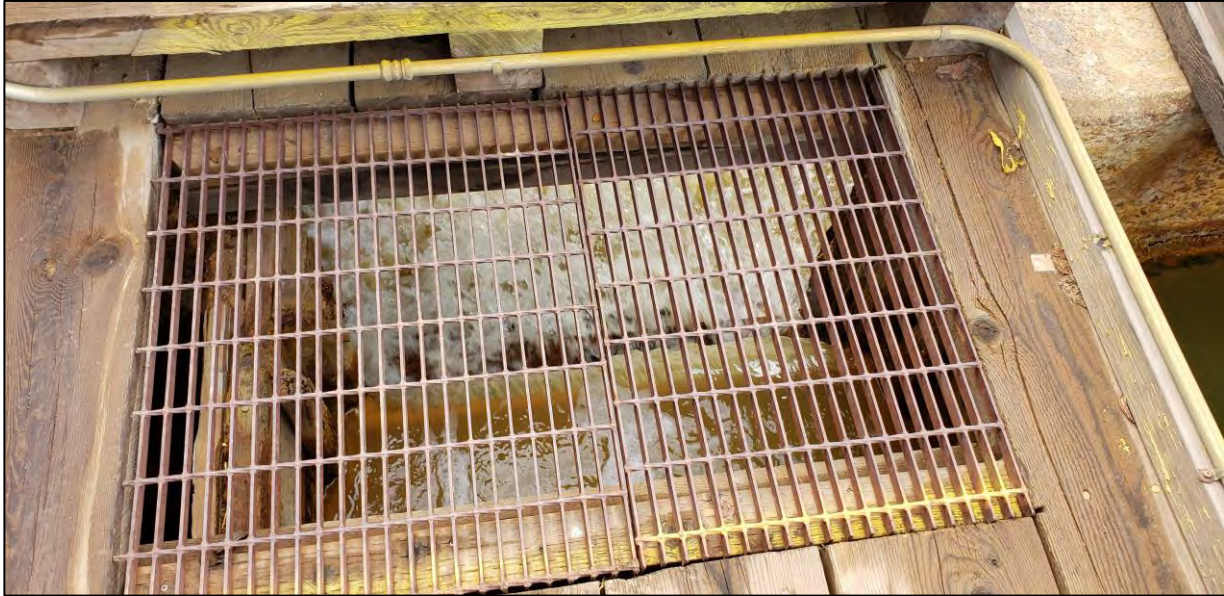
PHOTO 7 – Oct 30, 2020 – Flow through Precipitation Plant overflow weir.

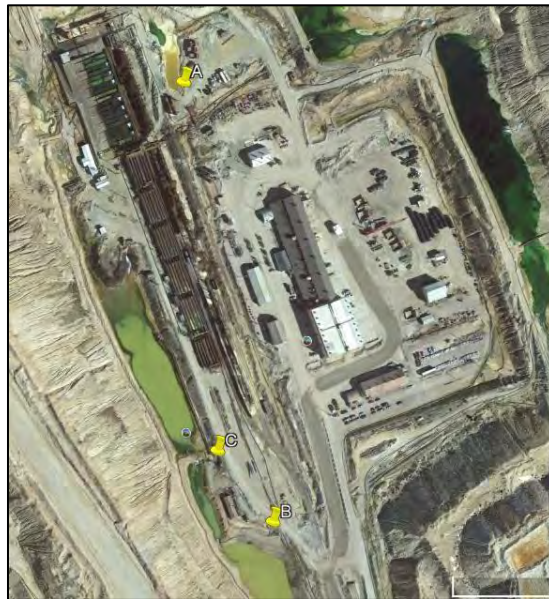
PHOTO 8 – Relevant locations regarding Hooligan Pond bypassing flows. A) Hooligan Pond; B) first discharge location; C) second discharge location.

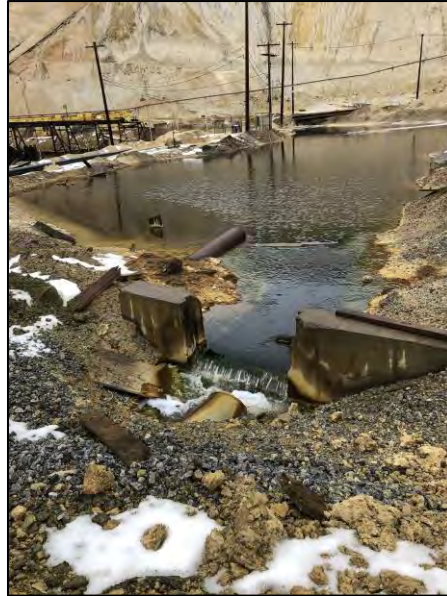
PHOTO 9 – Nov 18, 2020 – Hooligan Pond bypassing flows location A: Hooligan Pond and bypassing flow through weir.

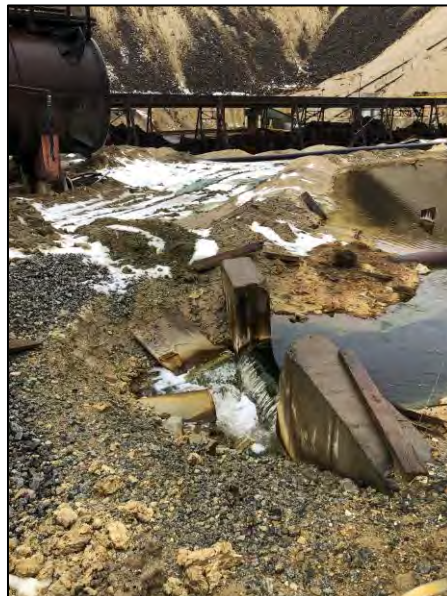
PHOTO 10 – Nov 18, 2020 – Hooligan Pond bypassing flows location A: close-up of flow bypassing through weir.

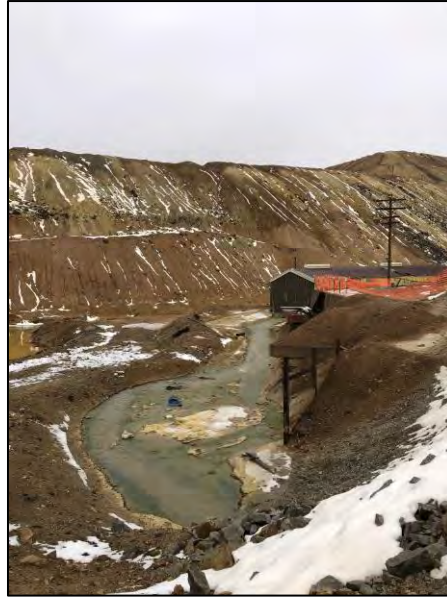
PHOTO 11 – Nov 18, 2020 – Hooligan Pond bypassing flows location B: flow at first discharge location in HsB Pond area.

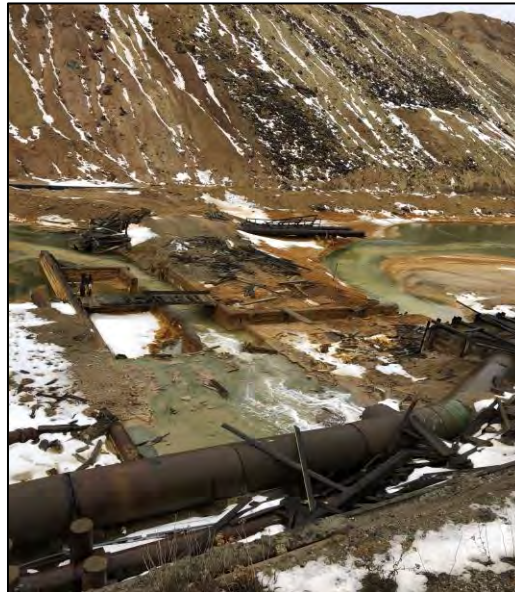
PHOTO 12 – Nov 18, 2020 – Hooligan Pond bypassing flows location B: flow at second discharge location in HsB Pond area.

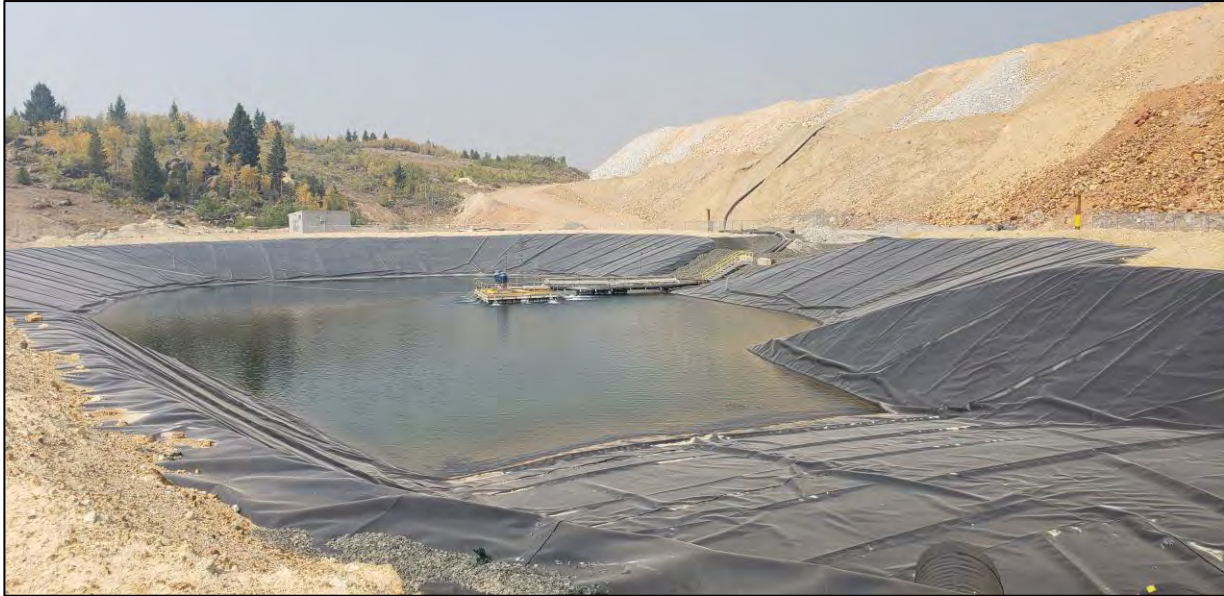
PHOTO 13 – Sep 16, 2020 – WED Extraction Pond and Dewatering System.

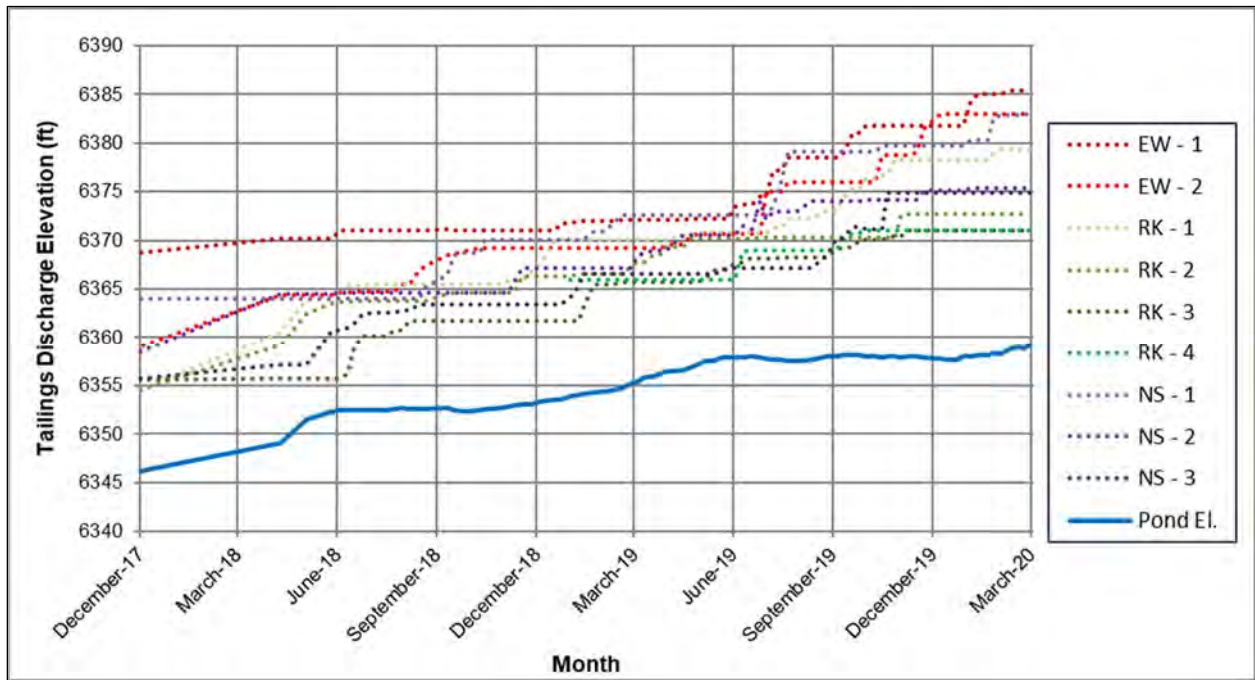
Figure 2.2 Tailings Discharge Elevation

Discharge location planning continues to focus on maintaining extensive tailings beaches adjacent to all three of the embankments. Tailings discharge records indicate that tailings were distributed from all three YDTI embankments during Q1 of 2020, with six of the discharge locations being used. Tailings discharge from Line 1 along the West Embankment (RK - 1 through RK - 4) only occurred at RK-1 until March 20 due to line maintenance. The tailings beach elevations at each of the discharge locations are shown in Table 2.1 and Figure 2.2.

The elevation difference between the highest (EW-1) and the lowest (RK-3) discharge elevations was approximately 14 ft at the end of Q1. This elevation differential is 3 ft greater than the differential measured in Q4 2019. The increased differential is a function of preferential use of some discharge points, primarily due to the line maintenance that occurred during Q1, which is now complete. Beach maintenance will continue along the West Embankment (RK-2 through RK-4) during Q2 now that the line maintenance is complete. The elevation difference between the lowest discharge elevation and the pond surface was approximately 12 ft at the end of Q1 2020. This is a 1 ft decrease compared to Q4 2019.

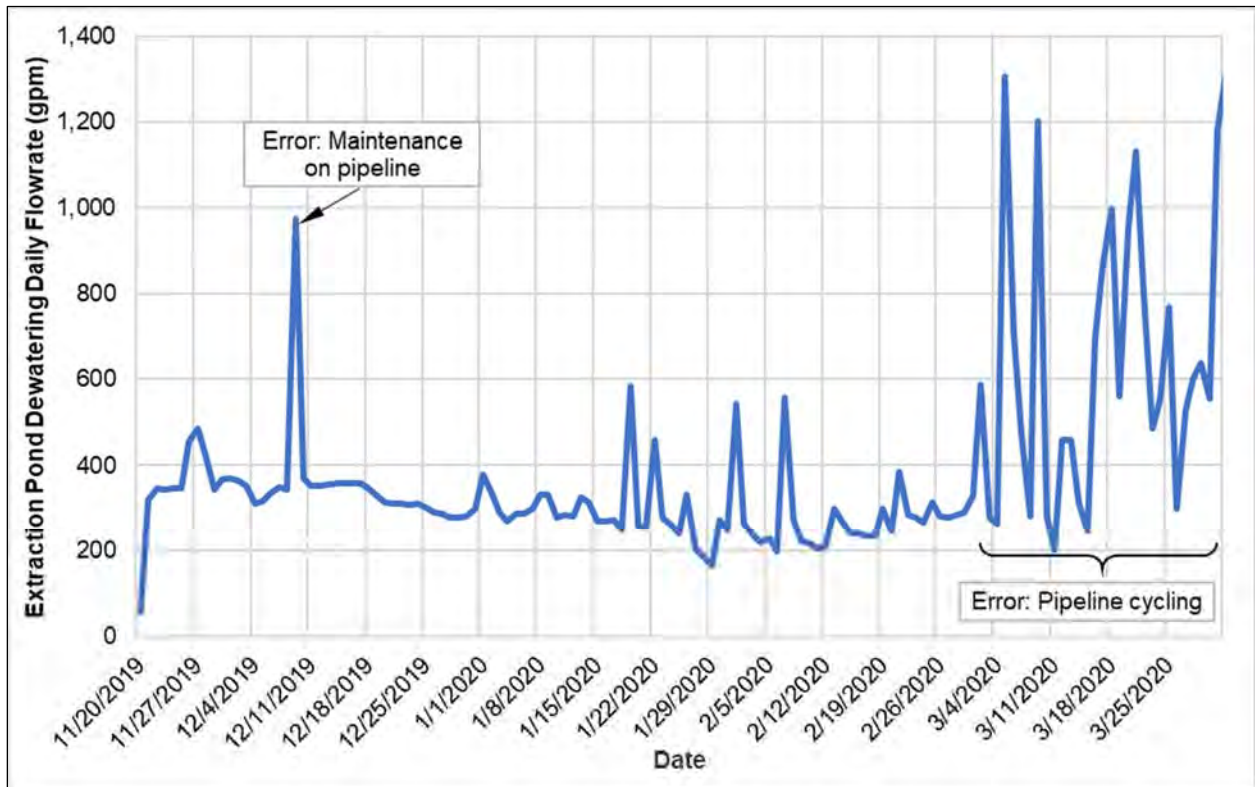
Figure 7.1 Average Daily Extraction Pond Dewatering System Flowrate

MR identified recording issues in March 2020 with the inline flowmeter. The issues were associated with the pumps cycling on and off when there were very low flows. The flowmeter recorded water filling the discharge pipe during the 'on' cycle, however when the pump switched off, the pipeline drained back into the extraction basin. This same water was then double counted during the next 'on' cycle. MR fixed this issue in April by adjusting the variable frequency in the pumps to reduce cycling and double counting of flows. The March data is therefore excluded in the flow analysis for the system.

The average flowrate recorded at the Extraction Pond Dewatering pump system during January through February 2020 was 290 gpm (0.41 Mgalpd), this flowrate is similar to those recorded in Q4 2019 when the system started operating. The average daily flowrate for the Extraction Pond Dewatering System from November 19, 2019 to Q1 2020 is shown on Figure 7.1. A longer data record is required to identify any trends or seasonal changes.

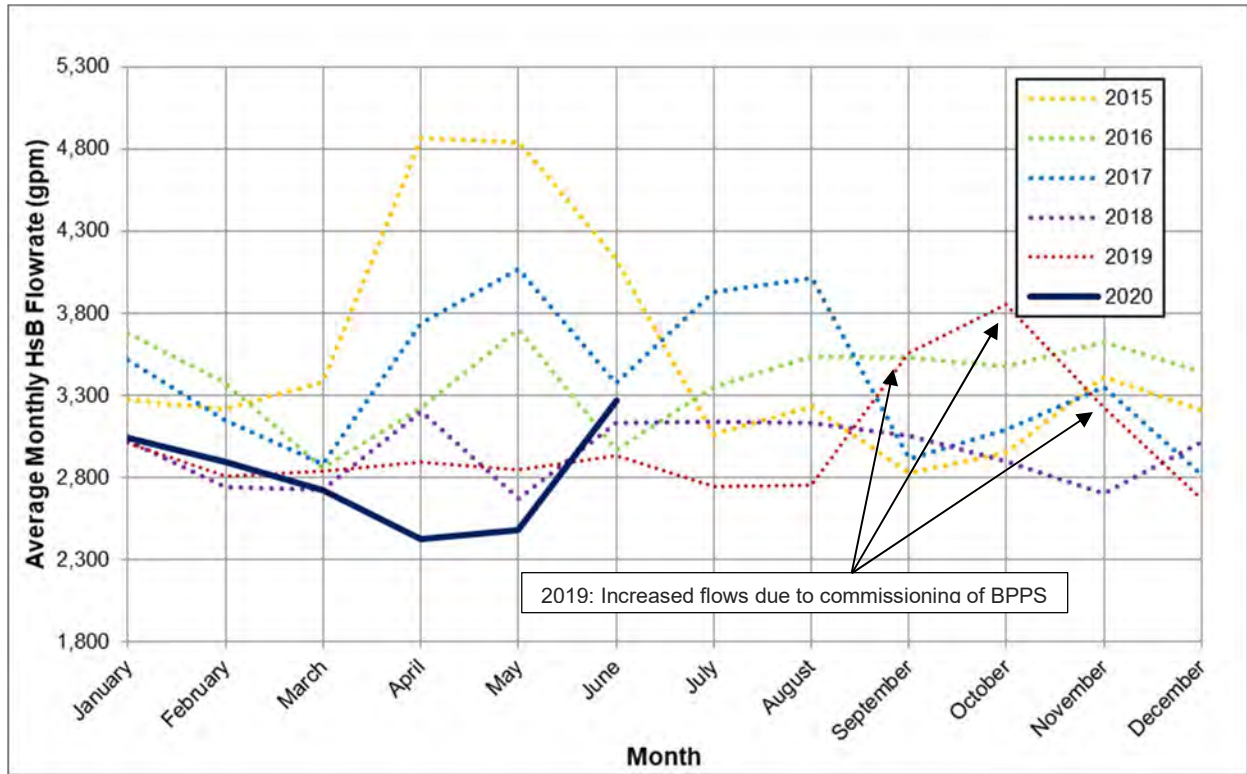
Figure 5.1 Average Monthly HsB Weir Flowrate

The average HsB flowrate during April and May was approximately 2450 gpm, which is 500 gpm (17%) lower than the average flows measured during this period over the previous three years. The HsB flowrates typically record higher values in April or May associated with the spring freshet and seasonal increase of precipitation during Q2. The April and May flows in 2020 however were lower than usual due to a delayed freshet and a dry April and May. Review of the climate data identified that precipitation during April and May was 50% lower and the April average temperature approximately 1.5 degrees cooler than the average values from the three years prior.

The HsB flowrates increased during June 2020 to 3,250 gpm, which is slightly greater (4%) than the average flowrates recorded over June for the previous three years. The increase in flows can be attributed to the delayed freshet and a wetter than usual June. The average monthly HsB Weir flowrates from 2015 through Q2 2020 are presented on Figure 5.1.

- A delayed freshet and dry April and May caused HsB Weir flows to be lower than usual (2450 gpm average). The flowrates increased during June to 3,250 gpm, which is 100 gpm (4%) greater than the average flowrates recorded over June for the previous three years.

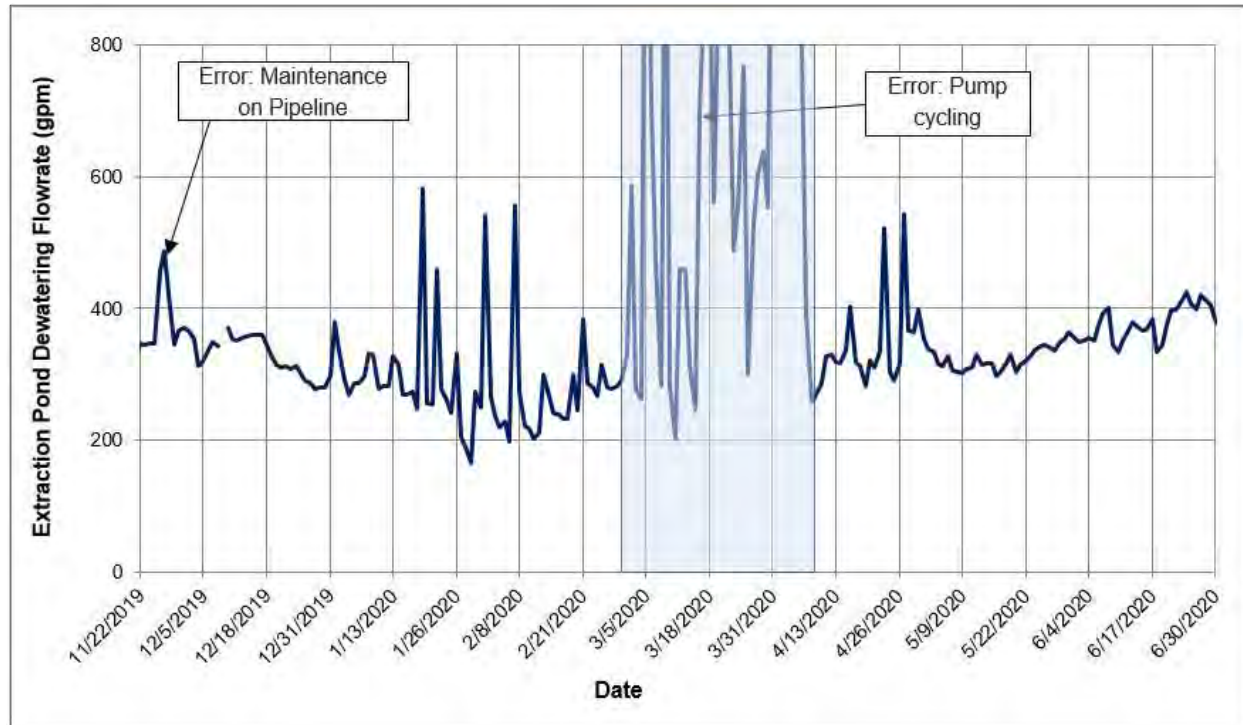
Figure 8.1 Extraction Pond Dewatering System Flowrate

MR identified recording issues in March 2020 with the inline flowmeter. The issues were associated with the pumps cycling on and off when there were very low flows and the discharge line draining back to the Extraction Pond. MR fixed this issue in April by adjusting the variable frequency in the pumps to reduce the flow cycling. The erroneous data is identified in Figure 8.1 and excluded in the flow analysis of the system.

The average flowrate recorded at the Extraction Pond Dewatering pump system during Q2 2020 was 350 gpm (0.50 Mgalpd). The Extraction Pond Dewatering System has recorded flowrates between 175 gpm and 600 gpm, when operating correctly, since the system was commissioned.

The average daily flowrate for the Extraction Pond Dewatering System from November 20, 2019 to Q2 2020 is shown on Figure 8.1. A longer data record is required to identify any trends or seasonal changes.

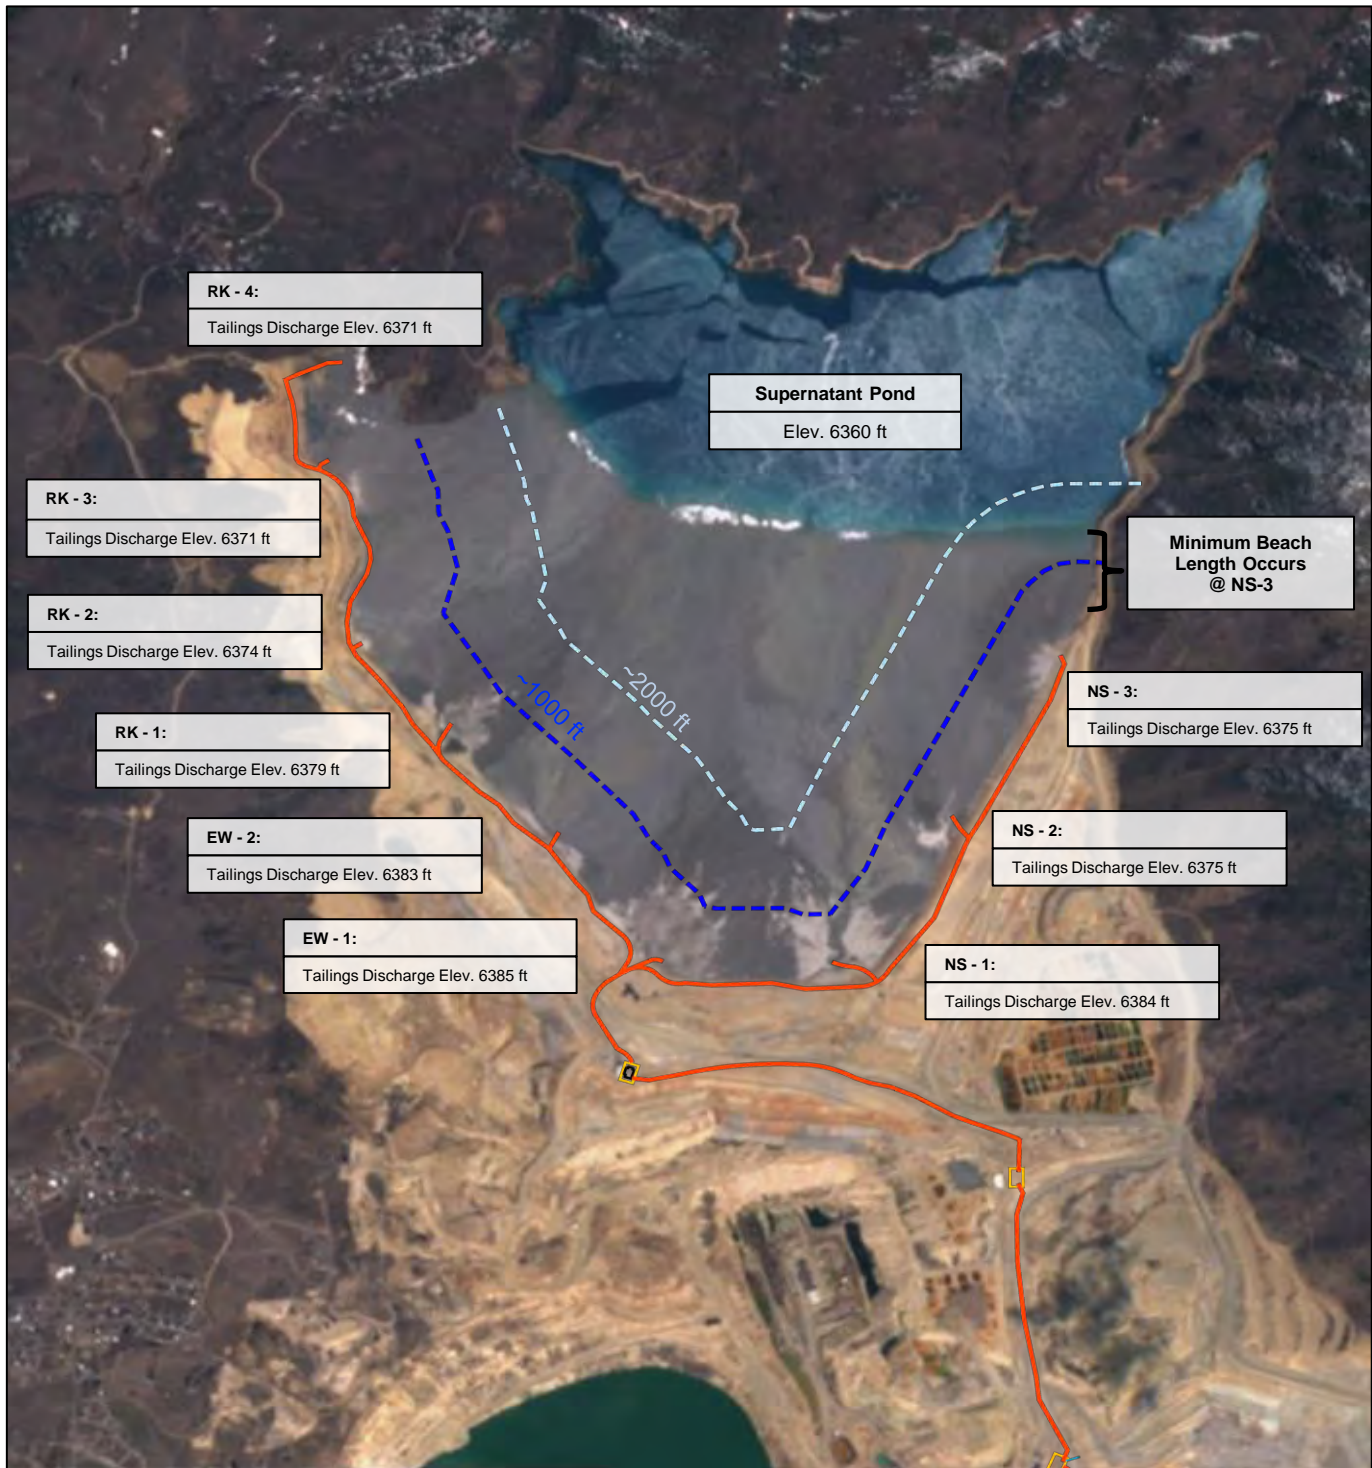
1. TAILINGS DISCHARGE AND SUPERNATANT POND ELEVATIONS WERE SURVEYED ON APRIL 27, 2020. ALL ELEVATIONS ARE RELATIVE TO THE ANACONDA DATUM.
2. SENTINEL-2 VISIBLE SATELLITE IMAGE TAKEN ON APRIL 28, 2020.

MONTANA RESOURCES, LLP.	
YANKEE DOODLE TAILINGS IMPOUNDMENT	
SENTINEL-2 SATELLITE IMAGERY TAILINGS BEACH ASSESSMENT APRIL 27, 2020	
Knight Piésold CONSULTING	P/A NO. VA101-126/23
	REF. NO. VA20-01418
FIGURE A.1	
REV 0	REV 0
