Prepared for
Montana Resources, LLP
600 Shields Avenue
Butte, Montana
USA, 59701

VA101-126/23-5

YANKEE DOODLE TAILINGS IMPOUNDMENT

2020 DATA ANALYSIS REPORT

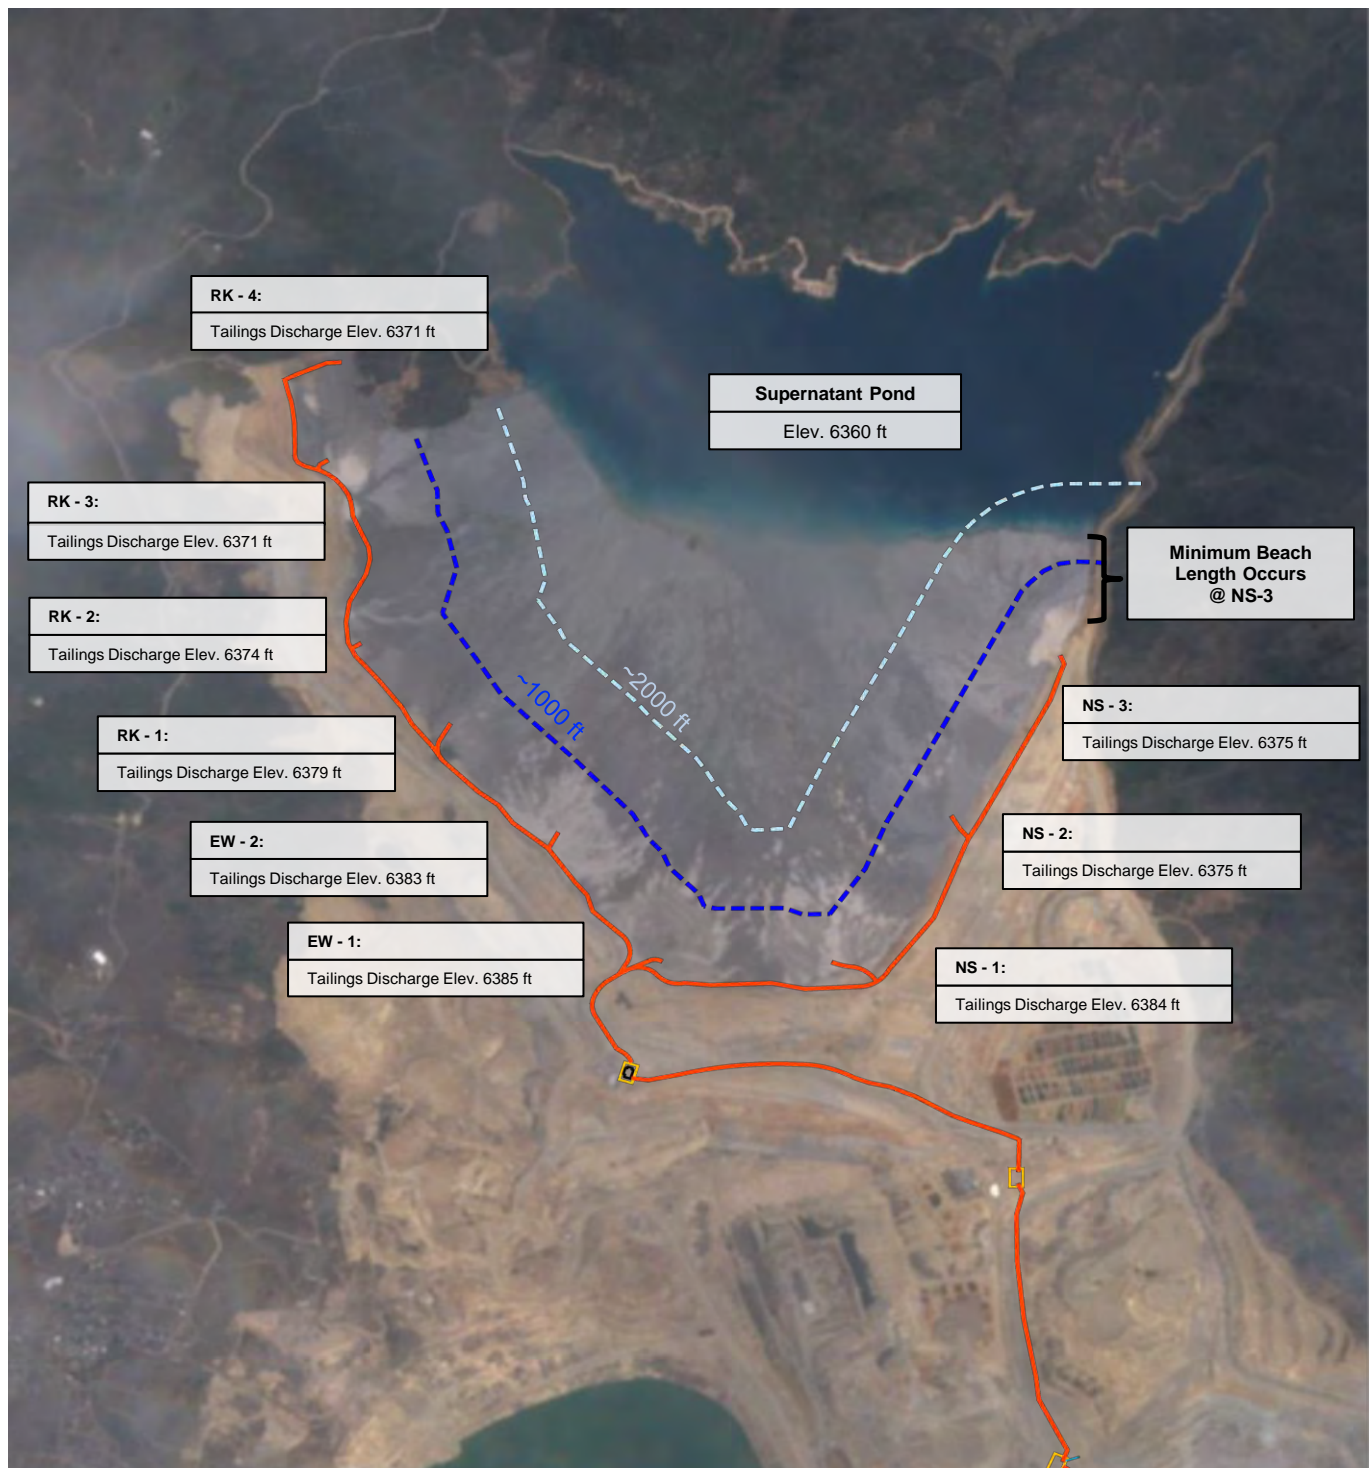
1. TAILINGS DISCHARGE AND SUPERNATANT POND ELEVATIONS WERE SURVEYED ON JUNE 2, 2020. ALL ELEVATIONS ARE RELATIVE TO THE ANACONDA DATUM
2. SENTINEL-2 VISIBLE SATELLITE IMAGE TAKEN ON MAY 28, 2020.

MONTANA RESOURCES, LLP.	
YANKEE DOODLE TAILINGS IMPOUNDMENT	
SENTINEL-2 SATELLITE IMAGERY TAILINGS BEACH ASSESSMENT JUNE 2, 2020	
Knight Piésold CONSULTING	P/A NO. VA101-126/23
	REF. NO. VA20-01418
FIGURE A.2	
REV 0

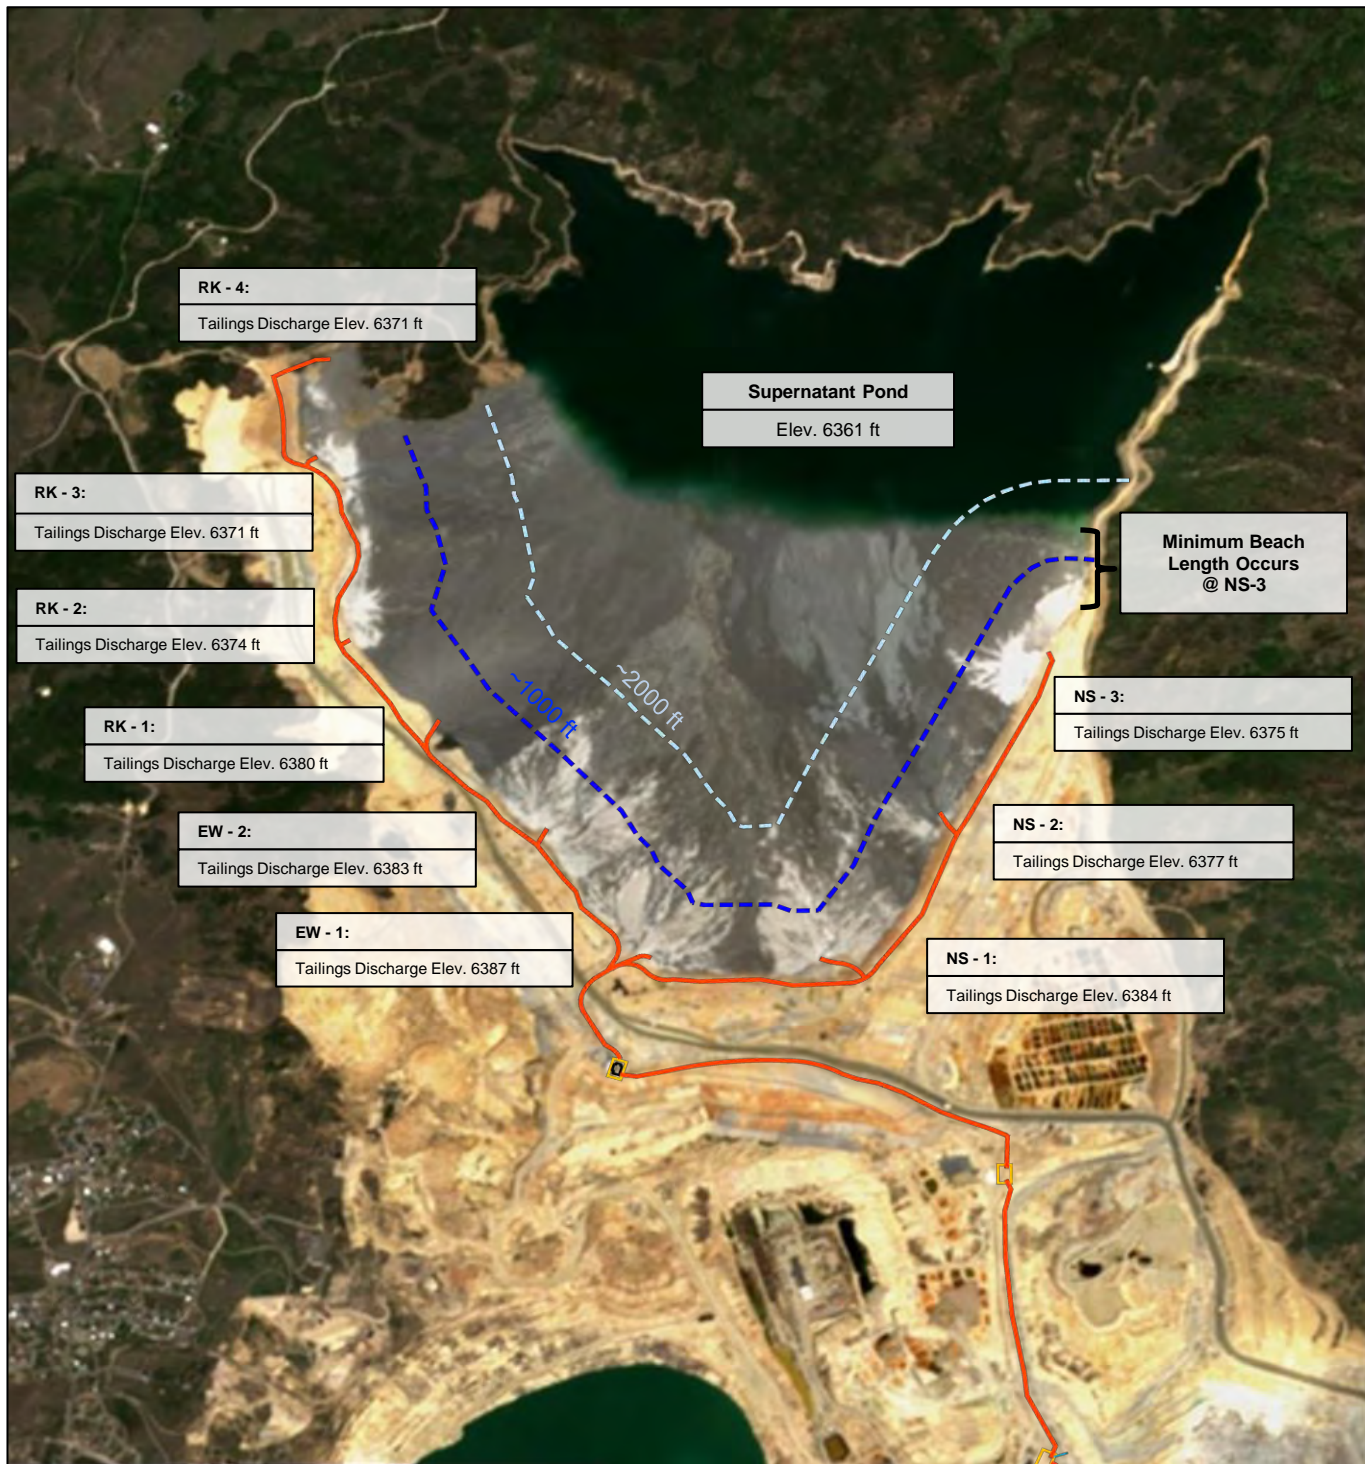
1. TAILINGS DISCHARGE AND SUPERNATANT POND ELEVATIONS WERE SURVEYED ON JUNE 29, 2020. ALL ELEVATIONS ARE RELATIVE TO THE ANACONDA DATUM.
2. SENTINEL-2 VISIBLE SATELLITE IMAGE TAKEN ON JUNE 24, 2020.

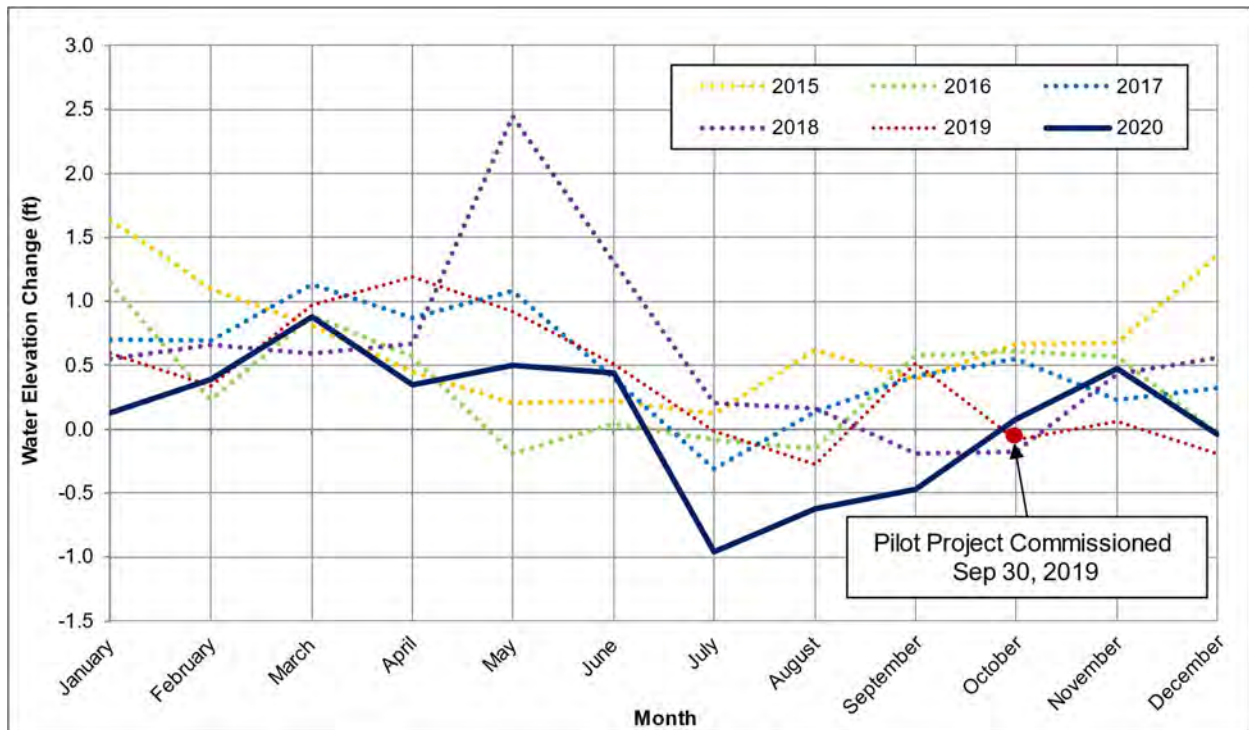
Figure 2.1 Monthly YDTI Pond Water Elevation Change

The Q4 pond elevation change in Q4 2019 and Q4 2020 (since the commissioning of the pilot project) followed a similar trend as presented on Figure 2.1. However, the November pond elevation increase during 2020 was greater than experienced in 2019 due to warmer than usual temperatures melting the early snowfall.

The annual pond elevation change during 2020 was approximately 1.2 ft. This is 81% (4.9 ft) less than the average annual pond elevation change over the previous five years, which is largely attributed to operation of the Pilot Project (detailed further in Section 2.3). The monthly supernatant pond water elevation changes from Q1 2015 through Q4 2020 are presented on Figure 2.1.

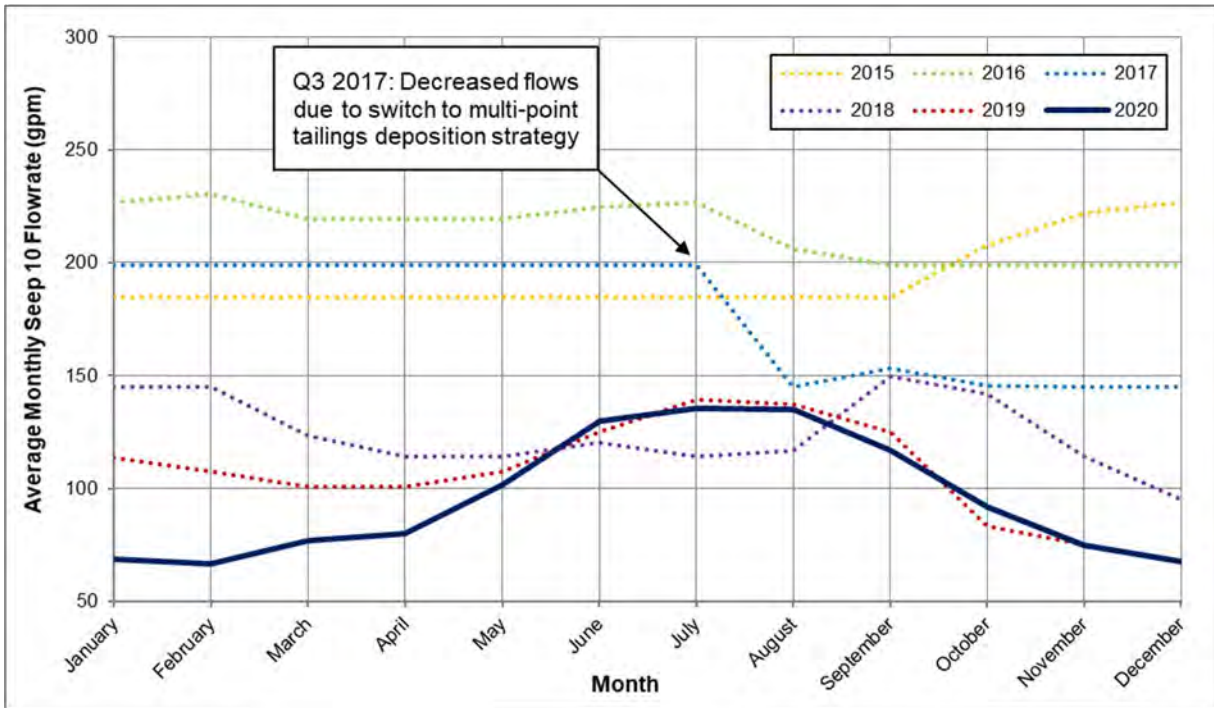
Figure 6.1 Average Monthly Flowrates at Seep 10

The average monthly Seep 10 flowrates from Q1 2015 through Q4 2020 are presented on Figure 6.1. The average Seep 10 flowrate in Q4 2020 was approximately 80 gpm. The magnitude and trend of the Seep 10 flows observed in Q4 2020 are similar those observed in Q4 2019.

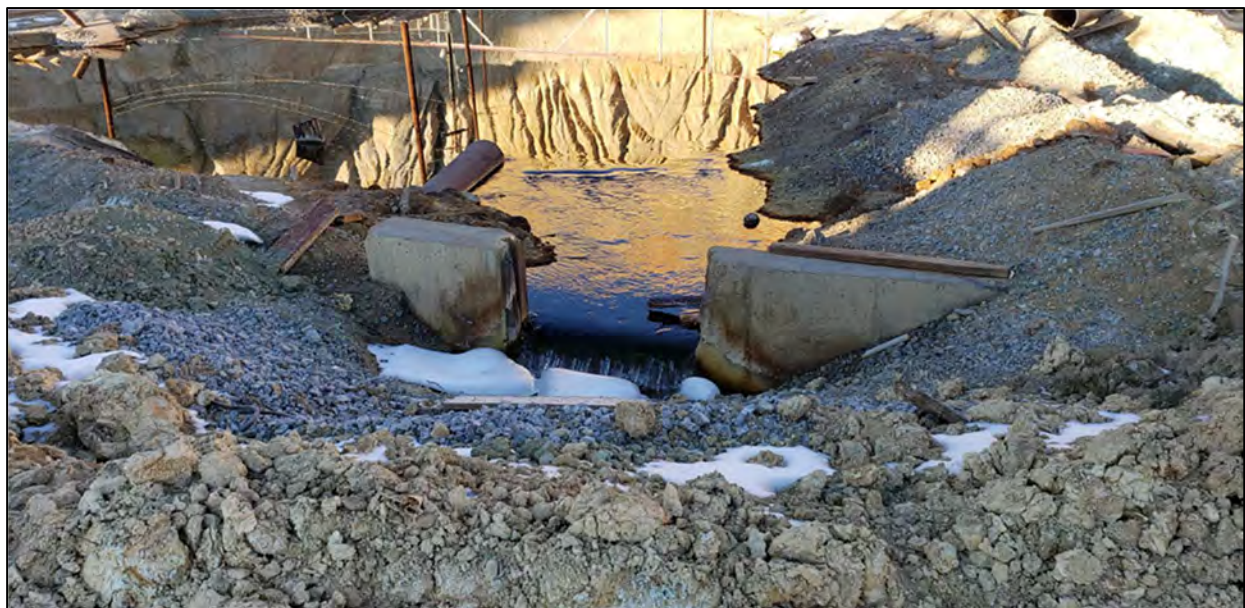
The overflow flowrates observed throughout 2020 were lower than those in the previous three years. The general reduction in flows can be attributed to changes to the water management strategy around the Precipitation Plant. A portion of the water reporting to Hooligan Pond is currently by-passing the Precipitation Plant via a weir and pipe (Photo 7.1) and discharging into two locations at the southern end of the HsB Pond. The flow is currently unmeasured. This diversion results in fewer inflows contributing to the recirculation pump house head tanks, and therefore lower overflow flowrates.

Photo 7.1 Hooligan Pond and By-passing Flow Through Weir (Dec 10, 2020)

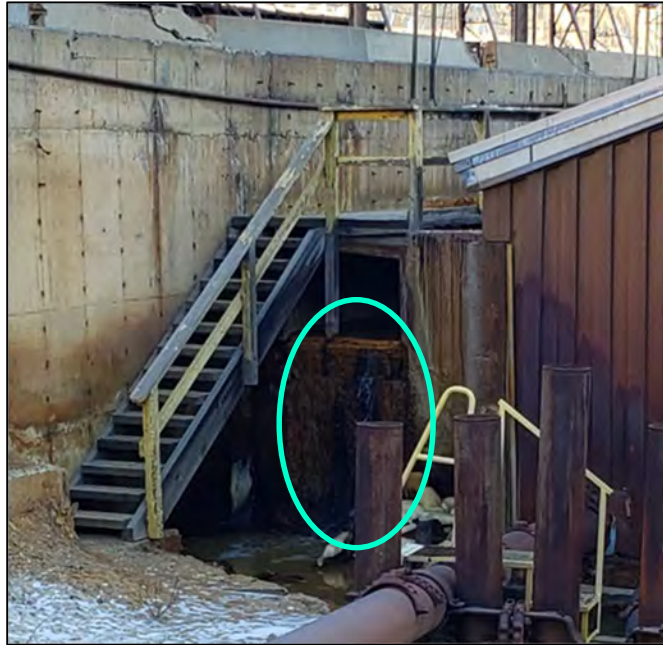
Water was seen overflowing from the Precipitation Plant recirculation pump house head tank and draining to the adjacent HsB Pond in Q4 2020 (Photo 7.2). This unmeasured flow also reduces contributing flows to the Precipitation Plant recirculation pumps and overflow. Overflow at this location has been observed intermittently since Q4 2019.

Photo 7.2 Precipitation Plant Recirculation Pump House - water is overflowing from the head tank under the stairs (Dec 10, 2020).

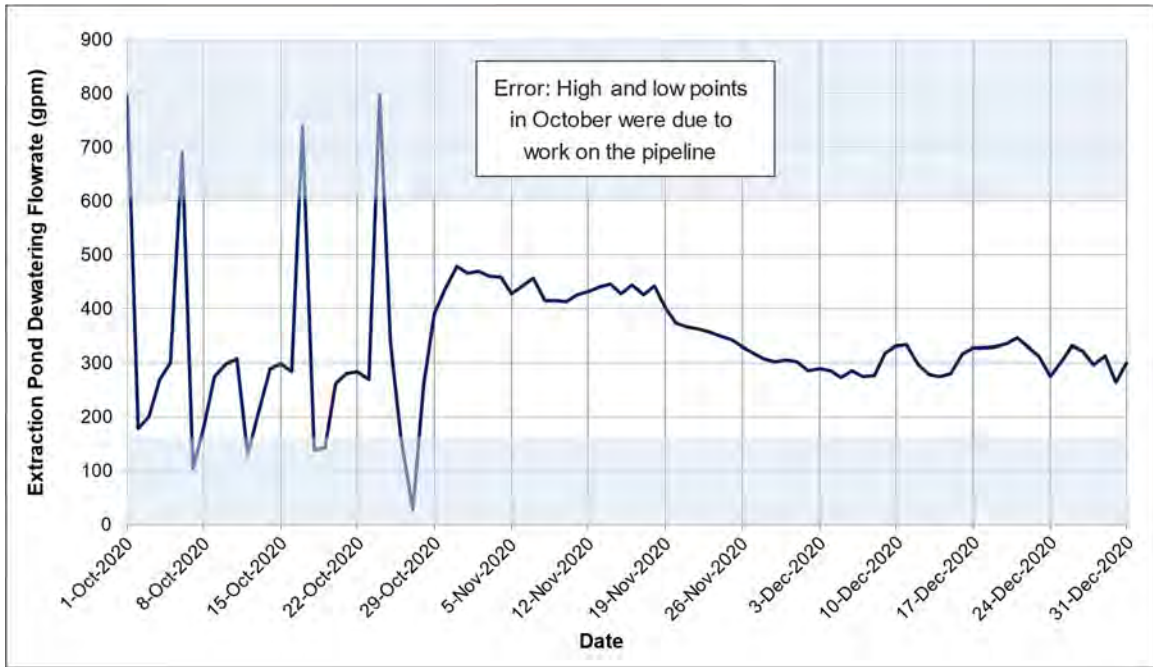
Figure 8.1 Extraction Pond Dewatering System Daily Flowrate (Q4 2020)

The Extraction Pond Dewatering System has recorded average weekly flowrates between 250 gpm and 450 gpm since commissioning. The average WED pump rate in Q4 2020 was 340 gpm, which is comparable to the average flowrate since the commissioning of the system. The pump rate was elevated for four days during October (as presented on Figure 8.1) due to maintenance of the discharge pipeline requiring the pumps to be temporarily turned off. The pump system therefore pumped at a higher-than-usual rate when the pumps were brought back online to transfer the water that had accumulated during the shut down. The flowrates observed at the Extraction Pond Dewatering System remained steady thereafter.

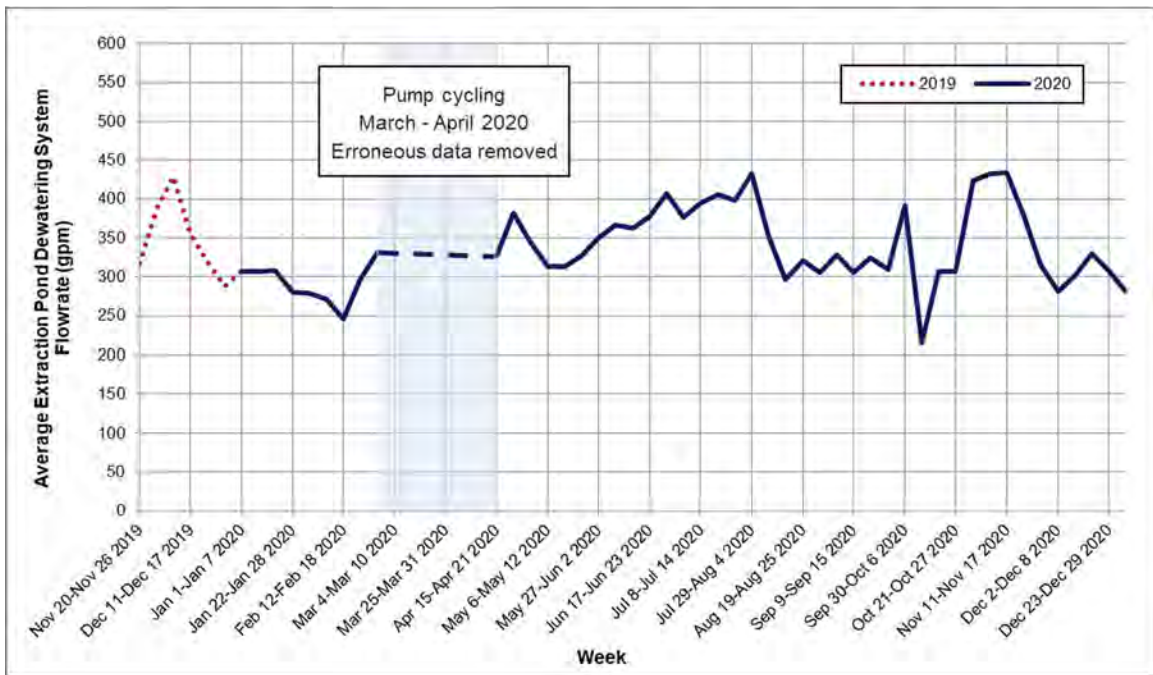
Figure 8.2 Extraction Pond Dewatering System Weekly Flowrate

A period of higher flows were recorded in early November in Q4 2020, which is attributed to a period of warmer daily temperatures. The average weekly flowrates for the Extraction Pond Dewatering System since it began operating on November 20, 2019 are presented on Figure 8.2. A longer period of data collection is required before any trends or seasonal changes can be determined.

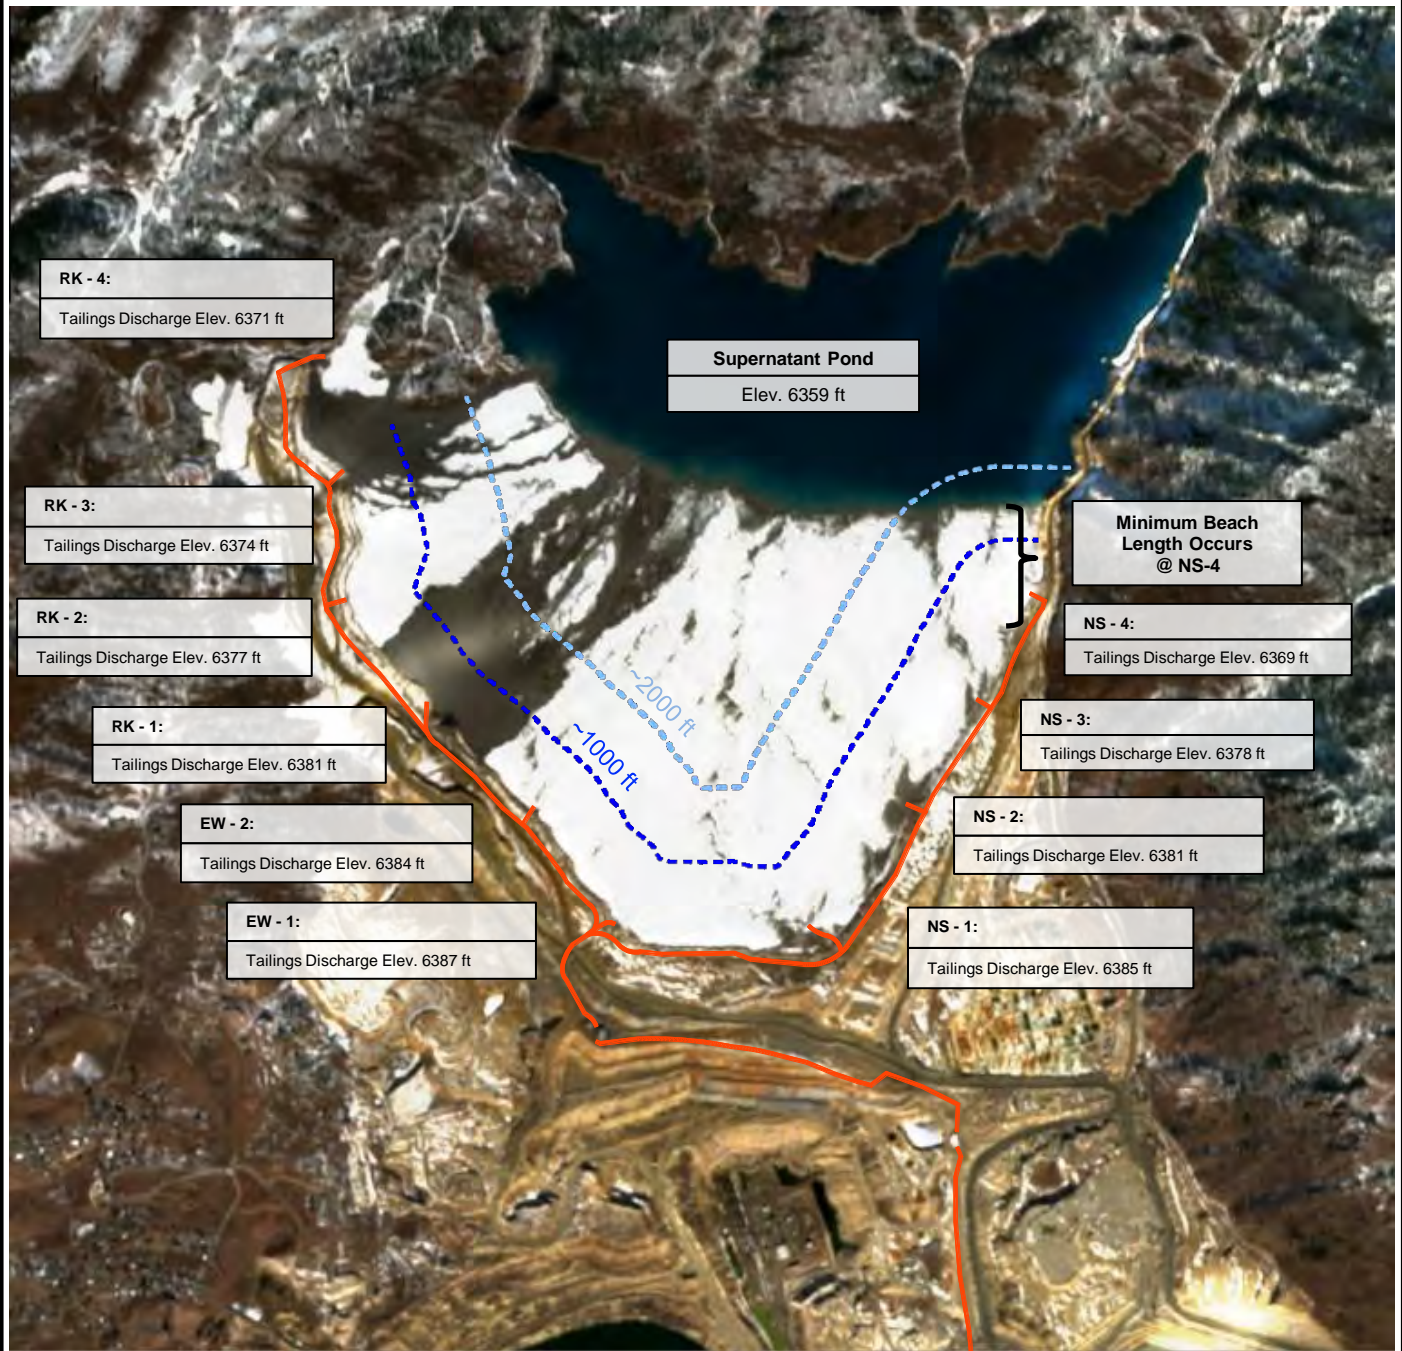
Knight Piésold CONSULTING	P/A NO. VA101-126/23
	REF. NO. VA21-00003
FIGURE A.1	
	REV 0

1. TAILINGS DISCHARGE AND SUPERNATANT POND ELEVATIONS WERE SURVEYED ON OCTOBER 29, 2020. ALL ELEVATIONS ARE RELATIVE TO THE ANACONDA DATUM.
2. THE MINIMUM BEACH LENGTH AT THE NORTHERN EXTREMITY OF THE N-S EMBANKMENT IS MEASURED FROM THE TAILINGS BEACH AND UPSTREAM EMBANKMENT INTERFACE, AT THE INTERSECTION OF THE N-S EMBANKMENT AND NATURAL TOPOGRAPHY OF RAMPART MOUNTAIN, TO THE TAILINGS BEACH AND POND SURFACE INTERFACE.
3. SENTINEL-2 VISIBLE SATELLITE IMAGE TAKEN ON OCTOBER 30, 2020.

Images captured by the Sentinel-2 satellite are reviewed twice per month to remotely observe the shape of the tailings beach and position of the supernatant pond relative to the embankments. The shortest beach length was observed at the northern end of the North-South embankment and estimated to be approximately 1,400 ft throughout Q4. This is similar to the beach length observed at the end of Q3. An overview of the facility observed from the Sentinel-2 satellite images at the end of October, November, and December 2020 are presented in the attached figures.

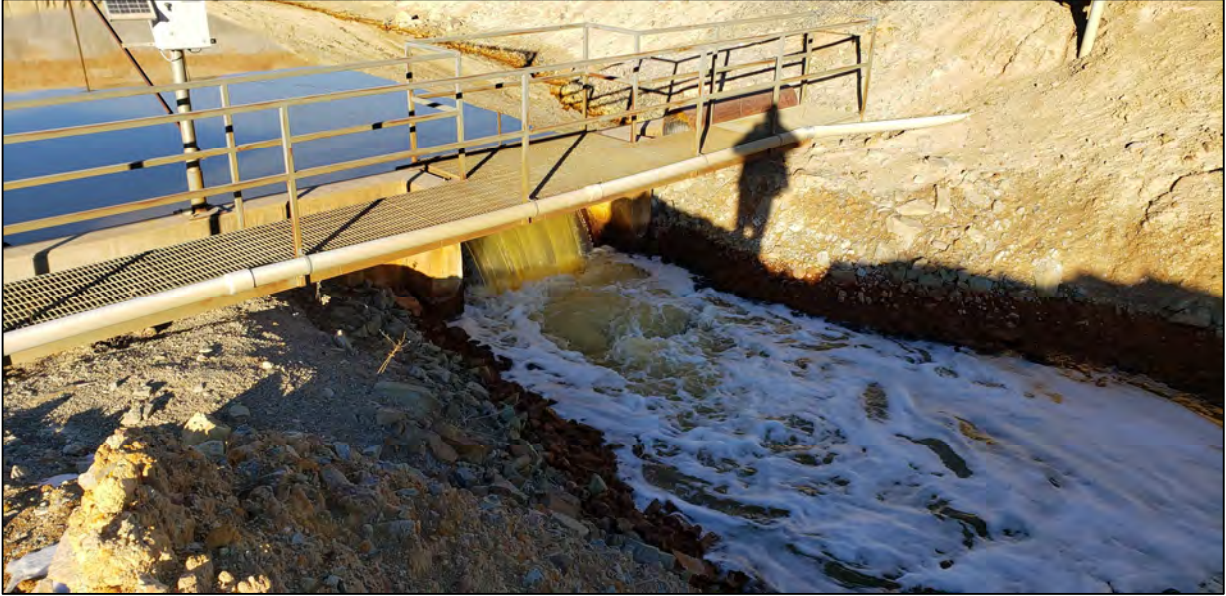
PHOTO 1 – Dec 10, 2020 – Flow through HsB Weir.

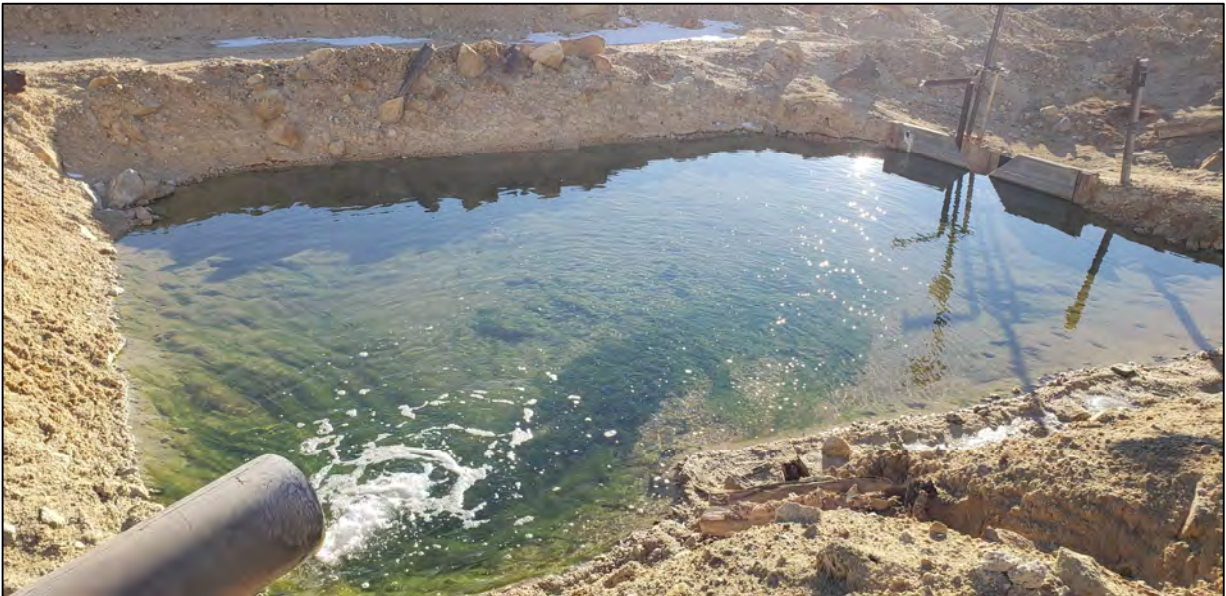
PHOTO 2 – Dec 10, 2020 – Seep 10 Stilling Pond.

The seepage is collected in a small pond on top of the EL 5,900 ft bench and is routed to the HsB seepage collection area via a pipe. The Seep 10 flows are measured using an ultrasonic lookdown level sensor that was installed in April 2019 to automatically measure the stilling pond level near the weir. The sensor was connected to the Remote Monitoring System (RMS) using a Sensemetrics ThreadX device on April 30, 2019. A photo of the Seep 10 Stilling Pond, Weir and Staff Gauge on December 10, 2020 is presented in Appendix A – Photo 2 and Photo 3.

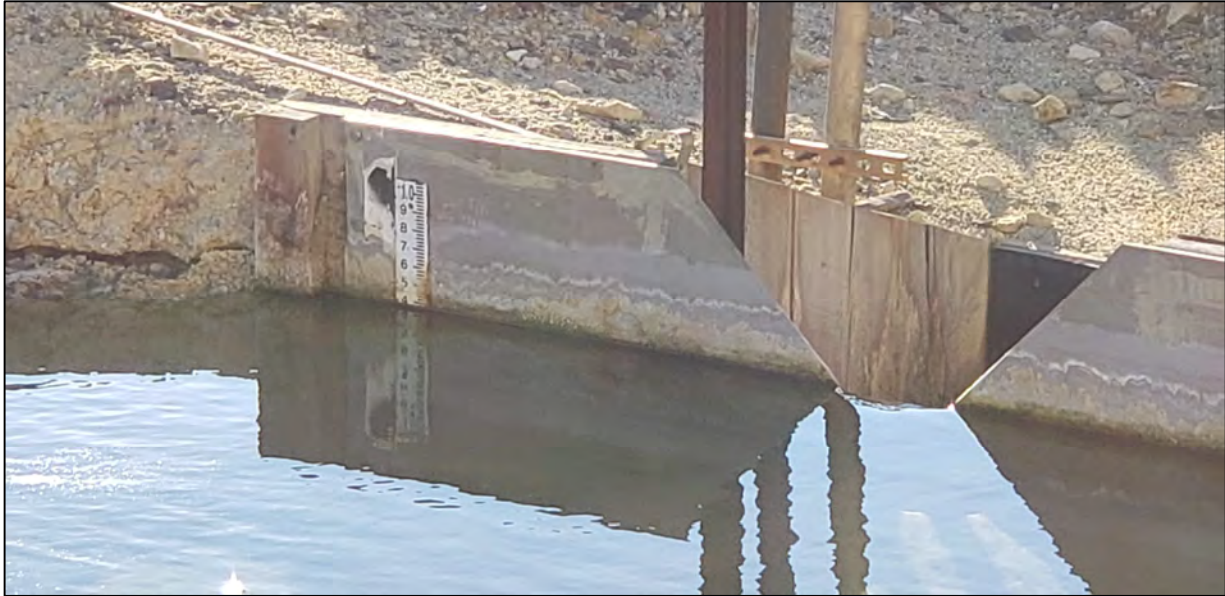
PHOTO 3 – Dec 10, 2020 – Seep 10 Weir and Staff Gauge. Staff Gauge reading slightly below 0.4.

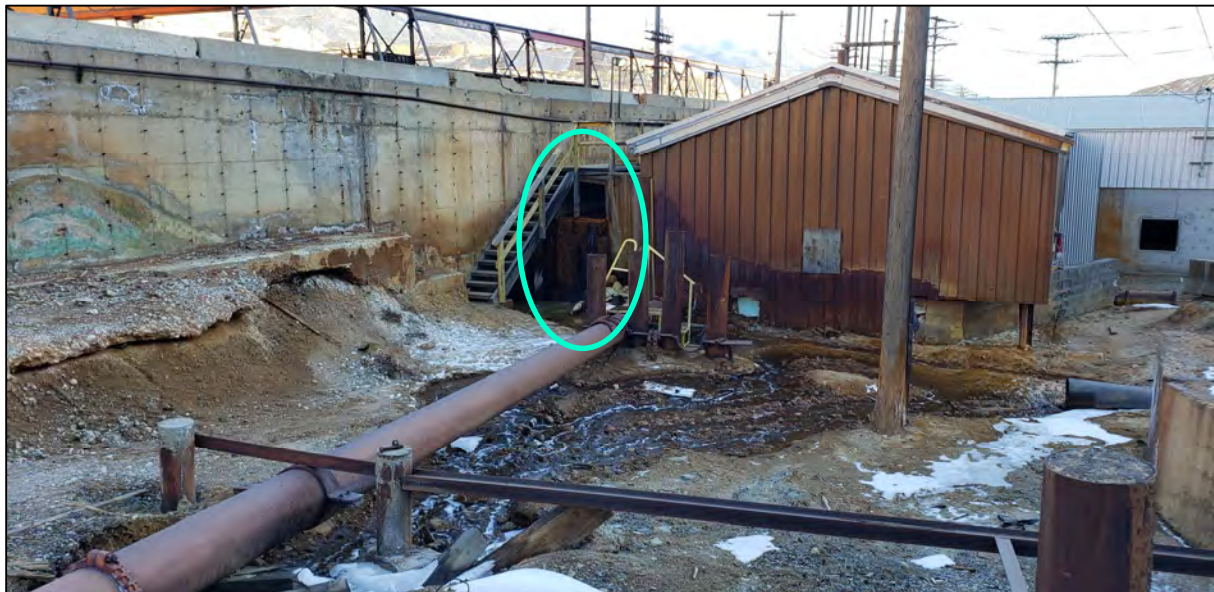
PHOTO 4 – Dec 10, 2020 – Precipitation Plant Recirculation Pump House. Water is overflowing from the head tank under the stairs.

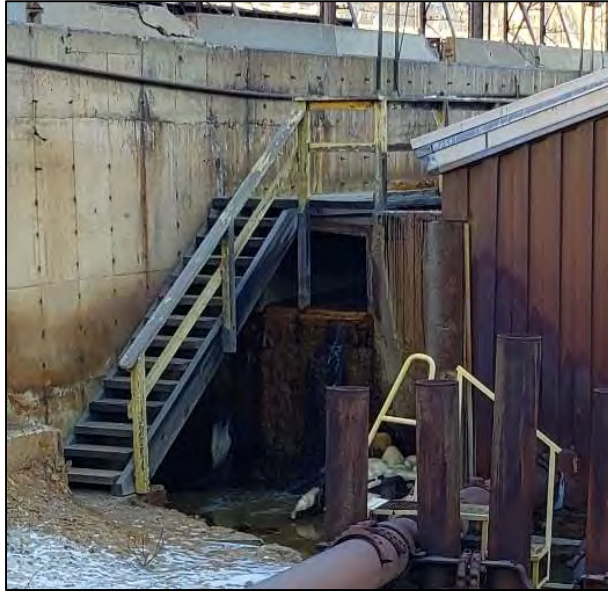
PHOTO 5 – Dec 10, 2020 – Close-up of overflowing head tank at the Precipitation Plant Recirculation Pump House.

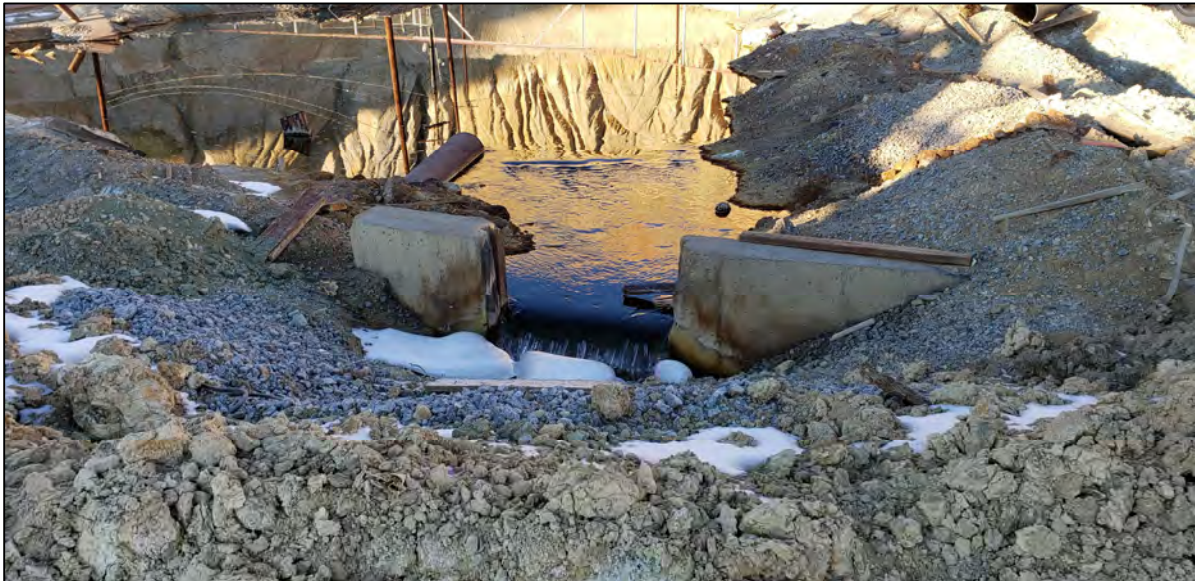
PHOTO 6 – Dec 10, 2020 – Hooligan Pond and bypassing flow through weir.

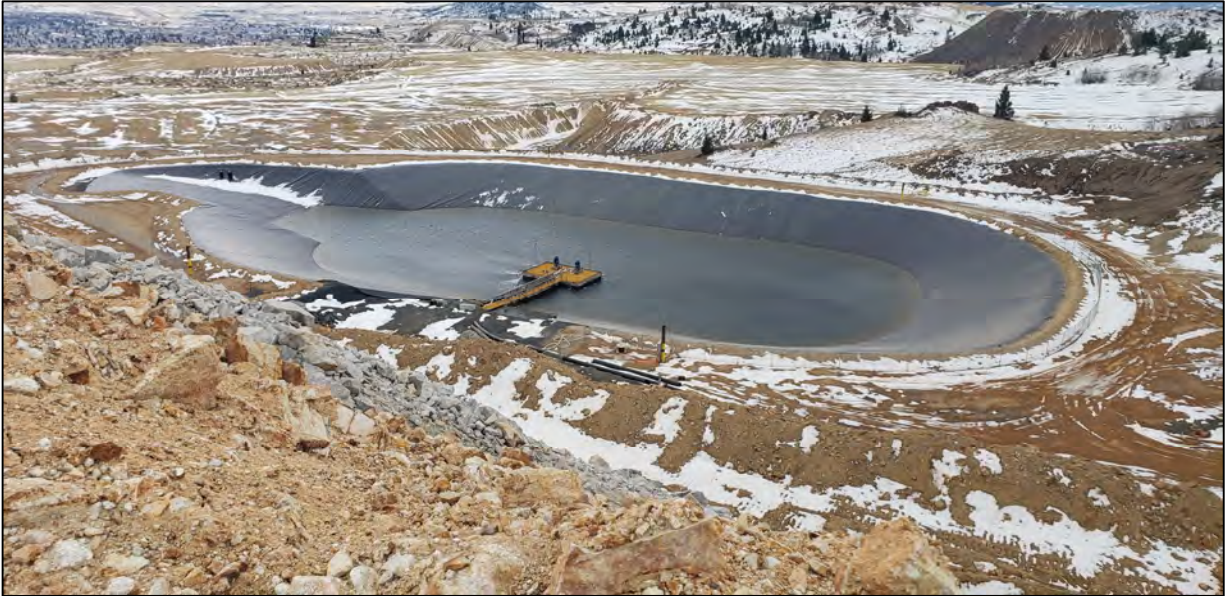
PHOTO 7 – Dec 9, 2020 – WED Extraction Pond and Dewatering System.

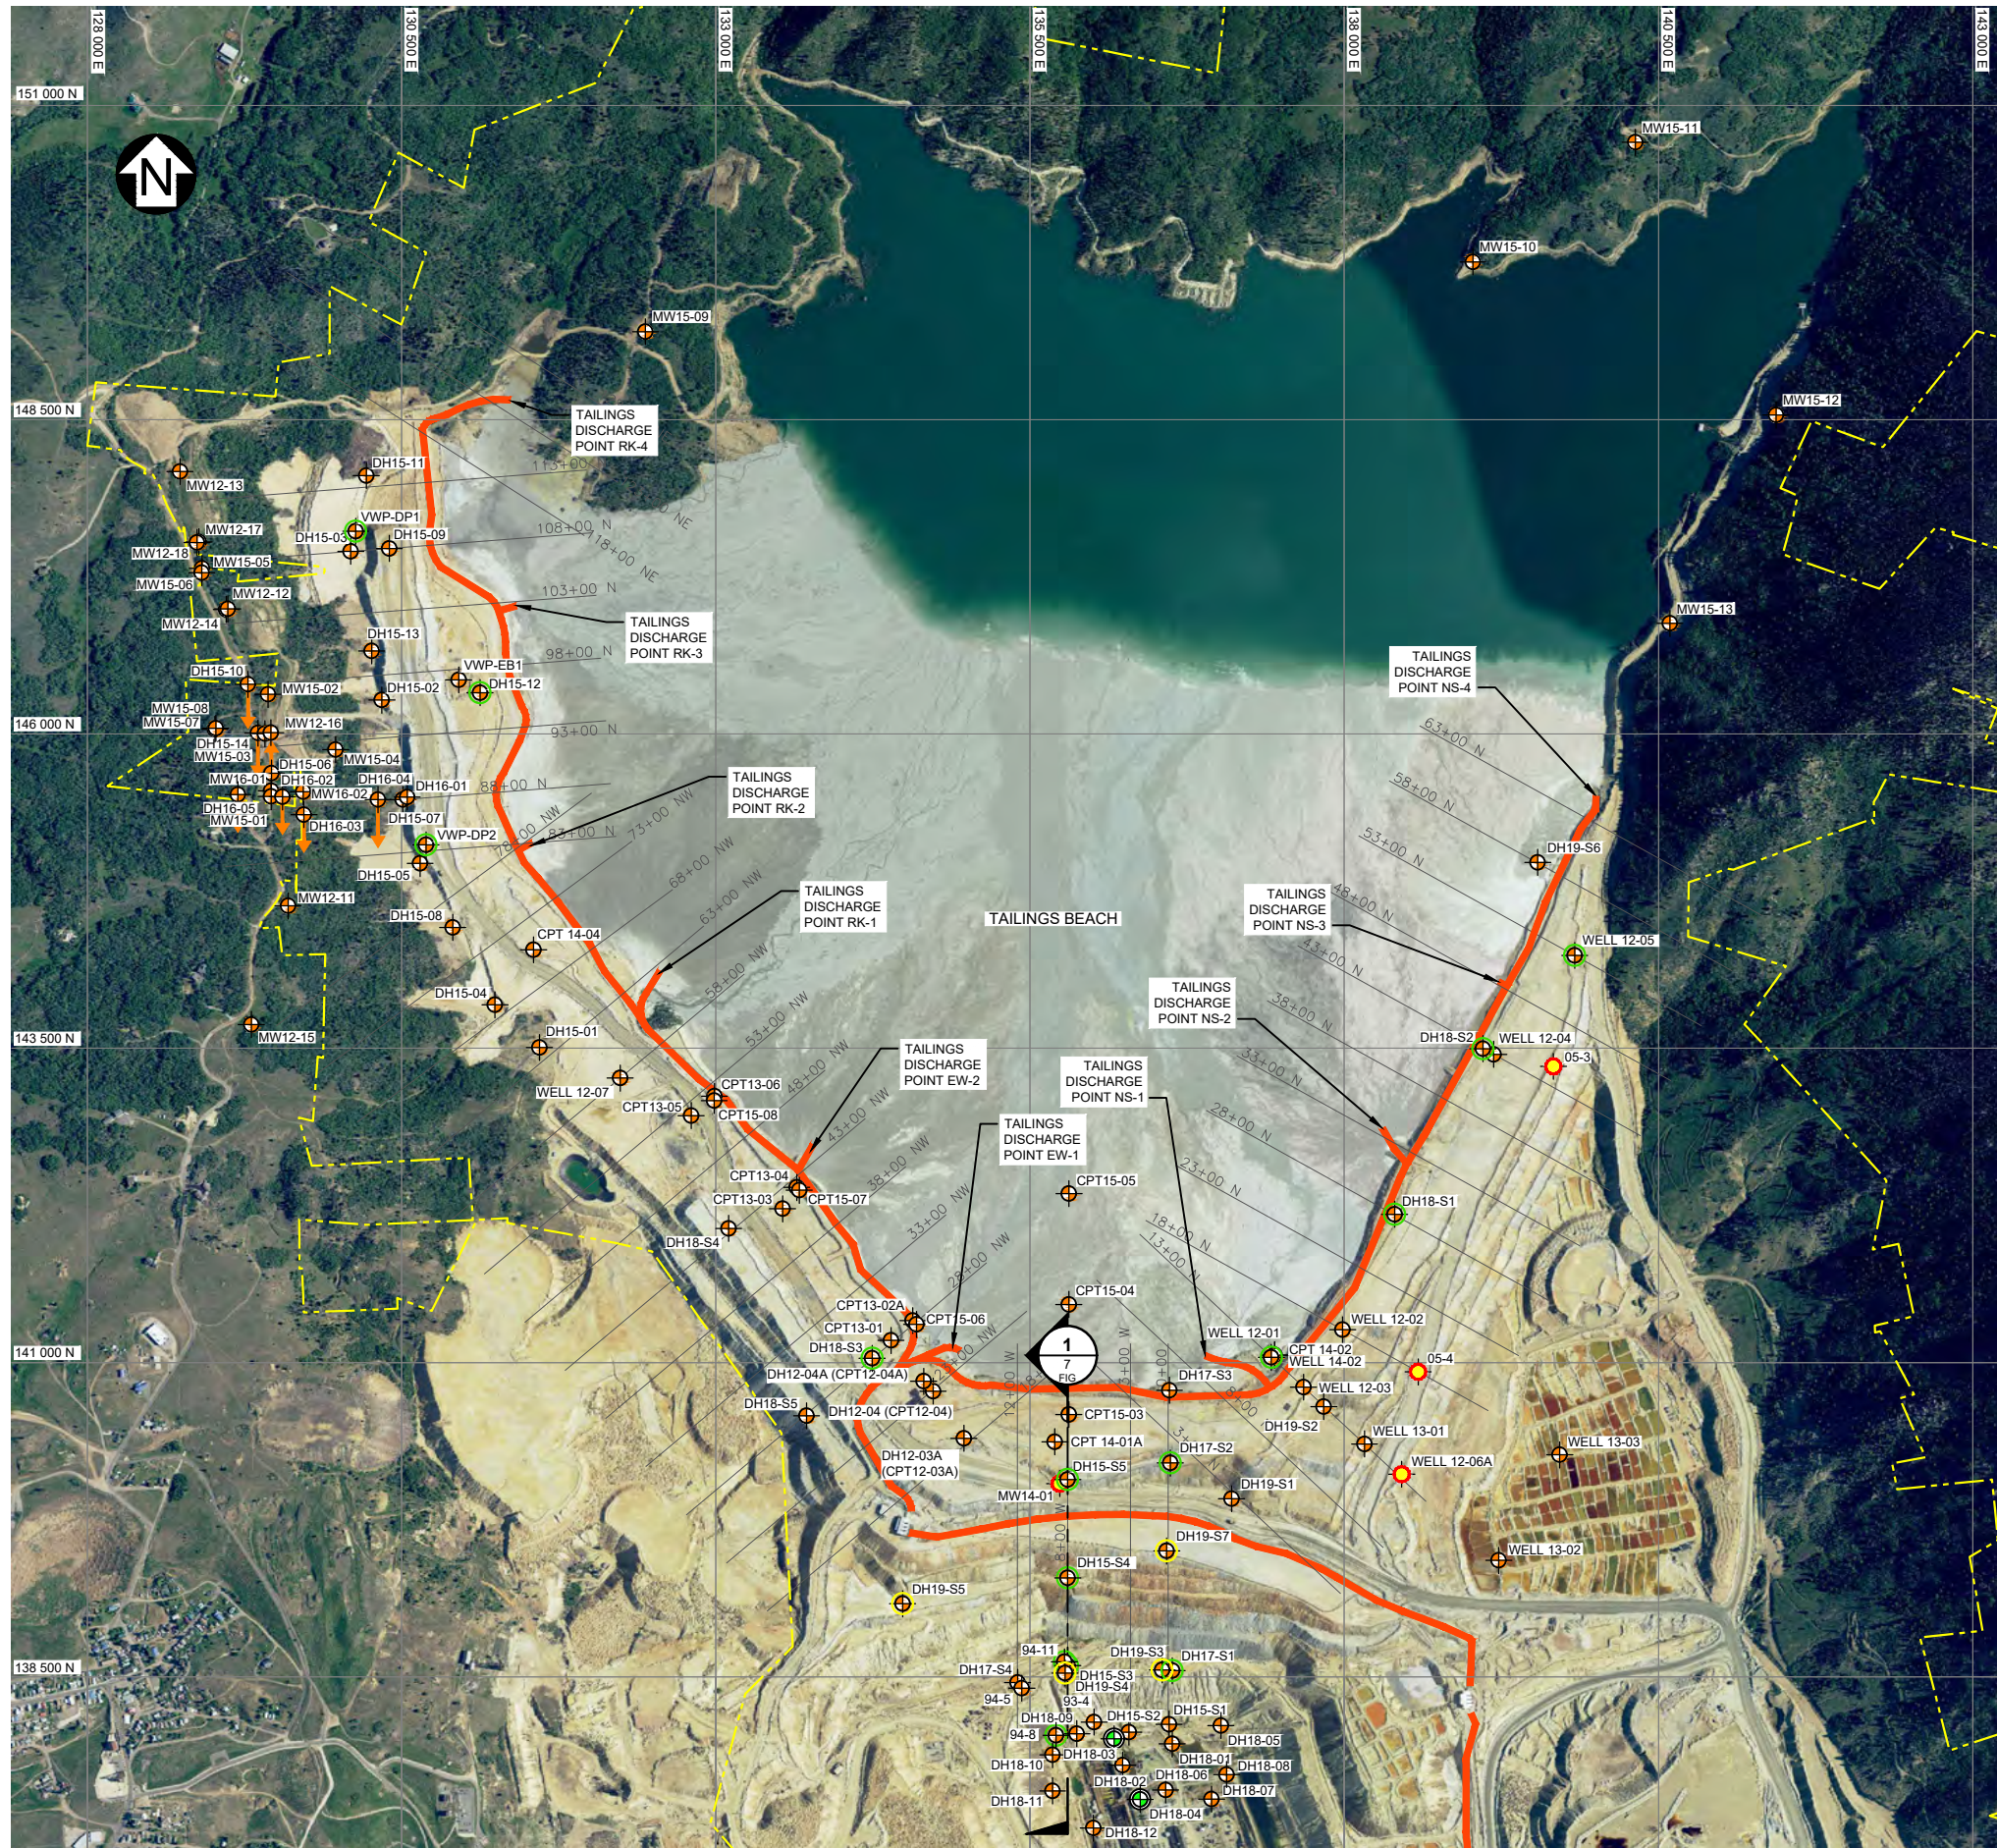
MONTANA RESOURCES, LLP	
YANKEE DOODLE TAILINGS IMPOUNDMENT	
ACTIVE PIEZOMETRIC INSTRUMENTATION AND MONITORING SITES	
	<small>P/A NO. REF. NO.</small> VA101-126/23 VA20-02198
FIGURE 1	
<small>REV 0</small>	<small>REV 0</small>

- LEGEND:**
- PIEZOMETRIC MONITORING SITE
 - WELL NOT ACCESSIBLE (BURIED OR ABANDONED)
 - QUANTITATIVE PERFORMANCE PARAMETER INSTRUMENT LOCATION
 - IN-PLACE INCLINOMETER SITE
 - GEOPHYSICAL TEST SITE
 - TAILINGS PIPELINE
 - PROPERTY LINE

- NOTES:**
1. COORDINATE SYSTEM AND ELEVATIONS BASED ON ANACONDA MINE GRID.
 2. QPP = QUANTITATIVE PERFORMANCE PARAMETER.
 3. AERIAL IMAGERY FROM JULY 9, 2020 PROVIDED BY MONTANA RESOURCES, LLP.

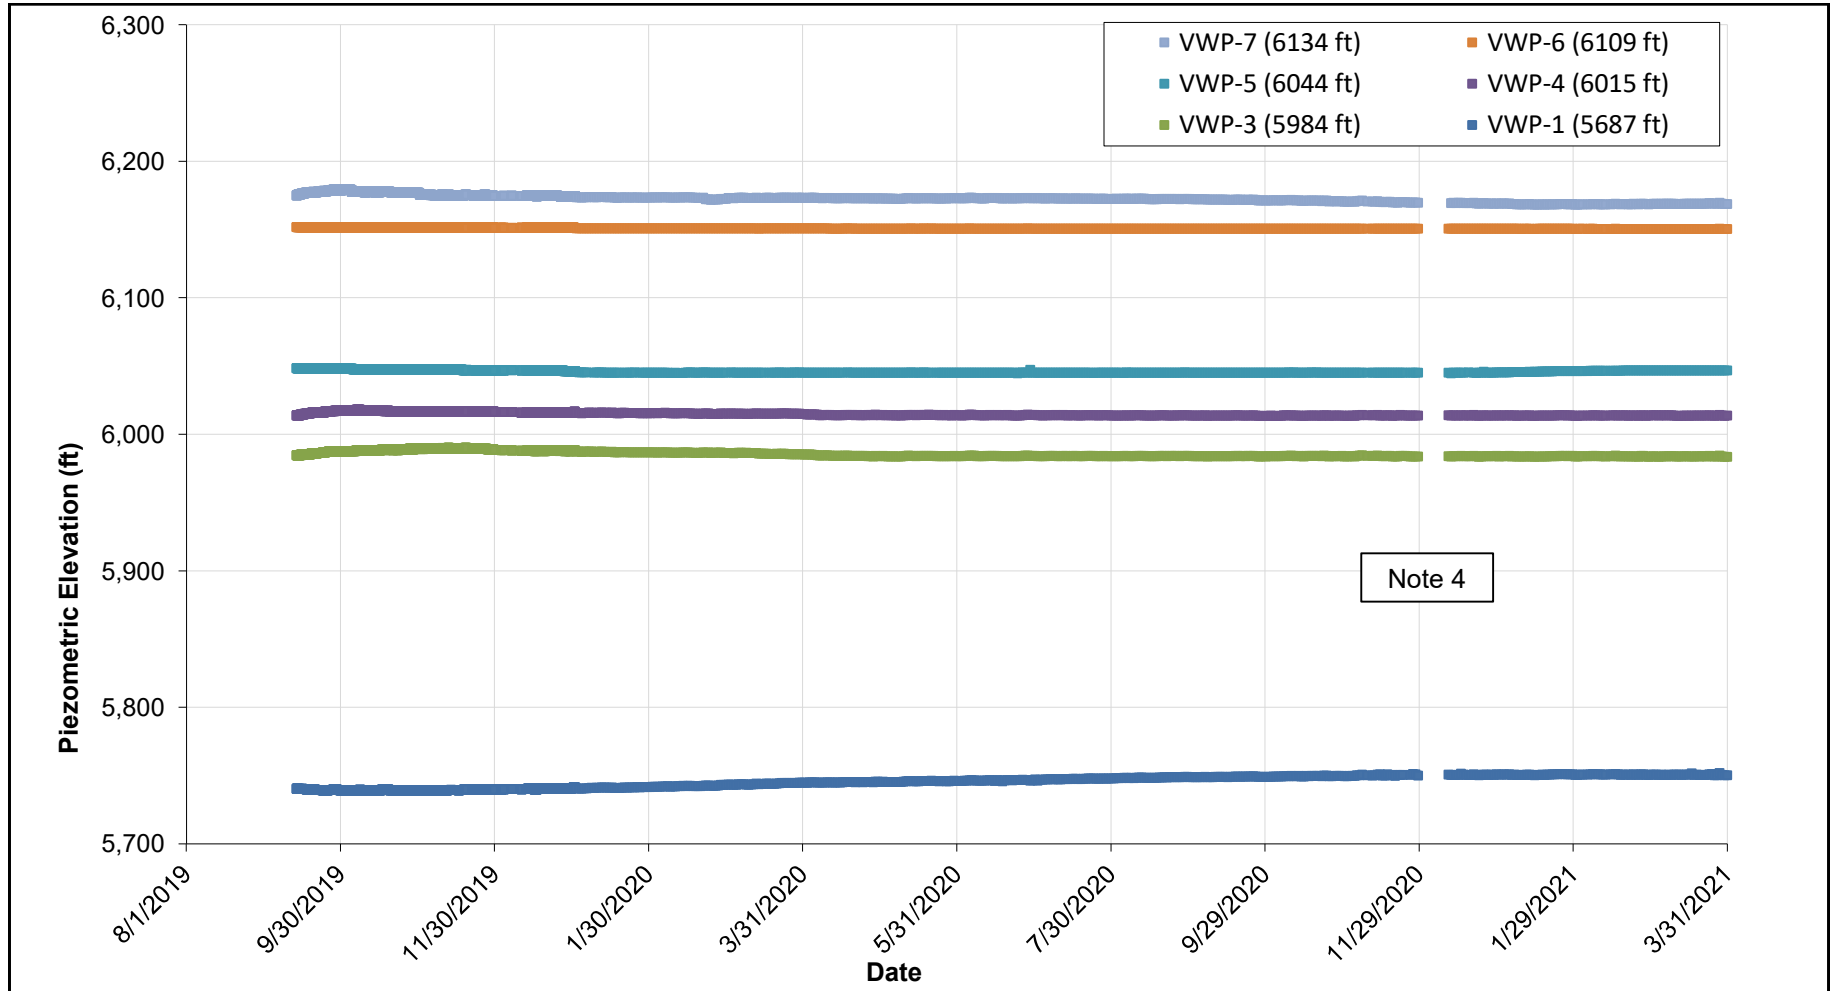
Knight Piesold CONSULTING	P/A NO. VA101-126/23	REF. NO. 5
	FIGURE C1.12	
		REV 0

1. SENSOR ELEVATIONS SHOWN IN LEGEND ARE RELATIVE TO ANACONDA MINE GRID.
2. SENSORS WERE CONNECTED TO THE REMOTE MONITORING SYSTEM FOLLOWING SENSOR INSTALLATION ON AUGUST 31, 2019.
3. VWP-2 HAS BEEN UNSATURATED SINCE SEPTEMBER 13, 2019 AND HAS BEEN OMITTED FROM PLOT FOR CLARITY.
4. NO DATA ARE AVAILABLE FROM NOVEMBER 30 TO DECEMBER 10 FOR ALL SENSORS DUE TO A DISCHARGED DATA LOGGER BATTERY.
