Prepared for
Montana Resources, LLP
600 Shields Avenue
Butte, Montana
USA, 59701

VA101-126/23-5

YANKEE DOODLE TAILINGS IMPOUNDMENT

2020 DATA ANALYSIS REPORT

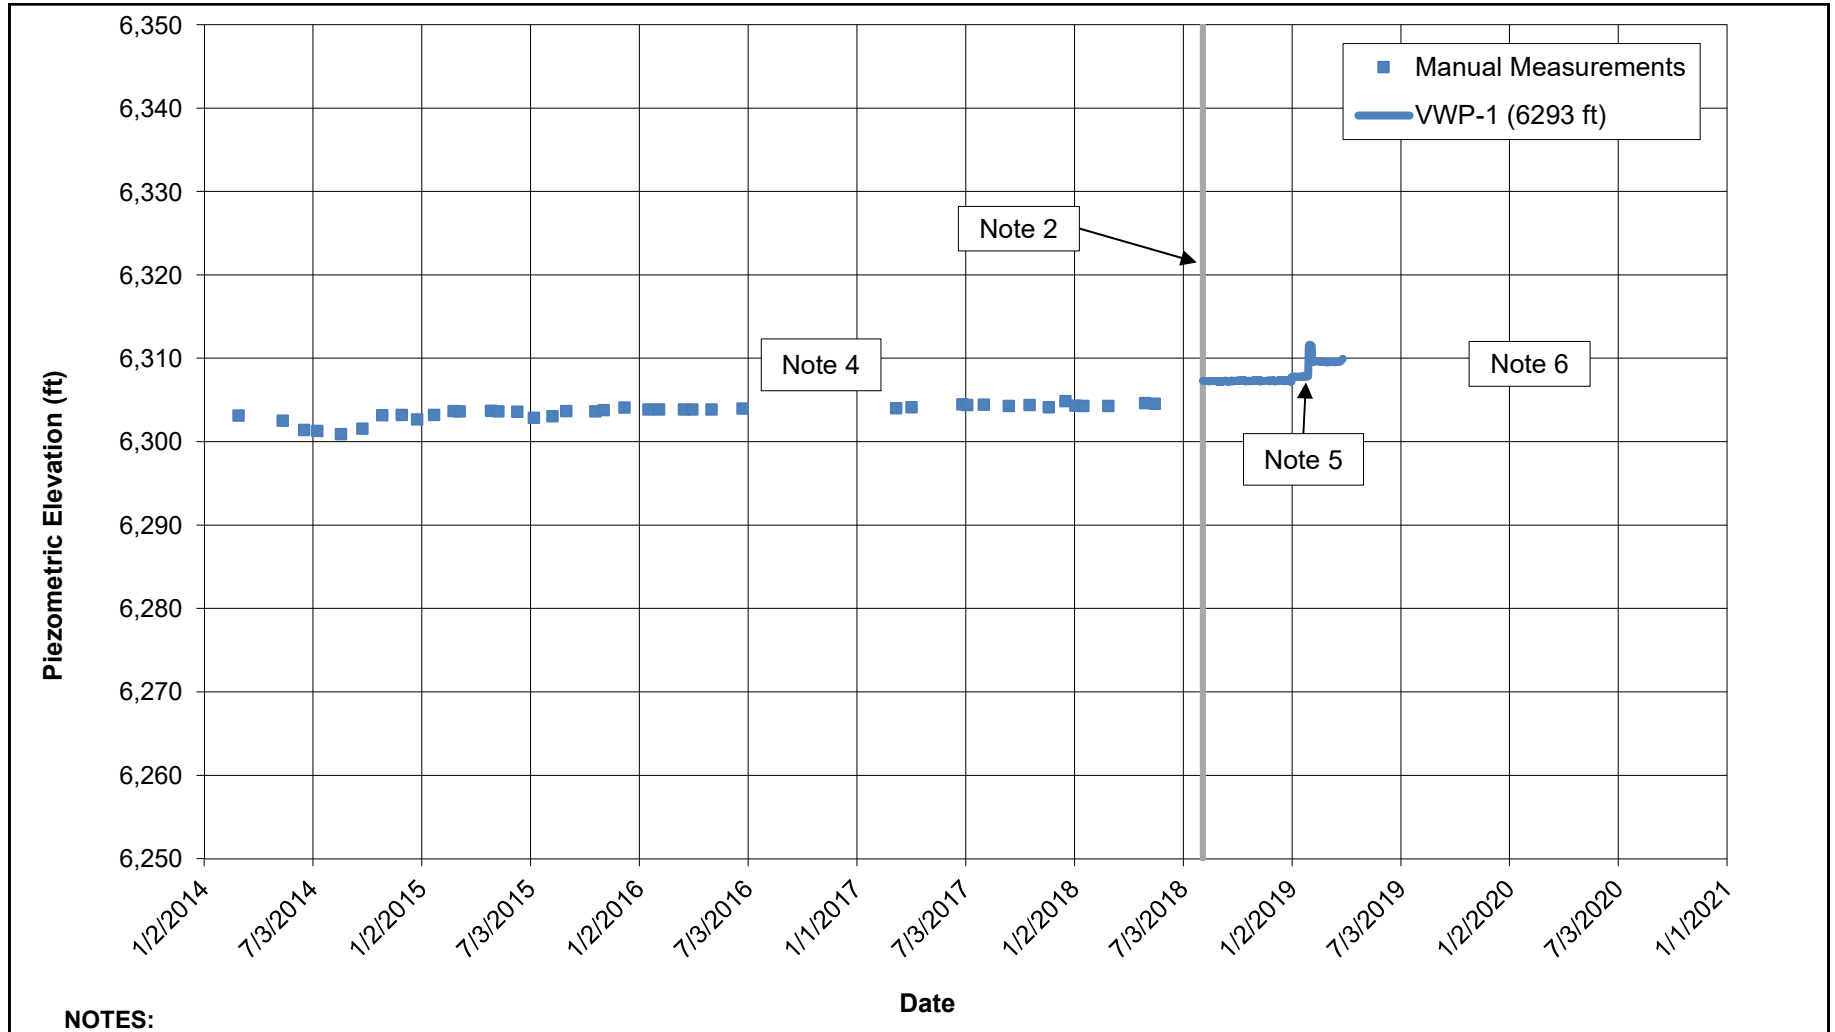
Knight Piesold CONSULTING	P/A NO. VA101-126/23 REF. NO. 5 FIGURE C1.16
REV 0	REV 0

NOTES:

1. SENSOR ELEVATION SHOWN IN LEGEND IS RELATIVE TO ANACONDA MINE GRID.
2. SENSOR WAS INTEGRATED INTO THE REMOTE MONITORING SYSTEM ON AUGUST 5, 2018.
3. STANDPIPE PIEZOMETER WAS INSTALLED AUGUST 22, 2012.
4. STANDPIPE PIEZOMETER WAS TEMPORARILY ABANDONED JUNE 29, 2016 DURING CONSTRUCTION OF ROCKY KNOB CUT. MANUAL MEASUREMENTS WERE RESTARTED FOLLOWING CONSTRUCTION ON MARCH 9, 2017.
5. ERRONEOUS SPIKE OCCURRED JANUARY 29 TO FEBRUARY 6, 2019 DUE TO UNKNOWN CAUSE.
6. NO DATA WERE COLLECTED AFTER MARCH 28, 2019 DUE TO SENSOR CONNECTIVITY ISSUE.

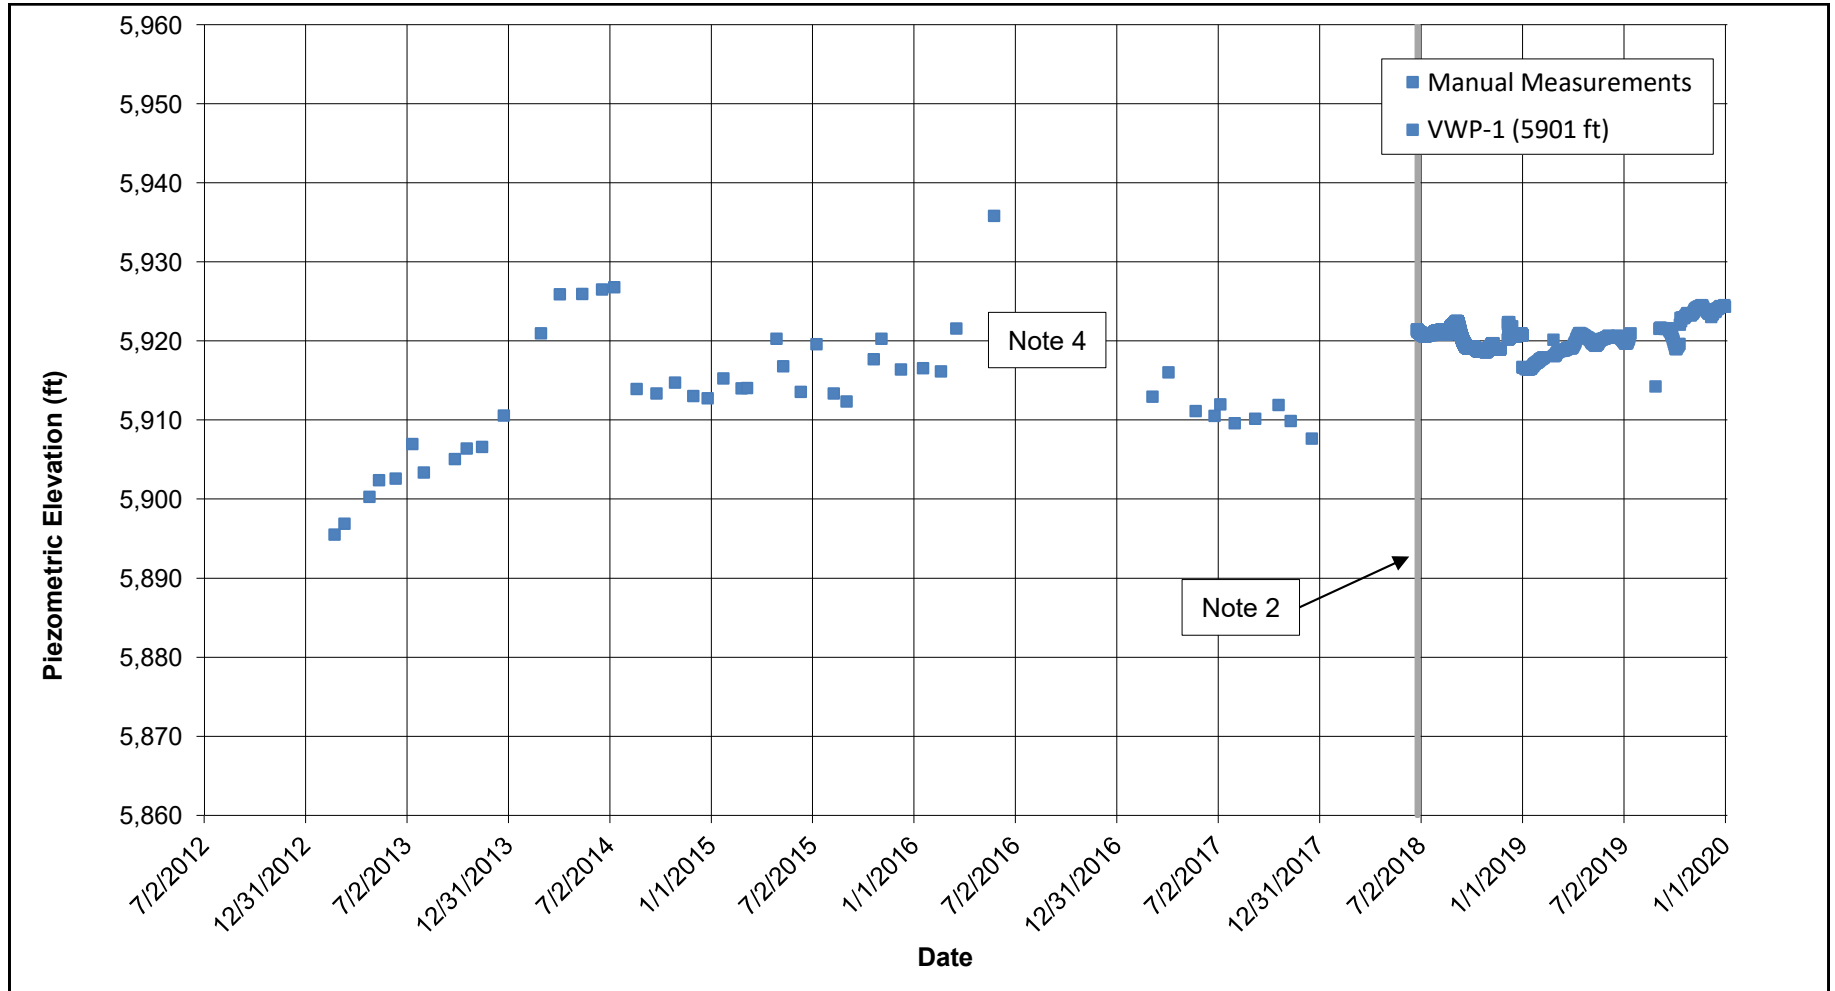
P/A NO. VA101-00126/23
	REF. NO. 5
FIGURE C2.13	
REV 0

- NOTES:**
1. SENSOR ELEVATION SHOWN IN LEGEND IS RELATIVE TO ANACONDA MINE GRID.
 2. SENSOR WAS INTEGRATED INTO THE REMOTE MONITORING SYSTEM ON JUNE 25, 2018.
 3. STANDPIPE PIEZOMETER WAS INSTALLED ON FEBRUARY 22, 2013.
 4. NO WATER LEVEL READINGS WERE TAKEN BETWEEN MAY 25, 2016 TO MARCH 6, 2017 DUE TO ACCESSIBILITY ISSUES.

MONTANA RESOURCES, LLP	
YANKEE DOODLE TAILINGS IMPOUNDMENT	
MW13-01 PIEZOMETER DATA PIEZOMETRIC ELEVATION (FEET)

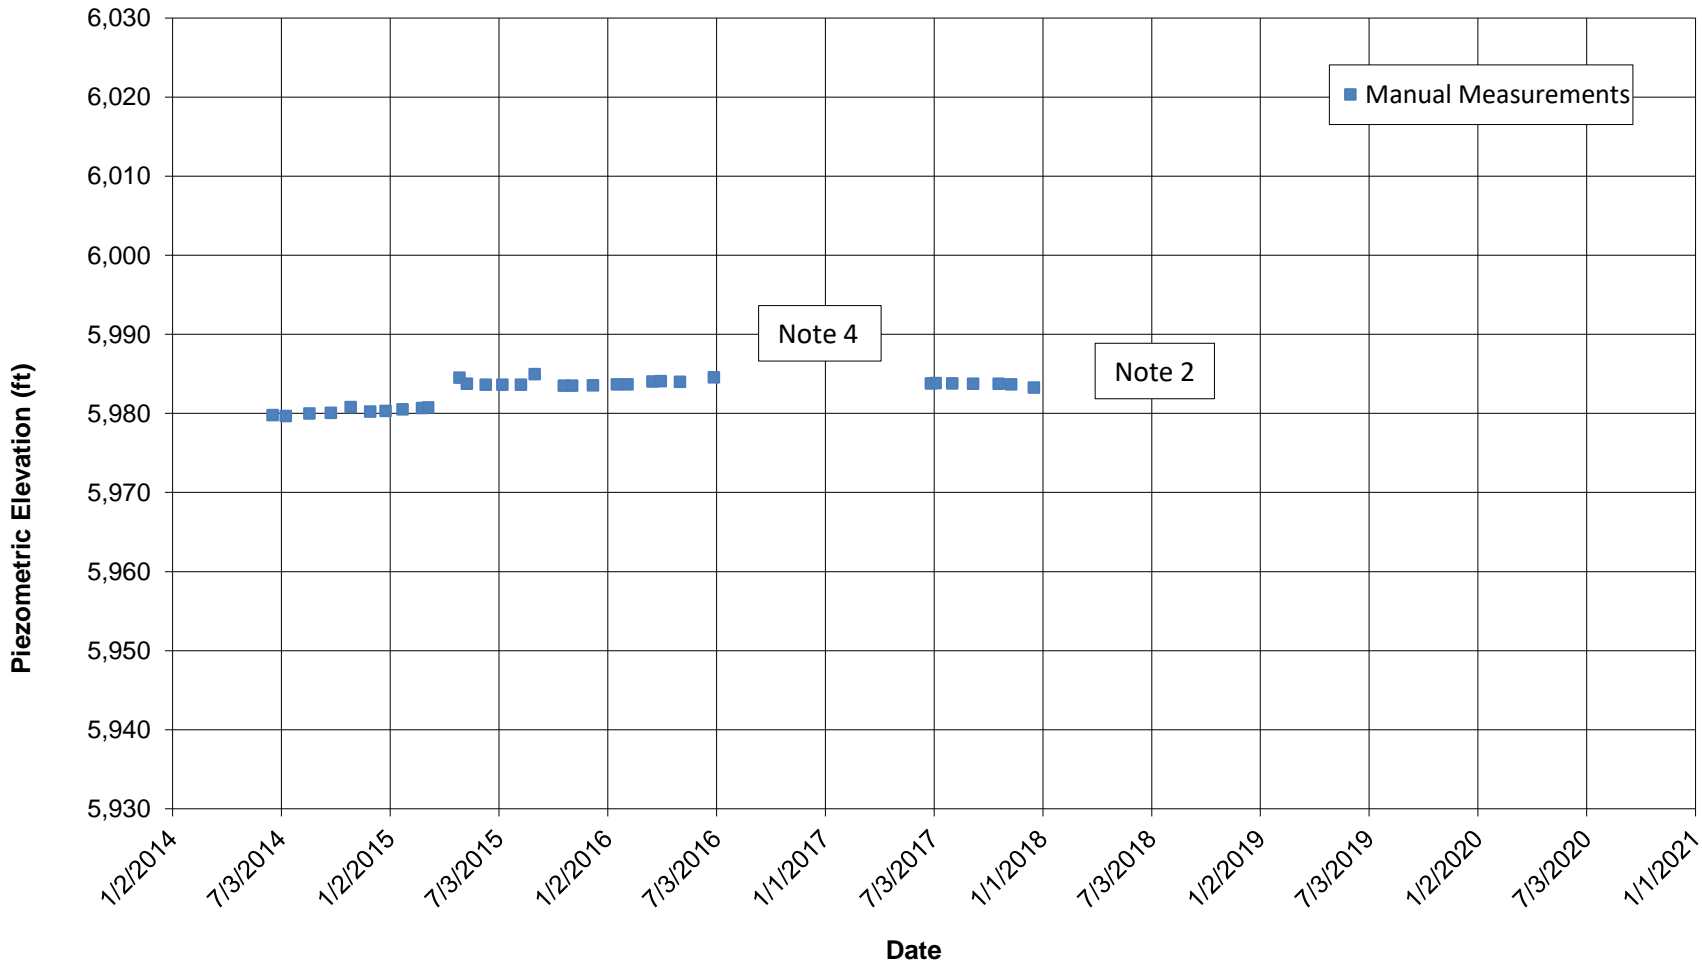
NOTES:

1. GROUND ELEVATION AT THE COLLAR LOCATION IS 6,391 ft BASED ON ANACONDA MINE GRID.
2. STANDPIPE HAS NOT BEEN INTEGRATED TO THE REMOTE MONITORING SYSTEM.
3. STANDPIPE PIEZOMETER WAS INSTALLED MAY 2, 2014.
4. NO MEASUREMENT WERE TAKEN BETWEEN MARCH 29, 2016 AND MARCH 28, 2017 DUE TO INACCESSIBILITY.

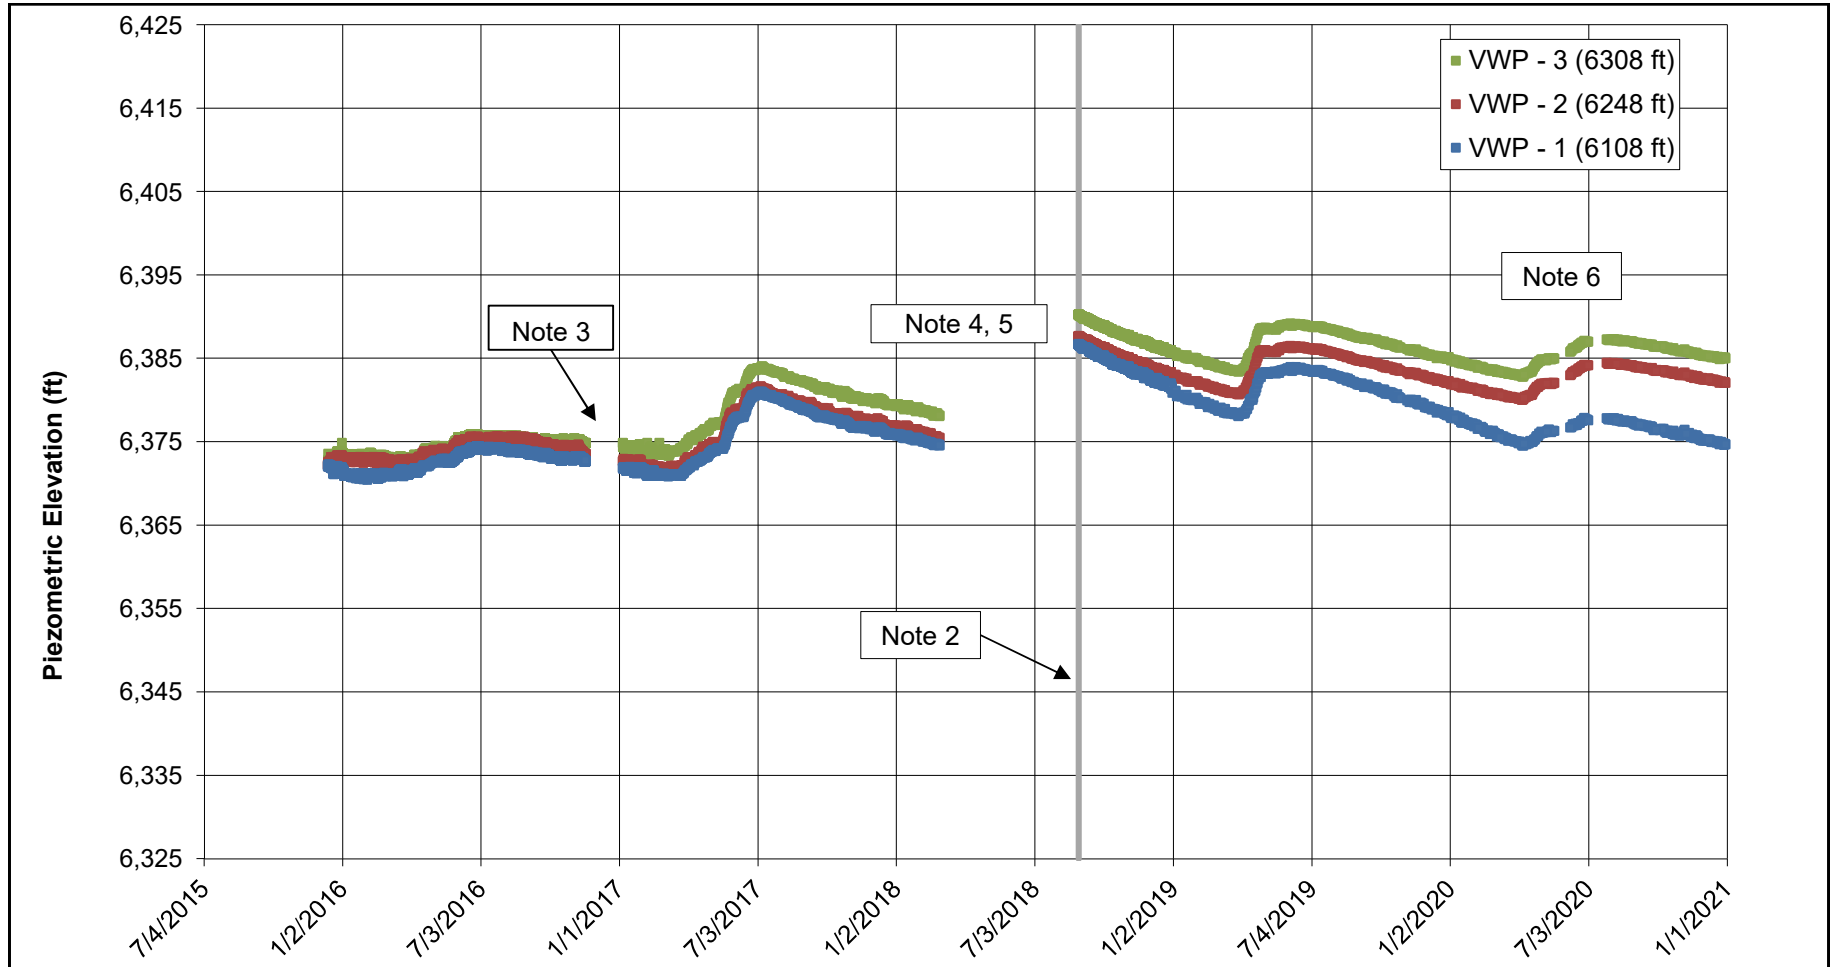
MONTANA RESOURCES, LLP		
YANKEE DOODLE TAILINGS IMPOUNDMENT		
DH15-02 PIEZOMETER DATA PIEZOMETRIC ELEVATION (FEET)		
	P/A NO. VA101-126/23	REF. NO. 5
	FIGURE C3.2	
		REV 0

NOTES:

1. SENSOR ELEVATIONS SHOWN IN LEGEND ARE RELATIVE TO ANACONDA MINE GRID.
2. SENSORS WERE INTEGRATED INTO THE REMOTE MONITORING SYSTEM ON AUGUST 30, 2018.
3. SENSORS STOPPED LOGGING DUE TO INSUFFICIENT BATTERY VOLTAGE.
4. NO DATA REPORTED BETWEEN FEBRUARY 28, 2018 TO AUGUST 30, 2018 DURING INTEGRATION WITH THE REMOTE MONITORING SYSTEM.
5. THE INCREASE IN PIEZOMETRIC ELEVATIONS BETWEEN FEBRUARY 2018 AND AUGUST 2018 ARE INFERRED TO RESULT FROM RISING WATER LEVELS WITHIN THE YDTI AND SEASONAL INCREASE SIMILAR TO THAT OBSERVED FOR THE SAME PERIOD IN 2017.
6. NO DATA WERE COLLECTED FOR ALL VWPS FROM MAY 20 TO JUNE 9, 2020 AND FROM JULY 4 TO 27, 2020 DUE TO A DEPLETED BATTERY.

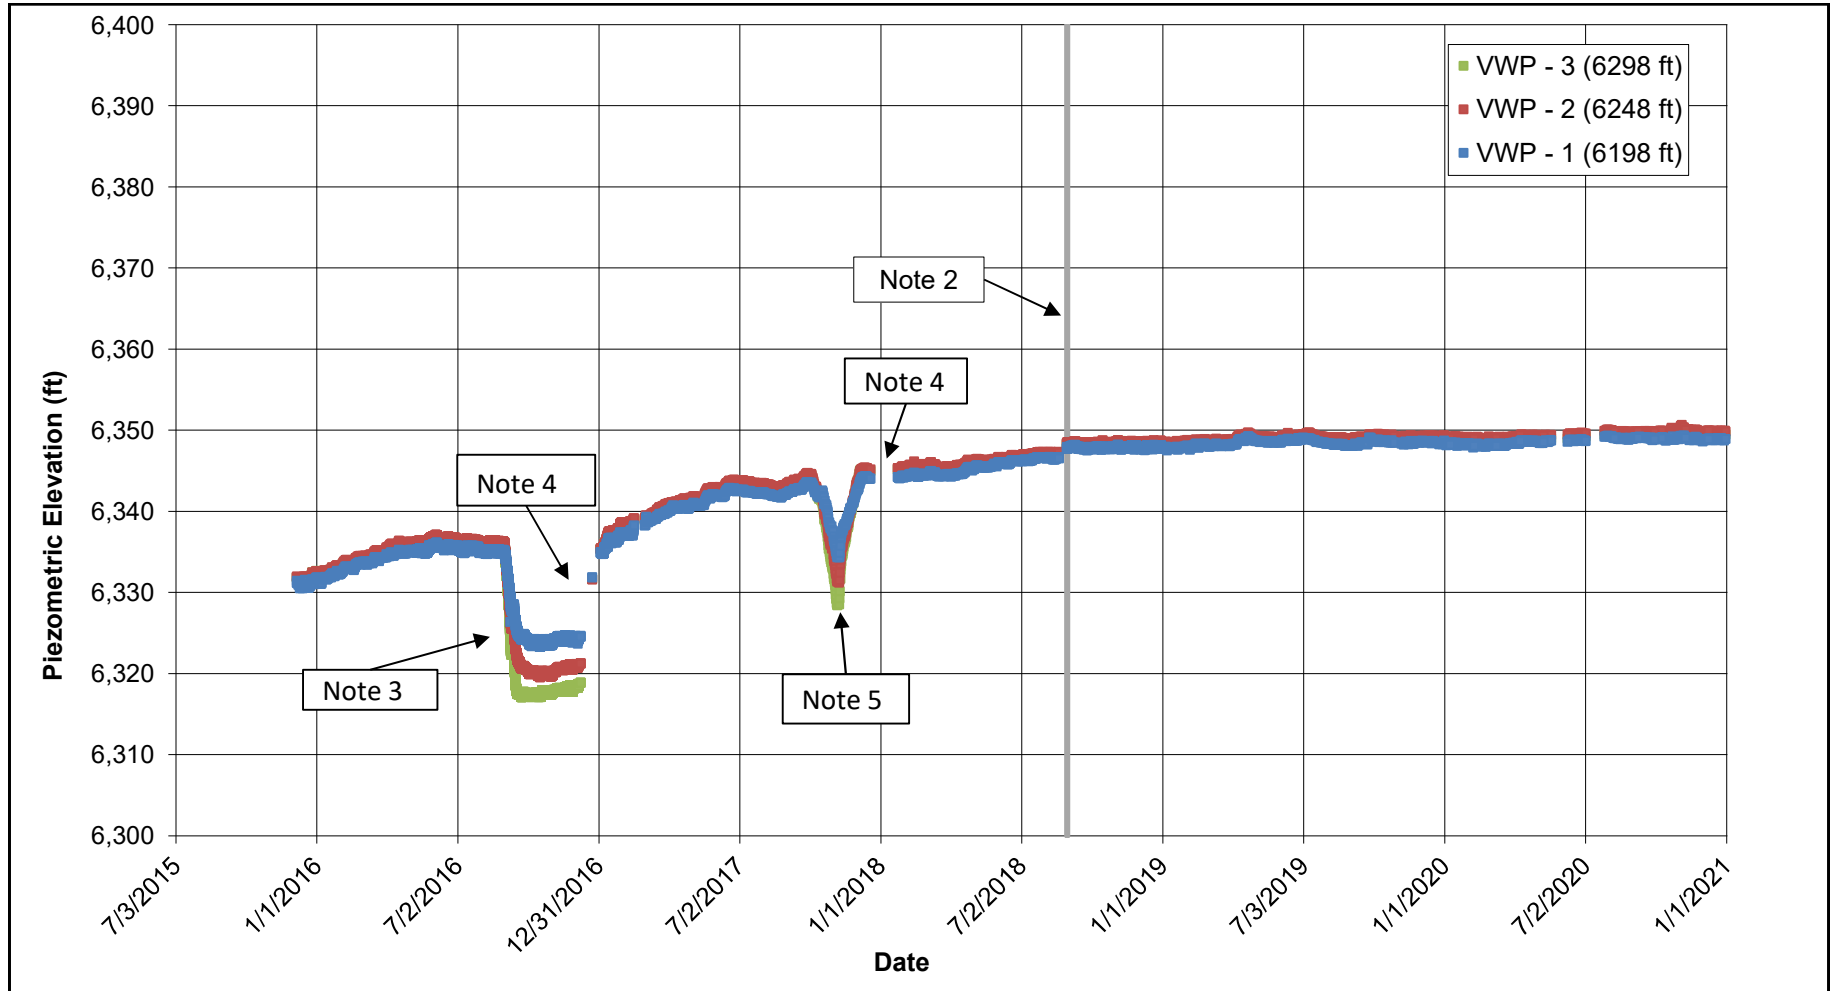
P/A NO. VA101-126/23
FIGURE C3.9	
REF. NO. 5	REV 0

1. SENSOR ELEVATIONS SHOWN IN LEGEND ARE RELATIVE TO ANACONDA MINE GRID.
2. SENSORS WERE INTEGRATED INTO THE REMOTE MONITORING SYSTEM ON SEPTEMBER 4, 2018.
3. THE DRAWDOWN BEGINING ON AUGUST 15, 2016 IS CAUSED BY CONSTRUCTION-RELATED PUMPING AT THE EXTRACTION BASIN TO THE EAST OF DH15-12.
4. SENSOR STOPPED LOGGING DUE TO INSUFFICIENT BATTERY VOLTAGE.
5. THE DRAWDOWN BEGINNING SEPTEMBER 30, 2017 IS CAUSED BY CONSTRUCTION RELATED PUMPING AT EXTRACTION BASIN 1.

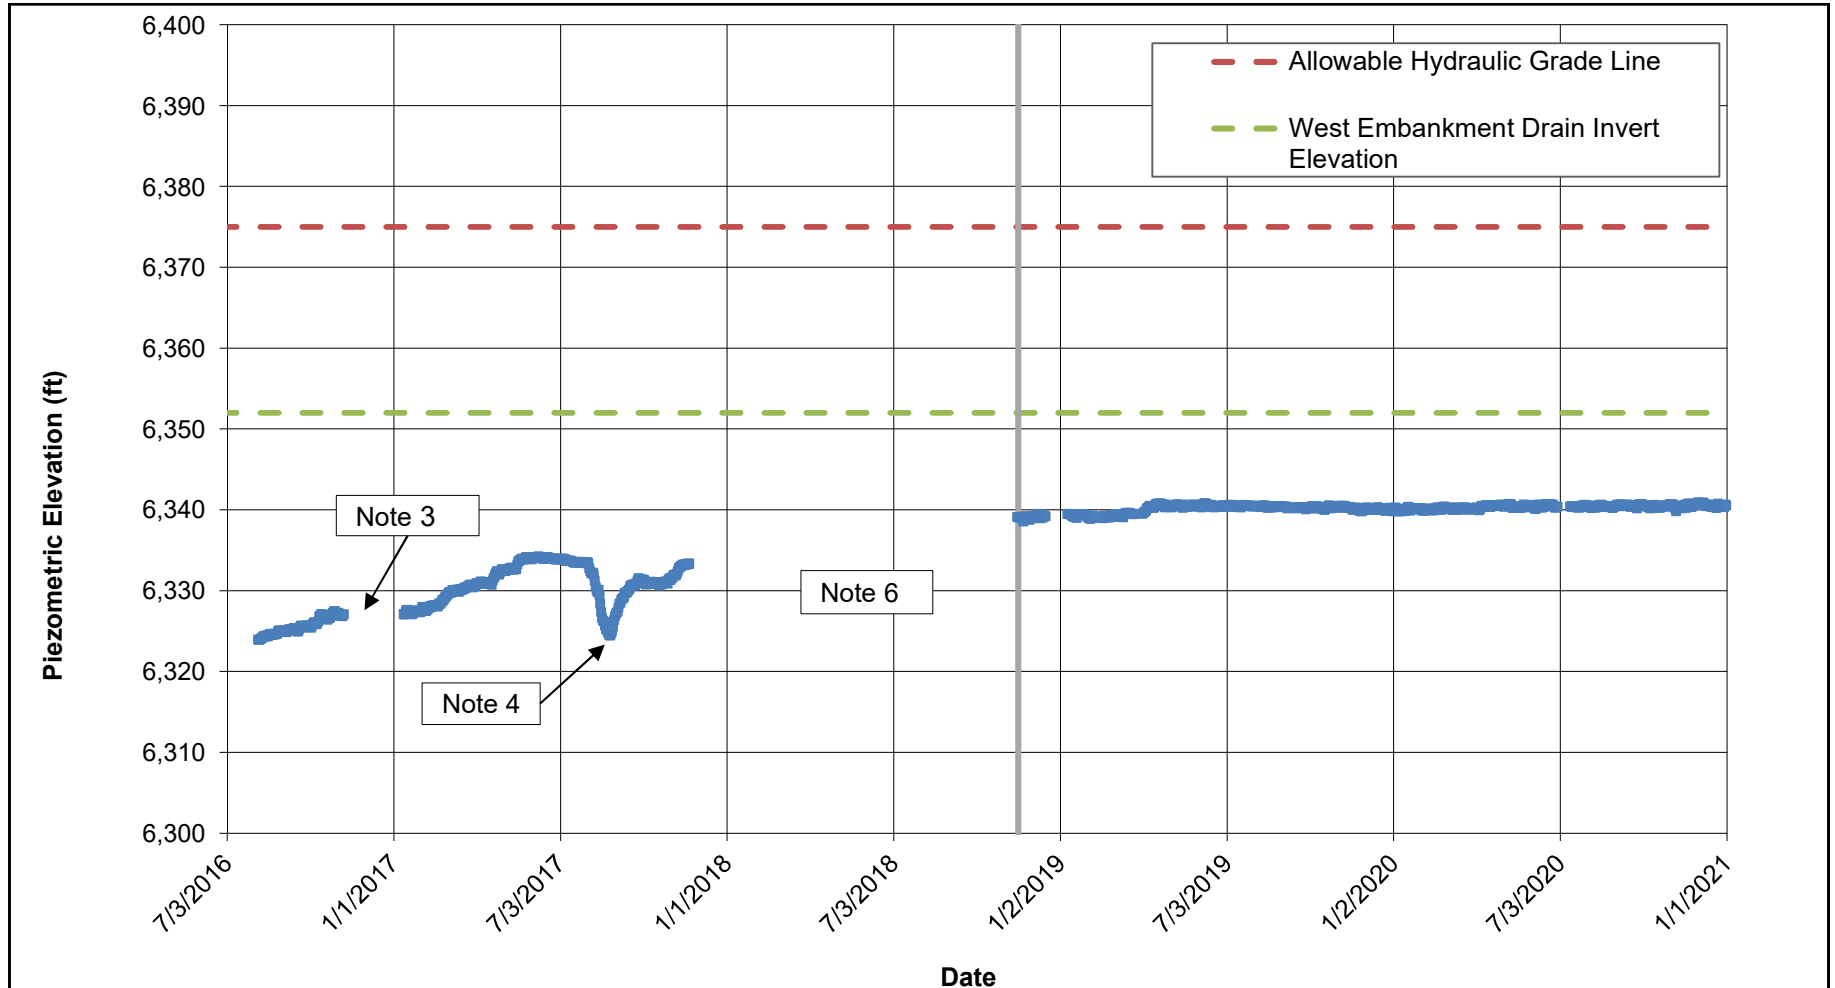
MONTANA RESOURCES, LLP		
YANKEE DOODLE TAILINGS IMPOUNDMENT		
DH15-13 PIEZOMETER DATA PIEZOMETRIC ELEVATION (FEET)		
	P/A NO. VA101-126/23	REF. NO. 5
	FIGURE C3.11	
		REV 0

1. SENSOR ELEVATION SHOWN IN LEGEND IS RELATIVE TO ANACONDA MINE GRID.
2. SENSOR WAS INTEGRATED INTO THE REMOTE MONITORING SYSTEM ON NOVEMBER 16, 2018.
3. SENSOR STOPPED LOGGING DUE TO INSUFFICIENT BATTERY VOLTAGE.
4. THE WATER LEVEL DRAWDOWN IS ASSOCIATED WITH CONSTRUCTION RELATED PUMPING AT DRAIN POND 1.
5. THE ALLOWABLE HYDRAULIC GRADE LINE REPRESENTS THE MAXIMUM HYDRAULIC HEAD DURING OPERATION WITHIN THE DRAIN POD #1; A 10 ft INCREASE IN HYDRAULIC HEAD ABOVE THE FILTER ZONE AND DRAIN CROWN.
6. NO DATA REPORTED BETWEEN NOVEMBER 21, 2017 TO NOVEMBER 16, 2018 DUE TO A HARDWARE ISSUE.

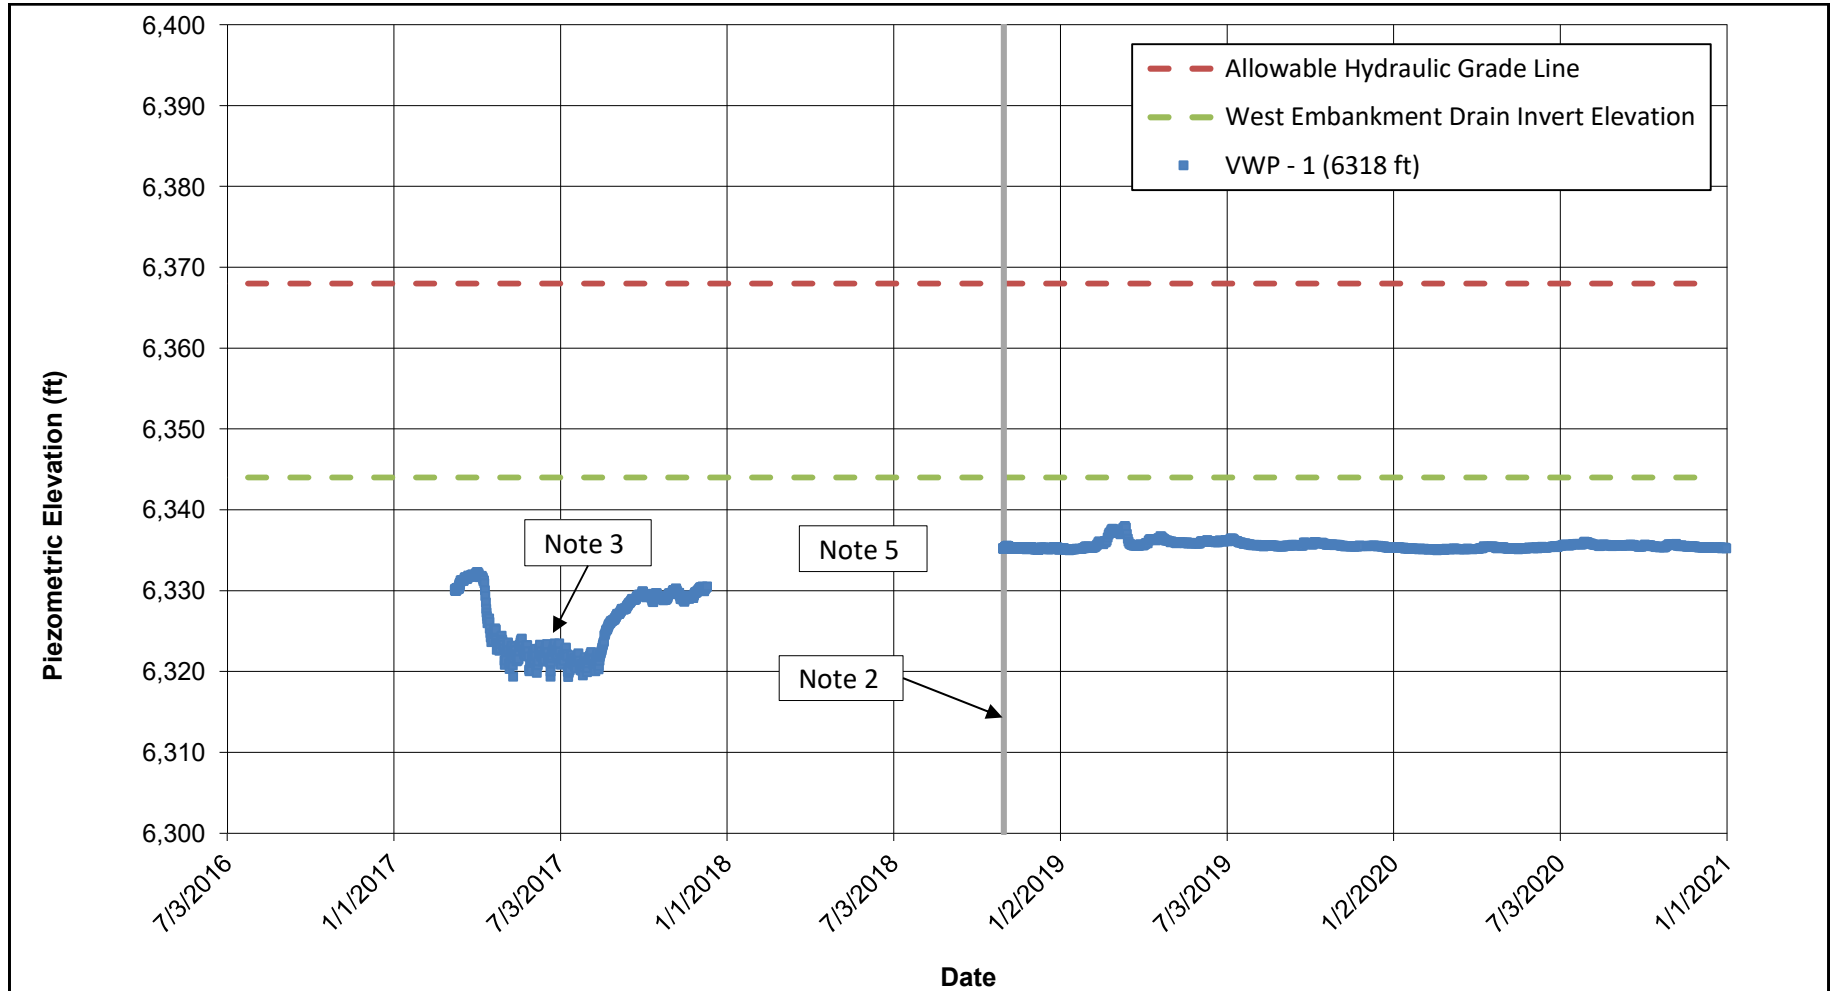
MONTANA RESOURCES, LLP		
YANKEE DOODLE TAILINGS IMPOUNDMENT		
DRAIN POD #1 PIEZOMETER DATA PIEZOMETRIC ELEVATION (FEET)		
	P/A NO. VA101-126/23	REF. NO. 5
	FIGURE C3.12	
		REV 0

1. SENSOR ELEVATION SHOWN IN LEGEND IS RELATIVE TO ANACONDA MINE GRID.
2. SENSOR WAS INTEGRATED INTO THE REMOTE MONITORING SYSTEM ON NOVEMBER 16, 2018.
3. WATER LEVEL DRAWDOWN IS ASSOCIATED WITH CONSTRUCTION RELATED DEWATERING OF THE SOUTH POND AREA AND FROM THE WEST EMBANKMENT DRAIN.
4. THE ALLOWABLE HYDRAULIC GRADE LINE REPRESENTS THE MAXIMUM ALLOWABLE HYDRAULIC HEAD; 10 ft OF HYDRAULIC HEAD ABOVE THE FILTER ZONE AND DRAIN CROWN.
5. NO DATA RECORDED BETWEEN DECEMBER 19, 2017 TO NOVEMBER 16, 2018 DUE TO A CONNECTIVITY ISSUE.

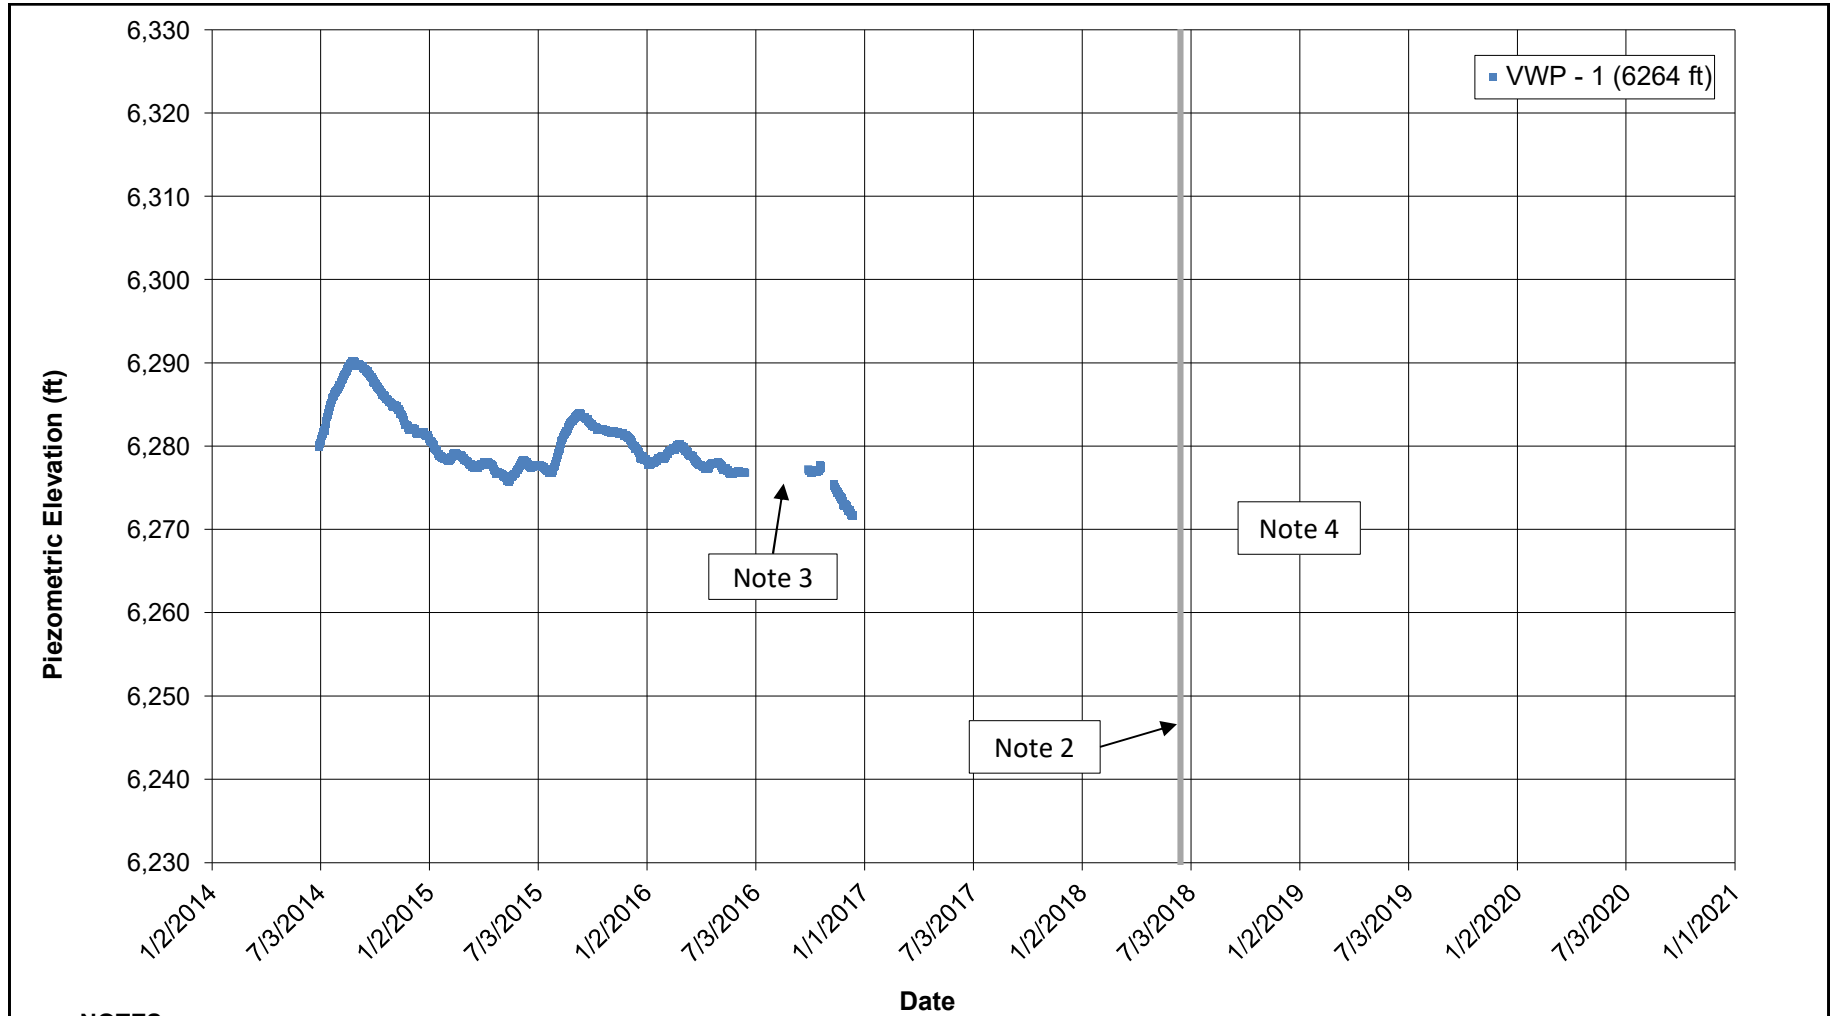
P/A NO. VA101-126/23
FIGURE C4.12	
REF. NO. 5	REV 0

1. SENSOR ELEVATION SHOWN IN LEGEND IS RELATIVE TO ANACONDA MINE GRID.
2. SENSOR WAS INTEGRATED INTO A REMOTE MONITORING SYSTEM JUNE 15, 2018.
3. NO MEASUREMENTS WERE RECORDED FROM JUNE 2016 TO SEPTEMBER 2016 DUE TO DATA LOGGER FAILURE.
4. NO DATA ARE SHOWN FROM NOVEMBER 29, 2016 TO DECEMBER 31, 2020 BECAUSE THE SENSOR BECAME UNSATURATED (DRY).
5. DATA PRIOR TO INTEGRATION OF REMOTE MONITORING SYSTEM ASSUMED A BAROMETRIC PRESSURE OF 1 ATM. THESE DATA HAVE SUBSEQUENTLY BEEN ADJUSTED TO COMPENSATE FOR LOCAL BAROMETRIC CONDITIONS.

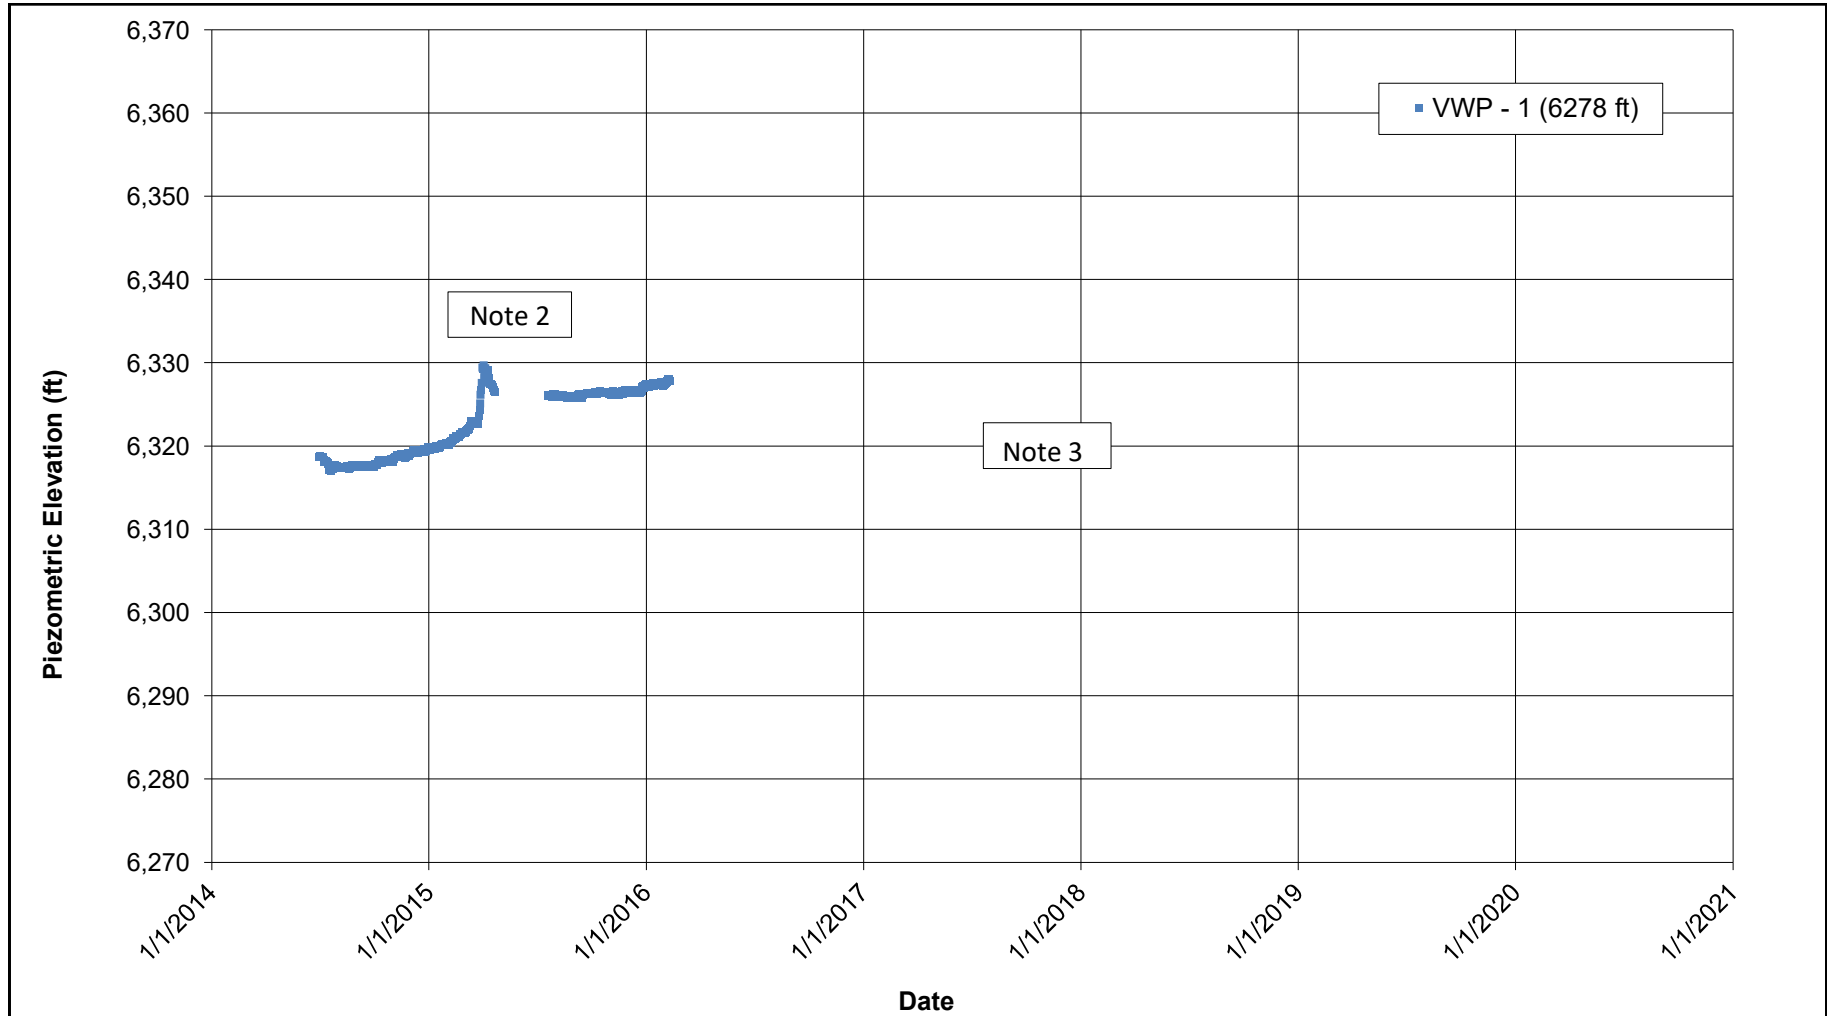
P/A NO. VA101-126/23
FIGURE C4.14	
REF. NO. 5	
REV 0

1. GROUND ELEVATION AT THE COLLAR LOCATION IS 6355 FEET BASED ON ANACONDA MINE GRID.
2. NO MEASUREMENTS WERE RECORDED FROM APRIL 2015 TO JULY 2015 DUE TO BATTERY FAILURE.
3. MONITORING SITE WAS ABANDONED FEBRUARY 12, 2016 DUE TO WEST EMBANKMENT CONSTRUCTION ACTIVITIES.

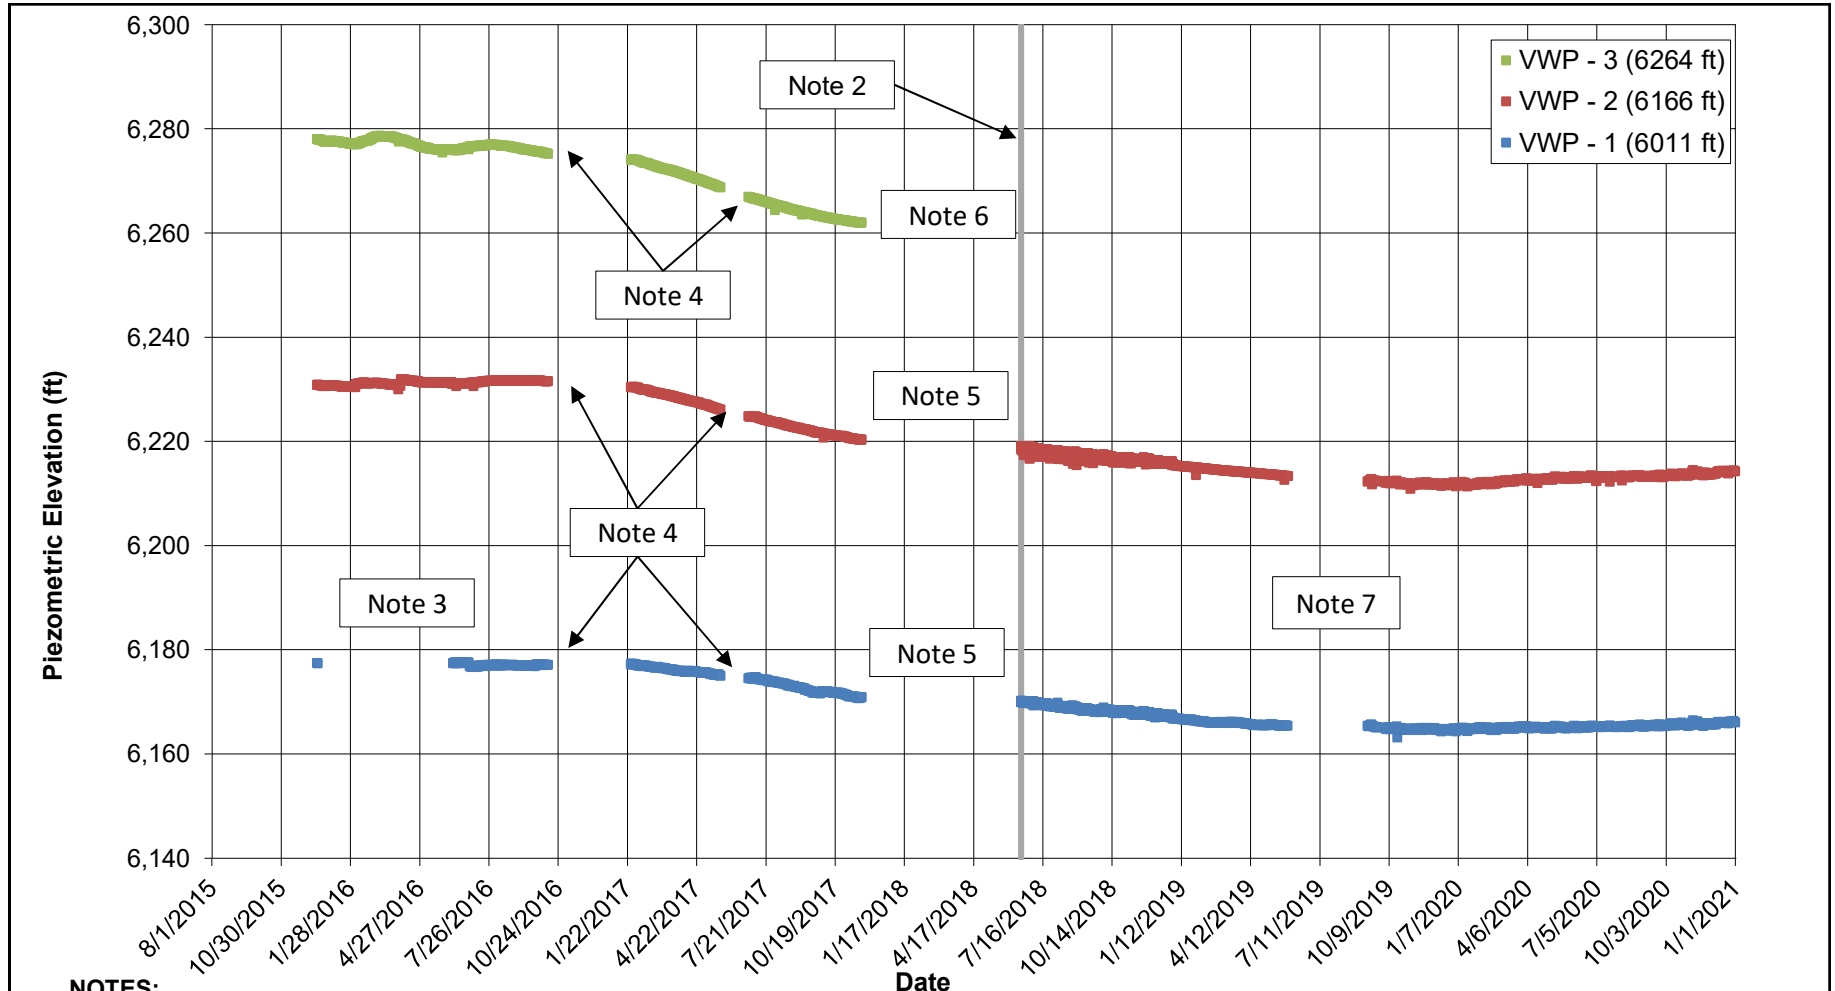
MONTANA RESOURCES, LLP		
YANKEE DOODLE TAILINGS IMPOUNDMENT		
SCPT15-04 PIEZOMETER DATA PIEZOMETRIC ELEVATION (FEET)		
	P/A NO. VA101-126/23	REF. NO. 5
	FIGURE C4.16	
		REV 0

1. SENSOR ELEVATIONS SHOWN IN LEGEND ARE RELATIVE TO ANACONDA MINE GRID.
2. SENSORS WERE INTEGRATED INTO THE REMOTE MONITORING SYSTEM ON JUNE 17, 2018.
3. THE VWP-1 SENSOR CABLE WAS SEVERED FOLLOWING DATA LOGGER INSTALLATION AND WAS RECONNECTED ON JUNE 9, 2016.
4. SENSORS STOPPED LOGGING DUE TO INSUFFICIENT BATTERY VOLTAGE.
5. NO DATA WERE REPORTED BETWEEN NOVEMBER 22, 2018 TO JUNE 17, 2018 DURING INTEGRATION WITH THE REMOTE MONITORING SYSTEM.
6. NO PIEZOMETRIC DATA ARE SHOWN AFTER NOVEMBER 22, 2018 BECAUSE THE SENSOR BECAME UNSATURATED.
7. NO DATA WERE RECORDED BETWEEN MAY 31, 2019 TO SEPTEMBER 2019 DUE TO HARDWARE ISSUE. SENSORS WERE CONNECTED TO MH-5 TEMPORARY LOGGER SEPTEMBER 11, 2019.

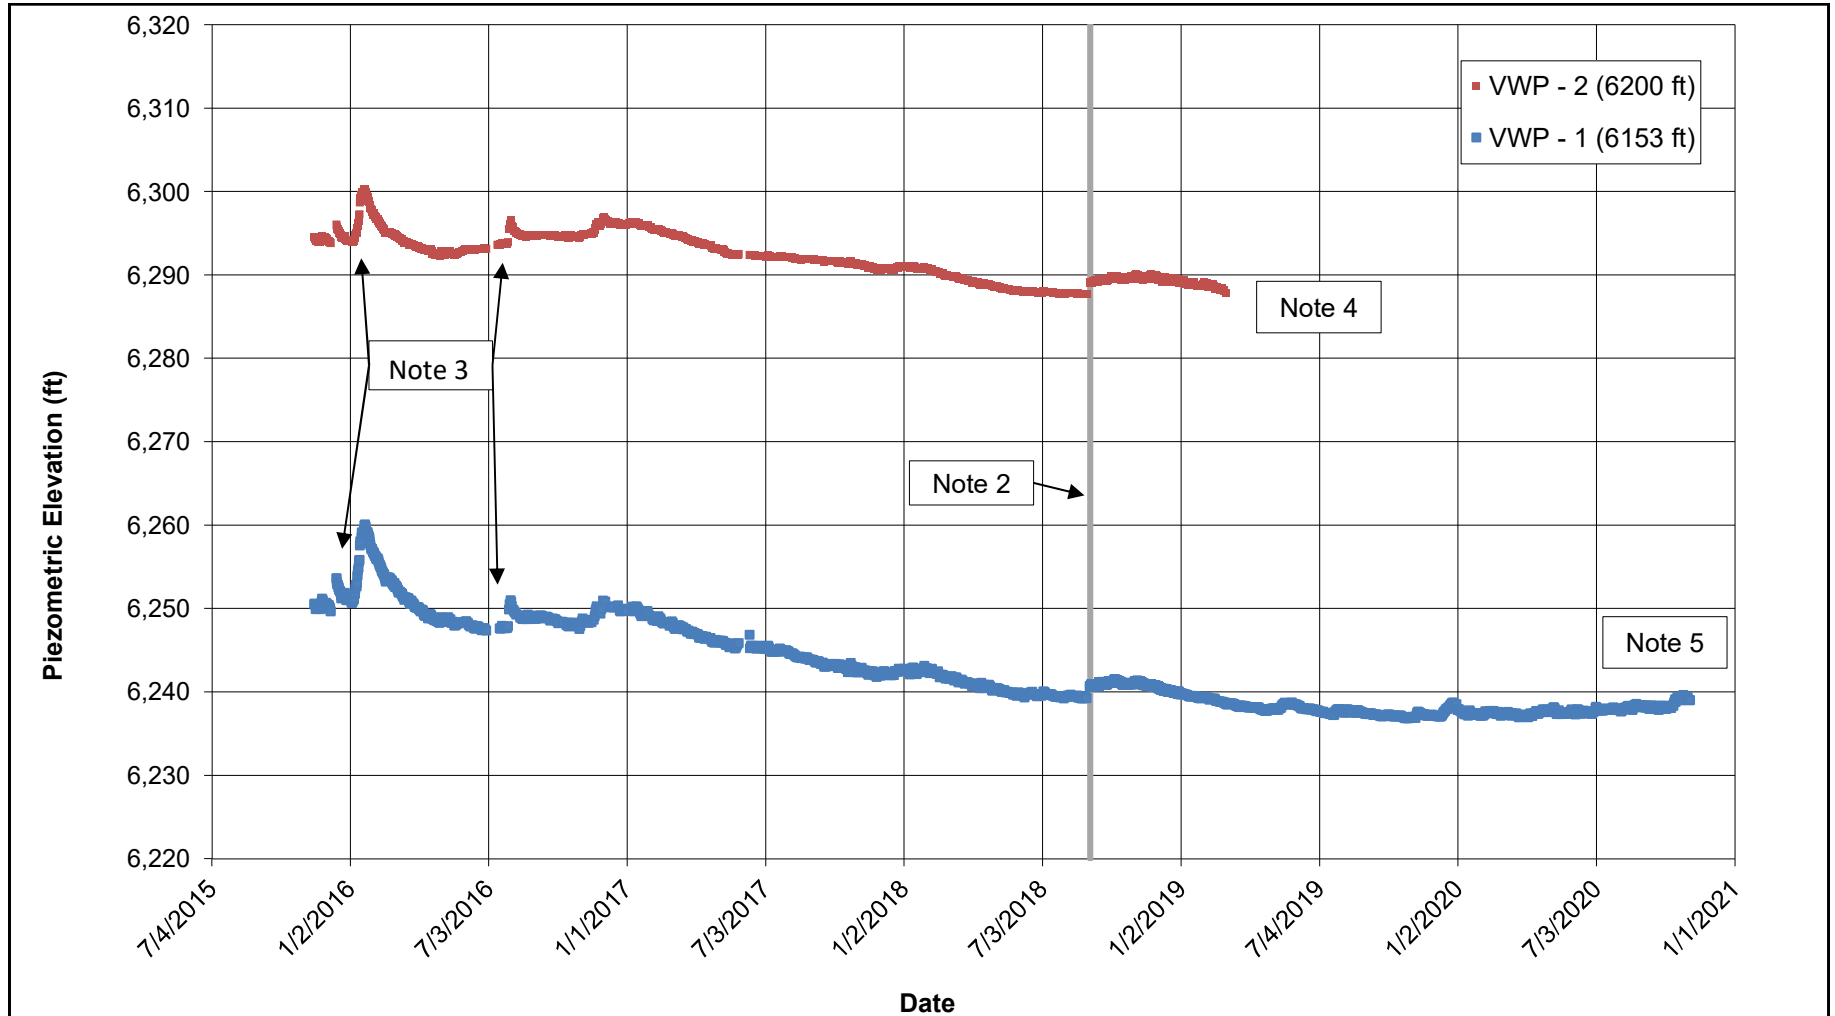
Knight Piesold CONSULTING	P/A NO. VA101-126/23 REF. NO. 5 FIGURE C4.19
REV 0	REV 0

1. SENSOR ELEVATIONS SHOWN IN LEGEND ARE RELATIVE TO ANACONDA MINE GRID.
2. SENSORS WERE INTEGRATED INTO A REMOTE MONITORING SYSTEM ON SEPTEMBER 4, 2018.
3. DATA GAPS EXIST FROM DECEMBER 8 TO DECEMBER 16, 2015 AND FROM JULY 1 TO JULY 16, 2016 WHEN THE DATA LOGGER WAS DISCONNECTED TO ADD AN ADDITIONAL CASING PRIOR TO A ROCKFILL LIFT.
4. ERRONEOUS DATA READINGS AT VW 2 SINCE MARCH 3, 2019 DUE SENSOR ERROR.
5. DATA FROM VWP-1 SINCE NOVEMBER 10, 2020 ARE ERRONEOUS DUE TO SUSPECTED SENSOR DAMAGE.
