Prepared for
Montana Resources, LLP
600 Shields Avenue
Butte, Montana
USA, 59701

VA101-126/23-5

YANKEE DOODLE TAILINGS IMPOUNDMENT

2020 DATA ANALYSIS REPORT

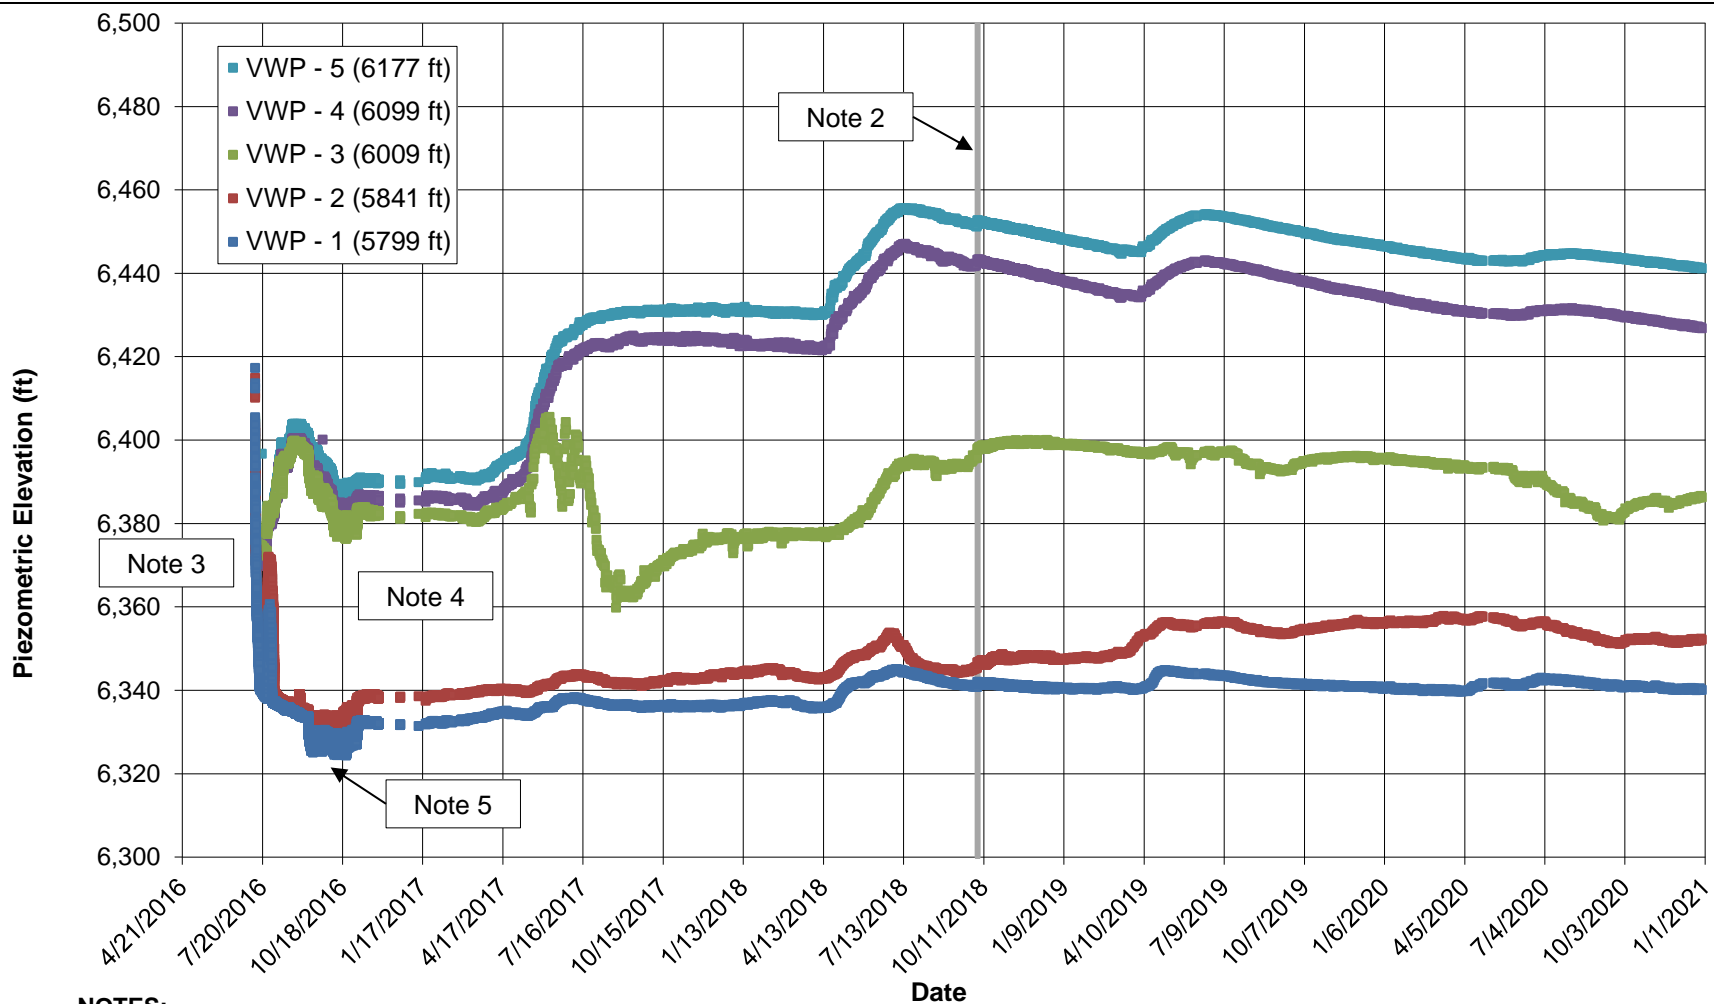
P/A NO. VA101-126/23
FIGURE C6.6	
REF. NO. 5	REV 0

1. SENSOR ELEVATIONS SHOWN IN LEGEND ARE RELATIVE TO ANACONDA MINE GRID.
2. SENSORS WERE INTEGRATED INTO THE REMOTE MONITORING SYSTEM ON OCTOBER 4, 2018.
3. WATER LEVEL PERTURBATION BEGINNING JULY 27, 2016 IS ATTRIBUTED TO THE STEP PUMPING TEST CONDUCTED AT MW16-02 BY HYDROMETRICS.
4. SENSOR STOPPED LOGGING DATA DUE TO INSUFFICIENT BATTERY VOLTAGE
5. WATER LEVEL FLUCTUATIONS FROM SEPTEMBER TO NOVEMBER 5, 2016 ARE CAUSED BY DATA LOGGER MALFUNCTION, AND ARE ERRONEOUS.

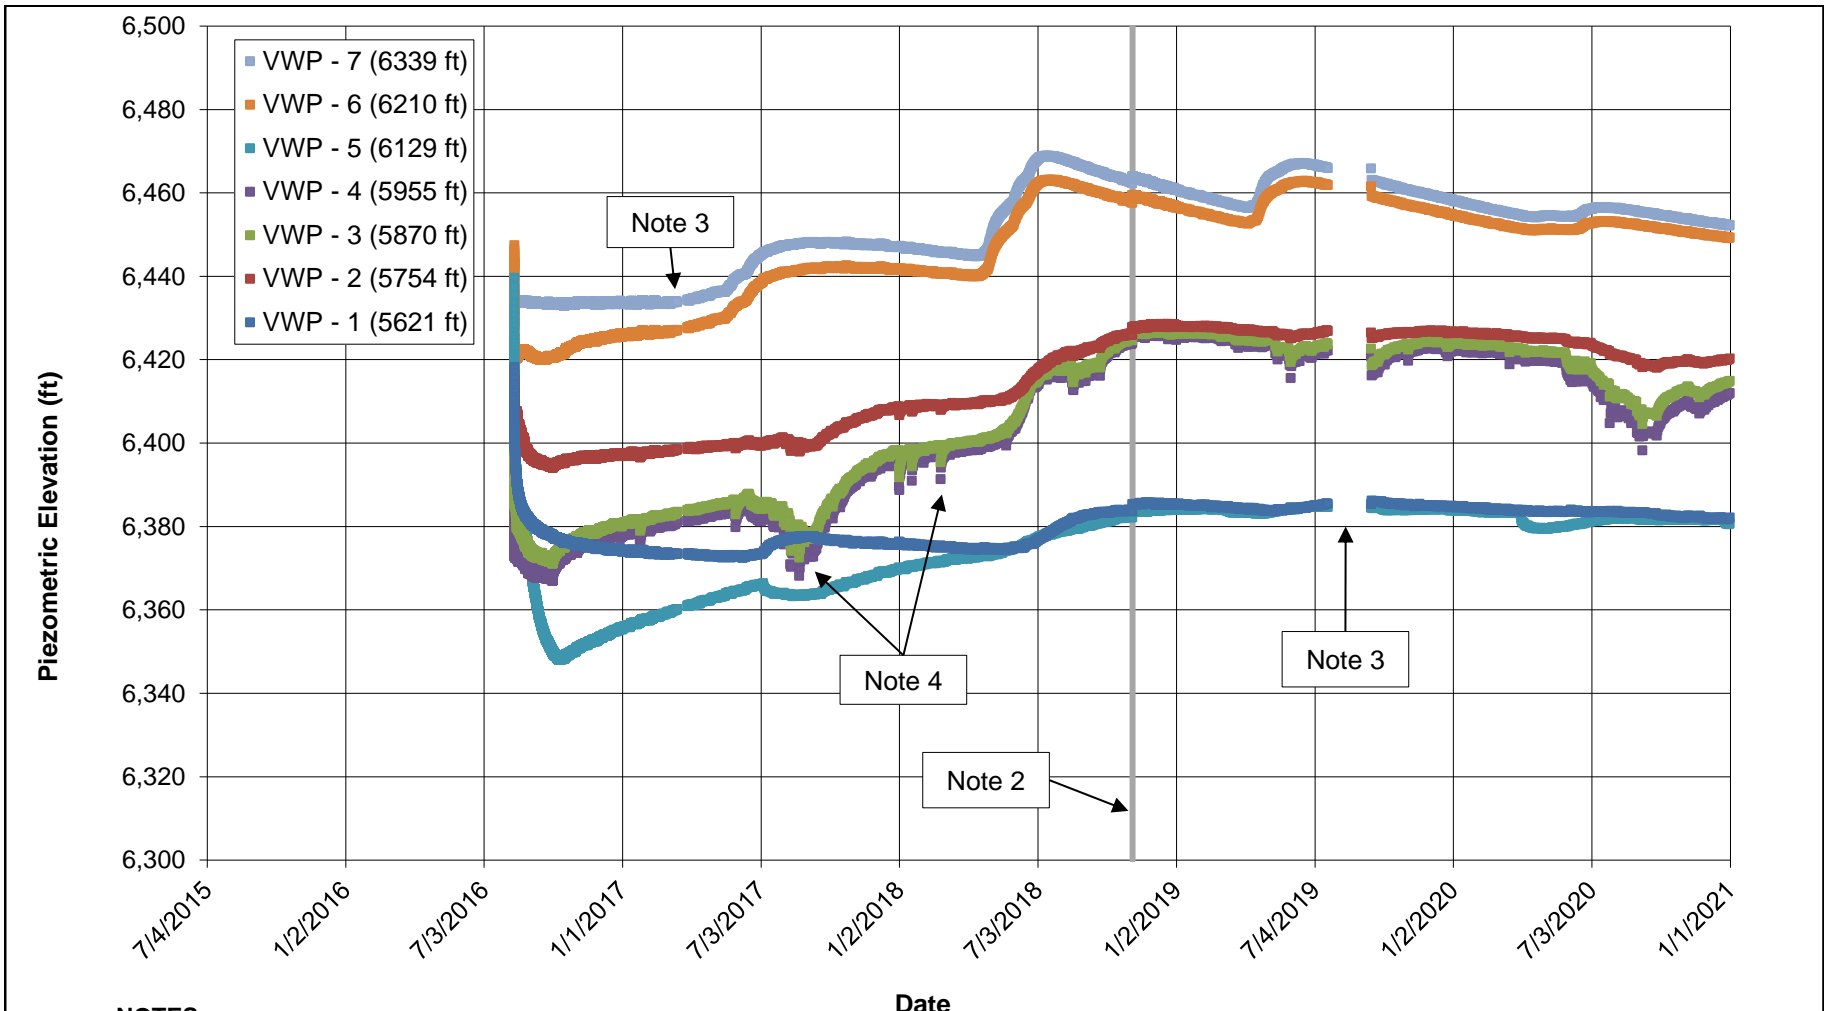
1. SENSOR ELEVATIONS SHOWN IN LEGEND ARE RELATIVE TO ANACONDA MINE GRID.
2. SENSORS WERE INTEGRATED INTO THE REMOTE MONITORING SYSTEM ON NOVEMBER 5, 2018.
3. SENSORS STOPPED RECORDING DUE TO INSUFFICIENT BATTERY VOLTAGE.
4. PIEZOMETRIC FLUCTUATIONS OBSERVED AT VWP-2, VWP-3 AND VWP-4 SENSORS ARE THE RESULT OF PUMPING AT RESIDENTIAL WELL 196757.

MONTANA RESOURCES, LLP	
YANKEE DOODLE TAILINGS IMPOUNDMENT	
DH16-05 PIEZOMETER DATA PIEZOMETRIC ELEVATION (FEET)	
	P/A NO. VA101-126/23
Knight Piésold CONSULTING	REF. NO. 5
FIGURE C6.8	
REV 0	REV 0

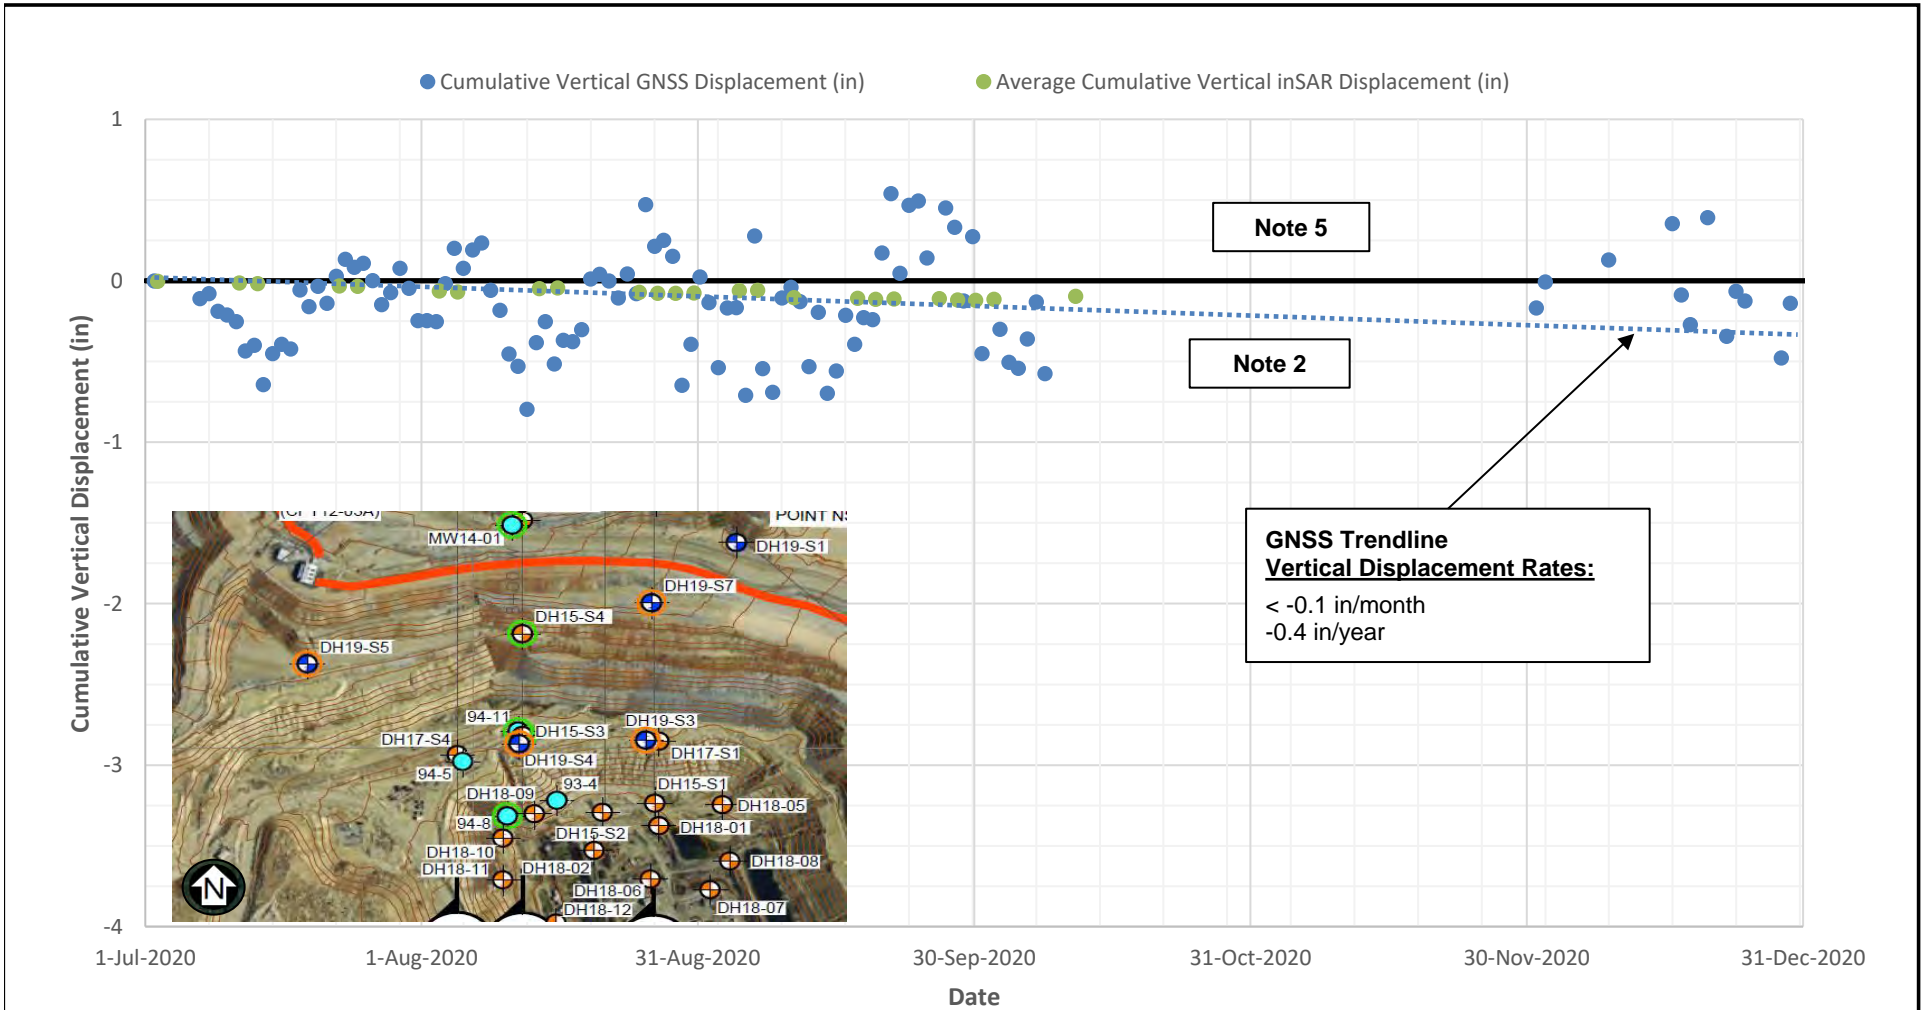
1. CUMULATIVE VERTICAL DISPLACEMENTS ARE CALCULATED RELATIVE TO JULY 1, 2020.
2. NO DATA WERE COLLECTED FROM OCTOBER 7 TO DECEMBER 2, 2020 DUE TO A POWER MANAGEMENT SCHEDULE ISSUE AT THE GNSS REFERENCE STATION (DH16-04).
3. NEGATIVE VERTICAL DISPLACEMENTS INDICATE DOWNWARD DISPLACEMENT.
4. THE AVERAGE CUMULATIVE VERTICAL INSAR DISPLACEMENT IS CALCULATED BY AVERAGING TIME-SERIES DISPLACEMENTS FROM NINE INSAR DATA POINTS LOCATED ADJACENT TO DH19-S3.
5. NO INSAR DATA ARE AVAILABLE AFTER OCTOBER 2, 2020 DUE TO THE ONSET OF WINTER

MONTANA RESOURCES LLP.		
YANKEE DOODLE TAILINGS IMPOUNDMENT		
CUMULATIVE VERTICAL DISPLACEMENTS MONITORED AT DH19-S3 (JULY 1, 2020 TO DECEMBER 31, 2020)		
	P/A NO. VA101-00126/23	REF. NO. 5
	FIGURE D2.2	
		REV 0

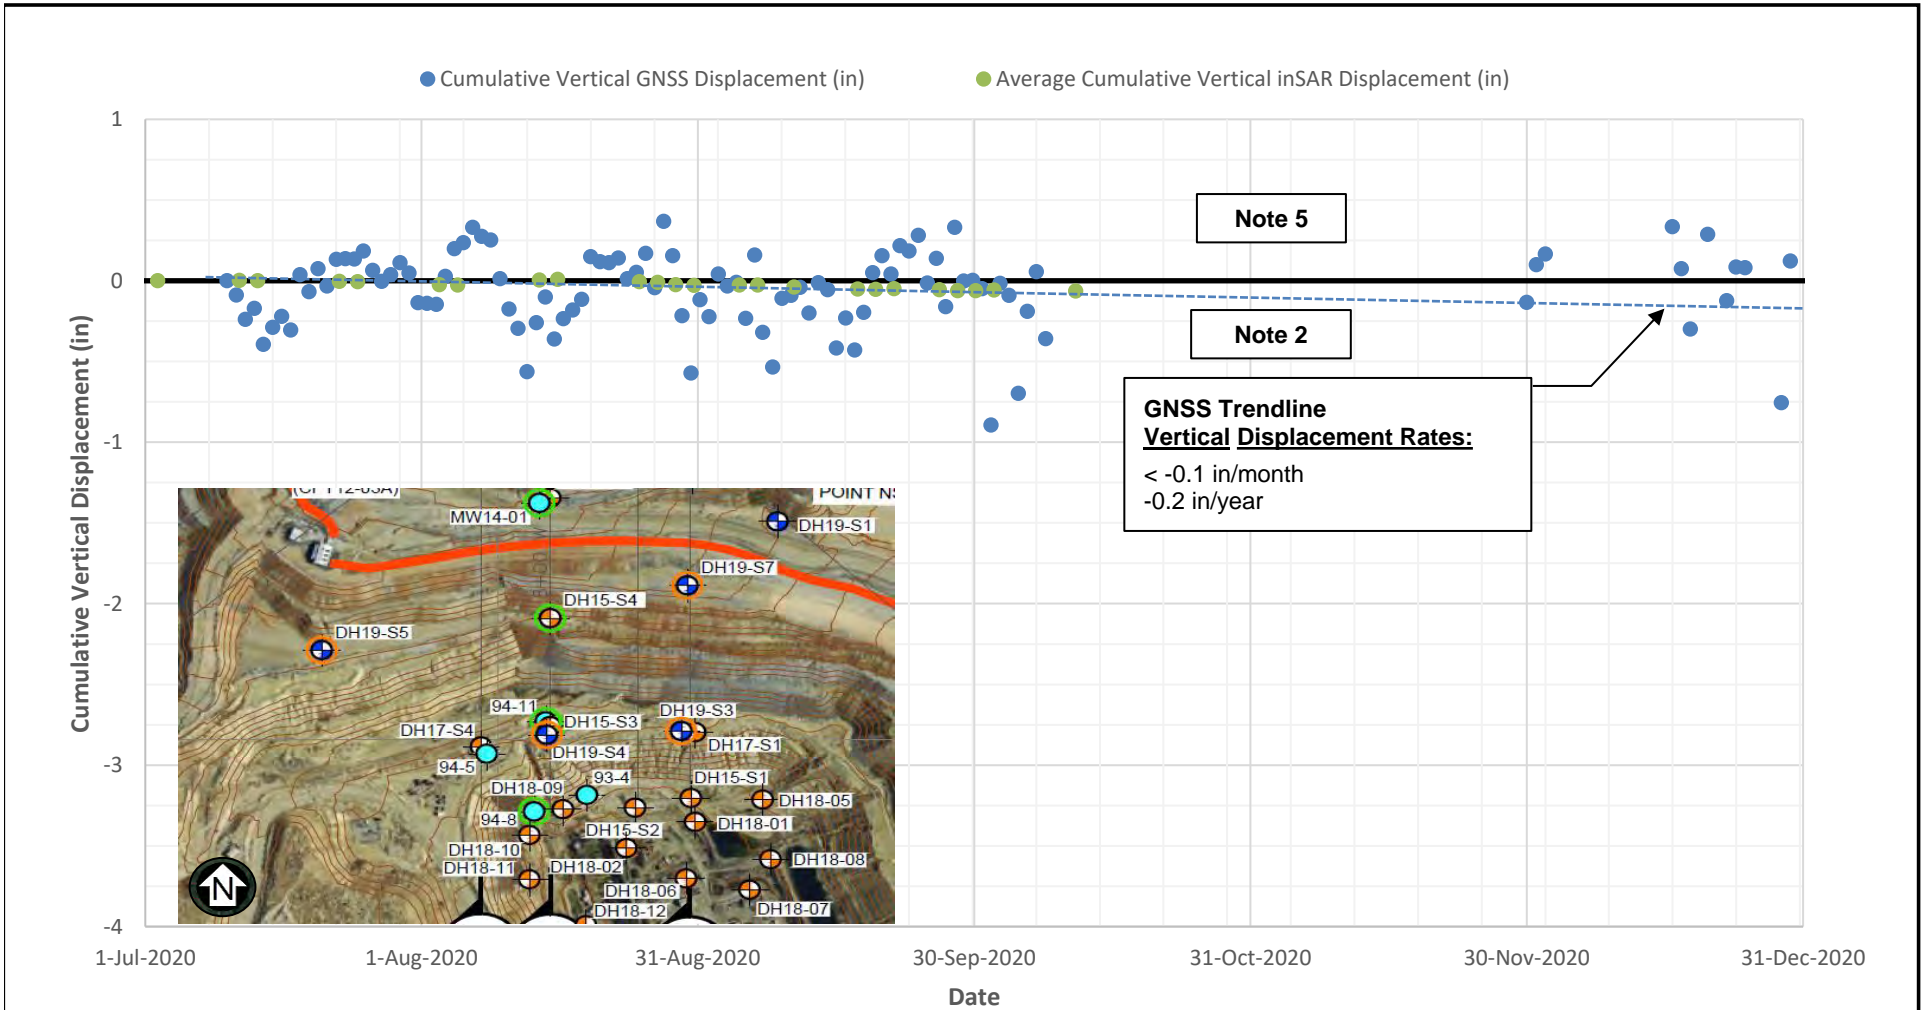
1. CUMULATIVE VERTICAL DISPLACEMENTS ARE CALCULATED RELATIVE TO JULY 1, 2020.
2. NO DATA WERE COLLECTED FROM OCTOBER 7 TO DECEMBER 2, 2020 DUE TO A POWER MANAGEMENT SCHEDULE ISSUE AT THE GNSS REFERENCE STATION (DH16-04).
3. NEGATIVE VERTICAL DISPLACEMENTS INDICATE DOWNWARD DISPLACEMENT.
4. THE AVERAGE CUMULATIVE VERTICAL INSAR DISPLACEMENT IS CALCULATED BY AVERAGING TIME-SERIES DISPLACEMENTS FROM NINE INSAR DATA POINTS LOCATED ADJACENT TO DH19-S5.
5. NO INSAR DATA ARE AVAILABLE AFTER OCTOBER 2, 2020 DUE TO THE ONSET OF WINTER CONDITIONS.

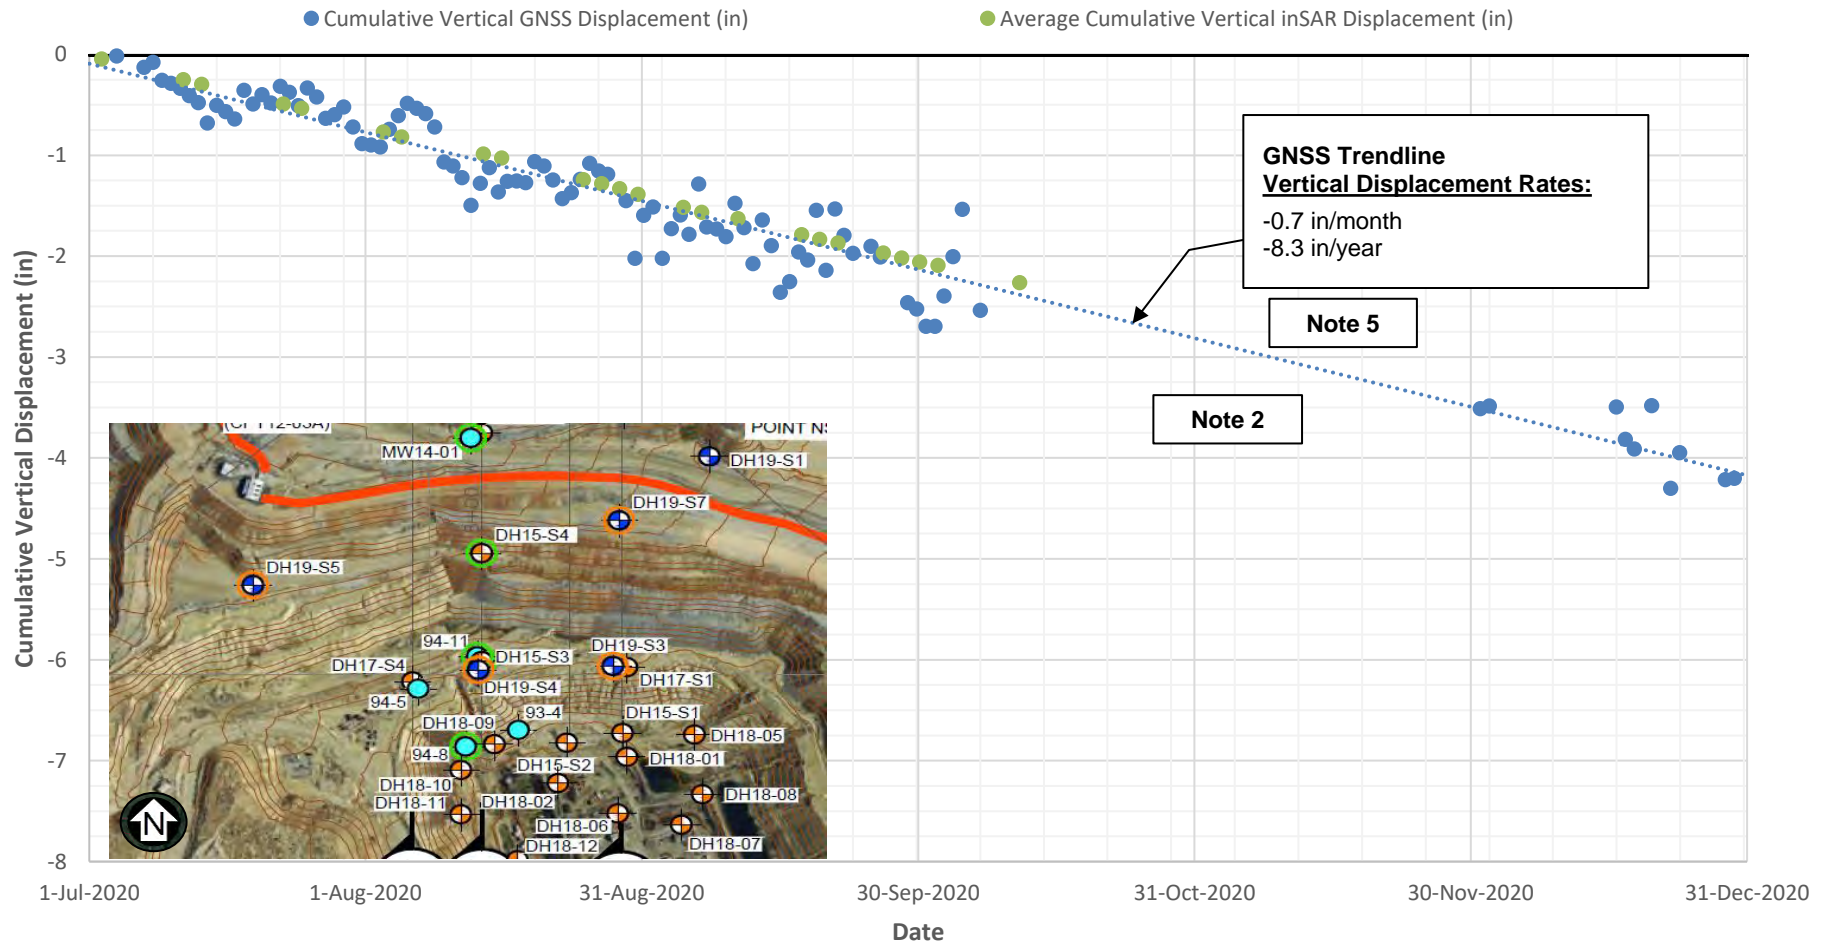
P/A NO. VA101-00126/23
	REF. NO. 5
FIGURE D2.7	
	REV 0

1. CUMULATIVE VERTICAL DISPLACEMENTS ARE CALCULATED RELATIVE TO JULY 1, 2020.
2. NO DATA WERE COLLECTED FROM OCTOBER 7 TO DECEMBER 2, 2020 DUE TO A POWER MANAGEMENT SCHEDULE ISSUE AT THE GNSS REFERENCE STATION (DH16-04).
3. NEGATIVE VERTICAL DISPLACEMENTS INDICATE DOWNWARD DISPLACEMENT.
4. THE AVERAGE CUMULATIVE VERTICAL INSAR DISPLACEMENT IS CALCULATED BY AVERAGING TIME-SERIES DISPLACEMENTS FROM NINE INSAR DATA POINTS LOCATED ADJACENT TO DH19-S7.
5. NO INSAR DATA ARE AVAILABLE AFTER OCTOBER 2, 2020 DUE TO THE ONSET OF WINTER CONDITIONS.

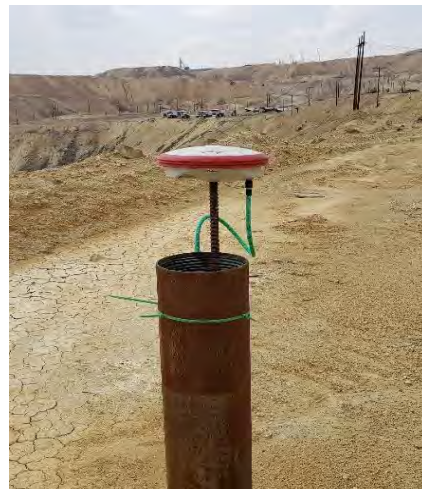
<table border="1" style="width: 100%; border-collapse: collapse;"> <tr> <td style="font-size: small;">P/A NO. VA101-126/23</td> <td style="font-size: small;">REF. NO. 5</td> </tr> </table>	P/A NO. VA101-126/23	REF. NO. 5
P/A NO. VA101-126/23	REF. NO. 5		
FIGURE D3.3	REV 0

1. COLLAR WANDER IS MONITORED USING GNSS INSTRUMENTATION INSTALLED AT THE INCLINOMETER COLLAR LOCATION.
2. THE PLOT ABOVE PRESENTS COLLAR POSITION BASED ON NORTH AND EAST CHANGE RELATIVE TO A JULY 1, 2020 BASELINE GNSS SURVEY.
3. NO DATA ARE AVAILABLE FOR NOVEMBER AS THE INSTRUMENTATION WERE OFFLINE DUE TO A POWER MANAGEMENT ISSUE.

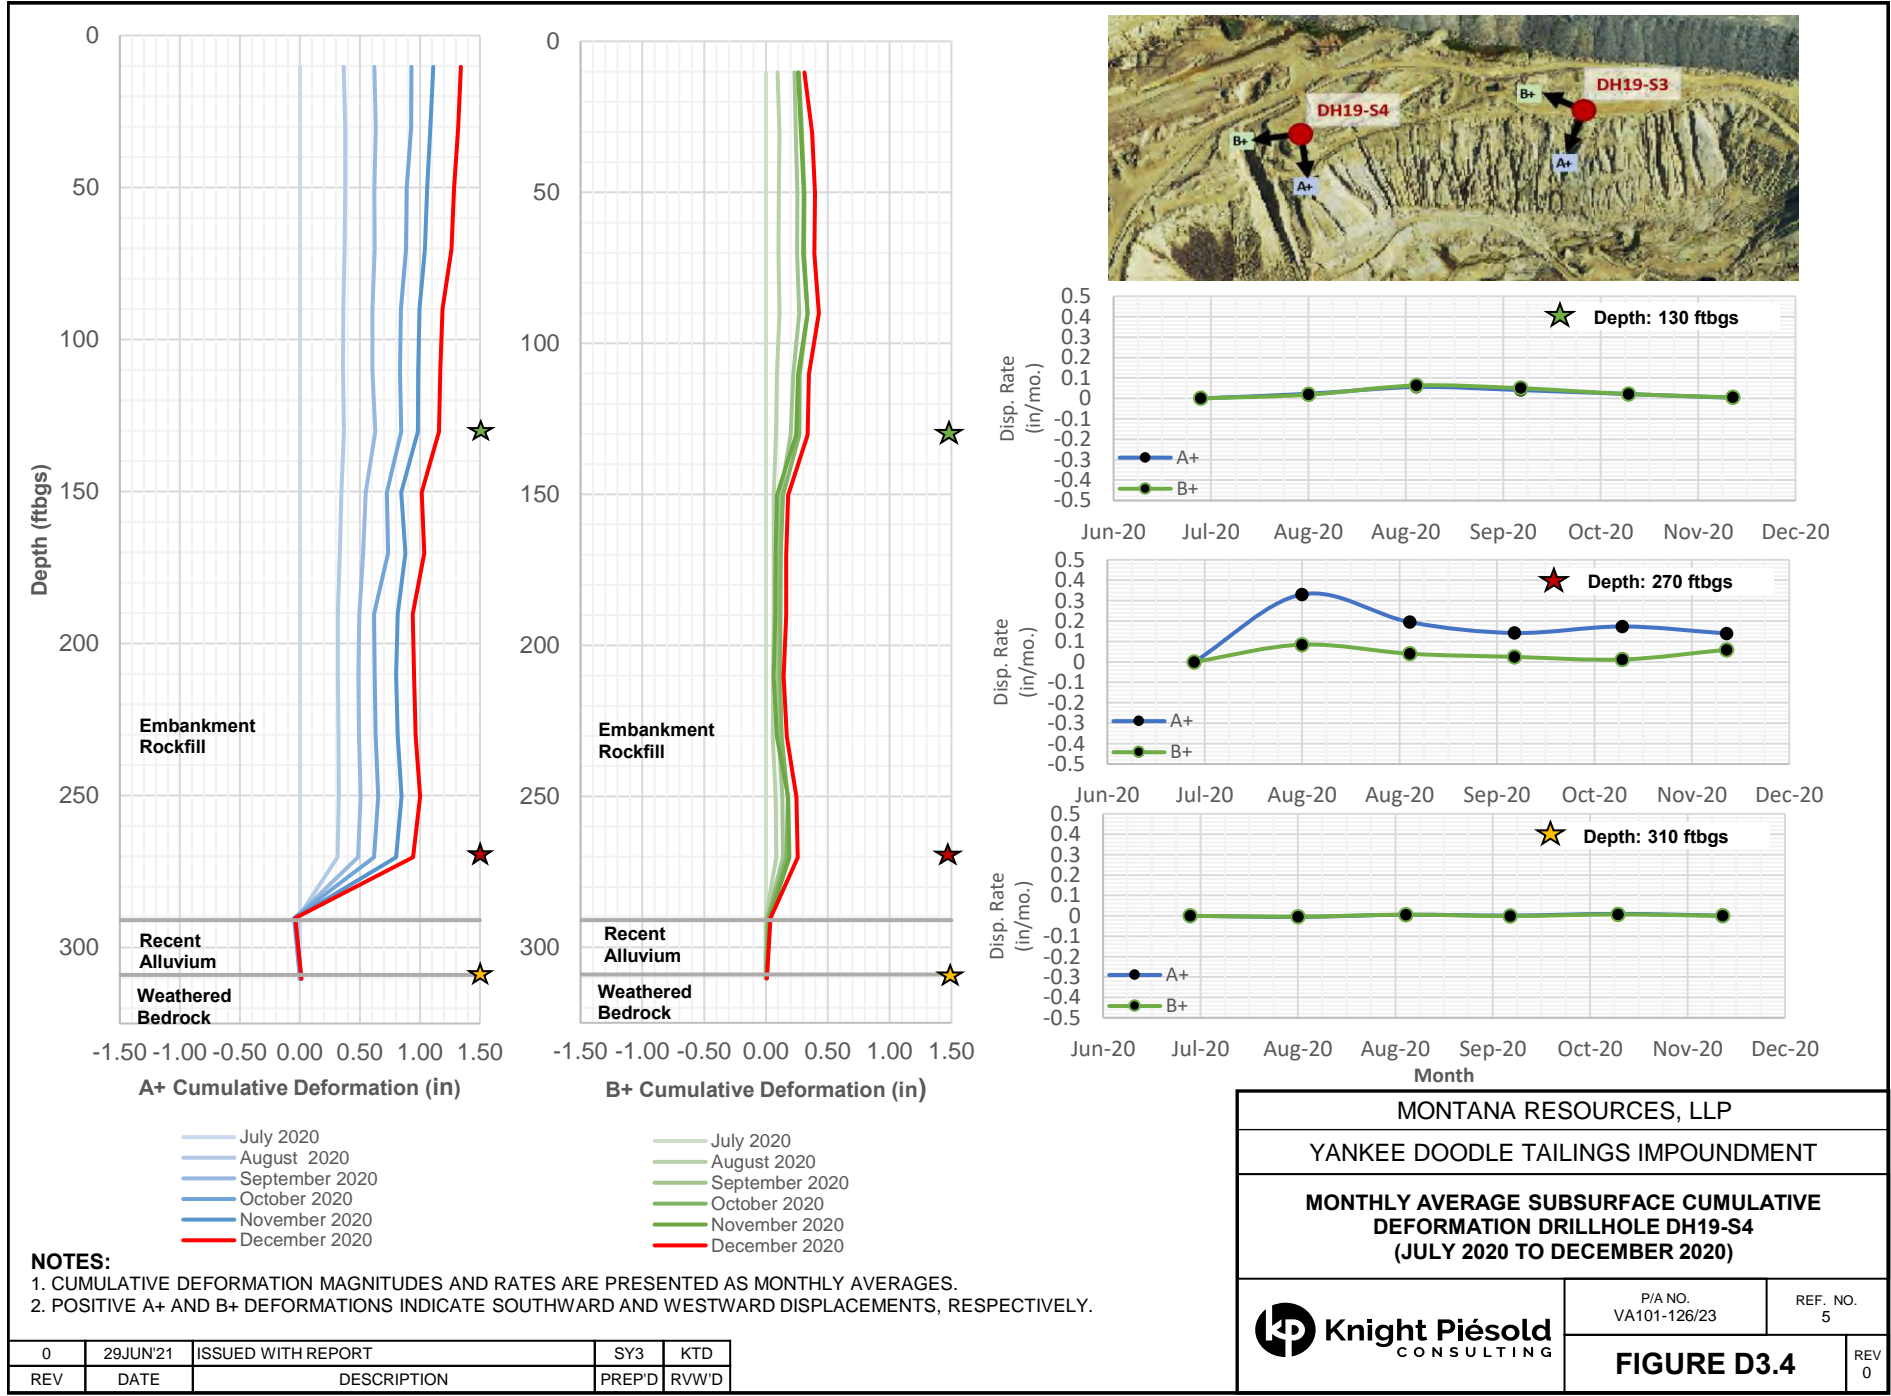
1. INCREMENTAL DEFORMATION MAGNITUDES AND RATES ARE PRESENTED AS MONTHLY AVERAGES.
2. POSITIVE A+ AND B+ DEFORMATIONS INDICATE SOUTHWARD AND WESTWARD DISPLACEMENTS, RESPECTIVELY.

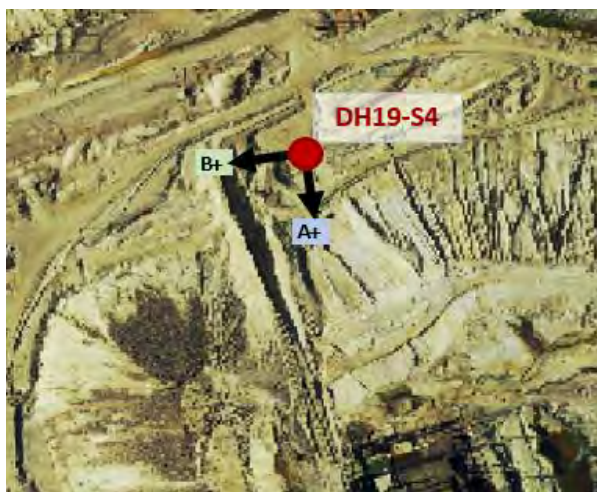
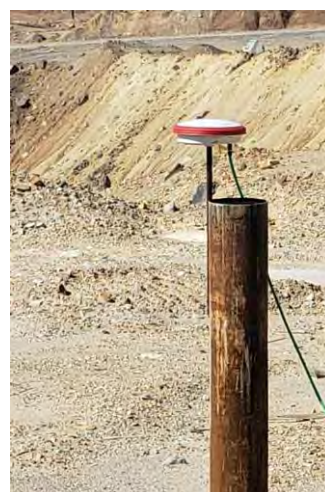
MONTANA RESOURCES, LLP	
YANKEE DOODLE TAILINGS IMPOUNDMENT	
DH19-S4 GNSS BASED INCLINOMETER COLLAR WANDER (JULY 1 TO DECEMBER 31, 2020)	
	P/A NO. VA101-126/23
REF. NO. 5	FIGURE D3.6
REV 0	KTD RVW'D

1. COLLAR WANDER IS MONITORED USING GNSS INSTRUMENTATION INSTALLED AT THE INCLINOMETER COLLAR LOCATION.
2. THE PLOT ABOVE PRESENTS COLLAR POSITION BASED ON NORTH AND EAST CHANGE RELATIVE TO A JULY 1, 2020 BASELINE GNSS SURVEY.
3. NO DATA ARE AVAILABLE FOR NOVEMBER AS THE INSTRUMENTATION WERE OFFLINE DUE TO A POWER MANAGEMENT ISSUE.

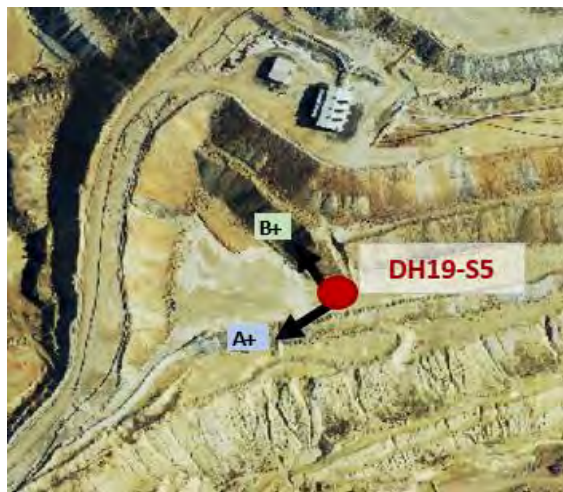
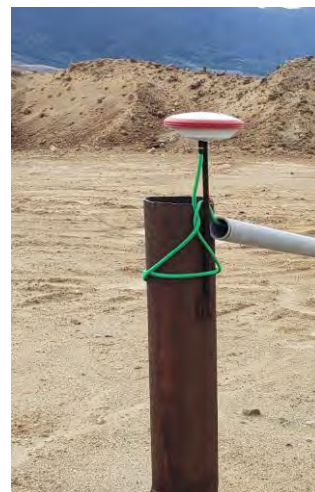
MONTANA RESOURCES, LLP	
YANKEE DOODLE TAILINGS IMPOUNDMENT	
DH19-S5 GNSS BASED INCLINOMETER COLLAR WANDER (JULY 1 TO DECEMBER 31, 2020)	
Knight Piésold CONSULTING	P/A NO. VA101-126/23
	REF. NO. 5
FIGURE D3.8	
	REV 0

1. COLLAR WANDER IS MONITORED USING GNSS INSTRUMENTATION INSTALLED AT THE INCLINOMETER COLLAR LOCATION.
2. THE PLOT ABOVE PRESENTS COLLAR POSITION BASED ON NORTH AND EAST CHANGE RELATIVE TO A JULY 1, 2020 BASELINE GNSS SURVEY.
3. NO DATA ARE AVAILABLE FOR NOVEMBER AS THE INSTRUMENTATION WERE OFFLINE DUE TO A POWER MANAGEMENT ISSUE.

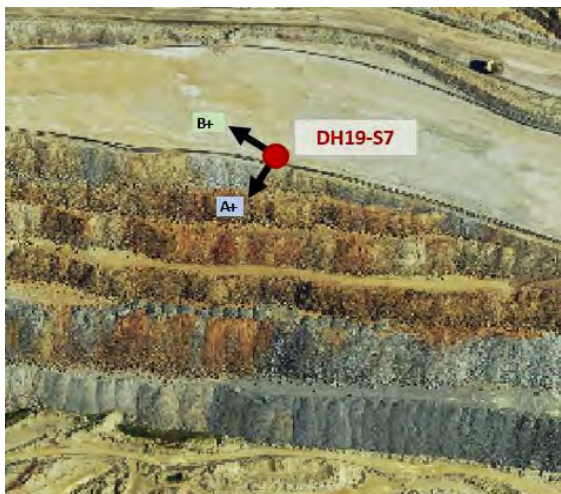
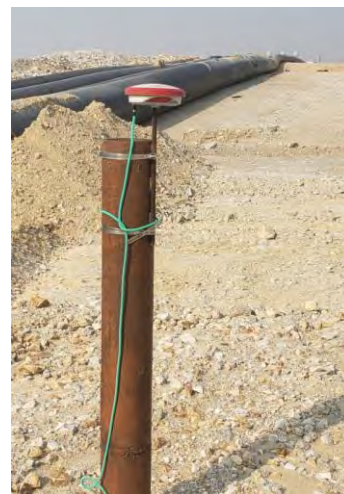
1. COLLAR WANDER IS MONITORED USING GNSS INSTRUMENTATION INSTALLED AT THE INCLINOMETER COLLAR LOCATION.
2. THE PLOT ABOVE PRESENTS COLLAR POSITION BASED ON NORTH AND EAST CHANGE RELATIVE TO A JULY 1, 2020 BASELINE GNSS SURVEY.
3. NO DATA ARE AVAILABLE FOR NOVEMBER AS THE INSTRUMENTATION WERE OFFLINE DUE TO A POWER MANAGEMENT ISSUE.
