**MONTANA RESOURCES, LLC  
YANKEE DOODLE TAILINGS IMPOUNDMENT**

**TAILINGS OPERATIONS, MAINTENANCE AND SURVEILLANCE  
(TOMS) MANUAL  
VA101-126/29-3**

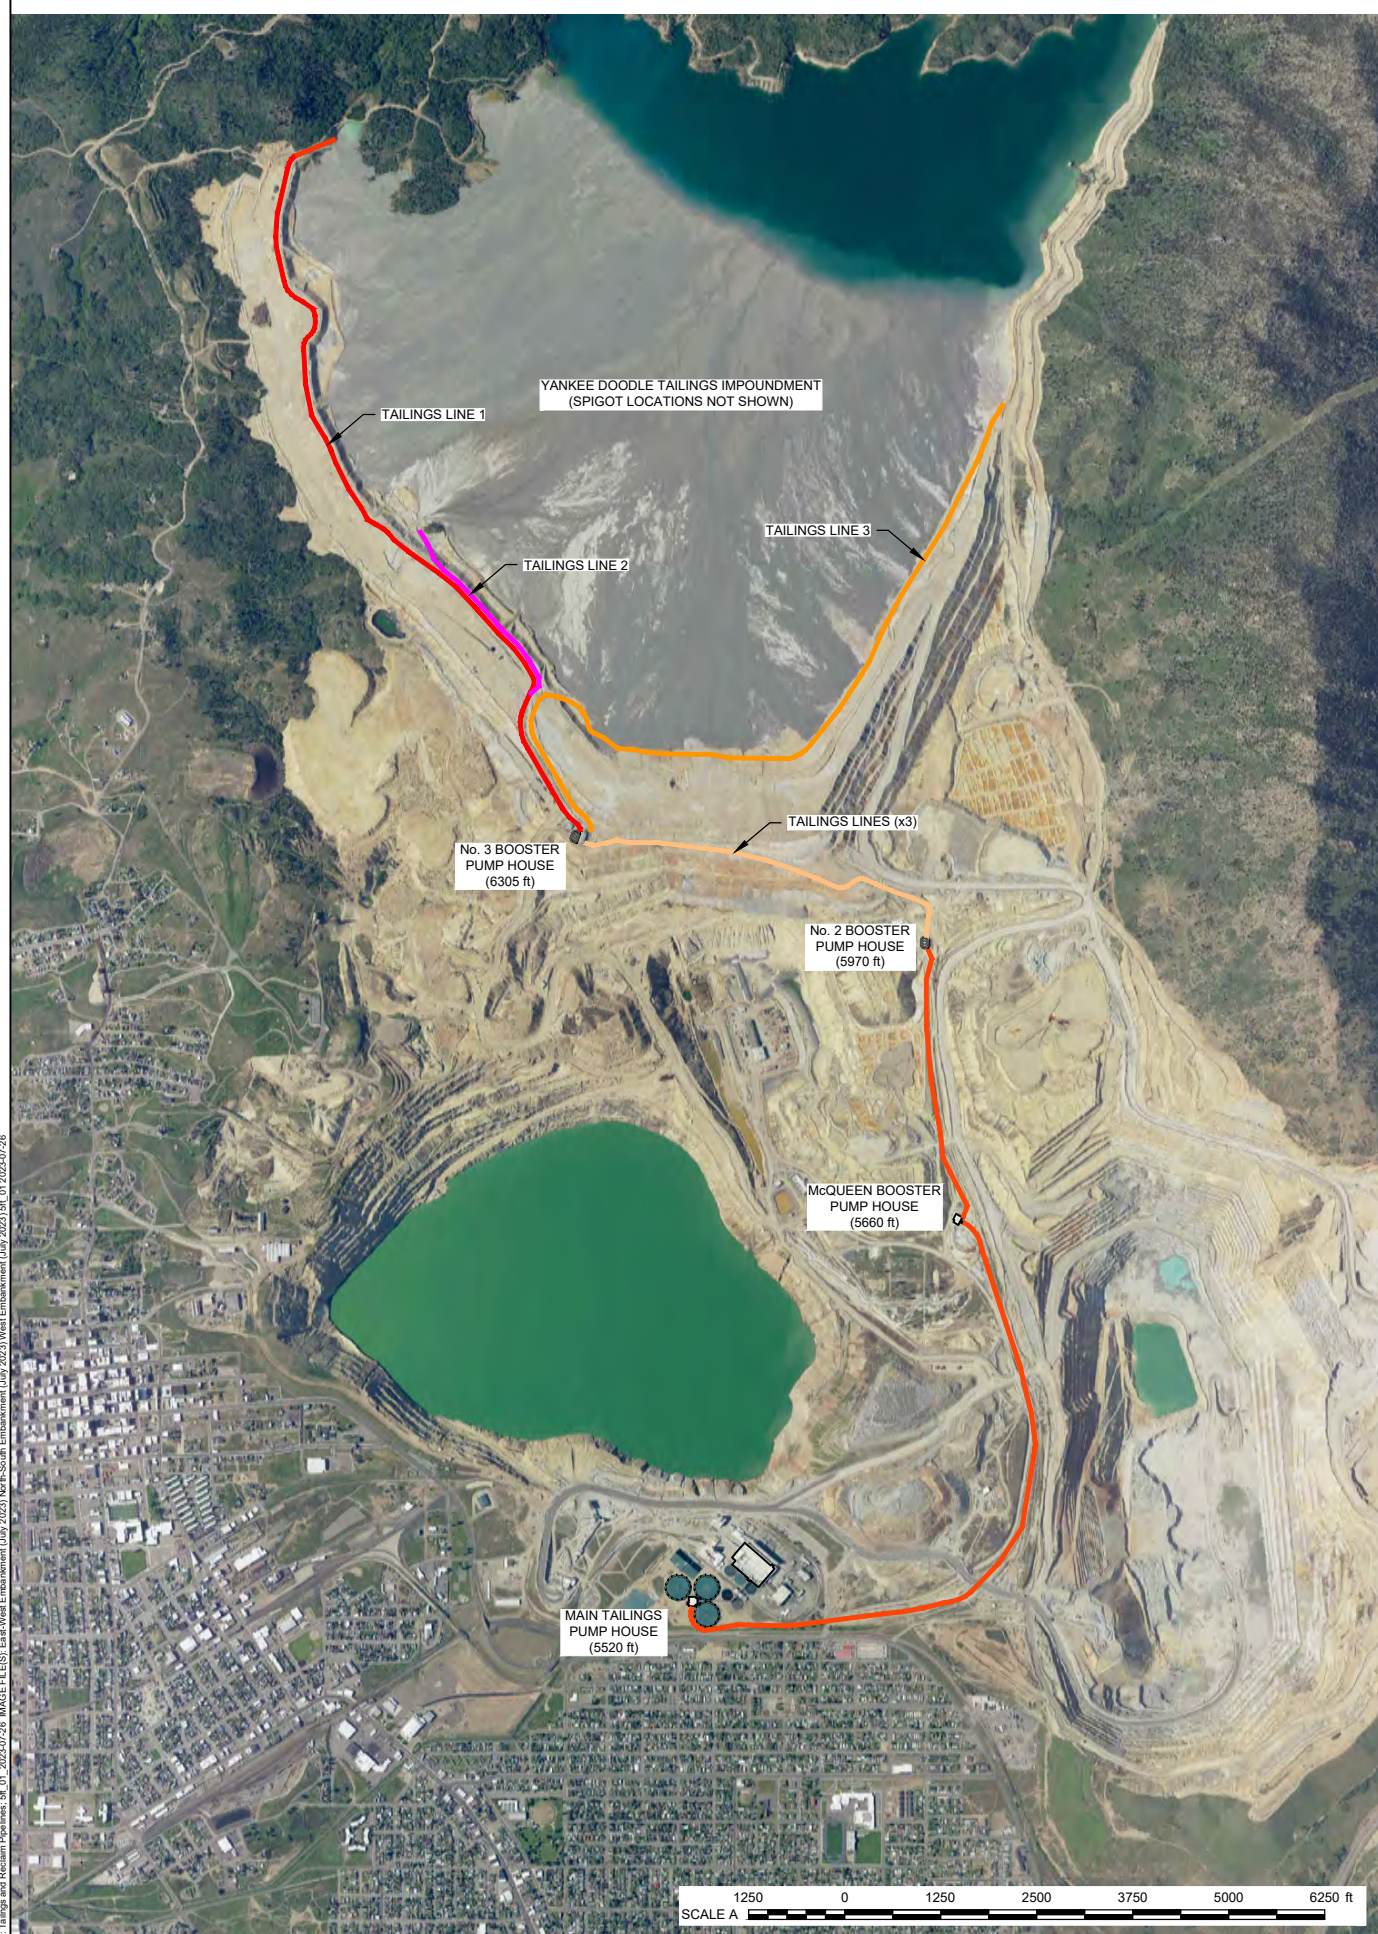
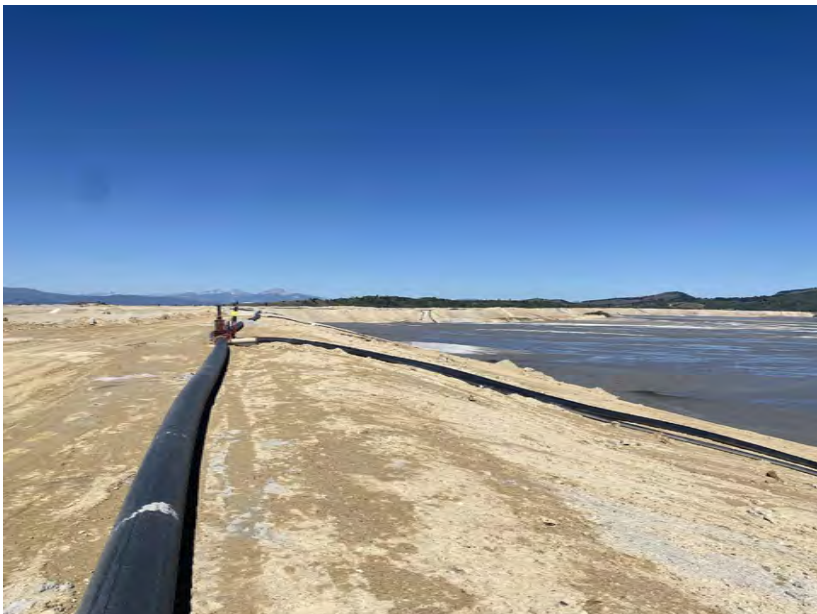
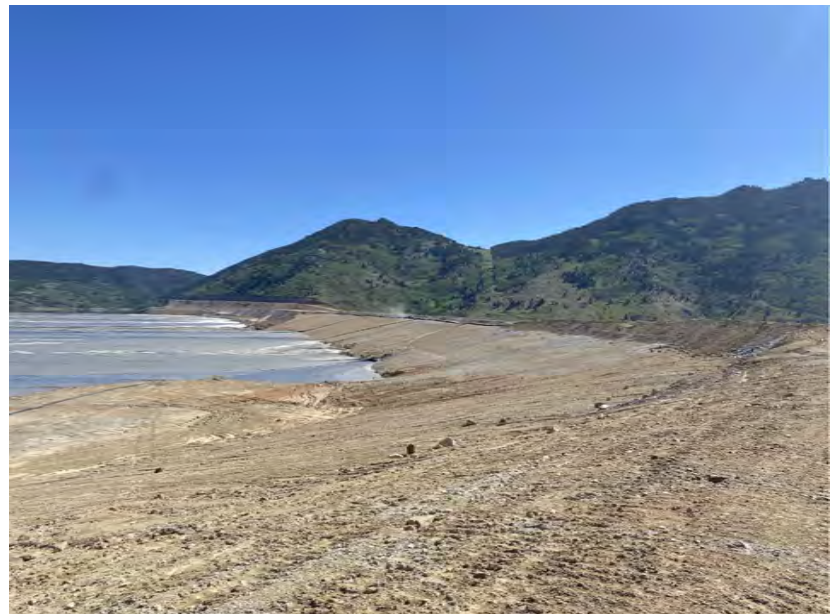
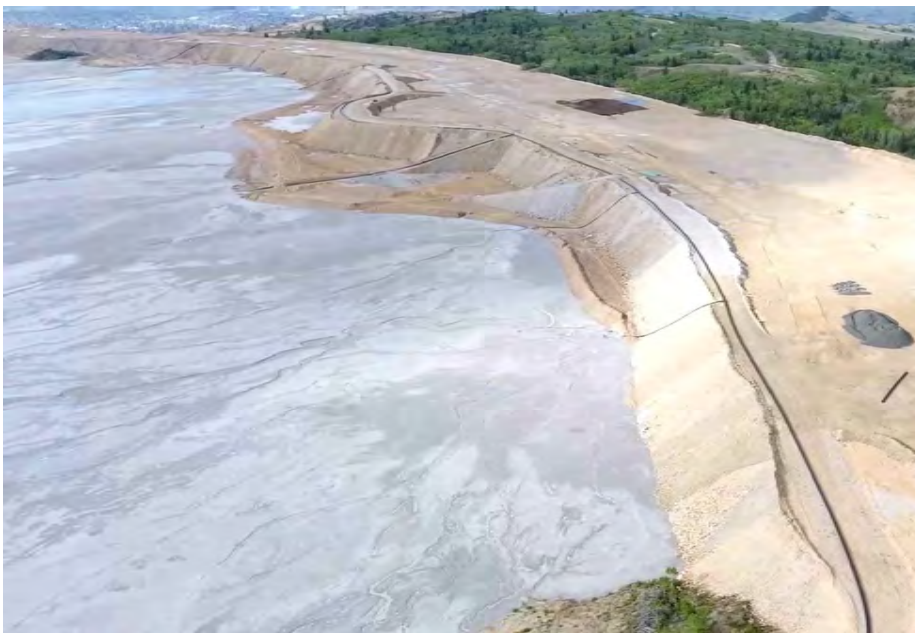
FIGURE 4.3

**EAST-WEST EMBANKMENT (JULY 2023)**

**NORTH-SOUTH EMBANKMENT (JULY 2023)**

**WEST EMBANKMENT (JULY 2023)**

The Tailings Delivery System consists of three tailings delivery pipelines (two operational and one standby) and four tailings pump houses (the Main Tailings Pump House (MTPH), McQueen Booster Pump House, No. 2 Booster Pump House, and No. 3 Booster Pump House) to transport tailings from the Mill to the YDTI at approximately 18,000 gpm. Tailings are pumped to a total elevation increase of approximately 900 ft using up to 13 pump stages. The 21,000 ft tailings delivery pipelines are constructed from a combination of 22” Steel, 24” HDPE or 26” HDPE pipe. The single walled tailings pipelines are installed on the ground surface and locally anchored with mounds of overburden or pipe supports. A schematic of the tailings delivery system and the general arrangement of the system components are shown on Figures 4.2 and 4.3, respectively.

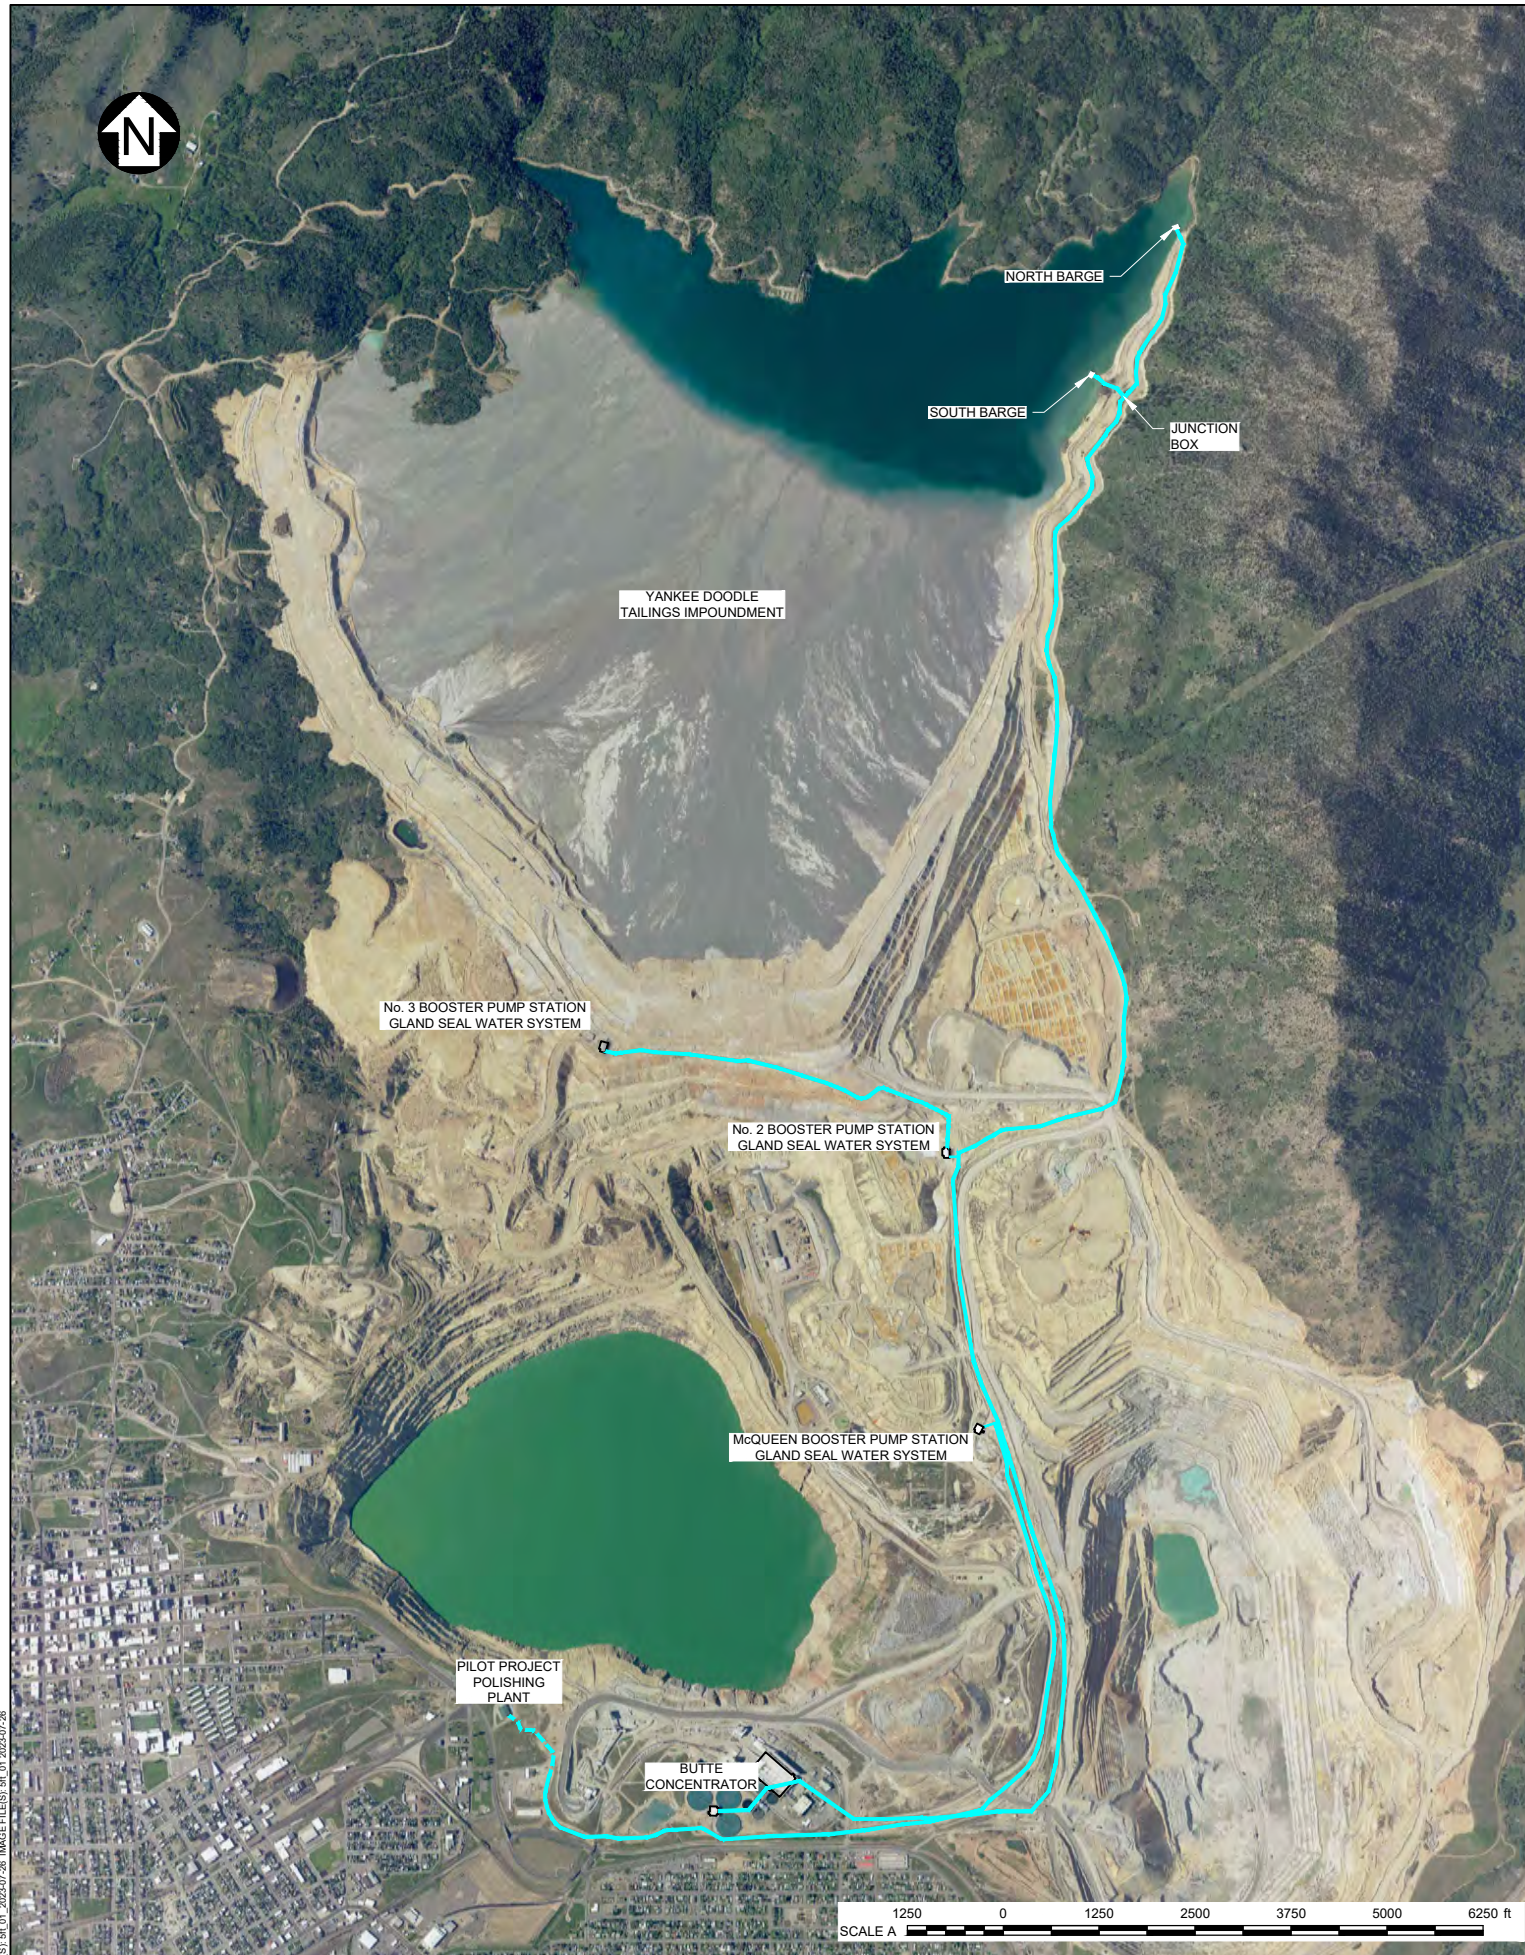
FIGURE 4.4

The YDTI water reclaim system supplies water for use in the mill process and treatment/discharge in the Pilot Project Polishing Plant. A schematic of the water reclaim system network is presented on Figure 4.4. Supernatant water is reclaimed from the northeast end of the YDTI using two floating pump barges (North Barge and South Barge). Each barge is equipped with three vertical turbine pump units. Generally, three to four (of the six) pump units are operational at any time. The barge pumps convey approximately 11,000 gpm to the Butte Concentrator, and when warranted, additional flows (typically between 2,100 to 6,000 gpm) to the Polishing Plant.

YANKEE DOODLE TAILINGS IMPOUNDMENT  
 RECLAIM PIPELINE NETWORK

The barge pumps deliver water into a junction box, as indicated on Figure 4.4, which is located on the east side of the pond along the 6,500 ft elevation reclaim road. The North Barge is connected to the box with two pipelines and the South Barge is connected with three pipelines. The outlet of the box feeds into two pipelines that converge downstream into a single 42" diameter HDPE pipeline. The last mile of reclaim pipeline prior to delivery at the mill is 30" HDPE pipe. The total pipeline length from the reclaim barge to the Concentrator is approximately 5.1 miles with an elevation decrease of approximately 810 ft. The offtake to supply reclaim water to the Pilot Project Polishing Plant (Section 4.1.5) is located near the McQueen Tailings Booster Pump House. The pipeline is approximately 13,300 ft long and constructed using 24" HDPE pipe.

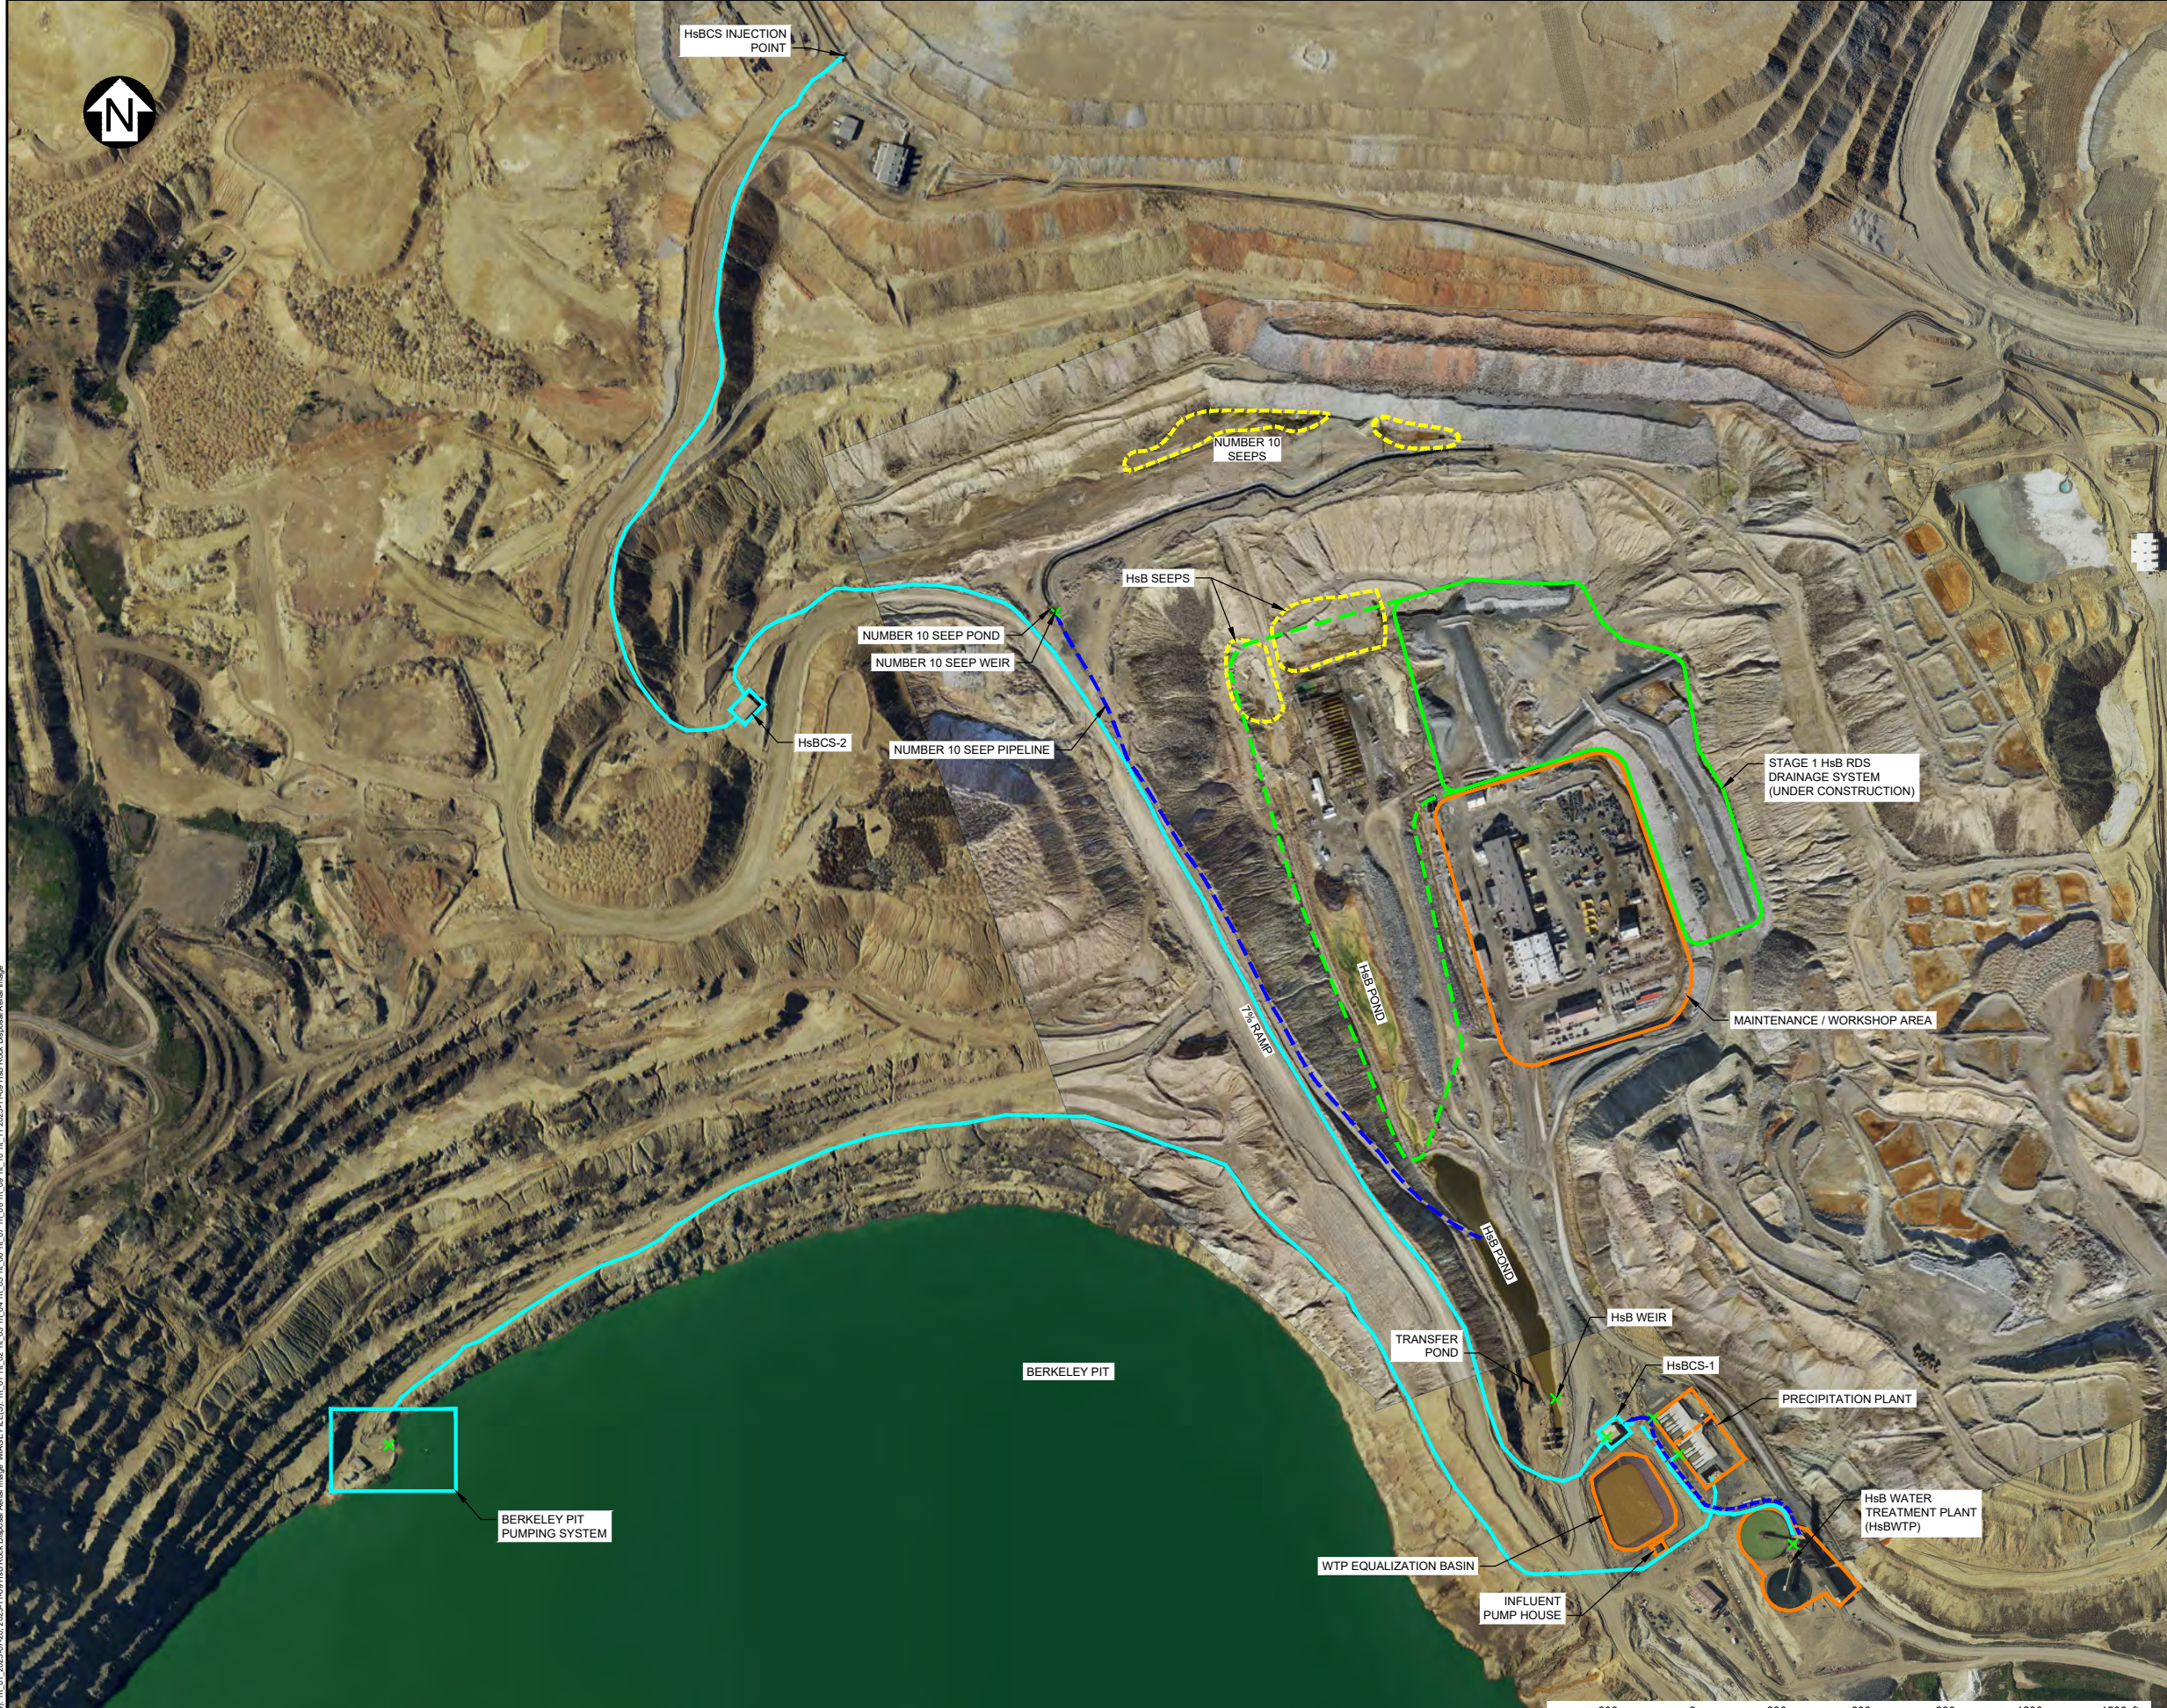
The HsB Weir records are representative of total flows within the HsB area. Historical flow data indicates a 98<sup>th</sup> percentile flow rate of 4,500 gpm. The HsB Pond discharges into a diversion structure at the south end of the pond. The structure directs the water by gravity to the WTP Equalization Basin during normal operations. The structure also has a high-water level gravity overflow into Berkeley Pit that can be used during upset conditions.

Construction of the Stage 1 HsB rock disposal site (RDS) drainage system in the HsB area commenced in 2022 and is scheduled to continue into 2024. The drainage system includes a foundation layer and a series of rock drains and perimeter ditches intended to convey seepage and precipitation runoff from under the future Stage 1 HsB RDS to the HsB Pond. Placement of rockfill material in the Stage 1 RDS is planned to commence in late 2023.

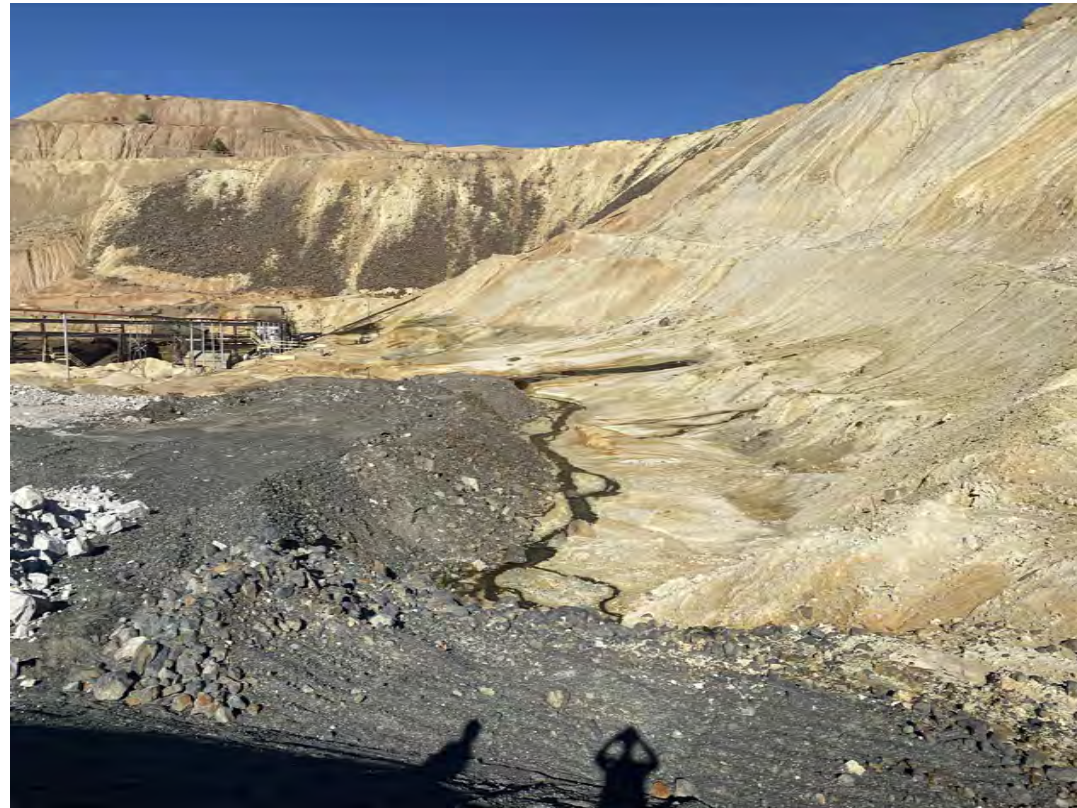
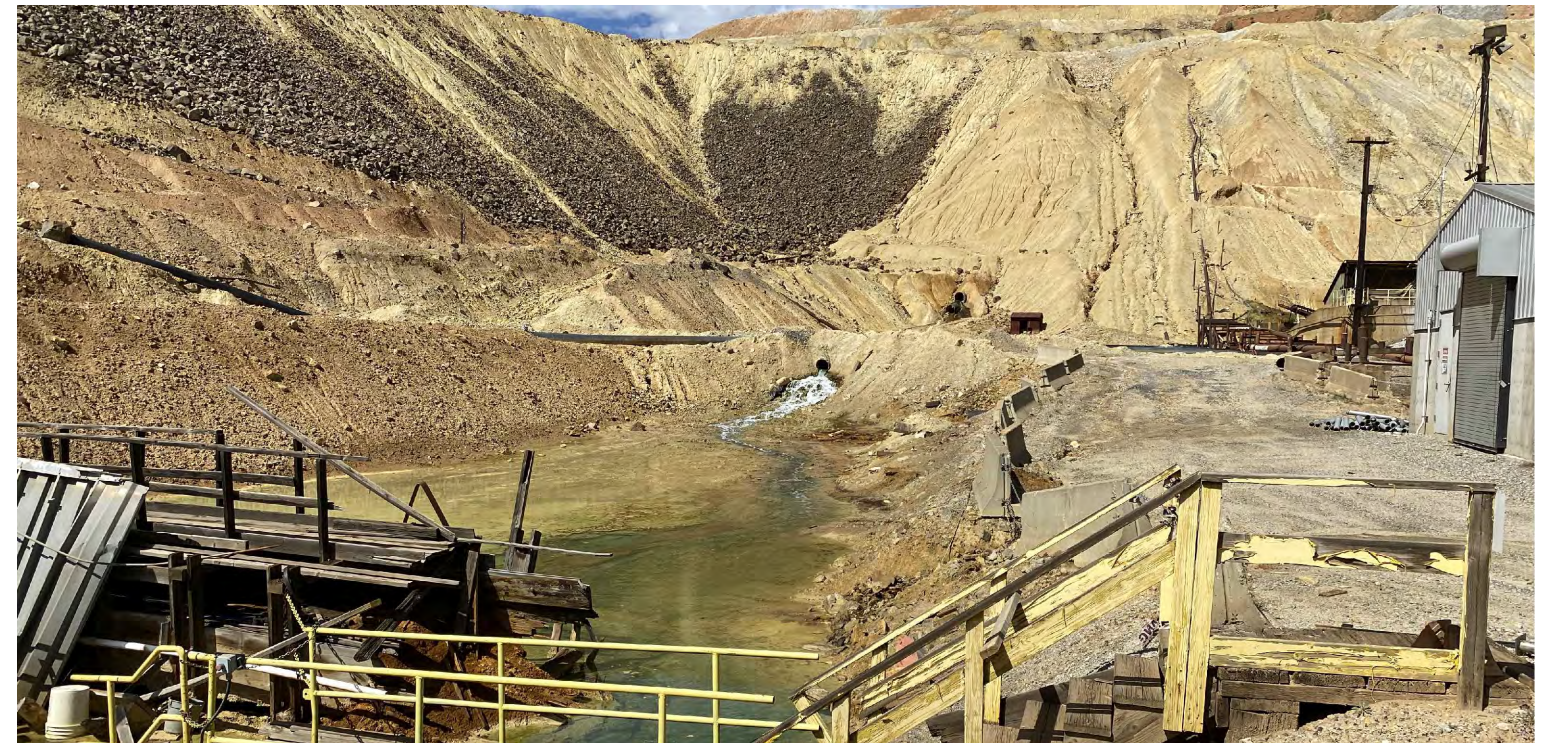
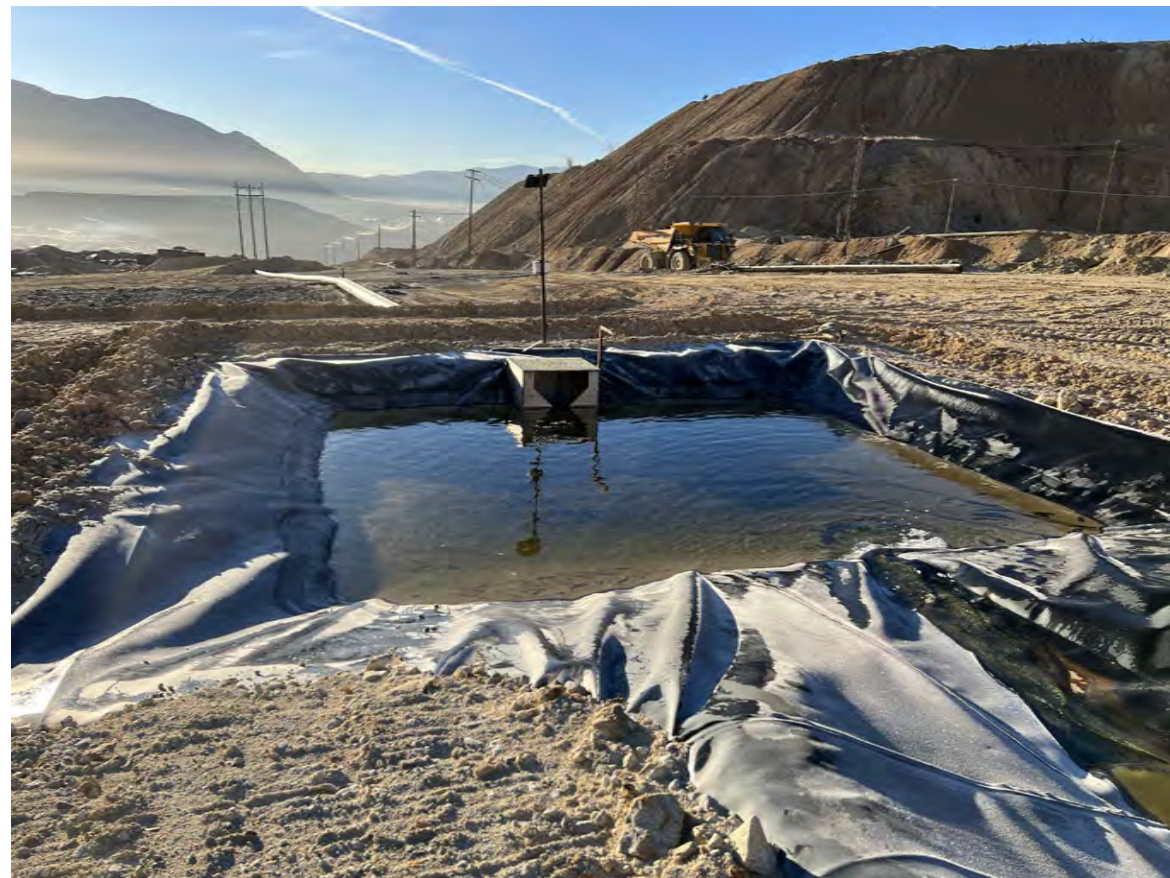
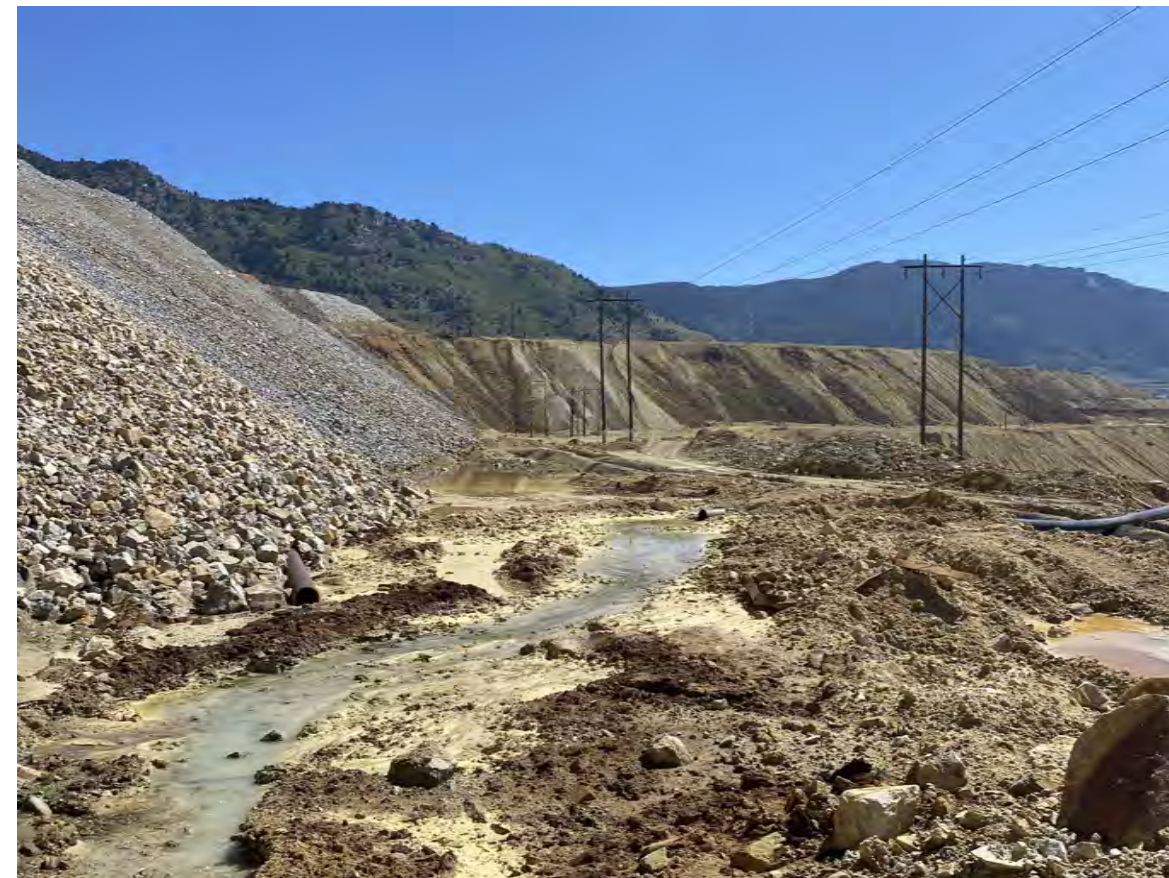
HsB SEEPS - NORTH SIDE

HsB SEEPS - UPPER POND AREA

NUMBER 10 POND AND WEIR

NUMBER 10 SEEPS

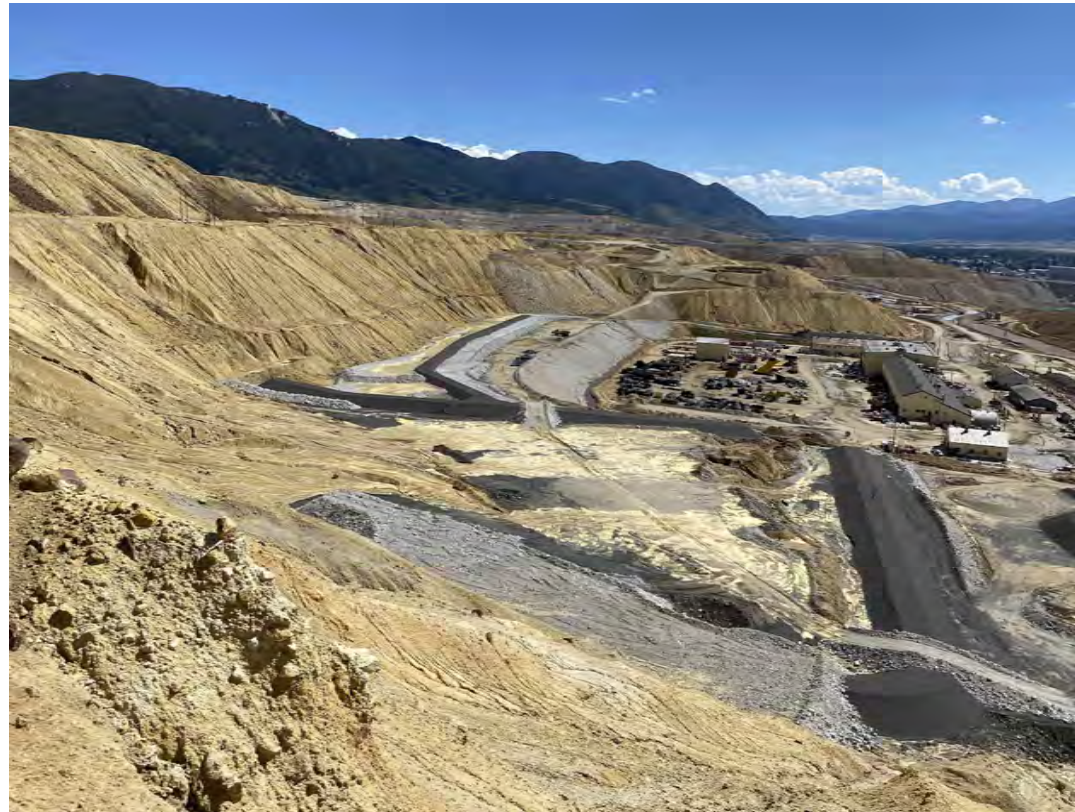
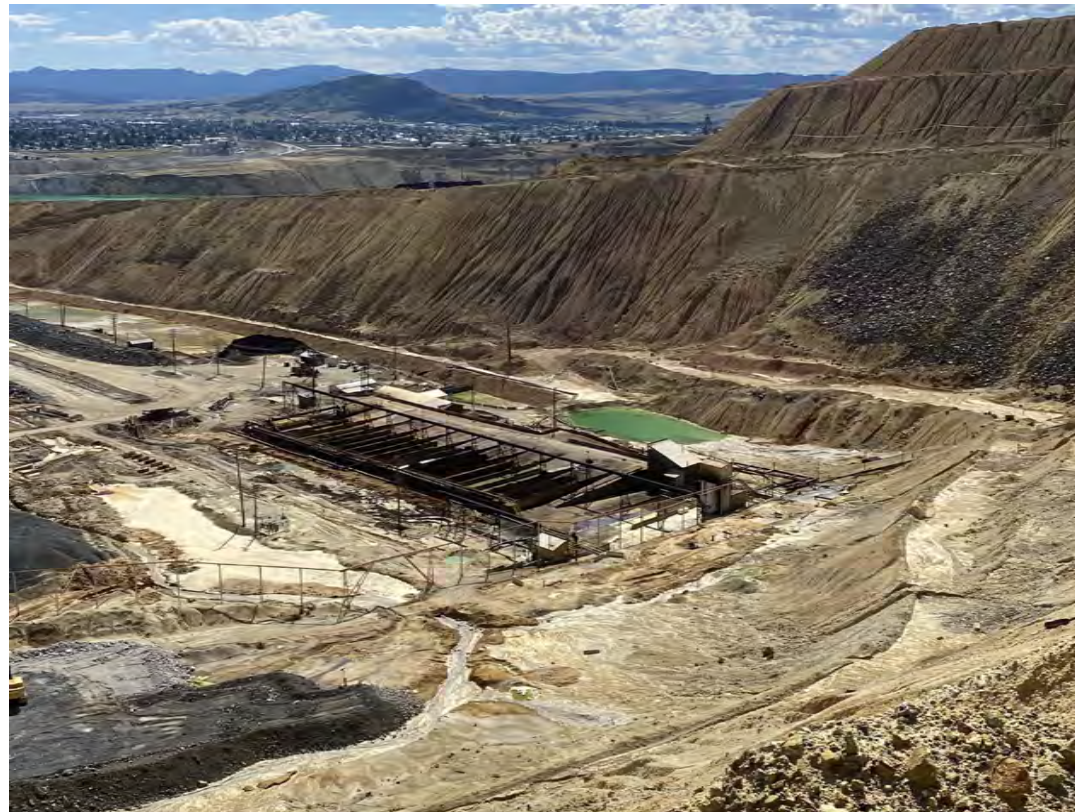
STAGE 1 HsB RDS DRAINAGE SYSTEM - EAST SIDE  
(UNDER CONSTRUCTION)

STAGE 1 HsB RDS DRAINAGE SYSTEM - WEST SIDE  
(UNDER CONSTRUCTION)

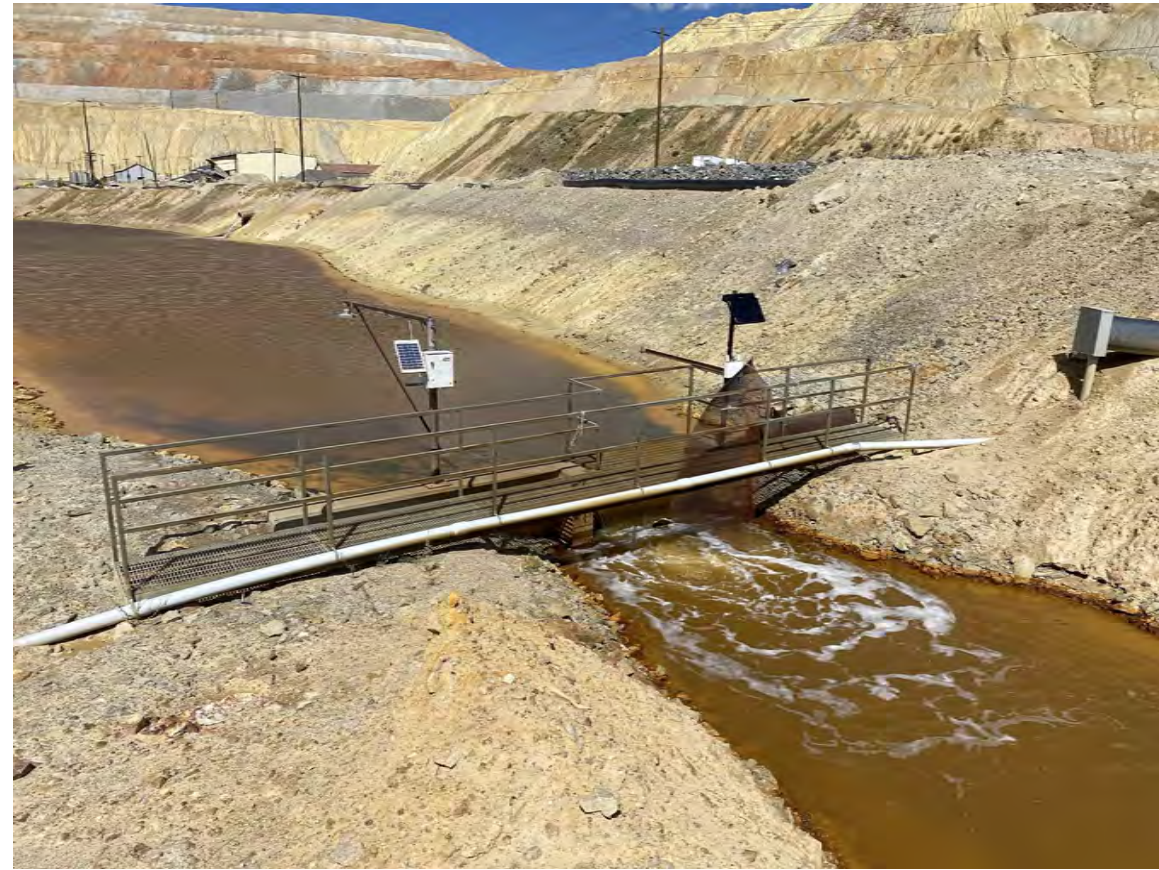
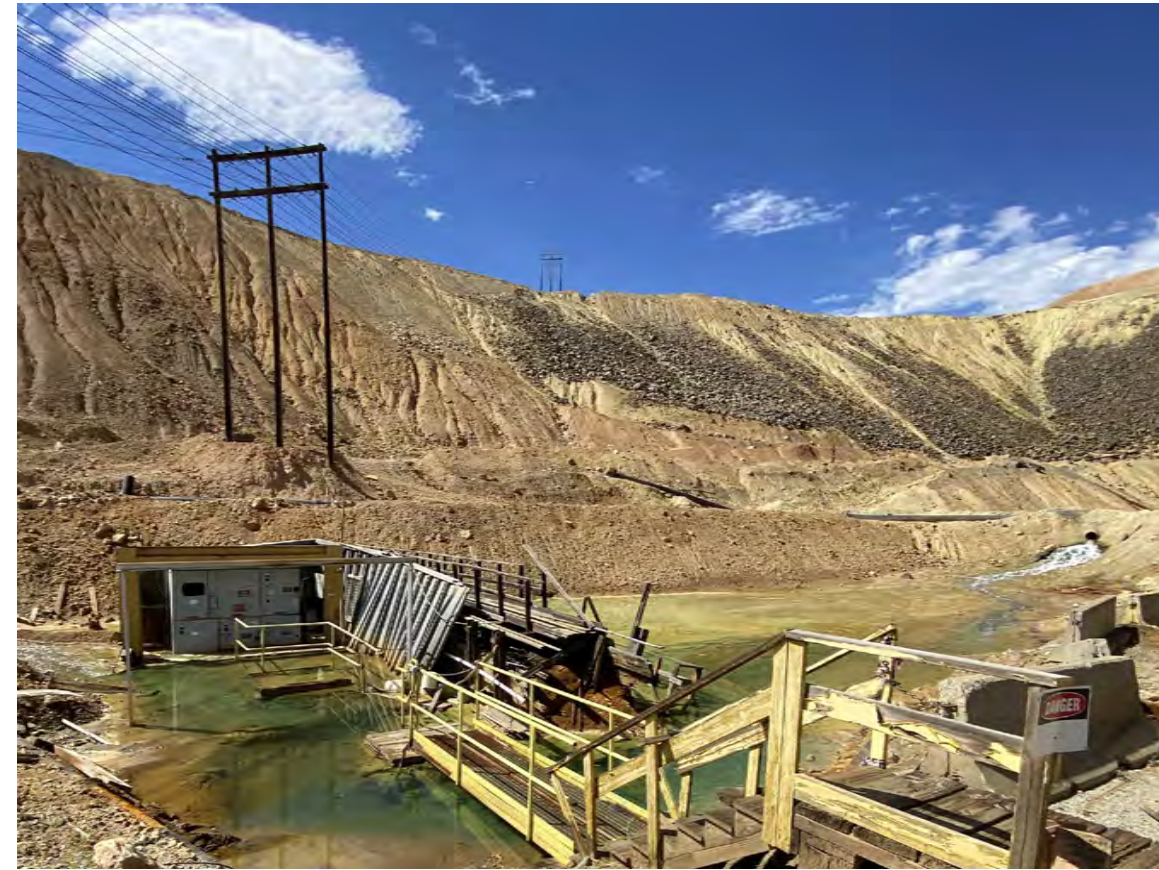
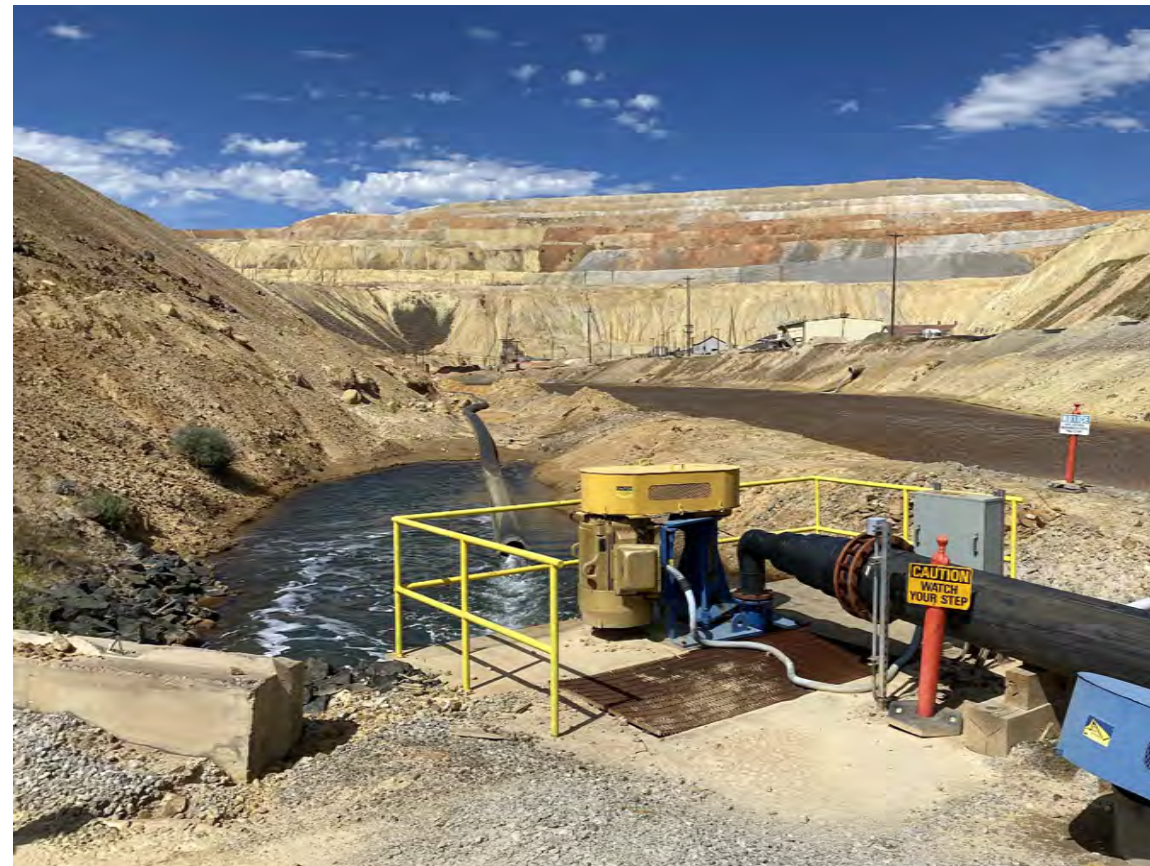
HsB WEIR

CELL 10 PUMP

HsBCS TRANSFER POND AND PUMP
