**MONTANA RESOURCES, LLC  
YANKEE DOODLE TAILINGS IMPOUNDMENT**

**TAILINGS OPERATIONS, MAINTENANCE AND SURVEILLANCE  
(TOMS) MANUAL  
VA101-126/29-3**

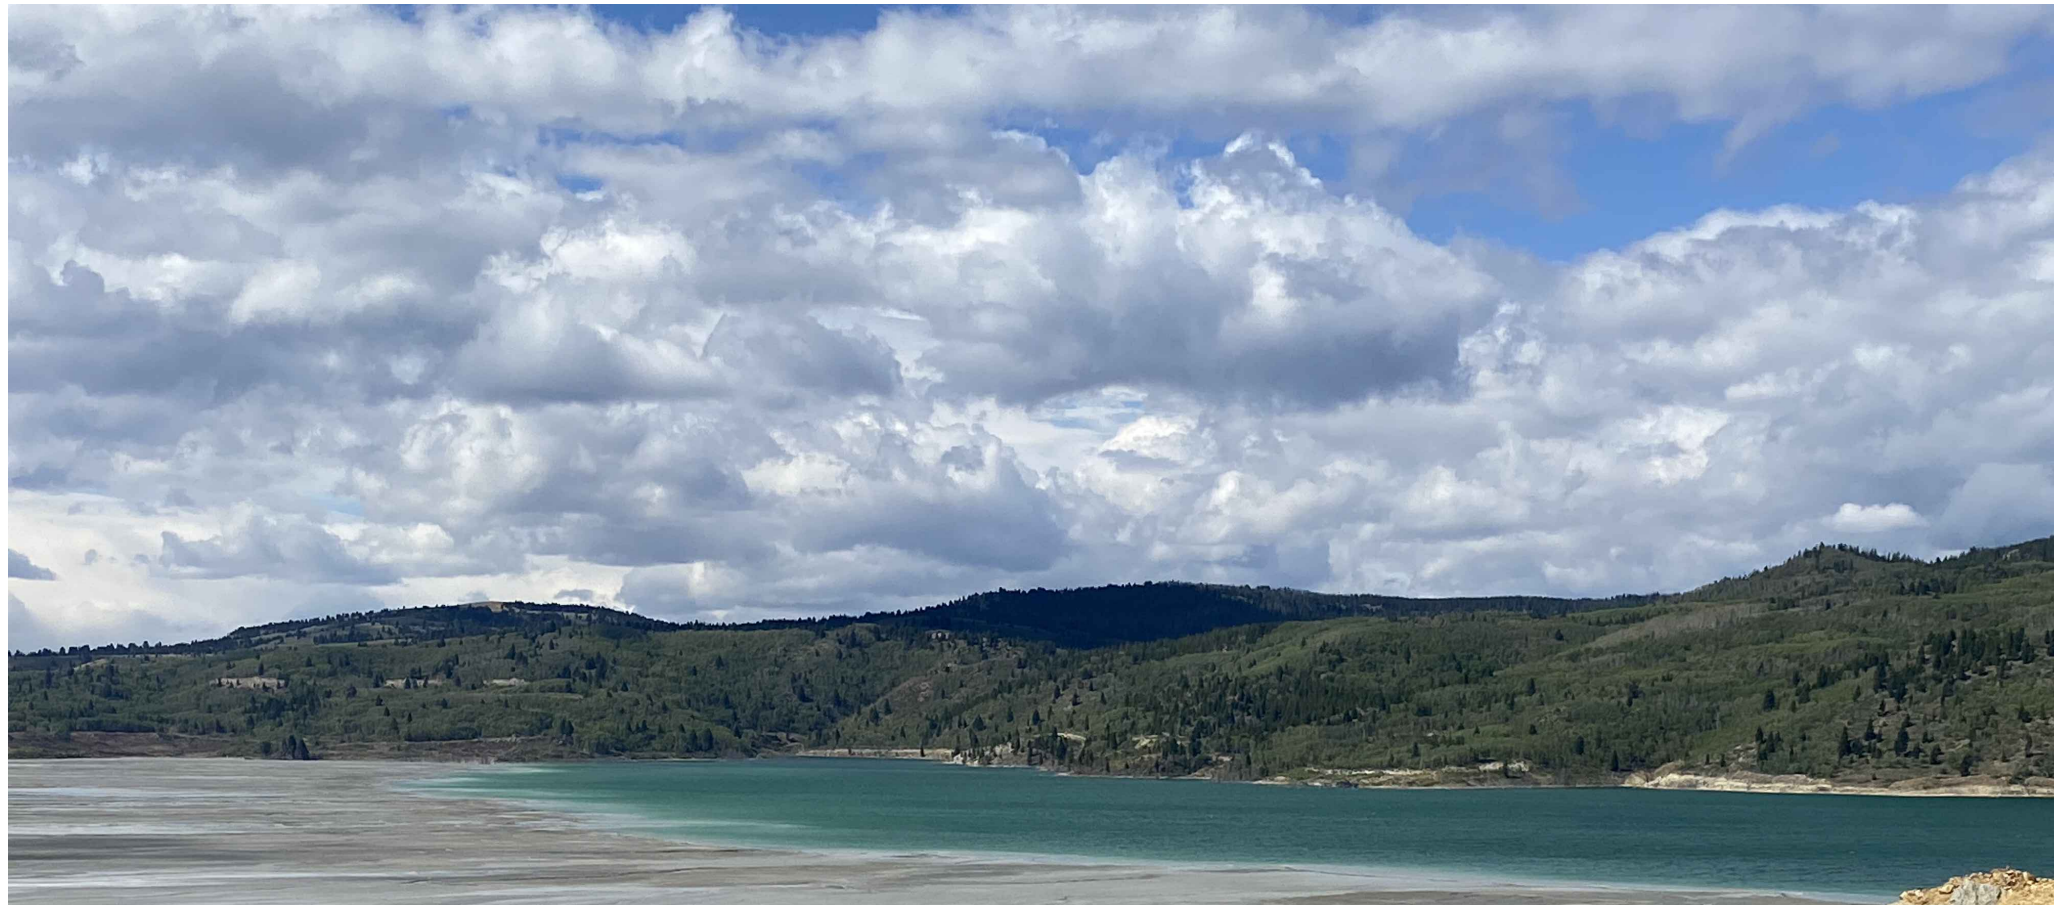
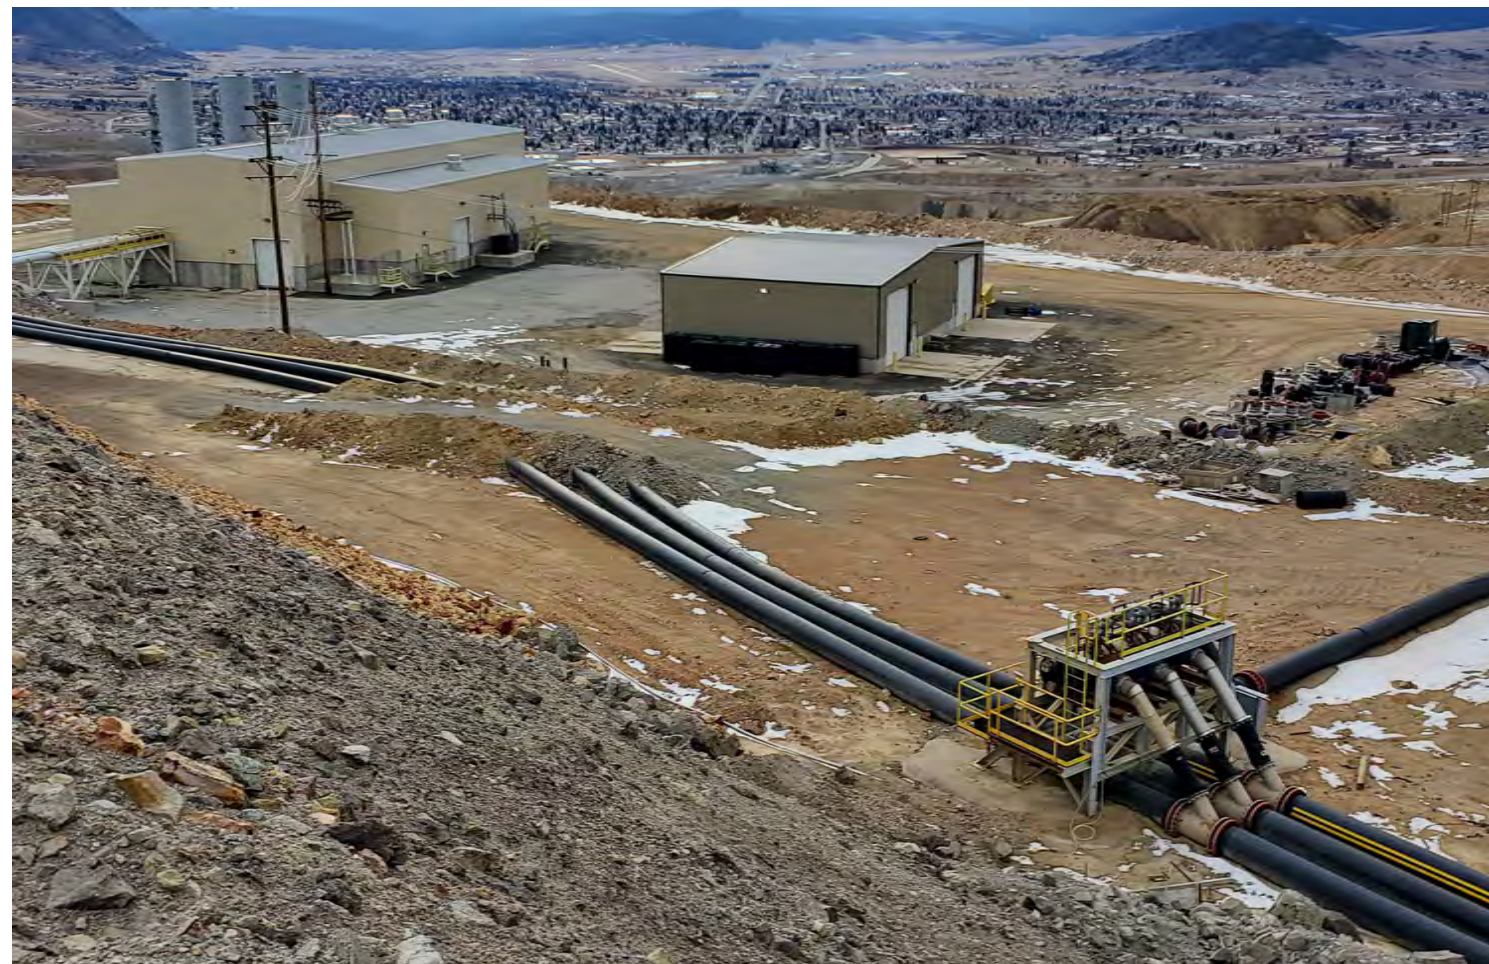
TAILINGS BEACH - SUPERNATANT POND INTERFACE

BOOSTER 3 PUMPHOUSE AND HsBCS MANIFOLD

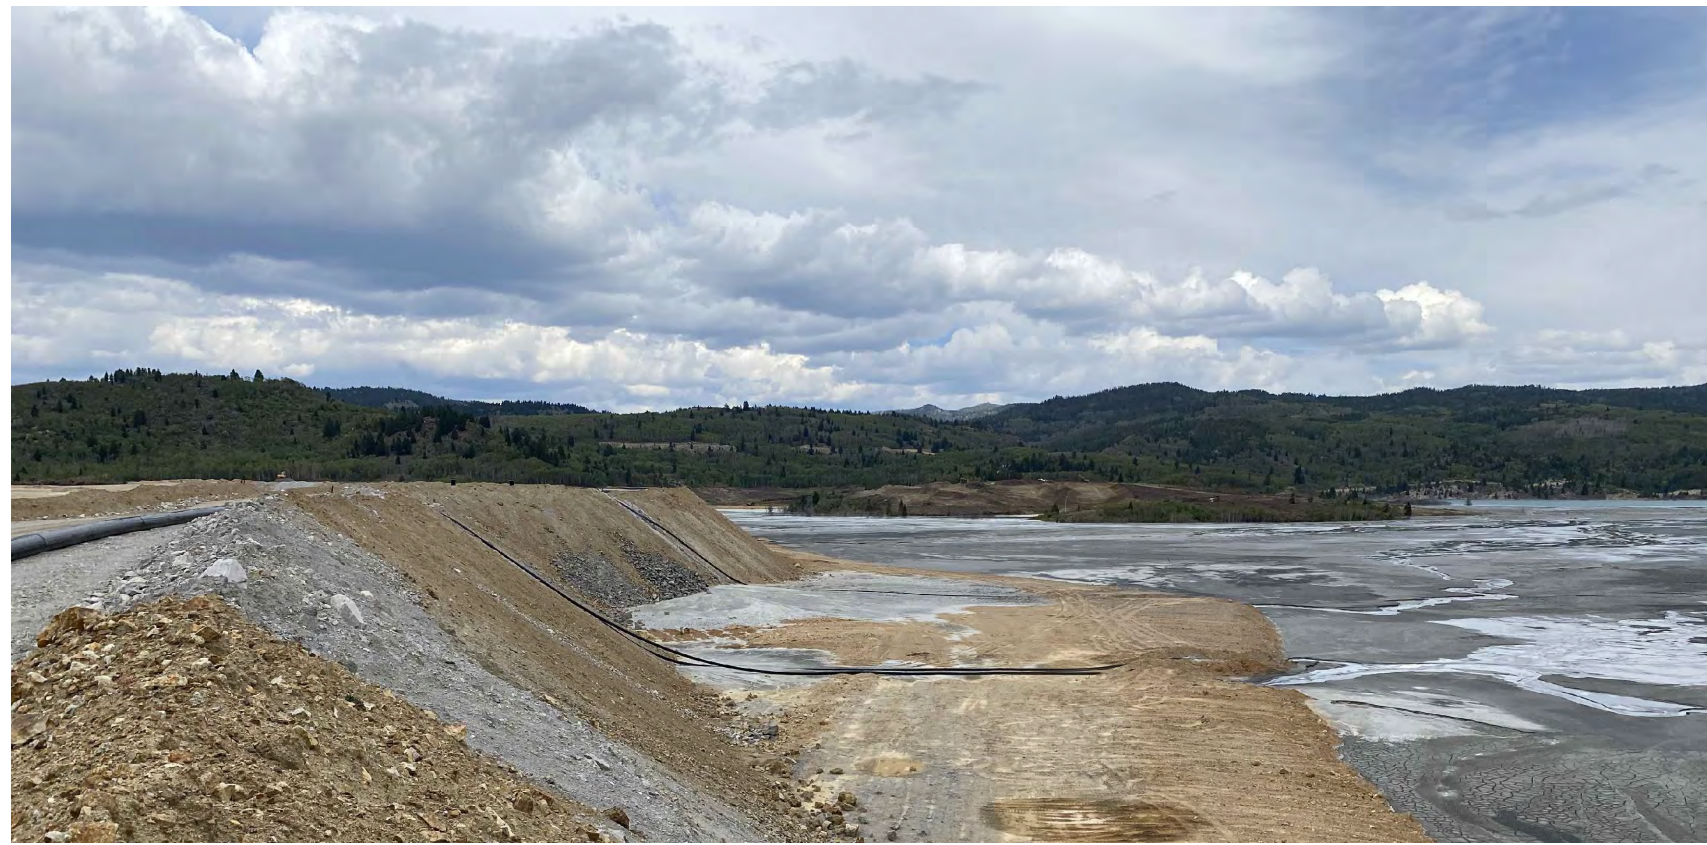
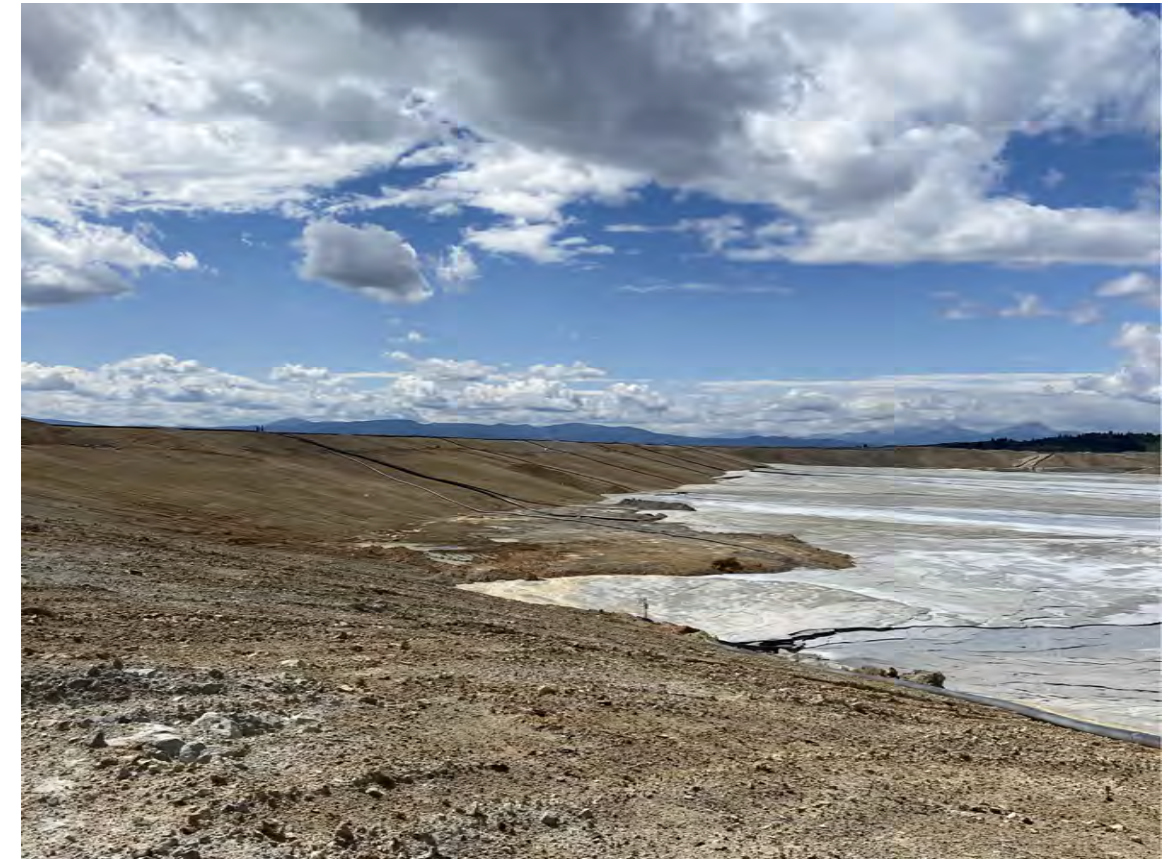
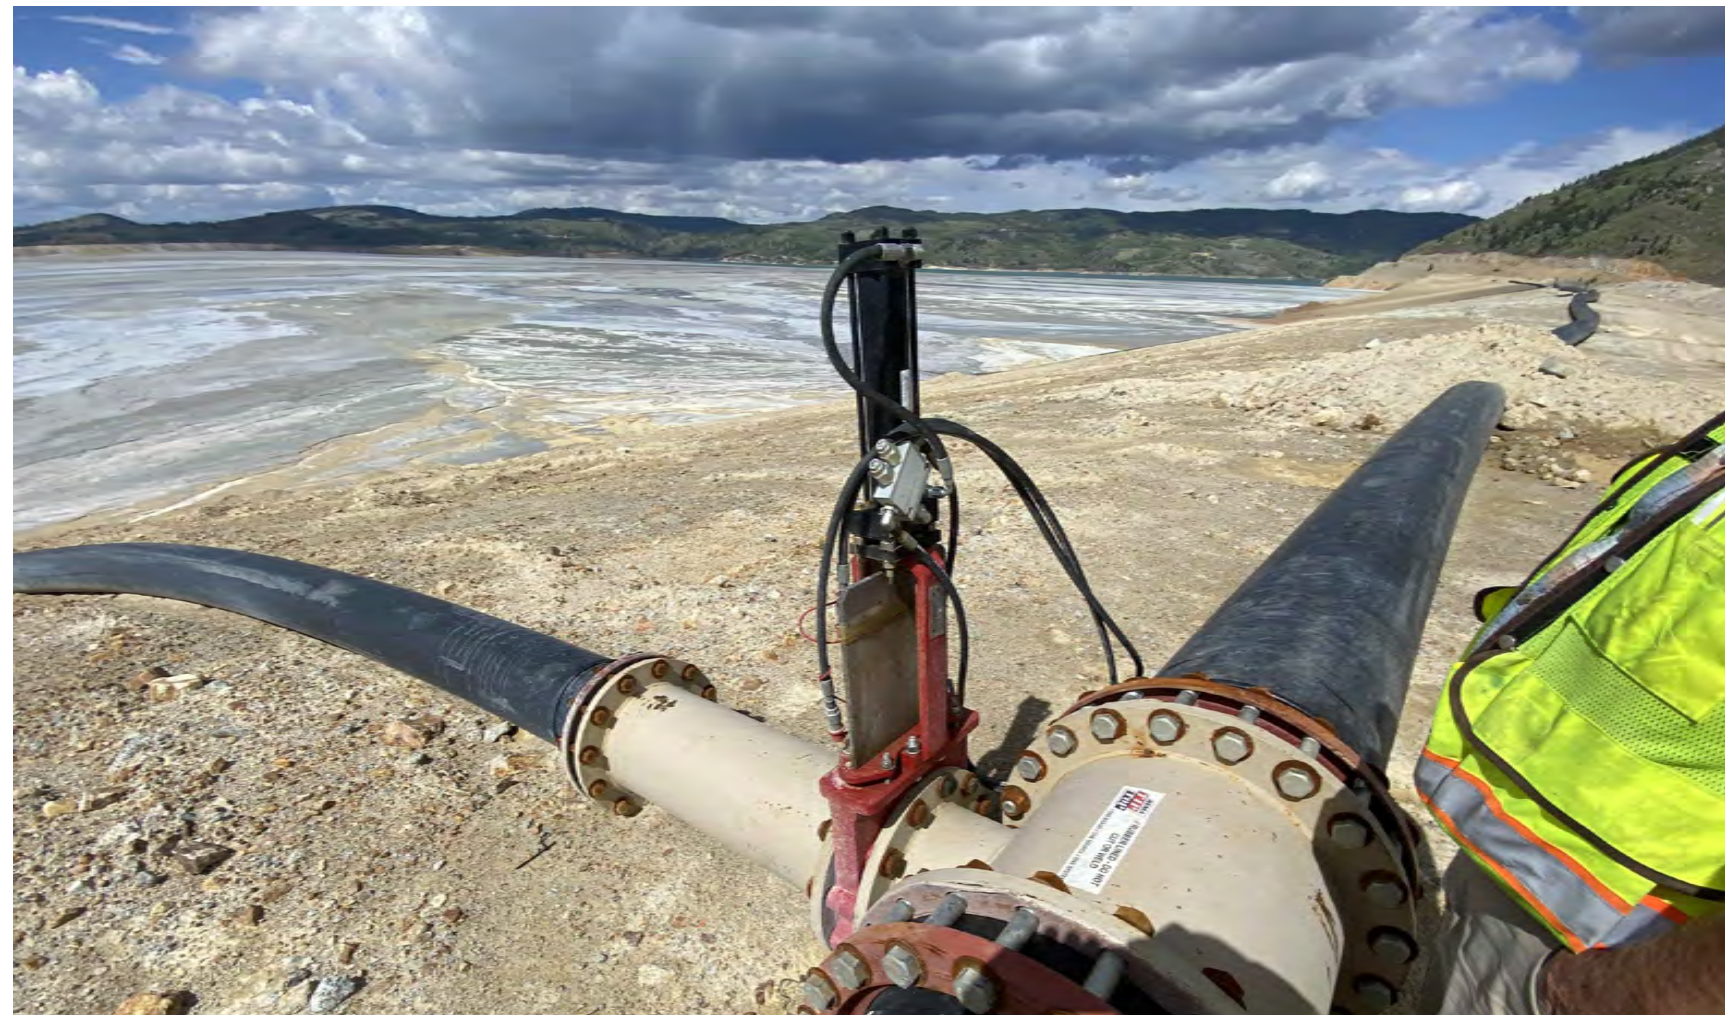
TAILINGS DISCHARGE WEST EMBANKMENT

TAILINGS DISCHARGE EAST-WEST EMBANKMENT

TAILINGS DISCHARGE NORTH-SOUTH EMBANKMENT

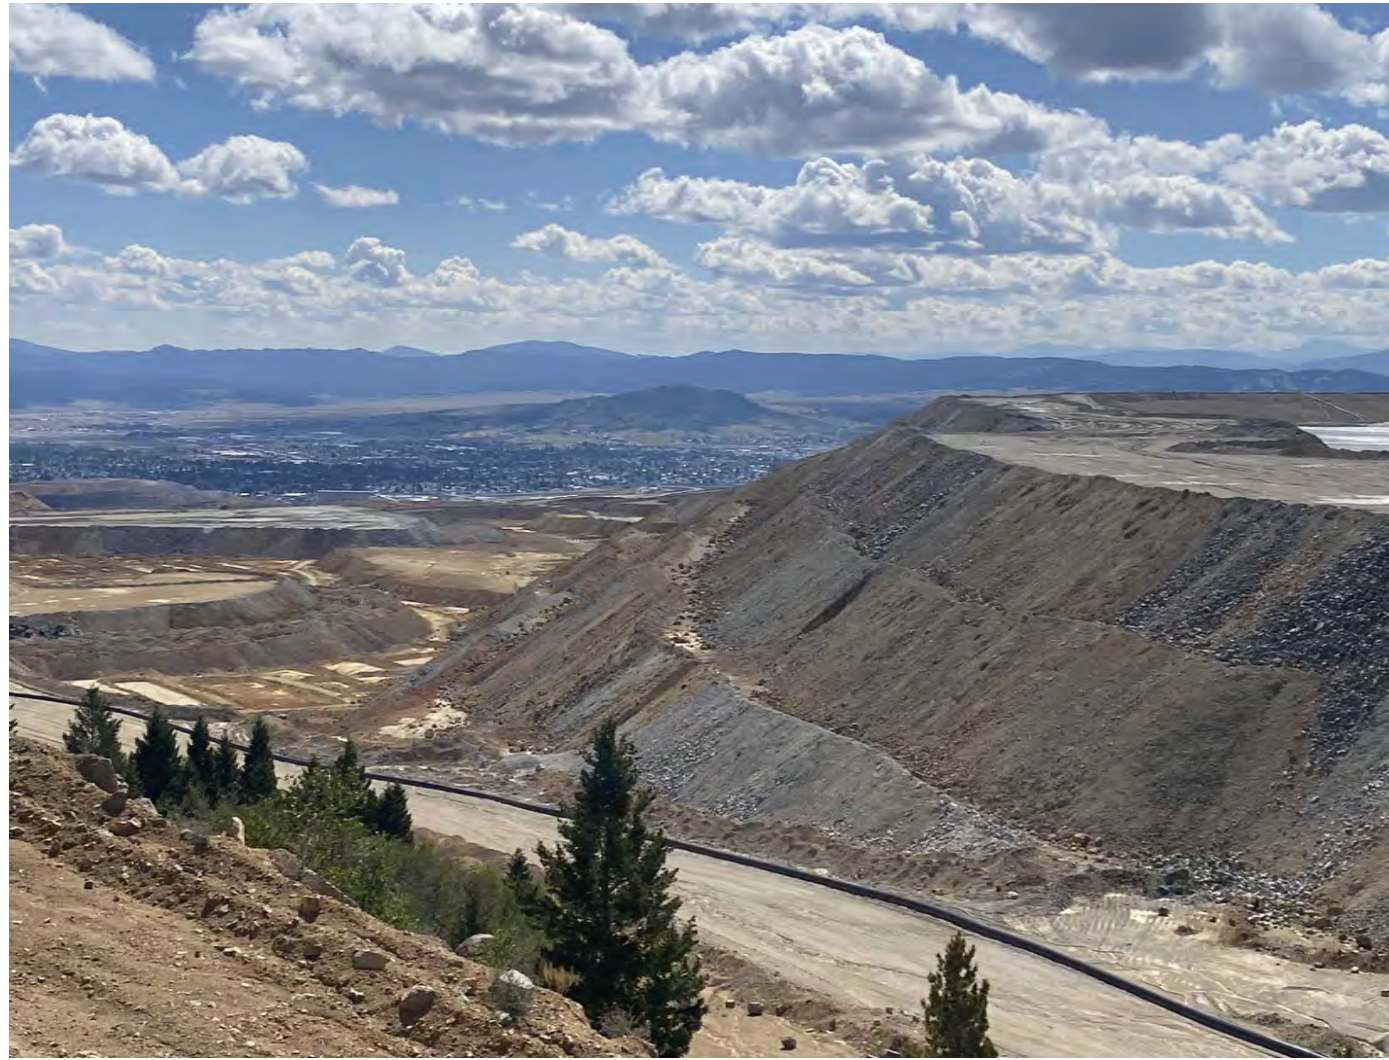
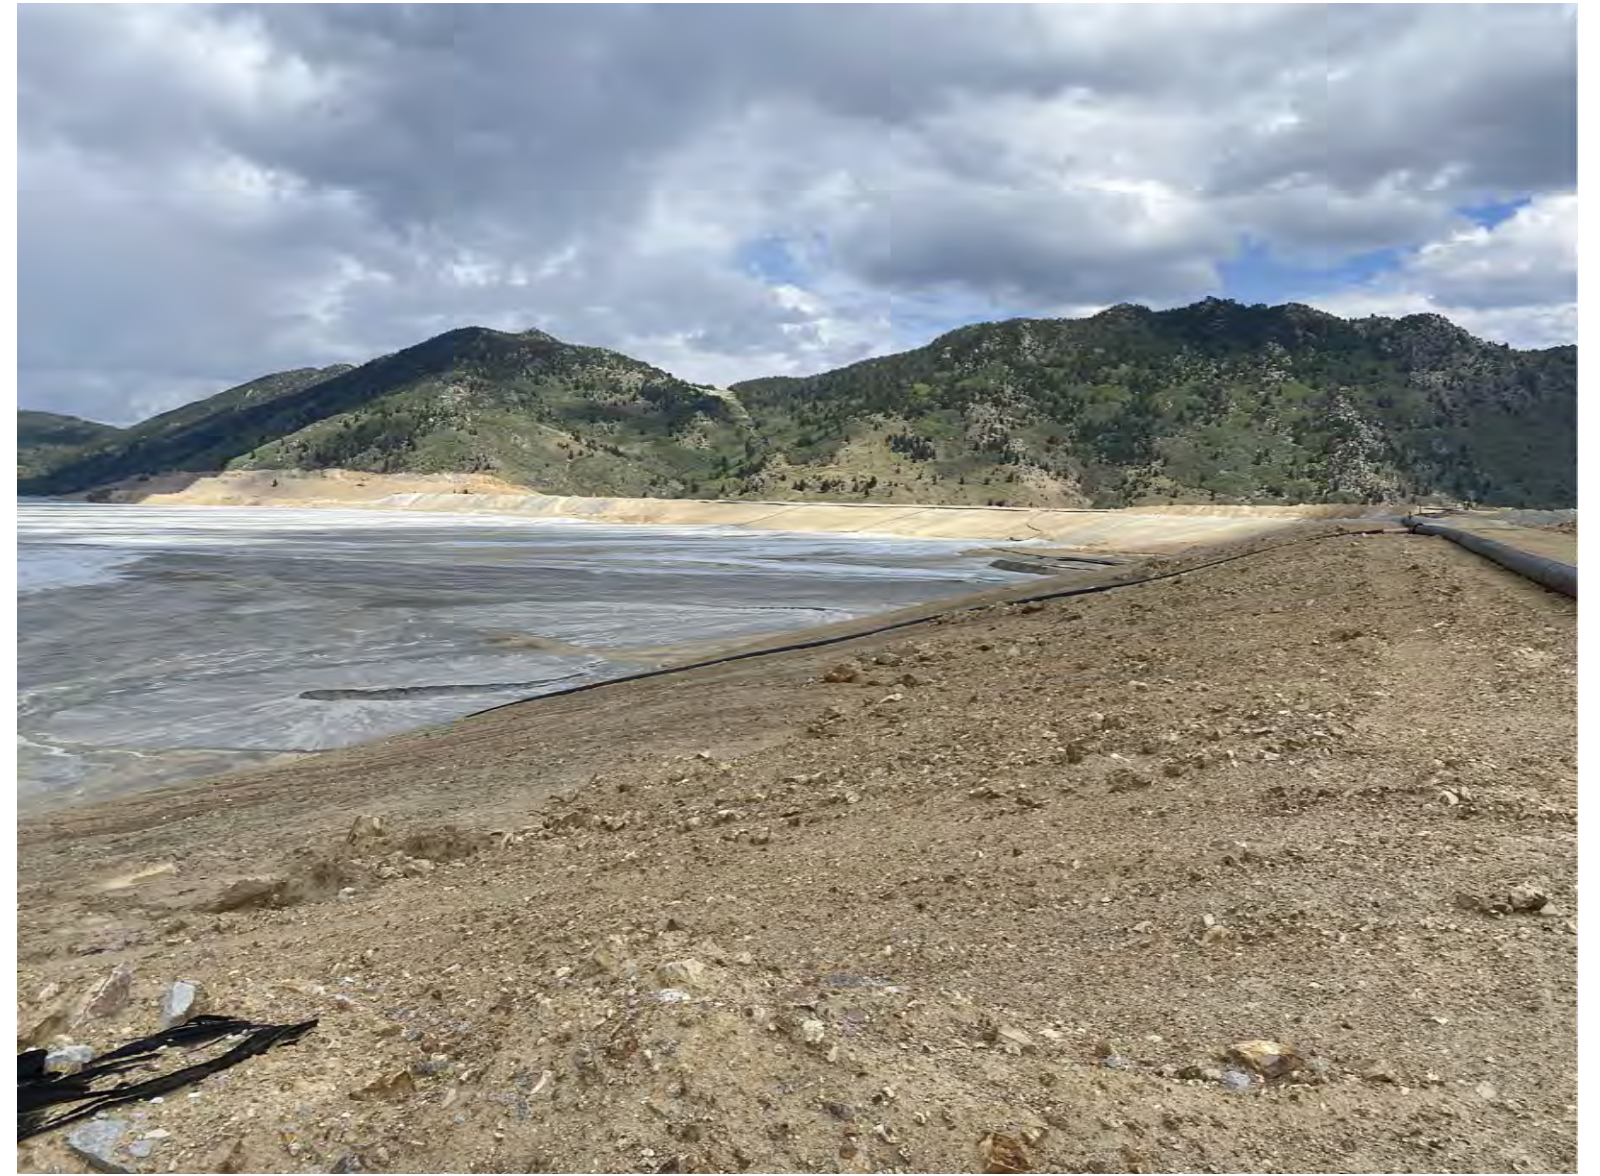
DOWNSTREAM EMBANKMENT SLOPE NORTH-SOUTH EMBANKMENT

UPSTREAM EMBANKMENT SLOPE EAST-WEST AND NORTH SOUTH EMBANKMENT

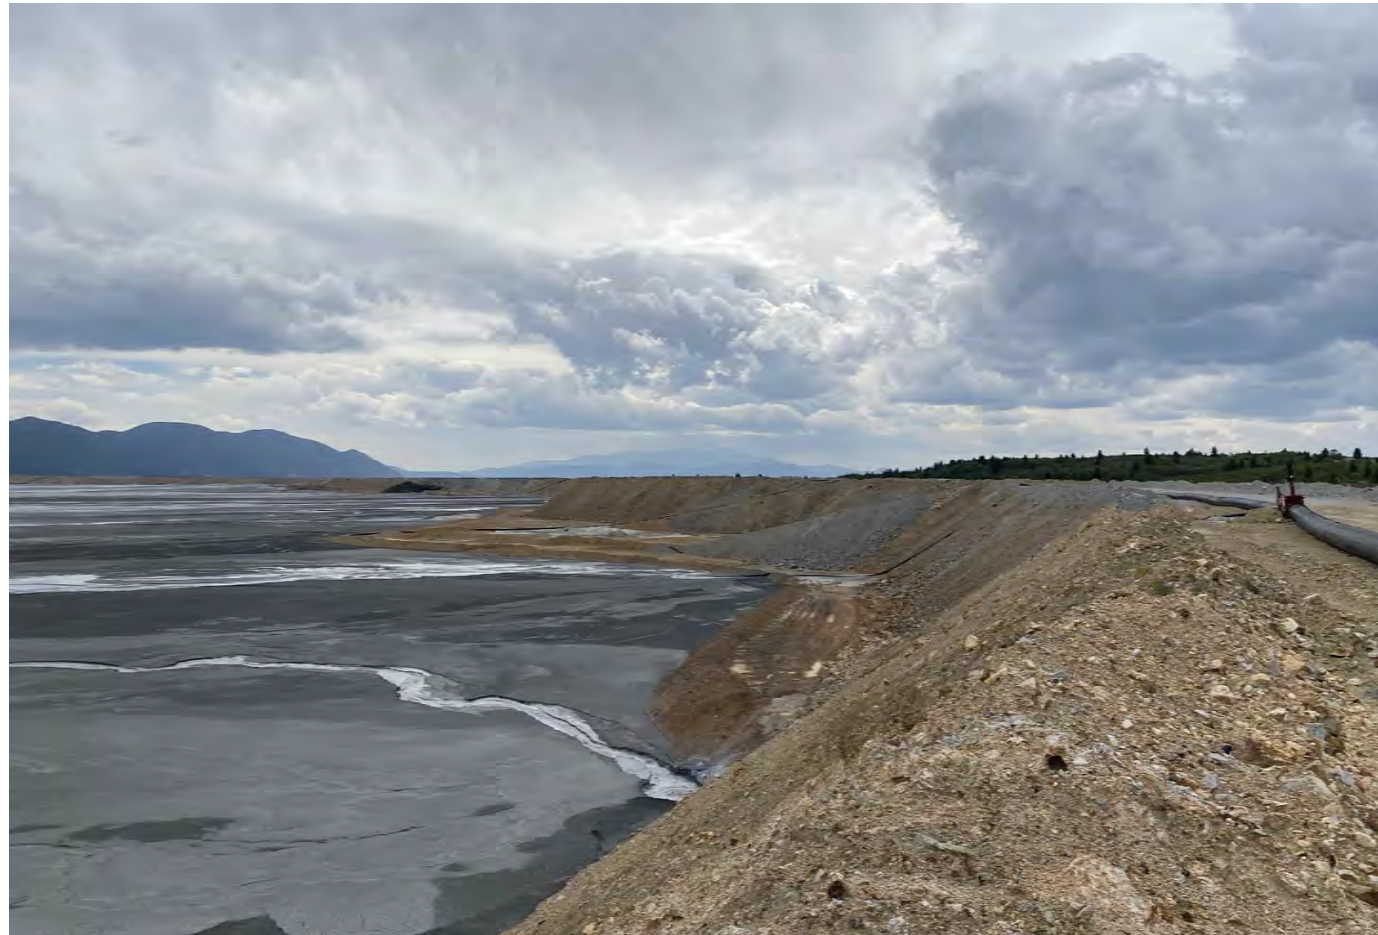
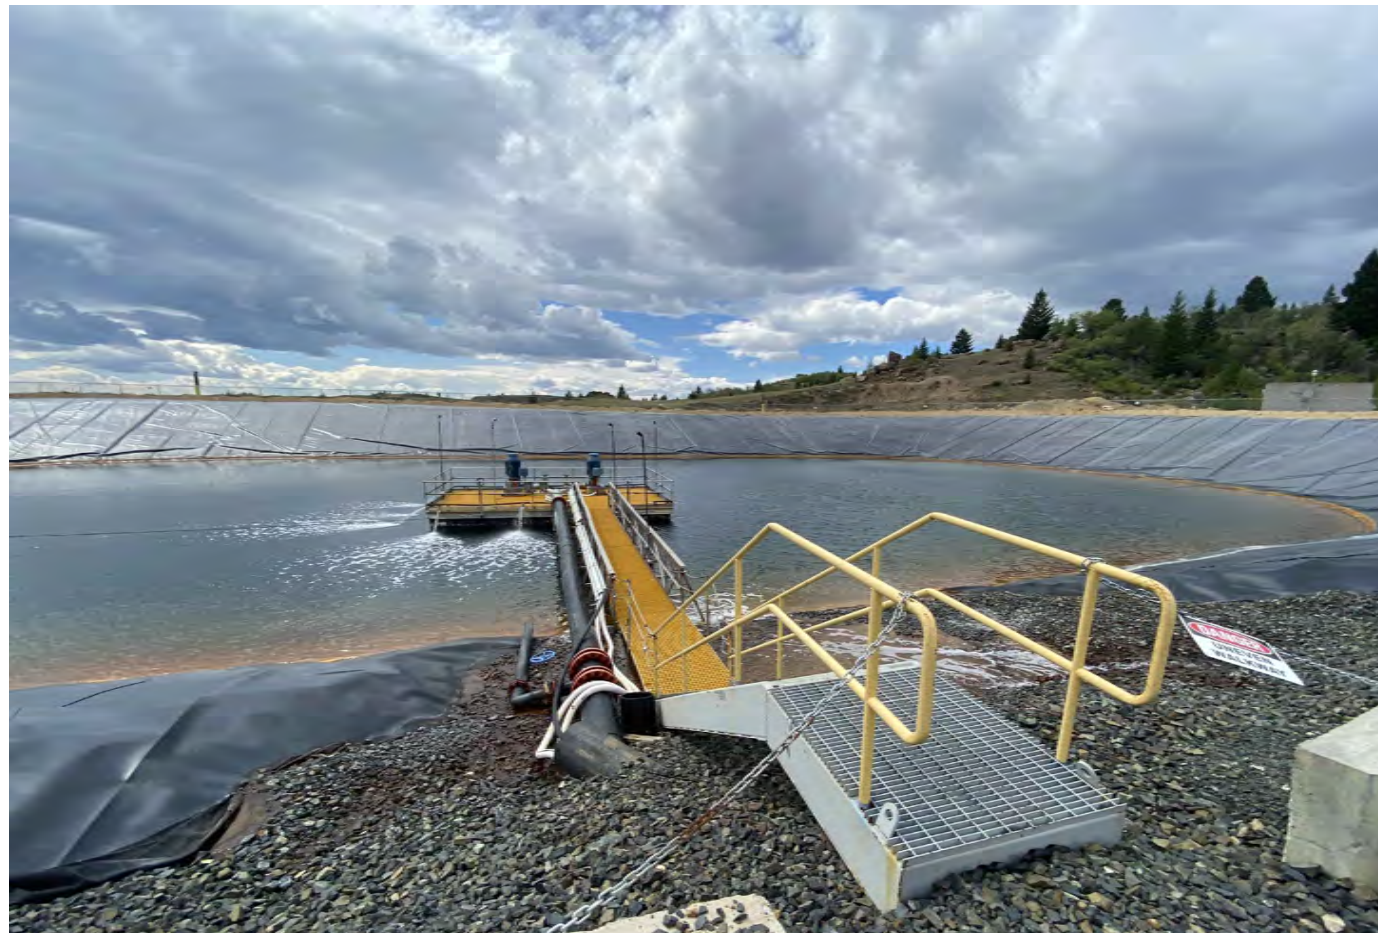
UPSTREAM EMBANKMENT SLOPE WEST EMBANKMENT

EXTRACTION POND

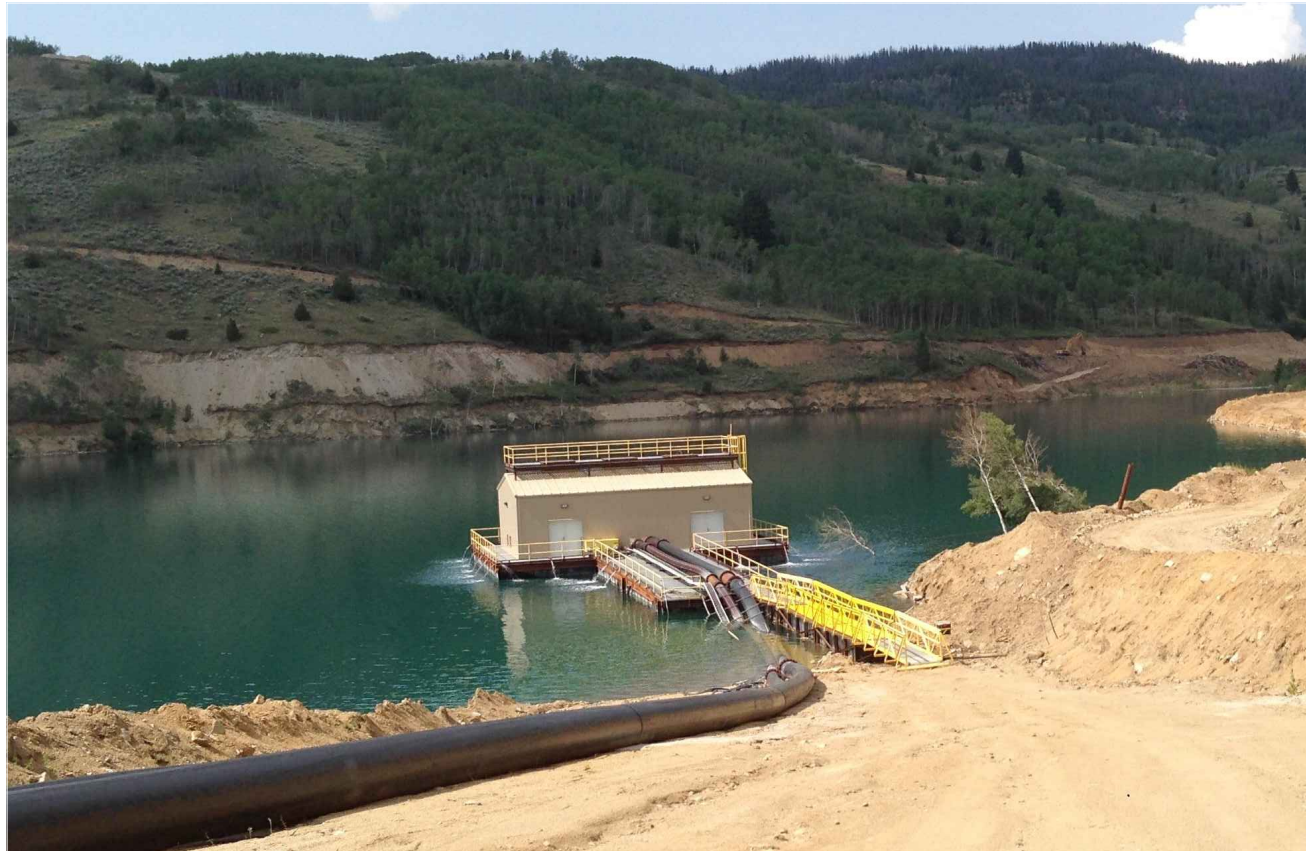
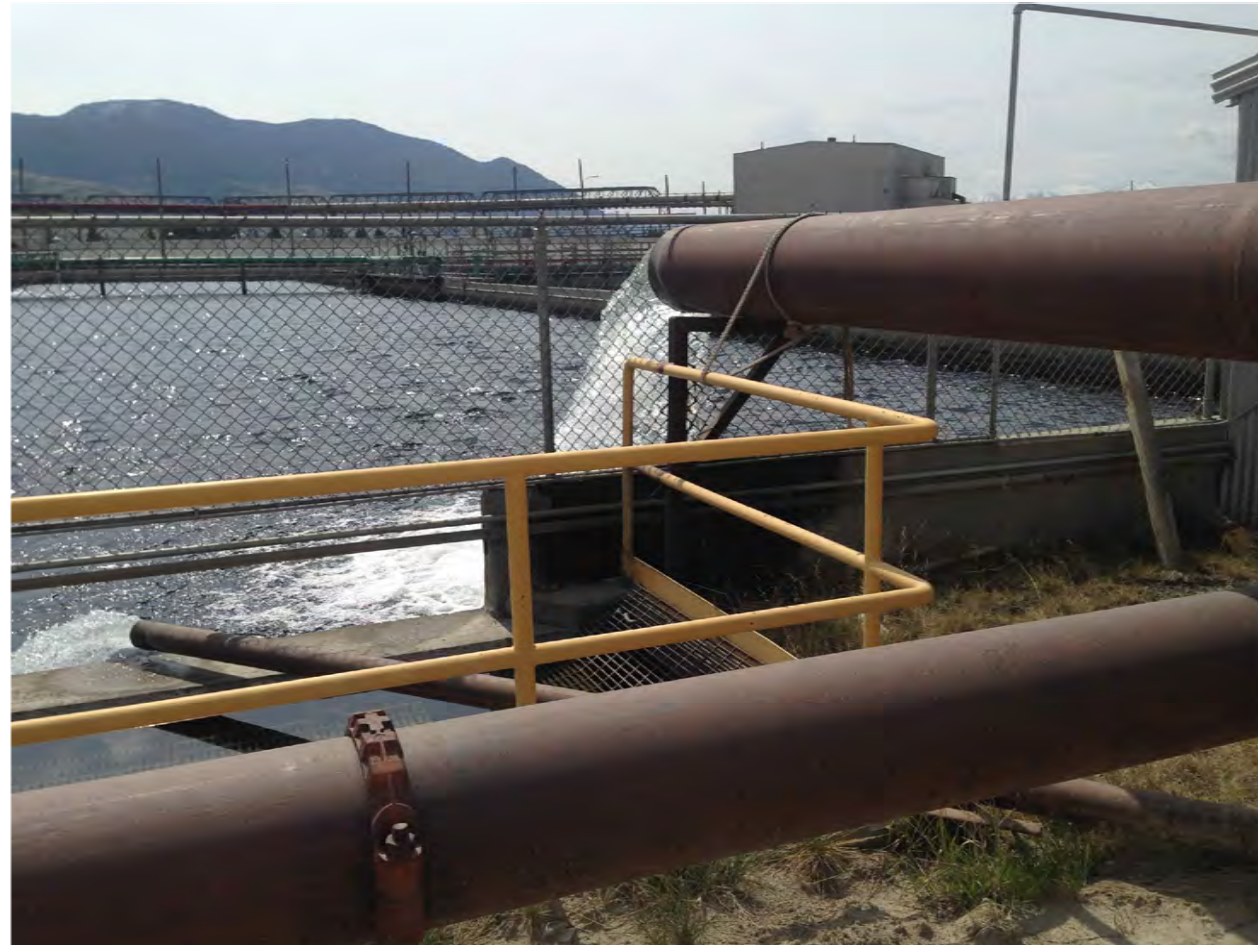
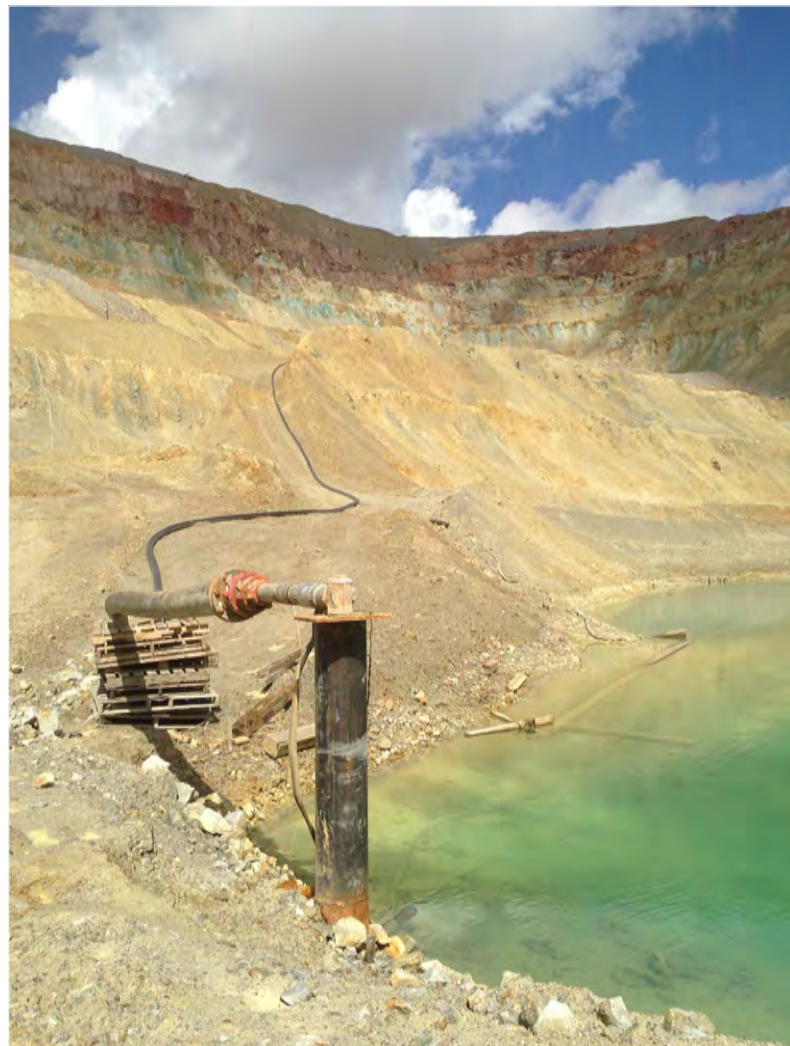
RECLAIM BARGE

RECLAIM DISCHARGE INTO MILL RESERVOIRS

CONTINENTAL PIT - SANSFIELD PUMP

RECLAIM WATER JUNCTION BOX

The YDTI water reclaim system supplies water for use in the mill process and treatment/discharge in the Pilot Project Polishing Plant. A schematic of the water reclaim system network is presented on Figure 4.4. Supernatant water is reclaimed from the northeast end of the YDTI using two floating pump barges (North Barge and South Barge). Each barge is equipped with three vertical turbine pump units. Generally, three to four (of the six) pump units are operational at any time. The barge pumps convey approximately 11,000 gpm to the Butte Concentrator, and when warranted, additional flows (typically between 2,100 to 6,000 gpm) to the Polishing Plant.

The barge pumps deliver water into a junction box, as indicated on Figure 4.4, which is located on the east side of the pond along the 6,500 ft elevation reclaim road. The North Barge is connected to the box with two pipelines and the South Barge is connected with three pipelines. The outlet of the box feeds into two pipelines that converge downstream into a single 42" diameter HDPE pipeline. The last mile of reclaim pipeline prior to delivery at the mill is 30" HDPE pipe. The total pipeline length from the reclaim barge to the Concentrator is approximately 5.1 miles with an elevation decrease of approximately 810 ft. The offtake to supply reclaim water to the Pilot Project Polishing Plant (Section 4.1.5) is located near the McQueen Tailings Booster Pump House. The pipeline is approximately 13,300 ft long and constructed using 24" HDPE pipe.

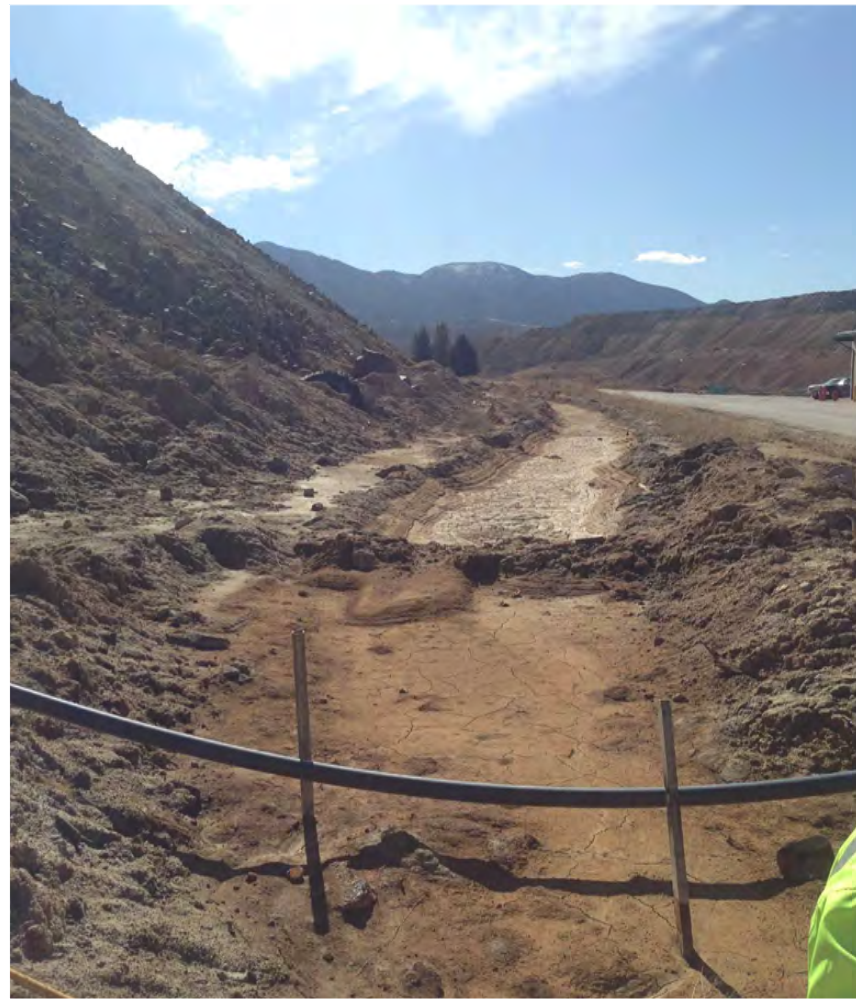
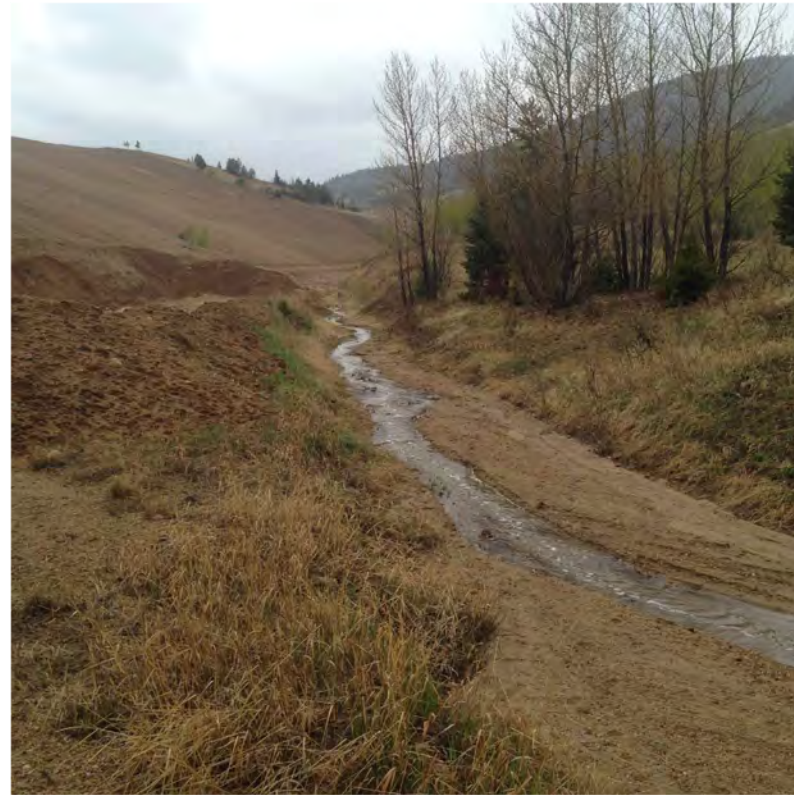
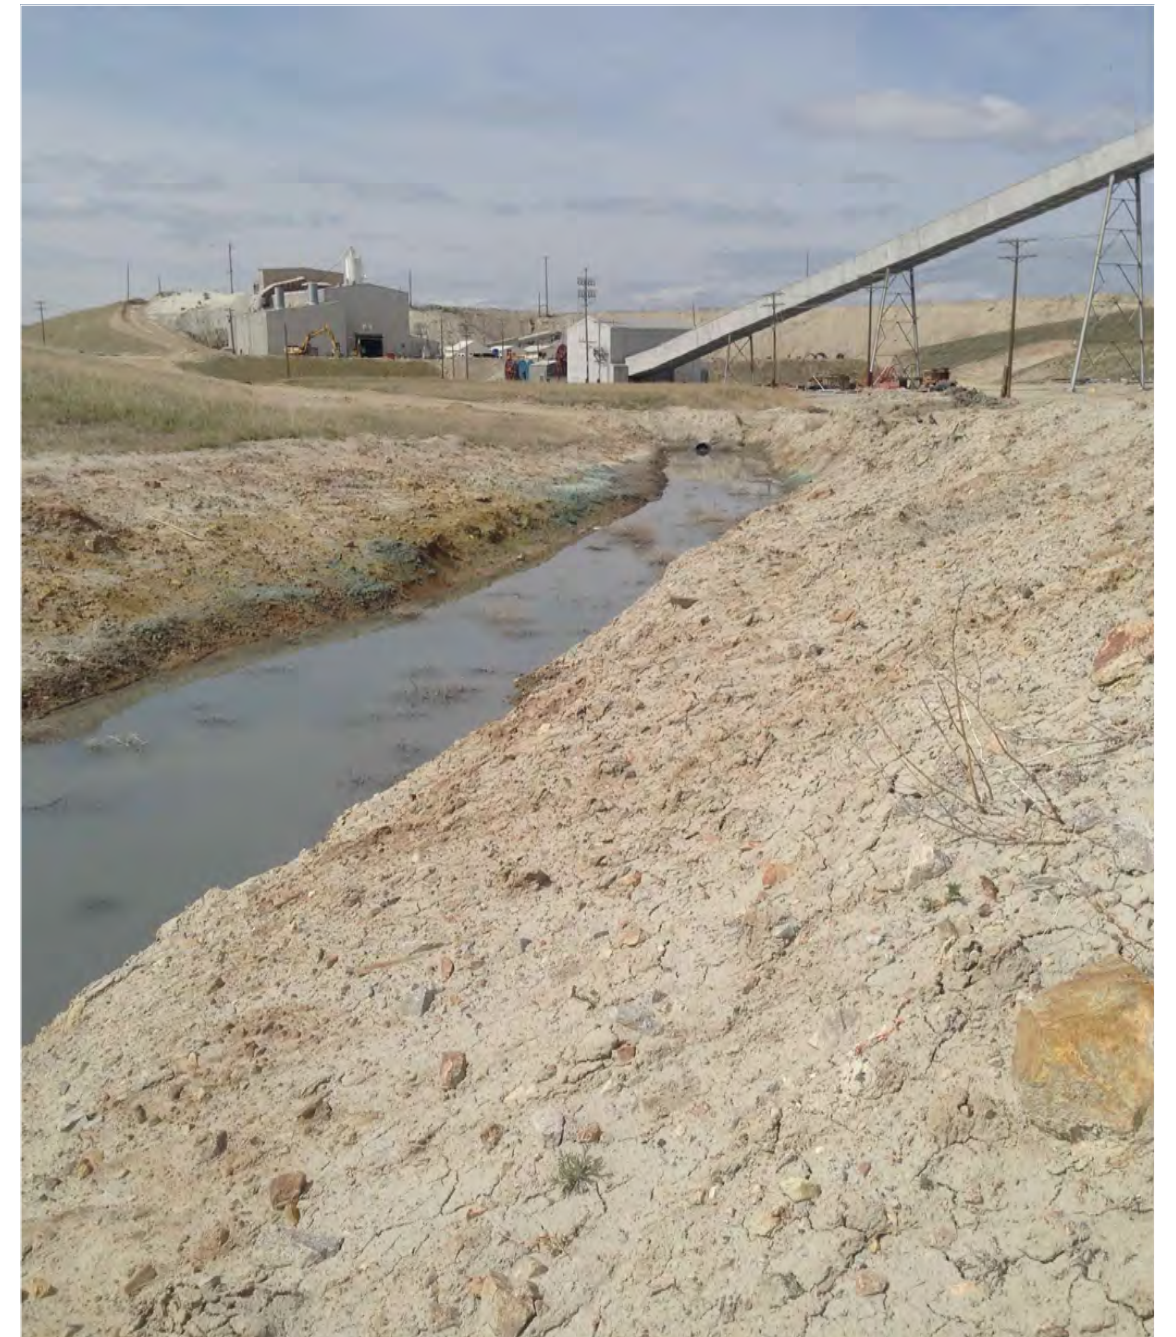
TYPICAL DRAINAGE DITCH

CLEAR WATER DITCH

SITE DRAINAGE DITCH
