MONTANA RESOURCES, LLP YANKEE DOODLE TAILINGS IMPOUNDMENT

DAM BREACH RISK ASSESSMENT

VA101-126/12-3
Rev 3
March 13, 2018

**DAM BREACH RISK ASSESSMENT
VA101-126/12-3**

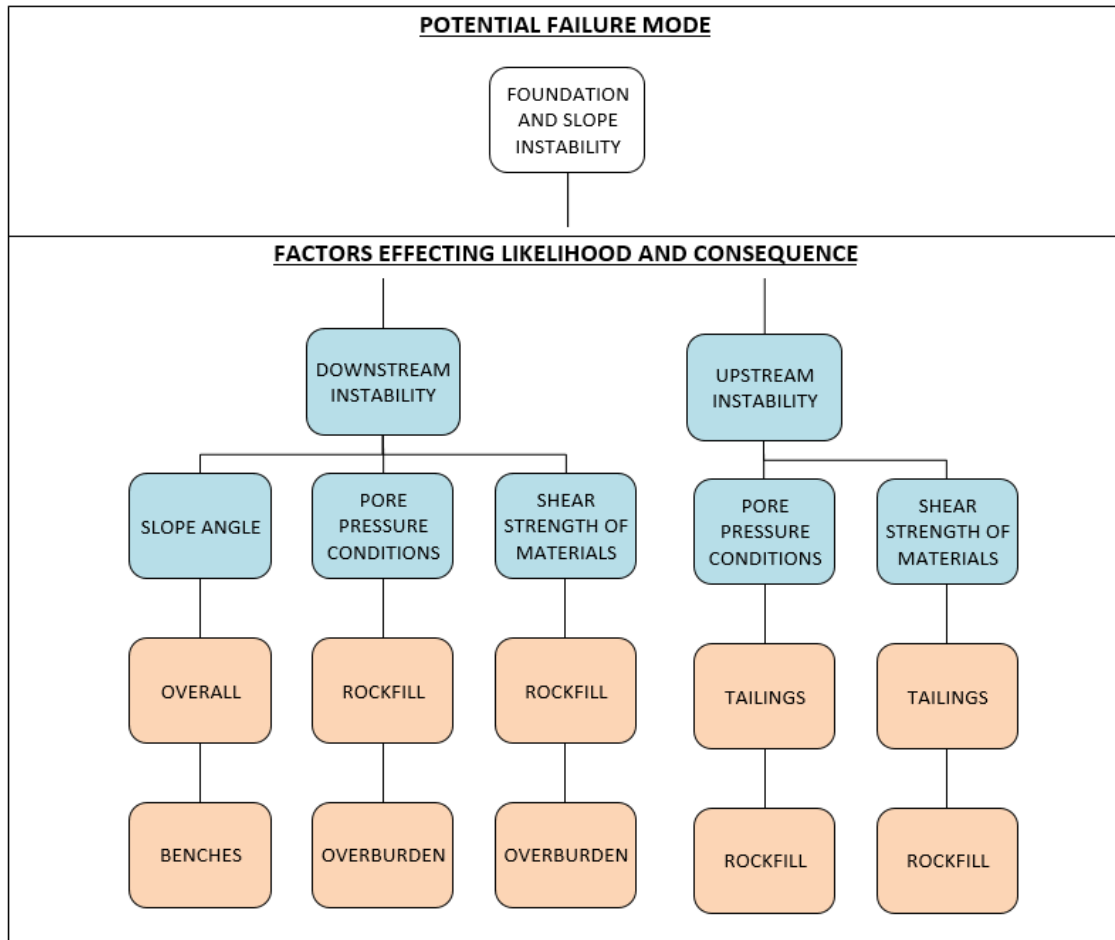
Figure 3.3 Factors Affecting Foundation and Slope Stability

The FS against foundation or slope instability is dependent on a number of factors. Figure 3.3 shows a summary of the factors affecting static slope stability.

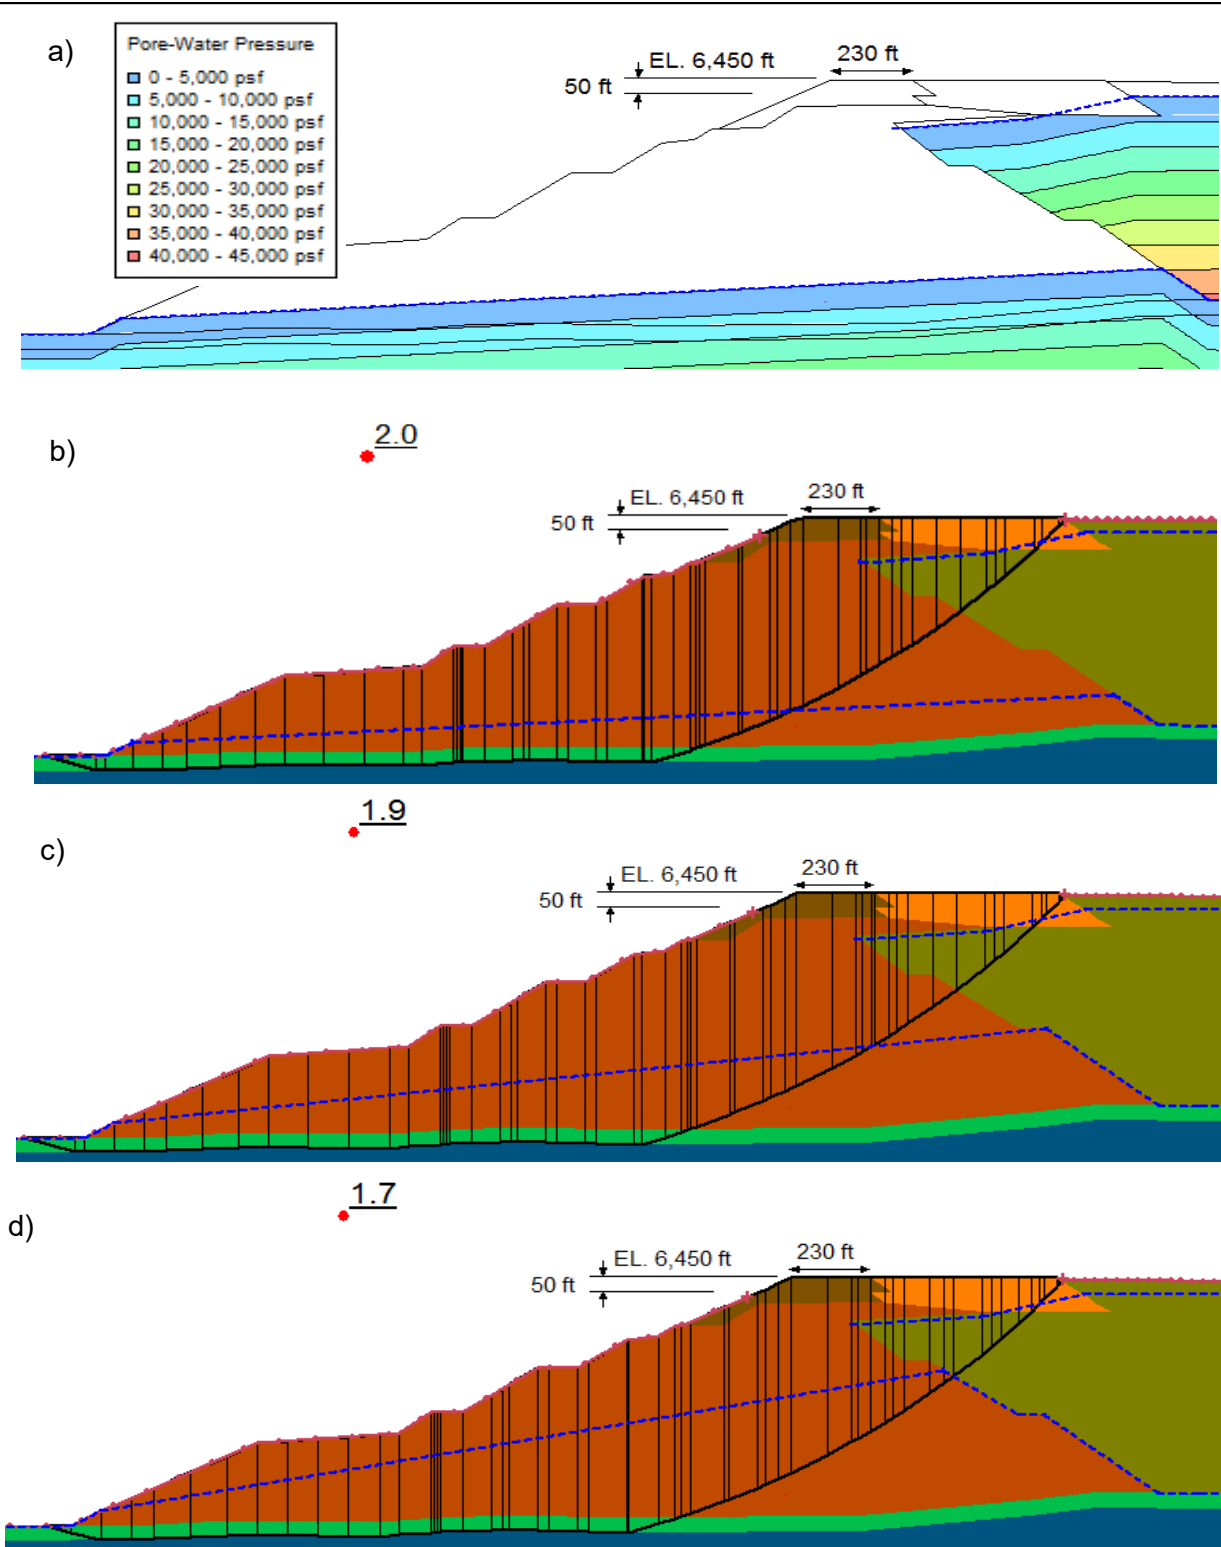
- a) PIEZOMETRIC CONDITIONS APPLIED IN SLOPE/W BASE CASE.
- b) FACTOR OF SAFETY (FS) CALCULATED FOR SLOPE/W BASE CASE.
- c) SENSITIVITY OF FS TO 150 FT STATIC PORE PRESSURE RISE.
- d) SENSITIVITY OF FS TO 300 FT STATIC PORE PRESSURE RISE.

The sensitivity of the slope stability FS to pore pressure conditions was evaluated by manipulating the pore pressure conditions in the lower bench of the embankment and the foundation for Section 8+00W of the East-West Embankment. The piezometric surface was increased to mimic a static rise in pore pressures. The analysis was performed by incrementally increasing the piezometric line in the embankment on the upstream side as indicated on Figure 3.4. These analyses were used to evaluate the effect of pore pressure conditions on global stability of the embankment. The calculated FS are included in Table 3.4. ▲ R2

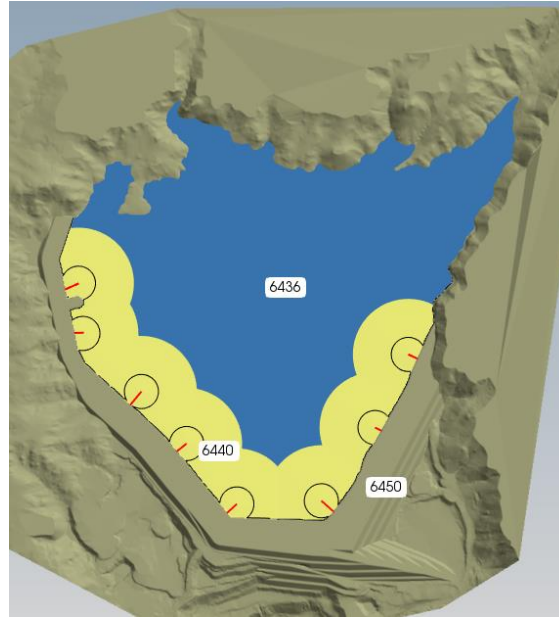
1 in 1,000 Year 30-day Rainfall Event
 Total Volume - 31,500 acre-ft
 Beach Length⁴ ~ 1,500 ft

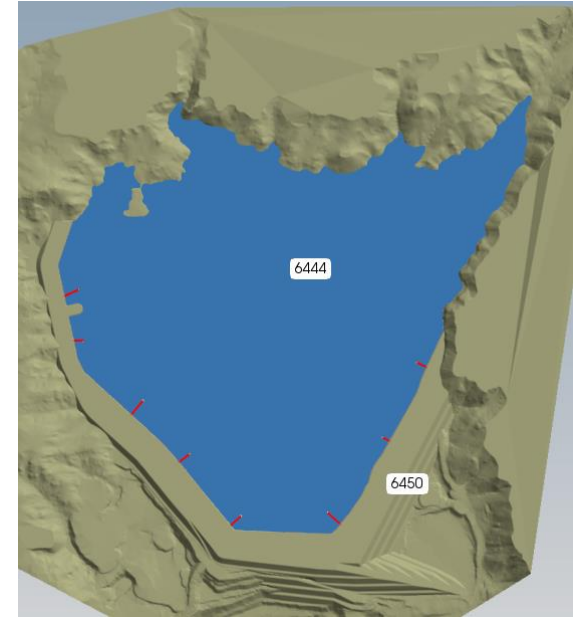
PMF Event
 Total Volume - 45,000 acre-ft
 Pond Against Embankment

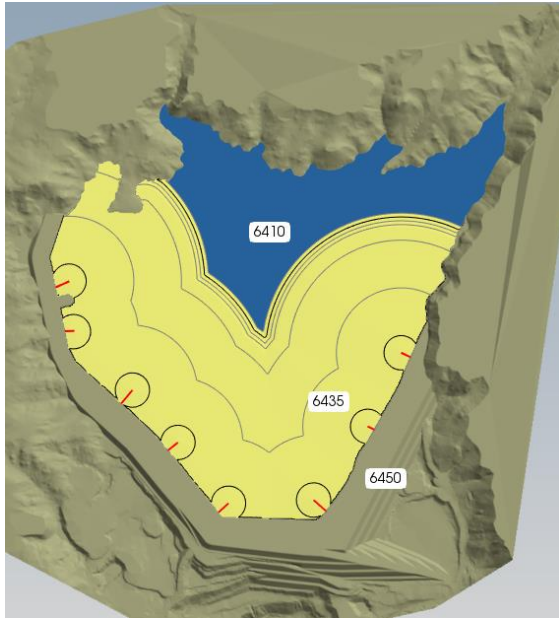
Normal Operating Conditions
Pond Volume - 15,000 acre-ft
Beach Length⁴ ~ 3,900 ft

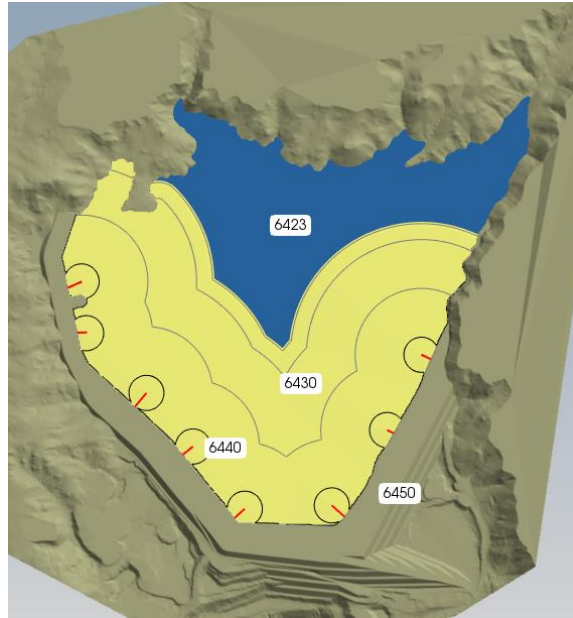
1 in 1,000 Year 30-day Rainfall Event
Total Volume - 21,500 acre-ft
Beach Length⁴ ~ 3,700 ft

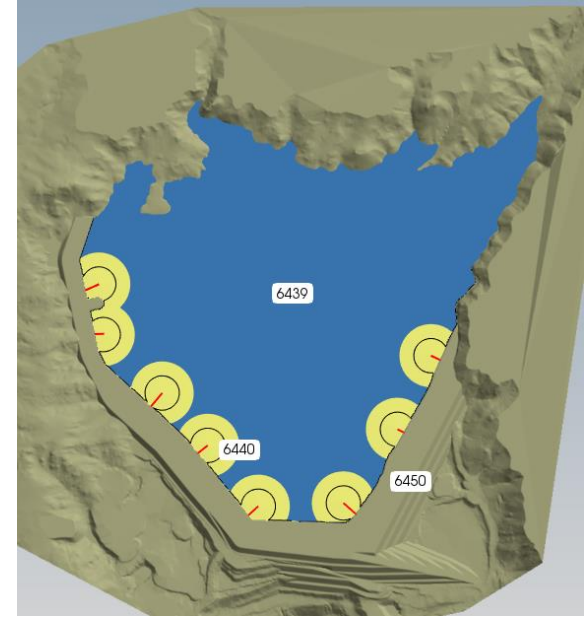
PMF Event
Total Volume - 35,000 acre-ft
Localized Pond Against Embankment

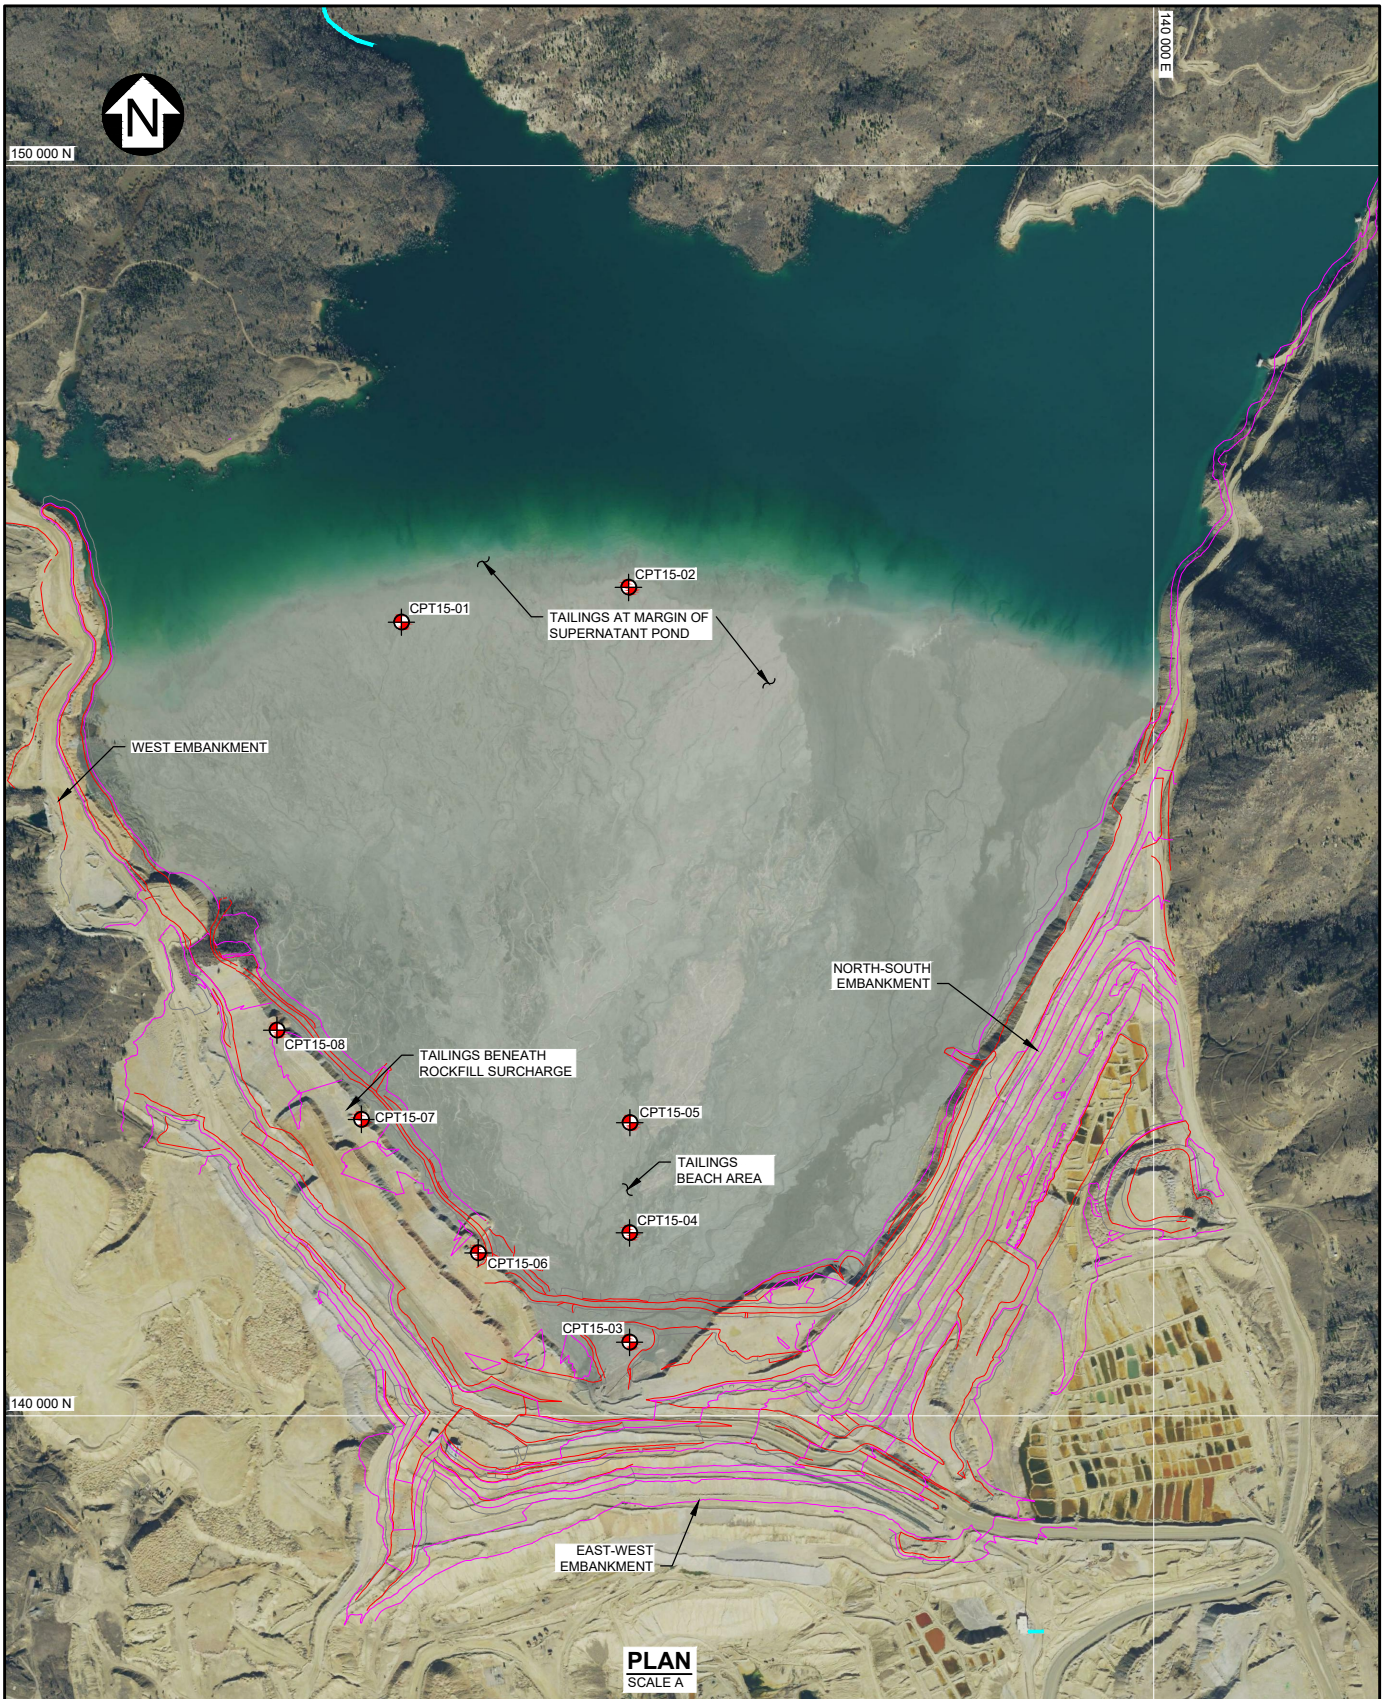
FIGURE 2

1. COORDINATE SYSTEM AND ELEVATIONS ARE BASED ON ANACONDA MINE GRID.
2. IMAGERY FROM 2015 AIR PHOTO PROVIDED BY MONTANA RESOURCES.
3. EMBANKMENT TOPOGRAPHY 2017 PROVIDED BY MONTANA RESOURCES ON MARCH 19, 2017.

The location of the CPT probings completed during the 2015 SI Program are shown on Figure 2. The tailings dry density profiles from the CPT probings are shown on Figure 3. The profiles were produced using the data from the CPT probings (CPT15-03, CPT15-04, and CPT15-05) located in the vicinity of the maximum section of the East-West Embankment. The dry density profiles are based on measured tip resistance and sleeve friction (Robertson, P.K., and Cabal, K.L., 2010) and measured shear wave velocity (Mayne, P.W. 2014).

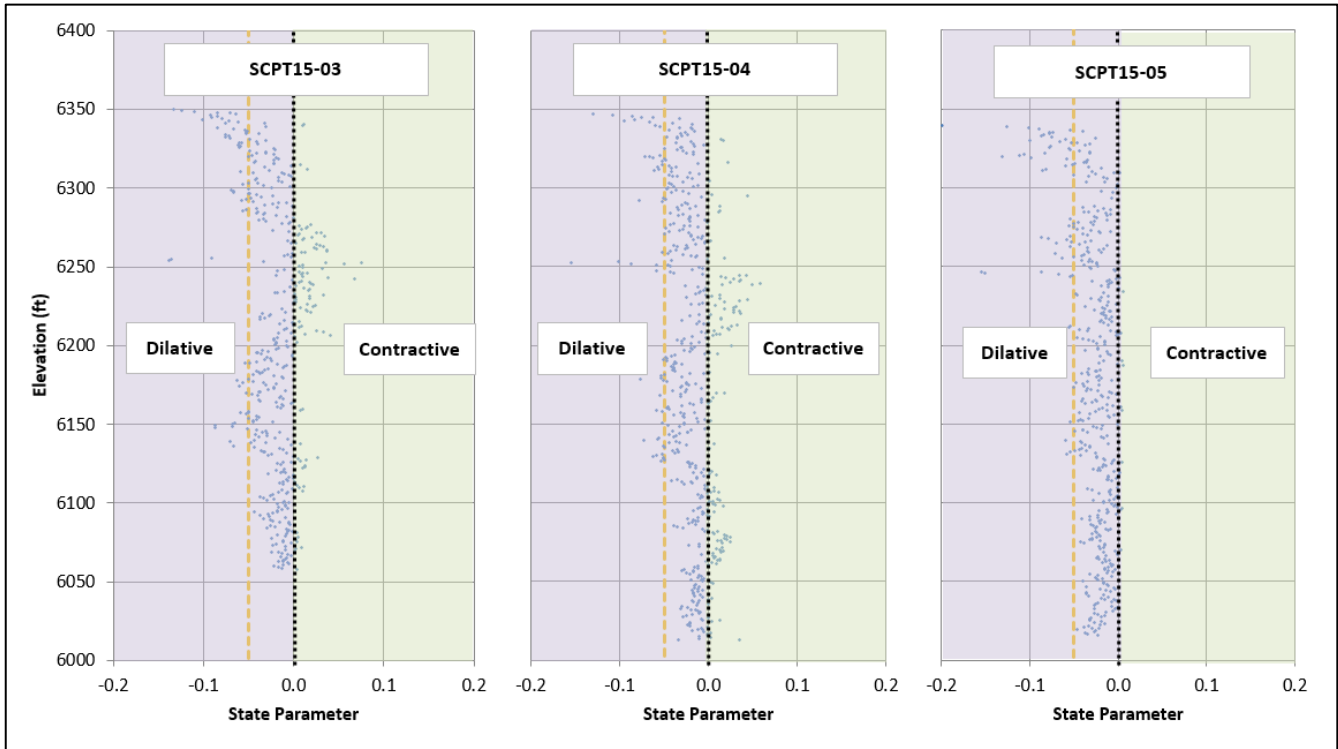
1. The division between dilative and contractive behaviour is generally accepted to be -0.05, indicated by the yellow dashed line, although a state parameter of < 0 is indicative of potentially dilative material.

State parameter profile plots were used to graphically identify potentially contractive tailings materials by comparison of the calculated state parameter values with both the $\gamma > 0$ and $\gamma > -0.05$ criteria. The state parameter profile plots for CPT15-03, CPT15-04, and CPT15-05 are shown on Figure 5.

CPTs within the tailings beach generally have state parameters on the boundary of potentially dilative and contractive behavior depending on whether the $\gamma < -0.05$ or $\gamma < 0$ is used. State parameter plots suggest that potentially contractive material types exist in CPT15-03 and CPT15-04 between EL. 6,275 and 6,200 ft; however, tailings at these elevations do not exhibit excess pore pressures. Predominantly negative normalized pore pressure differences (u) are present throughout the tailings profile suggesting that although the materials are on the boundary of potentially contractive or dilative based on state parameter, the excess pore pressures required for potentially contractive behavior are generally not present under existing conditions.

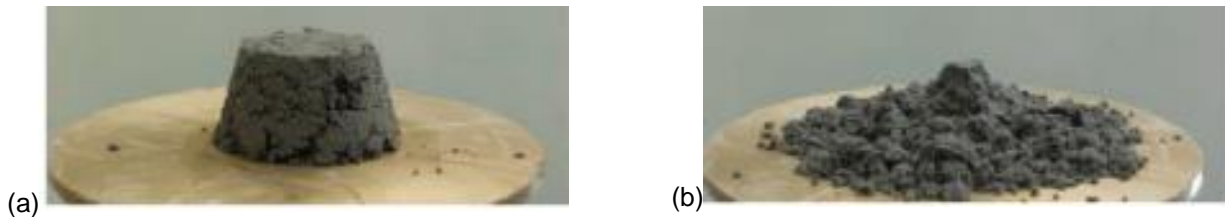
Figure 11 TML Test Specimen showing fragmentation (a) before test and (b) at completion

Typical photos of the TML tests for the tailings samples are shown on Figure 11 and Figure 12. The tests begin with a truncated circular pyramid of compacted tailings that is statically stable. The specimen diameter increases as the specimen and flow table shake. The diameter increase occurs from specimen fragmentation at low moisture contents (Figure 11) and due to liquefaction and viscous spreading at higher moisture contents (Figure 12).

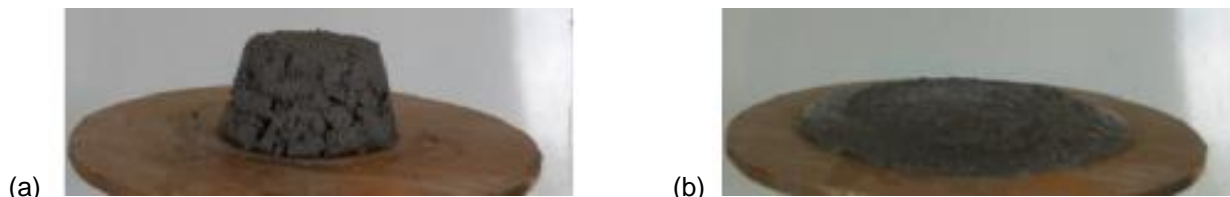
Figure 12 TML Test Specimen showing liquefaction (a) before test and (b) at completion

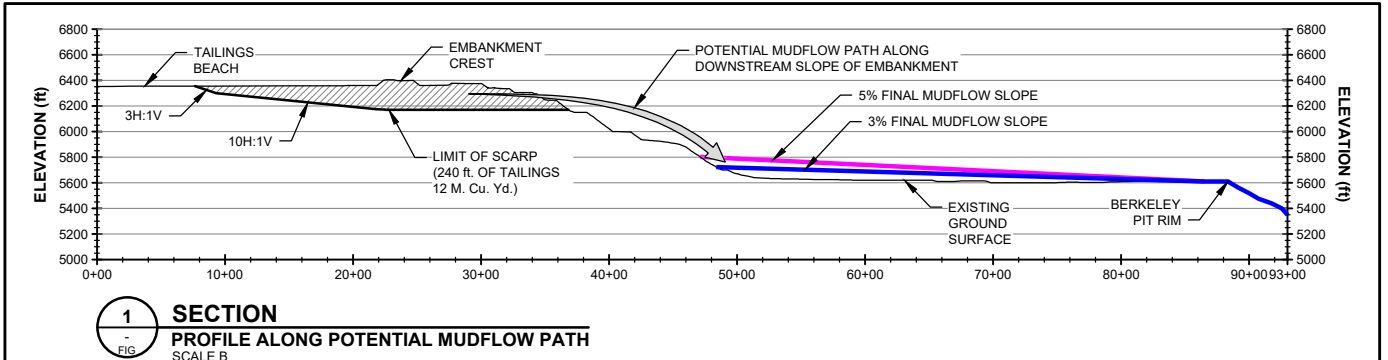
- LEGEND:**
- TAILINGS BEACH
 - EMBANKMENT FILL
 - MINE WATER
 - 5% FINAL MUDFLOW SLOPE
 - 3% FINAL MUDFLOW SLOPE

A 100 ft wide breach through the East-West Embankment was assumed along with final slope angles of approximately 33% (3H:1V) for the Upper Low Density Partially Saturated Tailings and 10% (10H:1V) for the Upper Medium Density Saturated Tailings. A gentler slope is a reasonable assumption for fully mobilized tailings at the base of the embankment. The final slope angle for transported mudflow tailings would be in the range of 3 to 5% based on case histories for mudflows generated for tailings dams, waste impoundments, and other earth structures (Lucia et al, 1981; Blight and Fourie, 2003).

The extents of this hypothetical mudflow would be limited to within the project area. The hypothetical mudflow would flow down gradient towards Berkeley Pit. The geometric conditions indicate that the mudflow would pass through the Horseshoe Bend (HsB) Area and bypass the HsB Water Treatment Plant (WTP). The mudflow would stop moving adjacent to the WTP, prior to the Berkeley Pit. The maximum potential limits are illustrated on Figure 16. The total volume of the mudflow would be in the order of up to 12 million cubic yards of tailings for a hypothetical 240 ft deep scarp. This hypothetical event would be preceded by an extreme earthquake ground motion directly in the vicinity of the project, which would initiate emergency response procedures even prior to the possible initiation of described potential consequences.

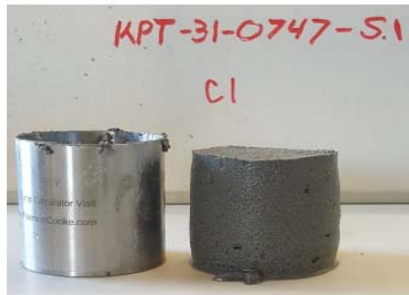
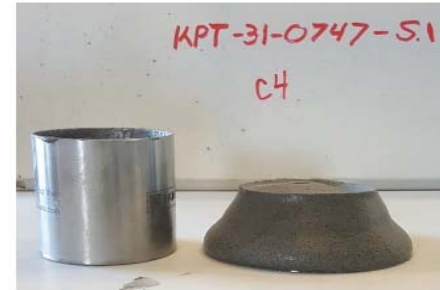
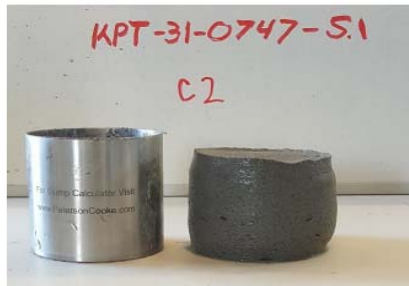
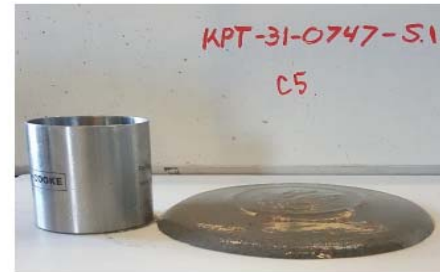
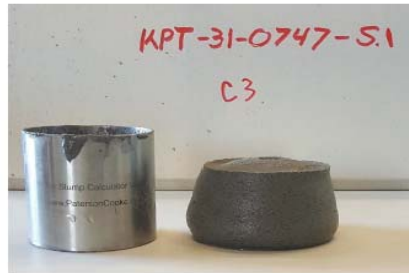
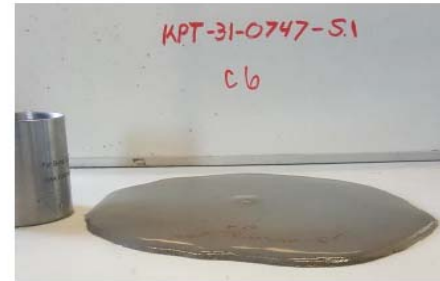
MC: 28%

MC: 35%

MC: 31%

MC: 44%

MC: 32%

MC: 53%

1. MC IS THE GRAVIMETRIC MOISTURE CONTENT BASED ON SOIL MECHANICS PRINCIPLES.

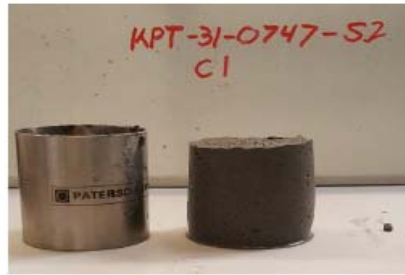
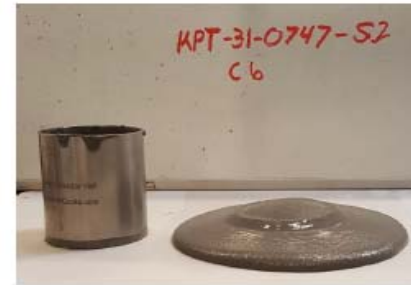
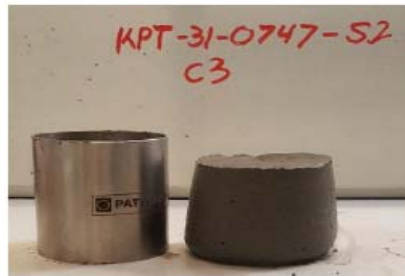
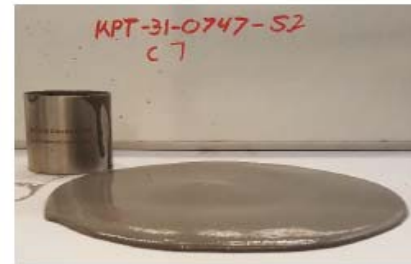
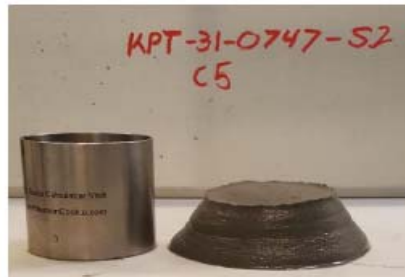
MC: 27%

MC: 42%

MC: 31%

MC: 47%

MC: 36%

1. MC IS THE GRAVIMETRIC MOISTURE CONTENT BASED ON SOIL MECHANICS PRINCIPLES.

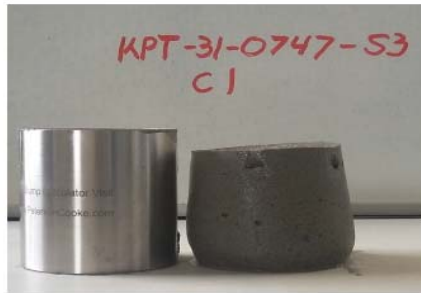
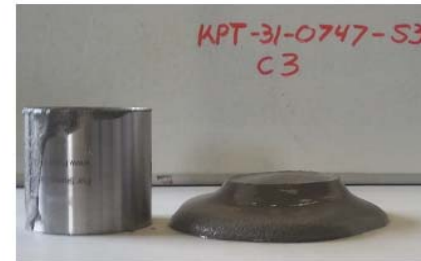
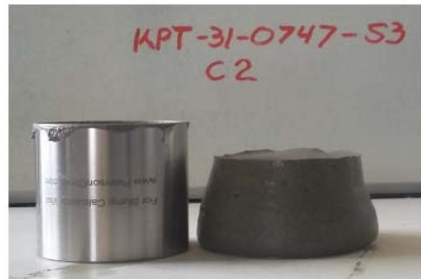
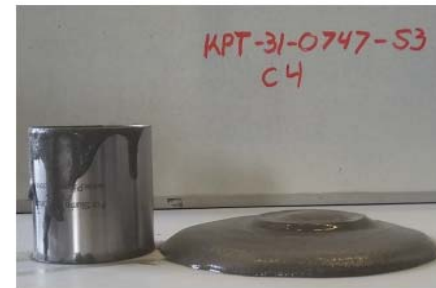
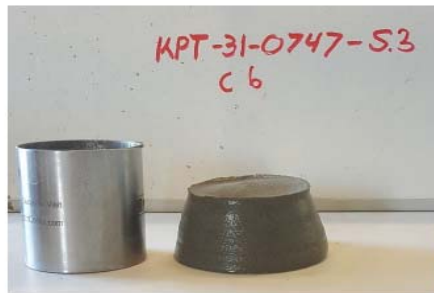
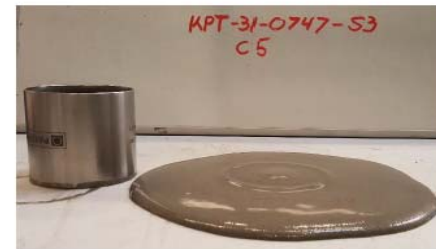
MC: 31%

MC: 38%

MC: 35%

MC: 44%

MC: 36%

MC: 49%

1. MC IS THE GRAVIMETRIC MOISTURE CONTENT BASED ON SOIL MECHANICS PRINCIPLES.

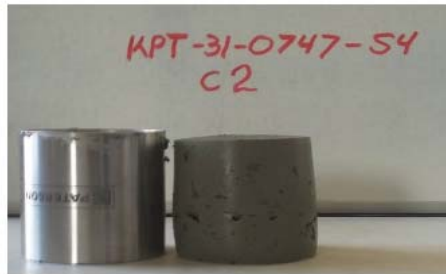
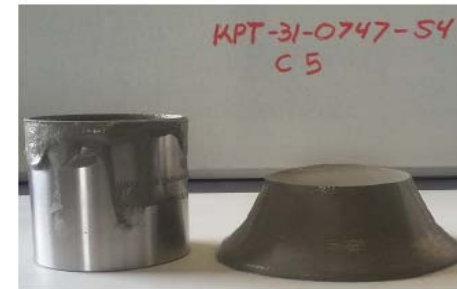
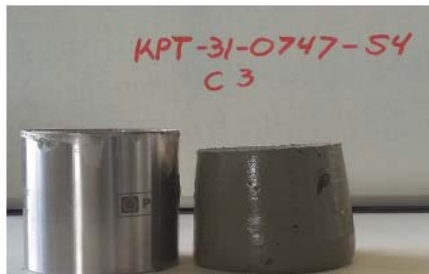
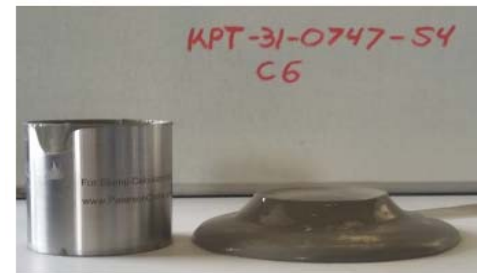
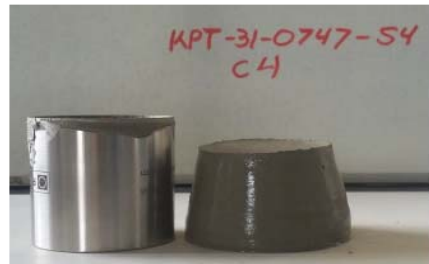
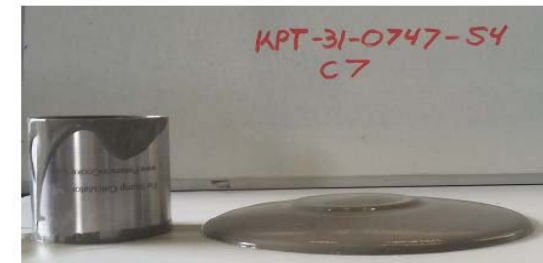
MC: 37%

MC: 60%

MC: 45%

MC: 68%

MC: 53%

MC: 86%

1. MC IS THE GRAVIMETRIC MOISTURE CONTENT BASED ON SOIL MECHANICS PRINCIPLES.

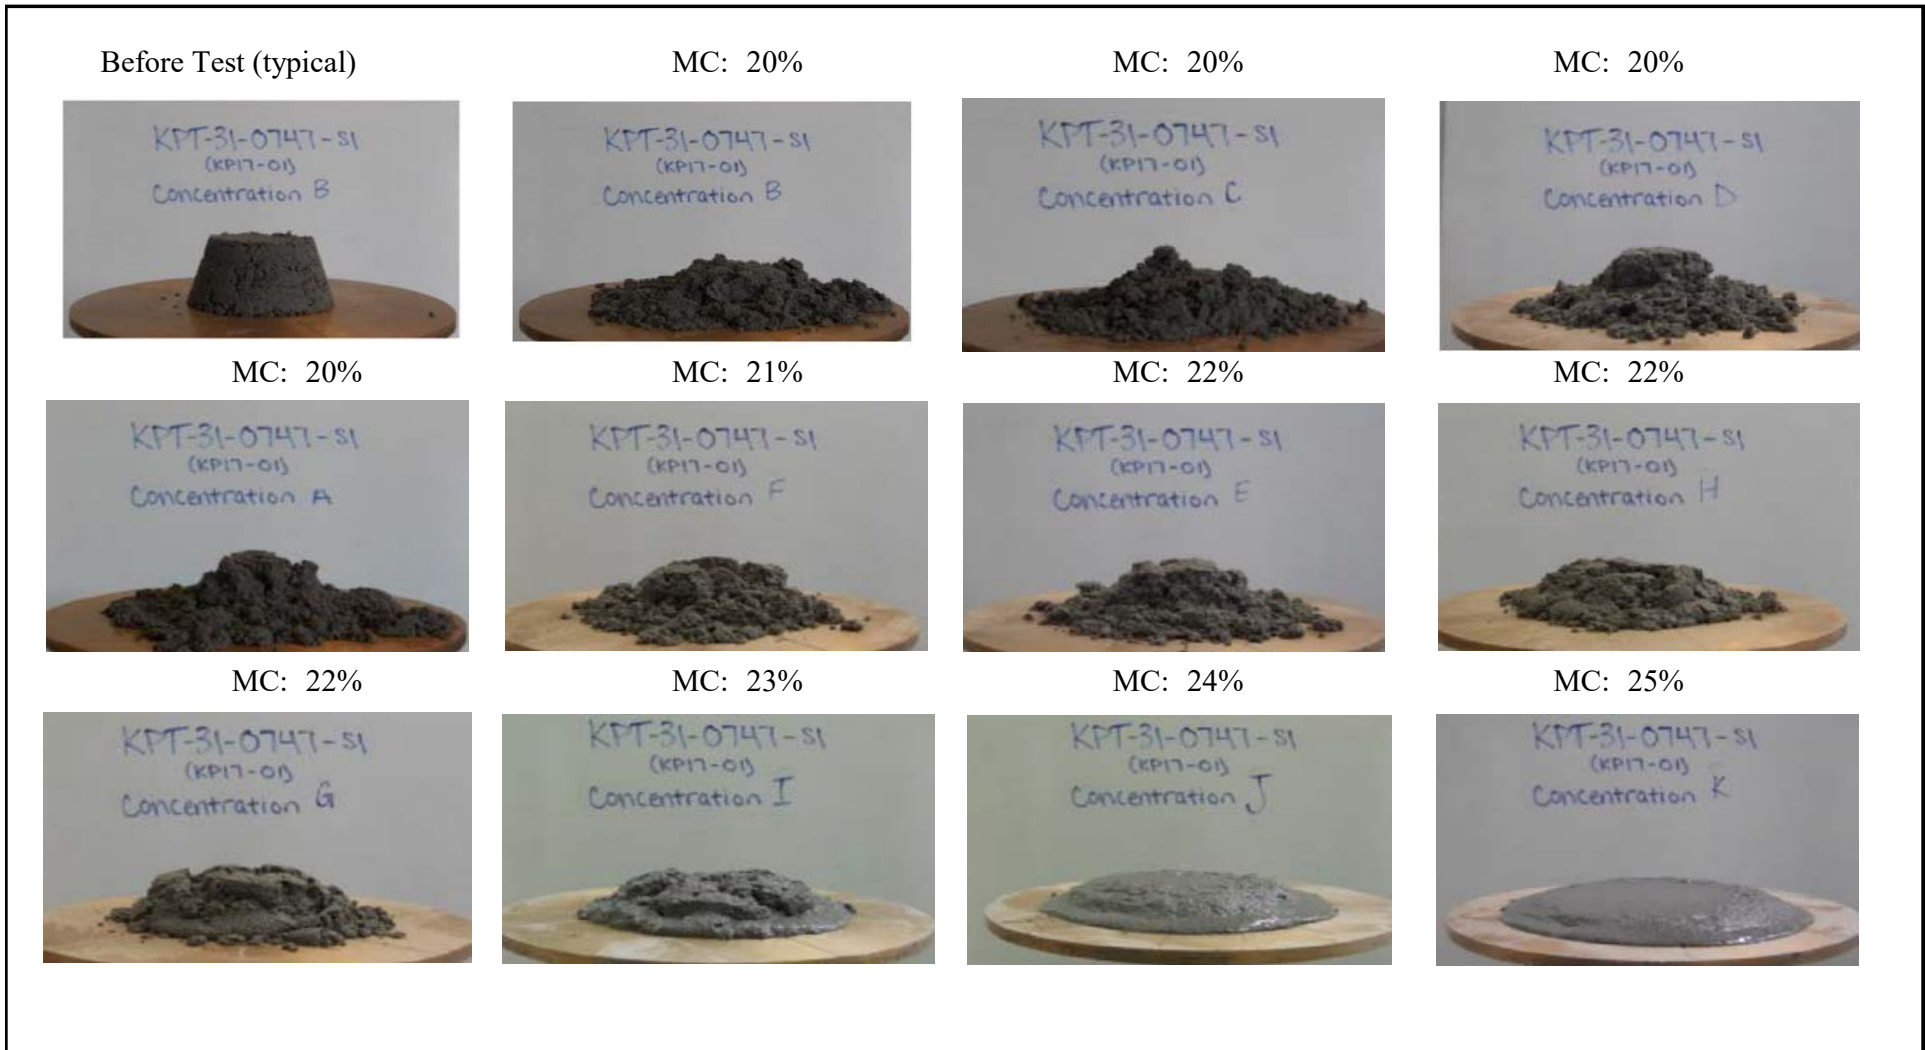
MONTANA RESOURCES, LLP.	
YANKEE DOODLE TAILINGS IMPOUNDMENT	
TRANSPORTABLE MOISTURE LIMIT TEST RESULTS KP17-01	
<i>Knight Piésold</i> CONSULTING	P/A NO. VA101-126/17
	REF. NO. VA18-00103
FIGURE B-1	
	REV 0

1. MC IS THE GRAVIMETRIC MOISTURE CONTENT BASED ON SOIL MECHANICS PRINCIPLES.

The TML testwork indicates that under sustained dynamic loading, flow liquefaction has the potential to develop at moisture contents in excess of approximately 25%. Viscous flow initiated at these moisture contents stopped under laboratory test conditions when dynamic loading ceased. A moisture content of 25% is indicated by the green dashed vertical line on Figure 13 for comparison with the inferred saturated moisture content from the CPT soundings. The tailings in the beach area below the unsaturated zone may have sufficient moisture content to flow in a viscous manner during active excitation (i.e. during seismic loading) without confinement. Viscous flow is likely to stop without active shaking (i.e. at the end of the earthquake). The following tailings zones are inferred from the relationship between CPT based in-situ moisture content and the TML testwork:

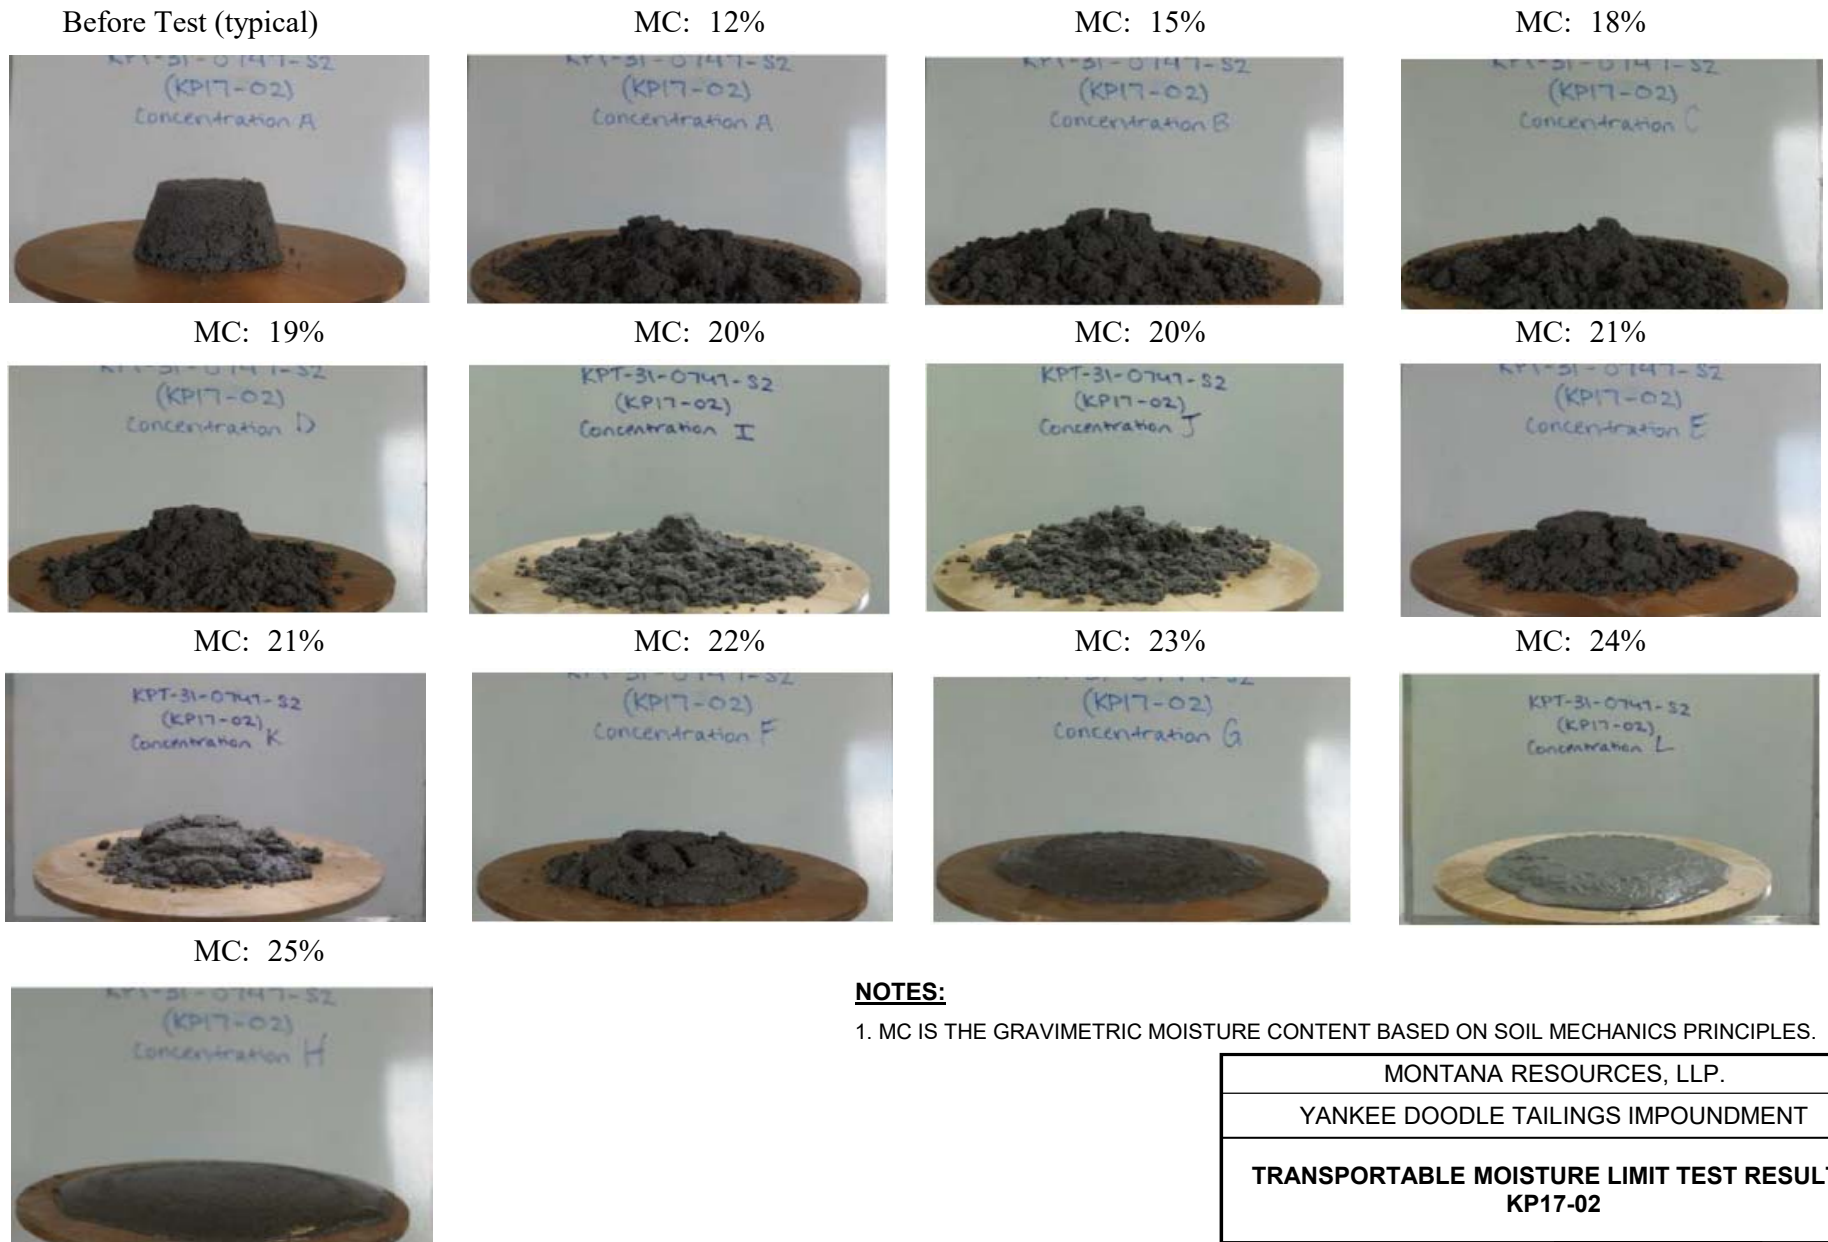
1. MC IS THE GRAVIMETRIC MOISTURE CONTENT BASED ON SOIL MECHANICS PRINCIPLES.

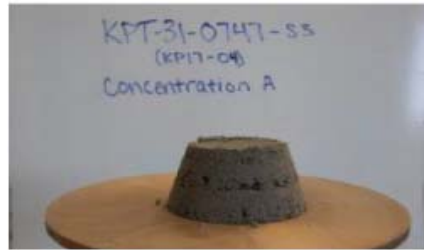
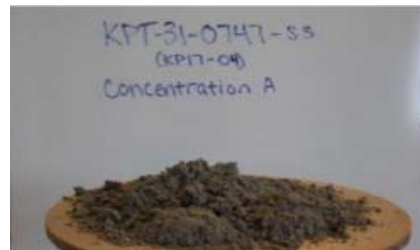
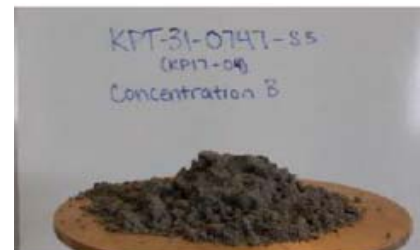
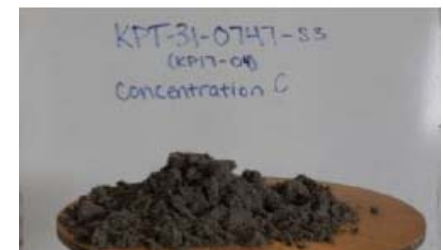
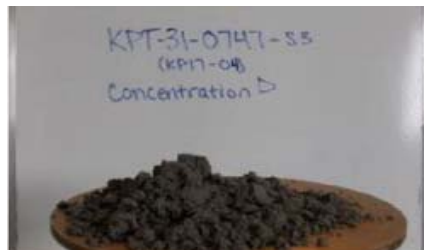
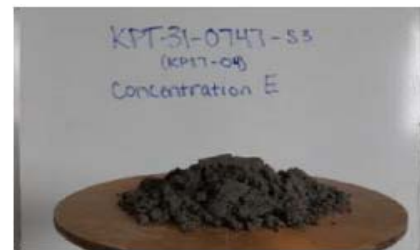
Before Test (typical)

MC: 22%

MC: 24%

MC: 20%

MC: 23%

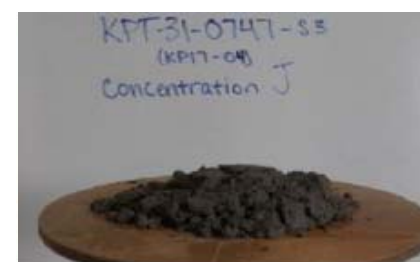
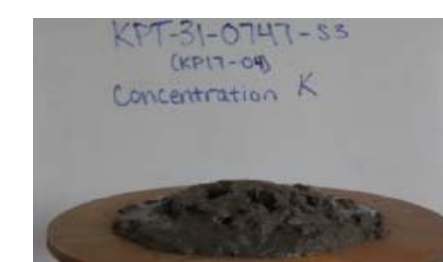
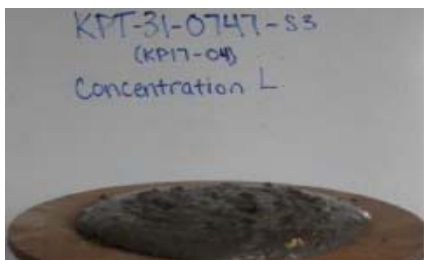
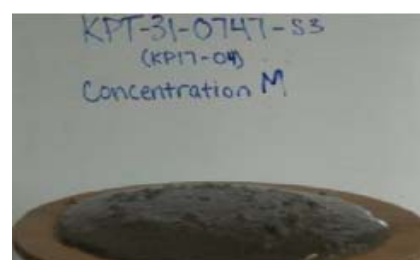
MC: 26%

1. MC IS THE GRAVIMETRIC MOISTURE CONTENT BASED ON SOIL MECHANICS PRINCIPLES.

MONTANA RESOURCES, LLP.	
YANKEE DOODLE TAILINGS IMPOUNDMENT	
TRANSPORTABLE MOISTURE LIMIT TEST RESULTS KP17-04	
Knight Piésold CONSULTING	P/ANO. VA101-126/17
	REF. NO. VA18-00103
FIGURE B-3	
	REV 0

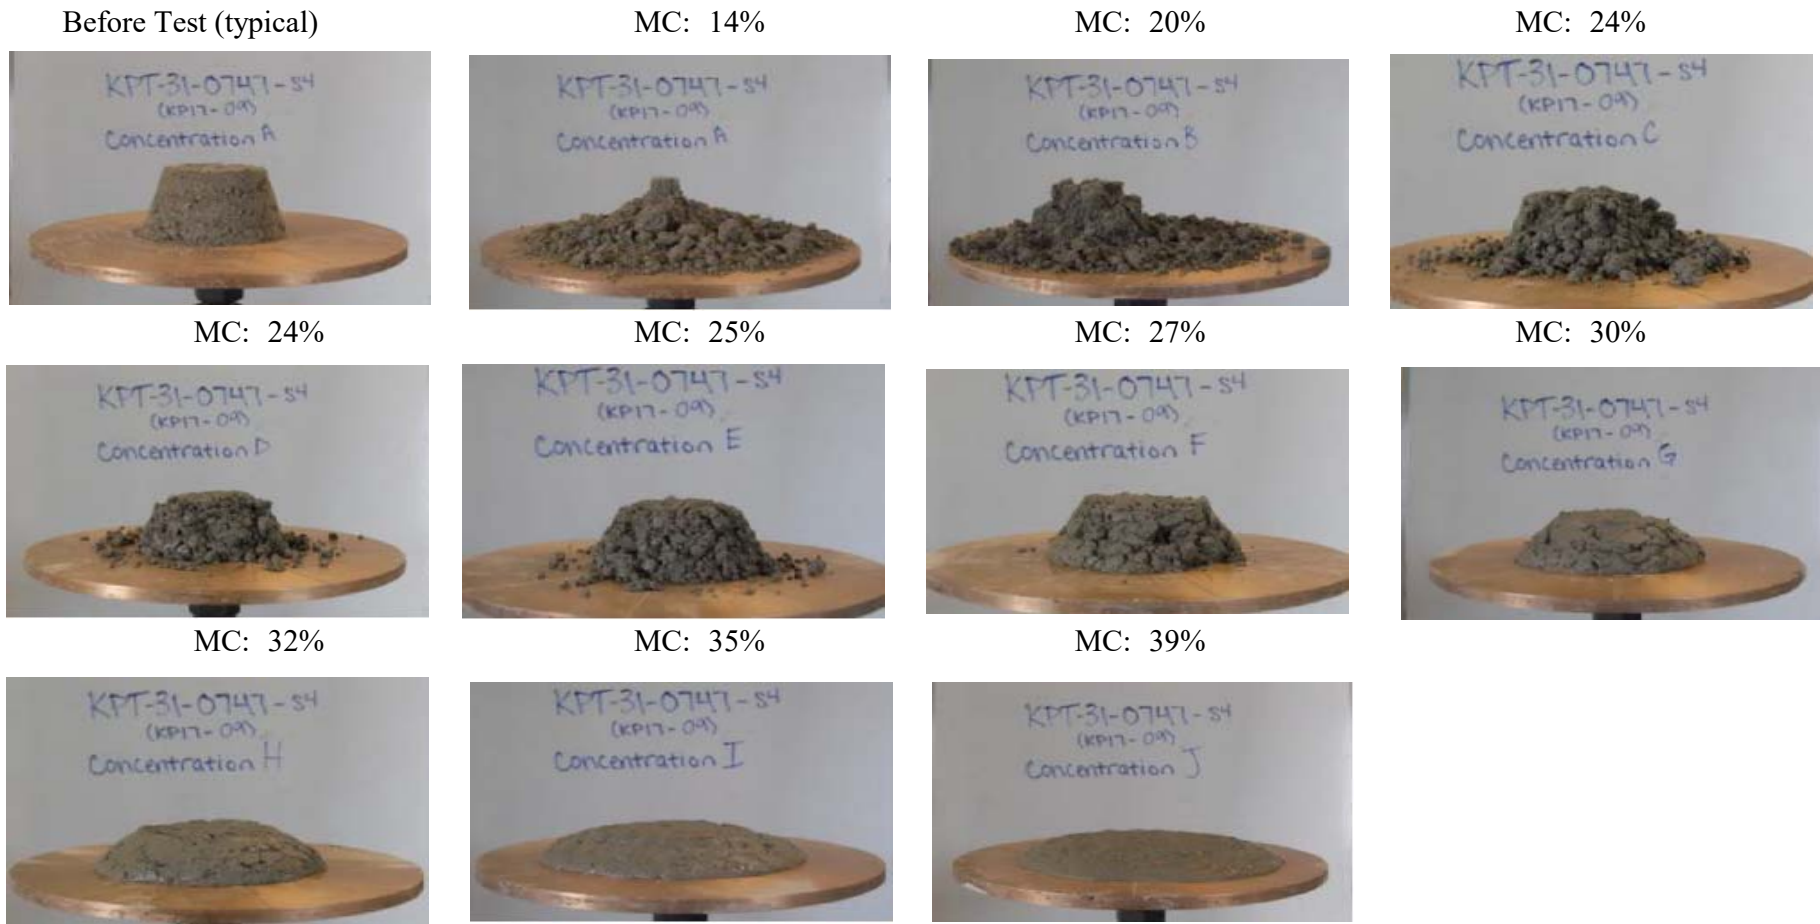
1. MC IS THE GRAVIMETRIC MOISTURE CONTENT BASED ON SOIL MECHANICS PRINCIPLES.

MONTANA RESOURCES, LLP.	
YANKEE DOODLE TAILINGS IMPOUNDMENT	
TRANSPORTABLE MOISTURE LIMIT TEST RESULTS KP17-09	
<i>Knight Piésold</i> CONSULTING	P/ANO. VA101-126/17
	REF. NO. VA18-00103
FIGURE B-4	
REV 0	REV 0
