Prepared for
Montana Resources, LLP
600 Shields Avenue
Butte, Montana
USA, 59701

Prepared by
Knight Piésold Ltd.
Suite 1400 - 750 West Pender Street
Vancouver, British Columbia
Canada, V6C 2T8

VA101-126/23-2

YANKEE DOODLE TAILINGS IMPOUNDMENT 2020 ANNUAL INSPECTION REPORT

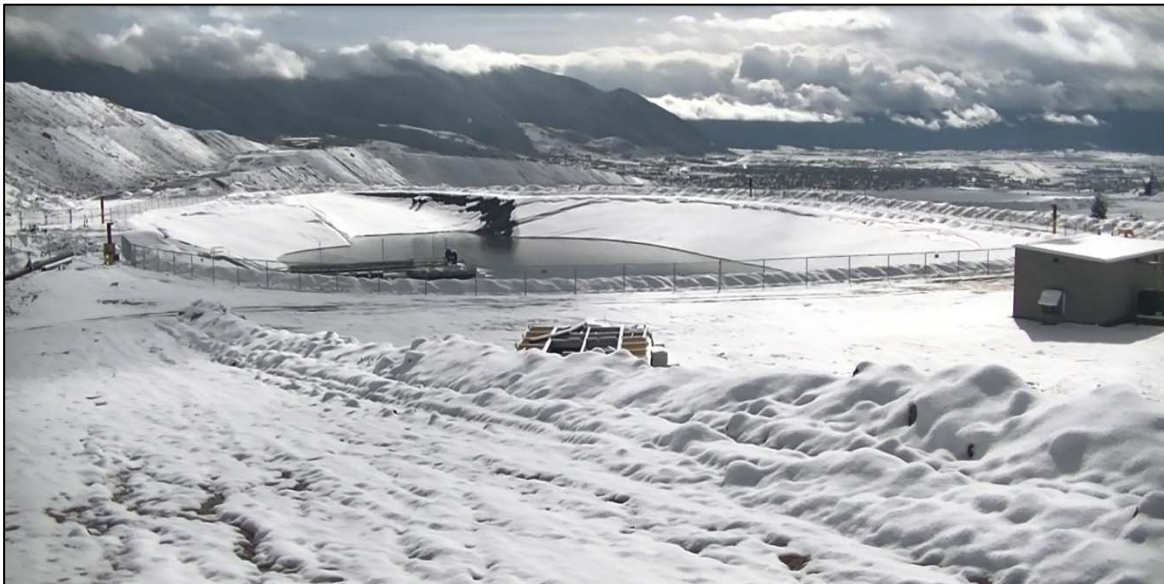
PHOTO 43 – Snow-covered WED Extraction Pond looking southeast.

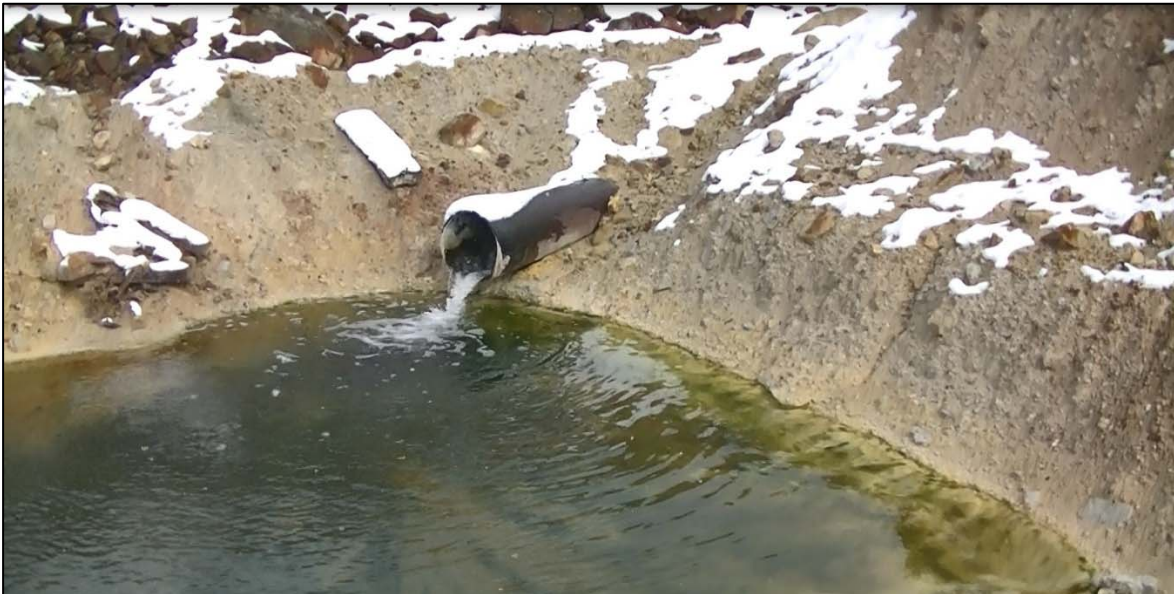
PHOTO 55 – Number 10 Seep stilling pond inflow.

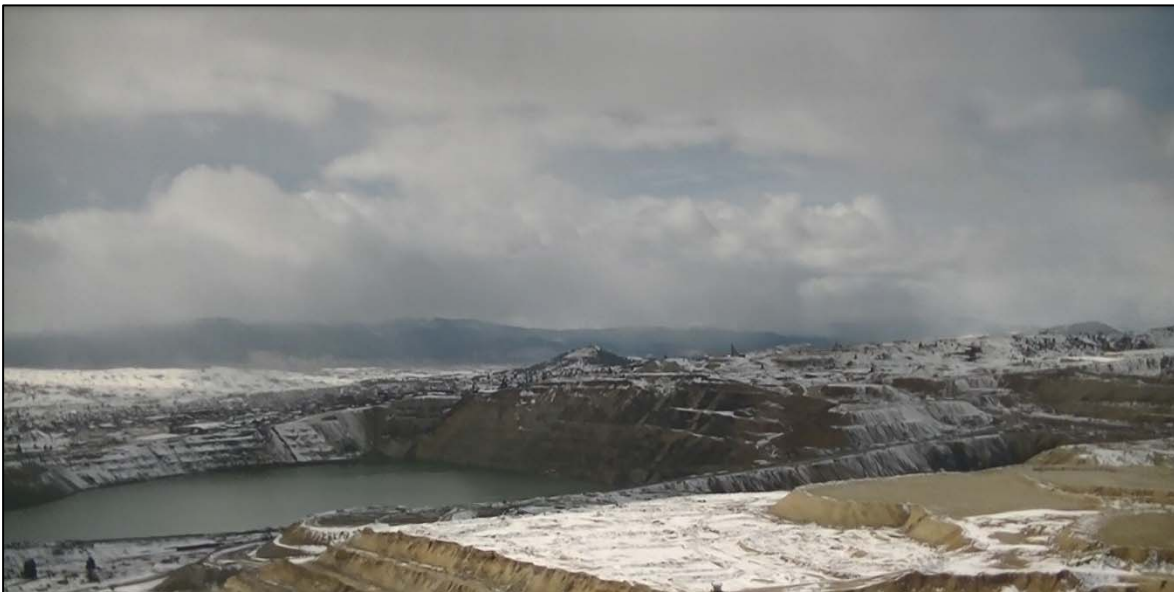
PHOTO 61 – Berkeley Pit, looking southwest from Sunflower Hill repeater.

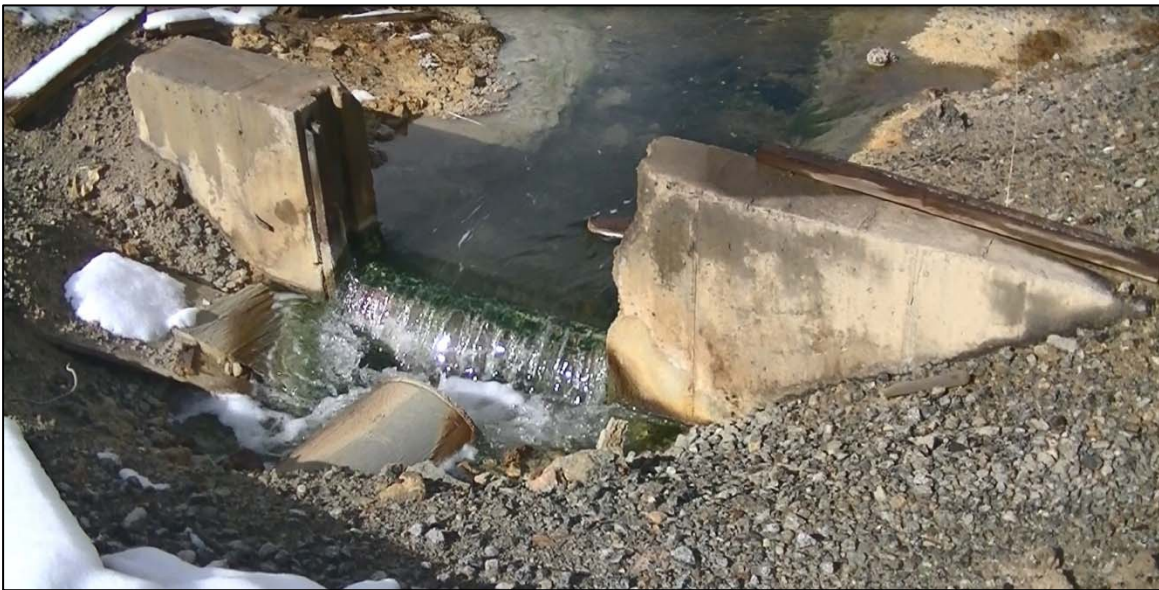
PHOTO 63 – Houligan Pond outflow.

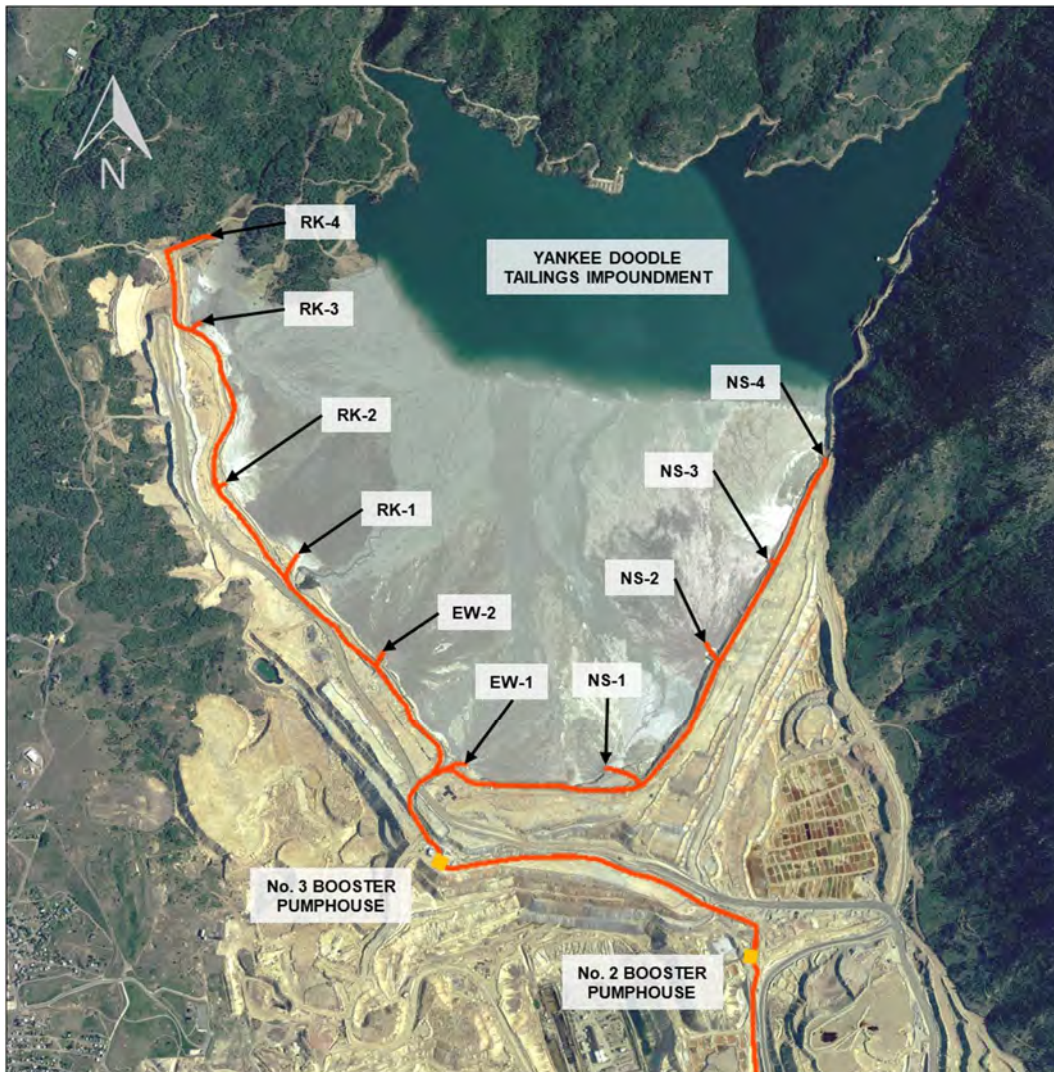
Several changes were made to Tailings Discharge Line 3 in Q3 2020; tailings discharge location NS-3 was relocated closer to NS-2 and a new discharge location NS-4 was added in August at the northern end of the North-South Embankment. The positions of the ten discharge locations at the end of Q3 are shown on Figure 3.1. Tailings discharge records indicate that tailings were distributed from all three YDTI embankments during Q3 2020, and all ten discharge locations were used.

Figure 3.1 YDTI Tailings Discharge Locations
