VA101-126/29-4

MONTANA RESOURCES

YANKEE DOODLE TAILINGS IMPOUNDMENT - 2023 ANNUAL INSPECTION REPORT

EXECUTIVE SUMMARY

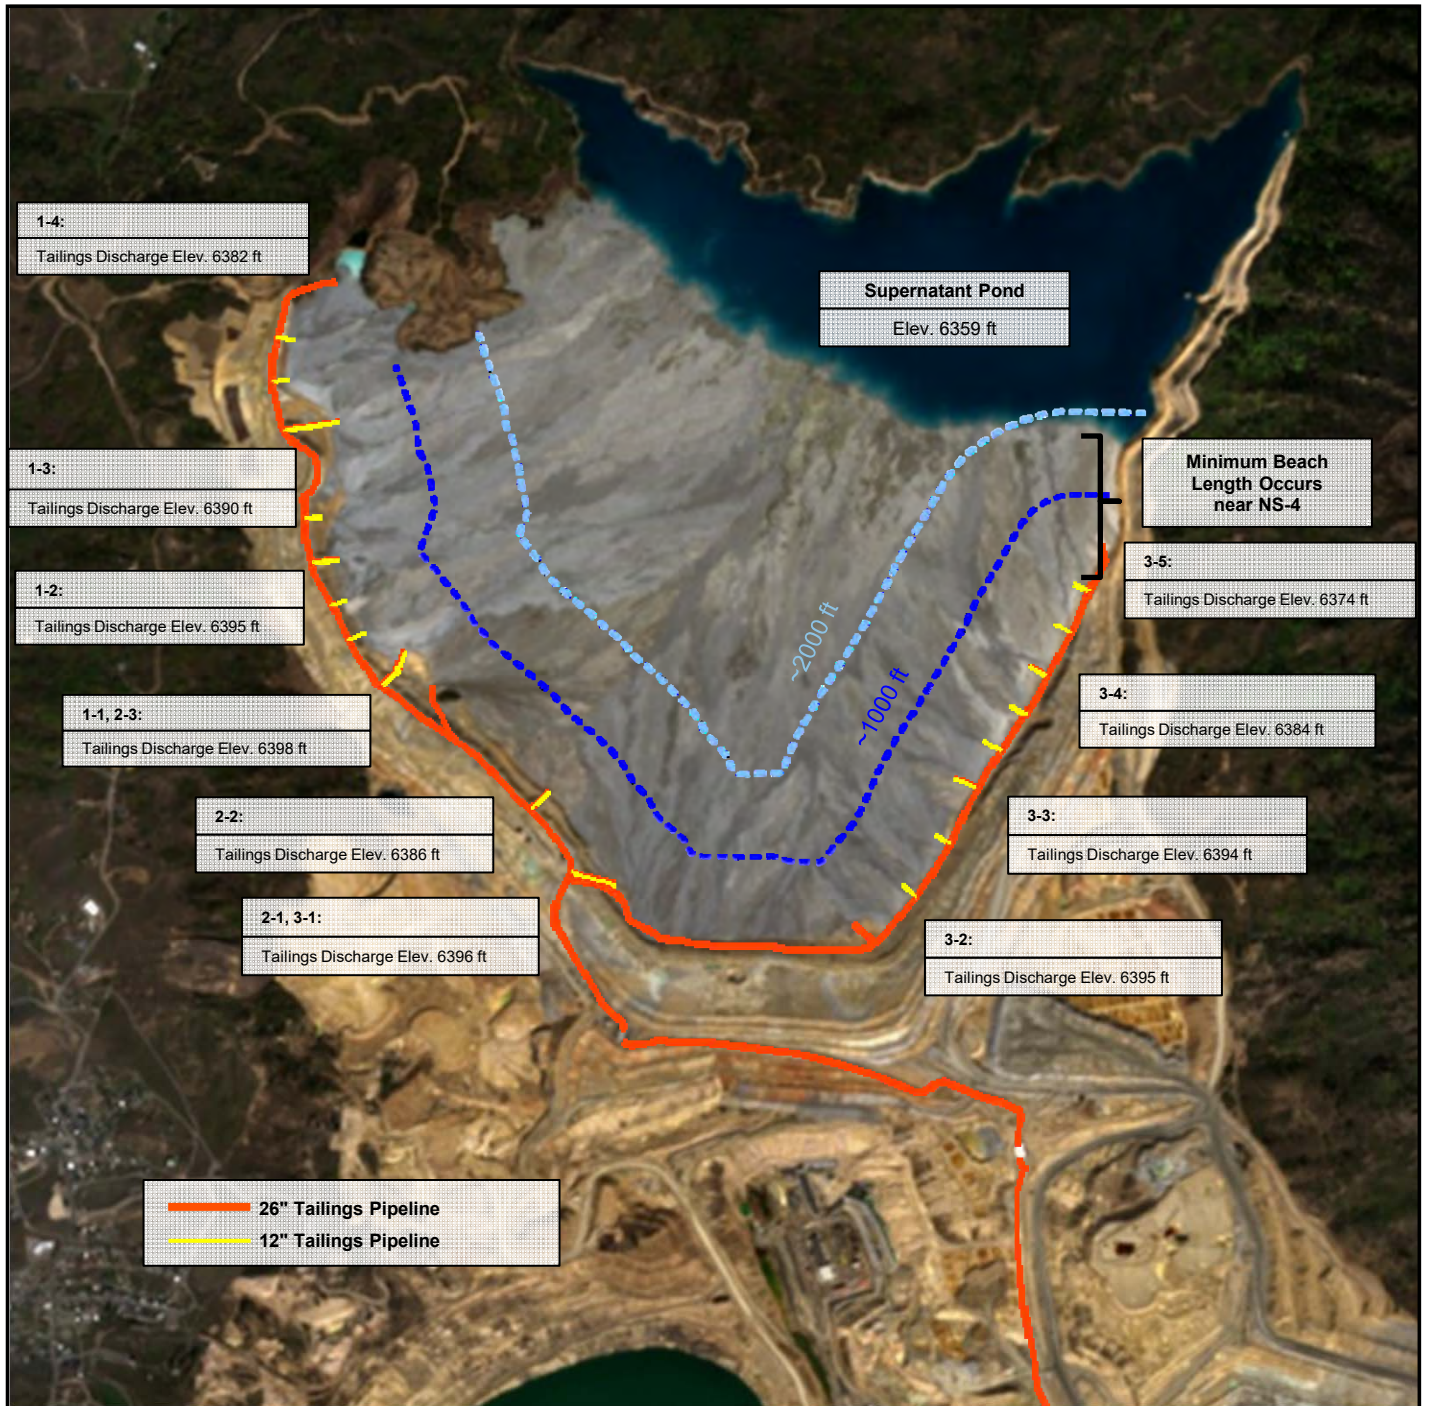
The annual inspection of the YDTI was completed by Mr. Daniel Fontaine, P.E., the EOR, on September 28 and 29, 2023. Mr. Fontaine was accompanied during the annual inspection by Mr. Mike Harvie (Manager of Engineering and Geology). The facility was observed to be in good condition, and active construction was ongoing along the North RDS and in the HsB area. Topsoil placement for progressive reclamation of the downstream embankment slope was also underway at the West Embankment during the inspection. Observations from the annual inspection are presented in Section 3. Select photographs from the annual inspection are included in Appendix A (Photos 29 to 80). An overview image of the facility observed from the Sentinel-2 satellite on September 25, 2023 is included on Figure 2.1.

The tailings beach continued to be well managed in 2023 with the shortest beach length (of over 1,500 ft) typically observed at the northern end of the North-South Embankment, consistent with previous years. The tailings beach remains well drained and appears to be firm where tailings are not being actively discharged. The tailings distribution system now includes twelve full size (24 and 26-inch) discharge locations distributed along the three tailings distribution lines and numerous 12-inch discharge lines (from Lines 1 and 3) distributed along the YDTI embankments. The approximate tailings discharge locations are shown on Figures 3.1 to 3.3.

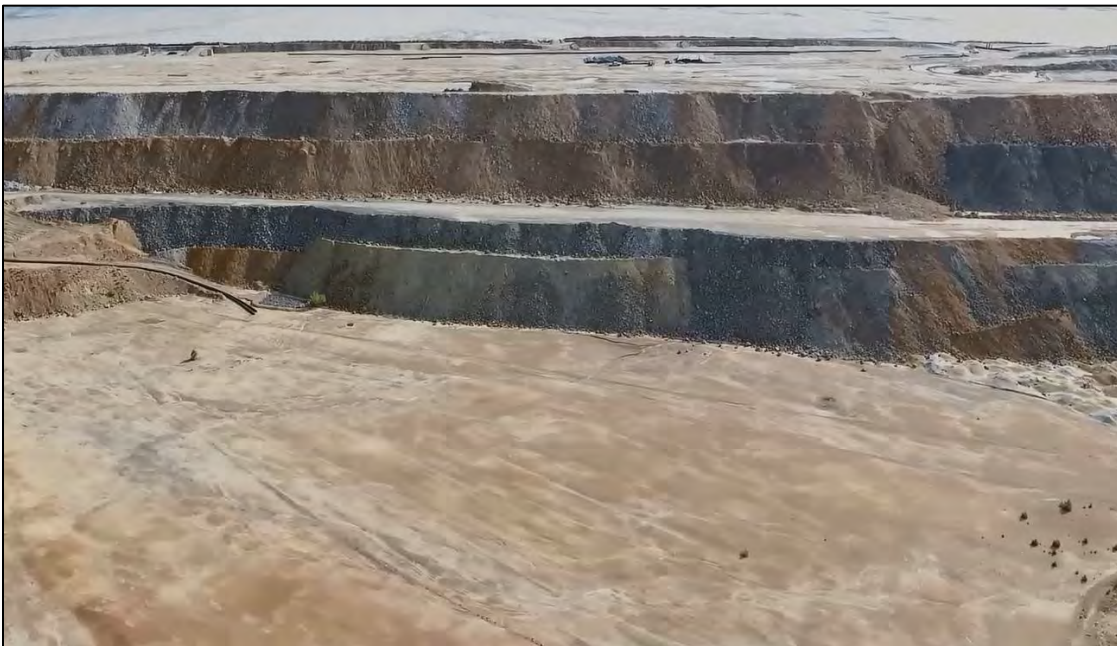
PHOTO 18 – East-West Embankment downstream slope along the northwest dumps area, facing northeast.

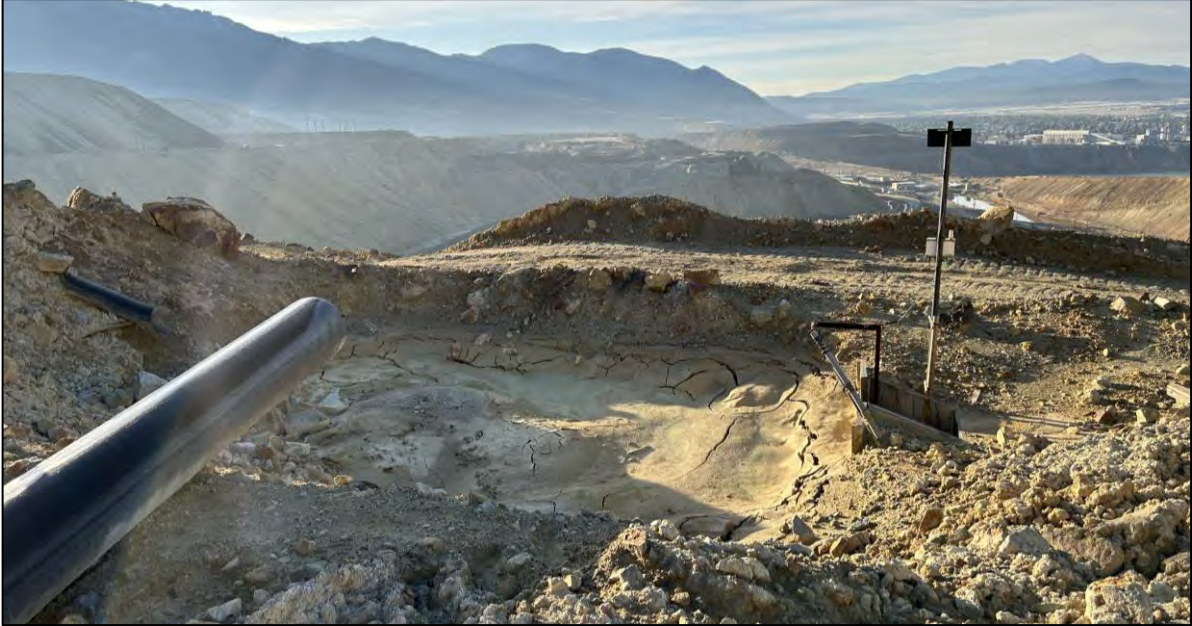
PHOTO 79 – Decommissioned historical Seep 10 pond, facing south.

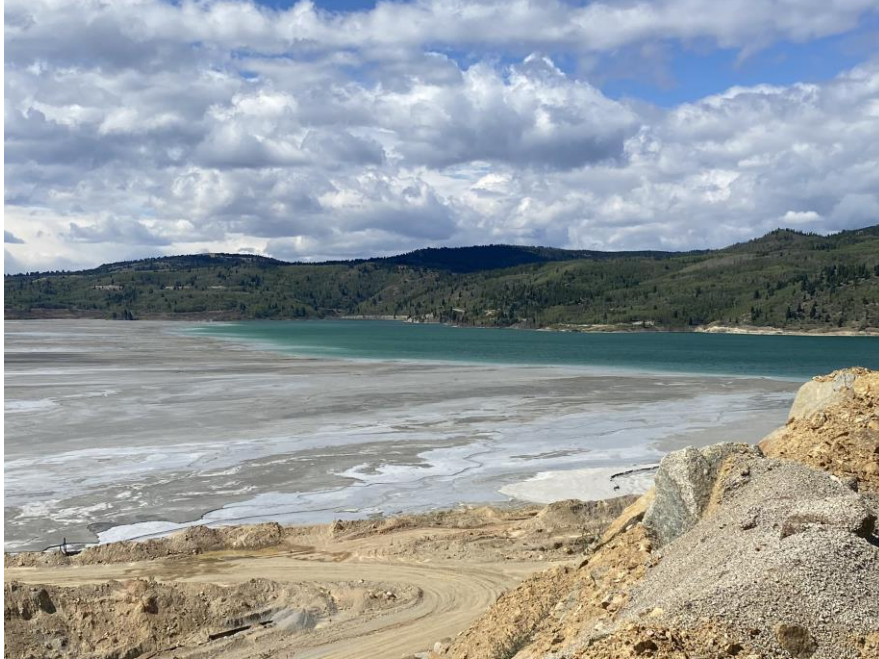
PHOTO 17 – Tailings beach and pond interface – Looking West from reclaim road

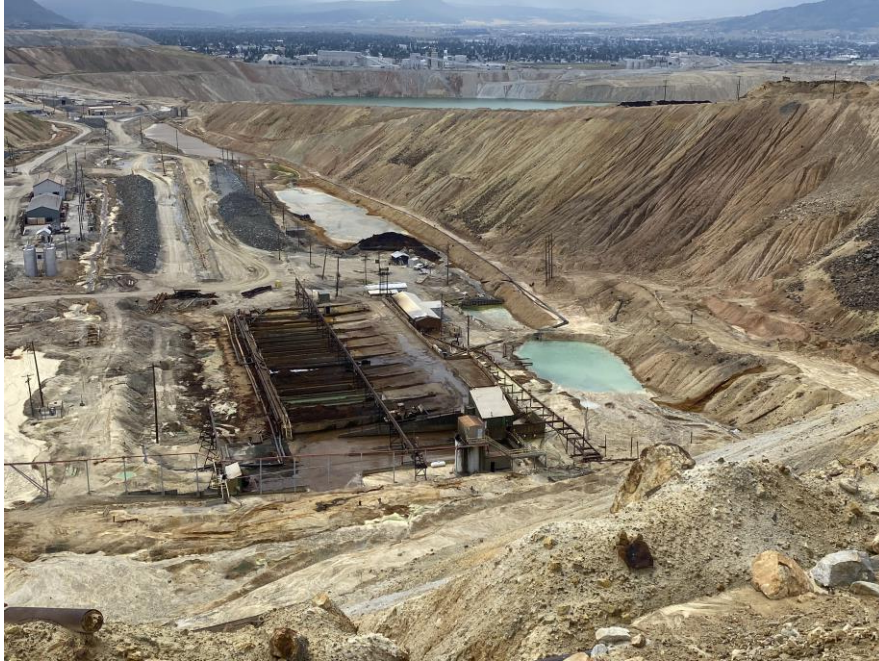
PHOTO 21 – Stage 1 HsB RDS – Overlook – Looking South

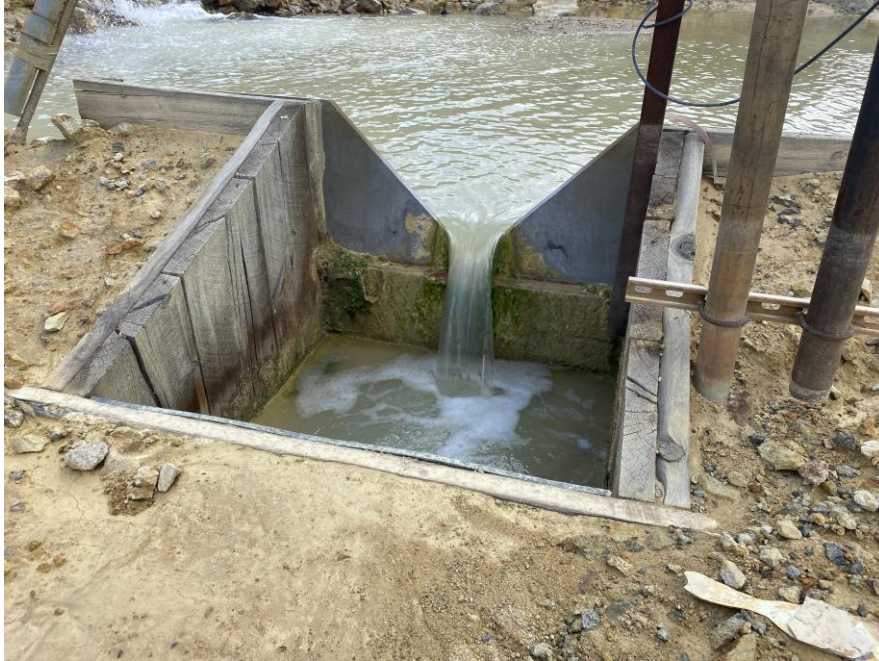
PHOTO 25 – Seep 10 – Weir

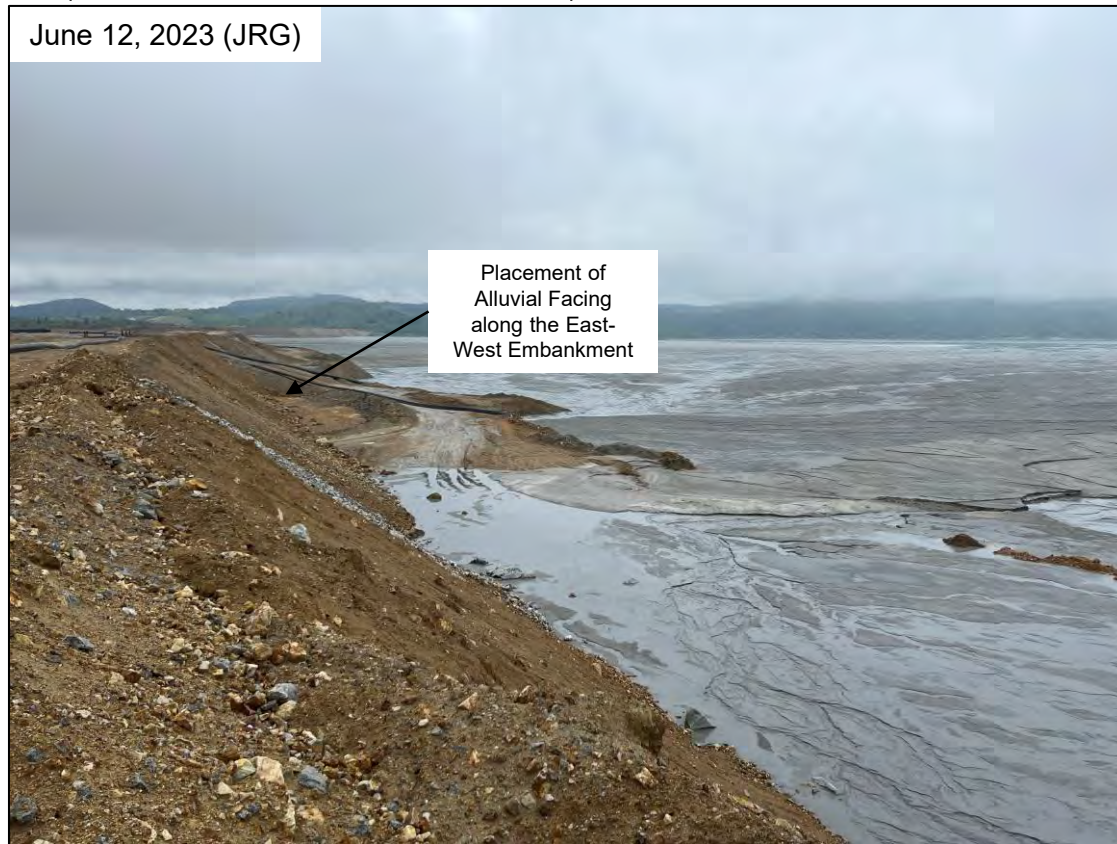
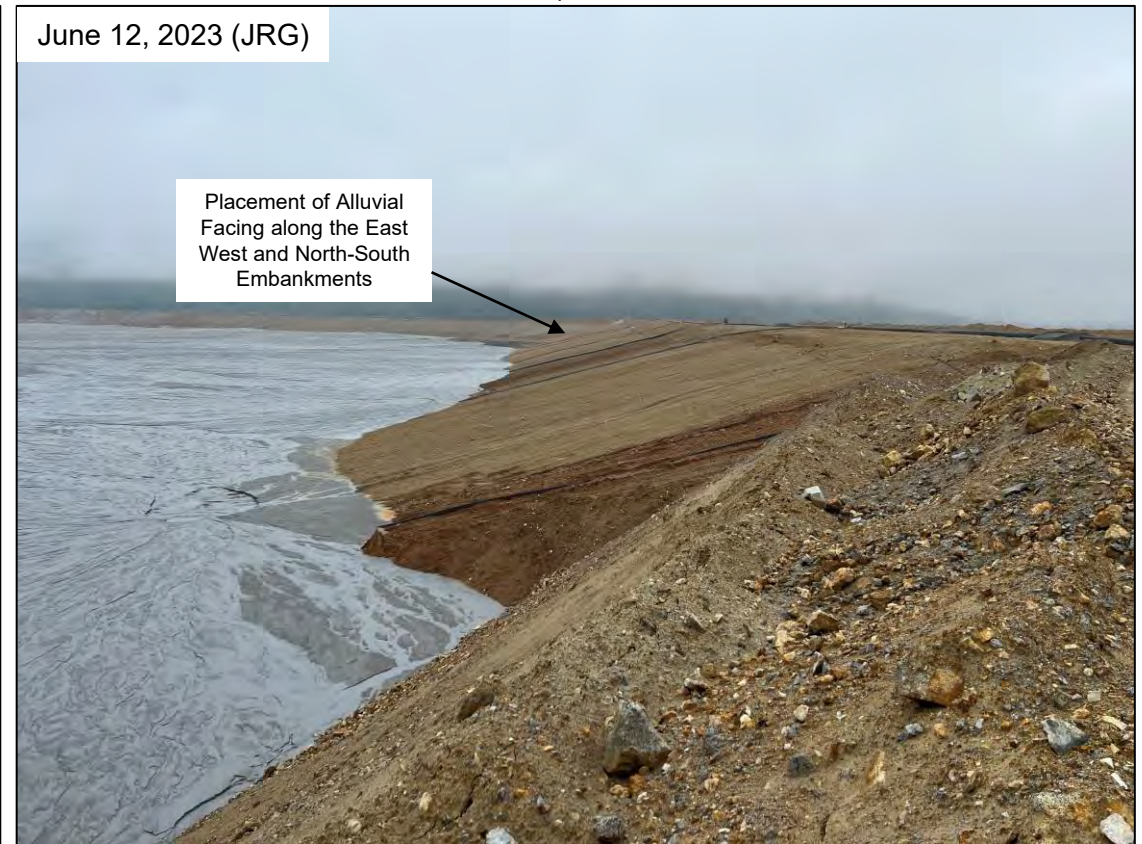
Upstream Alluvial Facing (April & May 2023)

- Placement of the Upstream Alluvial Facing (Zone F) material continued during April and May
- Slopes of 3H:1V have been implemented, with a minimum alluvial material thickness of 3 ft per CMP (2018).

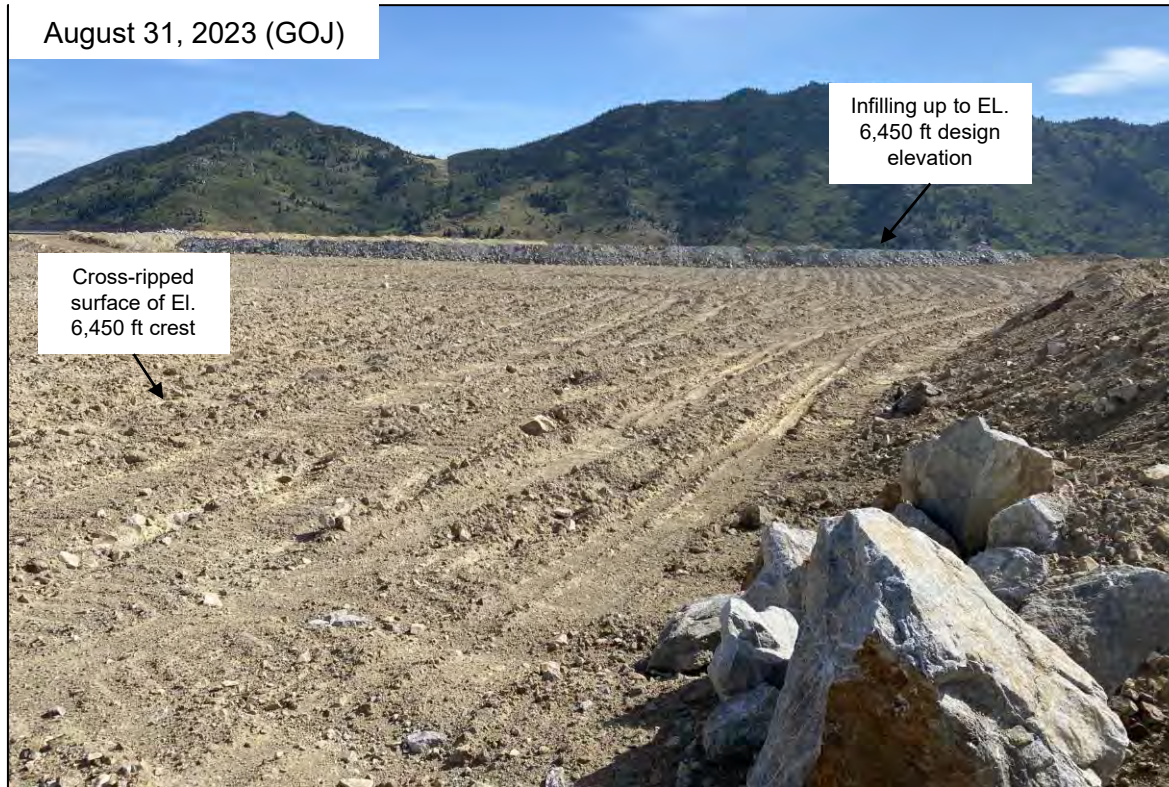
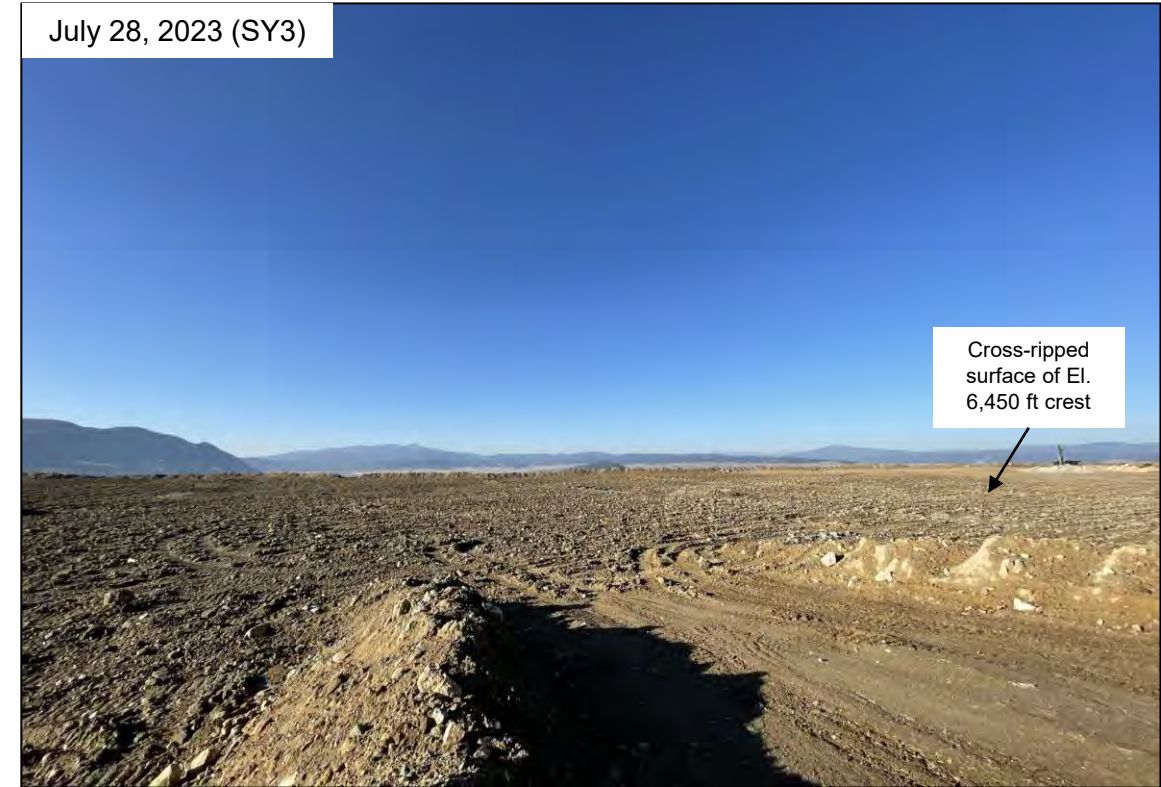
Central EL. 6,450 ft Lift Ripping and Regrading

- El. 6,450 ft Crest was cross-ripped and fill placement initiated for final grading up to El. 6,450 ft as per the EOR's request. MR began material placement in June 2023 and continued through August 2023
- Ripping and regarding is expected to continue within the Central Pedestal Area until the onset of winter conditions

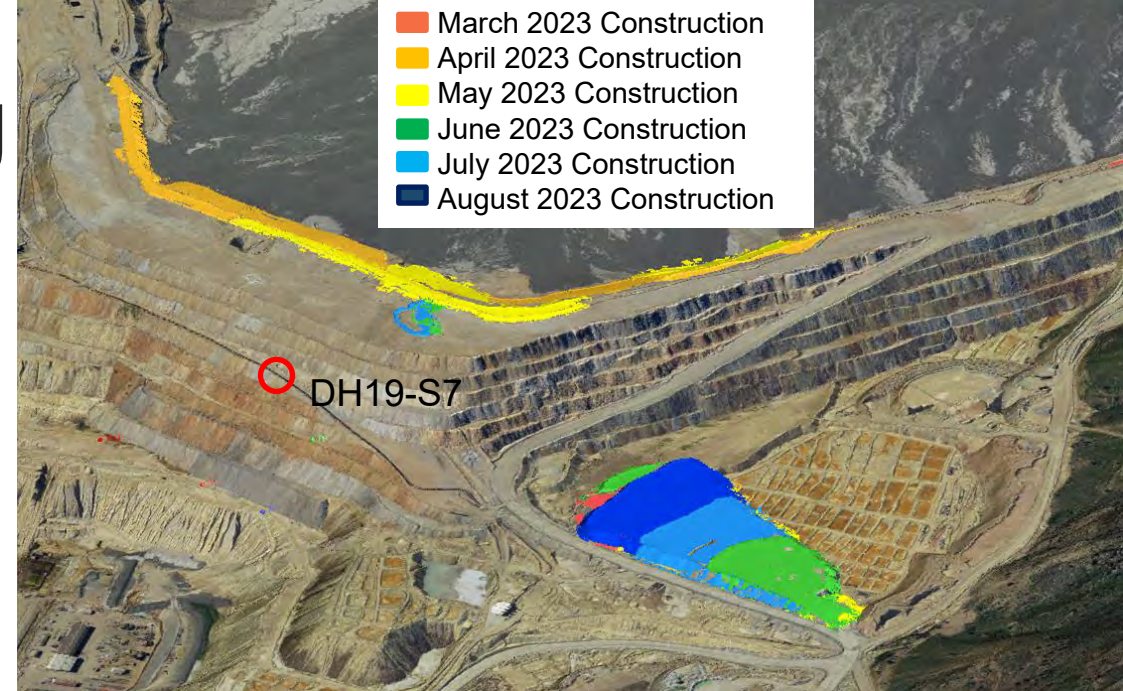
DH19-S7 VW7 Response

- DH19-S7 VW7 pore water pressures fluctuated from April through August 2023.
 - Long-term (monthly, quarterly average) changes appear to have stabilized
 - Pore pressure fluctuations were observed from April through August 2023 (20 – 25 ft) may not be representative of in-situ conditions and may be sensor performance issues. Continued monitoring is recommended.
- Conditions remain approximately 20 ft below the Moderate Risk threshold

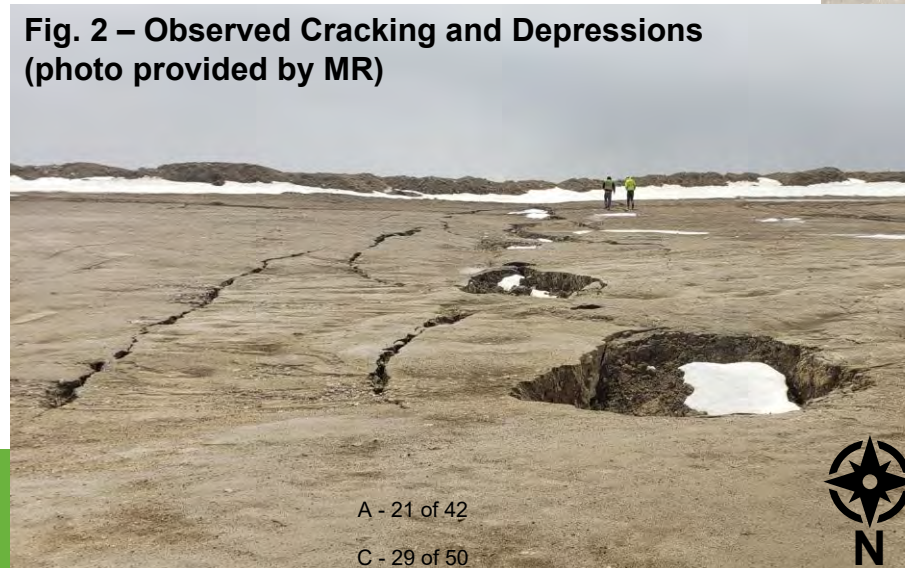
Fig. 1 – Aerial Photograph with KP Crack Mapping

- Significant transverse cracking and depressions were observed along the EL. 6,450 ft crest near Section 0+00 on April 27, 2023, which triggered a Level 1 Unusual Occurrence response that comprised on-site inspections (completed by MR and KP), a targeted monitoring campaign (developed by KP and the YDTI Engineer of Record (EOR)), and remedial activities completed by MR operations (reported previously in VA23-01198)
 - A detailed summary of the observed cracking and monitoring analyses was reviewed with the Independent Review Panel (IRP) on June 13, 2023
 - The response comprised:
 - EOR notification by MR
 - Heightened monitoring of cracking and deformation in the area.
 - Investigation of the cause
 - Test trenching/pitting within main cracking area
 - Review with ITRB
 - Implementation of remedial activities
 - Follow-up inspection following remediation

Crest Cracking Observed

- Cracking was remediated in mid-June 2023 (approximately June 16th through 20th, 2023). Remedial activities comprised ripping and shallow excavation of the main cracking/depression area and initial leveling/infilling of the low area around the location to minimize potential for further ponding. Widespread final grading up to the design grade at El. 6,450 ft is underway throughout the Central Pedestal Area.

- Additional inspection (by MR) and monitoring (by KP) following remediation was completed during Q2 2023 to screen for re-expression of cracking within the main cracking/depression area and monitor deformations in the area. No re-expression of cracking has been reported and deformation rates continue to slow following El. 6,450 ft lift construction (i.e., no evidence of accelerating deformations in proximity to the cracking area).
